EFFECT OF COVER GAS PRESSURES UP TO 4 ATMOSPHERES ON
ACCELERATED CAVITATION DAMAGE IN SODIUM

by S. G. Young and J. R. Johnston

TECHNICAL NOTE

Lewis Research Center

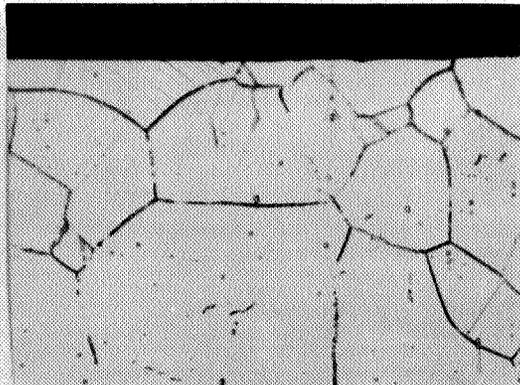
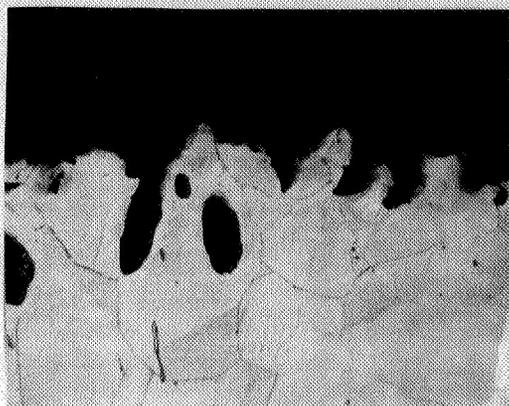
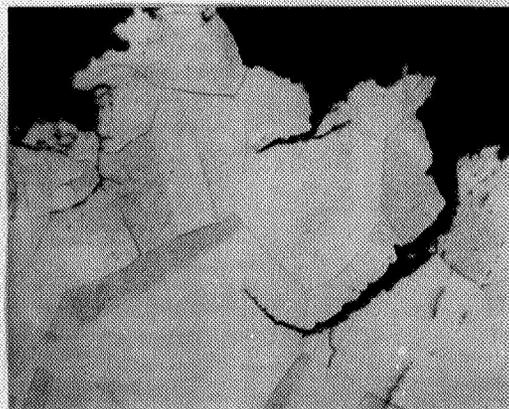
(b) 316 STAINLESS STEEL

FIGURE 16. - CONTINUED

Figure 16 shows photomicrographs of sectioned specimens of all materials before and after testing. All of the materials tested exhibited gross undercutting and transgranular cracking. Evidence of sub-surface deformation existed in the form of slip bands for all materials. Bending of twin boundaries was observed in L-605 (fig. 16(a)). Breaking of sub-surface carbides in Stellite 6B is apparent in figure 16(c). No evidence of any reaction zone was found in the cavitation damaged regions of any specimen.
