PAVEMENT GROOVING AND TRACTION STUDIES

A conference held at
LANGLEY RESEARCH CENTER
Hampton, Virginia
November 18-19, 1968

Technology Utilization Division
OFFICE OF TECHNOLOGY UTILIZATION
NATIONAL AERONAUTICS AND SPACE ADMINISTRATION
1969
Washington, D.C.

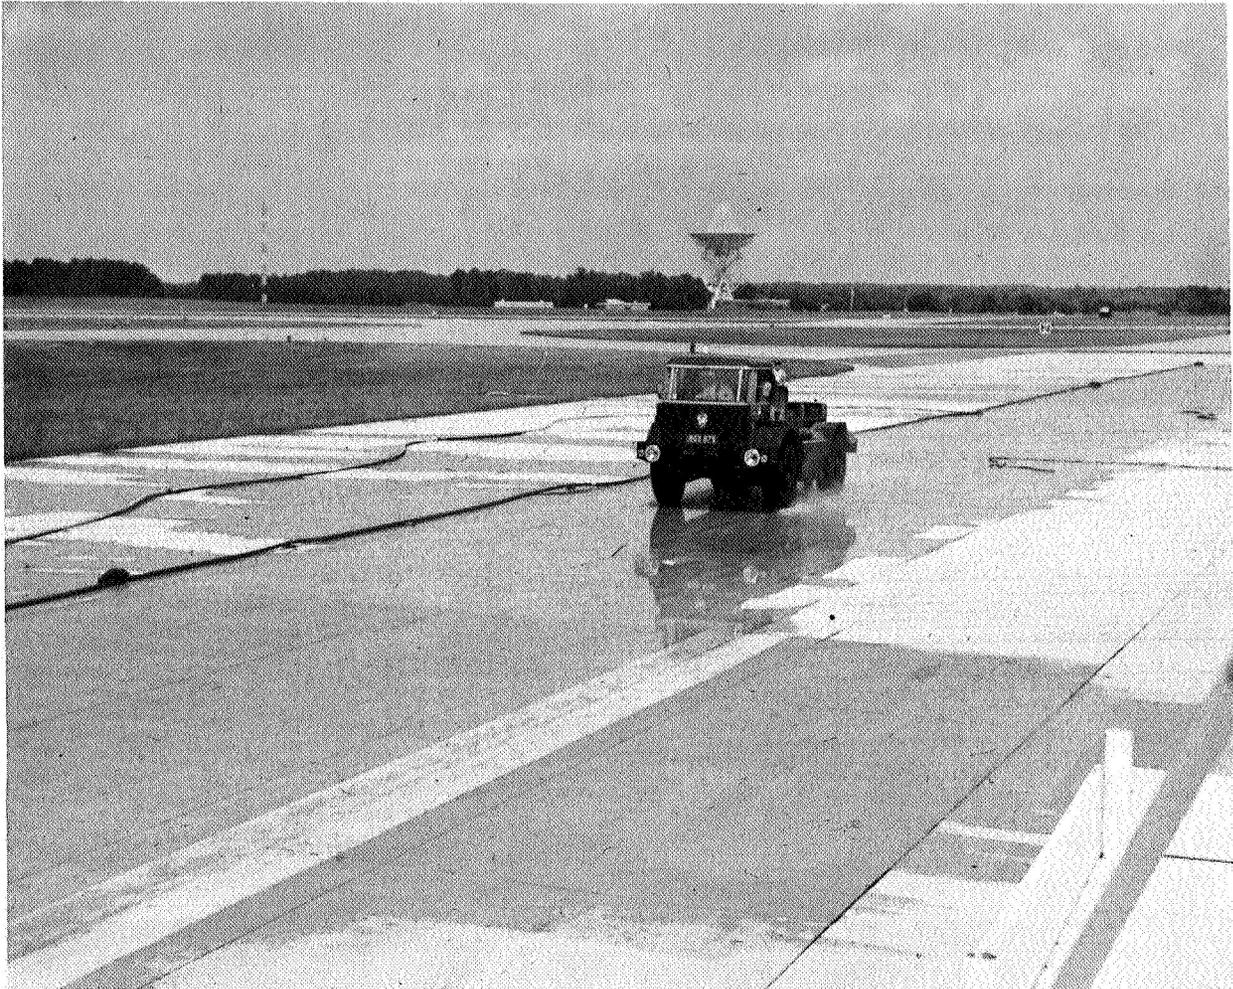
Figure 6.- The British "Juggernaut" test vehicle undergoing a braking test on surface A of site I under a wet and puddled pavement condition.

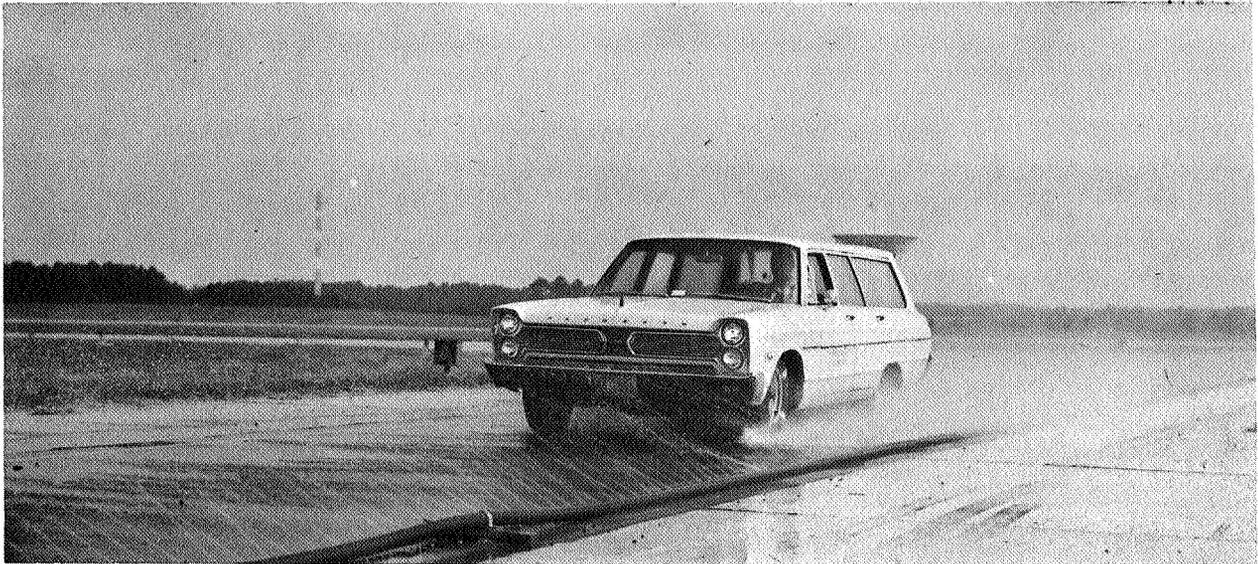
(a) NASA diagonal braking car undergoing test on surface E of site II under a flooded pavement condition provided by plastic-pipe sprinkler system.

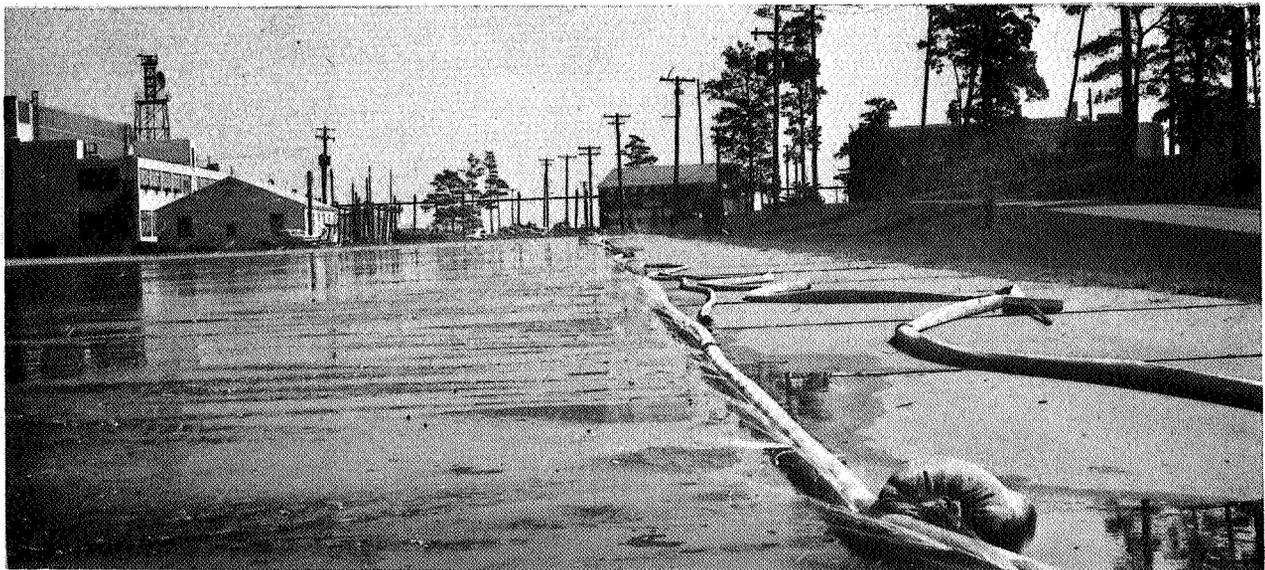
(b) Pierced-canvas-fire-hose sprinkler system used to wet or flood site III skid pad.
