QUARTERLY PROGRESS REPORT

THE EFFECT OF ALLOY COMPOSITION ON
THE MECHANISM OF STRESS-CORROSION
CRACKING OF TITANIUM ALLOYS IN
AQUEOUS ENVIRONMENTS

NATIONAL AERONAUTICS AND
SPACE ADMINISTRATION
Contract No. NASW-2242

BATTELLE
Columbus Laboratories
505 King Avenue
Columbus, Ohio 43201

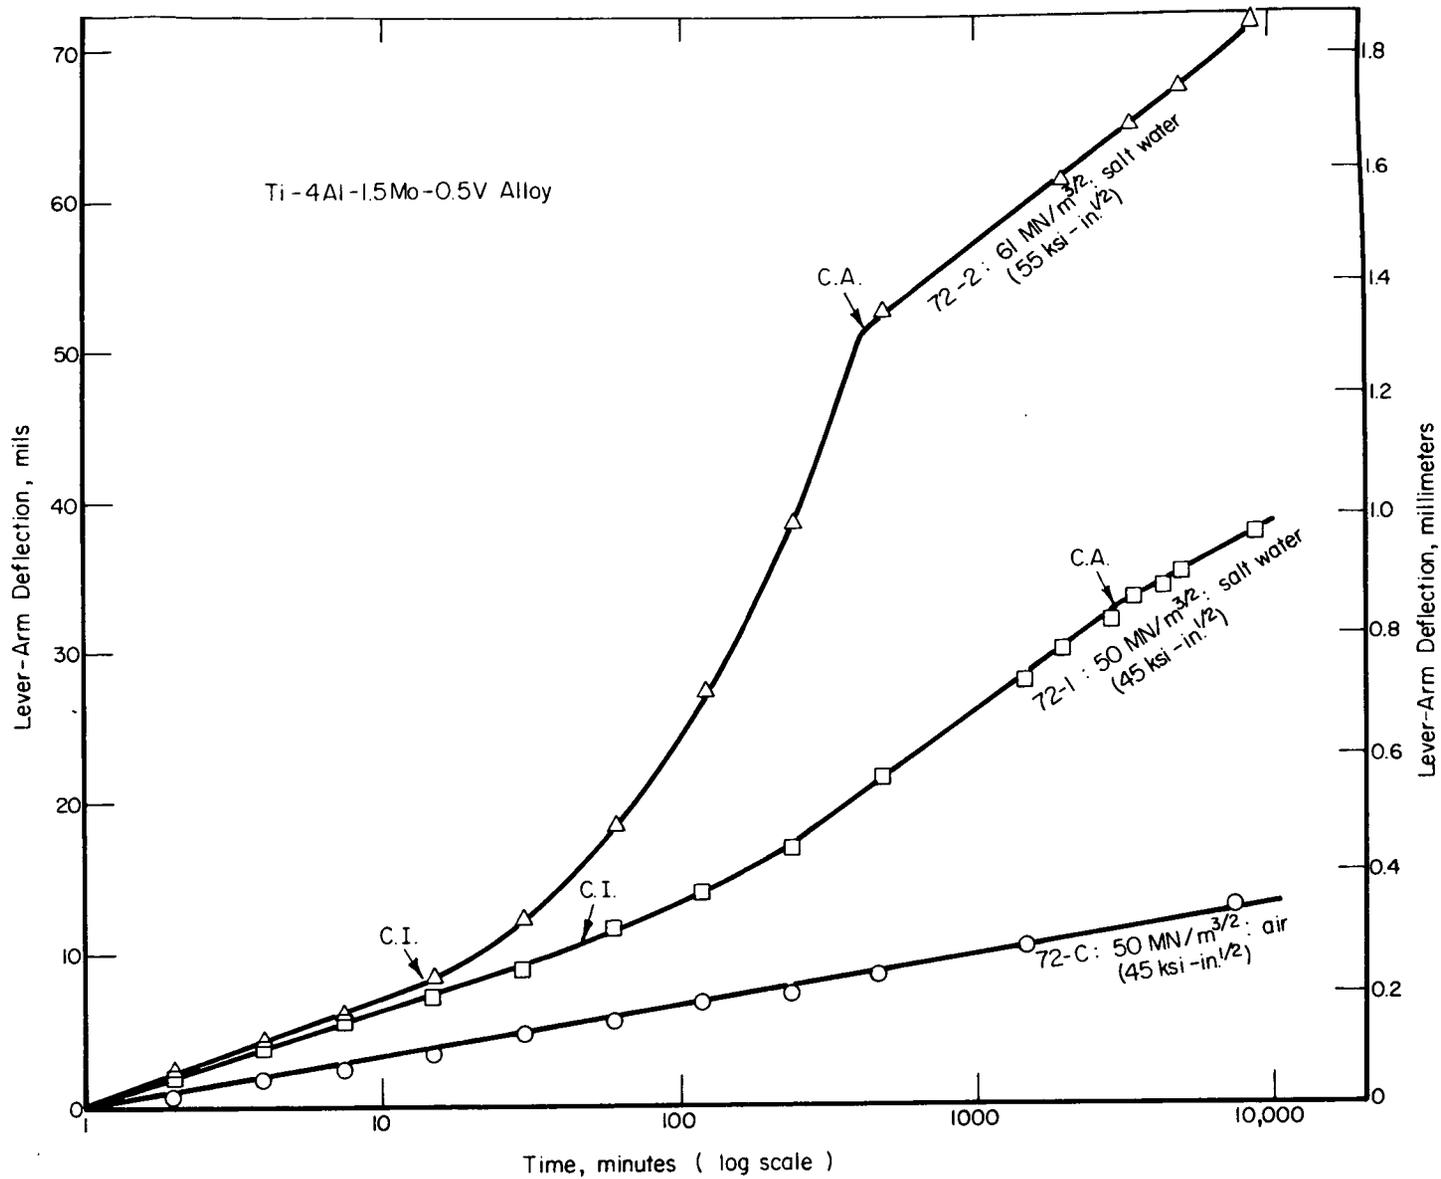
FIGURE 1. LEVER-ARM DEFLECTION AS A FUNCTION OF TIME AT CONSTANT LOAD
 C.I. = crack initiation; C.A. = crack arrest.

the period under load. The type of deflection:time behavior observed is shown in Figure 1, in which data are shown for three Ti-4Al-1.5Mo-0.5V alloy samples. Several comments of interest can be made regarding these curves:

- (a) In the absence of crack growth, a linear relationship is observed between lever arm deflection and log time. This deflection is apparently the result of creep. All samples tested showed creep, even at the lowest stress-intensity examined, $39 \text{ MN/m}^{3/2}$ ($35 \text{ ksi-in.}^{1/2}$). Creep behavior can be compared, qualitatively at least, on the basis of the slope of the deflection:log time curve.

- (b) Crack initiation (C. I.) is indicated by an increase in slope of the deflection:log time curve. In most cases, crack initiation occurred within 10 minutes after load application although, in several instances - usually, in tests at low stress intensities - crack initiation occurred only after several hours under load.

- (c) Crack arrest (C. A.) was indicated (apparently) by a return to a linear deflection:log time relationship. Crack arrest occurred anywhere from 20 to 3000 minutes after load application in the samples tested. In some cases, crack growth was still indicated after 10,000 minutes under load.

- (d) The increase in lever arm deflection, as compared with the expected deflection based upon extrapolation of behavior prior to crack initiation, provides a means of comparing amounts of crack growth:

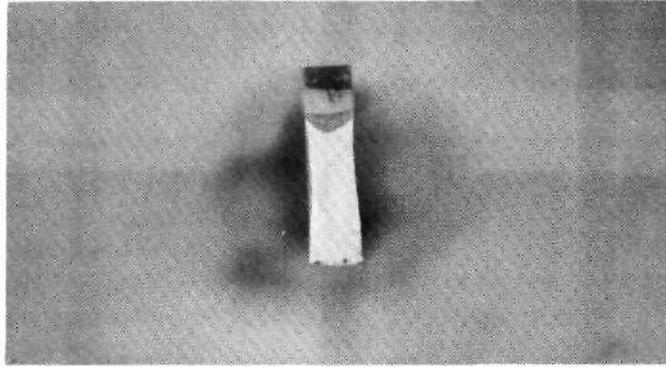
a. Sample 72-2, $61 \text{ MN/m}^{3/2}$ ($55 \text{ ksi-in.}^{1/2}$) in Saltwater

FIGURE 2. PHOTOGRAPHS OF THREE SAMPLES AFTER DYE MARKING OF CRACK FRONT AND MANUAL FRACTURING

In the second method of detecting crack growth, a dye was placed in the crack opening at the conclusion of the loading period, following which the sample was broken by manually depressing the lever arm. The location of the dye in the crack front was observed visually. In the case of tests in saltwater, the saltwater was removed and the sample dried before dye was applied. The characteristic of this method to show crack movement is illustrated in Figure 2. It is relatively easy to distinguish the interface between the fatigue crack and the crack grown under static load, and the interface between the crack grown under static load and the onset of rapid fracture induced manually is also obvious. In all cases examined, a marked tunnelling during slow crack growth was observed. In only two samples, 72-3 (shown in Figure 2) and 70-1, was any crack movement noted on the surface, and in these cases the surface crack extension was only 0.5 to 1.0 millimeter (0.02 to 0.04 inch). Surface crack growth undoubtedly occurred in Sample 70-4, which failed under constant load, but it was not detected at the last reading interval prior to failure. The two samples shown in Figure 2, a. and b., represent samples whose deflection:time behavior was reproduced in Figure 1. The correlation of maximum crack depth as determined using a marker dye with increase in lever-arm deflection is shown below.

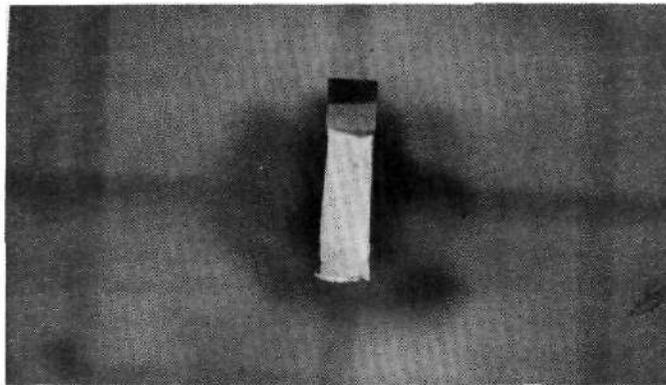
b. Sample 72-1, $50 \text{ MN/m}^{3/2}$ ($45 \text{ ksi-in.}^{1/2}$) in Saltwater

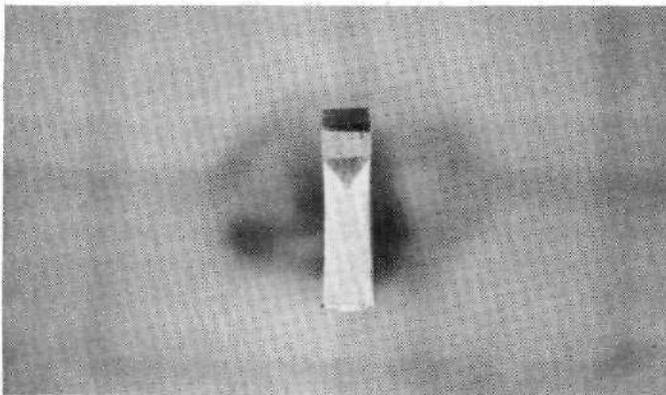
c. Sample 72-3, $72 \text{ MN/m}^{3/2}$ ($65 \text{ ksi-in.}^{1/2}$) in Air

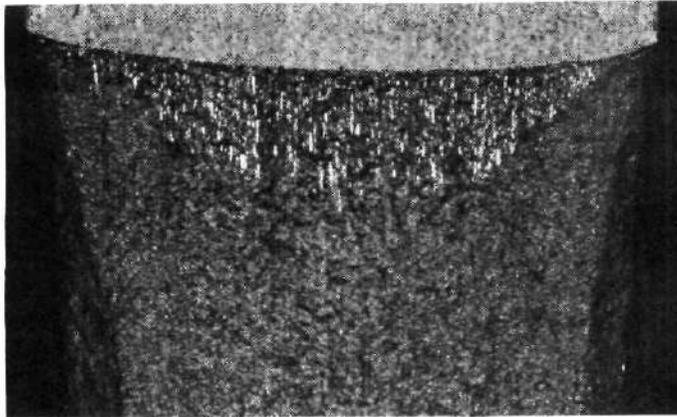
- a. Sample 72-2:
Loaded for 10^4 minutes
at $61 \text{ MN/m}^{3/2}$ ($55 \text{ ksi-in.}^{1/2}$) saltwater and then
rapidly loaded to failure
in air.

FIGURE 3. MACROPHOTOGRAPHS OF FRACTURE SURFACE IN
REGION OF SLOW CRACK GROWTH

Macroscopic examination of fractured samples also provided an indication of crack movement, since the fracture surface was found to have a distinctive appearance in regions showing slow crack growth. Macrophotographs of three fracture surfaces are shown in Figure 3. The upper two photographs show samples which developed cracks under constant load in saltwater and in air. The region of slow crack growth is made visible by the presence of reflective-appearing planar facets. Correlation of the faceted regions with marker-dye patterns showed them to be quite similar in shape and in extent. The fast fracture region was much grainier appearing and was free of these facets. Samples fractured in seawater by step loading showed another distinguishing feature as shown in Figure 3c, with secondary cracks running into the sample along a plane perpendicular to the fracture plane and containing the direction of slow crack growth (vertical in Figure 3). These cracks appear as short, dark lines clustered fairly close to the boundary separating the region of slow crack growth from the region of fast fracture accompanying final failure. The sample shown in Figure 3c also exhibited a considerable number of reflecting facets, especially in the areas of initial slow crack growth, but these are less apparent in Figure 3 since lighting was adjusted to emphasize the secondary cracks (dark lines).

FIGURE 5. SCHEMATIC REPRESENTATION OF FRACTURE SURFACE
Compare with Figure 3a.

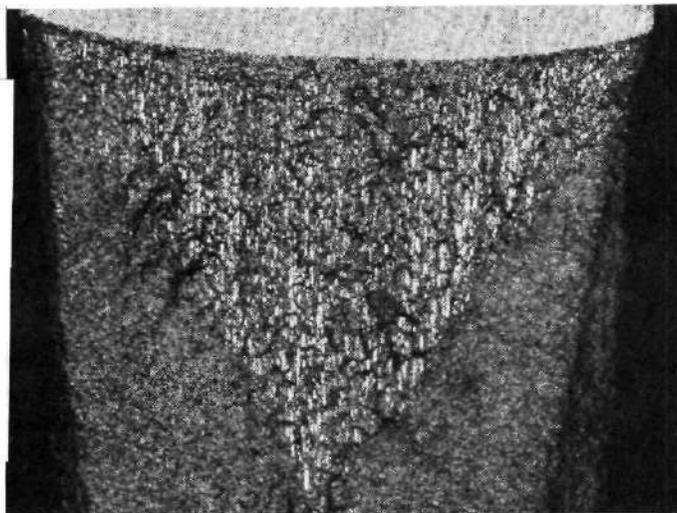
- b. Sample 72-3:
Loaded for 10^4 minutes
at $72 \text{ MN/m}^{3/2}$ ($65 \text{ ksi-in.}^{1/2}$) in air and then
rapidly loaded to failure.

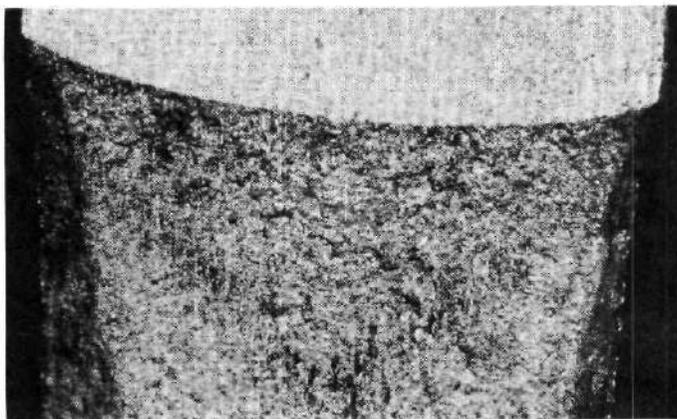
- c. Sample 72-A:
Step-loaded to failure in
saltwater after prolonged
static loading at 61 to
 $78 \text{ MN/m}^{3/2}$ (55 to 70
 $\text{ksi-in.}^{1/2}$).

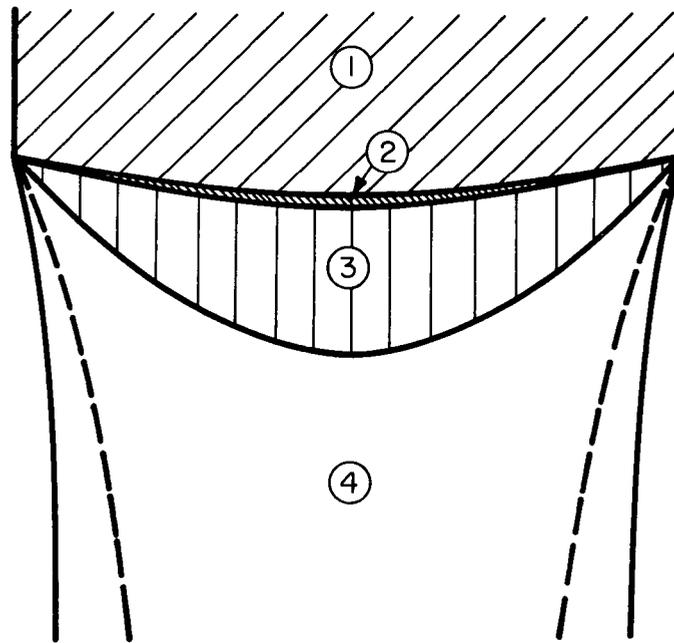
- (1) Fatigue-crack.
- (2) Region of fast crack growth on load application.
- (3) Region of slow crack growth under constant or slowly rising load.
- (4) Region of final rapid fracture.

Macroexamination of the fracture surfaces showed four distinct regions to exist in these samples as illustrated schematically in Figure 5. Examination of the fracture surface of selected samples using the scanning electron microscope indicated more clearly the characteristics of these different areas. Figure 6 shows three of these regions (1, 3, and 4) in a Ti-4Al-1.5Mo-0.5V sample which was stressed in air at $72 \text{ MN/m}^{3/2}$ ($65 \text{ ksi-in.}^{1/2}$). Of particular interest is the distinctive appearance of the slow crack growth region. Stringers of cleavage fracture are seen parallel with the direction of crack movement throughout Region 3. The cleavage stringers were separated by areas of ductile fracture. Slow crack growth in this alloy apparently occurs according to the stress-corrosion crack propagation model previously proposed for high-aluminum titanium-aluminum alloys [see Figure 28, Nov. 20, 1970, Annual Summary Report on Contract NASr-100(09)]. The areas of ductile failure in Region 3 are not greatly different in appearance from the ductile failure observed in Region 4. Figure 7 shows photographs of selected regions in a sample which exhibited slow crack growth in saltwater. No obvious differences were observed in the fracture appearance in Region 3 in saltwater as compared with that in air. Either both environments introduce a similar stress-corrosion cleavage failure mode, or cleavage failure is not a result of stress corrosion. Figure 7 includes two photographs of an area at the boundary between Regions 2 and 3. The distinguishing features of Region 2 are extreme roughness and an absence of cleavage fracture patches.

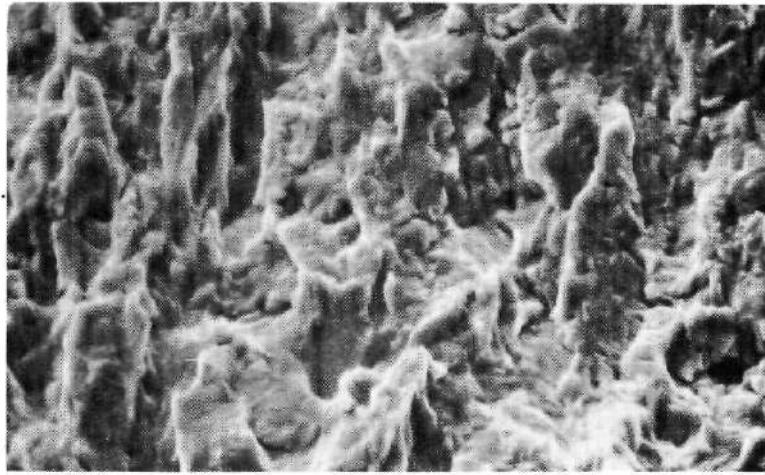
a. Fatigue Crack, Region 1

FIGURE 6. FRACTURE SURFACE OF Ti-4Al-1.5Mo-0.5V LOADED AT $72 \text{ MN/m}^{3/2}$ ($65 \text{ KSI-IN.}^{1/2}$) IN AIR (72-3)
 Direction of crack movement is vertical.

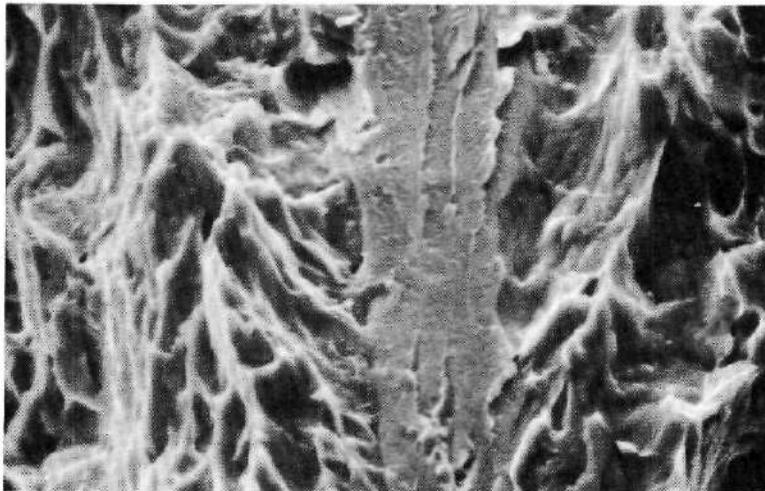
b. Slow Crack Growth, Region 3

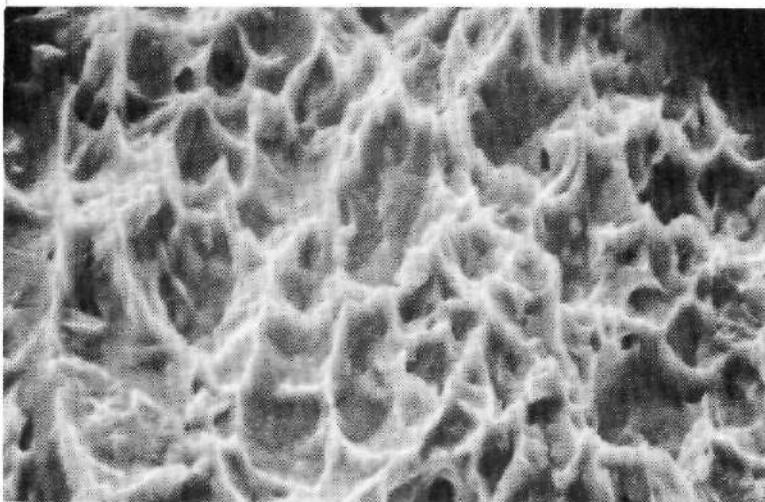
c. Fast Fracture, Region 4

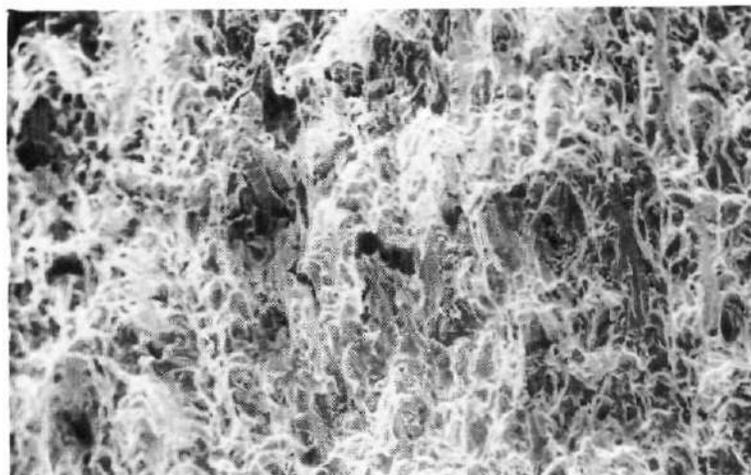
a. Boundary Between Regions 2 and 3

FIGURE 7. FRACTURE SURFACE OF Ti-4Al-1.5Mo-0.5V STRESSED AT $61 \text{ MN/m}^{3/2}$ ($55 \text{ KSI-IN.}^{1/2}$) IN SALTWATER (72-2)
 Direction of crack movement is vertical.

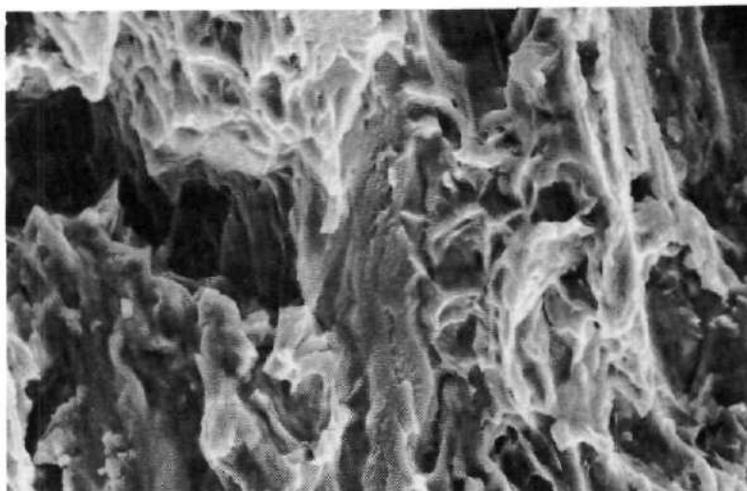
b. Boundary Between Regions 2 and 3

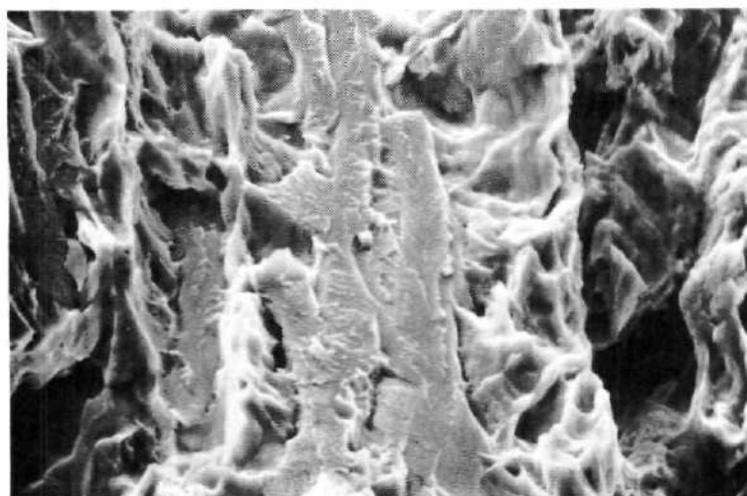
c. Slow Crack Growth, Region 3

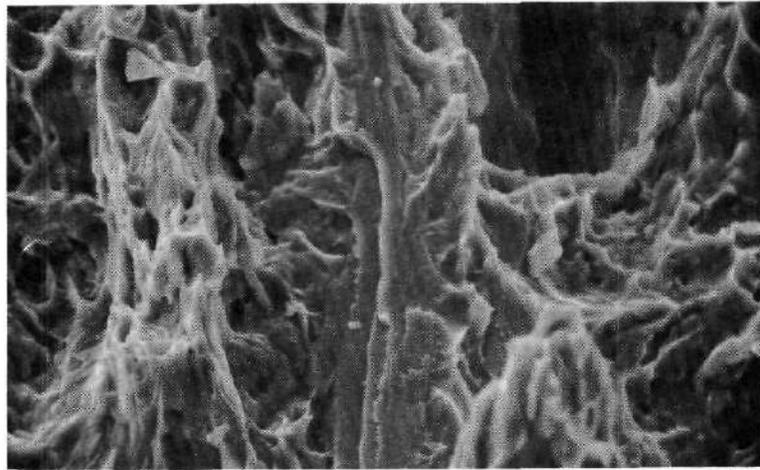
a. Initial Portion of Region 3

FIGURE 8. FRACTURE SURFACE OF Ti-4Al-1.5Mo-0.5V SAMPLE STRESSED AT 61 TO 78 MN/m^{3/2} (55 TO 70 KSI-IN.^{1/2}) FOR 3 x 10⁴ MINUTES AND THEN STEP LOADED TO FAILURE IN SALTWATER (72-A)

Figure 8 shows the transition in structure in the slow crack growth region of a sample which was stressed in saltwater for periods of 10^4 minutes at 61, 67, and 78 $\text{MN}/\text{m}^{3/2}$ (55, 60, and 70 $\text{ksi-in.}^{1/2}$) and was then step loaded over approximately a 5-hour period to failure at 98.1 $\text{MN}/\text{m}^{3/2}$ (88.4 $\text{ksi-in.}^{1/2}$). The initial portion of Region 3 was typical of the slow crack structure already described and probably represents crack movement under constant load at stress intensities between 61 and 78 $\text{MN}/\text{m}^{3/2}$ (55 and 70 $\text{ksi-in.}^{1/2}$). Deeper in the slow crack regions the amount of cleavage fracture decreases. This probably represents failure occurring during step loading in which, because of the higher stress intensity, less cleavage fracture is necessary before ductile overload failure will occur between the cleavage stringers. The third photograph shows an area near the end of Region 3 which contained secondary cracks, one of which is seen in this photograph running approximately vertically. Secondary cracking of this type is common in high-aluminum titanium-aluminum alloys which have failed under constant load in saltwater.

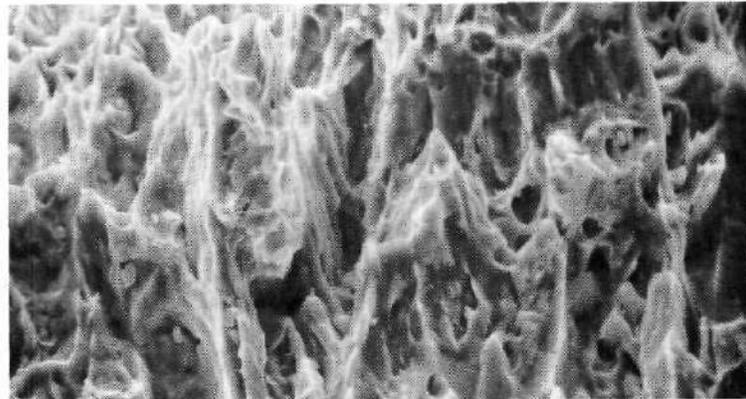
b. Intermediate Portion of Region 3

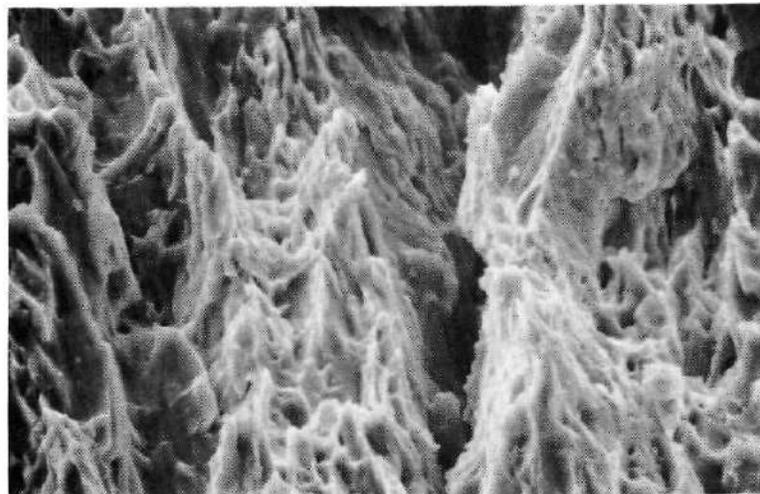
c. Final Portion of Region 3

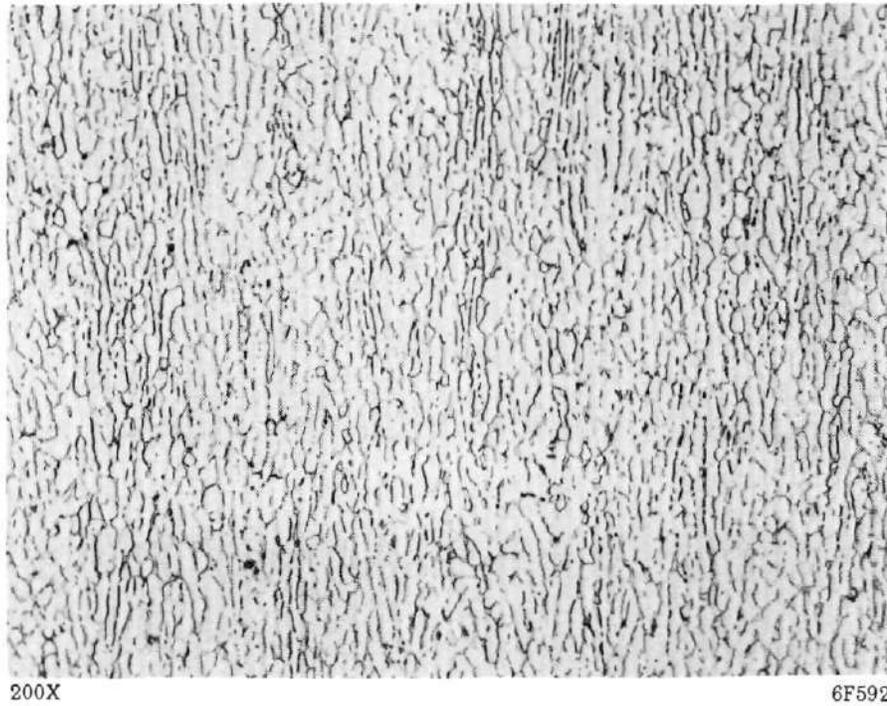
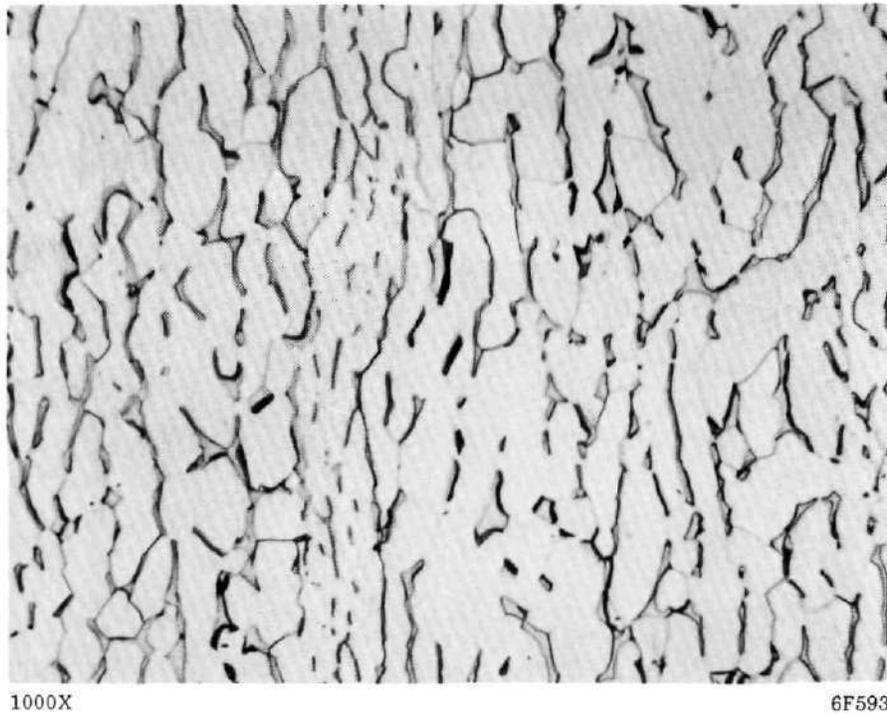
FIGURE 9. MICROSTRUCTURE OF Ti-4Al-1.5Mo-0.5V (72-2) IN A PLANE PARALLEL WITH THE FRACTURE SURFACE SHOWN IN FIGURES 6 THROUGH 8

Direction of crack propagation is vertical.

The microstructure of Ti-4Al-1.5Mo-0.5V as observed by optical microscopy in a plane parallel with the fracture surface is shown in Figure 9. Comparison with the fracture surfaces shown by scanning electron microscopy suggests the possibility that the regions of cleavage separation may correlate with regions of apparently similarly oriented stringered alpha grains, as indicated in Figure 5 by regions showing continuous beta grain boundary material and an absence of well developed alpha grain boundaries.
