Apollo 14 Flight Support and System Performance

Robert R. Rice
NASA MSC
Houston, Texas

Abstract

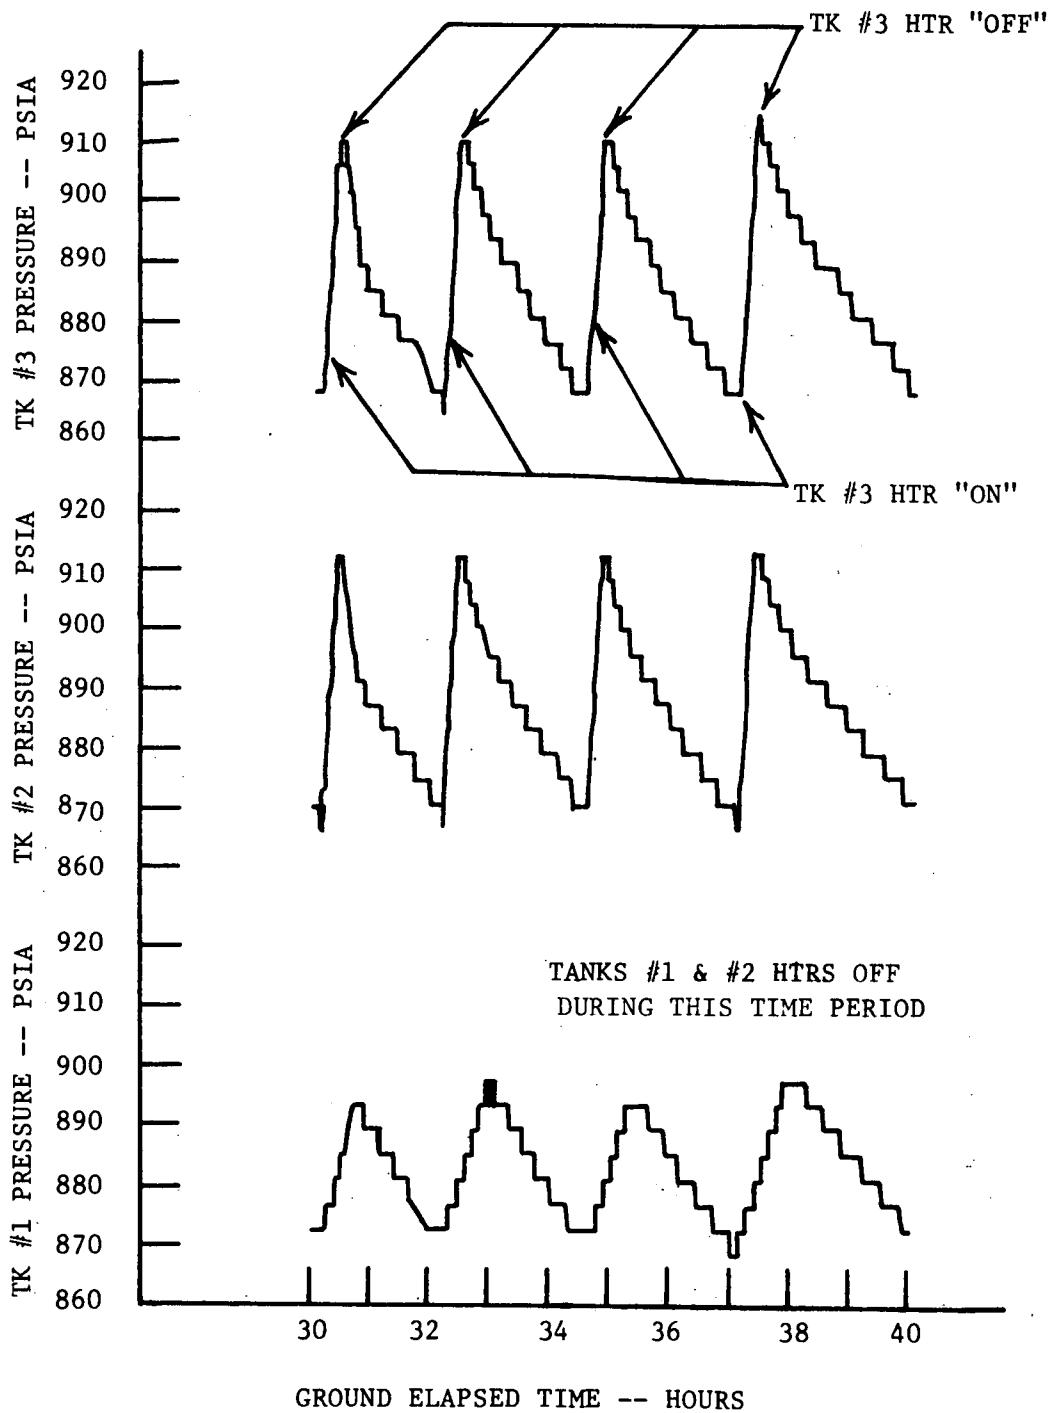
FIGURE 3 - FLIGHT DATA WITH A LEAKING CHECK VALVE

The first problem noted during the flight was that of a check valve leaking into tank number two. As can be seen in Figure 3, when tank number three's pressure rose, tank number two's pressure would track it. This meant that fluid from tank three was being forced back into tank two. This problem did not affect the overall mission since no fluid was being lost; however, it did affect the cryogenic management and the eventual conduct of the Detailed Test Objective (DTO).

The problem was that as the fluid was forced into tank two, heat energy was also transmitted--thus changing the effective thermal performance of the tank. This would in time affect the individual tank quantity schedule that had been planned prior to flight.

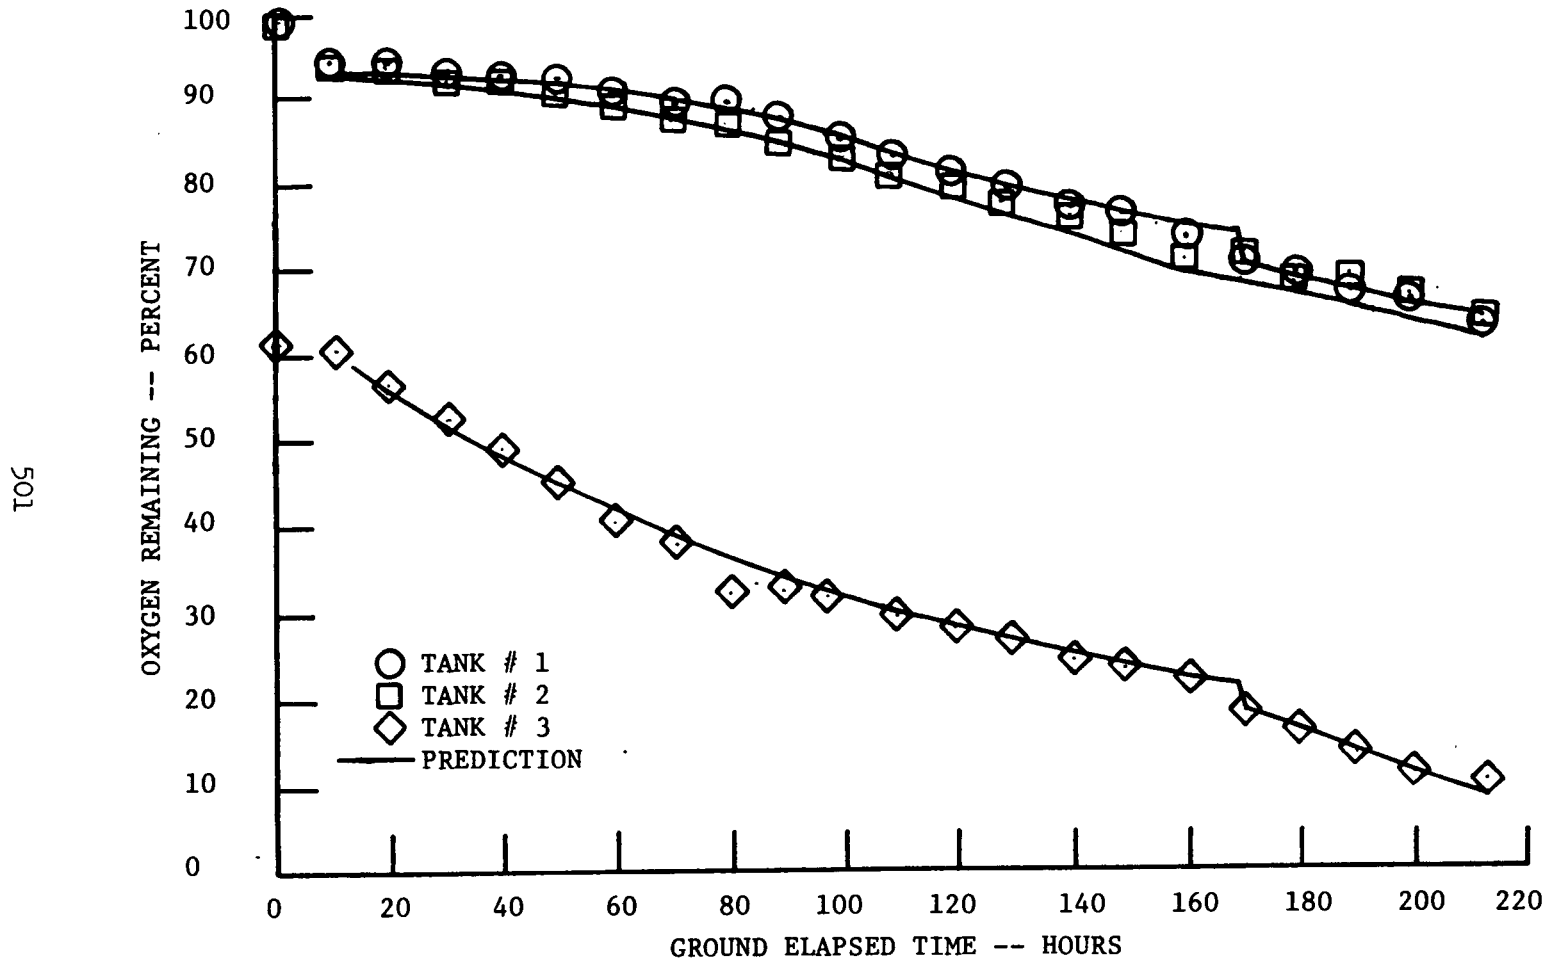
FIGURE 4 - FLIGHT QUANTITY PROFILES COMPARED TO THE PREDICTIONS

In order to solve this problem, the team members of the Mission Performance and Analysis Division (MPAD) were called upon. The program that they had written prior to flight was modified to include this additional heat and mass transfer into tank two, and the mission quantity schedules were recomputed. As can be seen in Figure 4, the resulting predictions came very close to the actual flight quantities.

It was concluded from this analysis that the leaking check valve would cause no problems during the remainder of the flight and that the DTO could be conducted without modifying the cryo schedule.

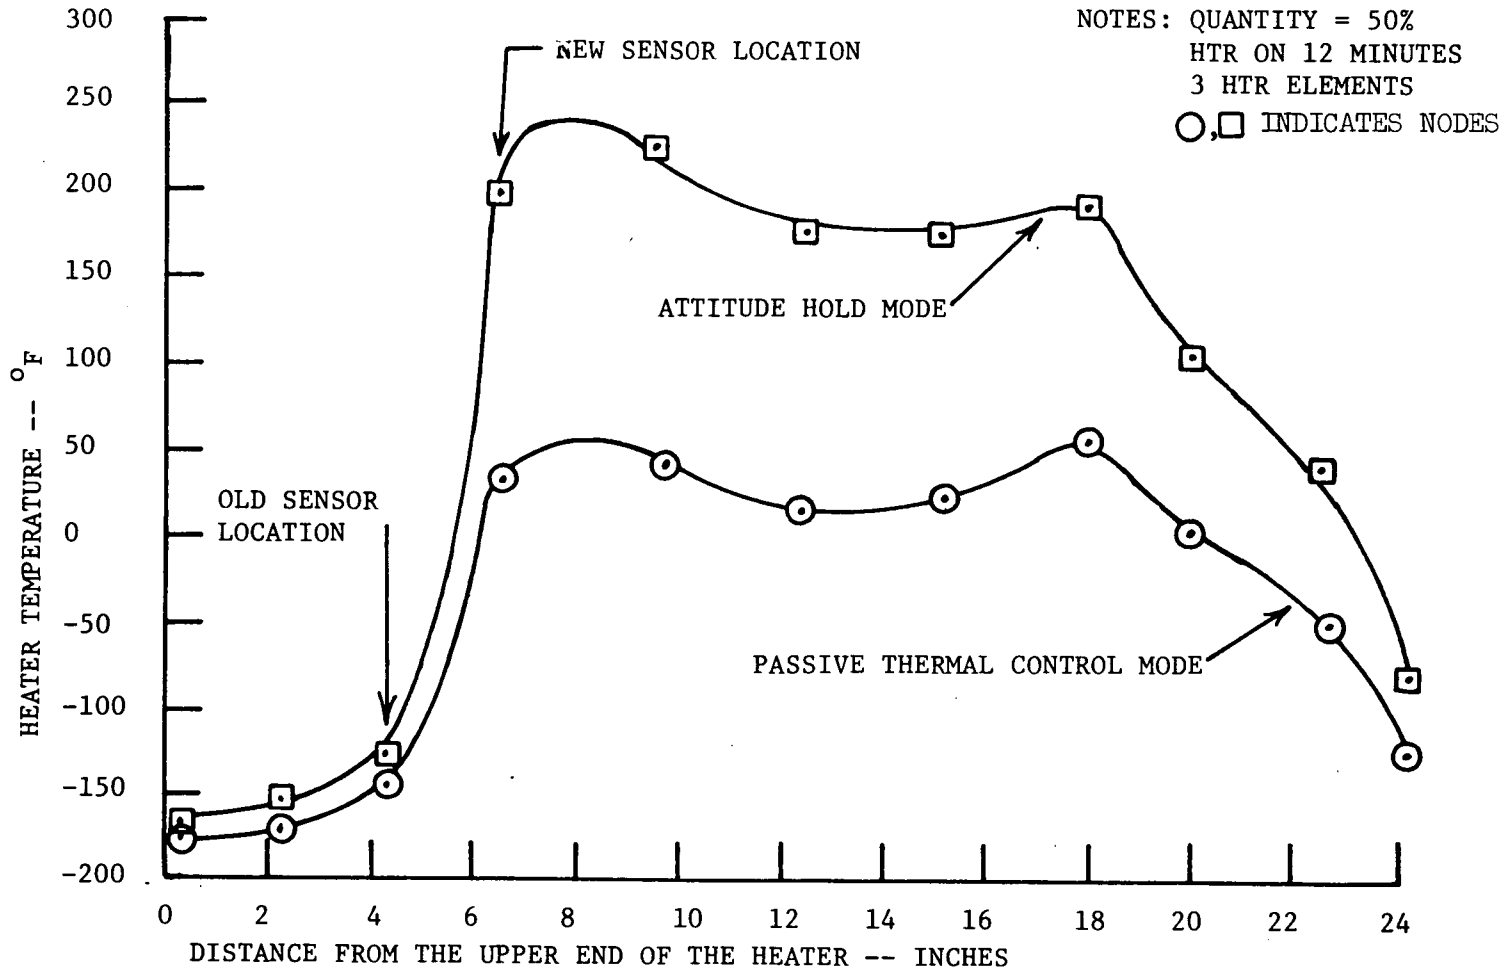
FIGURE 5 - HEATER TEMPERATURE PROFILES

Due to drawing and design changes, the temperature sensor was mislocated in the model by 1.0 to 2.0 inches. This position error occurred at a location where the temperature gradients were as large as 100°F to 300°F per inch. After this was discovered, it was noted that the sensor should and did reflect close to the maximum temperature on the heater. This is shown in Figure 5.

Next, it was found that at various times the heater temperature could lead the sensor indication by as much as 50°F. This was determined by performing a transient analysis of the sensor and heater system.

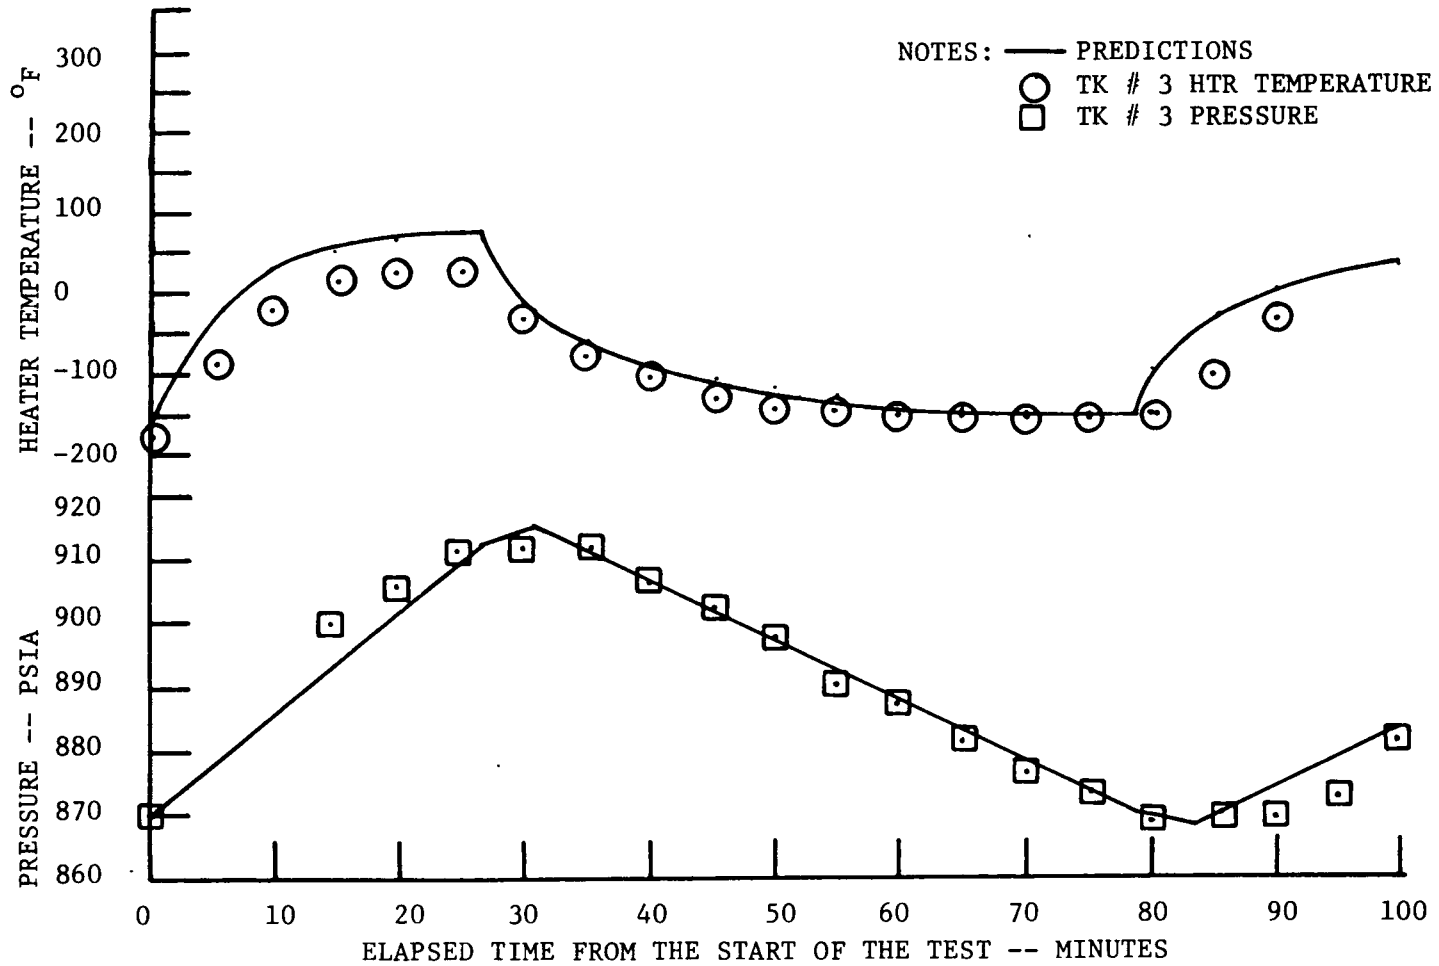
FIGURE 6 - DETAILED TEST OBJECTIVE SIMULATION AND FLIGHT DATA FOR TANK # 3

The predictions for tank number three along with the test data are shown in Figure 6. As can be seen, the data fell close to the trends predicted. In general, these predictions were such that the support team was able to distinguish between two heater element and three heater element operation.

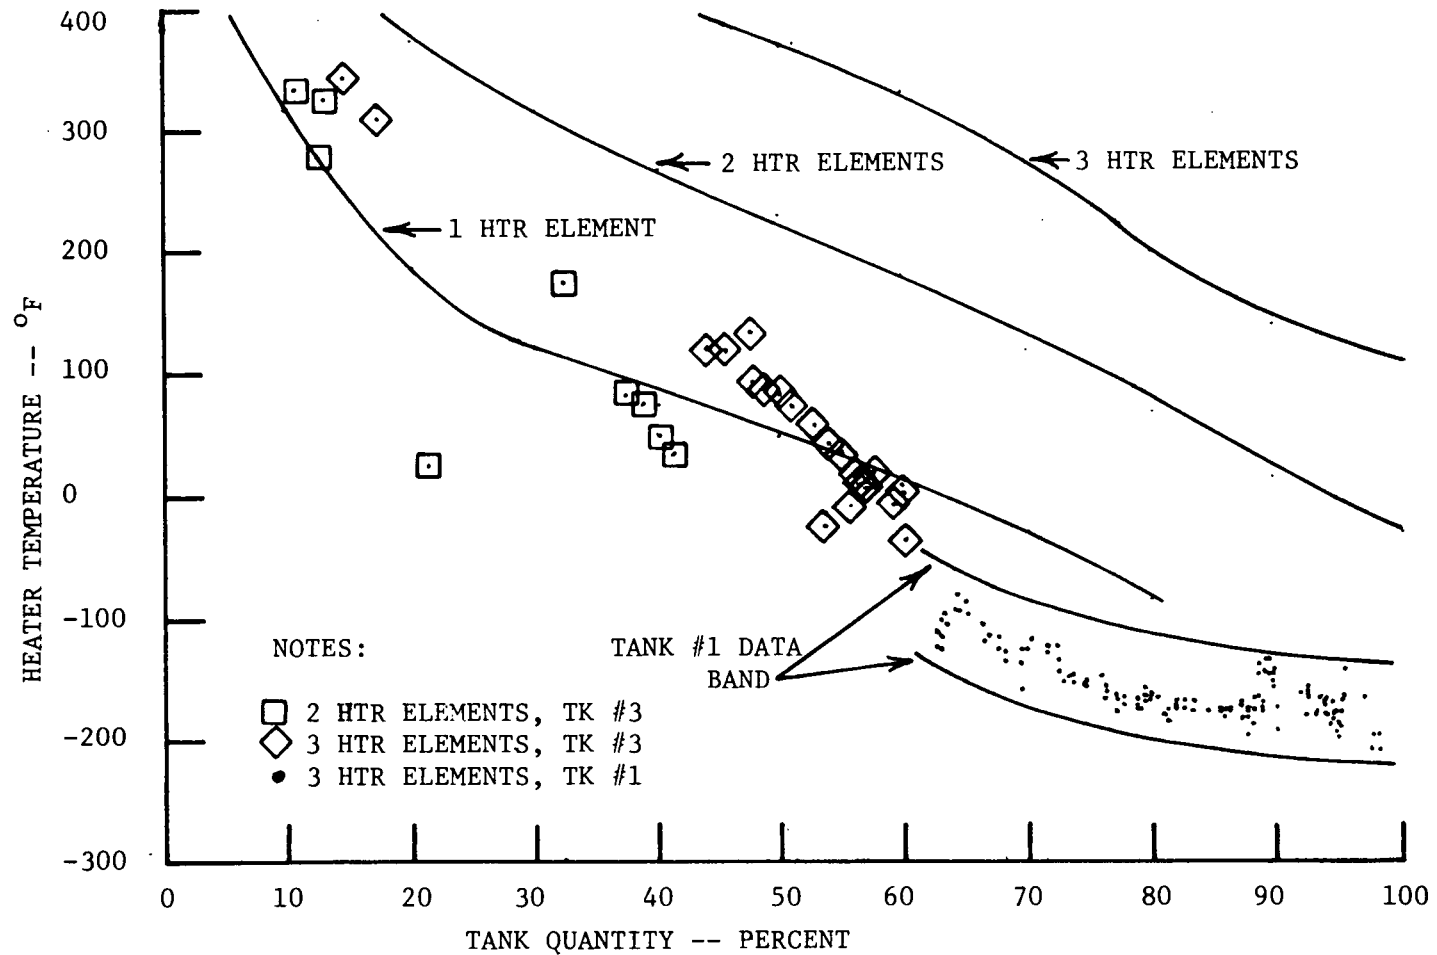
FIGURE 7 - HEATER TEMPERATURES OBSERVED DURING THE FLIGHT COMPARED TO THE MAXIMUM PREDICTED VALUES

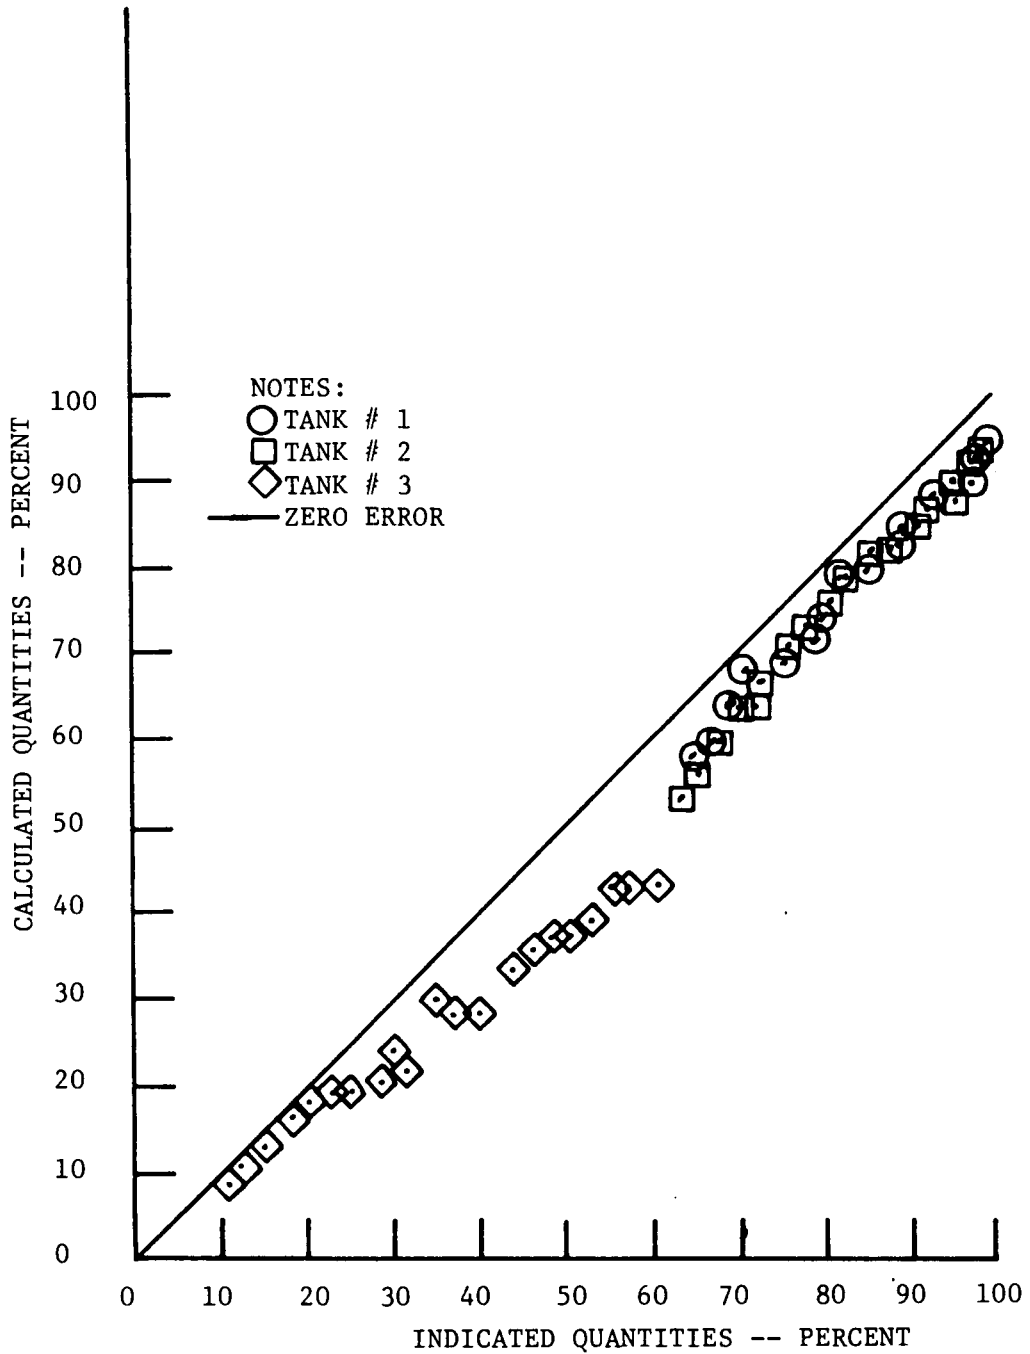
FIGURE 8 - A COMPARISON OF THE CALCULATED AND THE INDICATED QUANTITIES

1. Calculated vs Measured Quantities - Using the observed fluid temperatures and pressures in combination with thermodynamic data, densities were calculated. These densities were then used to calculate quantities which are shown compared to the indicated quantities in Figure 8. It should be noted that as the critical region is approached (30% to 50%), this method becomes more inaccurate; however, at the extremes, the method is consistent. This method of quantity determination is shown to be an acceptable backup if it is needed. Also, as part of this effort, these values were compared with Apollo's 11, 12, and 13 to establish the performance of the redesigned sensor. As can be seen in Figure 9, the new sensors are not as accurate as those that were on the old tanks. This was anticipated since the new location of the sensor removes it from intimate contact with the fluid.

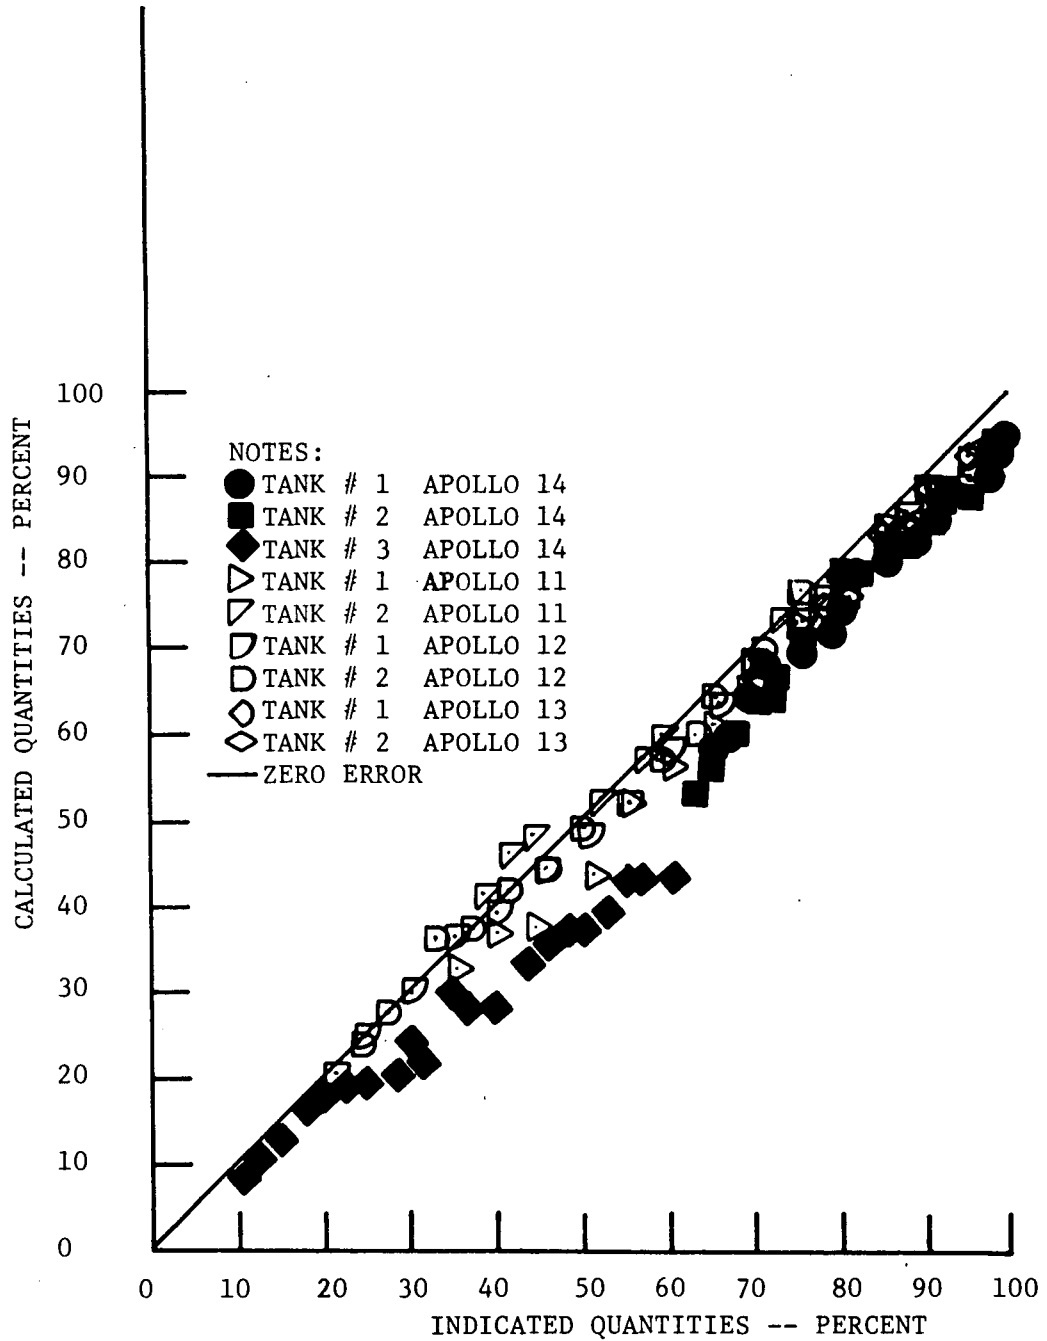
FIGURE 9 - A COMPARISON OF THE CALCULATED AND INDICATED QUANTITIES FROM FOUR APOLLO FLIGHTS

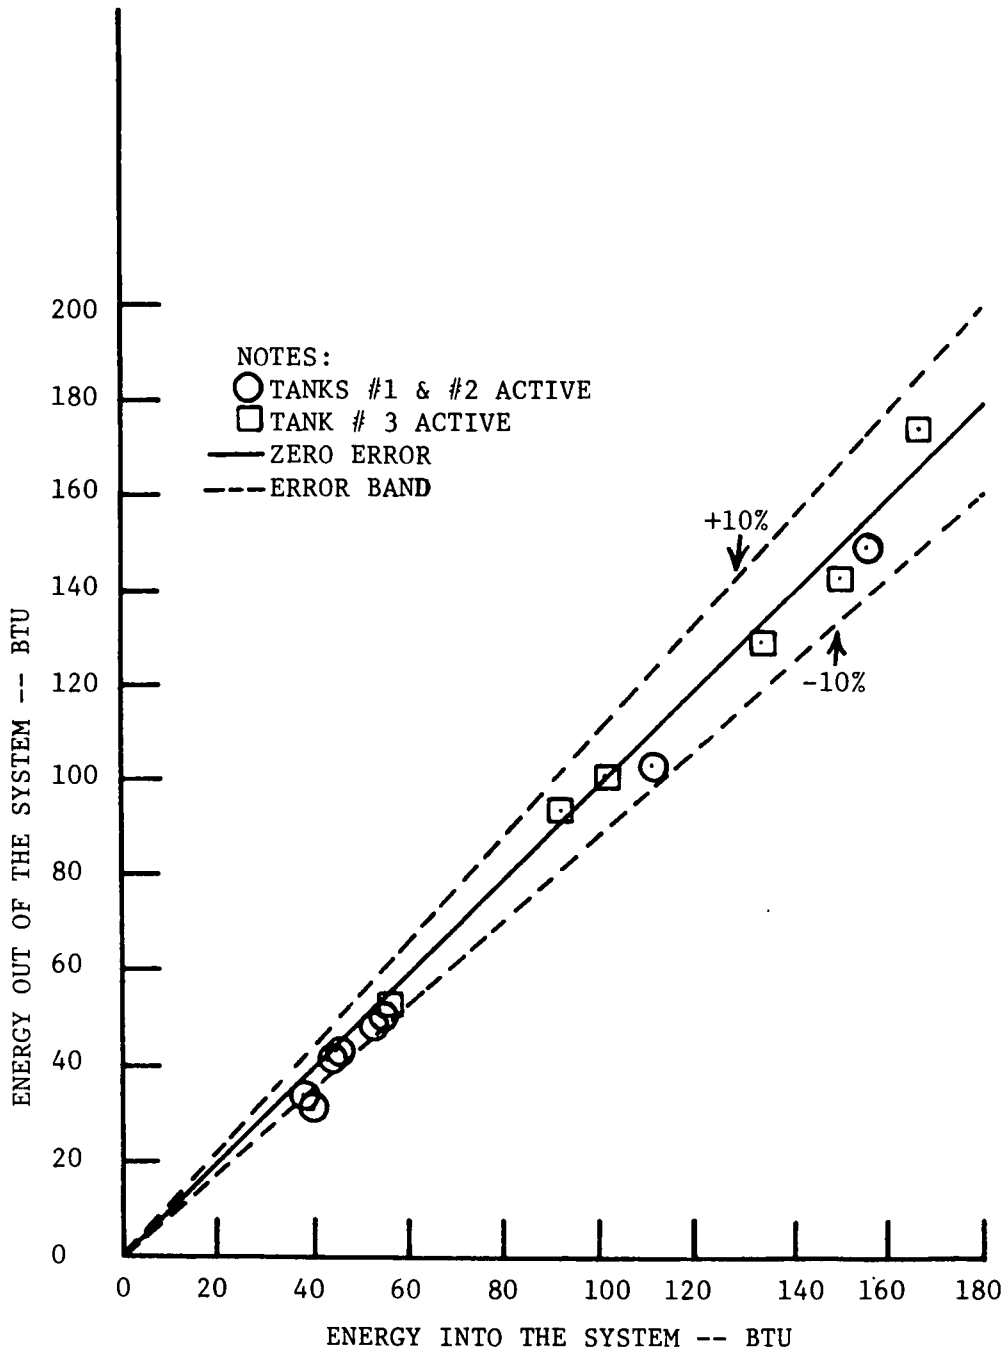
FIGURE 10 - OXYGEN TANK ENERGY BALANCE STUDY

2. Tank Energy Balance - This study was performed to establish the overall system energy balance at various times during the mission. This was done to establish whether or not stratification would affect the thermal efficiency of the system. Figure 10 presents the data calculated at various points in the mission. It should be noted that nearly all the data falls within a ten percent band. This is felt to be a remarkable accuracy, considering all of the variables that affect the problem. Also, it is seen that the scatter is random in nature-- indicating little or no loss in overall thermal efficiency.

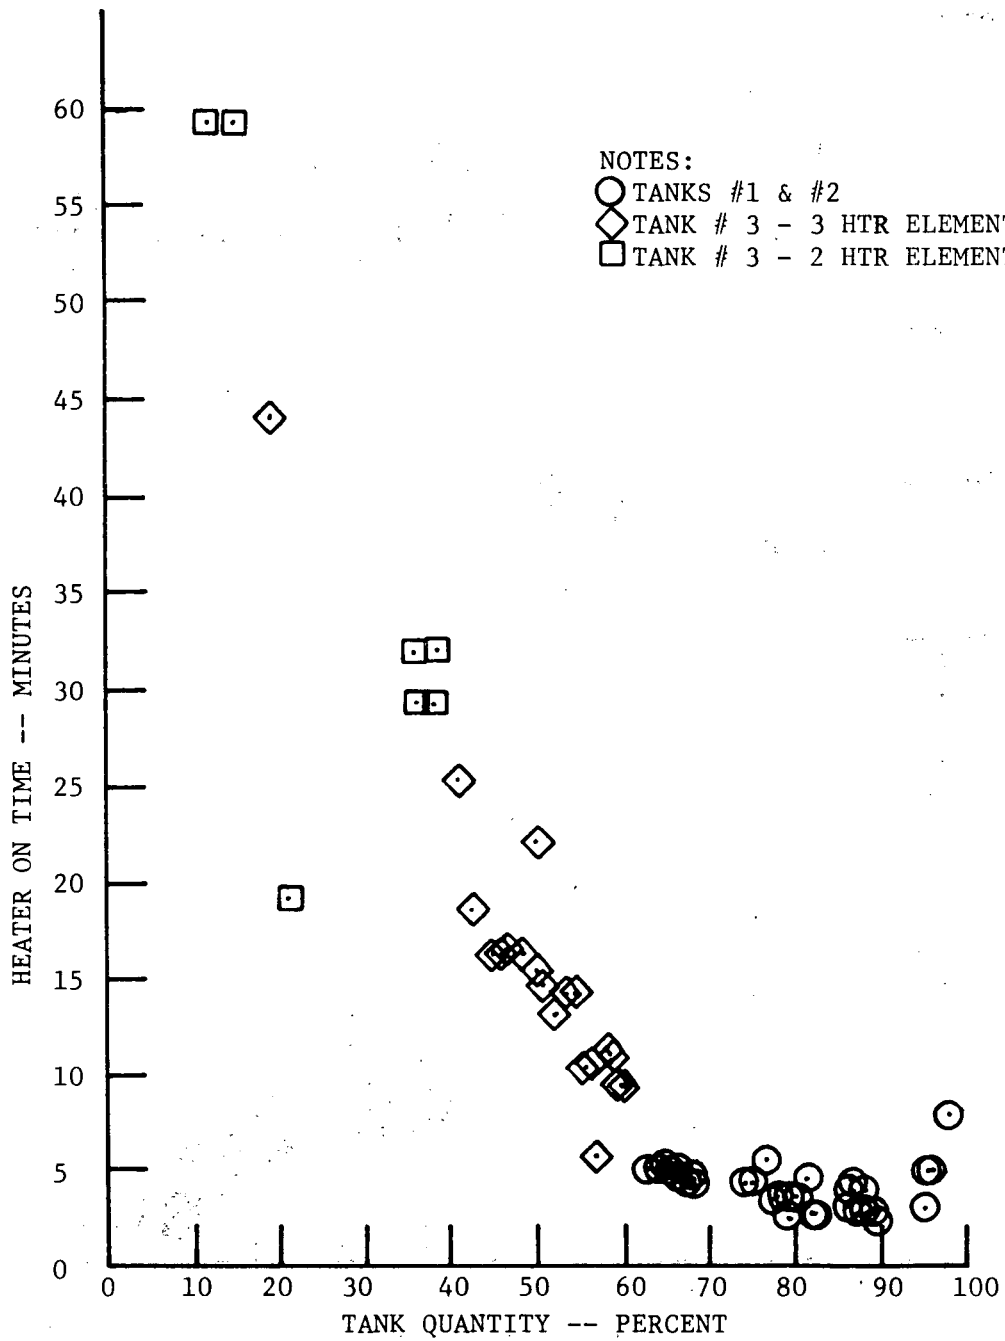
FIGURE 11 - HEATER "ON" TIMES DURING THE MISSION

3. Pressure Response Study - This work was performed so that the control characteristics could be established. This information will be used on future flights to aid in system monitoring. During this effort, there were two types of curves developed: heater on time and total cycle time. The results of the tabulation for heater on time are shown in Figure 11. As can be seen in this illustration, exact trends are difficult to observe. Again, this is indicative of a system with many operational variables. The total cycle times are shown in Figure 12; again, exact trends are hard to establish. But, the ranges of times that can be expected for future flights can be observed and also the variation of trend with quantity can be roughed out.

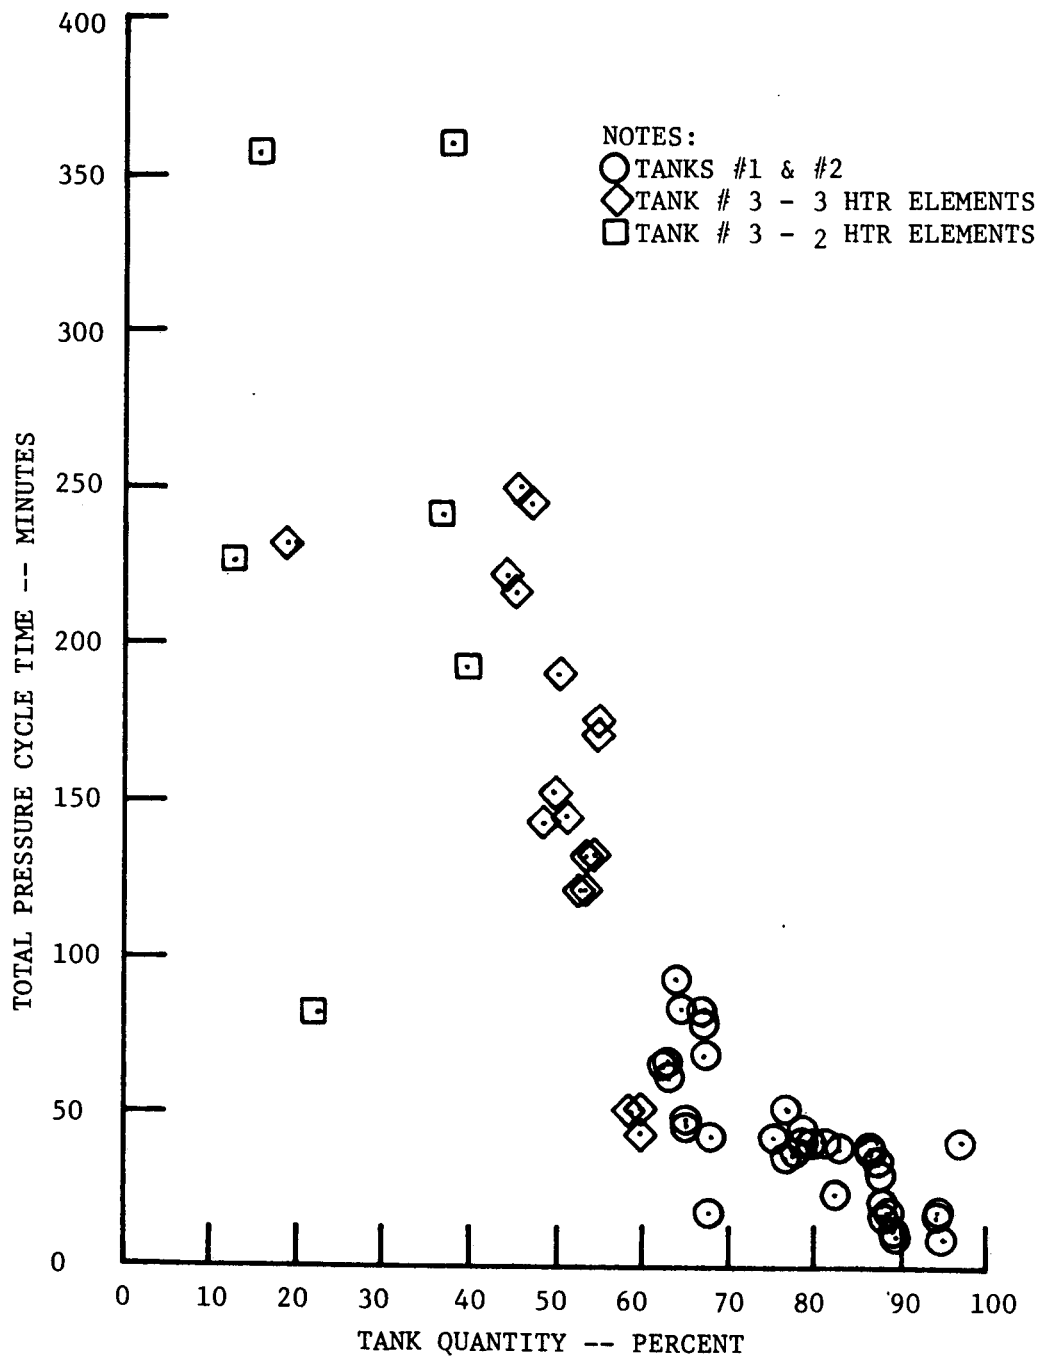
FIGURE 12 - PRESSURE CYCLE TIMES DURING THE MISSION
