NASA CR-121111  
WANL-M-FR-72-006  
DECEMBER 1972

**EVALUATION OF TANTALUM/316  
STAINLESS STEEL TRANSITION JOINTS**

**WESTINGHOUSE ASTRONUCLEAR LABORATORY**

prepared for  
**NATIONAL AERONAUTICS AND SPACE ADMINISTRATION**  
NASA Lewis Research Center

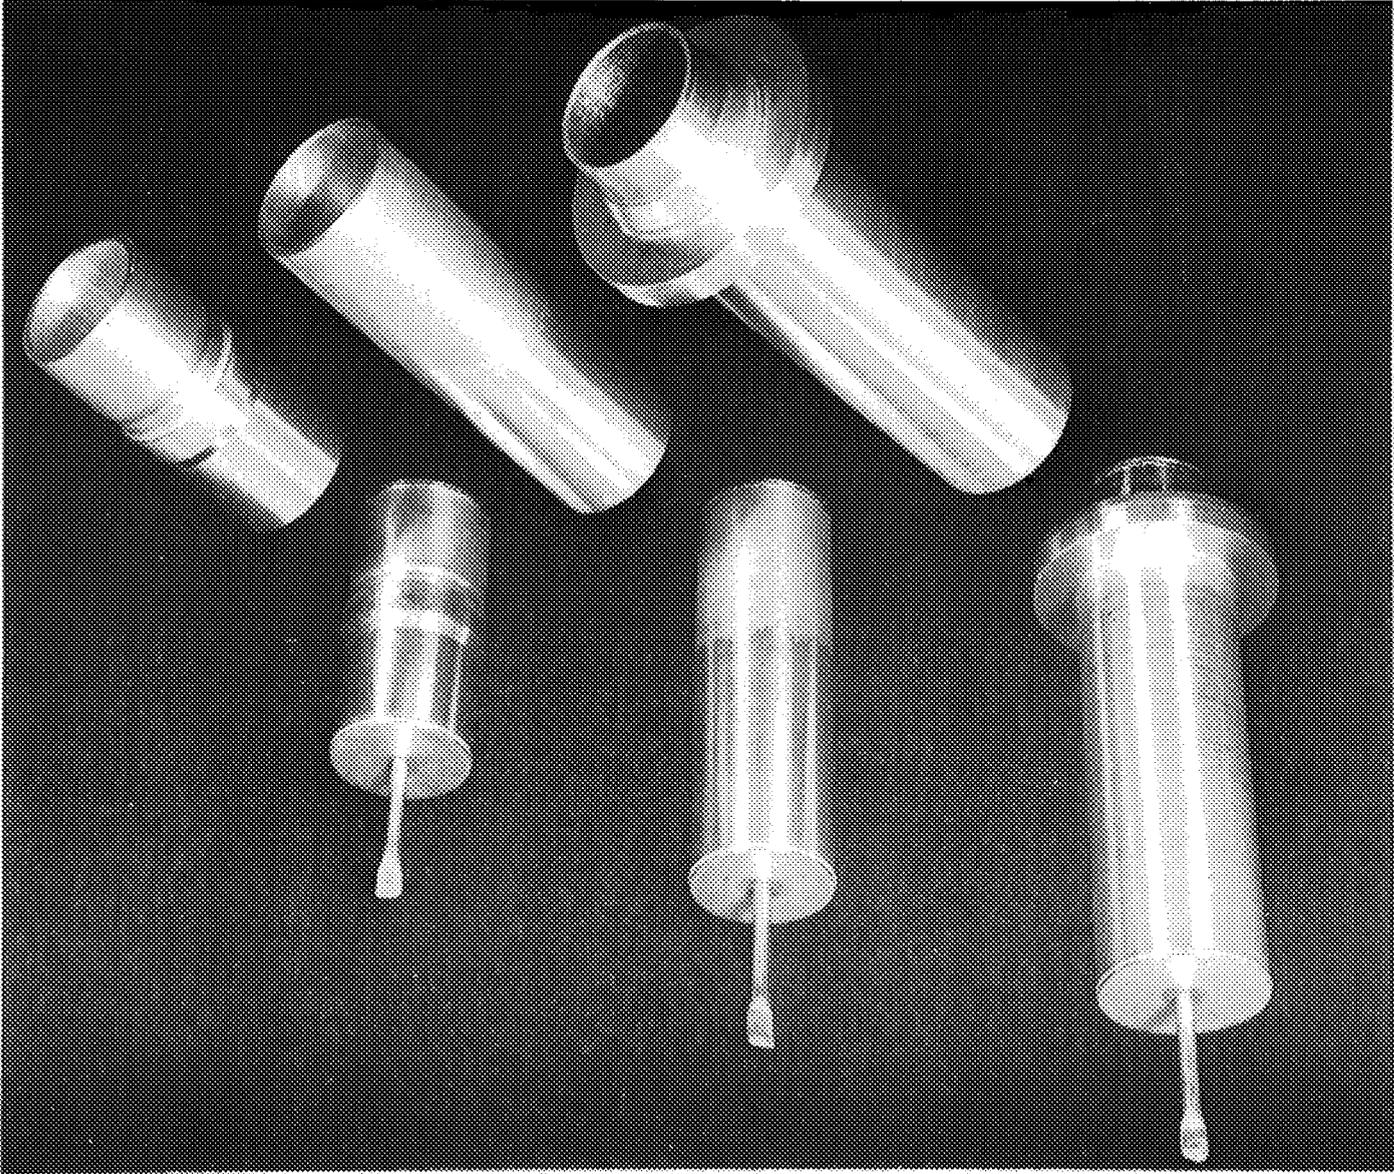
FIGURE 1. From Left to Right, Open and Closed Versions of Sleeve, Tandem, and Brazed Bimetal Transition Joints

Three types of 316 stainless steel to tantalum transition joints were evaluated for thermal cycle durability. Figure 1 shows the open and pressure sealed versions of the 50.0 mm (2.00 inch) diameter transition joints. From left to right in Figure 1 the transition joints are a sleeve joint, with a header plate simulating flange welded in place, a tandem joint, and a tongue and groove brazed joint. The sleeve joint and tandem joint were made by hot extrusion over a fixed mandrel, and the brazed joint was vacuum brazed using a high temperature cobalt base alloy. Although all three types of transition joints were in competition to provide a leak tight union between 316 stainless steel and tantalum, the sleeve joint was also useful as a header joint for a heat exchanger; hence, the welded flange simulating the header plate stress conditions.

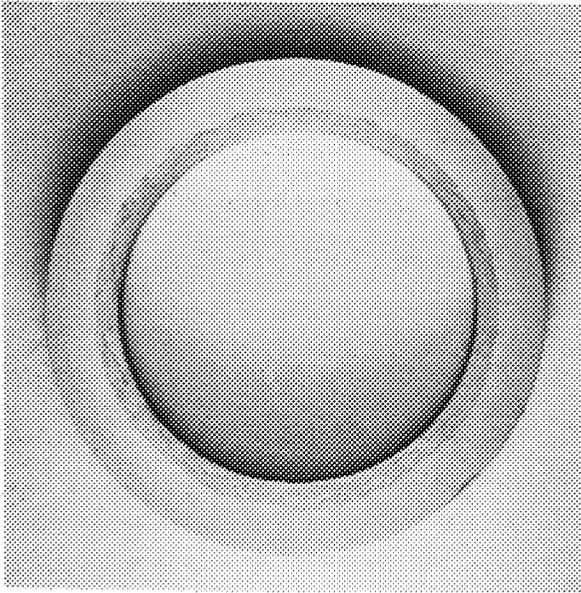
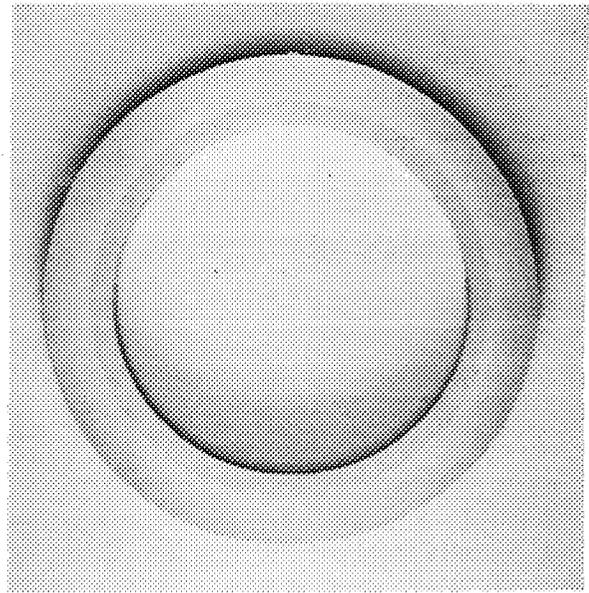
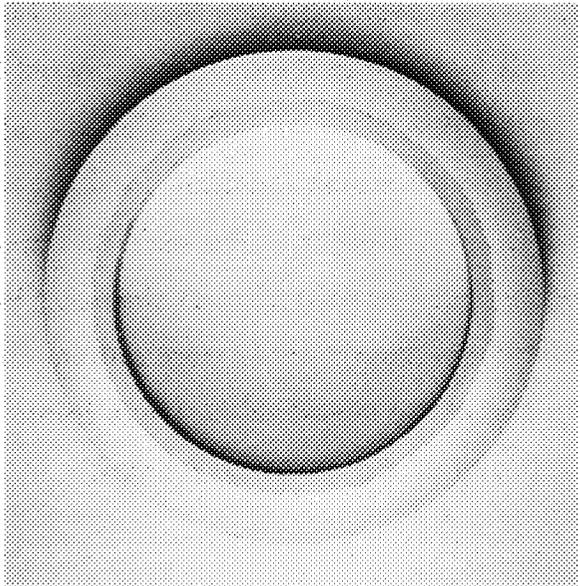
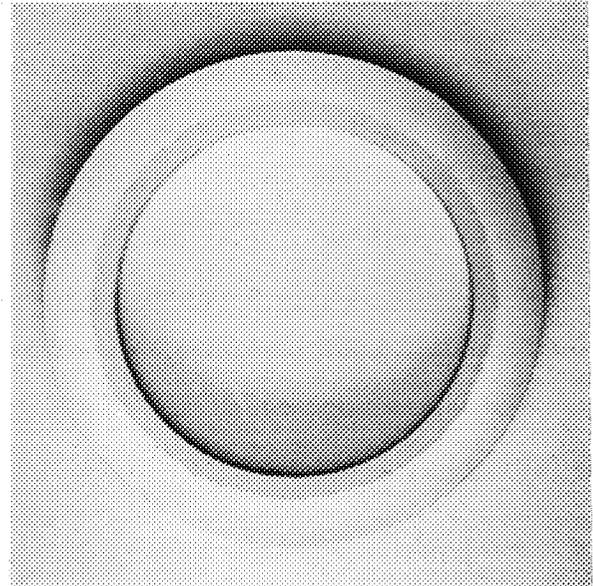
FIGURE 2. Transverse Sections of Sleeve Joint Extrusions As-extruded

Figure 2 compares full scale transverse ring sections from the as-extruded sleeve joints. The inside diameter surface, which in the clad state was extruded over a mandrel, was smooth. The inside layer of tantalum and the outside layer of 316 stainless steel were concentric.

Dimensions - Six of the eight sleeve joint extrusions were cut in two, and the outside diameter was machined. One of the pair of sleeve joints from each extrusion then had a heavy stainless steel flange electron beam welded to the wall to simulate the stresses expected in service as a tube to header joint. Table 2 compares the dimensions of the six flange-welded sleeve joints, and Figure 3 is a sketch which clarifies the dimension location. The great variation in center wall thickness, shown in Table 2 is not a product of the extrusion process but is due to the outside diameter machining of the cambered or bent bimetal sleeves. Had the tube lengths been press straightened prior to machining, considerably more uniform dimensions would have been obtained. The full section views of the as-extruded sleeve joints shown in Figure 2 are more indicative of the concentricity of the extrusion process.

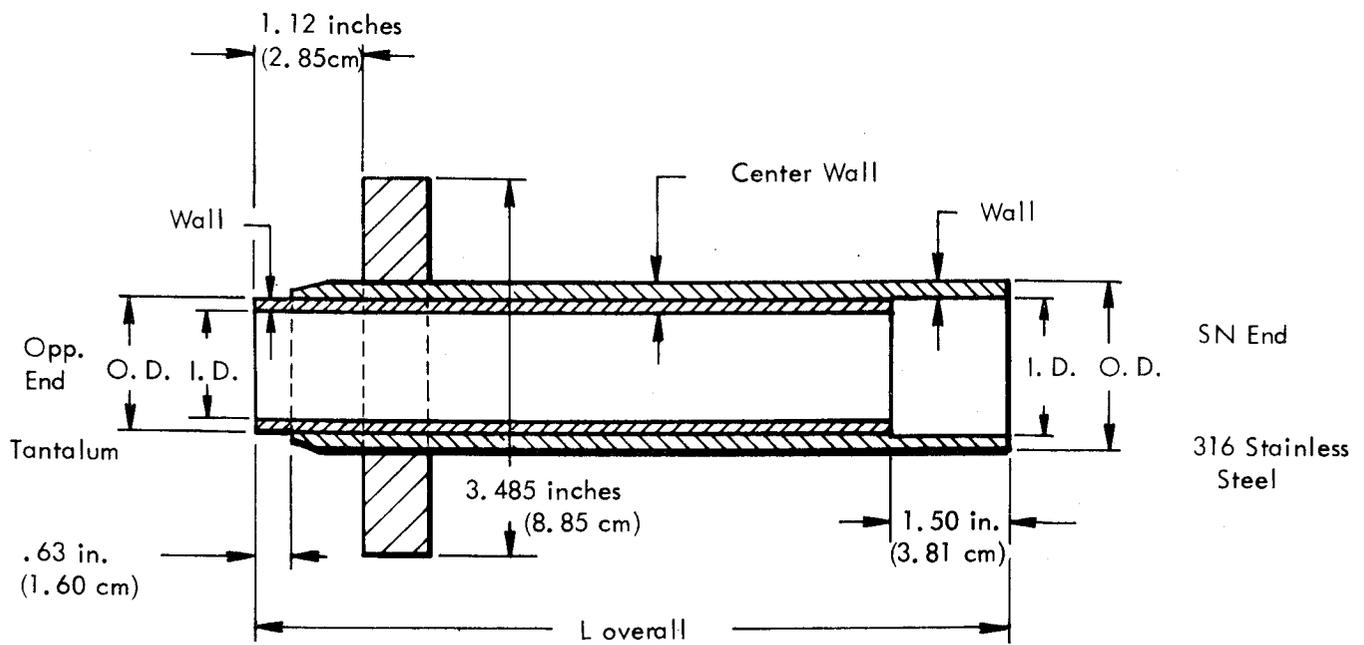
FIGURE 3. Dimension Locations of Flanged Sleeve Joints

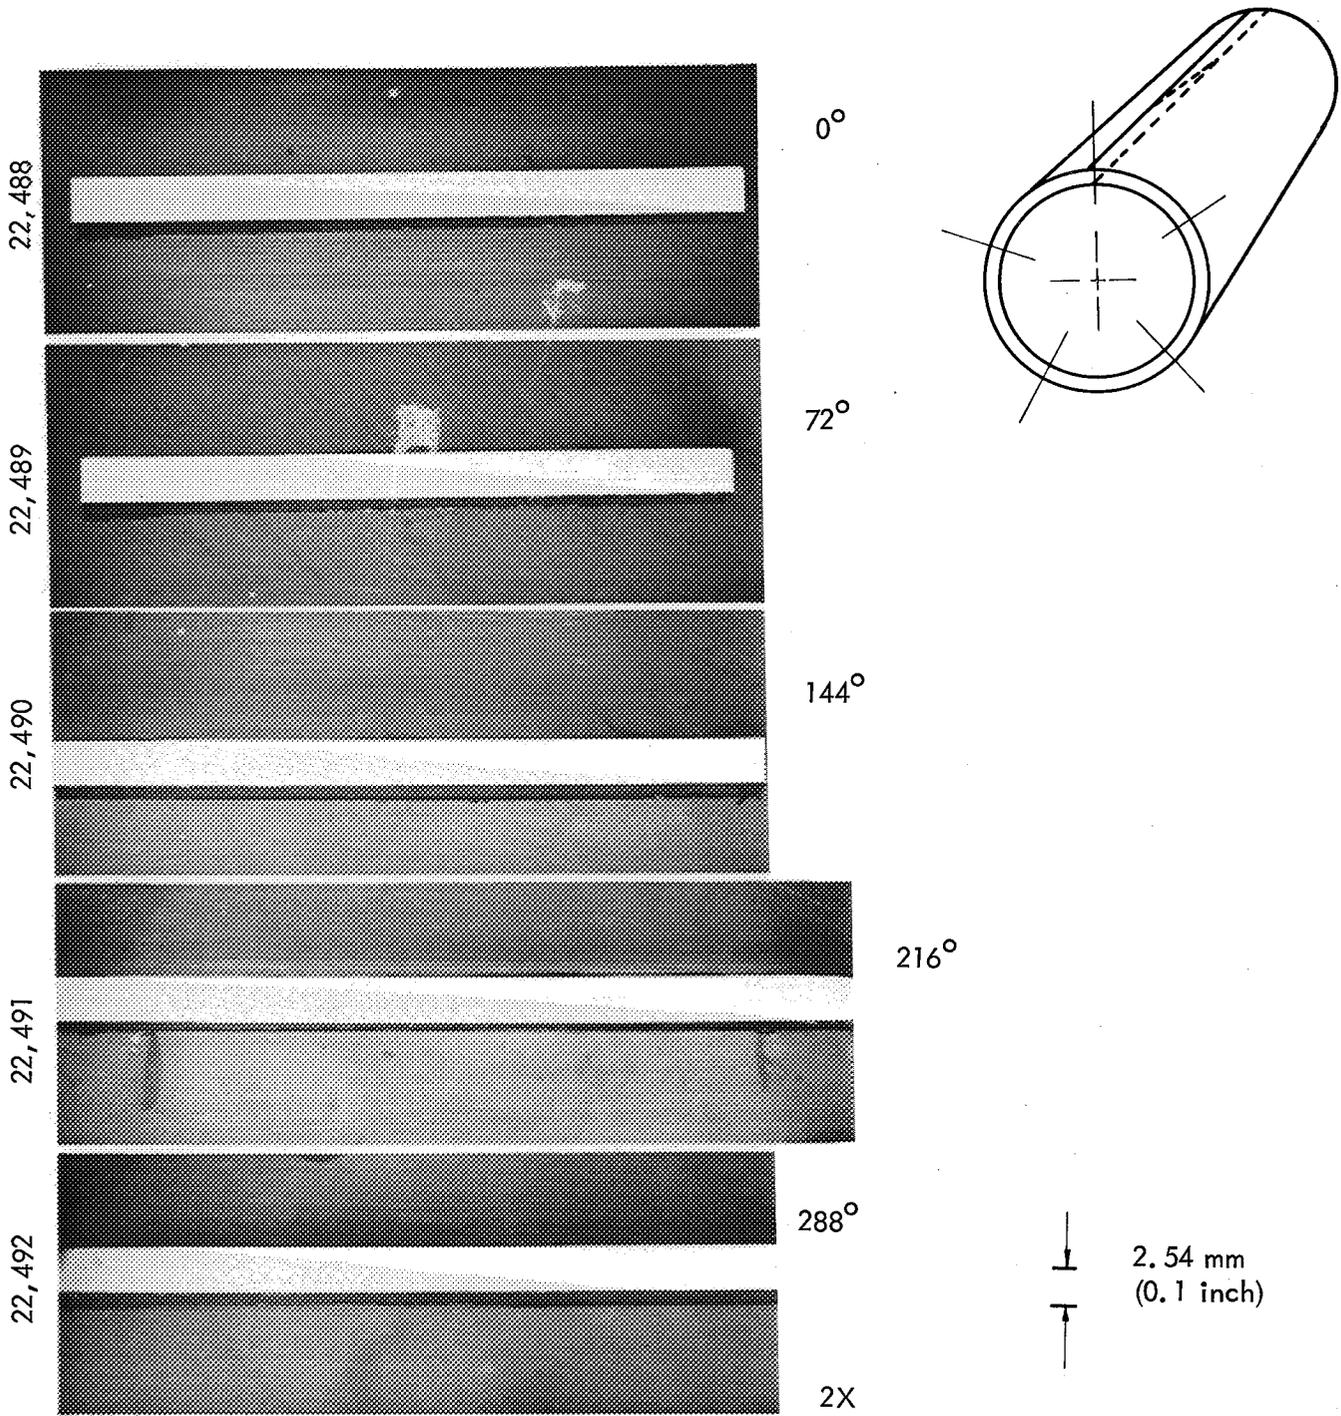
FIGURE 4. Longitudinal Sections from Joint No. 3  
in the As-Extruded Condition

Tandem transition joints are best observed in full longitudinal section as shown in Figure 4. The tapered transition joint is designed to distribute the dissimilar thermal expansion stresses and to prevent rupture during thermal cycling. To estimate the variation in taper length,

five longitudinal sections were obtained spaced  $72^\circ$  apart around a single transition joint. The sectioned taper length of joint No. 3 varied from 4.76 cm to 2.67 cm (1.875 inches to 1.060 inches) which compares favorably to the 4.80 cm to 3.7 cm (1.89 inches to 1.455 inches) variation measured by radiograph. Figure 5 lists the machined dimensions of the tandem joints including the only piece to piece variable dimension, the radiographically determined taper length. The taper lengths shown in Figure 5, although generally less than the target value of 3.8 cm (1.5 inches)<sup>(9)</sup>, are considered acceptable for a durable, leak tight transition joint of this diameter and wall thickness. A 1.02 cm (0.4 inch) bevel had been machined on the extrusion blanks to purposely increase the taper length of the 5:1 ratio extrusion.

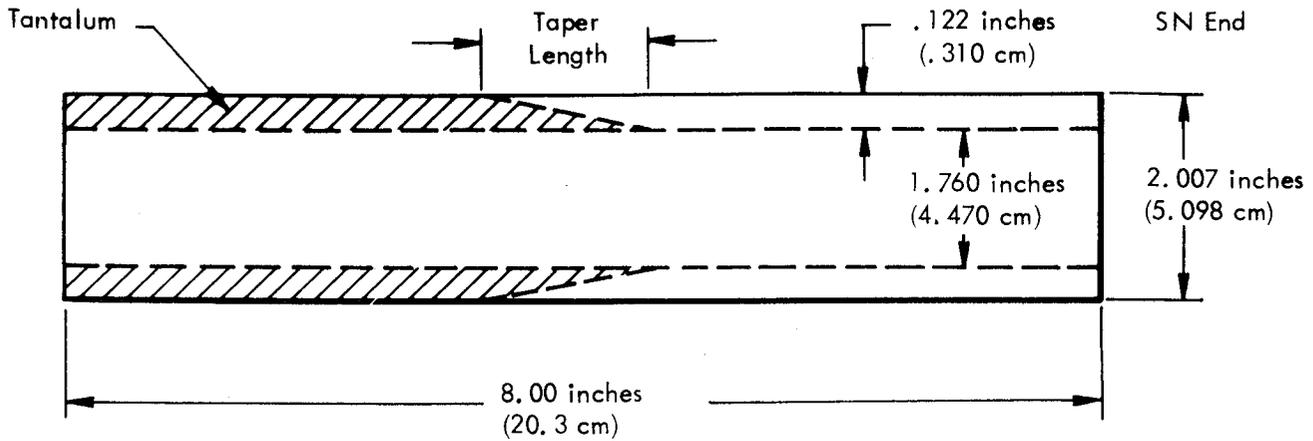
No.	Average Taper Length <sup>*</sup>		Special Characteristics
	inches	cm	
1	1.22	3.10	ID Unbond - Single Point
2	1.44	3.66	
3	1.67	4.24	
4	1.35	3.43	
5	1.06	2.69	
6	1.30	3.30	OD Defect - Dye Pen. - Single Point
7	1.01	2.56	
8	1.47	3.73	OD Defect - Dye Pen. - Line
9	1.33	3.38	
10	1.44	3.66	
11	1.35	3.43	
12	1.18	3.00

\* - Average of four locations measured by radiography

FIGURE 5. Tandem Transition Joint Dimensions and Special Characteristics

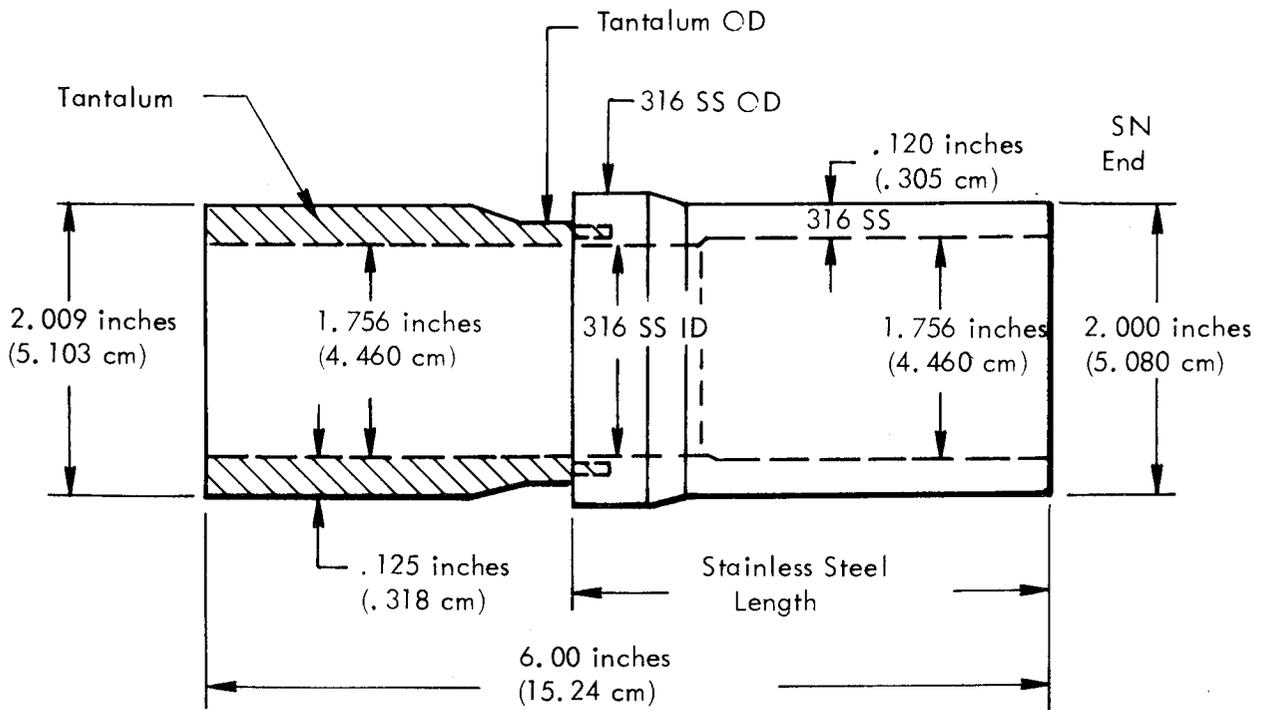
FIGURE 6. Brazed Transition Joint Dimensions

The brazed joint tongue and groove design is shown in Figure 6. The tantalum side of the transition joint was machined to a tongue to fit the stainless steel groove. Previous successful joints had been made at General Electric with a stainless steel tongue and a tantalum groove, but the present configuration was considered to be more favorable. A cobalt-base alloy, J-8400\*, also developed by General Electric, was used for the fluxless vacuum brazing operation. A brazing temperature of approximately  $1200^\circ\text{C}$  ( $2200^\circ\text{F}$ ) was required, and generally from 2 to 3 brazing cycles at successively higher temperatures were required to produce an acceptable braze as determined by ultrasonic inspection. Table 3 lists the brazing

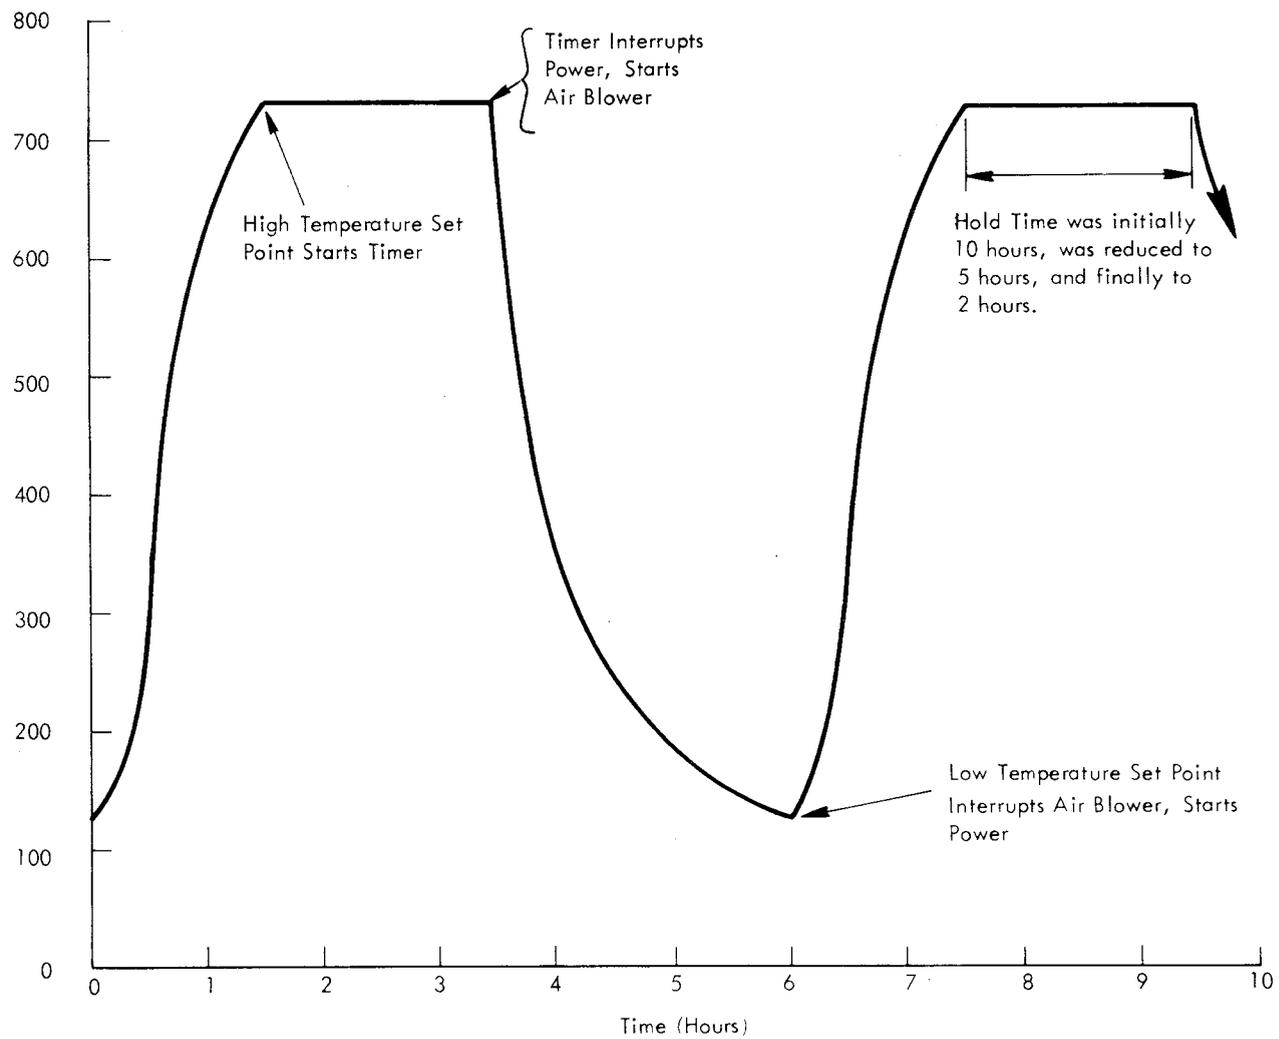
FIGURE 7. Thermal Cycle Test for Transition Joints

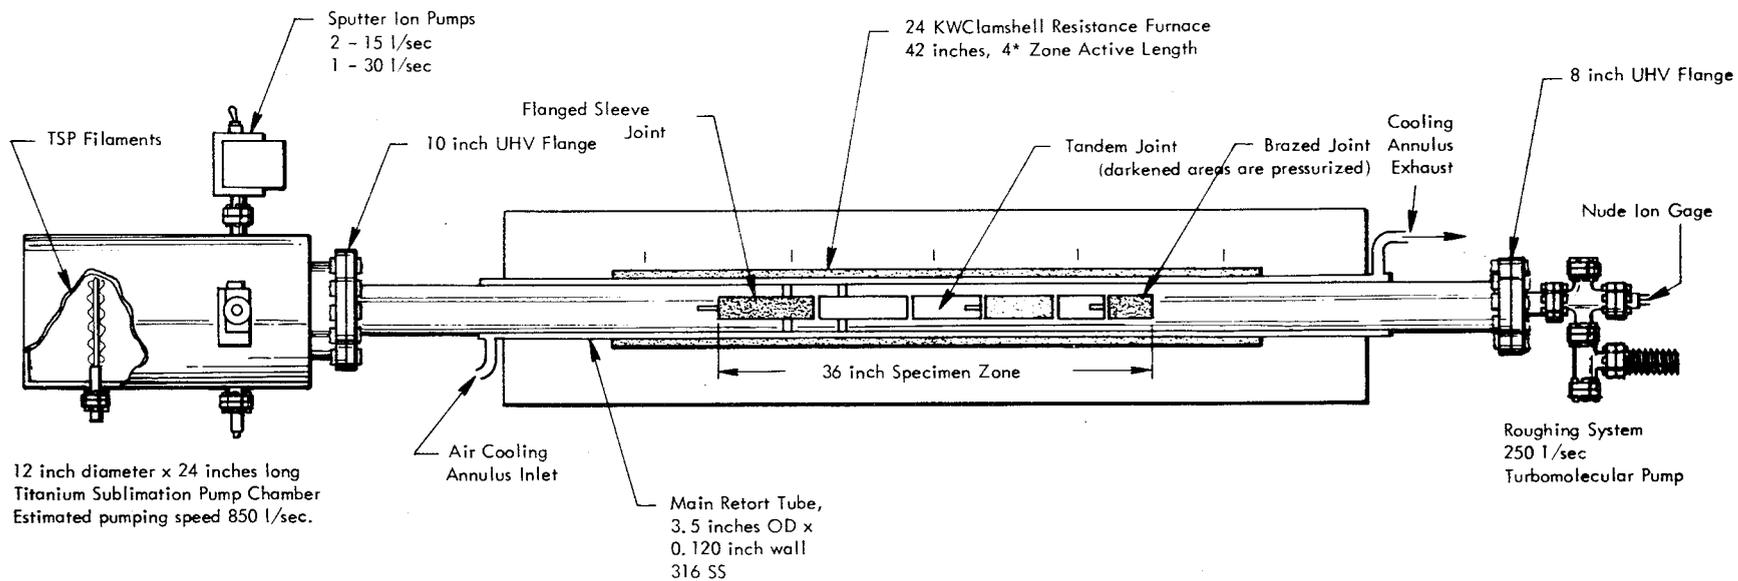
FIGURE 8. High Vacuum Thermal Cycling Furnace (1350°F) (730°C)

Figure 8 is a drawing of the hot wall furnace and the specimen array. The specimens were supported by a stainless steel rack. The temperature was monitored at three locations in the furnace interior, and the hot wall furnace was controlled by an external thermocouple adjacent to the furnace tube. The hot wall furnace was pumped by a titanium sublimation pump chamber and three small sputter ion pumps. The combined pumping capacity was approximately 900 l/sec for nitrogen. To provide the initial roughing vacuum and to aid the ion and sublimation pumps during bakeout, a 250 l/sec turbo-molecular pump was used. Furnace vacuum was monitored by a nude ion gage at the roughing end and by a cold cathode gage and the ion pump current at the sublimation chamber end. The pressures obtained were  $2 \times 10^{-7}$  torr with the furnace hot to  $5 \times 10^{-9}$  torr with the furnace cold. Figure 9 is a photograph of the hot wall furnace and associated control system.

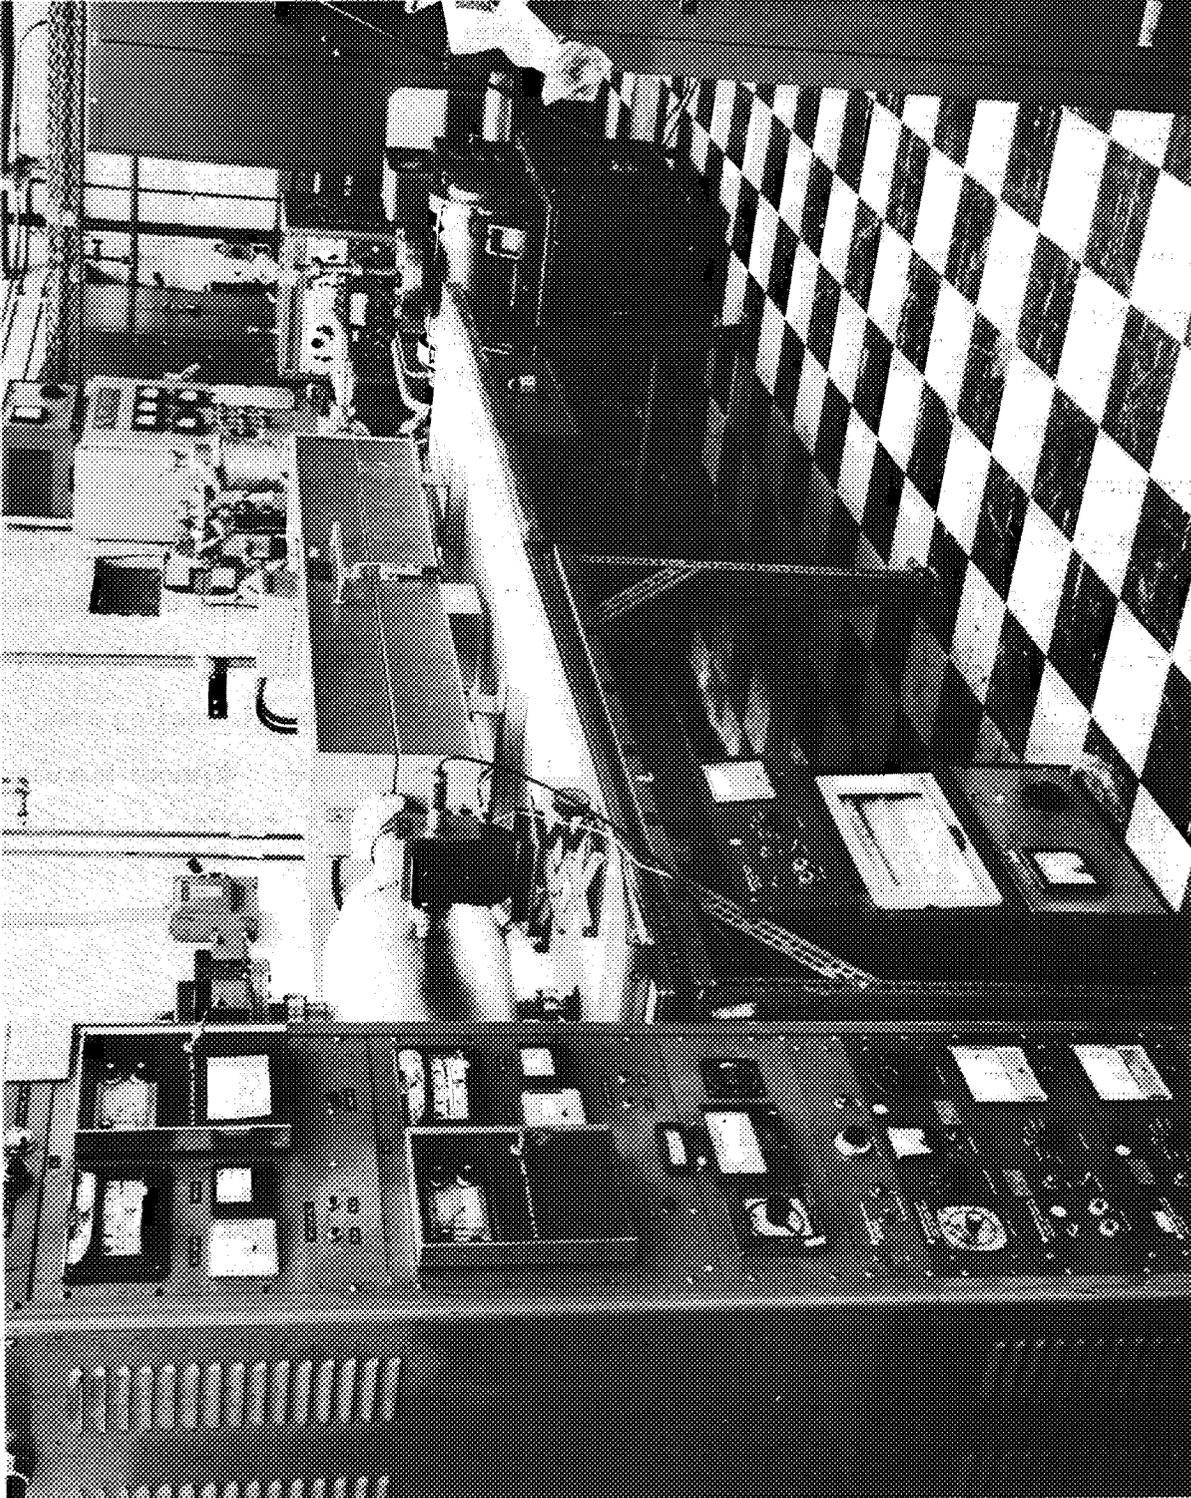
FIGURE 9. Photograph of Thermal Cycling Apparatus

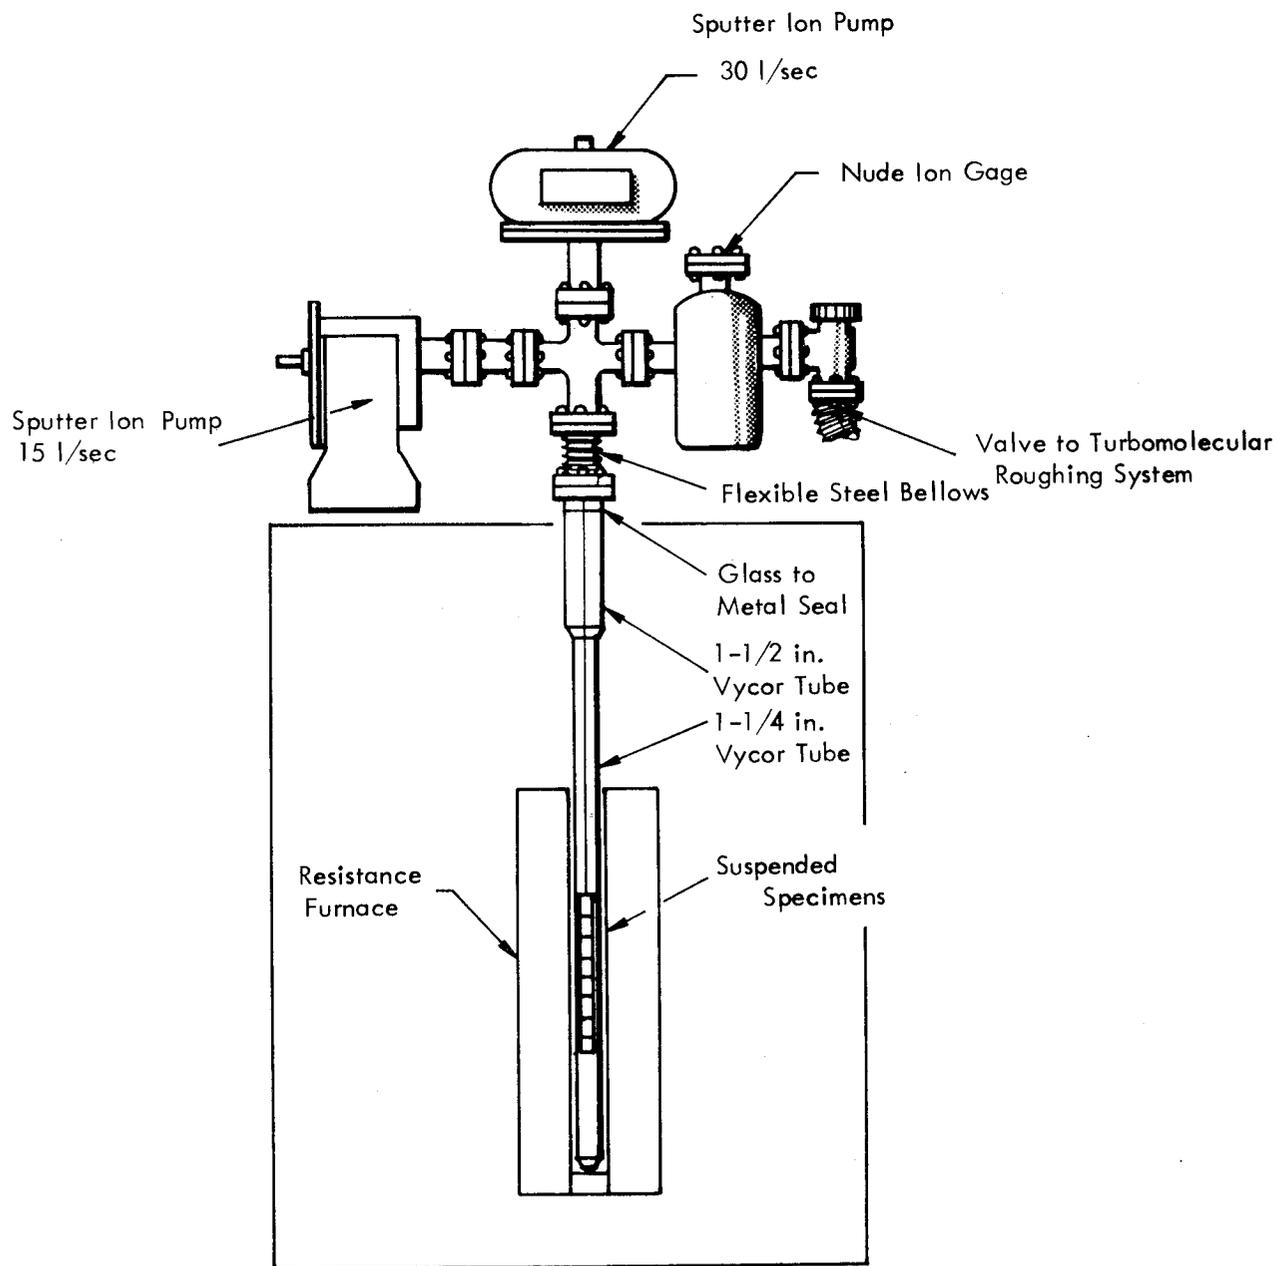
FIGURE 11. Vertical High Vacuum Aging Furnace

Aging Furnace - Sections of a brazed joint were exposed for 3000 hours at 730°C (1350°F) to determine the effect of extended service time on the complex, cobalt base, braze alloy. A vertical sputter ion pumped furnace was used as shown in Figure 11. Pressures measured in the pumping area of the furnace varied from  $6 \times 10^{-8}$  torr at temperature to  $4 \times 10^{-9}$  torr cold, following the 3000 hour run. The pressure at the beginning of the exposure was  $1 \times 10^{-6}$  torr. This type of hot wall quartz tube furnace had previously been used in high vacuum heat treating with good results<sup>(2)</sup>. As an added precaution, the bimetal specimens were wrapped in tantalum foil. Figure 9, the photograph of the thermal cycling furnace, also shows the sputter ion pump top section of the thermal exposure furnace in the background. The turbomolecular pump was used to rough pump the system to ion pump starting pressure.

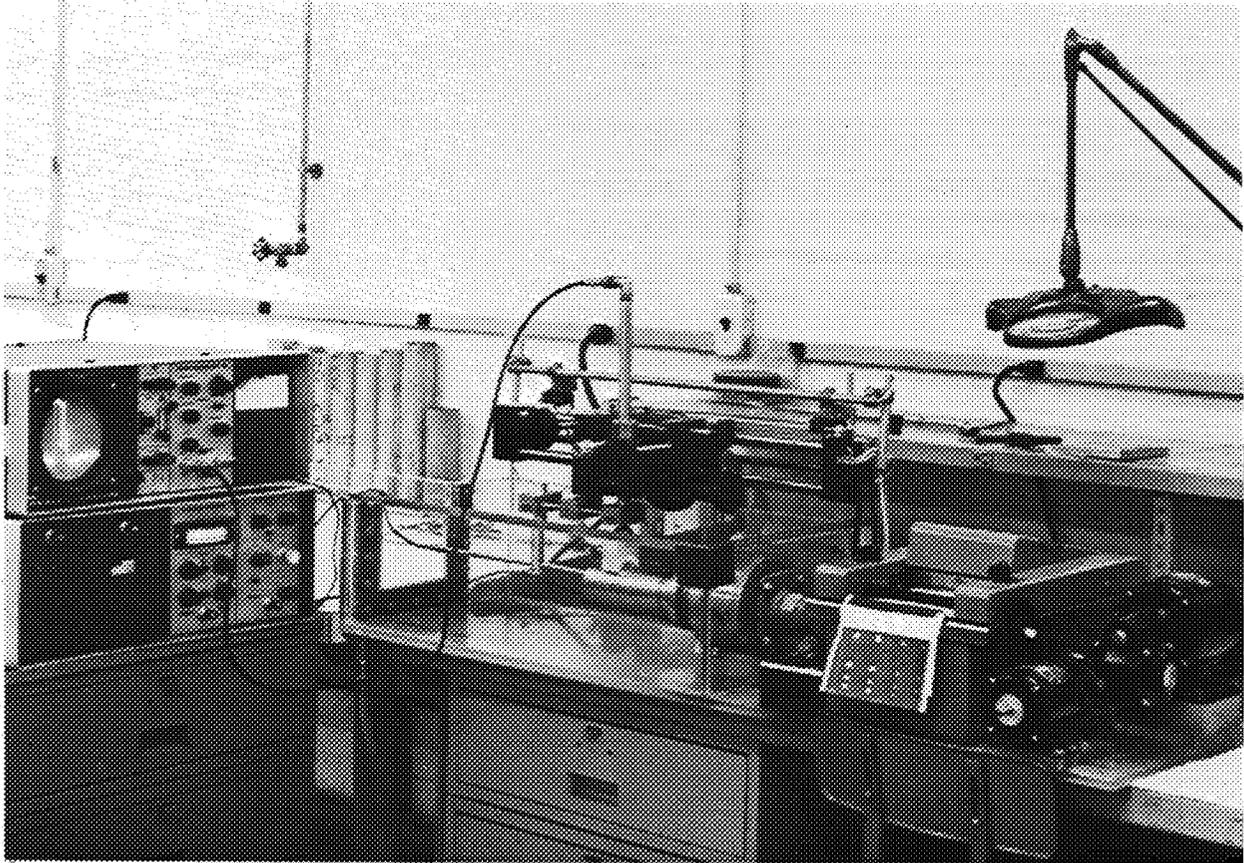
FIGURE 12. Water Immersion Automatic Traversing Transducer Head for Ultrasonic Testing and "C" Scan Recording

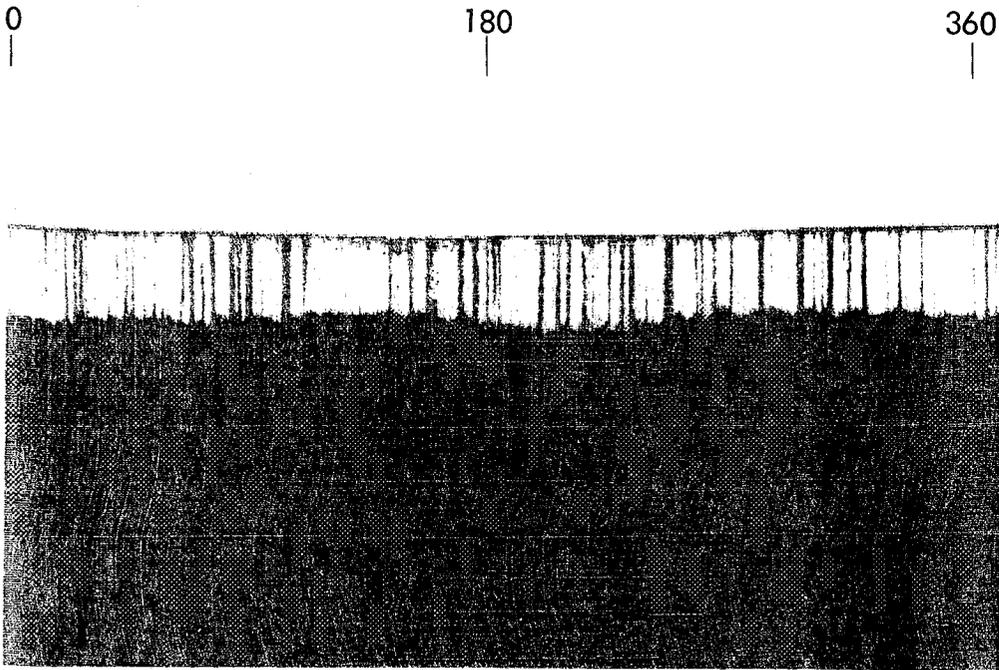
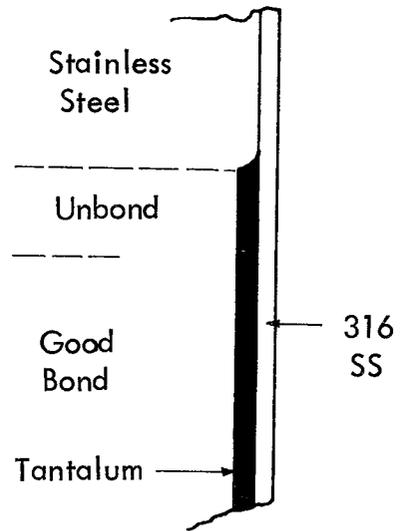
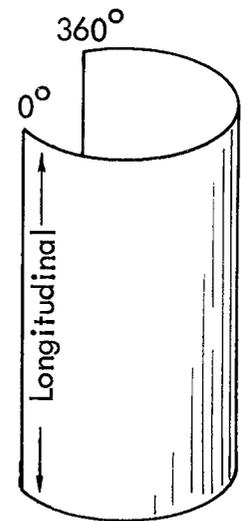
FIGURE 13. 15 MHZ Gated Pulse Echo "C" Scans of Unbond in Thermal Cycled Sleeve Joint No. 4

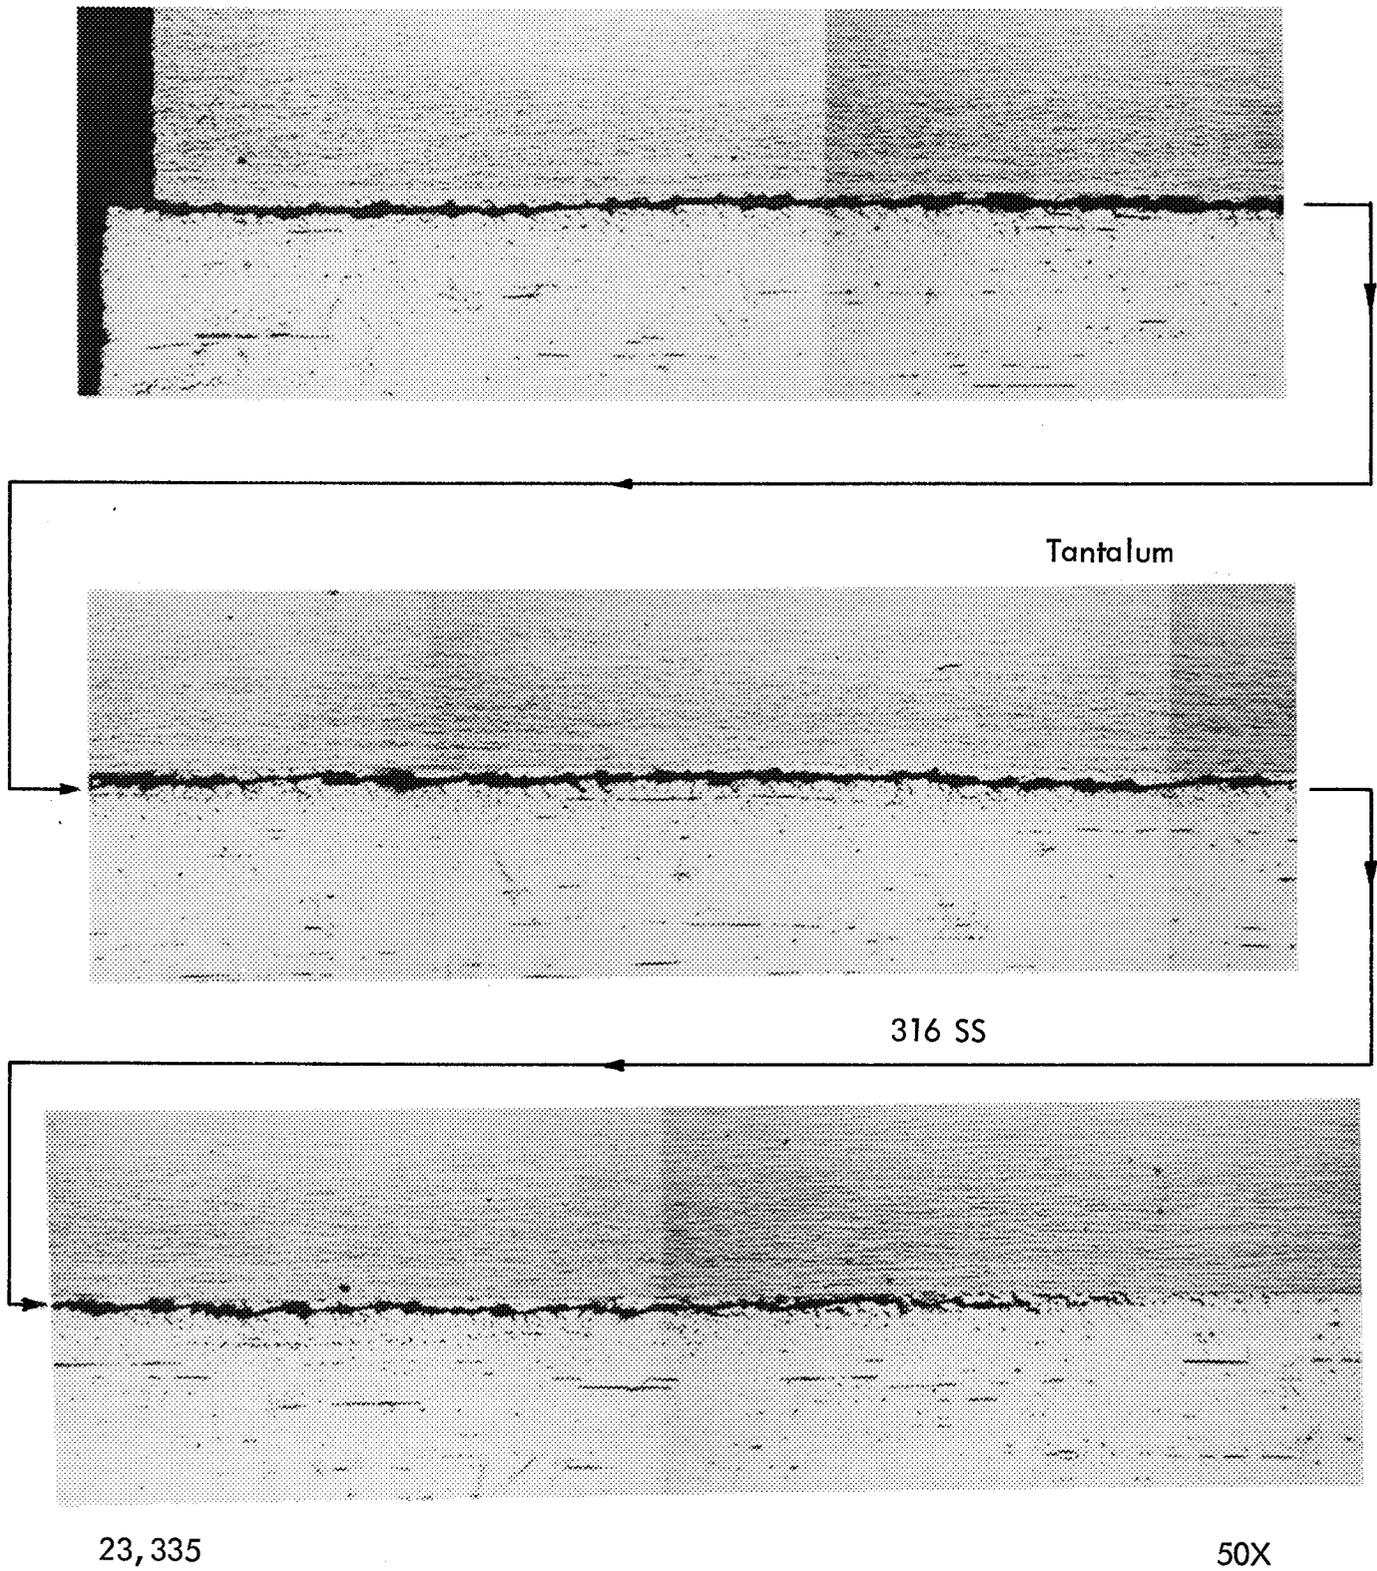
FIGURE 14. Longitudinal Section of 8.6 mm (0.340 in) Fissure Ultrasonically Detected in the Counterbored End of Thermal Cycled Sleeve Joint No. 4

steel component as shown by the significant offset in the lower photograph in Figure 28. A much deeper fissure generally occurred at the end opposite the flange area as shown in Figure 29. The fissure has propagated entirely in the stainless steel side of the sleeve joint to a depth of nearly 0.63 cm, (0.250 inch). A more extensive fissure in the counterbored end of sleeve joint No. 4 which was also detected by ultrasonic inspection, was shown in Figure 14.

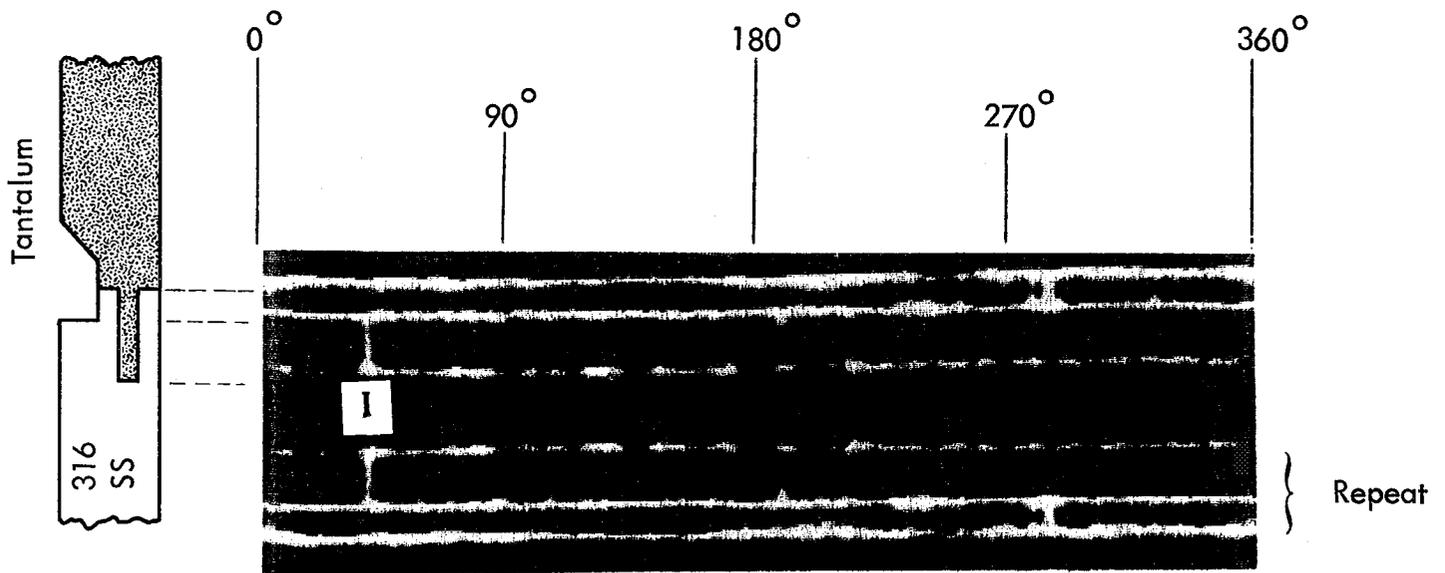
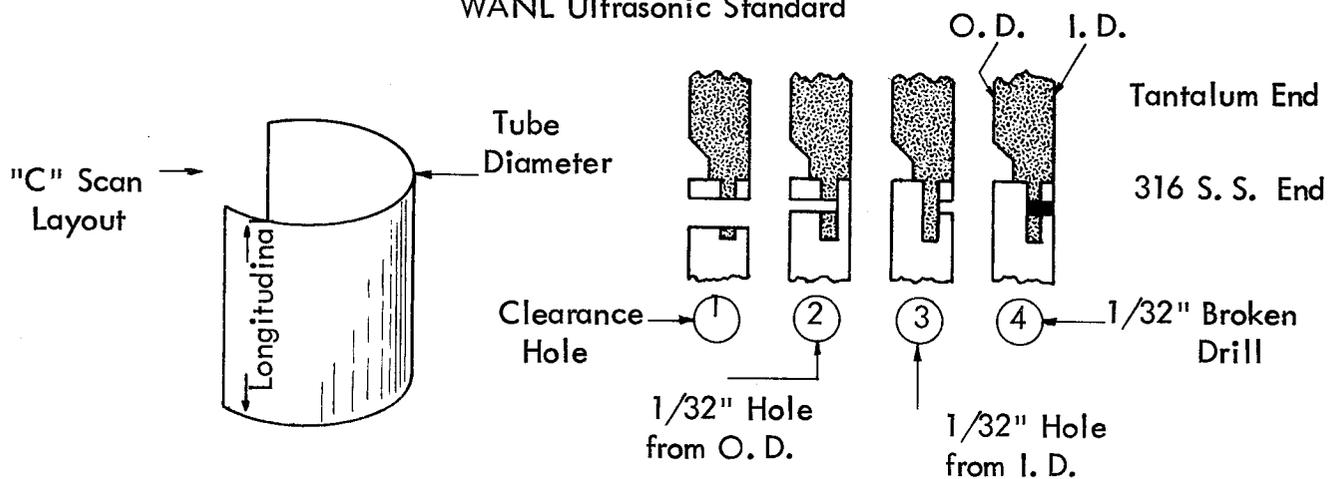
FIGURE 16. 5 MHz Through Transmission "C" Scans of Thermal Cycled Brazed Joint and Standard

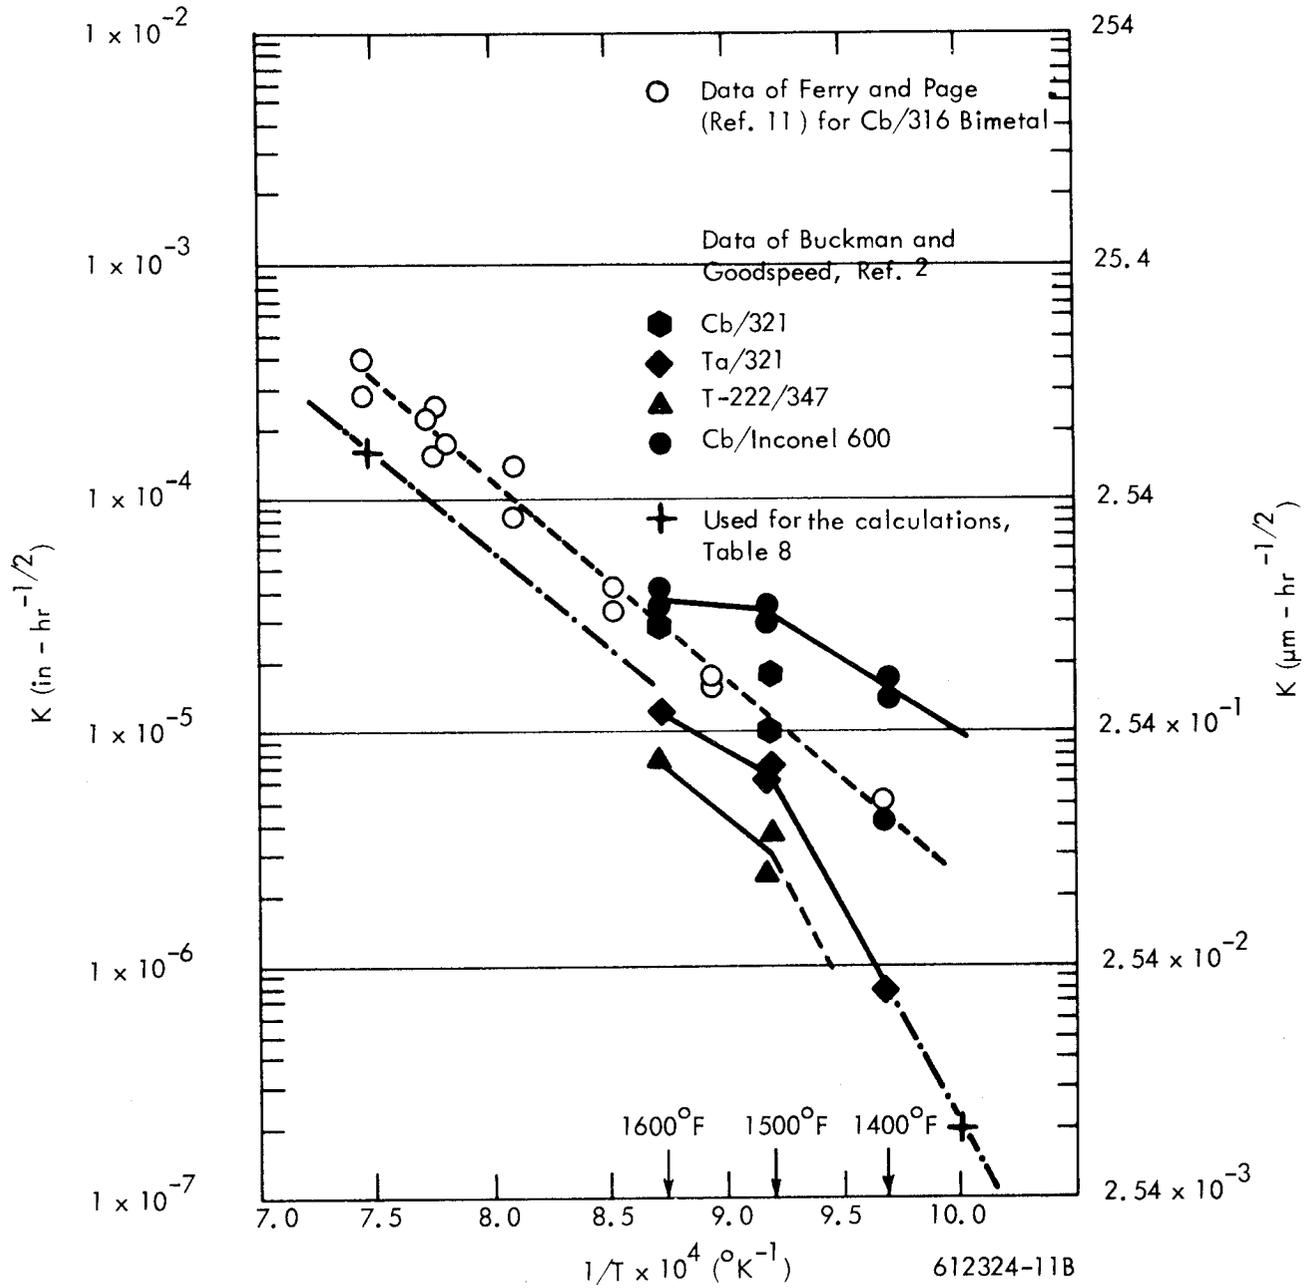
FIGURE 17. The Parabolic Reaction Rate of Interdiffusion Zone Growth as a Function of Reciprocal Temperature for Selected Refractory/Austenitic Bimetal Composites
