NASA CR-121111  
WANL-M-FR-72-006  
DECEMBER 1972

**EVALUATION OF TANTALUM/316  
STAINLESS STEEL TRANSITION JOINTS**

**WESTINGHOUSE ASTRONUCLEAR LABORATORY**

prepared for  
**NATIONAL AERONAUTICS AND SPACE ADMINISTRATION**  
NASA Lewis Research Center

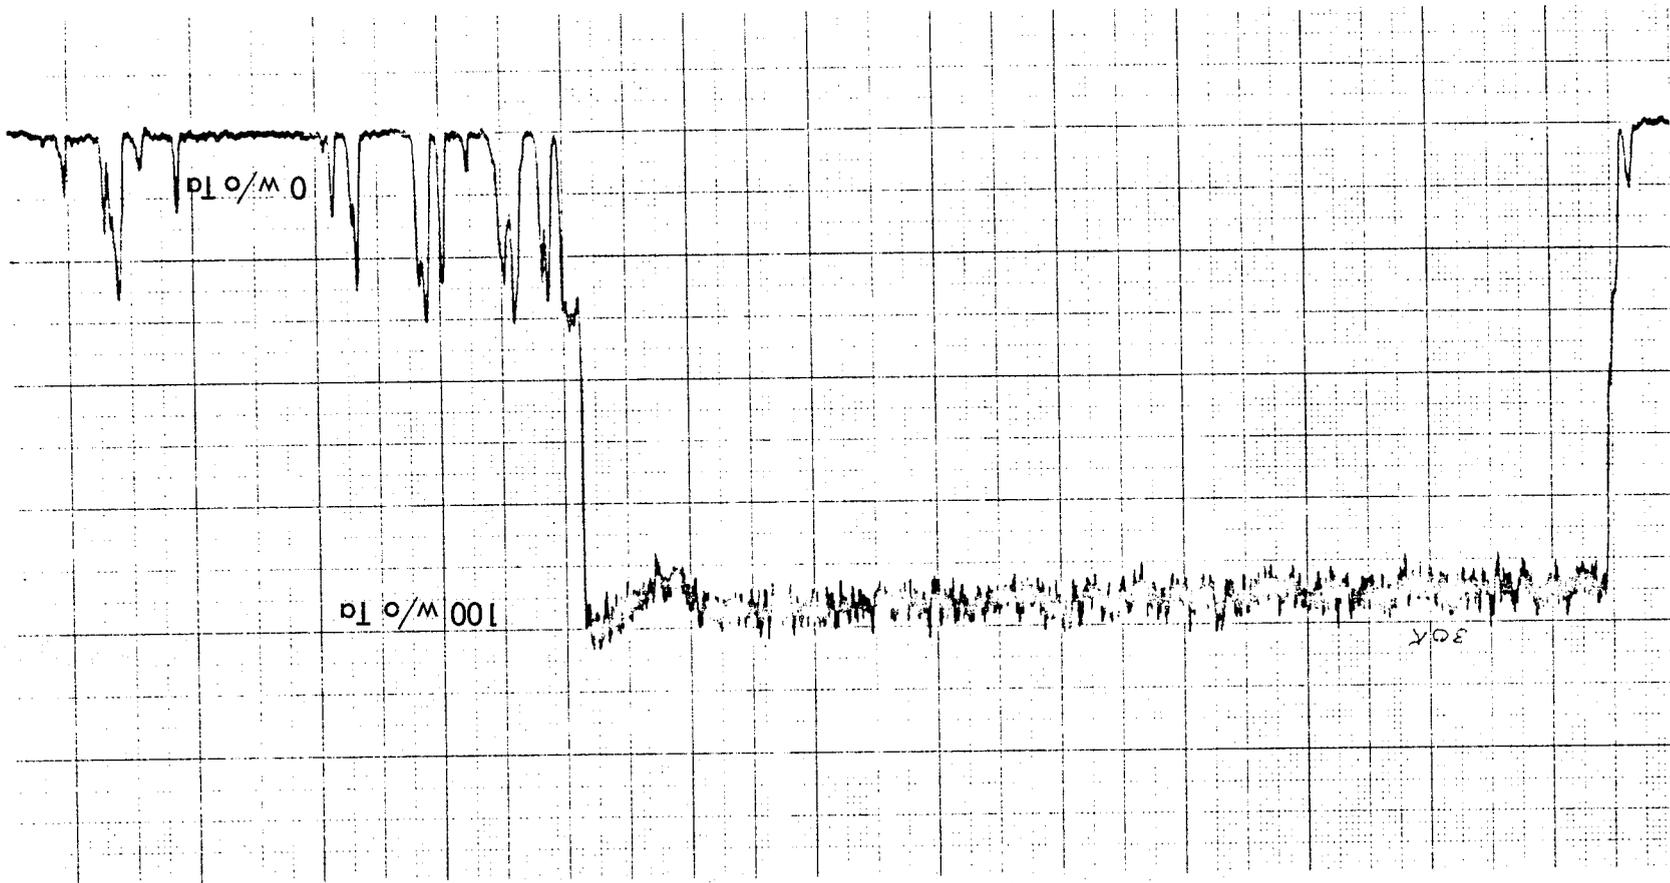
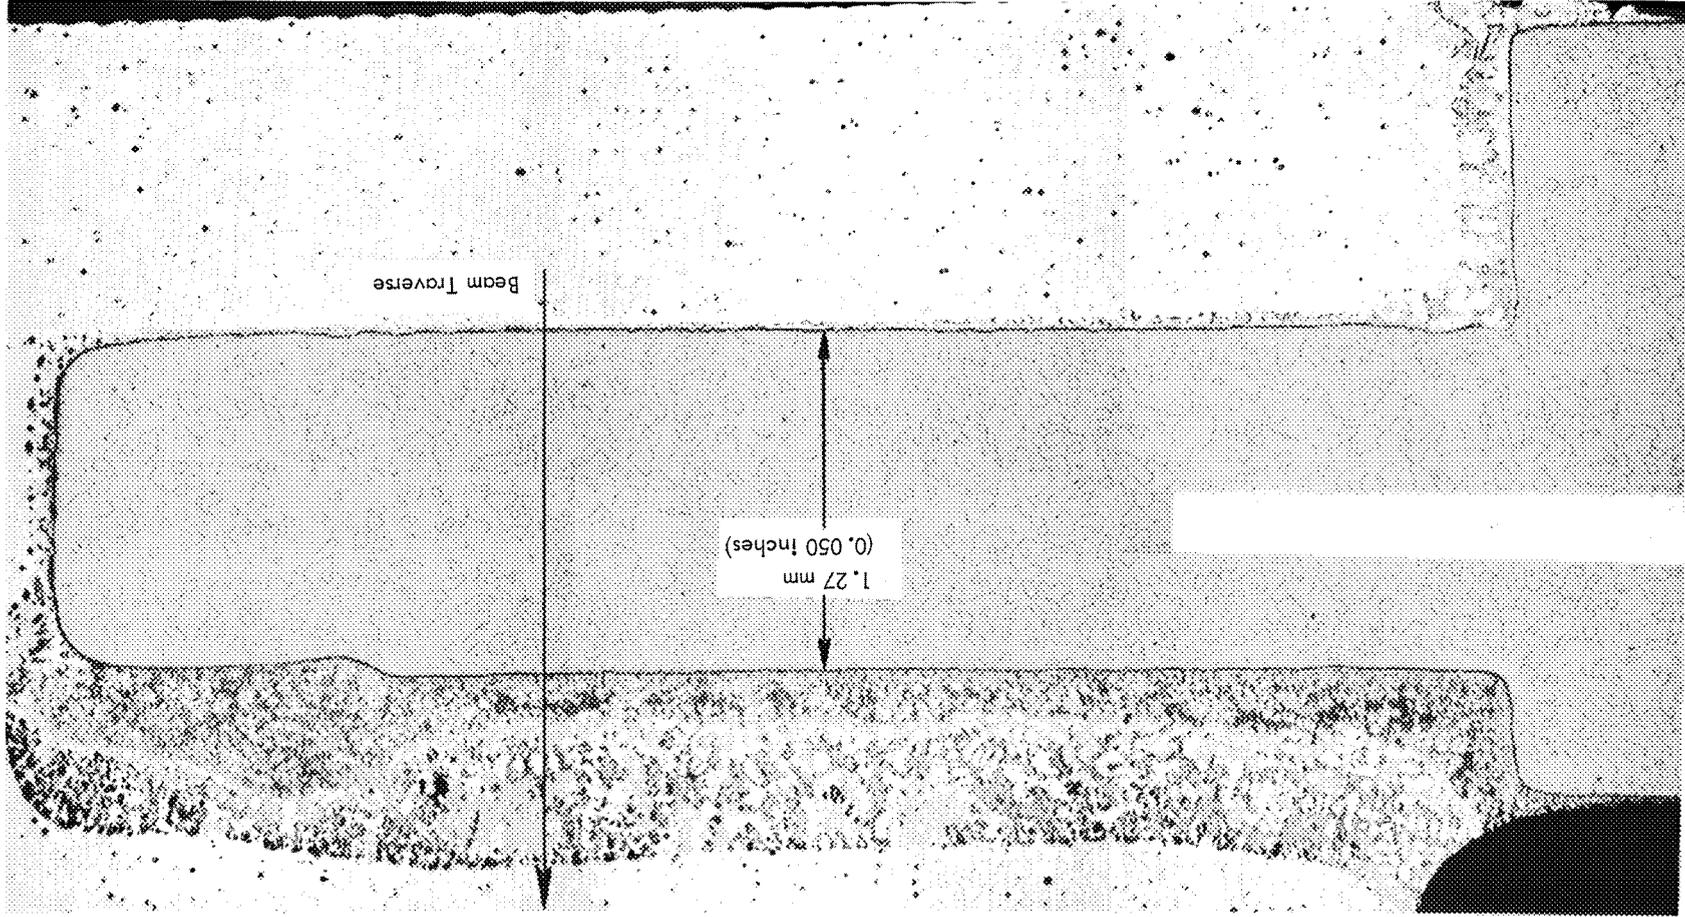
FIGURE 20. Longitudinal Section of Brazed Joint No. 11 in the As-brazed Condition

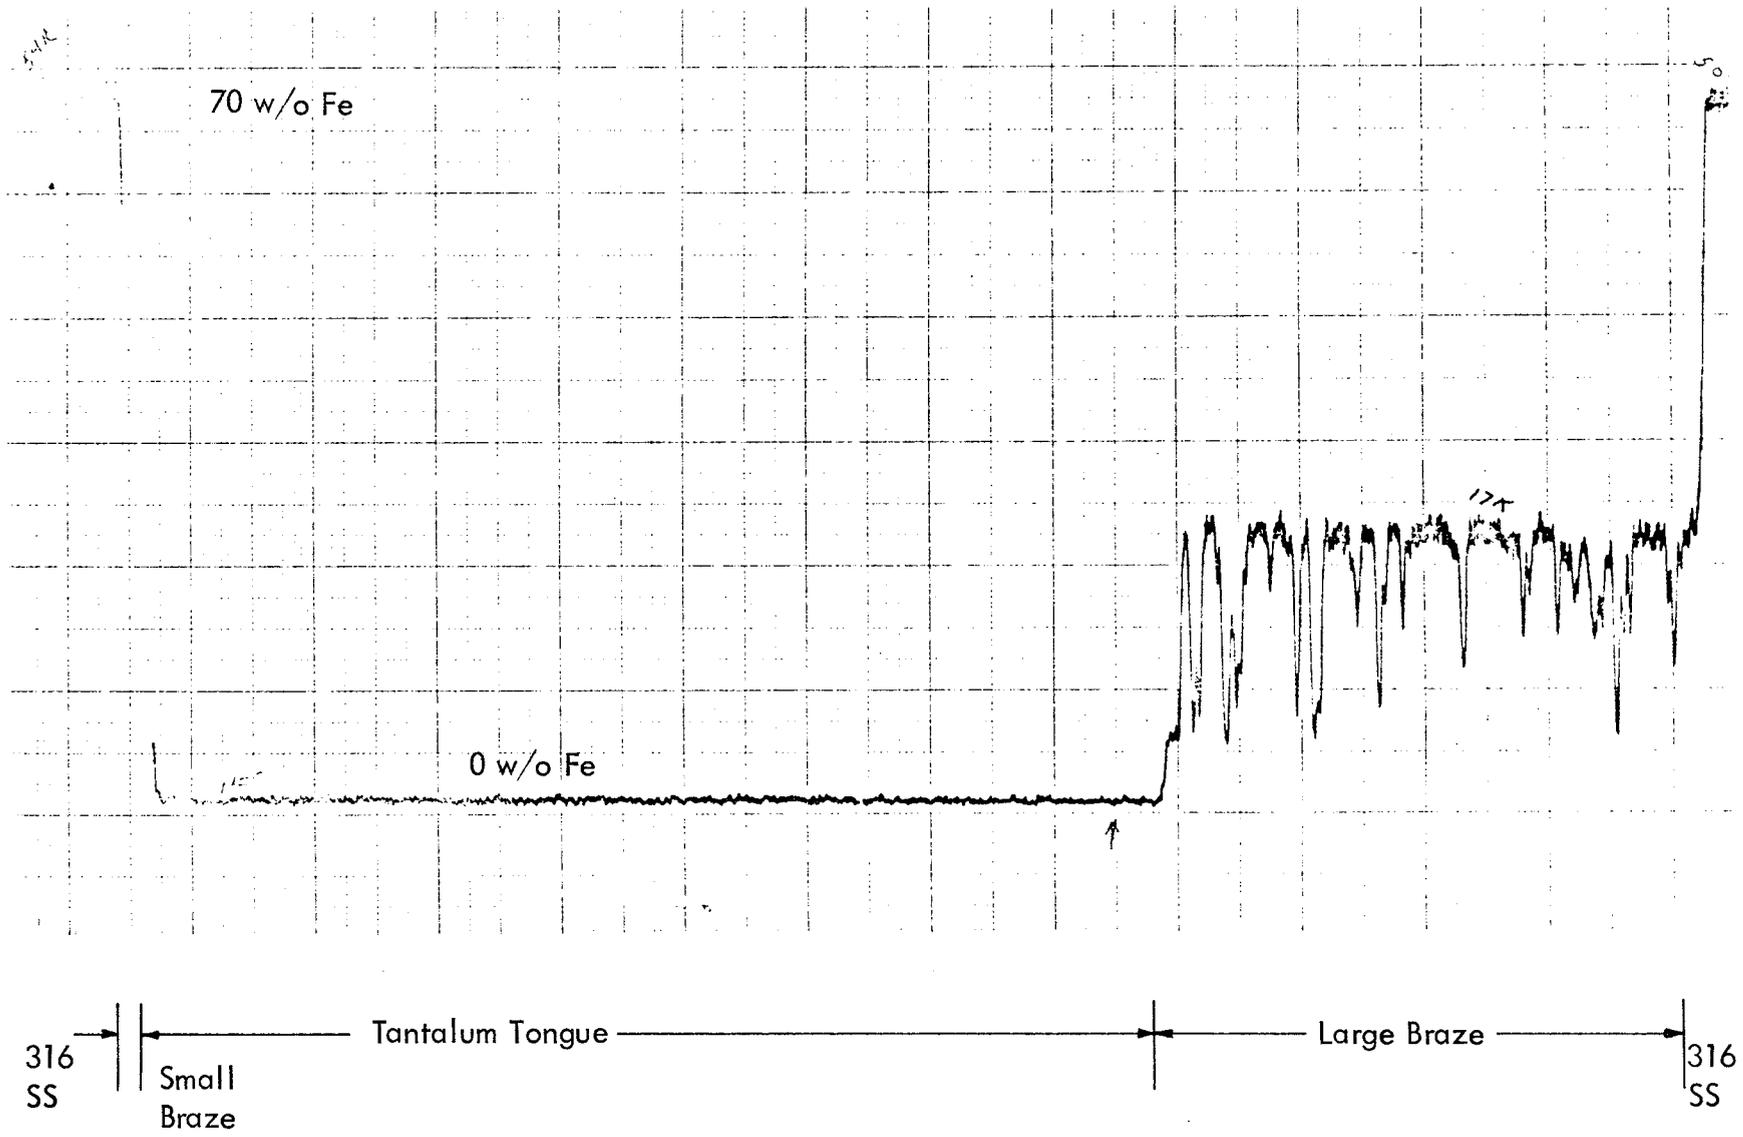
FIGURE 22. Low Magnification Electron Beam Microprobe Linear Scan for Iron Across Braze Joint No. 11, As-brazed Condition

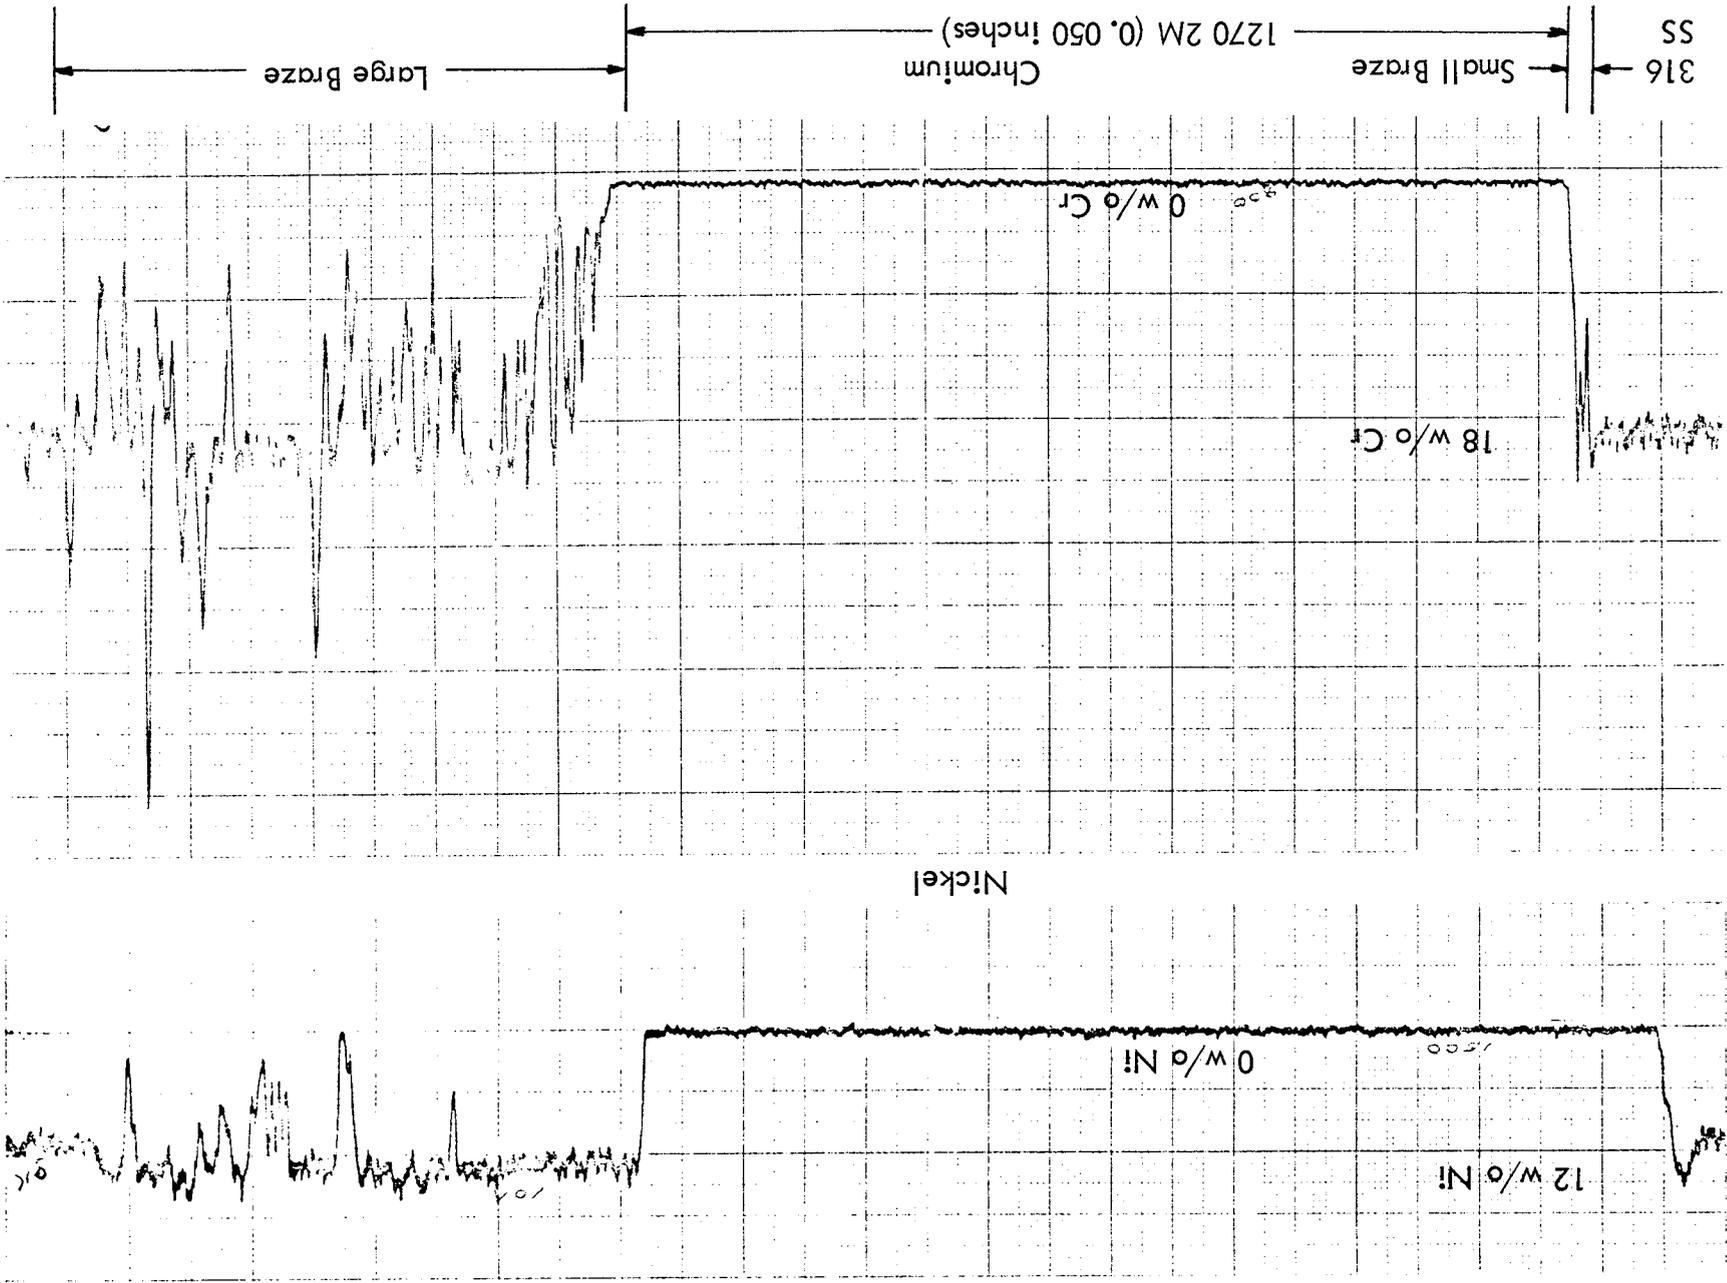
FIGURE 23. Low Magnification Electron Beam Microprobe Linear Scans for Nickel and Chromium Across Braze Joint No. 11, As-brazed Condition

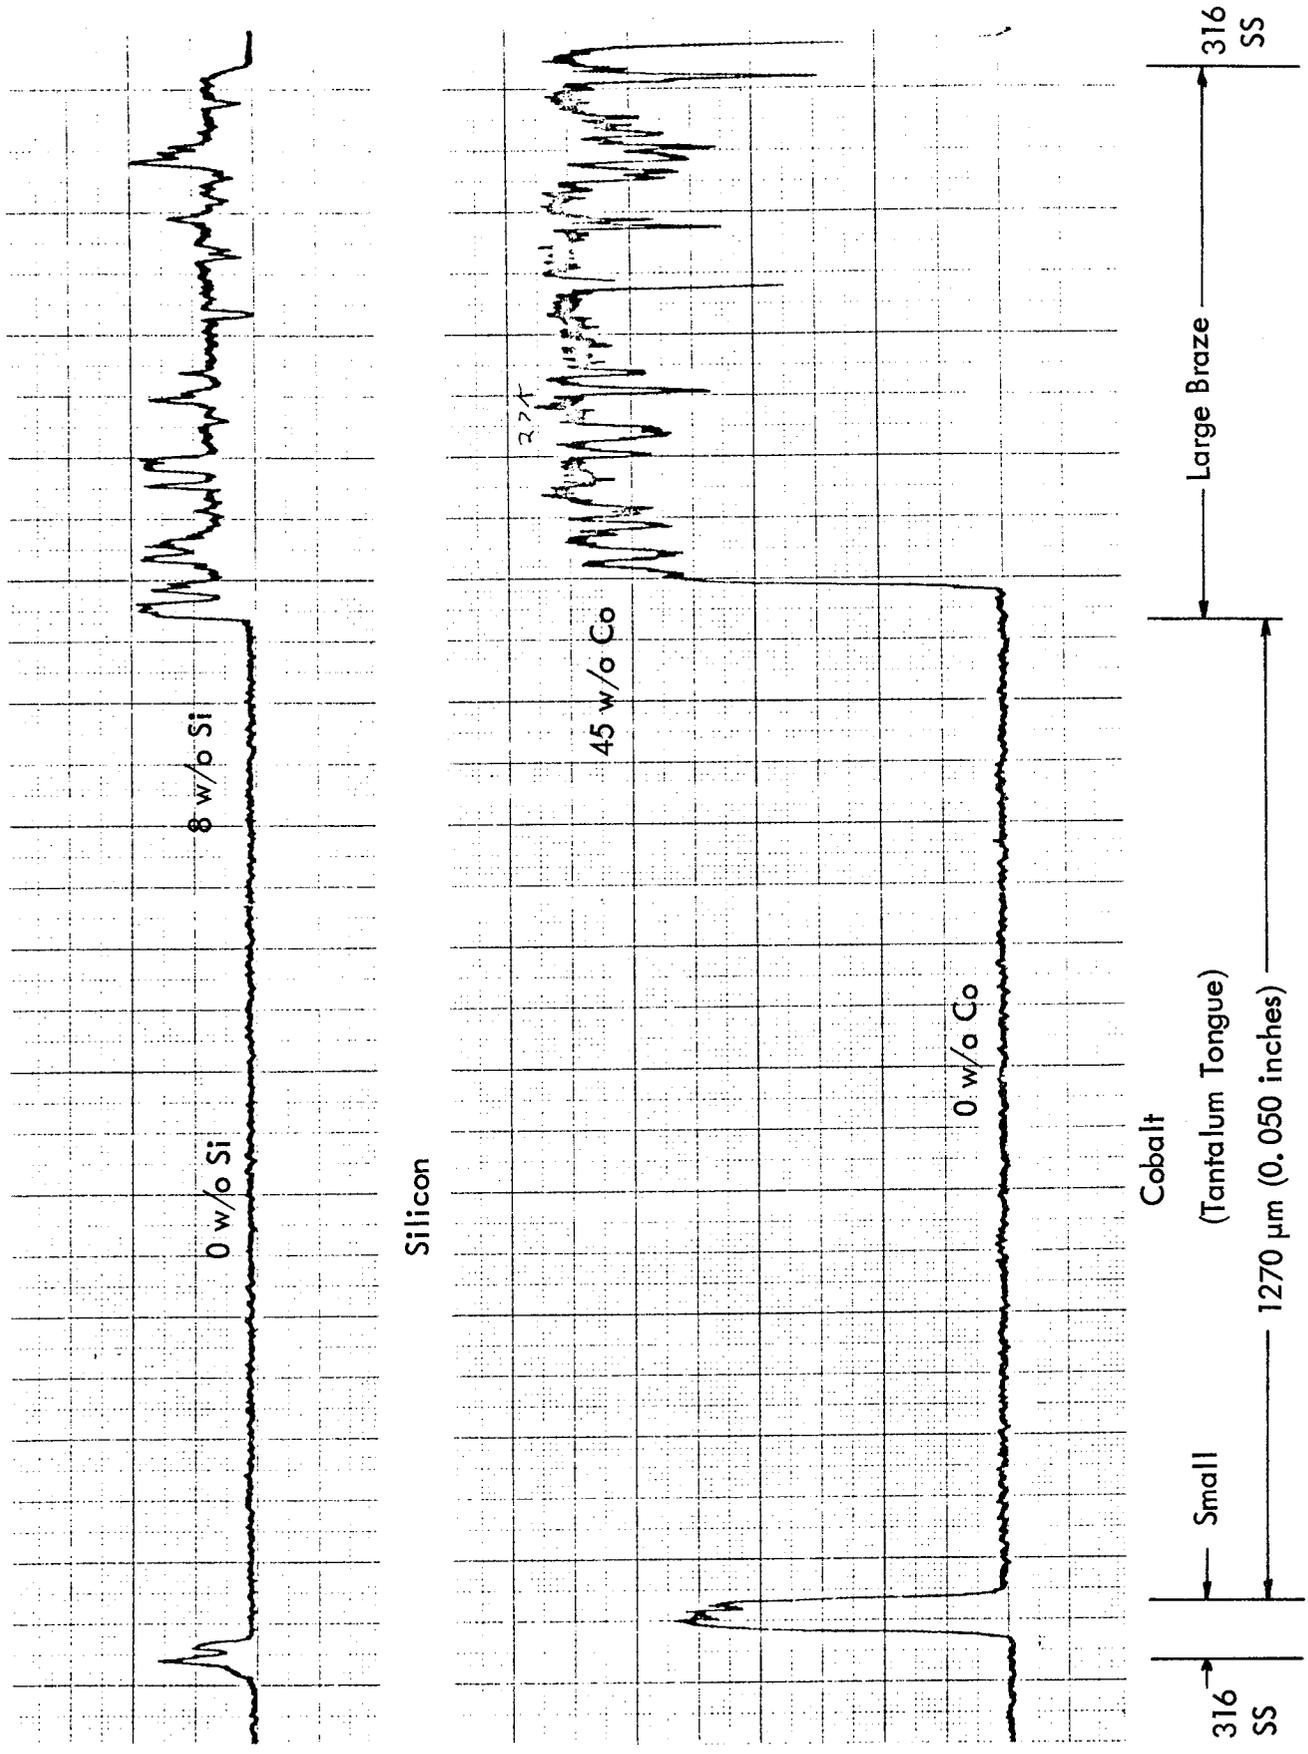
FIGURE 24. Low Magnification Electron Beam Microprobe Linear Scans for Silicon and Cobalt on Braze Joint No. 11, As-brazed Condition

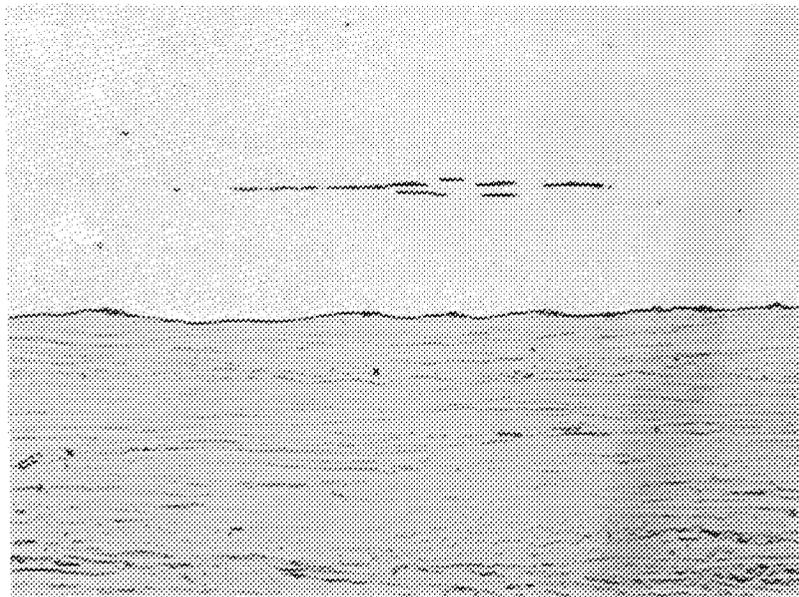
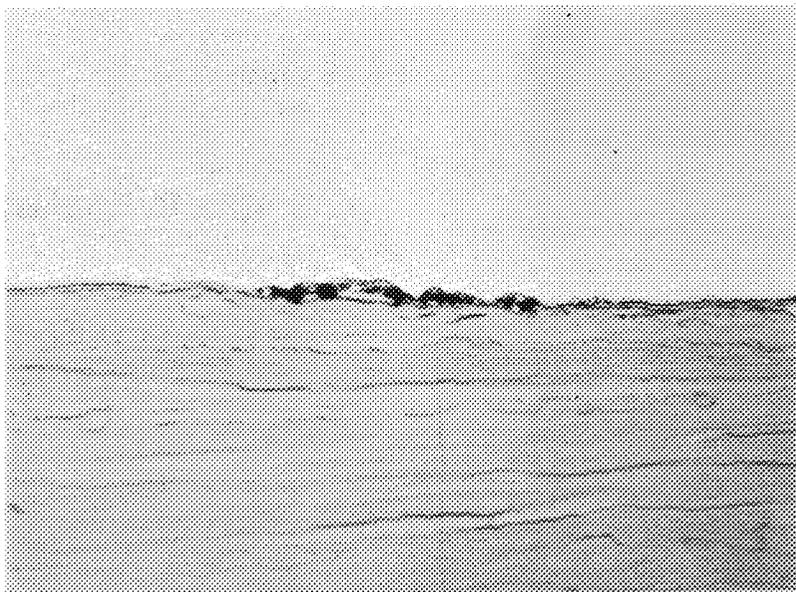
FIGURE 25. Longitudinal Section of Flanged Sleeve Joint No. 7  
at Location "A" As-extruded

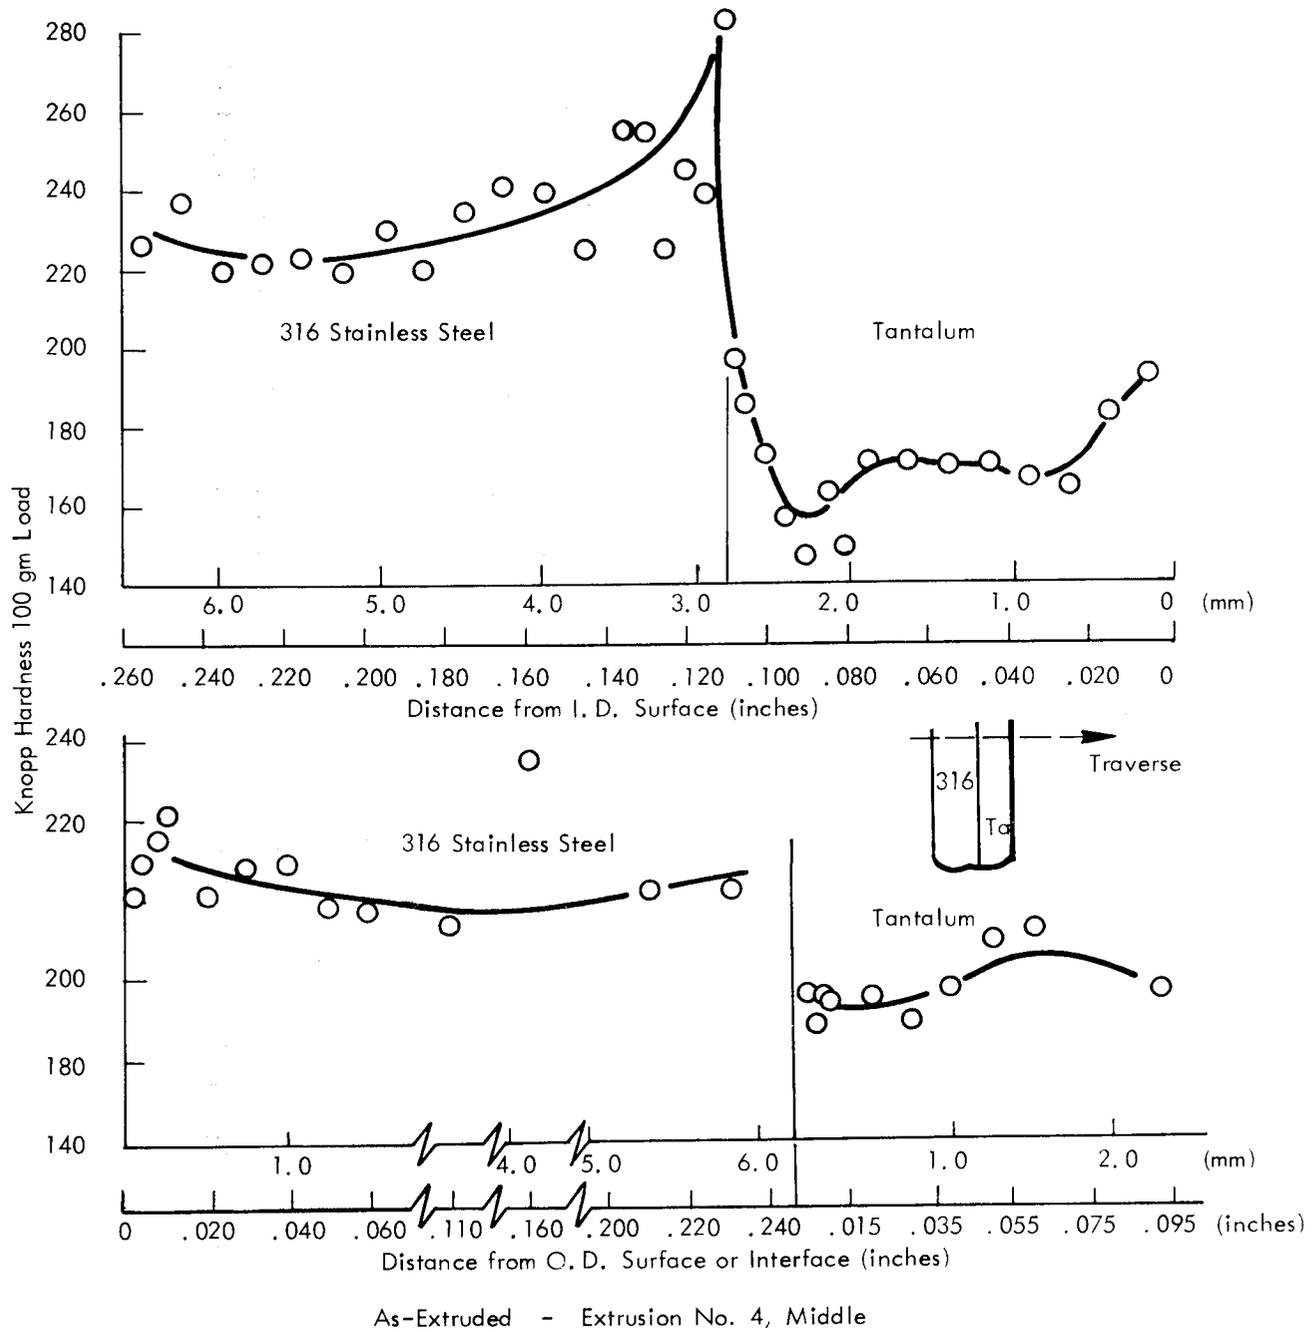
Figure 27. Comparison of As-Extruded and Thermal Cycled Hardness Traverses from Extrusion and Sleeve Joint No. 4, Longitudinal Sections

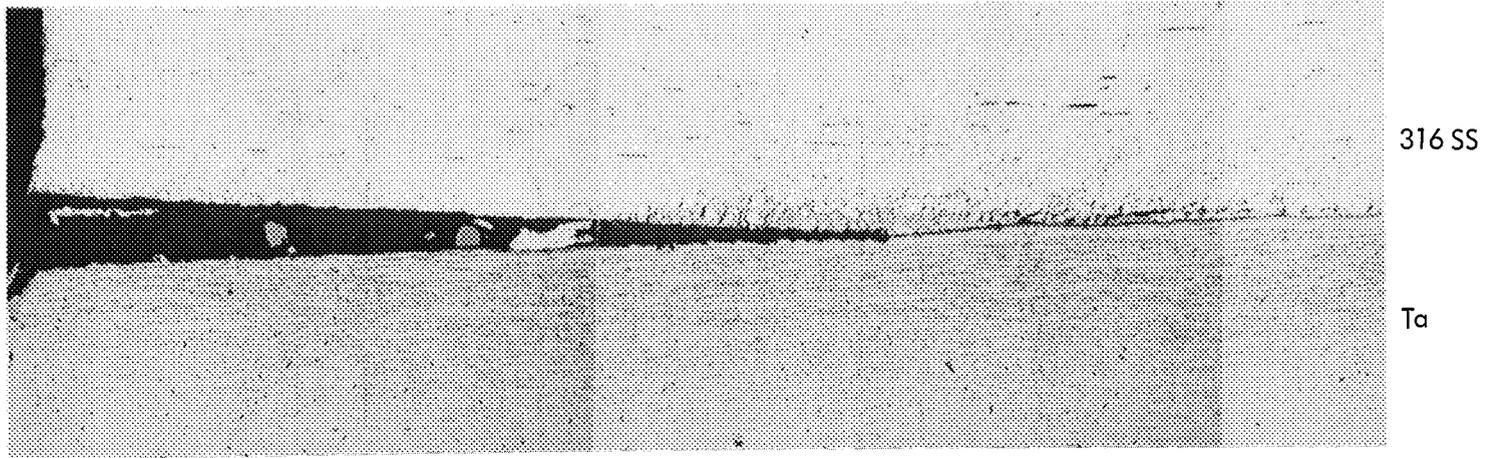
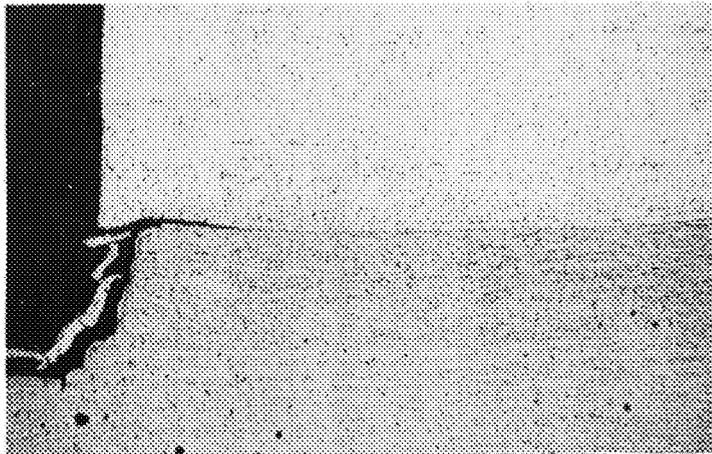
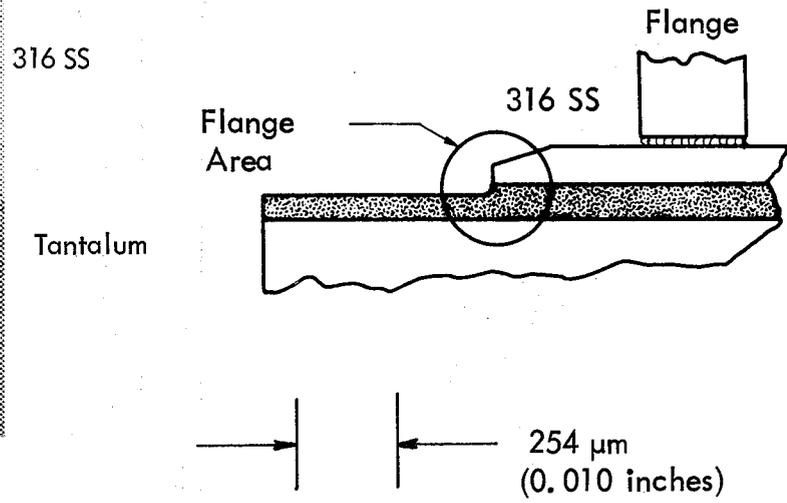
FIGURE 28. Flange End Interface in Thermal Cycled Sleeve Joints

steel component as shown by the significant offset in the lower photograph in Figure 28. A much deeper fissure generally occurred at the end opposite the flange area as shown in Figure 29. The fissure has propagated entirely in the stainless steel side of the sleeve joint to a depth of nearly 0.63 cm, (0.250 inch). A more extensive fissure in the counterbored end of sleeve joint No. 4 which was also detected by ultrasonic inspection, was shown in Figure 14.

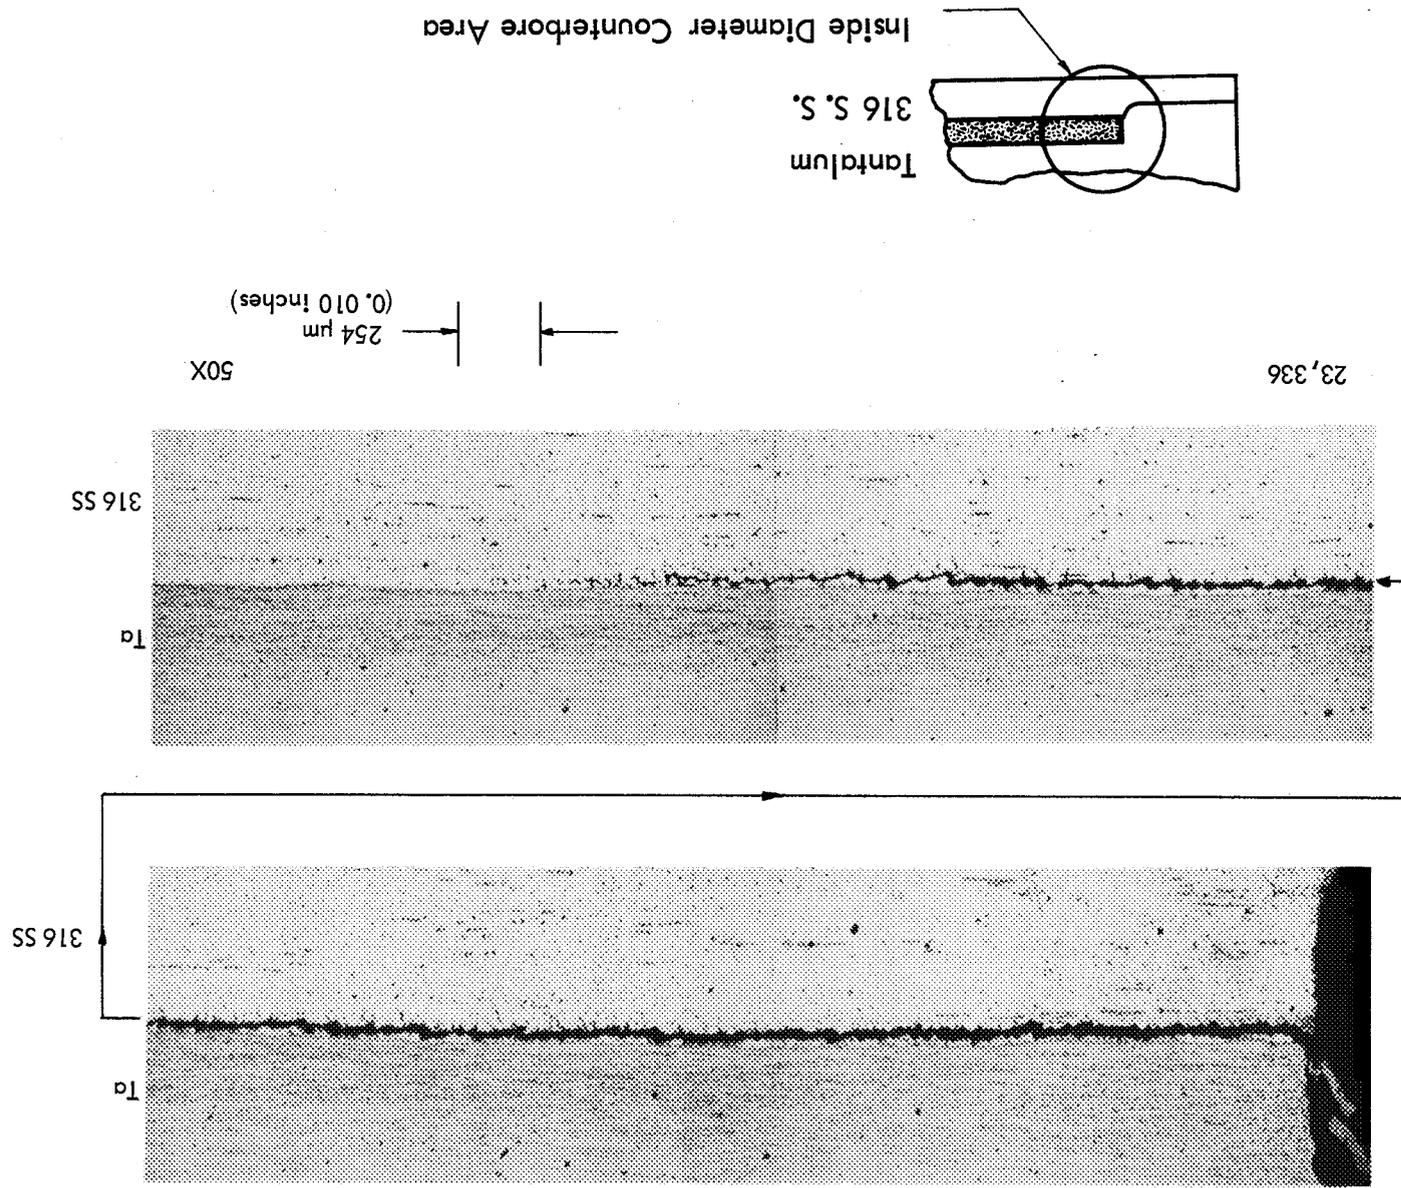
FIGURE 29. Bond Rupture Through Stainless Steel in Thermal Cycled Sleeve Joint No. 8, Counterbore Area

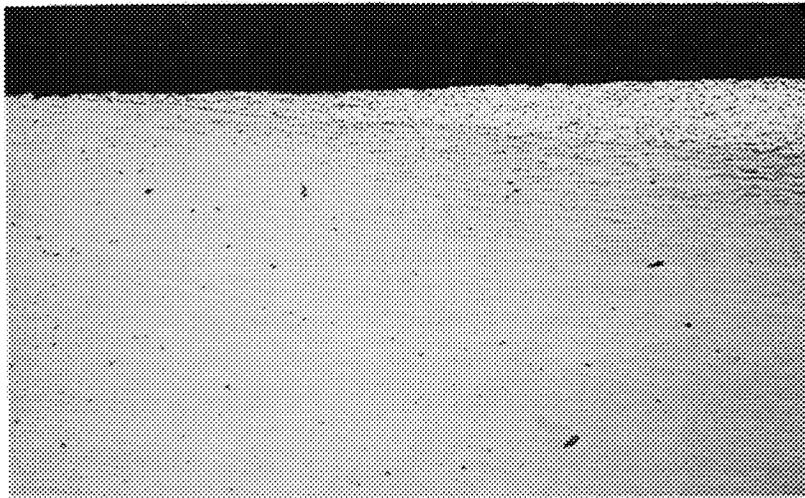
FIGURE 30. Longitudinal Sections of Tandem Joint No. 11 Following Thermal Cycling Showing Well Bonded Feather Edge

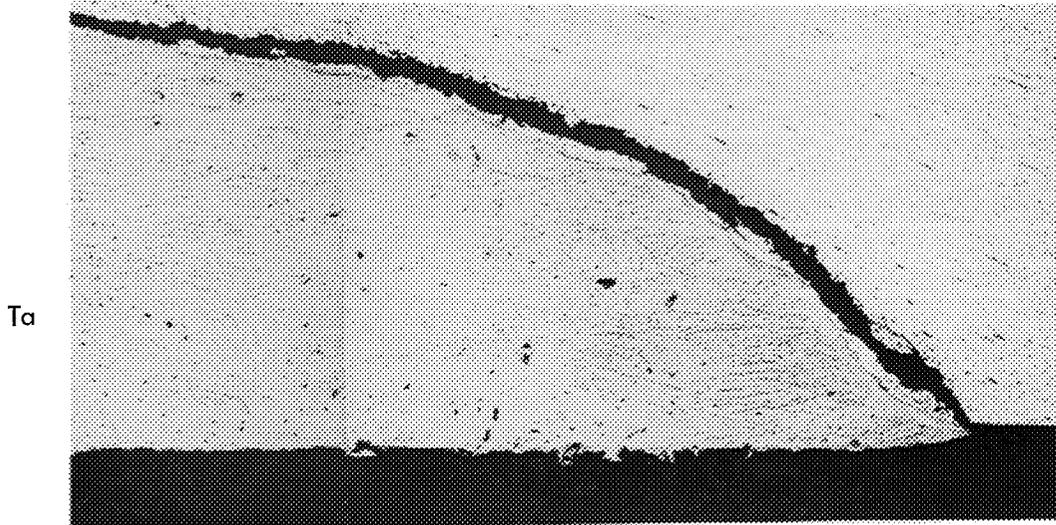
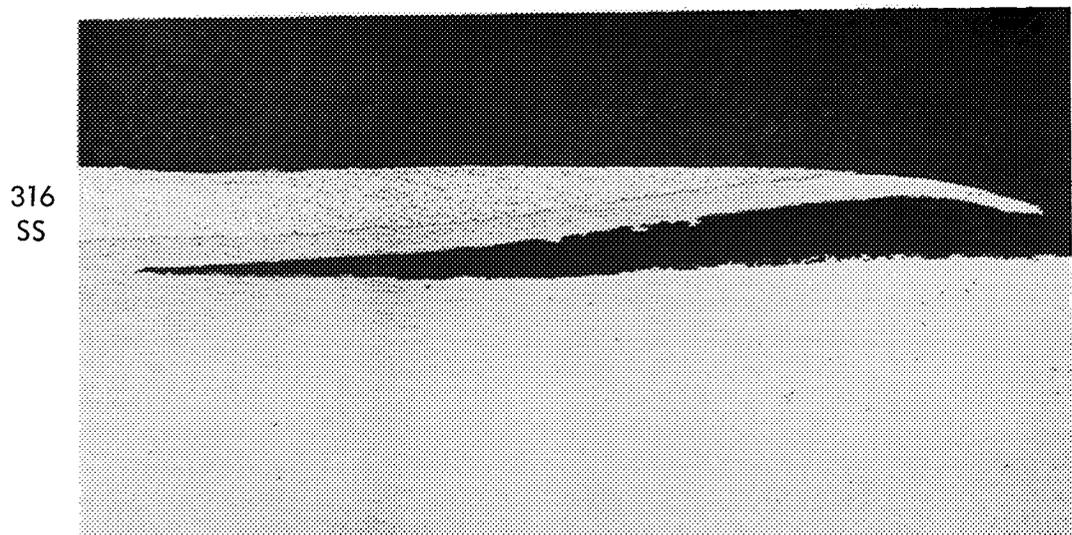
23,330 Inside Diameter Fissure in Stainless Steel Area 50X

FIGURE 31. Longitudinal Sections of Tandem Joint Following Thermal Cycling Showing Bond Line Fissures

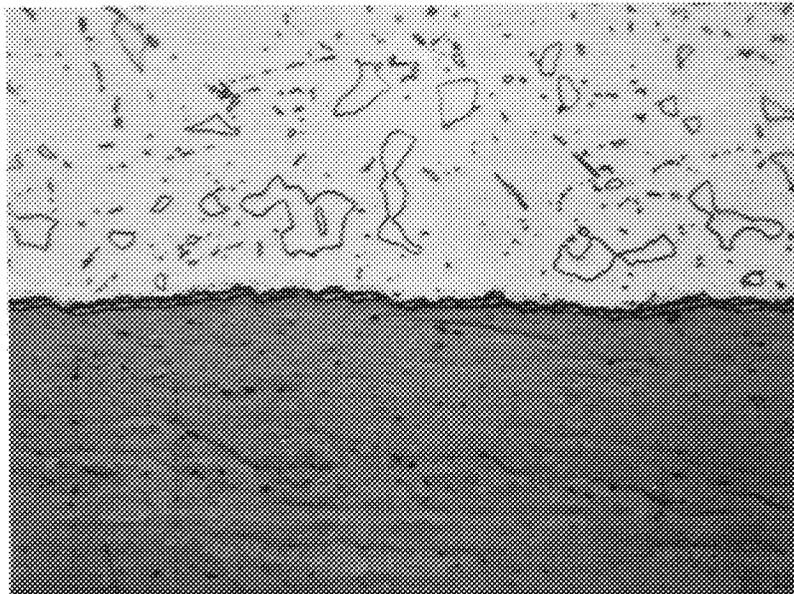
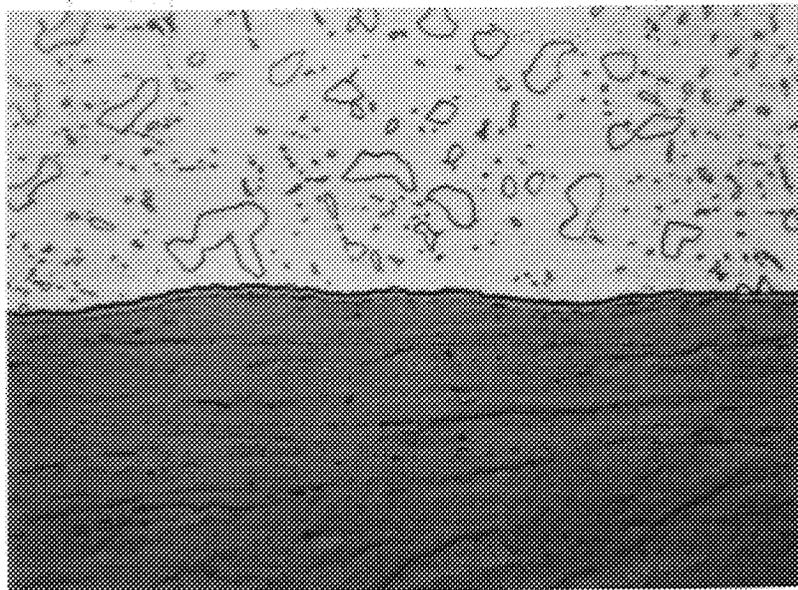
FIGURE 33. High Magnification Comparison of Interdiffusion Zone Growth in Thermal Cycled Tandem Joints

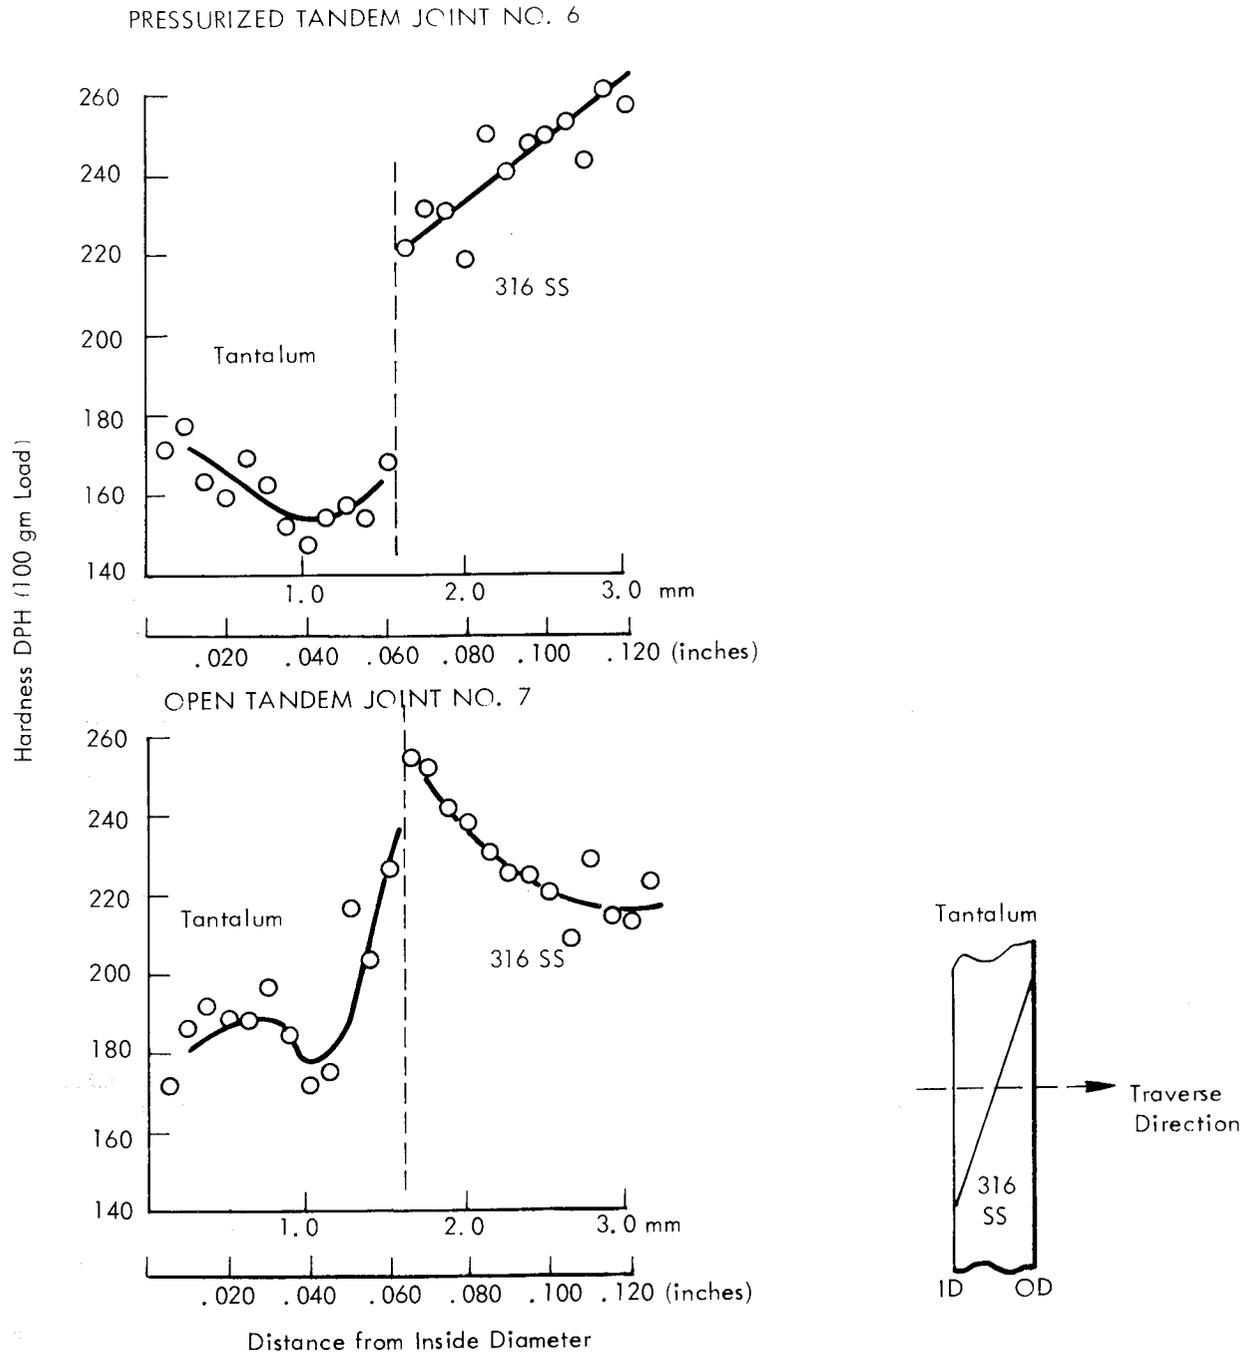
Figure 35. Hardness Traverse Across Wall Thickness of Thermal Cycled Tandem Joints (Plan A) Comparing Pressurized and Open Specimens

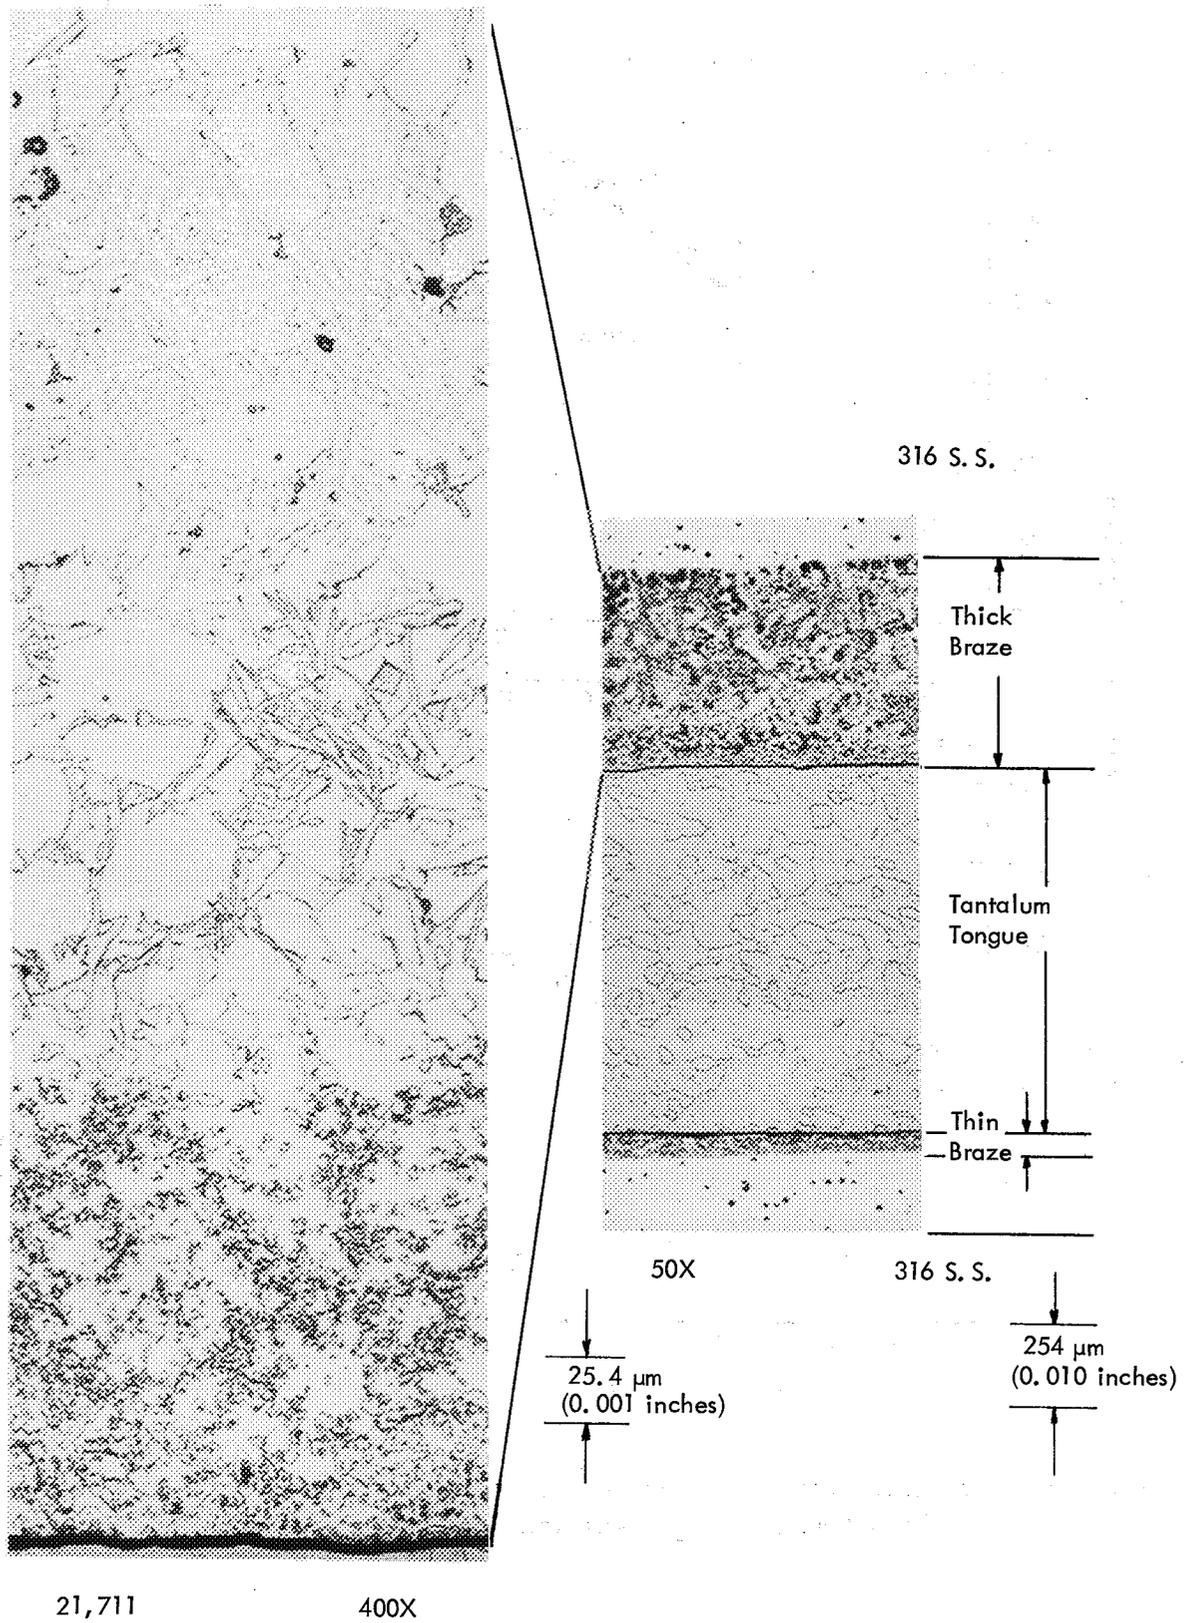
FIGURE 36. Braze Cross Section of As-brazed Joint No. 11 Longitudinal Section
