NASA CR-121111  
WANL-M-FR-72-006  
DECEMBER 1972

**EVALUATION OF TANTALUM/316  
STAINLESS STEEL TRANSITION JOINTS**

**WESTINGHOUSE ASTRONUCLEAR LABORATORY**

prepared for  
**NATIONAL AERONAUTICS AND SPACE ADMINISTRATION**  
NASA Lewis Research Center

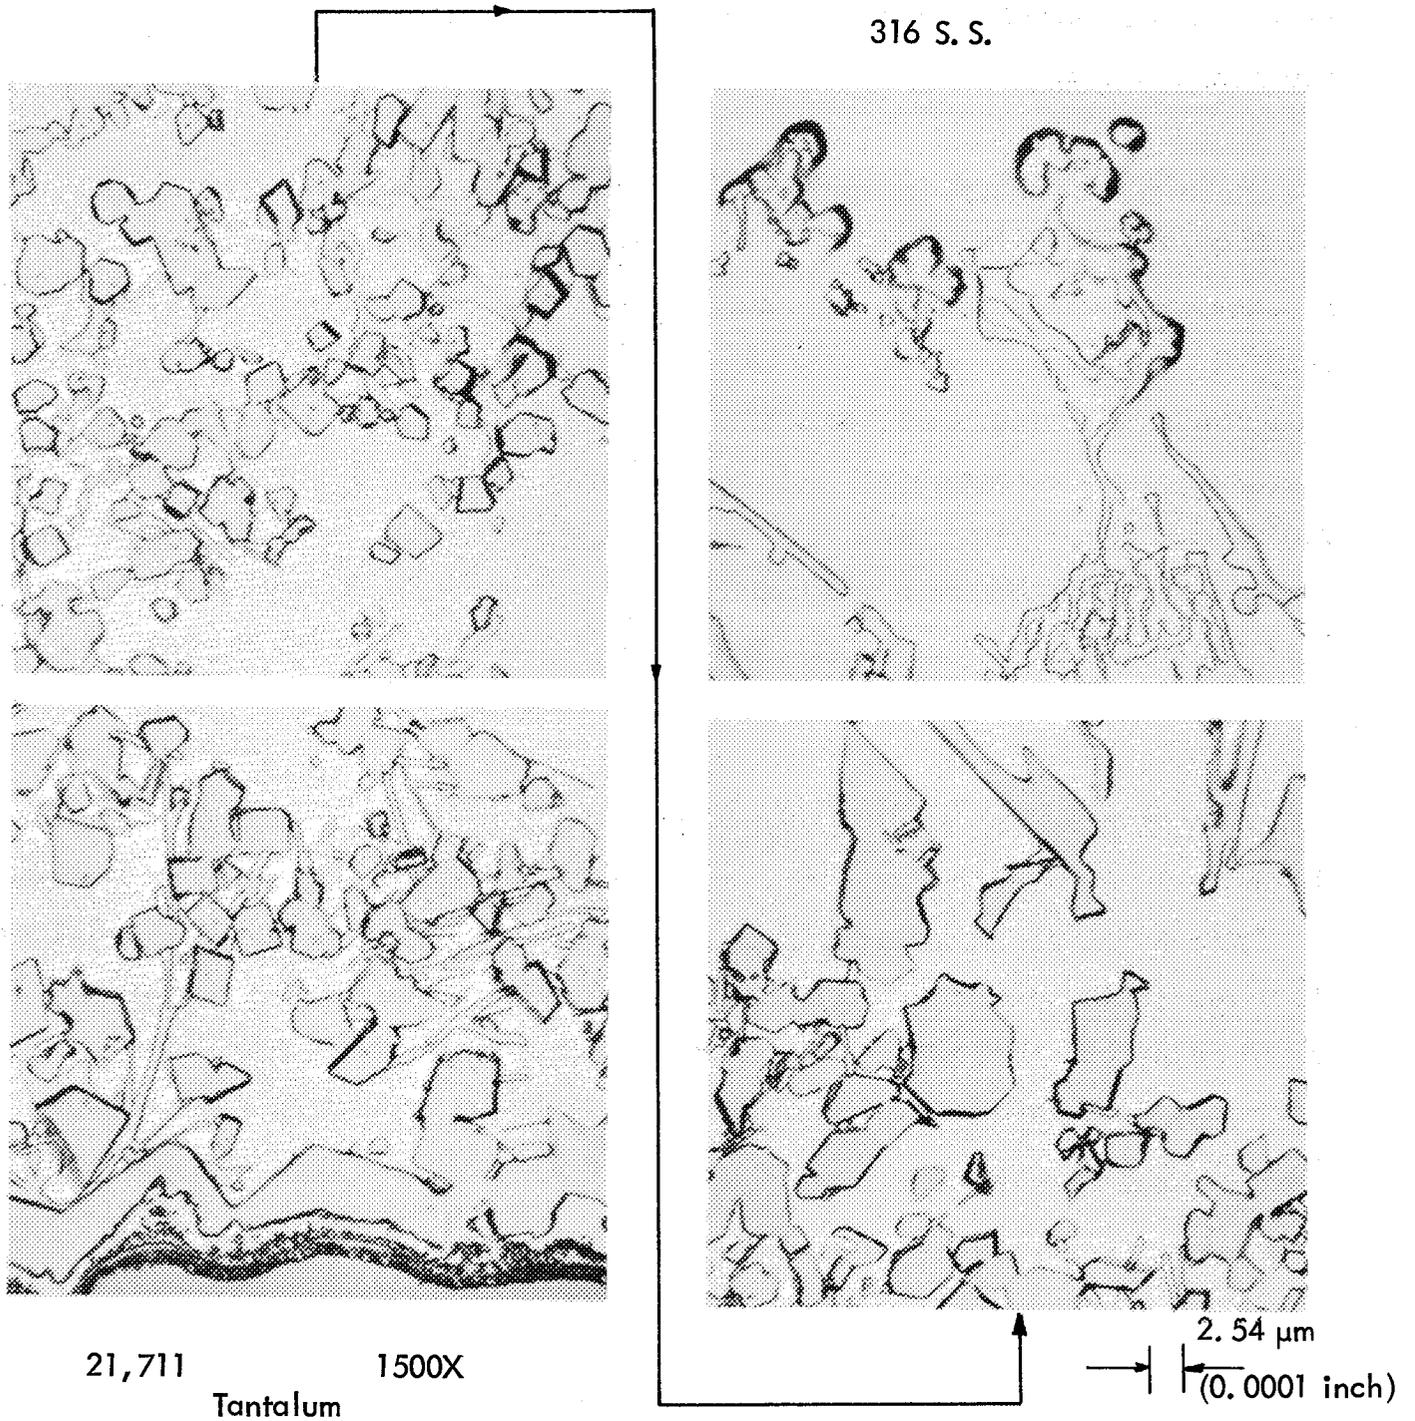
FIGURE 37. As-brazed Joint Cross Section Joint No. 11

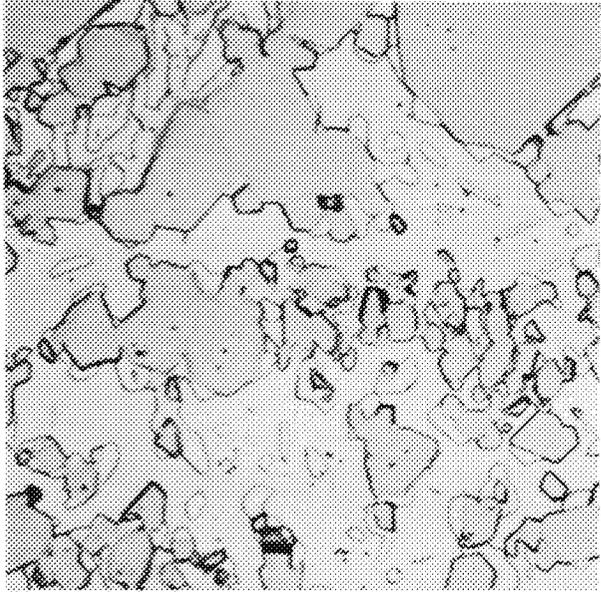
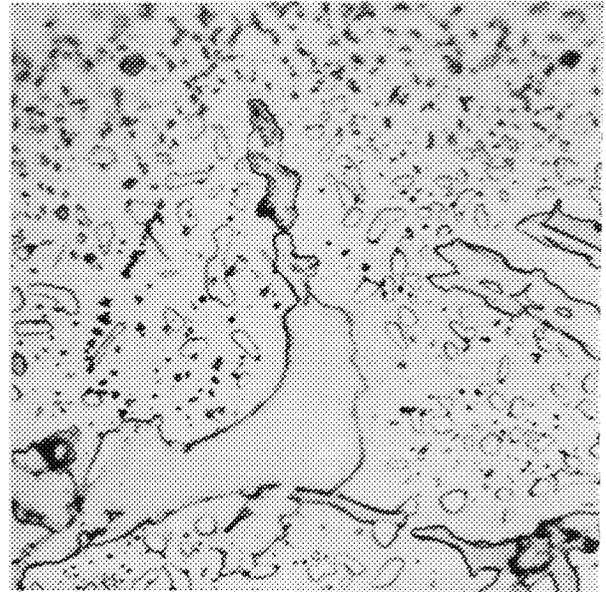
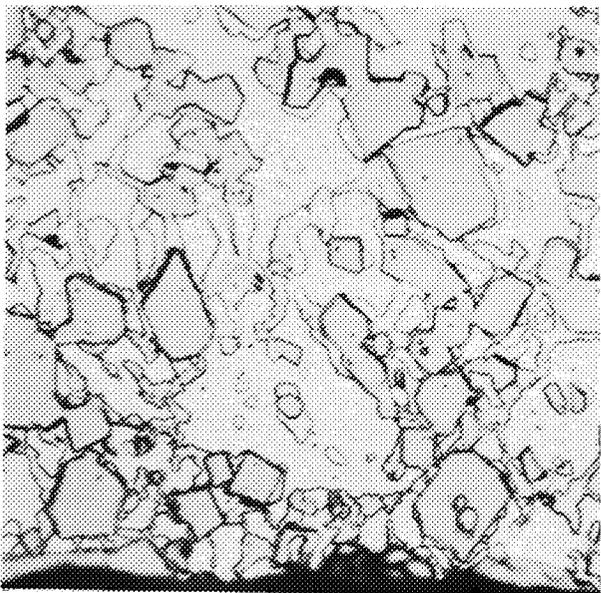
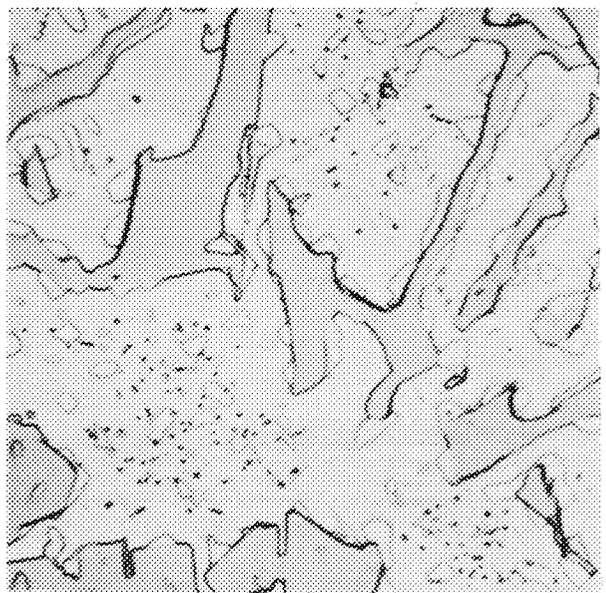
FIGURE 38. 2000 Hours at 730°C (1350°F) (Brazed Cross Section)

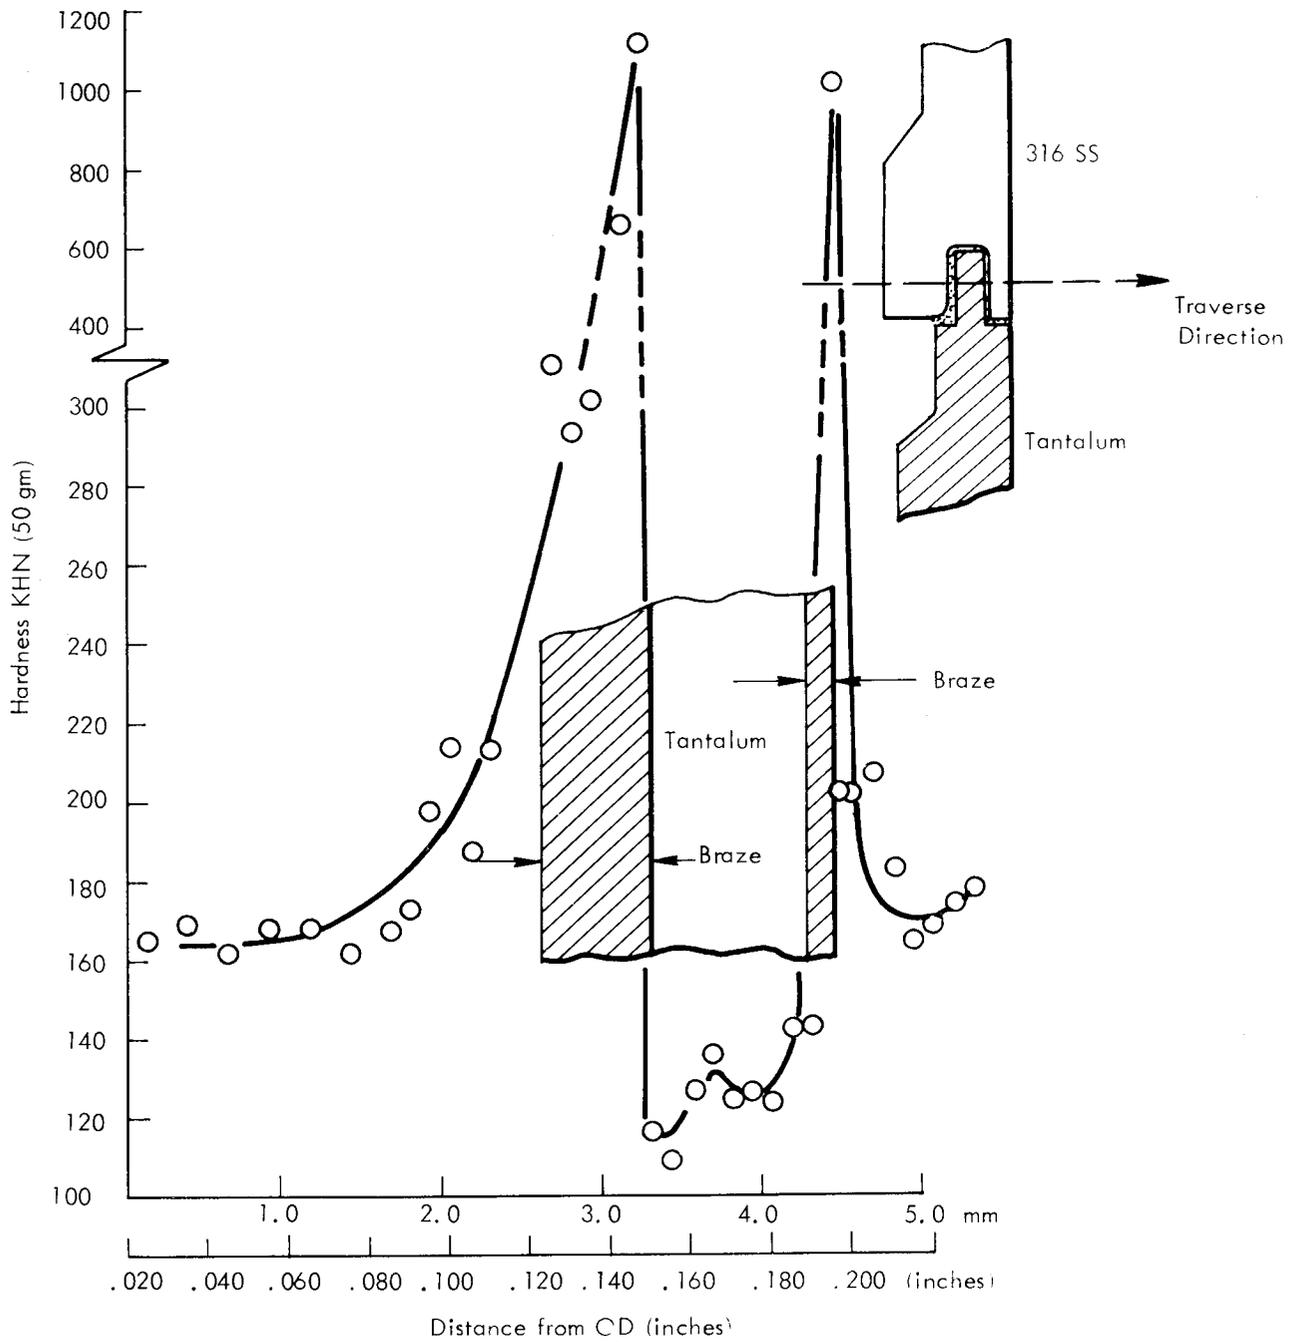
Figure 39. Hardness Traverse of As-Brazed Transition Joint No. 11

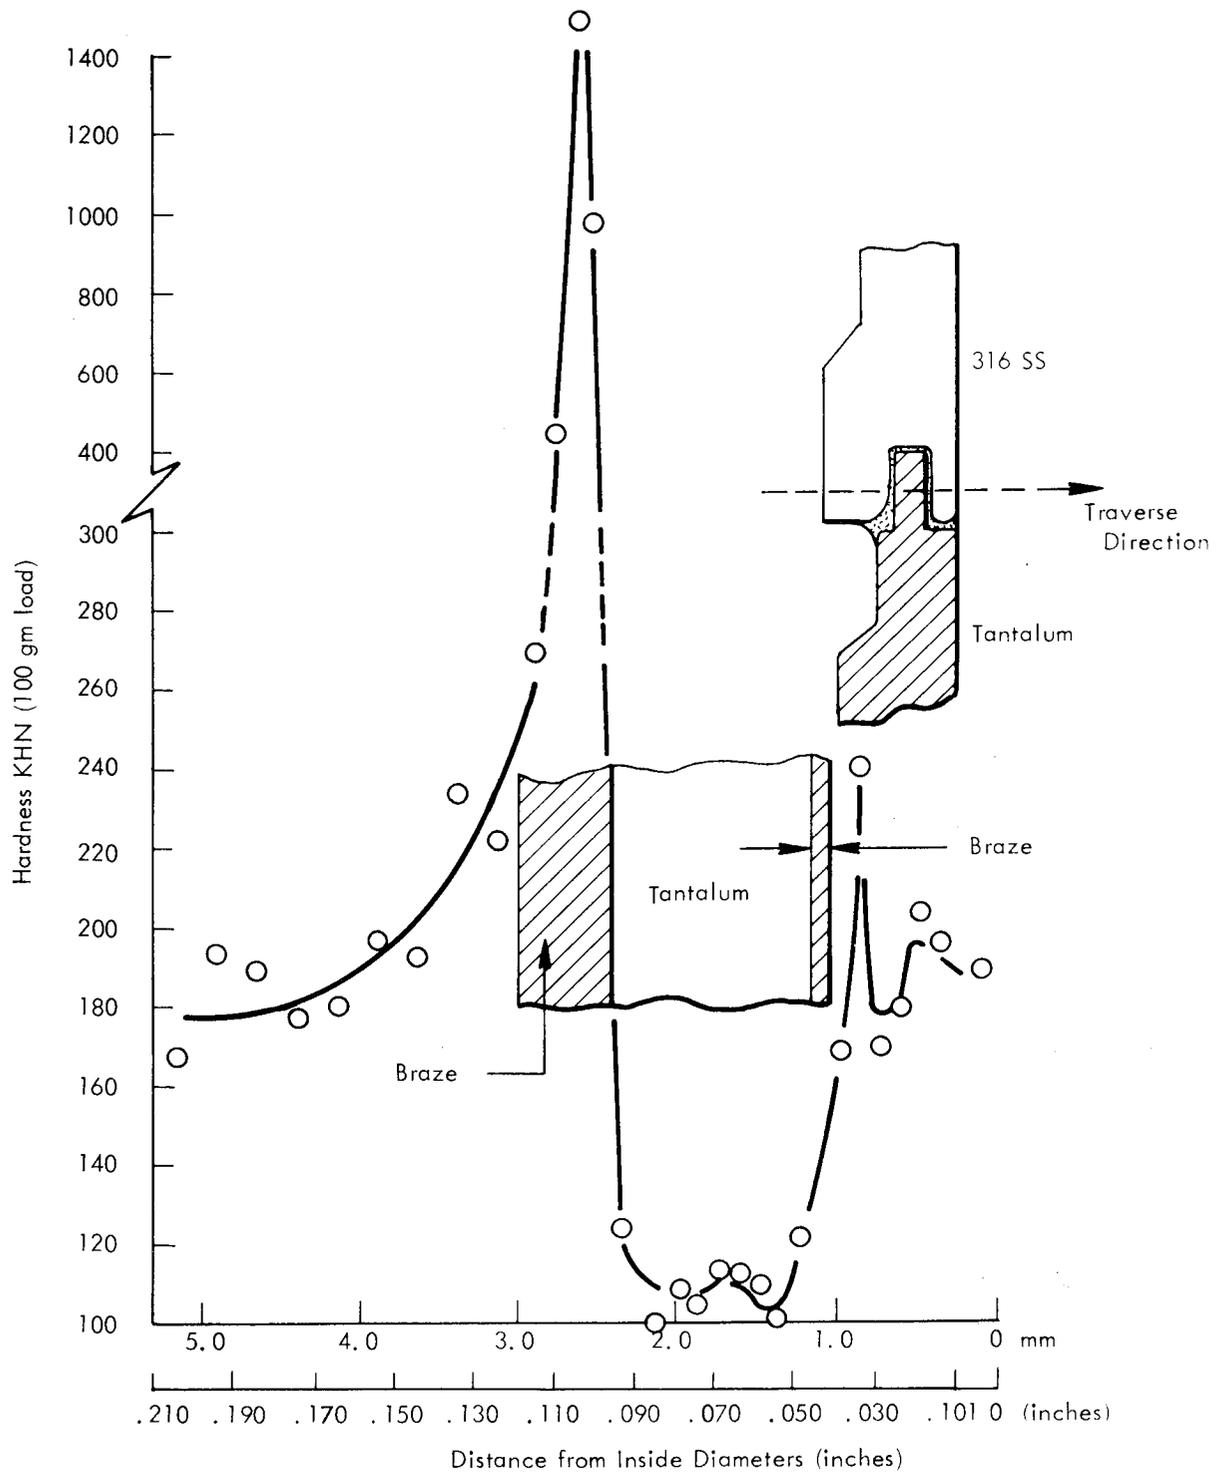
Figure 40. Hardness Traverse of Thermal Cycled Brazed Joint No. 15

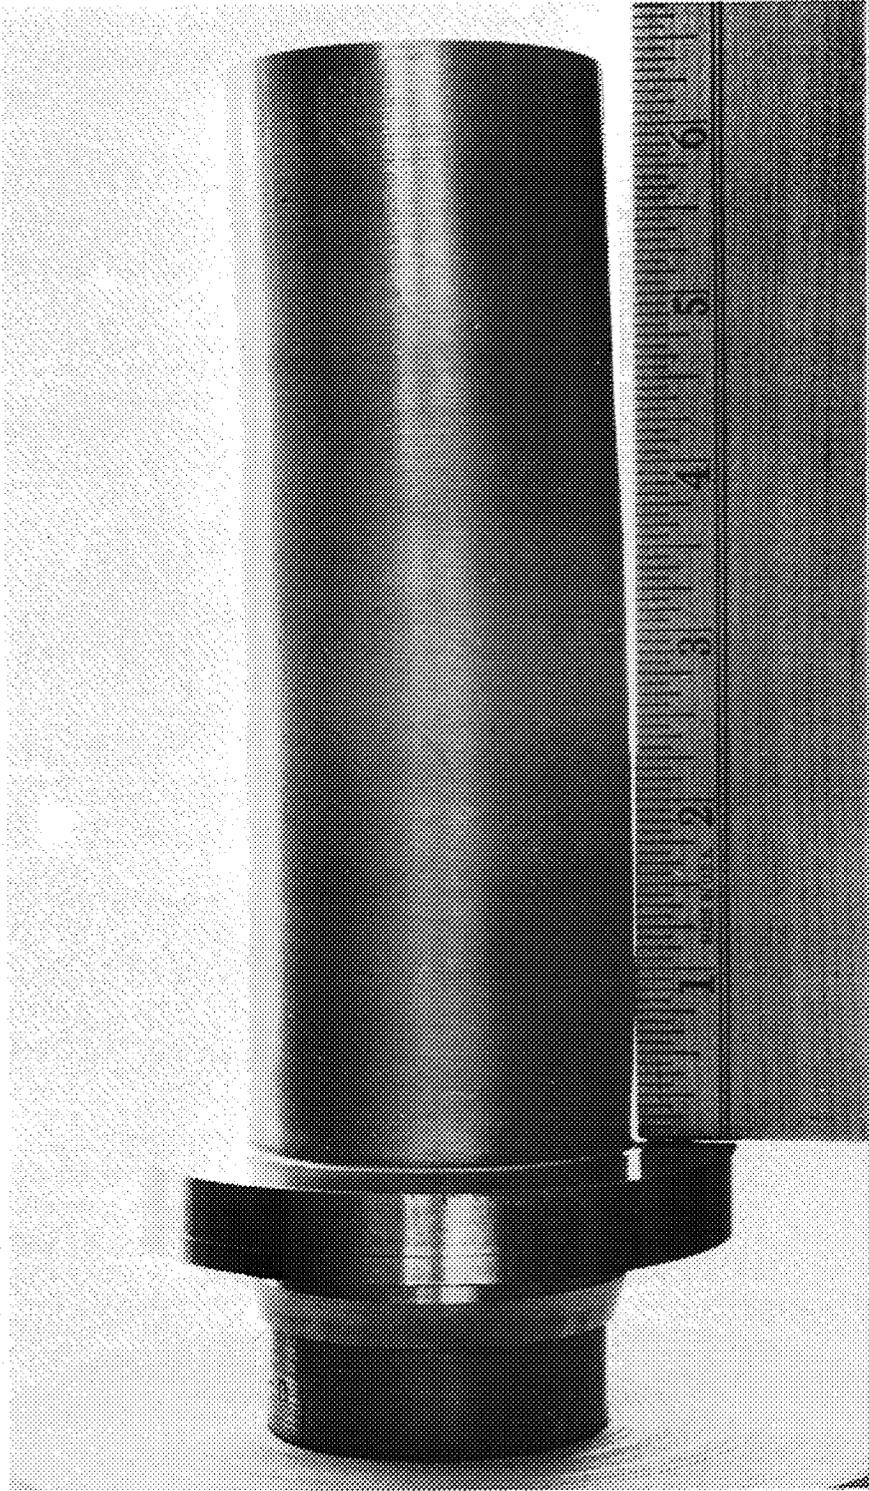
FIGURE 41. Sleeve Joint No. 6 Following 100 Thermal Cycles  
Showing Severe Diametral Contraction and Camber

As was discussed in the fabrication description of the sleeve joints, the outside diameter of the initially cambered tubes was machined straight, producing a nonuniform wall thickness, which in the worst case, sleeve joint No. 5, varied from 7.7 mm (0.302 inch) to 5.2 mm (0.203 inch). As determined by radiograph, the tantalum portion of the total wall varied from 5.1 mm (0.200 inch) to 2.3 mm (0.090 inch). The possibility exists that the thermal cycle related cambering is produced by nonuniform shrinkage related to the tube wall nonuniformity, but no direct relation was observed. For instance, sleeve joint No. 4 displayed the worst camber, but both total wall thickness uniformity and tantalum to stainless steel ratio were better than average. Table 11 lists the total wall and tantalum portion variation in wall thickness for the flanged sleeve joints. In general, the better sleeve joints with the best dimensional properties were picked for the thermal cycle tests to avoid complications from nonuniform wall thickness.

The internally pressurized specimens did not distort as severely as the open specimens. As listed in Table 10, specimens 6 and 8 were pressurized and specimens 2 and 4 were open. Also, specimen No. 2, which spent the longer time at temperature, (plan B specimens included a 1000 hour soak of 732°C (1350°F) prior to the last set of 10 thermal cycles), displayed a greater amount of contraction.
