NASA TN D-7111

APOLLO EXPERIENCE REPORT -
THE PROBLEM OF
STRESS-CORROSION CRACKING

by Robert E. Johnson
Manned Spacecraft Center
Houston, Texas 77058

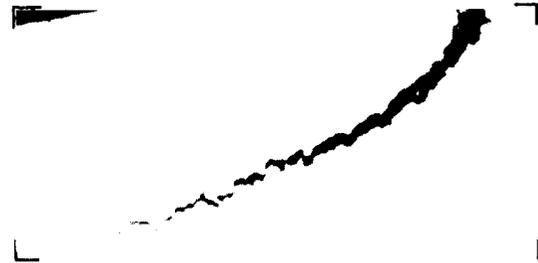
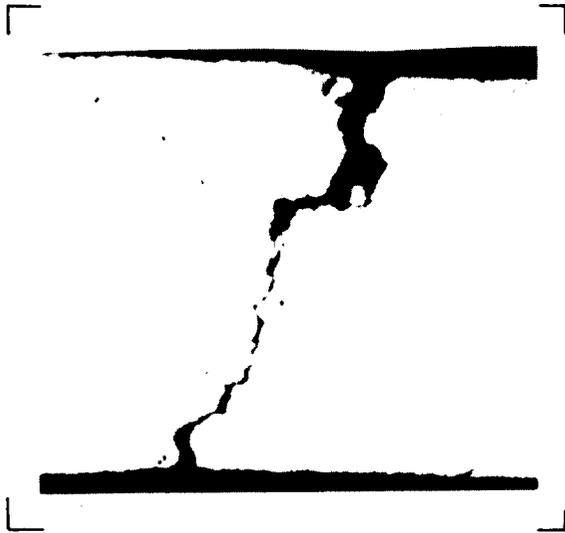
Figure 5. - Closeups of the cross-section points indicated in figure 4.

(a) Cross-section point A.

(b) Cross-section point B.

(c) Cross-section point C.

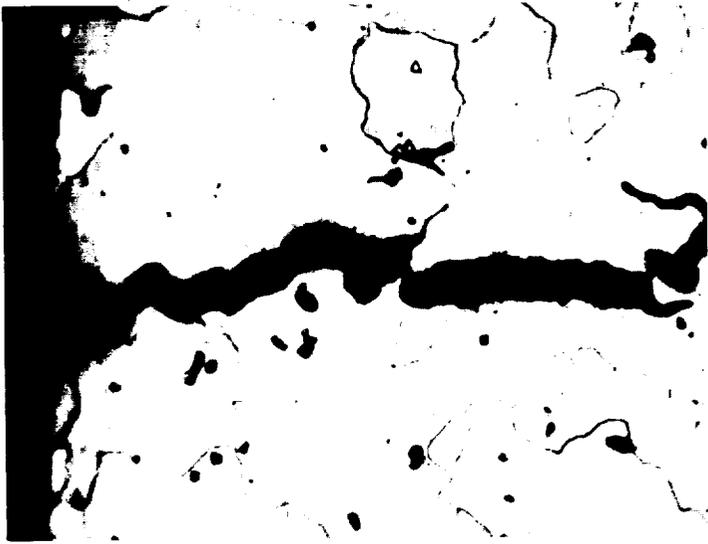
Figure 8. - Closeup of the outlined area shown in figure 7.
