**ASSESSMENT OF FLOOD DAMAGE IN ARIZONA BY MEANS OF
ERTS-1 IMAGERY**

Roger B. Morrison and Maurice E. Cooley, *U. S. Geological Survey, Denver, Colorado,
and Tucson, Arizona*

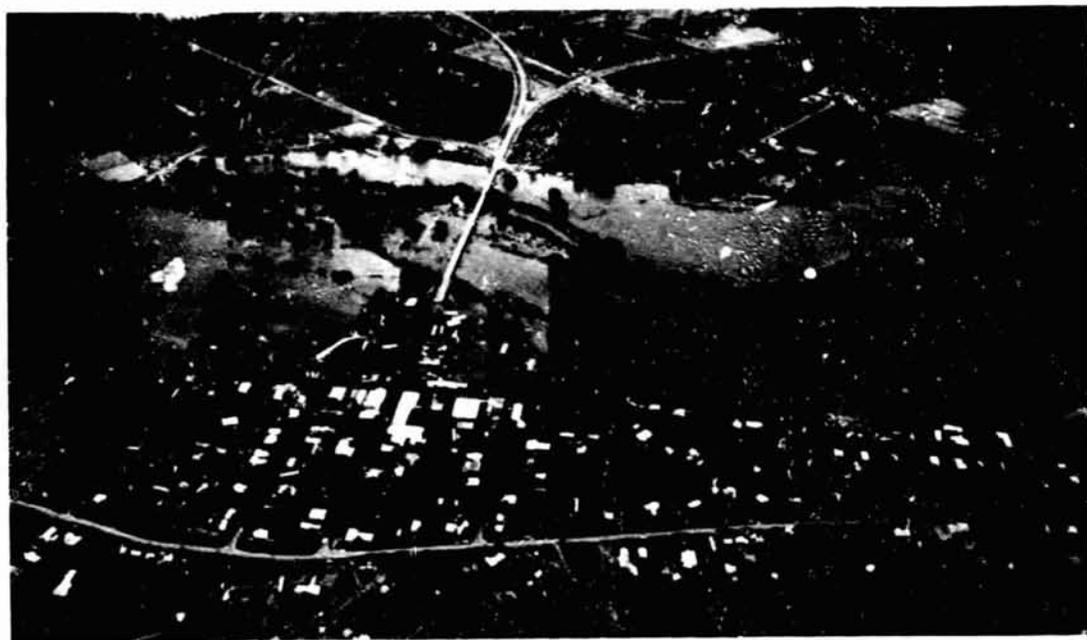
Figure 1. Low-altitude airphoto showing the inundation at Duncan, Arizona, near the crest of the October 20-21, 1972 flood on the upper Gila River. U. S. Geological Survey photograph.

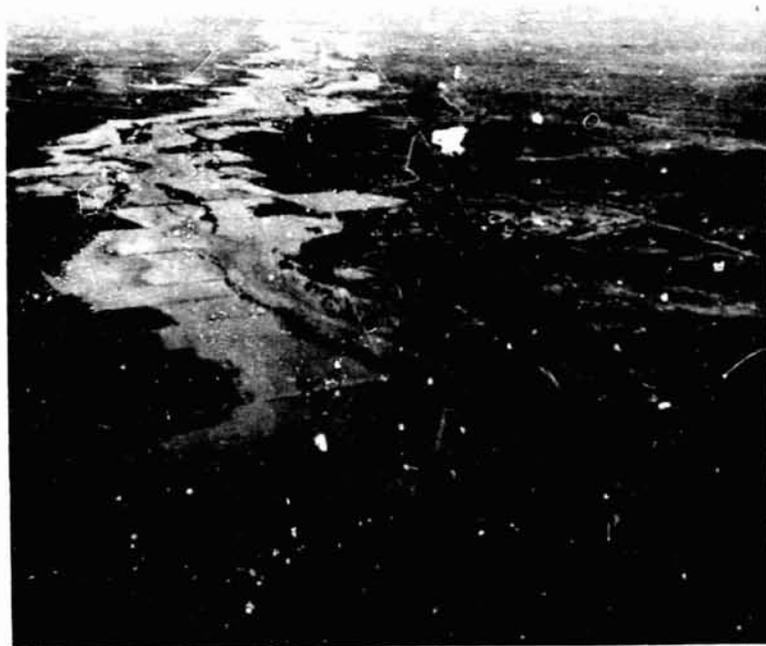
Figure 2. Low-altitude oblique airphoto of eastern Safford (Gila) Valley, near the peak of the October 20-21, 1972 flood on the upper Gila River. U. S. Geological Survey photograph.

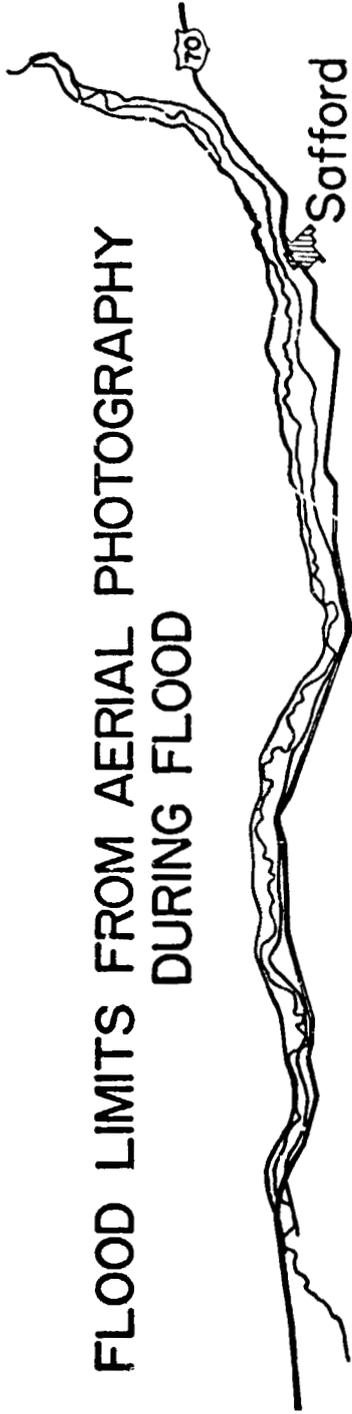
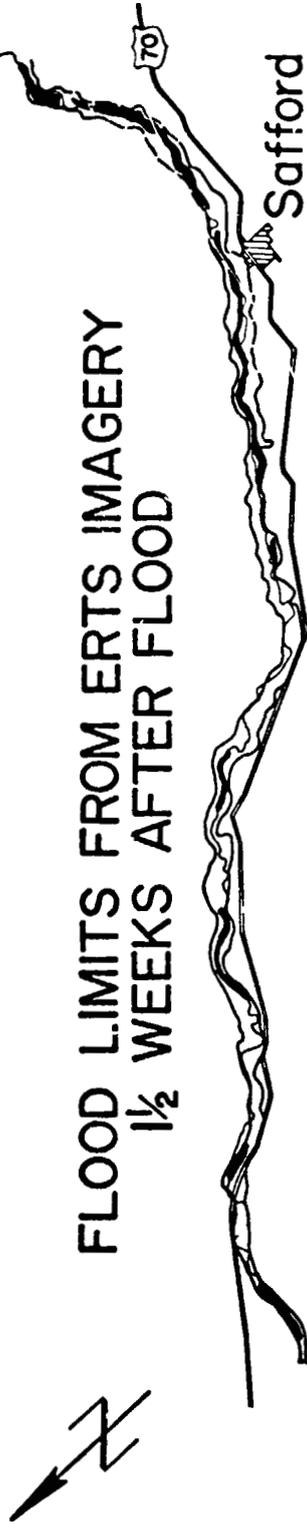
FLOOD LIMITS FROM AERIAL PHOTOGRAPHY DURING FLOOD

FLOOD LIMITS FROM ERTS IMAGERY 1 1/2 WEEKS AFTER FLOOD

6. Limits of October 20-21 flood on the upper Gila River in the Safford (Gila) Valley, Arizona, as determined from low-altitude aerial photography taken during the flood and from ERTS-1 imagery taken 1 1/2 weeks after the flood

We also noticed in the ERTS images taken after the Gila River flood that certain reaches of river-channel deposits had widened considerably, compared with the pre-flood images. The channel deposits, sand and gravel, show most clearly on band 5 as a very light-toned strip inside the inundated belt that appears dark on the infrared bands. The greatest widening of the channel-deposit strip is at the upper ends of two intermontane basins, the Duncan-Virden Valley and the Safford (Gila) Valley, where the Gila River debouches from narrow box canyons. Evidently these were the sites of strong sand and gravel erosion and deposition.
