NASA CR-72859
WANL-PR(VVV)-003
April, 1971

National Aeronautics And Space Administration
NASA Lewis Research Center
Task III of Contract NAS 3-11827
Paul Moorhead, Project Manager

INVESTIGATION OF HIGH TEMPERATURE
FRACTURE OF T-111 AND ASTAR-811C

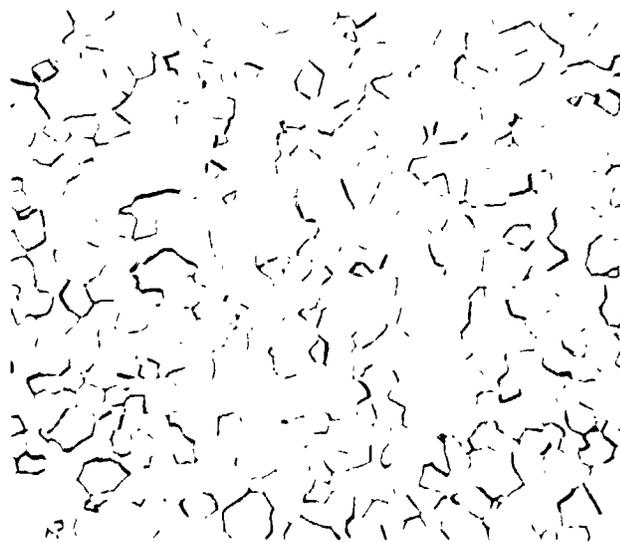
FIGURE 10 - Pre-Test Microstructure of Wrought-Recrystallized T-111
and ASTAR-811C.

23,171 Grain Size 0.029 mm. 100X
DPH 206
T-111

23,203 Grain Size 0.012 mm. 200X
DPH 265
ASTAR-811C

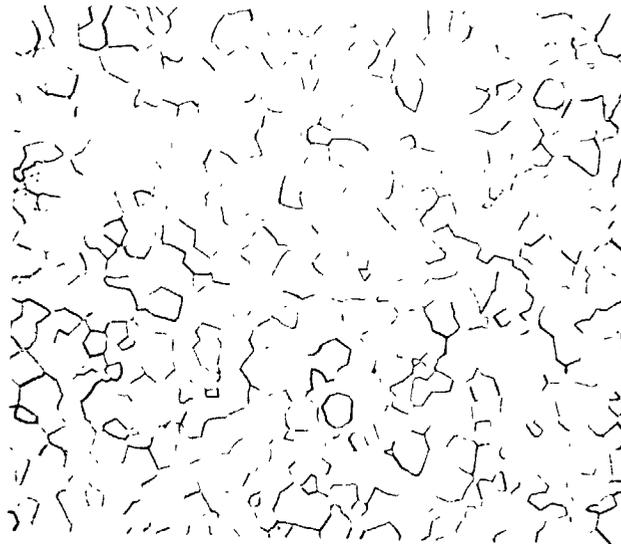
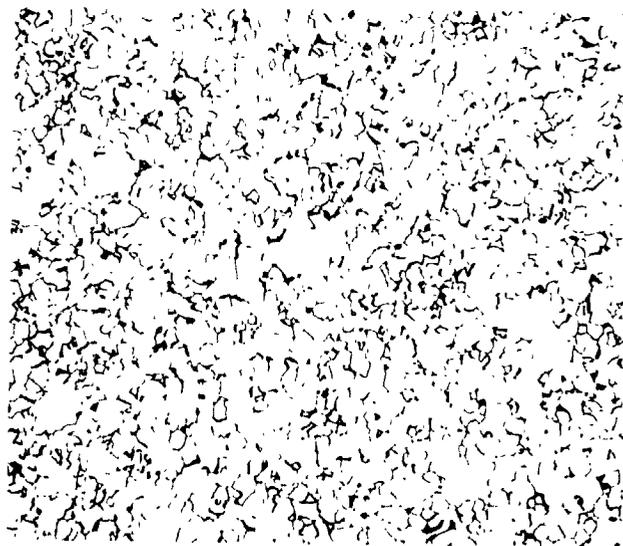
FIGURE 11 - Pre-Test Microstructure of T-111 and ASTAR-811C Sheet.

23,225 Grain Size 0.031 mm. 100X
DPH 224

23,332 Grain Size 0.017 mm. 100X
DPH 286

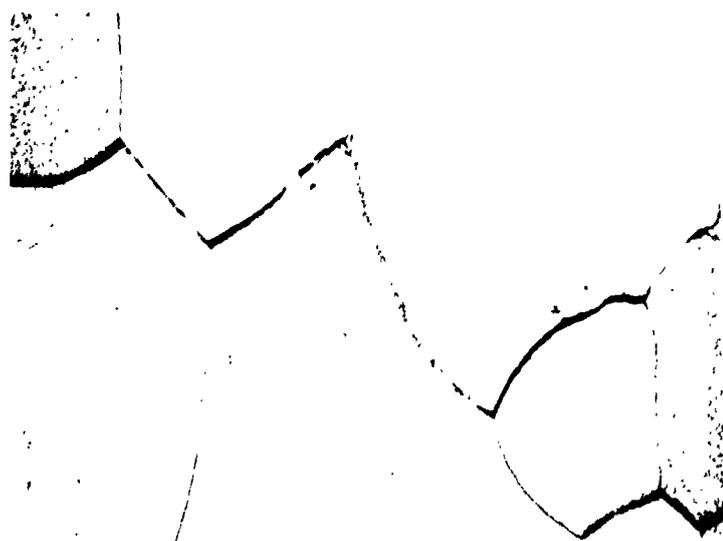
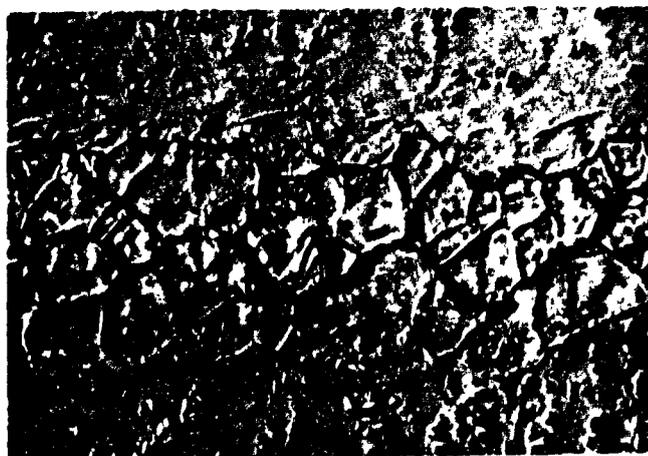
Fracture Strain 4.2%

Fracture Strain 1.0%

FIGURE 16 - Post - Test Microstructure of As-Cast ASTAR-811C
Specimens. Test Conditions as Indicated.

ASTAR-811C specimens demonstrated a lesser tendency toward internal grain boundary cracking than T-111 at most test temperatures. However, cracking was quite prominent in specimens tested at 1649°C (3000°F) and higher. Cracks were primarily along boundaries transverse to the stress axis (top, Figure 16) while boundaries oriented obliquely to the stress axis displayed the somewhat unusual appearance seen in the photomicrograph at the bottom of Figure 16. The region adjacent to the oblique boundary has apparently undergone extensive localized recrystallization, presumably as the direct result of the localized deformation occurring there during testing. Note the lack of deformation substructure in the areas away from the boundary.

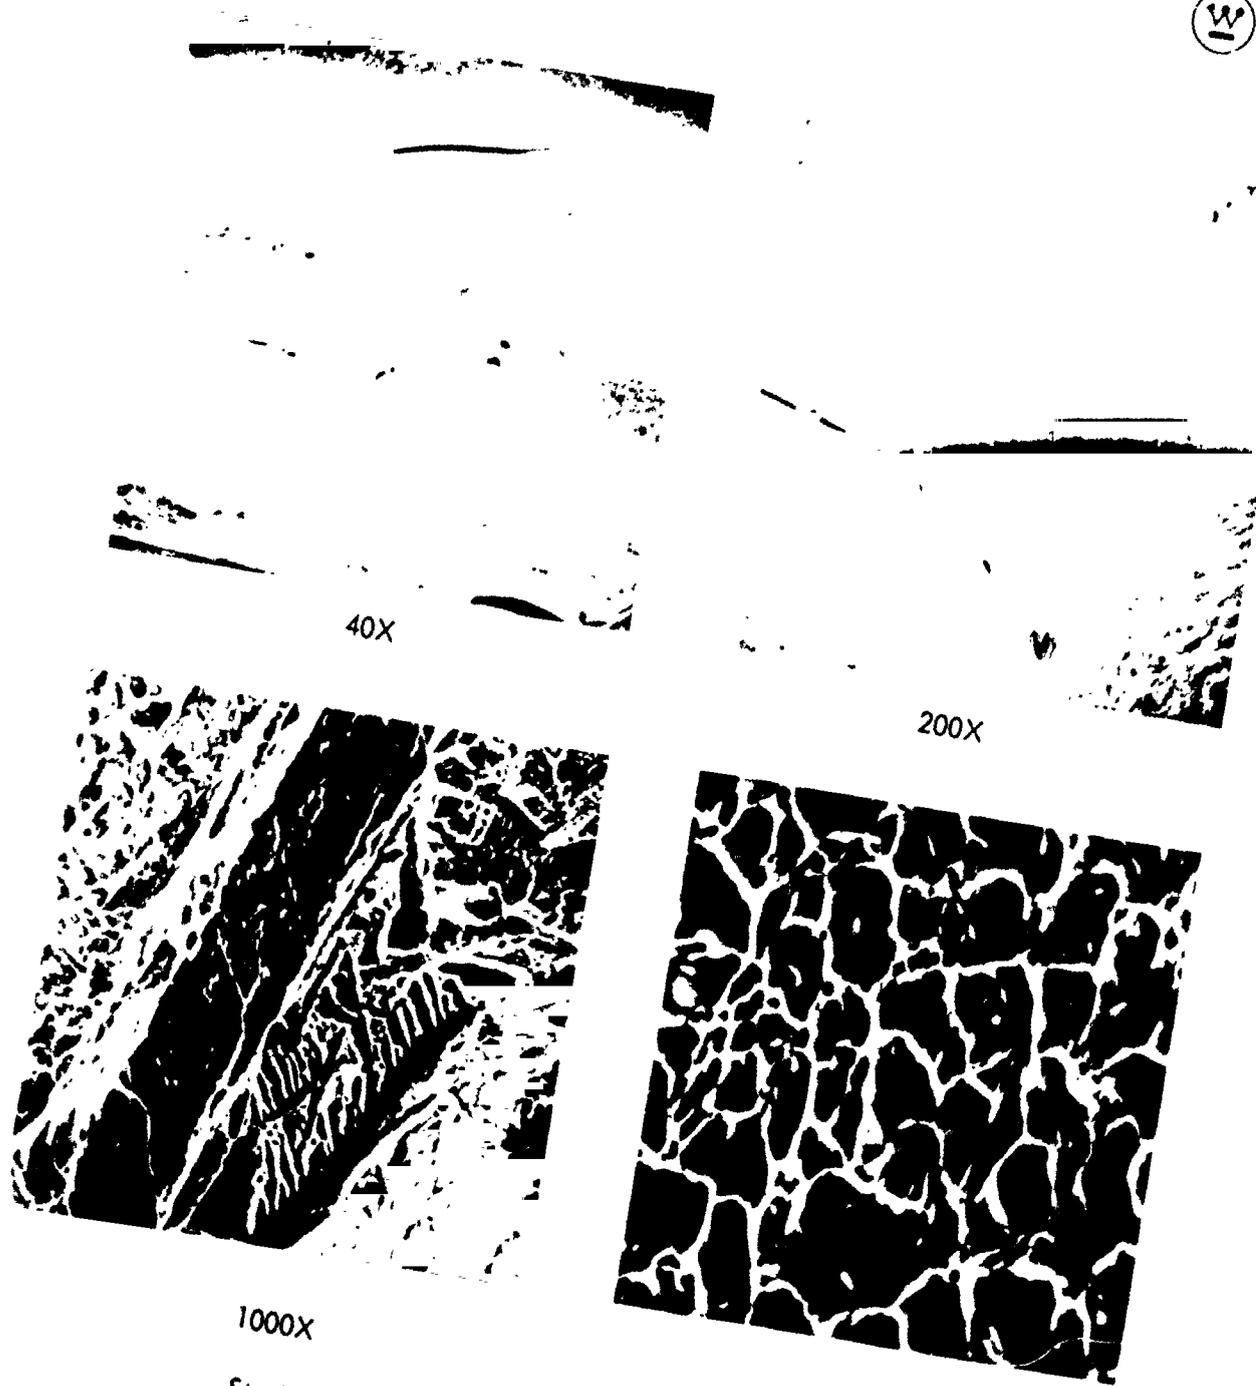
FIGURE 17 - Scanning Electron Micrographs of the Fracture Surface of an As-Cast T-111 Specimen Tested at 2200°F (1205°C).

Scanning micrographs of the as-cast T-111 specimen tested at 1205°C (2200°F) are shown in Figure 17. Despite the "brittle" appearance at low magnifications, inspection at high magnifications reveals dimpled features characteristic of ductile fracture⁽⁹⁾. Note also the turbulent-appearing zone adjacent to the grain boundary in the 1000X micrograph. Dimpled rupture is shown in several different orientations in the T-111 specimen tested at 1427°C (2600°F), Figure 18. After testing at 1649°C (3000°F), where the fracture strain was only 0.1 percent, evidence of dimpled rupture persists, Figure 19. However, the size of the "zone" associated with the dimples appears to have increased.

1000X
Strain Rate 0.005 min^{-1}
Fracture Strain 6.4%
4000X

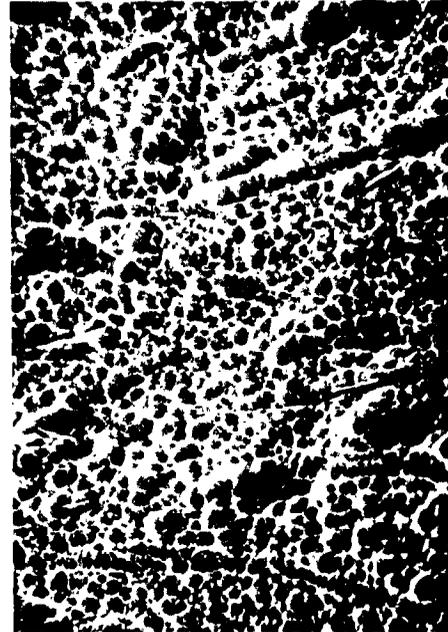
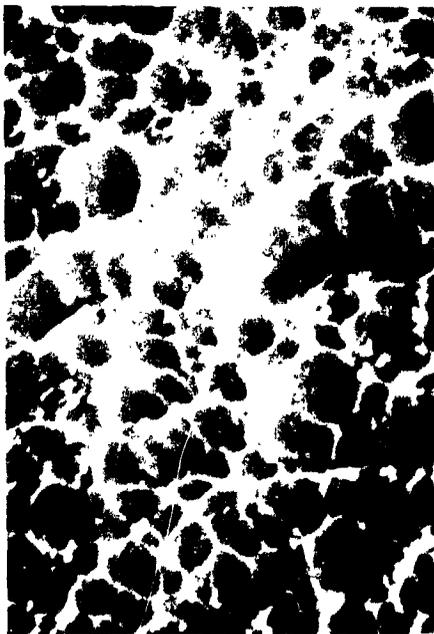
Strain Rate 0.005 min^{-1} .

Fracture Strain 14.4%.

FIGURE 22 - Scanning Electron Micrographs of the Fracture Surface of an As-Cast ASTAR-811C Specimen Tested at 2600°F (1427°C).

Representative micrographs of the fracture surfaces of the as-cast ASTAR-811C specimens tested at 1427°, 1649° and 1816°C (2600°, 3000° and 3300°F) are shown in Figures 22 and 23. Differences between the two alloys are not large although, except for the 1649°C (3000°F) test, the ductility loss is not quite as drastic in ASTAR-811C.

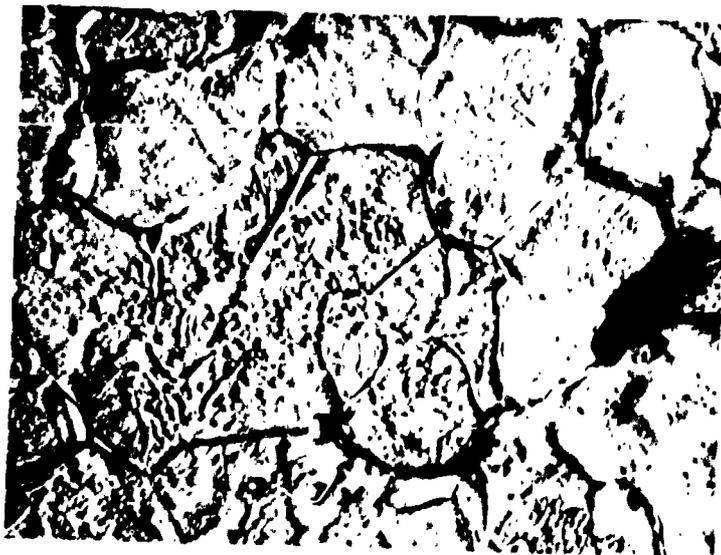
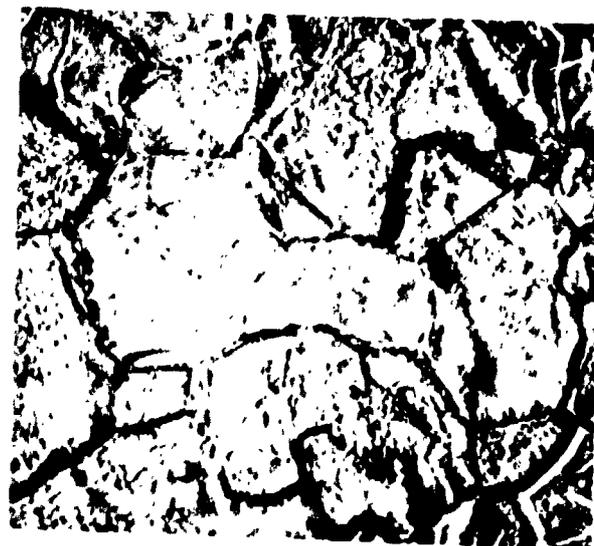
Strain Rate 0.05 min^{-1} . Fracture Strain 71.9%.

FIGURE 28 - Post-Test Microstructure of Wrought-Recrystallized
ASTAR-811C Specimen Tested at 3000°F (1649°C).

The 1427°C (2600°F) ASTAR-811C specimen was not fractured due to the load limit of the testing machine being used. Only about 1% plastic strain was achieved and, as reference to Figure 27 shows, the microstructure was unaffected. Testing ASTAR-811C at 1649°C (3000°F), Figure 28, resulted in much less intergranular cracking than was observed for similar tests on T-111 (Figure 25). The regions adjacent to the grain boundaries have undergone considerable local change, including grain boundary migration and substructure development. The specimen tested at 1816°C (3300°F), Figure 29, looked quite similar to the 1649°C (3000°F) specimen except possibly that a small amount of grain growth had occurred at the higher test temperature.

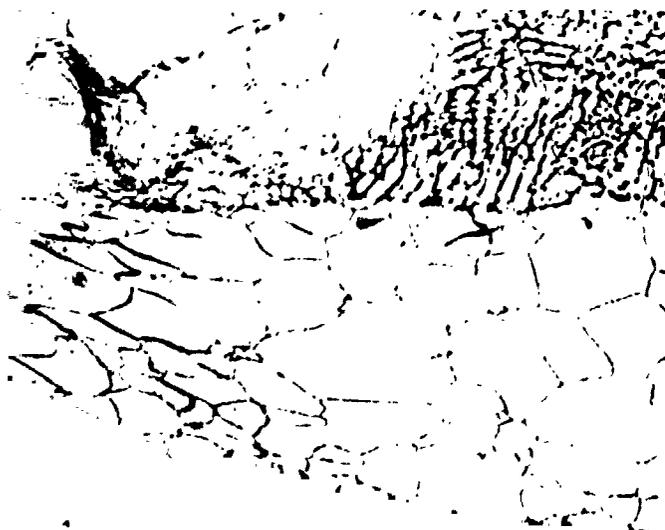
23,311 ASTAR-811C Specimen 1 100X

Tested at 2400°F (1316°C). Fracture Strain 11.37%.

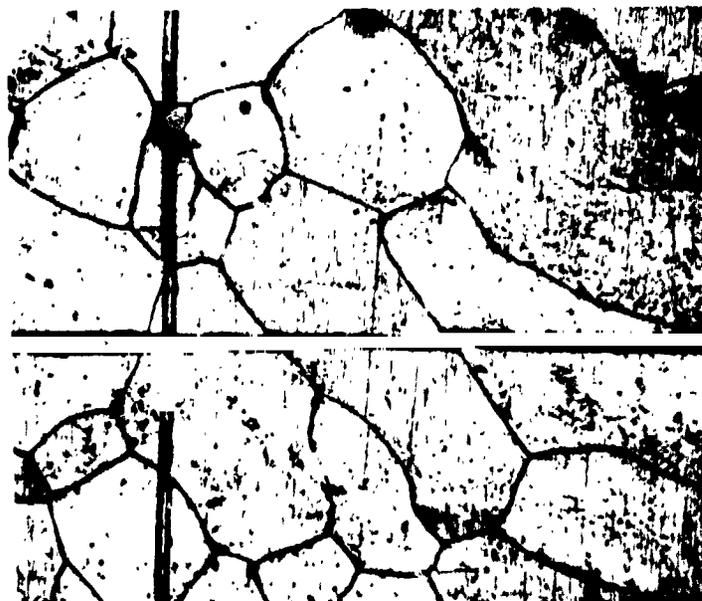
FIGURE 46 - Surface Photographs of ASTAR-811C Sheet Specimens
after Creep Testing as Indicated.

ASTAR-811C Specimen 1 400X
After 11.37% Strain. Tested at 2400°F (1316°C).

ASTAR-811C Specimen 3 50X
After 5.47% Strain. Tested at 2600°F (1427°C) and
2800°F (1538°C).
