NASA CR-134502
PWATM-4727

**IMPACT RESISTANCE OF FIBER COMPOSITE
BLADES USED IN AIRCRAFT TURBINE ENGINES**

**PRATT & WHITNEY AIRCRAFT
DIVISION OF UNITED AIRCRAFT CORPORATION**

Prepared for
NATIONAL AERONAUTICS AND SPACE ADMINISTRATION

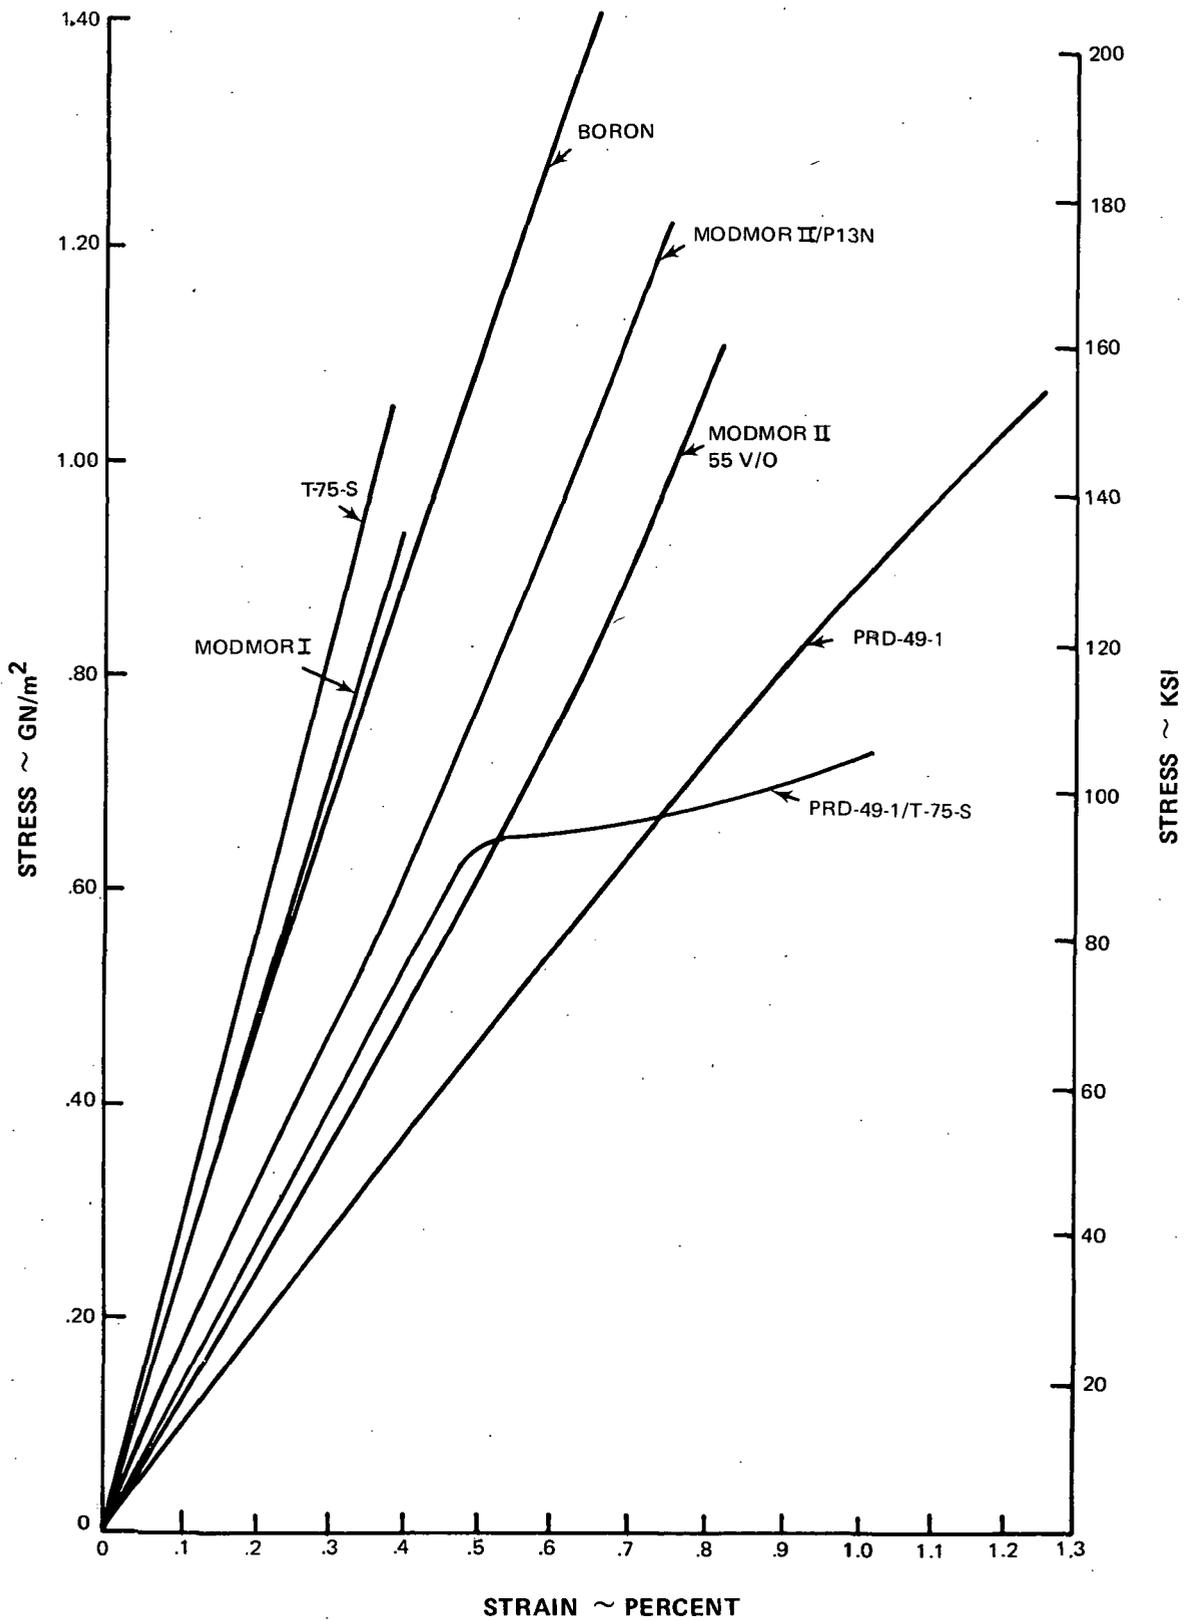
Figure 1 Typical Longitudinal Tensile Stress Versus Strain Curves for Unidirectionally Reinforced PR-286 Epoxy Composite Systems and the Modmor II/P13N Polyimide System

Typical longitudinal tensile stress-strain curves are plotted in Figures 1 and 2 for unidirectional composites. The Modmor I/PR-286, S-glass + T-75-S/PR-286, T-75-S/PR-286, and boron/PR-286 systems display linear elastic behavior to fracture, while the S-glass/PR-286, PRD-49-1/PR-286, and the T-75-S + PRD-49-1/PR-286 systems exhibit initial linear behavior followed by nonlinear behavior prior to failure. The nonlinear behavior of the T-75-S + PRD-49-1/PR-286 is probably a result of fracture of the strain-limited T-75-S fiber prior to specimen ultimate failure.

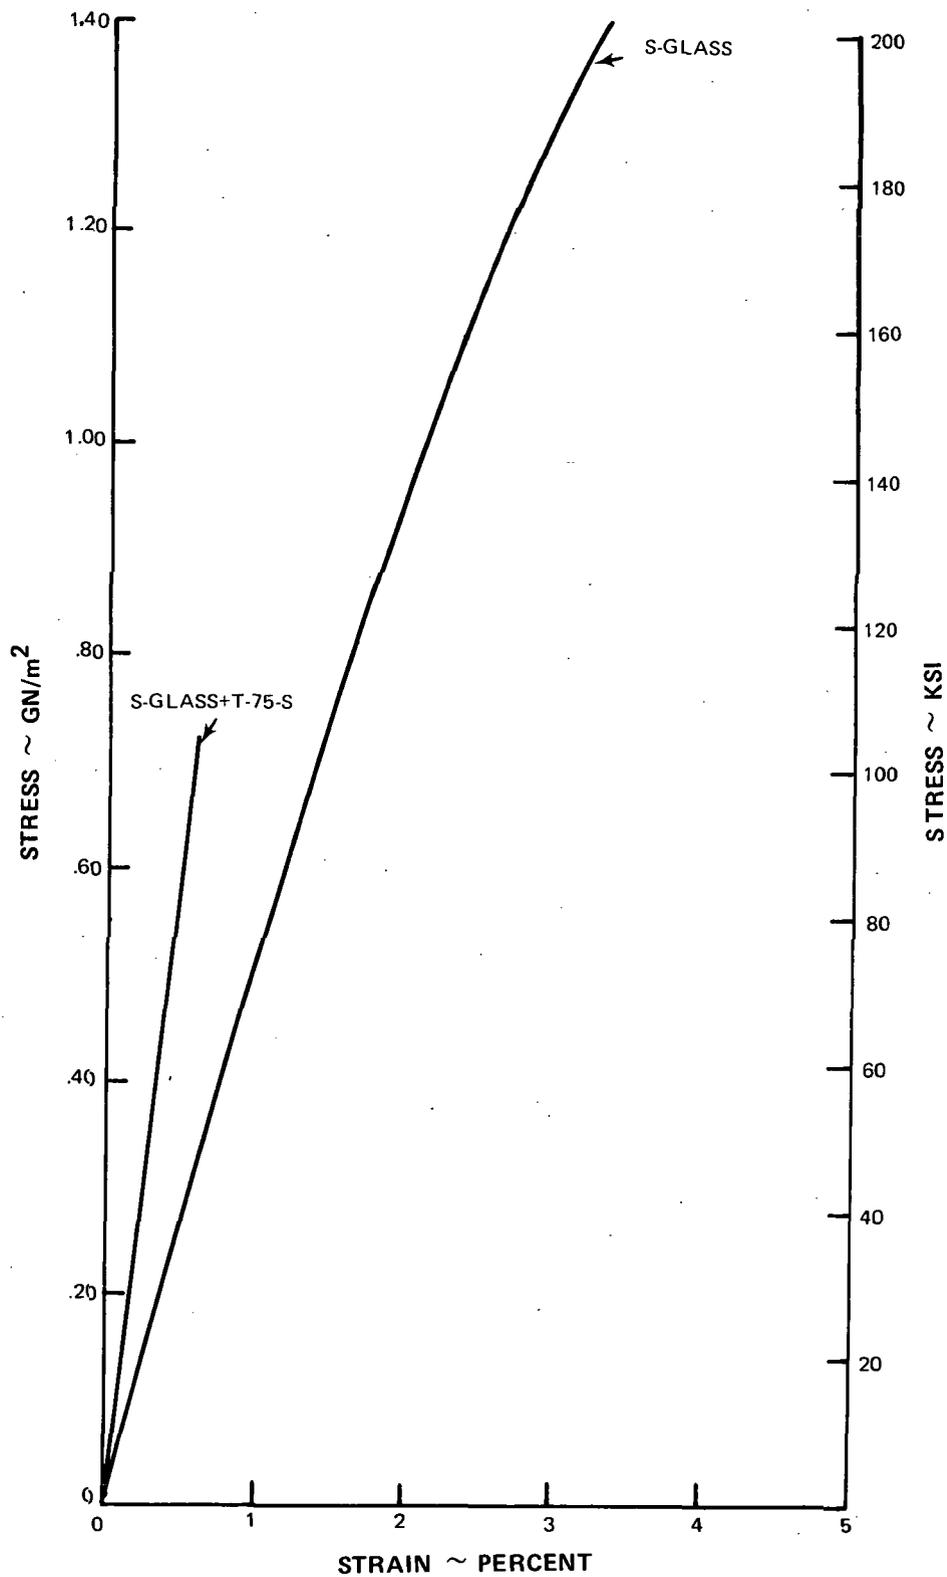
Figure 2 Typical Longitudinal Tensile Stress Versus Strain Curve for the Unidirectionally Reinforced S-Glass/PR-286 and S-Glass plus T-75-S/PR-286 Epoxy Composite Systems

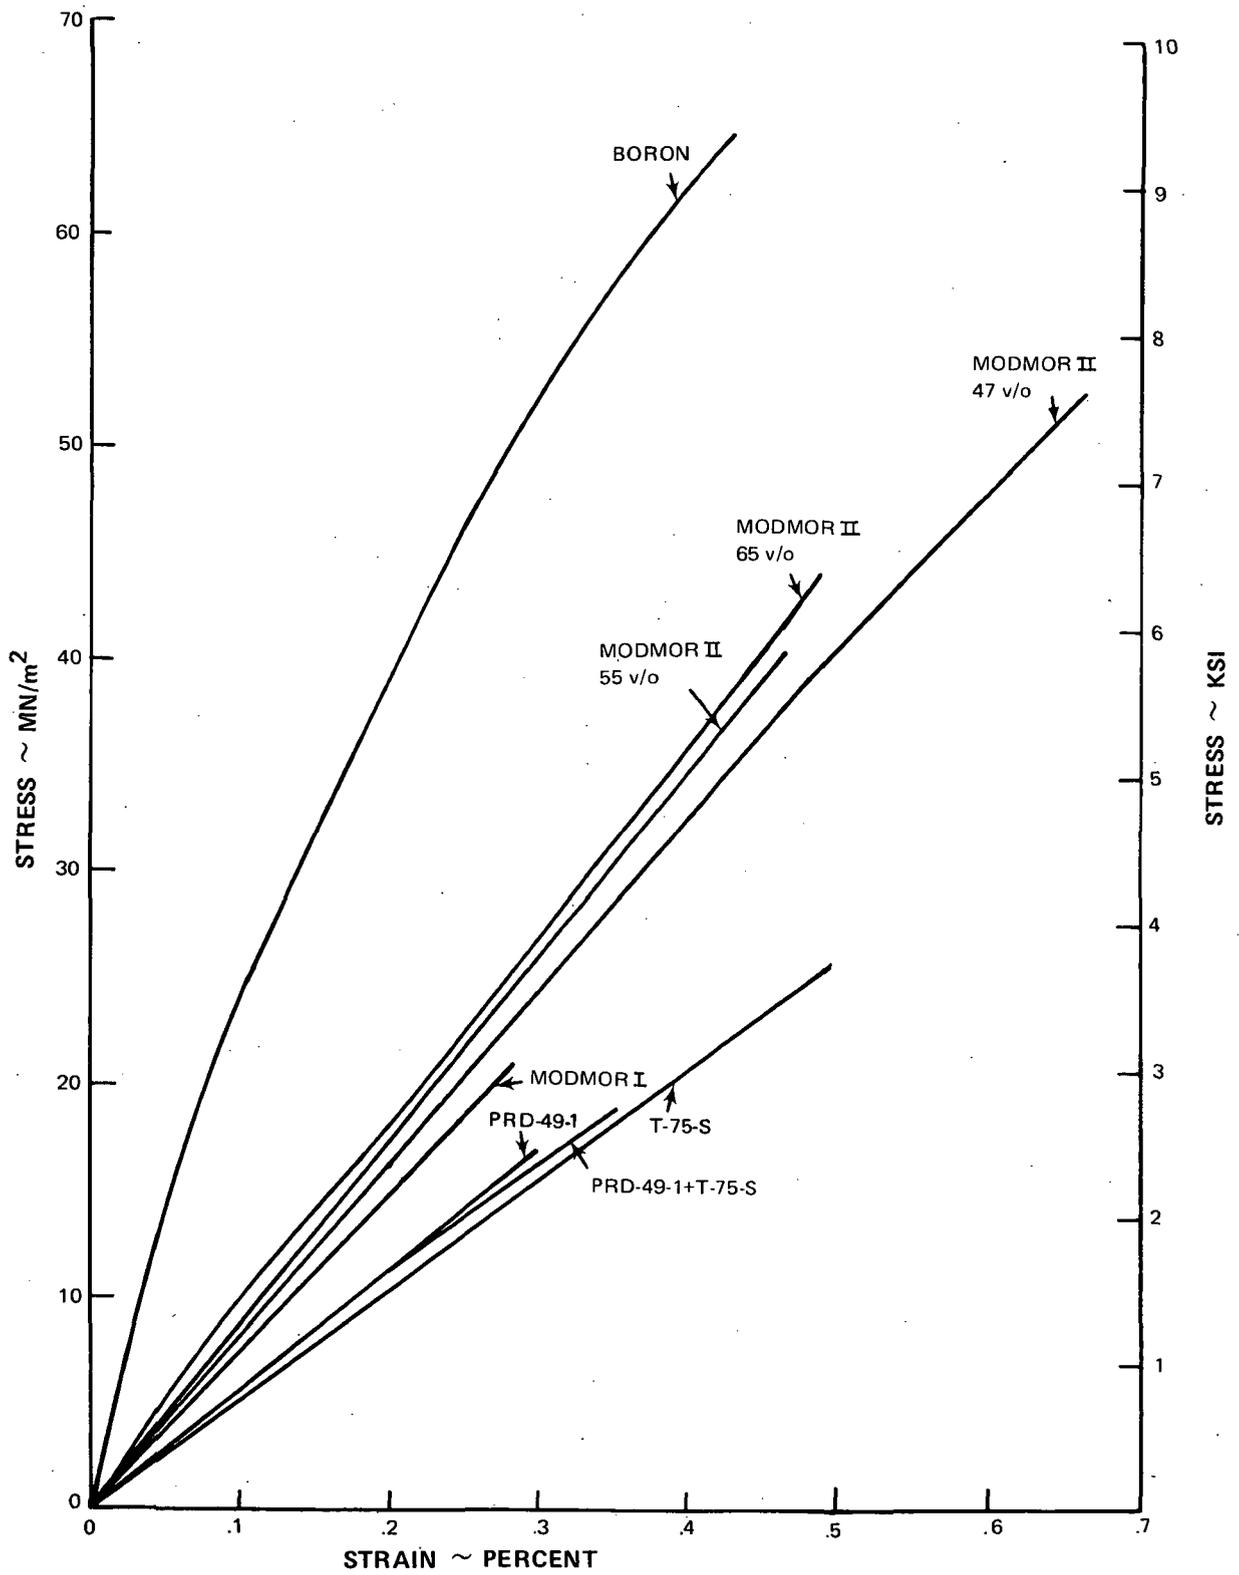
Figure 3 Typical Transverse Tensile Stress Versus Strain Curves for Unidirectionally Reinforced PR-286 Epoxy Composite Systems

Typical transverse tensile stress-strain curves are shown in Figures 3 and 4 for unidirectional composites. The 55 percent and 65 percent Modmor II, Modmor I, T-75-S, S-glass + T-75-S and PRD-49-1 reinforced PR-286 epoxy composites and the Modmor II/P13N polyimide composite system are all linear to failure. The 47 percent Modmor II, boron, S-glass and T-75-S + PRD-49-1 reinforced PR-286 epoxy composites are initially linear but show nonlinear behavior prior to failure. The addition of the T-75-S graphite to the S-glass reduces both the modulus and the ultimate strain in transverse tension, as seen in Figure 4.

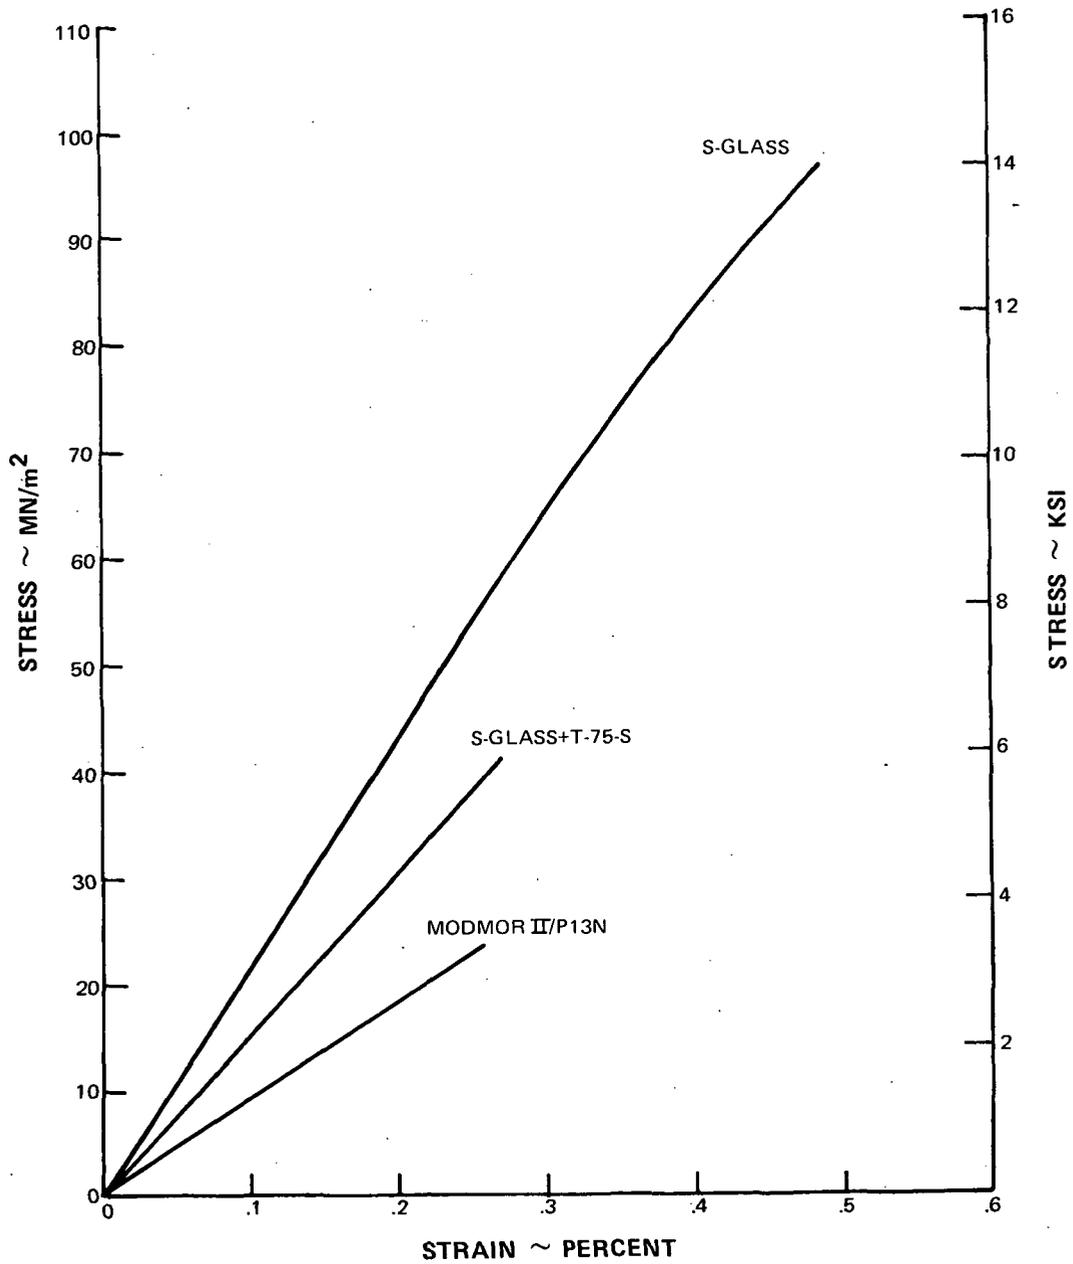
Figure 4 Typical Transverse Tensile Stress Versus Strain Curve for the Unidirectionally Reinforced S-Glass/PR-286 and S-Glass plus T-75-S/PR-286 Epoxy Composite Systems, and the Modmor II/P13N Polyimide System

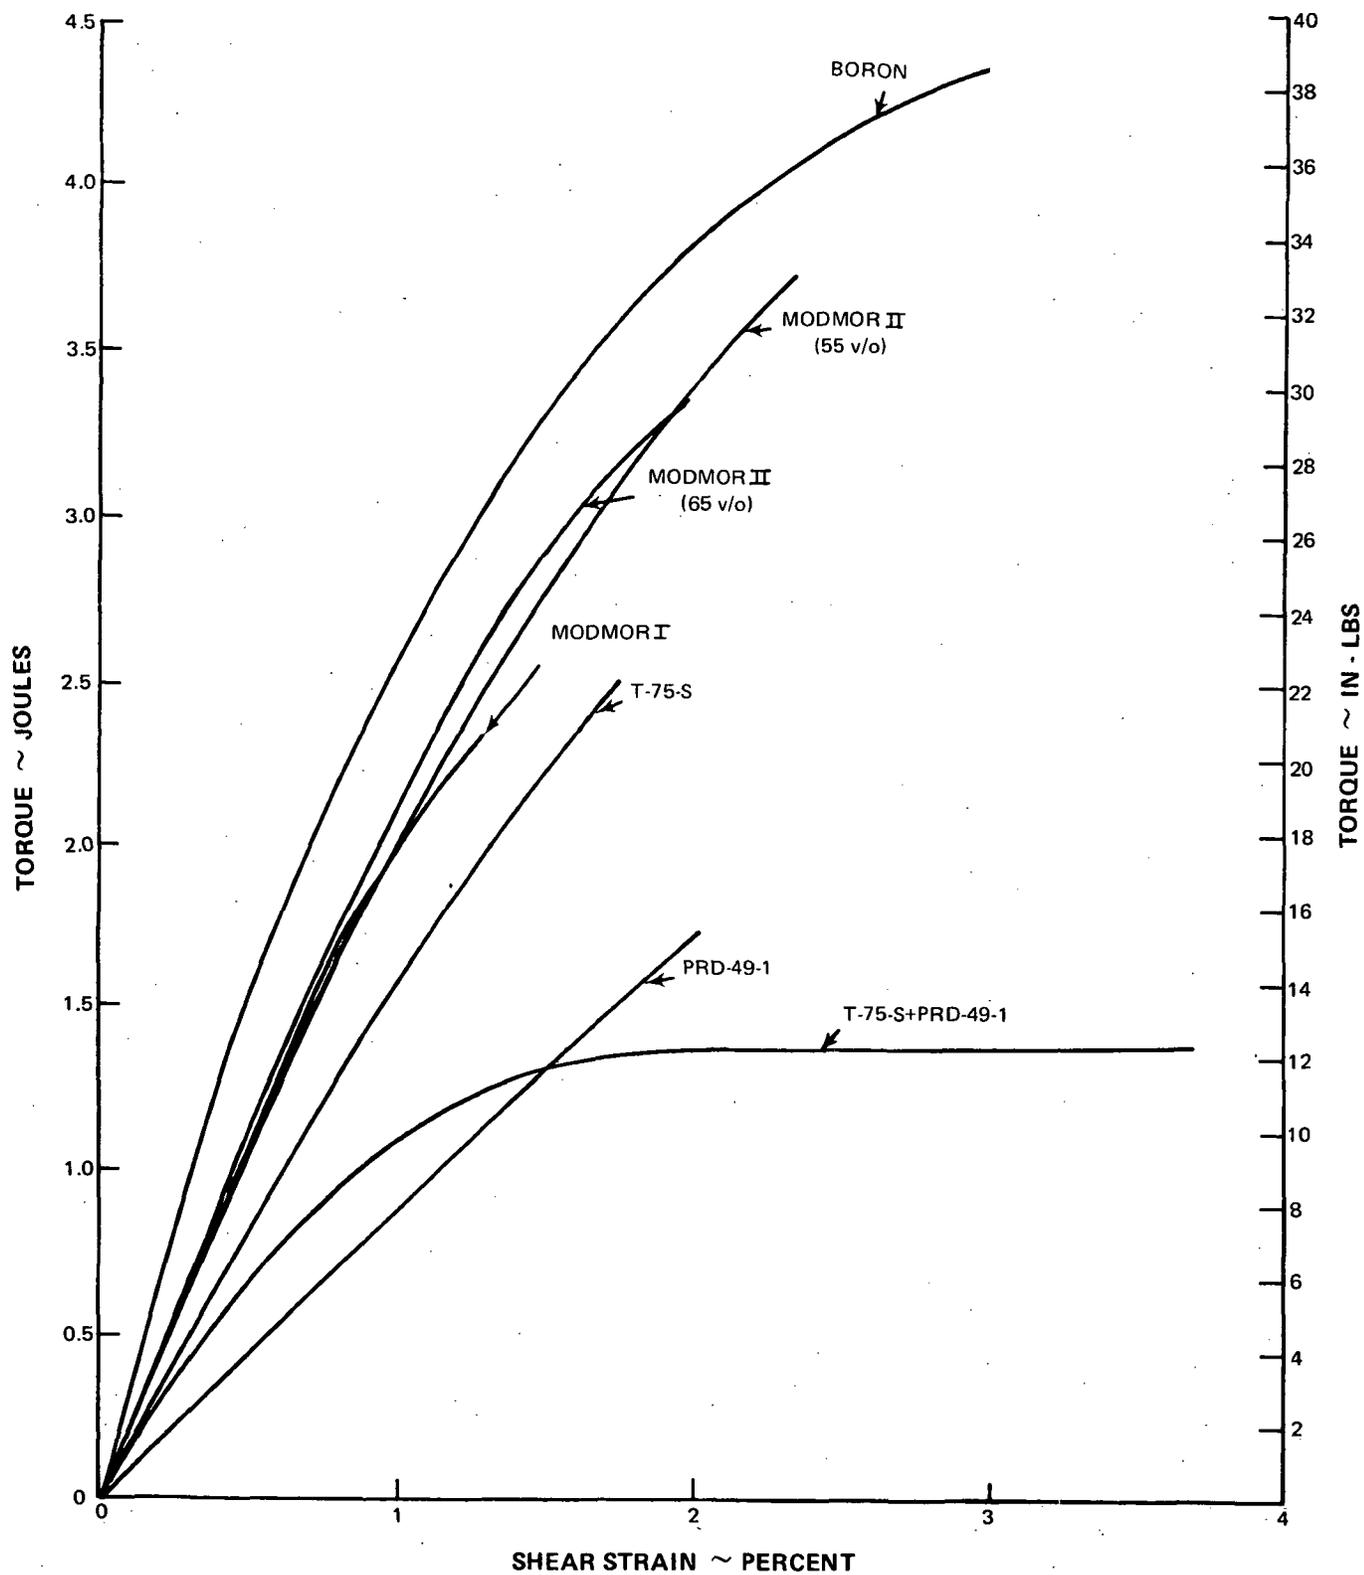
Figure 5 Typical Torque Versus Shear Strain Curves for Unidirectionally Reinforced PR-286 Epoxy Composite Systems

Typical torsion rod torque versus shear-strain curves are shown in Figures 5 and 6 for unidirectionally reinforced composites. Except for the Modmor II/P13N composite system, all curves show yielding prior to fracture. Ultimate shear strains vary from approximately 0.90 percent in Modmor II/P13N to 5 percent in S-glass/PR-286. The Modmor II composite containing PR-286 epoxy resin exhibits twice the ultimate shear strain of the Modmor II composite containing P13N polyimide resin.

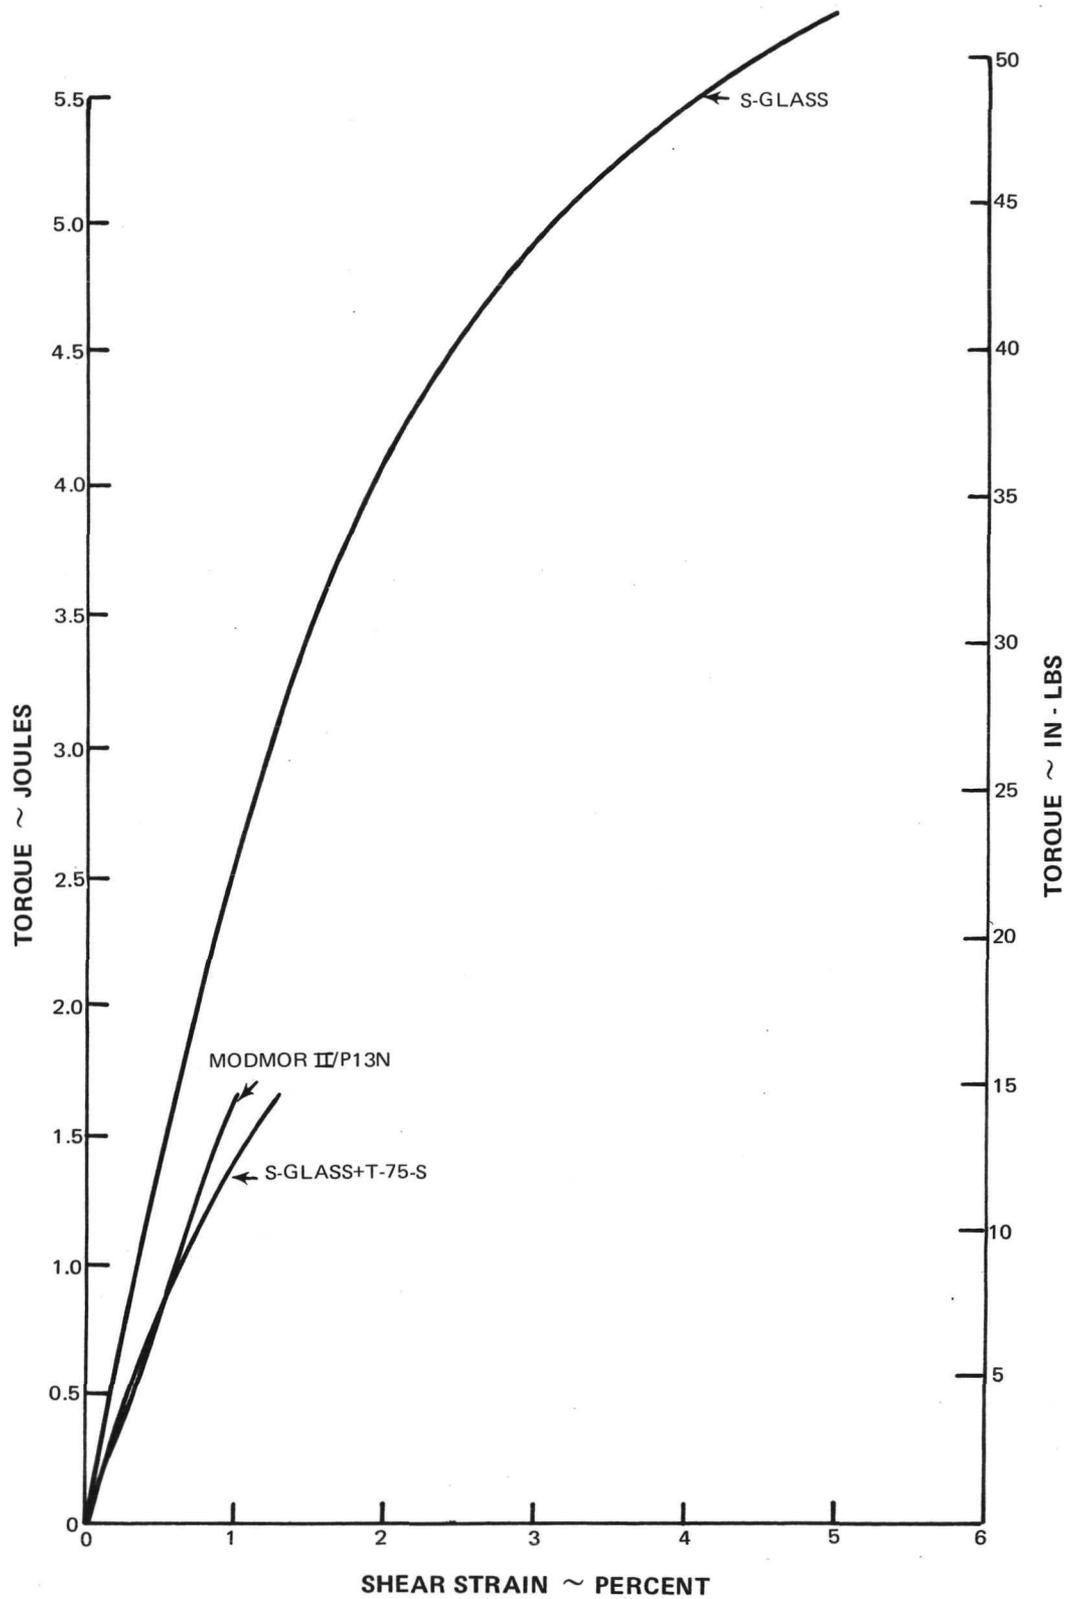
Figure 6 Typical Torque Versus Shear Strain Curve for the Unidirectionally Reinforced S-Glass/PR-286, S-Glass Plus T-75-S/PR-286, and Modmor II/P13N Composite Systems

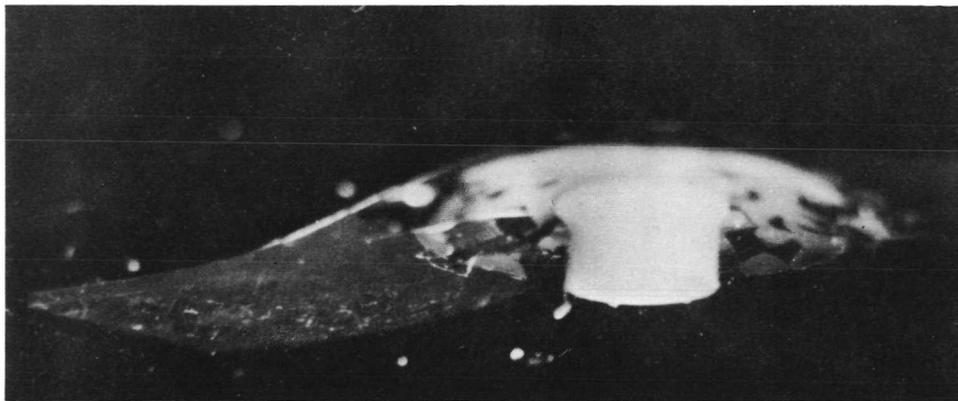
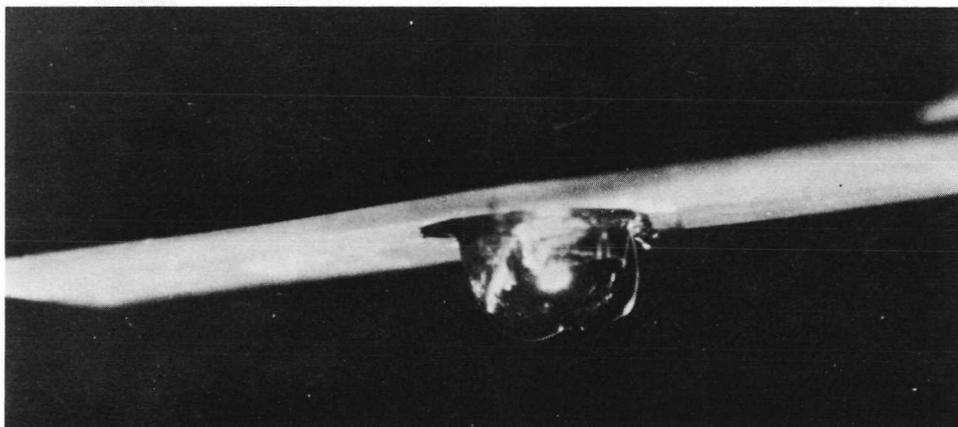
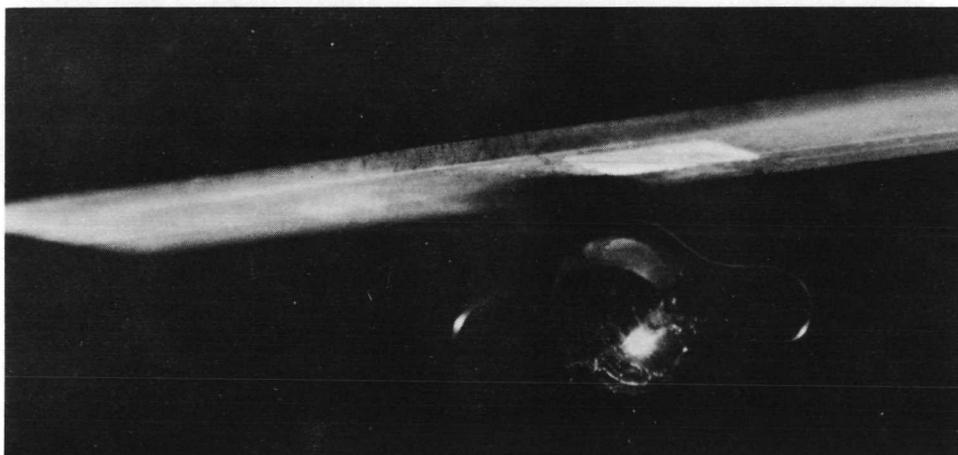
Figure 8 High Speed Strobe Photographs Showing Approach and Impact of a 2.54 cm Diameter Gelatin Ball

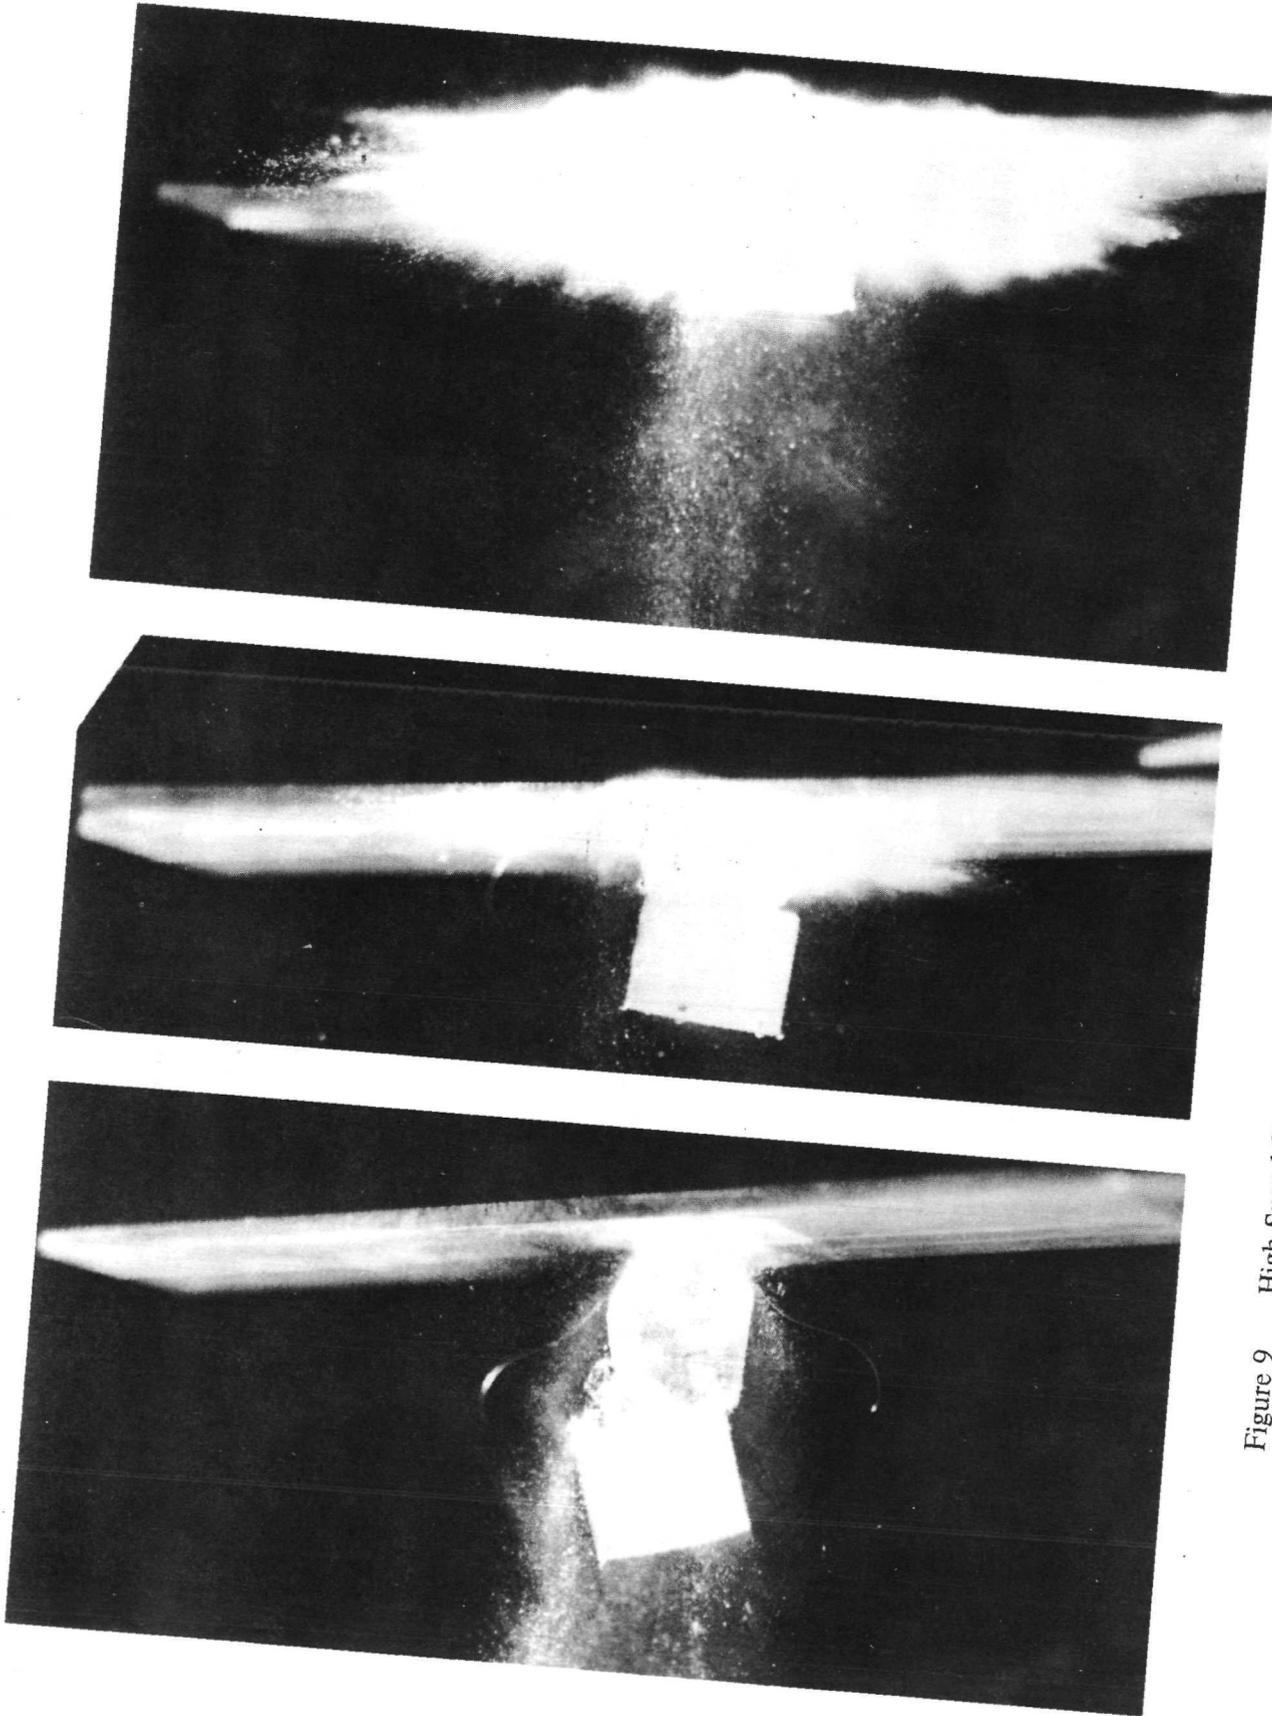
Figure 9 High Speed Strobe Photographs Showing Approach and Impact of a 2.54 cm Diameter Ice Ball

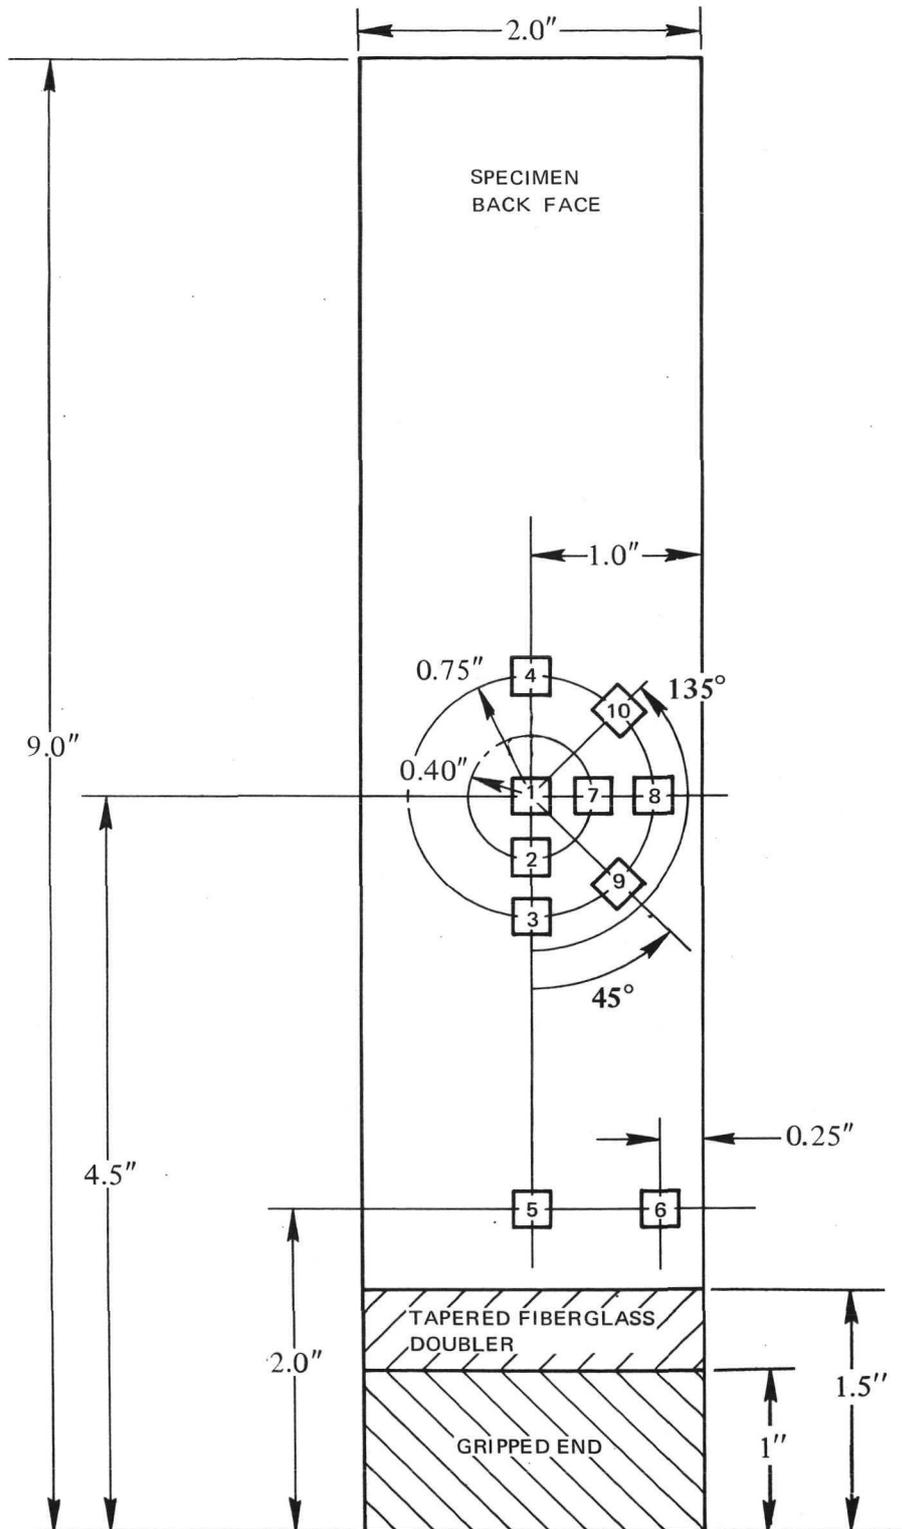
Figure 10 Location of Strain Gages on Task I Instrumented Impact Specimens

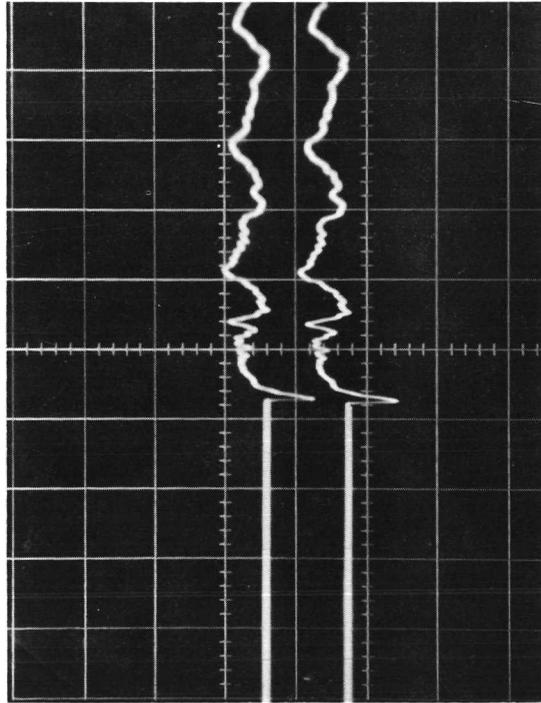
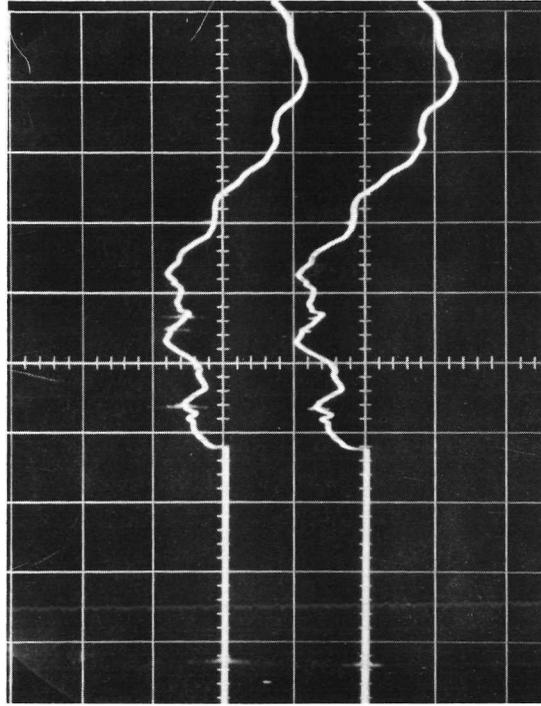
Figure 11 On Line Oscilloscope Photograph Comparisons of Dynamic Strain Response as a Function of Amplifier Frequency Response. Upper Traces Are Directly Through Oscilloscope (1000 KHz), While Lower Traces Have Passed Through Translator Amplifier (50 KHz)

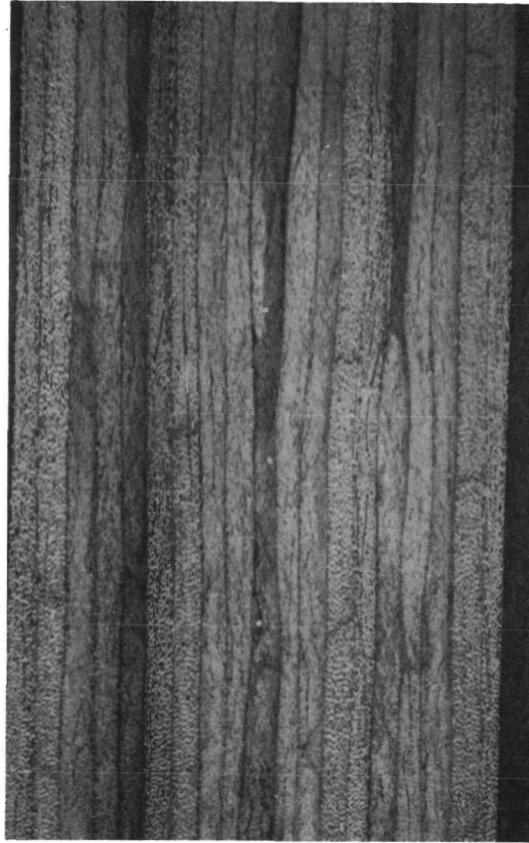
Figure 12 Transverse Cross Section View of Modmor II/PR-286 Pseudo-Isotropic Layout Specimen After Impact With 1.27 cm Diameter Ice at 282 m/sec

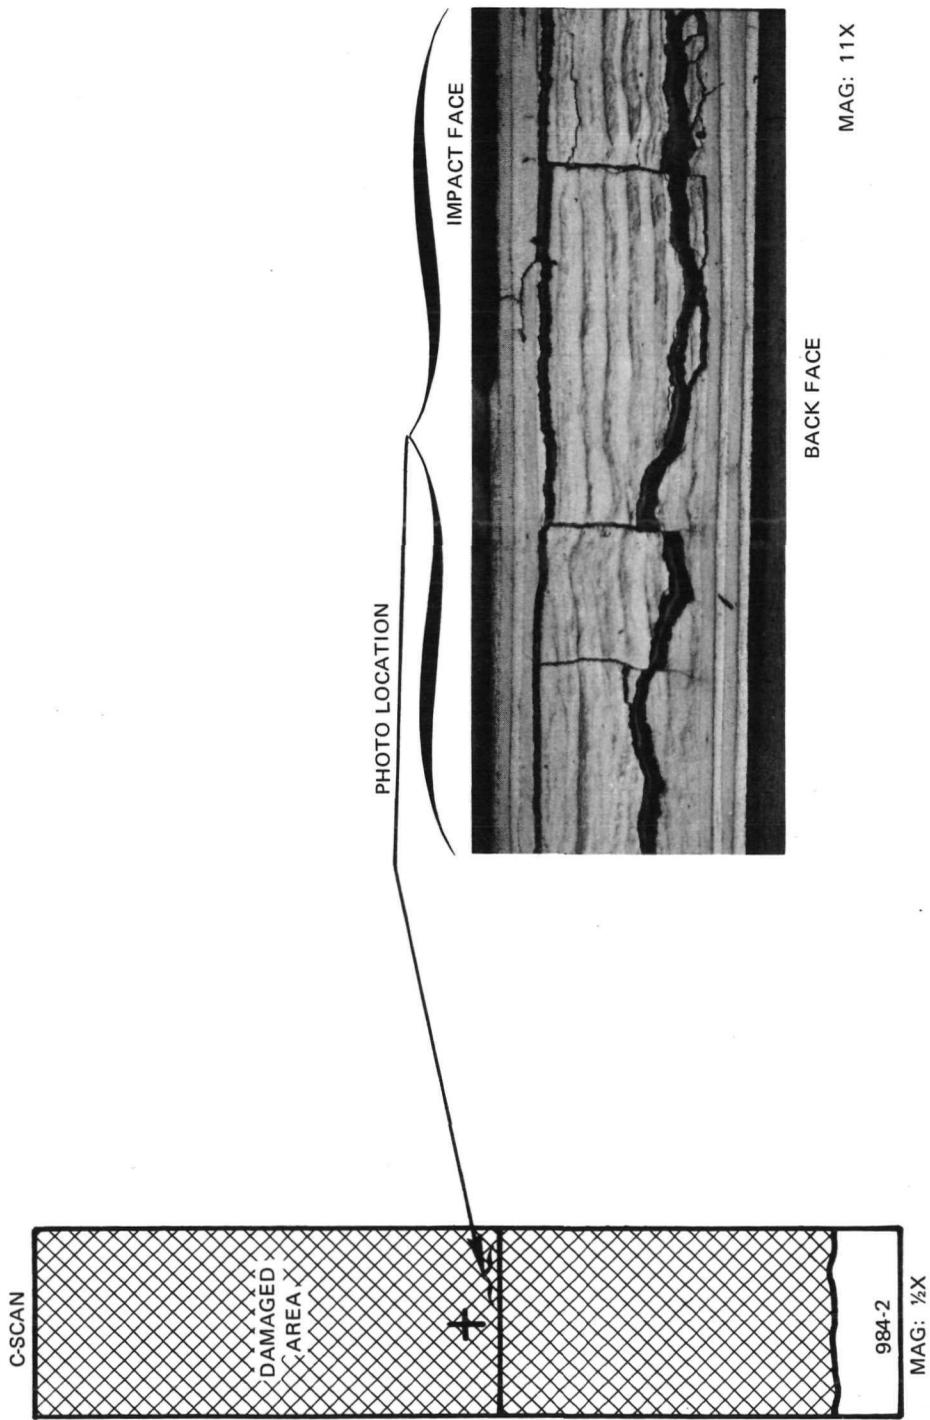
Figure 13 Transverse Cross Section View of $[(\pm 45)_2 | 0_{12} | (\mp 45)_2]_T$ Modmor II/PR-286 Specimen After Impact With 2.54 cm Diameter Gelatin at 107 m/sec

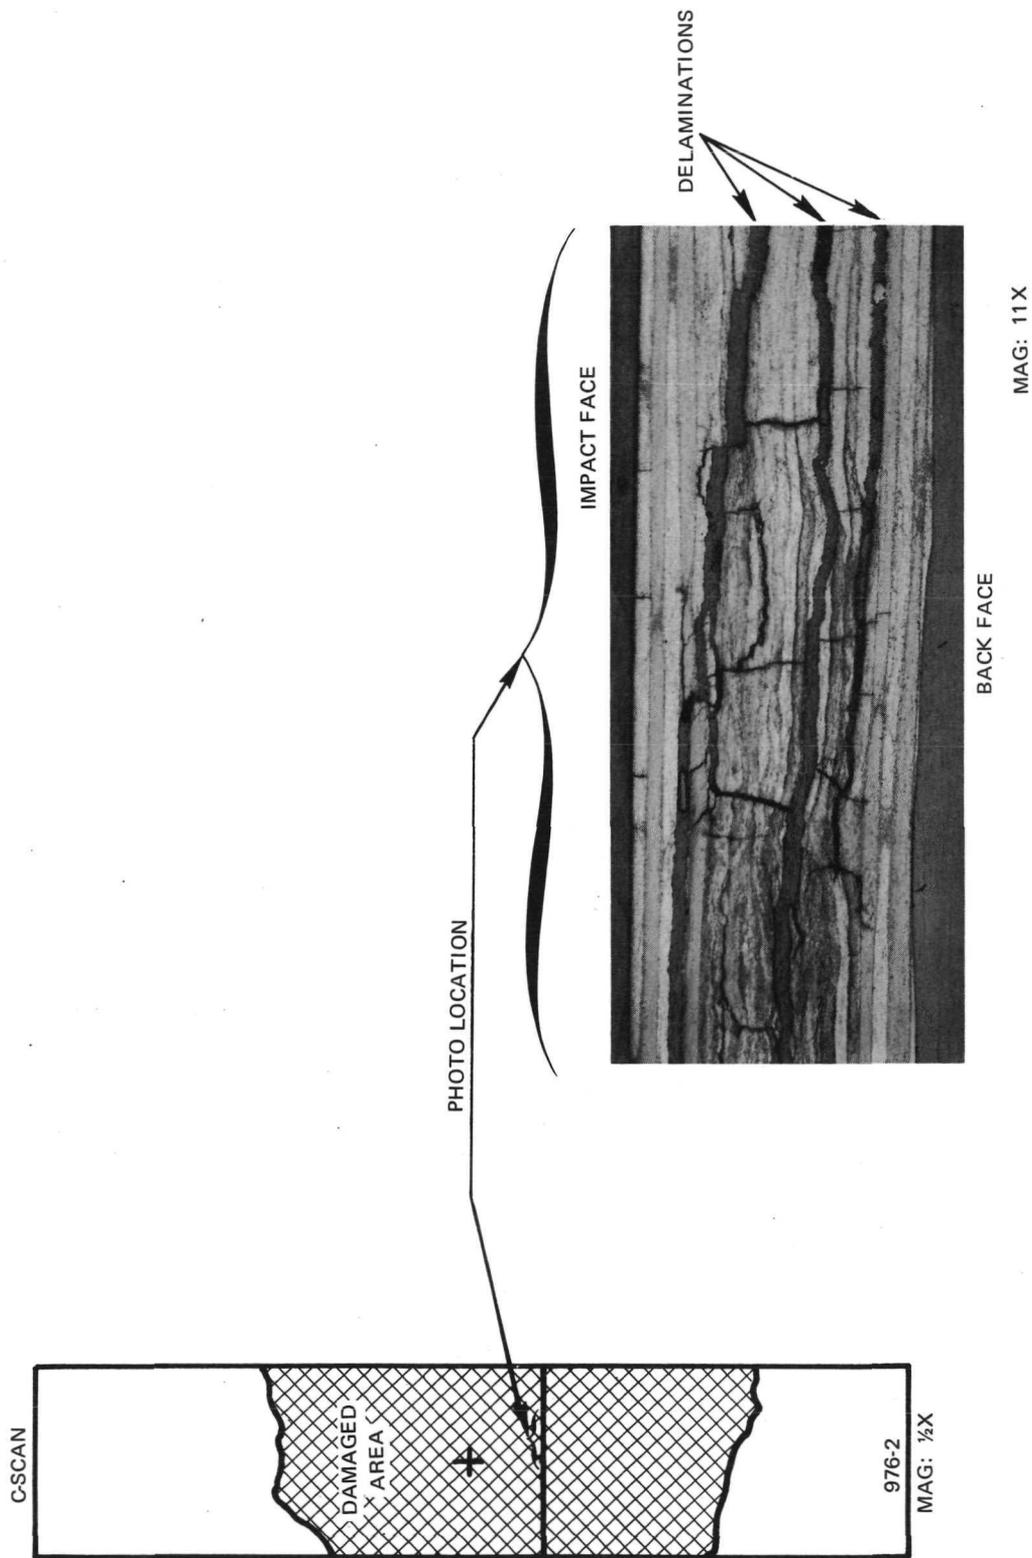
Figure 14 Transverse Cross Section View of $[(\pm 45)_2 | 0_{12} | (\mp 45)_2]_T$ Modmor II/PR-286 Specimen After Impact With 1.27 cm Diameter Gelatin at 274 m/sec. (Note Multiple Cracks and Delamination)

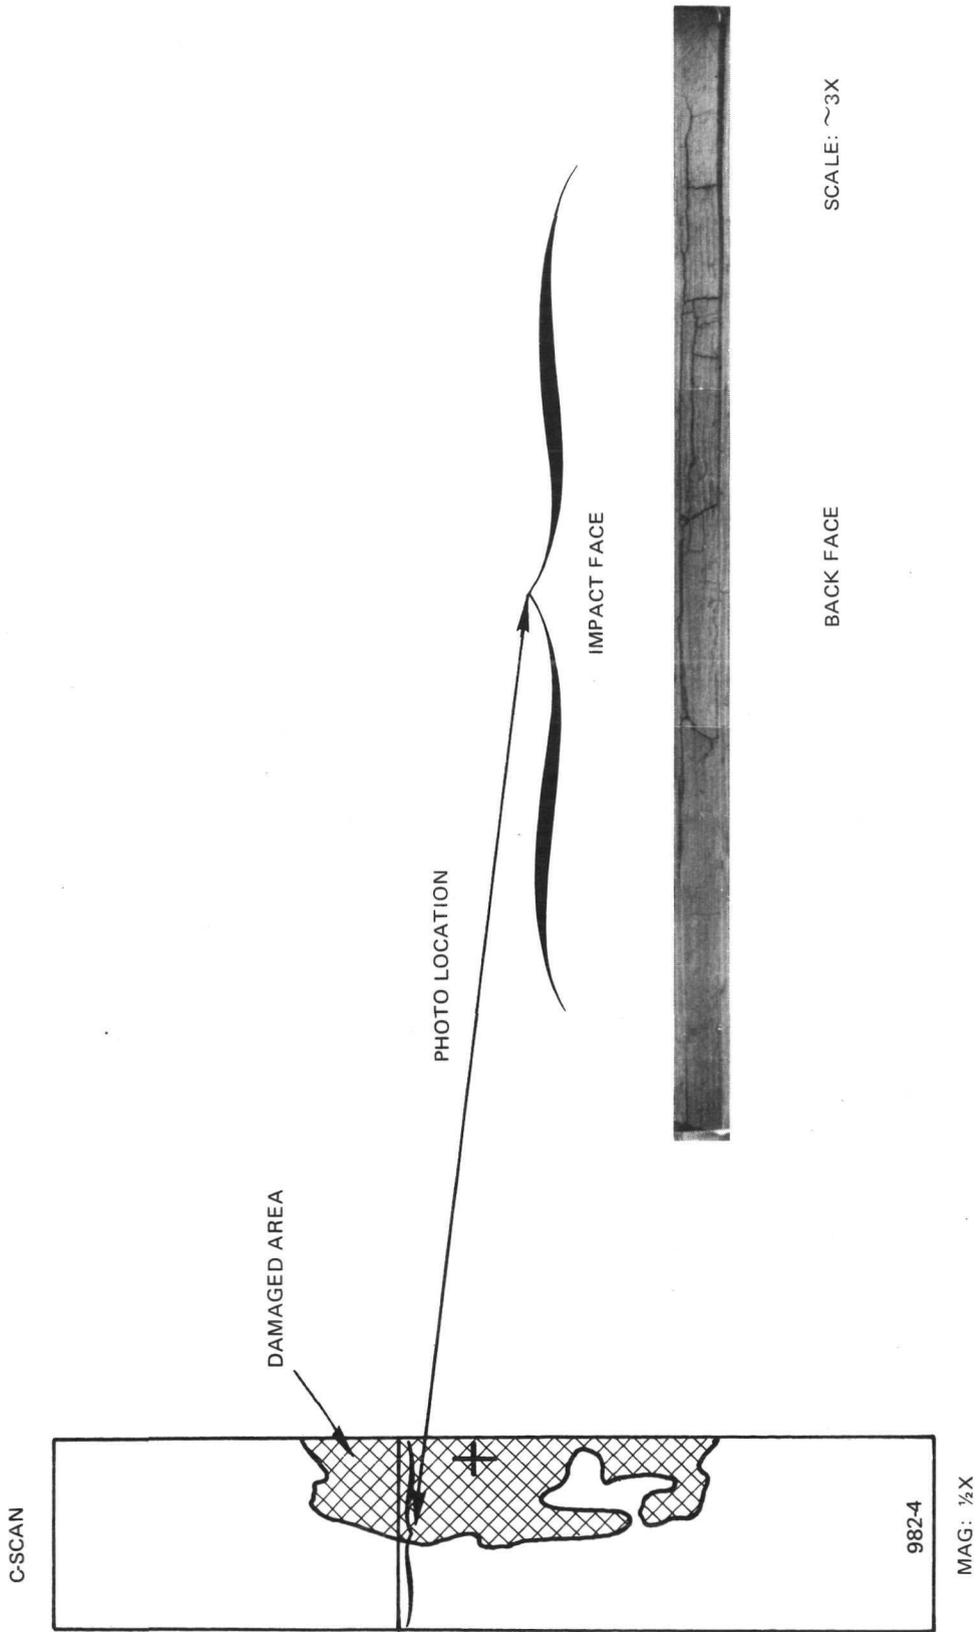
Figure 15 Transverse Cross Section View of $[(\pm 45)_2 | 0_{12} | (\mp 45)_2]_T$ Modmor II/PR-286 Specimen After Impact With 1.27 cm Diameter Ice at 279 m/sec
