NASA CR-134502
PWATM-4727

**IMPACT RESISTANCE OF FIBER COMPOSITE
BLADES USED IN AIRCRAFT TURBINE ENGINES**

**PRATT & WHITNEY AIRCRAFT
DIVISION OF UNITED AIRCRAFT CORPORATION**

Prepared for
NATIONAL AERONAUTICS AND SPACE ADMINISTRATION

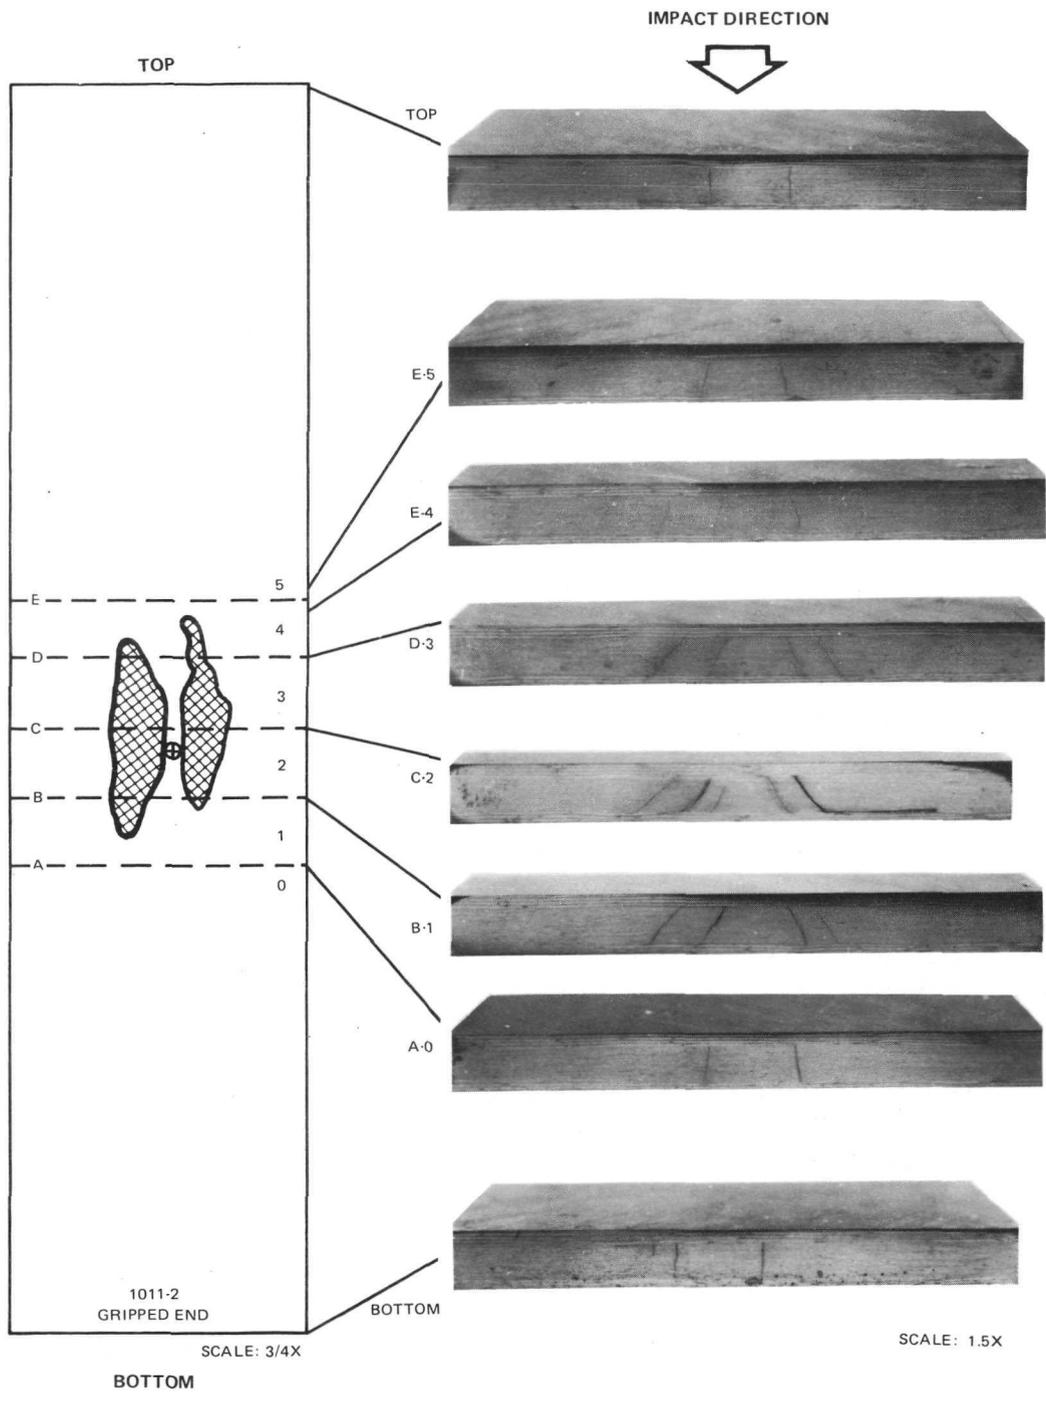
Figure 16 Comparison of Ultrasonic C-Scan Inspection With Transverse Metallographic Sections Taken From $[(\pm 45)_4 | 0_{24} | (\mp 45)_4]_T$ Modmor II/PR-286 Specimen

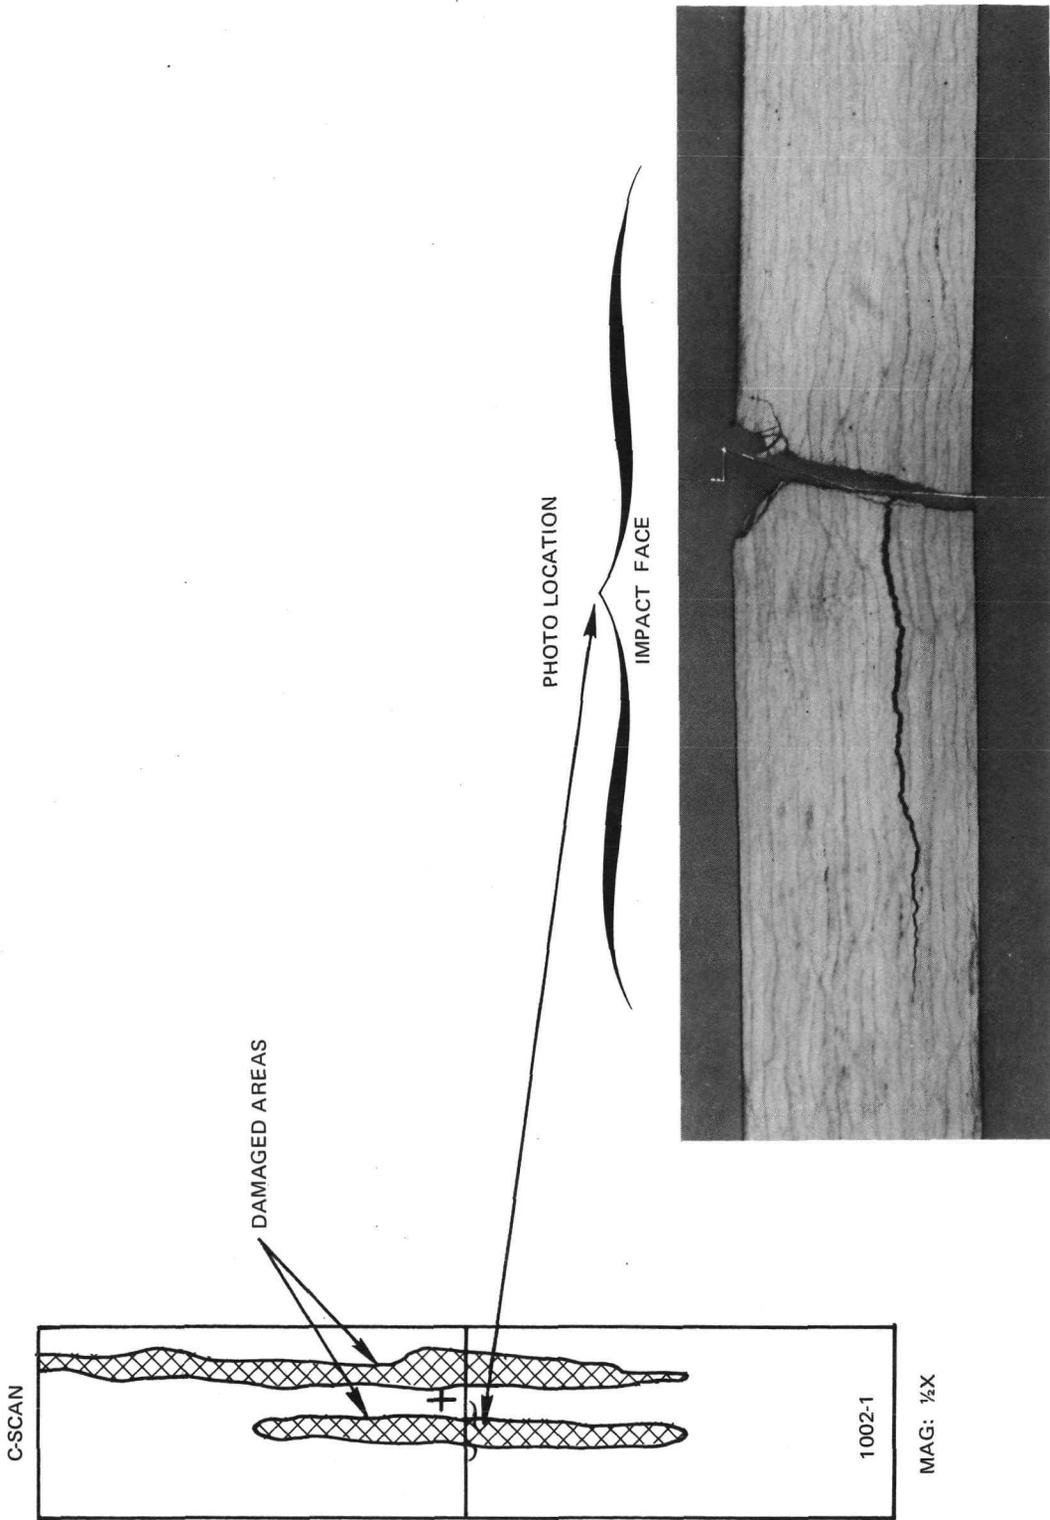
Figure 18 Transverse Cross Section View of $[0_{20}]_T$ Modmor II/PR-286 Specimen After Impact With 1.27 cm Diameter Ice at 262 m/sec

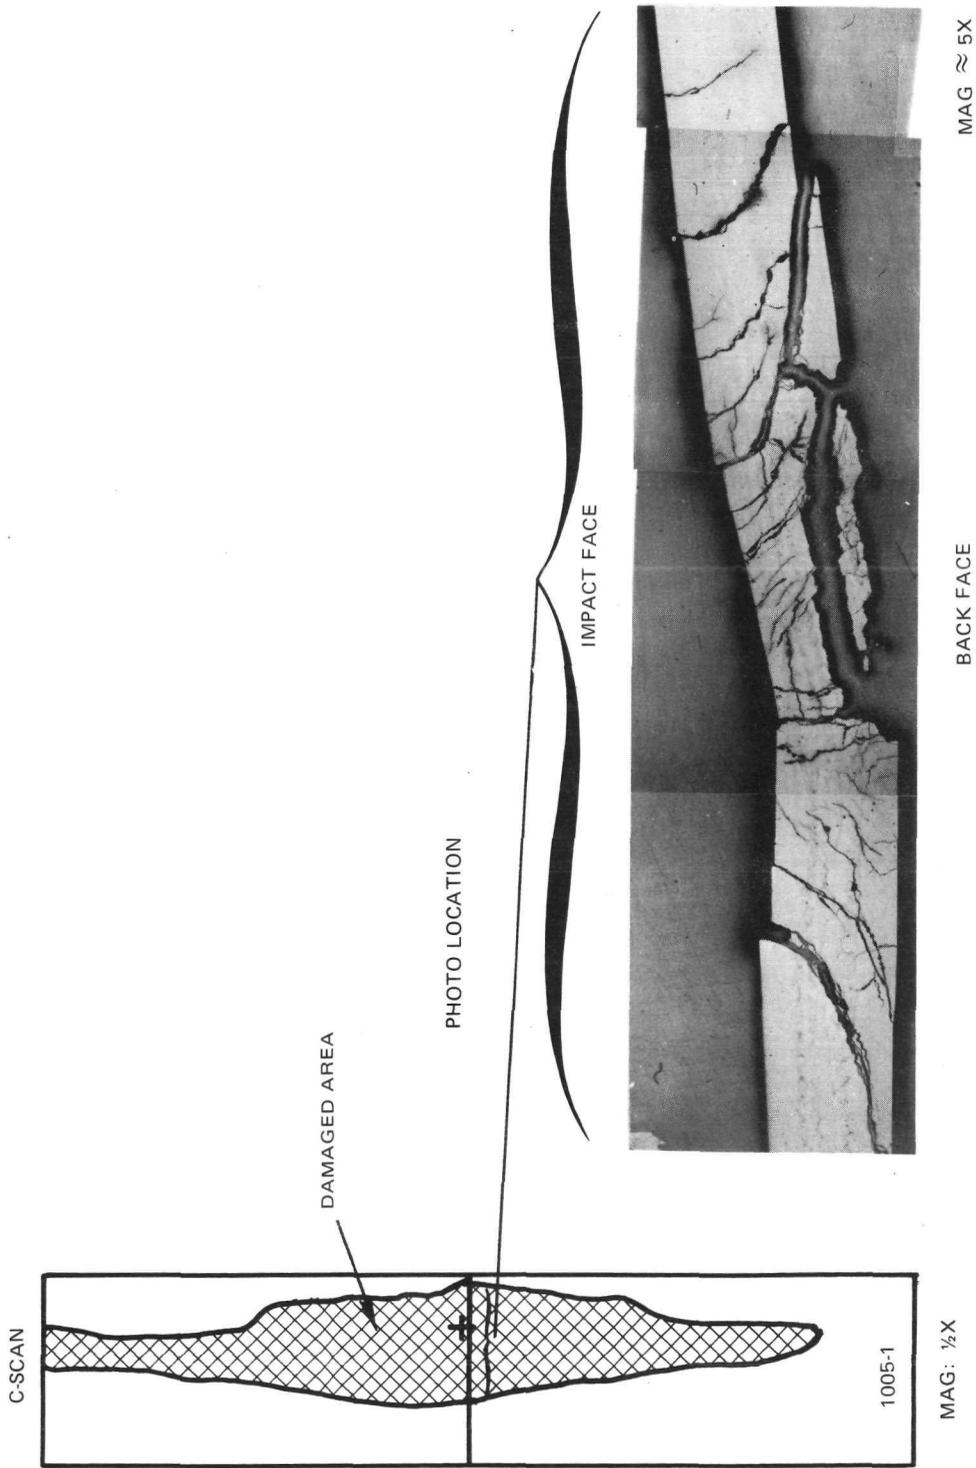
Figure 19 Transverse Cross Section View of $[0_{18}]_T$ T-75-S/PR-286 Specimen After Impact With 1.27 cm Diameter Ice at 260 m/sec

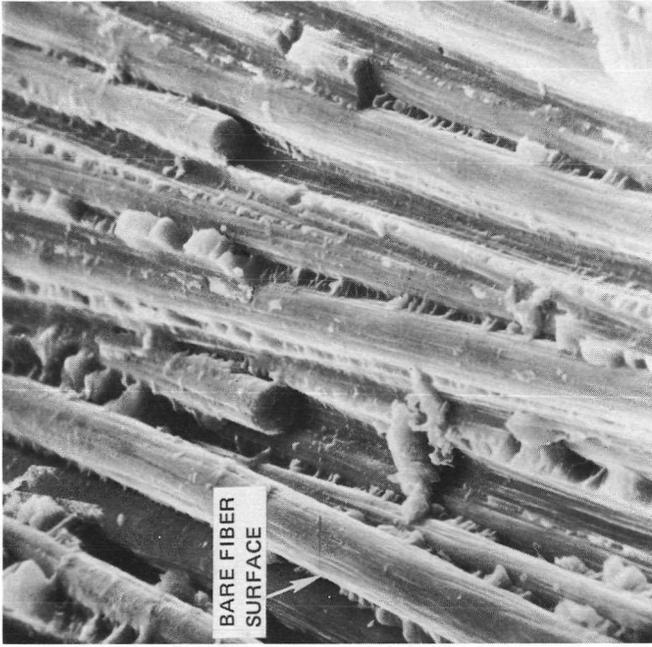
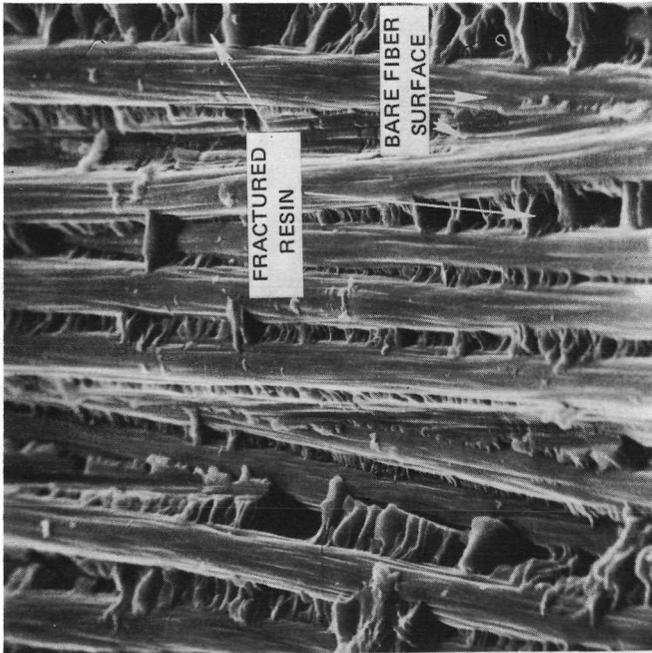
Figure 20 Scanning Electron Microscope Photographs of Typical Interlaminar Fracture Surfaces From Impacted Modmor II/PR-286 Specimens

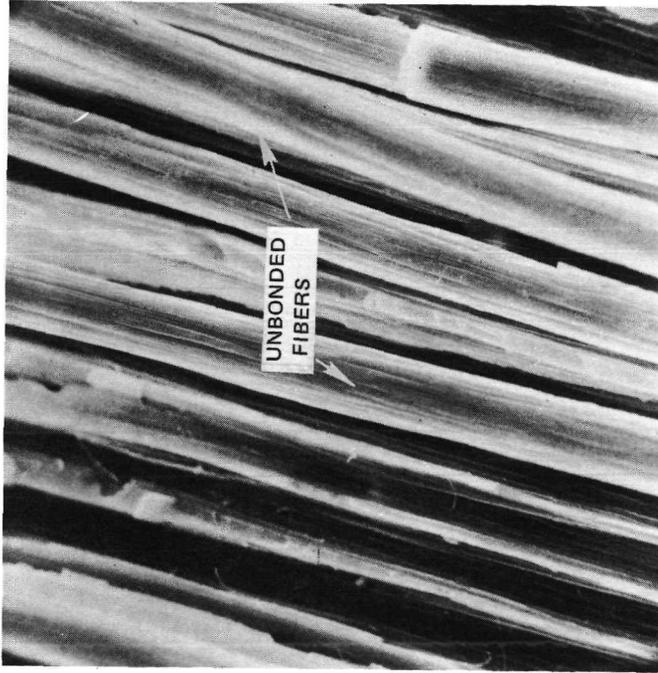
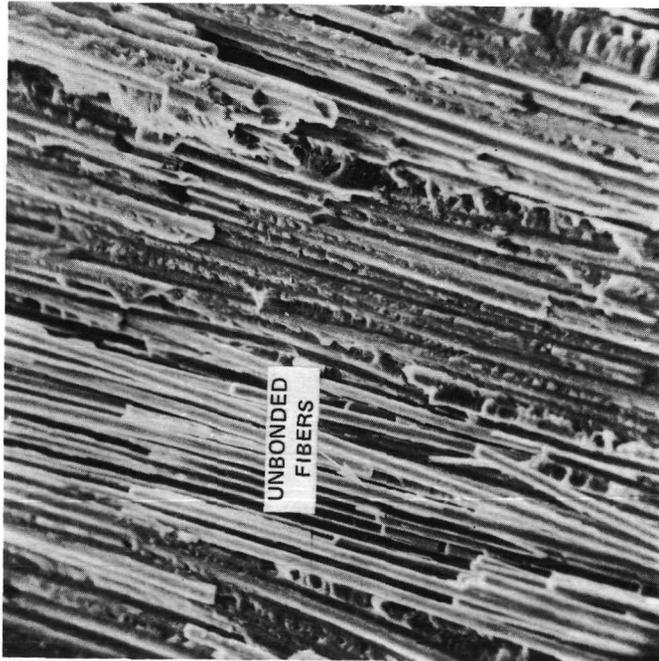
Figure 21 Scanning Electron Microscope Photographs of a Modmor II/PR-286 Transverse Tensile Specimen Fracture. (Note Completely Unbonded Fibers)

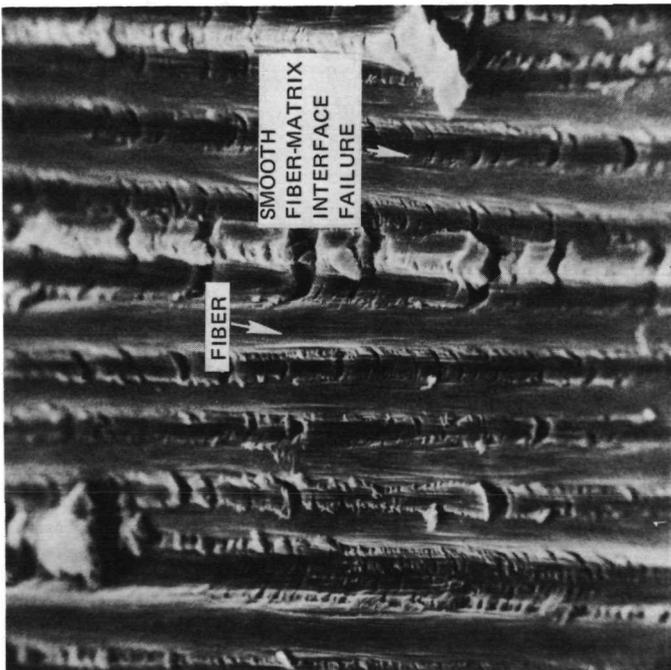
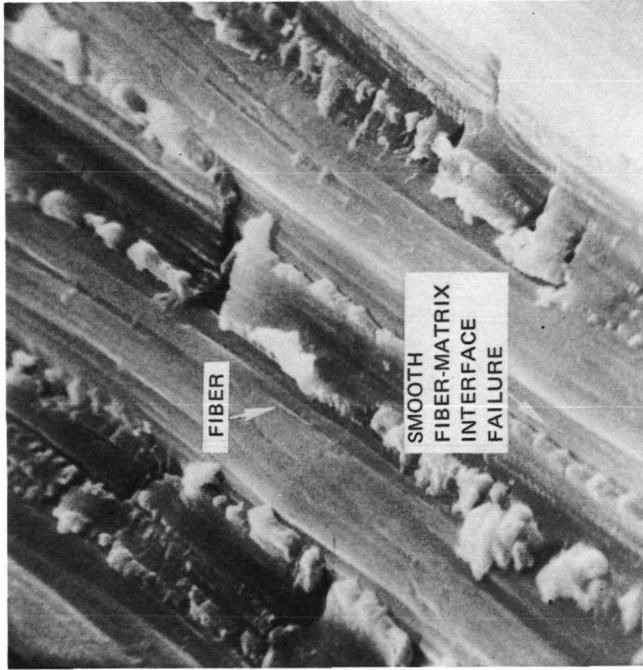
Figure 22 Scanning Electron Microscope Photographs of a Modmor II/PR-286 Short Beam Interlaminar Shear Specimen Fracture. (Note Lack of Matrix Tensile Fracture)

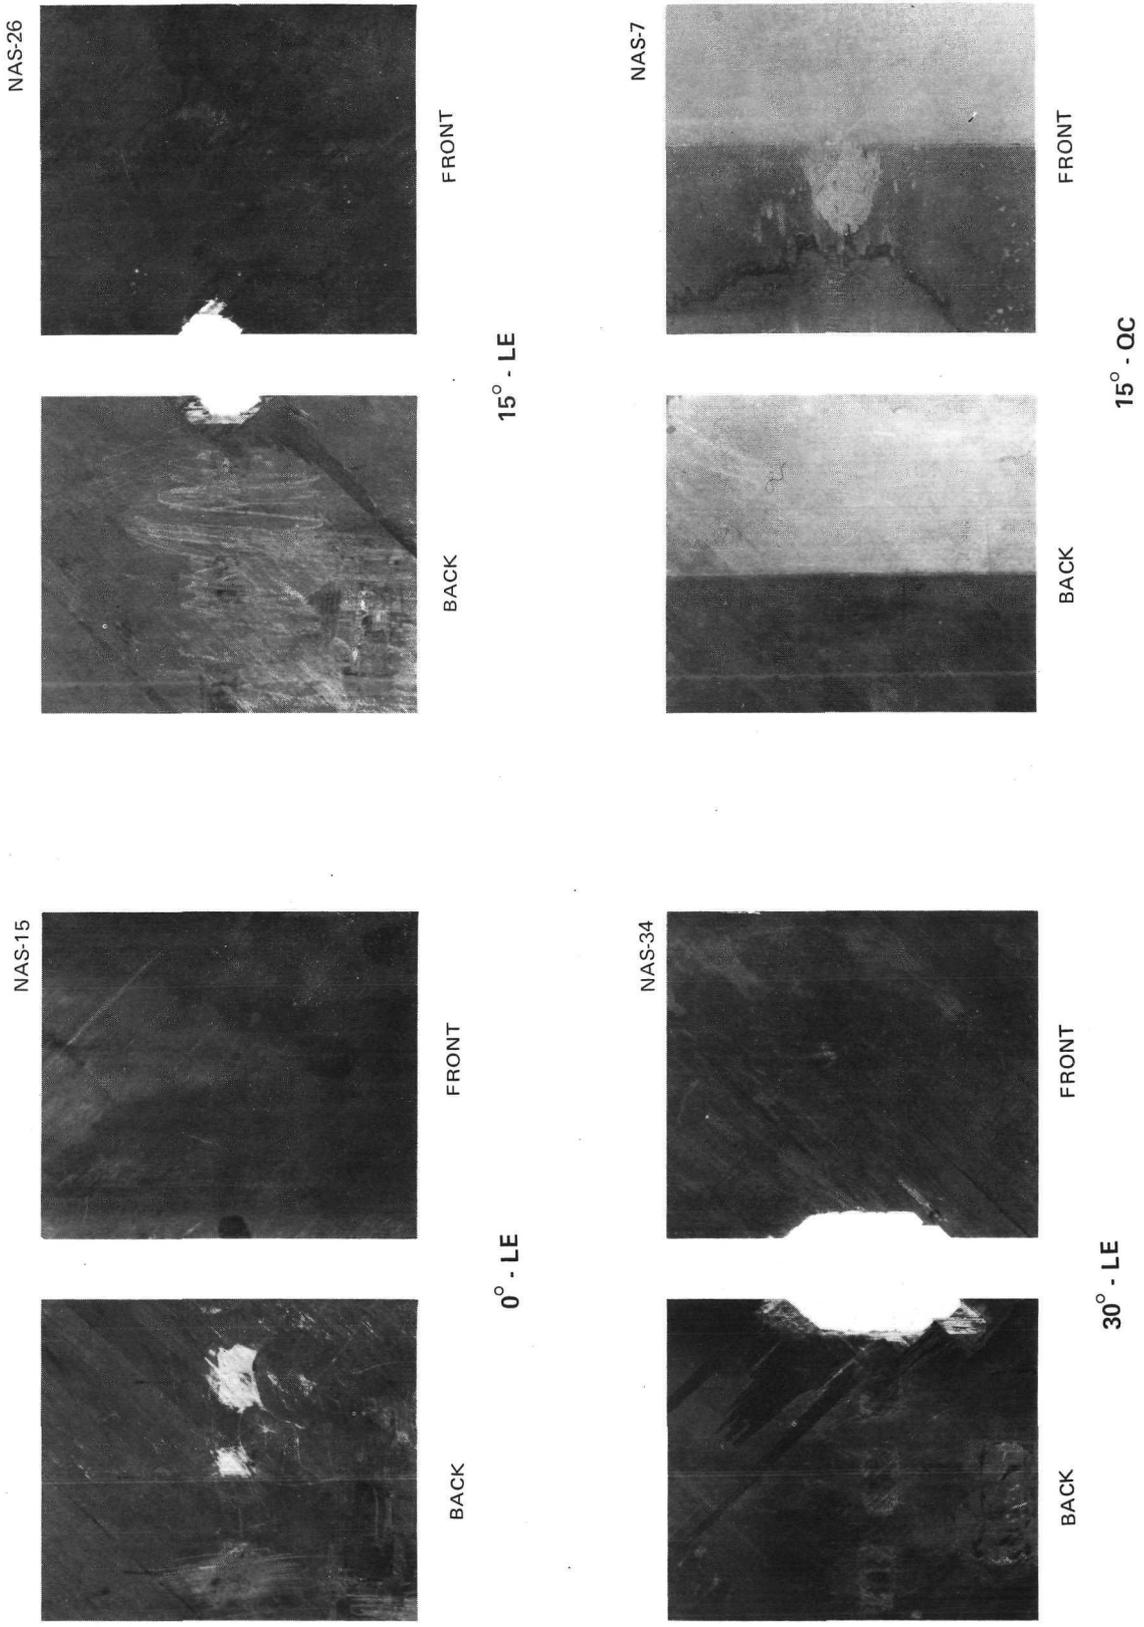
Figure 27 Effect of Impact Location and Angle Upon Damage to 0°, ±45° Modmor II/ PR-286 Simulated Blade Specimens Impacted With 1.27 cm Diameter Ice at Approximately 274 m/sec. (Mag: 0.7X)

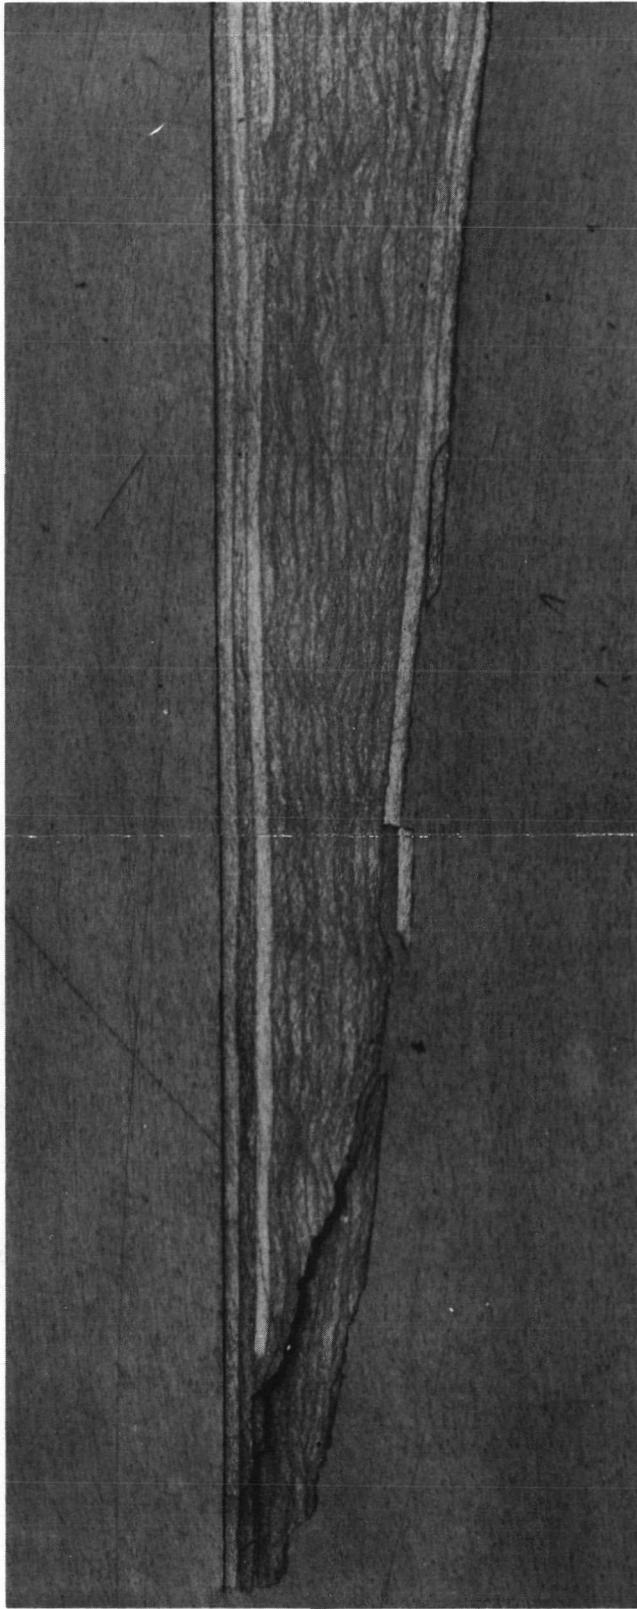
NAS-40

Figure 28 Transverse View Showing Typical Leading Edge Damage Caused by 1.27 cm Diameter Gelatin Impact at 30° to the Leading Edge

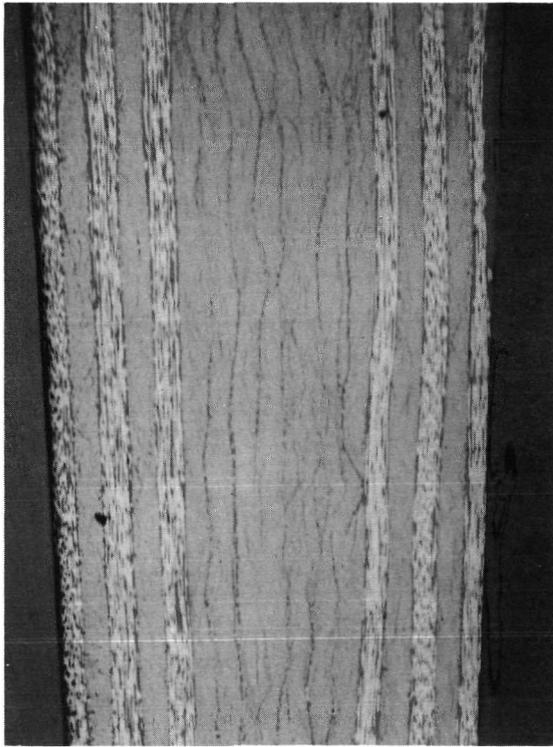
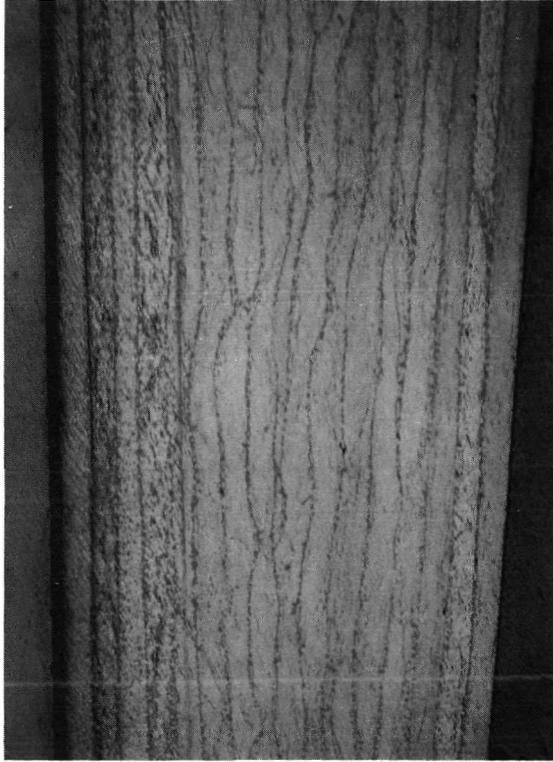
Figure 29 Transverse Cross Section Views of 0°, 90° and 0°, ±45° Modmor II/ PR-286 Specimens at the Quarter Chord Location Showing No Damage After Impact With 1.27 cm Diameter Gelatin at 15° - QC

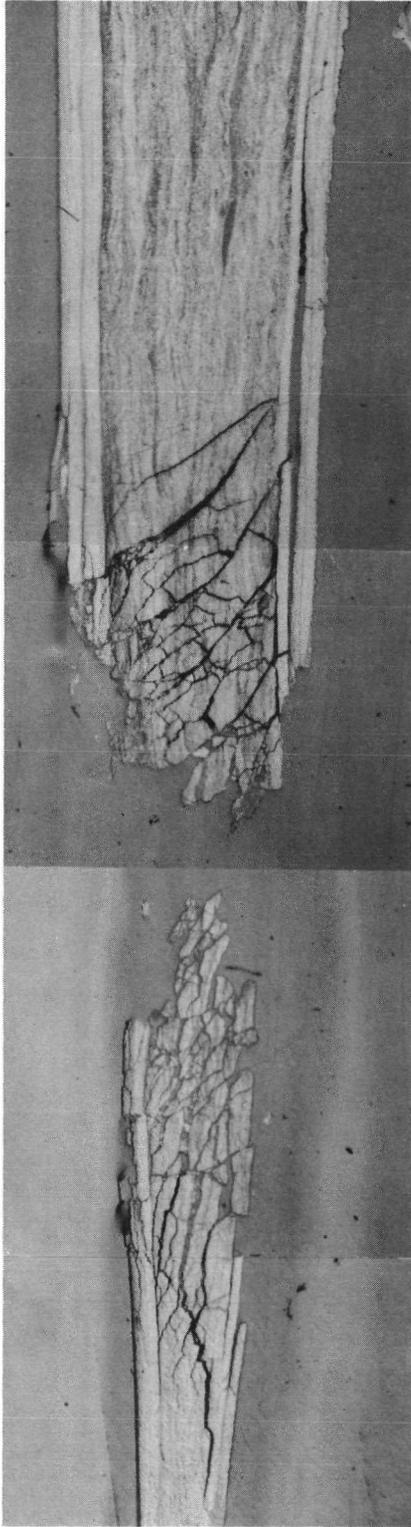
NAS-28

Figure 30 Cross Section View of Specimen Impacted With 0.64 cm Diameter Steel at 15° Quarter-Chord and 274 m/sec Showing Multiple Fractures Typical of Stress Wave Damage

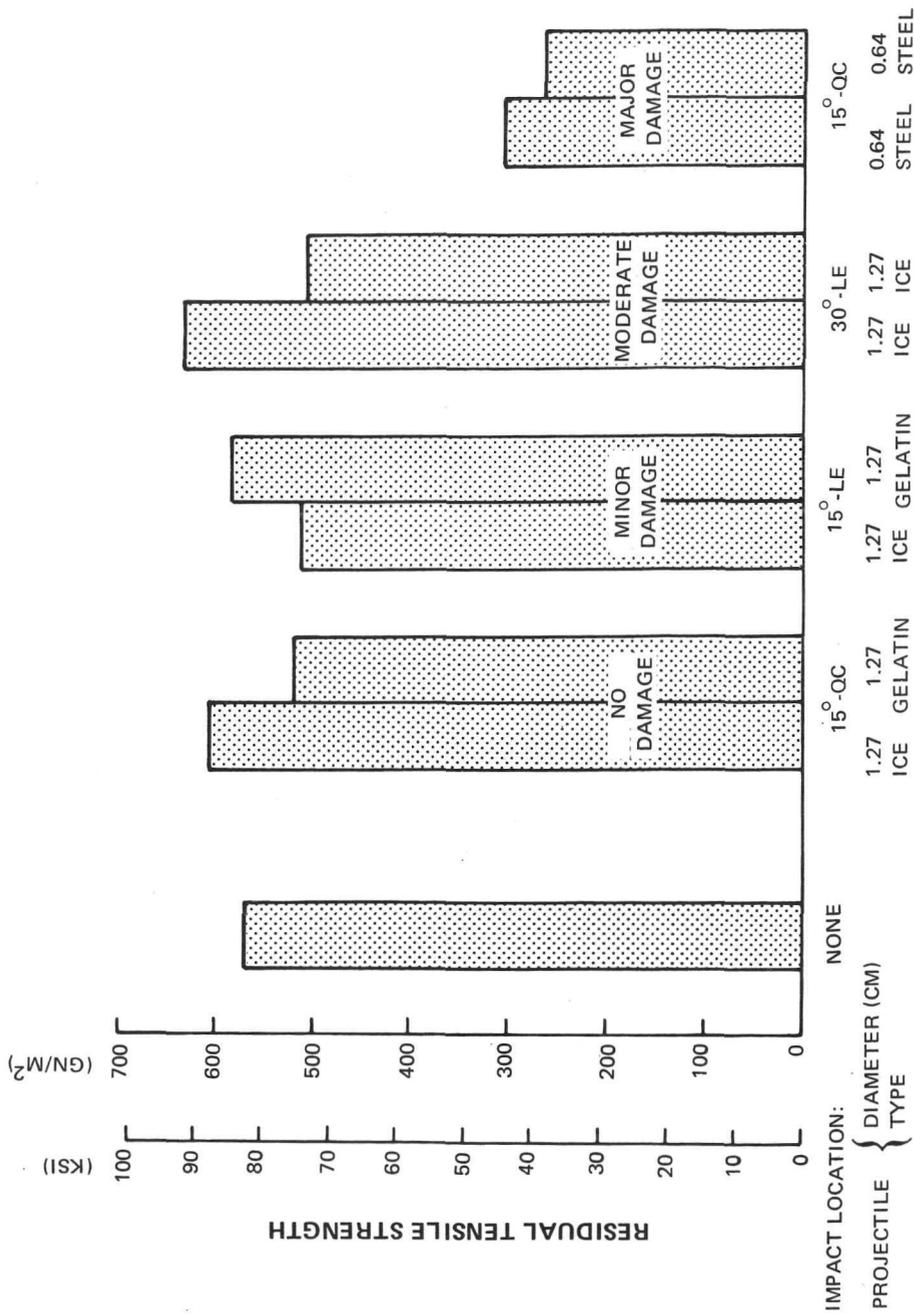
Figure 31 Residual Tensile Strength As a Function of Impact Damage (All Impacts at 274 m/sec)

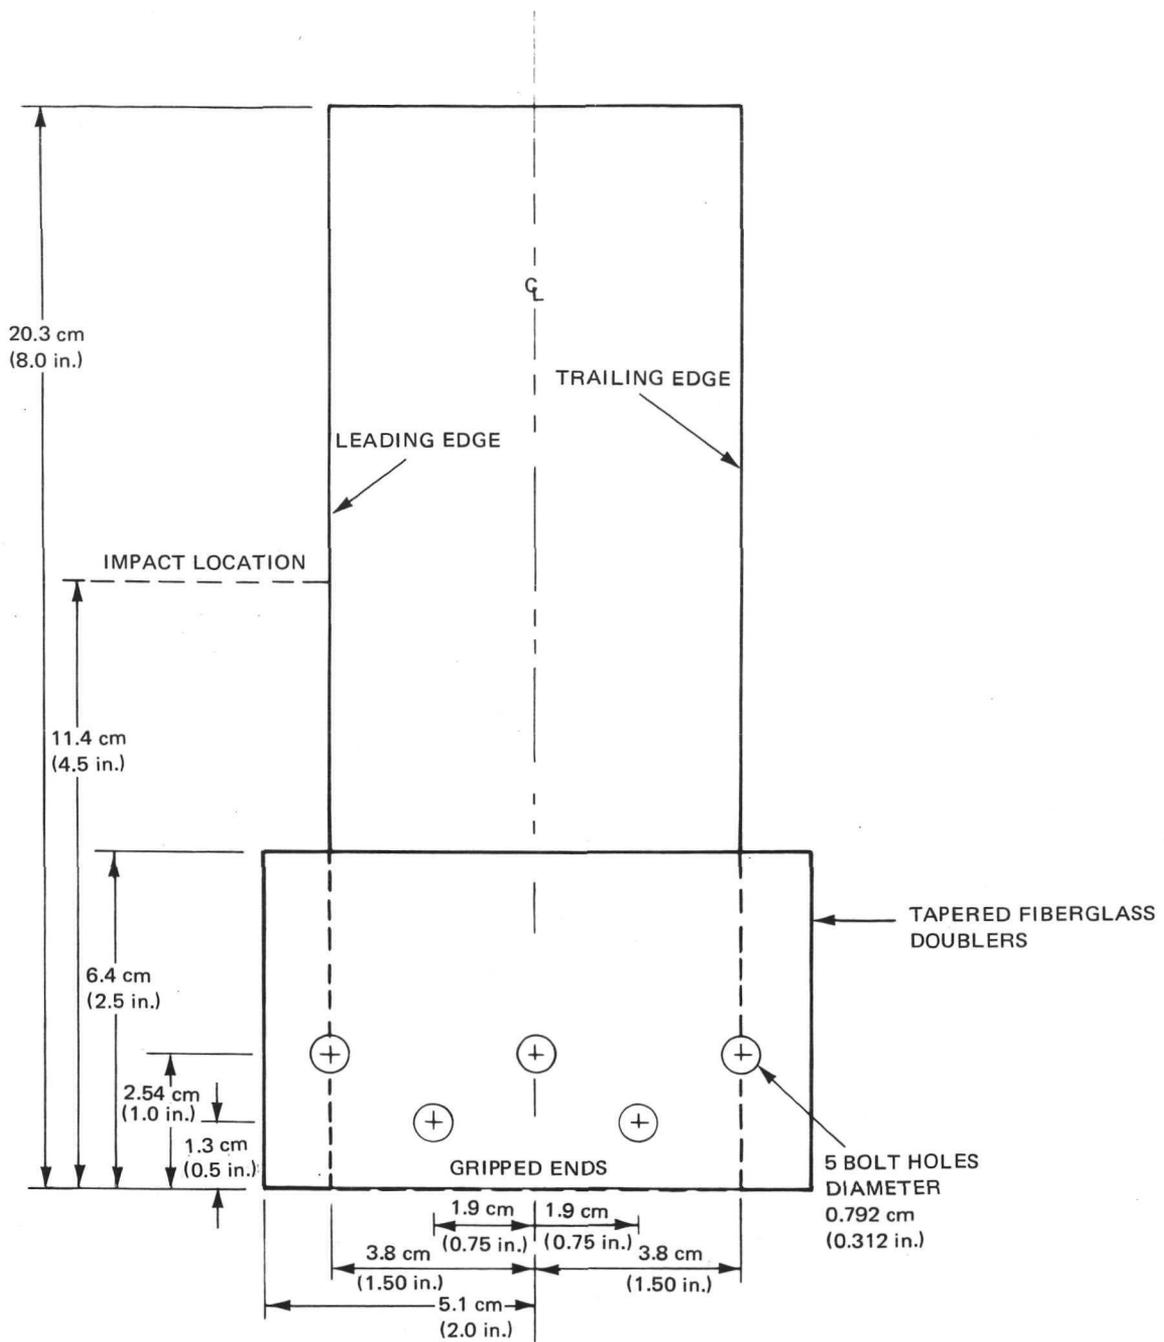
Figure 32 Task II Spin Impact Specimen Attachment Configuration

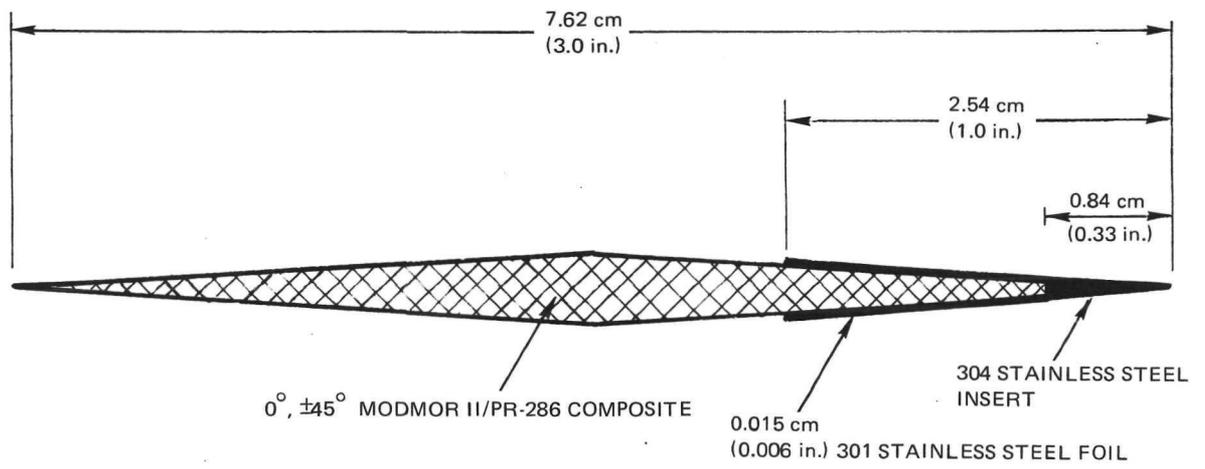
Figure 33 Cross Section View Showing Simulated Blade Specimen With Leading Edge Protection

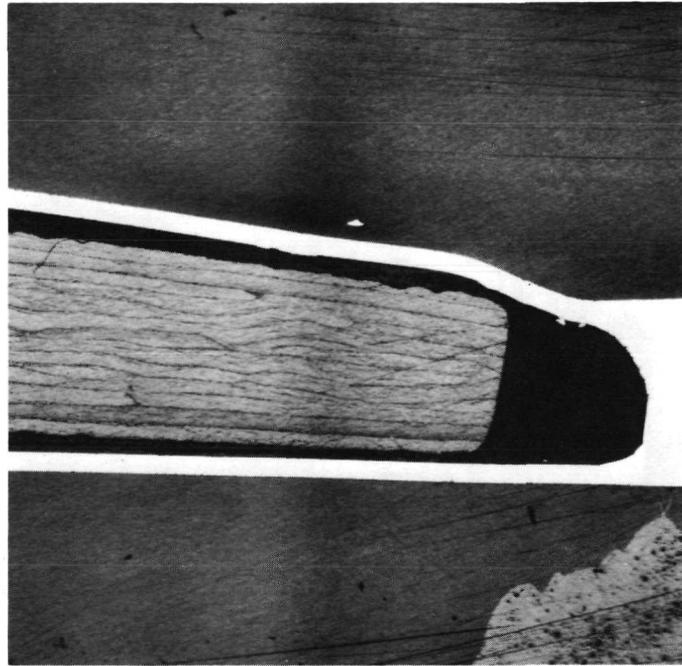
NAS-22

Figure 38 Transverse Cross Section View of Modmor II/PR-286 Specimen Just Behind Point of Impact on FOD Shield Which was Spin Impacted With 0.64 cm Diameter Steel at 274 m/sec. Note Lack of Damage to Composite

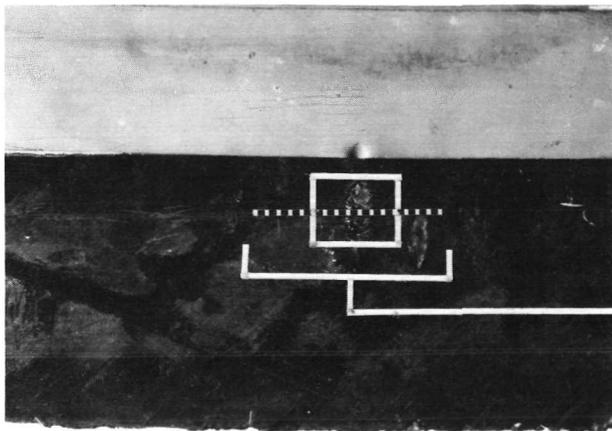
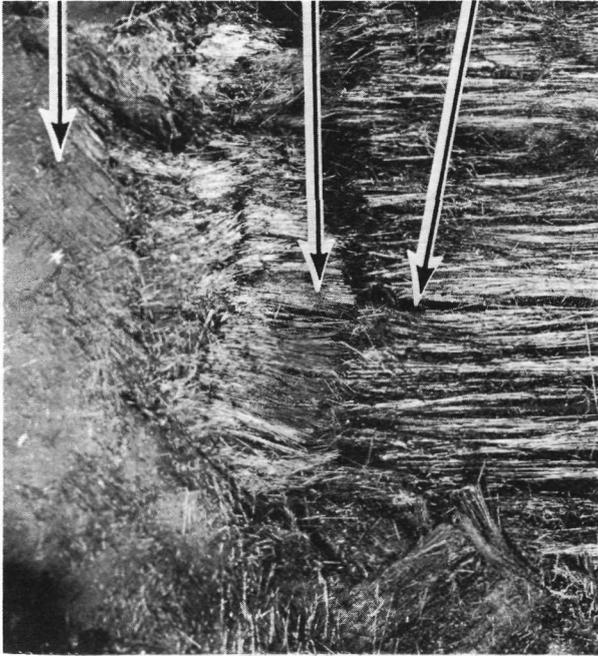
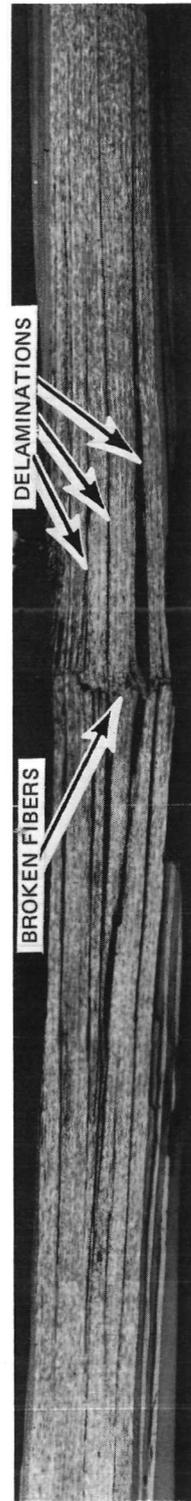
BROKEN FIBERS IN OUTER LONGITUDINAL LAYER

BROKEN FIBERS IN SECOND LAYER

DELAMINATIONS

Figure 39 Specimen NAS-29 After Two Glancing Impacts at Mid-Chord With 0.64 cm Diameter Steel at 274 m/sec. Insert 1 Shows Minimal Visual Damage at Impact Points. Inserts 2 and 3 Reveal That Broken Longitudinal Fibers and Delamination Extends Through Entire Specimen Thickness.

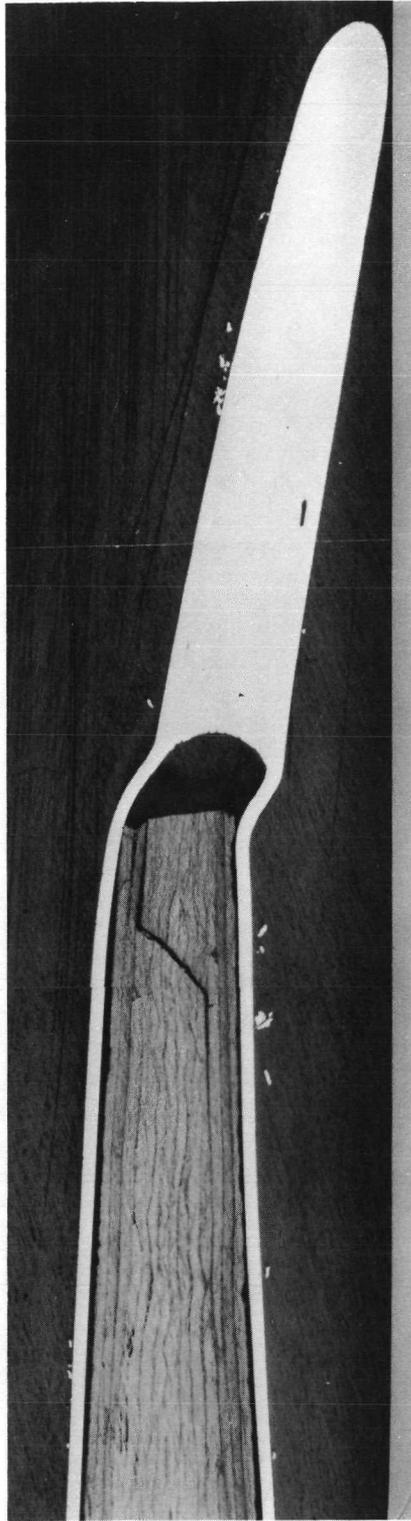
NAS-48

Figure 40 Transverse Cross Section View of Leading Edge Shield-to-Composite Region Showing Ductile Behavior of Foil and Slight Cracking in Composite After 2.54 cm Diameter Ice Impact at 274 m/sec and 30° to the Leading Edge

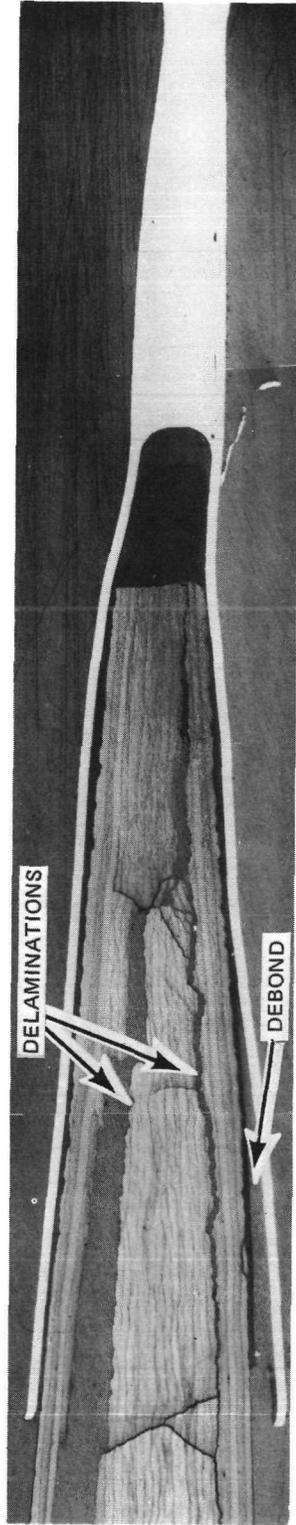
Figure 41 Transverse Cross Section View of Leading Edge-to-Composite Region Showing Severe Delamination in Composite After 2.54cm Diameter Gelatin Impact at 274 m/sec and 30° to the Leading Edge

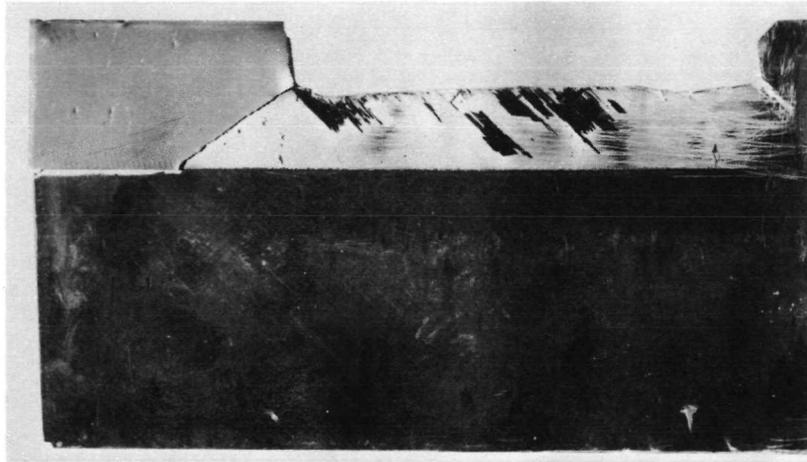
Figure 42 Effect of Leading Edge FOD Shield Against 2.54 cm Diameter Ice Projectiles at 396 m/sec (1300 ft/sec). All Impacts at 15° on Leading Edge. (Mag: 0.9X)

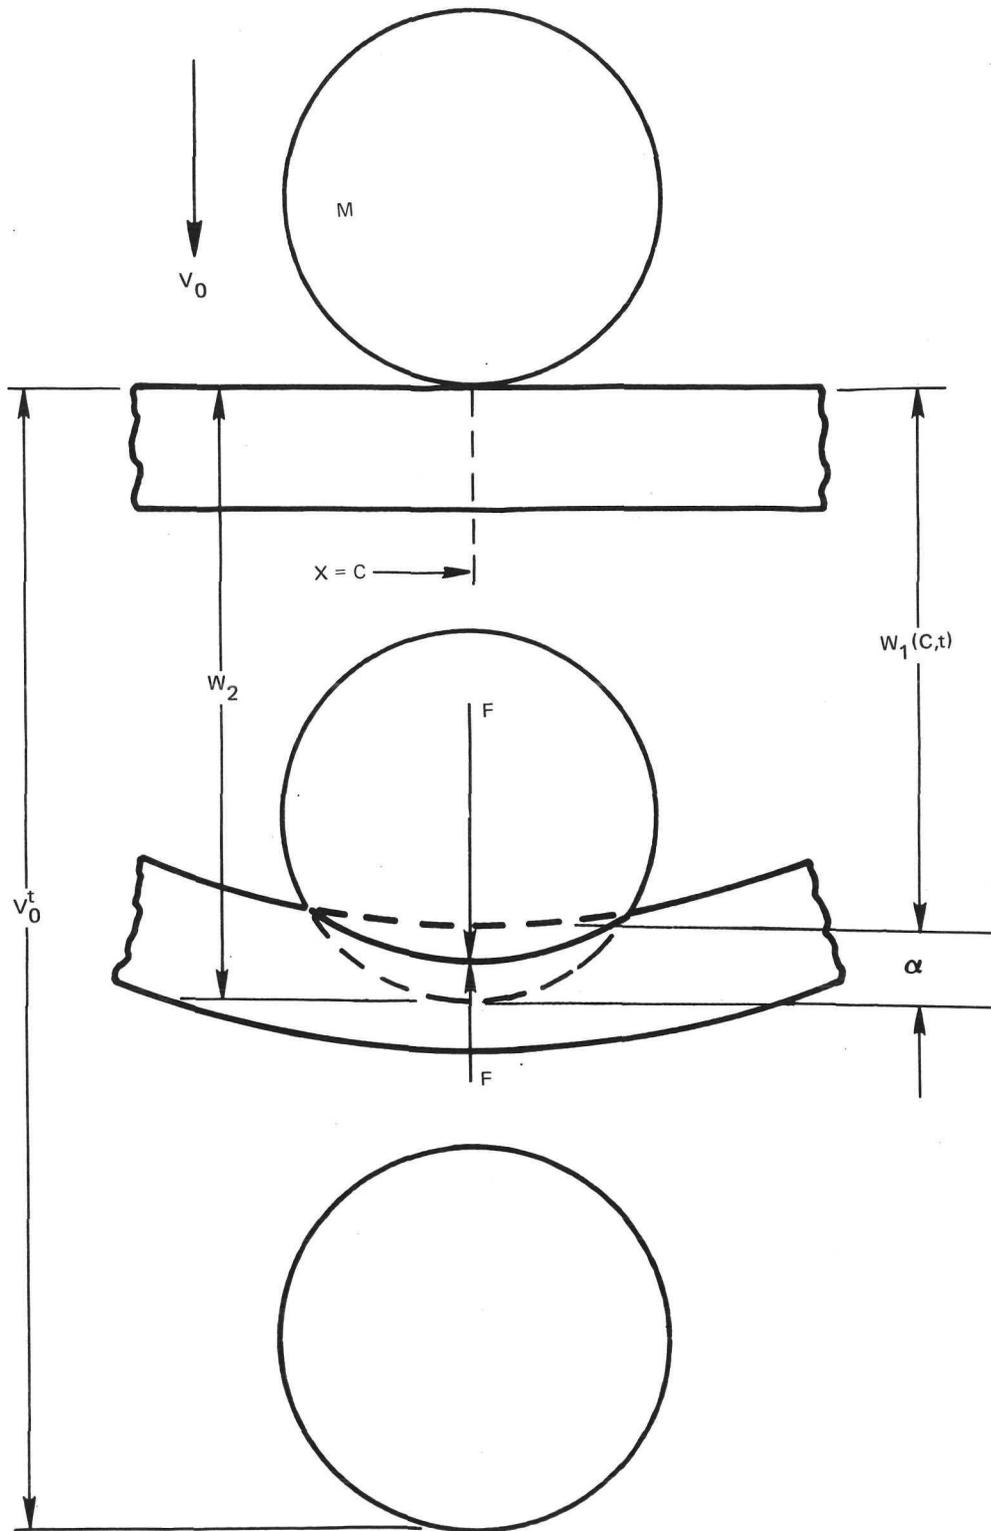
Figure 43 Geometry of Spherical Projectile Impact on a Beam

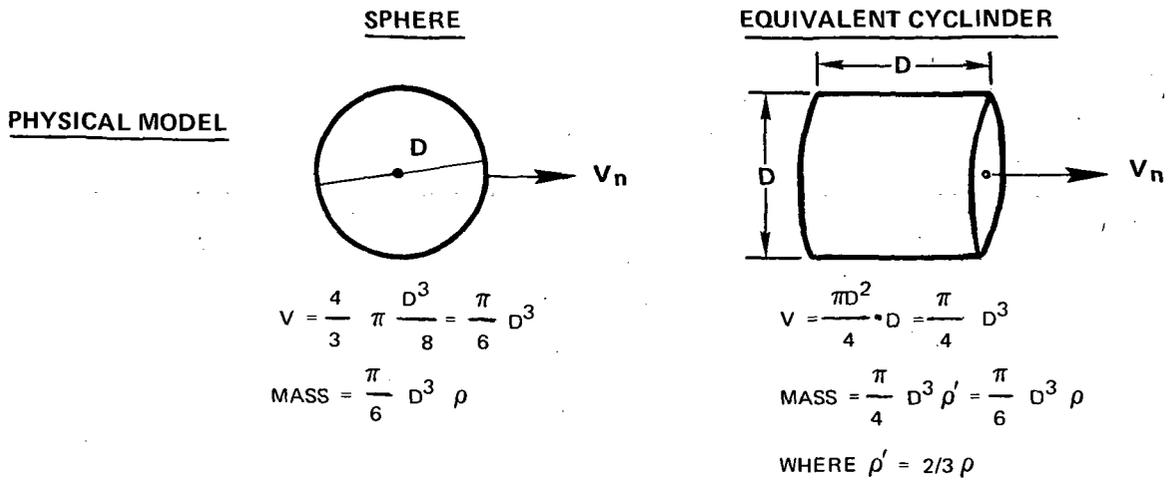
Figure 44 Dimensions of Equivalent Cylinder Used to Calculate the Average Momentum-Impulse Force

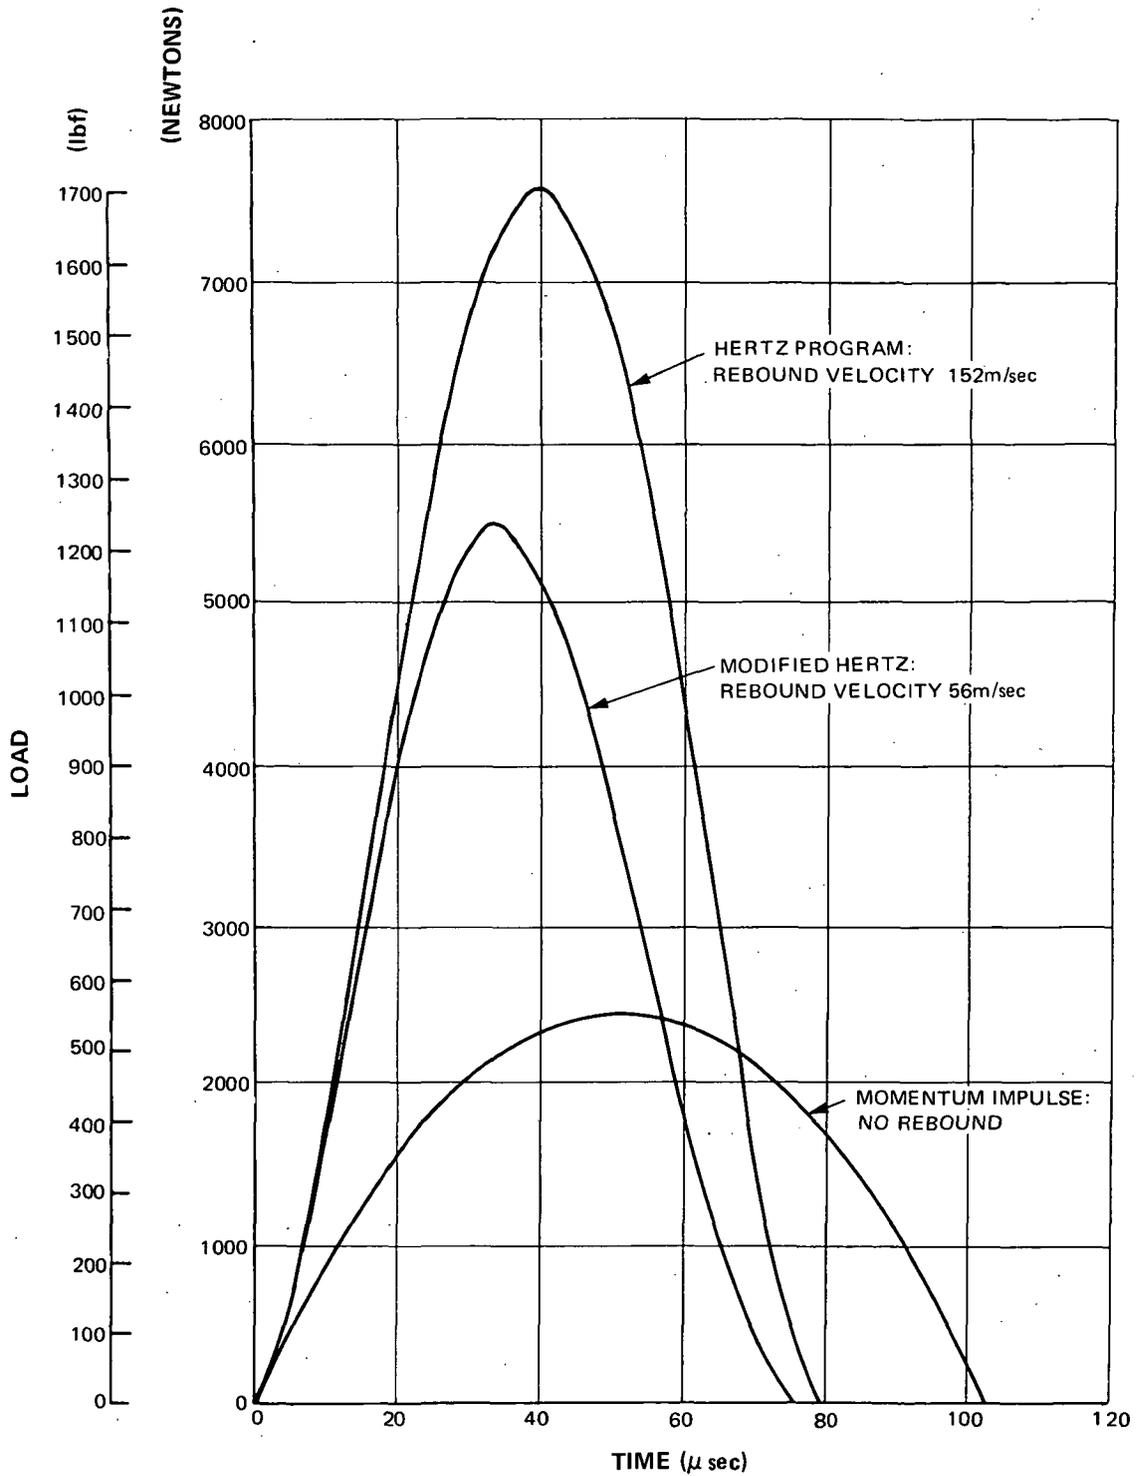
Figure 46 Load as a Function of Time for 1.27 cm Diameter Gelatin at 152 m/sec
