NASA CR-134502
PWATM-4727

**IMPACT RESISTANCE OF FIBER COMPOSITE
BLADES USED IN AIRCRAFT TURBINE ENGINES**

**PRATT & WHITNEY AIRCRAFT
DIVISION OF UNITED AIRCRAFT CORPORATION**

Prepared for
NATIONAL AERONAUTICS AND SPACE ADMINISTRATION

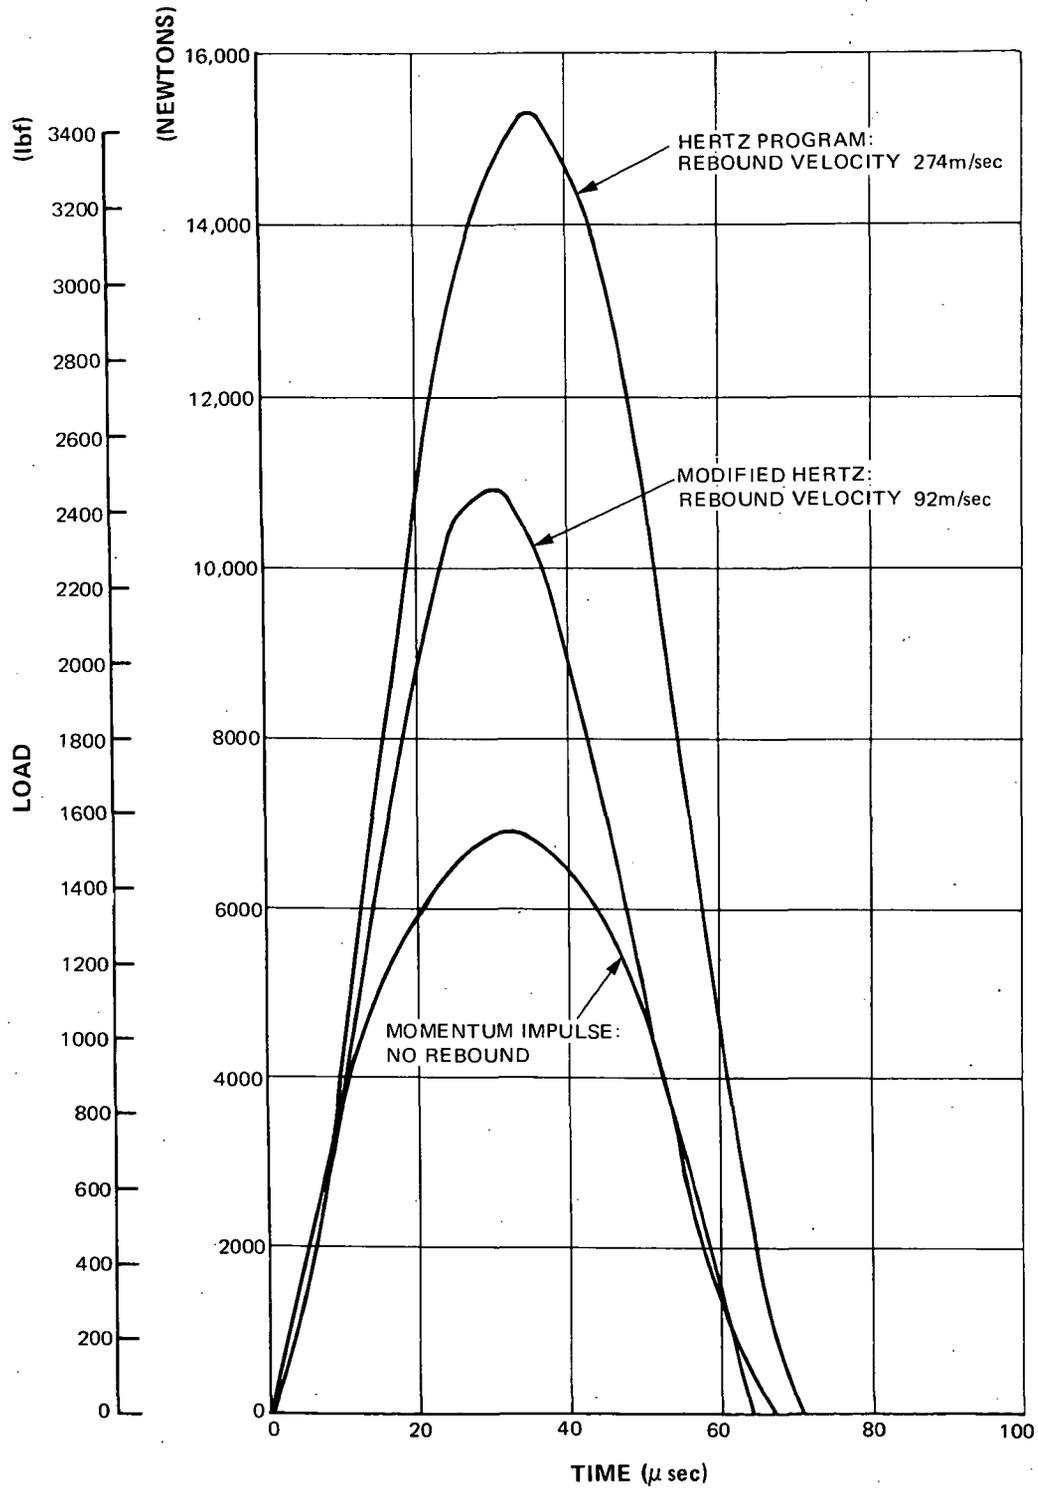
Figure 47 Load as a Function of Time for 1.27 cm Diameter Gelatin at 274 m/sec

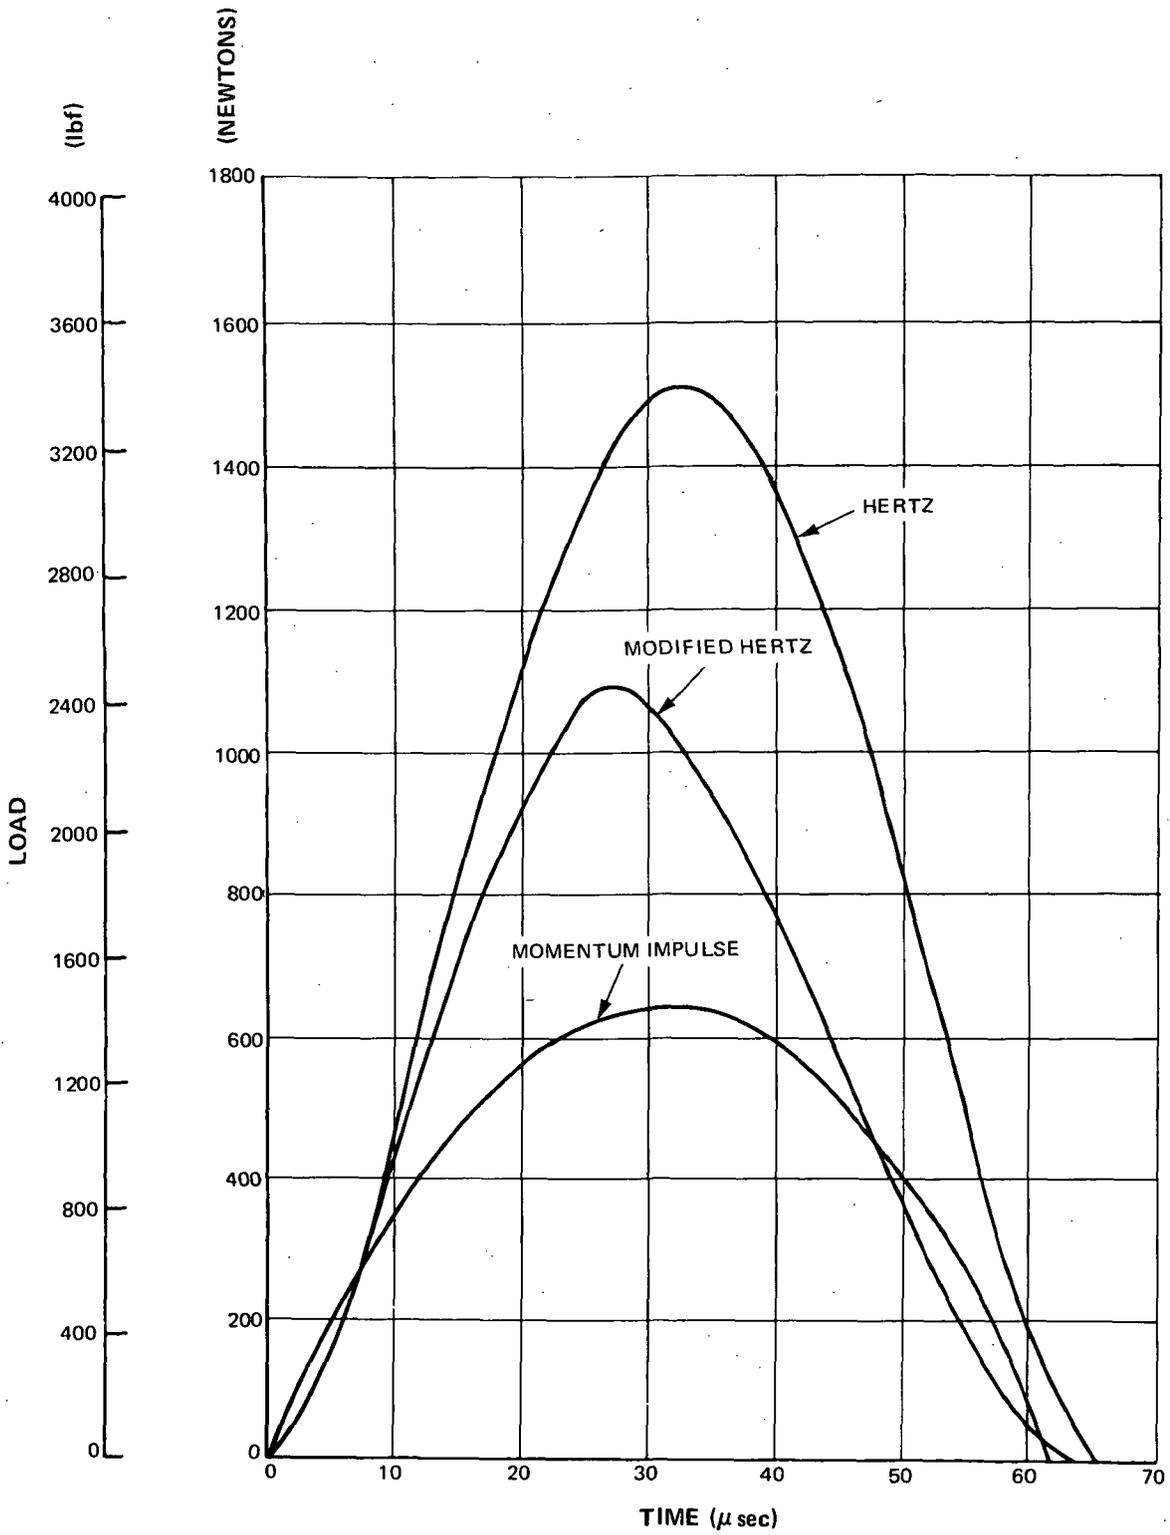
Figure 48 Load as a Function of Time for 1.27 cm Diameter Ice at 274 m/sec

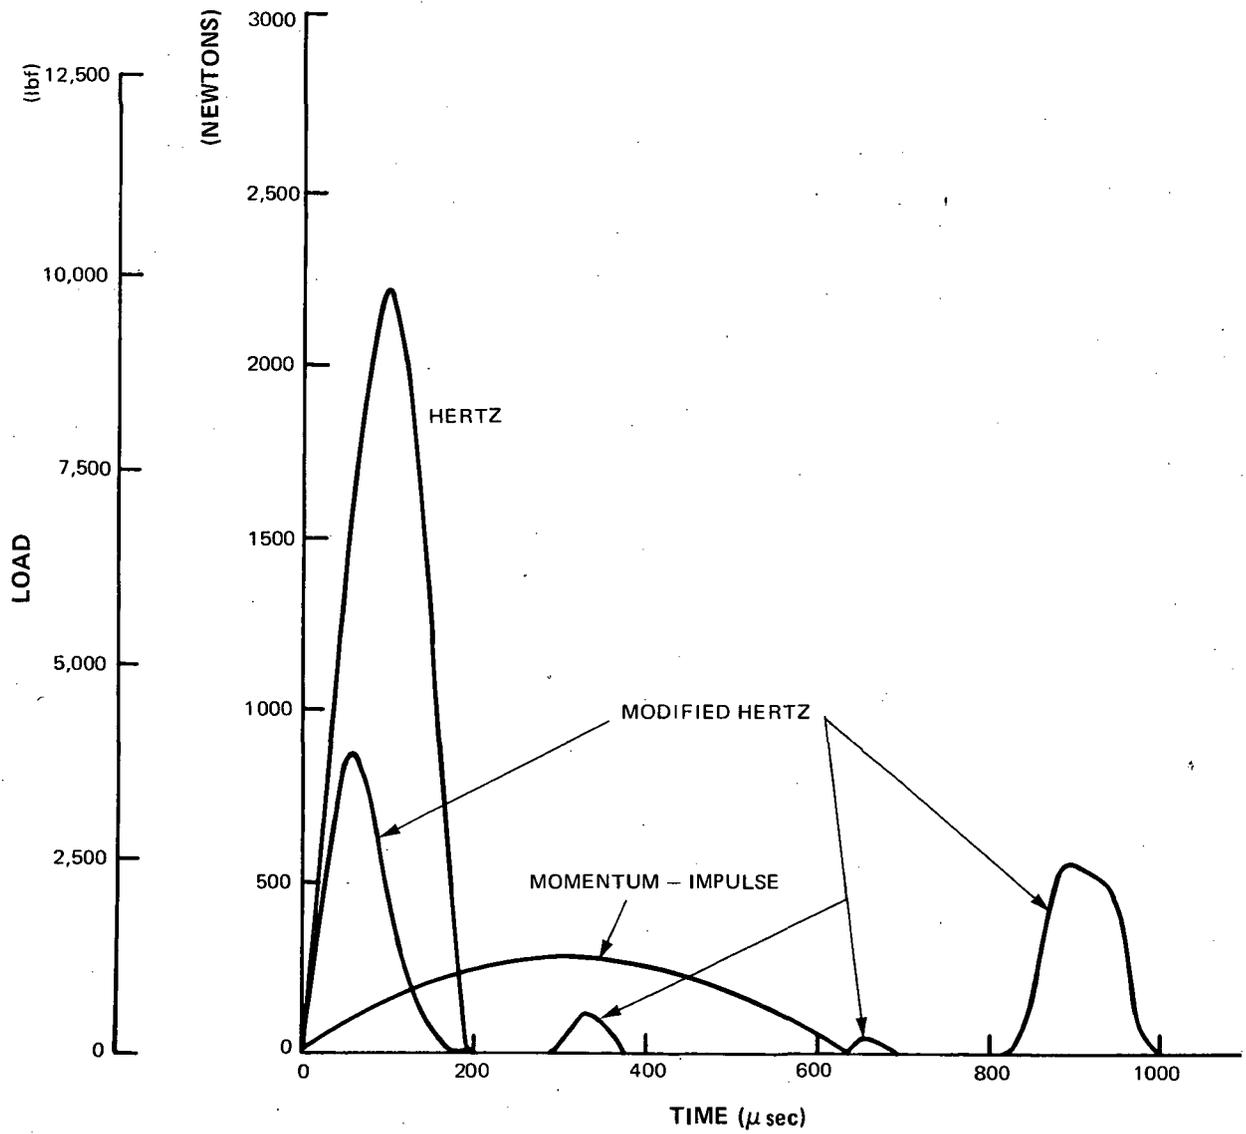
Figure 49 Load as a Function of Time for 2.54 cm Diameter Gelatin at 61 m/sec

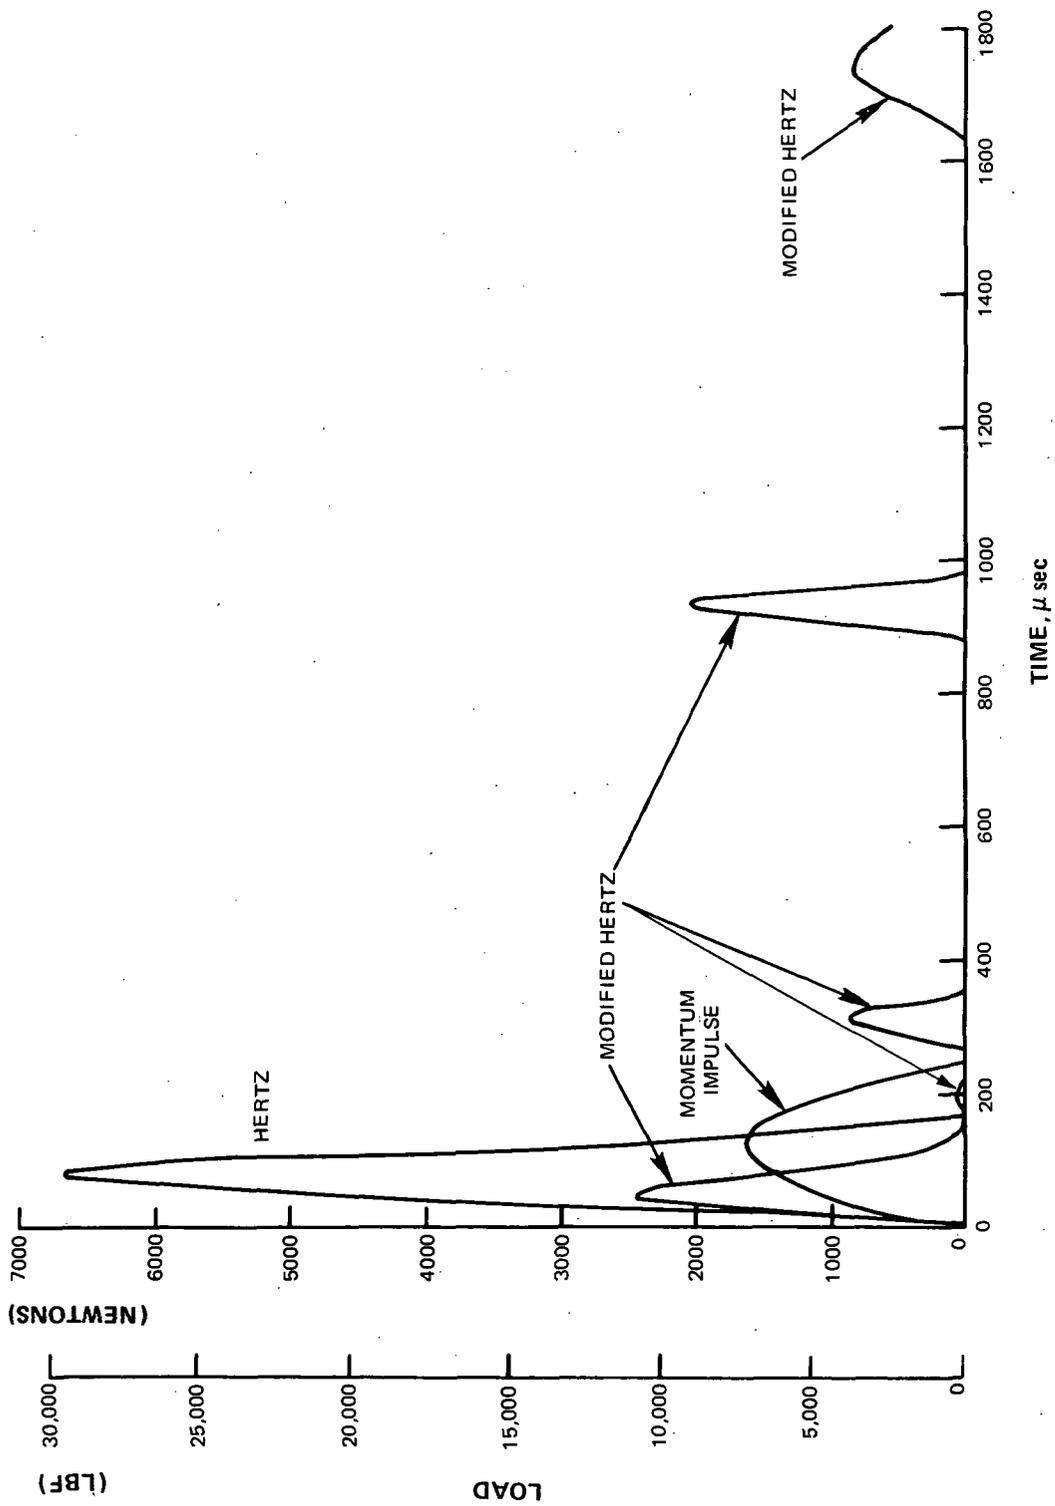
Figure 50 Load as a Function of Time for 2.54 cm Diameter Gelatin at 152 m/sec

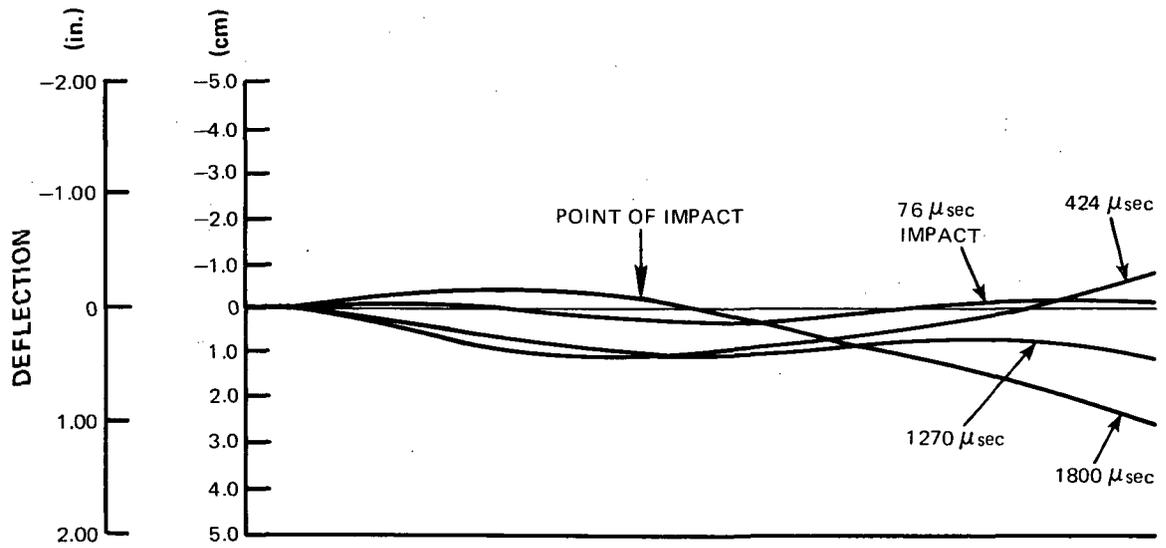
Figure 51 Deflection as a Function of Time for a Cantilevered $[(\pm 45)_2 | 0_{12} | (\mp 45)_2]_T$ Modmor II/PR-286 Composite Beam Impacted by 1.27 cm Diameter Gelatin at 152 m/sec

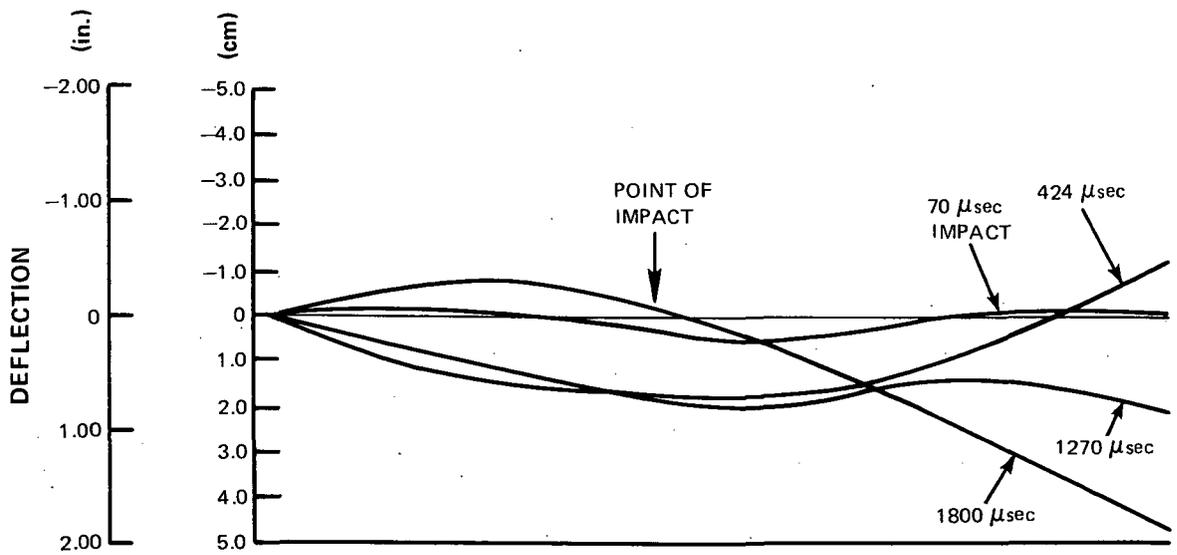
Figure 52 Deflection as a Function of Time for a Cantilevered $[(\pm 45)_2 | 0_{12} | (\mp 45)_2]_T$ Modmor II/PR-286 Composite Beam Impacted by 1.27 cm Diameter Gelatin at 274 m/sec

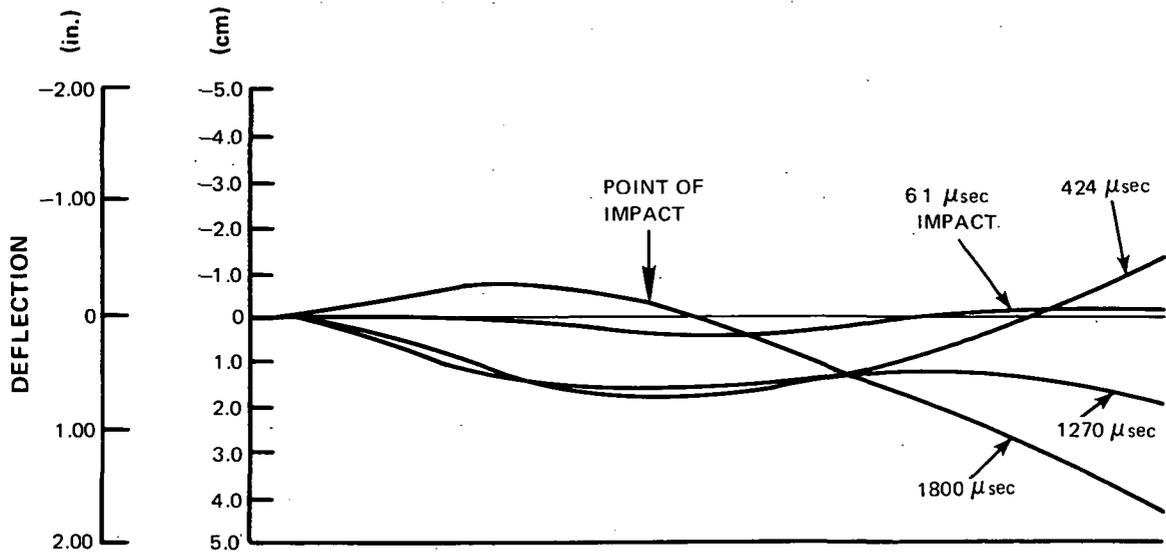
Figure 53 Deflection as a Function of Time for a Cantilevered $[(\pm 45)_2 | 0_{12} | (\mp 45)_2]_T$ Modmor II/PR-286 Composite Beam Impacted by 12.7 cm Diameter Ice at 274 m/sec

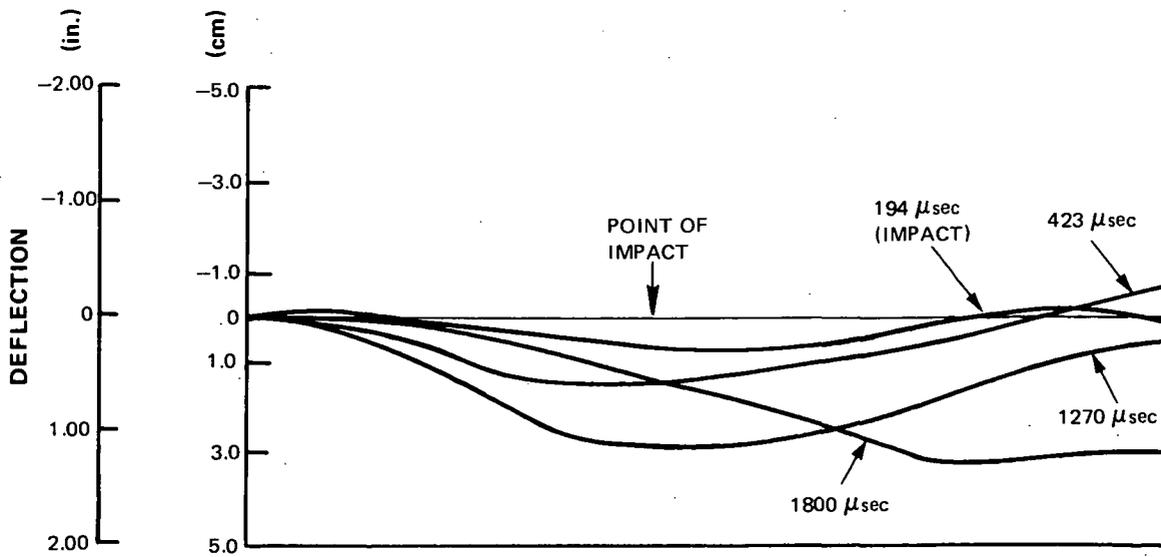
Figure 54 Deflection as a Function of Time for a Cantilevered $[(\pm 45)_2 | 0_{12} | (\mp 45)_2]_T$ Modmor II/PR-286 Composite Beam Impacted by 2.54 cm Diameter Gelatin at 61 m/sec

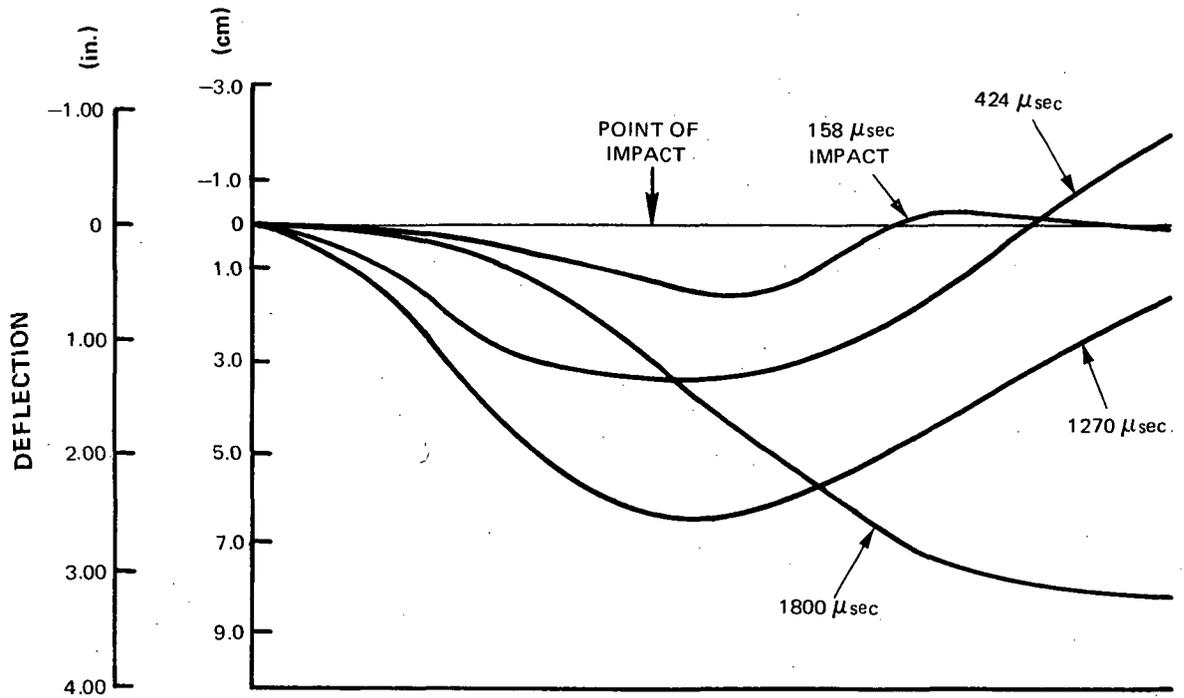
Figure 55 Deflection as a Function of Time for a Cantilevered $[(\pm 45)_2 | 0_{12} | (\mp 45)_2]_T$ Modmor II/PR-286 Composite Beam Impacted by 2.54 cm Diameter Gelatin at 152 m/sec

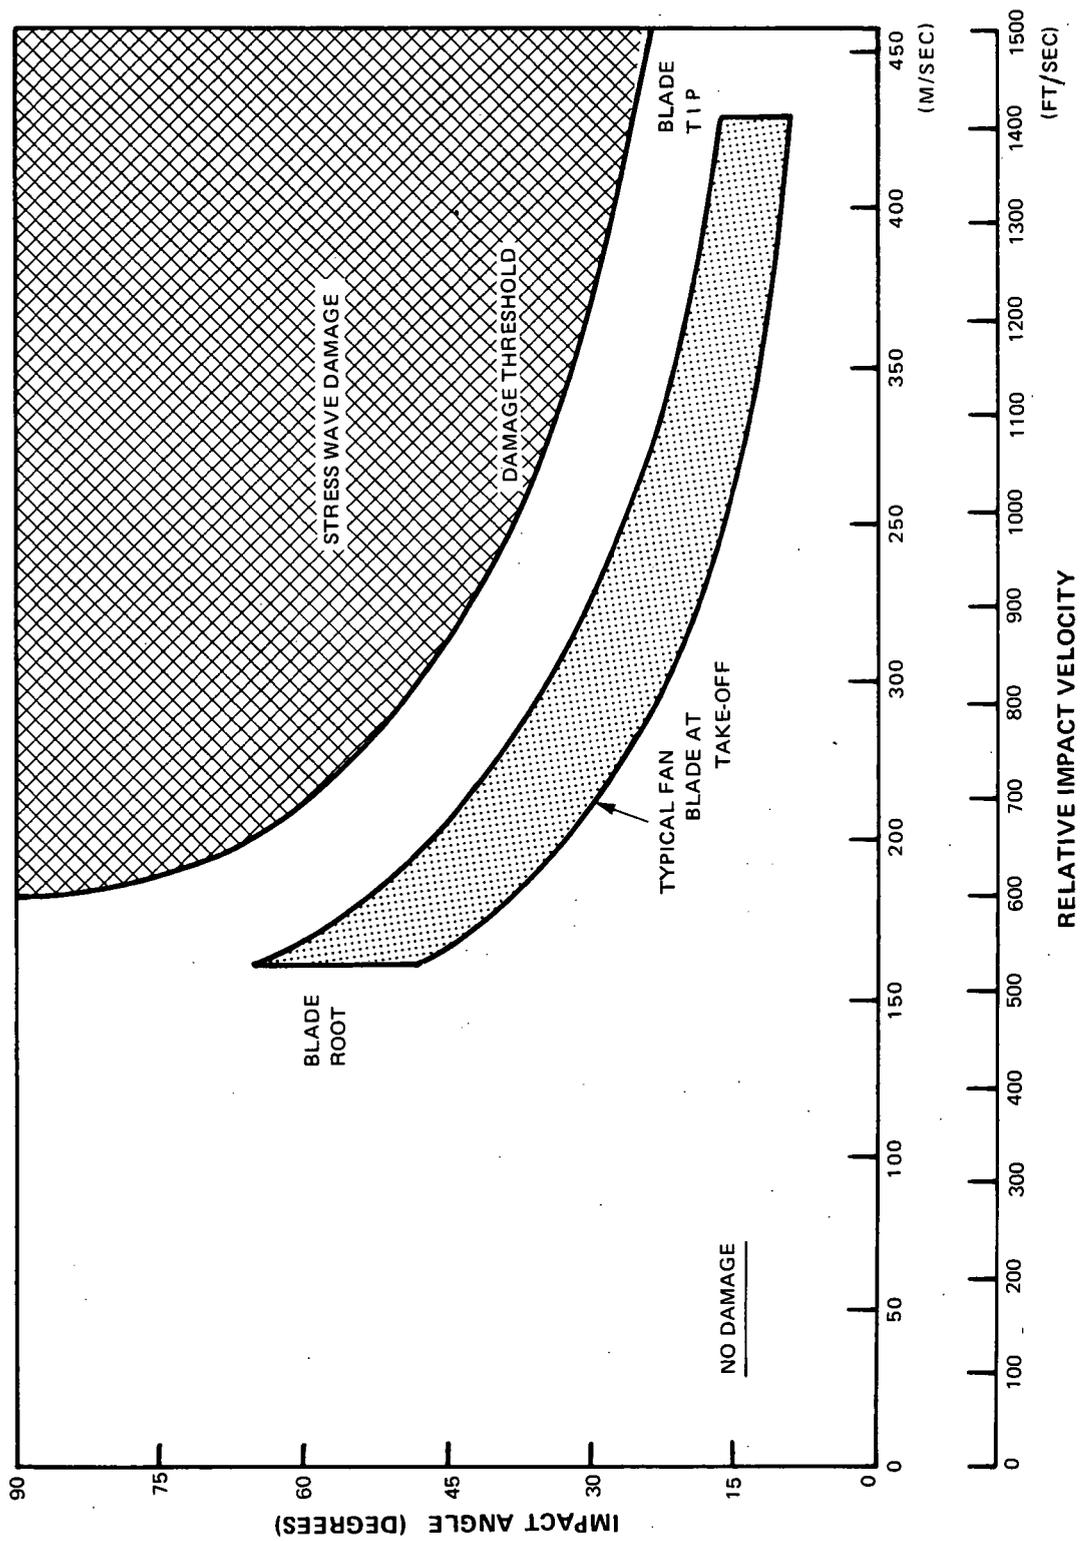
Figure 57 Damage Threshold as a Function of Relative Velocity and Impact Angle for Gelatin Projectiles

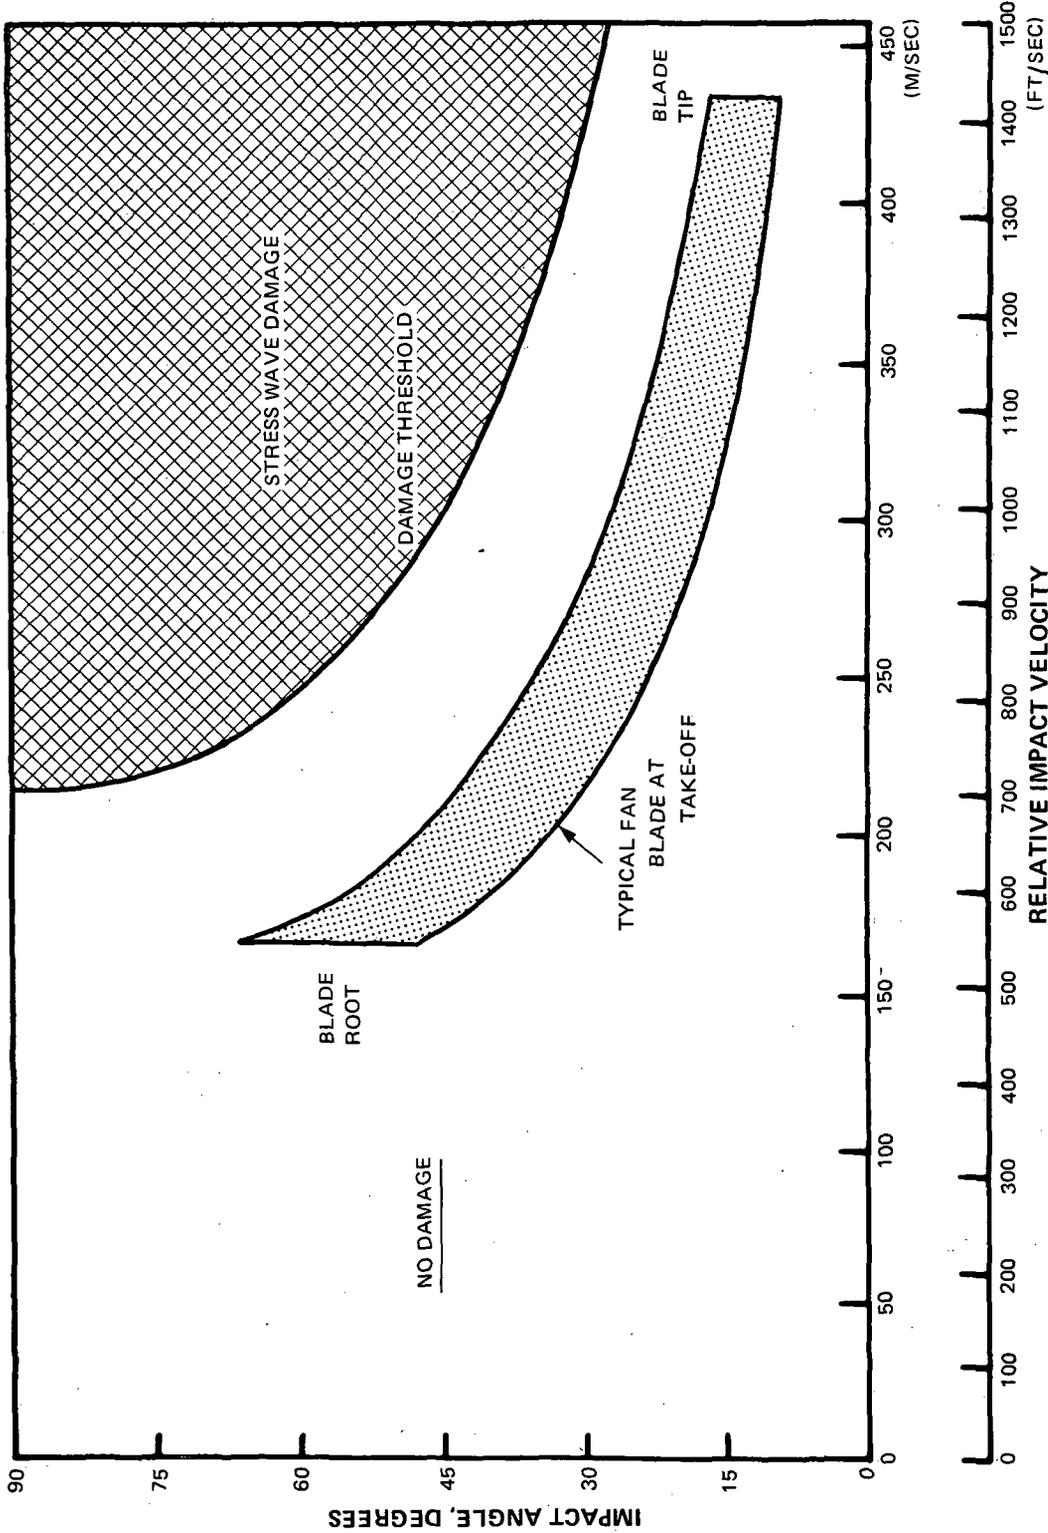
Figure 58 Damage Threshold as a Function of Relative Velocity and Impact Angle for Ice Projectiles

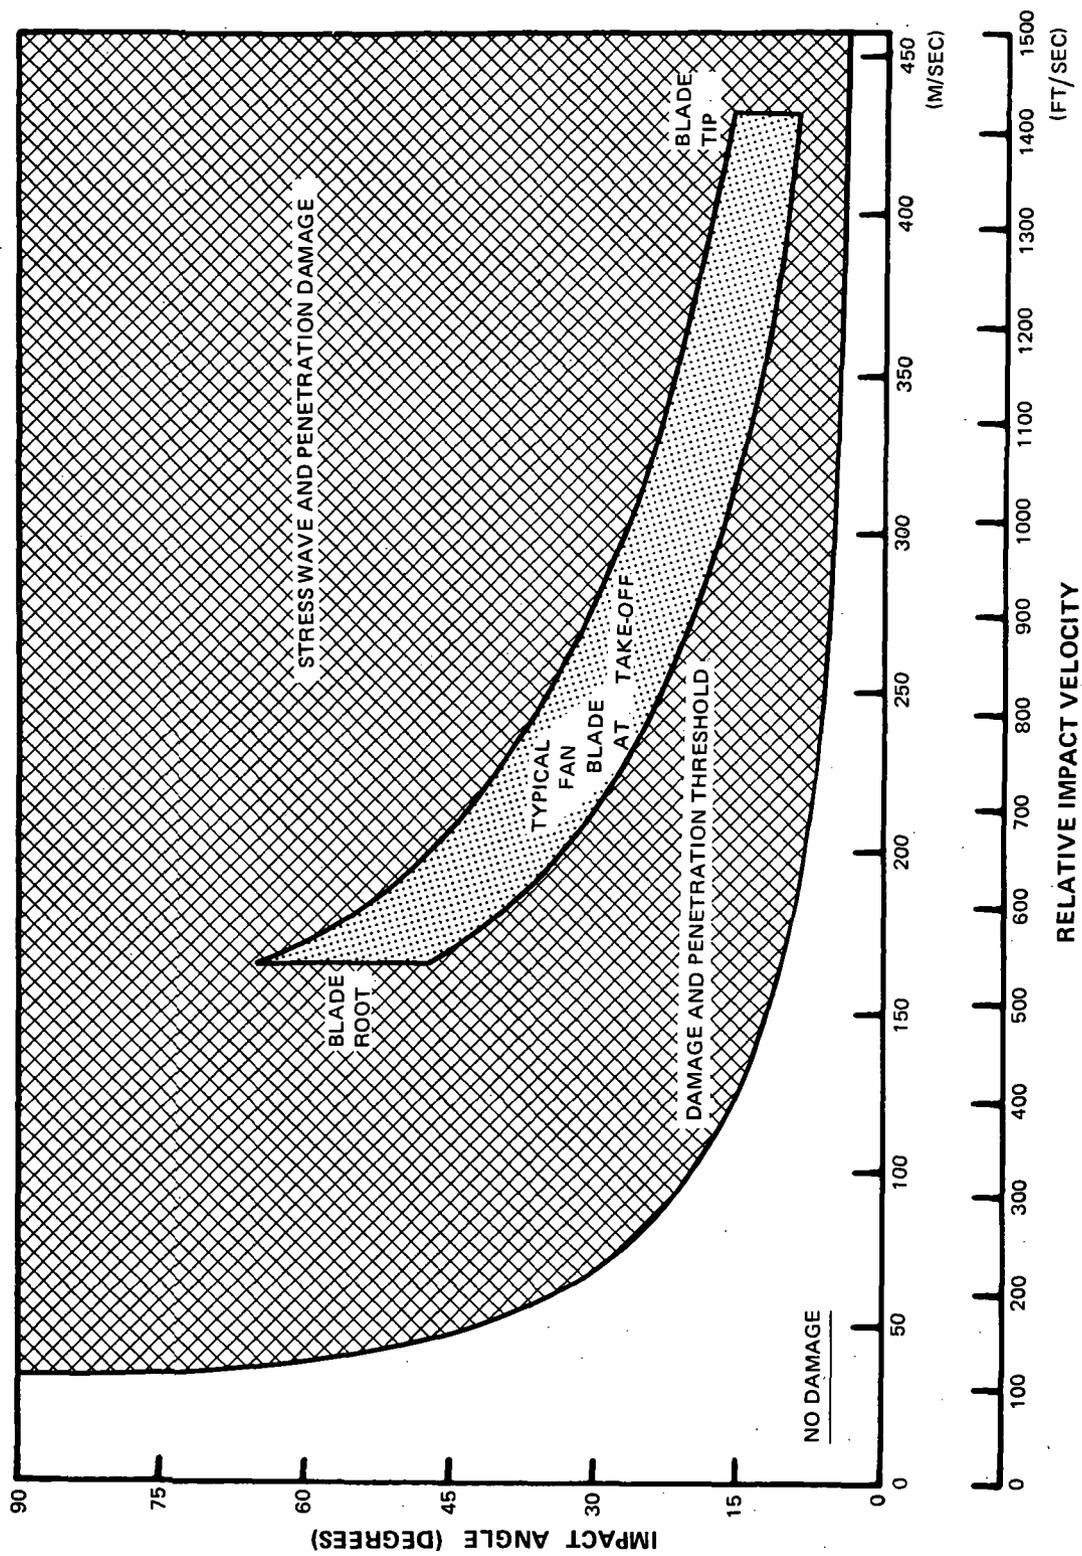
Figure 59 Damage Threshold as a Function of Relative Velocity and Impact Angle for Steel Projectiles
