NASA CR-121212
IITRI-B6107-34
(Part 2)

ADDITIONAL THERMAL FATIGUE DATA ON
NICKEL- AND COBALT-BASE SUPERALLOYS

Maurice A. H. Howes
Metals Research Division

IIT RESEARCH INSTITUTE
10 West 35th Street
Chicago, Illinois 60616

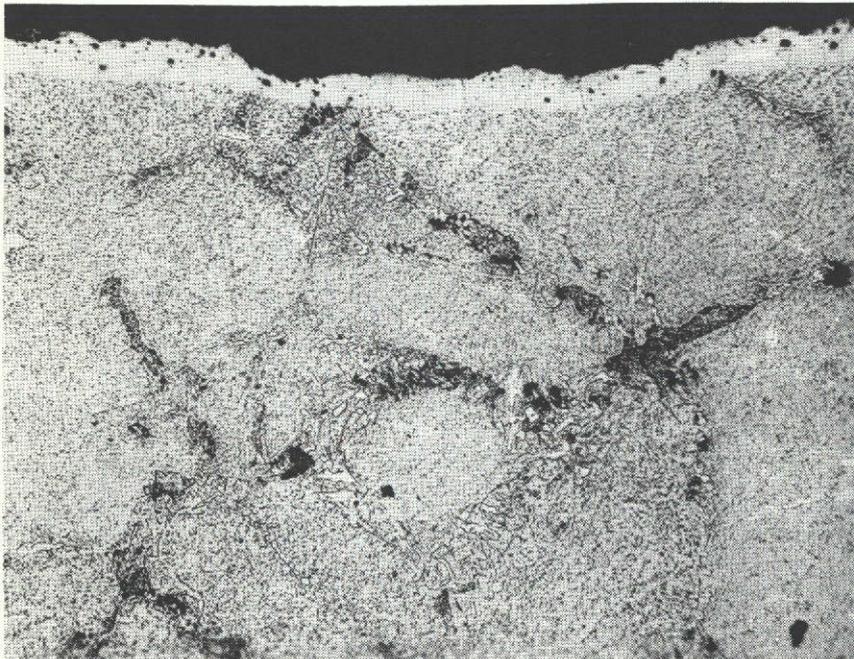
(f) X100
As (c), transverse section
Figure 12 (cont.)

NX-188 DS is shown in Figures 12 and 13. These sections show gamma prime/gamma structures with little evidence of grain boundary weakness except in the transverse sections (Figures 12f and 13f). The oxidized surface in Figure 12 shows clear evidence of depletion which extends down the sides of cracks (Figure 12c). The RT-1A coating appears to be diffused very well into the DS alloy (Figure 13), but the coating appears to be attacked.

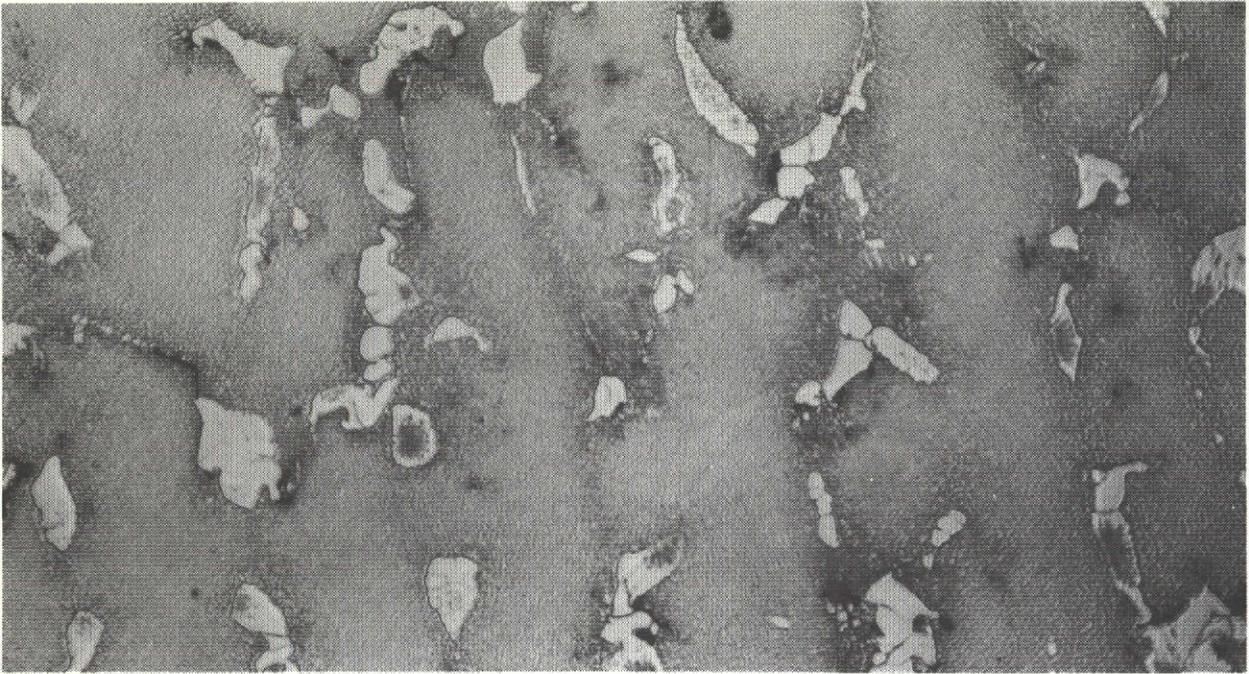
Figure 18

Microstructure of TAZ-8A Directionally Solidified (Kalling's etch)

(a) X500
Untested transverse section from uniaxial specimen

The TAZ-8A directionally solidified material is shown in Figure 18, and it appears that the poorer performance of this alloy may be due to the interconnected areas of primary gamma prime. The random solidified structure shown in Figure 16e can be expected to perform better than the directionally solidified structure shown in Figure 18a because of the large islands of gamma allowing easy crack propagation paths.

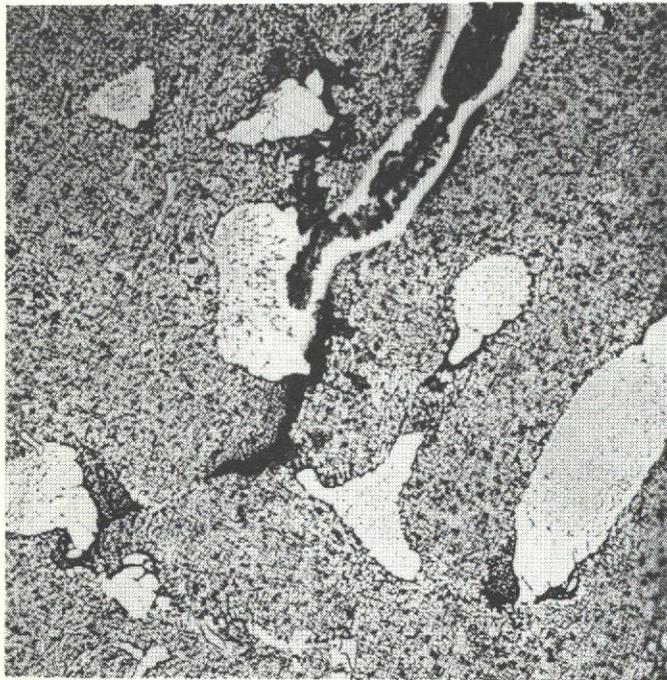
(c) X500
As (a), showing crack tip

This structure consists of primary or eutectic M_6C particles and MC particles in the solid solution matrix. The carbide formation at the grain boundaries provides lines of weakness for crack propagation.
