# ENGINEERING EVALUATION OF 24-CHANNEL MULTISPECTRAL SCANNER

by  
P. F. Lambeck

INFRARED AND OPTICS DIVISION  
WILLOW RUN LABORATORIES  
INSTITUTE OF SCIENCE AND TECHNOLOGY  
THE UNIVERSITY OF MICHIGAN

Subject: Engineering Evaluation of 24-Channel Multispectral Scanner

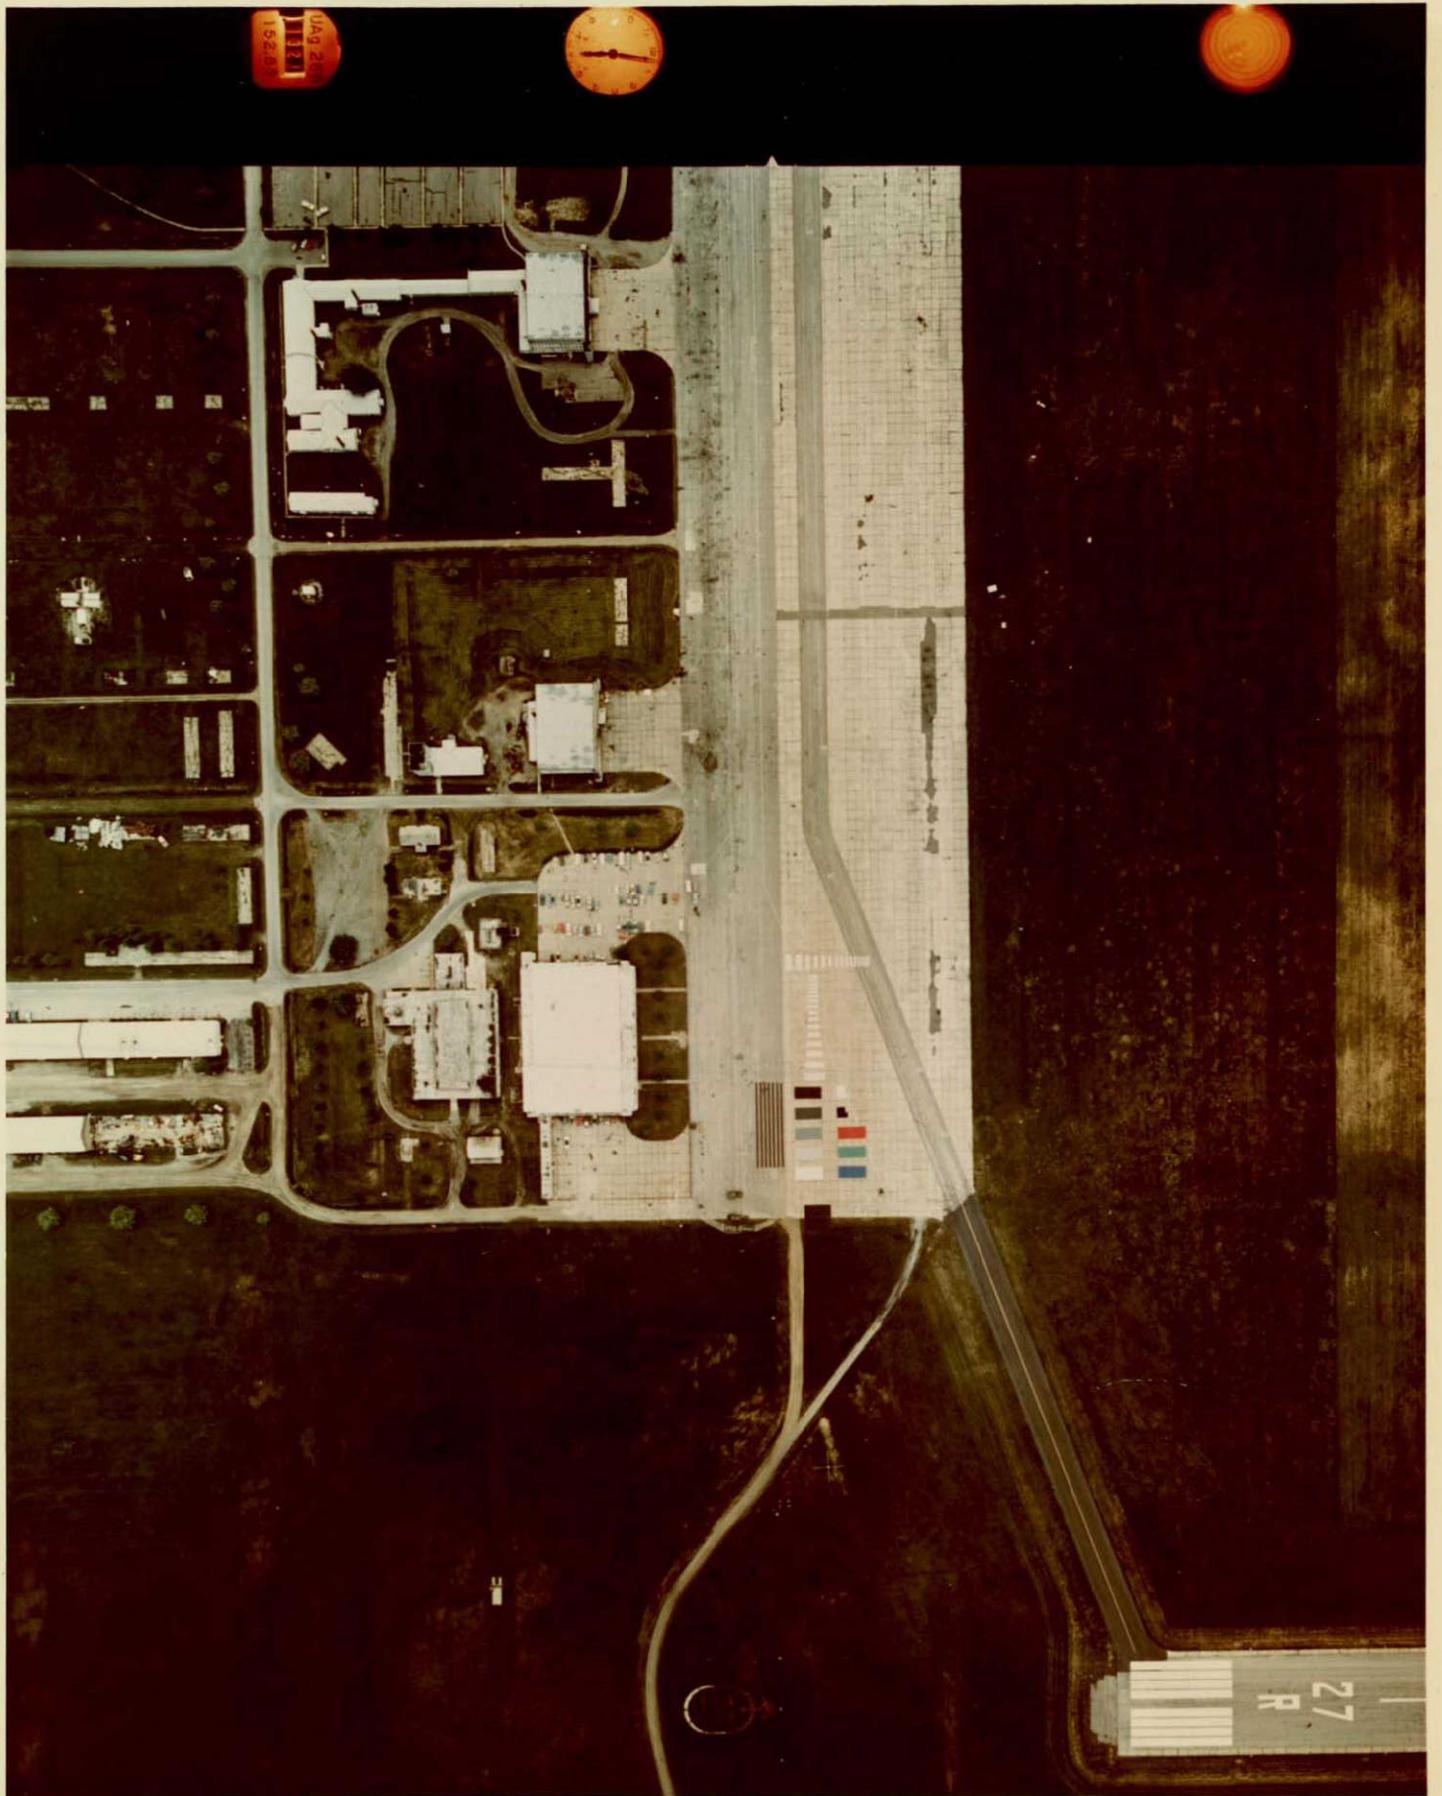
Figure 1.1  
1.7K ft. of targets  
6/2/72 (overcast)

Figure 10.4 is a digital graymap of data from run 12 (for channel 2) for the flight of 2 June. This figure may be compared with Figures 1.1 and 1.5. The most serious moiré patterns are generally caused by scanning nearly, but not quite, in line with the stripes of some other true pattern as in Figures 10.1 and 10.2. On 2 June the intent was to show that moiré patterns could also arise from digitizing data not quite in phase with the stripes of an existing pattern (a color television hexagonal matrix picture tube provides even more opportunities for moiré patterns). For this purpose the tar paper strips were lined up parallel to the flight line. Note once again that regions can be identified where the tar paper strips appear separated. Between these regions are bands of a moiré pattern representing areas where definition of the tar paper strips is lost. In Figure 10.5, a contour plot of the tape edit from which Figure 10.4 was taken, these bands can be identified as white patches running through the tar paper strip region. Figure 10.6 plots a series of resolution elements traced across scan lines through this edit (100 scan lines per inch). Note the low frequency waves running through the portions of these traces representing response to the tar paper area (starting .4 inches from the left edge of each trace and ending .8 inches from the left edge) indicating the moiré effect. In non-digitized data this particular instance of the moiré pattern would not have occurred. Note in this case that although truly representative data for the tar paper strips (as well as separation from their surroundings) has been lost in the bars of the moiré pattern, from a standpoint of absolute reflectance calibration none of this particular data for these strips could be truly representative of their full signal level anyway due to the inherent response limitations of the scanner caused by the aperture size and the integrate and hold circuitry. For strips parallel to the flight line, fully representative data can only barely be obtained for strips which are 2 resolution elements wide and cannot be guaranteed unless these strips are at least 3 resolution elements wide (barring other response limitations). Strips 3 resolution elements wide would give rise to virtually no moiré effect regardless of their orientation. In the instance of Figures 10.1-10.3 for 4 June, fully representative data for the tar paper strips could be obtained between the bars of the moiré pattern in spite of the 1 resolution element width of these strips, since the integrate and hold circuitry primarily affects consecutive resolution elements within a scan line and has minimal effect between successive scan lines (the aperture affects both).

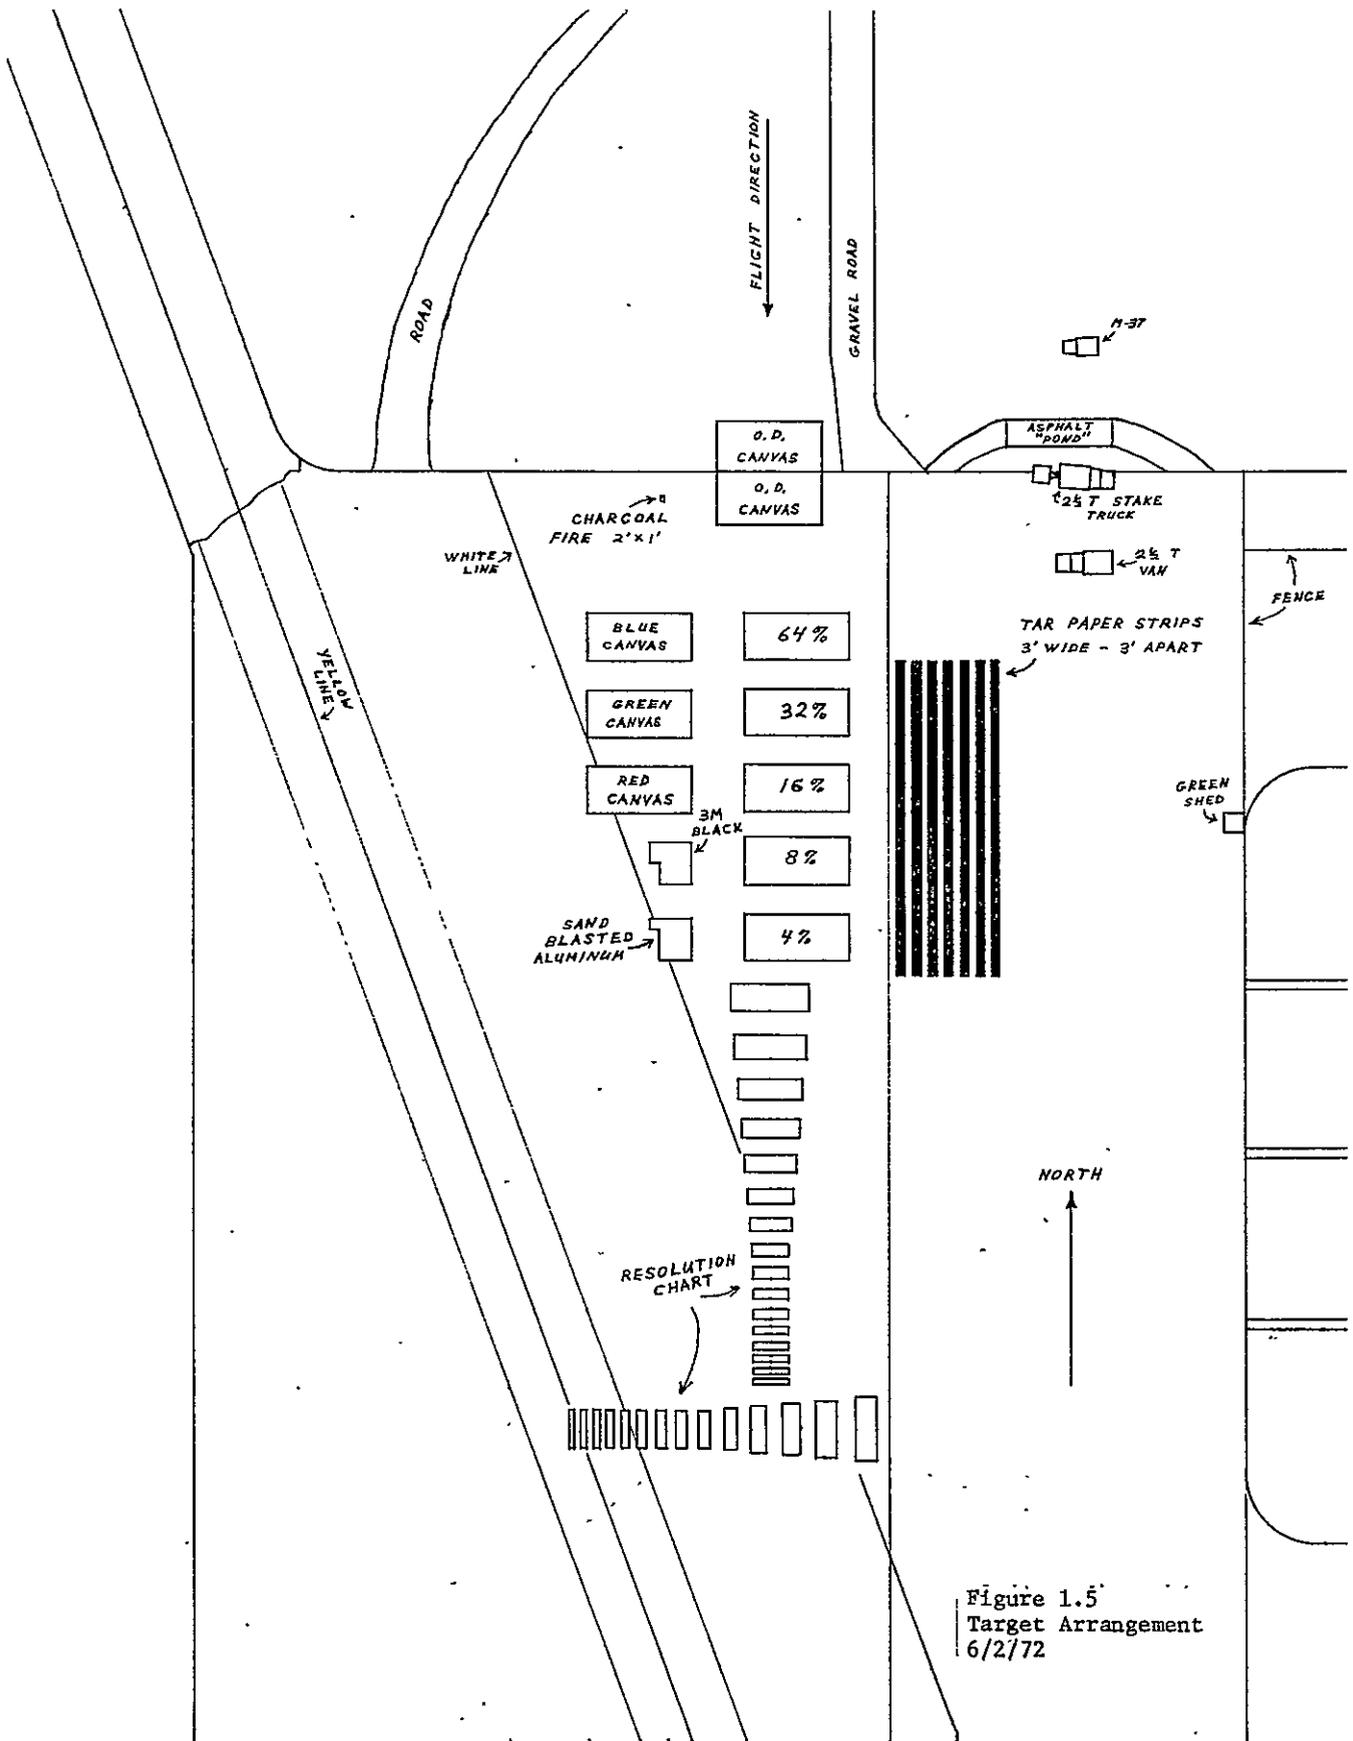
Figure 1.5  
 Target Arrangement  
 6/2/72

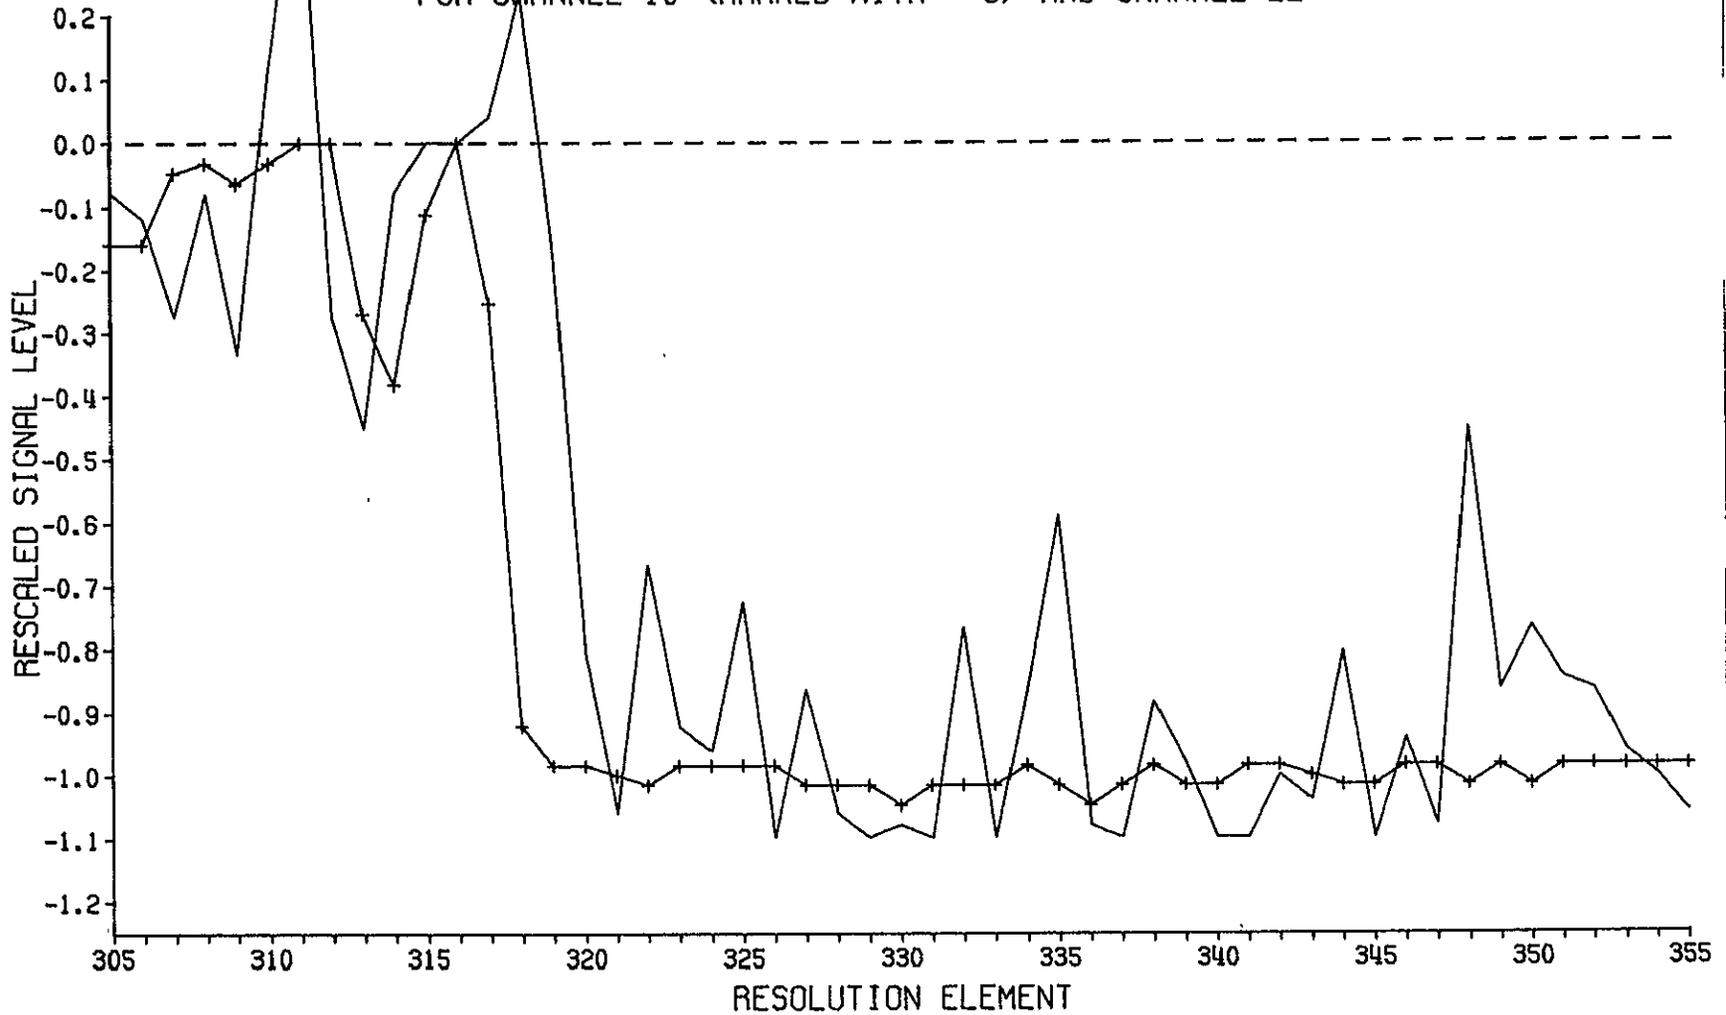
Channel 22 was delayed in response by more than 2 resolution elements, possibly due to inadequate cooling (see Figure 2.12).

RESCALED RADIANCE PLOT OF SCAN LINE SEGMENT  
CROSSING CONCRETE AND 4% GRAY PANEL  
FOR CHANNEL 10 (MARKED WITH '+'S) AND CHANNEL 22

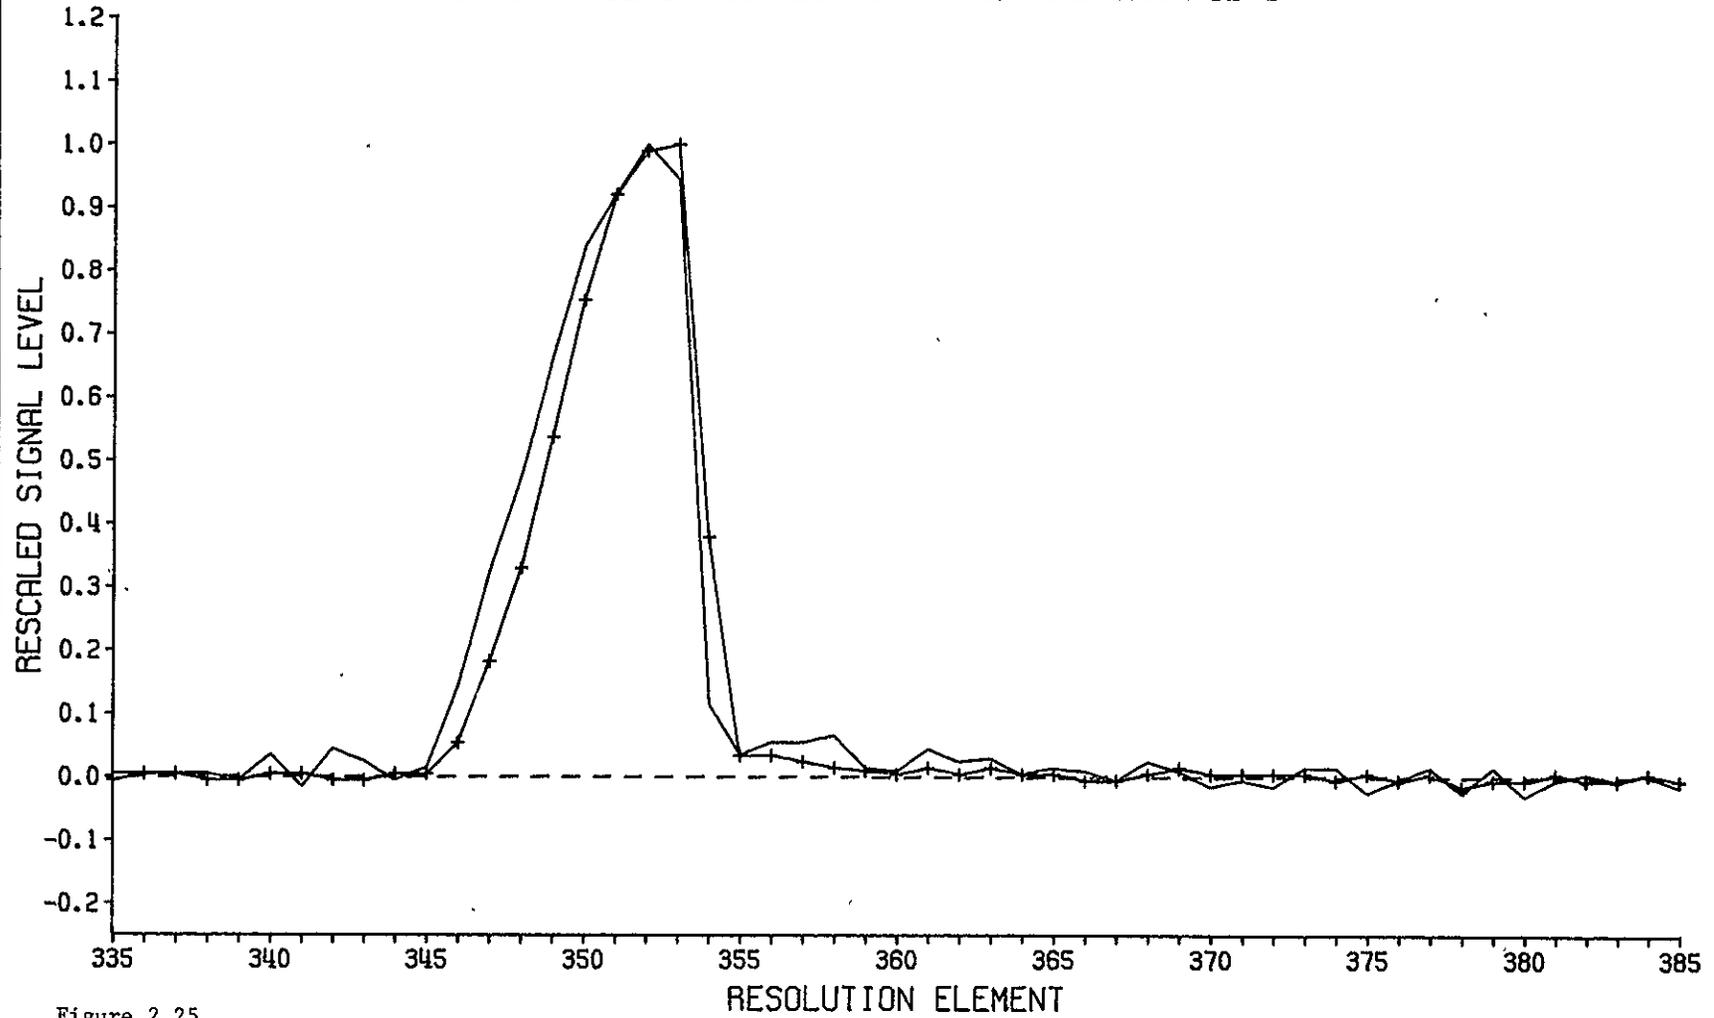
Figure 2.25

RESCALED RADIANCE PLOT OF SCAN LINE SEGMENT CROSSING KNIFE EDGE  
FOR CHANNEL 9 (MARKED WITH '+'S) AND CHANNEL 2

Figures 2.26 and 2.27 show the knife edge improperly oriented, but illustrate a peculiarity in the response of channels 4 and 5.

Many of the knife edge tests run at Hobby Airport, 25 May, were run with the knife edge reversed from the orientation that was requested, as noted in Section 2.

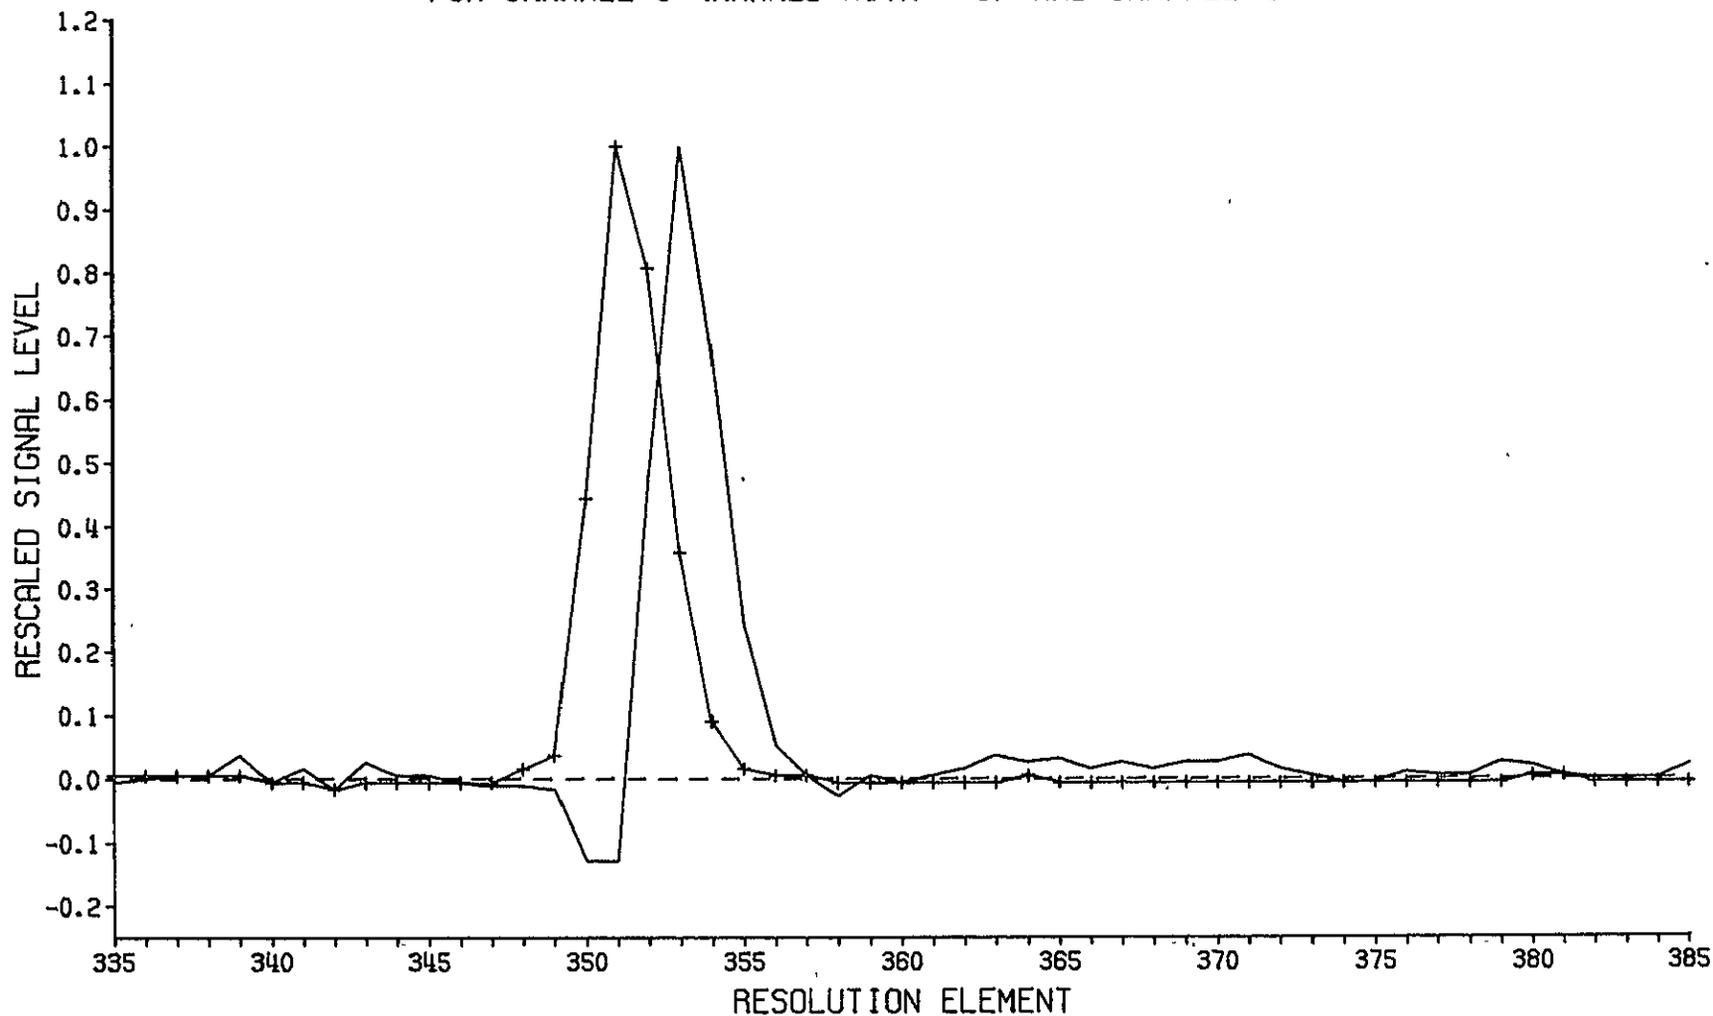
RESCALED RADIANCE PLOT OF SCAN LINE SEGMENT CROSSING KNIFE EDGE  
FOR CHANNEL 9 (MARKED WITH '+'S) AND CHANNEL 4

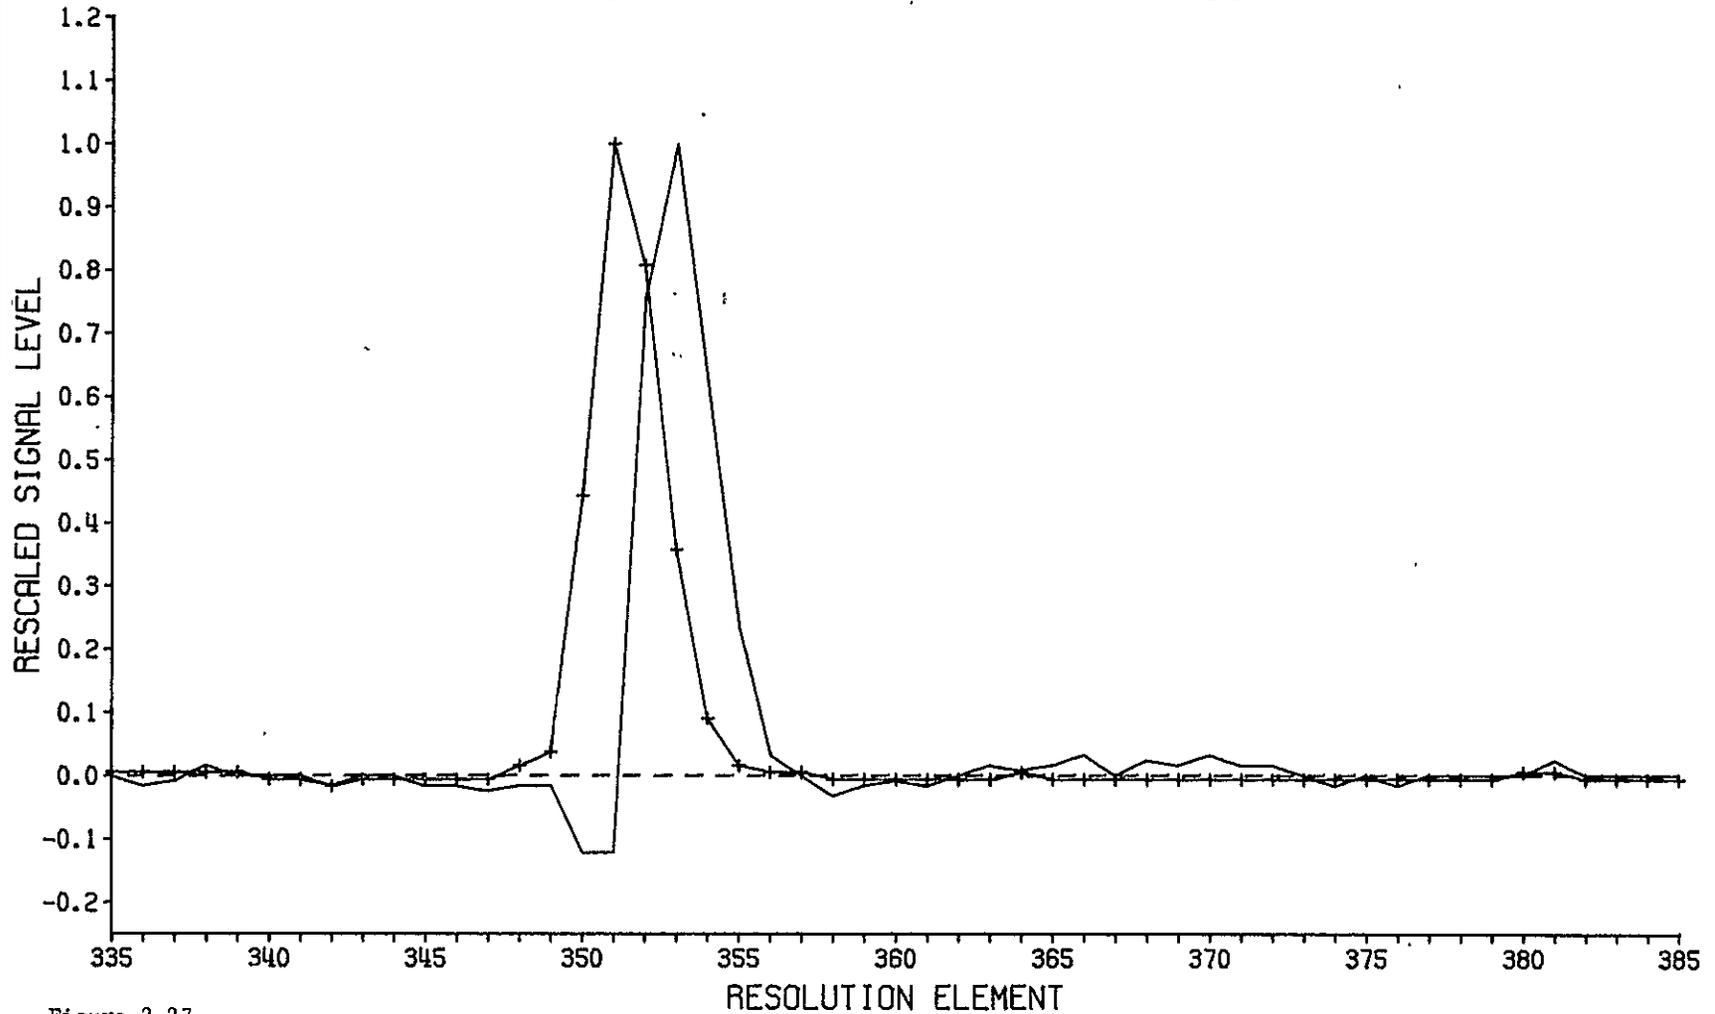
Figure 2.27

RESCALED RADIANCE PLOT OF SCAN LINE SEGMENT CROSSING KNIFE EDGE  
FOR CHANNEL 9 (MARKED WITH '+'S) AND CHANNEL 5

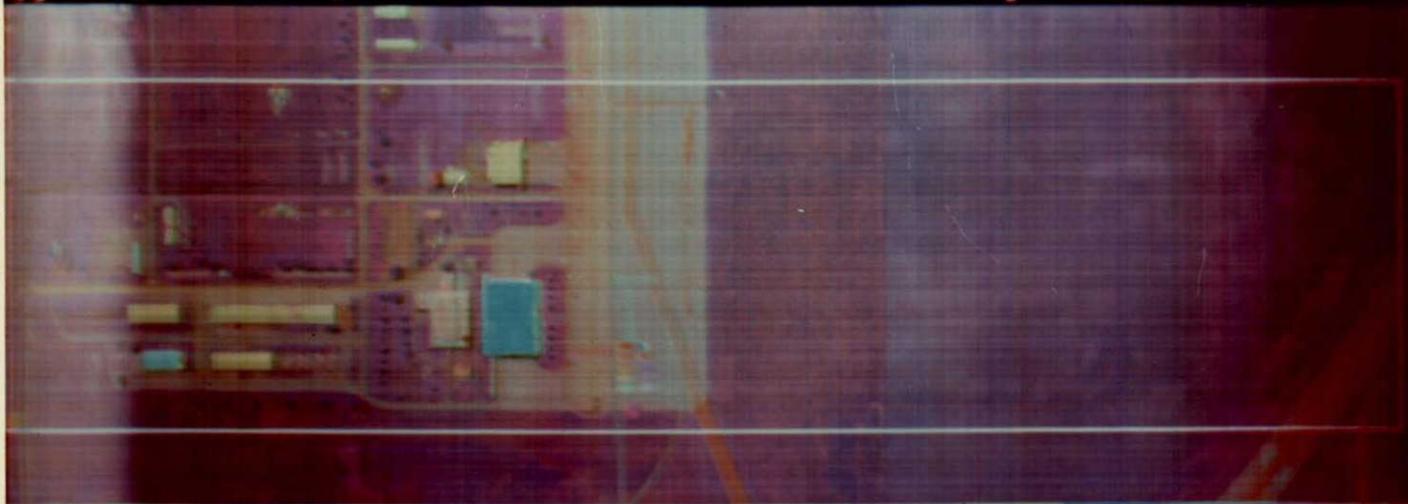
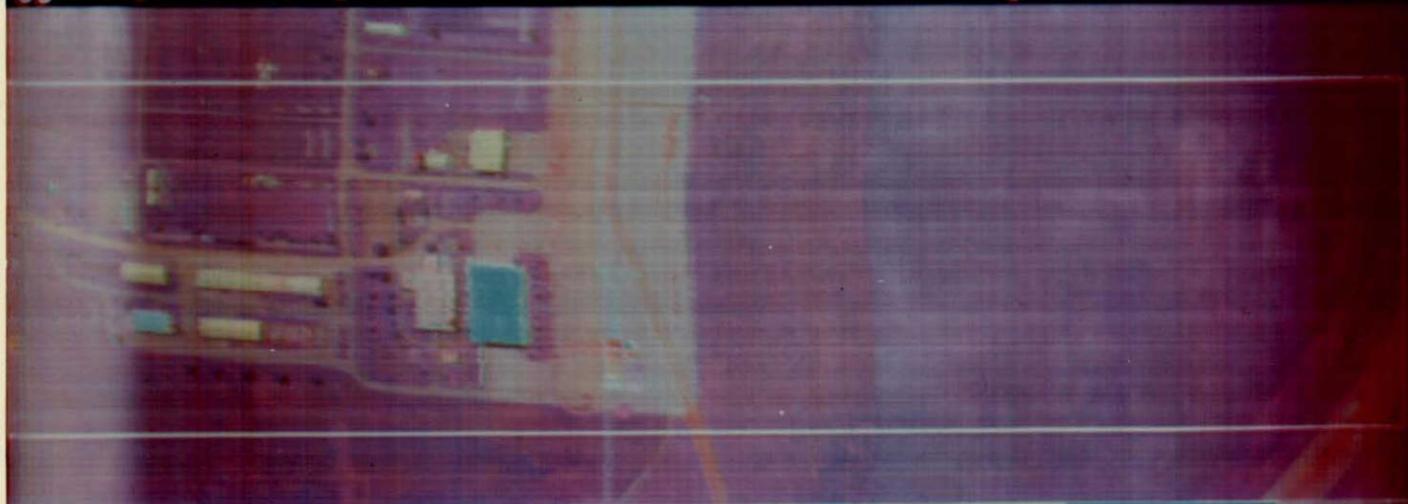
Figure 4.2  
DAS Film, Runs 8 & 9  
3.4K ft. 6/4/72  
19-R 2-G 11-B

HSS158-72-C, F3 L2 R8 (CLEAR) 3.4K, PANELS, ETC. ON RAMP (R6/15/72)  
V/W=0.0007 LON TEMP=+10.9°C ΔT=36.7°C FILTER SELECT=1 7.858μSEC/ELEMENT  
SEGMENT 1 OF 1  
CHANNEL 2: CAL 2, SCALE=.25X, OFFSET=1

Inspection of the DAS film edits we received revealed a few instances where successive scan lines appeared to waver in and out of registration by plus or minus 1 resolution element. In Figure 4.2, edit 9, one can see jagged edges on the large blue building rooftop near the ramp while in edit 10 such jagged edges are not evident. Steplike variations in edges might be expected due to the effect of digitization, but oscillating variations such as those in edit 9 would be unlikely. Figure 4.1 shows two contour plots of tape edits we obtained which correspond to the two DAS film edits of Figure 4.2. The stairstep edges visible on some of the roads are due to the effects of digitization, which is not smoothed in these plots. Note that while the plot for run 9 (airspeed 270 knots and virtually no drift) looks very clean, the plot for run 8 (airspeed 160 knots with noticeable drift) shows jagged edges very much like those in DAS edit 9. Close inspection of the contour plot for run 8 (plotted to a larger scale in Figure 4.3) indicates that the variations in registration of the scan lines can be identified across almost the entire width of the scan (note variations in edges of road at resolution element 15 and similar variations in edges of building rooftop near elements 292 and 315; especially near scan line 1722 - Figure 4.3). Listings obtained for our tape edits indicate that channel swapping did not occur during this edit, hence these registration oscillations could be due to variations in the timing of the start of each scan line. This phenomenon may be related to roll gyro problems.

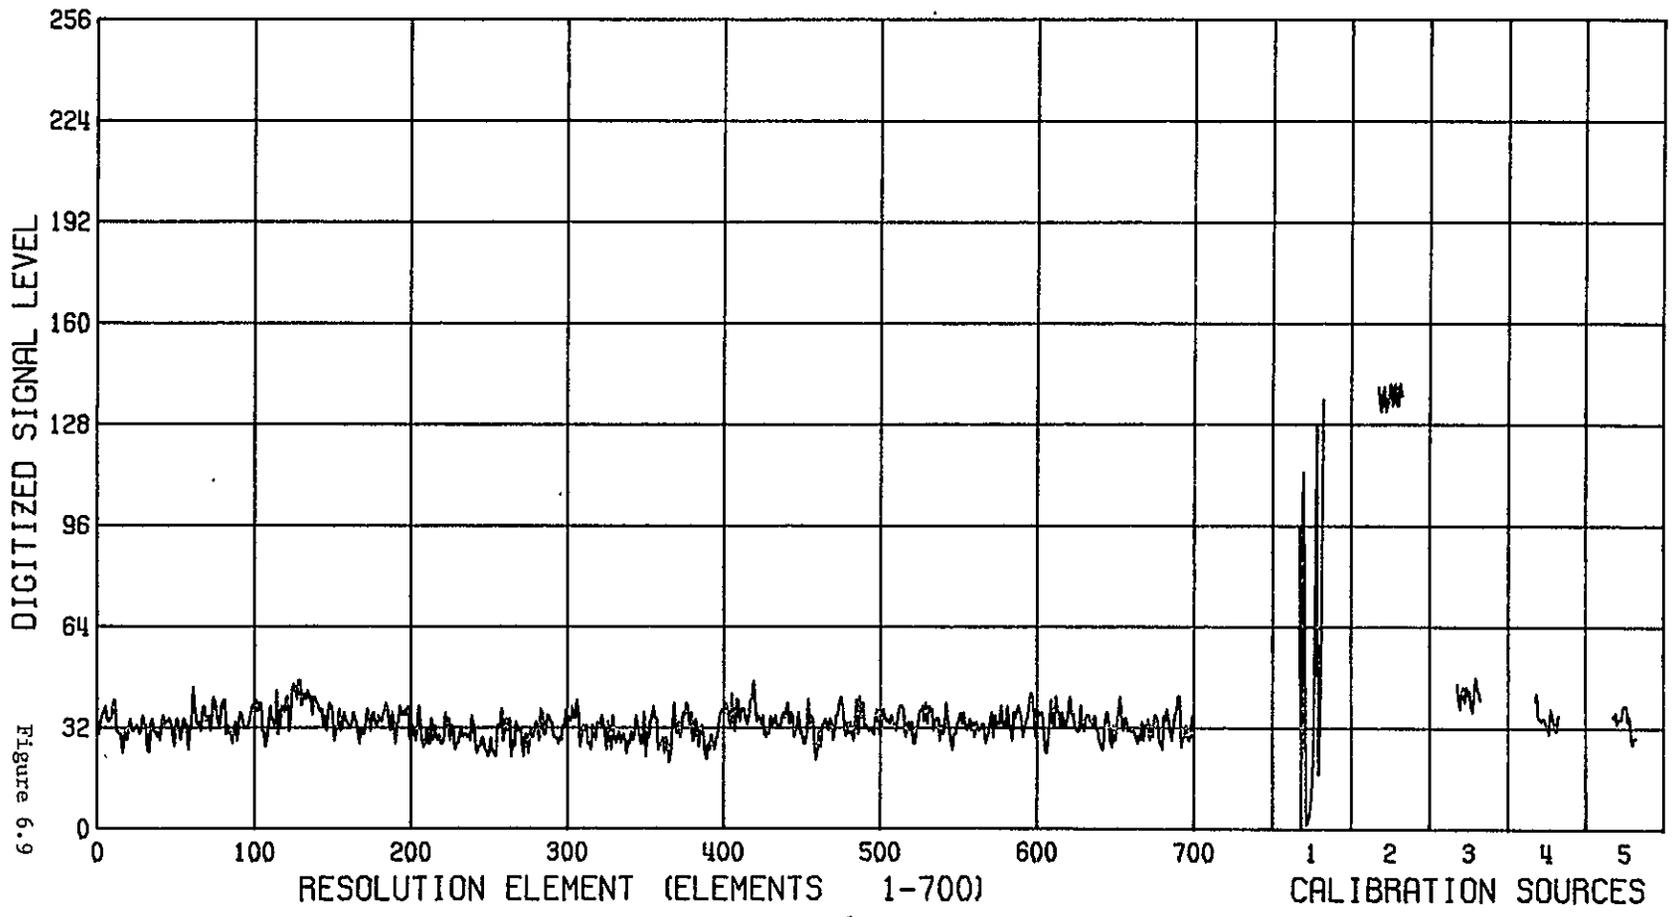
Figure 6.9

Channels 12 through 15 showed traces of low frequency noise components which were at their worst in channel 15 (see Figures 6.9-6.12). In channels 13 through 15 this noise is probably due to cooler microphonics from the cooler for array 3 although it could also be caused by amplifier drift (see Section 8). Note in Figure 6.13 ( $V/H = .022$  compared to  $V/H = .16$  in Figure 6.12) that the period of the noise in channel 15 comprises  $1/7$  as many resolution elements as at the  $V/H$  of Figure 6.12 (i.e. the period of the noise in microseconds is nearly the same). Figure 6.13 may be correlated with Figure 9.1 (a contour plot of the tape edit from which Figure 6.13 was taken) and compared to Figure 6.15 (the same scan line plotted for channel 20) to determine which features of the signal in Figure 6.13 might not be due to noise.

### SINGLE SCAN LINE OVER LAKE

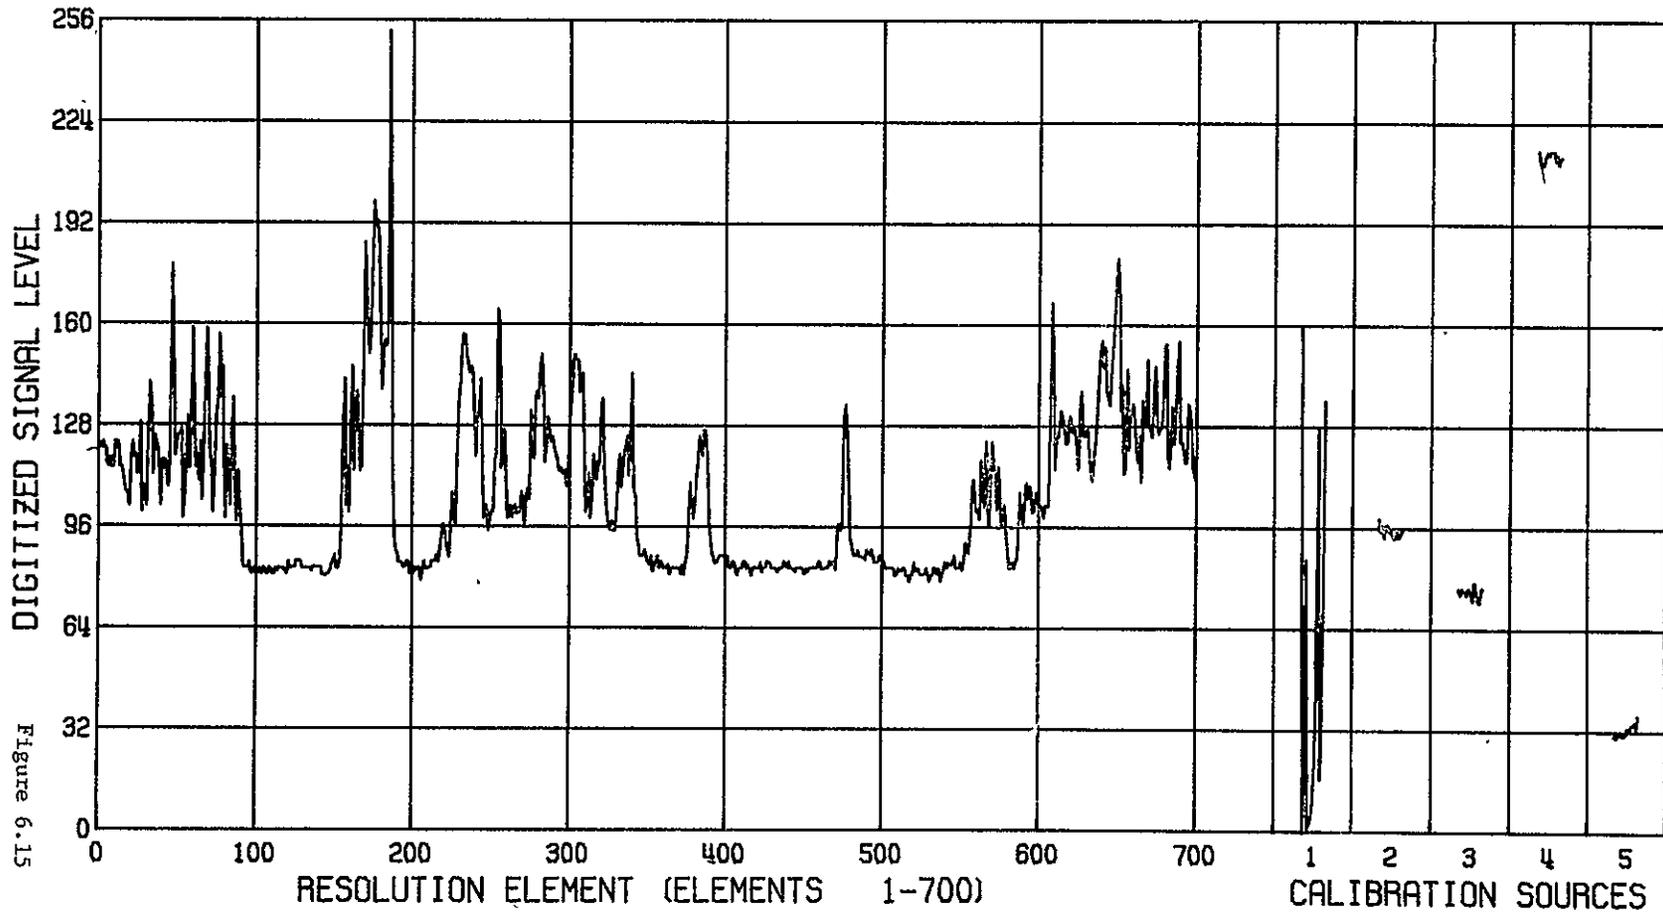
Figure 6.16

Noise in channels 20, 21 and 22 is typified in Figures 6.15-6.17 ( $V/H = .022$ ), taken from the edit contoured in Figure 9.1. Note the increase of noise in channels 21 and 22 compared to channel 20. At a  $V/H$  of .16 (as would be expected) the noise in these channels was 2 to 3 times greater than shown for a  $V/H$  of .022. Channels 17 through 19 were similar in noise level to channel 20. The increasing noise level in channels 21 and 22 and the increased Gaussian noise level in channel 16 relative to channels 17-20 was probably due to deficient cooling near the ends of array 4. This same noise trend has been apparent in previous MSDS data.

### SINGLE SCAN LINE OVER LAKE

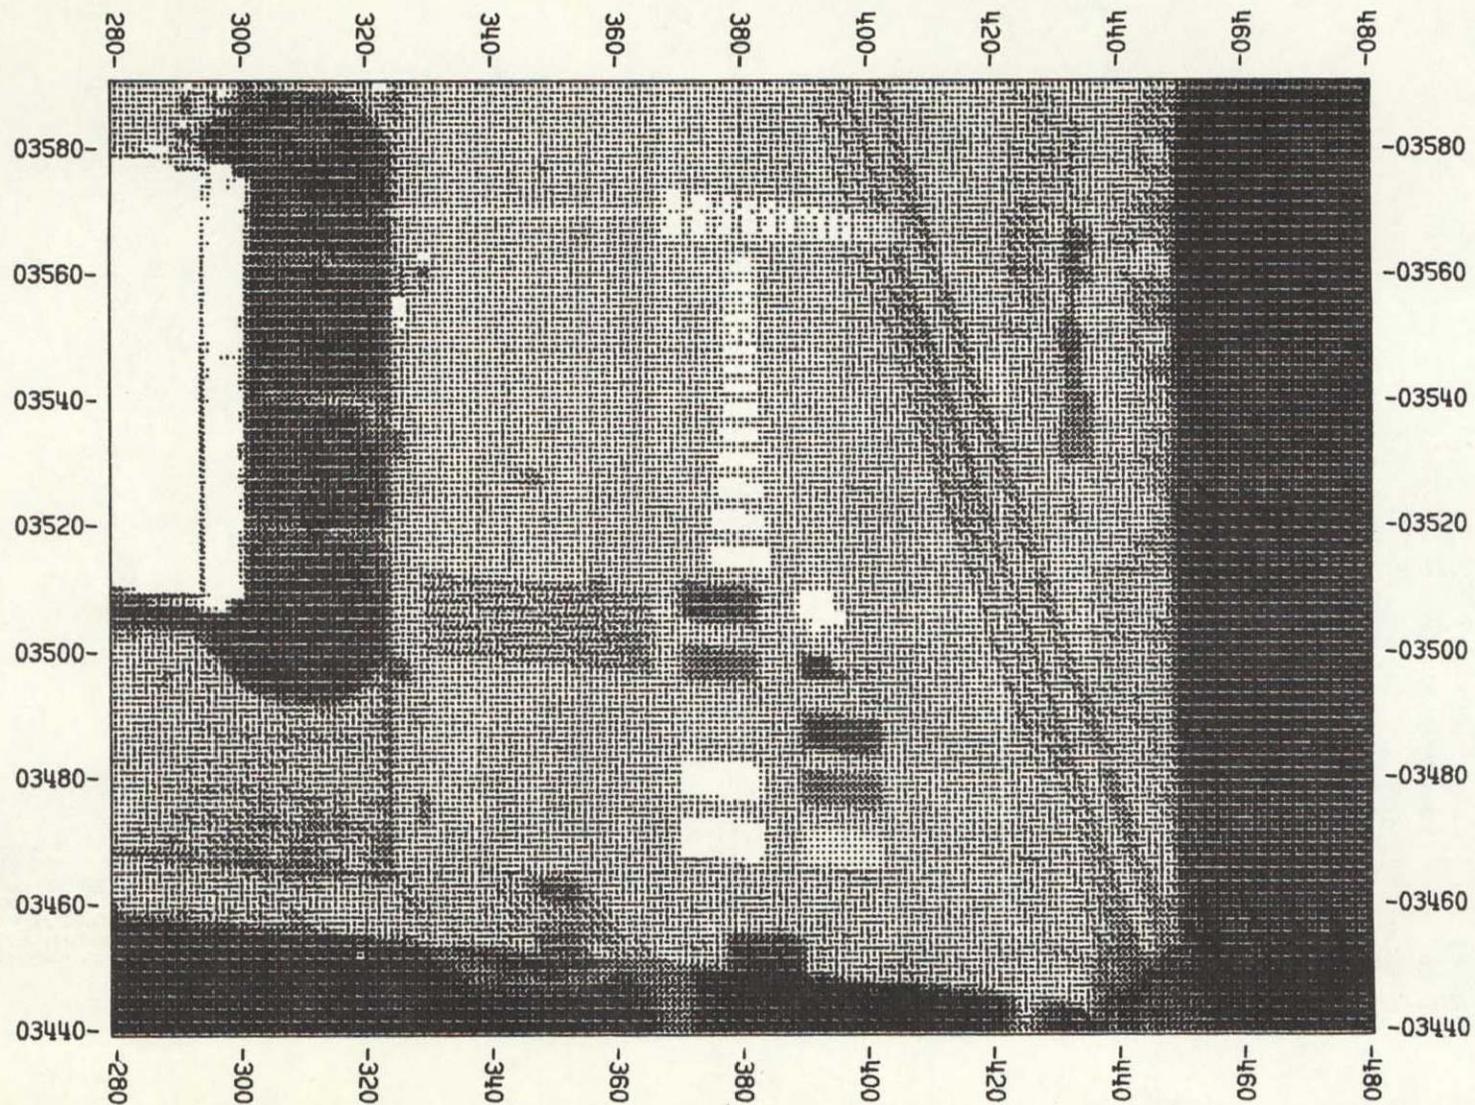
Figure 10.1

Note the effect of a "channel swap" between channels 1 and 2 which is visible in Figures 10.1 and 10.2 during scan line 3570. During the editing of data from the original flight tape onto the 9-track tape we obtained, a tape reading error (skipping over data from one resolution element in channel 2) caused data from channel 1 (which alternates with channel 2 on the flight tape) for the succeeding resolution element to be

### PANELS, TAR PAPER STRIPS, AND RESOLUTION CHART ON RAMP

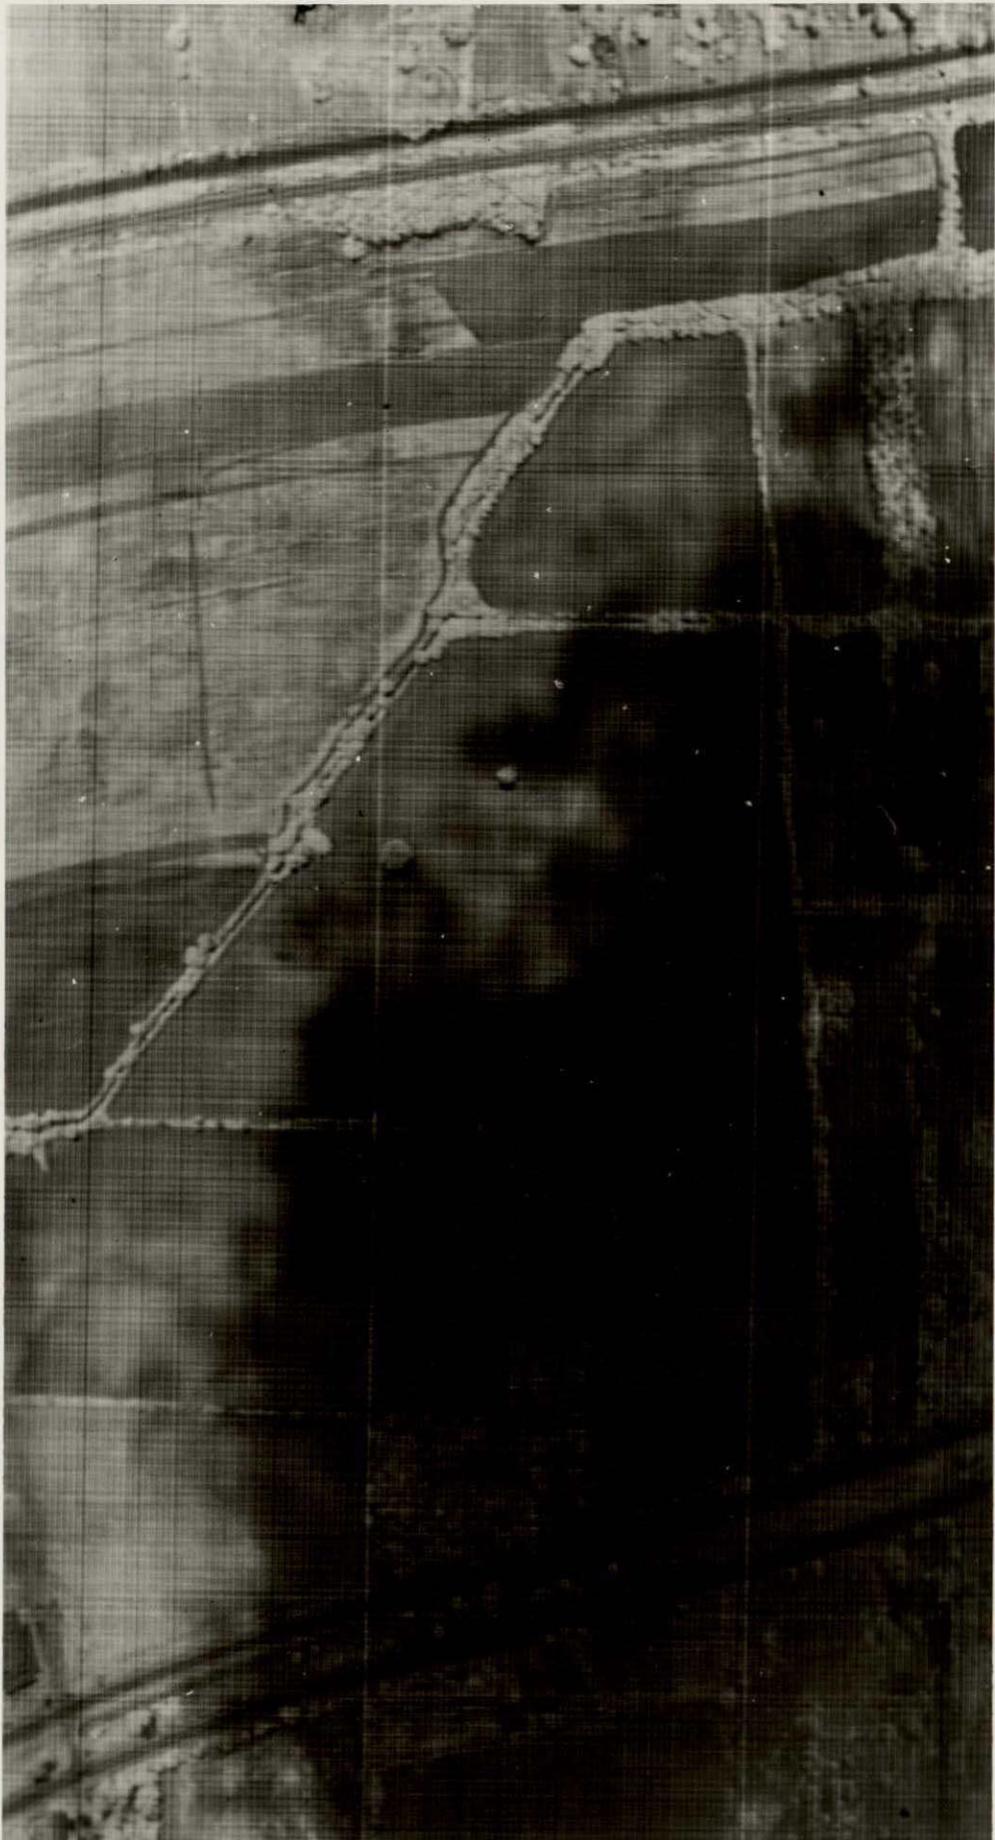
Figure 11.2  
Inflight Film, Ch.8  
1.5K ft. 6/4/72

HSS158-72-E, F3 L2 R10 (CLEAR) 1.5K, CLOUD SHADOW - PART 2 (08/15/72)  
V/M=0.178 LON TEMP=+11.2°C ΔT=36.0°C FILTER SELECT=1 3.557μSEC/ELEMENT  
SEGMENT 1 OF 1  
CHANNEL 8: CAL 2, SCALE=1X, OFFSET=1

Figure 11.1 is a print made from an RC-8 photograph taken from 1.5 thousand feet showing a cloud shadow which was present over a freshly planted field along the flight line north of the ramp during run 18 on 4 June. Figure 11.2 is an enlargement made from the inflight film recorder output for channel 8 during this run. Most of the horizontal streaks visible in this film are probably due to non-uniformities in the incremental movement of the film past the CRT which exposes it, while the lengthwise streaks are probably due to non-uniformities in the CRT phosphor or to non-uniformities in the staircase CRT sweep waveform.

Note the differences between Figures 11.1 and 11.2 in the location of various portions of the cloud shadow, indicating that the cloud was both moving and changing shape. Since the cloud was more or less following the path of the aircraft but at a slower speed, the outline of the cloud depicted in Figure 11.2 is elongated slightly in the flight direction relative to what appears in Figure 11.1. This indicates that the RC-8 film should not always be trusted to indicate the precise shape and location of a cloud shadow in the scanner data.

Figure 11.3 is a contour plot showing an approximate outline for this cloud shadow as indicated in channel 8 (compare with Figure 11.2). In this figure note the outline of a small tree and its shadow, close to one edge of the cloud shadow, near resolution element 340 in scan line 2040. Figure 11.1 indicates that the center of the aircraft shadow probably passed over this tree crown. Figure 11.4 plots the average of the 16 sample elements from the sky reference calibration signal for each scan line from line 2100 through 3050 in channel 8, while Figure 11.5 plots a single element (340) traced across scan lines (and over the crown of the small tree) for lines 1476-2157 in channel 8, approximating the path of the aircraft shadow over the ground. A low signal level representing the tree shadow followed by a high signal representing the sunlit crown of the small tree appears between scan lines 2028 and 2043 in Figure 11.5, followed by a dip in the signal representing the small blob of cloud shadow next to this tree. In Figure 11.4 the sky reference shows a similar signal dip between scan lines 2230 and 2290, indicating that the aircraft actually flew through this portion of the cloud shadow about 200 scan lines after it had scanned over it on the ground. This would correspond (from geometrical calculations) to the sun being approximately  $22^\circ$  away from zenith, ahead of the aircraft at 17:43 GMT (12:43 EST), which is about right. This indicates the lack of correlation one would expect between the sky reference signal and the location of small, sharply defined cloud shadows.
