# ENGINEERING EVALUATION OF 24-CHANNEL MULTISPECTRAL SCANNER

by  
P. F. Lambeck

INFRARED AND OPTICS DIVISION  
WILLOW RUN LABORATORIES  
INSTITUTE OF SCIENCE AND TECHNOLOGY  
THE UNIVERSITY OF MICHIGAN

Subject: Engineering Evaluation of 24-Channel Multispectral Scanner

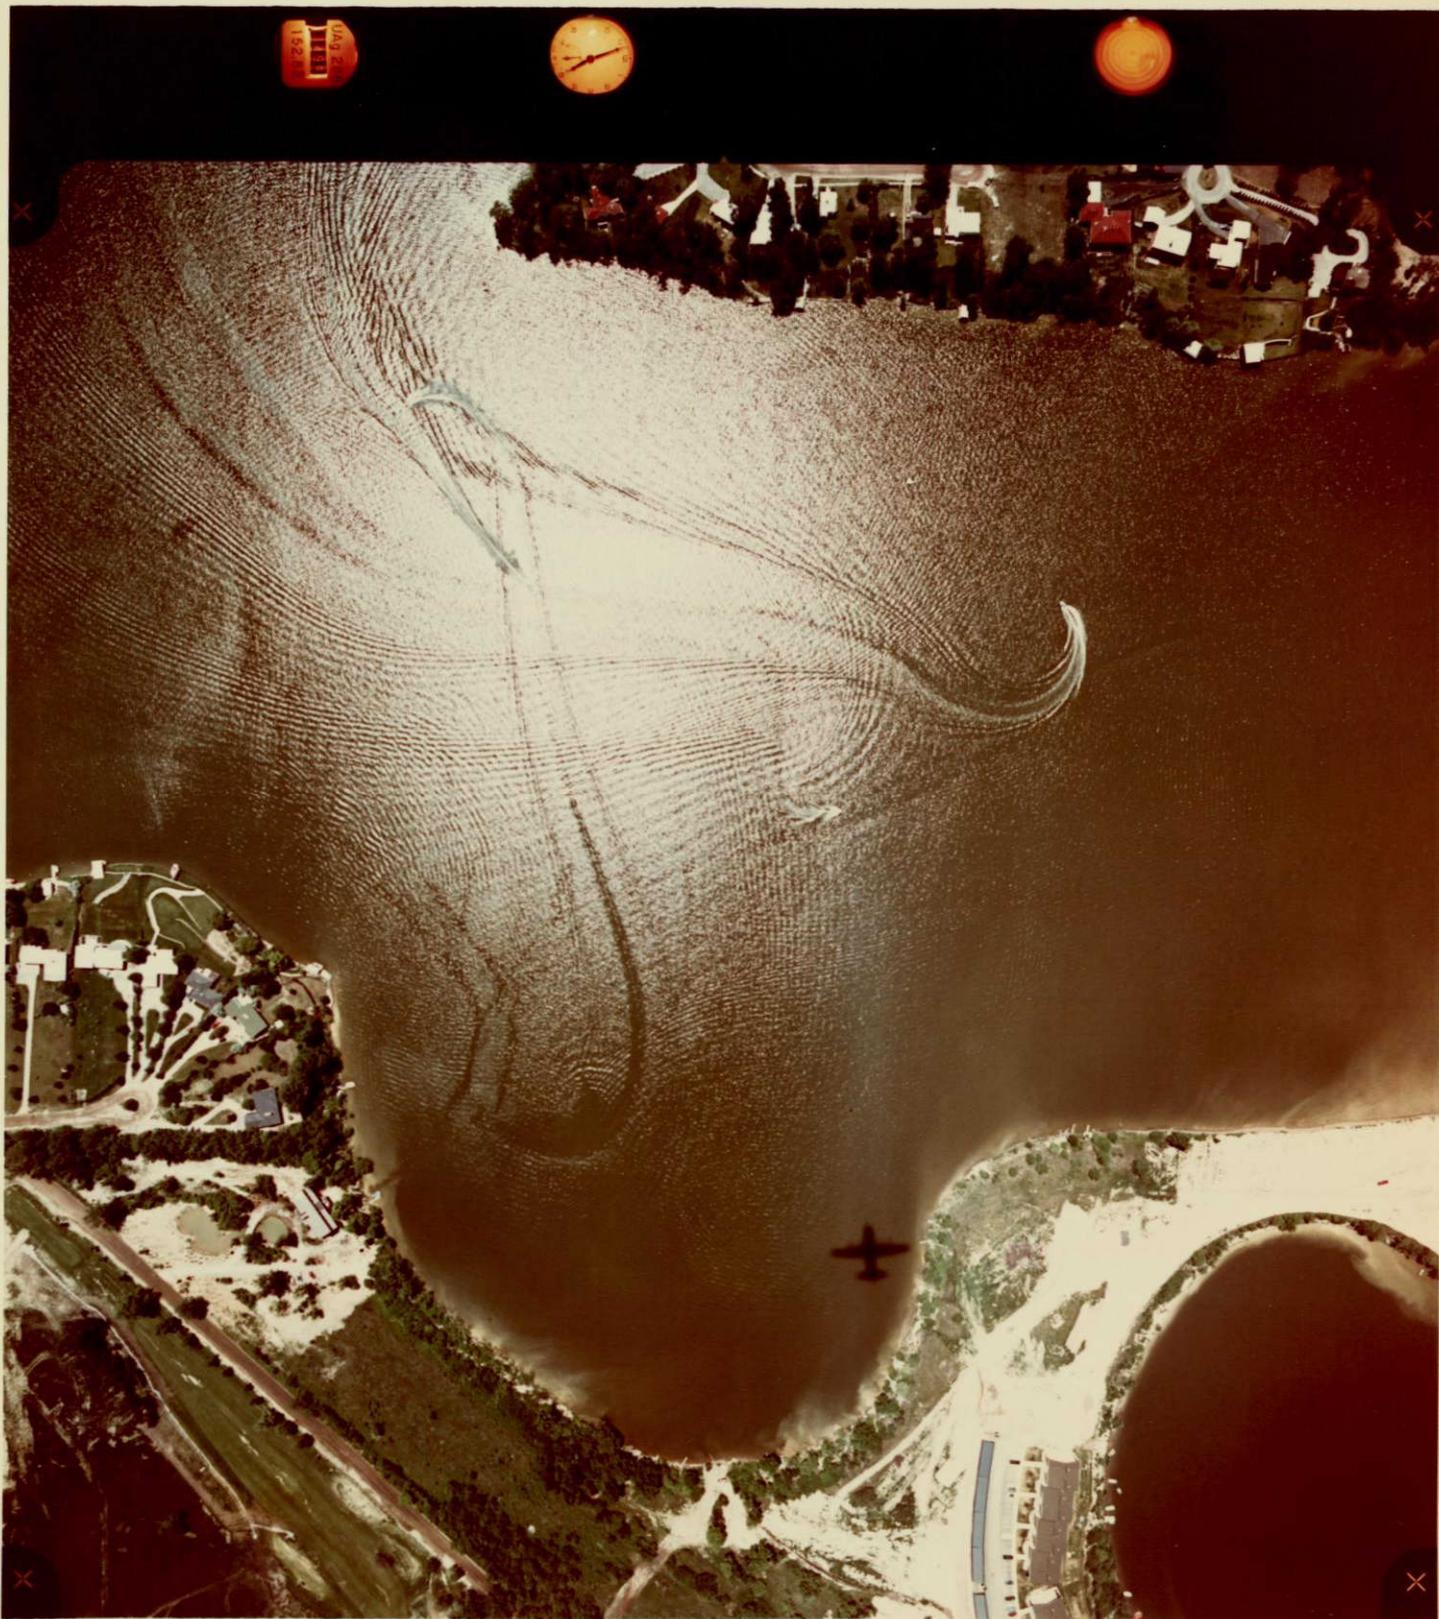
Figure 12.1  
1.7K ft. over lake  
6/4/72 (clear)

Figure 12.1 is a print made from an RC-8 photograph taken over Belleville Lake during run 12 (1.7 thousand feet) on 4 June. Figure 12.2 is an enlargement of output from the inflight film recorder for this same portion of run 12 for channel 3. Note that sun glint forms a different pattern in the scanner data from that shown in the RC-8 photograph.

Again horizontal and vertical streaks are visible in the film recorder printout as mentioned in Section 11. Close inspection of this film indicates that individual resolution elements can perhaps be identified occasionally, although there appears to be emphasis in brightness upon alternate resolution elements as if the CRT sweep waveform preferred "even" voltage levels over "odd" ones, or vice versa. There is an even more prominent emphasis on every 4th resolution element, giving rise to the vertical white streaks which appear in the enlargement, spaced a little less than 1mm apart.

Note the lack of evidence for clipping or ringing in this film recorder output for channel 3. Earlier in this same run clipping and ringing were noted in the digitized data for this channel (see Section 6 and Figure 6.21). This indicates that the abnormalities in channel 3 occur downstream from the connection for input to the film recorder in this channel.

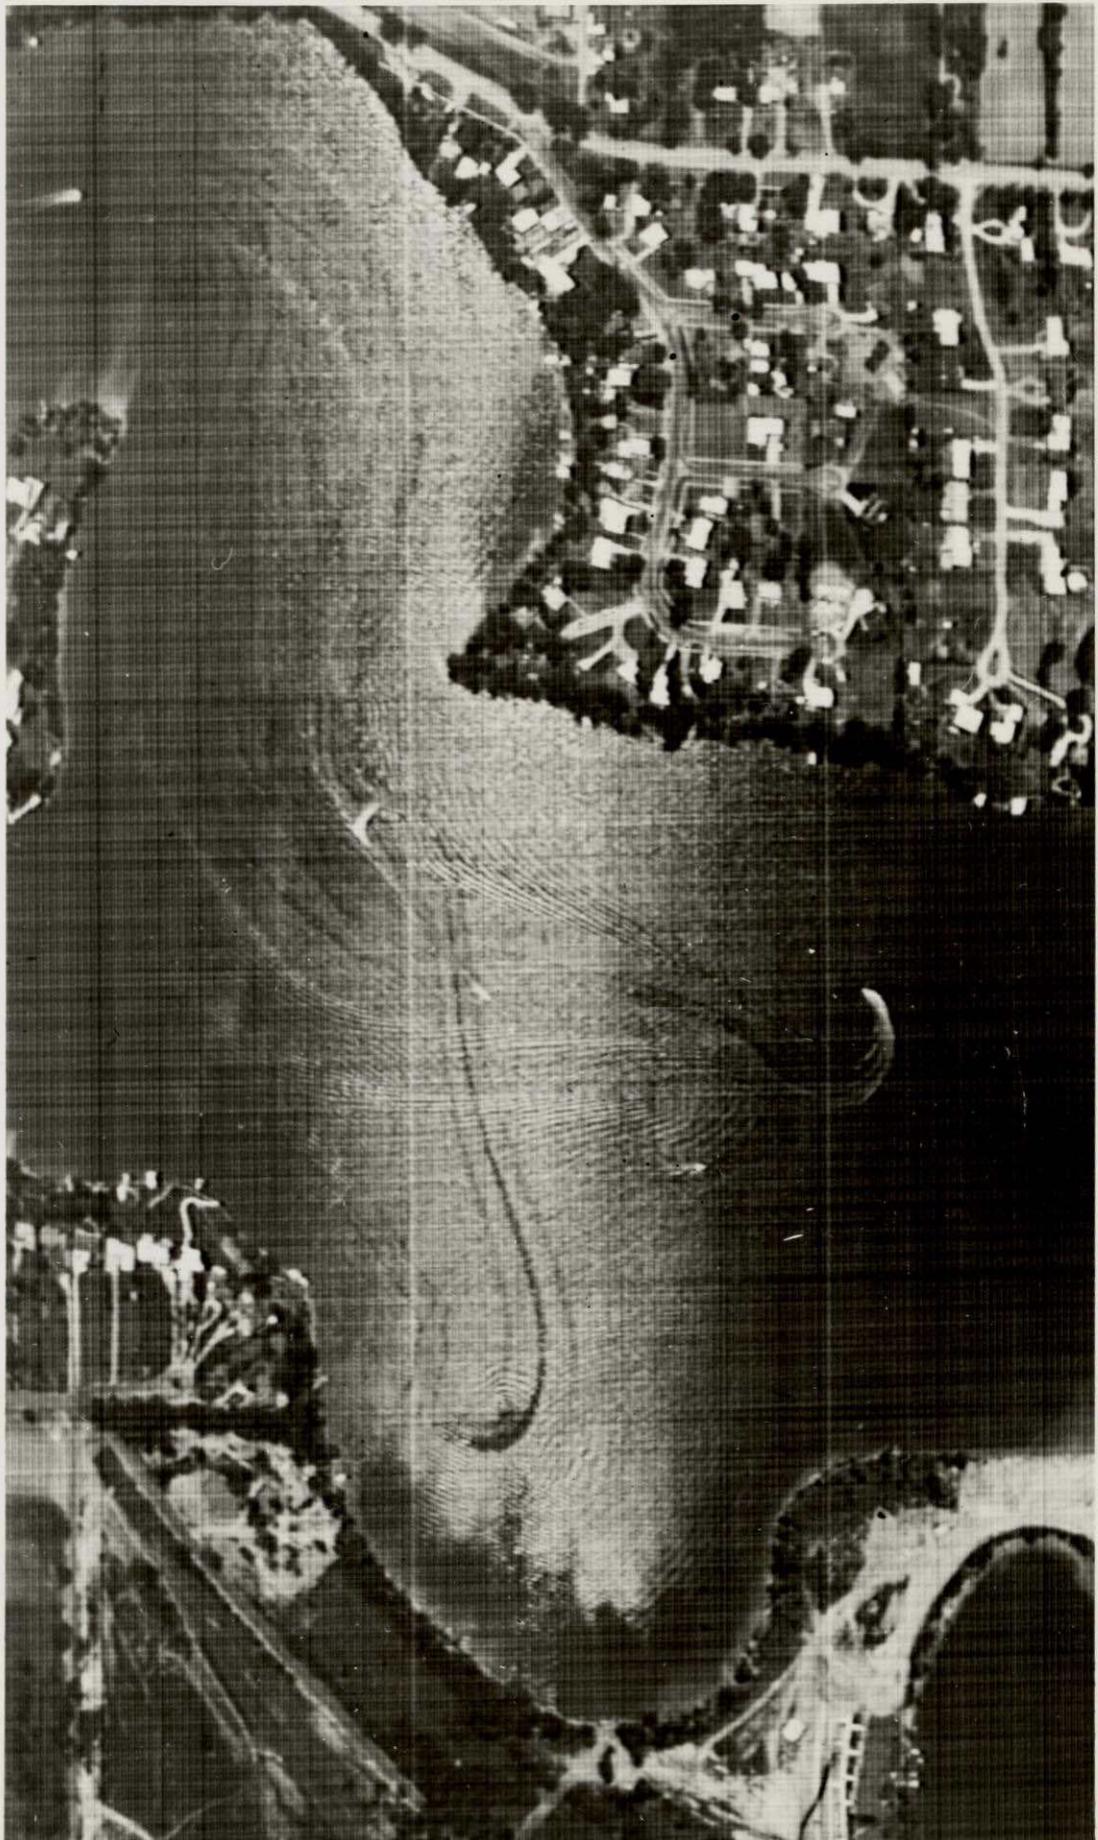
Figure 12.2  
Inflight Film, Ch. 3  
1.7K ft. 6/4/72
