# EVALUATION OF SHUTTLE SOLID ROCKET BOOSTER CASE MATERIALS

NASA-CF-120160) EVALUATION OF SHUTTLE  
SOLID ROCKET BOOSTER CASE MATERIALS.  
CORROSION AND STRESS CORROSION  
(McDonnell-Douglas Astronautics Co.)  
100 p HC \$8.00

28 December 1973

McDonnell Douglas Astronautics Company  
St. Louis, Missouri

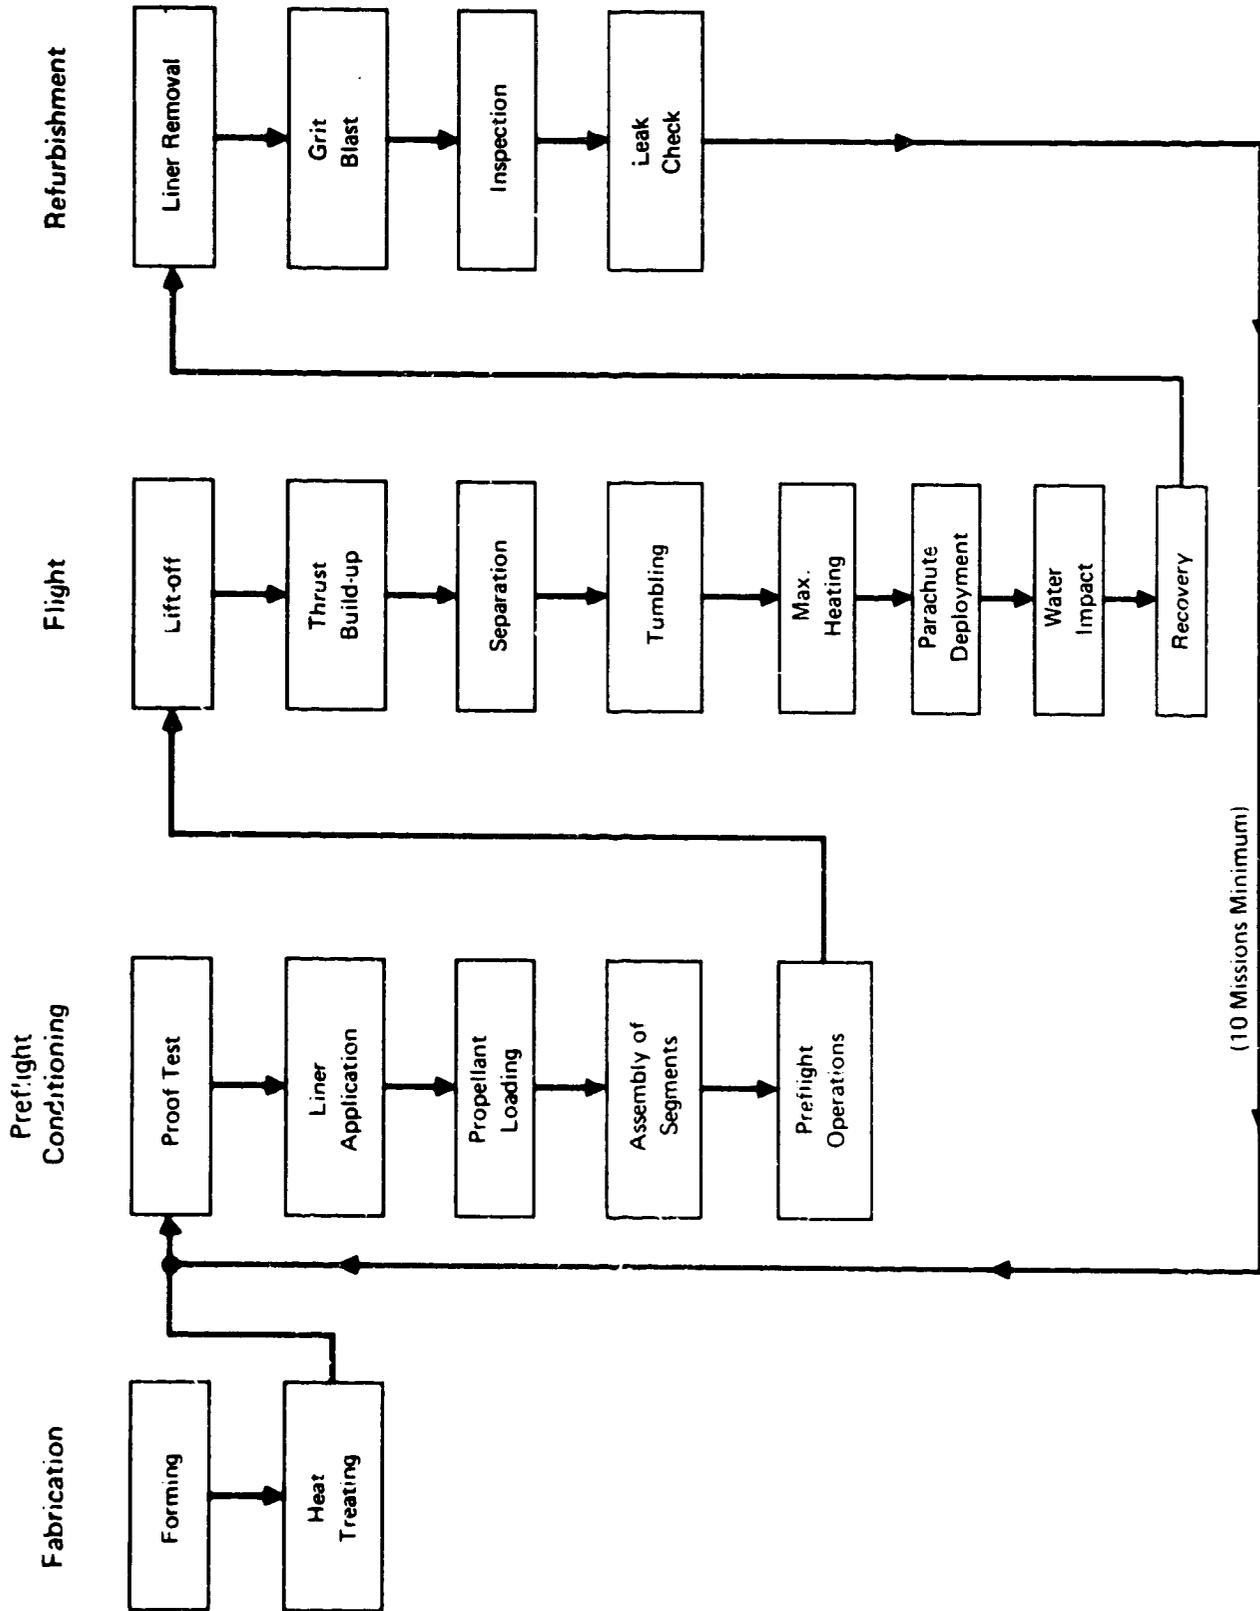
**FIGURE 2-1**  
**EXPECTED SRB SERVICE LIFE EVENTS**

(10 Missions Minimum)

Five distinct temperature cycles will also be associated with each mission, as indicated in Table 2-1. The maximum temperature experienced by the case is expected to occur during refurbishment, when the case is heated to  $589^\circ\text{K}$  ( $600^\circ\text{F}$ ) for a maximum period of up to 12 hours. Heating of the case to this temperature represents one method proposed for removal of the elastomeric liner that bonds the propellant to the case and protects the case from the burning solid propellant. The temperature reached by the case during the pressurized portion of the SRB flight cycle is not expected to exceed  $339^\circ\text{K}$  ( $150^\circ\text{F}$ ).

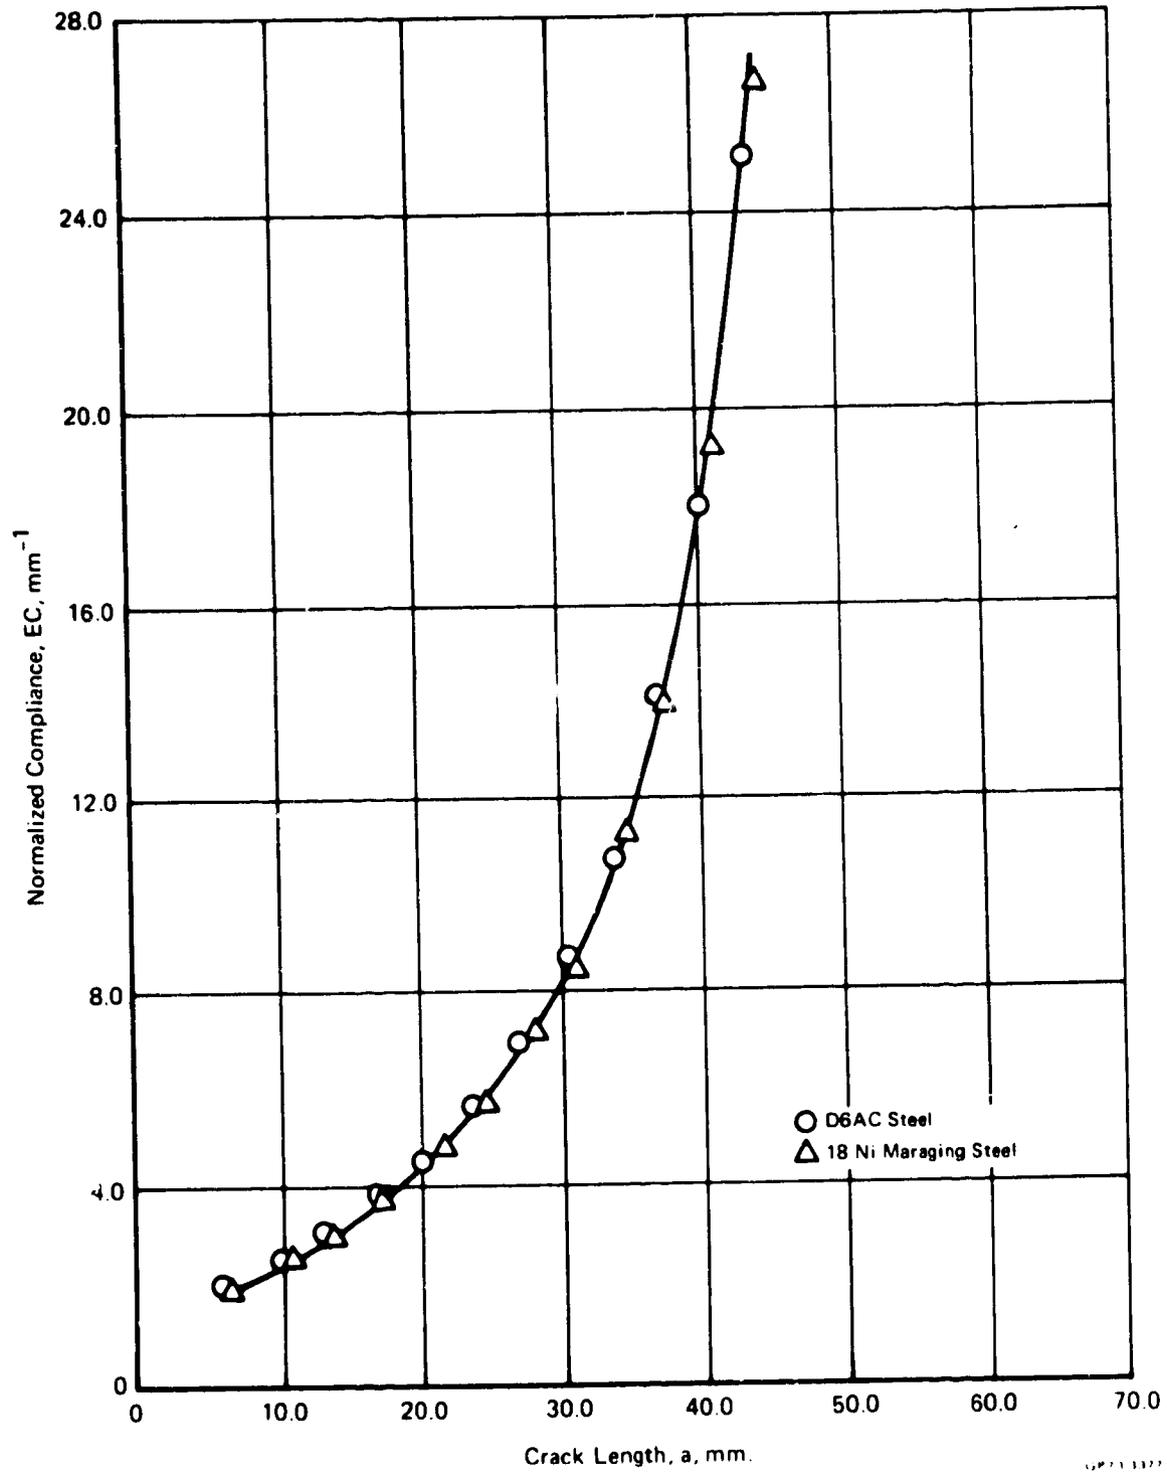
**FIGURE 4-3**  
**NORMALIZED COMPLIANCE (AT CENTERLINE OF LOADING) vs CRACK LENGTH**

This correction factor has been found to be conservative in predicting centerline compliance values, particularly at the shorter crack lengths. However, for the shortest crack length used in the present study, the value of stress intensity calculated using this curve is overestimated by no more than 10 percent.

where  $c$  is the crack length and  $c_1$  the distance between the centerline of load application and the point at which displacement measurements are taken. The corrected values of normalized compliance are presented in Table 4-2 and Figure 4-3.

For the self-stressed MWOL specimens, a high strength steel bolt and a 17-7 PH stainless steel loading pin were used to apply an initial load to each specimen that corresponded to approximately 85% of the average  $K_{IIc}$  value reported in Table 4-3. The displacement of each specimen required to give the desired stress intensity at the crack tip was determined from the calibration curve of Figure 4-3 and is tabulated in Table 4-5.

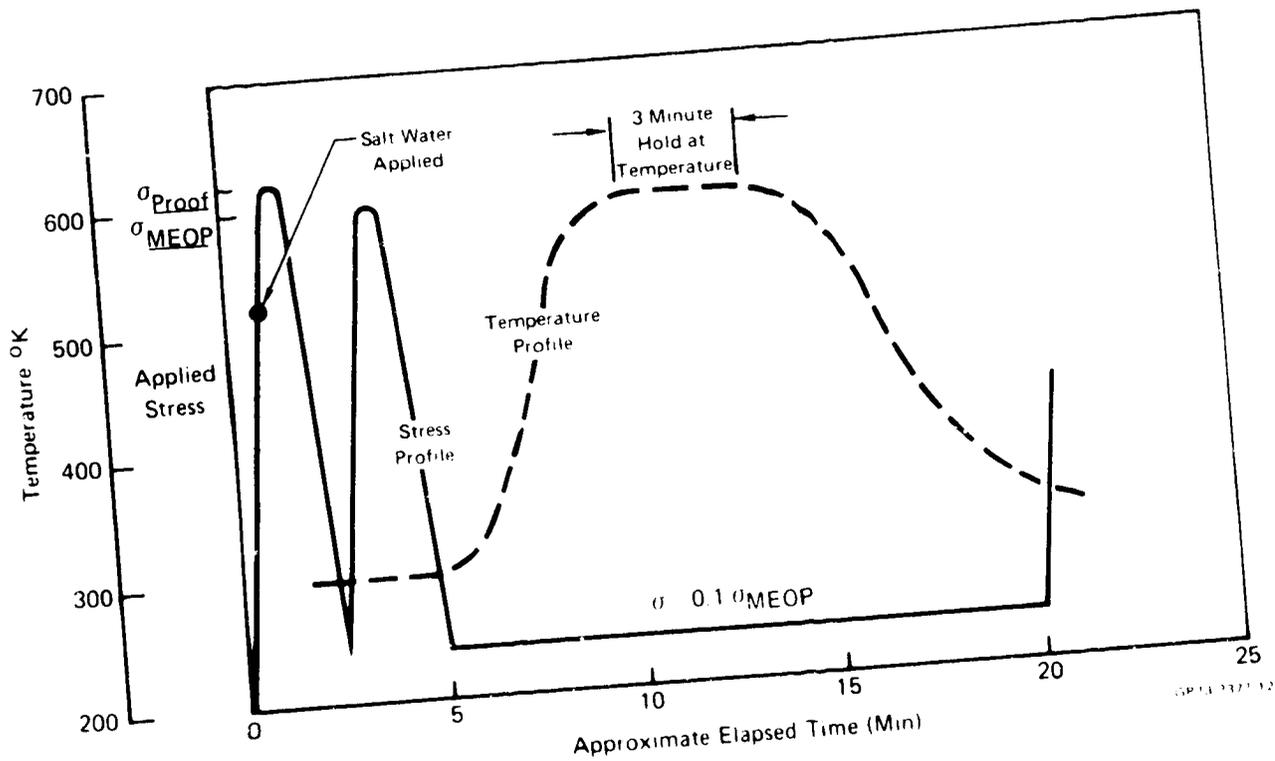
FIGURE 5-4  
STRESS/TEMPERATURE CYCLE FOR CRACK PROPAGATION TESTING

During the temperature cycle, the applied stress was held constant at 108 MN/m<sup>2</sup> (15.6 ksi), corresponding to a stress ratio of 0.1. In order to maintain this stress level, the load was adjusted during the heating and cooling portion of the temperature cycle to offset the effects of thermal expansion. To minimize the time required to test each specimen, the fastest possible heating and cooling rates were used. No more than four minutes was required to heat the specimen to 589°K (600°F), and approximately eight minutes was required to achieve a temperature of 150°F using forced air cooling. Loading for the next test cycle was initiated once this temperature was achieved by all four thermocouples.

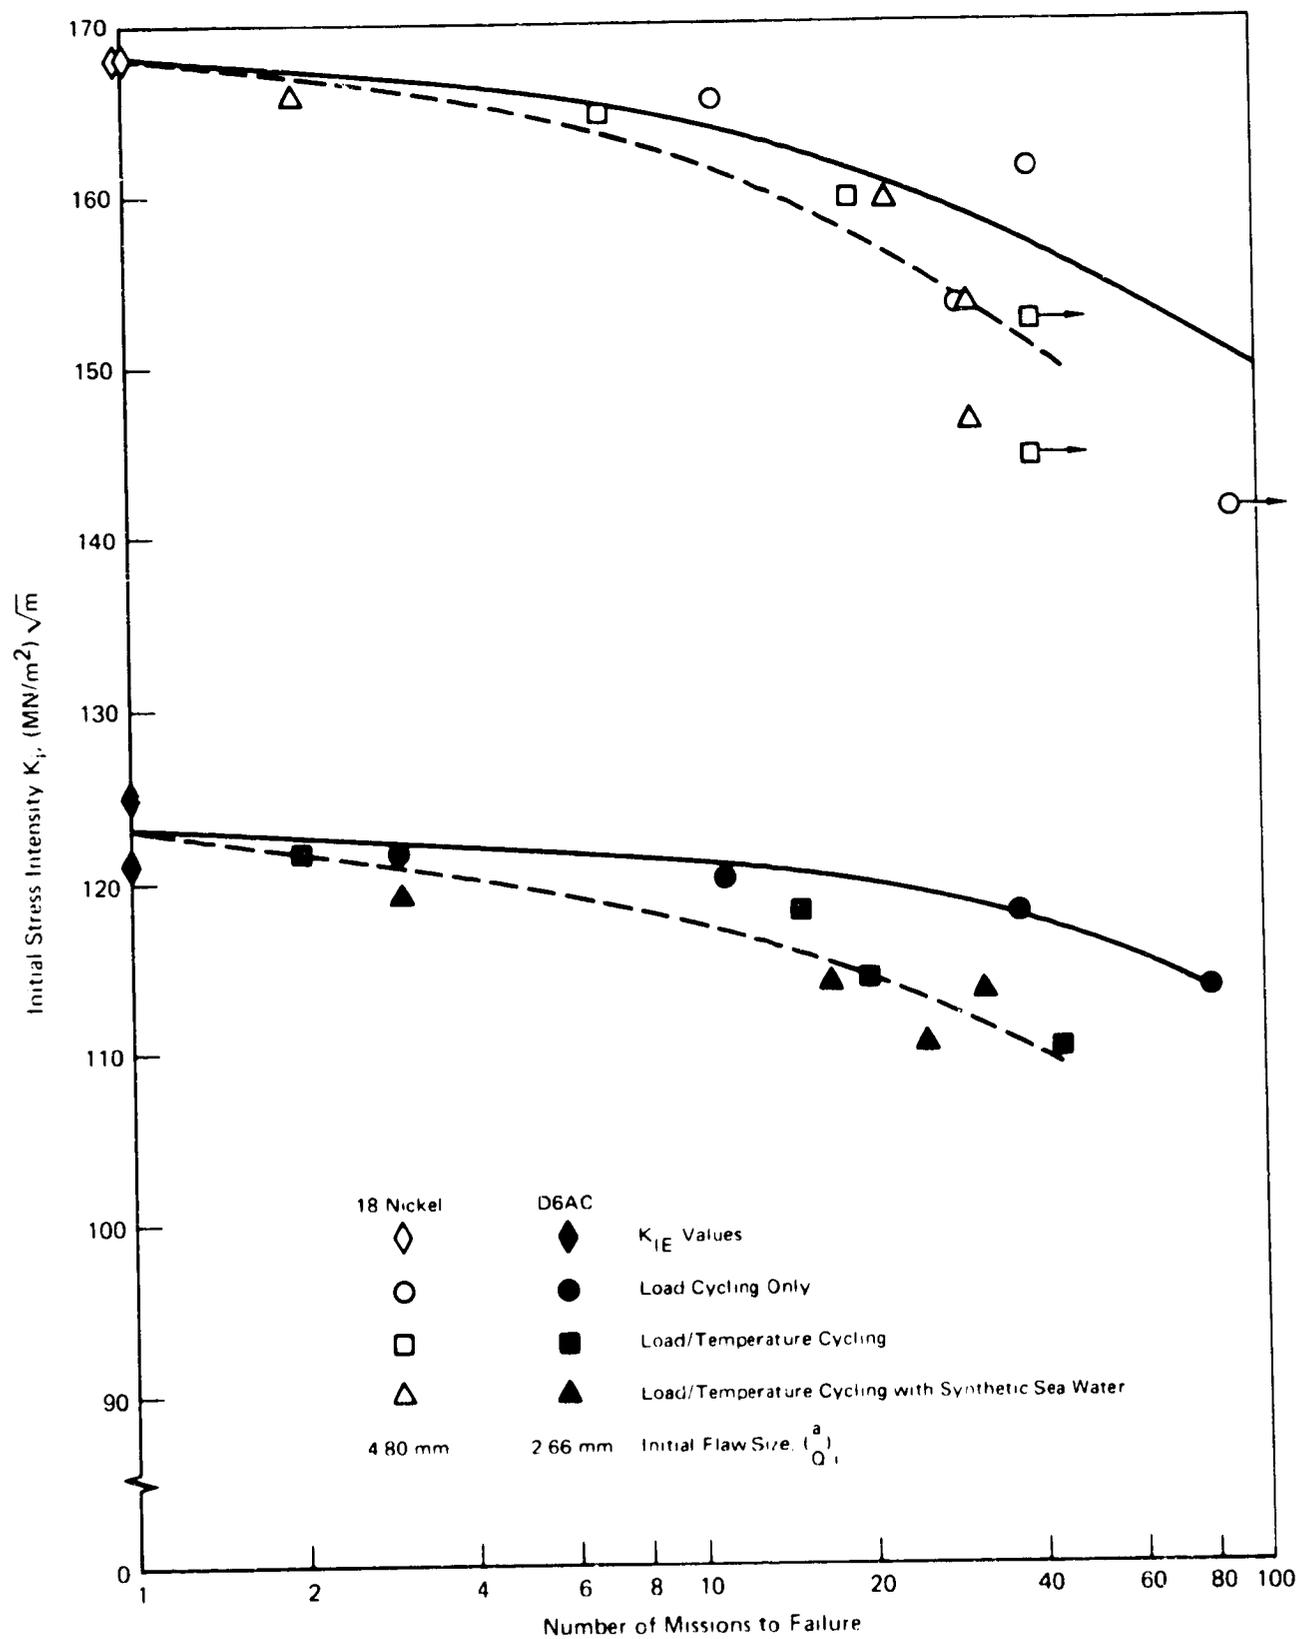
**FIGURE 5-5**  
**RESULTS OF CRACK PROPAGATION TESTING**

The cyclic test data of Appendix B, plotted in Figure 5-5 as initial stress intensity vs the number of cycles to failure, indicates that the cyclic flaw growth behavior of 18 Ni maraging steel is unaffected by expected liner removal temperatures. However, at longer exposure times, accelerated flaw growth appears to have occurred in the specimens exposed to synthetic sea water. In contrast, the cyclic test data for D6AC steel indicates that flaw growth is accelerated by temperature cycling to  $589^\circ\text{K}$  ( $600^\circ\text{F}$ ); subsequent exposure to synthetic sea water under similar cyclic load and temperature conditions produces no further decrease in cyclic life.

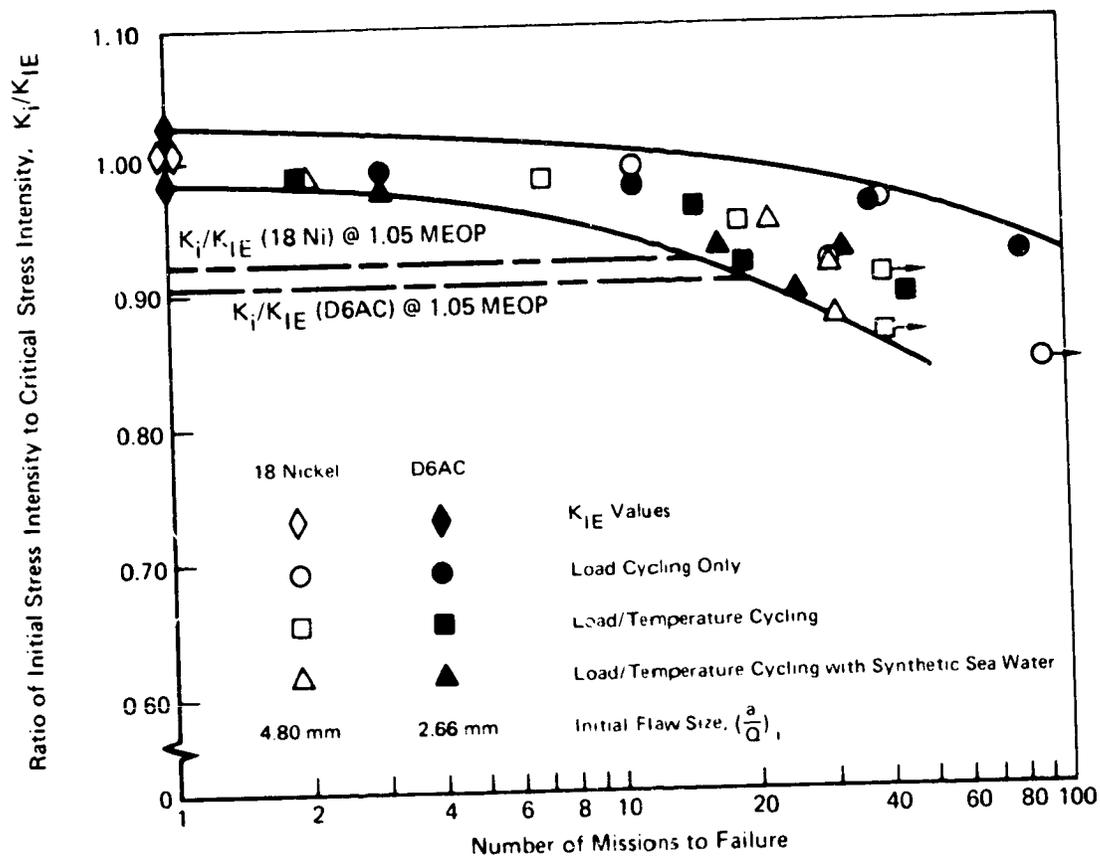
**FIGURE 5-9**  
**RELATIONSHIP BETWEEN NORMALIZED STRESS INTENSITY AND**  
**MISSIONS TO FAILURE FOR D6AC AND**  
**18 NICKEL MARAGING STEEL**

The cyclic flaw growth data for D6AC and 18 Ni maraging steel obtained in the present study can be compared by normalizing the initial stress intensity to account for differences in fracture toughness ( $K_{IE}$ ). This is done in Figure 5-9 by plotting the ratio of initial-to-critical stress intensity,  $K_i/K_{IE}$ , vs the number of missions to failure. This figure shows that the cyclic flaw growth behavior of these two alloys are remarkably similar when normalized to account for differences in fracture toughness. Furthermore, this data appears to indicate that an SRB fabricated from D6AC might survive more missions than one of 18 Ni maraging steel, since the  $K_i/K_{IE}$  ratio for the latter alloy is slightly higher. If such small differences are ignored and lower bound data is used, then an SRB fabricated from either alloy would survive approximately 15 missions before failure would occur. This estimation of cyclic life is based upon the preliminary design parameters quoted in Section 2.1 and can be increased by either decreasing the operating stress level of the case, keeping the initial proof stress constant, or by increasing the initial proof stress in order to decrease the initial flaw size present after fabrication.

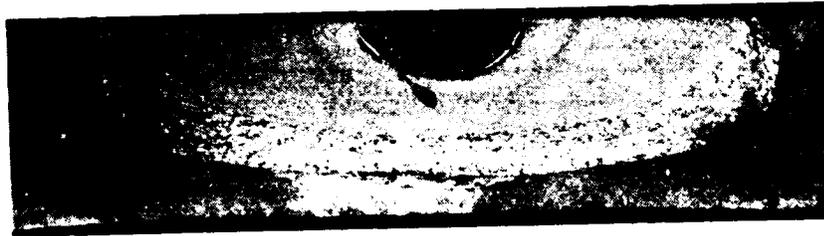
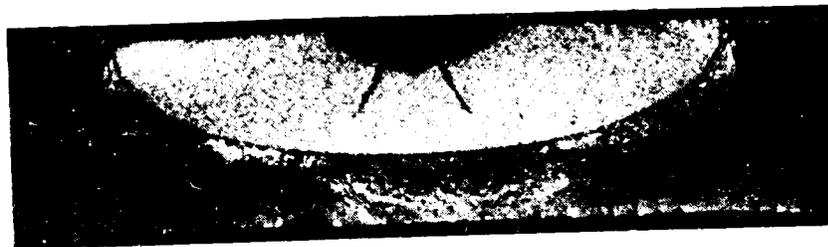
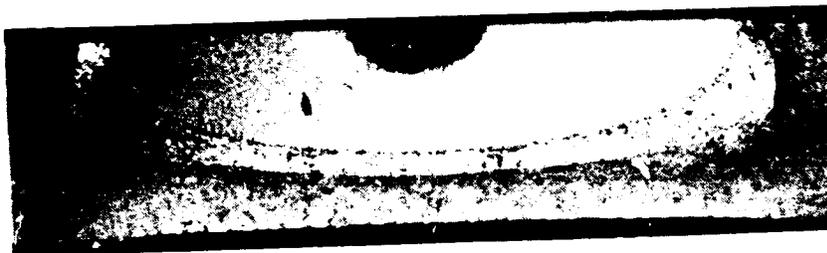
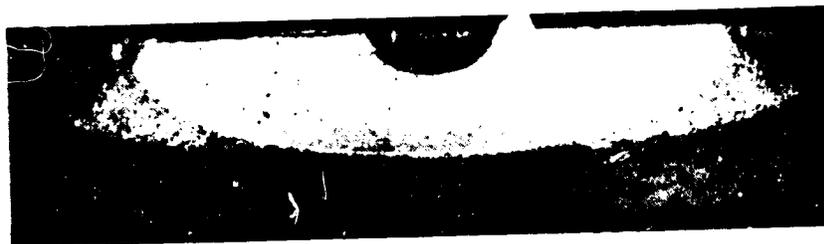
FIGURE C-1  
FRACTURE SURFACES OF 18 NICKEL MARAGING STEEL  
SPECIMENS AFTER LOAD CYCLING (X3)

- Specimen M1
- Cycled @ MEOP
  - >90 Missions to Failure

- Specimen M2
- Cycled @ 1.05 MEOP
  - 30 Missions to Failure

- Specimen M3
- Cycled @ 1.10 MEOP
  - 39 Missions to Failure

- Specimen M4
- Cycled @ 1.13 MEOP
  - 11 Missions to Failure

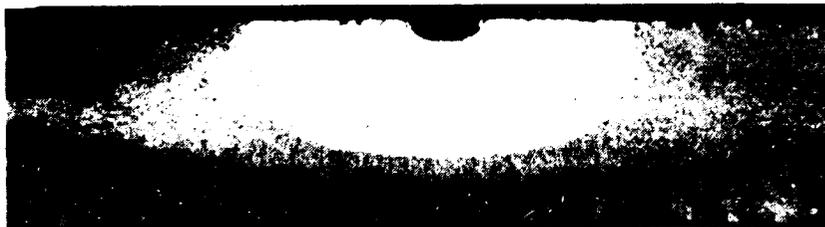
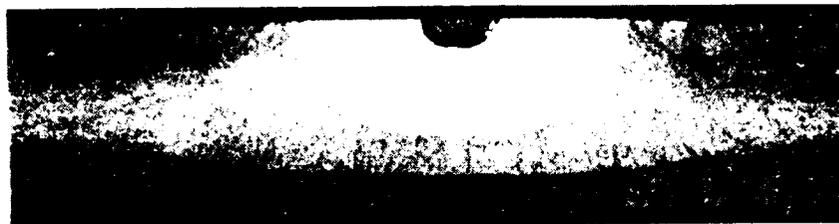
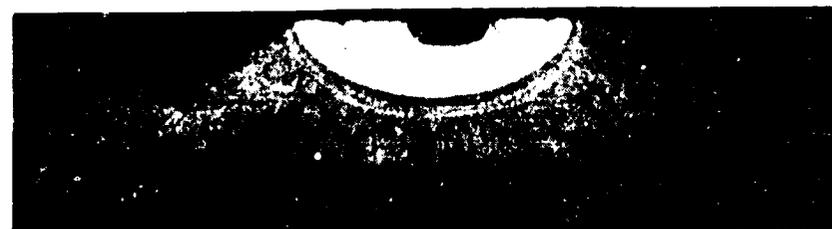
FIGURE C 4  
FRACTURE SURFACES OF D6AC STEEL SPECIMENS  
AFTER LOAD CYCLING (X3)

- Specimen D1
- Cycled @ 1.05 MEOP
  - 80 Missions to Failure

- Specimen D2
- Cycled @ 1.10 MEOP
  - 37 Missions to Failure

- Specimen D4
- Cycled @ 1.13 MEOP
  - 3 Missions to Failure

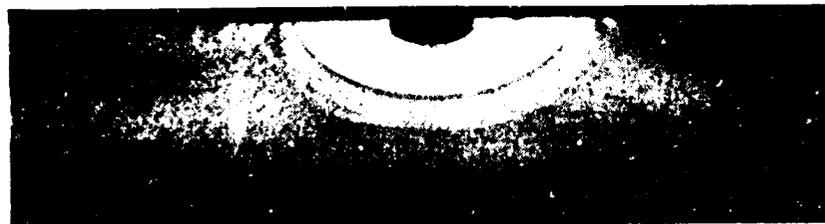
- Specimen D3
- Cycled @ 1.115 MEOP
  - 11 Missions to Failure

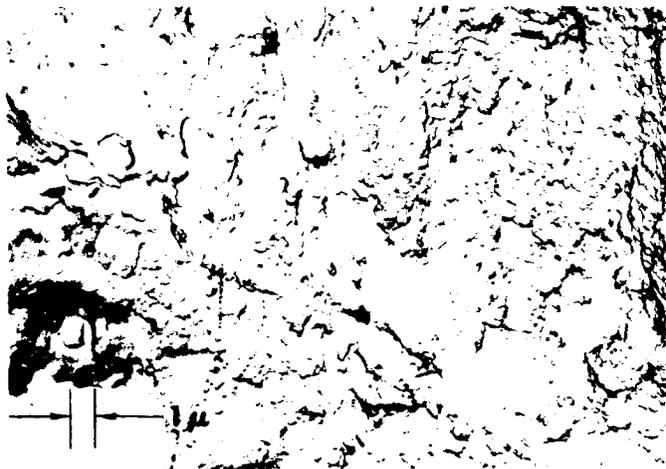
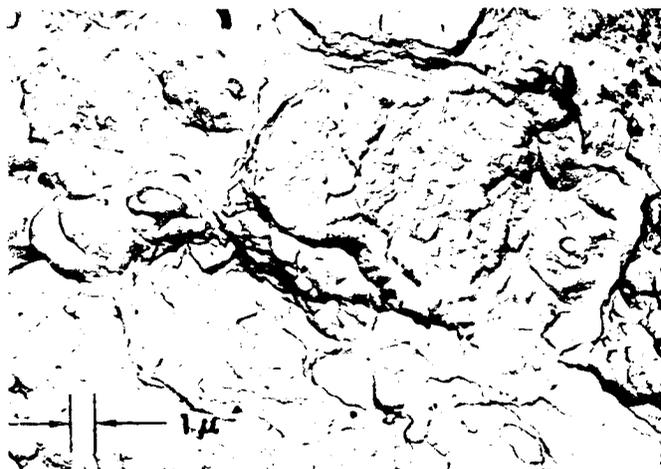
FIGURE C-15  
TWO STAGE PLASTIC-CARBON REPLICAS OF D6AC  
STEEL SPECIMENS AFTER MISSION  
CYCLING AT 1 05 MEOP (X3300)

- Load Cycling Only
- 80 Missions to Failure

- Load and Temperature Cycling
- 20 Missions to Failure

- Load and Temperature Cycling with Salt Water
- 32 Missions to Failure
