**FINAL REPORT**

**RI 1170 ADVANCED  
STRAPDOWN GYRO**

**Contract NAS 12-687**

**HSER 6197**

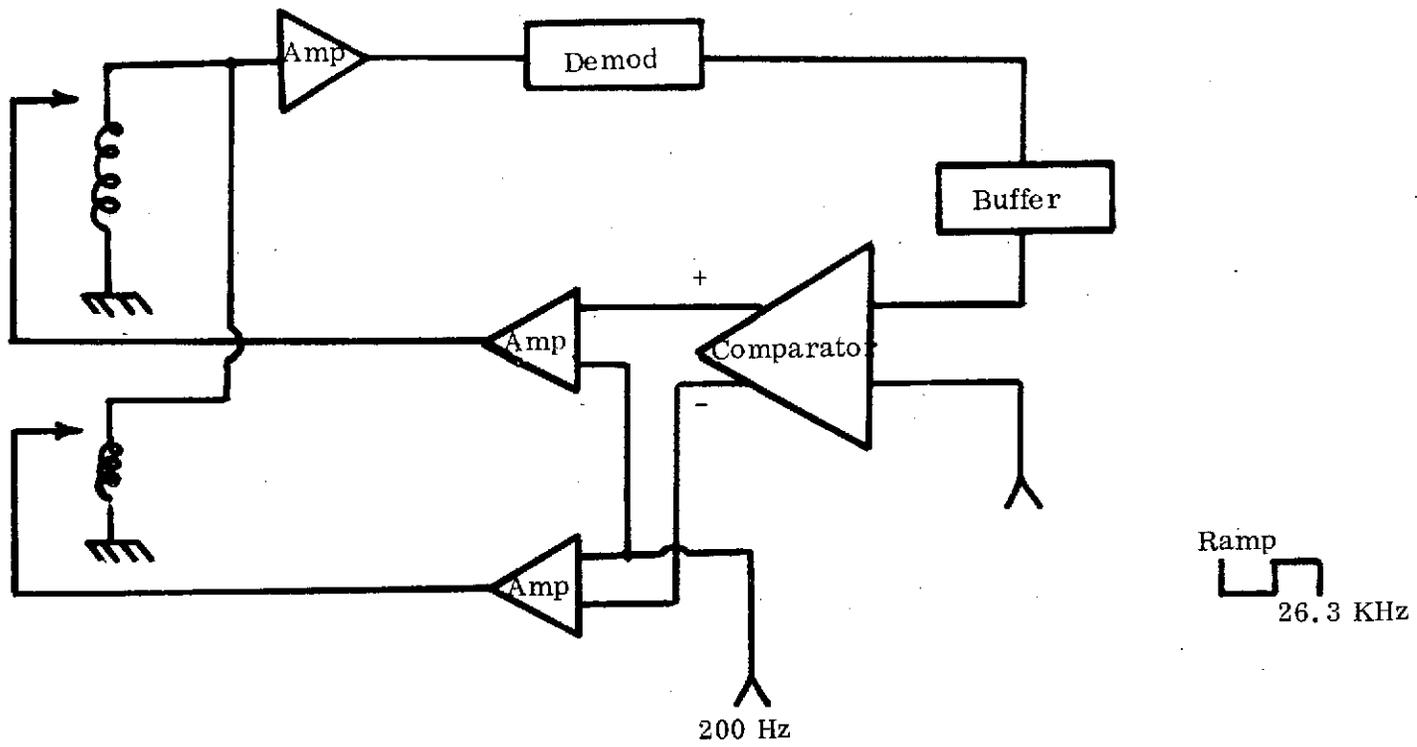
Figure 3.2-16 MSE Design

Figure 3.2-16 shows schematically the redesigned loop. The amplifier/driver are fed a constant amplitude 200 Hz sine wave drive signal. The individual amplifier/drivers are enabled on a variable duty cycle established by the DC error signal and a 26.3 KHz ramp at the comparator. The timing is shown in Figure 3.2-17. The uppermost signal is the 200 Hz constant amplitude drive to the amplifier/drivers. Below it in exaggerated time scale, is the 26.3 KHz ramp. Superimposed on the ramp is a slewed error signal, swinging from positive to negative extremes. The resulting output

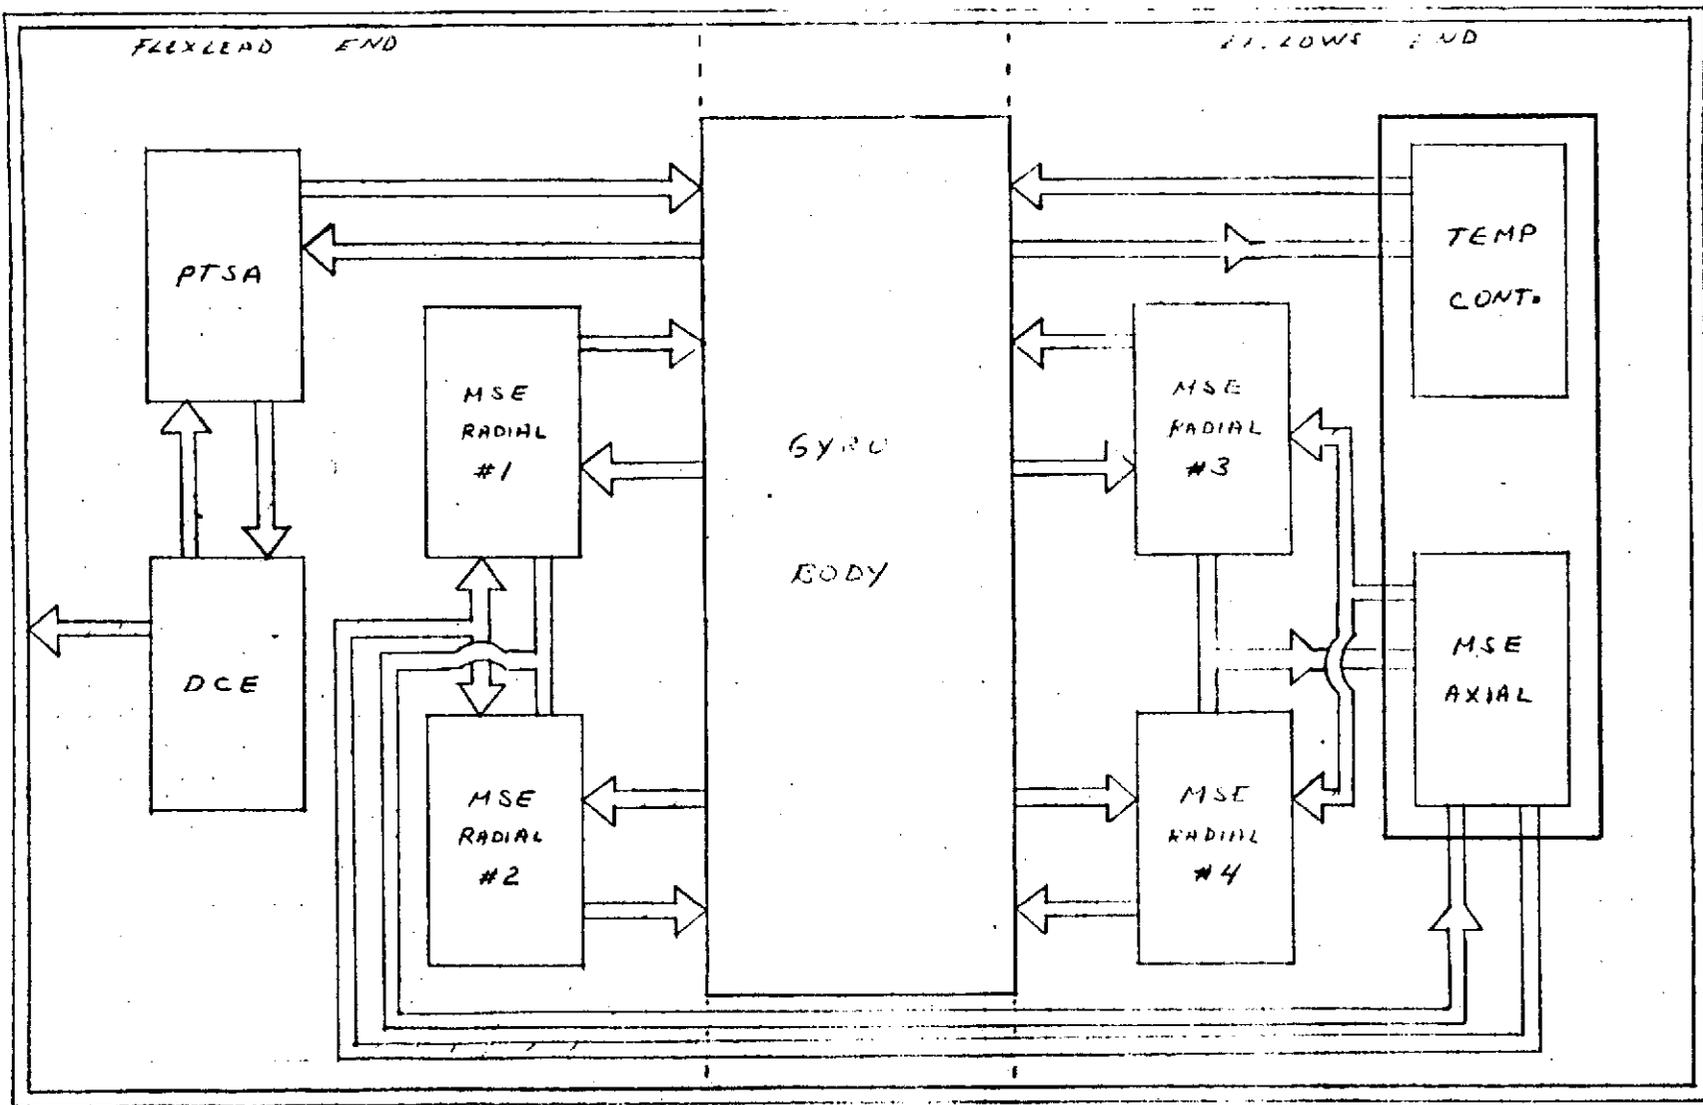
FIGURE 3.3-5 RI-1170 ELECTRONICS CONTROL DATA FLOW

Figure 3.3-5 gives a pictorial representation of the interdependence of the electronic system constituting the RI 1170 gyro electronics which guided packaging design. The PTSA interacts directly with the gyro proper and the DCE. The PTSA pickoffs are located on either side of the gyro and are fed differentially into the PTSA. All necessary timing information is obtained from the DCE. The DCE also controls the determination of operation in the high scale factor (145 ma) or low scale factor (72.5 ma) modes. Except for test points and supply connections, all data are transmitted to the outside world via the DCE, the only connection of the rebalance loop electronics to the outside.

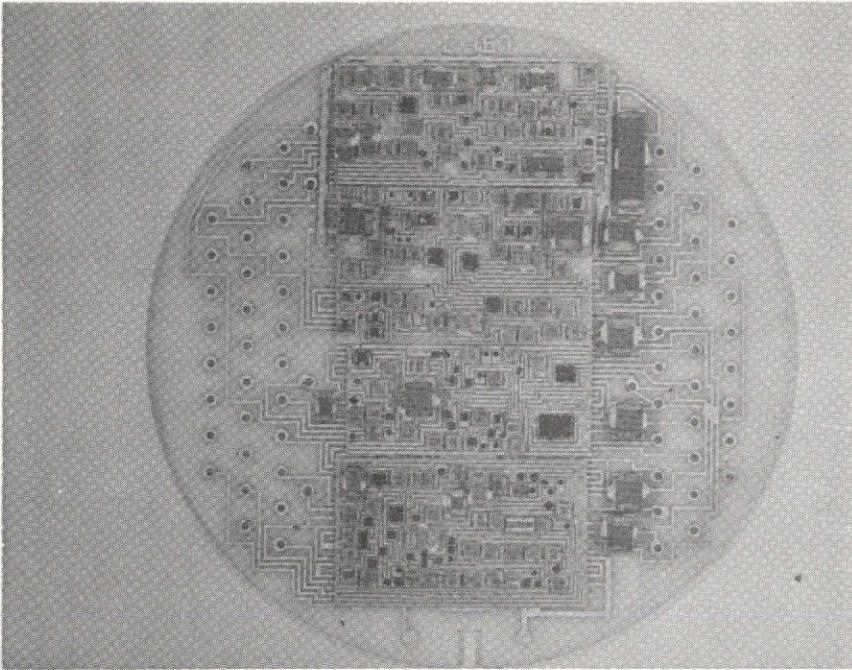
Figure 3.3-6  
C-167 Wafer  
Pulse Torque  
Servo Amplifier

The electronics are divided into seven hybrid wafers. Each wafer is approximately 2 1/4 inches in diameter. Figure 3.3-6 gives an overall view of the basic construction technique utilized in fabricating the wafers. This particular wafer is the Pulse Torque Servo Amplifier circuit. Figures 3.3-7 through 3.3-9 are magnified sections of Figure 3.3-6. All the wafers consist of one large substrate which contains the gold conductors necessary for interconnection of wafers and for interconnection of the circuit substrates. Also found on the large, or mother, substrate are the decoupling capacitors which are located at the point of entry for the individual conductors involved. The size of the conductor is determined by the amount of current it must carry. The screen painting technique is used to apply the conductor patterns to the substrate. Conductor patterns are generated on the screen by the use of a development process which leaves clear areas on the screen through which the film (ink) can be deposited on the substrate. The conductor elements are produced on the substrate when ink is forced through the clear areas of the screen by use of a blade or squeegee. The substrate is then fired at a very high temperature. The actual circuitry is located on smaller rectangular shaped substrates which are attached to the mother substrate by means of a non-conductive adhesive. The conductor lines and pads are placed on the circuit substrates using the same technique employed on the mother substrate. Once the conductors have been fired, the components are placed on the substrates, using either conductive or non-conductive adhesives as the individual part requires.

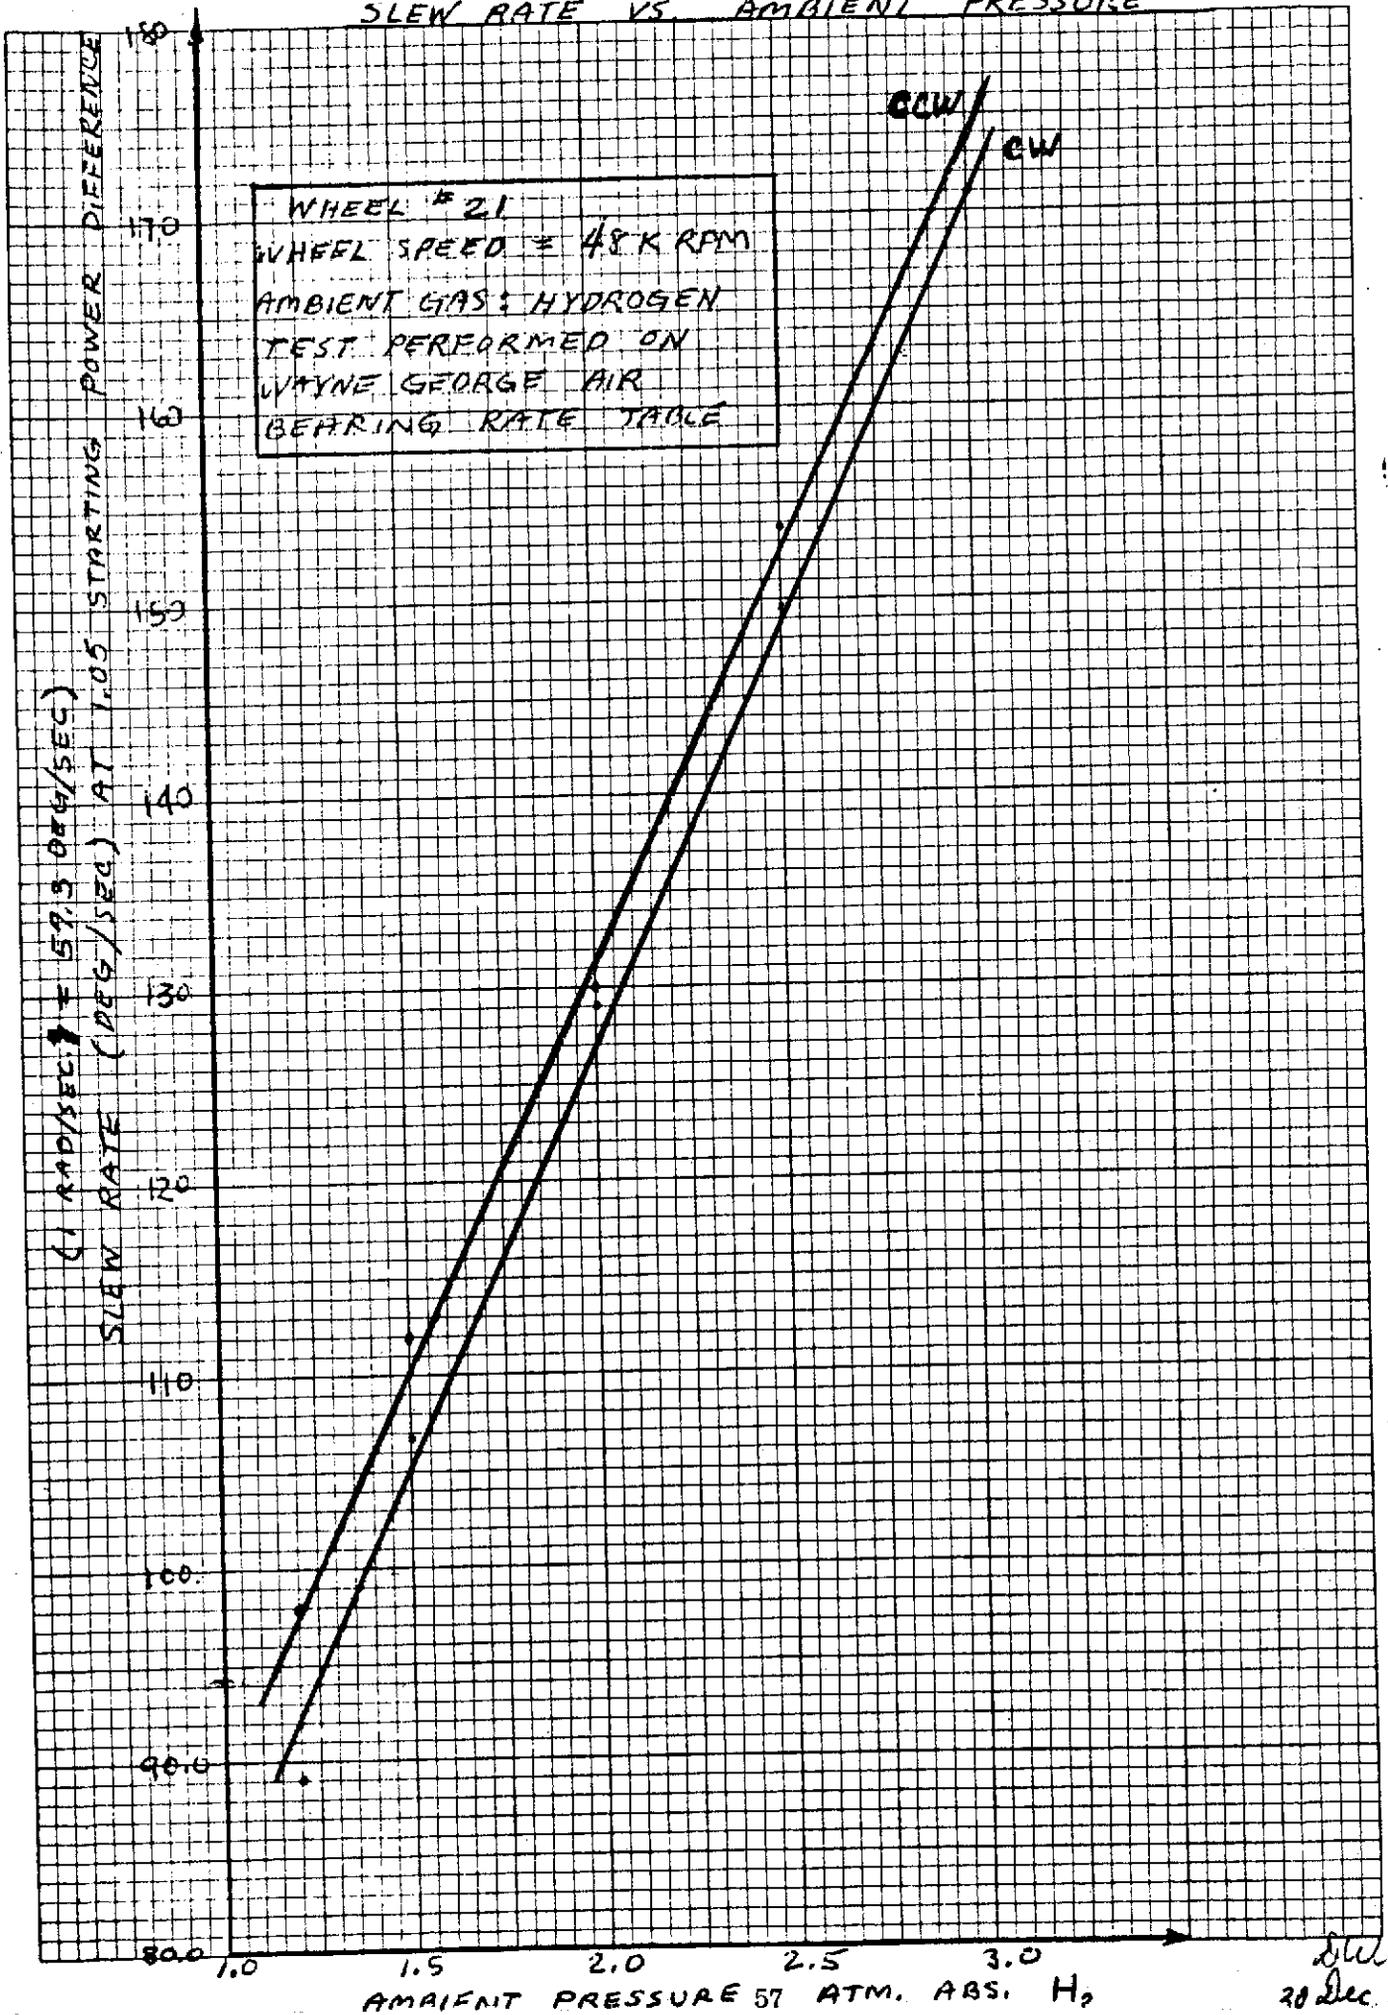
Figure 3.4-2  
SLEW RATE VS AMBIENT PRESSURE

It had been confirmed (See Figure 3. 4-2 ) that an increase in ambient pressure raises the wheel slew capacity. Therefore, wheels S/N 021 and S/N 022 were tested in 2 atm abs of  $H_2$ ; however, this still failed to raise the slew capacity of these gas bearings to the design goal level.

It has been confirmed (See Graph, Figure 3.4-2) that increase in ambient pressure raises the wheel slew capacity. Therefore, we tested Wheels S/N 021 and S/N 022 in 2 atm abs of H<sub>2</sub>; however, this still failed to raise the slew capacity of these gas bearings to an acceptable level. The slew capacity of these same bearings is even lower in an environment of 1.5 atm abs, the design specification.

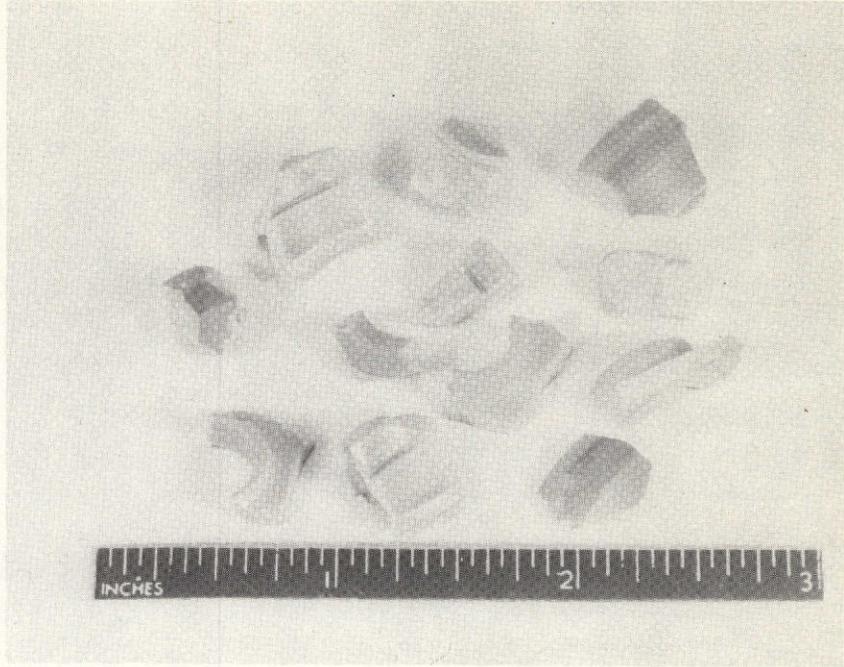
FIG. 20

Upon removal of the lid of the running pot (figure 17), it was discovered that the wheel had disintegrated into many small pieces (figure 18). When the running rig was removed from the pressure pot, it was observed that the rotor had completely fractured and had delaminated the hysteresis rings (figure 19). The delaminated rings are shown in figure 20.

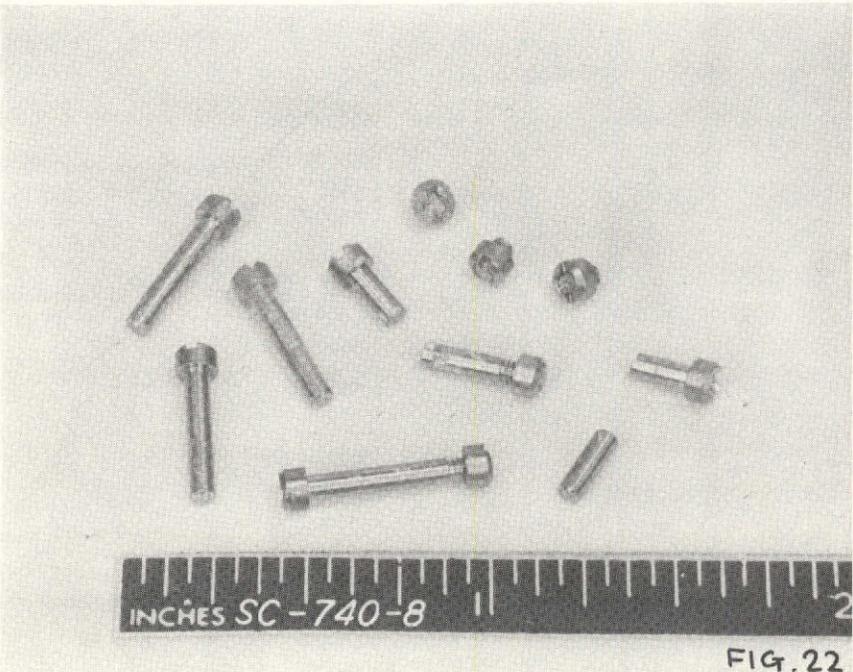
FIG. 22

One thrust plate had broken, but one was still intact (figure 21). One screw was intact, one had broken into three pieces, and the remainder had broken into two pieces (figure 22). The shaft had broken into three pieces, figure 23, with the threaded area at either end being broken off.

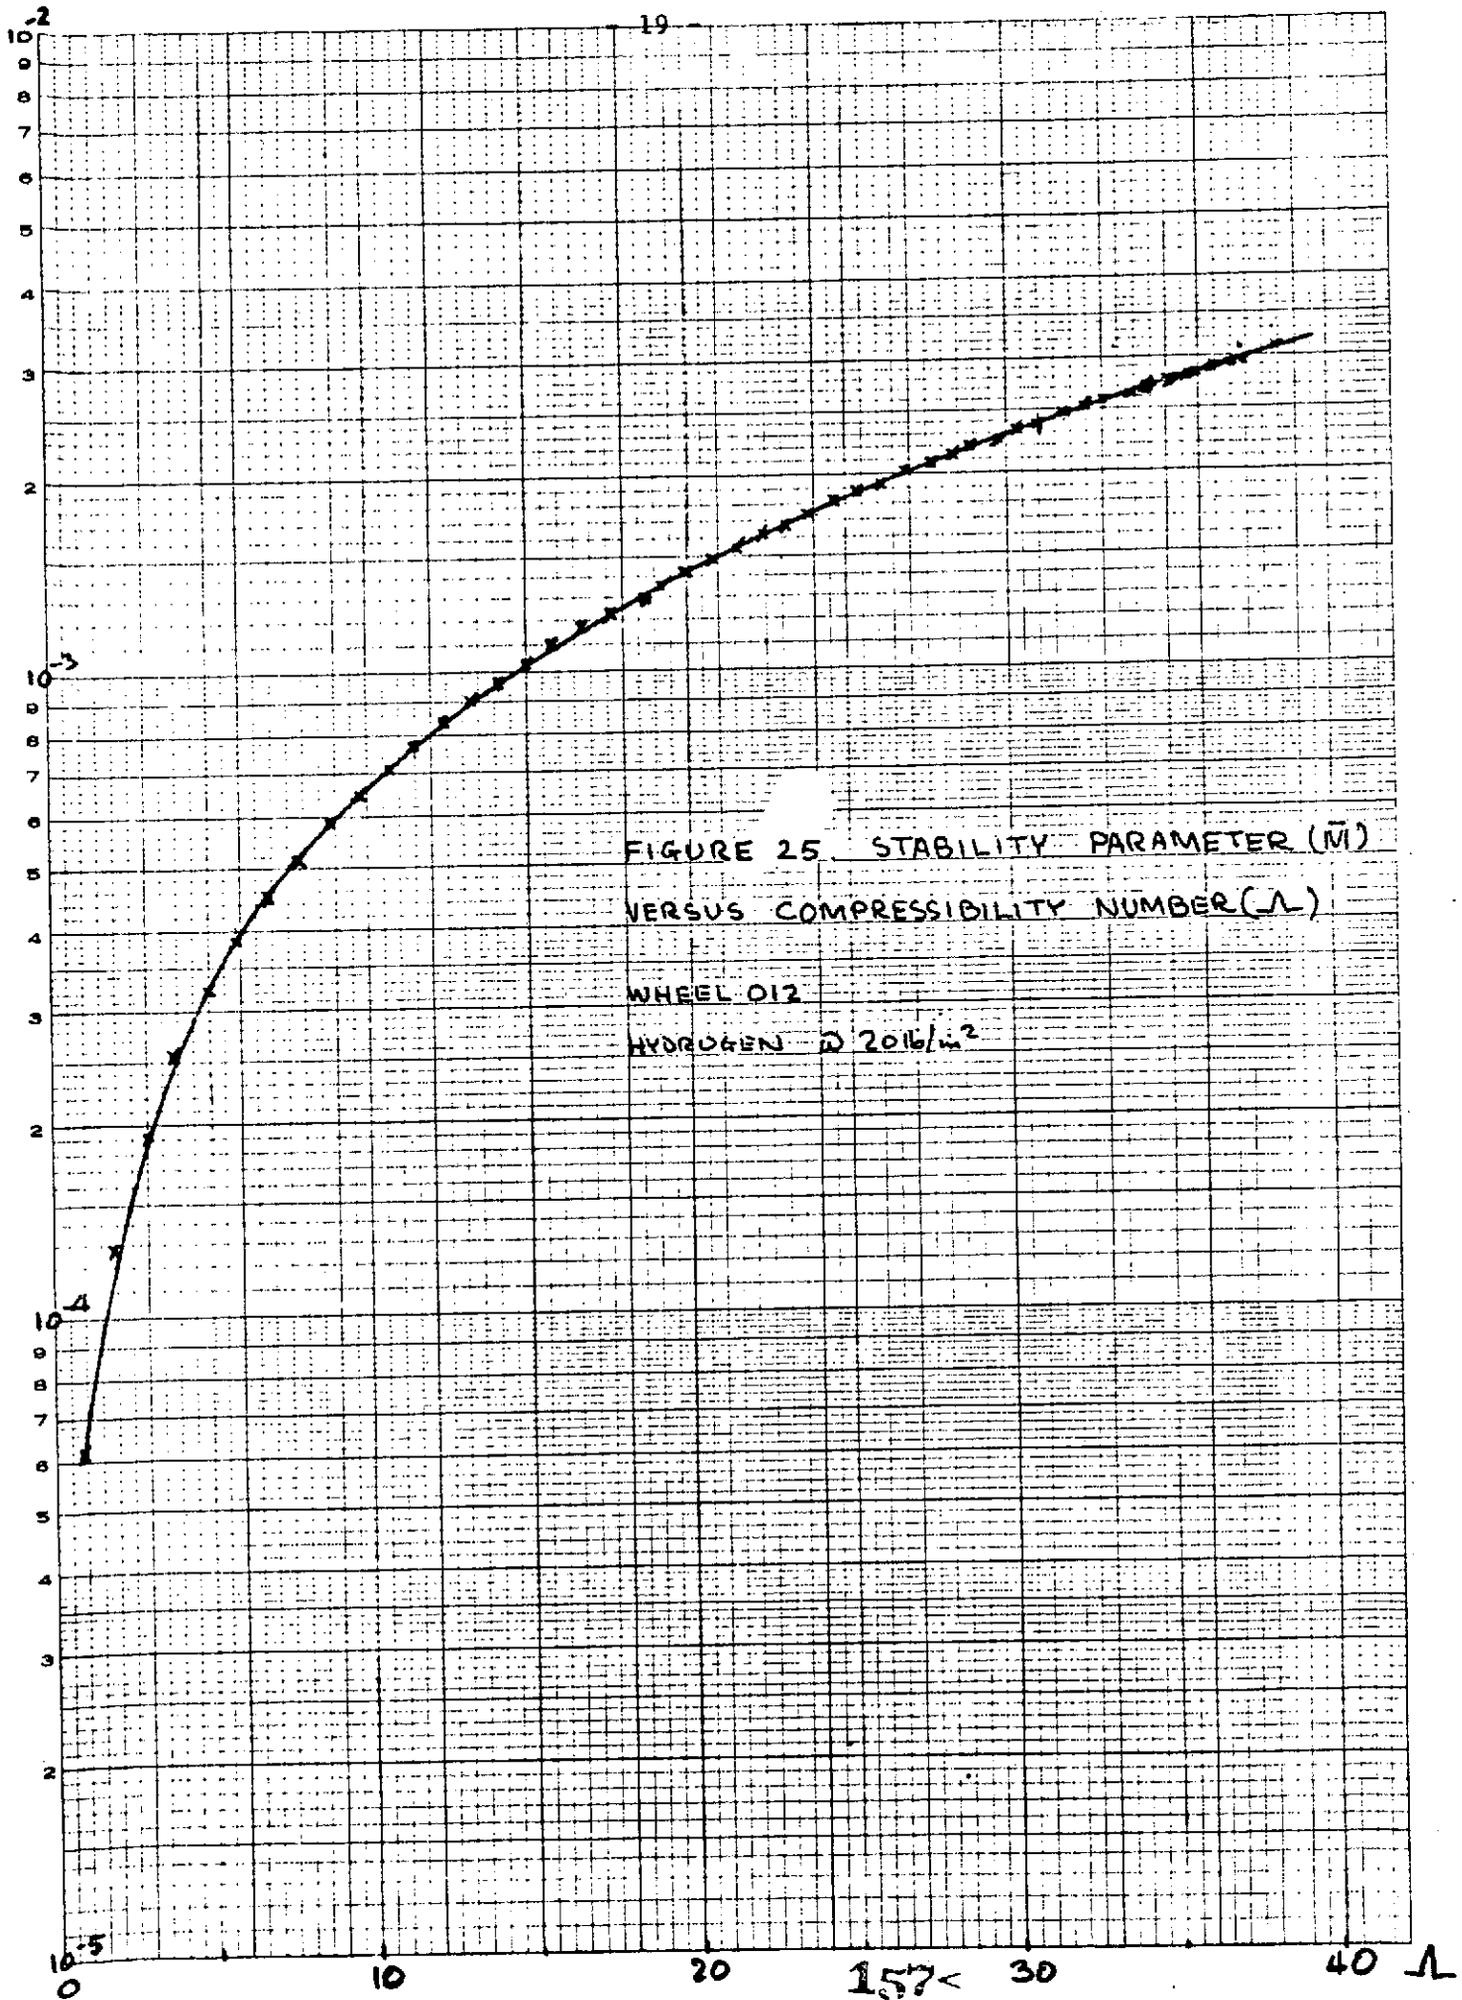
FIGURE 25. STABILITY PARAMETER ( $M$ )  
VERSUS COMPRESSIBILITY NUMBER ( $\Lambda$ )

It is possible, but not very probable, that wheel failure was initiated by a hydrodynamic instability (such as conical whirl). This could have led to a high speed touchdown in the bores. It is possible that the wheel could have a fair stability margin at 24 K rpm in air and yet be unstable at 32 K rpm in hydrogen. To check this possibility, the stability parameter ( $\bar{M}$ ) was checked for a range of compressibility numbers for the running conditions and actual geometry of wheel 012 (see figure 25). Comparing these results with the critical mass parameters for whirl instability, given in reference 8, it can be seen that

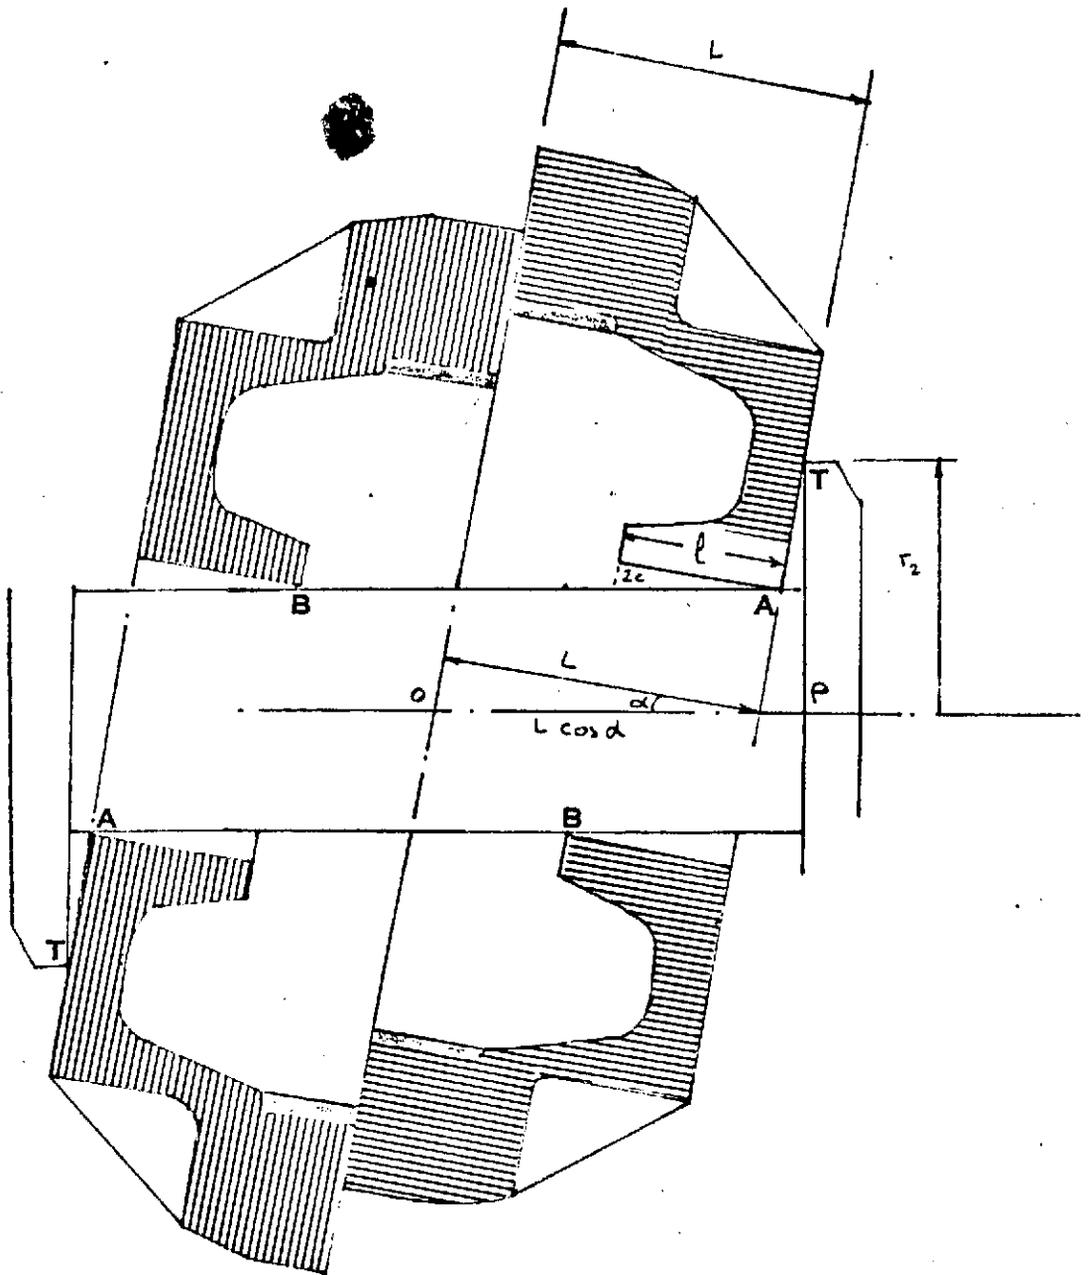
FIGURE 26. MISALIGNMENT OF GAS BEARING

It is most unlikely that simultaneous failure occurred at both the inside and outside diameters. If failure occurred initially at the outside then a mechanism must be proposed that could lead to subsequent failure at the inside. This could occur, it is hypothesized, if failure on the outside had resulted in slip between the two interfaces of the rotor halves, as shown in figure 24. The consequence of this would be that the two rotor halves would touch in the shaft with sufficient velocity to initiate cracking on the inside. The fact that the cracks occurred at the points A (figure 26) but not at B can be explained by the thicker section which exists at B. It can be shown (Appendix A) that the

wheel will touchdown on the shaft first, assuming that it is running centrally located between the two thrust plates. This does not, of course, preclude touchdown on the thrust surface at one end as a result of impact on the journal.

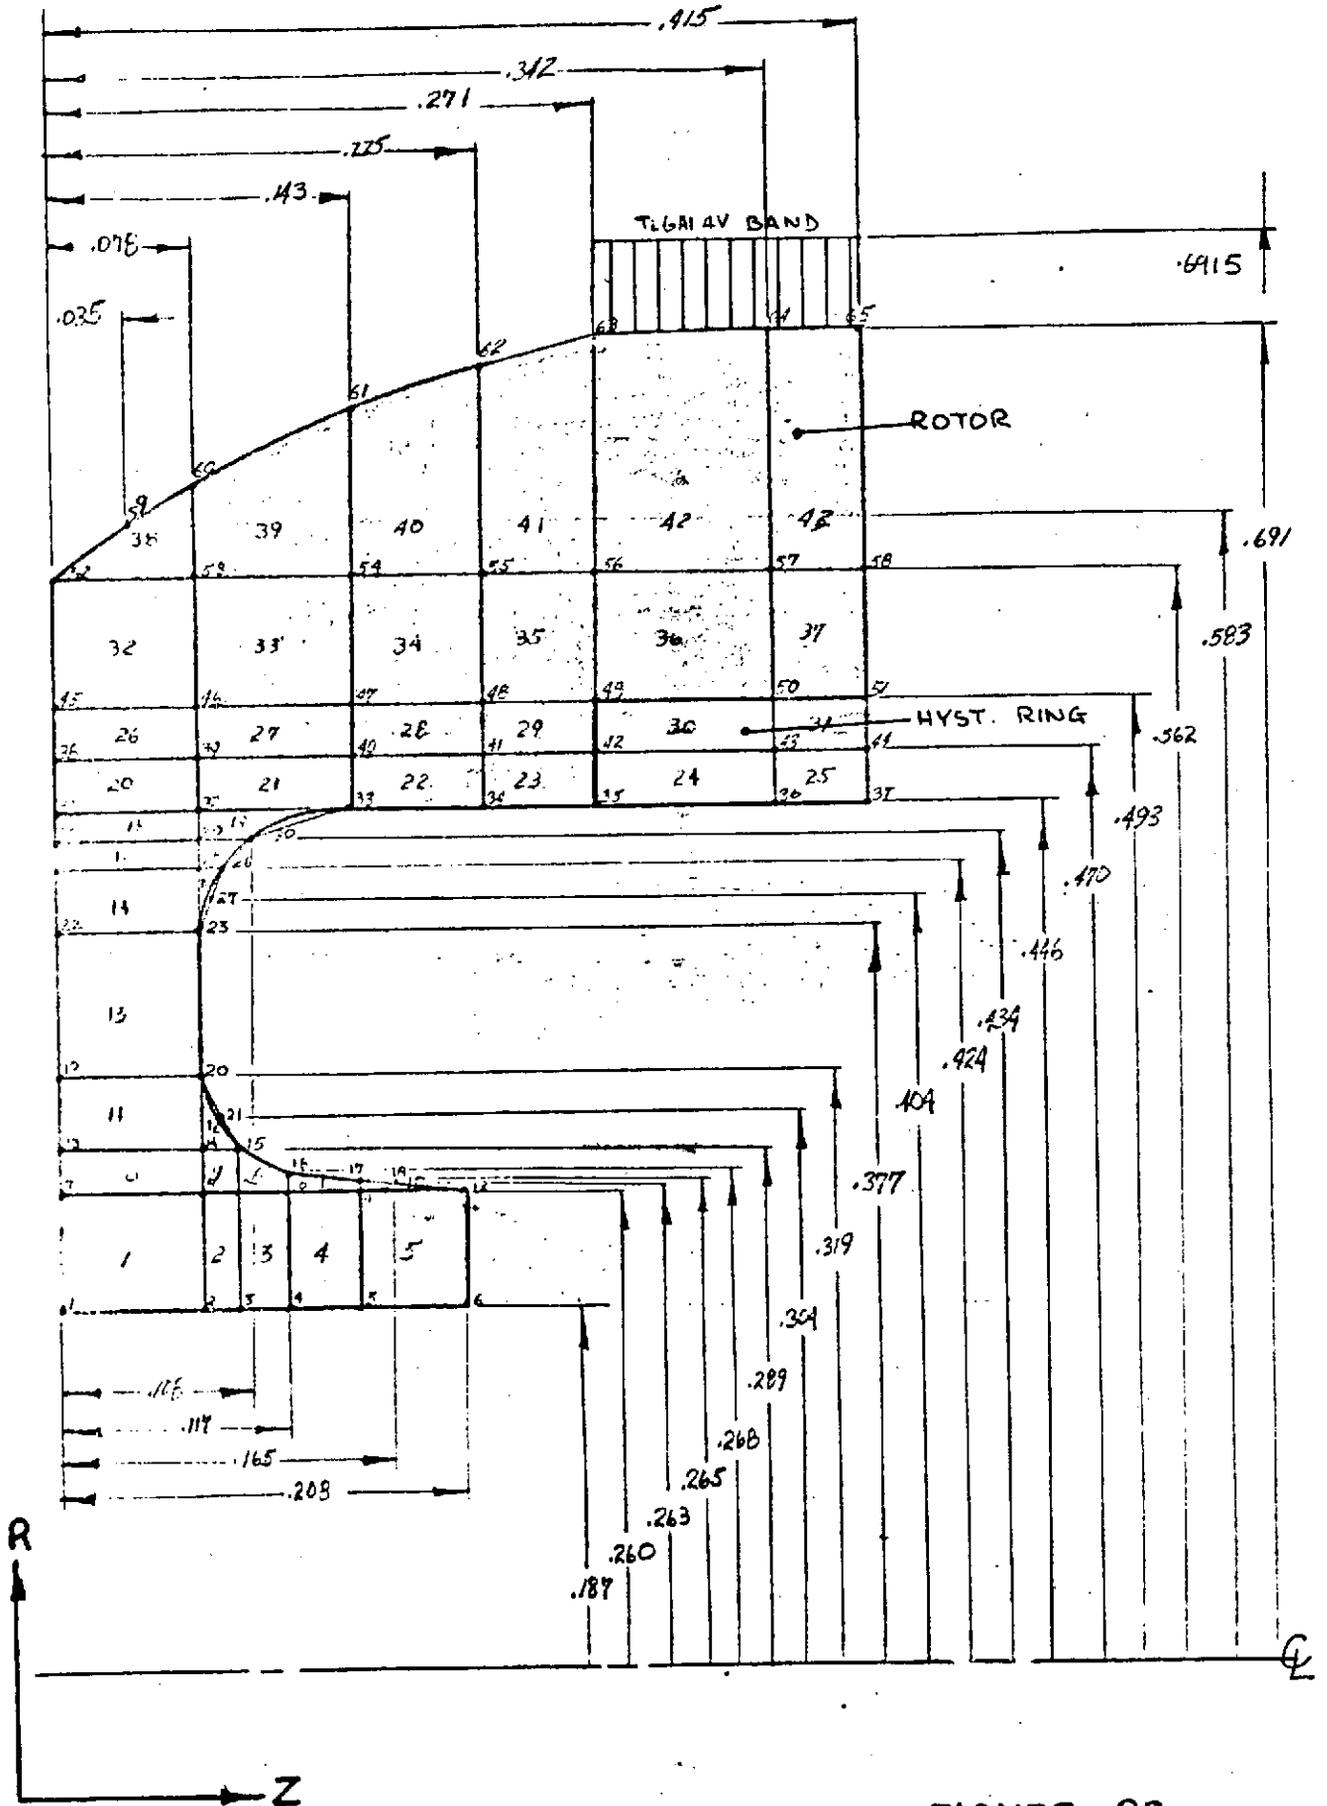
# RI1170 ROTOR HALF STRESS MODEL

Considering the rotor half stress model, as shown in figure 29, initially without the Ti 6Al 4V band, the stresses in elements 38, 39, and 40 (outside) and elements 3, 4, and 5 (inside) are of interest. As shown in Table 2 and figures 19 and 20 the radial stresses are  $616 \text{ lbs/in}^2$  and  $290 \text{ lbs/in}^2$  at the I.D. and O.D. respectively. The tangential stresses are  $2050 \text{ lb/in}^2$  at the O.D. rising to  $4117 \text{ lbs/in}^2$  at the I.D.

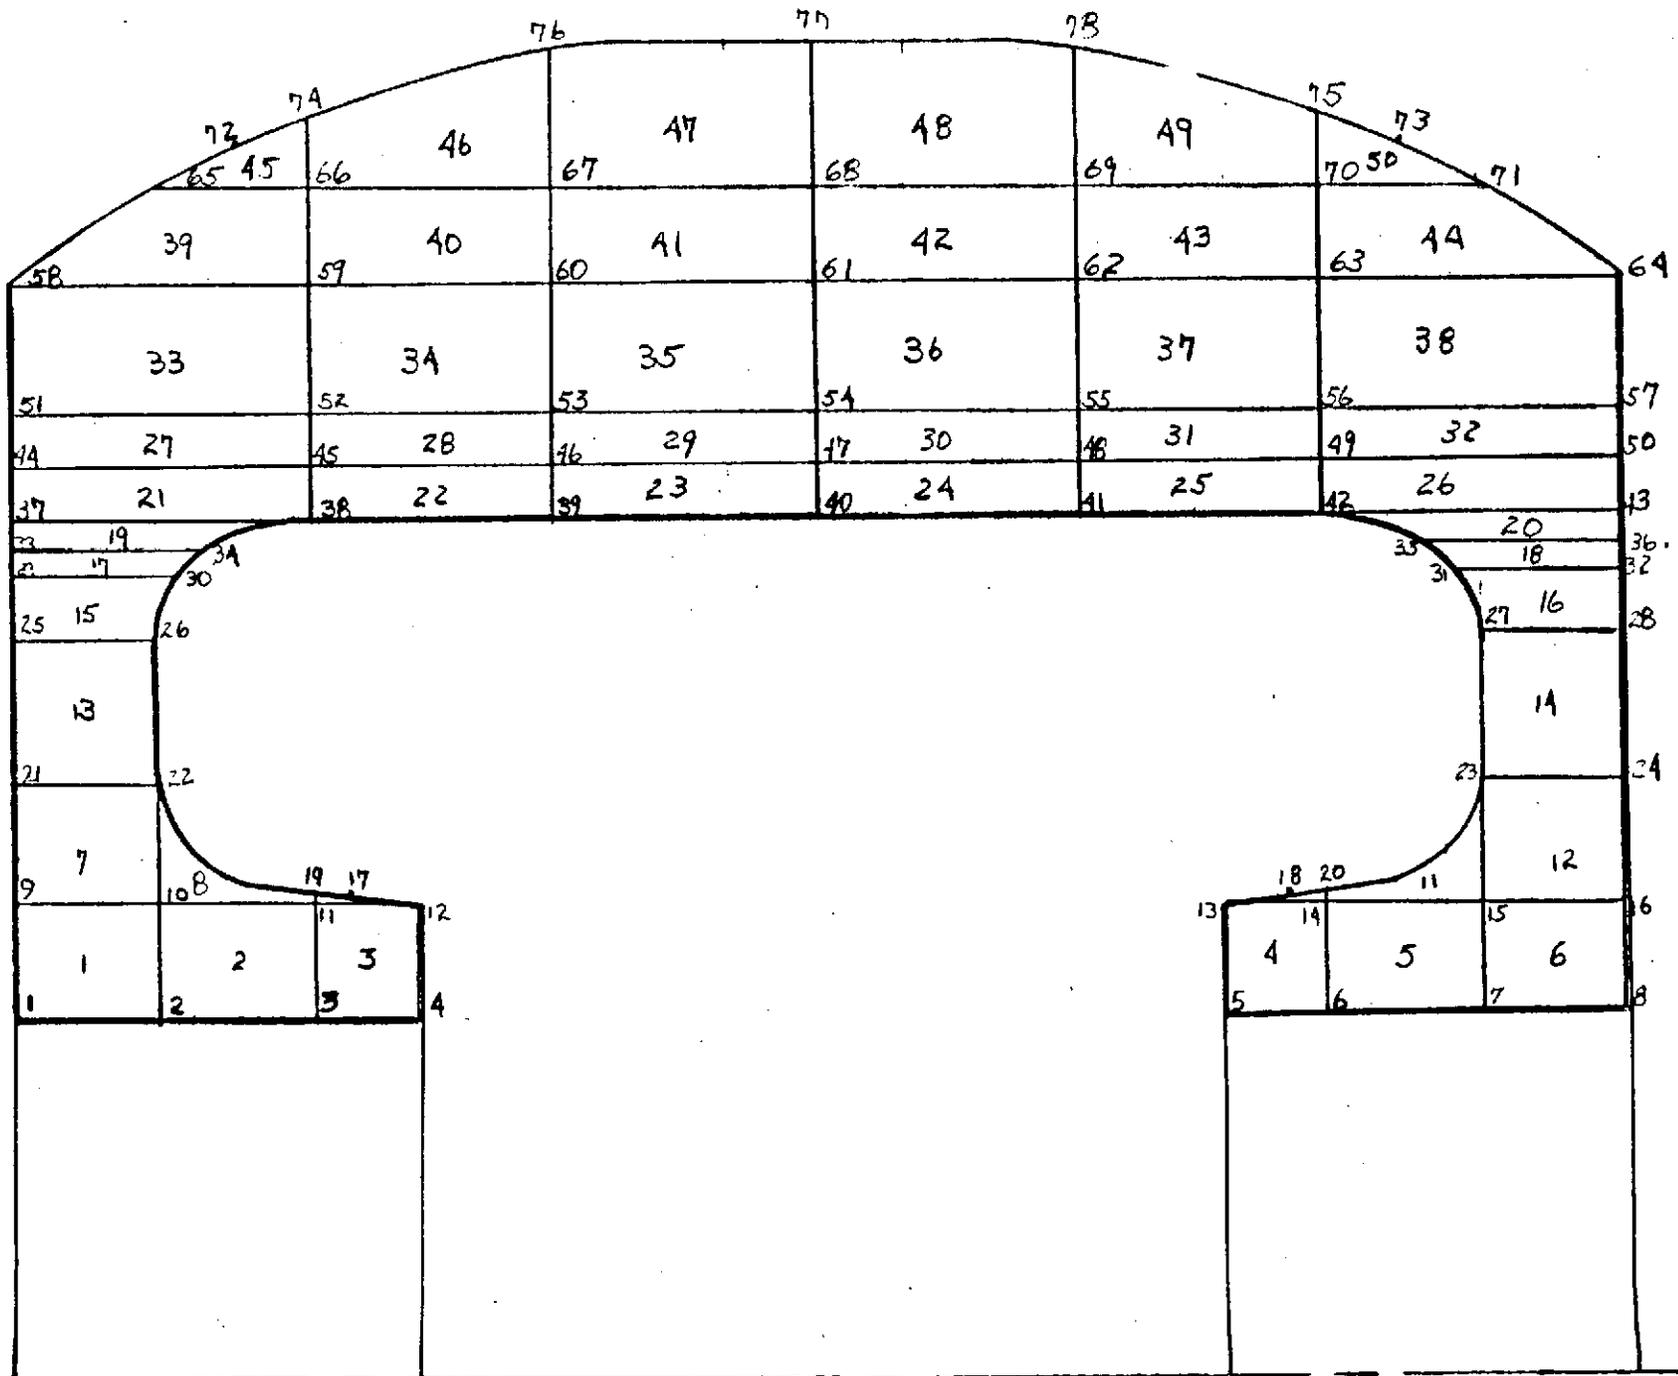
FIGURE 31. FINITE ELEMENT MODEL TO EVALUATE INTERFACIAL PRESSURES 168

A comprehensive stress analysis of the gas bearing assembly was done using both conventional and finite element techniques (reference 1). However, in view of the wheel failure, it was felt to be necessary to repeat the wheel calculations using more conservative calculations where necessary.

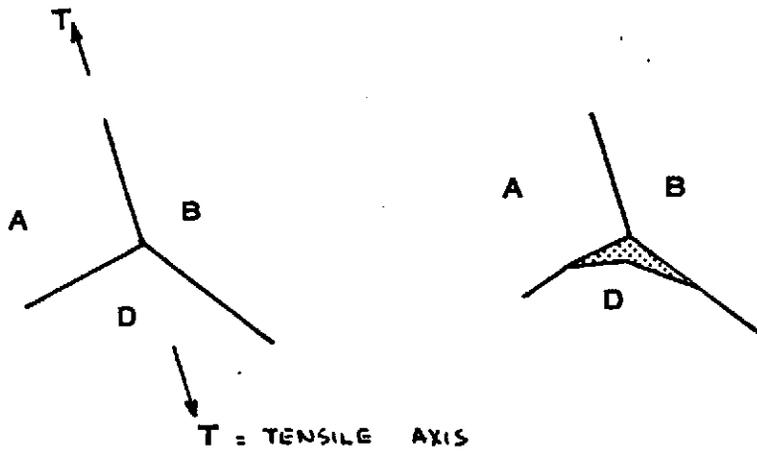
FIGURE 35 FORMATION OF CRACK IN BCC MATERIAL

Of special interest are the Y shaped cracks close to the bores. In BCC materials, cracks of this type can result from successive intersections of deformation twins (see figure 35). A similar mechanism occurs in high temperature creep tests, where some of the deformation is caused by sliding along grain boundaries. In this case a crack forms at a grain boundary which is normal to the applied tensile stress and intersects two other grain boundaries along which some sliding has already occurred. HCP ceramics such as  $Al_2O_3$  have an extremely complex structure which results in an insufficient number of independent slip systems for general deformation. However, it is suggested that a high energy impulse could propagate a crack along the TT axis (figure 35) in an intergranular fashion up to the triple point. Here two other grain boundaries would make it energetically favorable to split into the "Y" configuration.
