NASA CR-134384

Final Report

# Firefighter's Compressed Air Breathing System Pressure Vessel Development Program

MARTIN MARIETTA CORPORATION  
P. O. Box 179  
Denver, Colorado 80201

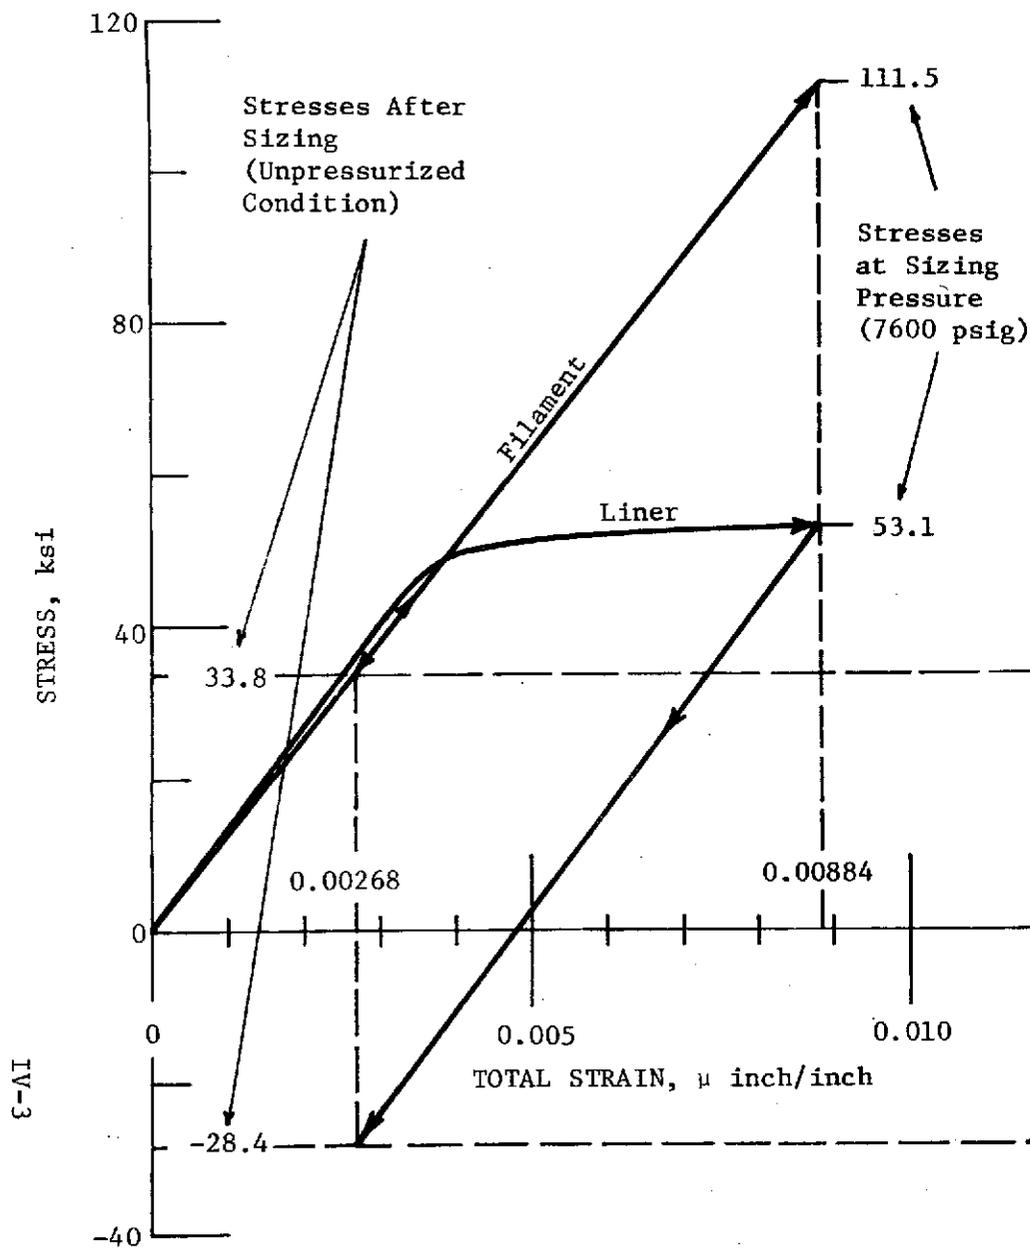
Figure IV-1(a) Sizing Cycle Stress Behavior for Liner and Fiberglass Filament

The concept of sizing and its effect upon operating stress levels for the FBS design is shown graphically in Figures IV-1(a) and IV-1(b). These figures show the stress levels attained in the liner and fiberglass filaments in the cylindrical section of the vessel (hoop direction) when the overwrapped vessel is subjected to a sizing pressure (immediately after fabrication) and the subsequent operating cyclic stress range of these structural components during normal operation of the vessel. Note, that the liner is forced into compression during sizing and is thereafter constrained by the overwrap material to operate in an increased elastic strain range extending from compression (-28.4 ksi) in the unpressurized condition to tension (+19.9 ksi) at the maximum operating pressure of 4500 psig.

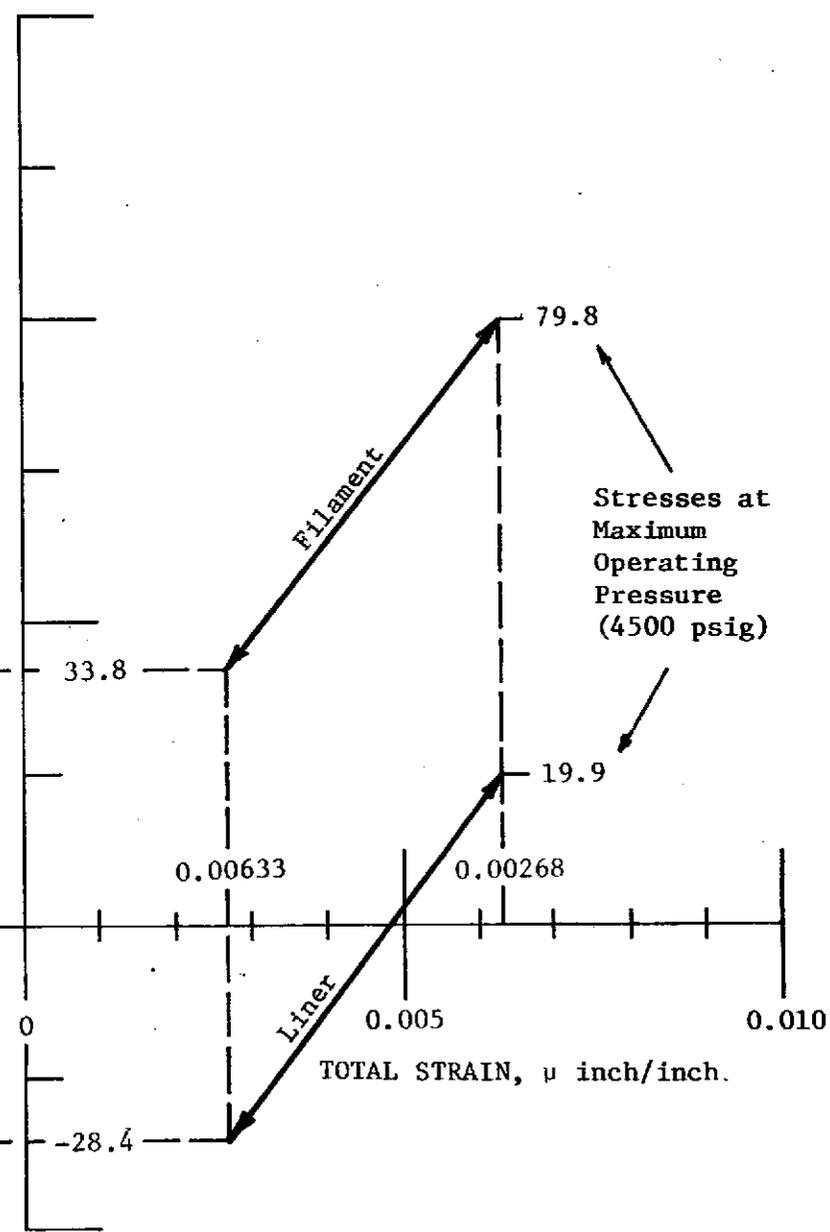
Figure IV-1(b) Operating Stress Range for Liner and Fiberglass Filament (Post-Sizing)

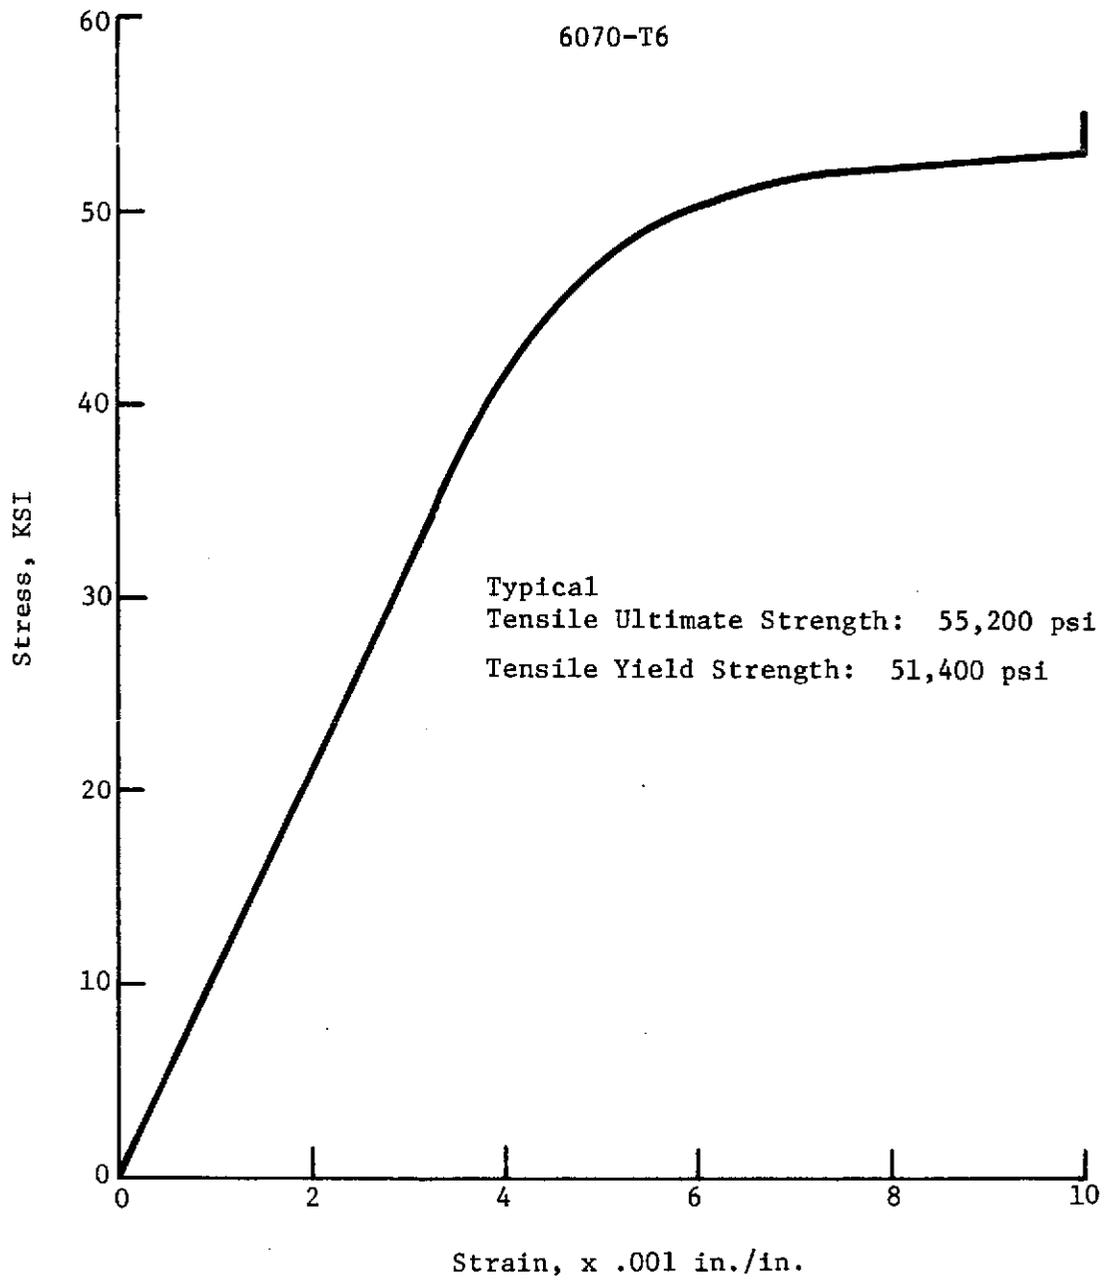
Figure IV-2 Typical Stress-Strain Curve for 6070-T6 Aluminum

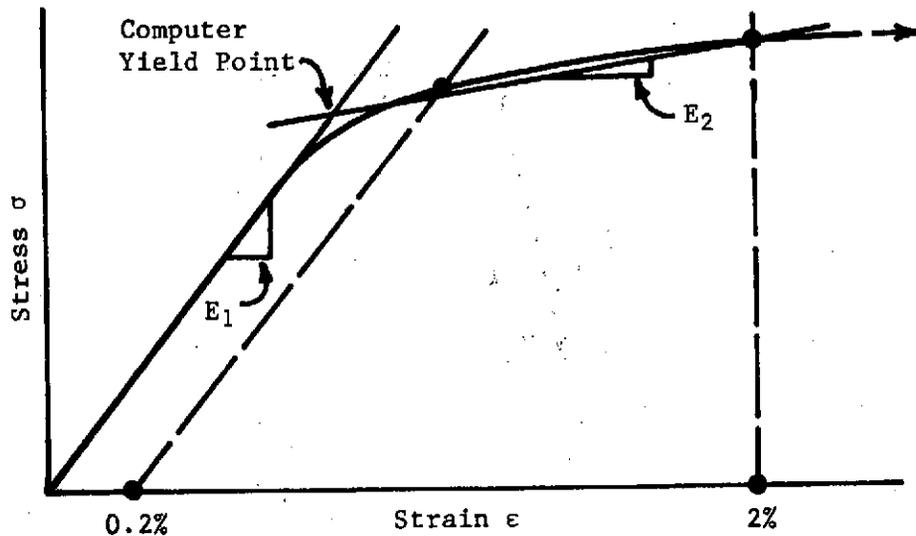
Figure IV-3 Bilinear Approximation of Stress-Strain Curve

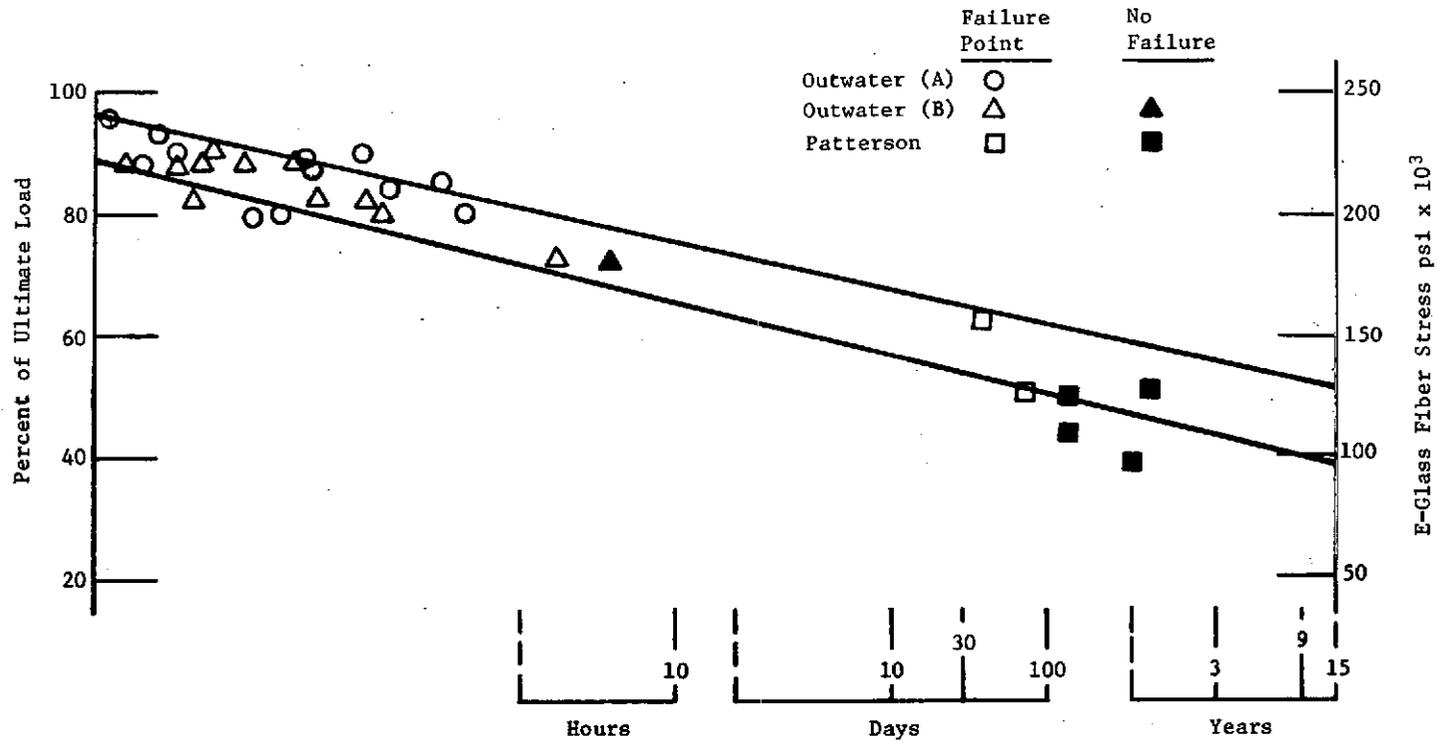
Figure IV-4 Static Fatigue Behavior of E-Glass Fiber-Overwrapped Pressure Vessels in an Environment

NOL ring tensile test data for our selected S-2 fiber glass and epoxy resin system (Chapter III.B) showed a fiber strength level of 300 ksi. Extrapolation of this data in Figure IV-3 shows only 40% strength retention after 15 years. This would produce failure at a fiber strength level of 120 ksi. Some degree of uncertainty must be placed upon such a procedure, thus a design stress level of 80,000 psi was selected as the maximum allowable fiber stress at operating, 4000 psig, vessel pressure or 88,000 psi at the maximum operating pressure--4500 psig.

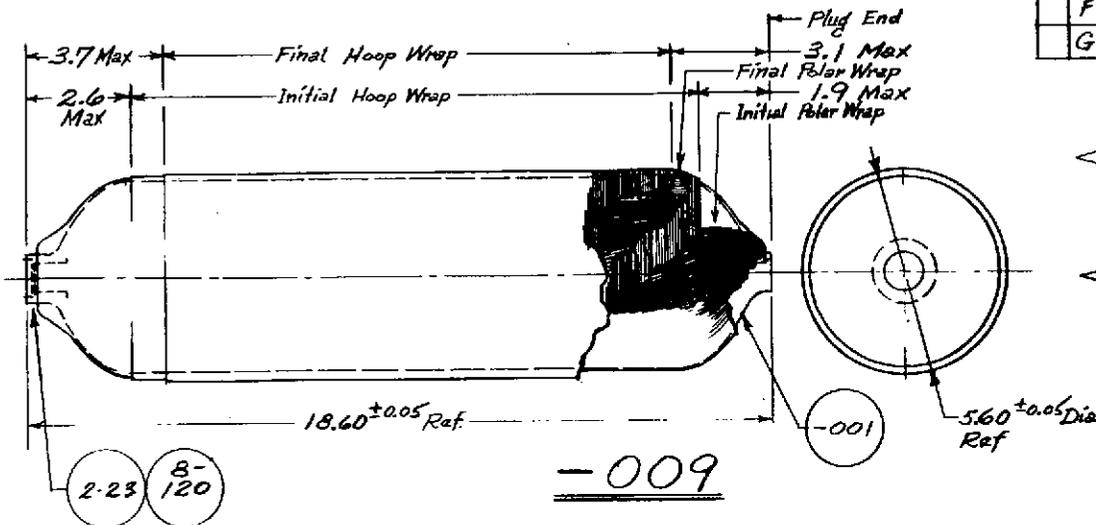
Figure VI-5 Pressure Vessel Design Drawing

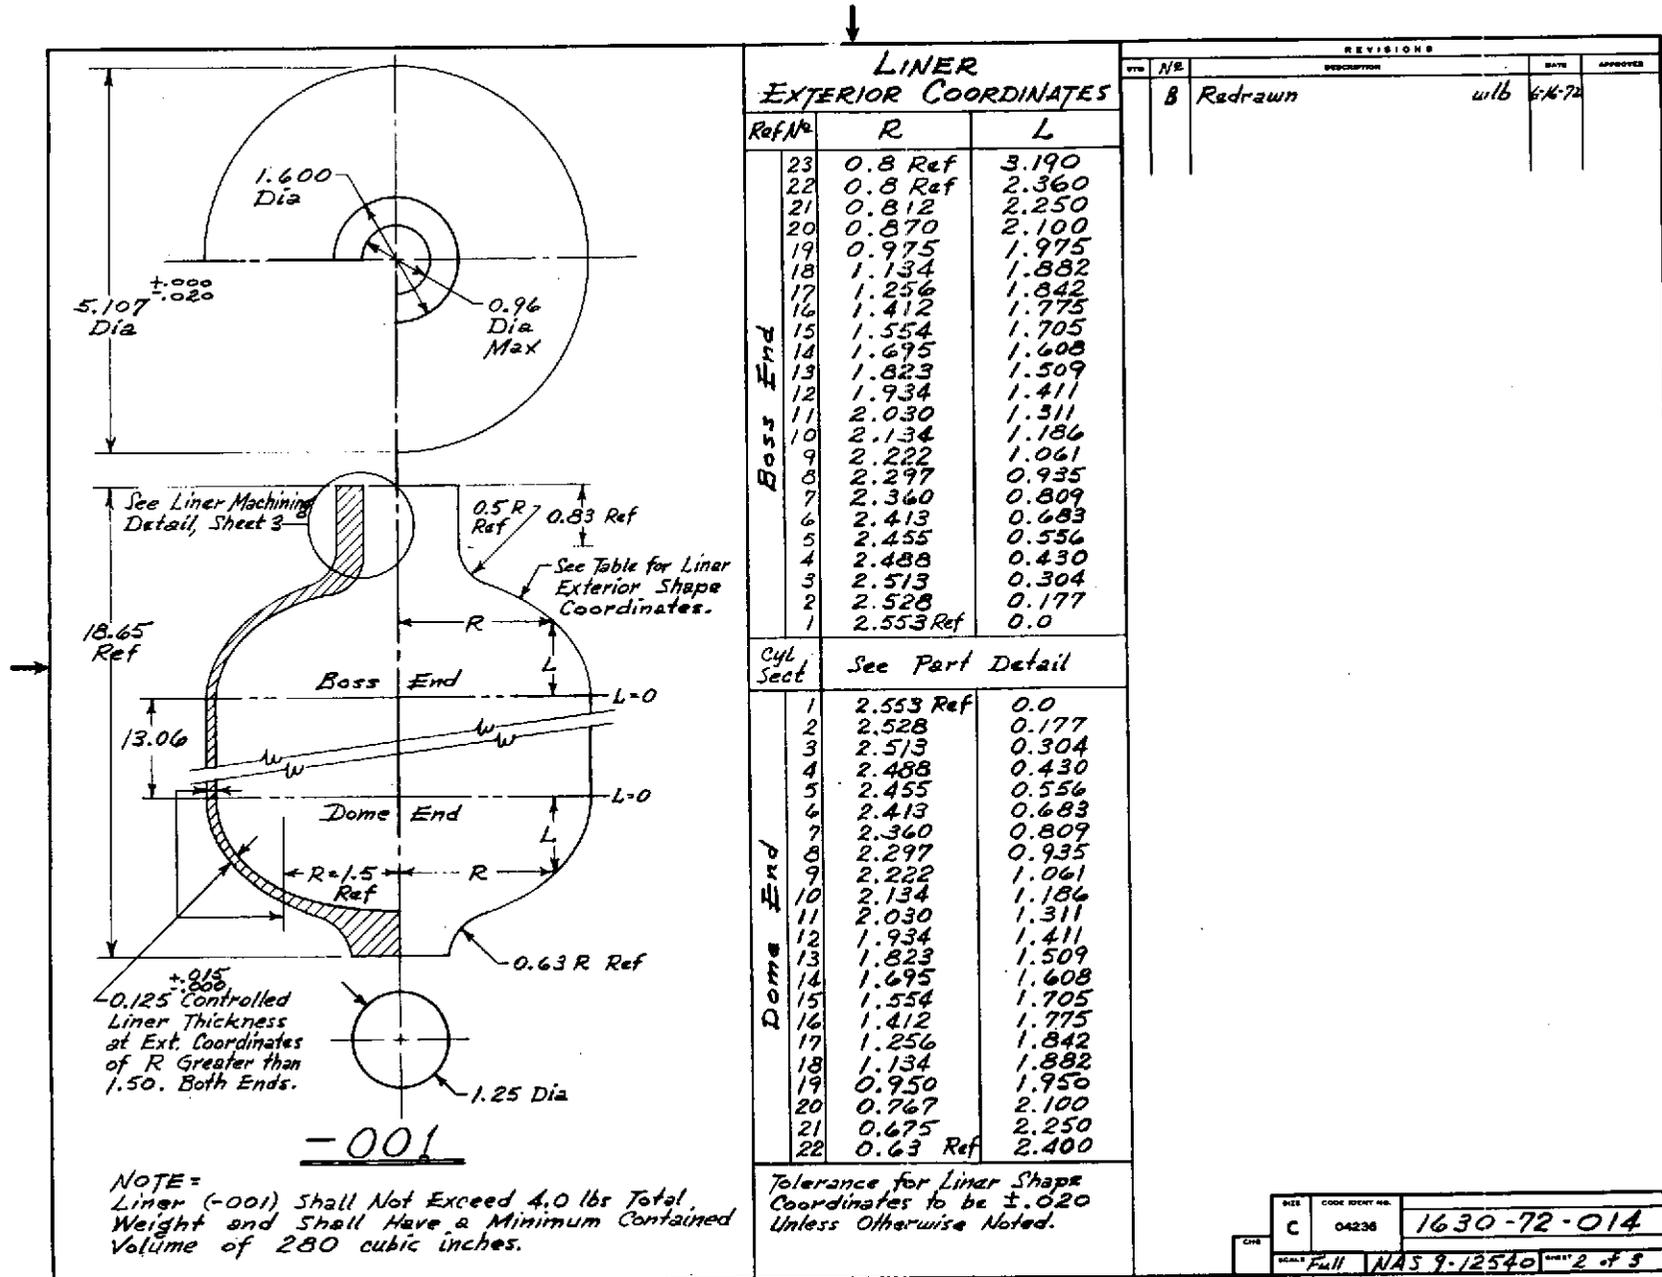
Figure VI-6 Liner Detail Drawing

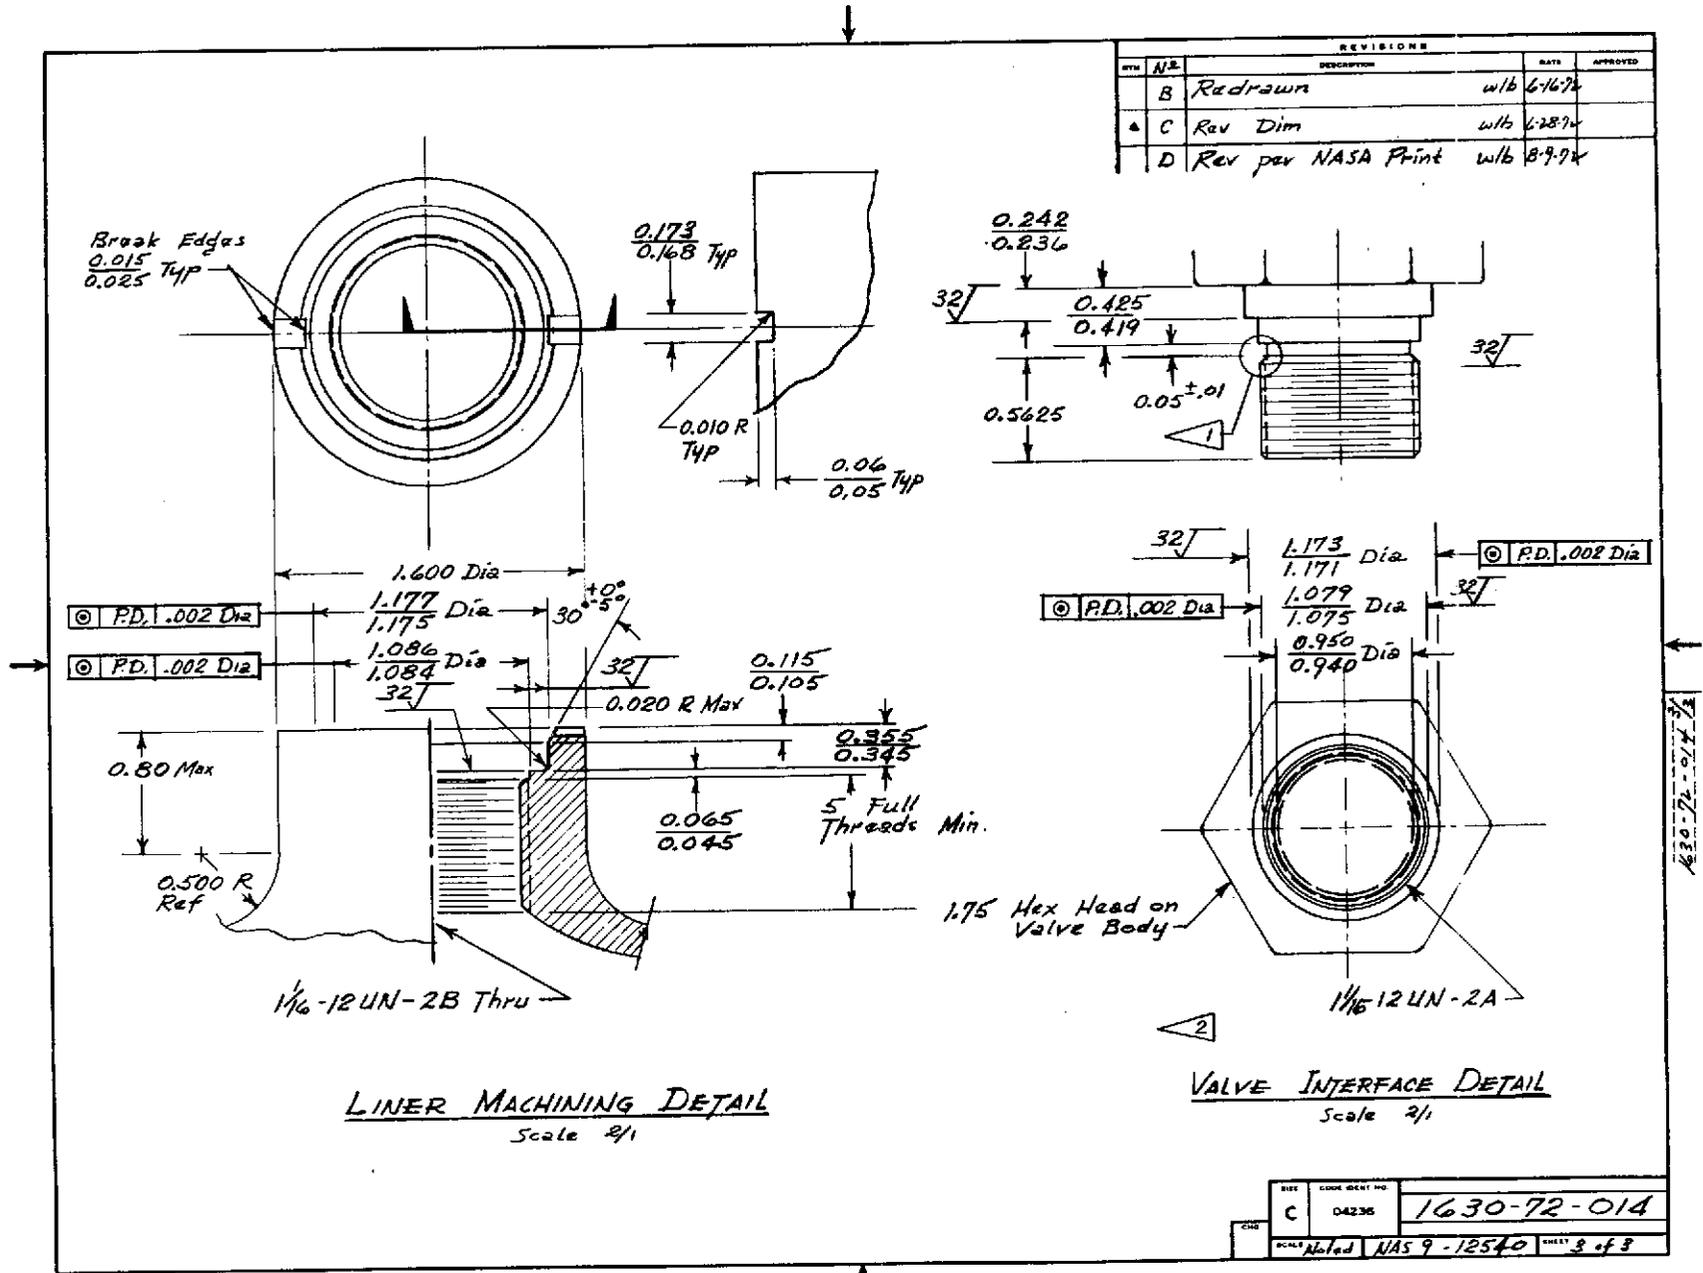
Figure VI-7 Boss End Detail

Severe mechanical test requirements for the pressure vessel forced development of an end-plug/valve body design which would protect the liner outlet boss in service. A wide flange on the end-plug/valve body prevents accidental bending or damage to the lip of the outlet boss in service and puts that portion of outlet boss above the threads in slight axial compression (after tightening the end-plug to 30 or 40 ft-lb torque). A lock-tab washer is used to anchor the assembly after tightening.

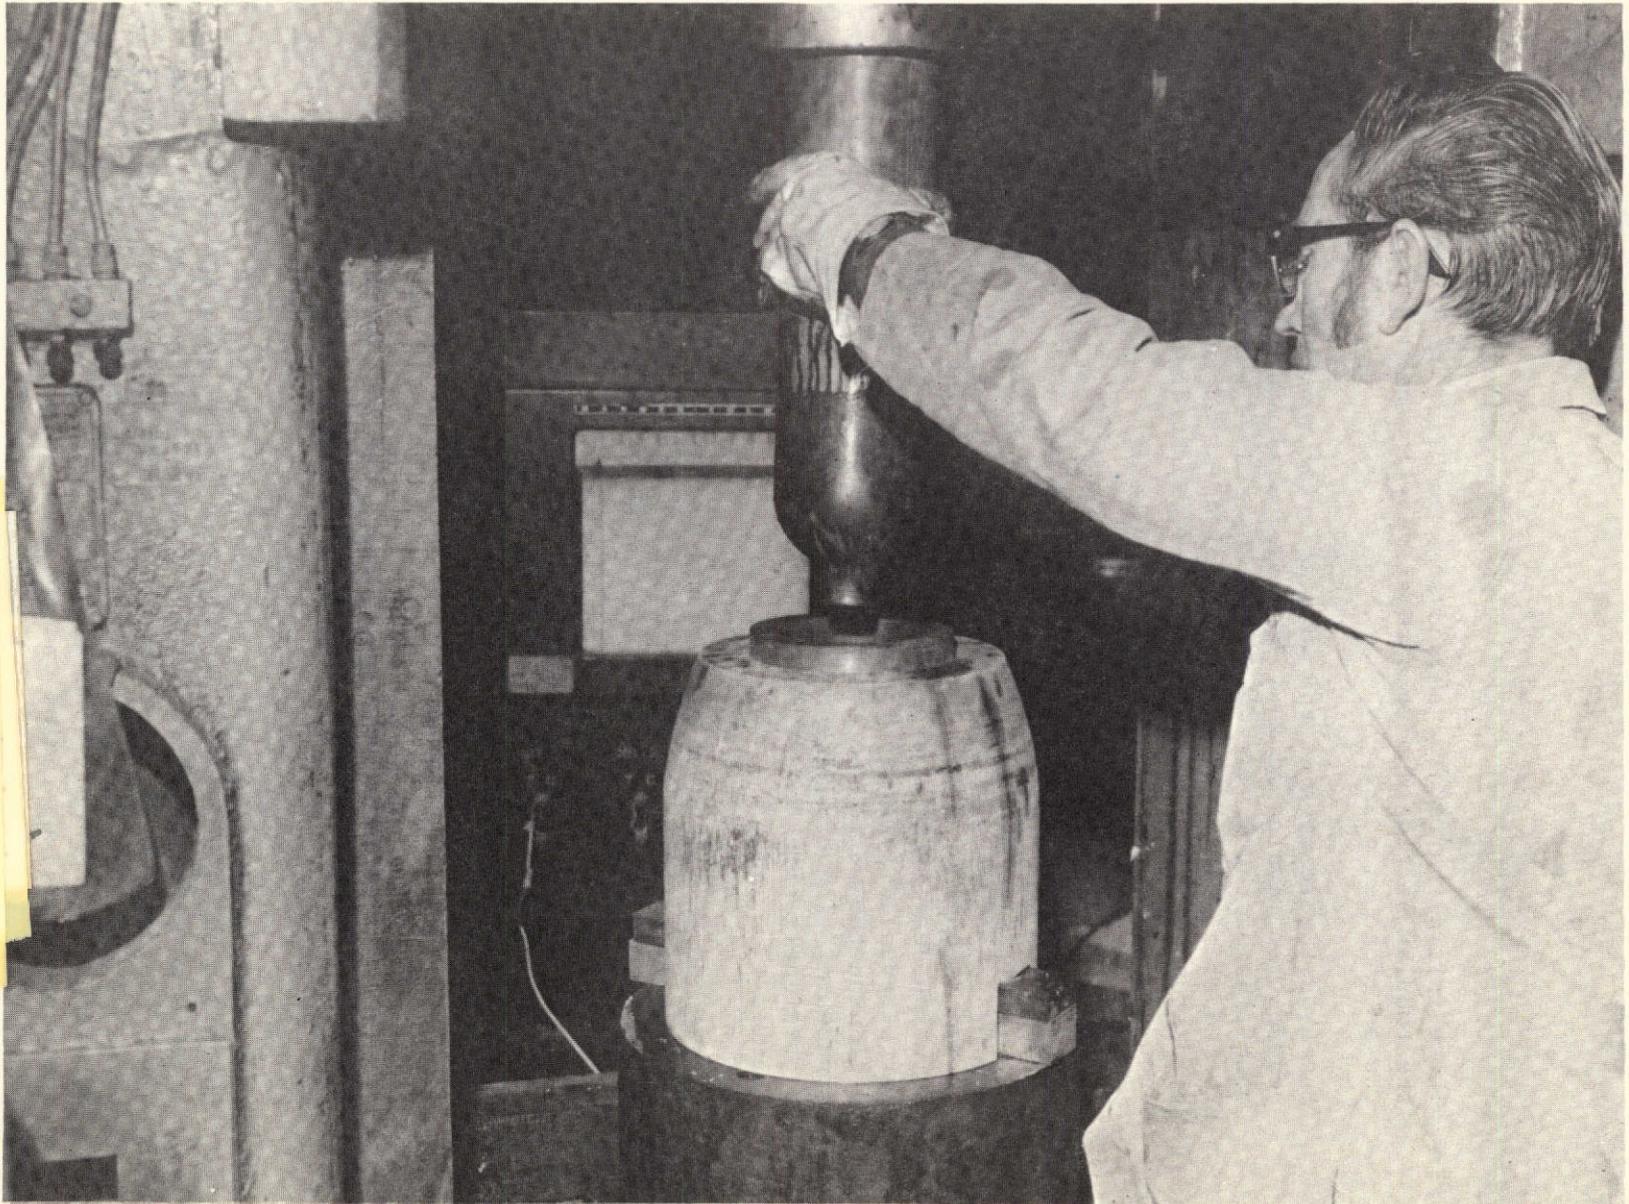
*Figure V-1 Hot Die Neck Forming Operation*

The original lot of parts produced, and subsequently shipped to Martin Marietta's Denver division for evaluation, consisted of neck forging in a "one-pass" hot die operation with the extruded blank in the as-impacted condition. After heat treatment to the final temper representative parts were sectioned and examined for macrostructure and visual surface appearance in the heavily-reduced neck area. Although material in this area must gather causing a thickening of the wall during forming, these initial parts showed a heavy wrinkling condition of the I.D. of the part with some cracking at the root of the folds. This condition was attributed to the highly elongated, as-extruded grain structure present in the part during forming. The macrostructure in this area after heat treat showed a coarse recrystallized grain structure caused by the critical amount of work induced during the hot die-forming operation on the unrecrystallized grain structure of the as-extruded blank.

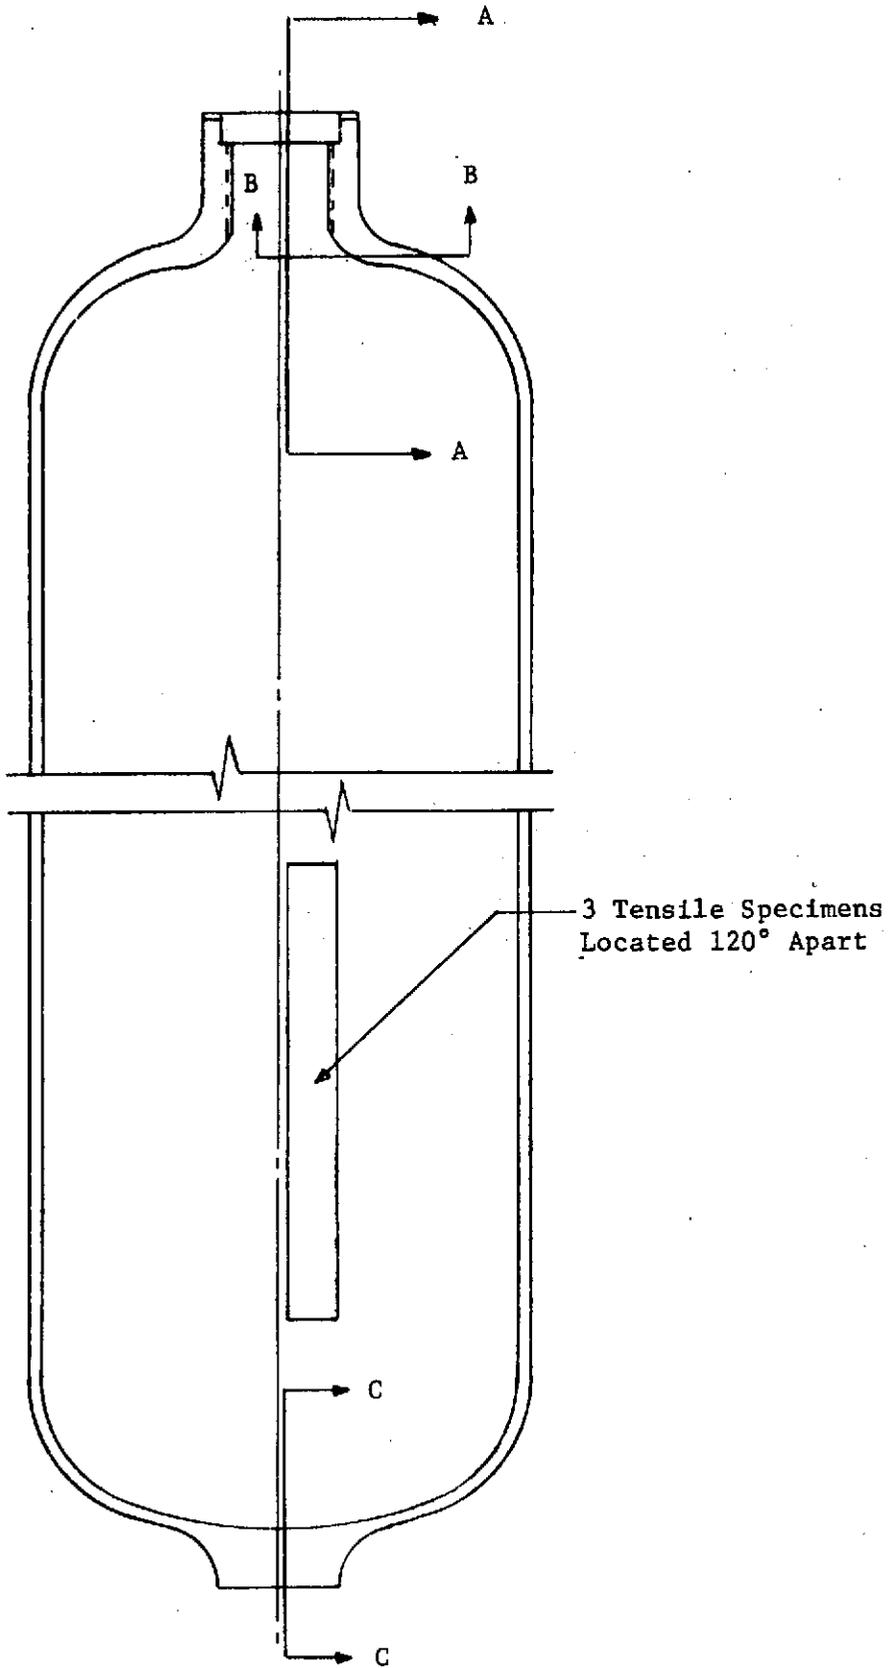
Figure V-2 Specimen Location for Mechanical-Property and Macrostructure Examination

(1) Specimens taken from tubular section 120° apart.

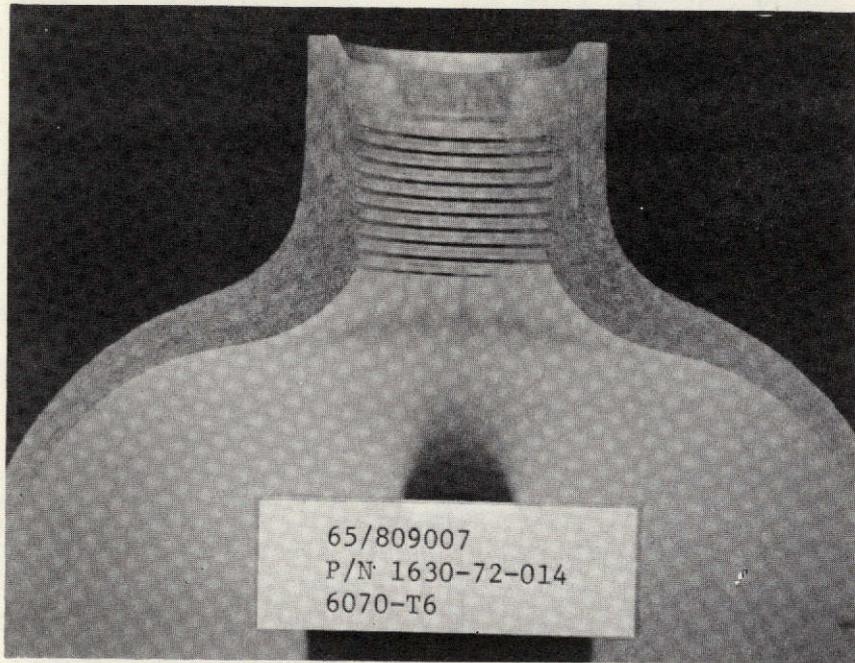
Figure V-3 Photomicrograph of Section A-A (Figure V-2) Showing Grain Flow Pattern in Neck Formed Area of Bottle, (Part Shows Relatively Fine Recrystallized Grain Structure Throughout Cross-Section.) Mag: IX Etch: Caustic

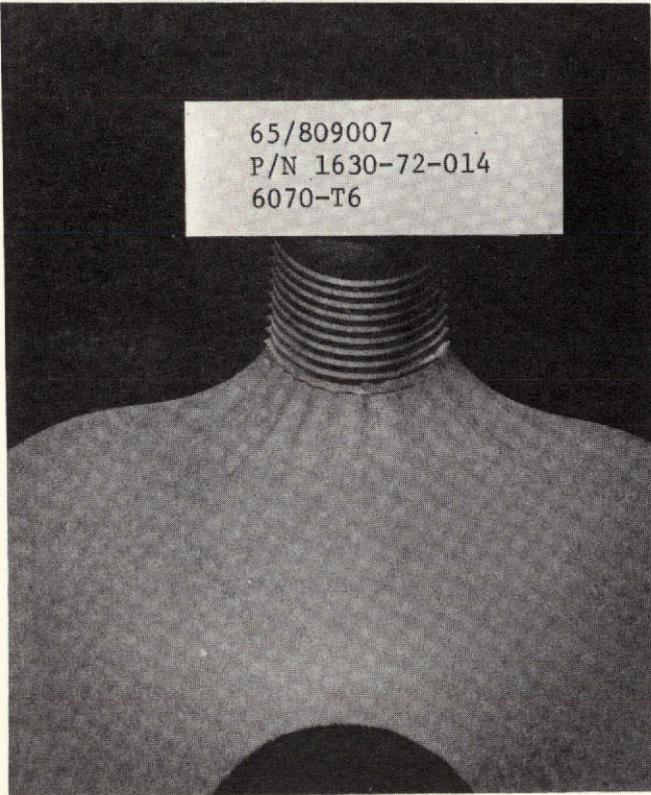
Figure V-4 Cross-Section of Inside of  
Bottle in Neck Formed Area  
Showing Slight Wrinkling  
where Material Gathered  
during Forming. Mag: IX  
Etch: Caustic

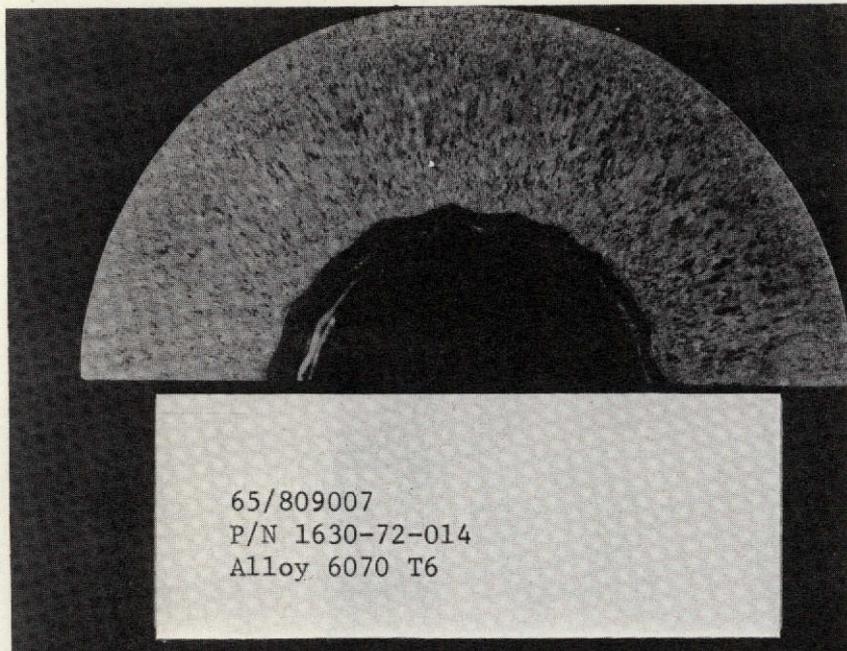
*Figure V-5 Transverse Macrostructure of Section B-B (Figure V-2) Showing Base of Neck Formed Area of Bottle (Wrinkles Due to Metal Gathering During Forming are Very Shallow and Show no Folds or Cracks.) Mag: 2X, Etch: Caustic*

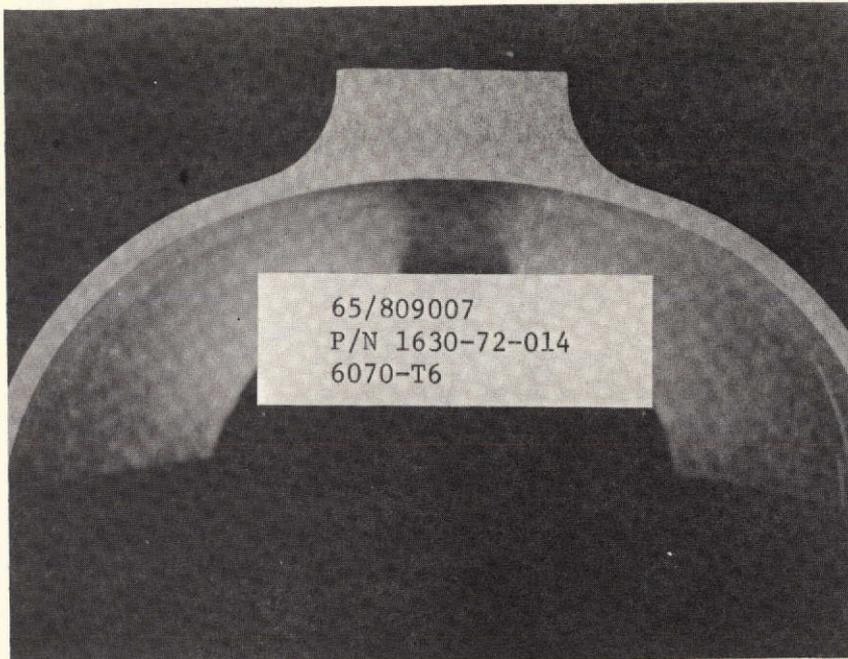
*Figure V-6 Macrostructure of Contour-Machined Base Area of Bottle-Section C-C of Figure V-2 (Cross-Section Shows Very Fine, Uniform Recrystallized Grain Structure) Mag: 1X, Etch: Caustic*

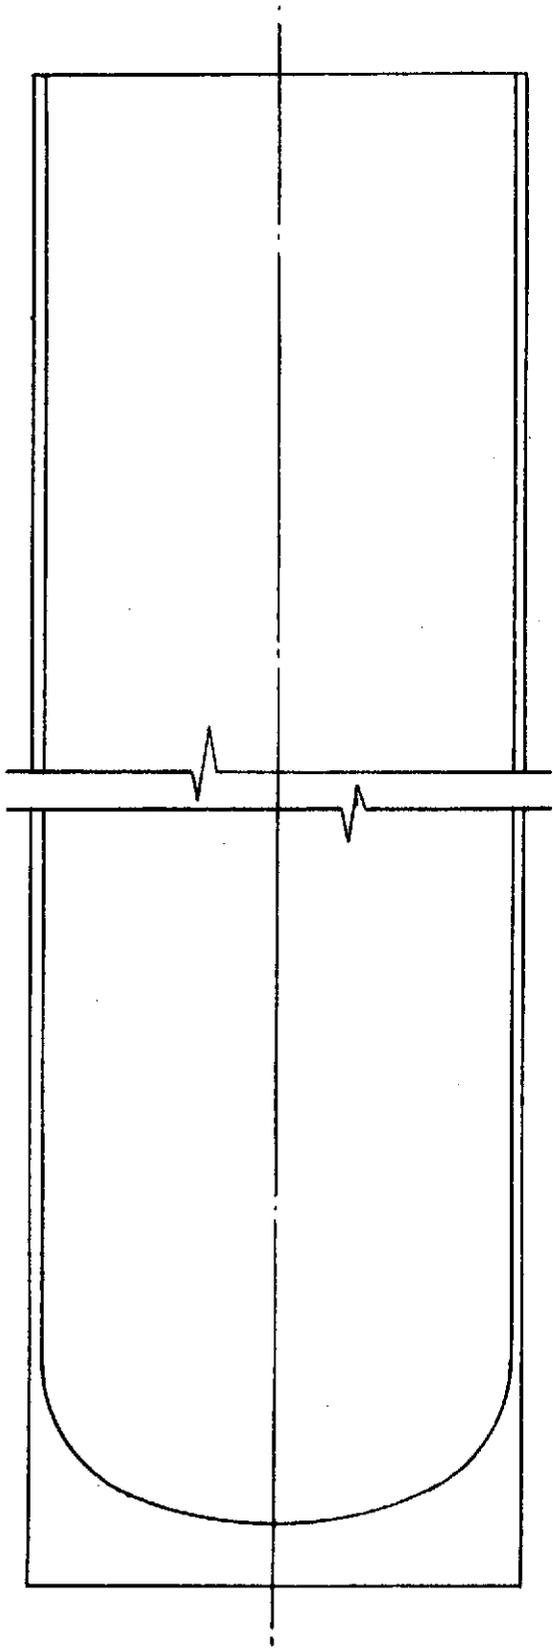
*Figure V-7 Impacted Tubular Blank*

<u>Process Sequence</u>	<u>Operation</u>
1.	Saw stock to required length.
2.	Face and machine corner radius of stock blank.
3.	Anneal stock blank per MIL-H-6088
4.	Clean and apply phosphate-bonderlube coating.
5.	Impact to tubular blank with solid base (See Figure V-7).
6.	Trim to length.
7.	Inspect for surface condition.
8.	Contour machine closed end (See Figure V-8).
9.	Heat treat and age to T6 temper per MIL-H-6088.
10.	First neck form operation - hot die (See Figure V-9).
11.	Final neck form operation - cold die (See Figure V-10)
12.	Re-heat treat and age to T6 temper per MIL-H-6088.
13.	Submit test sample to Laboratory for metallurgical testing and job release.
14.	Machine port end (See Figure V-11) and identify.
15.	Chemical clean.
16.	Inspect - visual, dimensional, weight and volume.

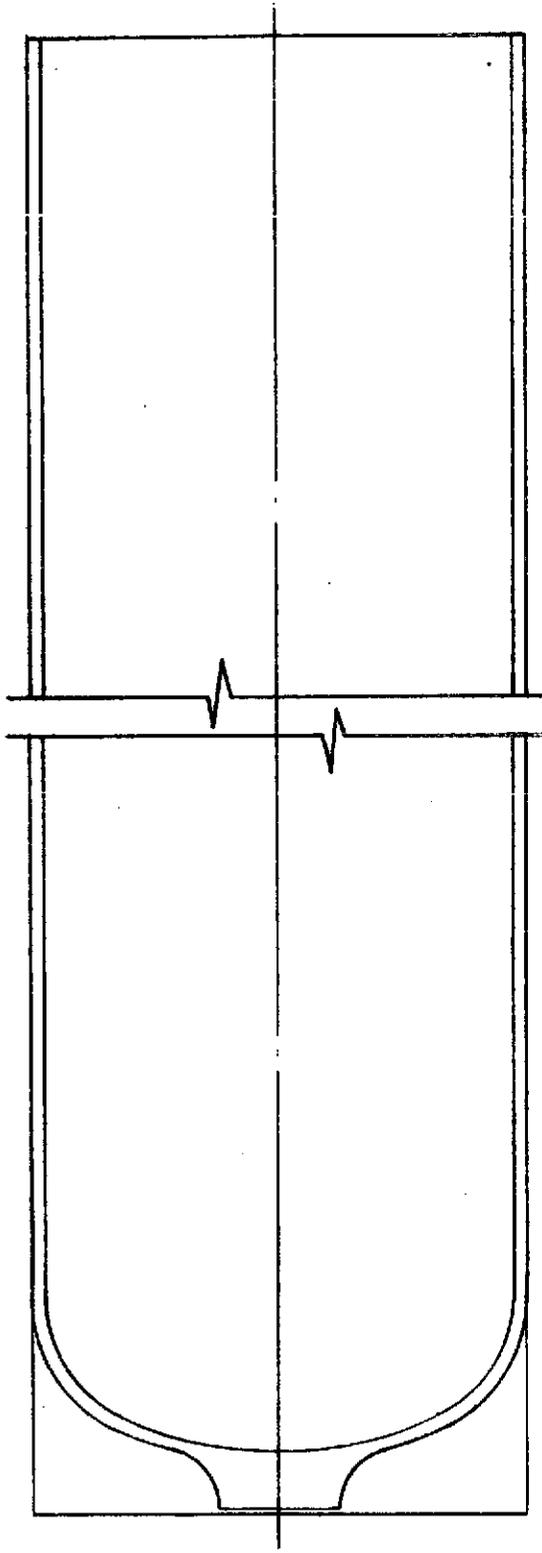
*Figure V-8 Contour-Machined Closed End*

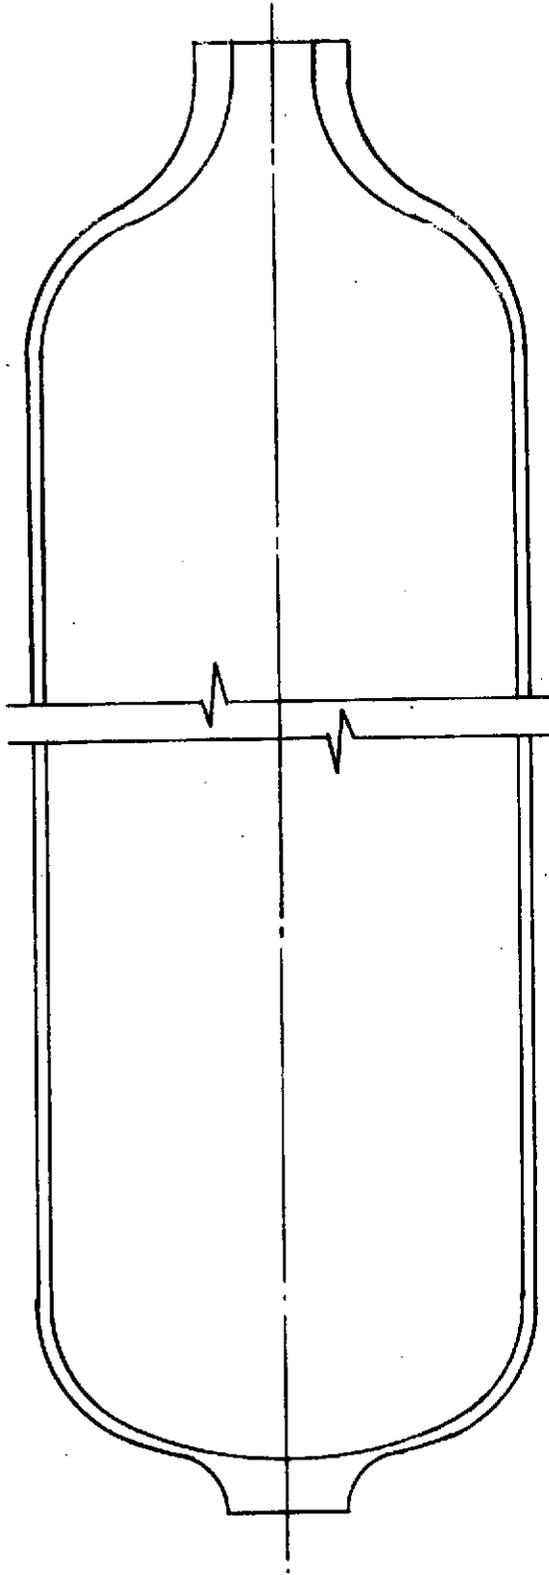
*Figure V-9 First Neck-Form Operation*

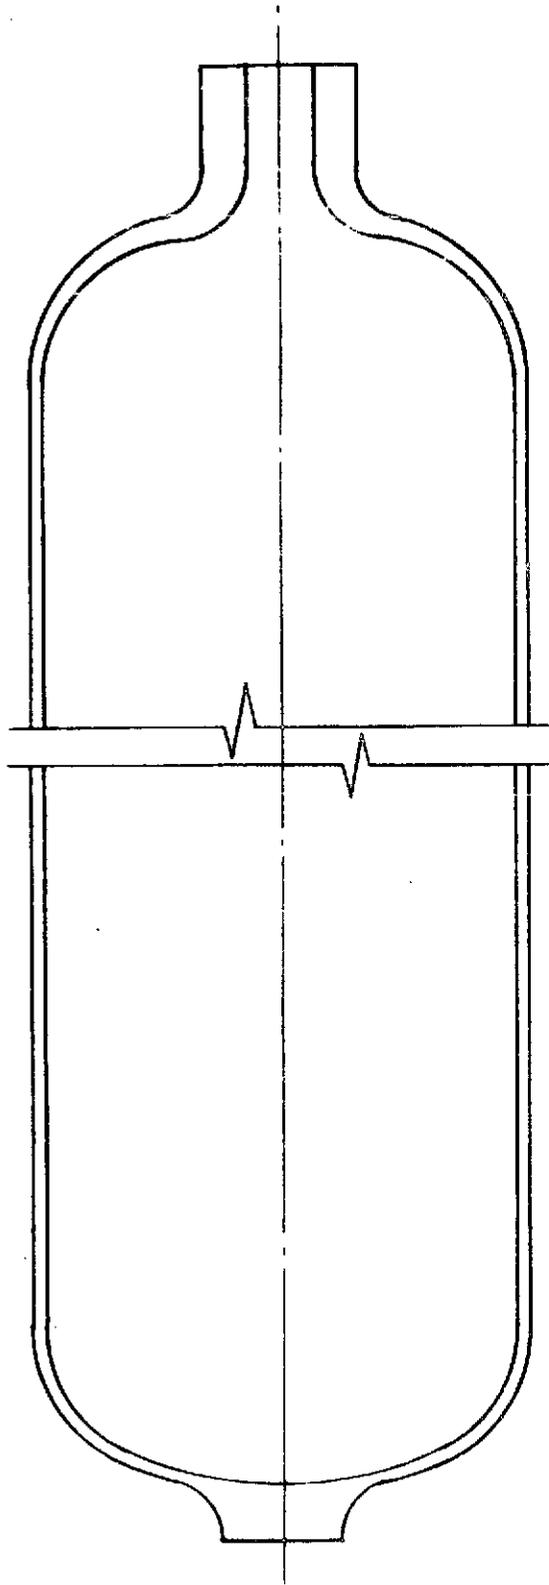
*Figure V-10 Final Neck-Form Operation*

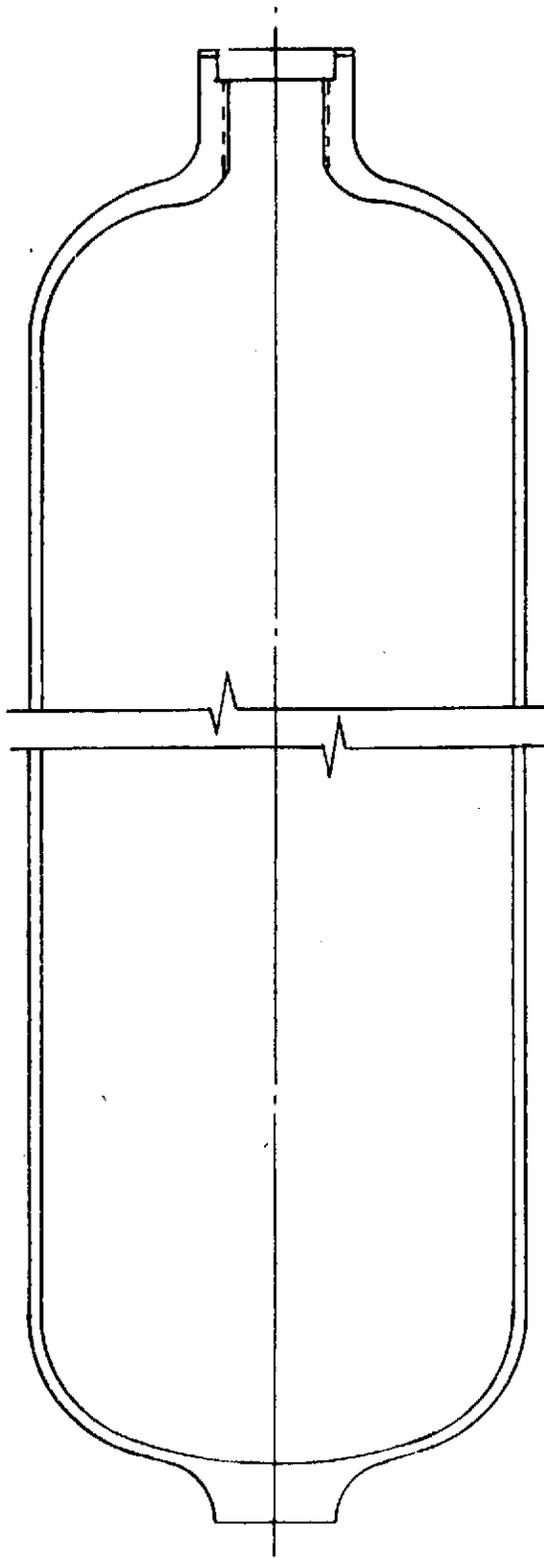
*Figure V-11 Final Machining of Port End*
