NASA CR-134384

Final Report

# Firefighter's Compressed Air Breathing System Pressure Vessel Development Program

MARTIN MARIETTA CORPORATION  
P. O. Box 179  
Denver, Colorado 80201

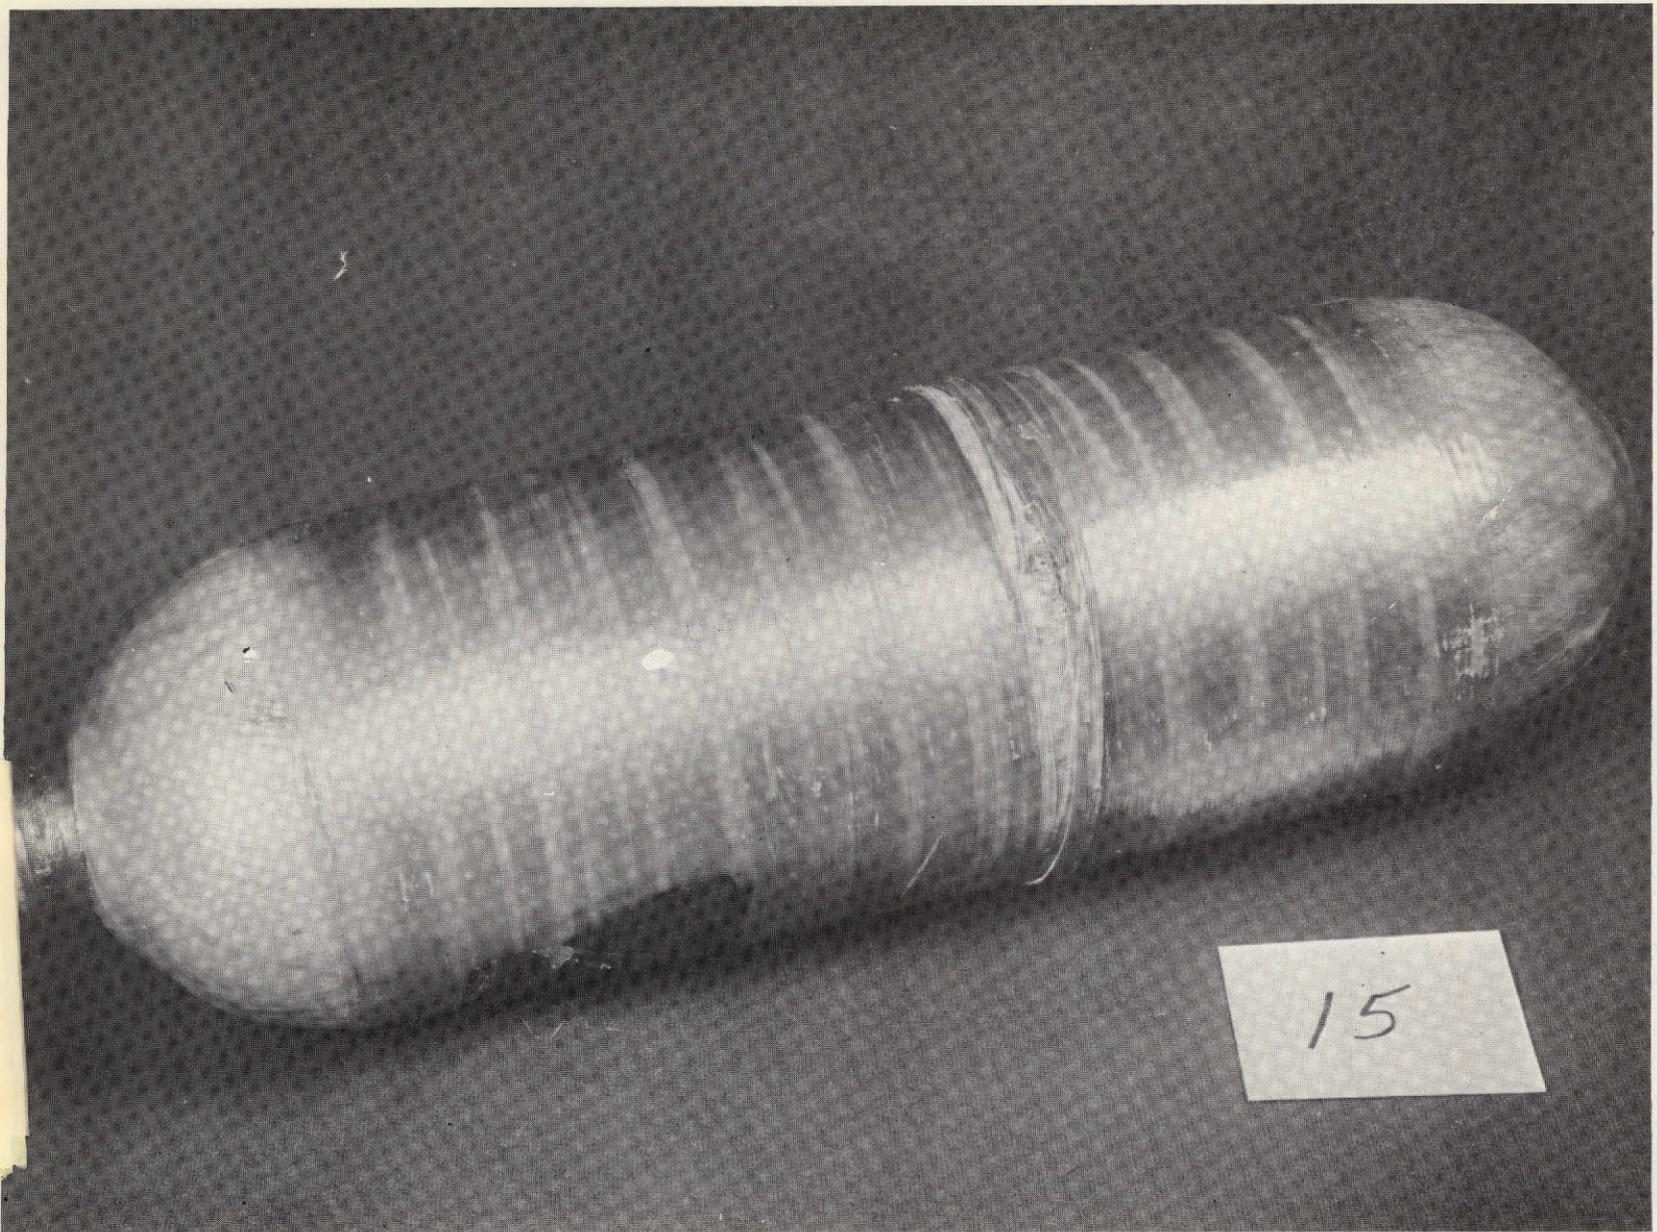
Figure VII-1 Vessel S/N 15 After Fragmentation Test

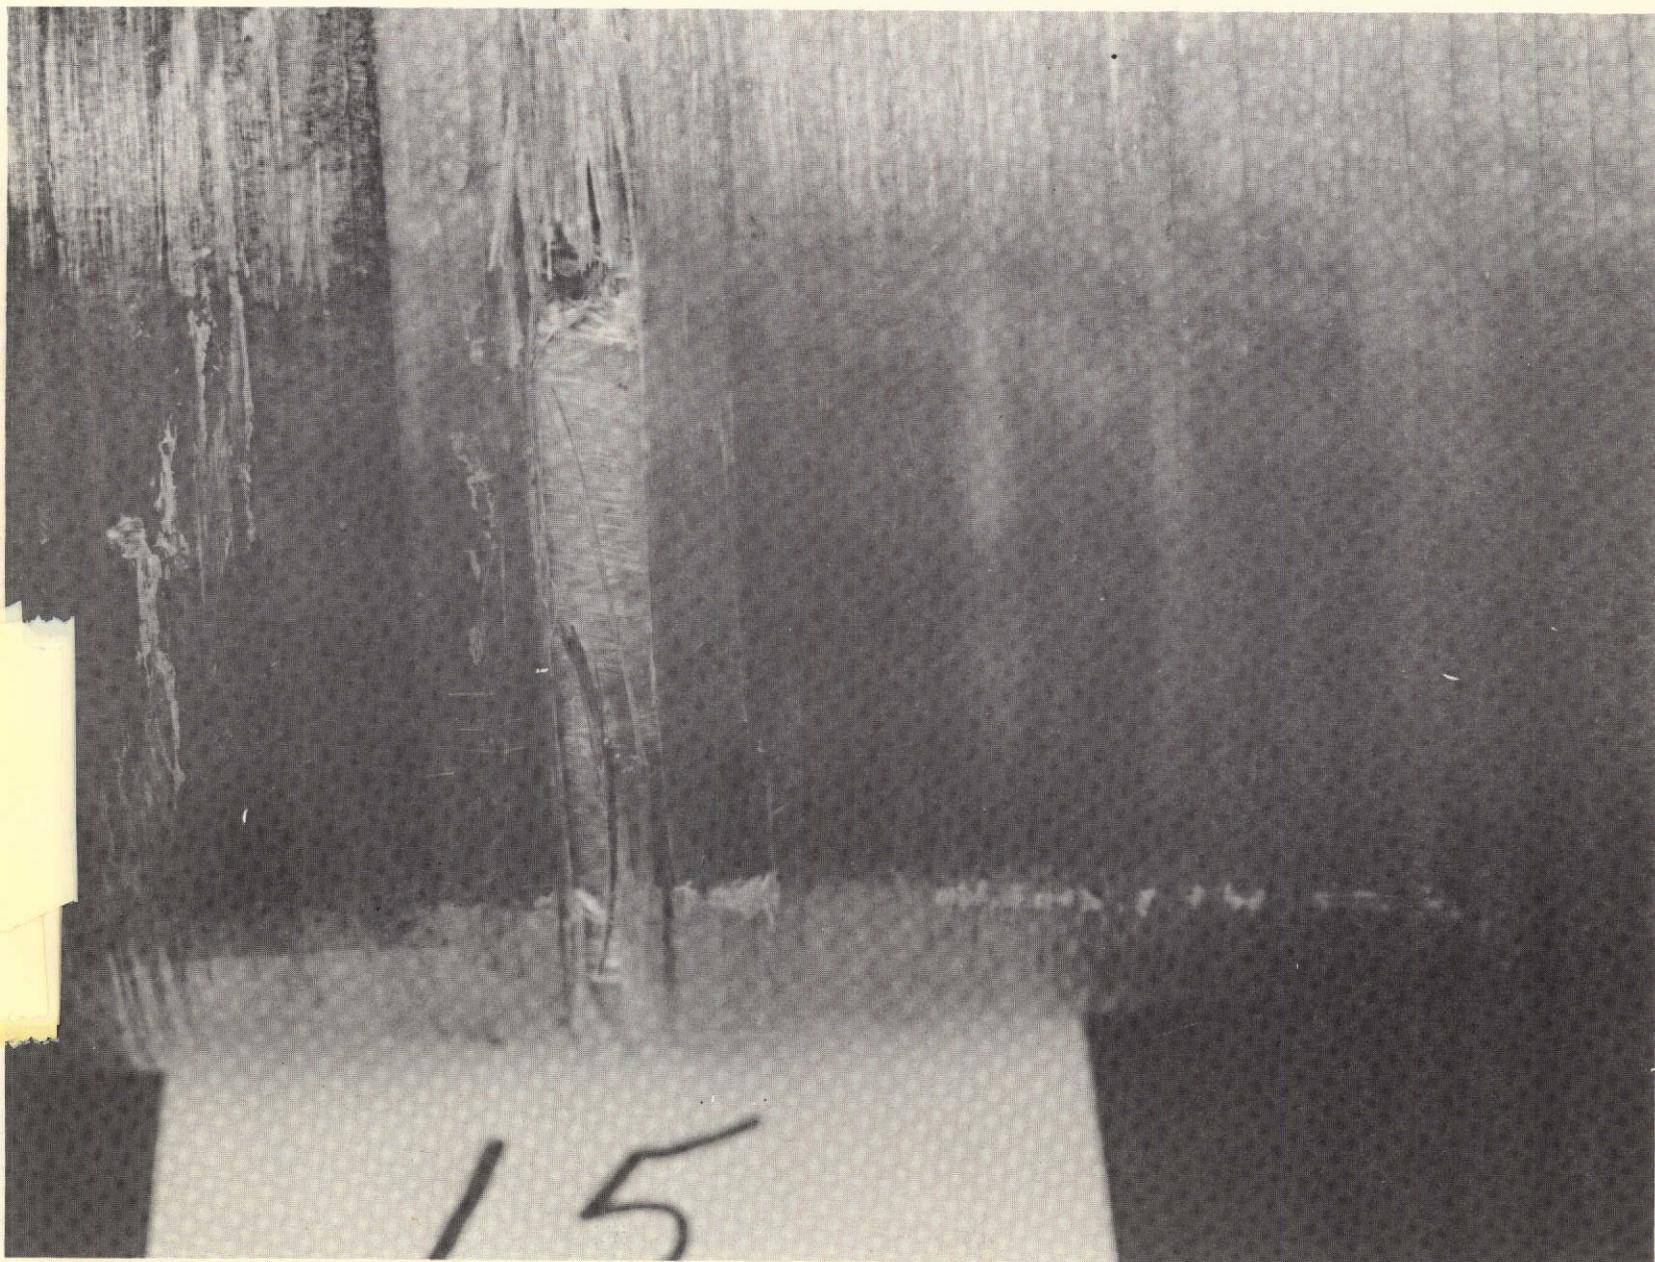
*Figure VII-2 Vessel S/N 15 Bullet Entry Hole*

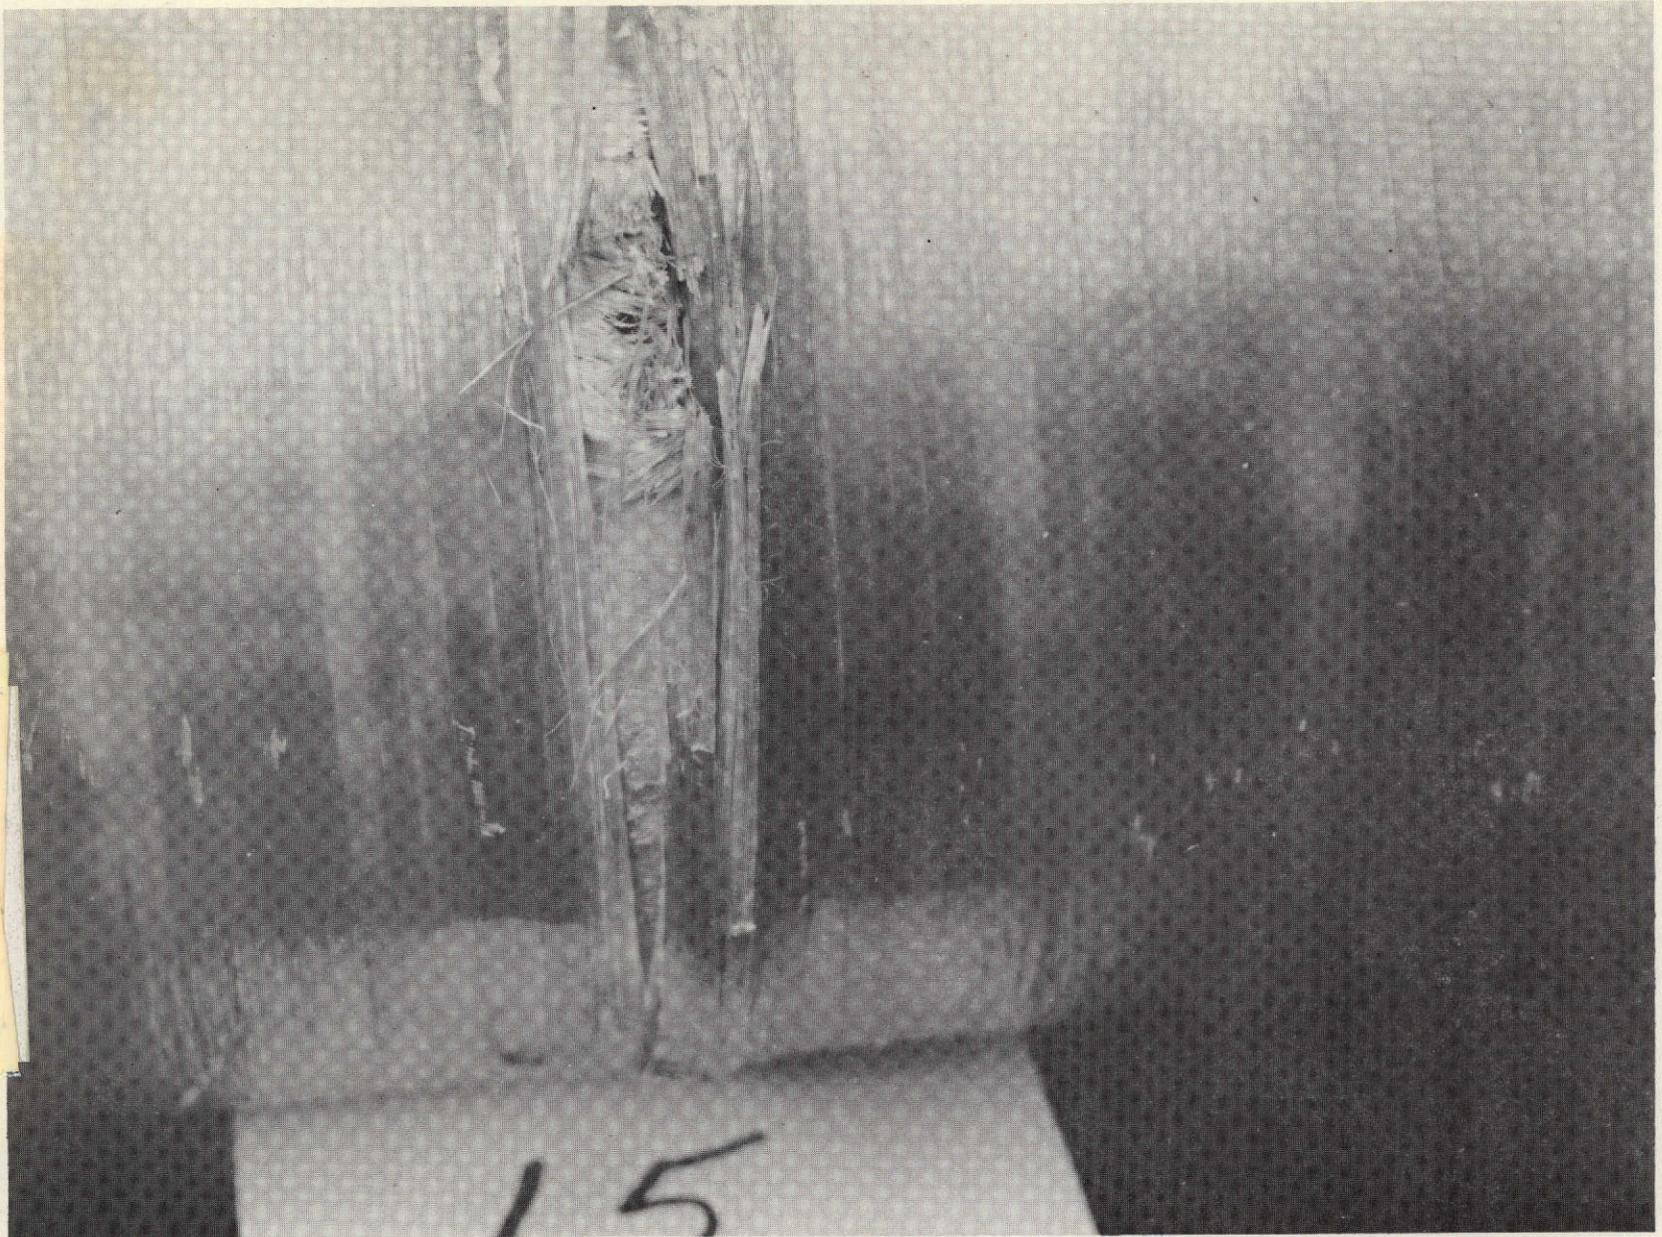
*Figure VII-3 Vessel S/N 15 Bullet Exit Hole*

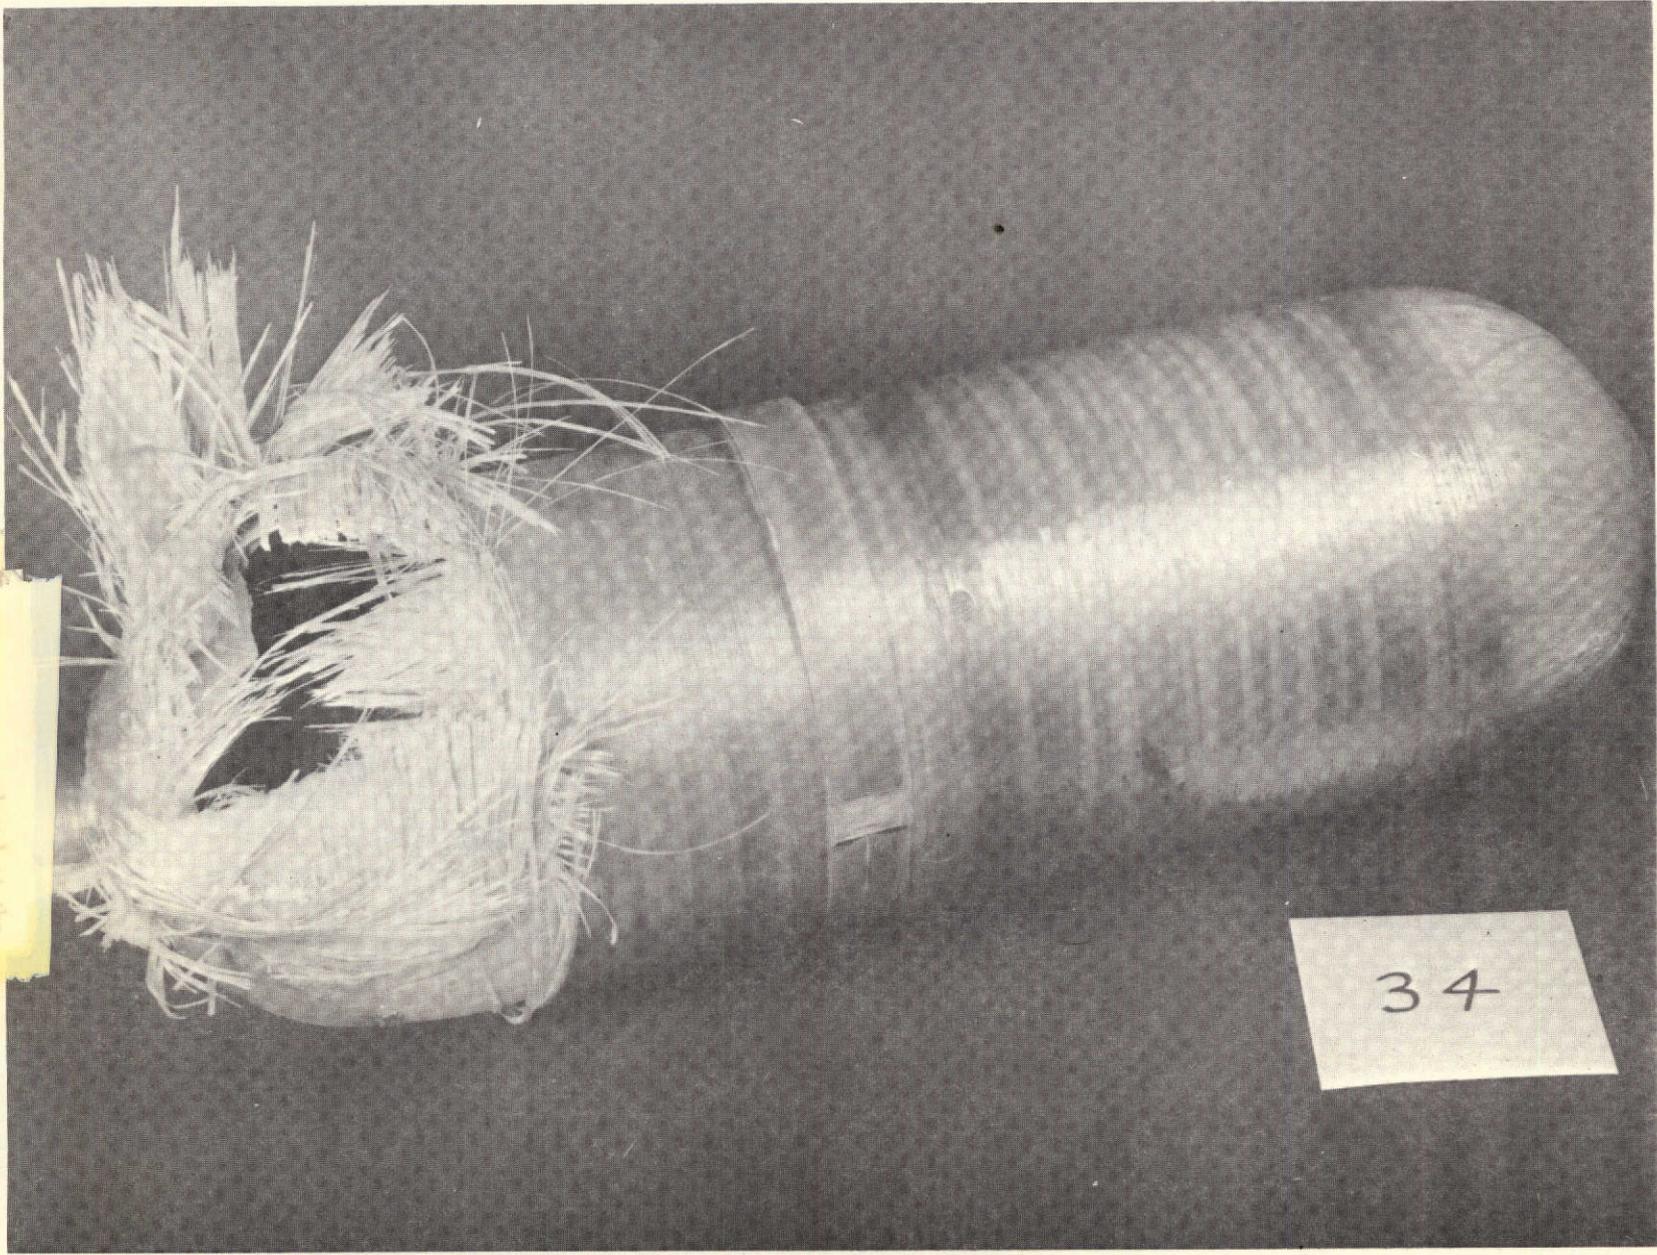
Figure VII-4 Vessel S/N 34 After Burst Test

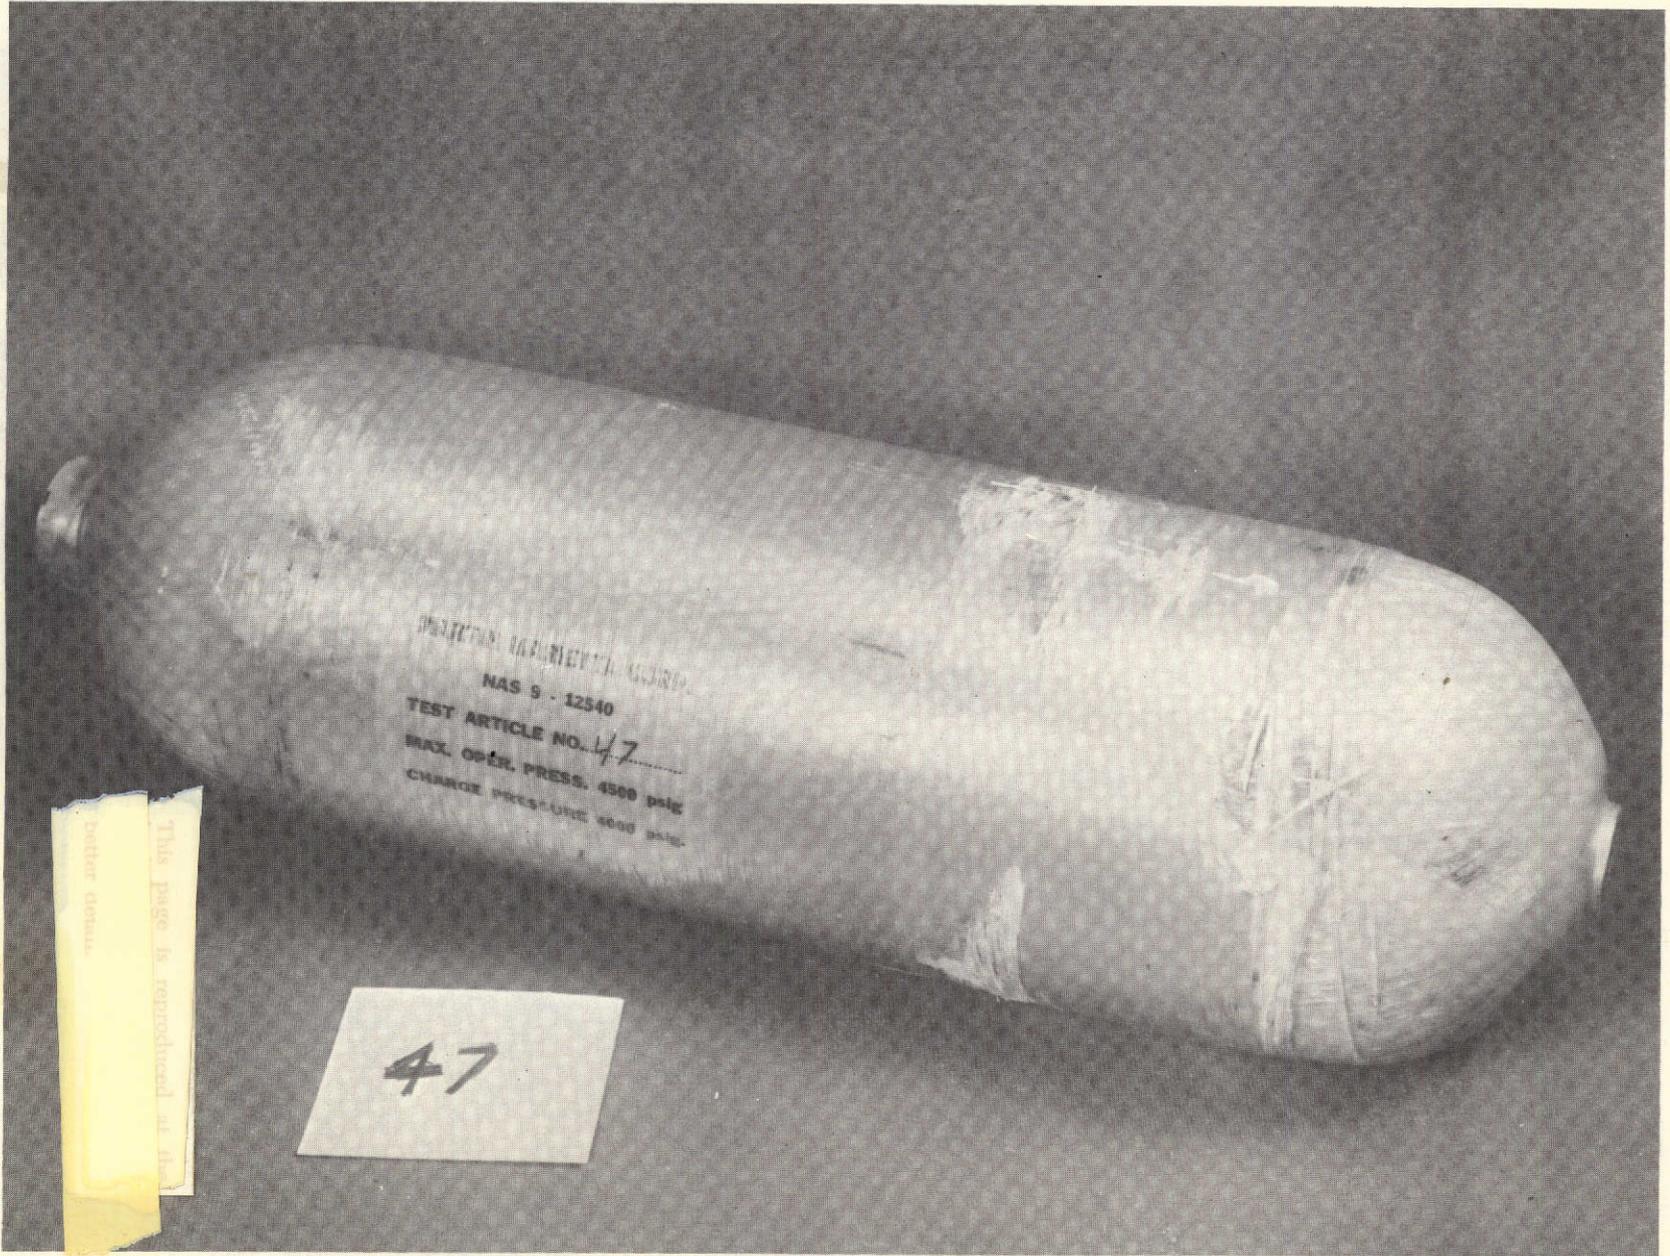
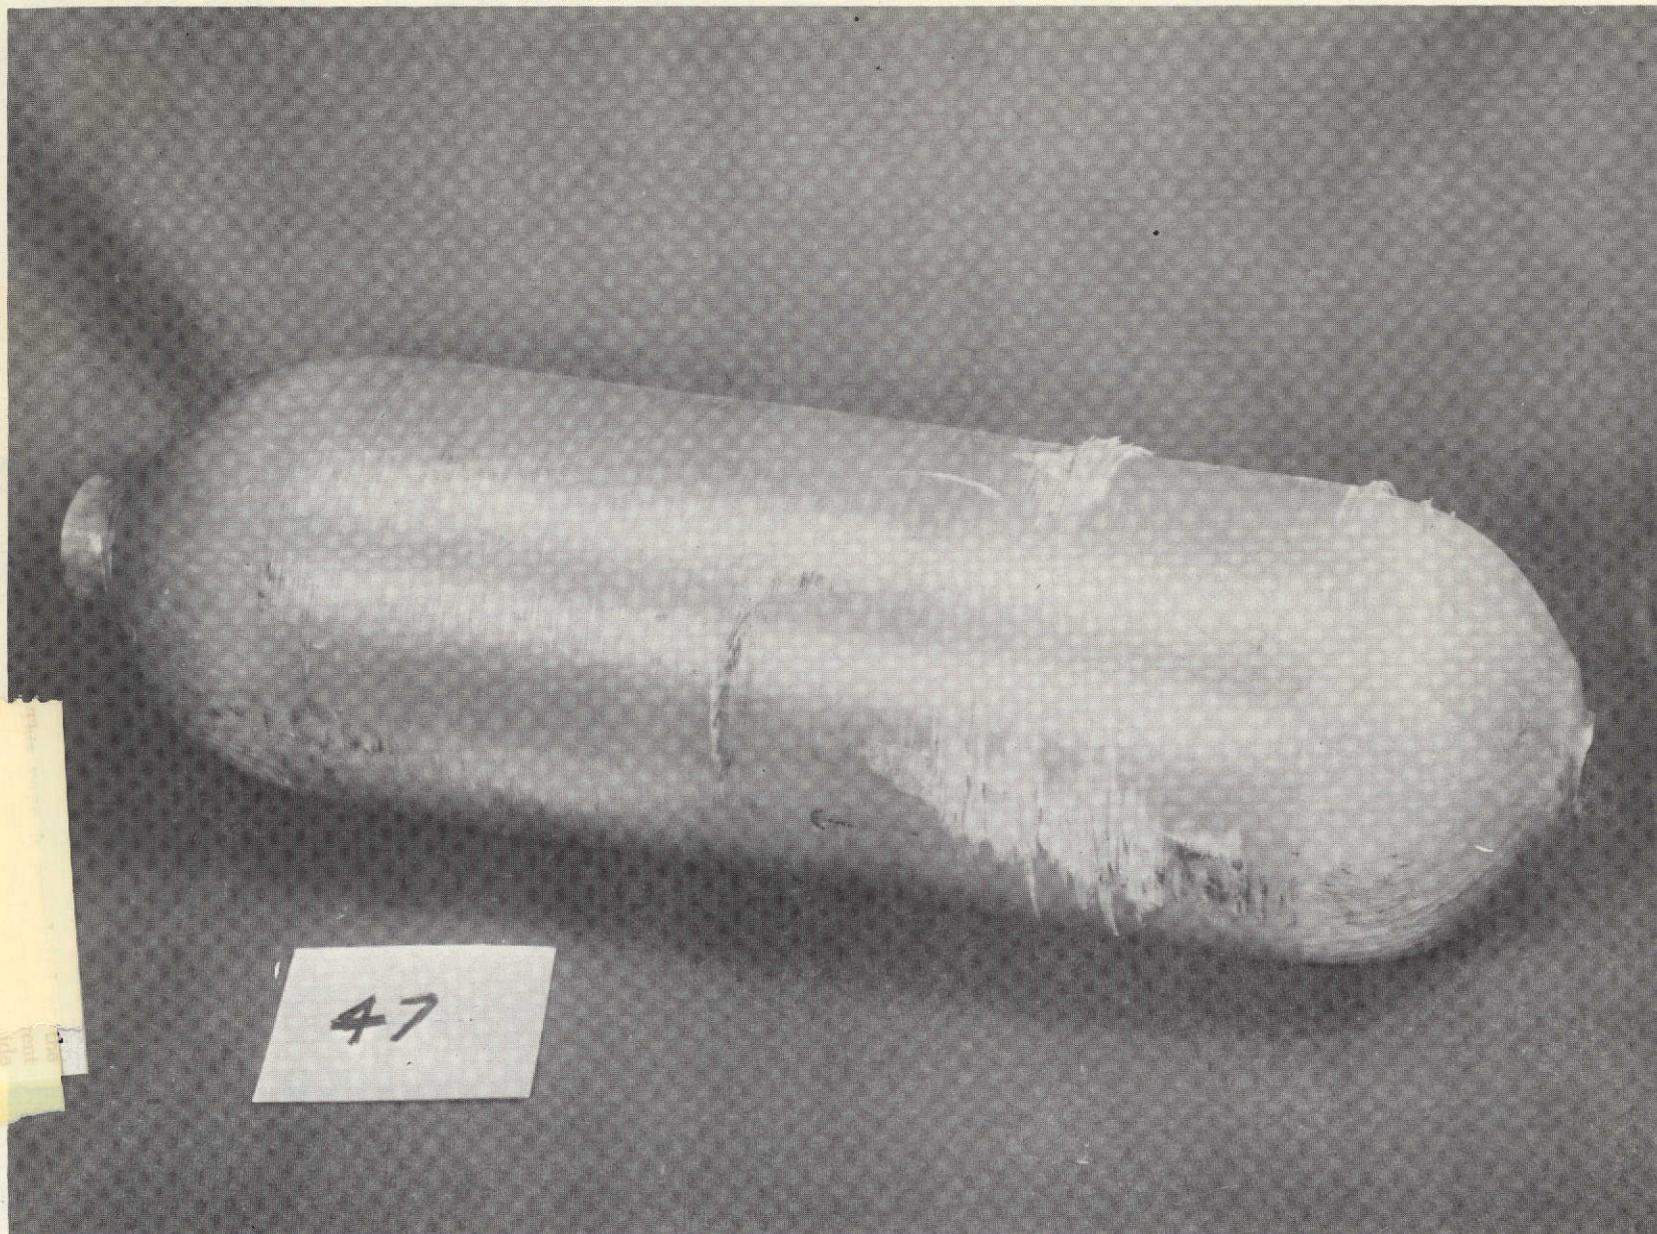
Figure VII-5 Vessel S/N 47 After Drop Test

Figure VII-6 Vessel S/N 47 After Drop Test

- The most severe physical battering that was imposed on a vessel, S/N 47, occurred during the drop test. The damage can be observed in Figures VII-5, 6, and 7. This 16-foot drop test with a simulated man-like weight of 200 lb strapped to the vessel caused

cuts several inches long, which penetrated through two layers of hoop wrap material into polar material, to be inflicted into the vessel. This severe damage reduced the final burst pressure to 10,200 psig. Failure originated at the cut in the junction region of the vessel.

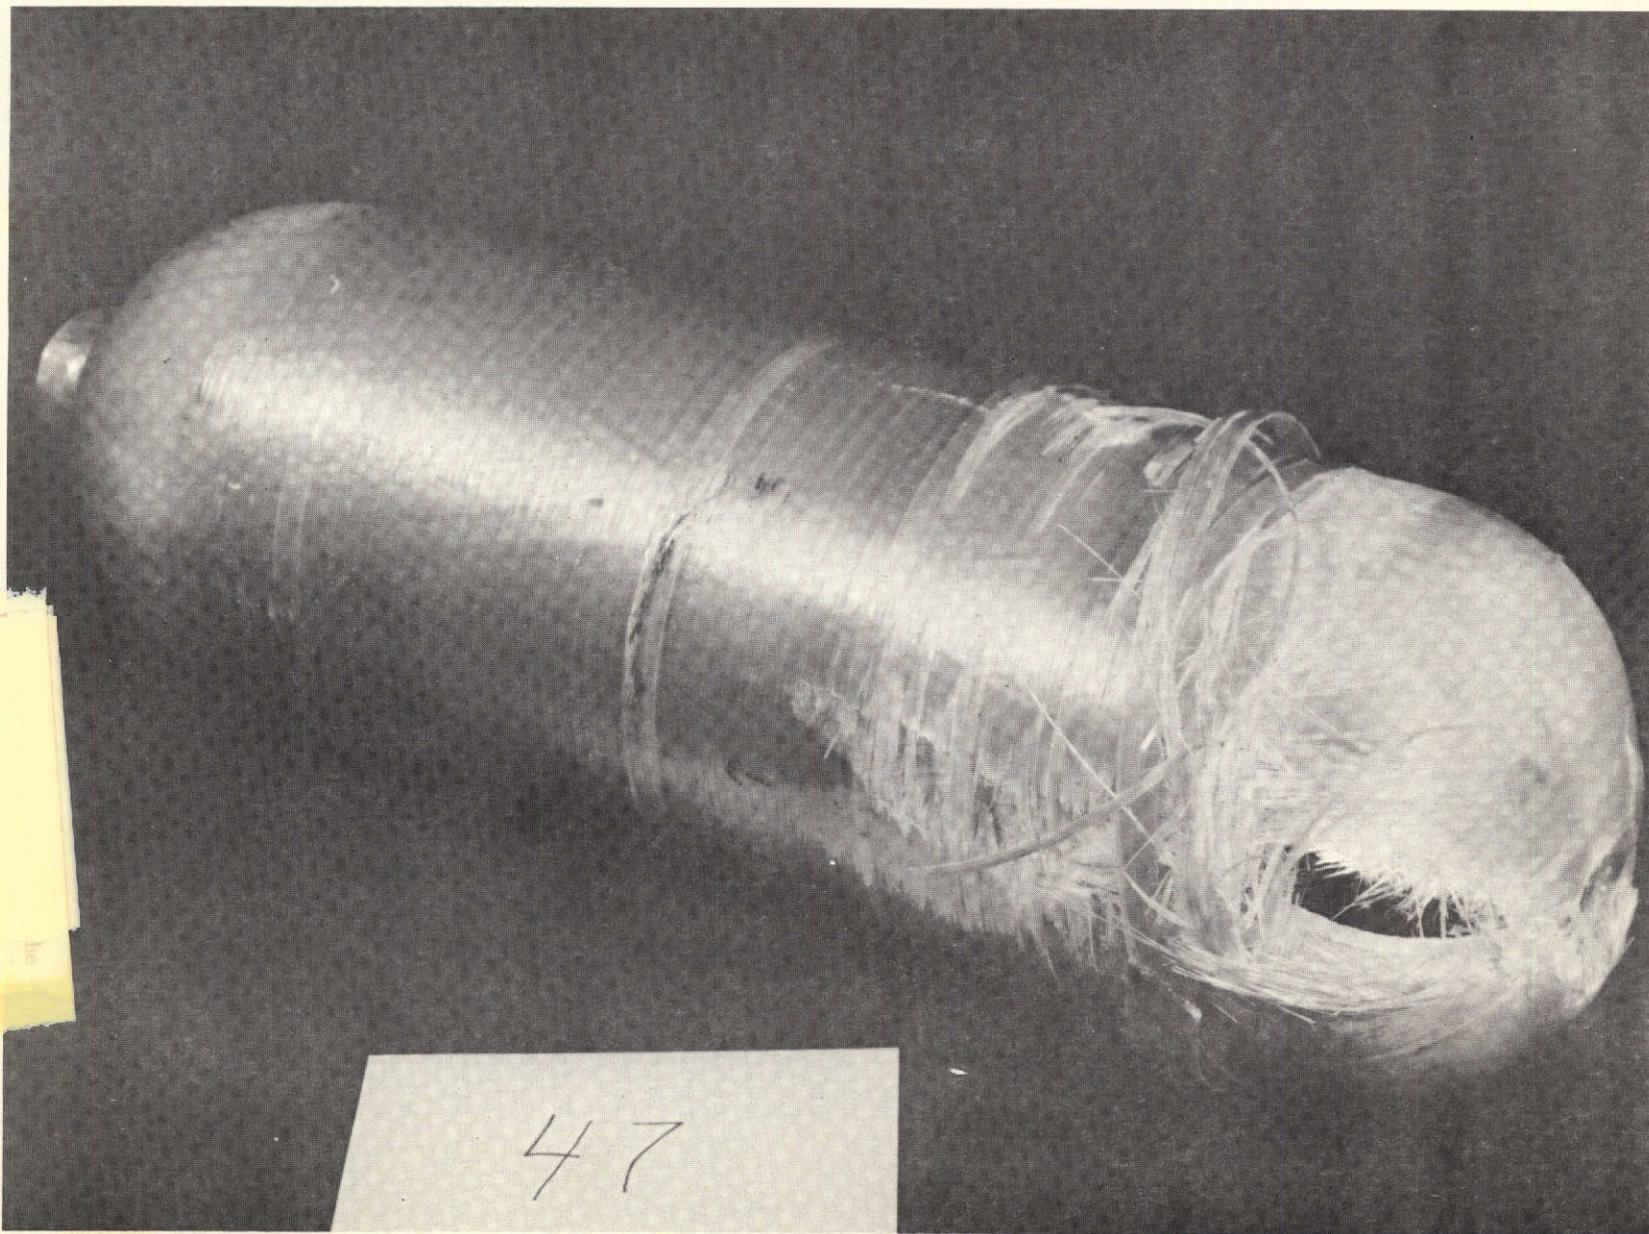
Figure VII-7 Vessel S/N 47 After Burst Test

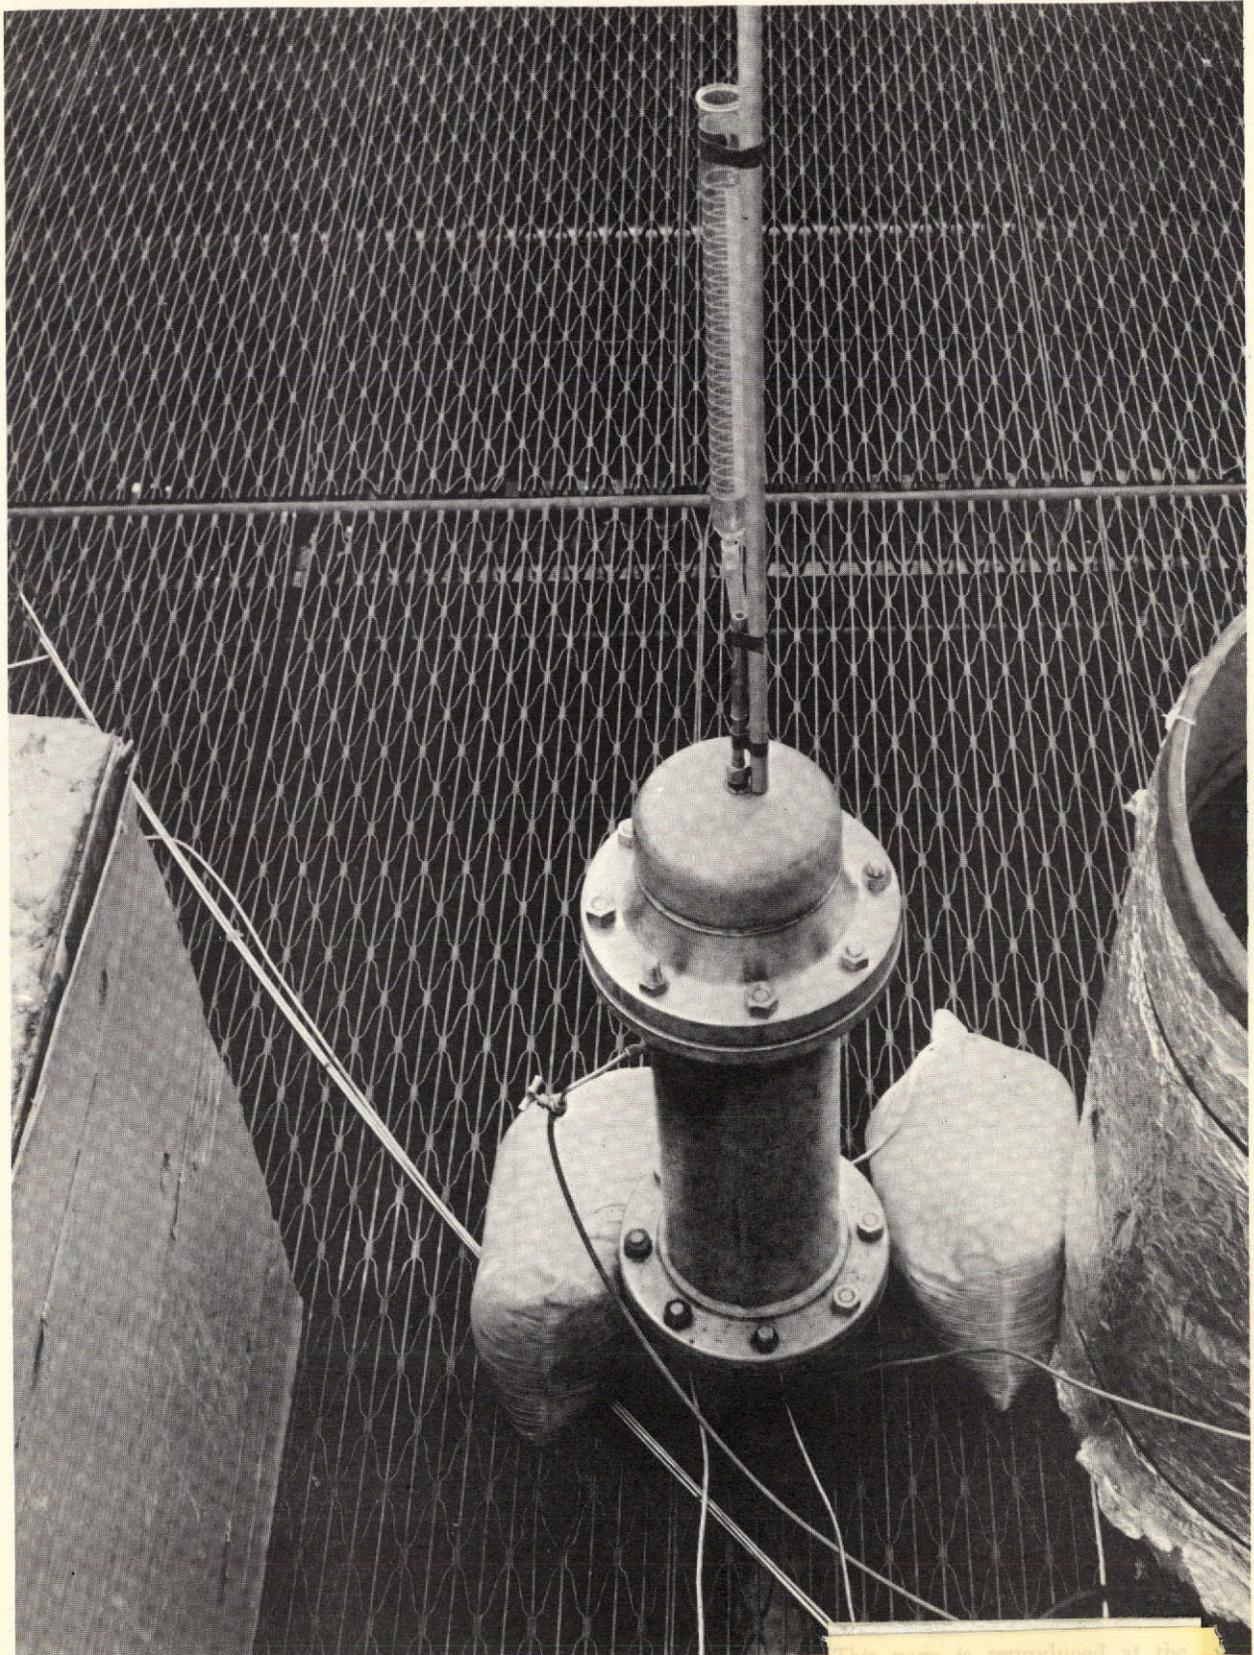
Figure B-2 Volumetric Expansion Test Setup

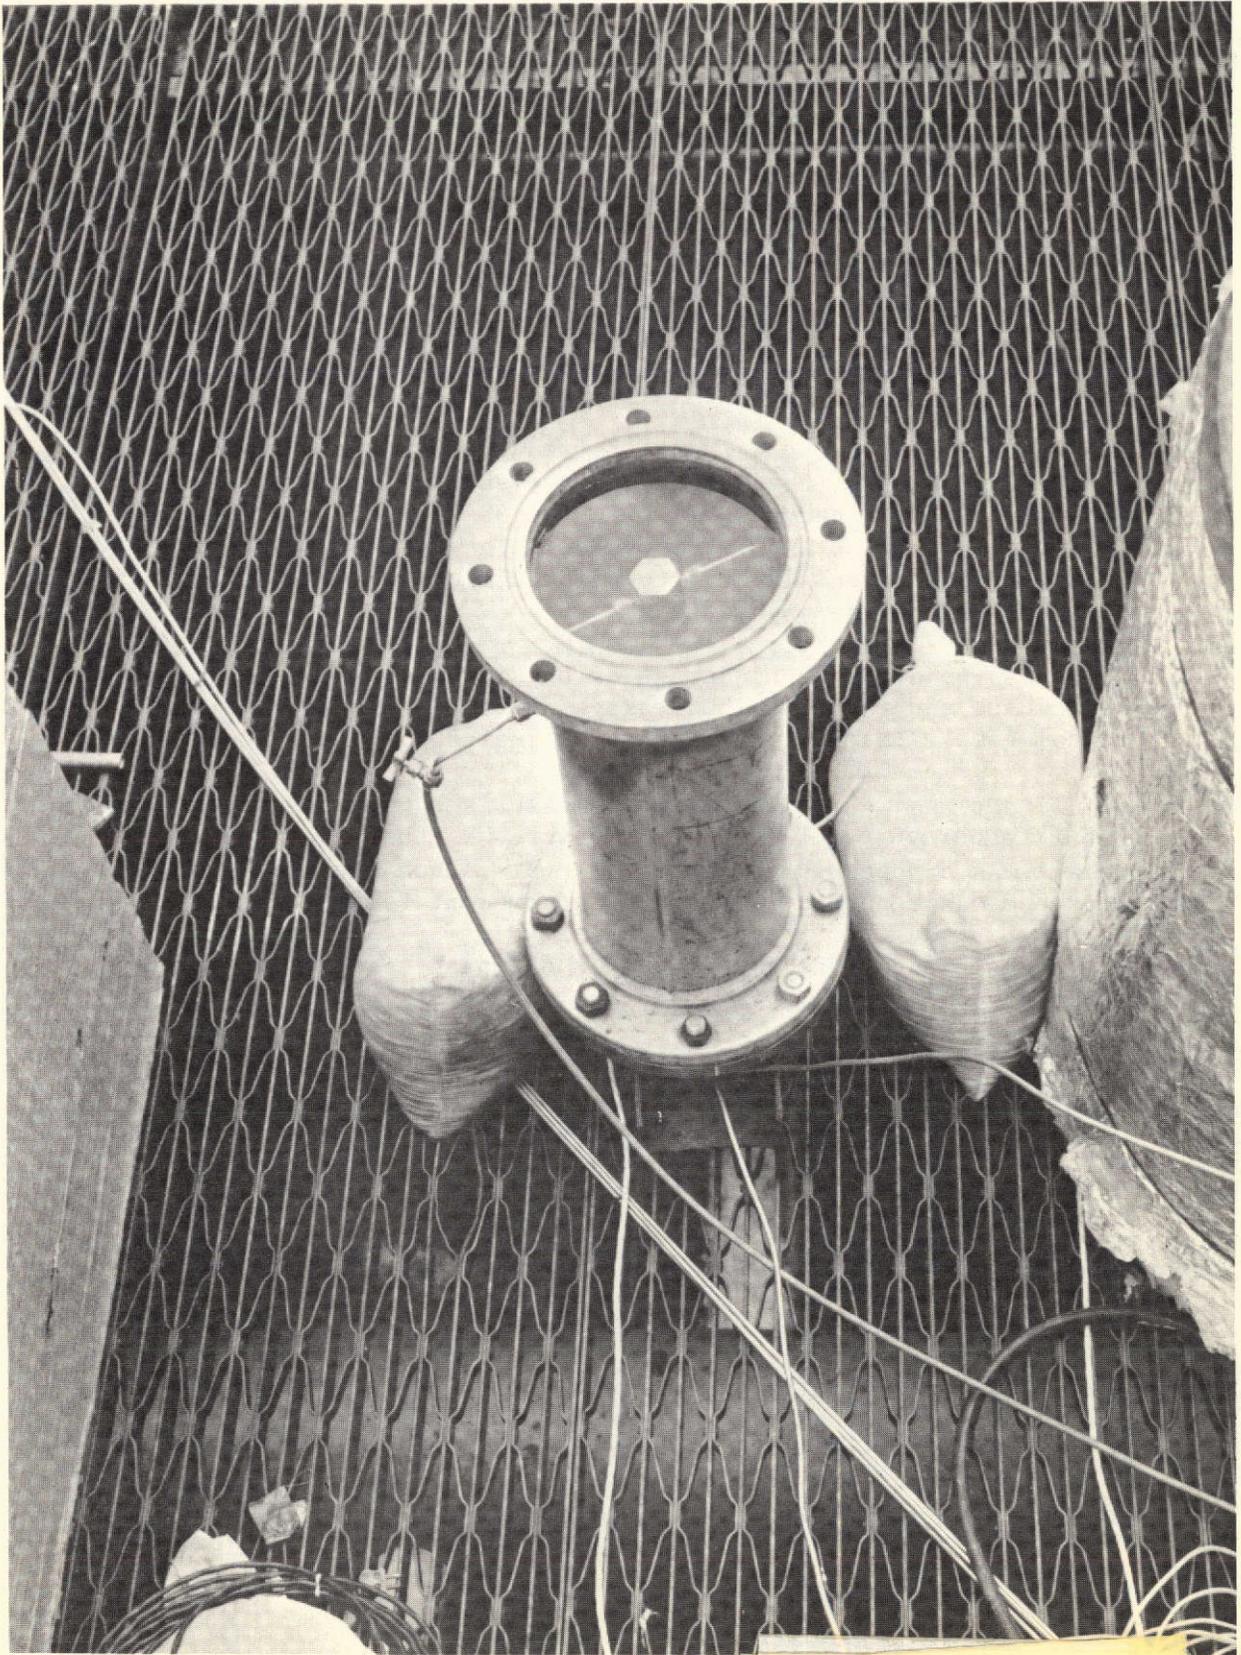
*Figure B-3 Functional Capability Test Setup*

There was no evidence of damage or physical degradation after the 10,000 cycles except the outer loop wrap had peeled approximately 3 in. to a depth of the intentional cylindrical section flaw. This peel apparently caused no degradation in vessel performance during this or subsequent tests. There was no leakage during the subsequent functional test and the test data sheet is included as Table B-6.

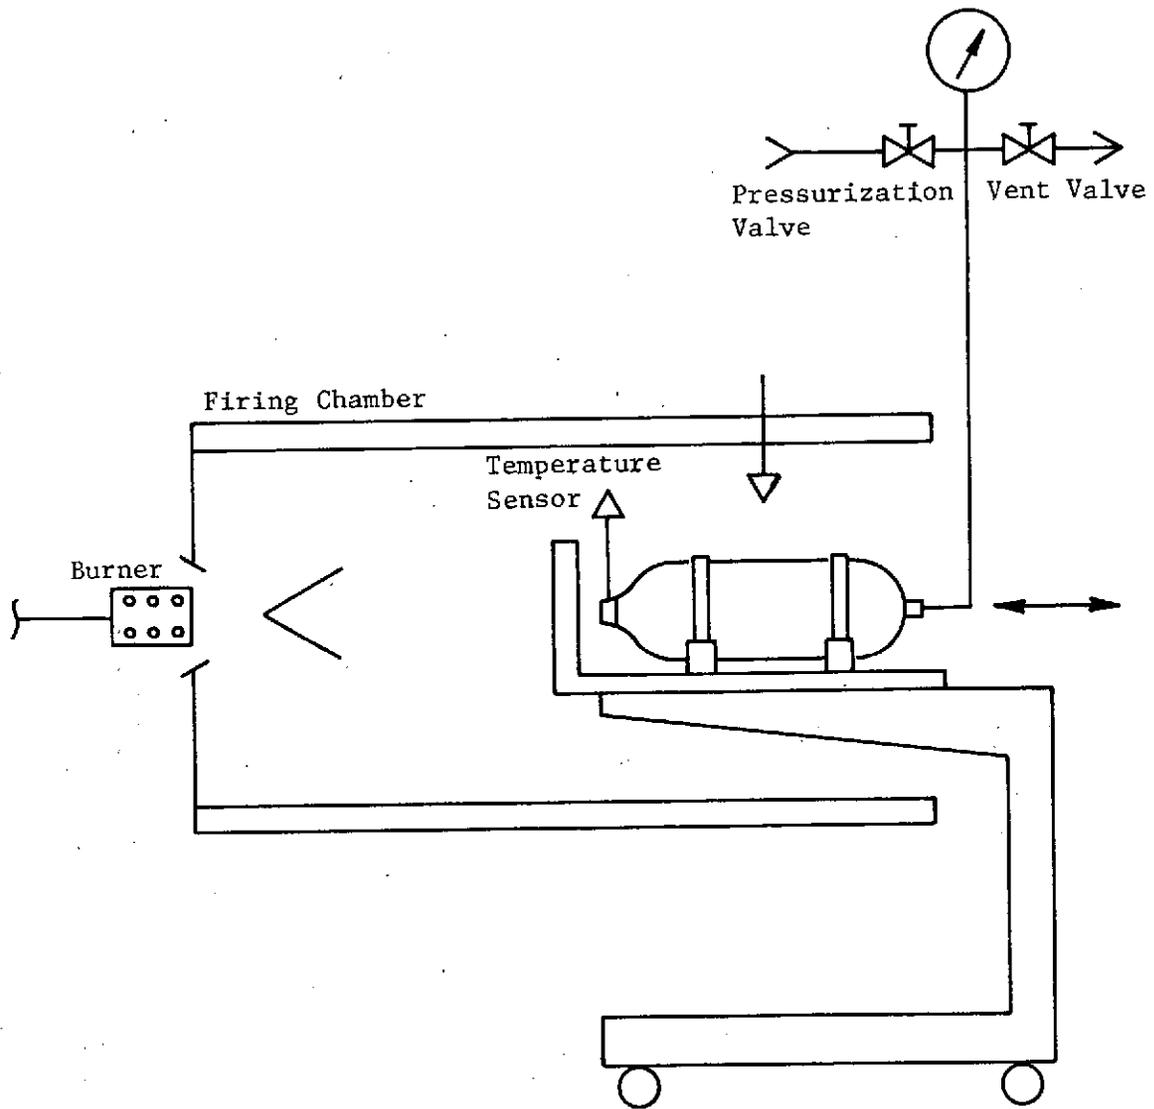
Figure B-4 High Temperature Exposure

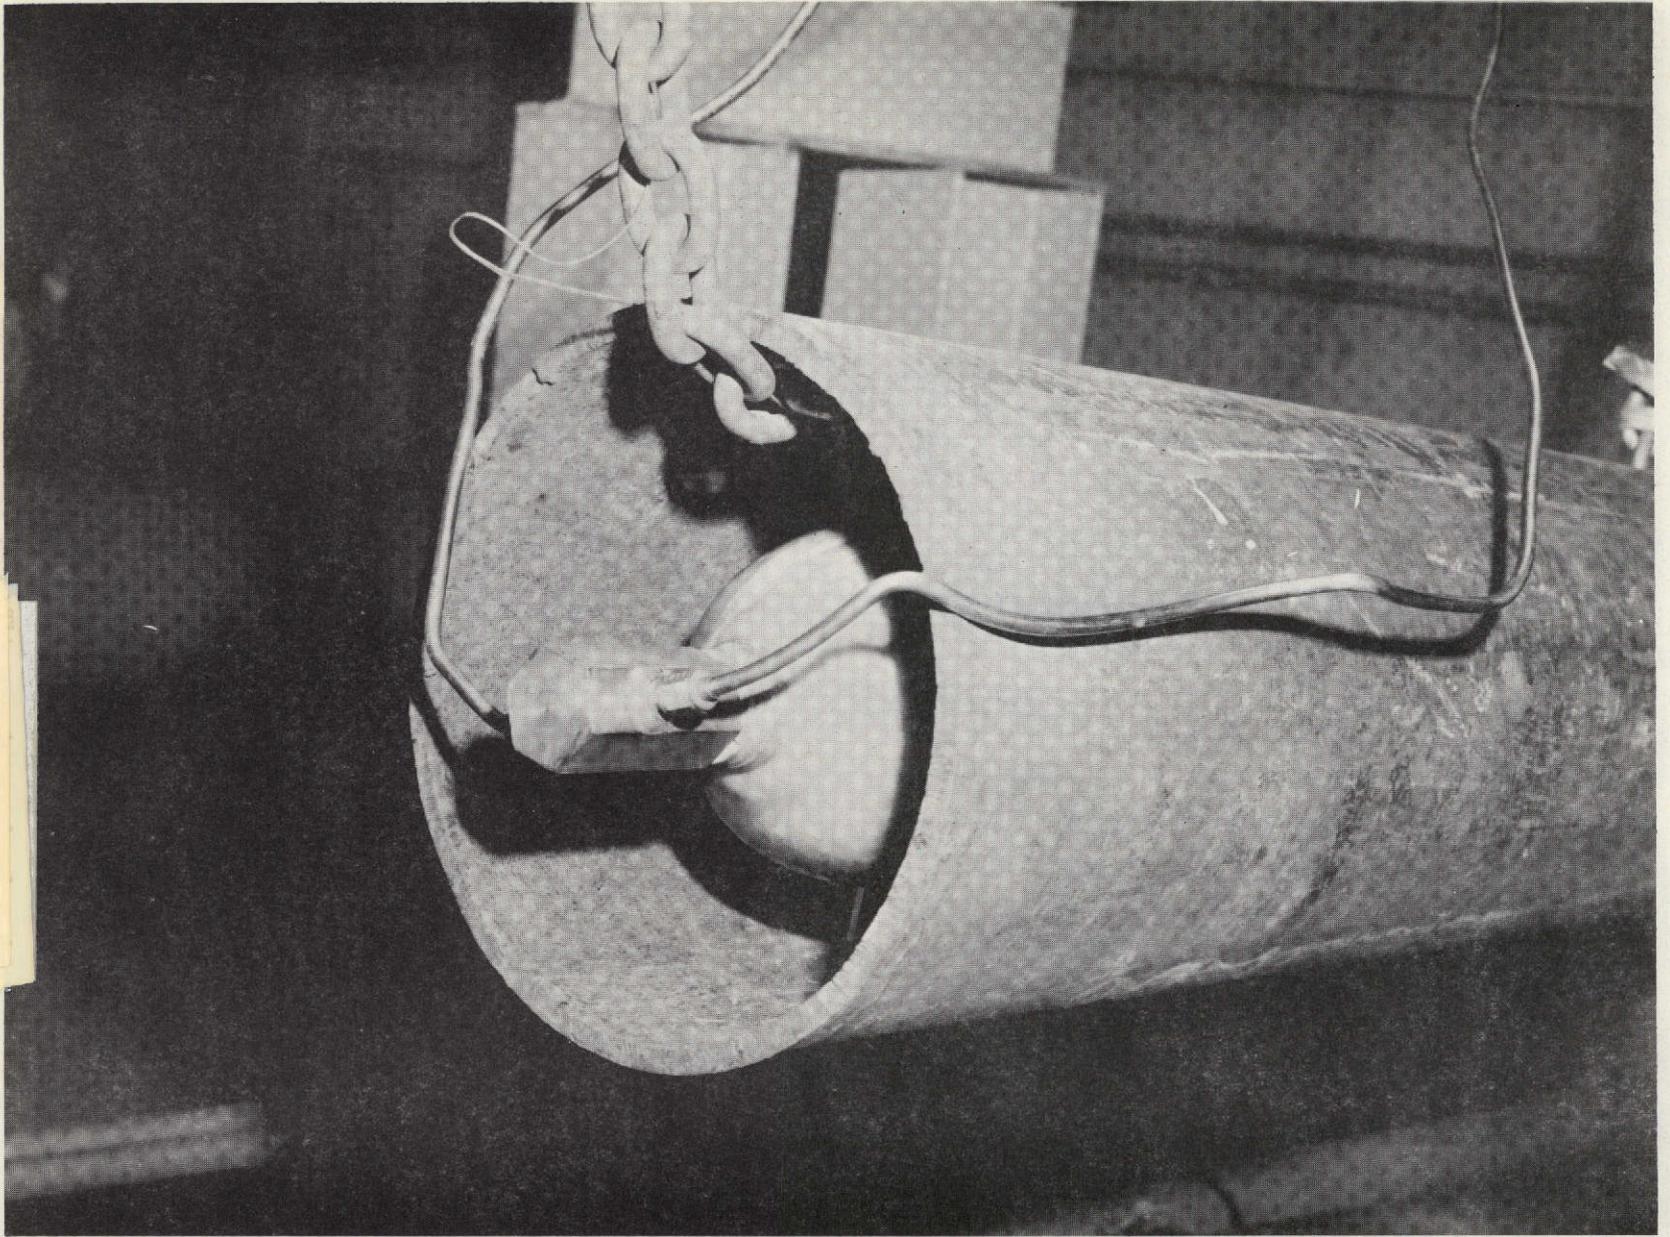
Figure B-6 High Temperature Exposure Test Setup

\*This Test Was Repeated By Increasing Vessel Temperature To 430°F (T2) While Maintaining Pressure at 2000 Psig. The Temperature Criteria of 430°F Was Determined by Placing S/N 15 In A 600°F Oven for 5 Min and Temperature T-2 Rose To 430°F. S/N 21 Showed Slight Discoloration Due To Heat. No Other Damage.
