NASA CR-134384

Final Report

# Firefighter's Compressed Air Breathing System Pressure Vessel Development Program

MARTIN MARIETTA CORPORATION  
P. O. Box 179  
Denver, Colorado 80201

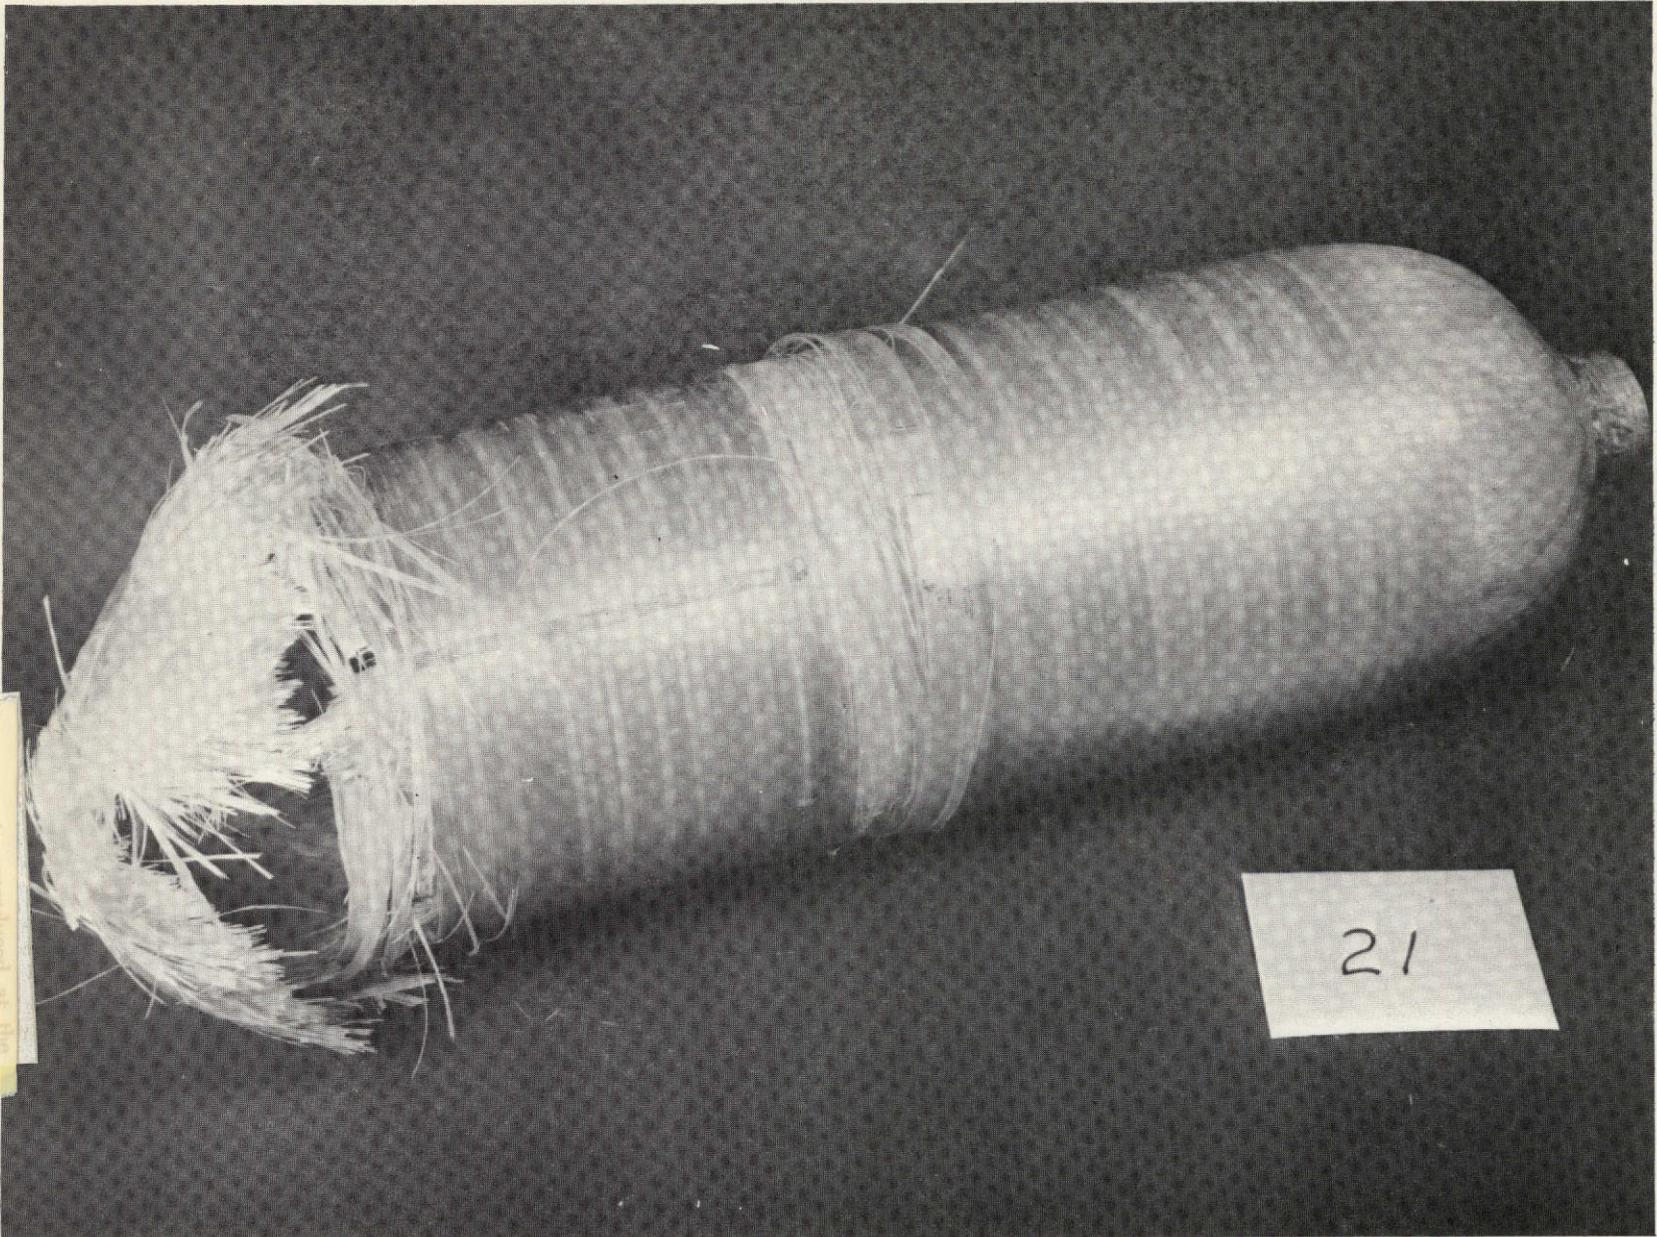
Figure B-7 Vessel S/N 21 After Burst Test

*j. Burst Test* - The vessel was pressurized hydrostatically at a rate of 200-300 psi per min until rupture occurred. Rupture occurred at 12,800 psig, originated in the lower dome, and was due to a glass failure. The test data sheet is included as Table B-12 and the oscillograph recordings made during this test will be available at the Engineering Propulsion Laboratory for six months for further inspection and analysis. A photograph of the vessel after rupture is shown in Figure B-7.

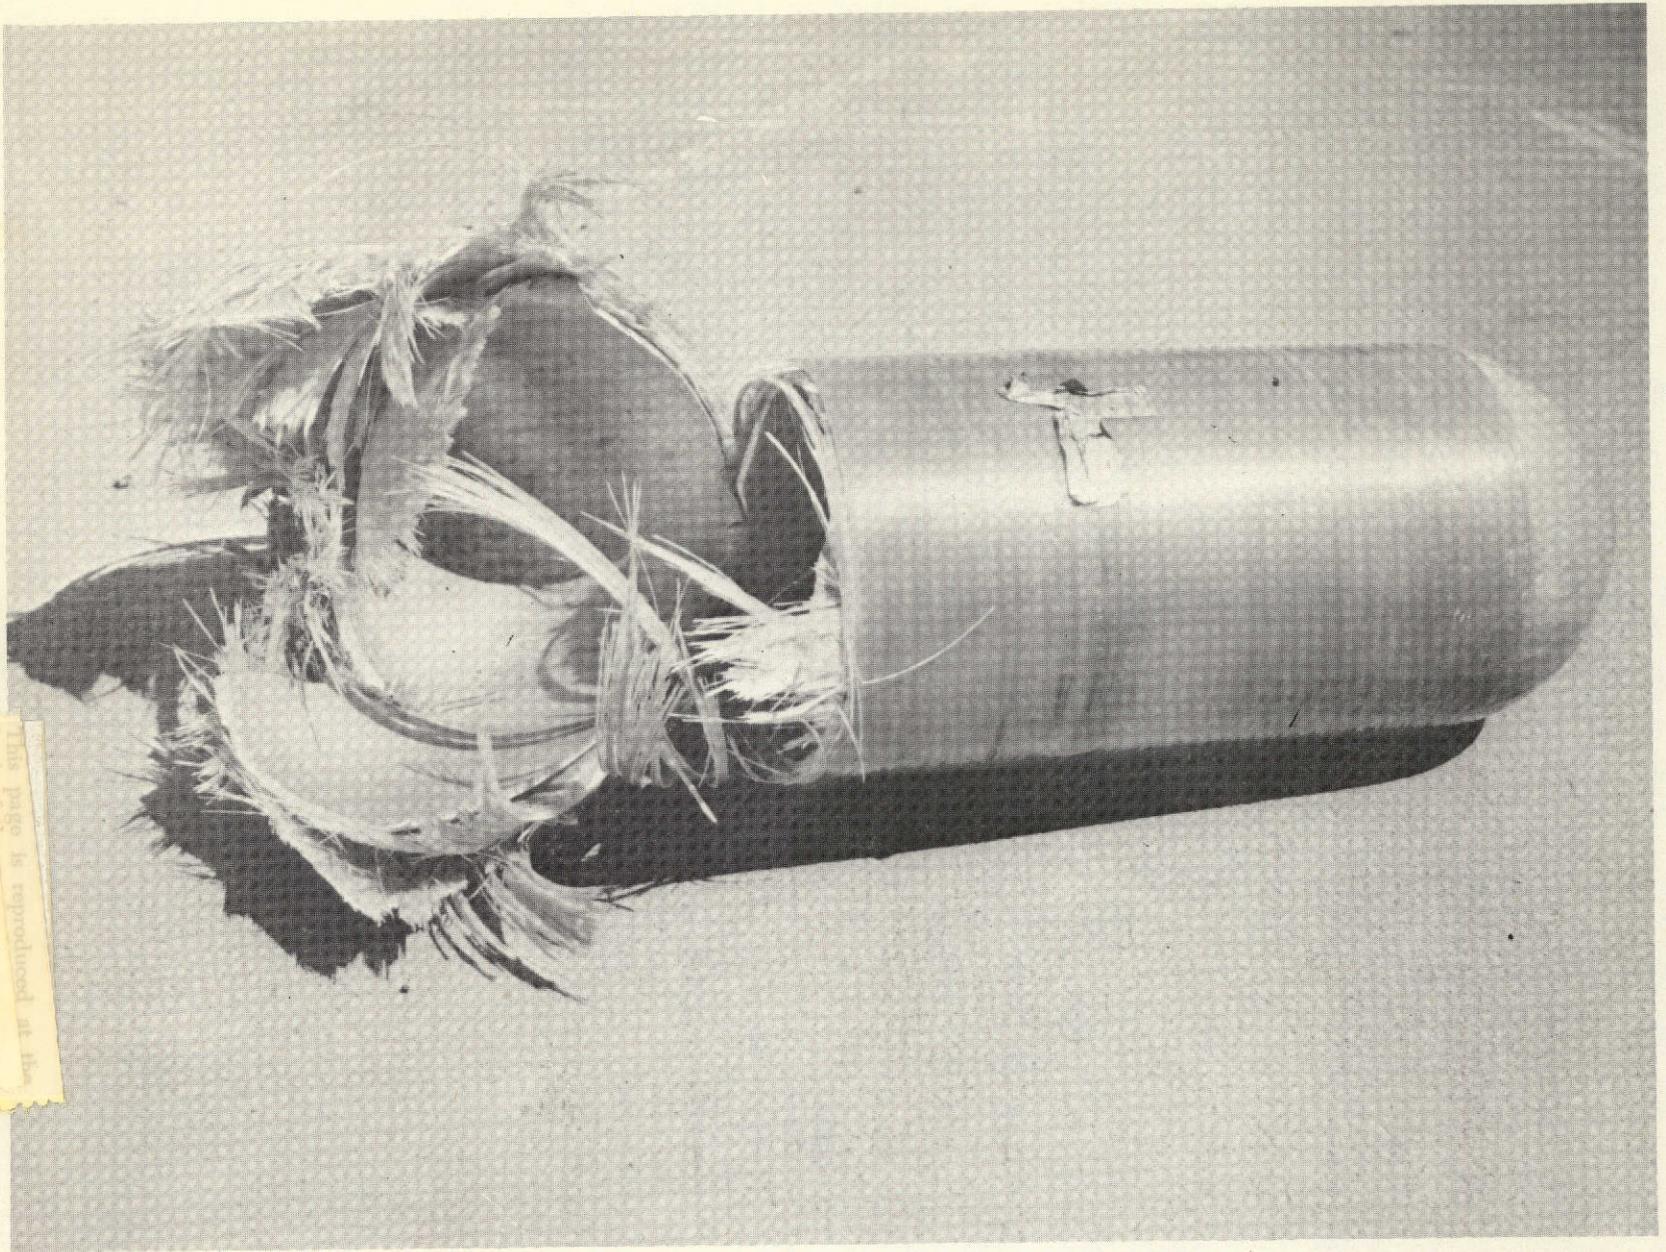
Figure B-8 Vessel S/N 14 After Failure

\*Vessel ruptured catastrophically after 13 min in the second hot bath immediately before being pulled out. Two cold soaks and one hot soak had successfully been completed. Vessel temperature was 183.9°F.

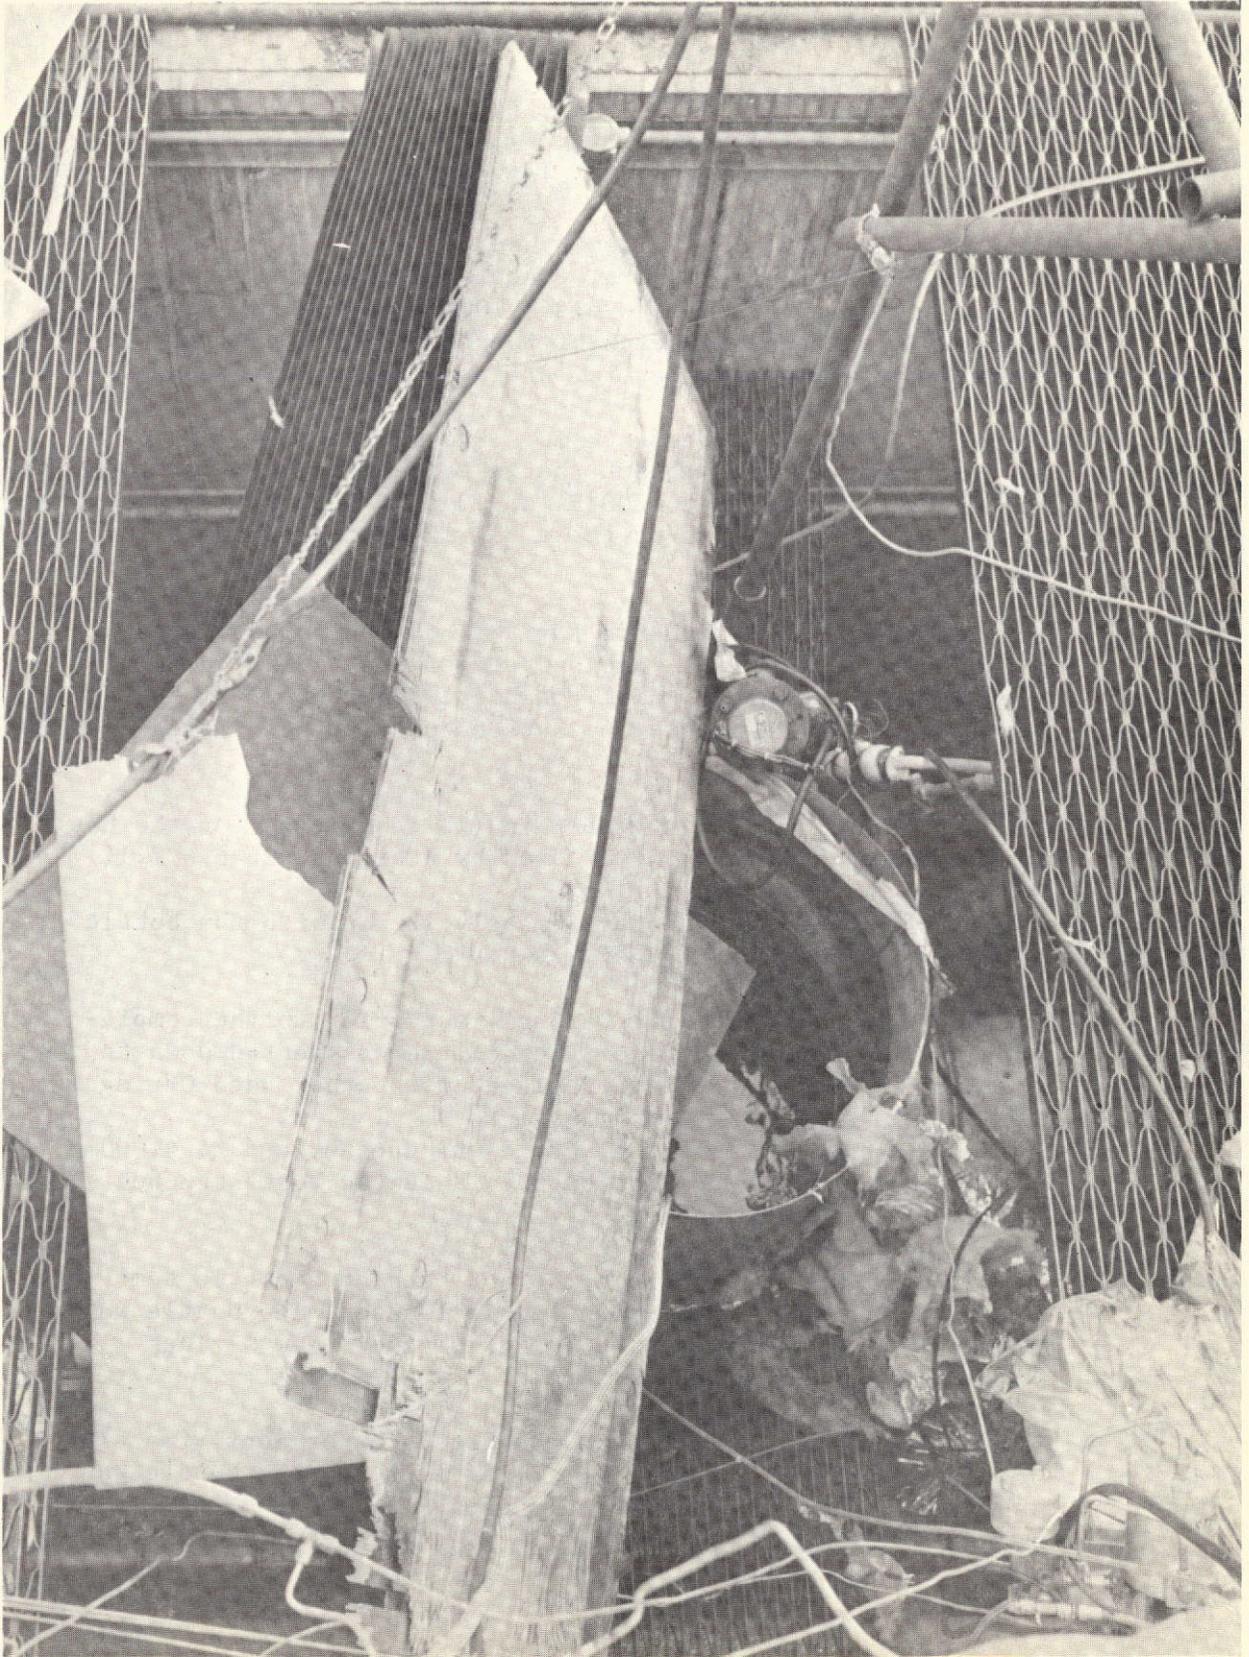
Figure B-9 Thermal Cycle Test Damage

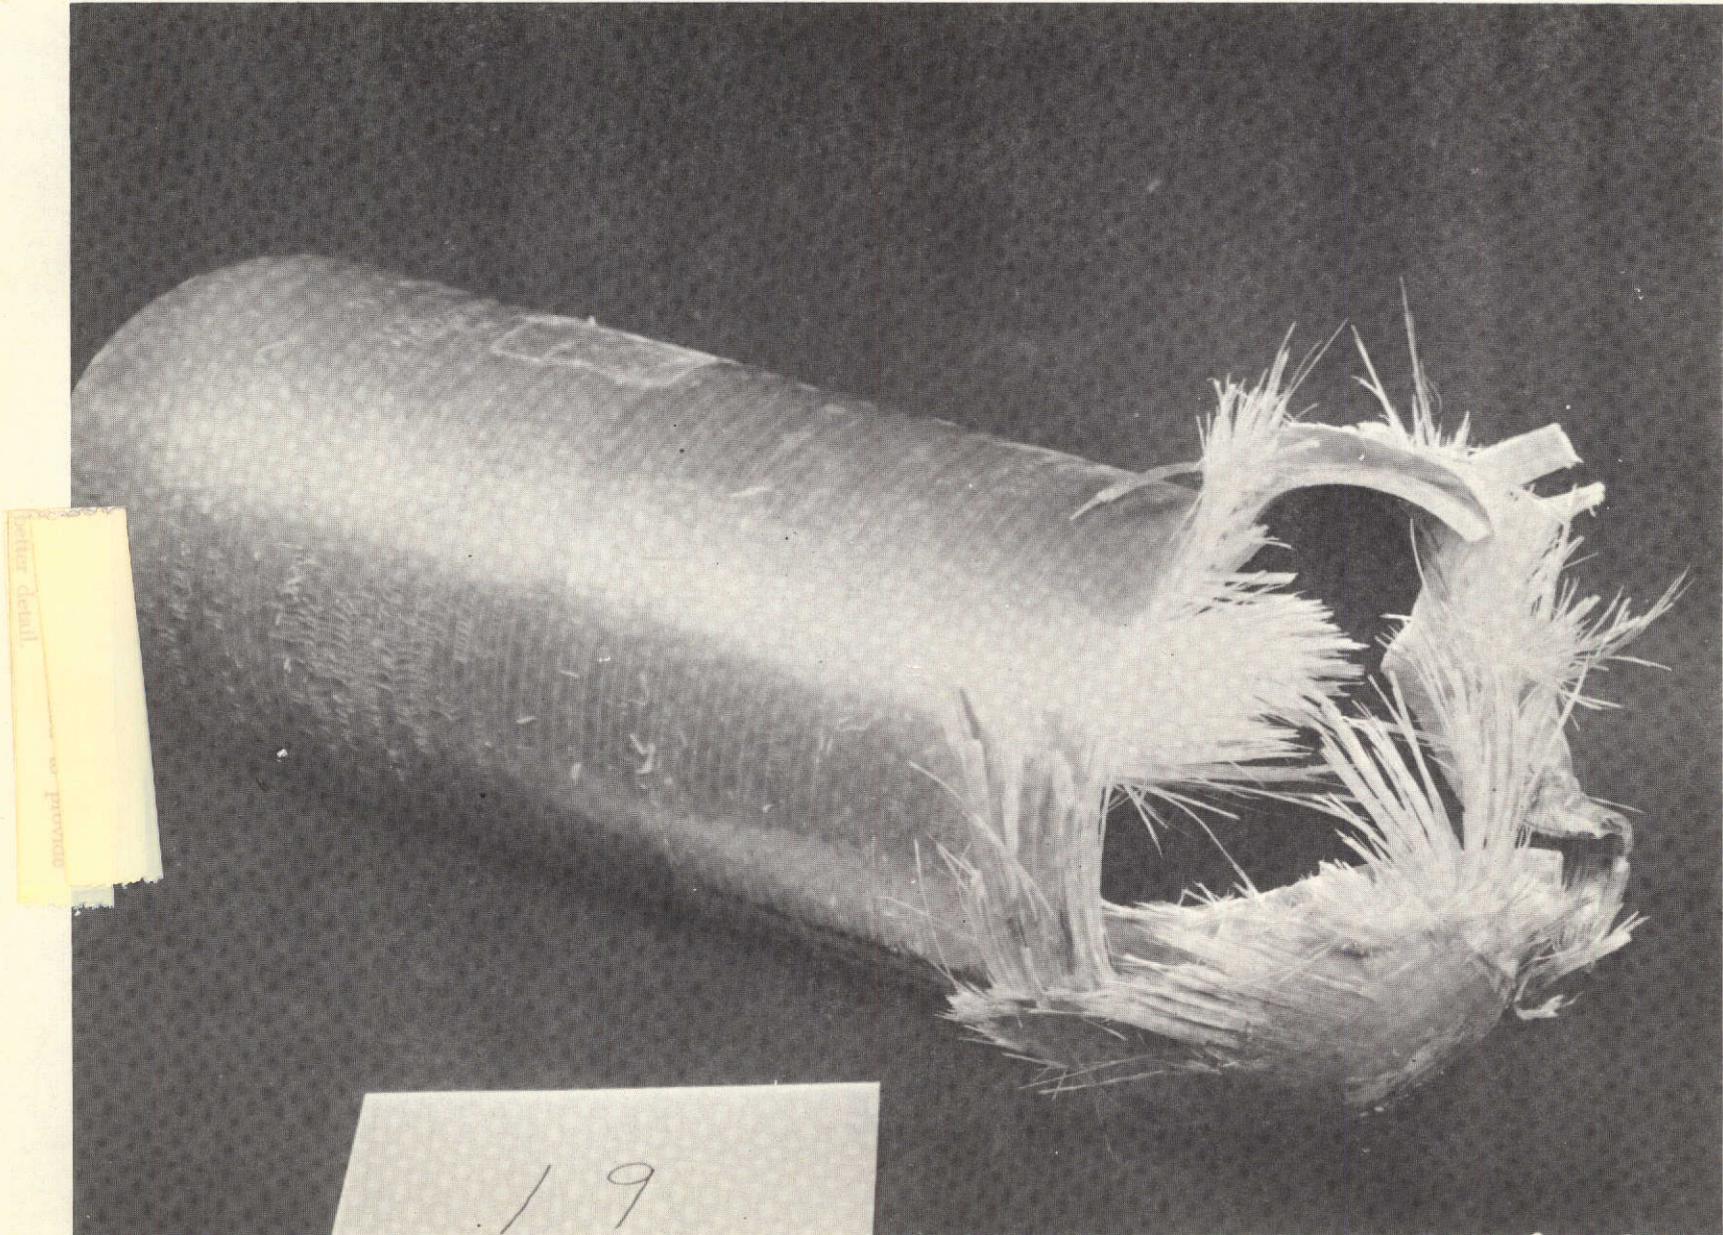
Figure B-10 Vessel S/N 19 After Burst Test

The test data sheet is included as Table B-23 and the oscillograph recordings made during this test will be available at the Engineering Propulsion Laboratory for six months for further inspection and analysis. A photograph of the vessel after rupture is shown in Figure B-10.

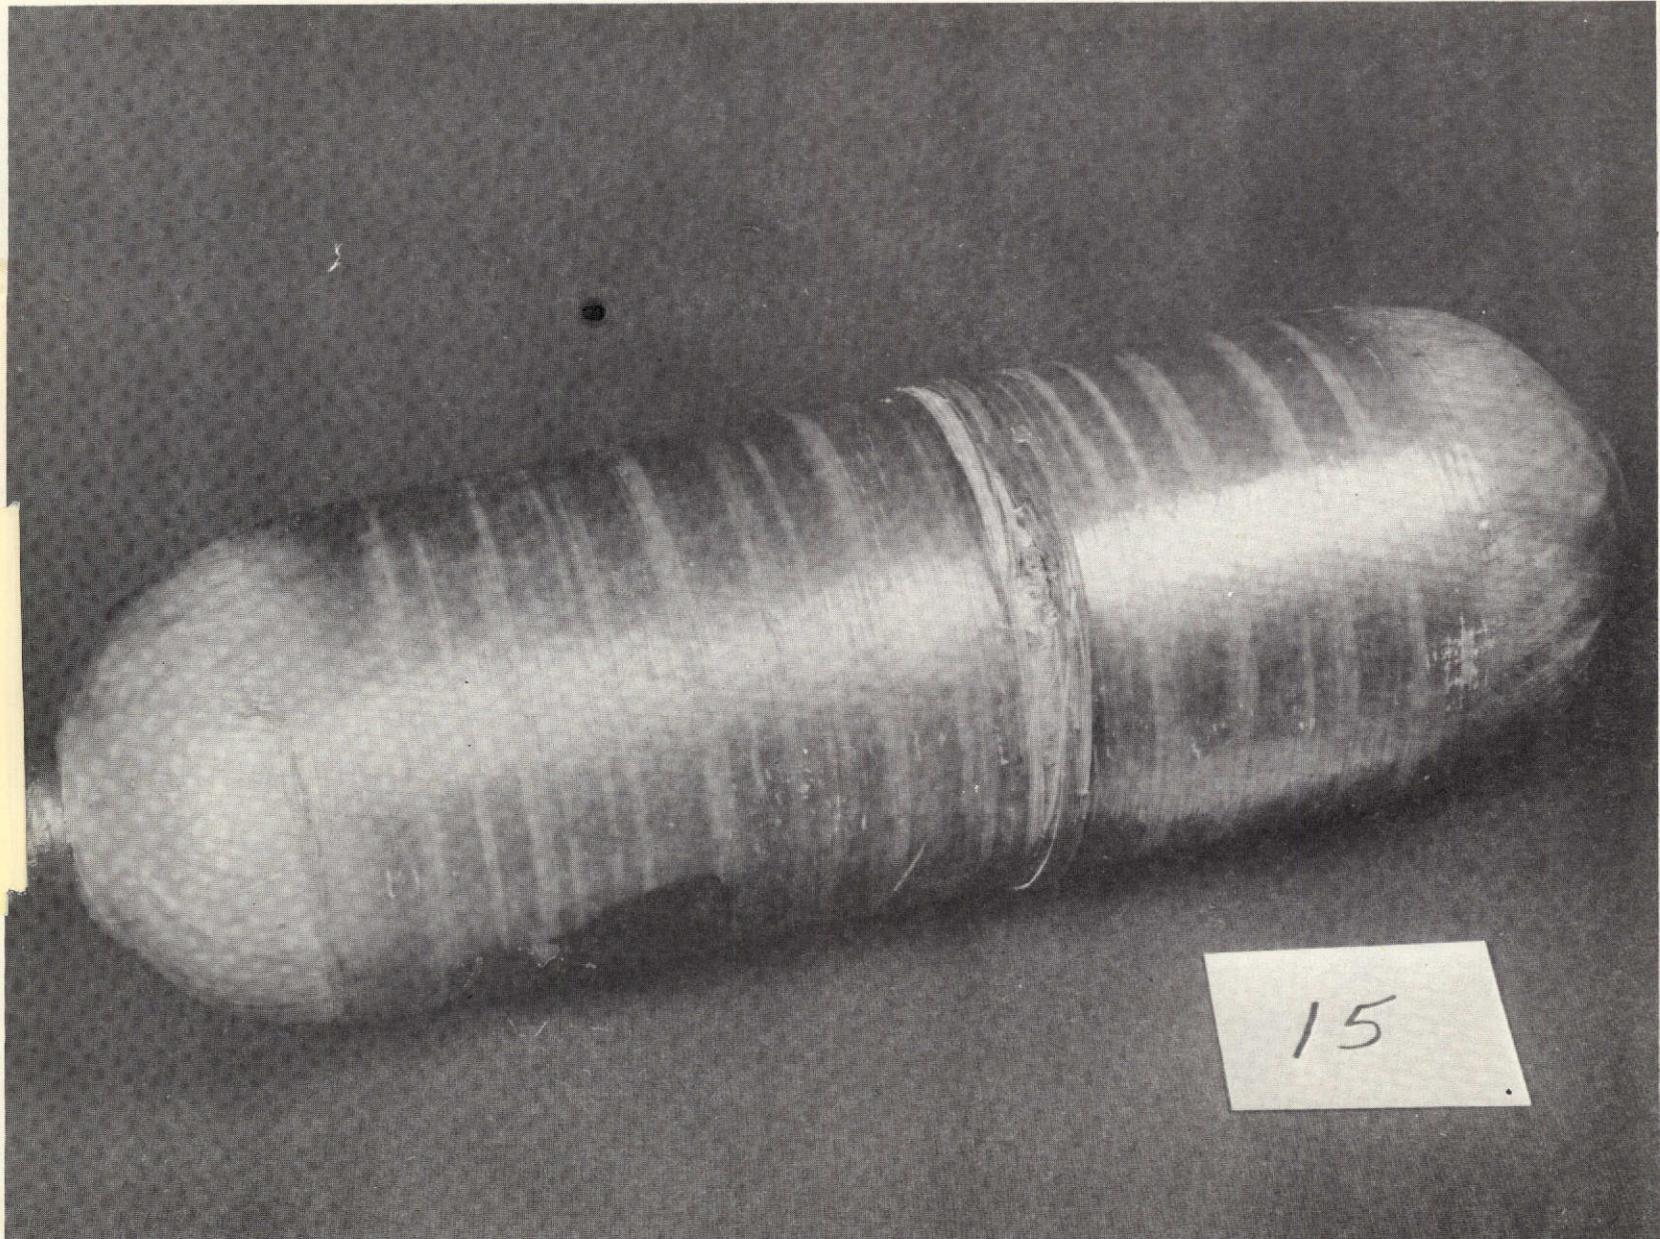
Figure B-11 Drop Test Setup

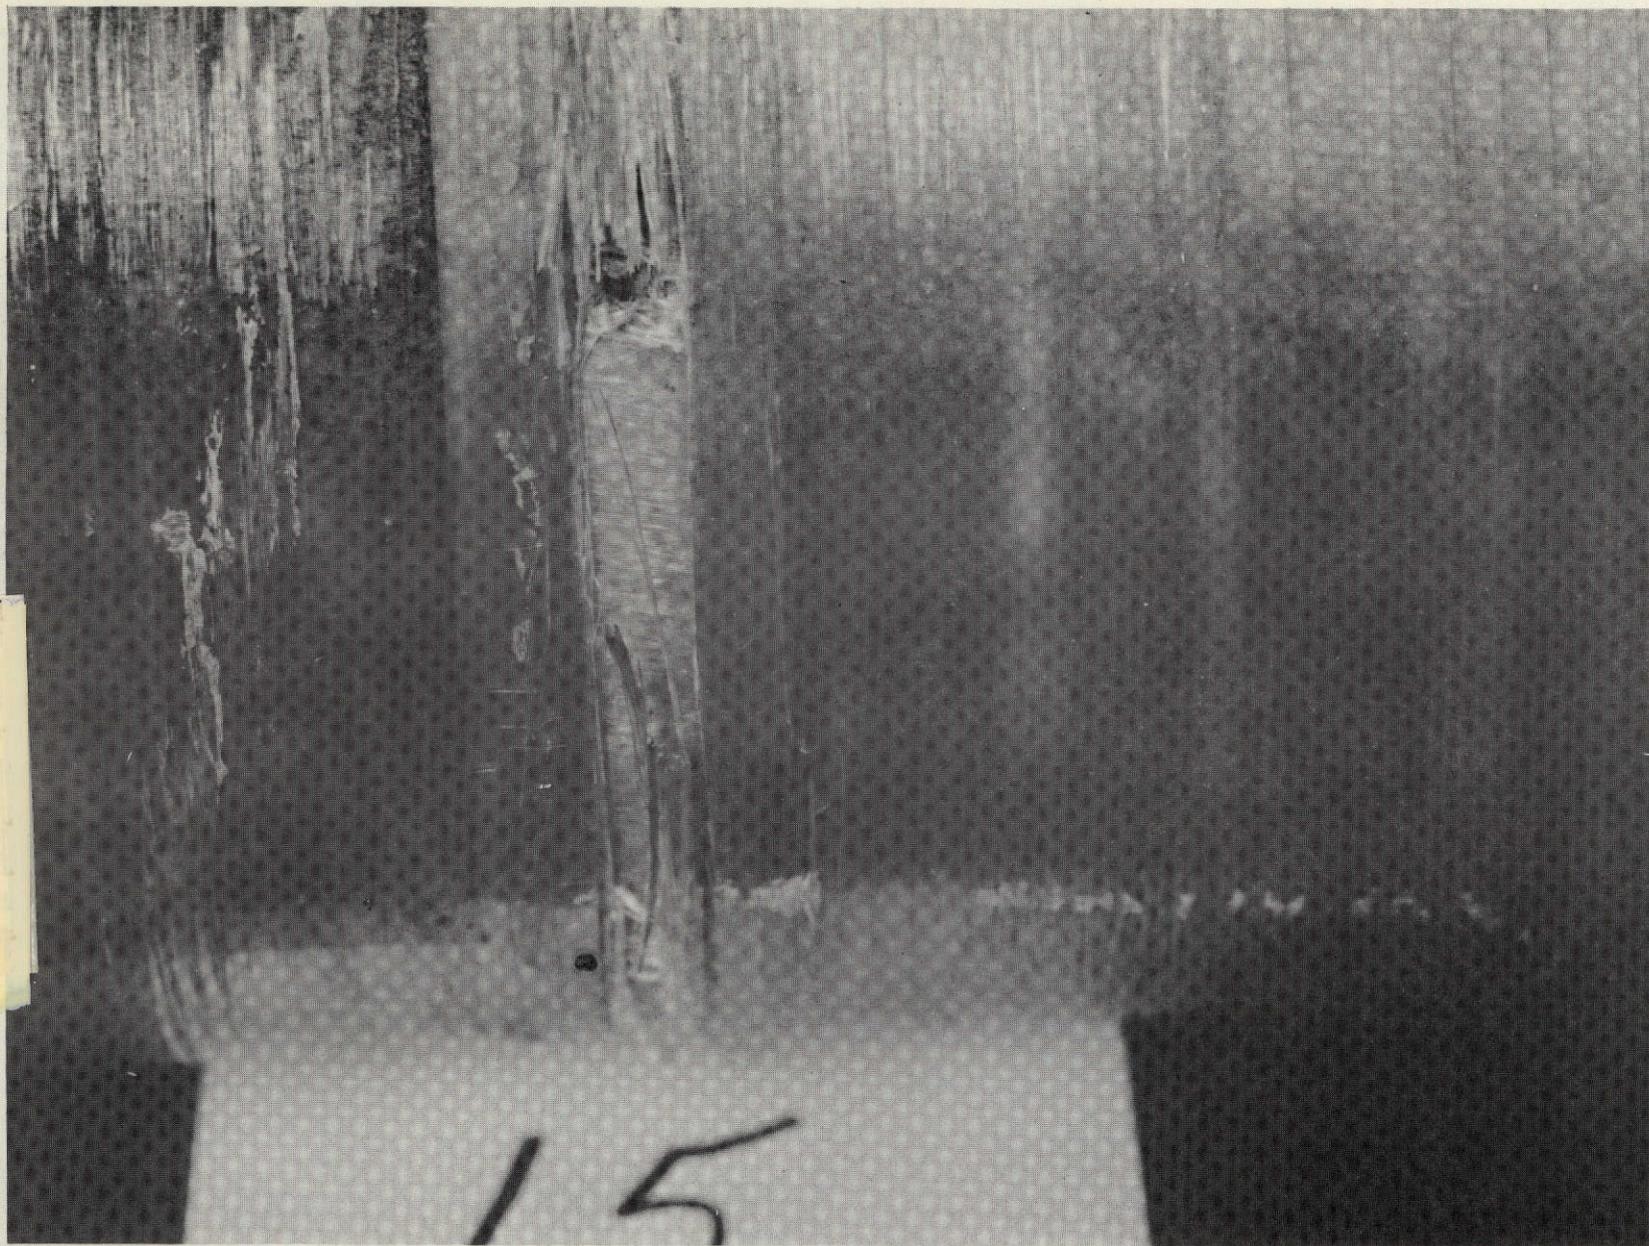
Figure B-12 Vessel S/N 15 Bullet Entry Hole

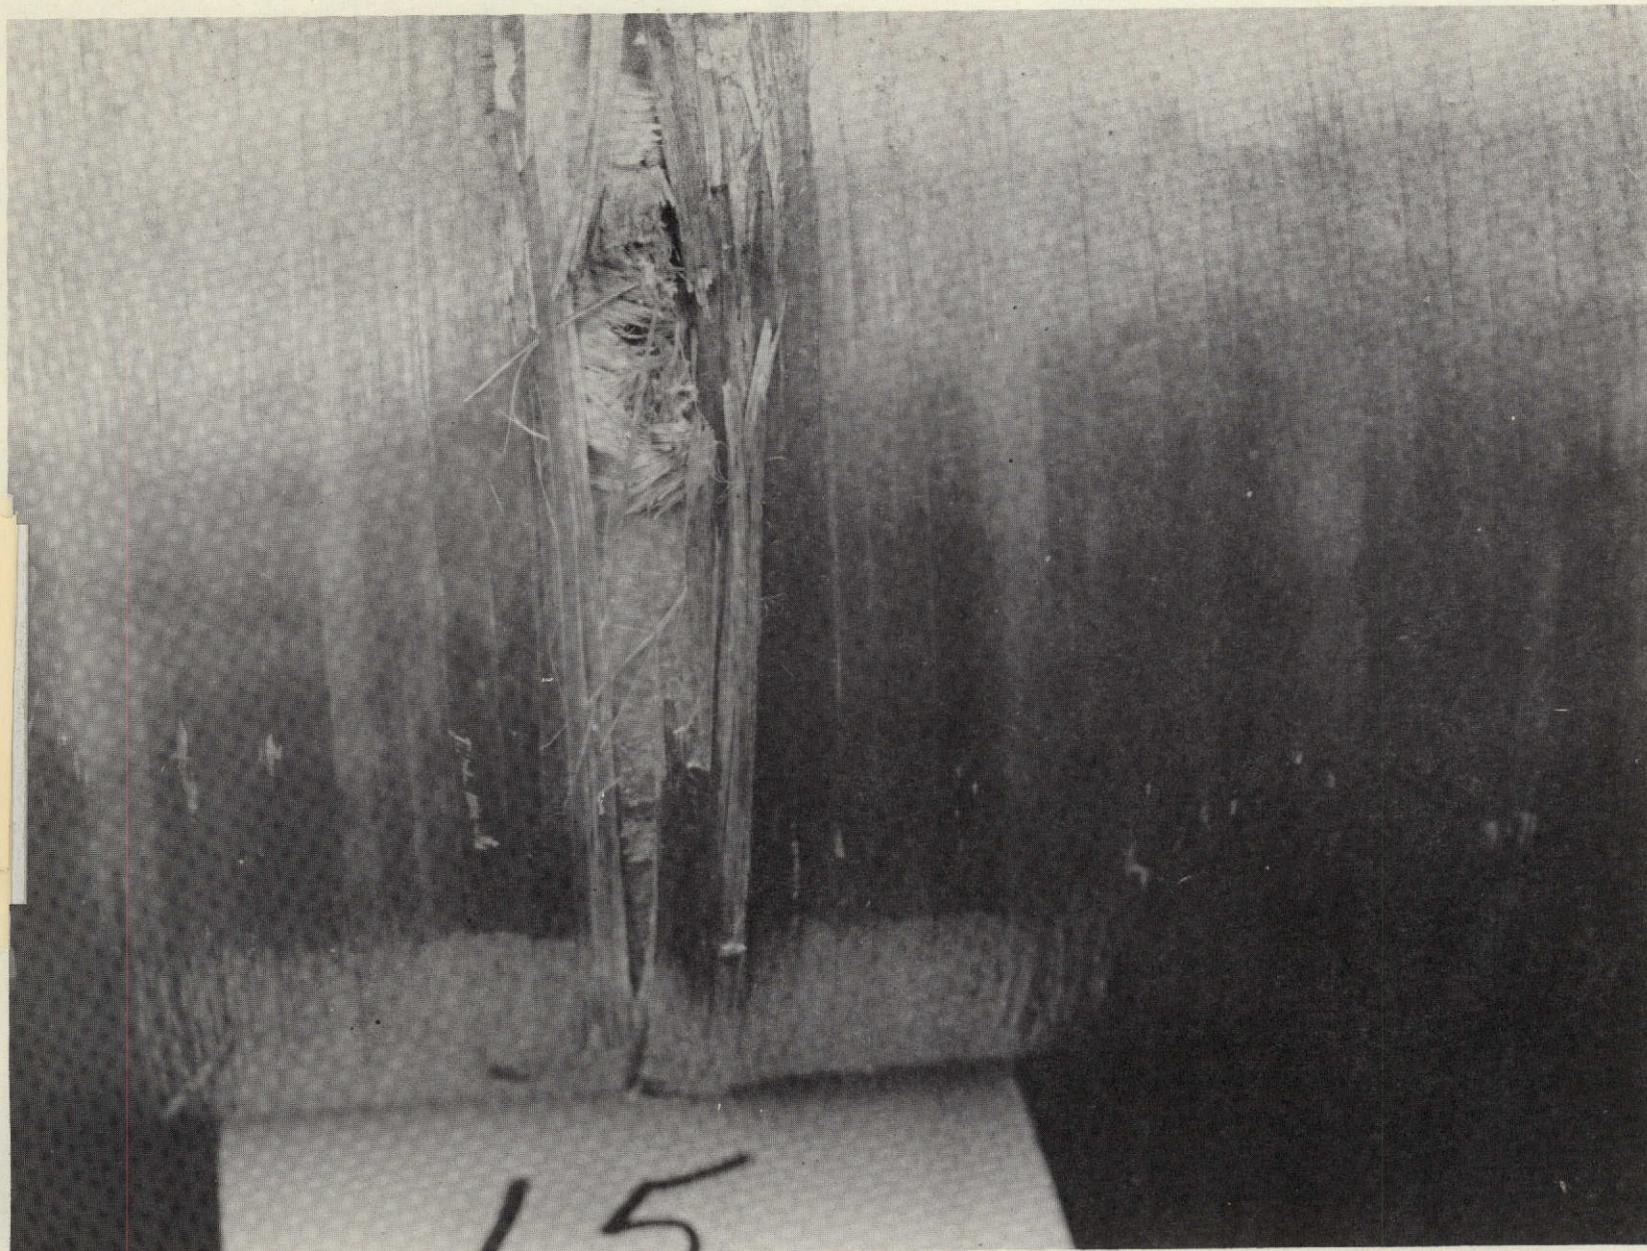
Figure B-13 Vessel S/N 15 Bullet Exit Hole

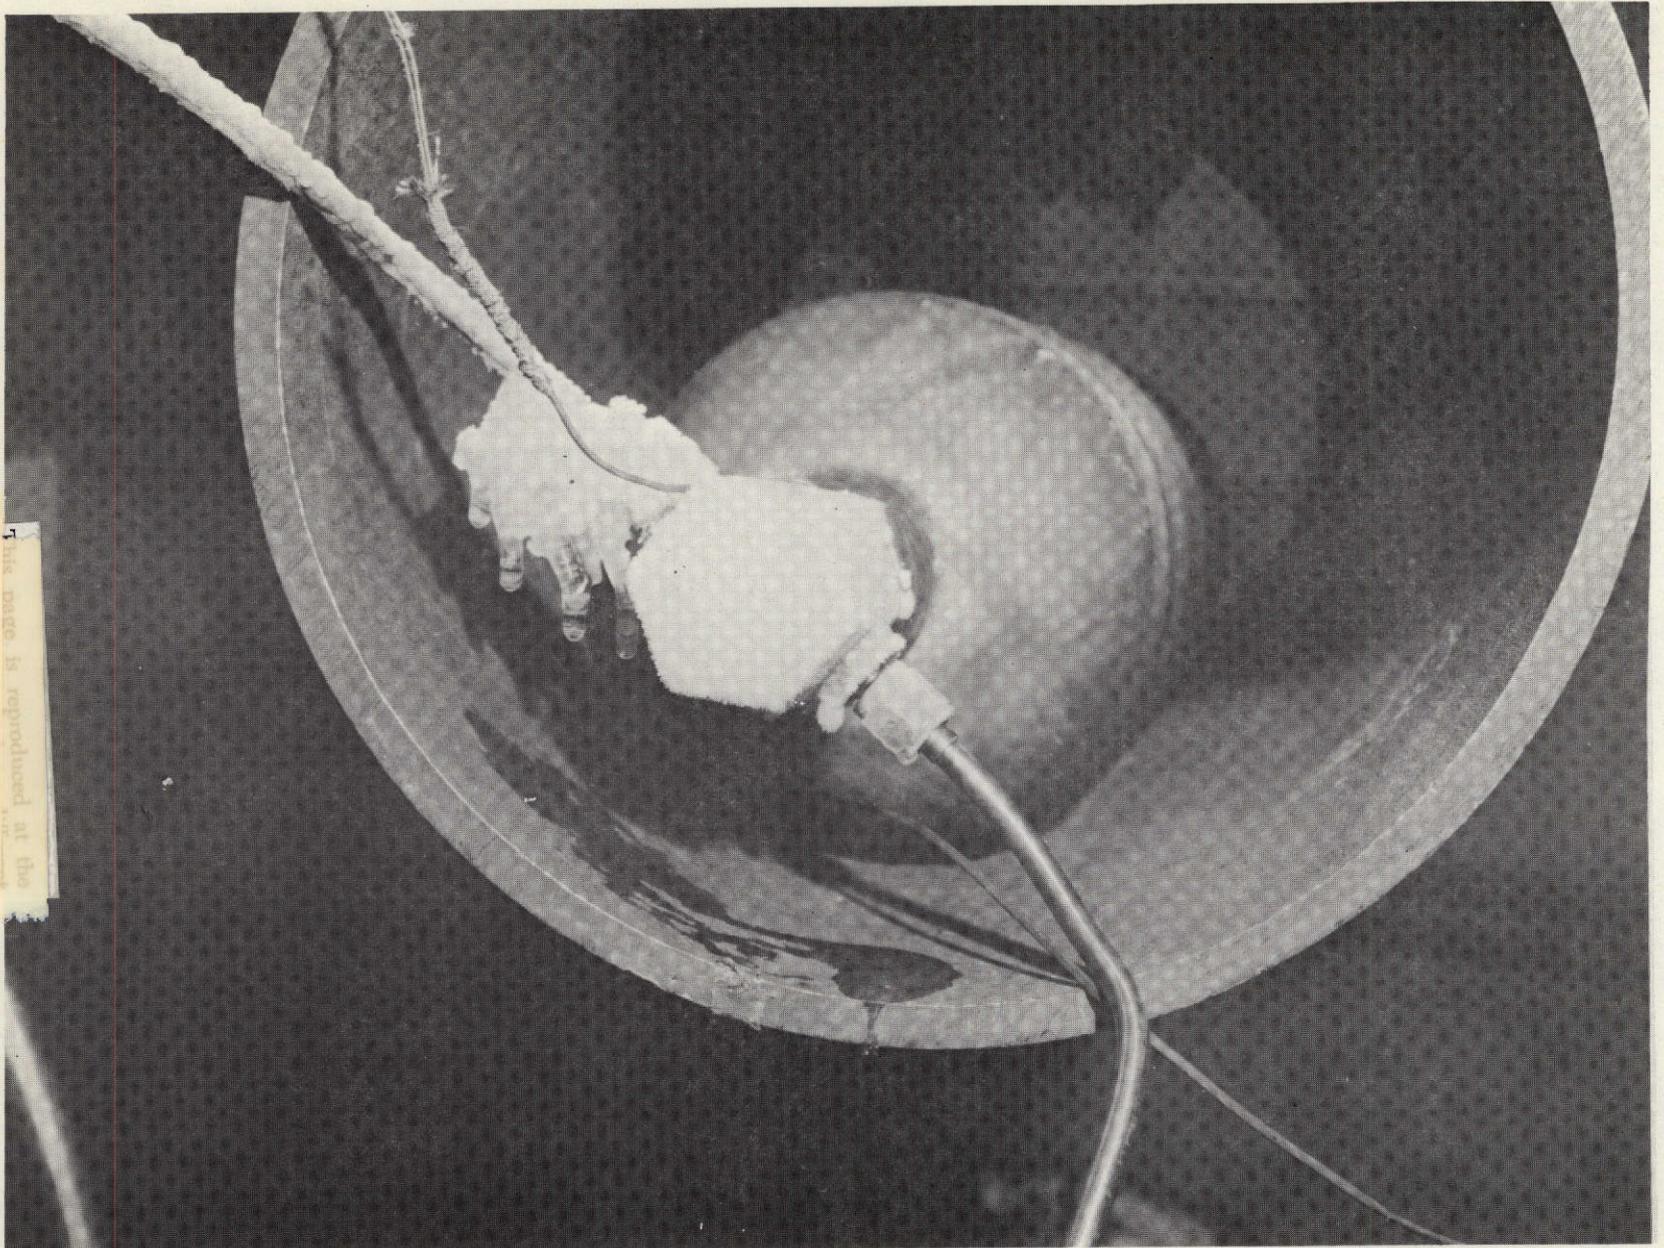
Figure B-14 Flow Growth Test Setup

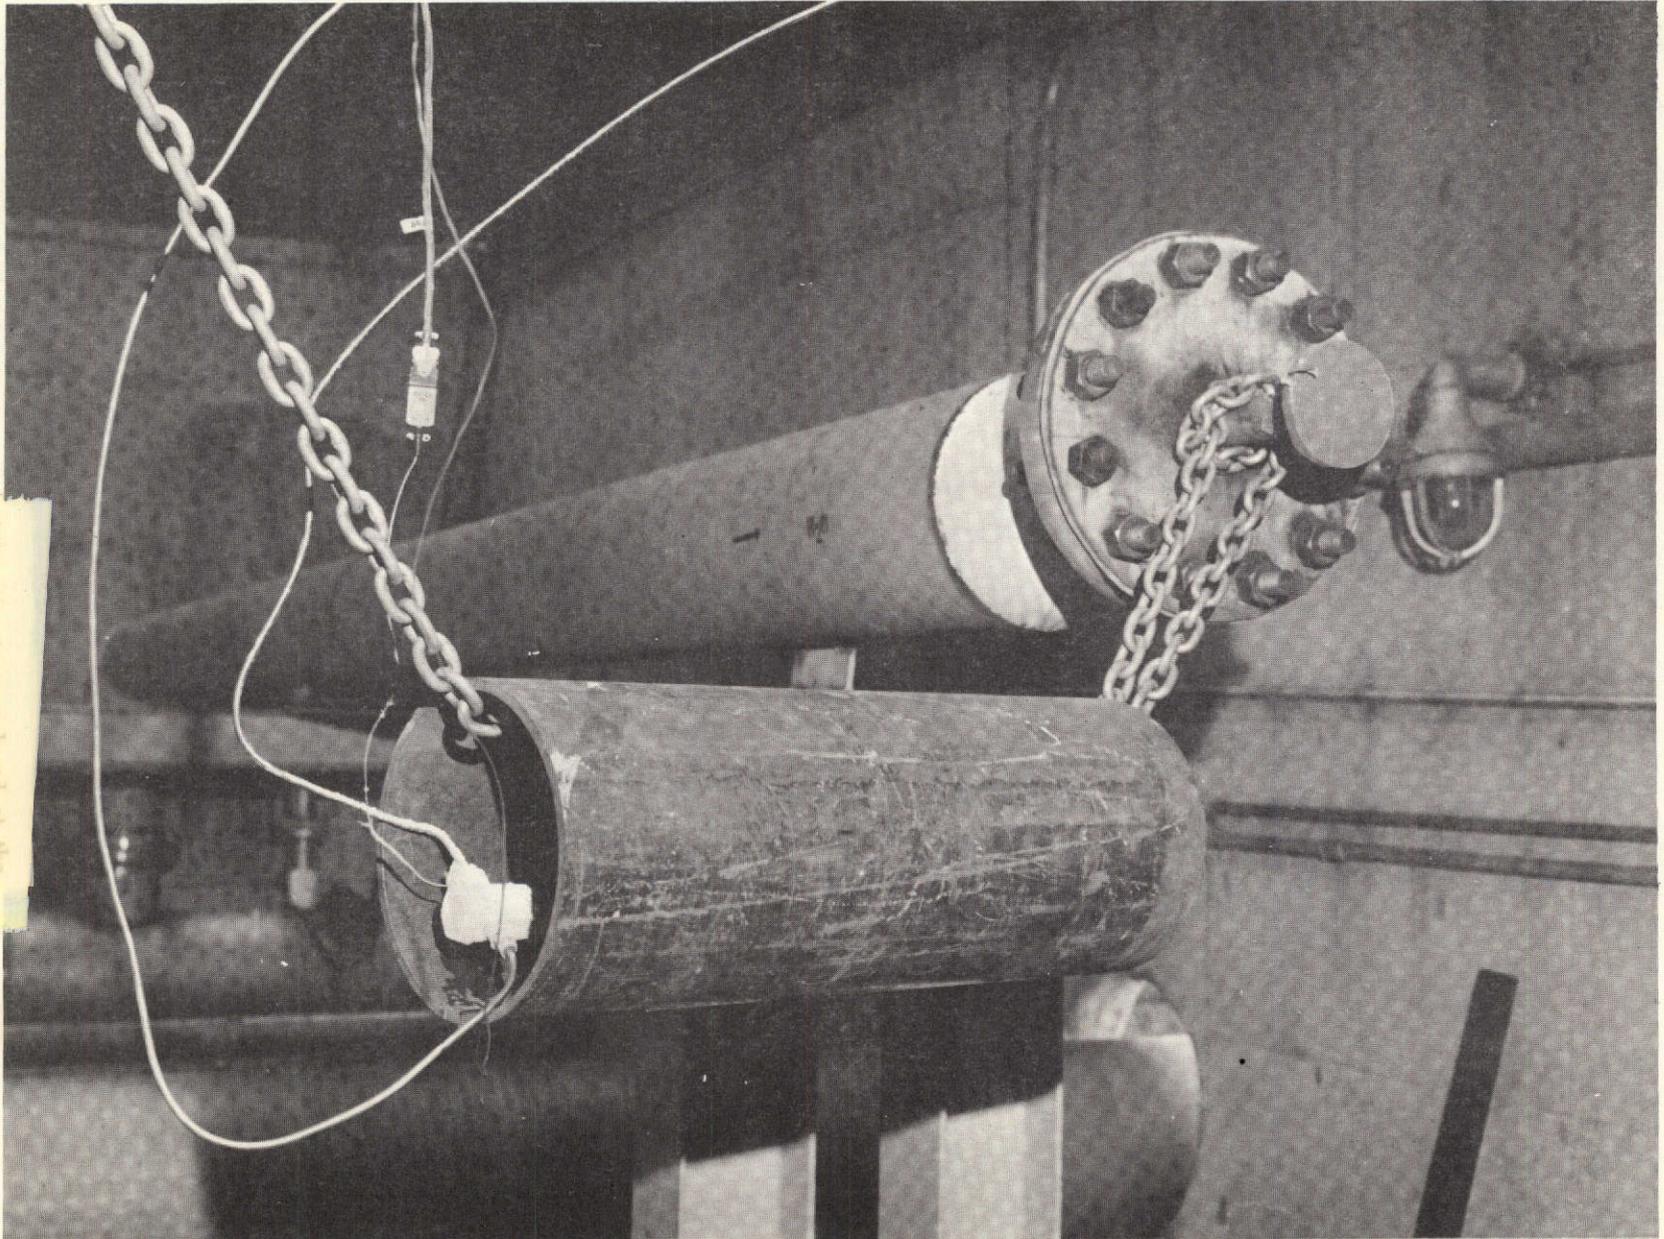
Figure B-15 Flaw Growth Test Setup

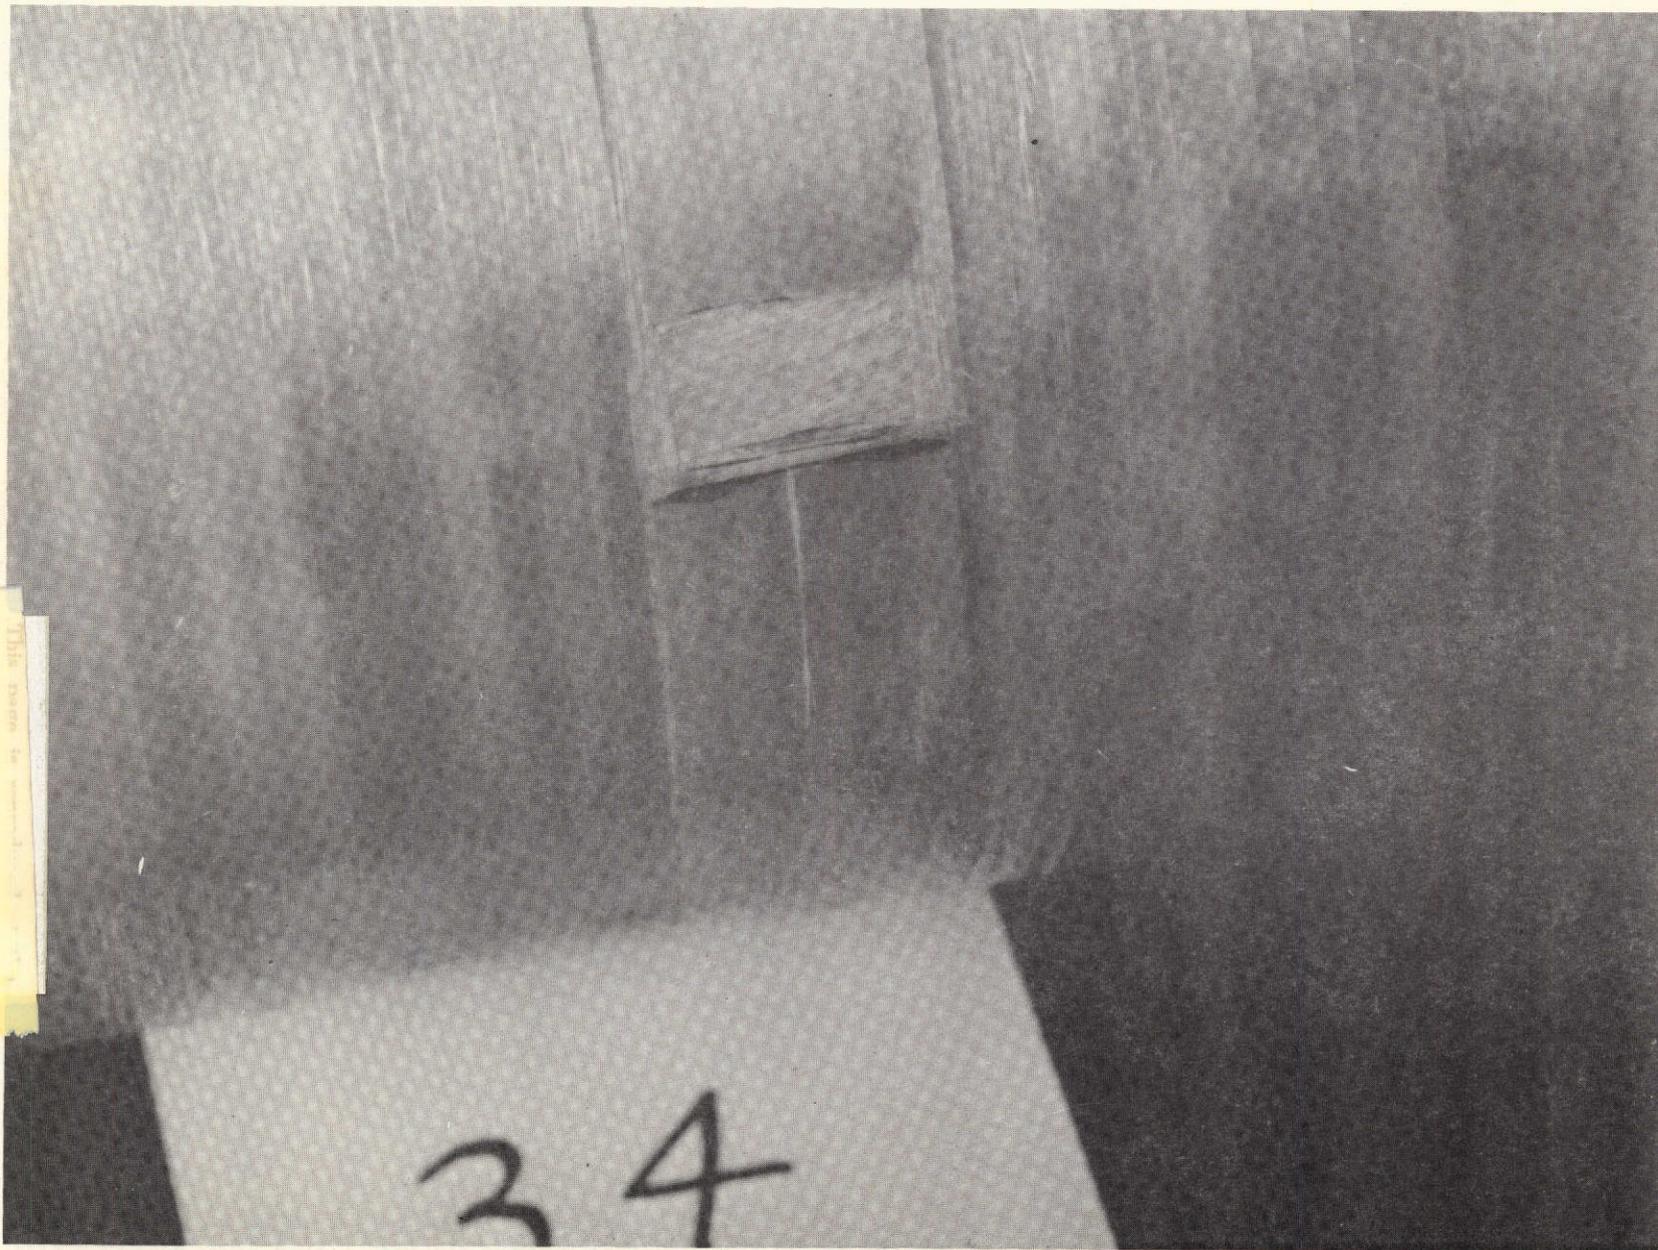
Figure B-16 Vessel S/N 34 Induced Flow After Cycling

The vessel successfully completed the 1000 pneumatic operating cycles with no evidence of damage or degradation. The major induced flaw after cycling is shown in Figure B-16. During the burst test the vessel ruptured in the upper dome at 12,200 psig due to a glass failure and two liner pieces (6-in.<sup>2</sup> and 3-in.<sup>2</sup>) were not contained by the glass wrap. The test data is included in Table B-31. Photographs of the test setup are shown in Figures B-5 and B-6, and a photograph of the ruptured vessel is shown in Figure B-17.
