NASA CR-134384

Final Report

# Firefighter's Compressed Air Breathing System Pressure Vessel Development Program

MARTIN MARIETTA CORPORATION  
P. O. Box 179  
Denver, Colorado 80201

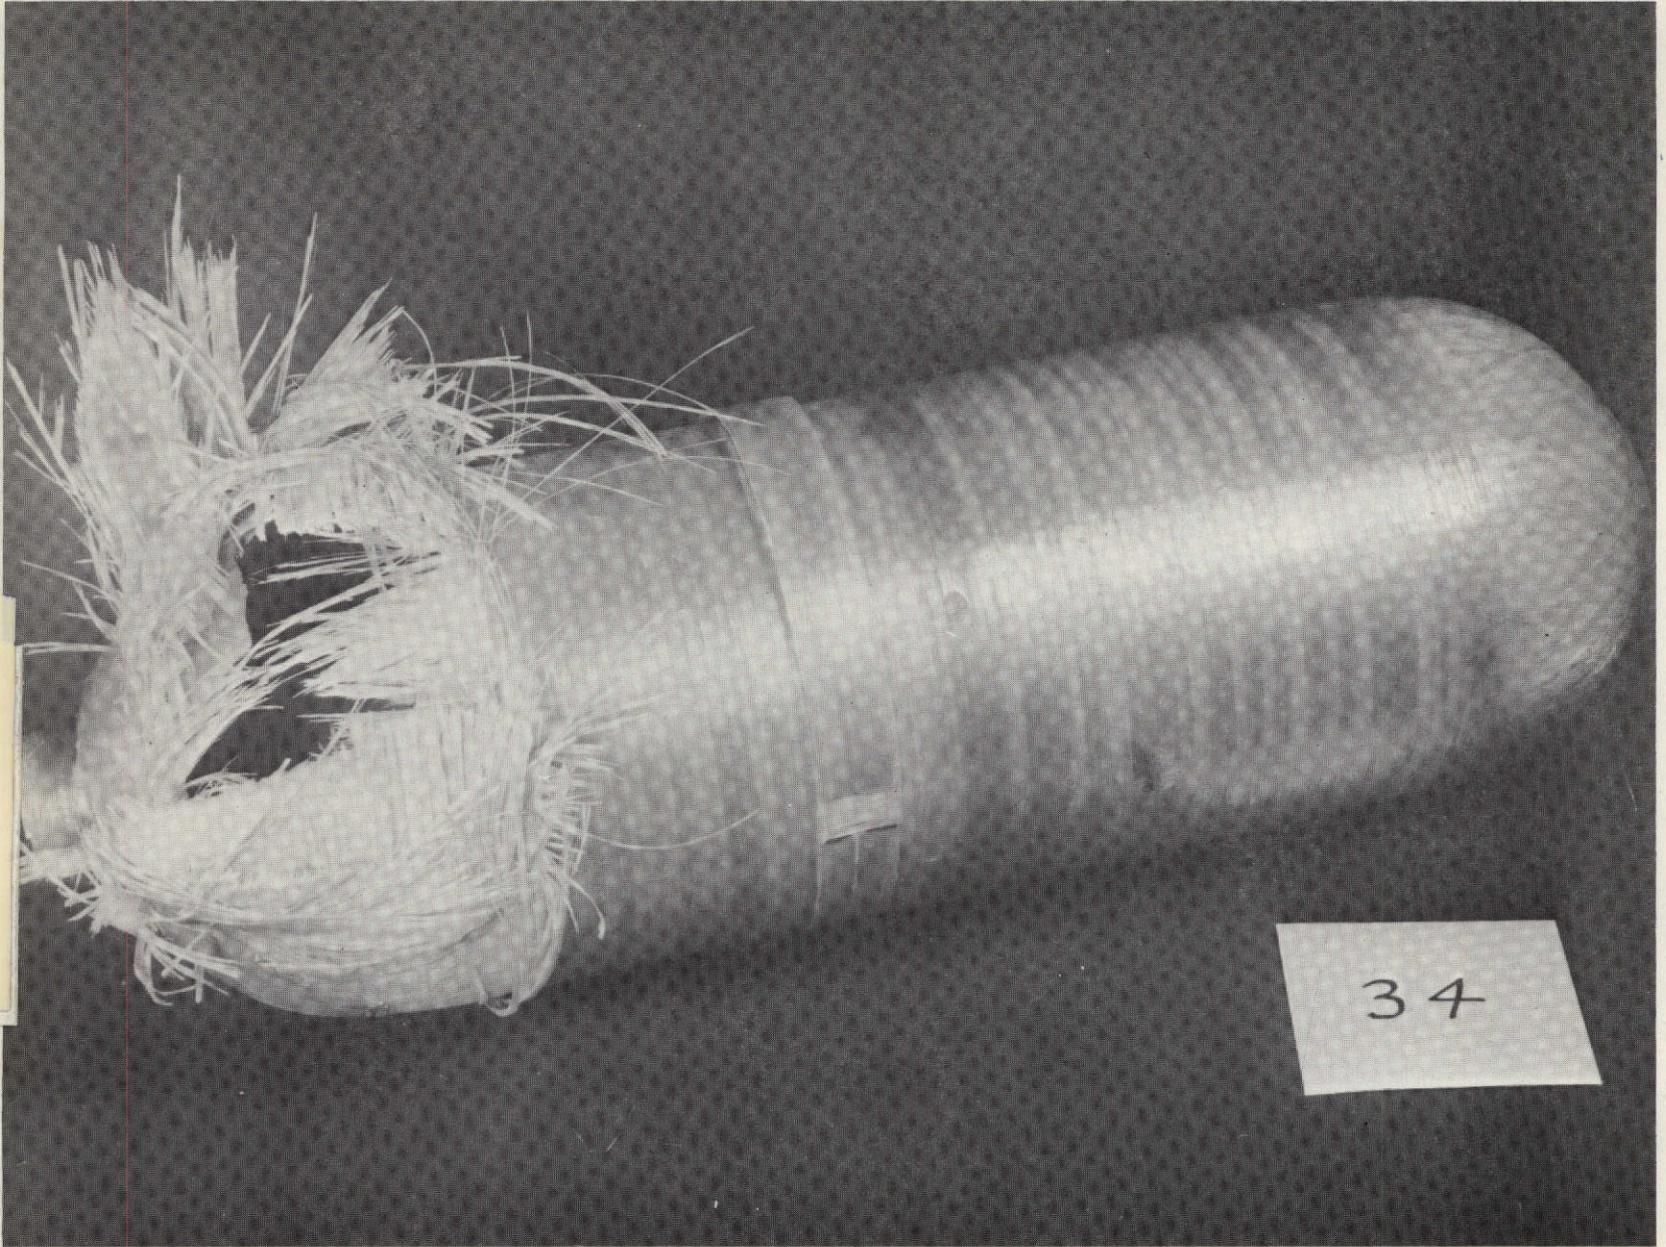
Figure B-17 Vessel S/N 34 After Burst Test

The vessel successfully completed the 1000 pneumatic operating cycles with no evidence of damage or degradation. The major induced flaw after cycling is shown in Figure B-16. During the burst test the vessel ruptured in the upper dome at 12,200 psig due to a glass failure and two liner pieces (6-in.<sup>2</sup> and 3-in.<sup>2</sup>) were not contained by the glass wrap. The test data is included in Table B-31. Photographs of the test setup are shown in Figures B-5 and B-6, and a photograph of the ruptured vessel is shown in Figure B-17.

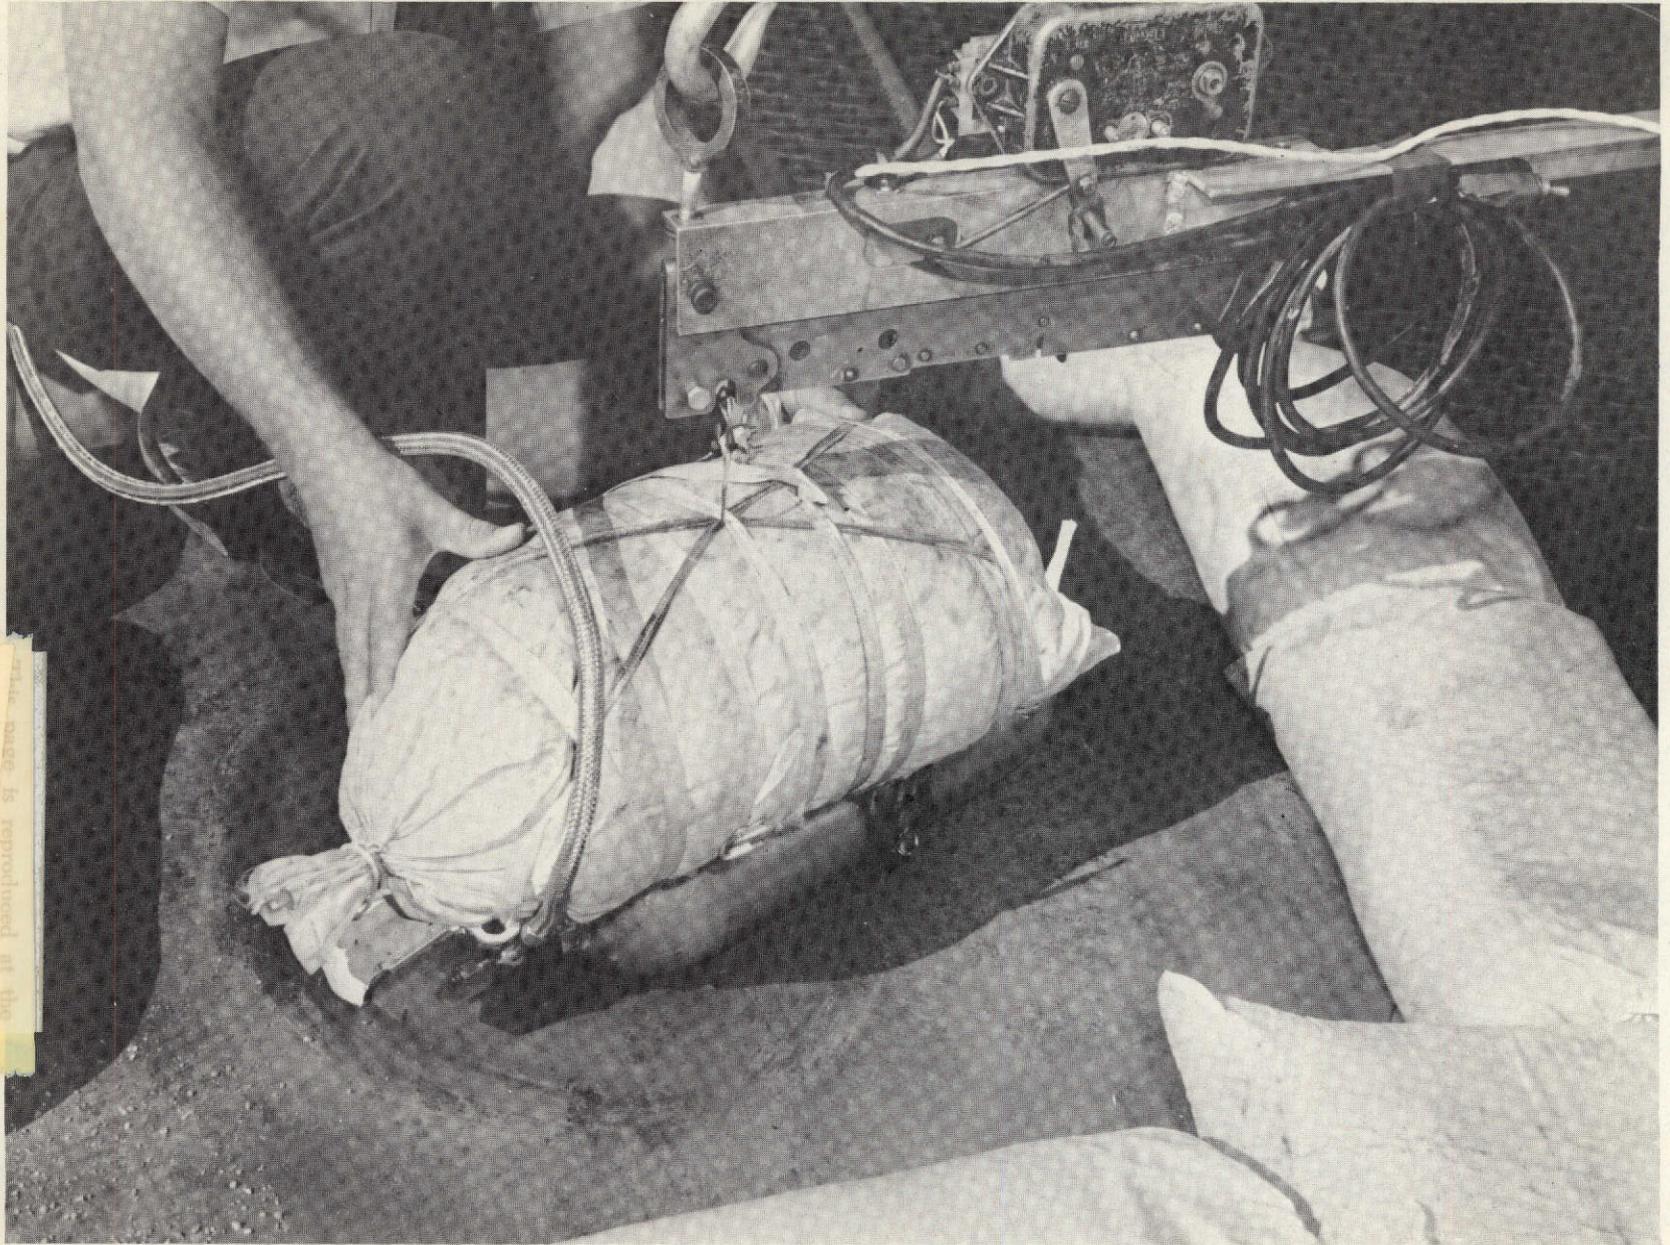
Figure B-18 Drop Test Setup

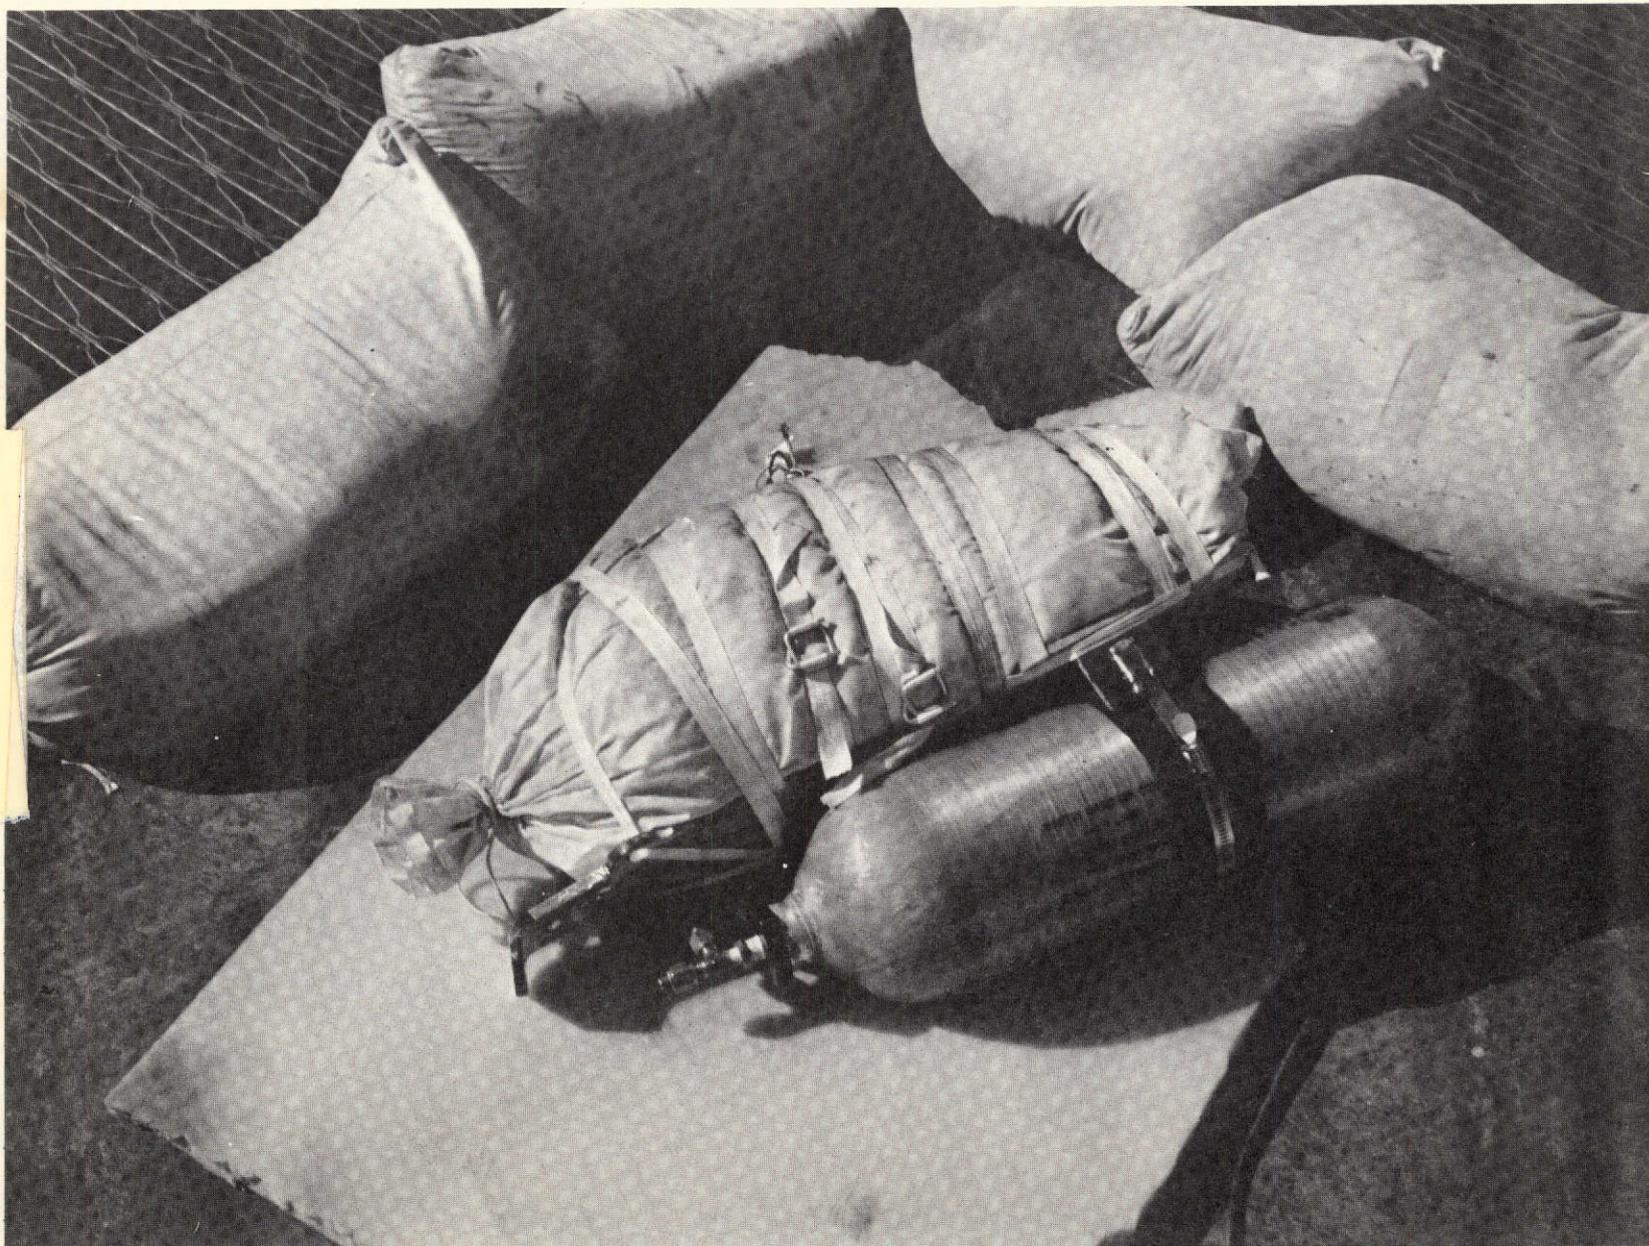
Figure B-19 Drop Test Setup

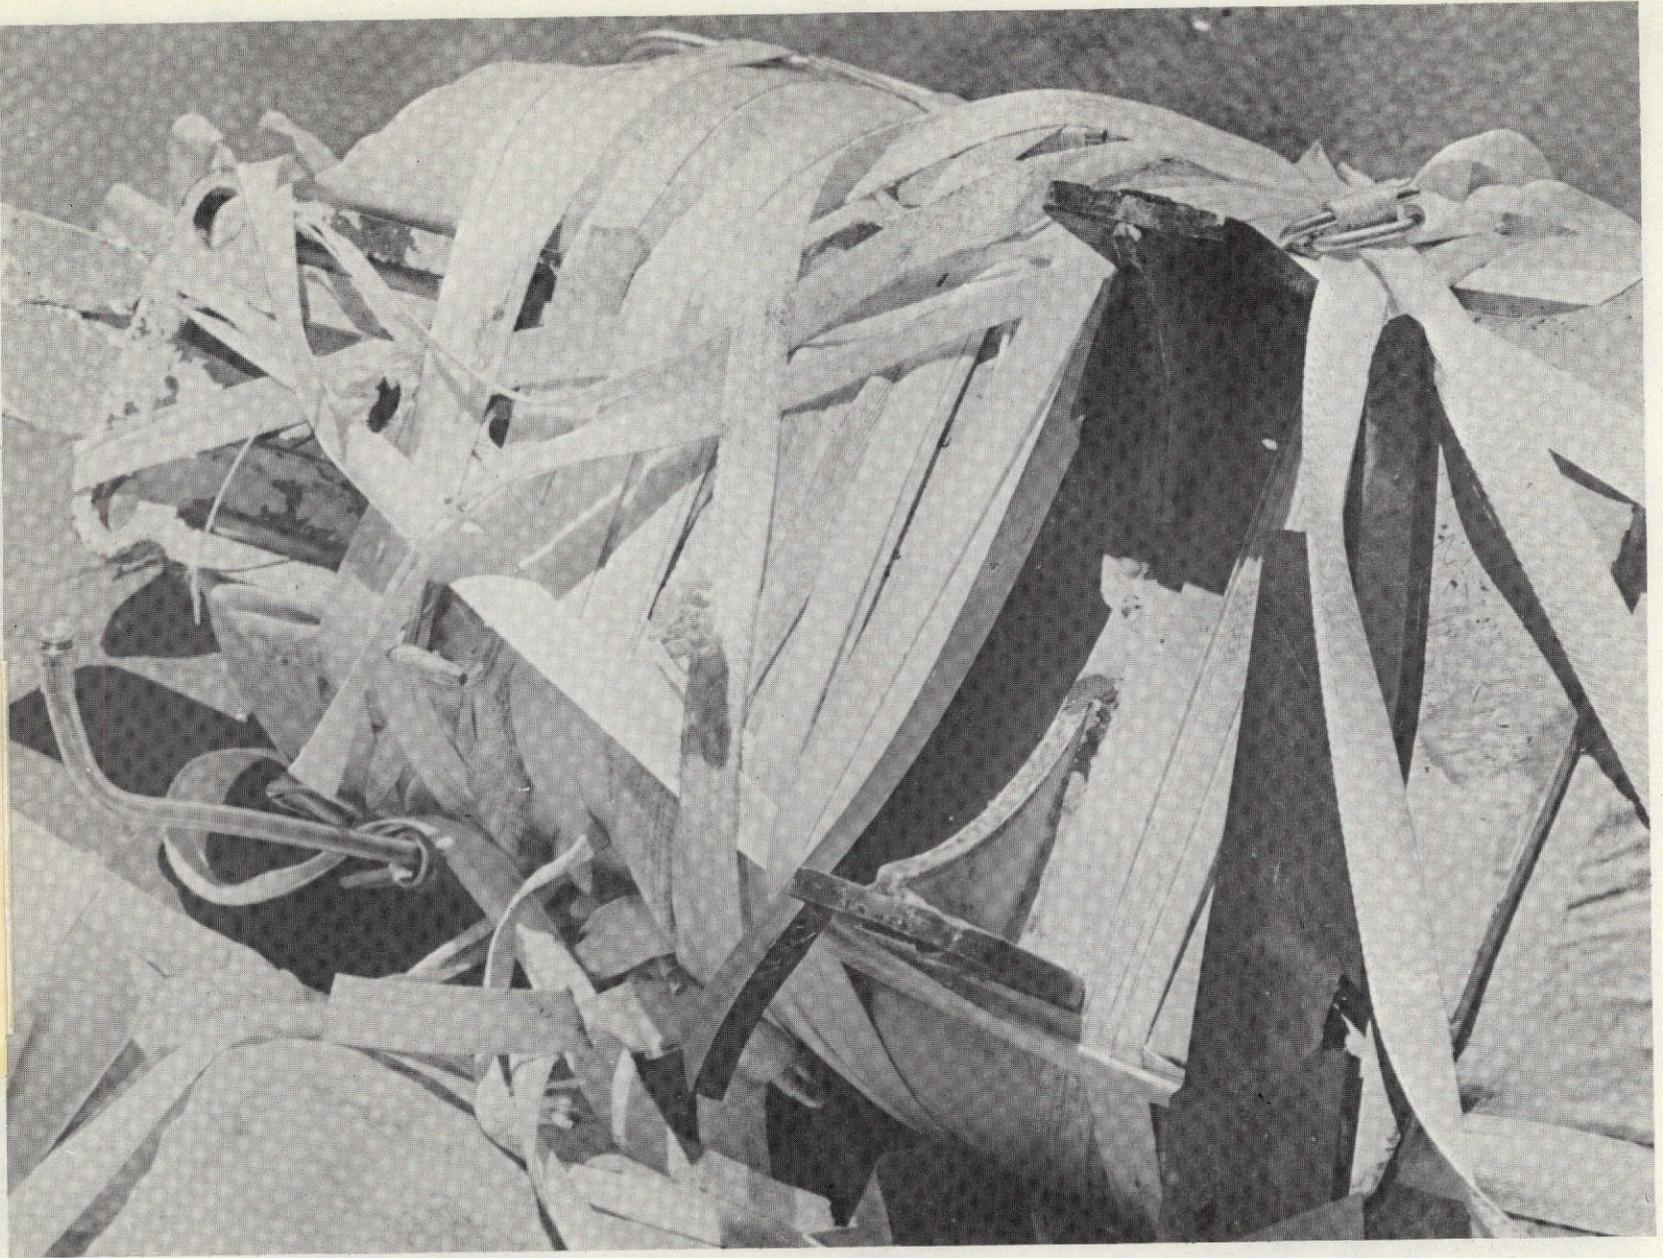
Figure B-20 Drop Test Backpack

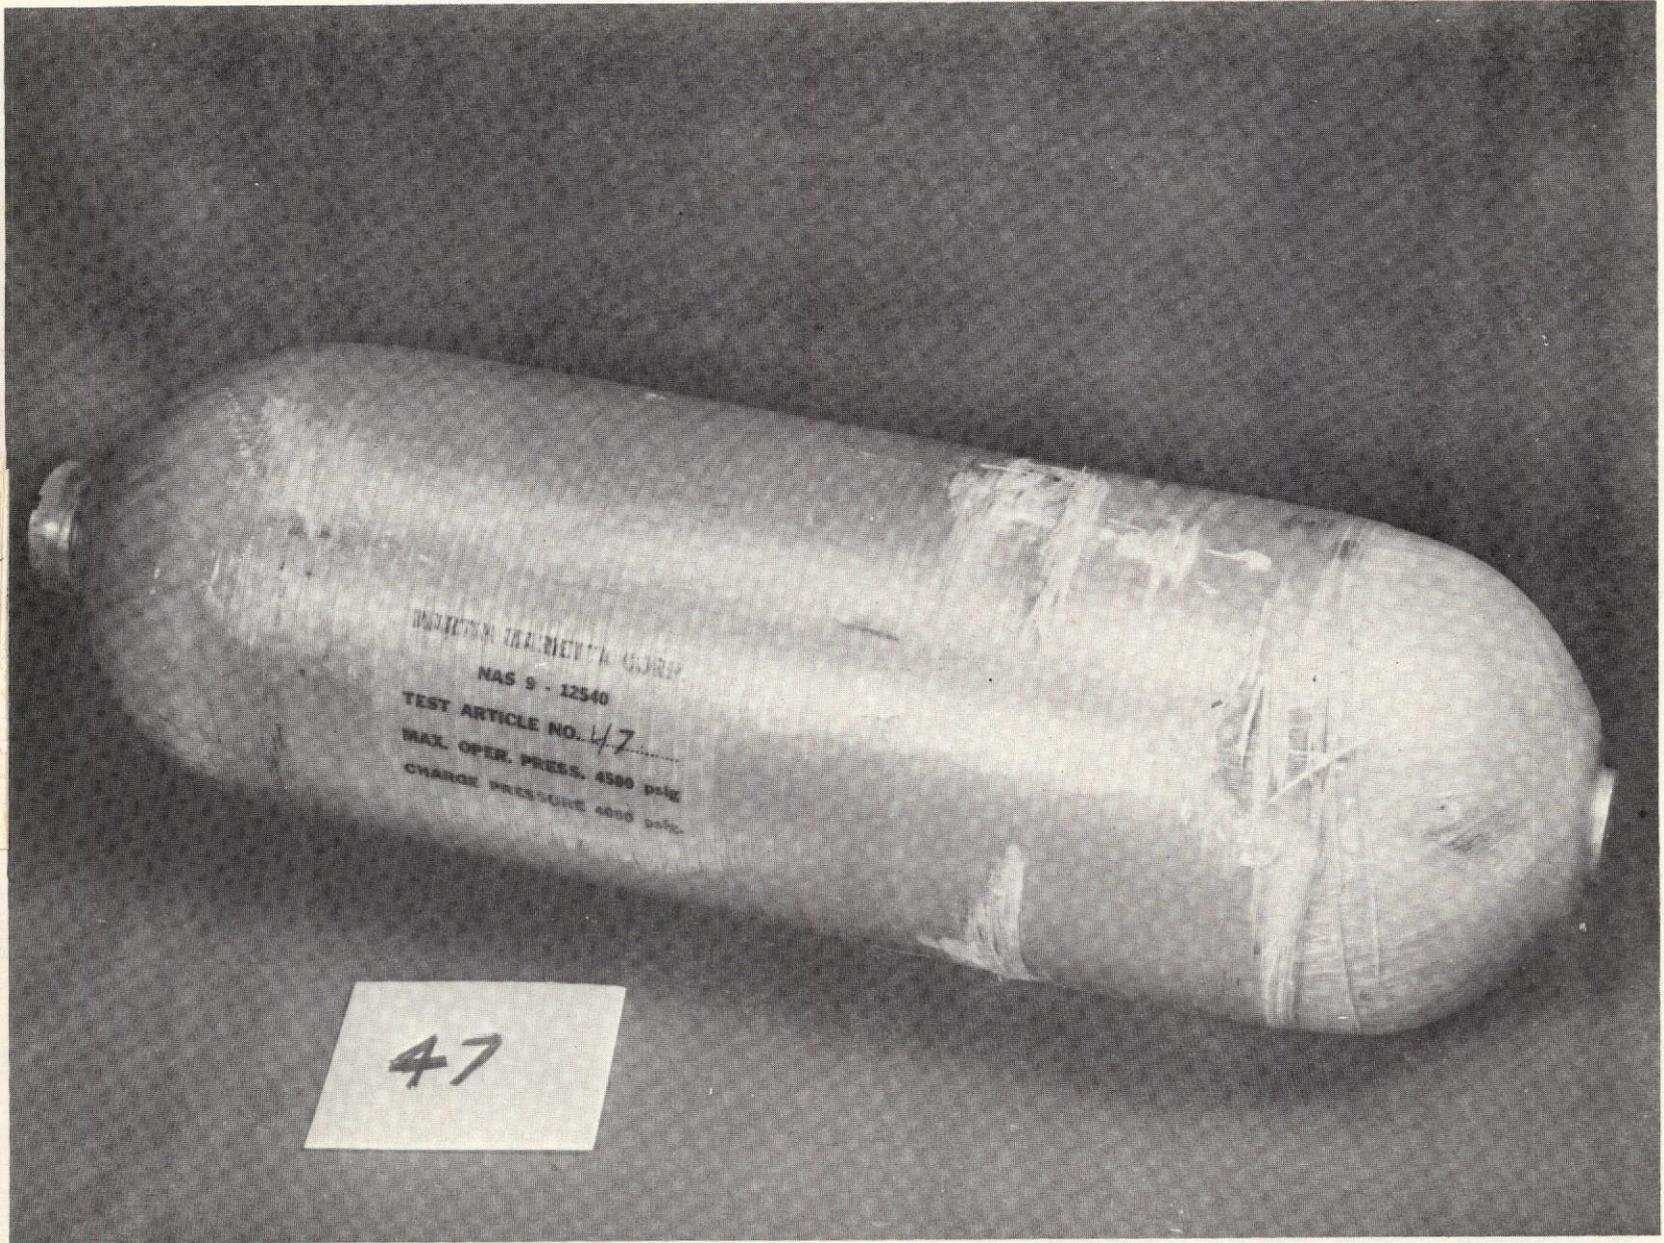
Figure B-21 Vessel S/N 47 After Drop Test

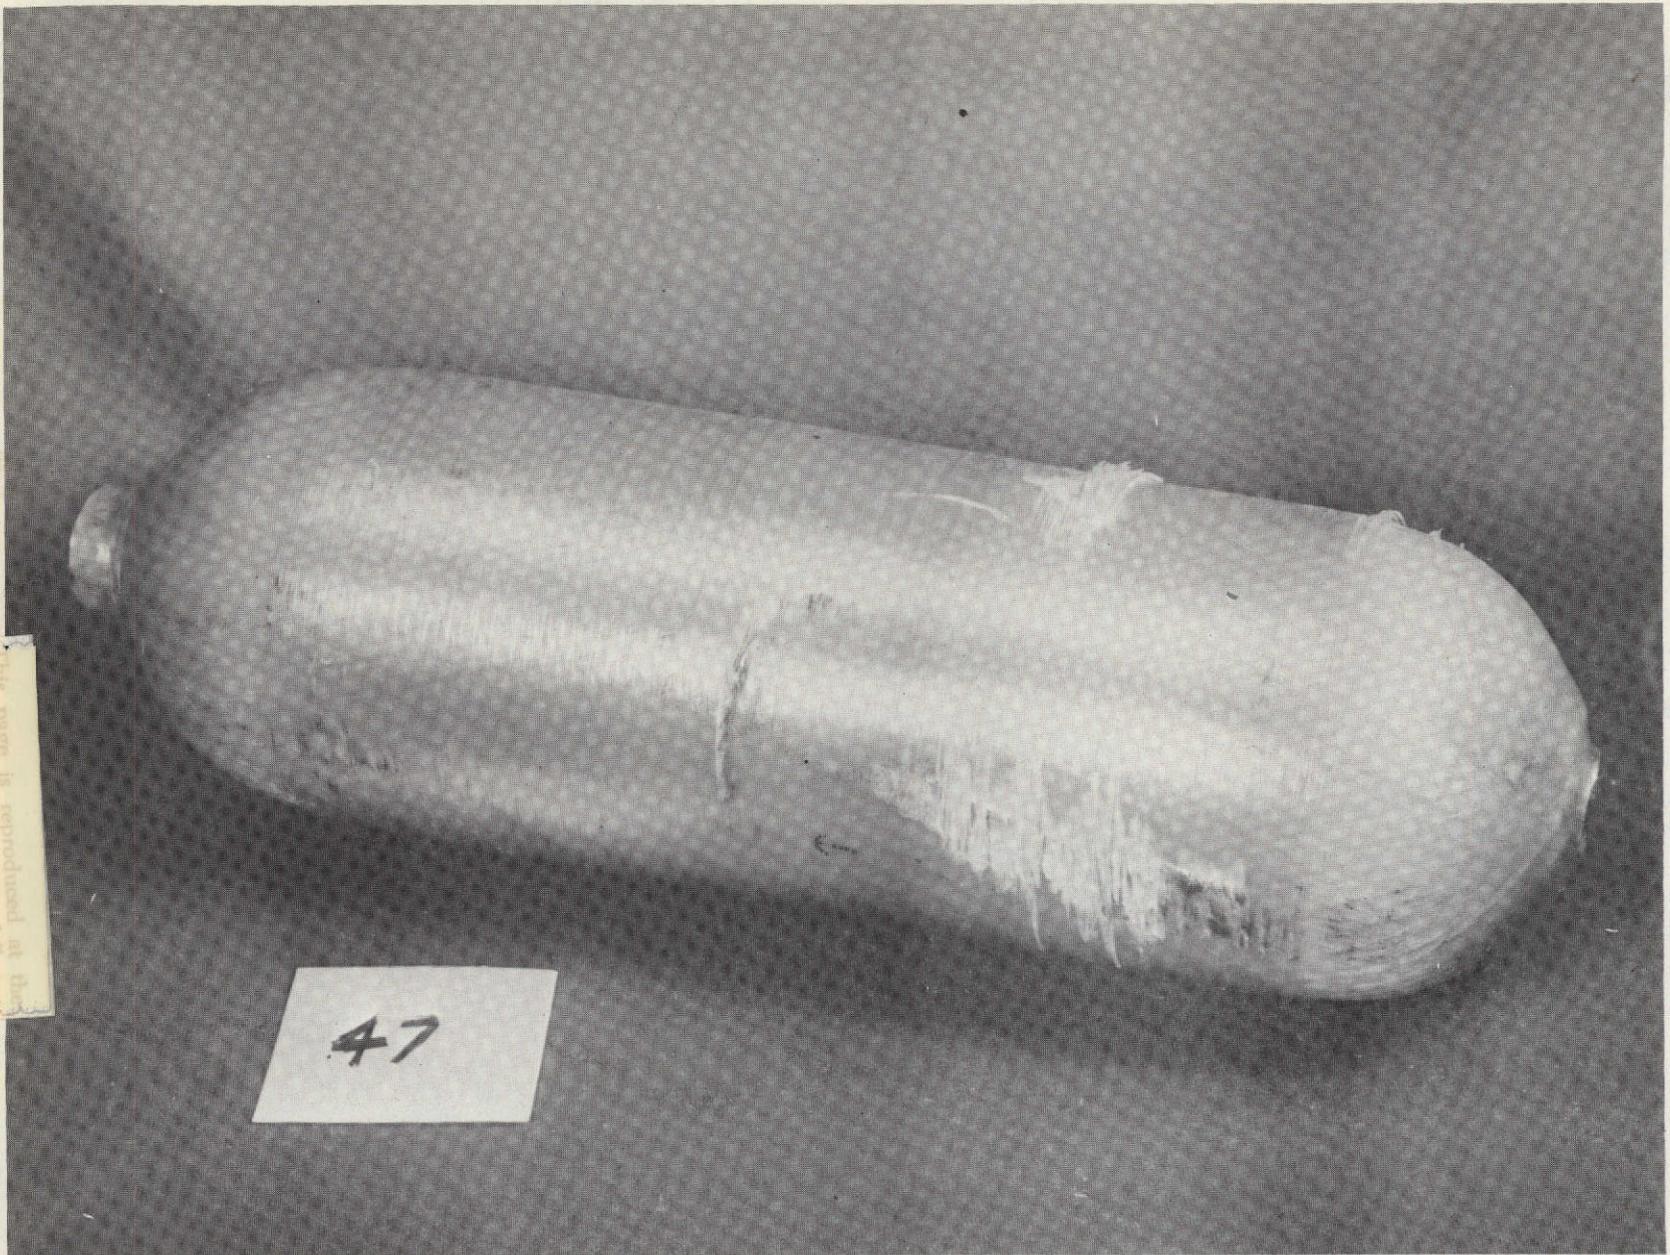
Figure B-22 Vessel S/N 47 After Drop Test

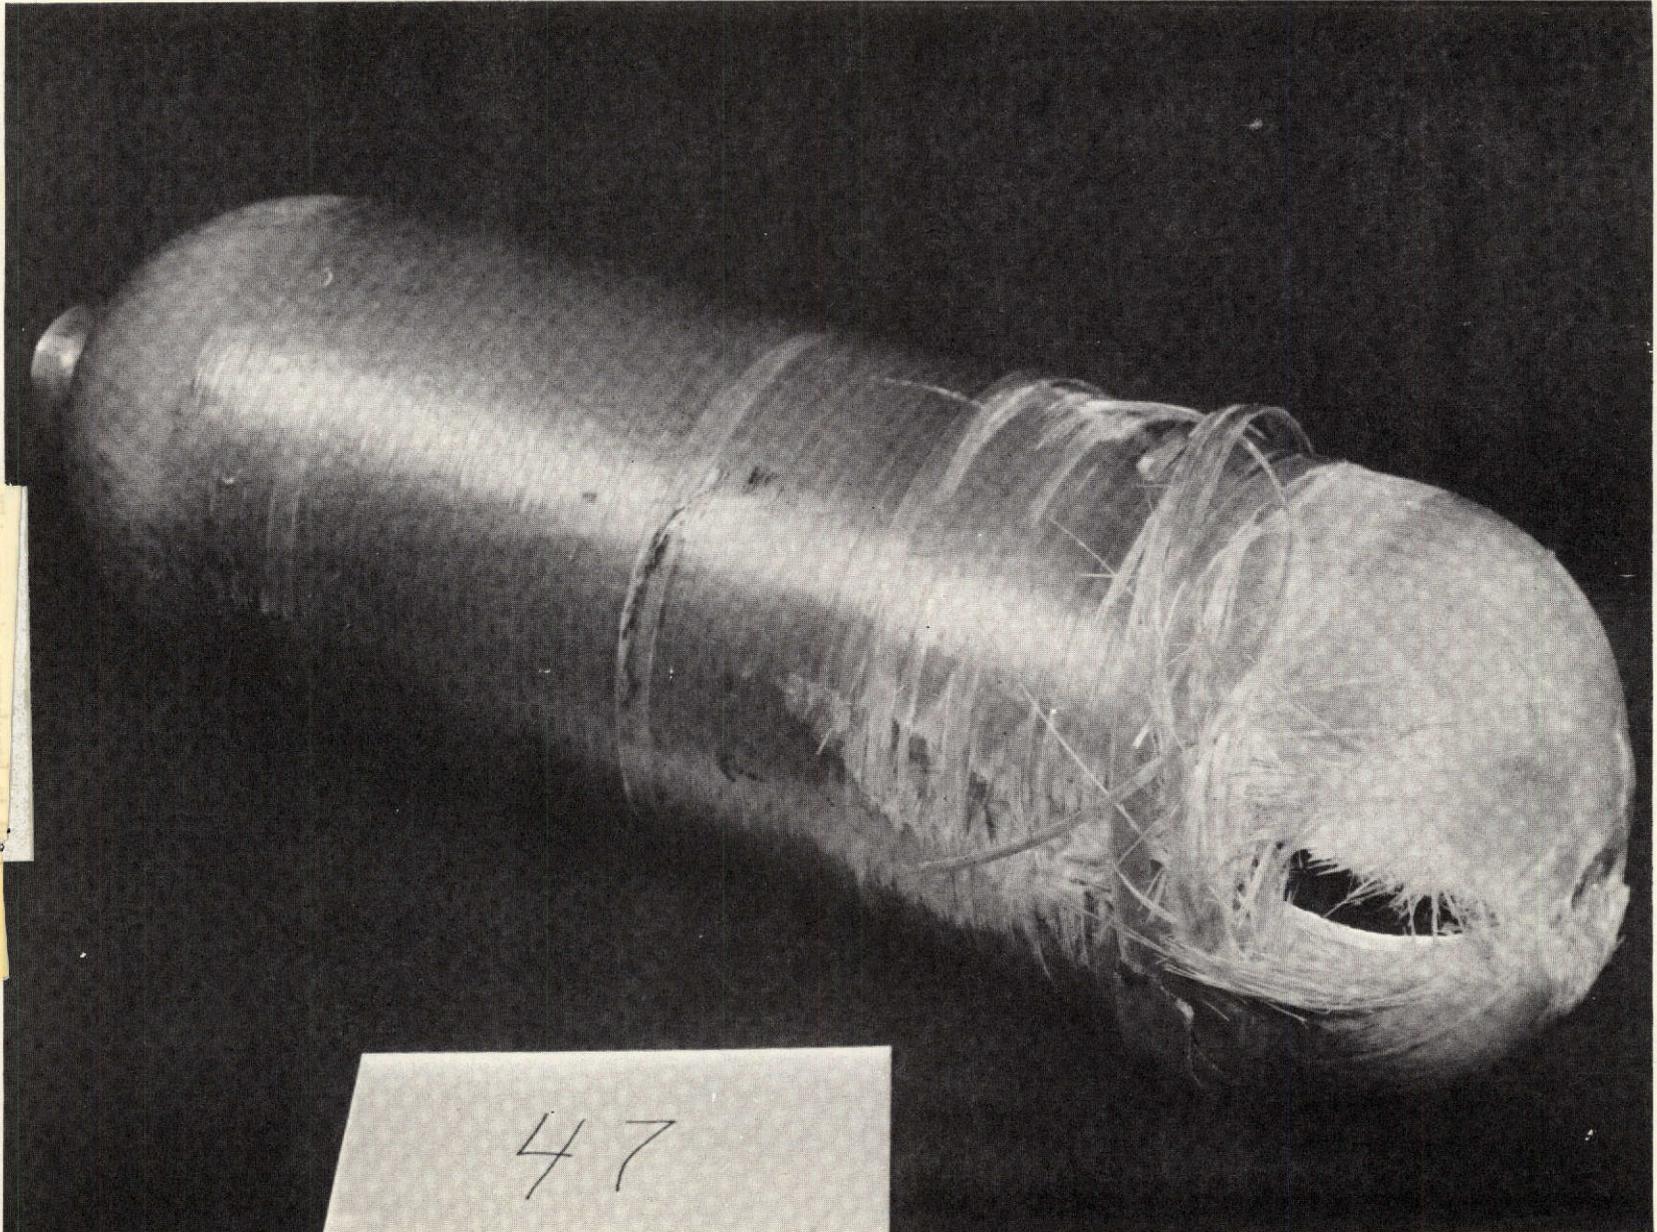
Figure B-23 Vessel S/N 47 After Burst Test

The test data sheet is included as Table B-33. A photograph of the vessel after rupture is shown in Figure B-23.

Parameter	Allowable	Actual
Burst Pressure	8900 psig min	10,200
Volume Increase Enter Burette readings at pressure 100 prior to pressurization 248 difference 148 cc (volume increase)	N/A	148 cc
Failure Mode	N/A	(All of liner contained with- in glass.
Other Observations	N/A	Failure origin was at point of severe glass damage at inter- section of barrel and lower dome.

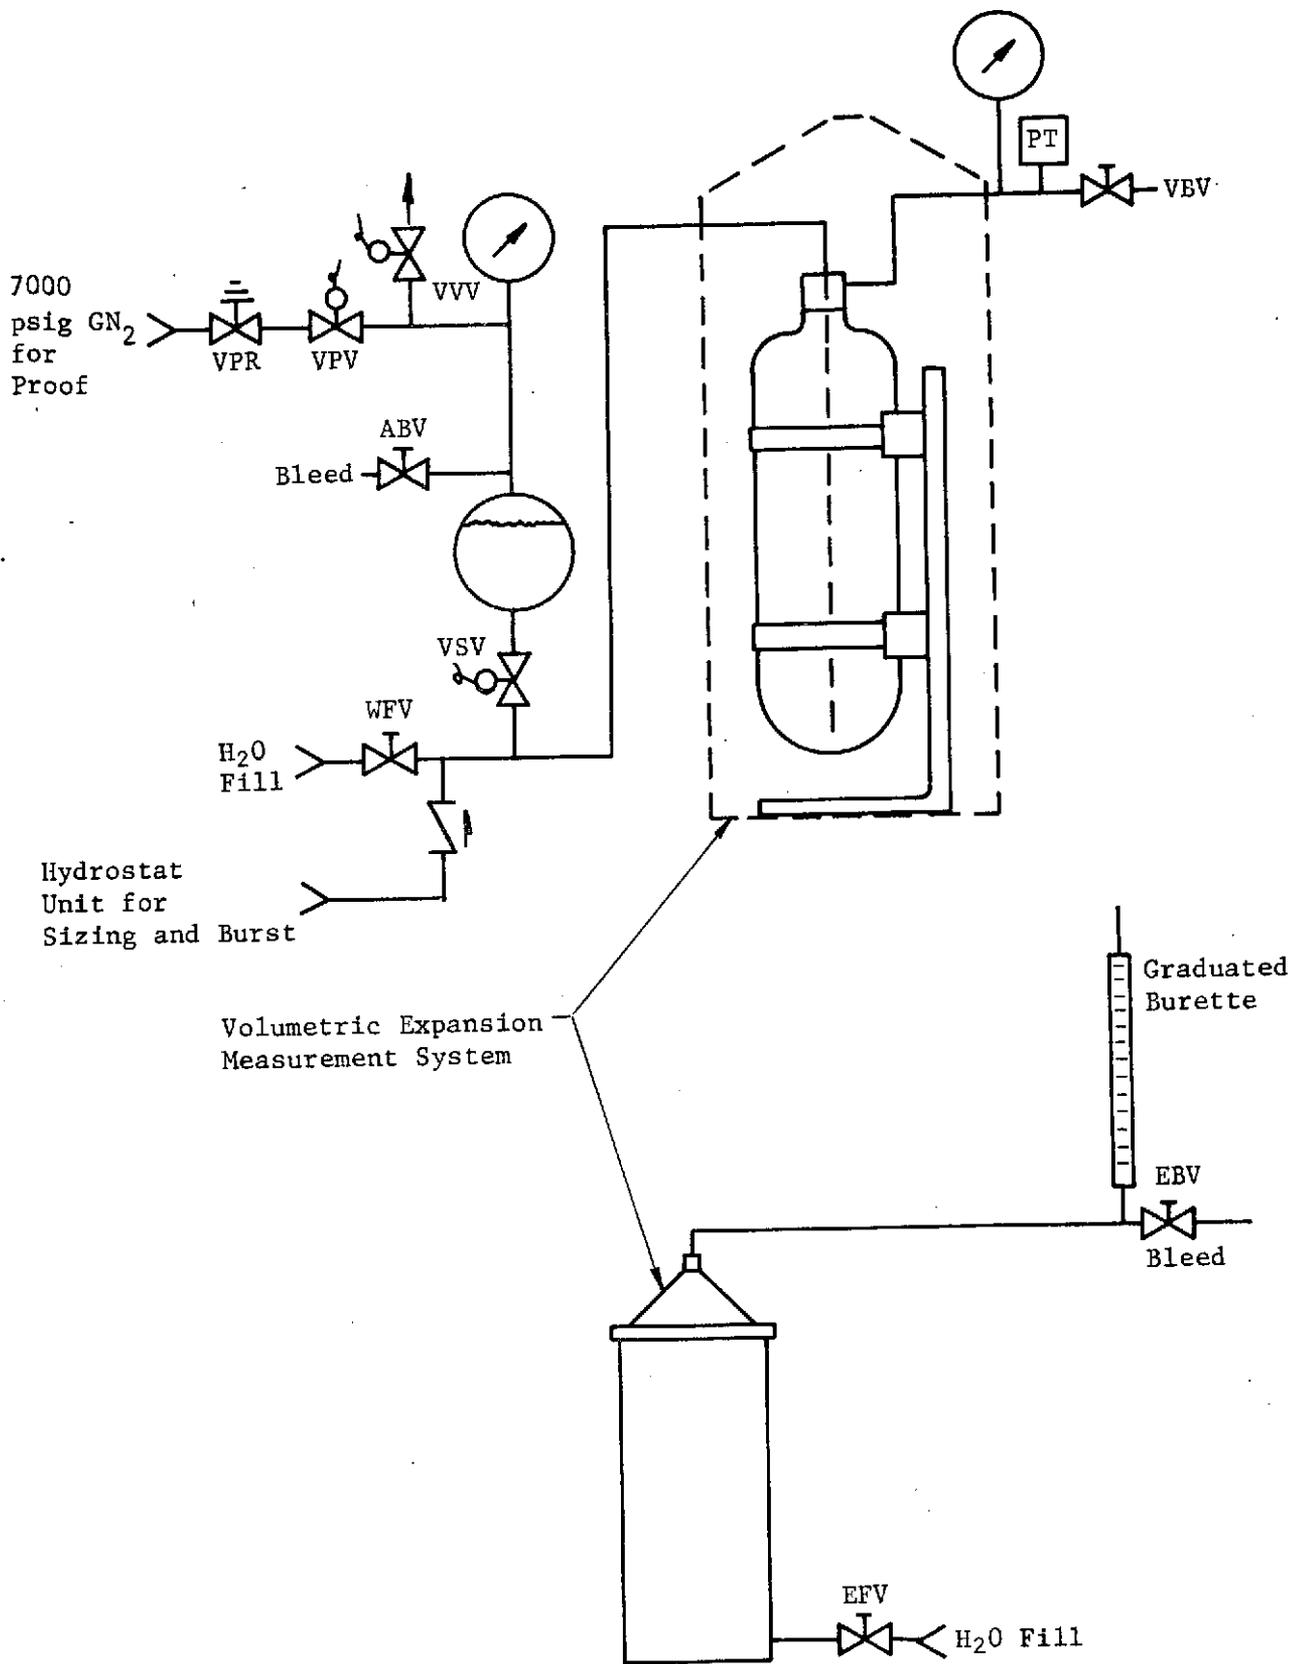
Figure C-2 Pressurization Fixture

- 6.2.3 Open WFV, VSV and ABV and fill the accumulator with water. Also bleed water through the hydrostat unit. Close ABV and VSV.
- 6.2.4 Open VBV and fill the vessel with water. Close VBV while flowing water through it. Then close WFV.
- 6.2.5 Open EBV and EFV and fill the volumetric fixture with water. Adjust the water level in the graduated burette to the lower part of the scale. Close EFV and EBV.
- 6.2.6 Verify no leakage through EFV or EBV by verifying no perceptible change in the water level during a 5-minute period.
- 6.2.7 Place the test area in RED condition and make an appropriate P.A. announcement. Verify that no personnel are in the vicinity of the vessel.

- 6.4.1 Install the vessel in the test setup of Figure C-2 except that the volumetric expansion fixture is not required. Two vessels may be tested in parallel if desired.

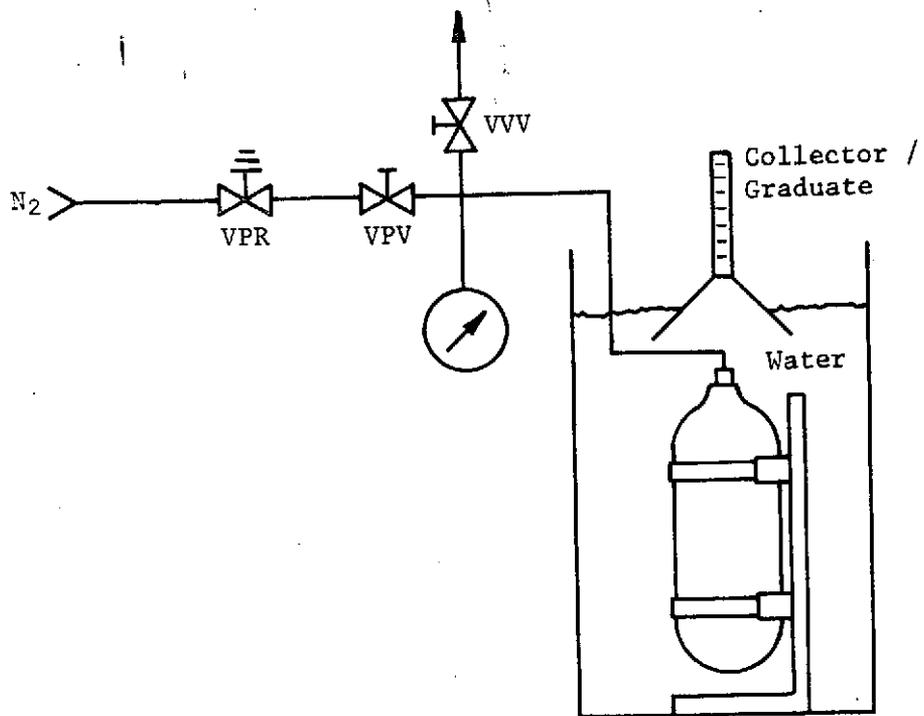
Figure C-4 Functional Capability Setup

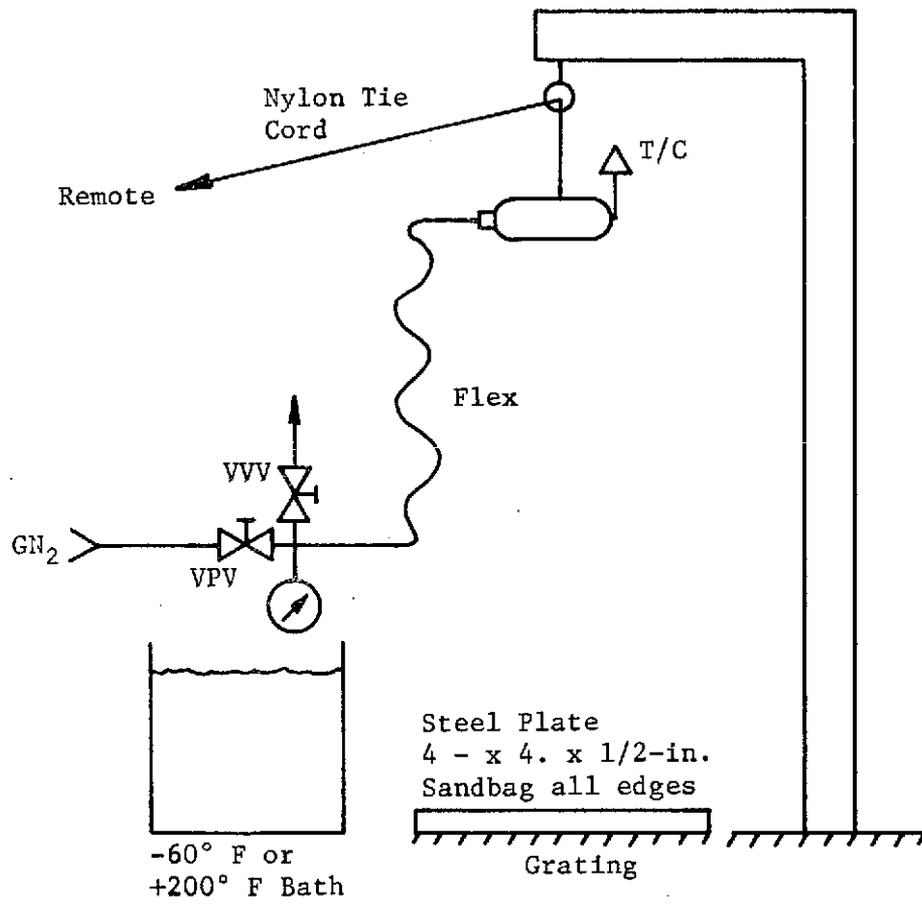
Figure C-8 Impact and Shock Setups

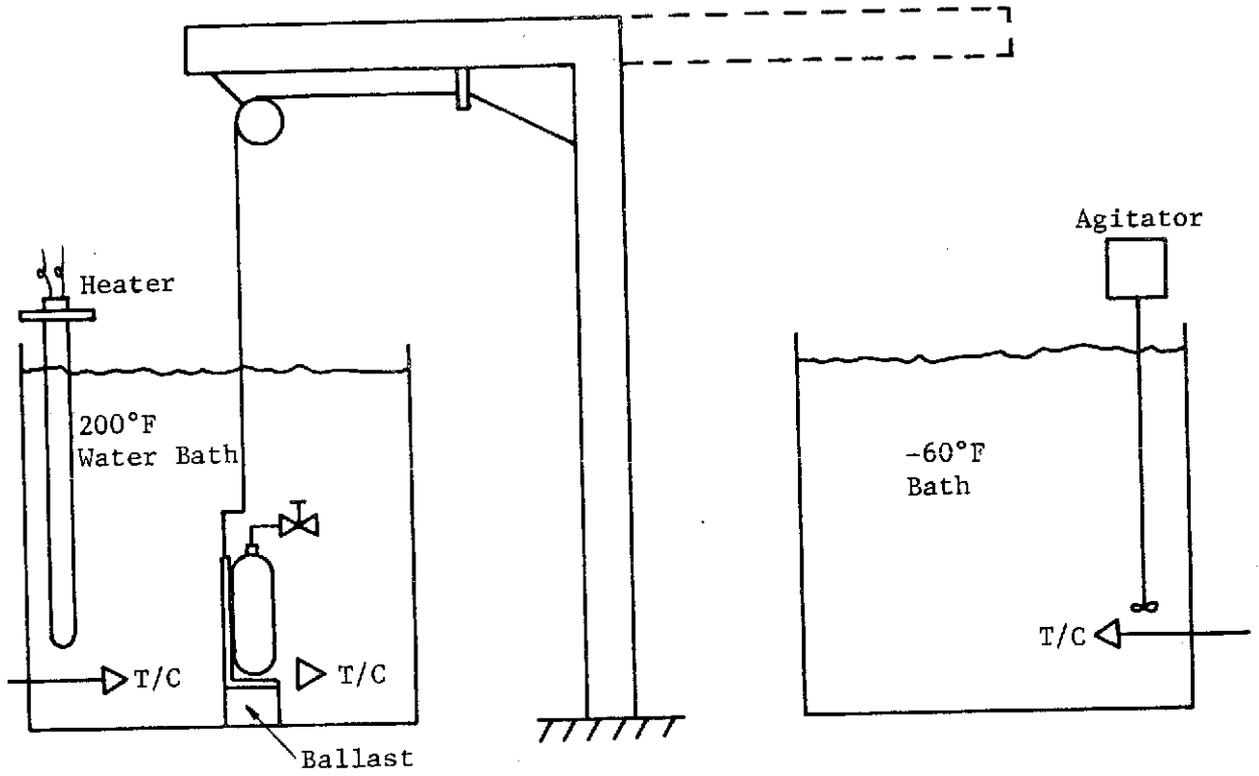
Figure C-11 Thermal Cycling Setup

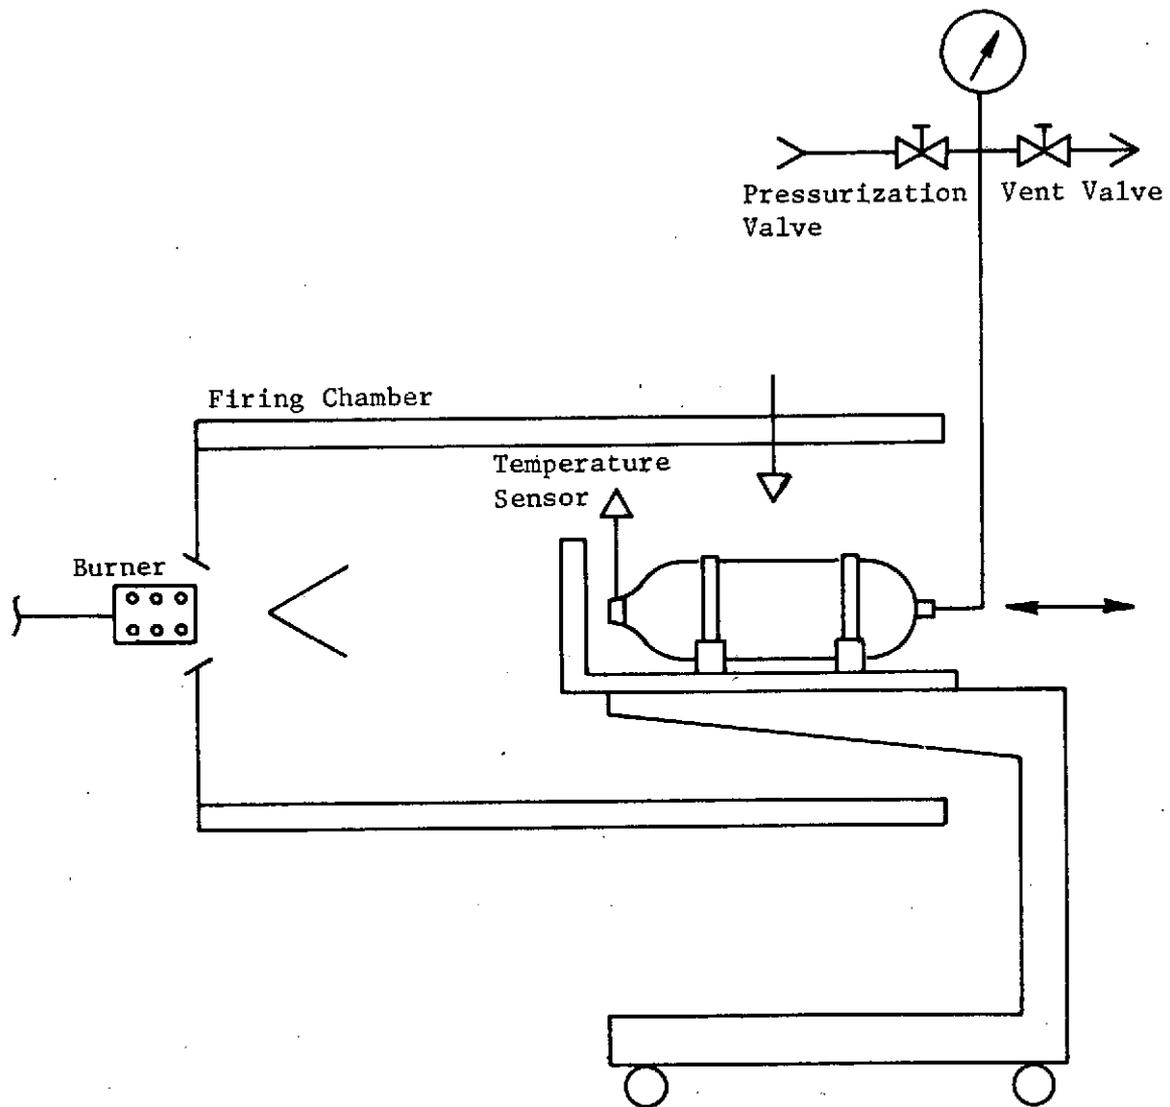
Figure C-14 High Temperature Exposure
