SKYLAB PROGRAM

EARTH RESOURCES EXPERIMENT PACKAGE

SENSOR PERFORMANCE REPORT
VOLUME VII (S190B)
SL2, SL3 AND SL4 EVALUATION

MSC-05528

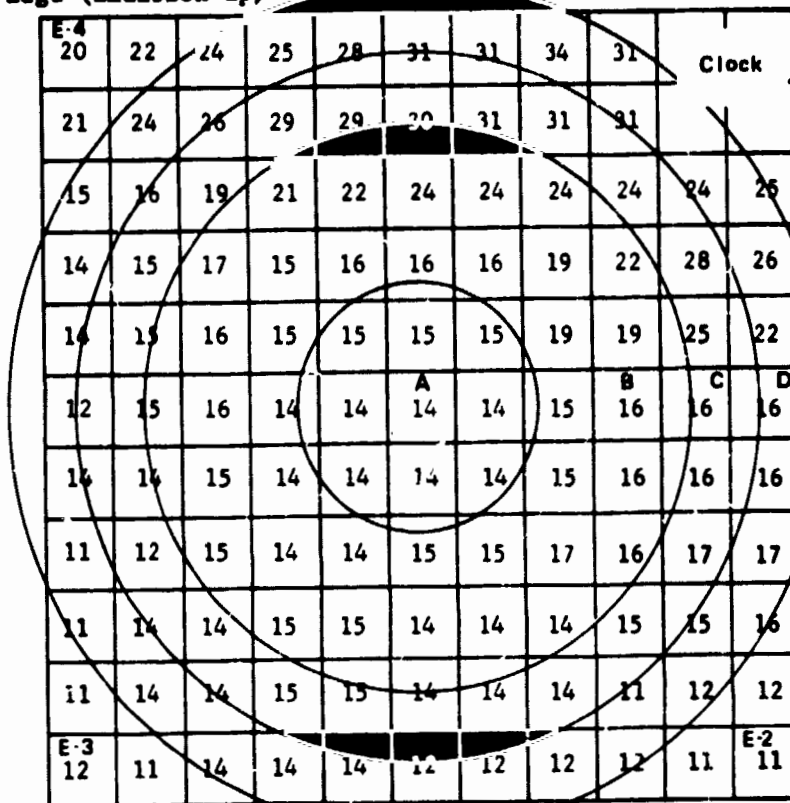
Figure 6.1.1-2 - VIE Resolution - 3414 Film

Resolution — Average of two or more readings per centimeter area.

The image quality of a typical panchromatic duplicate transparency frame can best be described by reviewing the pattern indicated by the VIE resolution numbers shown in Figure 6.1.1-2. Within a given frame the quality of the imagery changes by a factor of three, the best resolution being in this area adjoining the clock and along the titled edge. The highest quality image observed yields approximately 75-foot ground resolved distance (GRD) while the poorest yields approximately 250-foot GRD. Approximately 52 percent of the 3414 photography furnished is cloud covered.

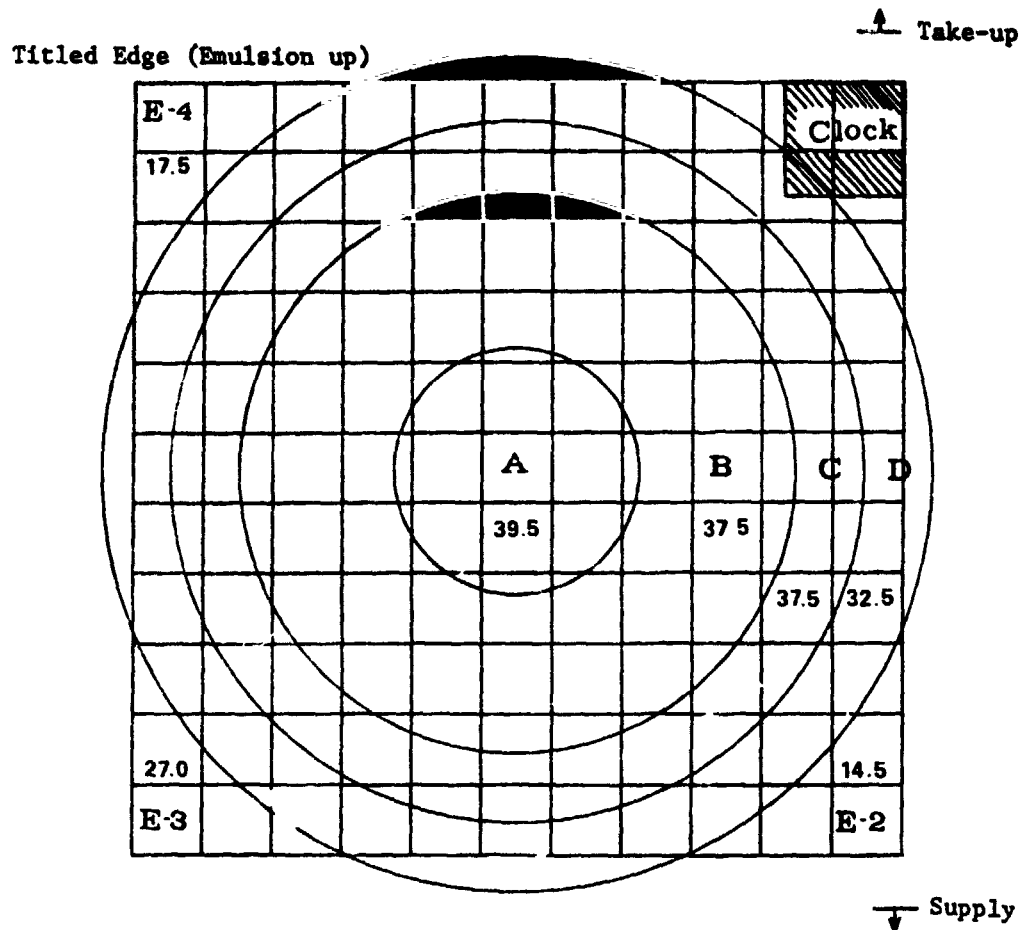
Figure 6.1.1 - 3 - VIE Resolution - S0242 Film

Resolution - Average of 10 or more readings per zone.

Zone	Resolution (lp/mm)
A	39.5
B	37.5
C	37.5
D	32.5
E-1	Clock
E-2	14.5
E-3	27.0
E-4	17.5

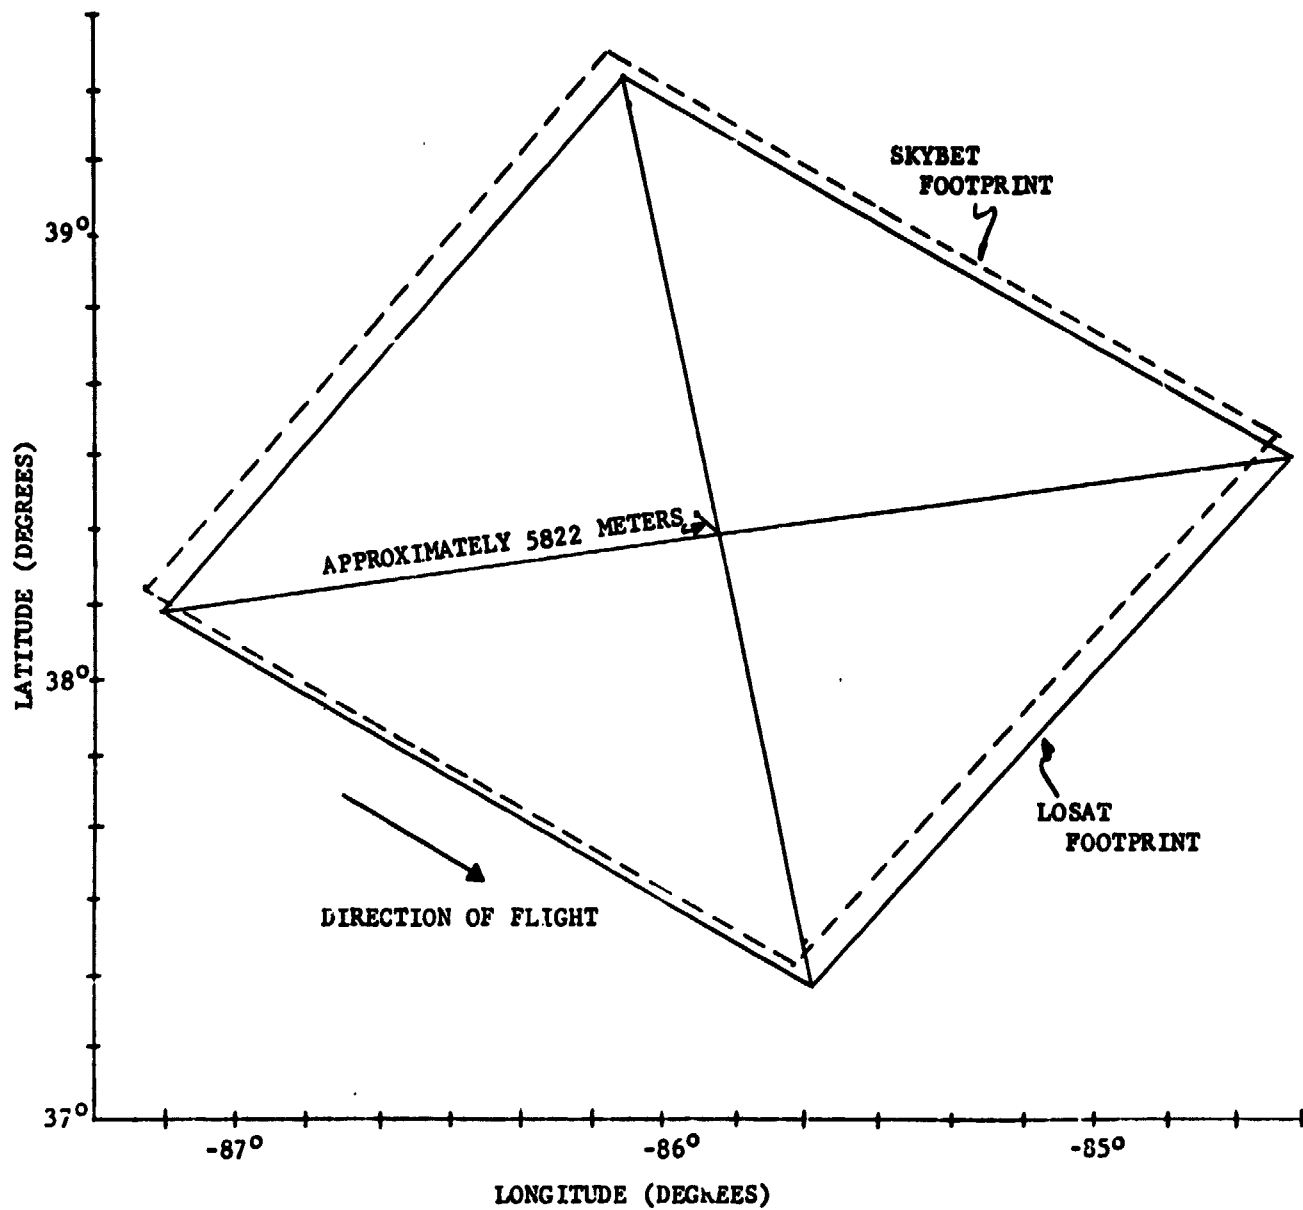
Figure 8.1.1-1 Comparison of SKYBET S190B Photographic Footprint and Footprint Derived from Photogrammetric Fit to Ground Control (SL2)

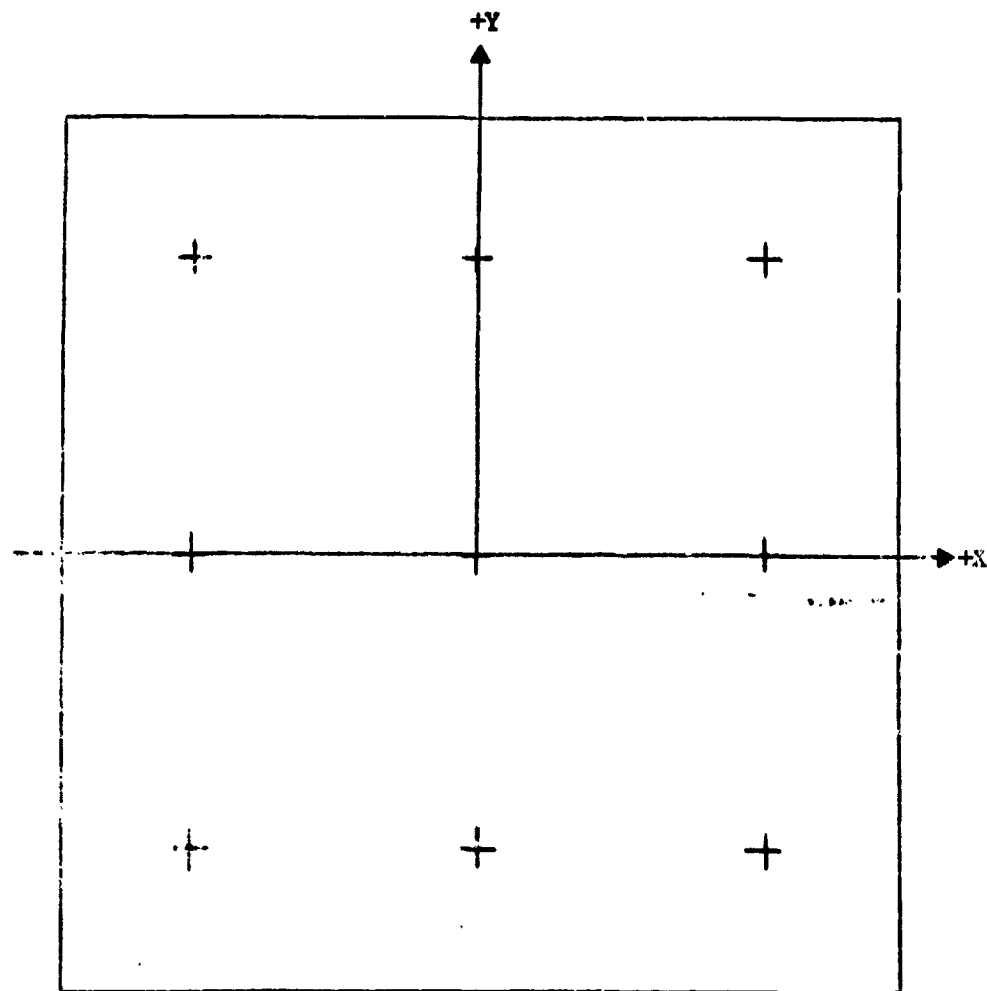
Figure 8.1.2-1 S190A Photo Coordinate System (Station 5, dispositive, emulsion up)

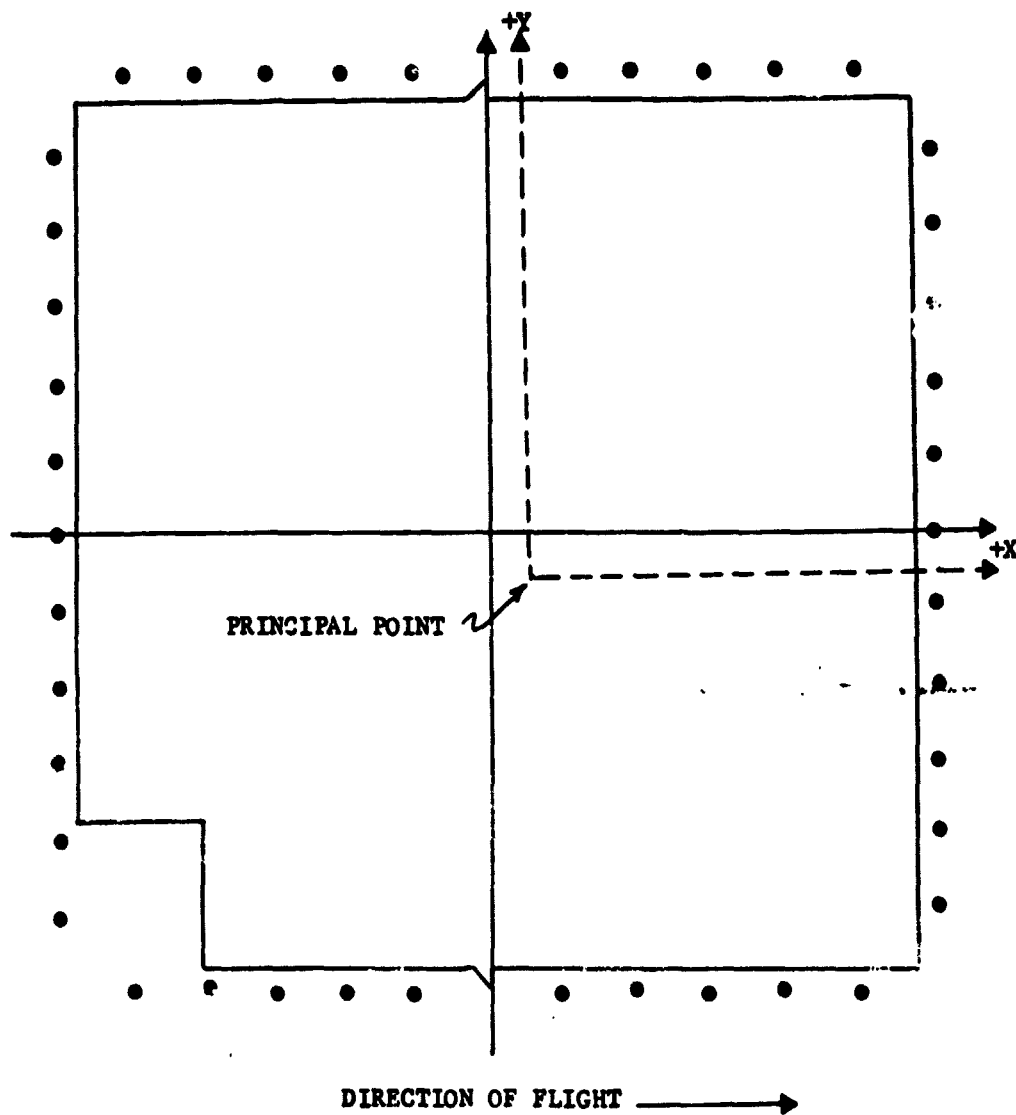
Figure 8.1.2-2 S1908 Photo Coordinate System (dispositive, emulsion up)

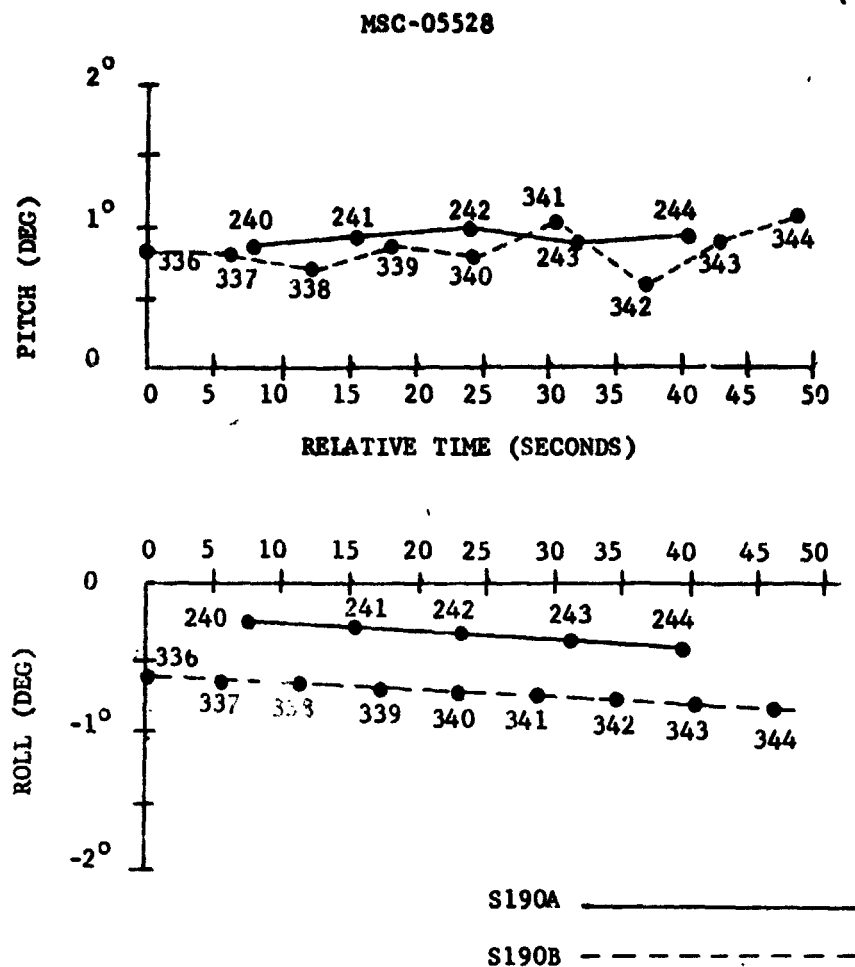
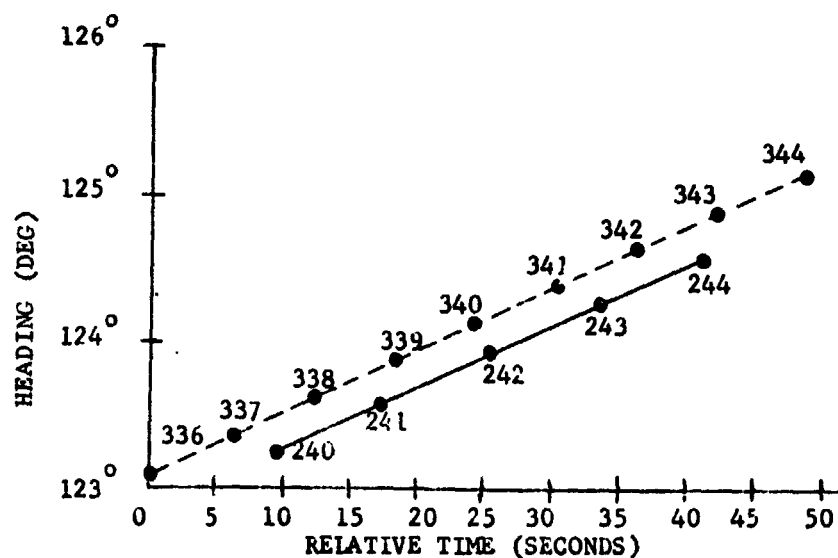
Figure 8.1.2-3 S190A (Station 5) and S190B Camera Orientation Angles as Determined Photogrammetrically by Rigorous Simultaneous Fit to Ground Control (Skylab 2, EREP Pass 7, Track 33)

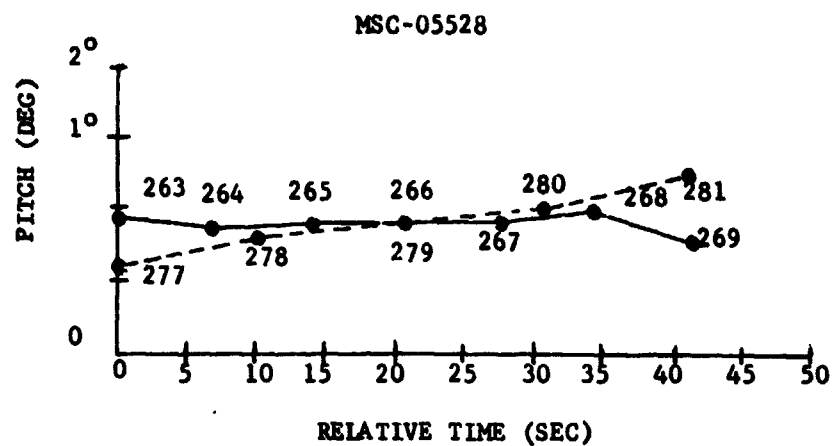
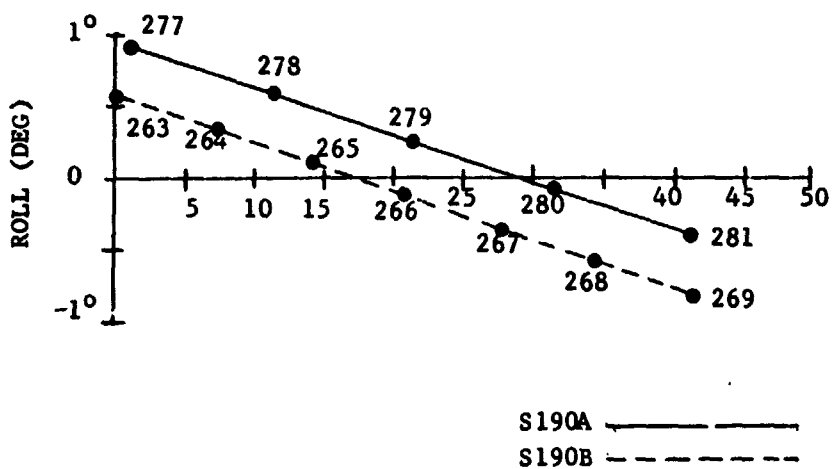
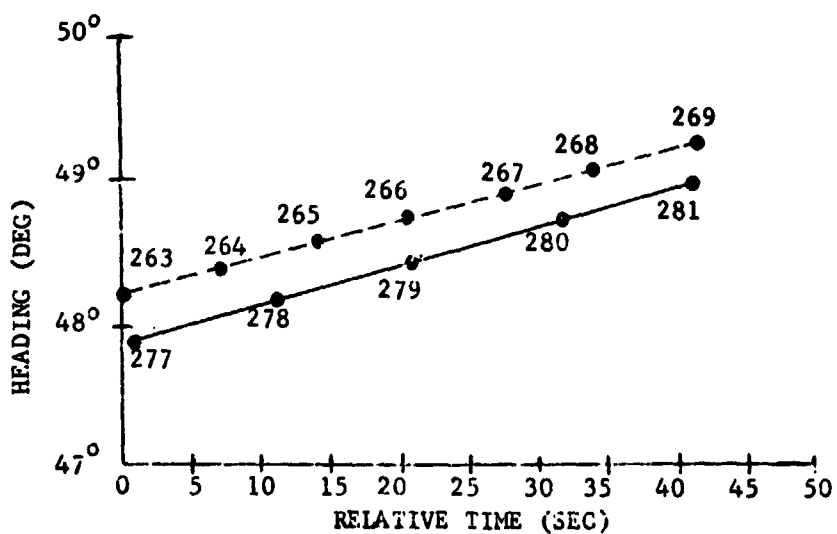
Figure 8.2.2-1 S190A (Station 5) and S190B Camera Orientation Angles as Determined Photogrammetrically by Rigorous Simultaneous Fit to Ground Control (Skylab 2, Pass 52)

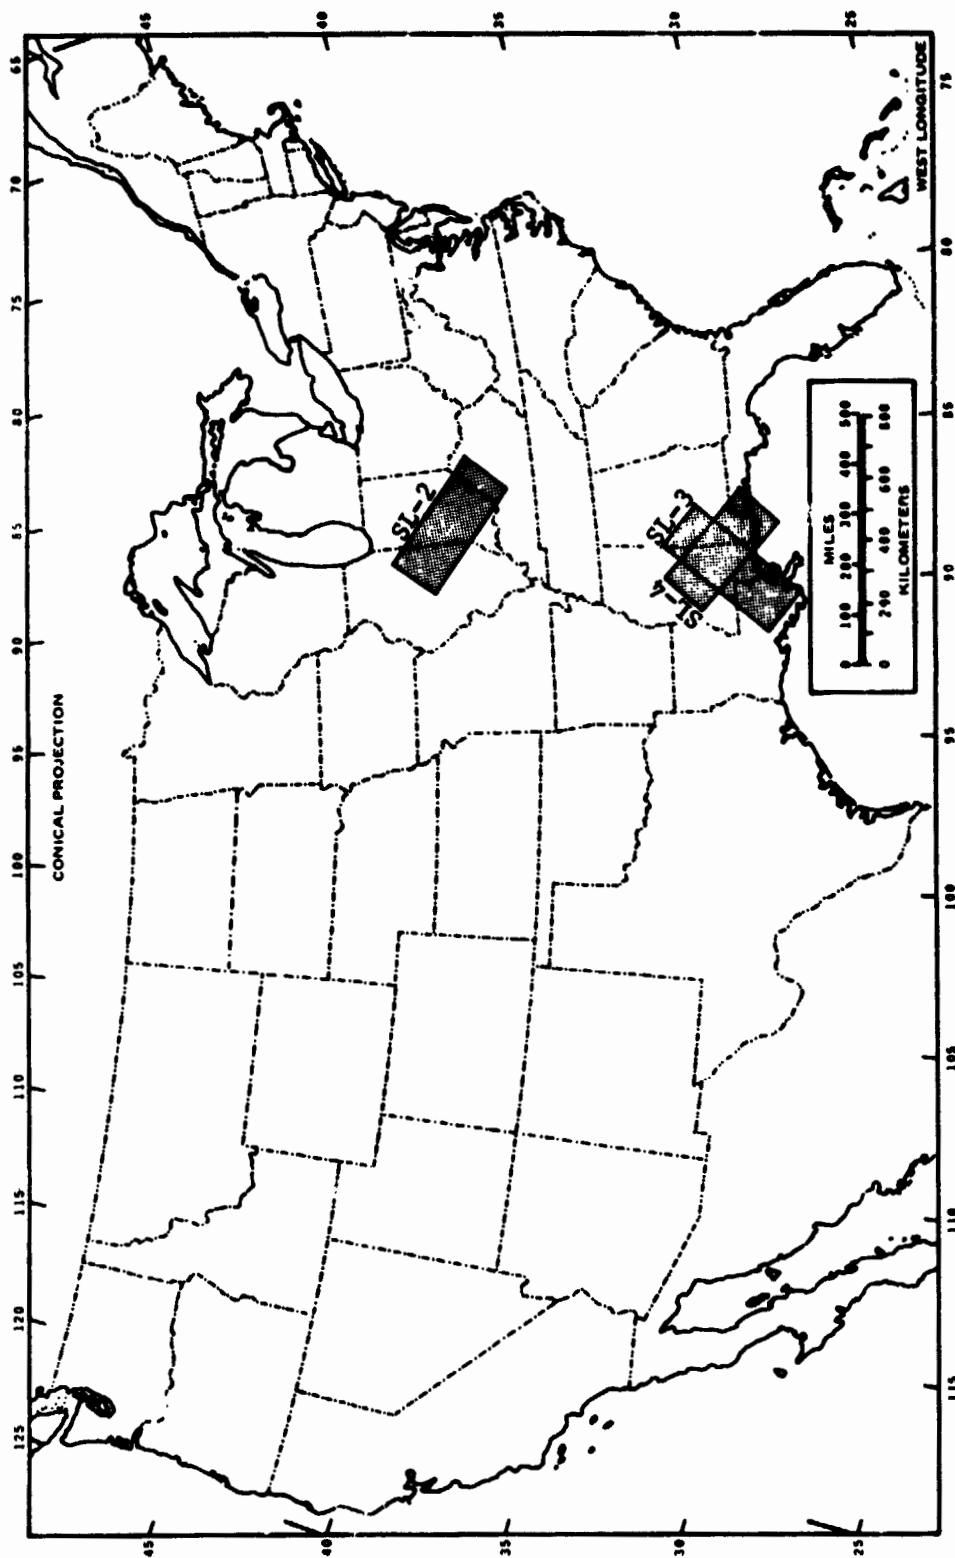
Figure 8.3.1-1 Approximate Areas of Imagery Used for Pointing Accuracy Evaluation and Interlock Angle Determination

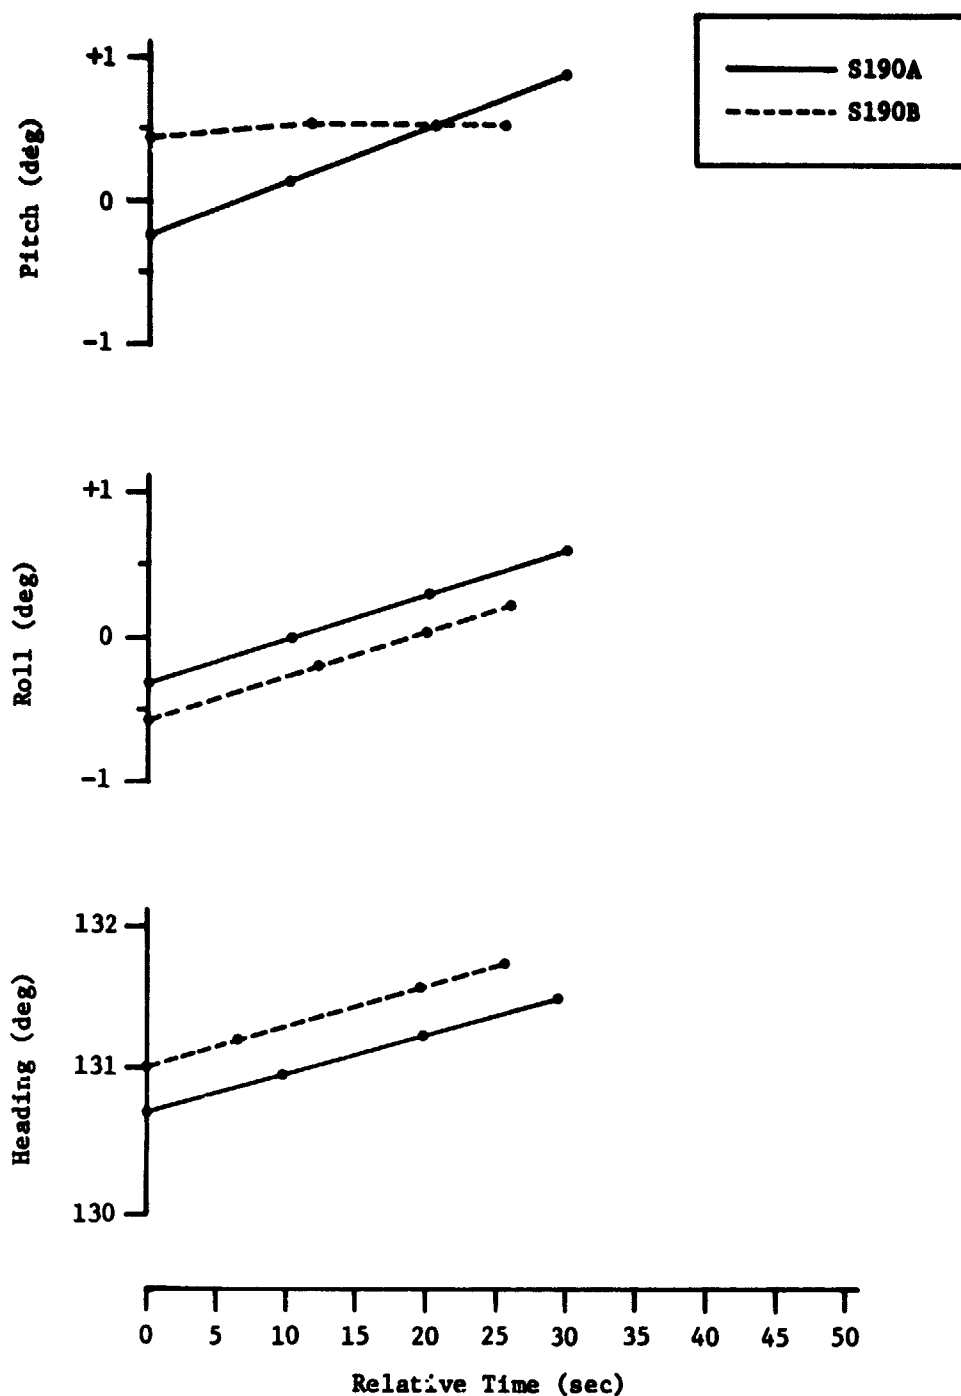
Figure 8.3.2-1 S190A (Station 5) and S190B Camera Orientation Angles as Determined Photogrammetrically by Rigorous Simultaneous Fit to Ground Control (Skylab 4)

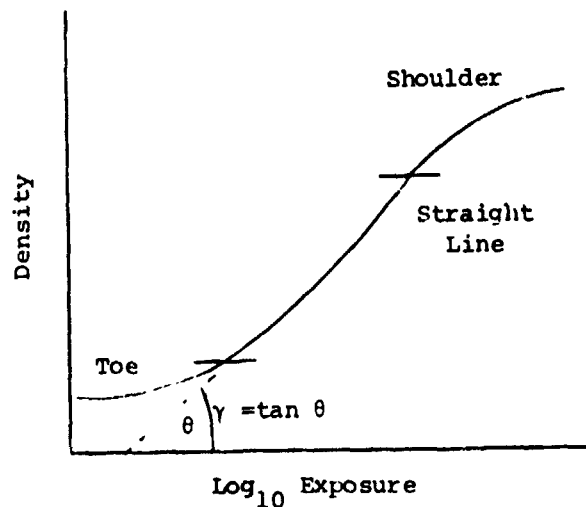
9.4.3 Characteristic Curve - Various known as the D-log E curve or H&D curve (after its originators, Hurter and Driffield), the characteristic curve is the most common way of presenting a film's sensitometric response.

The curve is constructed by plotting density as a function of the logarithm of the exposure necessary to produce that density.

The figure shown previously illustrates the three sections of the characteristic curve.

Toe - this is the region from threshold film response to the beginning of the straight line portion. The relationship of density to log exposure is non-linear with an increasing gradient.

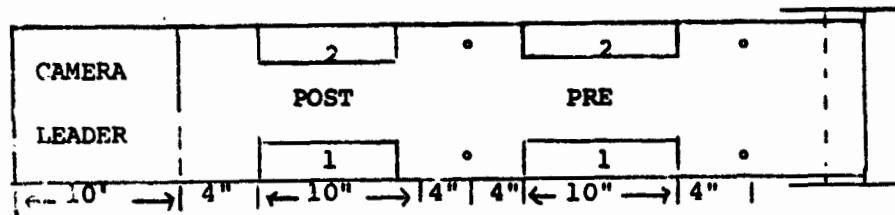
Figure 9.5-1 S190B Pre- and Postmission Sensitometry

° punched for I.D.

- No. 1. - Pre- and postmission sensitometry incorporating one of the broad band filters to be used on the mission.
No. 2. - Pre- and postmission spectral sensitivity exposures.

9.5 S190B Sensitometry - Sensitometric calibration exposures are placed on all original film for two purposes. One is to provide a check on processing and sensitometric effects such as sensitivity loss and latent image failure. A second purpose is to allow conversion of image density to image exposure.

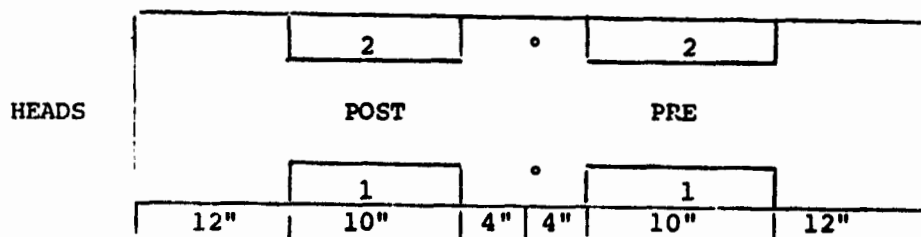
° punched for I.D.

- No. 1. - Pre- and Postmission sensitometry incorporating one of the broad band filters to be used on the mission.
No. 2. - Pre- and postmission spectral sensitivity exposures.
