NASA TN D-7891

EVALUATION OF REFRACTORY-METAL-CLAD  
URANIUM NITRIDE AND URANIUM DIOXIDE  
FUEL PINS AFTER IRRADIATION FOR TIMES  
UP TO 10 450 HOURS AT 990° C

*Kenneth J. Bowles and Richard E. Gluyas*

*Lewis Research Center*

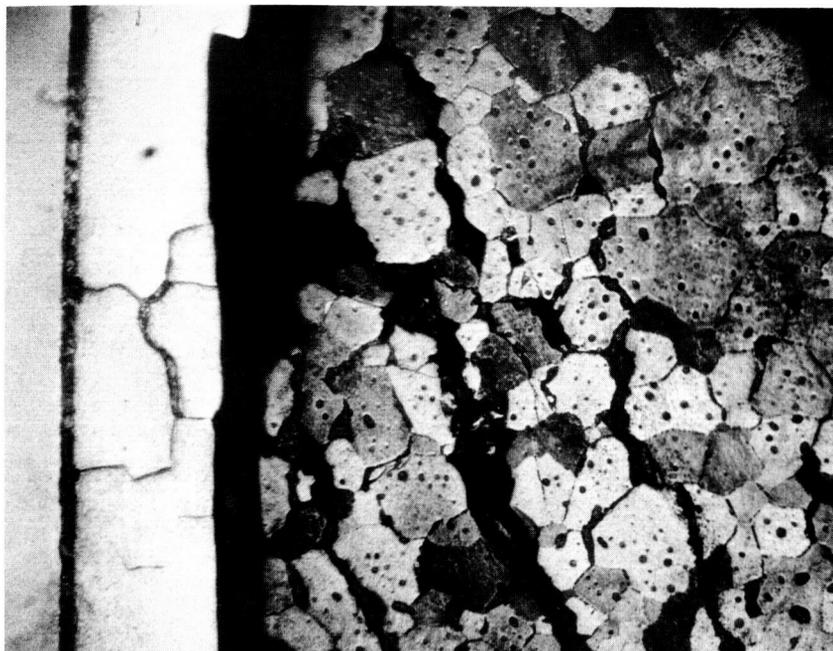
(see ref. 7). The larger voids are as-fabricated porosity. Grain delineation by fission gas bubbles was not visible in the irradiated 85 percent dense UN (fig. 15). Figures 17 and 18 show the same UN specimens that are shown in figures 15 and 16 but in the etched condition. Some unidentified second-phase particles were visible in the 85 percent dense UN (fig. 17). These particles are very fine ( $\sim 0.08$ -mm (0.0012-in.) diam) and are sparsely distributed. It is possible that this phase consists of oxide particles formed in the fabrication of the pellets - although none were observed in the thermally aged sample (see fig. 14(b)). No second phase was observed in the larger grained 95 percent dense UN fuel (see fig. 18).

Figure 18. - Irradiated 95 percent dense UN fuel (10 035 hr at 990°C).  
No second phase is visible; note separation of grains. Etched. x250.

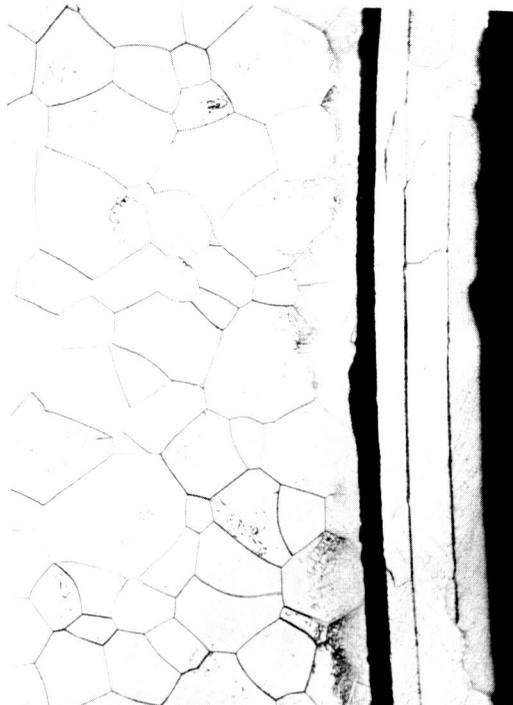
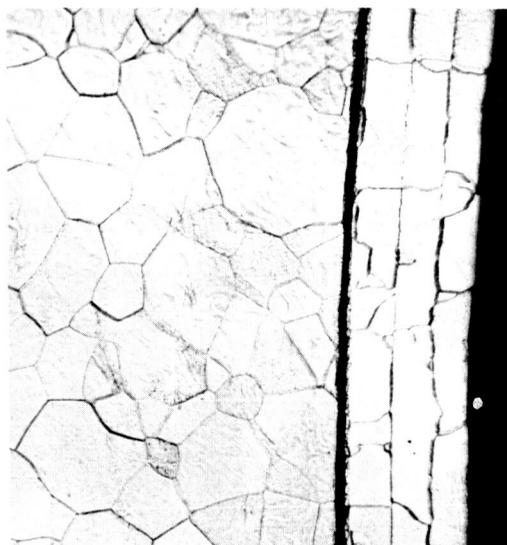
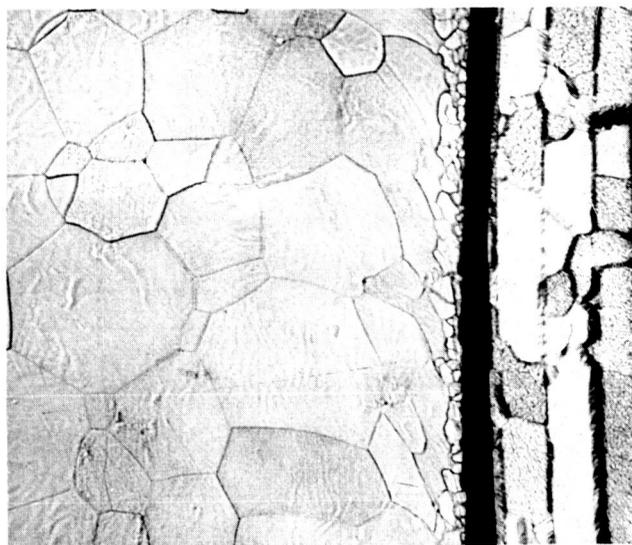
Metallographic examination revealed no unusual change in microstructure. The aged cladding (fig. 21) and fuel (fig. 14) both appear as expected from previous observations for aged cladding and aged fuel.

(a) T-111 and 85 percent dense UN.

(b) T-111 and 95 percent dense UN.

(c) T-111 and 94 percent dense UO<sub>2</sub>.

(d) Cb-1Zr and 94 percent dense UO<sub>2</sub>.

Figure 21. - Microstructure of out-of-reactor thermal simulation pin claddings. Etched.  $\times 250$ .
