NASA TM X-64937

## INVESTIGATION OF DISCRETE COMPONENT CHIP MOUNTING TECHNOLOGY FOR HYBRID MICROELECTRONIC CIRCUITS

By Salvadore V. Caruso and J. O. Honeycutt  
Electronics and Control Laboratory

May 1975

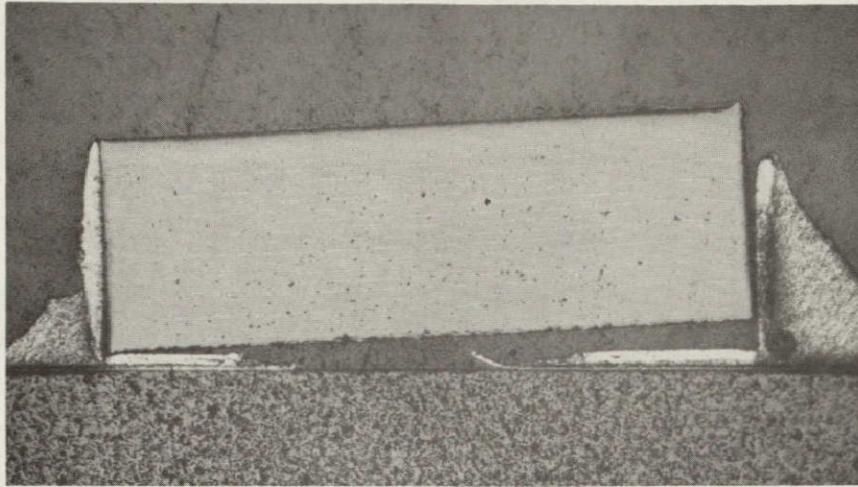
(40X magnification)

0805 size, NPO type

(100X magnification)

Figure 22. Indalloy no. 7 bonded Kemet capacitor to thin film substrate, capacitance failure (photographed after 500 thermal cycles).

Cross sections of two of the electrical failures that occurred in Indalloy no. 7 mounted capacitors during thermal cycling are shown in Figures 22 and 23. Figure 22 shows a capacitance failure caused by complete separation between the plates and the inner silver electrode metallization. Note again the absence of the copper guard.

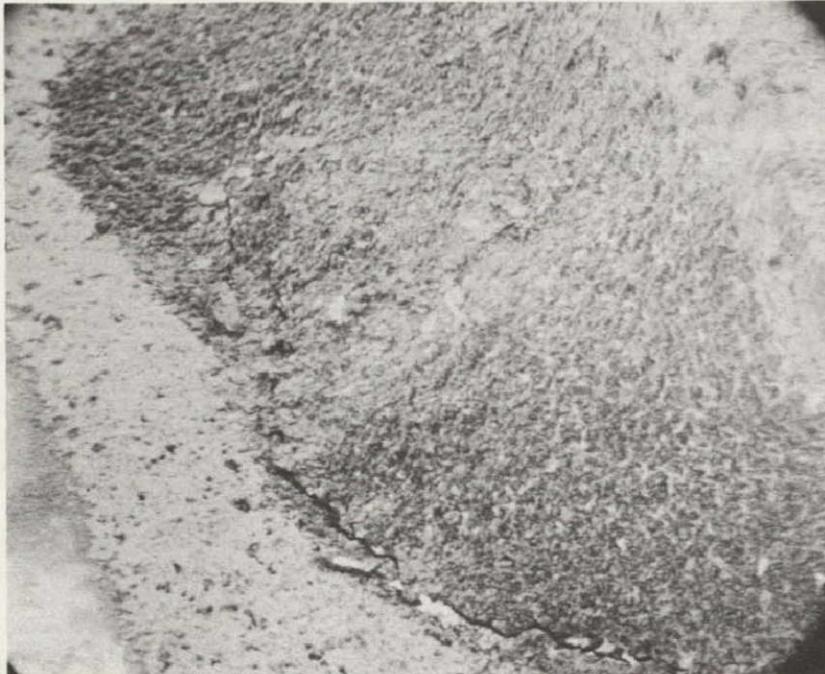
R25 size, K1200 type (89X magnification)

R25 size, NPO type (130X magnification)

Figure 27. Ablebond 58-1 epoxy bonded MDI capacitors to thick film substrate, fillet cracking (photographed after 500 thermal cycles).

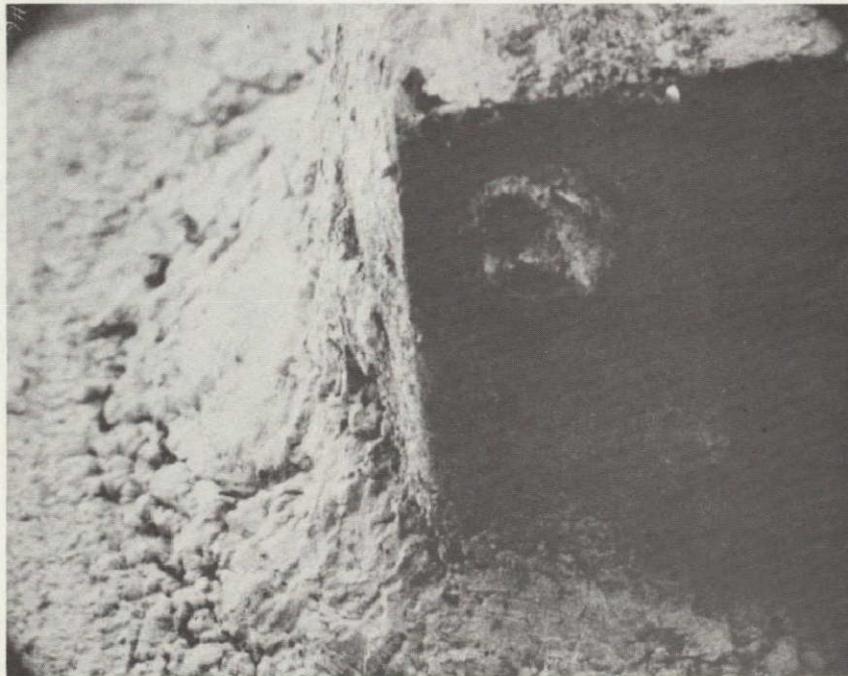
a. R25 size, K1200, solder crazing (67X magnification).

b. R15 size, K1200, solder cracking (99X magnification).

Figure 30. 10/90 solder bonded MDI capacitors to Pt/Au thick film substrate (photographed after 500 thermal cycles).
