National Aeronautics and Space Administration
Research Grant NGR 39-087-003

THE EFFECT OF MICROSTRUCTURE AND
STRENGTH ON THE FRACTURE TOUGHNESS
OF AN 18 Ni, 300 GRADE
MARAGING STEEL

Technical Report No. 7

August 1975

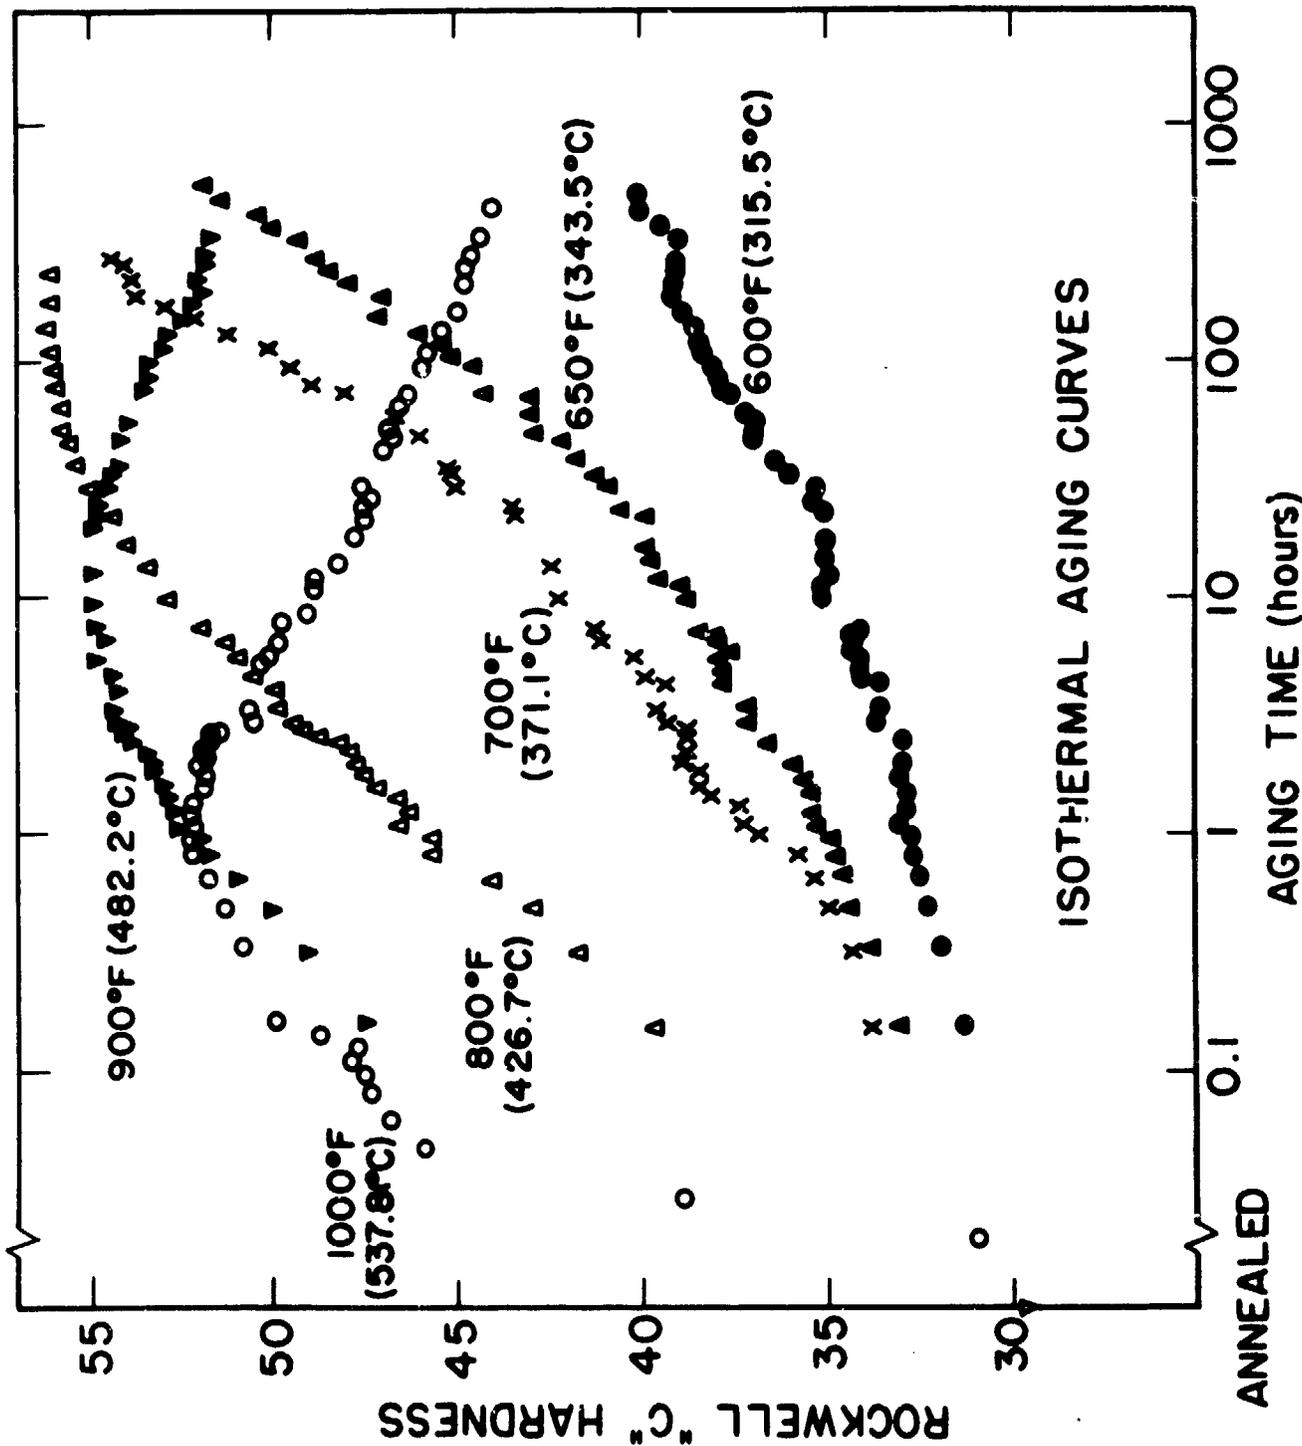
Figure 1 Hardness versus logarithm of time at temperature for some of the aging treatments used on the 18 Ni, 300 grade maraging steel.

A study aimed at determining the age hardening behavior of the 18 Ni, 300 grade maraging steel was carried out. By variation of both aging time and temperature, mechanical test specimens were aged to attain specified strength levels. For this reason it is important to know the extent of hardening and the kinetics of the age-hardening process as a function of both time and temperature. To this end, an isothermal aging study has been completed. Hardness blanks of 0.25-inch thickness were isothermally aged at 316°C (600°F), 344°C (650°F), 371°C (700°F), 427°C (800°F), 482°C (900°F), and 538°C (1000°F) for times up to 300 hours. Aging treatments were performed in air to parallel the heat treatment procedure necessary for aging toughness specimens which will be as large as 17 inches long by 4 inches wide in the 2-inch thick case. A plot of Rockwell "C" hardness was generated as a function of the logarithm of time at each of these aging temperatures. Each datum point is the average of five hardness indentations per test block. A separate test block was used for each point on the plot presented in Figure 1. As with most age hardenable alloys, the 300 grade maraging steel rapidly overages at a high temperature such as 538°C (1000°F). Although kinetically less rapid, aging at lower temperatures yields a maximum hardness which is greater than that attained at higher temperatures. In this system, loss of hardness (strength) due to overaging is due in part to classical precipitate coarsening and to a time-dependent reversion of the metastable body-centered cubic martensite to the equilibrium face-centered cubic austenite.⁶

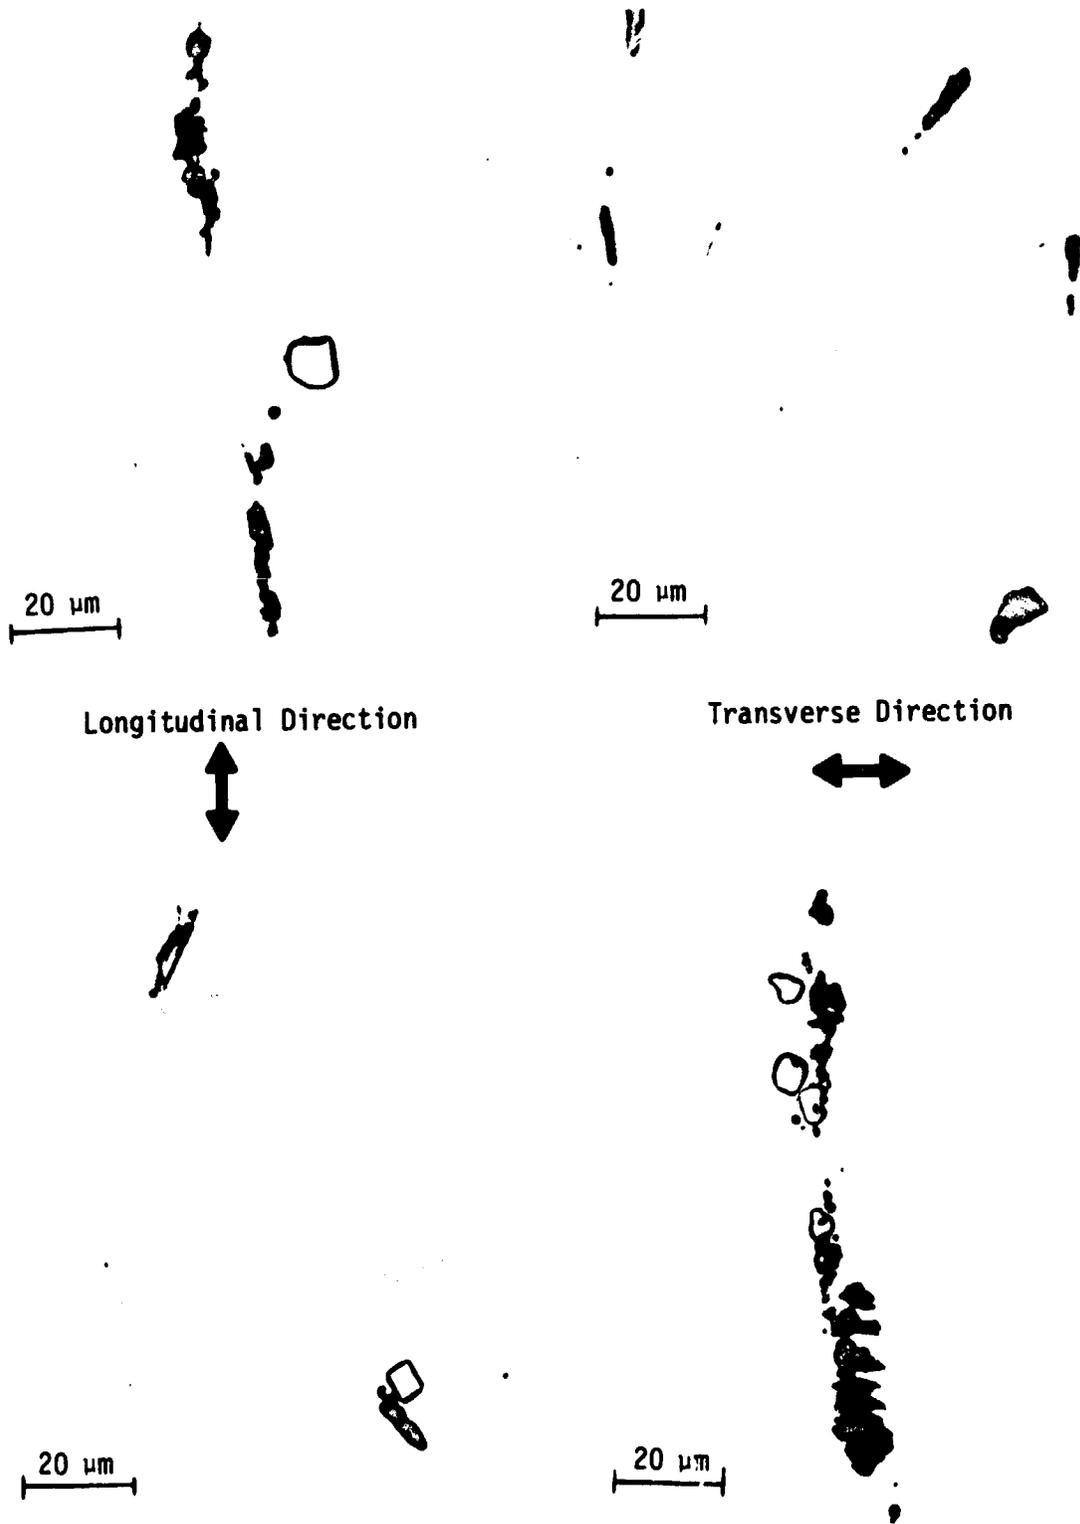
Figure 3 Optical micrographs of the most prevalent inclusions in the 18 Ni, 300 grade maraging steel.

and irregular inclusions appearing light gray in Figure 3 are similar to titanium sulfides (Ti_2S) and titanium carbides (TiC) observed in a previous investigation.⁹ Since the irregular inclusions are in the forging direction, they were undoubtedly plastically deformed during the hot-forging operations. Some of the inclusions have cracked, presumably due to the mechanical working. The cuboidal inclusions are usually less than 10 μm on edge. The elongated inclusions are frequently 20 μm long and usually less than 10 μm in width. The inclusions that are less than 1 μm in diameter will be examined with the aid of surface replica techniques and the TEM. As noted earlier, there is a fixed distribution of second-phase inclusion sizes in this heat of maraging steel which will not change with aging at the relatively low temperatures used in this program. Quantitative microscopy will be used to assess, by type, the size and spatial distribution of the second-phase impurity inclusions present in the 300 grade maraging steel.

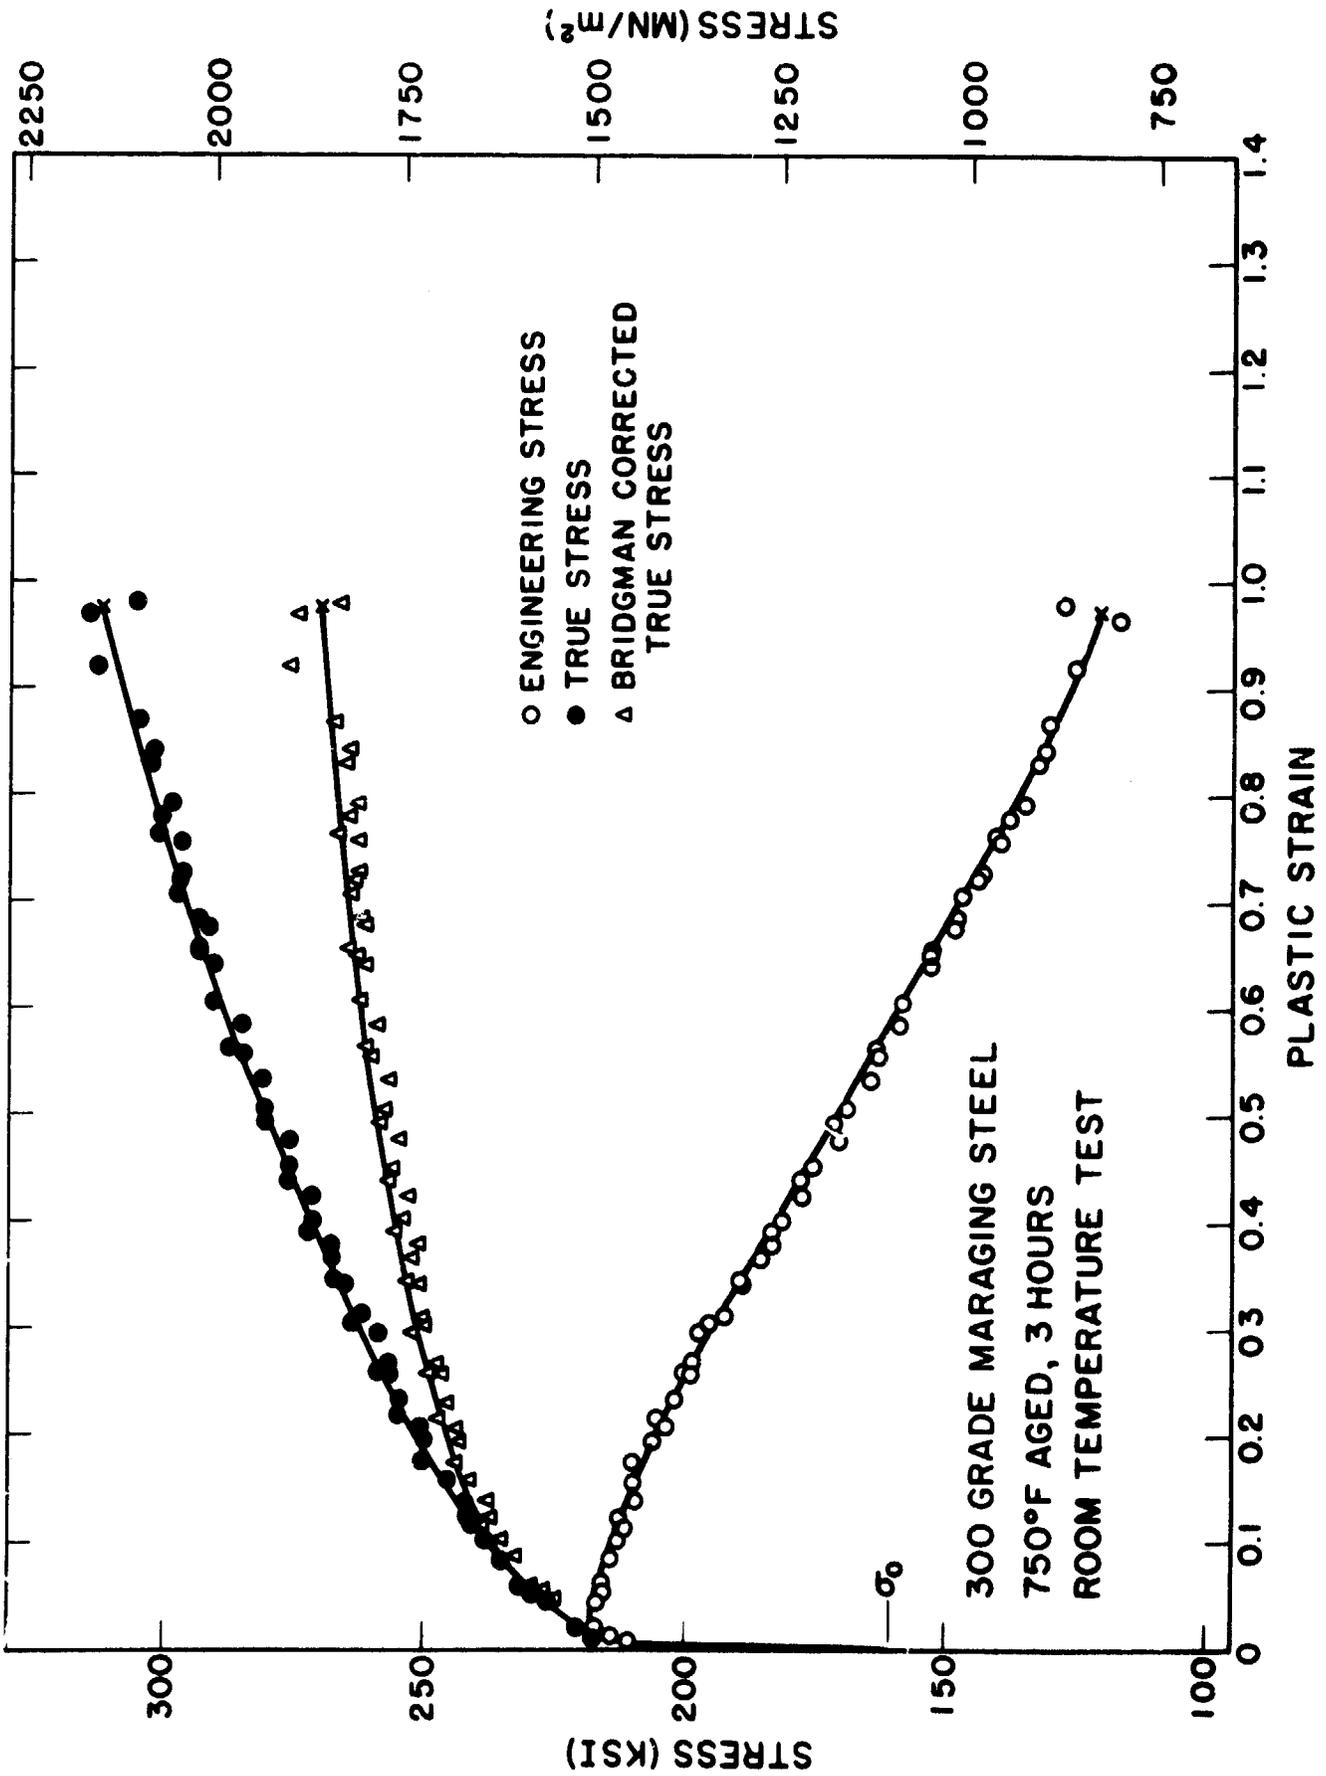
Figure 8 Example engineering, true, and Bridgman corrected true stress-strain curves.

The stresses calculated from the regression analysis using Equation (4) were usually within 1 or 2 percent of the experimental values. Figure 8 shows an example of the engineering stress, true stress, and Bridgman corrected true stress (flow curve) plotted against the true plastic strain for room temperature tests on the 300 grade maraging steel aged for 3 hours at 399°C (750°F).

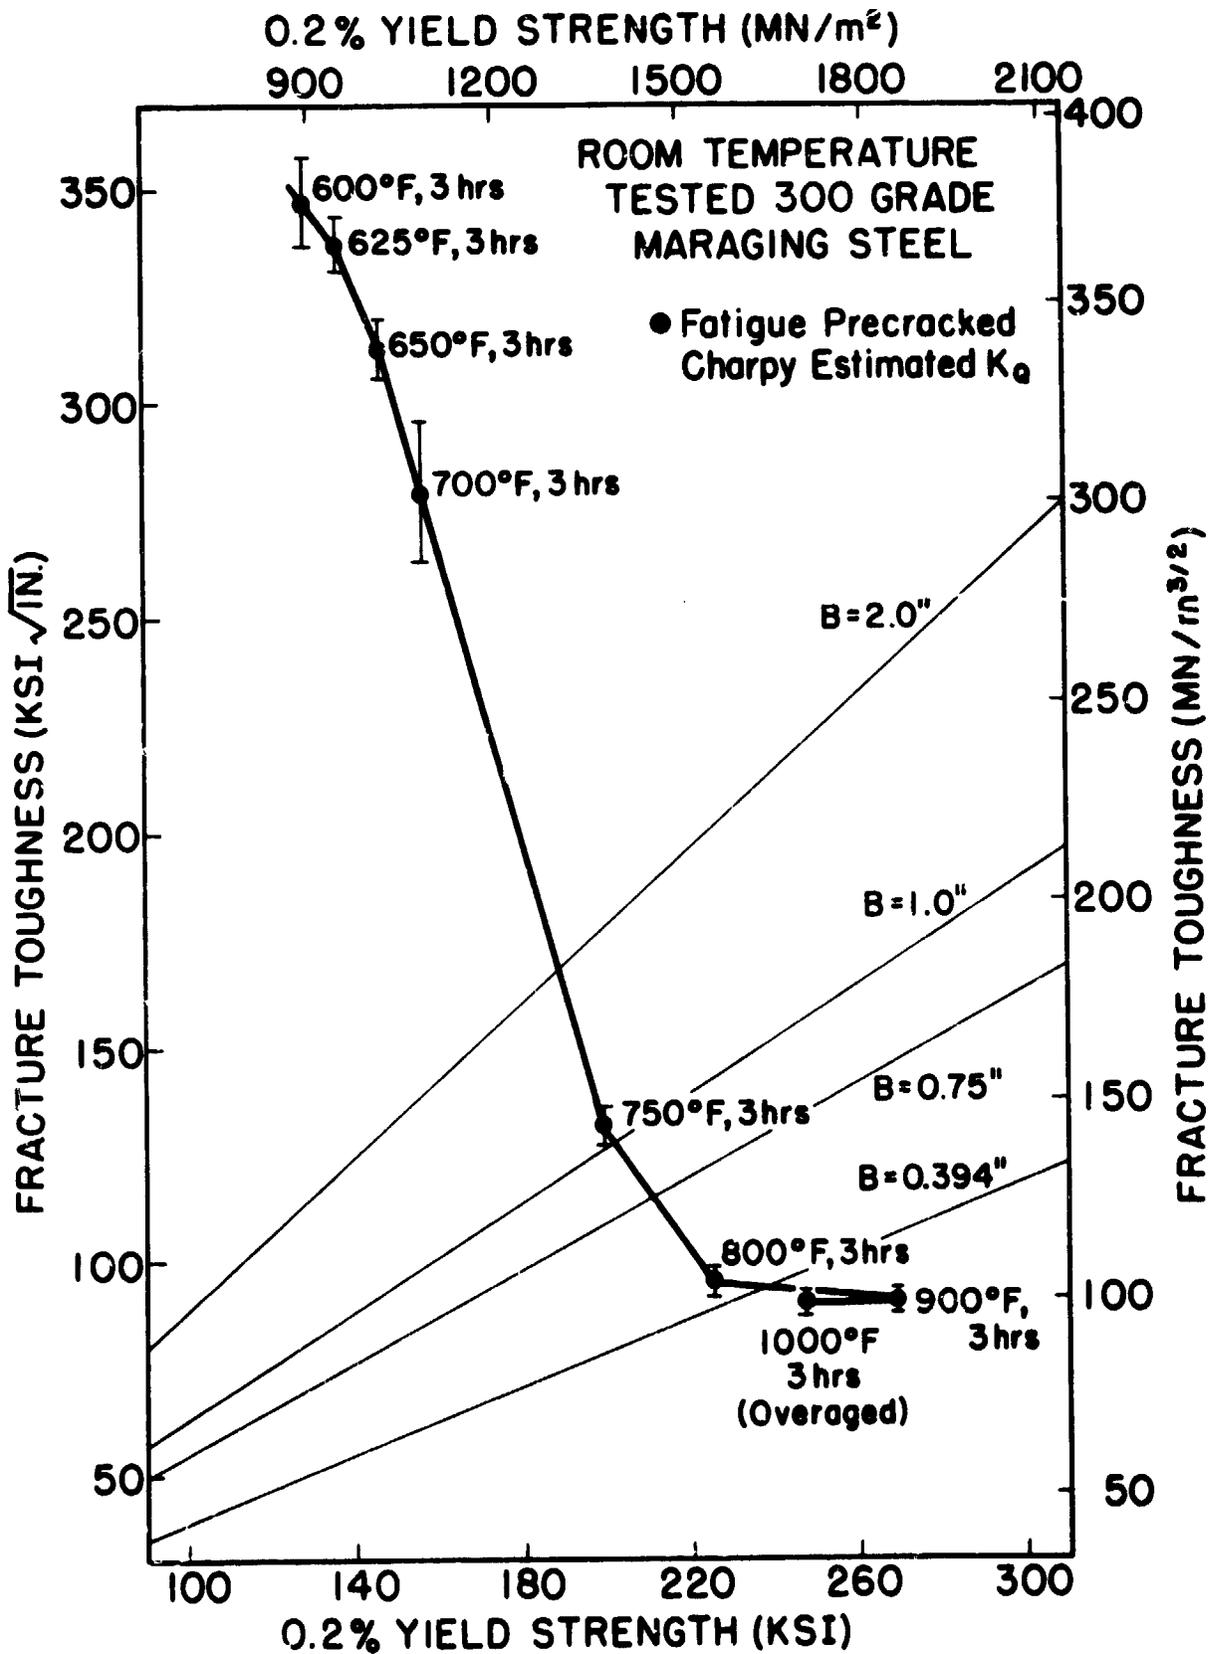
Figure 9 Fatigue precracked Charpy estimated K_Q as a function of strength for room temperature impact tests.

As expected, the fatigue precracked Charpy impact, W/A, data correlated to fracture toughness, K_Q , shows an extensive property variation with strength. Figure 9 is a plot of the data given in Table II and quite clearly the inverse relationship between strength and this crude measure of toughness is evident. It should be noted that the ability of the fatigue precracked Charpy impact test to estimate K_{IC} rapidly decreases as the strength decreases. The energy required to break a low strength Charpy is expended mainly in the gross plastic deformation of the material rather than in crack propagation. The plastic flow associated with shear lip formation increases as strength decreases since the Charpy thickness is inadequate to maintain plane-strain constraint at the crack tip. These data do, however, illustrate the strength-toughness trend necessary for this program.

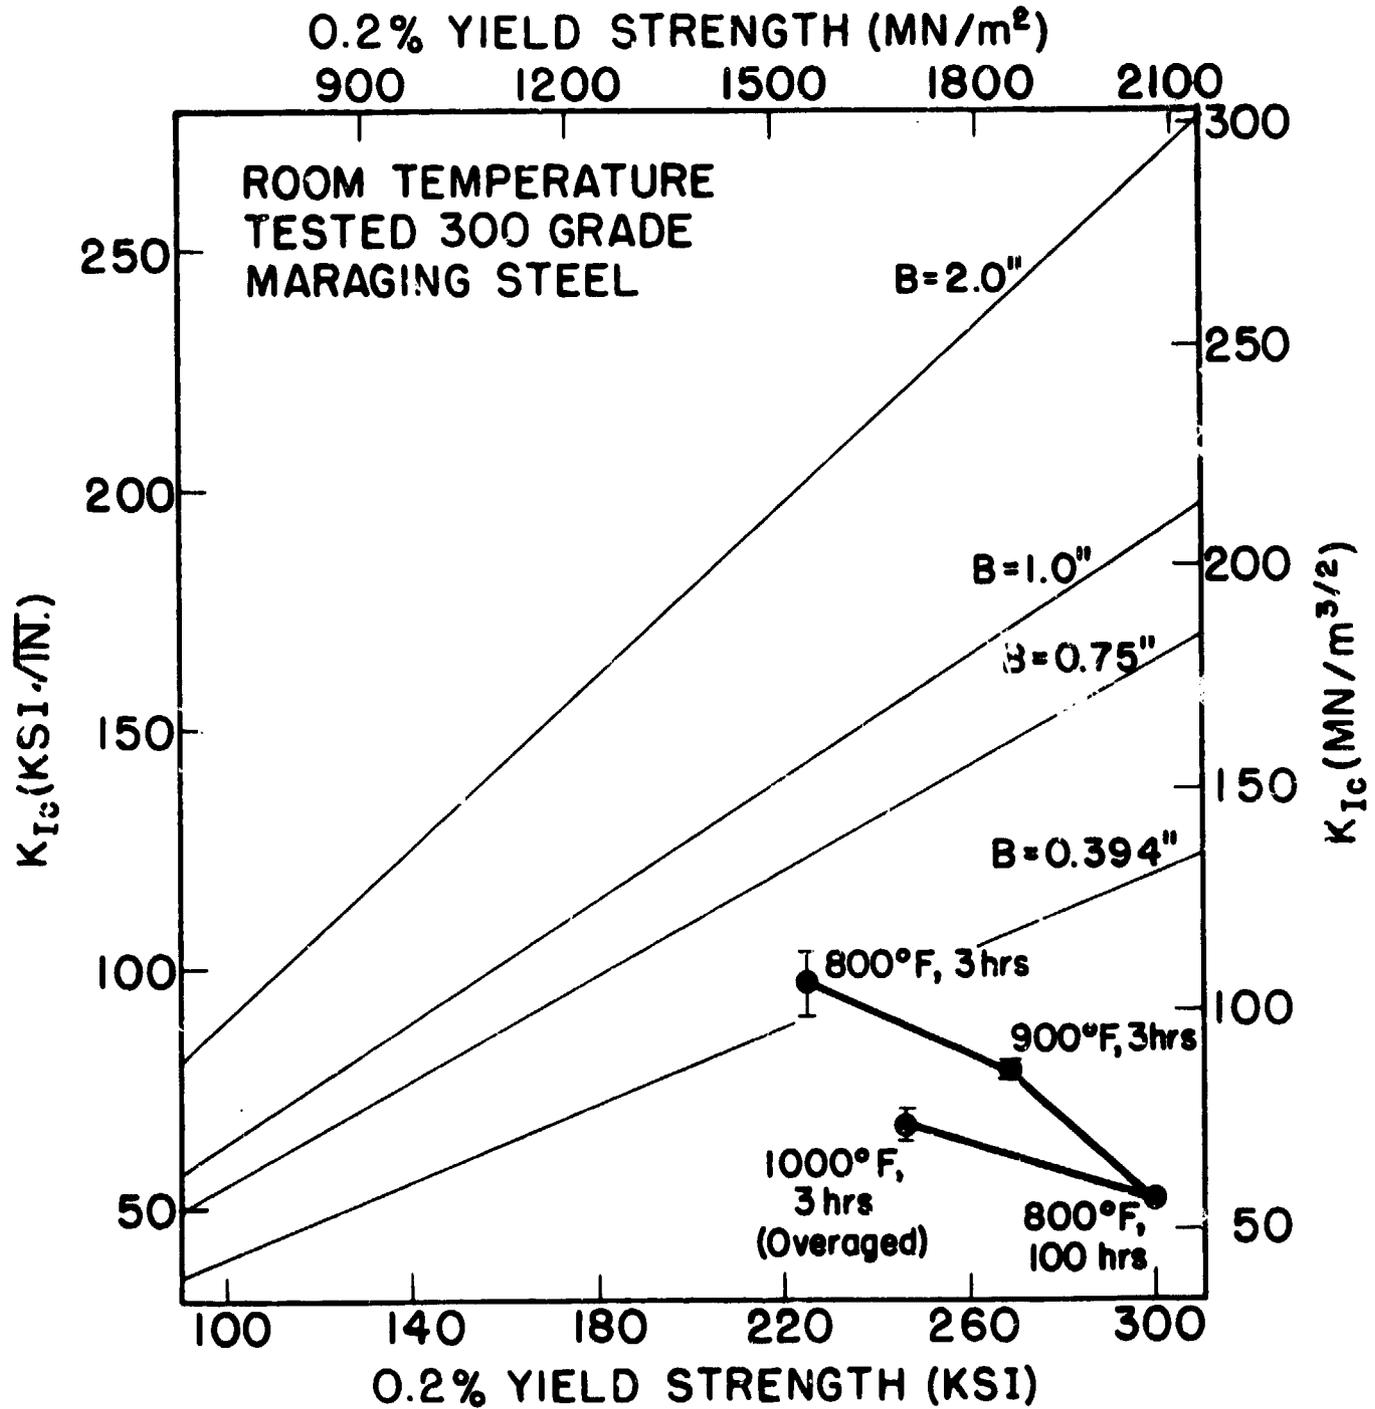
Figure 10 Valid K_{Ic} fracture toughness of variously strengthened 18 Ni, 300 grade maraging steel at 20°C (68°F) determined using 0.75-inch thick compact tension specimens.

A similar plot of strength versus toughness is given in Figure 10. In this figure are plotted valid K_{IC} against the 0.2% offset yield strength data available to date. These data are averages of at least three tests per condition. The error bars indicate the range of plus and minus one standard deviation (68 percent confidence limits). Where error bars are not shown, the standard deviation is smaller than the point representing the average

value. The invalid K_{IC} data for the 399°C (750°F) aging condition are not shown in Figure 10 since the scatter in the results would only serve to confuse the trend. A detailed explanation for the degree of scatter of the invalid toughness data for the 399°C (750°F) aging condition will be given in the next section of this report. It is also indicated in Figure 9 that toughness decreases with increasing strength and with overaging. In other words, at a yield strength of about 1725 MN/m² (250 ksi) the underaged material is expected to be about 22 MN/m^{3/2} (20 ksi√in) tougher than the overaged material. A possible explanation for the continued decrease in toughness with overaging is related to the size of overaged precipitates and their role in the void coalescence process. Details of this explanation and some fractographic evidence will be presented in the fractography section of this report. It is interesting to note that the tensile fracture strain data decrease with increasing strength and/or overaging in a similar fashion to the toughness data. This trend provides at best a rough indication that deformation in the tensile and K_{IC} specimens might be comparable.

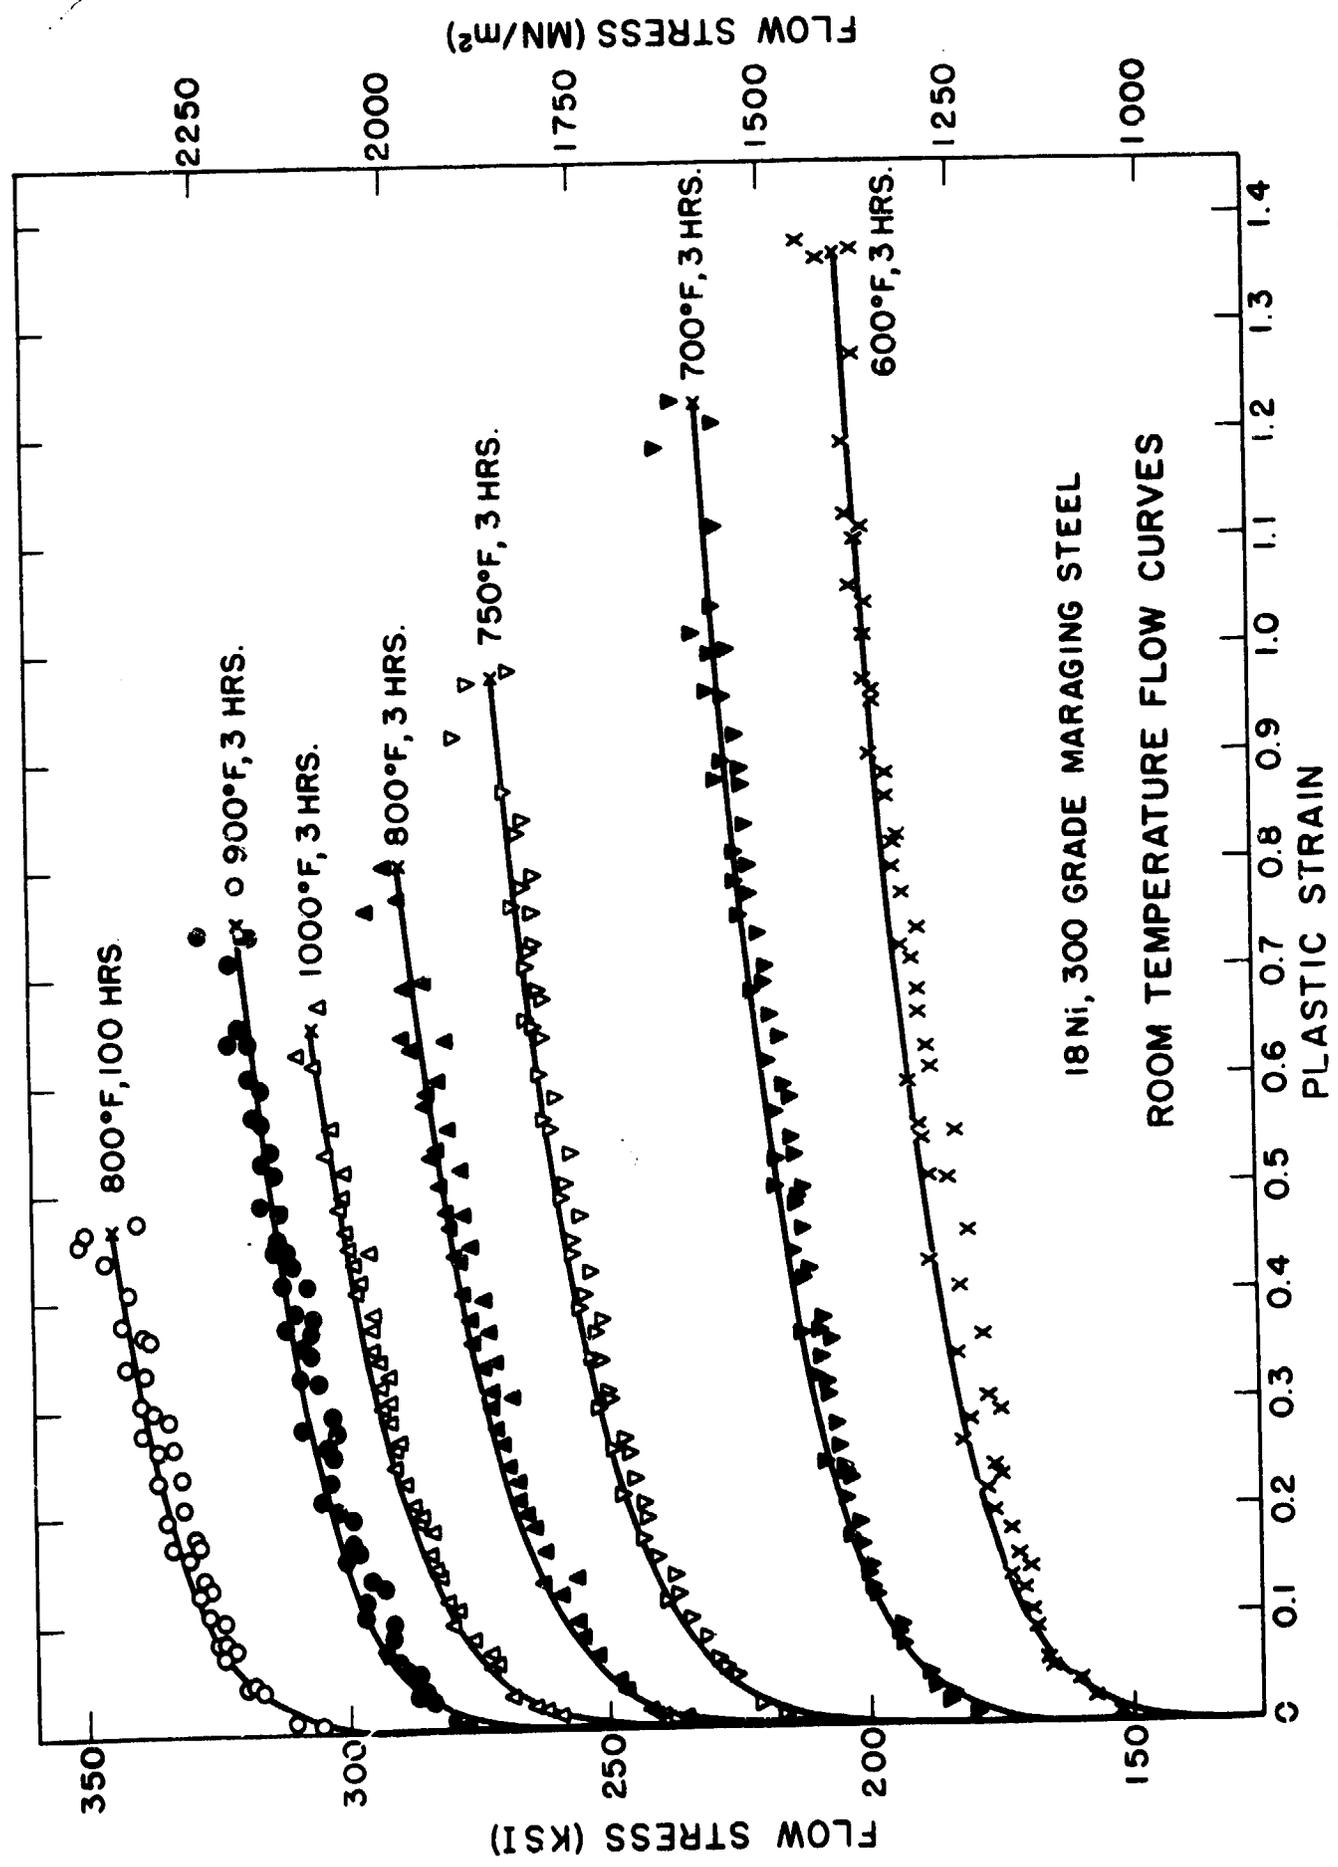
Figure 11 Room temperature tensile flow curves of variously aged 300 grade maraging steel. Solid lines are the result of the regression analysis.

The tensile flow curves of the 18 Ni, 300 grade maraging steel aged to the strength levels given in Table II are plotted in Figure 11. The symbols shown are experimental data points from multiple tensile specimens for each strength level and the solid curves are the results of the least squares regression empirical flow curves of the form given previously in Equation (4). Use has been made of a different symbol for each flow curve for visual aid purposes only. The fitted curves are terminated at the average fracture strain given in Table II and indicated by a small "x." It should be noted that the tensile flow curves for the solution treated, the 329°C (625°F) and the 344°C (650°F) conditions were not included in Figure 11 since they were only slightly different than the 316°C (600°F) age.

With all of the curves included, the additional data points and regression lines would only serve to confuse the trend in flow properties that Figure 11 is intended to illustrate. Some of the data points measured from the load-extension test records are not shown in Figure 11 but were used in the regression analysis. The data not shown is only for strains up to about 0.0 and again this is for purposes of clarity in the figure. The constants σ_0 , A , and m from the empirical flow curves at each strength level are listed in Table III. The statistical significance, which is a measure of the goodness of fit of the curves to the data is also given in Table III. The statistical significant value was calculated using a paired t- test⁴⁹ by comparing the experimental flow stress with that calculated from the empirical flow curve at a given plastic strain. This was done for each strength level considered. The significance can be interpreted as the probability that the experimental flow curve data and the empirical flow curve values belong to the same population. The fit of the data to this form of flow curve is excellent for all strength levels examined. The fit of the data to the empirical form given in Equation (5) is in all cases not as good as with that in Table III but it too would be an acceptable alternative.

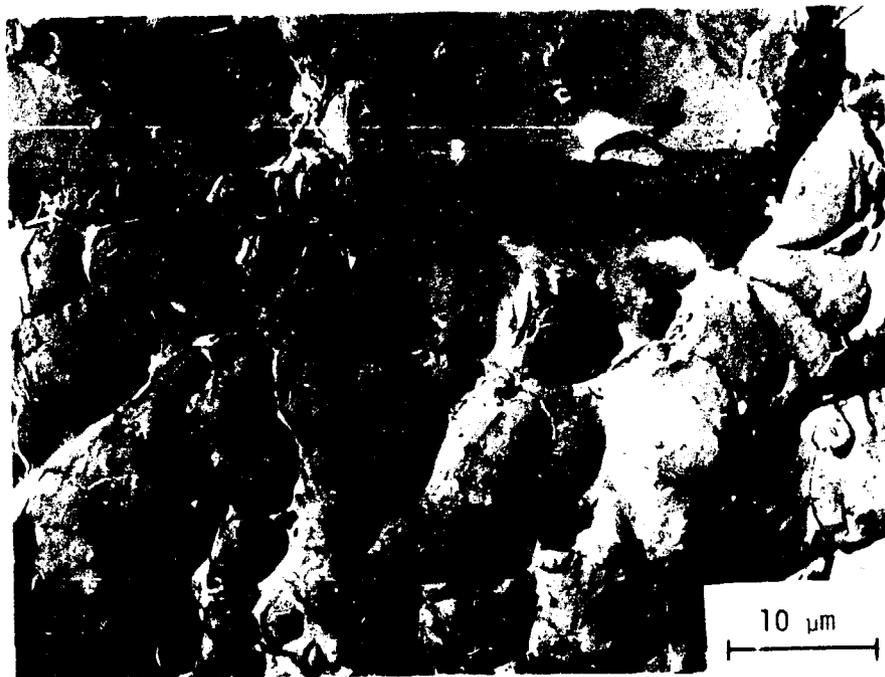
Figure 17 TEM fractographs from tensile fractures (a and b) of the 18 Ni, 300 grade maraging steel aged for 3 hours at 371°C (700°F). (A small dimple region and an initiation site are marked by "X" and an arrow respectively in figure 17a. Extracted fragments of inclusions are shown in figure 17b marked by "Y.")

With increasing strength, examples of the fracture surfaces of smooth tensile specimens aged for 3 hours at $371^{\circ}C$ ($700^{\circ}F$) are shown in Figure 17. There now appears to be a greater number of dimples within an area equal to the fractographs of Figure 16. Very few dimples are as large as $15\ \mu m$ in diameter. The majority of the fracture surface is now covered by dimples from $5-10\ \mu m$ in size. Small inclusions evidently of the $Ti(C,N)$ type occupy sites marked "X" in Figure 17a. Indicated by an arrow in Figure 17a is the impression of an inclusion approximately $5\ \mu m$ long and $2\ \mu m$ wide which may have failed by interface separation as revealed by the replicating tape which has surrounded the particle. In Figure 17b are fragments of inclusions which have broken up and have been extracted from the fracture surface. The fragments which are too thick to transmit the electron beam are marked as "Y."

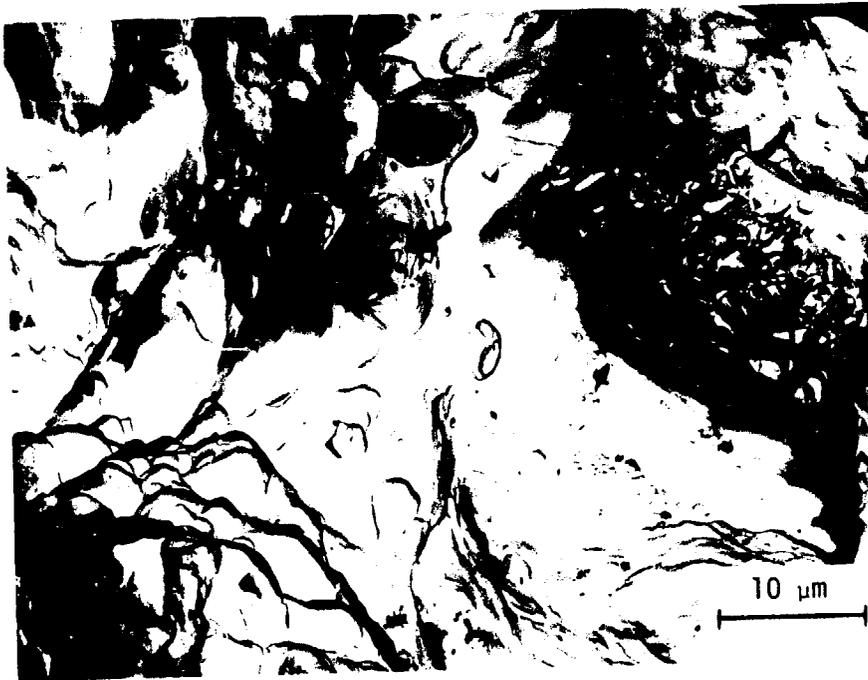
Figure 18 TEM fractographs from tensile fractures (a and b) of the 18 Ni, 300 grade maraging steel aged for 3 hours at 399°C (750°F). (At "X" in figure 18a are many fragments of inclusions. Arrows mark void initiation sites.)

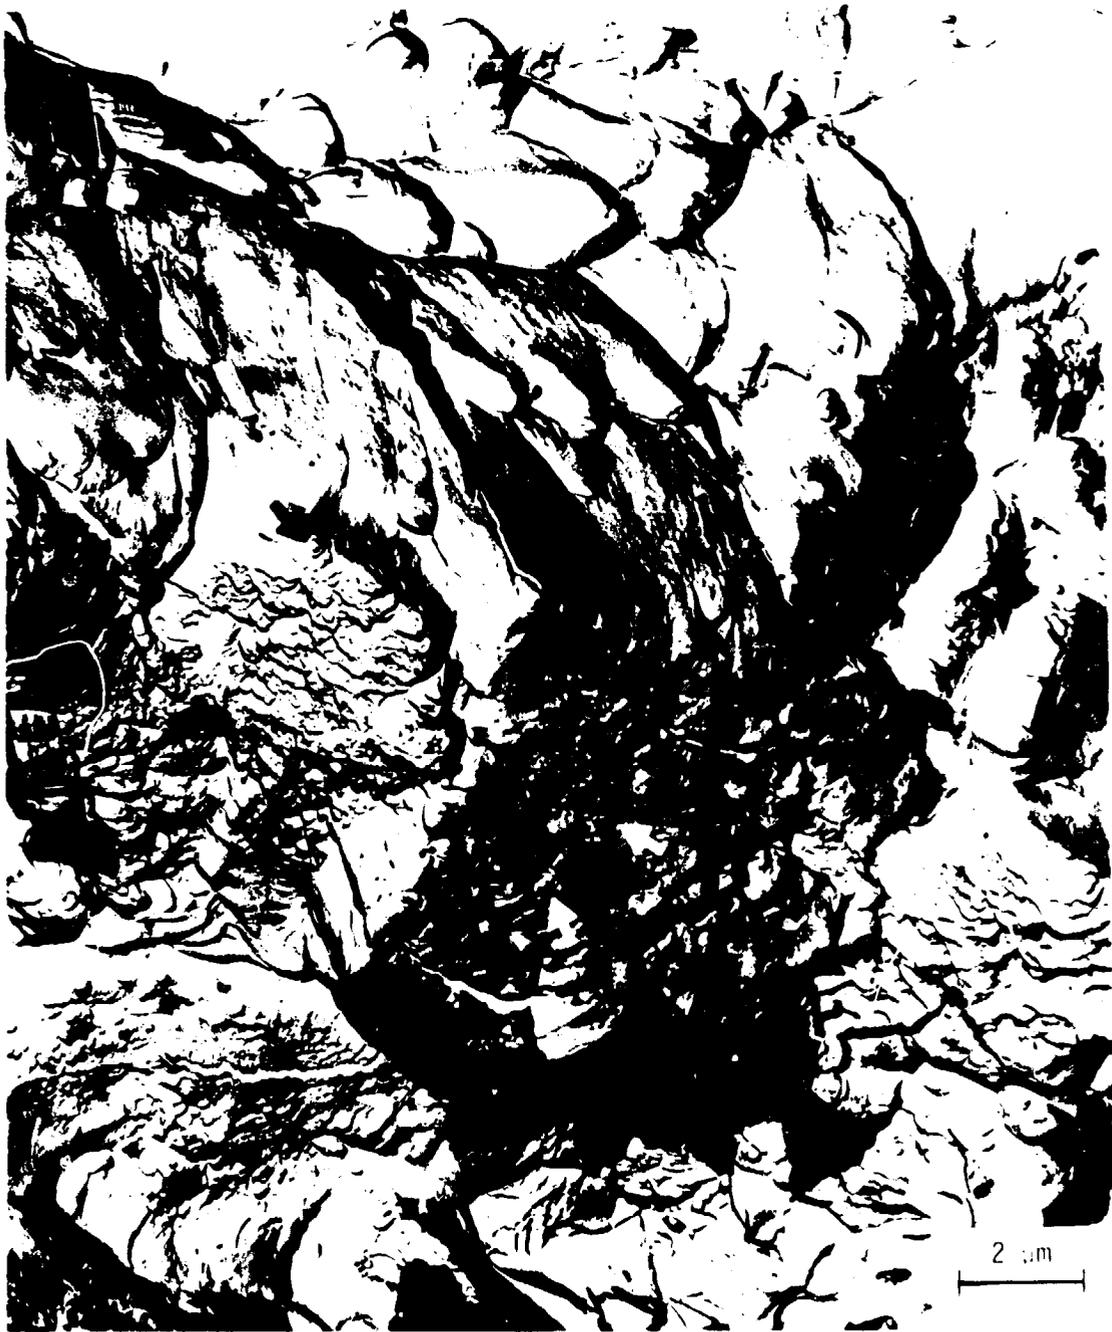
Figure 23 TEM fractograph from a K_{Ic} fracture of the 18 Ni, 300 grade maraging steel aged for 100 hours at 427°C (800°F). This is a typical high magnification fractograph of a ledge area similar to those shown in figure 22. (Impressions of submicron initiation sites are indicated by arrows.)

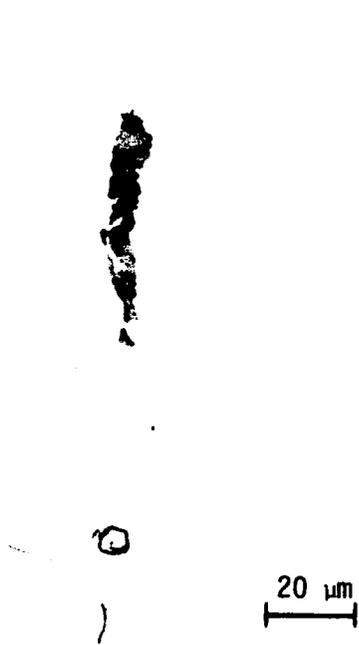
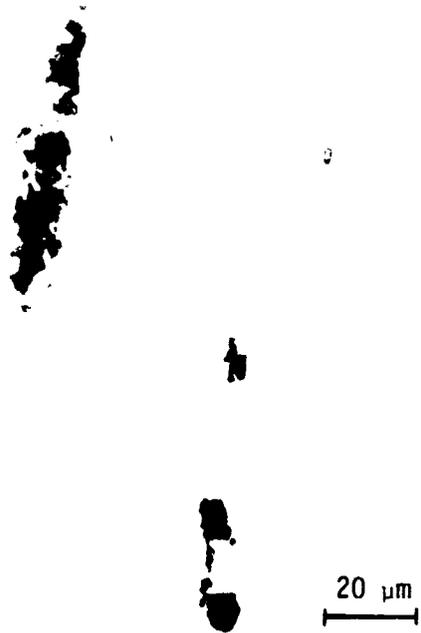
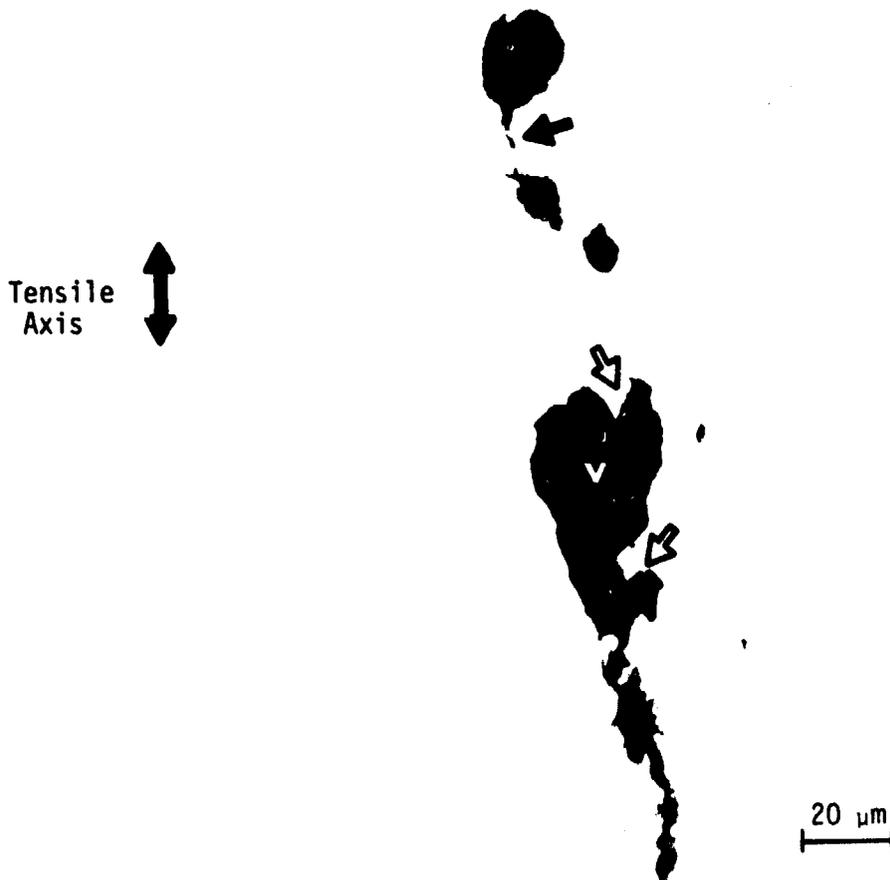
Figure 24 Void initiation and growth in smooth tensiles aged 3 hrs. at 427°C (800°F). Fracture strain for condition is 0.778. (In fig. 24c large void is marked "v" and open arrows indicate particle fragments. A solid arrow indicates a possible site of void coalescence between two large voids.)
