NASA EREP INVESTIGATION 9669

**APPLICABILITY OF SATELLITE REMOTE SENSING
FOR DETECTION AND MONITORING
OF COAL STRIP MINING ACTIVITIES**

Type of Report: Final Technical

SEPTEMBER 1975

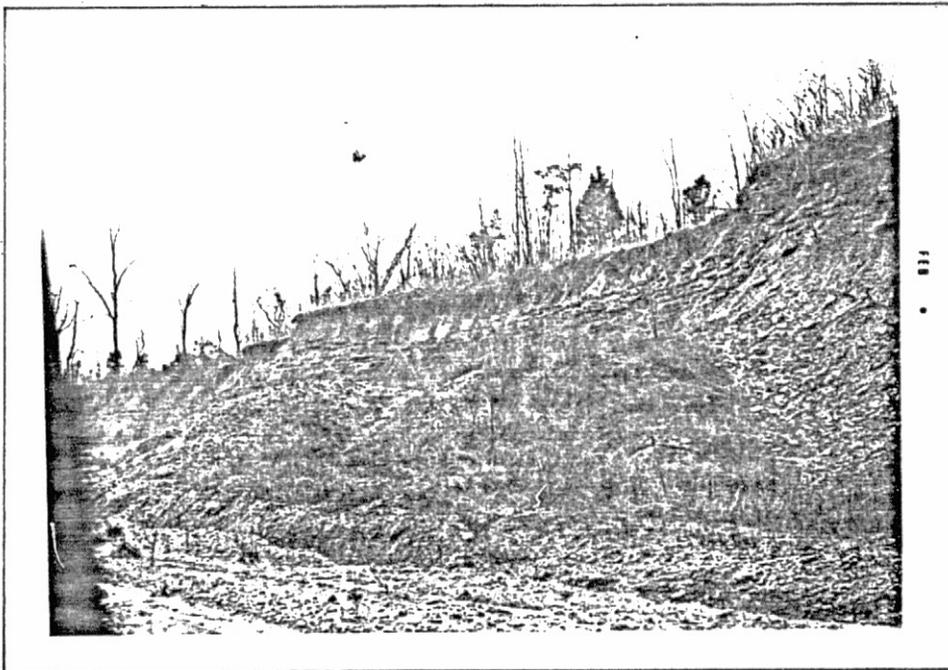
FIGURE 3.3
Orphan Area, Hopkins County, Kentucky

In 1964 the first effective Reclamation Law was passed in the State of Kentucky.. Prior to this law more than 700,000 acres had been mined in the Western Kentucky Coal fields. Area strip mining left spoil ridges; whatever little vegetation is present was natural growth under these harsh conditions since no effort was made to cover the acid producing materials. Presently there are more than 40,000 acres of these "orphan areas" in Western Kentucky (see Figure 3.3). Since the 1964 law and particularly since the newer, more effective law of 1966 orphan areas have not been produced. It should be noted here that no one is responsible to reclaim pre-law orphan areas and the State of Kentucky is in dire need of funds to put reclamation practices in effect in these aesthetic and ecologic eyesores. The purpose of the law was to create the Division of Reclamation in the Department of Natural Resources and Environmental Protection, Bureau of Land Resources. The main goal of this agency is the "minimization of

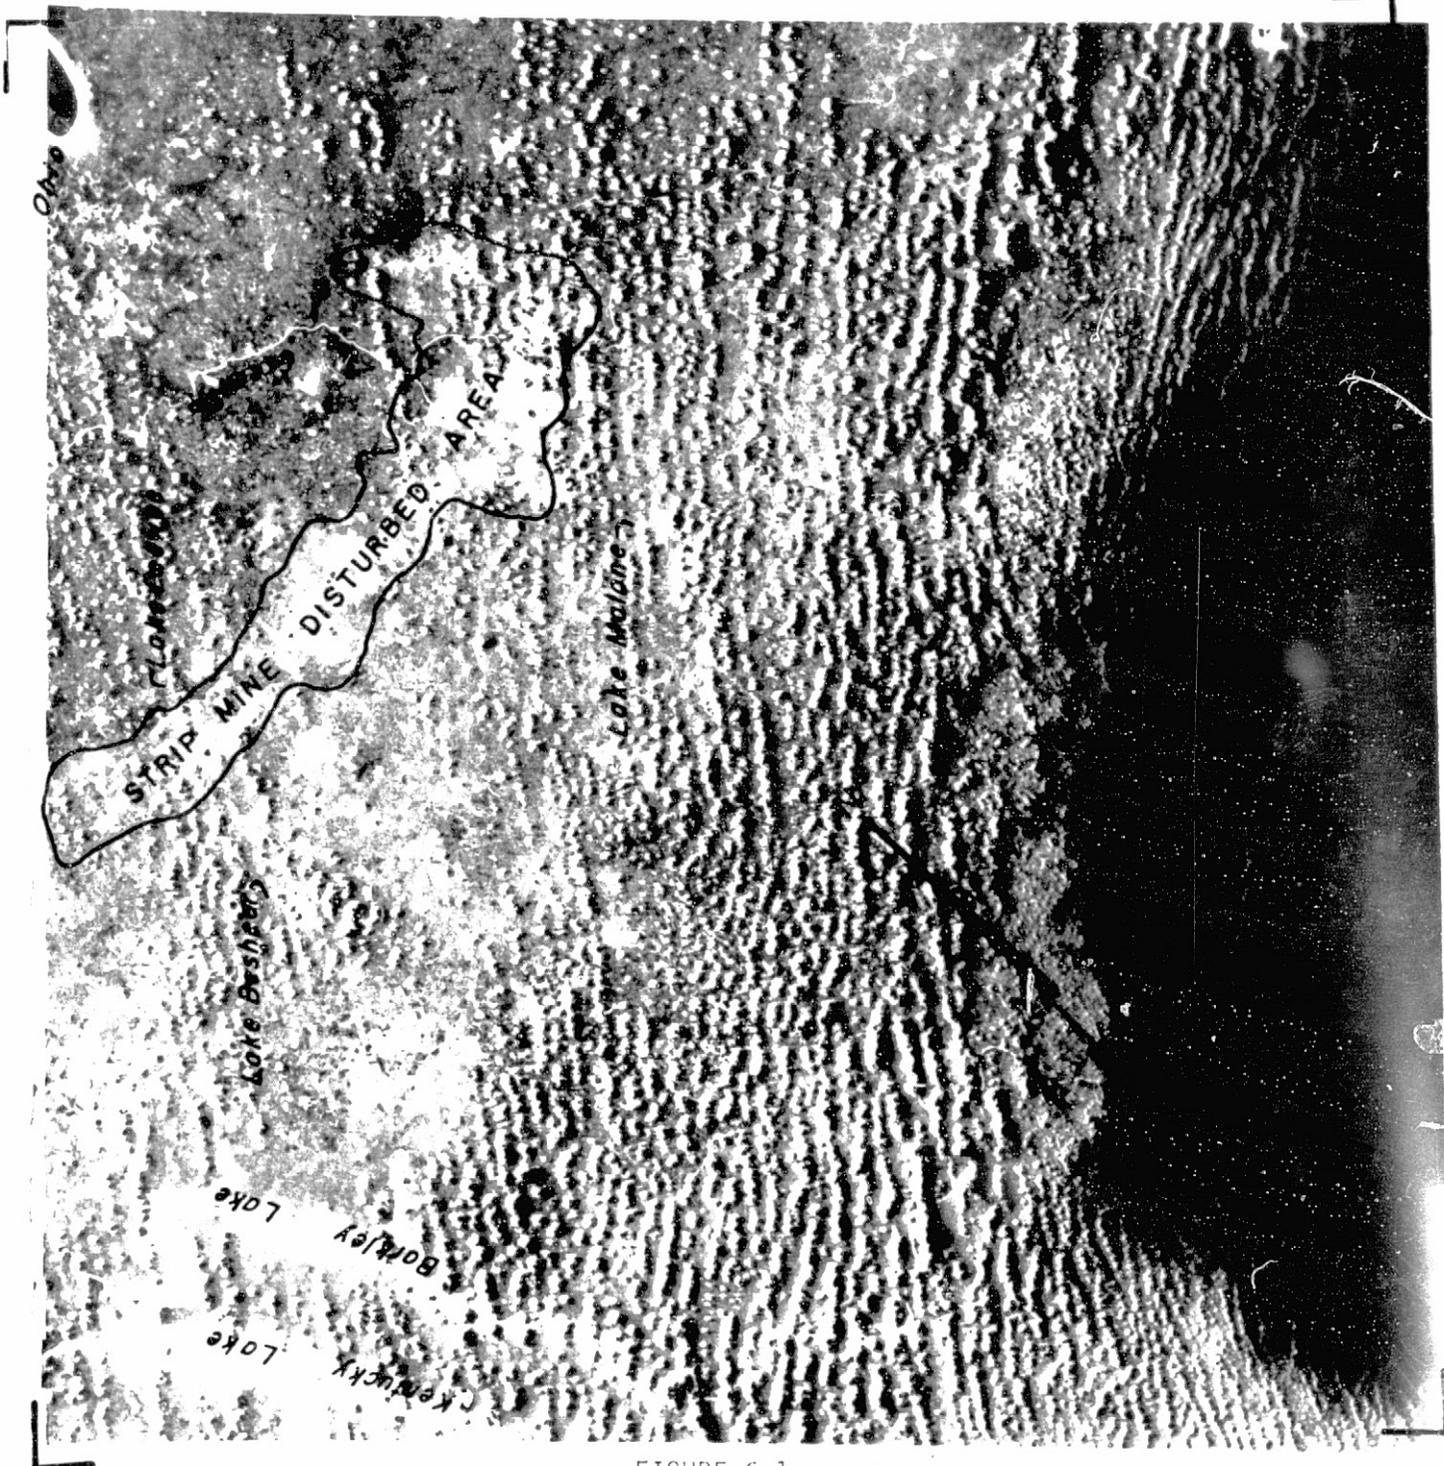
FIGURE 6.1

Figure 6.1 is an annotated print of the negative transparency. As can be seen, the most outstanding feature in this print is the elongated, U-shaped feature formed by the Kentucky and Barkley Lakes. It should be noted here that this large water body proved to be a valuable feature in the initial recognition and orientation of the transparencies. Medium sized lakes such as Lake Beshear and Lake Malone were also identified. It was decided to use the negative transparency because it afforded better tonal contrasts. In the negative transparency, even small lakes such as Peewee Lake, Pleasant View Lake, and Loch Mary Reservoir appear as very distinct light features contrasting with darker tones surrounding them. The area disturbed by strip-mining is distinguished by its light tone, and by the series of lighter toned lines representing the highwalls of the area strip mines. These lighter tones are due to the lower infrared reflectance of these barren and exposed surfaces. Please notice the almost perfect correlation between the outline of strip mines in this Figure 6.1 and the outline of the western Kentucky coal producing

areas shown in Figure 3.1, which represents the southernmost outcrop of the coal bearing beds in the regional structure.

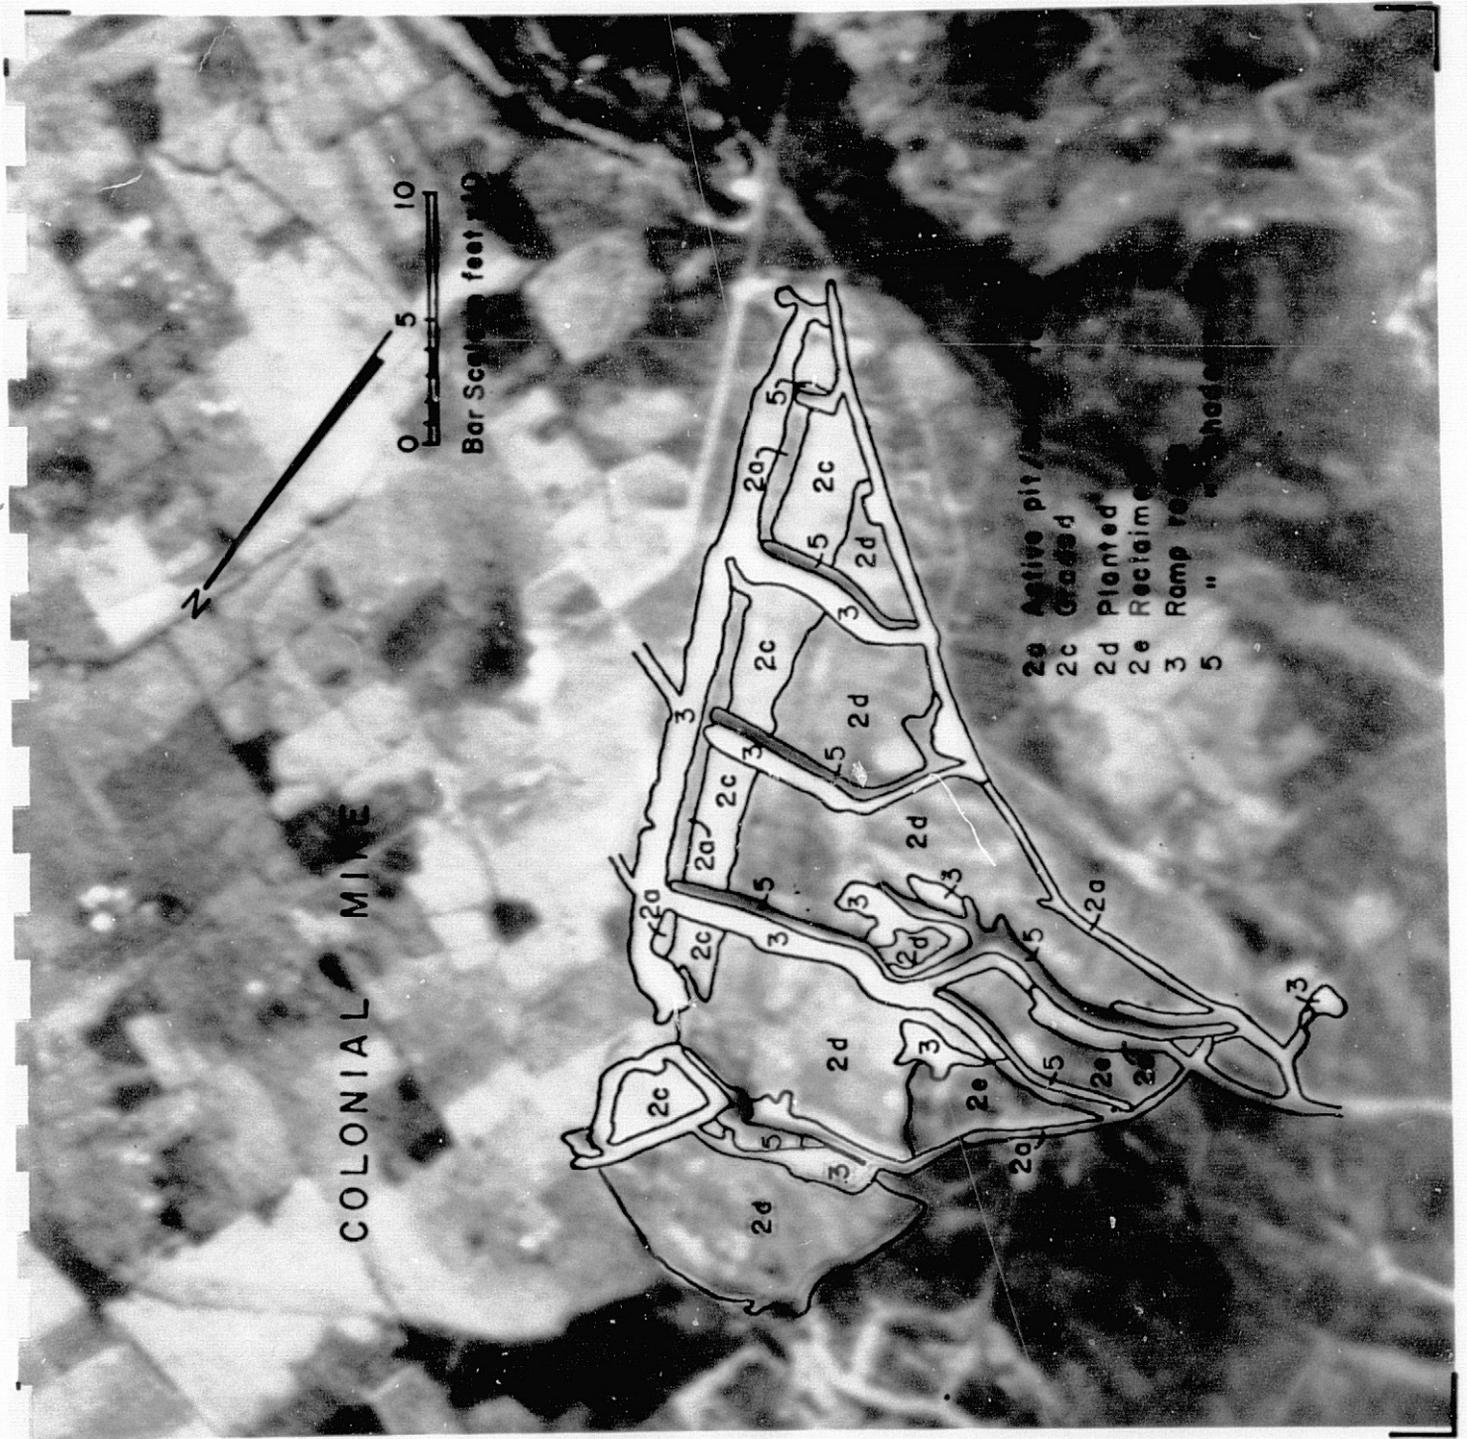
FIGURE 7.15

immediately recognized as a strip mine in this photograph is the area mine operated by Colonial Coal Company just west of Madisonville, Kentucky (see Figure 7.15). This Figure is a further enlargement of the same SL-4, 190-B color transparency. This mine presently consists of a large north-south trending pit (identified as 2A) which is being worked in an easterly direction. A series of ramp roads are leading into the pit and trending east-west (identified as 3) and built on top of a series of spoil ridges. The area west of the present pit has been reclaimed as the operations progress. Notice the gradation in intensities of blue (2E, 2D, 2C) indicative of successive stages of reclamation. It should be noted here that the area coded 2E has been recognized in the field as a reclaimed area in which army-worm infestation has drastically altered the reclaiming process. This specific example of Colonial Coal Company is a dramatic indication of the outstanding capabilities of this type of imagery.
