MCR-75-457
Contract NAS8-31615

Revitalizing the Hydrodynamic Support for Space Shuttle

Martin Marietta Aerospace has completed the inventory, inspection, preliminary layout drawing, list of spare parts required, and an implementation plan for adapting the Saturn V Hydrodynamic Support (HDS) to the Space Shuttle Mated Vehicle Ground Vibration Test (MVGVT).

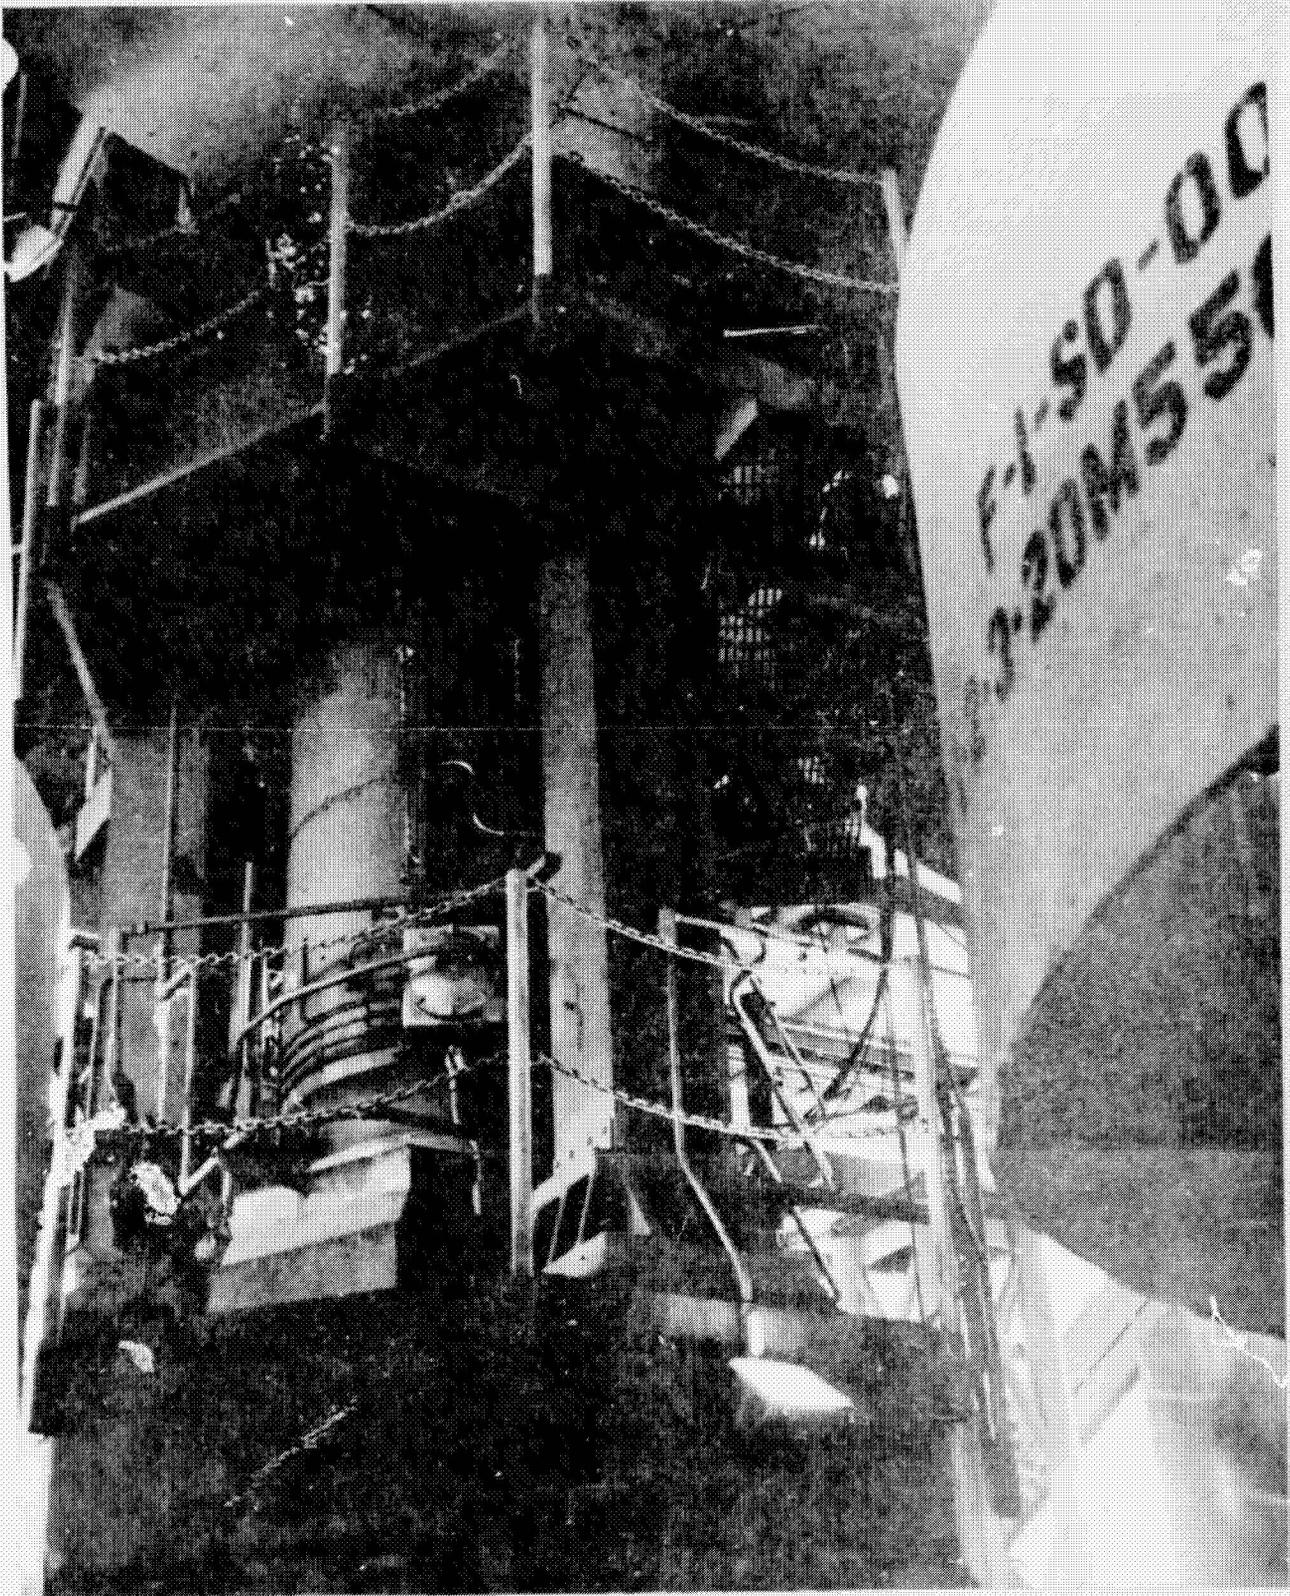
Figure IV-2. Piston and Cylinder Installation on Pedestal

One piston and cylinder assembly may be installed in a Park Structure assembly off-site in order to prefabricate and develop installation hardware (see Figures IV-2 and IV-3). The equipment to be developed and installed is similar to that on drawing 88A4100488 and consists of the following:
