28990 Investigation of Environmental
Change Pattern in Japan
(Classification of Shorelines)

Quarterly Report

Classification of Shorelines

Dr. Daitaro SHOJI
Chief Hydrographer

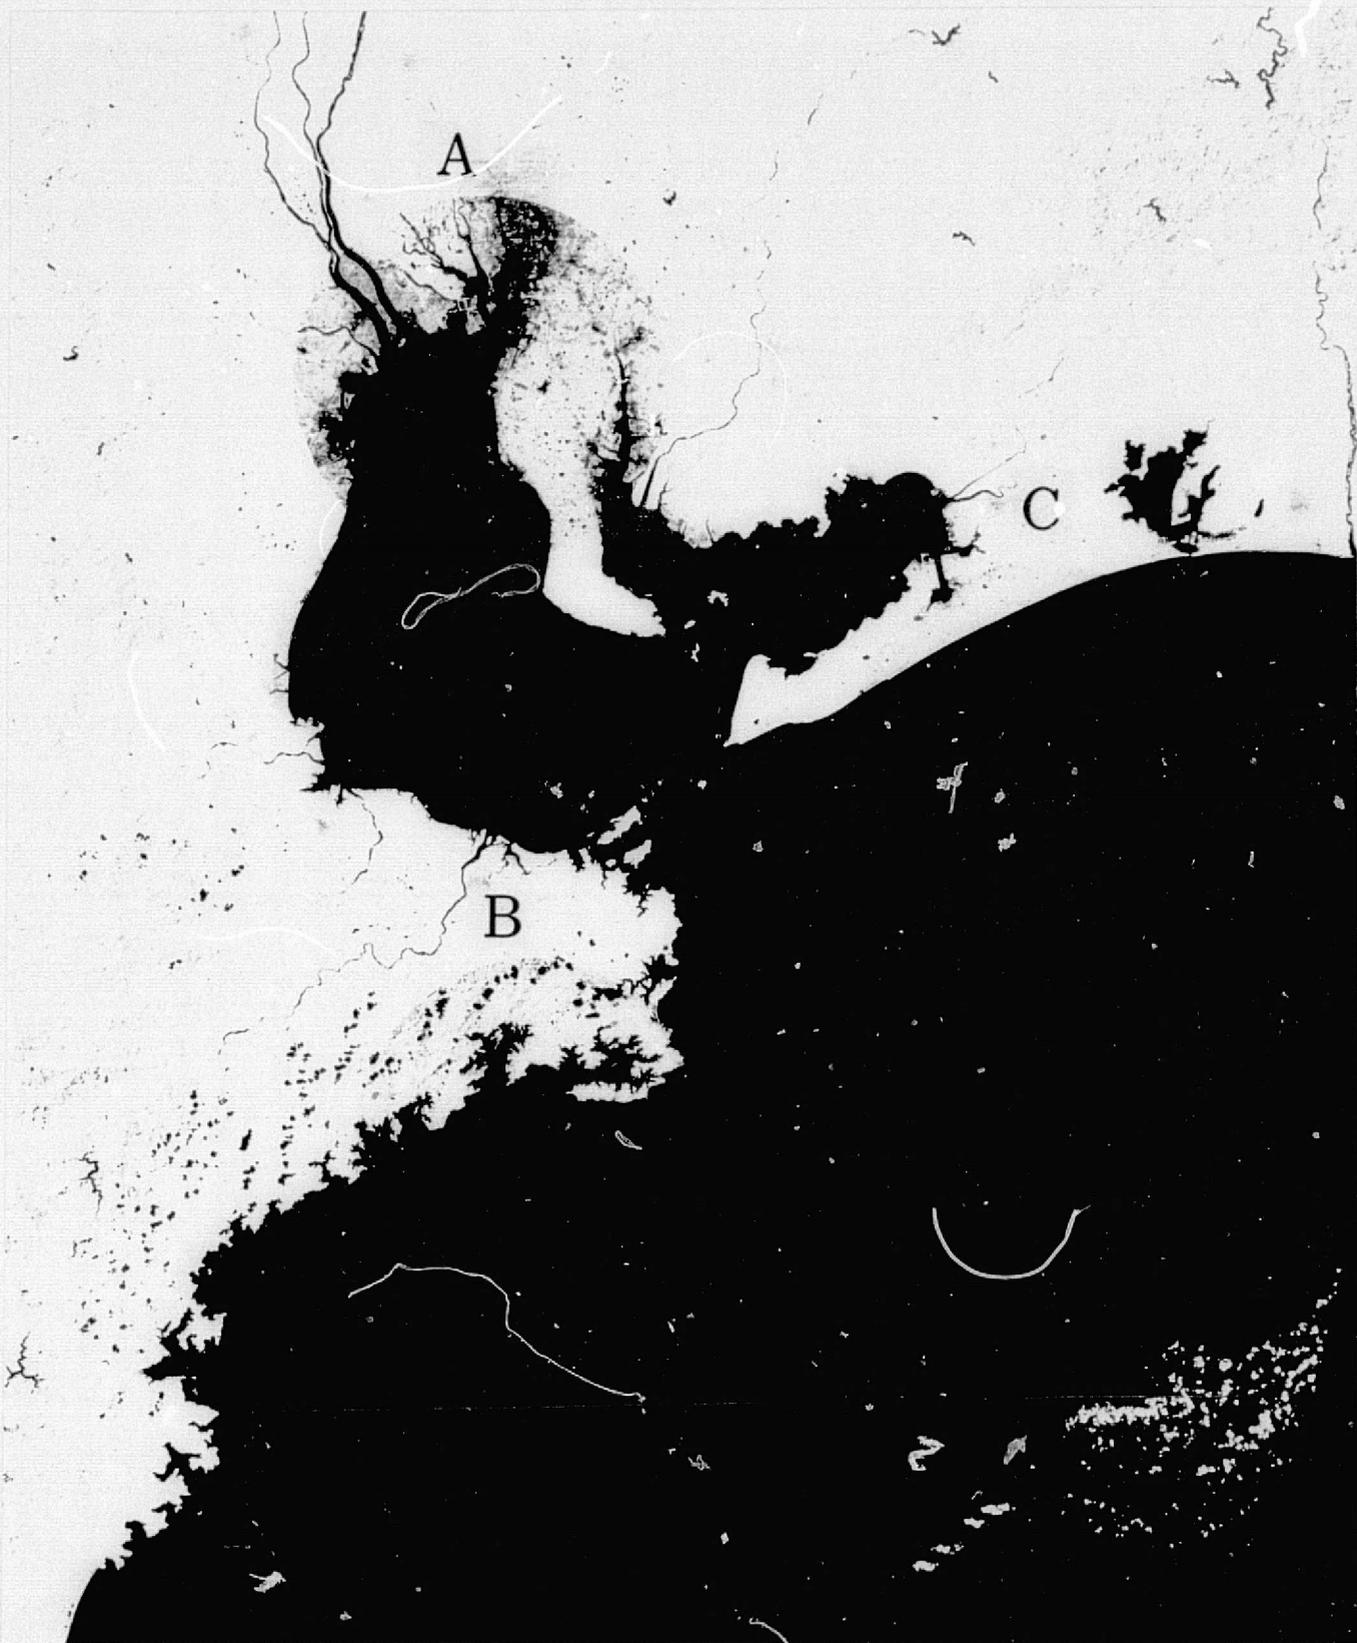
Fig. 1 Selected test site
 A; reclaimed lands B; rias coast C; sandy beach

There are many reclaimed lands along the head of Ise Bay (Fig.1-A), while the coast along Kumano Nada Sea shows a rias coast (Fig.1-B) and the coast of Enshu Nada Sea shows a monotonous sandy beach (Fig.1-C). Accordingly, the area of Ise Bay and its vicinity was selected as the most suitable test site.

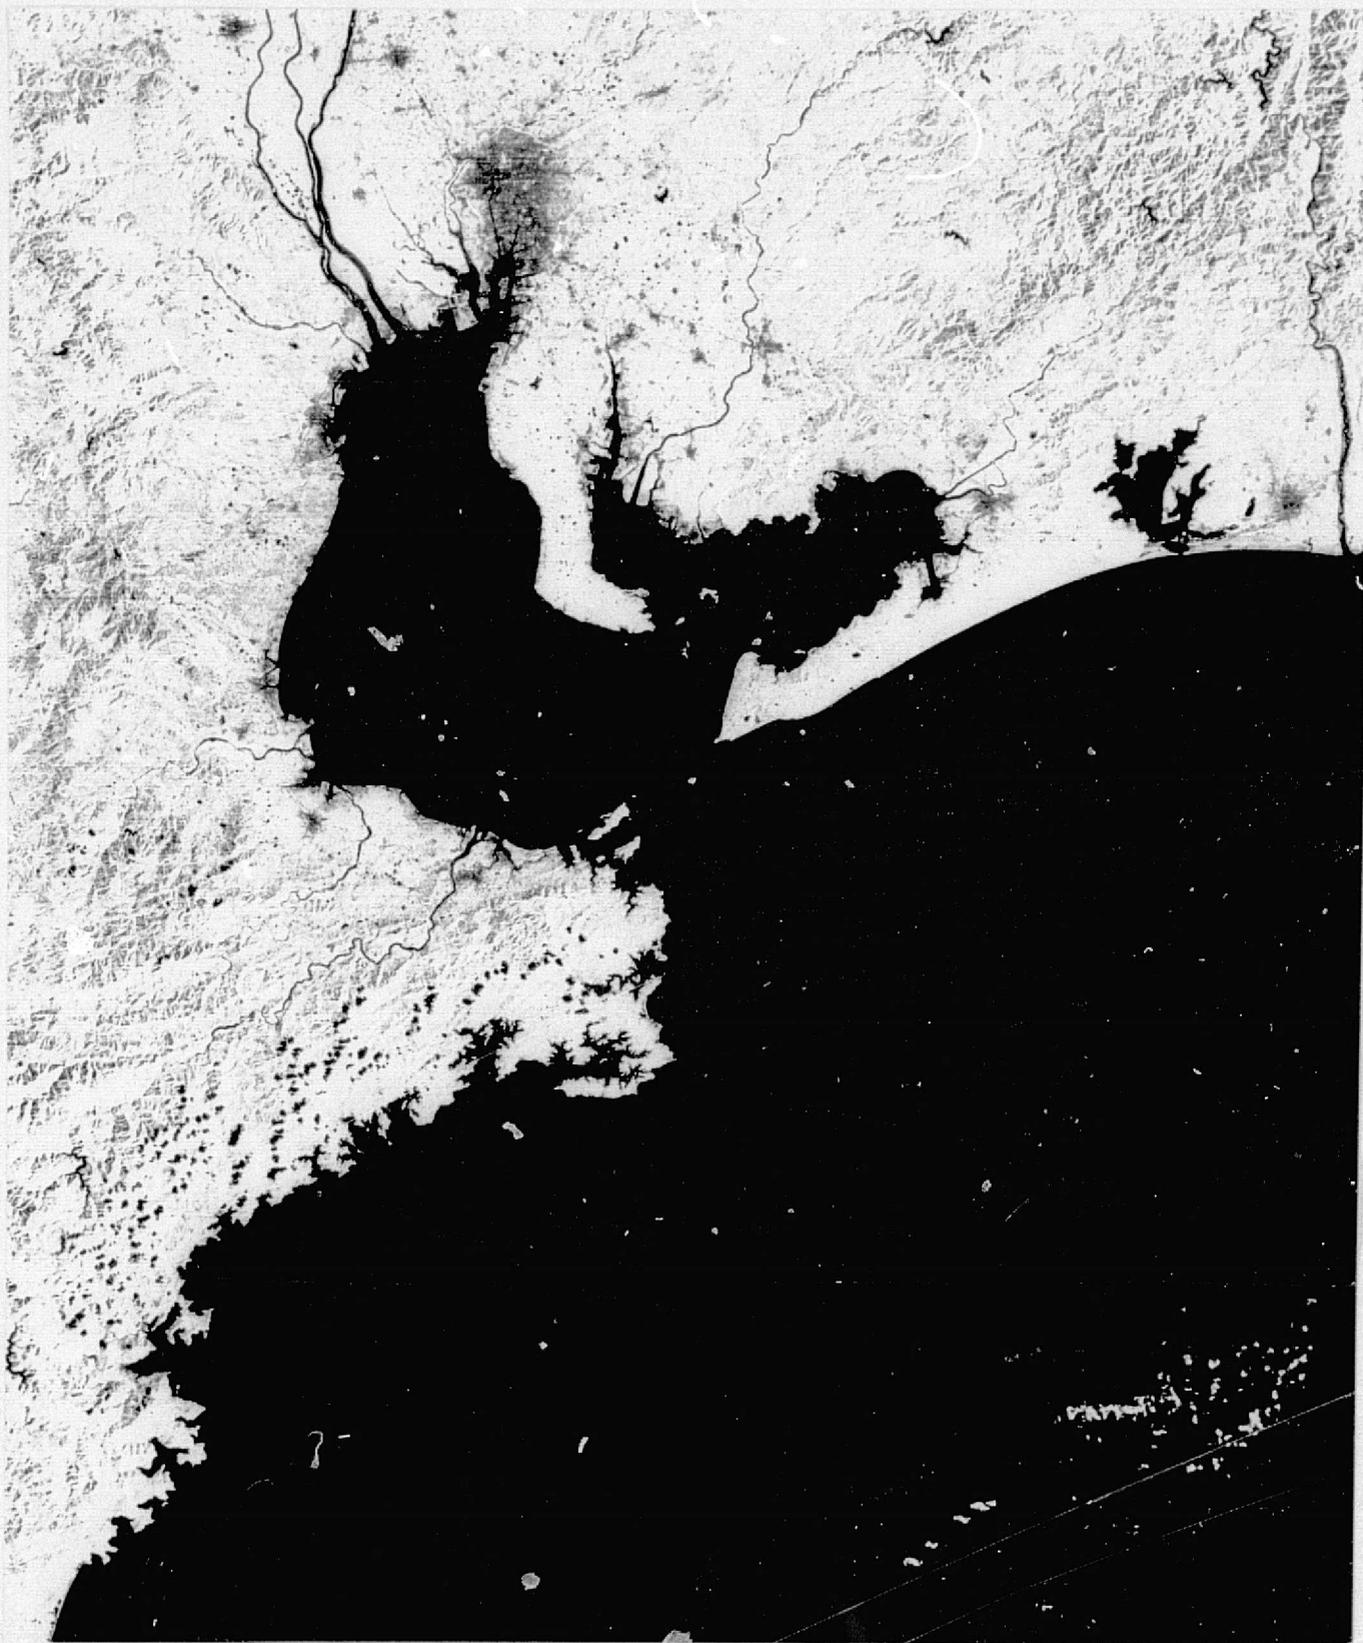
Fig. 2 Band 7 image

Qualitative analysis on black-and-white bulk positives, as many researchers already reported, is quite useful for classification of coastlines (Fig.2).

Generally, the coastline becomes more monotonous as the composition of materials changes from coarse to fine grain. On the other hand, the coastline of a reclaimed land is mostly close to a straight line.

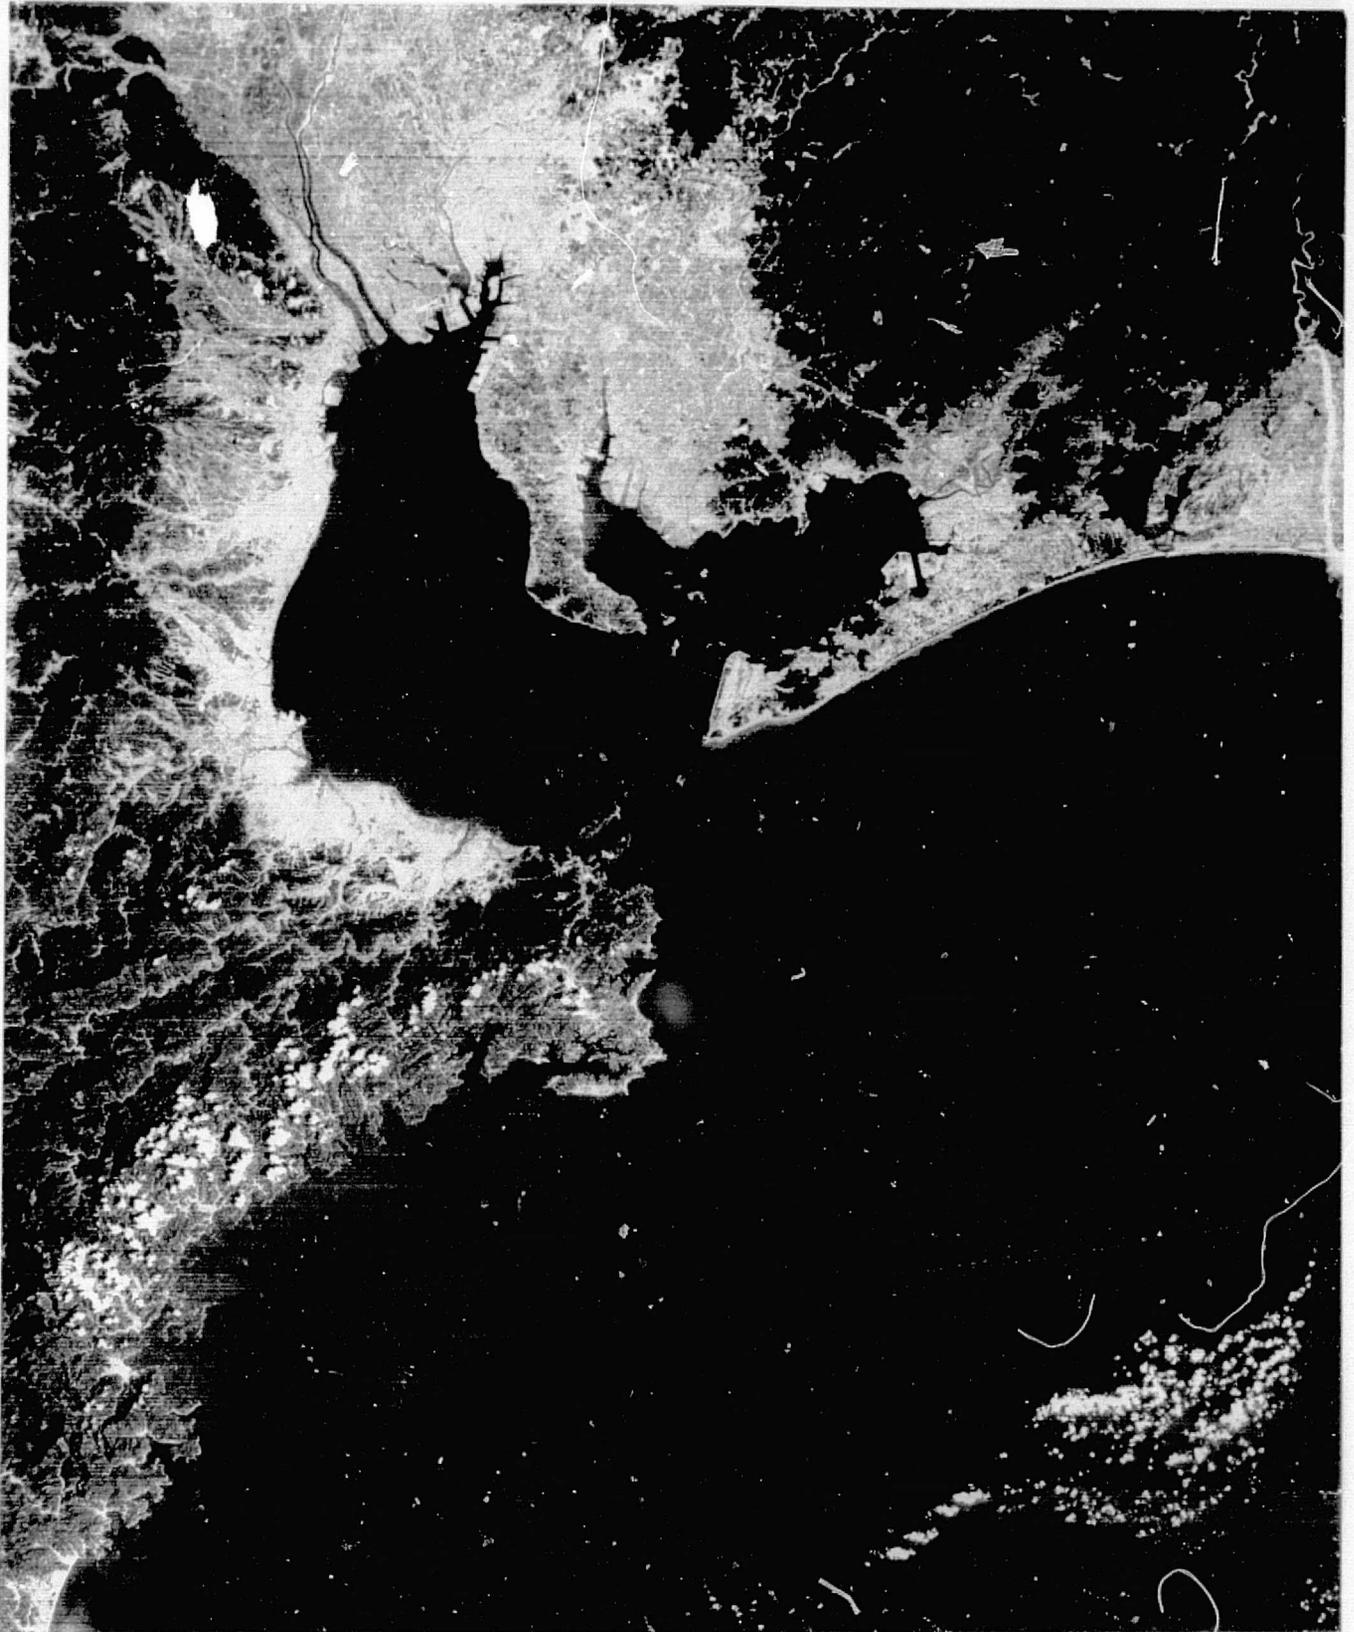
Fig. 3 Band 4 image

The situation of reclamation can be known by the density of image in band 7 and the distribution of muddy sea water in the vicinity of the reclaimed land in band 4 (Fig.3).

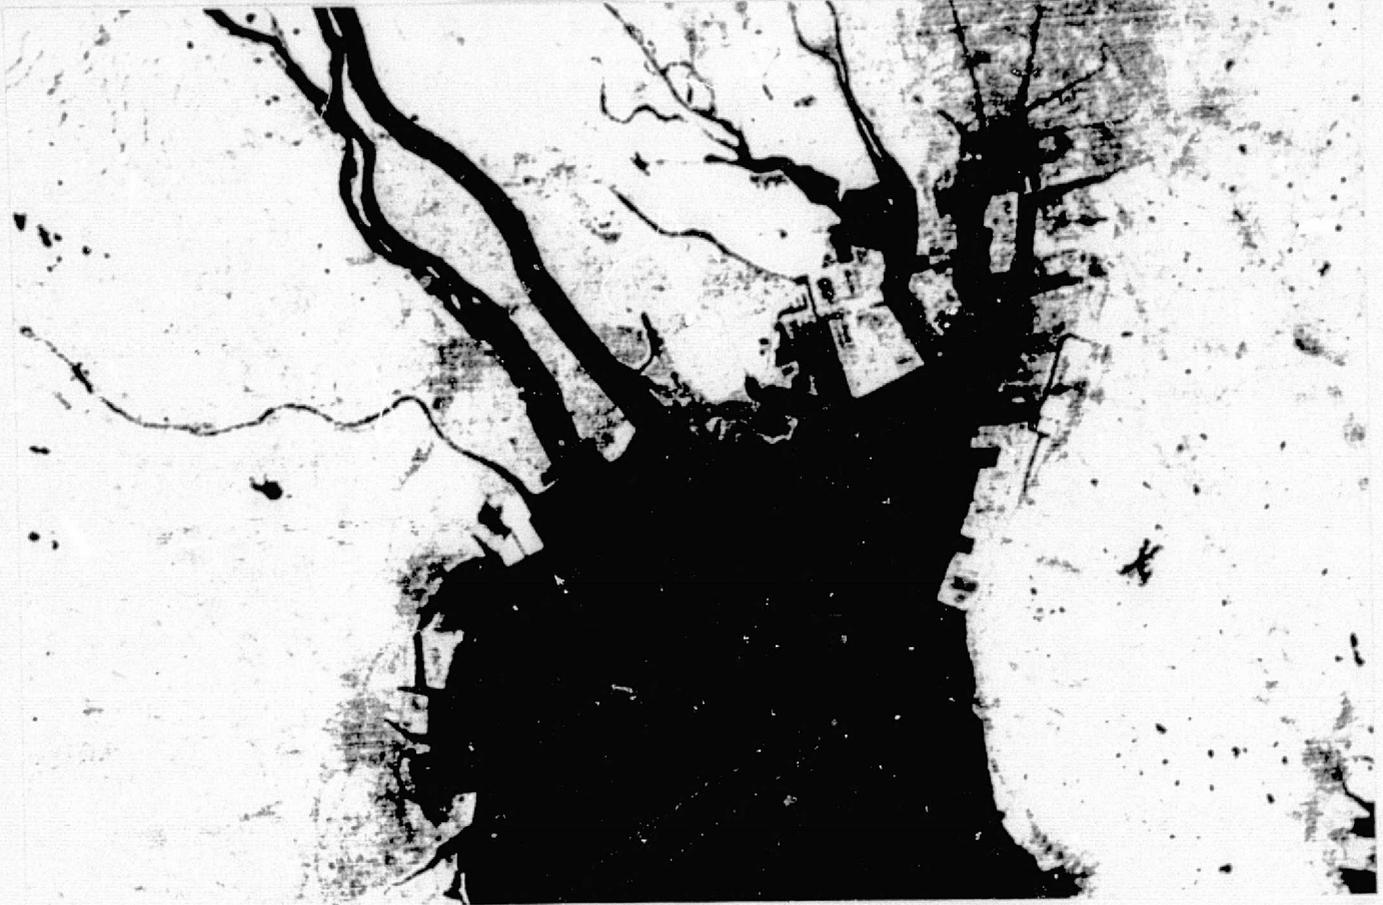
Fig. 4 Reclaimed lands at the head of Ise Bay (band 7)

- a) Band 7 image (Fig.4) shows the state of the reclaimed lands at the head of Ise Bay very well.
- b) Comparison of band 4 (Fig.5) with band 7 (Fig.4) shows the existence of water pools on reclaimed lands.
- c) Fig.6 and Fig.7 show Toyohashi Harbor. Band 7 (Fig.6) also shows the state of reclaimed lands very well.
- d) The history and the state of each reclaimed land are now under investigation.
- e) Furthermore, it is planned to make comparison of the ground truth with CCT data.
- f) Classification of natural coastlines will be made by using CCT.

It was found in the band 7 that the image density of some parts of reclaimed lands had the same density with that of the sea. (Fig.4 and Fig.6) It will be solved by making a CCT analysis.

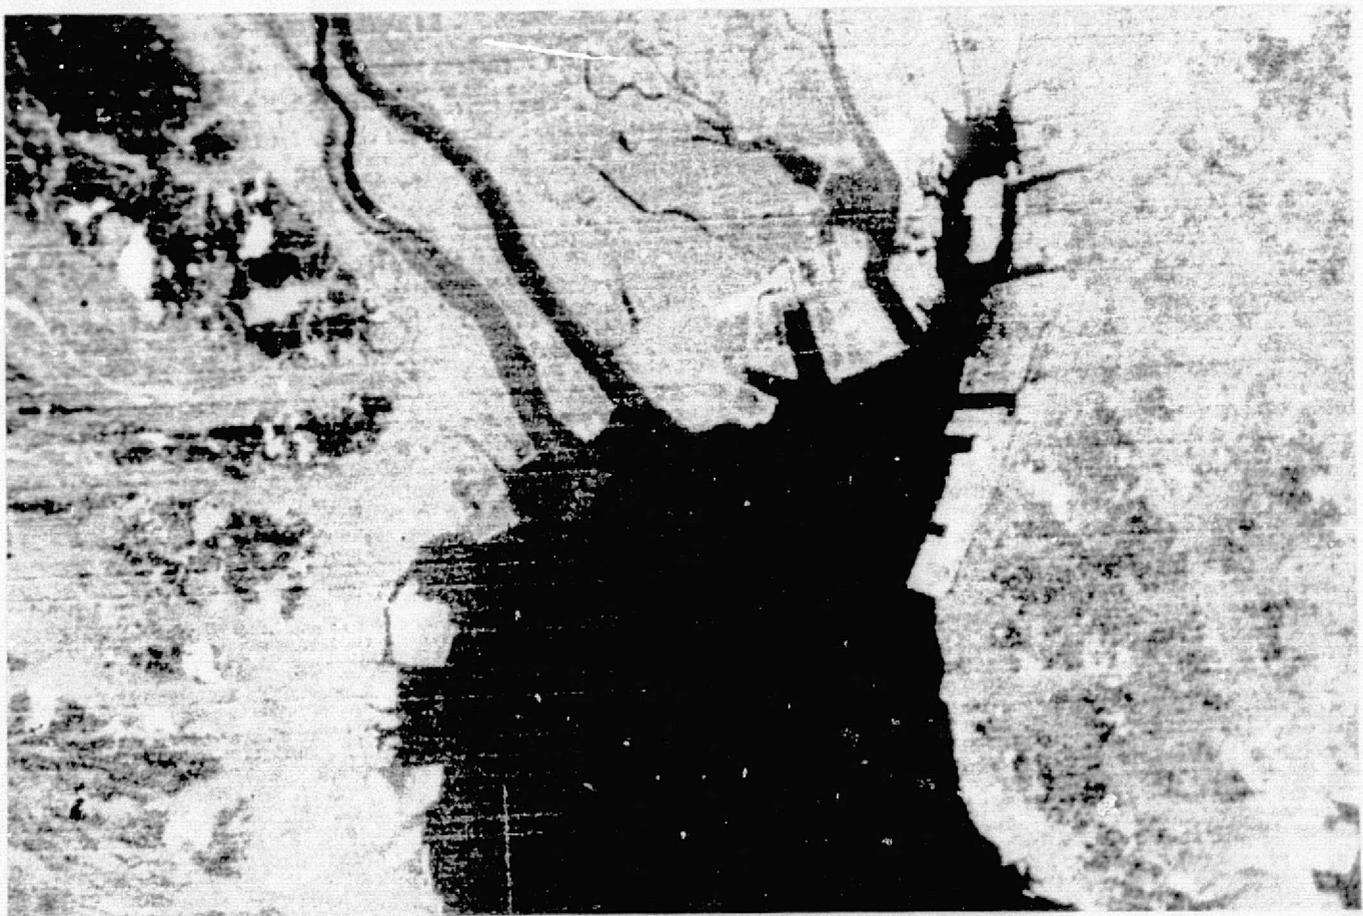
Fig. 5 Reclaimed lands at the head of Ise Bay (band 4)
