## SOME WEAR STUDIES ON AIRCRAFT BRAKE SYSTEMS

TING-LONG HO

TRIBOLOGY LABORATORY  
DEPARTMENT OF MECHANICAL ENGINEERING,  
AERONAUTICAL ENGINEERING & MECHANICS  
RENSSELAER POLYTECHNIC INSTITUTE  
TROY, NEW YORK 12181

OCTOBER 1975

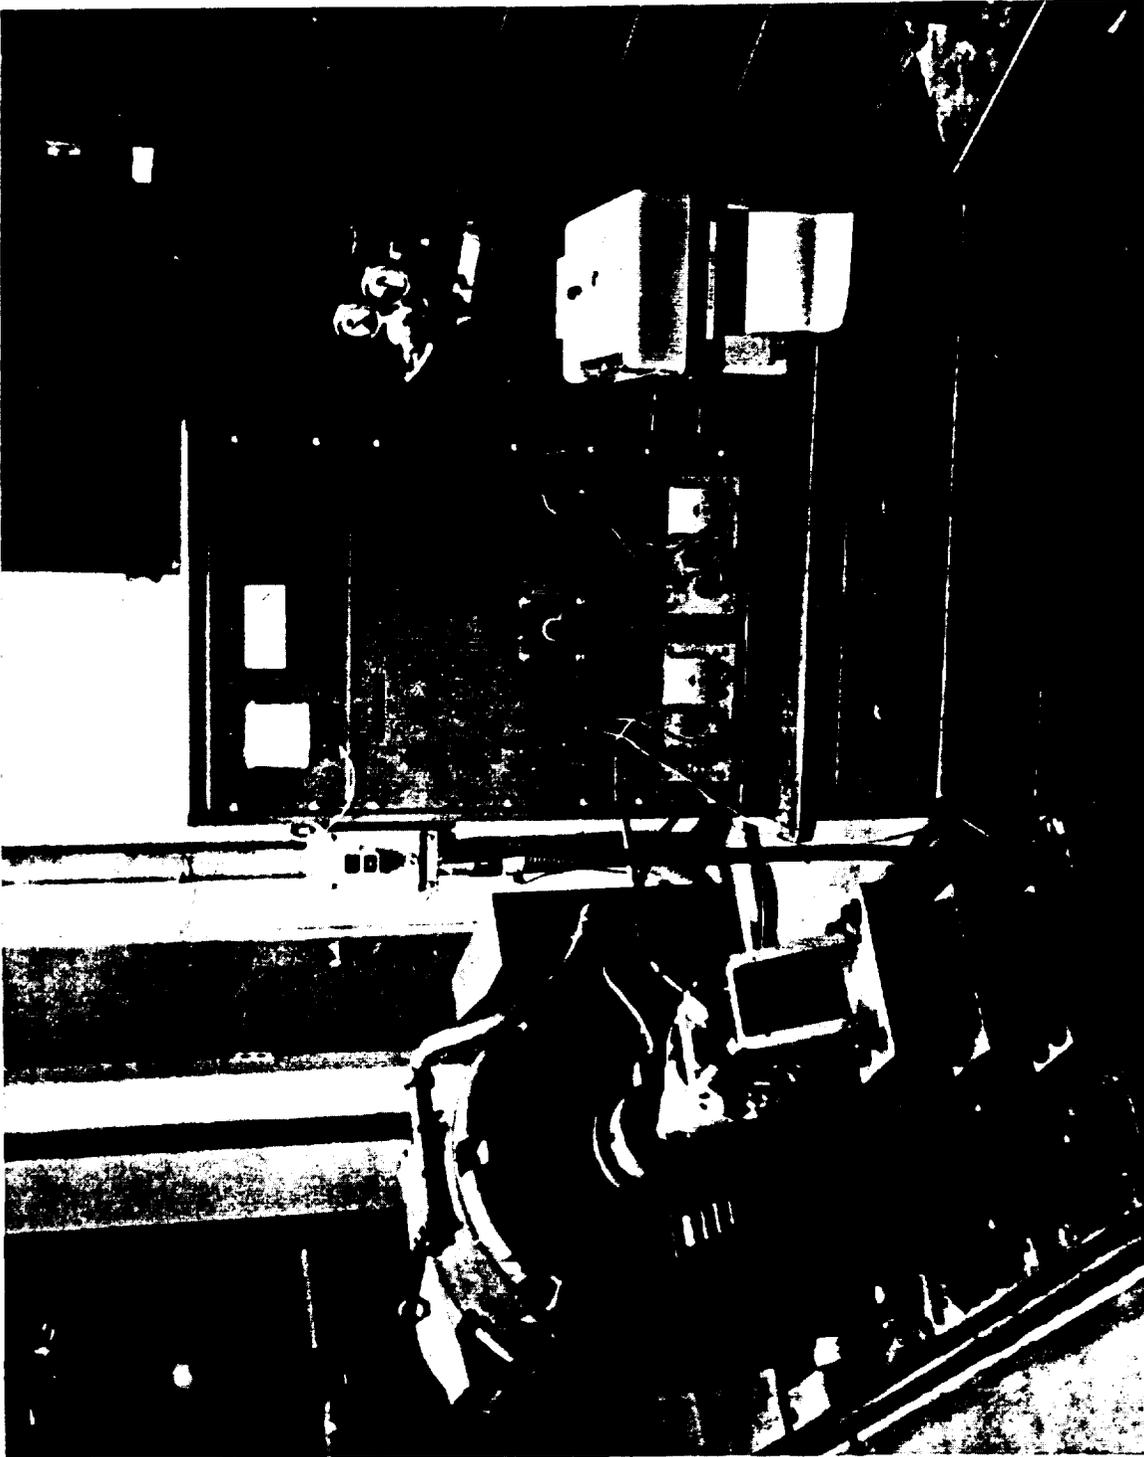
Figure 7 Photograph of Test Apparatus for Brake Material Evaluation (Rig A)

- 1 - WHEEL HALF
- 2 - DISC BRAKE
- 3 - PRESSURE TRANSDUCER
- 4 - STRAIN GAGE TORQUEMETER
- 5 - THERMOCOUPLES
- 6 - TACHOMETER
- 7 - SOLENOID VALVE
- 8 - REGULATED COMPRESSED AIR SUPPLY

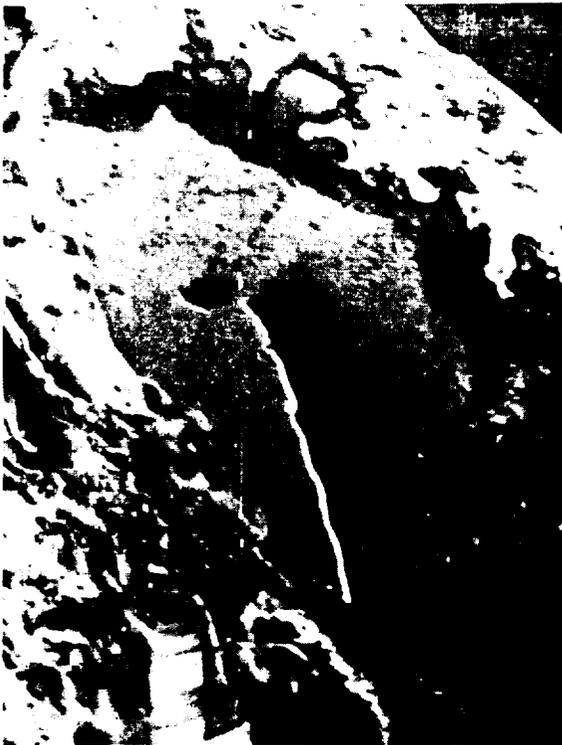
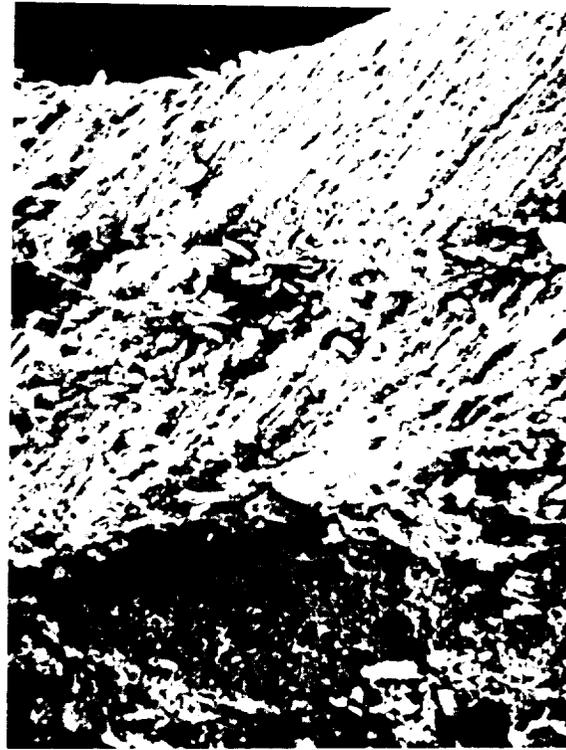
Figure 13 SEM Photographs Showing Four Different Surface Conditions of Wear Particles Collected from the Tests of Cu-Based Brake Materials Sliding Against Steel.

Four such sheet-like particles are shown in Figure 12. Three micrographs, "a", "b" and "c" show the sliding surface sides, picture "d" gives a view of the fracture surface in which lots of cracks are seen. Figures 13a and b show the irregularity of the fracture surfaces at higher magnifications. The small particles connected on the surface are thought to be oxides and the hole to be the site where a large particle (may be abrasive) was imbedded and removed.

The removal of the wear platelets is shown in Figures 13c and d. It is felt that subsurface cracking underneath the interface has taken place before the sheet-like particle can leave. Lots of oxides stay on the substrate where debris was detached (see left of Figure 13c). Also the sliding tracks are seen on the heavily oxidized substrate which locates left as shown in Figure 13d.

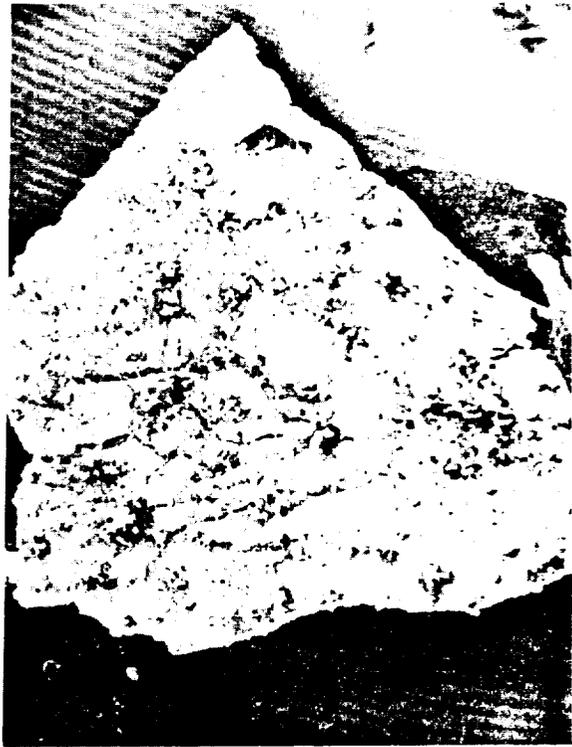
d X 50

Figure 12 SEM Photographs Showing Four Sheet-Like Particles Collected from the Tests of Cu-Based Brake Material Sliding Against Steel

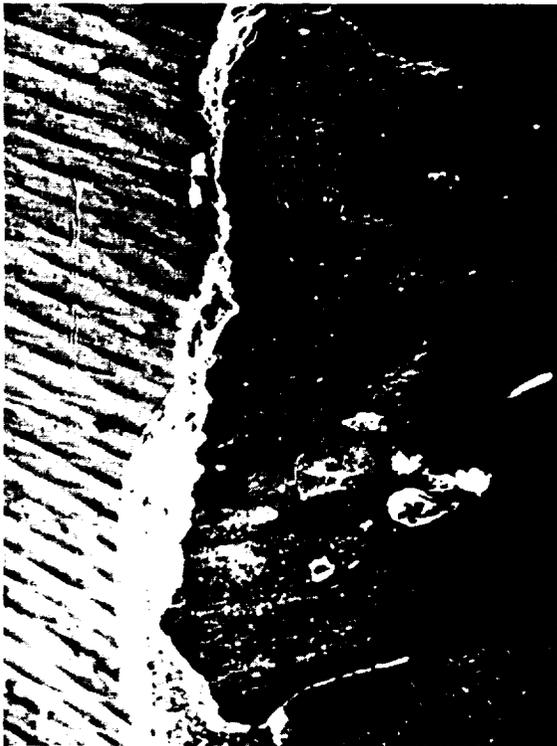
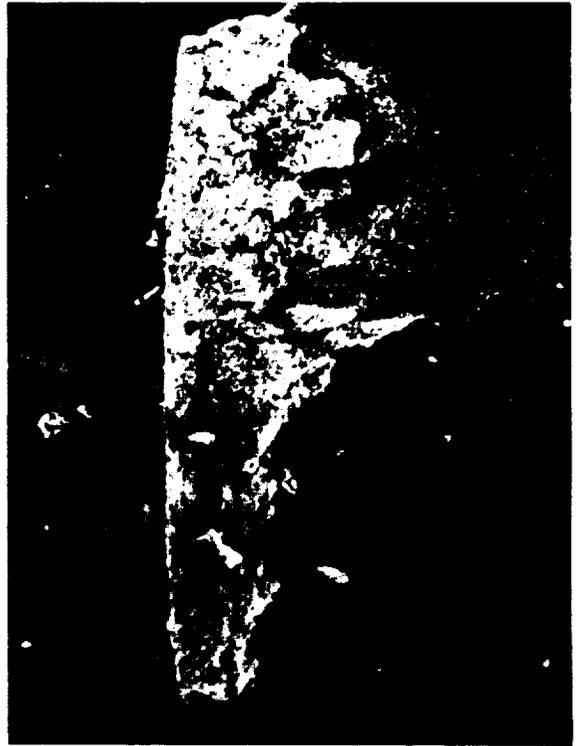
Figure 14 SEM Photographs Showing Three Views and Sliding Surfaces of a Wear Particle of Cu-Based Brake Material Sliding Against Steel

In Figure 14, a wear particle is shown in three different views labeled "a", "b" and "c", respectively. The size is about  $18 \times 10^{-4}$  meter  $\times 7 \times 10^{-4} \times 2.5 \times 10^{-4}$ . This sheet-like particle has a facet with frictional tracks which is shown at higher magnifications in picture "d" (200  $\times$ ) and "e" (2000  $\times$ ). It appears that the tracks are covered by a smooth and thin film which resulted from high frictional heating. The rest surrounding the particle is the failure surface of irregular geometry (see Figure 14b).

Two things are noticeable here. First, the side curve of the sliding surface is slightly convex. It is felt that this bending is due to stress relief. Second, two large particles associated with the subsurface cracks which are parallel to and below the sliding surface are found in the left of the picture.

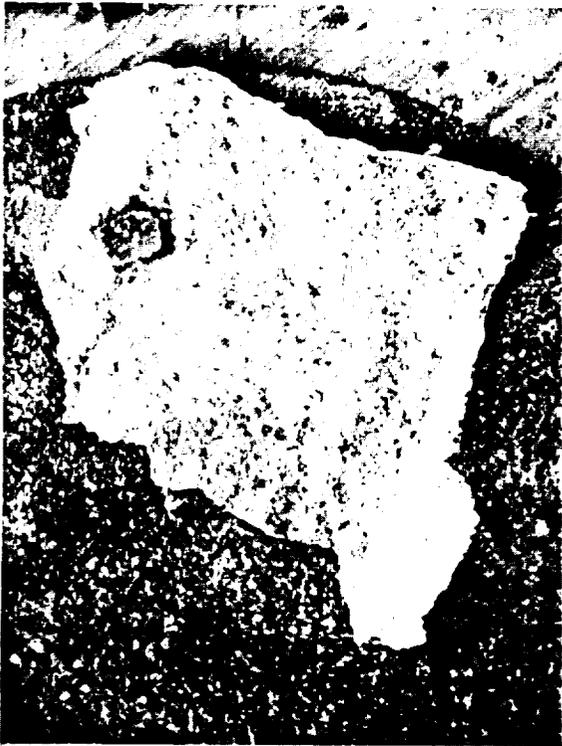
Figure 23 SEM Photographs Showing a Wear Particle and its Sliding Surfaces, Collected from the Tests of Carbon Sliding Against Steel

The sheet-like particles prevail in this wear debris. Two typical ones with similar size of  $5 \times 10^{-4}$  meter by  $4 \times 10^{-4}$  meter are shown in Figure 23. Picture "a" illustrates the friction surface. Picture "b" indicates at a higher magnification (1000  $\times$ ) the small piece of particle sticking on the surface. It may be a piece of debris from the steel rotor. It is difficult to find the sliding tracks on the friction surface. Picture "c" shows the failure surface of another particle which is also shown with 1000 magnification in picture "d". It seems that the structure has not been affected by friction. At least it is different from those for the metal based materials rubbed against steel mentioned before. Also Figures 24c and d show the failure surfaces with a crack in picture "c" and lots of oxides in picture "d".
