STATUS OF RUNWAY SLIPPERINESS RESEARCH

Walter B. Horne  
NASA Langley Research Center

SUMMARY

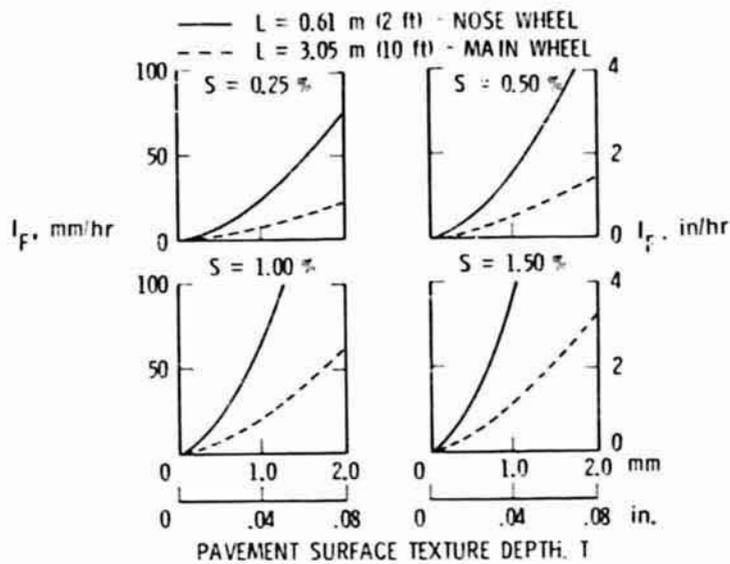
Figure 1.- Rainfall rate required to flood tire path on conventional runway surfaces. Landings on center line.

It should be noted that equations (1) are derived from data obtained on ungrooved pavements and from pavements that have not been treated with a porous friction course. Figure 1 illustrates how equations (1) can be used to predict whether a flooded runway condition will exist for a typical jet transport landing on the runway center line during a rainstorm. The trends shown in figure 1 suggest that a pavement must be provided with a good cross slope and a good surface texture to minimize the risk of runway flooding and dynamic hydroplaning occurring to aircraft during take-off and landing in rainstorms.

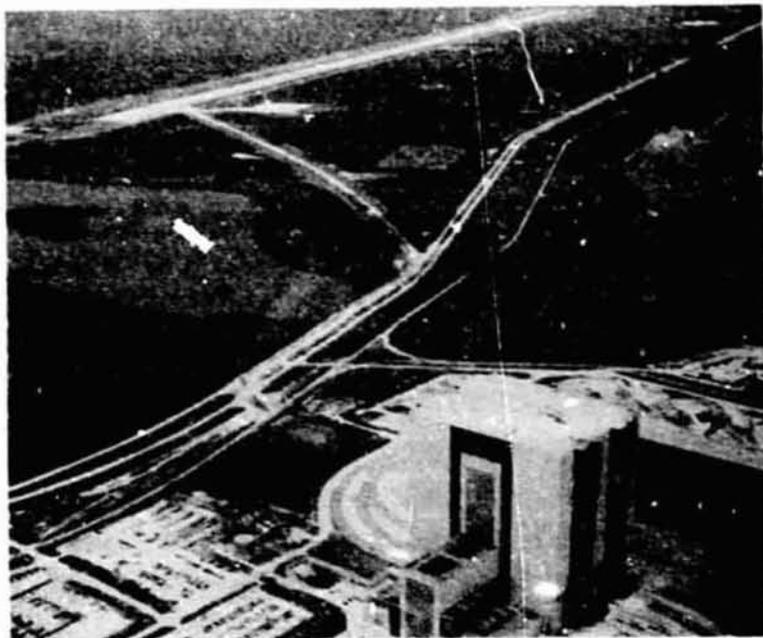
Figure 3.- Space shuttle landing facility at KSC.

NASA has constructed a concrete runway 4372 m (15 000 ft) long and 91 m (300 ft) wide at the Kennedy Space Center (KSC) for the space shuttle. (See fig. 3.) A longitudinal broom surfacing treatment was given the fresh concrete as it was paved by a slip-form paver (fig. 4). The concrete runway surface several months after paving was grooved by diamond saws to a transverse  $29 \times 6 \times 6$  mm ( $1\frac{1}{8} \times \frac{1}{4} \times \frac{1}{4}$  in.) pattern with the resulting surface texture shown in figures 5 and 6. The Langley Research Center (LaRC) performed drainage and traction studies on the space shuttle runway in June 1976.

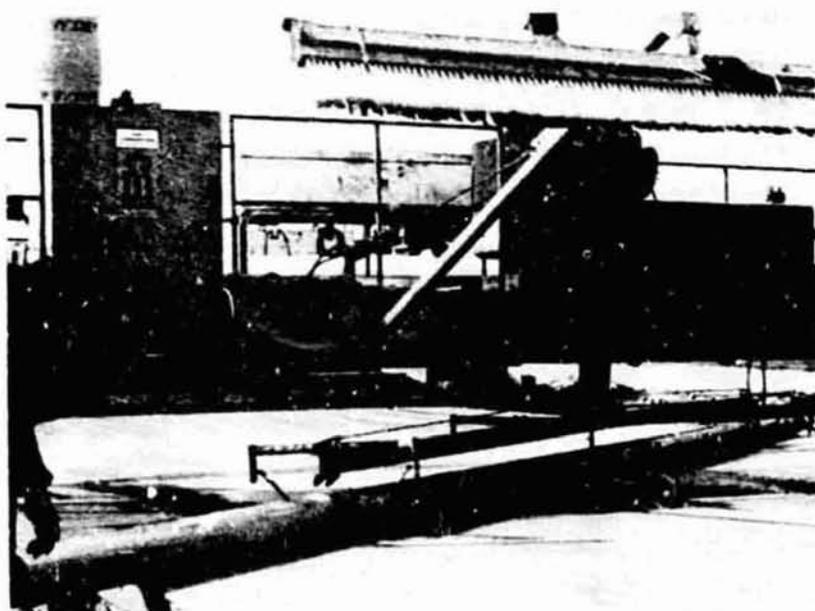
Figure 4.- Space shuttle landing facility at KSC with slip-form paving equipment, leveling tube, and longitudinal broom.

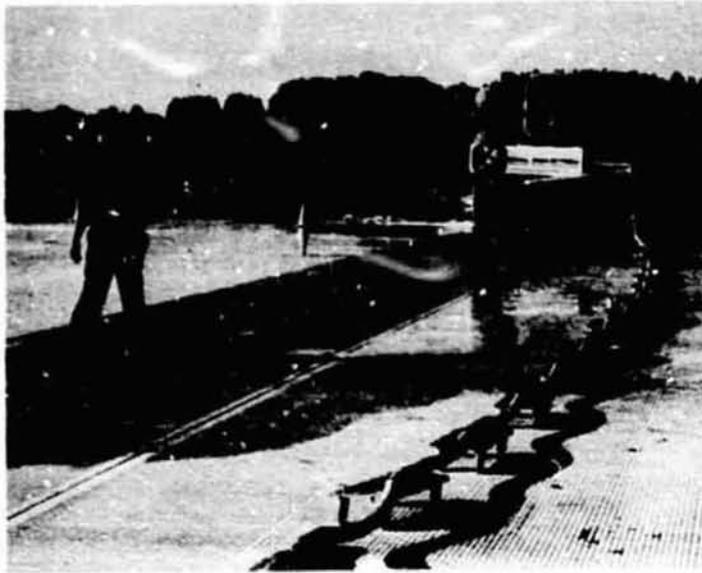
Figure 5.- Space shuttle landing facility at KSC with pavement grooving machine (diamond blades).

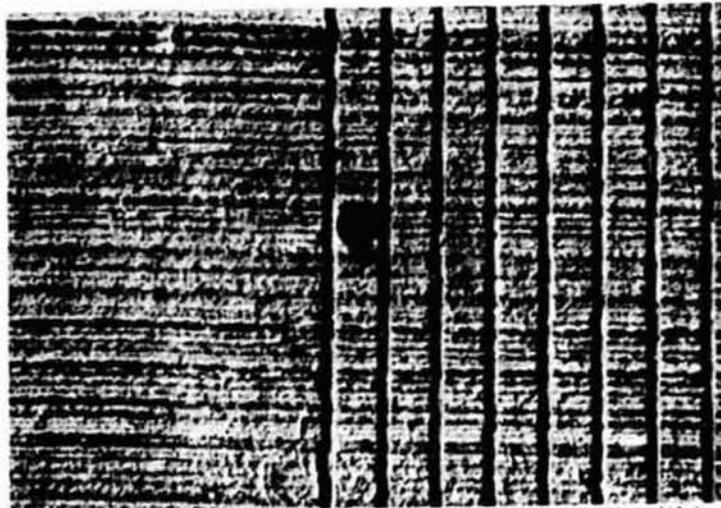
LONGITUDINAL BROOM FINISH  
 ATD = 0.38 to 0.64 mm  
 (0.015 to 0.025 in.)

TRANVERSE GROOVE PATTERN  
 ATD = 1.70 to 1.91 mm  
 (0.067 to 0.075 in.)

Figure 6.- Concrete runway surface texture of space shuttle landing facility at KSC.

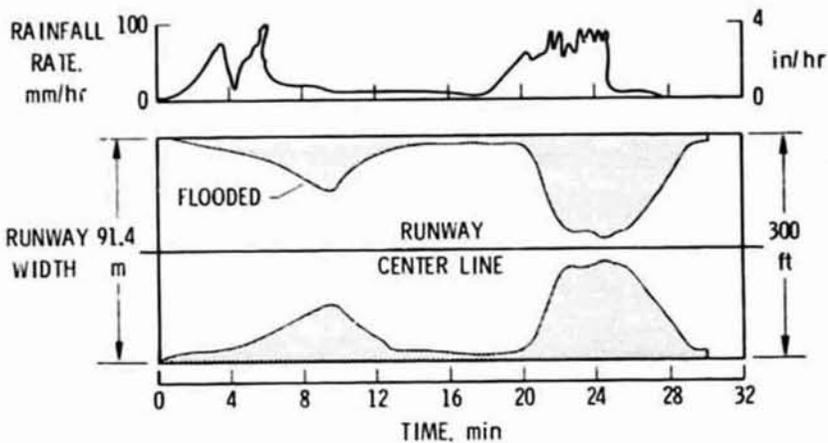
Figure 7.- Surface flooding on space shuttle grooved runway during thunderstorm 6/20/76.

On June 20, 1976, the Cape Canaveral area was subjected to a series of thunderstorms during which heavy rain fell on the shuttle runway. Figure 7 shows the rain rates and surface flooding that occurred on the shuttle runway during a 30-minute period as one of the thunderstorms passed over the runway. The space shuttle runway is oriented in a north/south direction; a wind of approximately 10 knots magnitude from the southwest was observed during the storm. For this wind condition, the data in figure 7 show that a rain rate of approximately 81 mm/hr (3.2 in/hr) is required to start runway flooding in the shuttle main gear tire paths (landing on runway center line).

The predicted rain rate (from eqs. (1)) required to flood the runway in the shuttle main tire path is 47.1 mm/hr (1.85 in/hr). This difference between observed (81 mm/hr (3.2 in/hr)) and estimated (47.1 mm/hr (1.85 in/hr)) rain rates gives added weight to features long observed on runways grooved with a diamond saw technique; that is, the polished groove channels (from the diamond saw cuts) greatly reduce water flow resistance over water draining through and over the comparatively much rougher texture of conventional surface treatments.

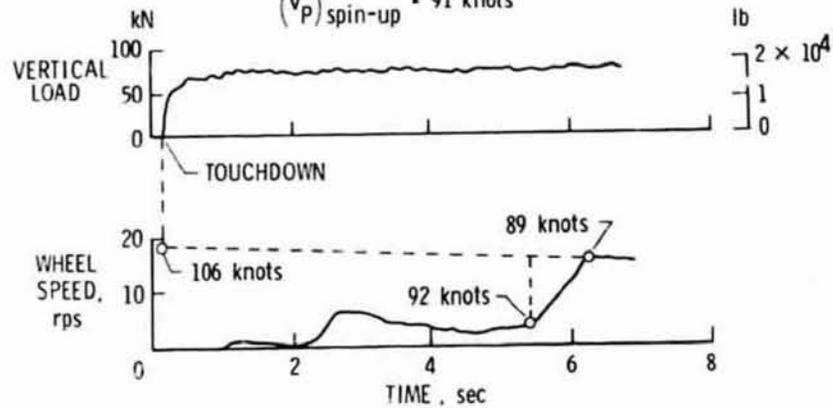
NASA TRACK TEST: DC-9 MLG RIB-TREAD TIRE  
 WATER DEPTH: 2.5 TO 3.8 mm (0.10 TO 0.15 in.)  
 TIRE INFLATION PRESSURE: 965 kPa (140 lb/in<sup>2</sup>)  
 $(V_P)_{\text{spin-down}} = 106 \text{ knots}$   
 $(V_P)_{\text{spin-up}} = 91 \text{ knots}$

Figure 9.- Delayed wheel spin-up at touchdown on flooded runway.

Additional verification of this new hydroplaning equation (eqs. (3)) is given in reference 8 and shown in figure 9. It is important that aircraft flight-manual hydroplaning speeds be changed to reflect the values given by equations (3) since this hydroplaning speed represents the actual tire situation for aircraft touchdown on flooded runways.

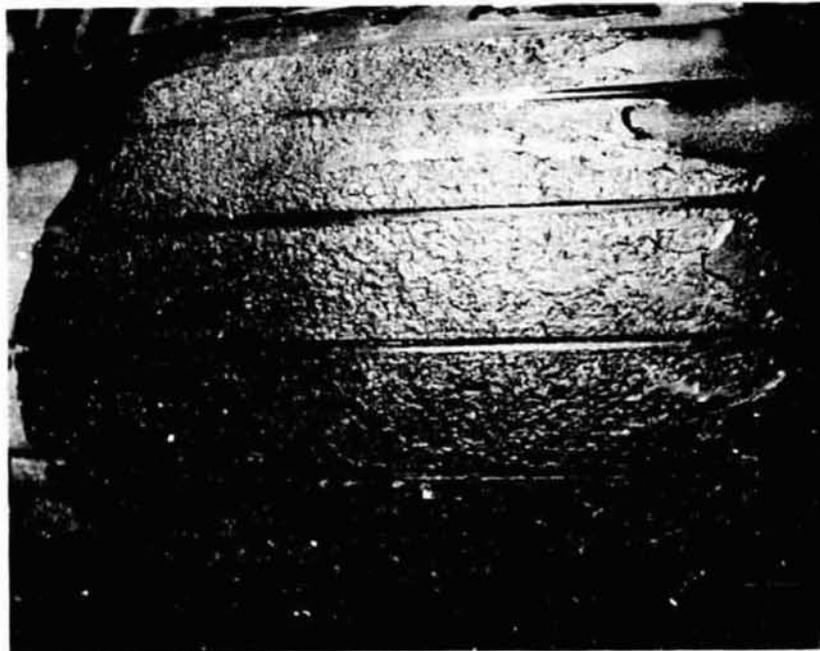
Figure 10.- B-737 tire reverted rubber skid patch after 1.8 km (6000 ft) locked-wheel skid on wet smooth concrete.

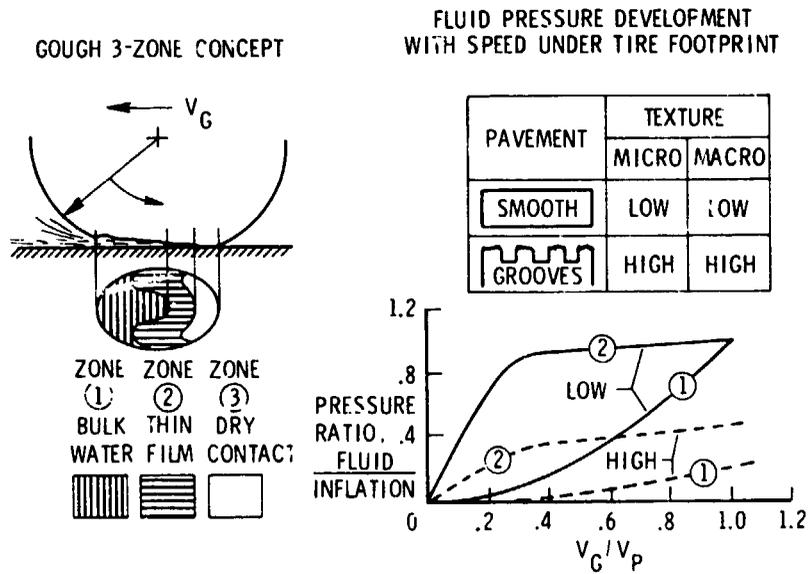
Figure 12.- NASA model for combined viscous and dynamic tire hydroplaning.

Most researchers now agree that the loss of tire friction on wet or flooded pavements with speed is due to the combined effects of viscous and dynamic hydroplaning phenomena acting in the tire footprint as shown in figure 12. The tire hydroplaning model shown in this figure was first proposed by Gough in 1959 in reference 12. (See also ref. 13.) The footprint and sketch in this figure show a pneumatic rolling at medium speed across a flooded pavement. For this partial hydroplaning condition, zone 1 describes the fraction of the tire footprint that is supported by bulk water, zone 2 describes the fraction of tire footprint that is supported by a thin water film, and zone 3 describes the fraction of the tire footprint that is in essentially dry contact with the peaks of the pavement surface texture. The length of zone 1 represents the time required for the rolling tire for this speed condition to expel bulk water from under the footprint; correspondingly, the length of zone 2 represents the time required for the tire to squeeze out the residual thin water film remaining under the footprint after the bulk water has been removed. Since fluids cannot develop shear forces of appreciable magnitude, it is only in zone 3 (essentially dry region) that traction forces for steering, decelerating, and accelerating a vehicle can be developed between the tire and the pavement. The ratio of the

dry contact area (zone 3) to the total tire footprint area (zone 1 + zone 2 + zone 3) multiplied by the friction coefficient the tire develops on a dry pavement yields the friction coefficient the tire can develop for this flooded pavement and speed condition.

When flooding on a runway occurs, the pavement surface macrotexture plays the important role of providing escape channels to drain bulk water from zone 1 (fig. 12). The drainage channels are provided by the tire tread draping over the high spots (asperities) of the pavement surface texture leaving valleys between the tire tread and the low points of the surface texture through which bulk water can easily drain out from under the tire footprint. Bulk water drainage through the pavement macrotexture thus delays to much higher speeds the buildup of fluid dynamic pressure with speed found for pavements with no or poor macrotexture. This effect is illustrated in figure 12 for smooth and grooved pavements. The macrotexture of a pavement can be assessed to some degree by methods such as the NASA grease test (ref. 14), the British sand patch test (ref. 15), and the Texas Transportation Institute silicone putty test (ref. 16).

Providing the pavement with a good microtexture is the major means of combating viscous hydroplaning or preventing the development of viscous fluid pressures in zone 2 of the tire footprint. (See fig. 12.) Pavement microtexture is difficult to detect by eye but can usually be determined from touching the surface. A good pavement microtexture has a sharp-harsh-gritty feel such as obtained when touching fine sandpaper. The touch test is qualitative and not infallible and should be confirmed by ground vehicle friction tests under wet conditions. Pavement microtexture performs its function by providing the pavement surface thousands of sharp pointed projections that, when contacted by the tire tread, generate local bearing pressures of several thousand Pa ( $1\text{b}/\text{in}^2$ ).

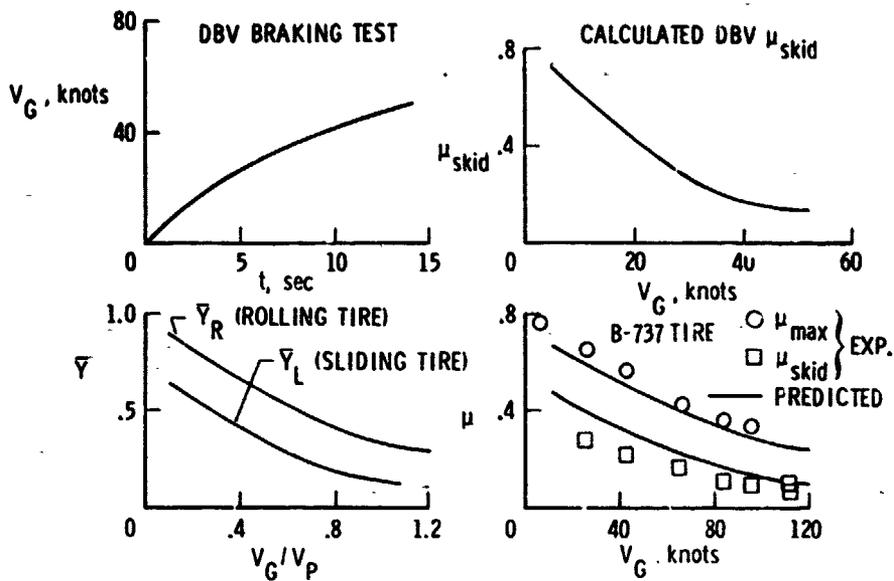
Figure 13.- Prediction of aircraft tire friction coefficient from ground-vehicle braking test on a wet runway by NASA theory.

The DBV method for evaluating the slipperiness of wet runways is to lock a diagonal pair of wheels on a four-wheel ground vehicle at a speed of 52.2 knots and decelerate the vehicle to a stop under both wet and dry runway conditions. (See ref. 19.) The wet-dry stopping distance ratio (SDR) obtained is an index to the slipperiness of the runway surface; the higher the SDR, the slipperier the runway is under wet conditions. The upper left plot shown in figure 13 describes the variation of DBV ground speed with time during a typical DBV test run at Roswell during the B-737 flight test program described in references 10 and 11. This speed time history was differentiated with respect to time to obtain the curve for DBV  $\mu_{skid}$  against speed shown in the upper right plot of figure 13. The values of DBV  $\mu_{skid}$  were obtained from the equation

The viscous-dynamic hydroplaning theory states that any experimentally obtained variation of tire friction coefficient with speed on a wet pavement can be converted to an equivalent nondimensional hydroplaning-parameter ( $\bar{Y}$ )-speed-ratio form (lower left plot of fig. 13) by means of the relationships

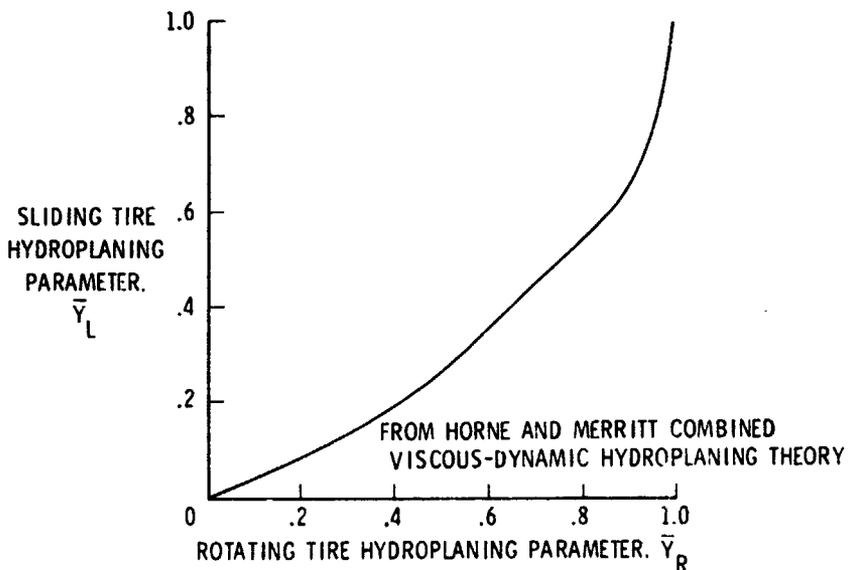
Figure 14.- Empirically derived relationship between sliding ( $\bar{Y}_L$ ) and rotating ( $\bar{Y}_R$ ) tire hydroplaning parameters.

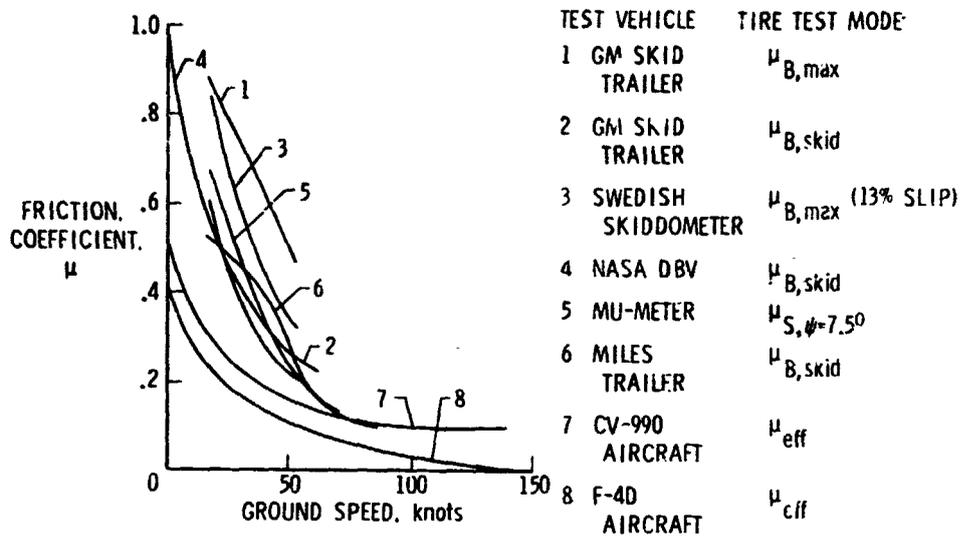
Figure 15.- Aircraft/ground-vehicle correlation problem for wet and puddled smooth concrete surface.

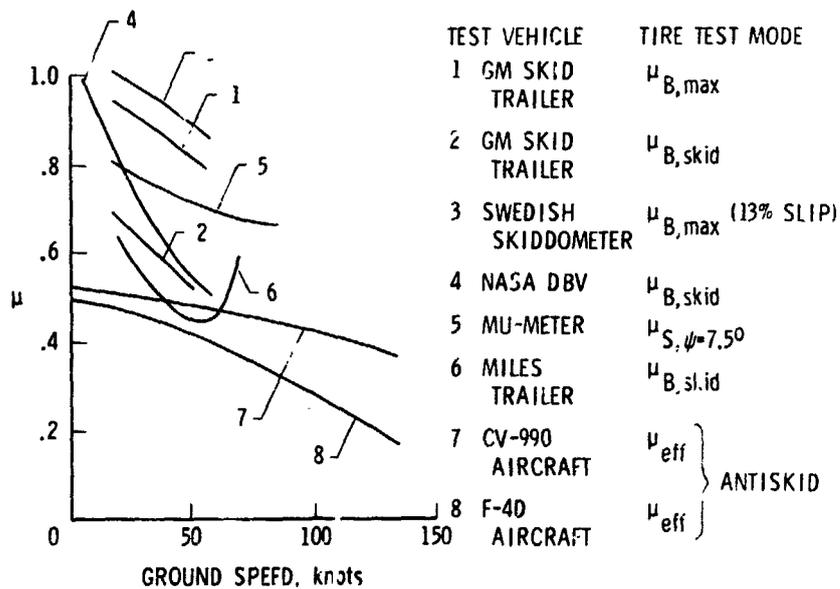
Figure 16.- Aircraft/ground-vehicle correlation problem for wet and puddled grooved asphalt.

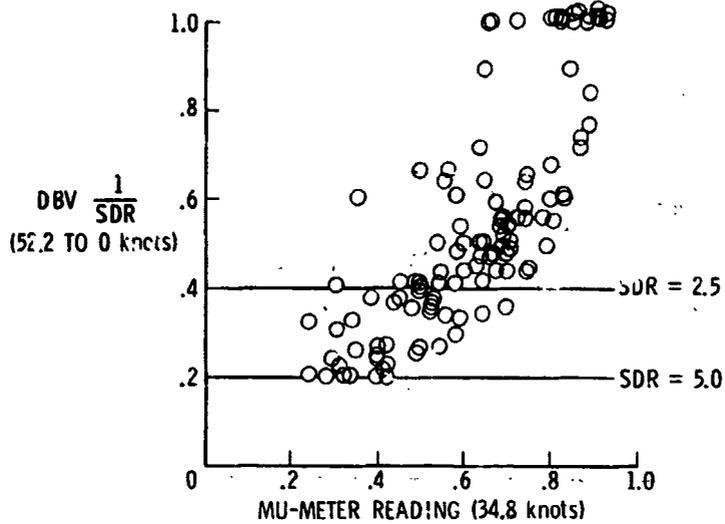
Figure 17.- DBV/Mu-Meter relationship found by USAF tests (ref. 28).

from ref. 28)) and FAA (fig. 18 (data from ref. 29)). The data shown in both figures exhibit similar trends and indicate very poor correlation between a device (DBV) which measures vehicle stopping distance over a speed range of 52.2 to 0 knots with diagonal wheels locked and a yawed-rolling trailer which measures tire cornering force at constant yaw angle ( $\psi = 7.5^\circ$ ) and constant speed ( $V_G = 34.8$  knots) for the wet runway surfaces investigated. A similar trend is noted for the Roswell smooth concrete runway surface shown in figure 19. In this instance only one runway surface was tested, but the runway wetness condition (water depth) varied. These data for the DBV and Mu-Meter were obtained from reference 11. Figures 20 and 21 show the correlation obtained between the DBV and the skiddometer and the DBV and the Miles trailer at Roswell (ref. 11), respectively. The data in these figures show that the skiddometer (fig. 20) (like the Mu-Meter) exhibits poor correlation with DBV SDR measurements, whereas the Miles trailer compares better (fig. 21). The skiddometer runway slipperiness rating was achieved by testing the pavement at a constant speed of 34.8 knots (like the Mu-Meter), whereas the Miles trailer tested the pavement over a speed range of 85 to 0 knots (similar to the DBV).

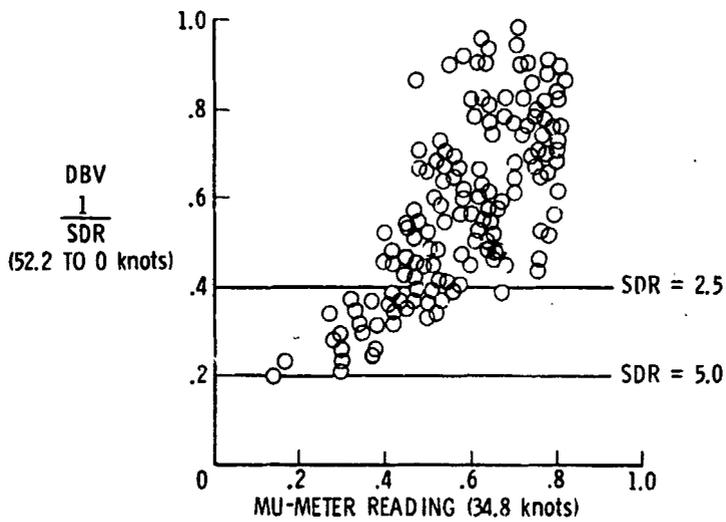
Figure 18.- DBV/Mu-Meter relationship found by FAA tests on 31 runways.

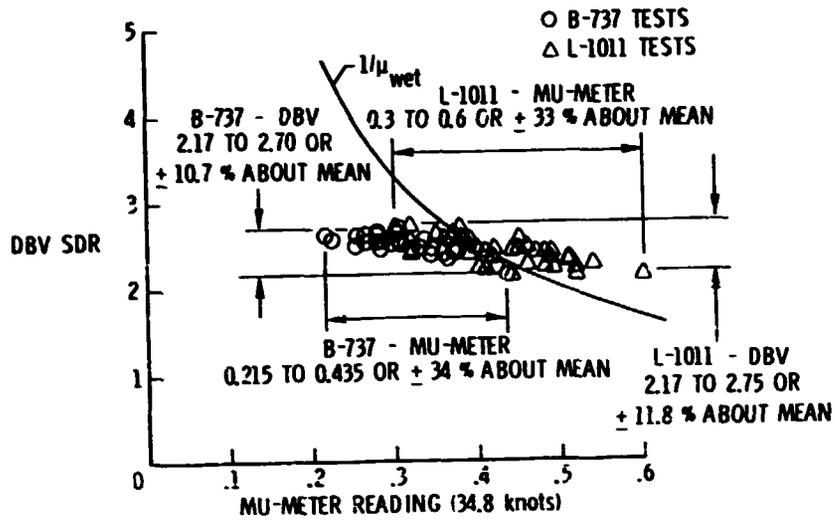
Figure 19.- Comparison of NASA DBV with Mu-Meter.

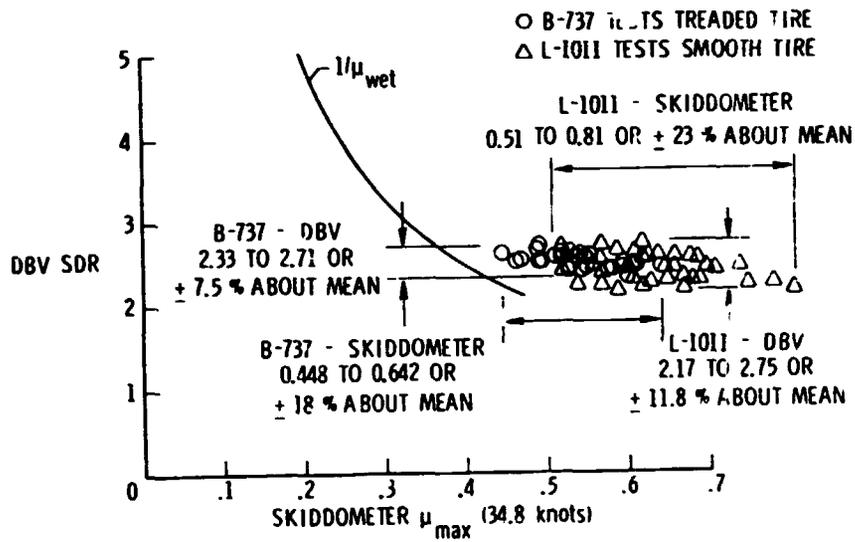
Figure 20.- Comparison of NASA DBV with skiddometer.

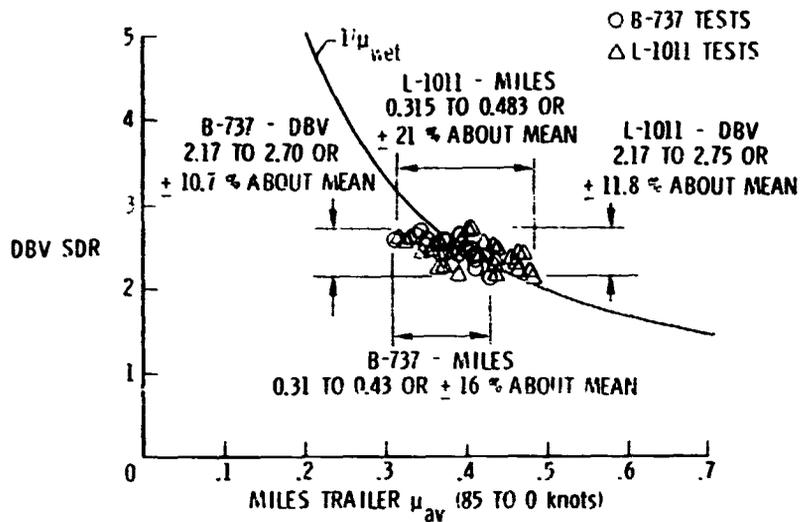
Figure 21.- Comparison of NASA DBV with Miles trailer.

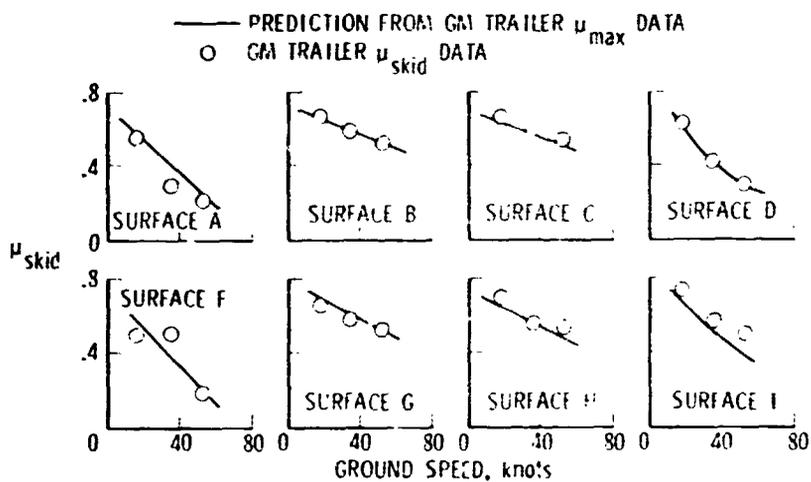
Figure 22.- Prediction of GM trailer  $\mu_{skid}$  from GM trailer  $\mu_{max}$  data. ASTM smooth tread tire; data from reference 22.

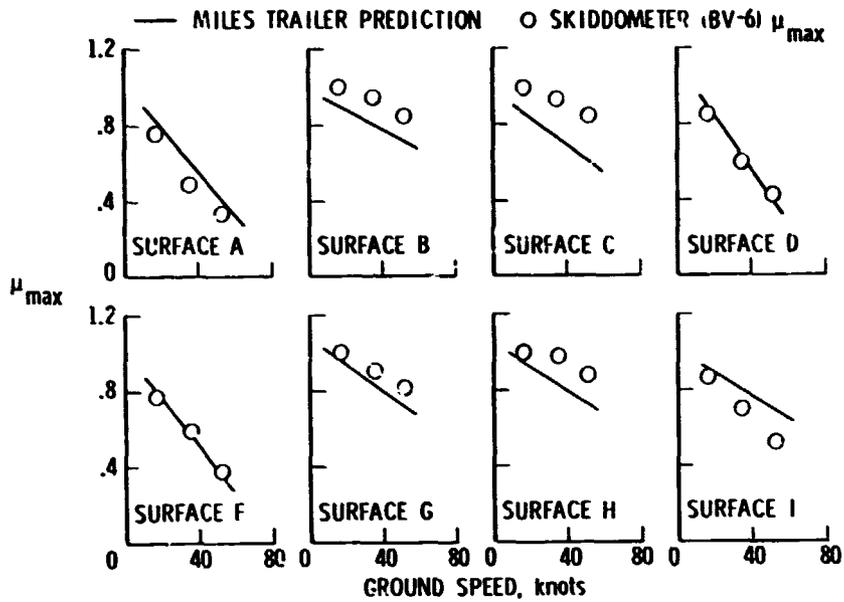
Figure 23.- Prediction of skiddometer  $\mu_{\max}$  from Miles trailer  $\mu_{\text{skid}}$  data. Data from references 21 and 22.

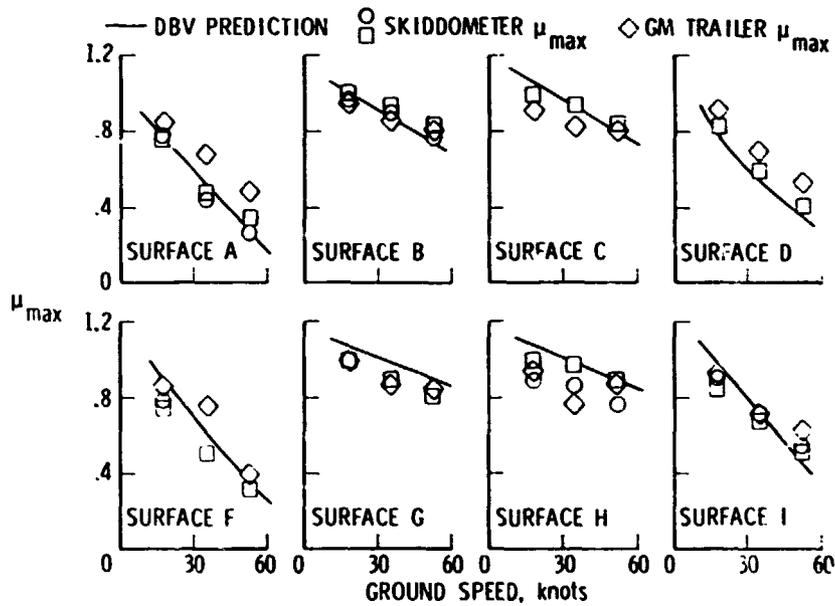
Figure 24.- Prediction of skiddometer and GM trailer  $\mu_{\max}$  from DBV  $\mu_{\text{skid}}$  data. Data from references 21, 22, and 30.

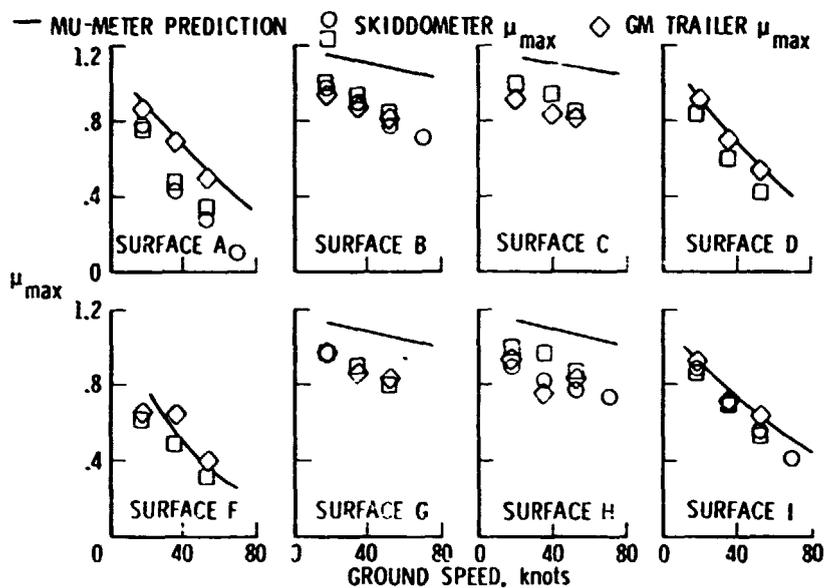
Figure 25.- Prediction of skiddometer and GM trailer  $\mu_{max}$  from Mu-Meter friction reading ( $\psi = 7.5^\circ$ ). Data from references 21, 22, and 30.

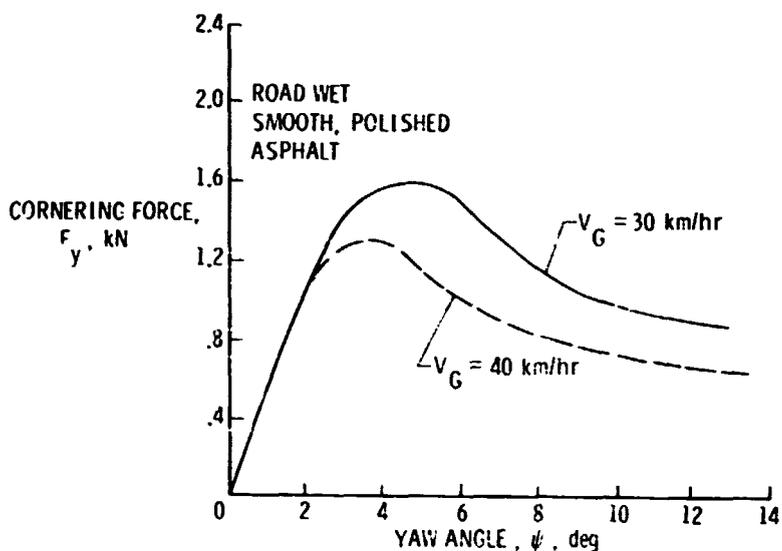
Figure 26.- Effect of ground speed on cornering-force-yaw-angle relationships for 5.60-13 automobile tire.  $F_z = 2.70$  kN;  $p = 167$  kPa; from reference 31.

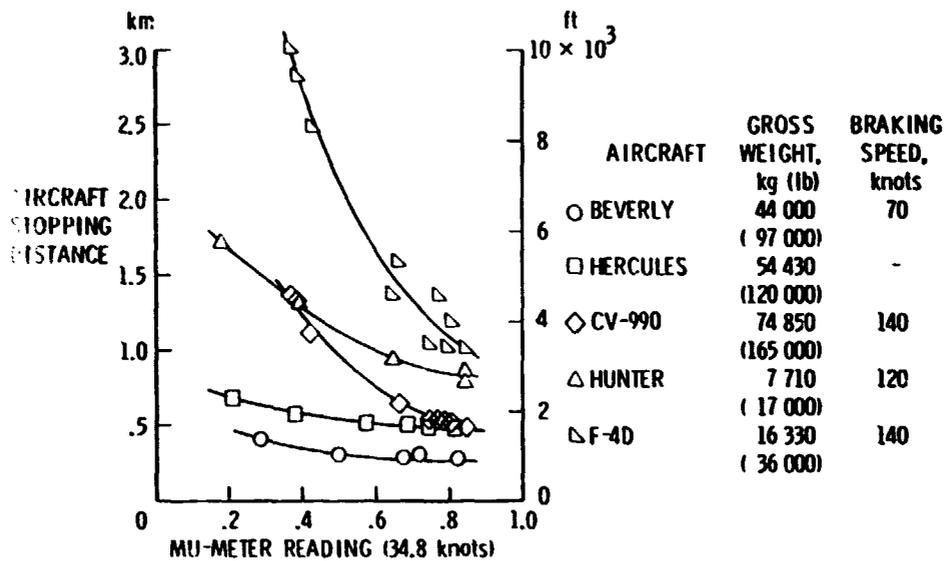
Figure 27.- Mu-Meter correlation with aircraft stopping distances on wet surfaces.

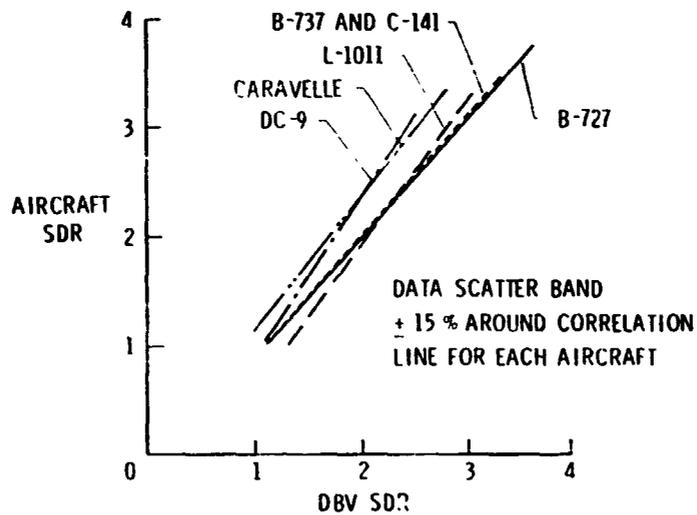
Figure 28.- Aircraft/DBV correlation on wet runways for different jet transports.

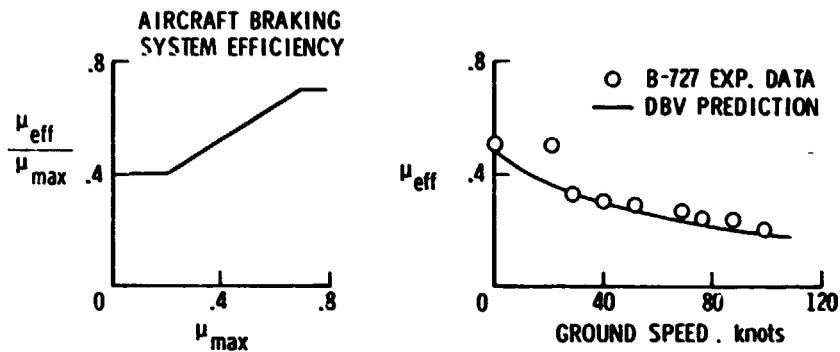
Figure 29.- Prediction of aircraft braking performance on wet runway from DBV braking test. JFK runway 4R/22L; grooved concrete; water truck wetting.

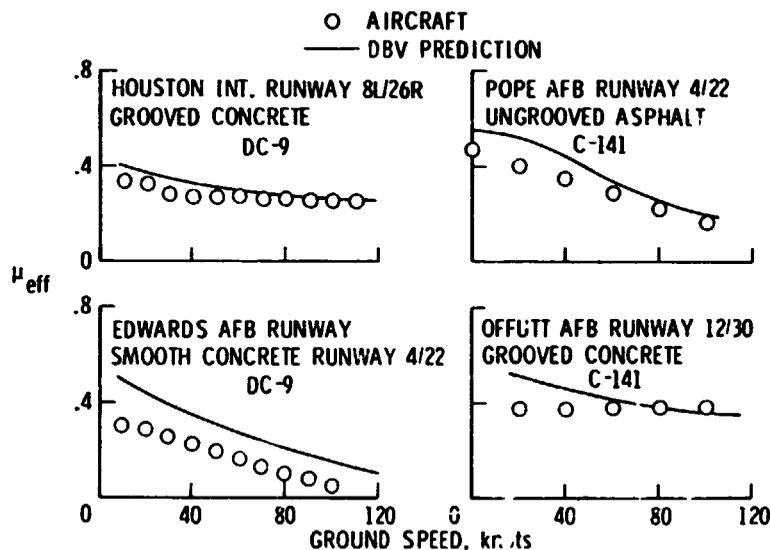
Figure 30.- Prediction of aircraft braking performance on wet runways from DBV braking test for DC-9 and C-141 jet transports.

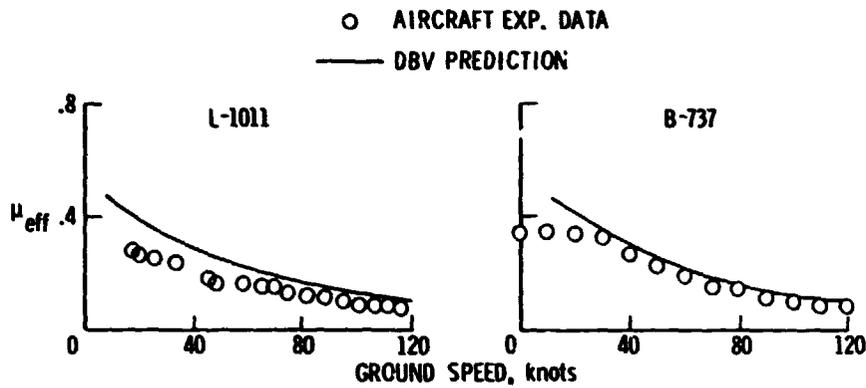
Figure 31.- Prediction of aircraft braking performance on wet runway from DBV braking test for B-737 and L-1011 jet transports. Roswell runway 3/21; smooth concrete.

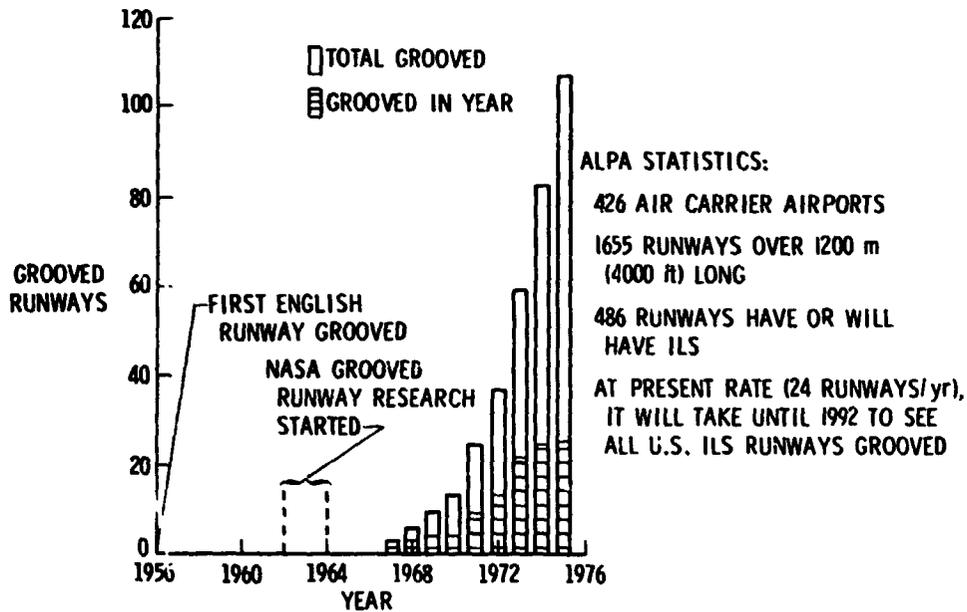
Figure 32.- Number of grooved runways at U.S. air carrier airports.

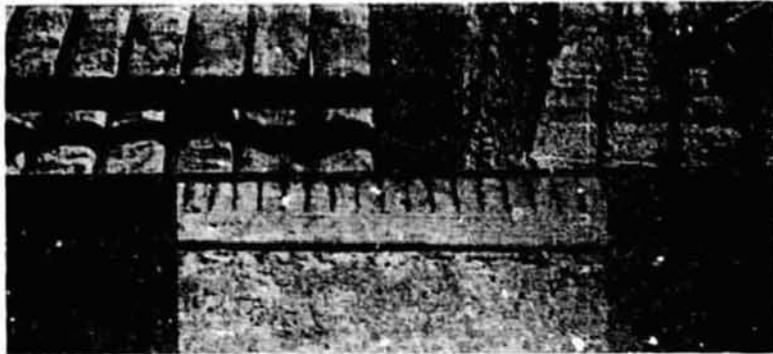
(a) Plastic grooving with segmented drum.

(b) Plastic grooving with wire comb.

Figure 33.- Examples of plastic grooving of Portland cement concrete.

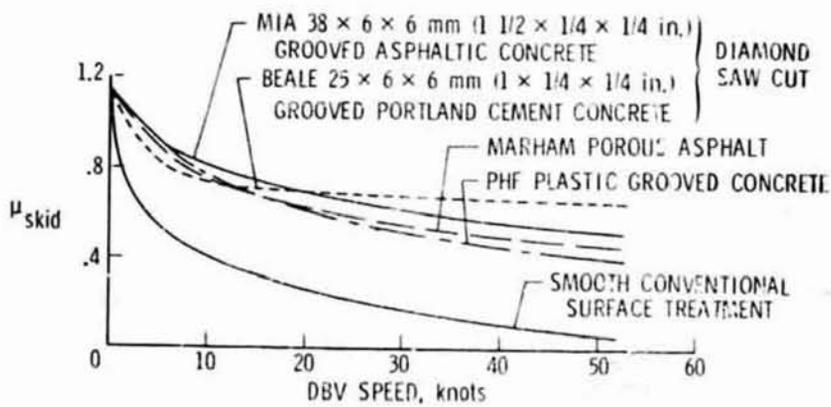
Figure 34.- Wet skid resistance of several new type runway surface treatments. Artificial wetting.

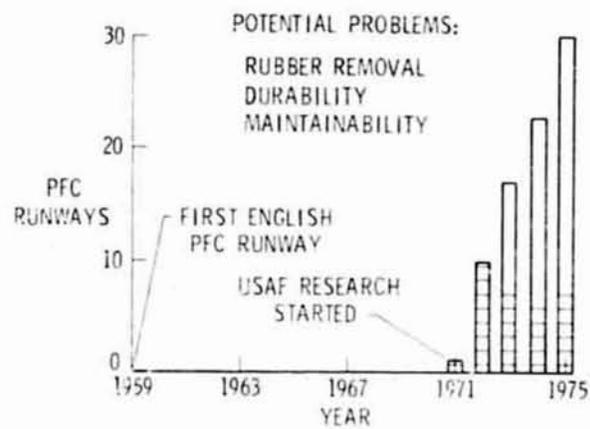
Figure 36.- Number of porous friction course runways at U.S. air carrier airports.

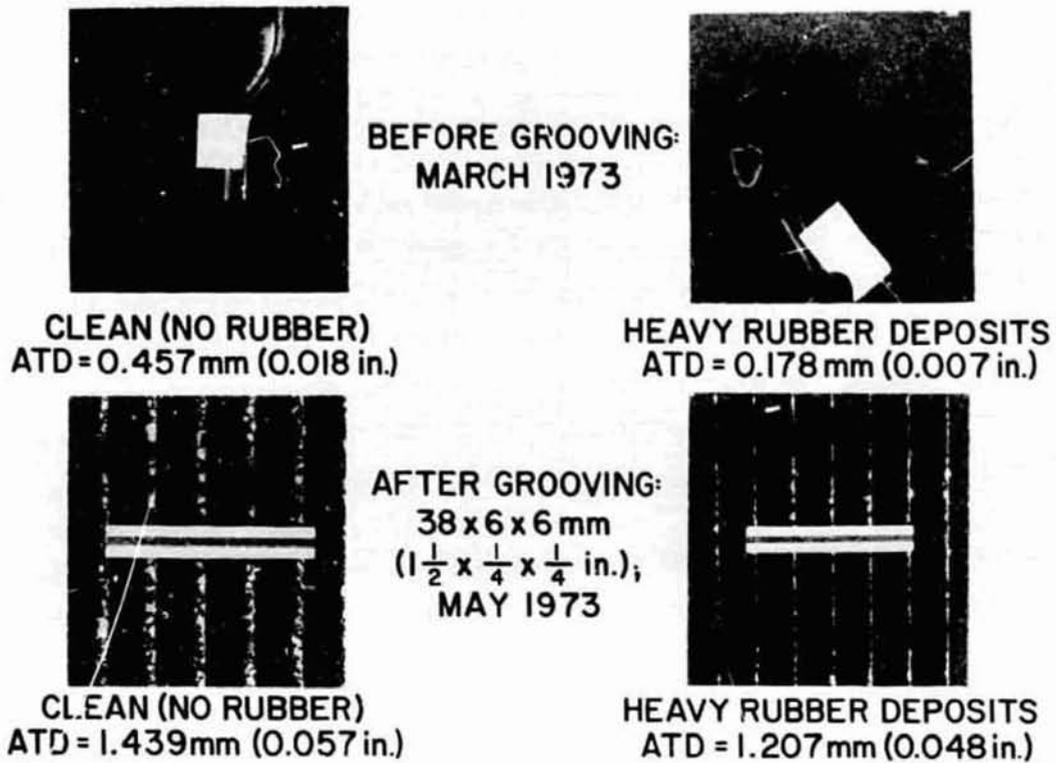
Figure 37.- Effect of rubber deposits on runway surface texture.

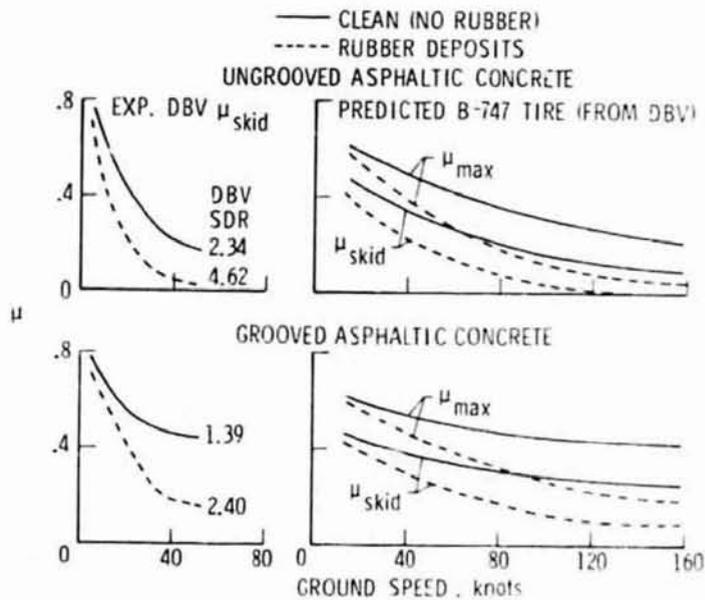
Figure 38.- Effect of rubber deposits on runway traction before and after grooving.

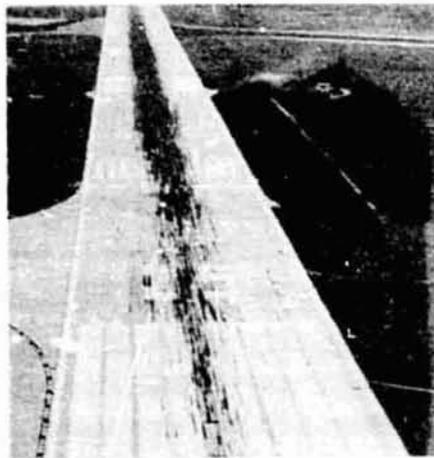
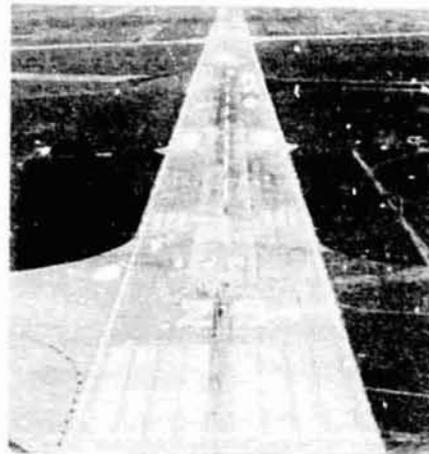
BEFORE RUBBER REMOVAL  
MAY 15, 1975

AFTER RUBBER REMOVAL  
MAY 30, 1975

Figure 39.- Approach end of LAFB runway 25 before and after rubber removal by high-pressure water blast.

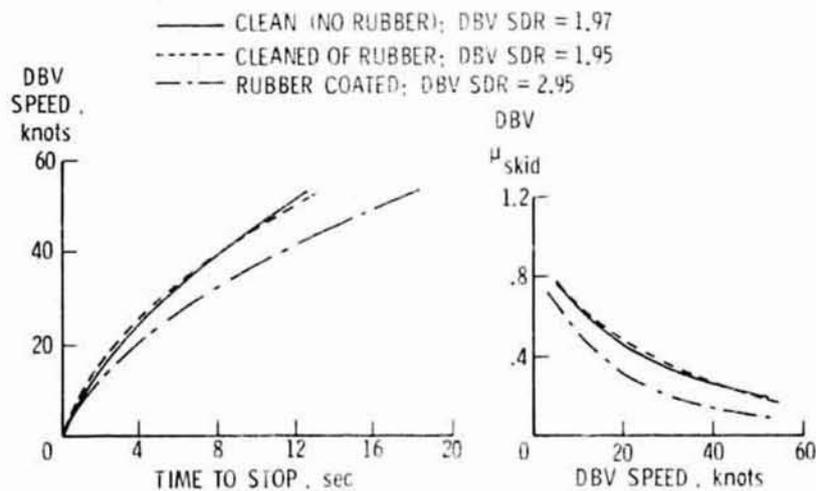
Figure 40.- Effect of rubber removal by high-pressure water blast on runway traction. LAFB runway 25; May 1975.
