Fabrication of Stainless Steel Clad Tubing

Contract NAS 3-20098

Final Report

Colt Industries  
Crucible Materials Research Center  
P. O. Box 88  
Pittsburgh, Pennsylvania 15230

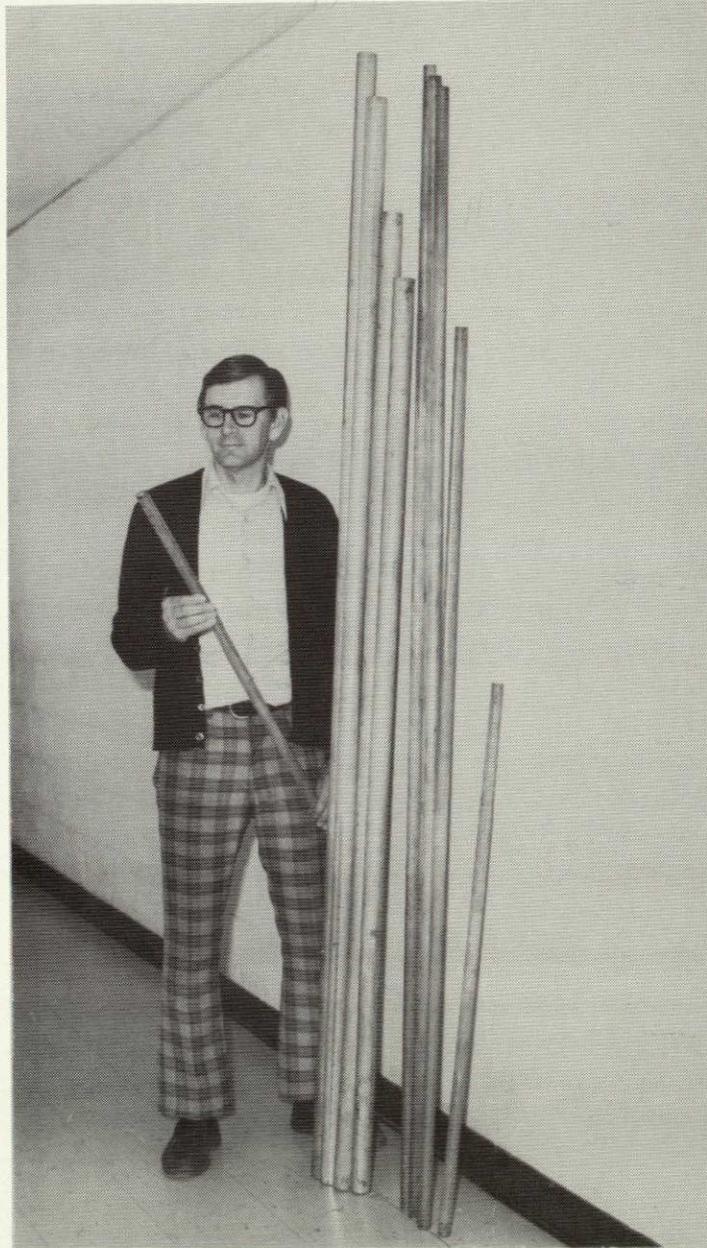
Figure III-7. Completed Task II Tubing.

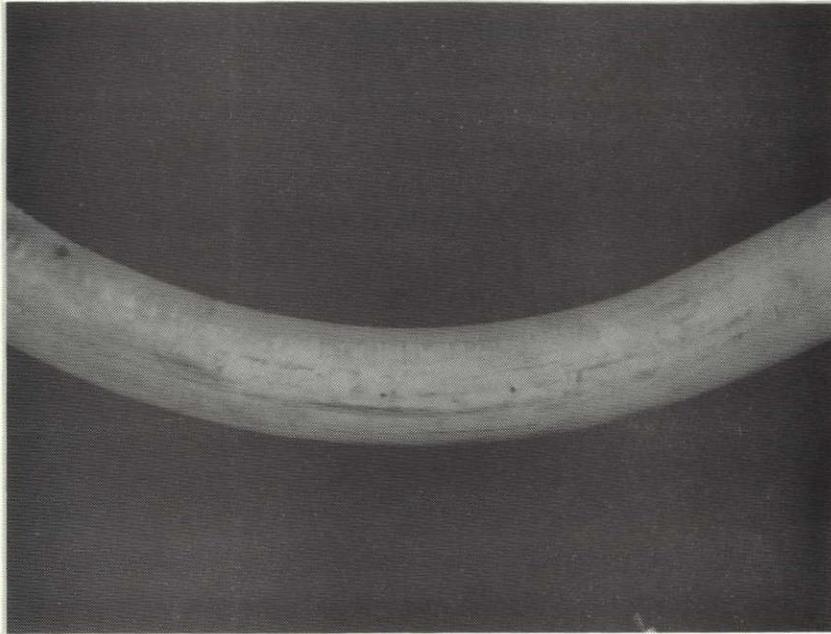
Figure IV-22. Appearance of Task II-d Tubes After Bend Testing.

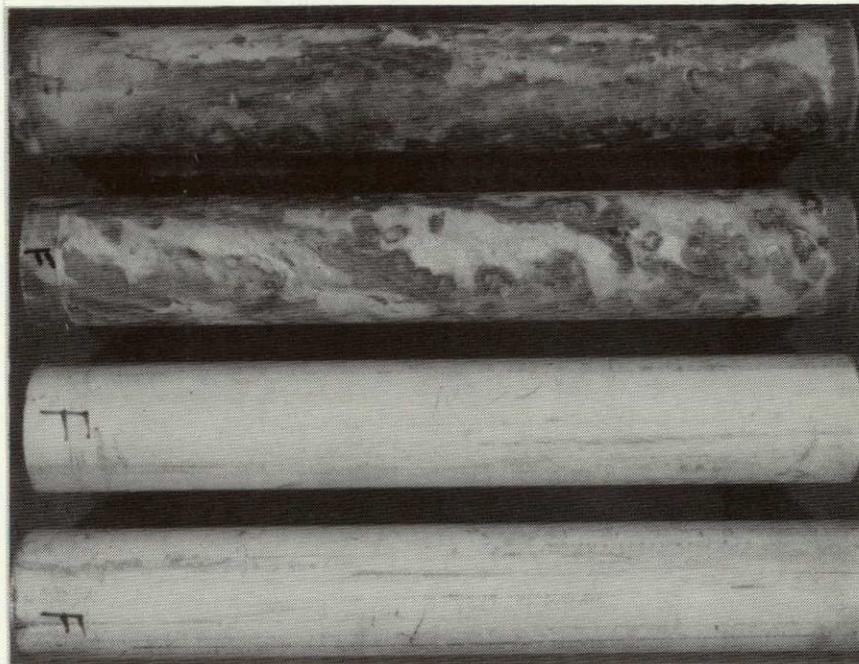
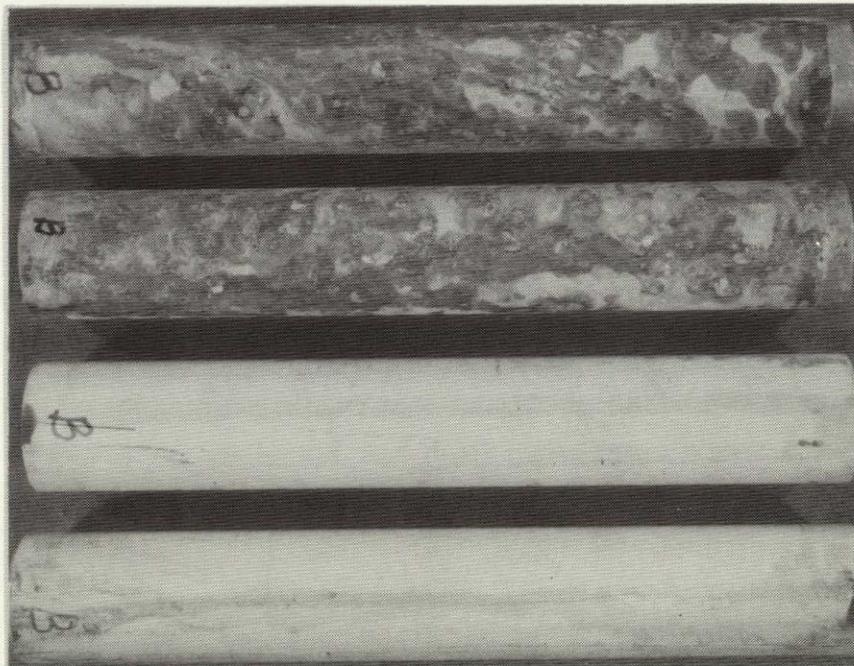
Figure IV-27. Appearance of Task II Tube Specimens After 15 Days Exposure to CASS Corrosion Test.
