NASA CR-159597
R79AEG625

FEASIBILITY OF SiC COMPOSITE STRUCTURES FOR 1644 K (2500° F) GAS TURBINE SEAL APPLICATIONS

FINAL REPORT

GENERAL ELECTRIC COMPANY

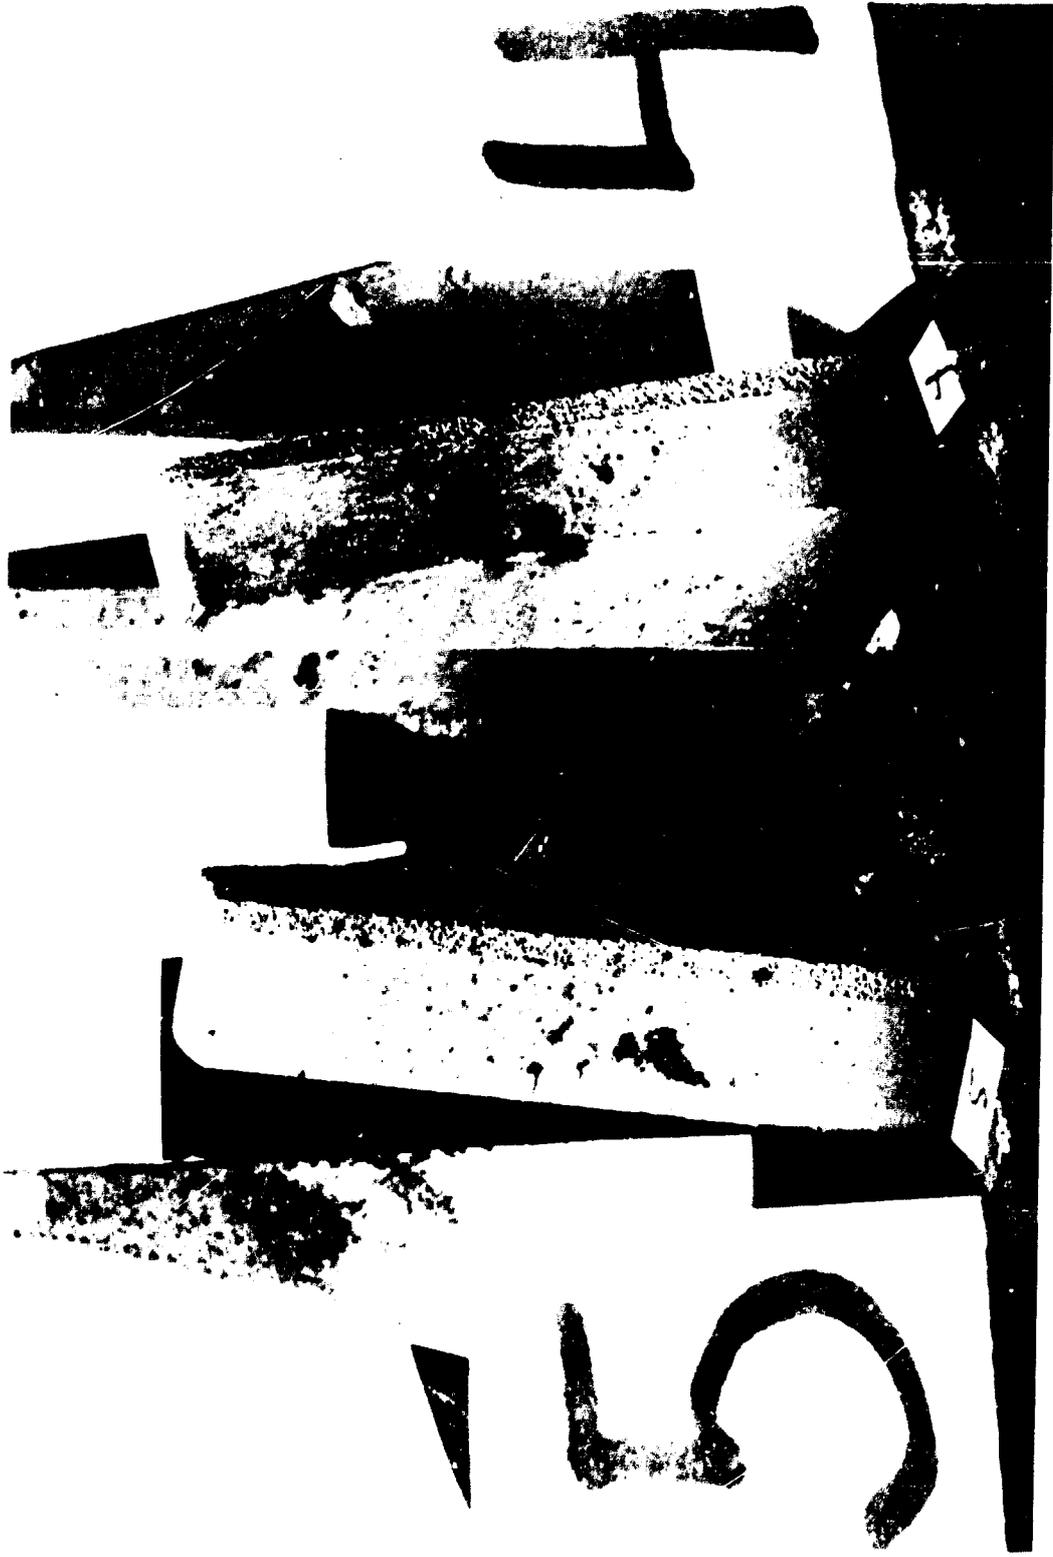
Figure 25. Task I Mach 1.0 Oxidation Test Specimens After 84 Hours at 1477 K (2200° F) and 16 Hours at 1589 K (2400° F).

The first attempt to run the Mach 1.0 oxidation/erosion test at 1589 K (2400° F) resulted in fracture of all the specimens near the base where they were being held in the cooled metal holder. Therefore, the second test was run with a modified holder on new specimens at 1477 K (2200° F) for 84 hours. The test was run at 1589 K (2400° F) for 16 hours unintentionally due to clogging of the IRCON window during the overnight run after the specimens had completed 15 hours at 1477 K (2200° F). Figure 6 shows the Mach 1.0 oxidation/erosion test specimens assembled in the holder, and Figure 24 shows the typical geometry of the specimen. Figures 25 and 26 show the test specimens after 100 hours of exposure time. All the specimens except Specimen 4 completed the 100 hour test. Figures 27 through 29 show the specimens after 31, 45, 67, and 100 hours of exposure. Specimen 4 (SOA + 10 g BN composition layer with SiC derived from graphite fiber on a sintered SiC substrate block) fractured at the base where it was being held in the metal holder after one cycle to 1477 K (2200° F) (Figure 26). The layer on this specimen showed signs of local gas

1. Material systems of Specimens 1 and 3 survived Mach 1.0 gas oxidation/erosion and thermal shock at 1589 K (2400° F) for at least 16 hours with no signs of layer erosion. The layer in Specimen 2 eroded excessively during overtemperature to 1589 K (2400° F) in the early part of the test. No further layer degradation was observed in this specimen when the test was continued at 1477° F (2200° F).

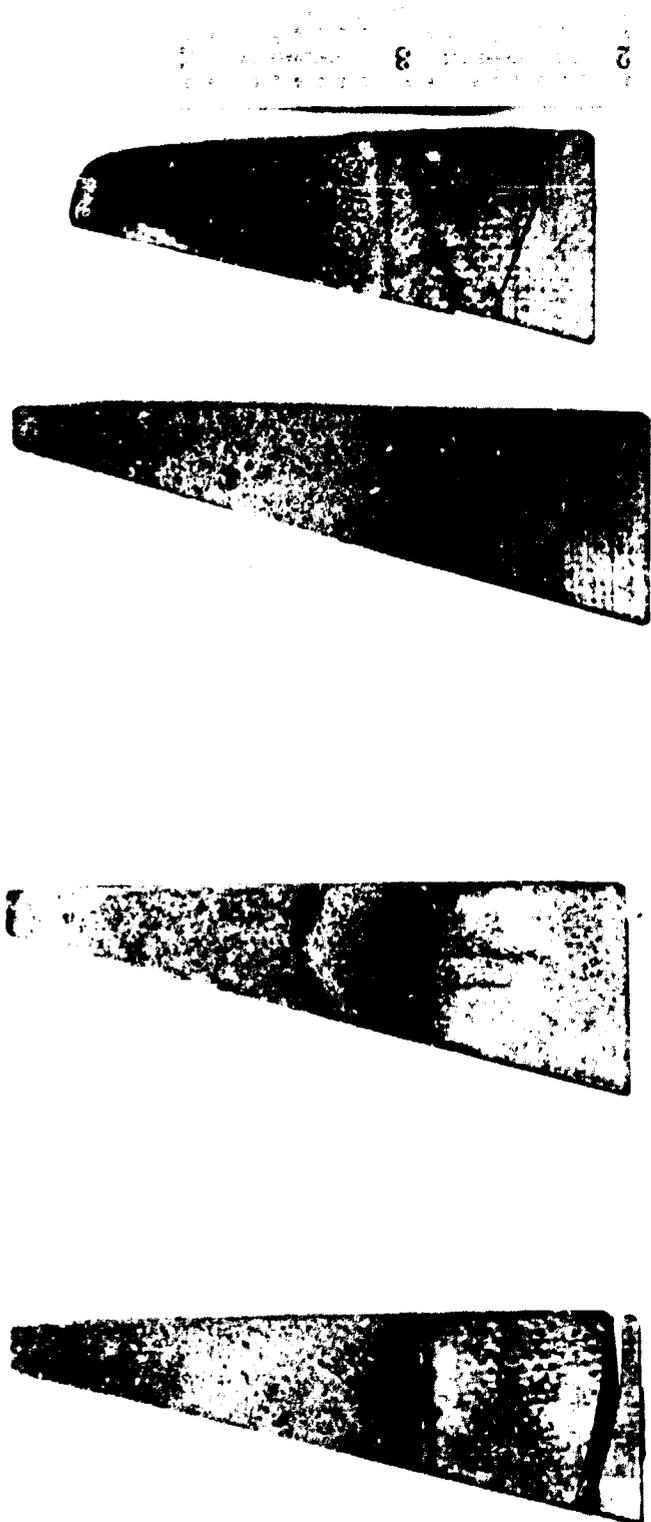
Specimen 1 Specimen 2 Specimen 3 Specimen 4

Figure 26. Task I Mach 1.0 Oxidation Test Specimens Showing the Rub Layers After 84 Hours of Exposure at 1477 K (2200° F) and 16 Hours at 1589 K (2400° F).

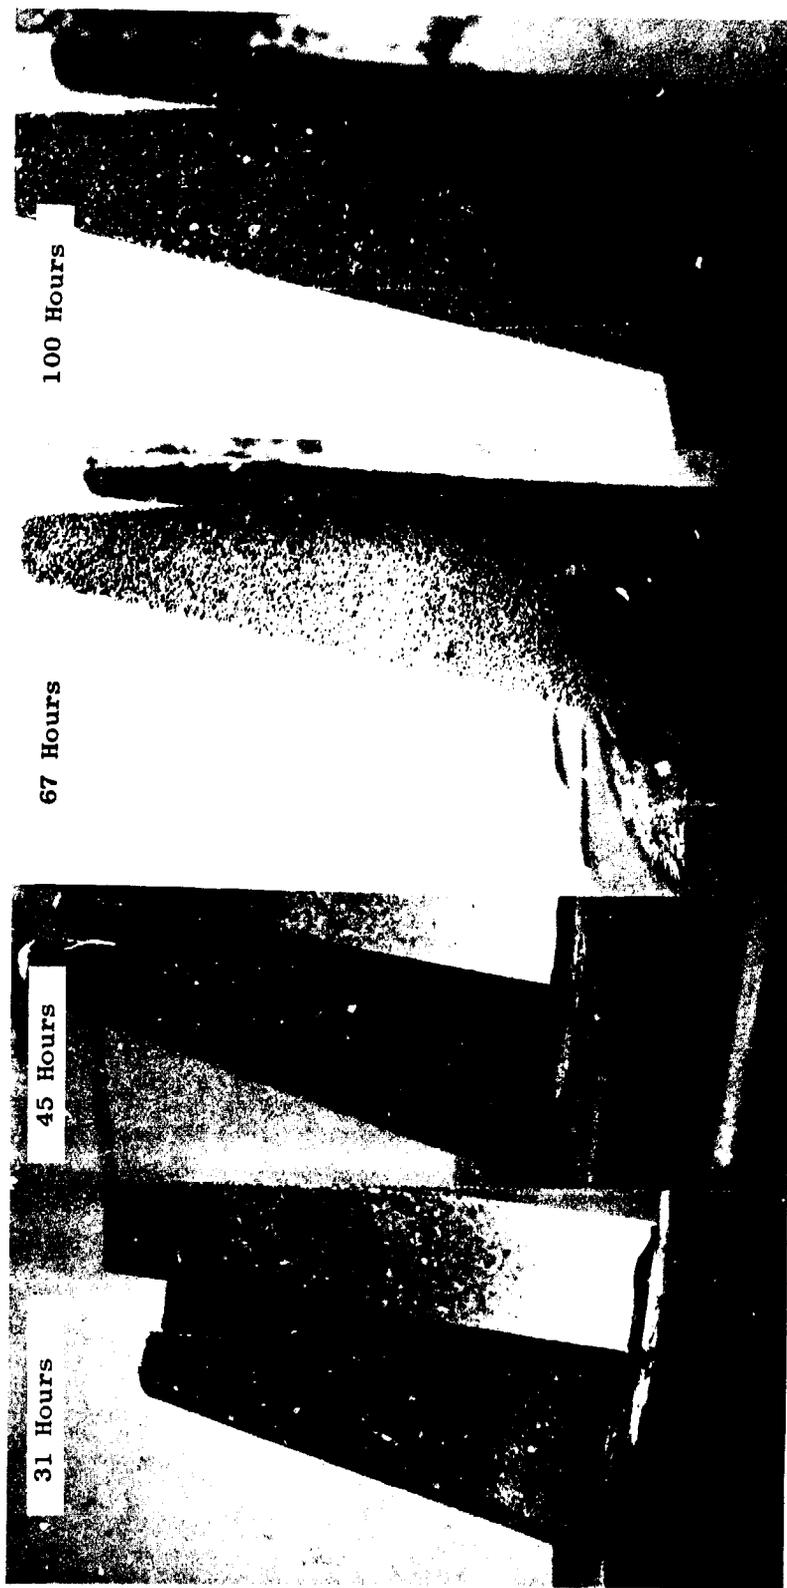
Figure 27. Task I Mach 1.0 Oxidation Test Specimen 1 After 31, 45, 67, and 100 Hours of Exposure.

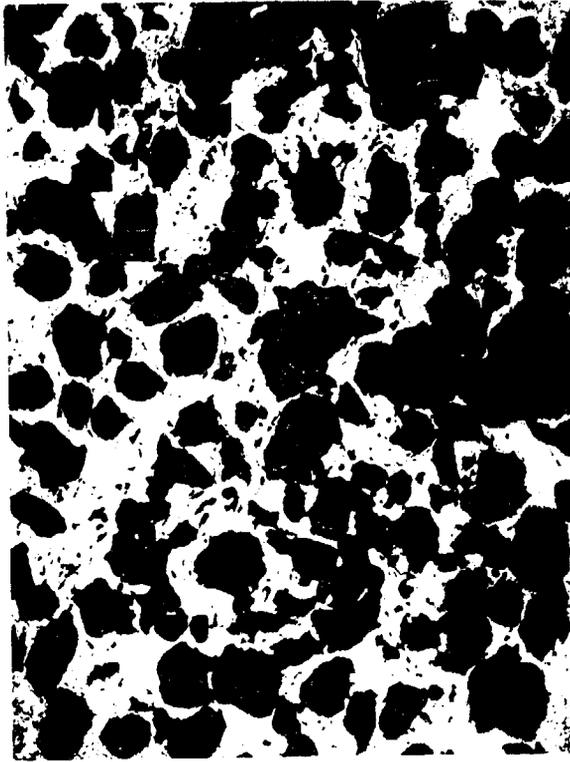
Specimen 1 (Table 11)

Figure 31. Typical Microstructures of Cross Sections of Rub Layers After Mach 1.0 Oxidation/Erosion Test.

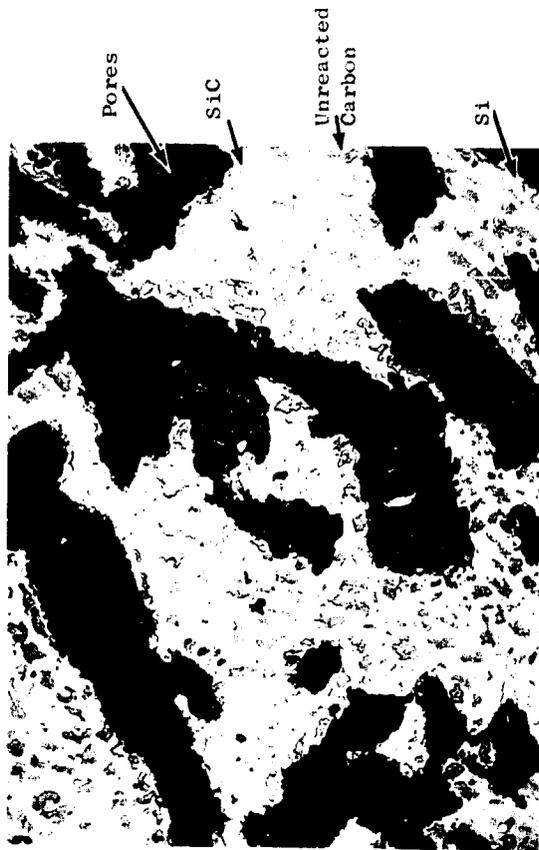
Figure 32. Typical Microstructure of a BN-Free Material of $1.45 \times 10^3 \text{ kg/m}^3$ (1.45 g/cm^3) Density and $250 \text{ }\mu\text{m}$ Pore Size.

- The black areas are pores, the light gray areas are SiC, the white areas are Si, and the dark gray areas inside the SiC network are unreacted carbon.

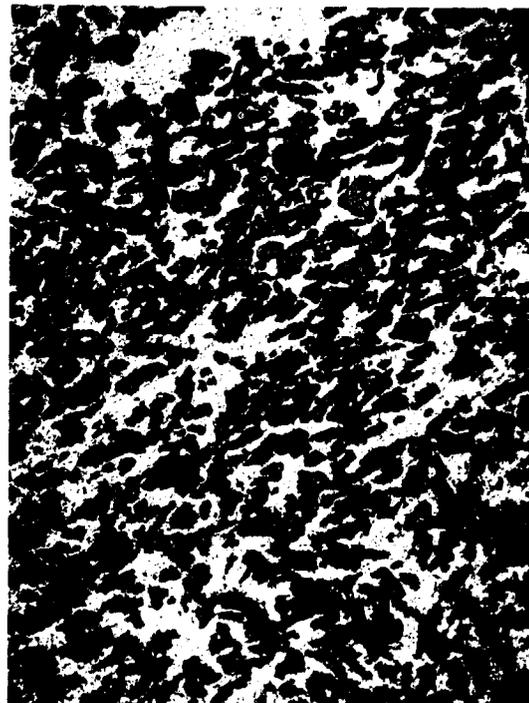
(a) 180 μm Pore Size

Figure 33. Typical Microstructure of a BN-Free Material of $1.45 \times 10^3 \text{ kg/m}^3$ (1.45 g/cm^3) Density at 180 μm and 125 μm Pore Sizes.

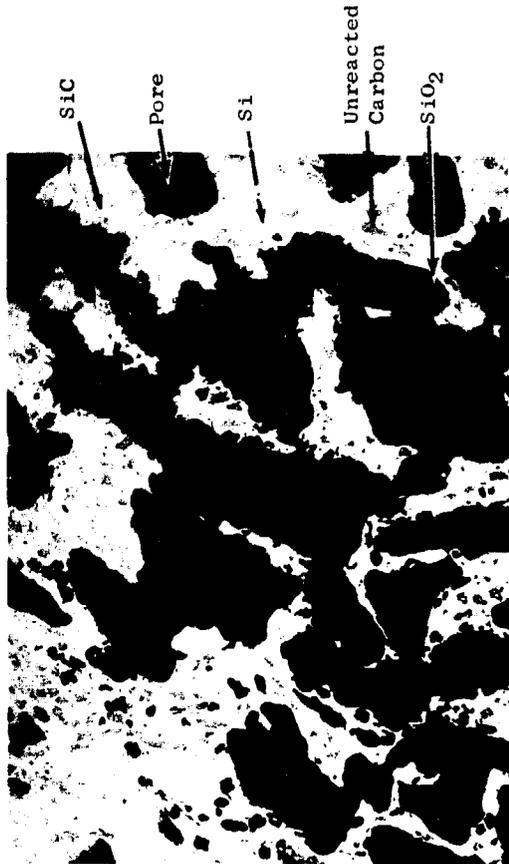
- The black areas are pores, the light gray areas are SiC, the white areas are Si, and the dark gray areas inside the SiC are unreacted carbon. The SiO₂ scale surrounds the Si/SiC network.

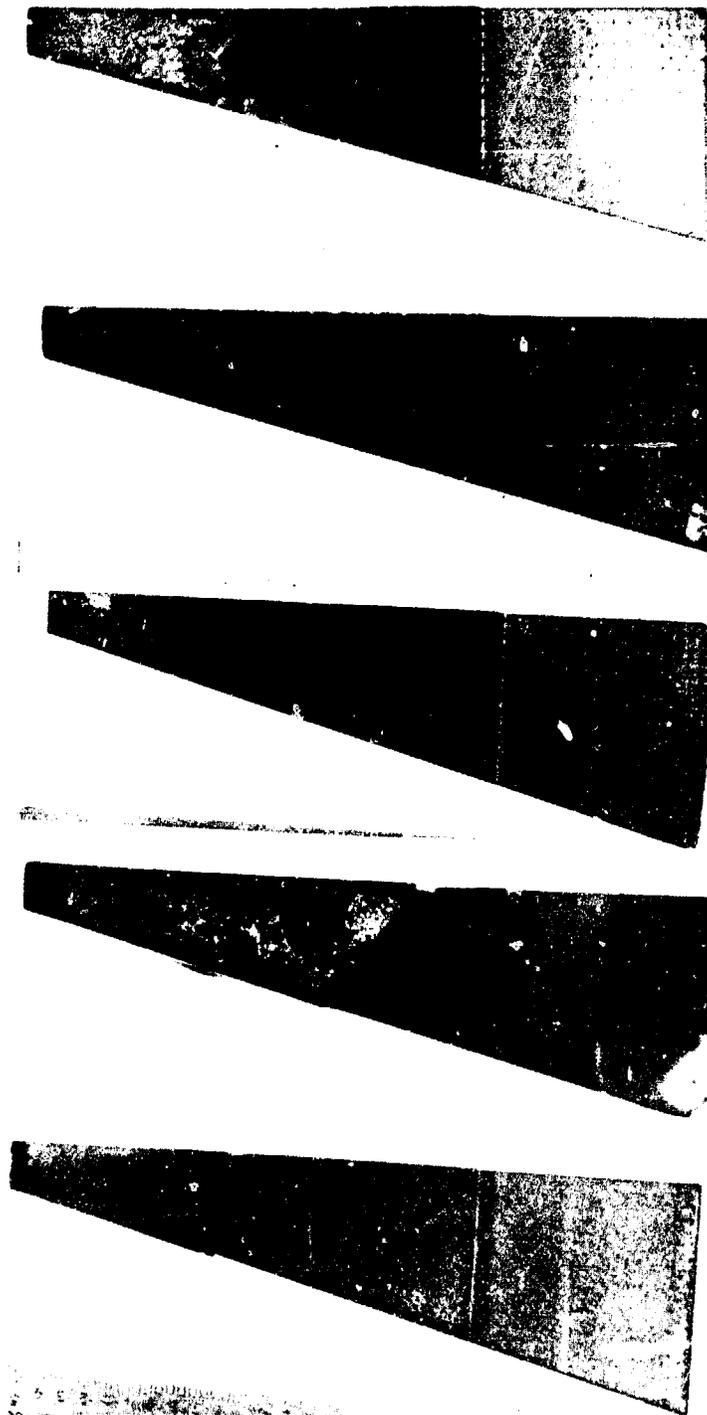
15F2A 23GA2 16FA1 7F3A 35F1B

Figure 46. First Task III Mach 1.0 Gas Oxidation/Erosion Specimens After 5 Hours at 1644 K (2500° F).

The Mach 1.0 gas oxidation/erosion test was conducted at 1644 K (2500° F) with the layer containing specimens. Three of the six specimens had hot pressed silicon carbide; the other three had SilcompTM as the substrate materials. As shown in Table 17 and Figure 46 five out of six BN-containing layers showed excessive layer erosion in only 2 to 5 hours of testing at 1644 K (2500° F). Also, on inspection after the third and the fifth cycles, two of the specimens were found to have fractured, and the layers from two specimens spalled off at Cycle 3. It was noted that the two specimens had fractured in the area exposed to the high-velocity gas stream, and not in the areas where the specimens were held in the metal holder, indicating the adequacy of the test holder. The test was stopped after 5 hours of testing. After the oxidation test, the specimens were evaluated for surface hardness (R_{15y}), room temperature abrasability, and cold particle erosion resistance.

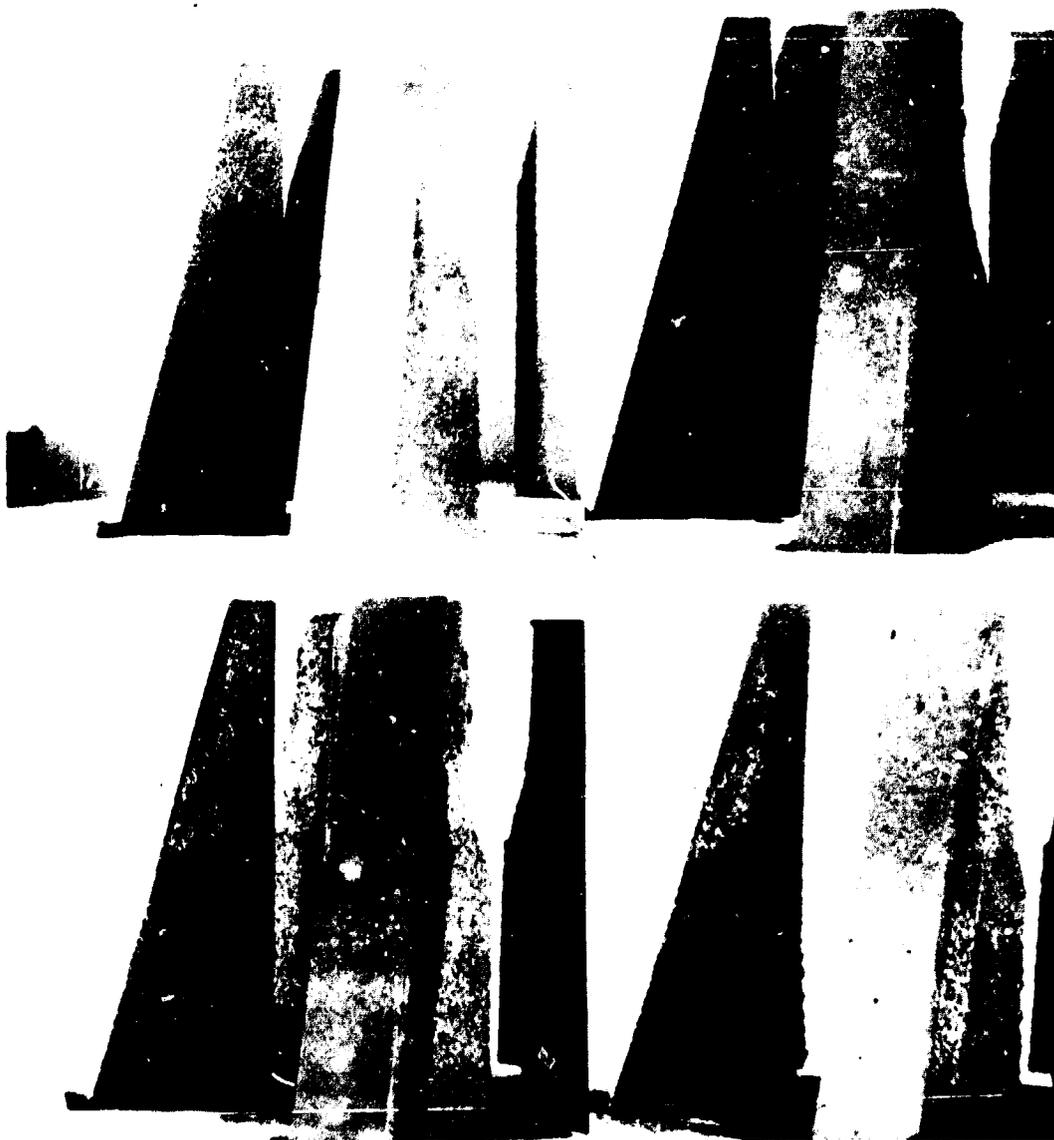
Figure 49. Second Task III Mach 1.0 Gas Oxidation/Erosion Specimen 16FA2 at Various Stages of Testing at 1589/1533 K (2400°/2300° F).

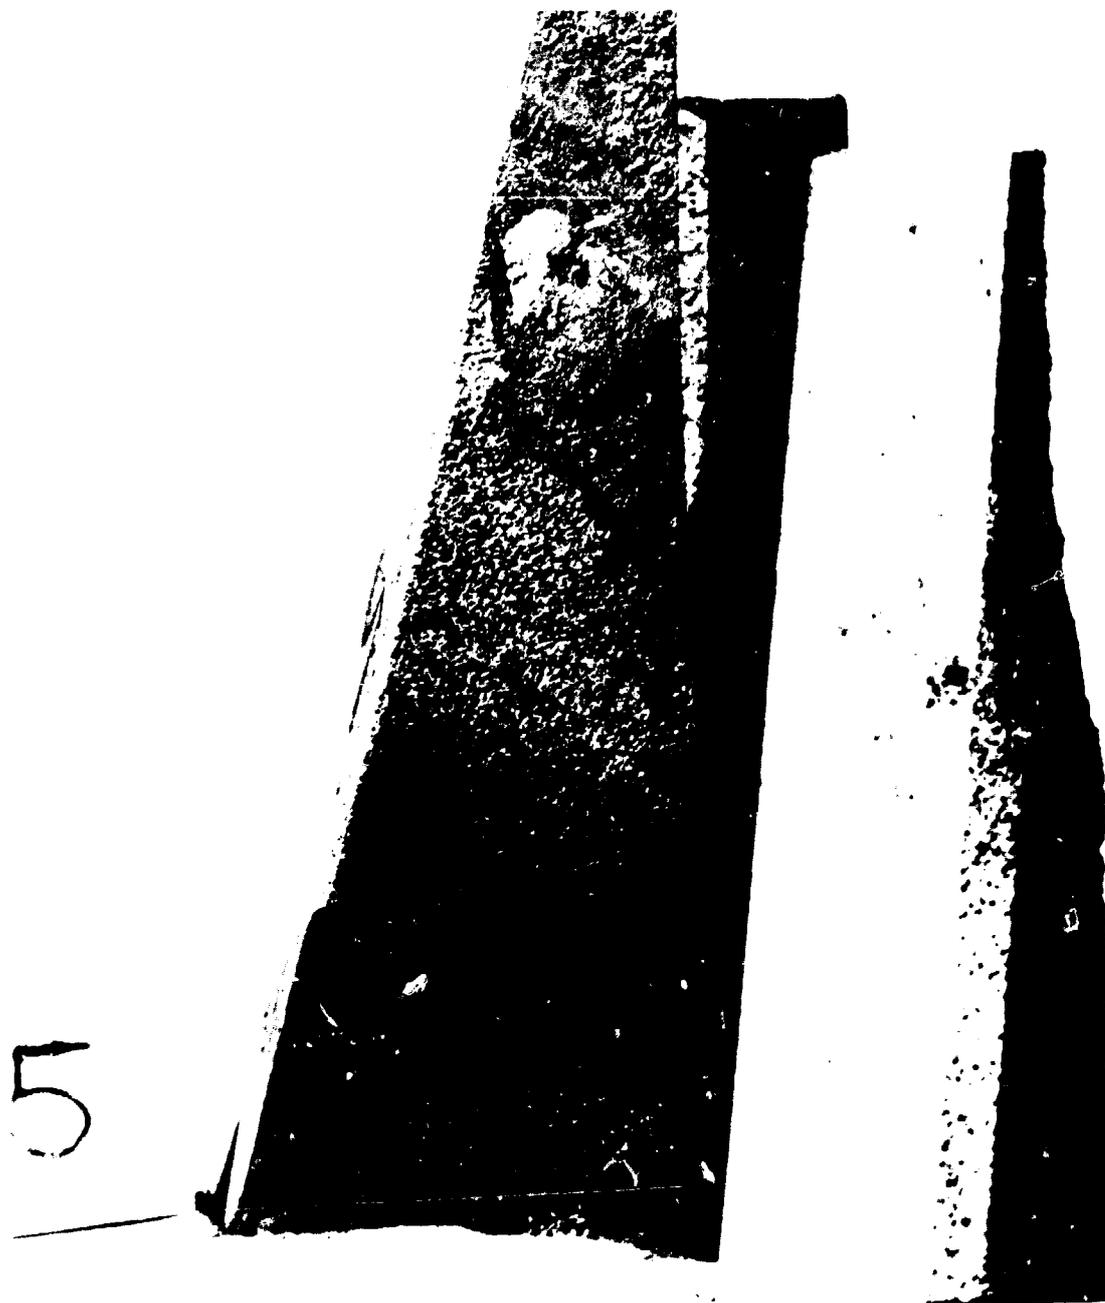
Figure 50. Closeup View of Task 111 Mach 1.0 Gas Oxidation Specimen 23GA1
After 8 Hours at 1589 K (2400° F) and 10 Hours at 1533 K (2300° F).

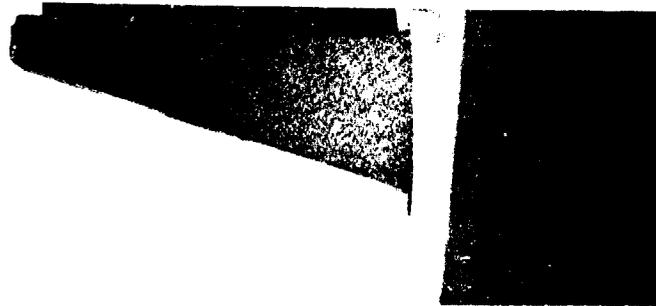
(a) As Fabricated
