NASA Conference Publication 2186

Capacitor Technologies, Applications and Reliability

Proceedings of a symposium sponsored by
NASA Marshall Space Flight Center and IEEE Components,
Hybrids and Manufacturing Technology Society
and held at Marshall Space Flight Center
February 24-25, 1981

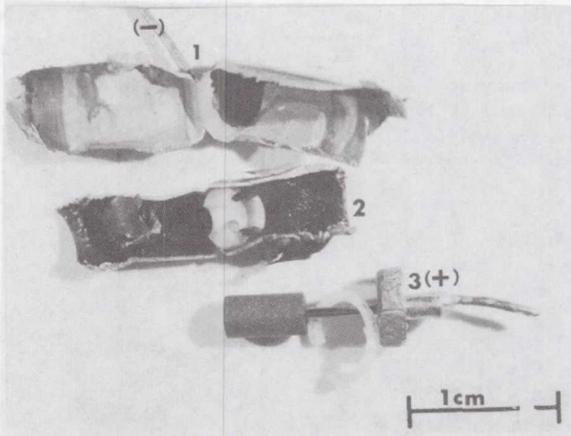
Figure 3: M39006/09-4786 "Break-down".
