Manufacturing Development of DC-10 Advanced Rudder

by A. Cominsky, et al.

MCDONNELL DOUGLAS CORPORATION
DOUGLAS AIRCRAFT COMPANY
LONG BEACH, CALIFORNIA 90846

16. Abstract This is the final technical report covering design, manufacture and ground test activities during development of production methods for an advanced composite rudder for the DC-10 transport aircraft.

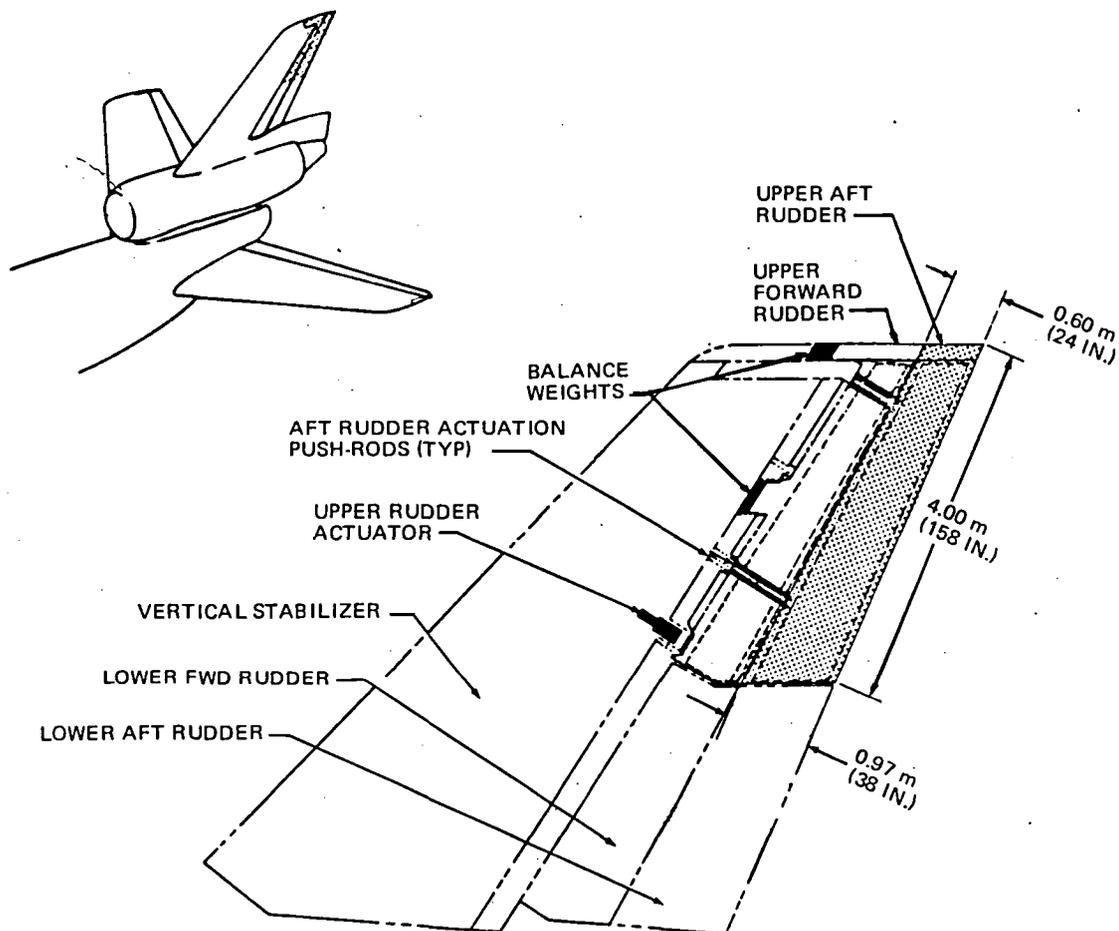
FIGURE 1. GENERAL ARRANGEMENT OF RUDDER SYSTEM

The objectives of this program were to develop and demonstrate production manufacturing processes for the graphite/epoxy composite rudder to show that it is cost-competitive with the metal rudder it replaces. The composite rudders were fabricated by the thermal expansion molding (trapped rubber) process. The details of this process as applied to the rudder component were developed under NASA Contract NAS1-12954 from January 1974 through April 1976. The rudder system and dimensions are shown in Figure 1.

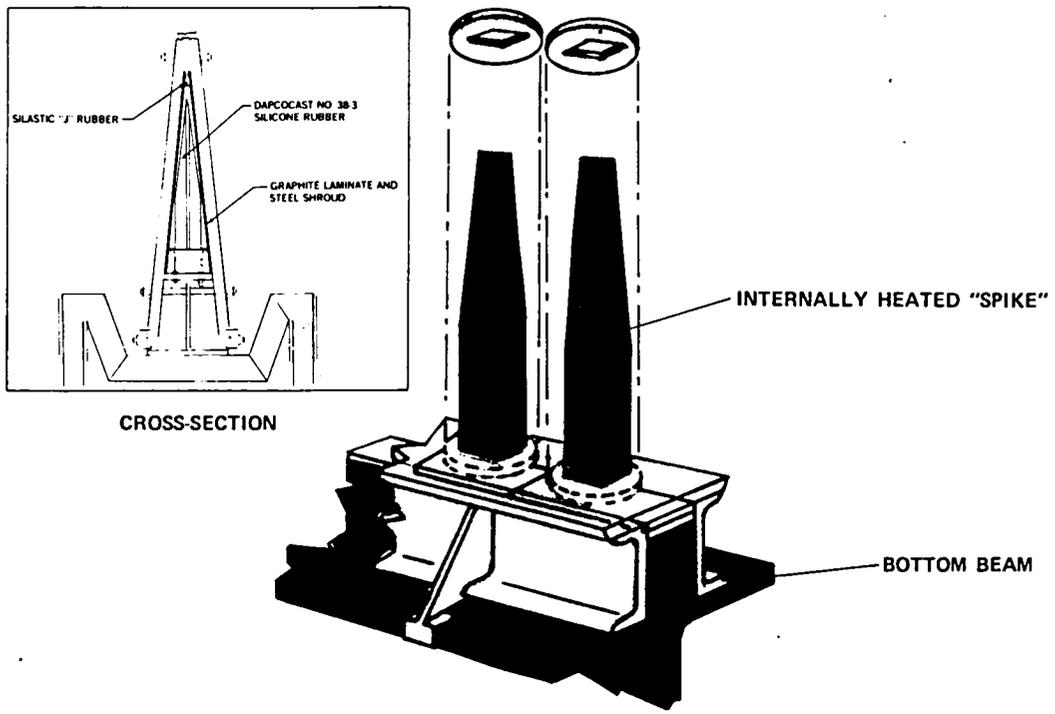
FIGURE 4. PLM SPAR PLANE LOCATOR MODIFICATION

Replacing the individual pedestals on the PLM (Figure 4) with one continuous member allowed the thermocouple conduit to be a straight tube that could greatly reduce tool cleanup time. A means of quickly replacing a faulty heater element was also incorporated into the tool. The old design requires a tool downtime of about 2 days to replace a heater.

The front spar web locator was redesigned to increase its rigidity and to be a net fit on the rib-bay spikes. The individual spike pedestals were eliminated and replaced by one full-length member. The front spar locator and the base beam were reworked so that the front spar locator lifts the cured rudder box assembly from the tool. The increased rigidity could eliminate (1) hand-fitted shims beneath the rudder hinges and (2) a different tool setup

operation (adjusting the jack screw tubes using a depth micrometer, then bolting the spar locator to them). The close fit on the rib-bay spikes should prevent front spar damage if any metal mandrels inadvertently stick to a spike (Figure 4). The rework of the front spar locator was estimated to effect a 15-percent man-hour savings (Table 4).

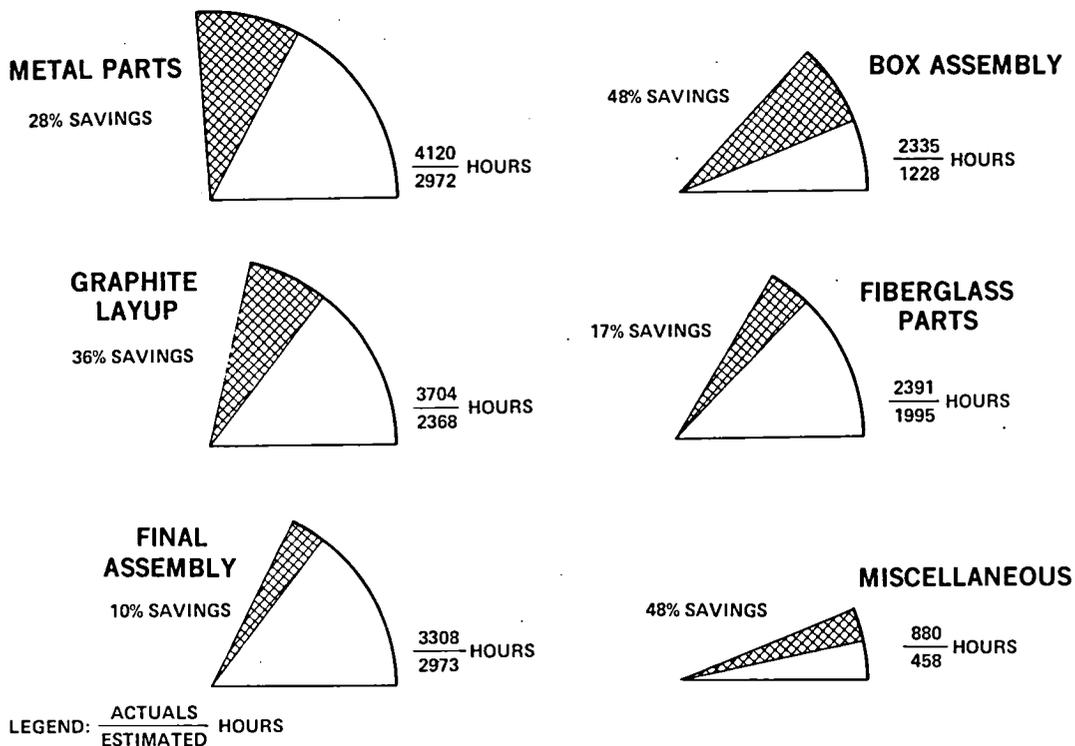
FIGURE 6. EXPECTED MAN-HOUR IMPROVEMENTS

As a result of the proposed tooling modifications and process refinements, the following man-hour improvements were anticipated per operation (Figure 6).

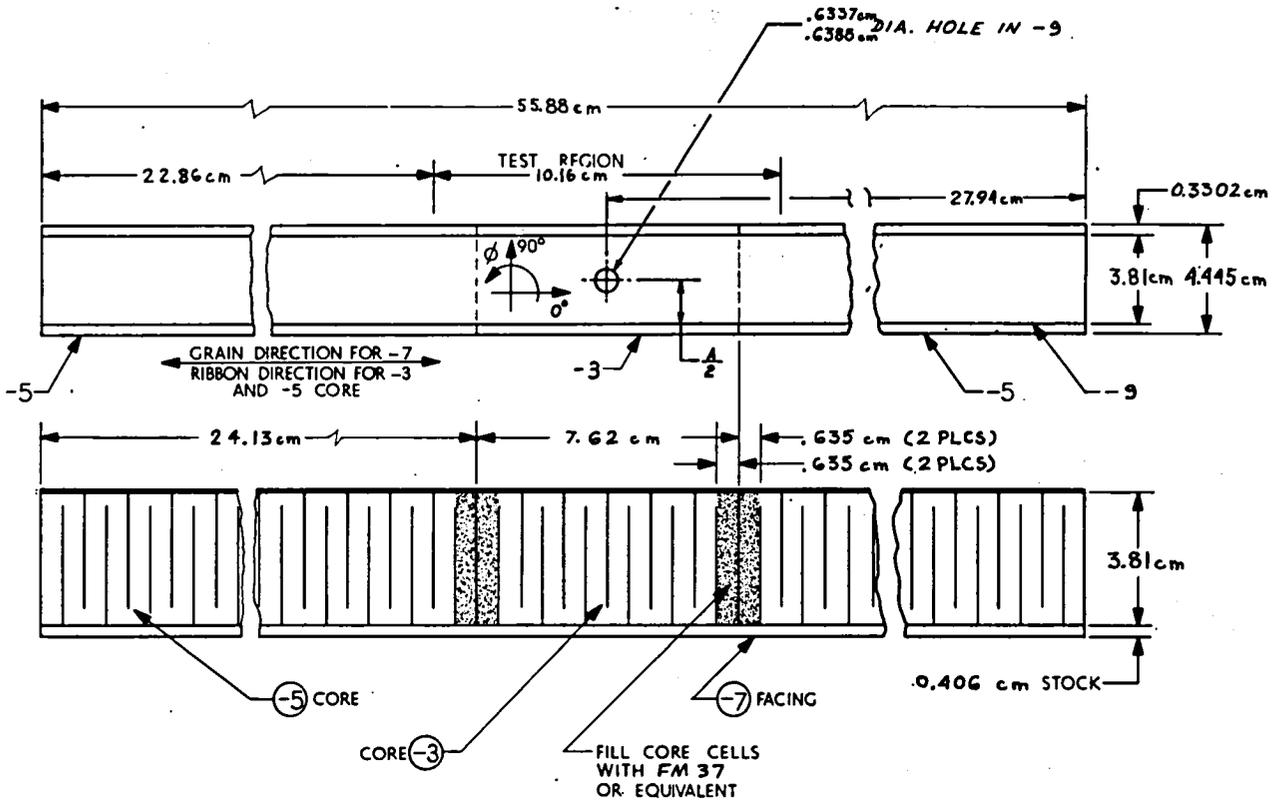
FIGURE 12. SPECIMEN ASSEMBLY - COMPOSITE FACING HONEYCOMB SANDWICH BEAM TEST

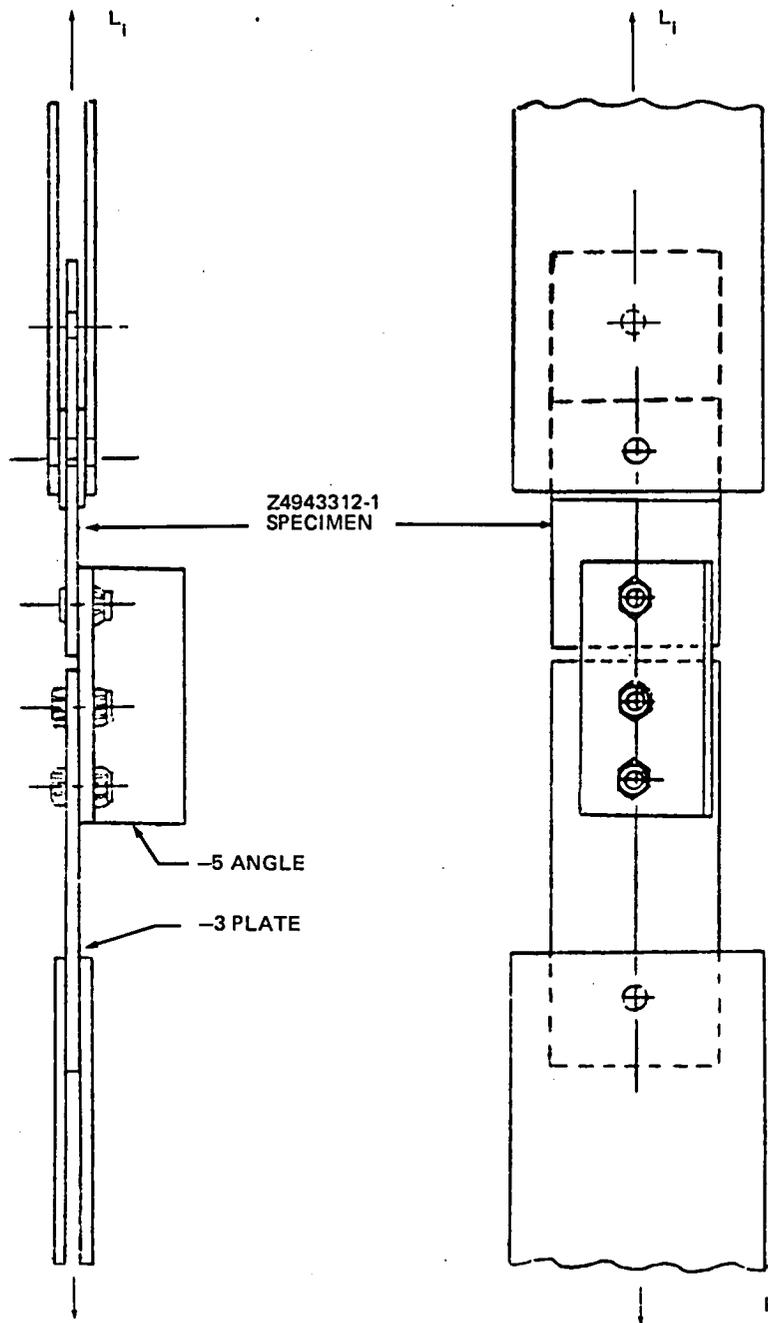
NOTE: THIS SPECIMEN IS DESIGNED TO REPRESENT THE SINGLE SHEAR MODE OF ATTACHMENT OF THE HINGE FITTING TO THE SPAR FLANGE/SKIN COMBINATION. AFTER THE FAILURE AT ONE END, THE SPECIMEN CAN BE LOADED THROUGH THE OTHER END FOR A SECOND TEST.

FIGURE 13. TEST SETUP FOR BOLT BEARING TEST

SPECIMEN NO. (i)	Li FAILURE LD (kN)	Li-L _{AVG} (kN)	FAILURE DESCRIPTION
1	27.69	-1.51	BOLT TENSION
2	31.47	2.27	COMPOSITE BEARING
3	27.25	-1.96	BOLT TENSION
4	28.02	-1.18	BOLT TENSION
5	29.87	-0.67	COMPOSITE BEARING
6	29.02	-0.18	COMPOSITE BEARING
7	27.36	-1.85	BOLT TENSION
8	29.47	0.27	BOLT TENSION
9	27.85	-1.36	BOLT TENSION
10	32.32	3.11	COMPOSITE BEARING
11	30.58	1.38	BOLT TENSION
12	29.51	0.31	BOLT TENSION
AVG	29.20

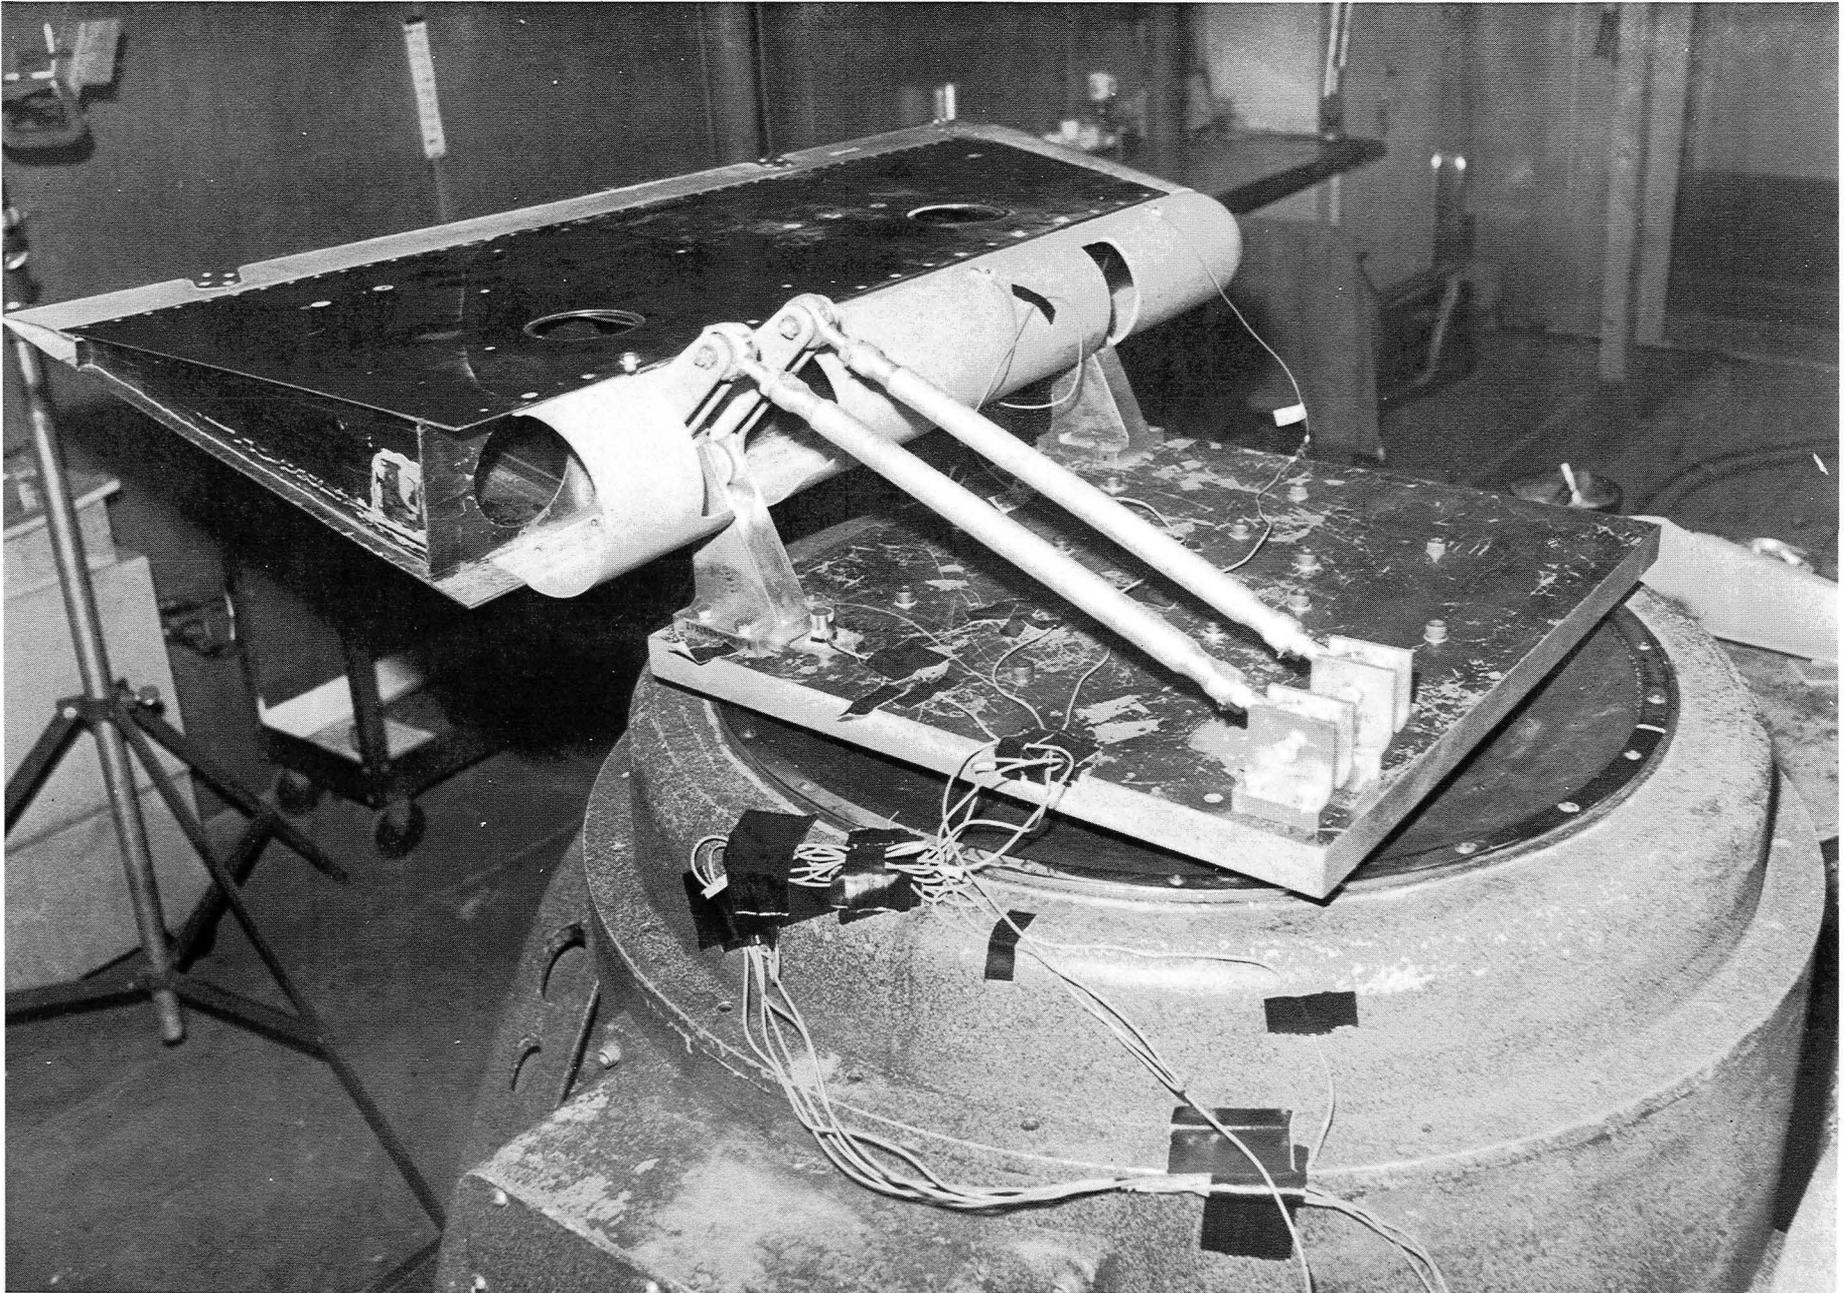
FIGURE 16. BOX - VIBRATION TEST SETUP

A modal survey was conducted first and six channels of strain gages were installed to monitor stresses in the component at selected locations on the skin panels. A random vibration environment, based on measured service conditions at the DC-10 fin tip and on acoustic levels at the upper rudder, was then applied to the specimen. The random vibration input, over a frequency bandwidth from 350 to 1800 Hz, was equivalent to 8.6-g root-mean-square lateral acceleration of the rudder.

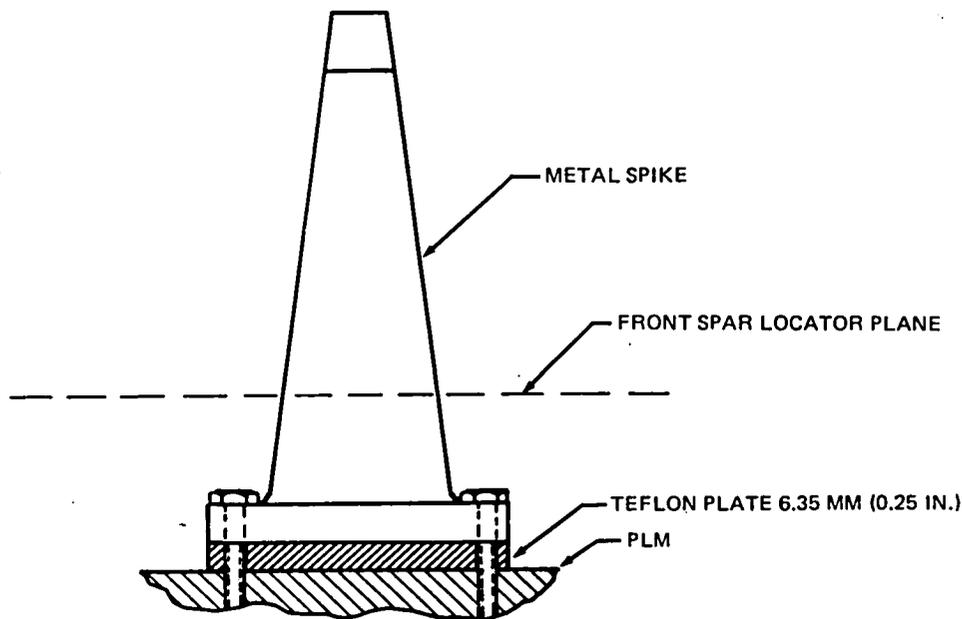
FIGURE 18. DIAGRAM OF 6.35 MILLIMETER (0.25 INCH) TEFLON PLATE AT BASE OF THE PLM METAL SPIKE

To open the molding tool (PLM), the steel side plates and the closing bars were first removed, thereby permitting the rudder box to be removed by lifting upward. Considerable difficulty was encountered in lifting the rudder box. This was later thought to be caused by the shift of the internal metal mandrels, which in turn was attributed to the use of 6.35-mm (0.25-inch) Teflon insulation plates at the base of each metal mandrel heater spike (see Figure 18).

5. LOOSE METAL MANDRELS AFTER CURE CYCLE	DEFORMATION OF 1/4-INCH TEFLON PLATE AT BASE OF EACH METAL MANDREL	REMOVE THE TEFLON PLATE AND REPLACE BY ONE OF ALUMINUM

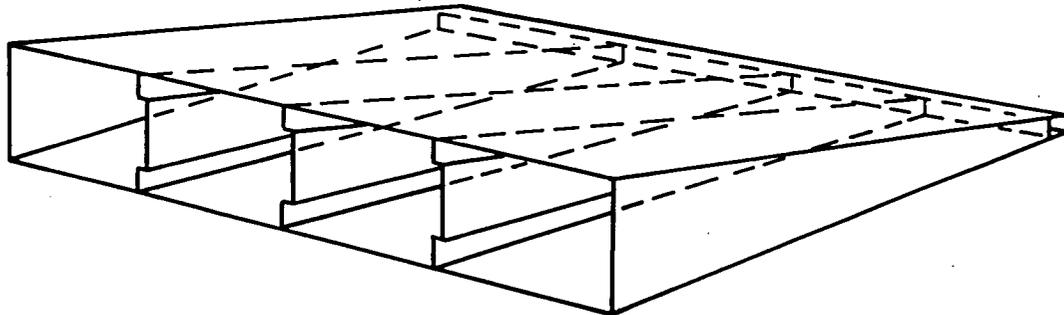
FIGURE 19. RIB INDENTATIONS

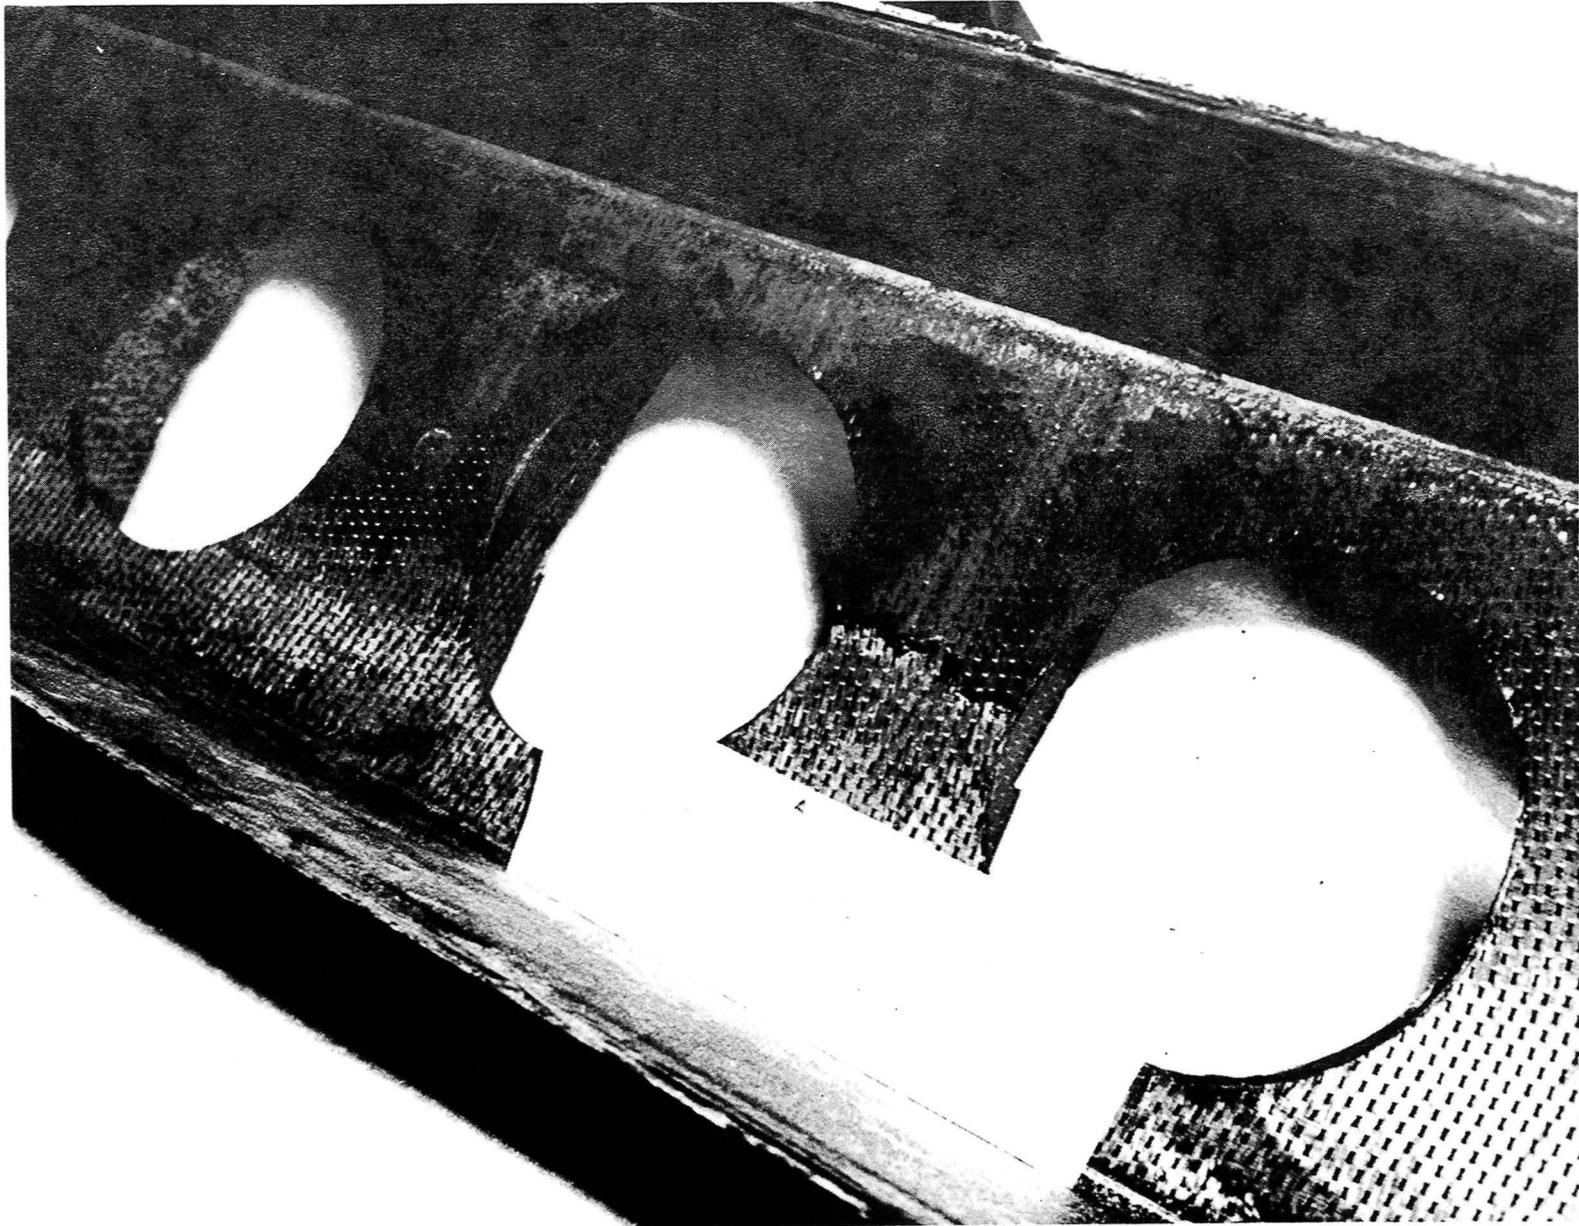
FIGURE 21. FRONT SPAR WEB DAMAGE – STA $Z_{AR} = 482.10$

Rib and front spar web failures (Problems 2 and 3 of Table 14) were caused primarily by the spring-back of the rudder box molding tool during tool cool-down. During heat-up, the trapped rubber expands and exerts considerable pressure on the PLM steel side plates. These plates deflect due to the rubber pressure and the rudder box skins gel against the steel side plates in this oversize condition. When the cure is complete, the cooldown phase commences. As the rubber pressure gradually reduces to zero, the steel side plates tend to spring back and exert pressures on the rudder box inside the steel molding tool. Gradually, the allowable compressive strains in the rib and front spar webs were exceeded, resulting in failure.

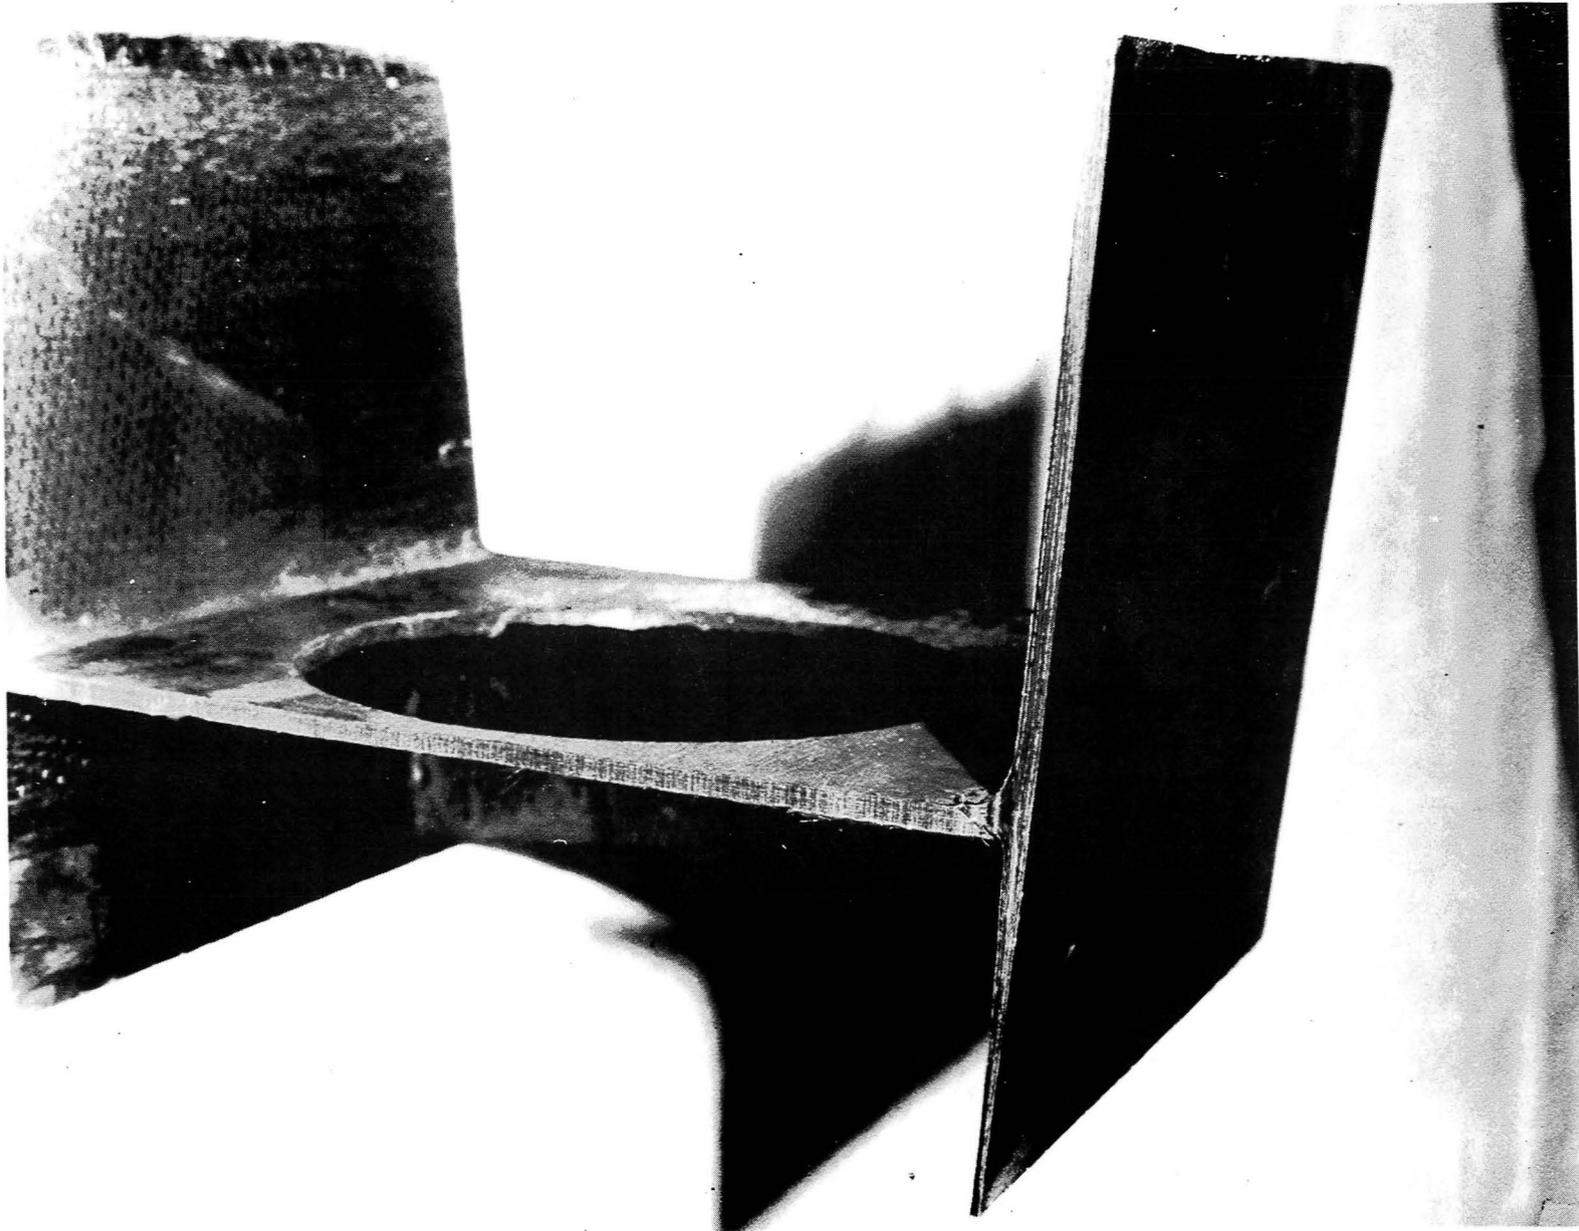
FIGURE 22. FRONT SPAR WEB TO FLANGE DAMAGE

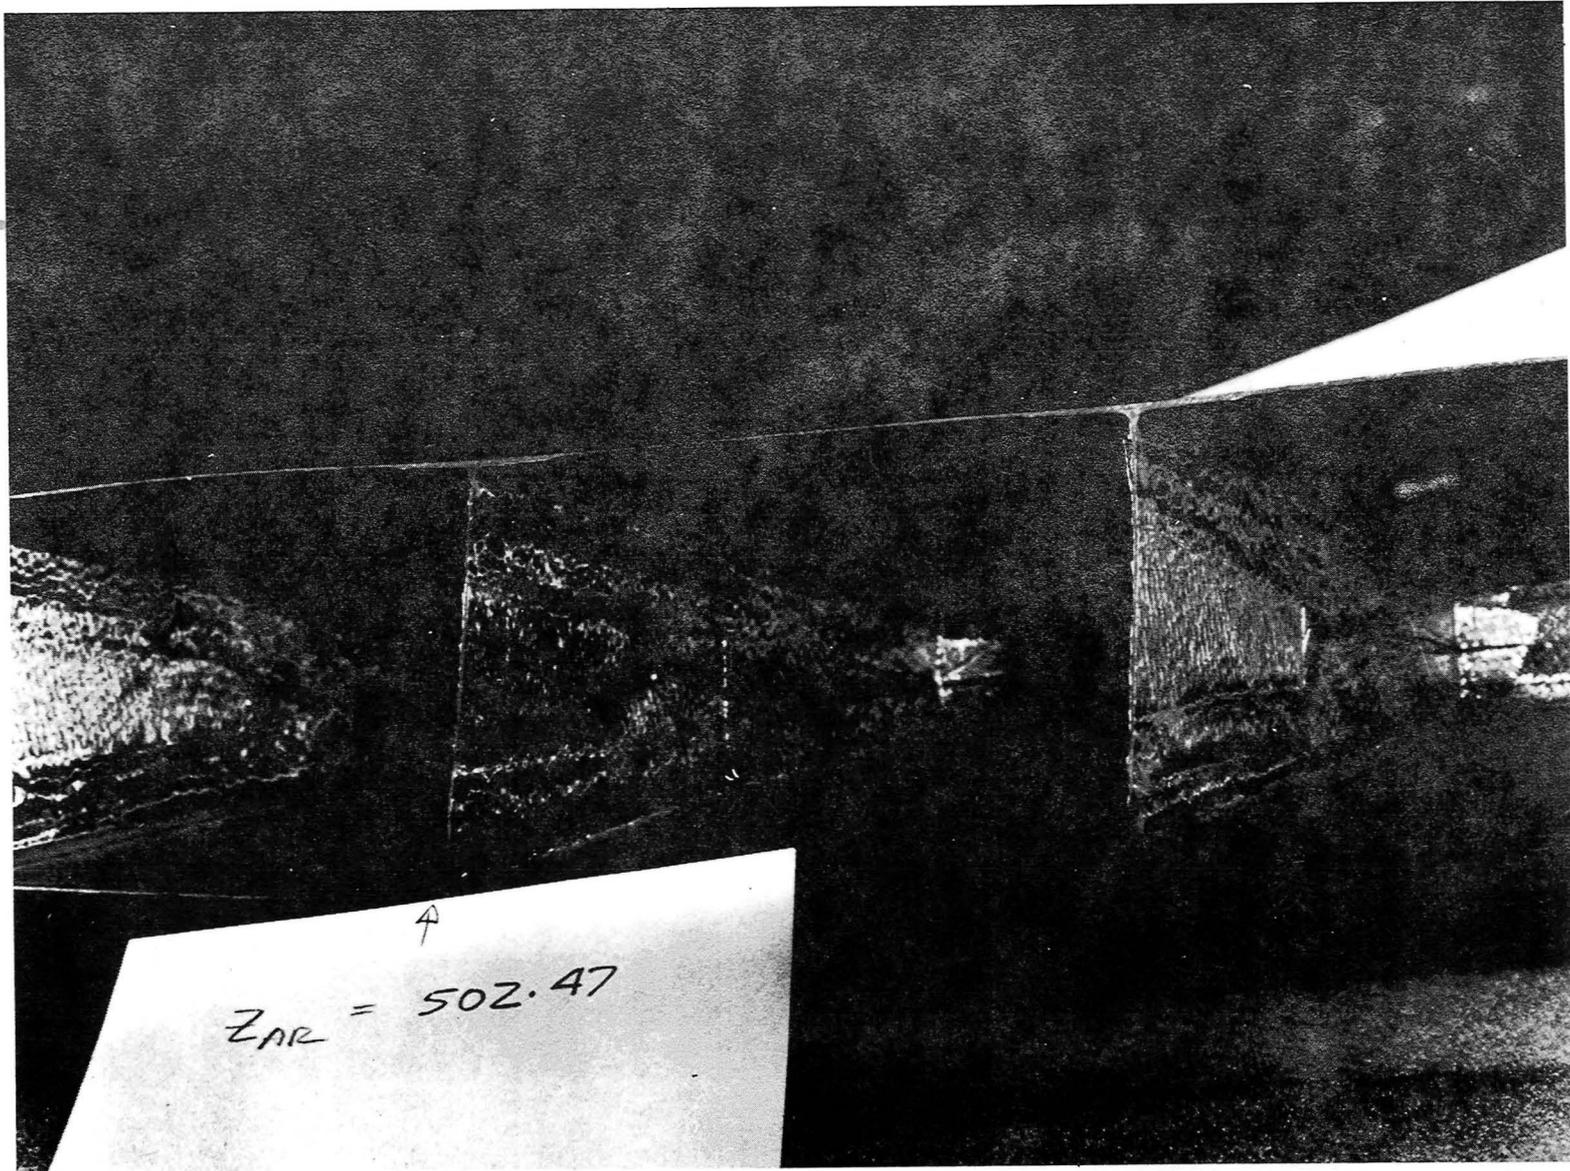
FIGURE 23. RIB WEB DAMAGE — STA $Z_{AR} = 502.47$

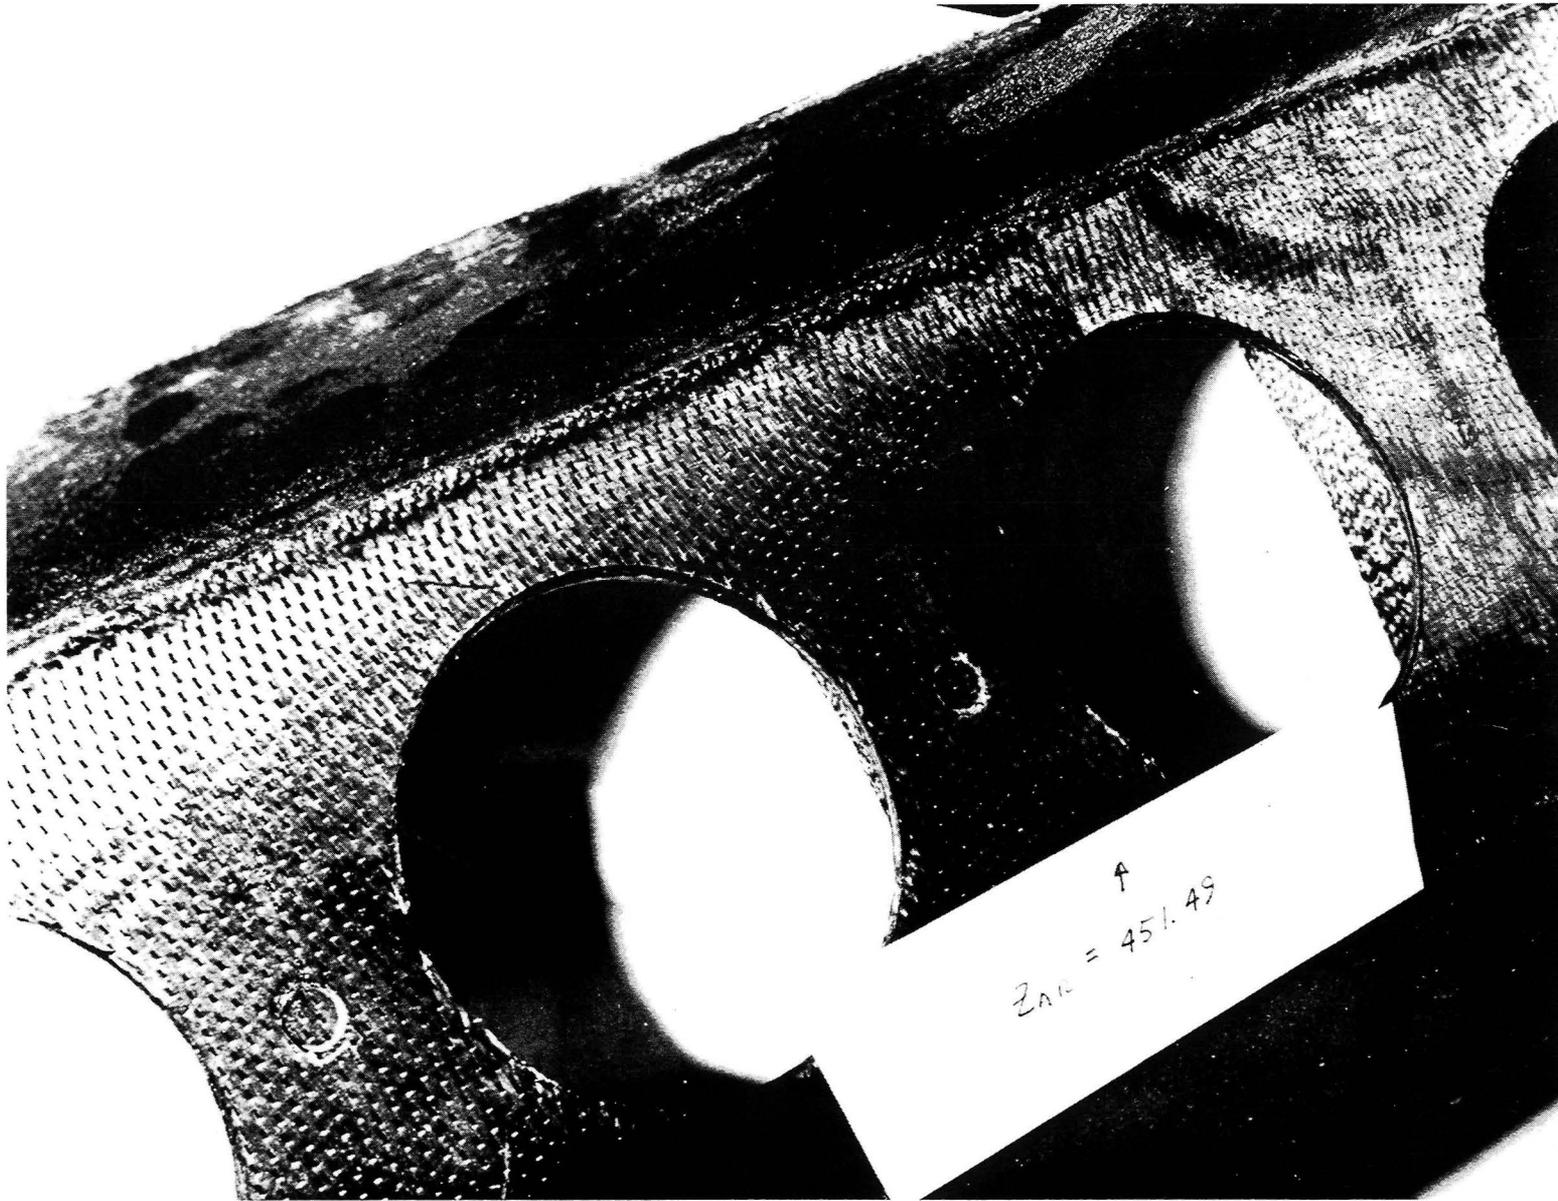
FIGURE 24. FRONT SPAR WEB THERMOCOUPLE INDENTATIONS

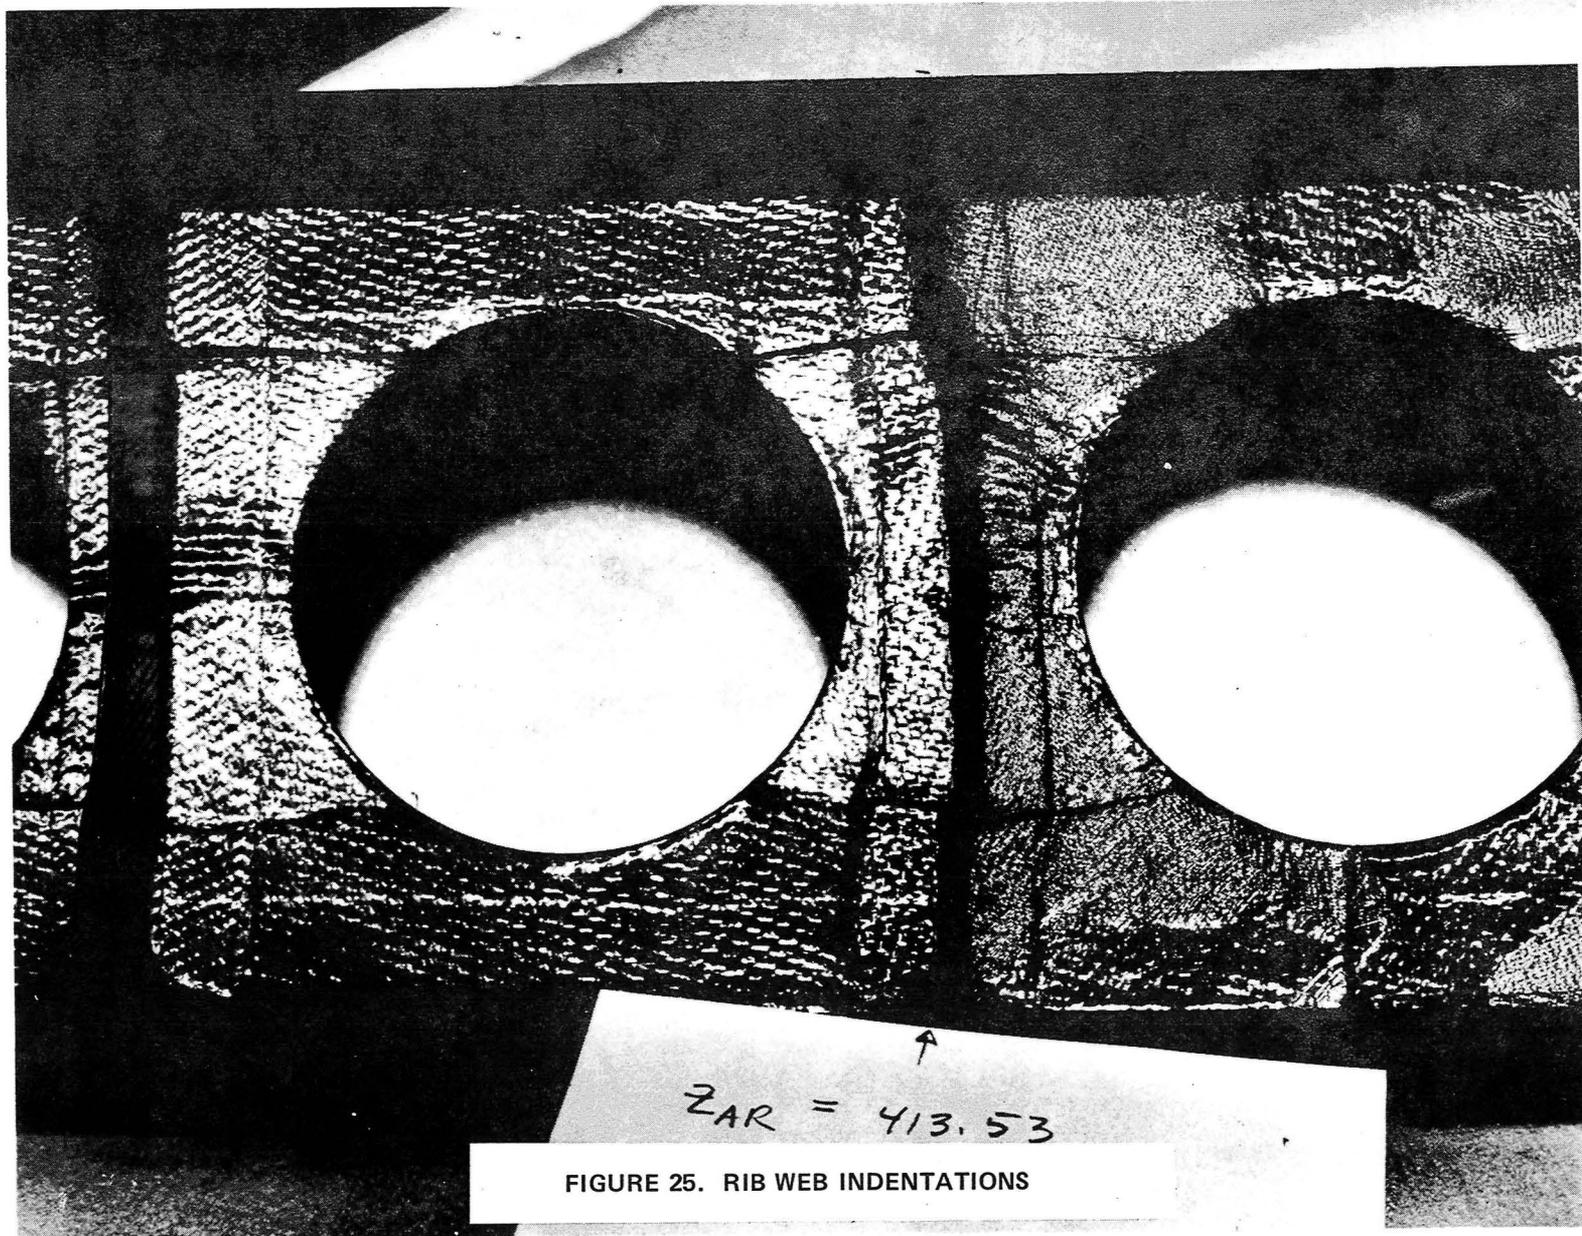
FIGURE 25. RIB WEB INDENTATIONS

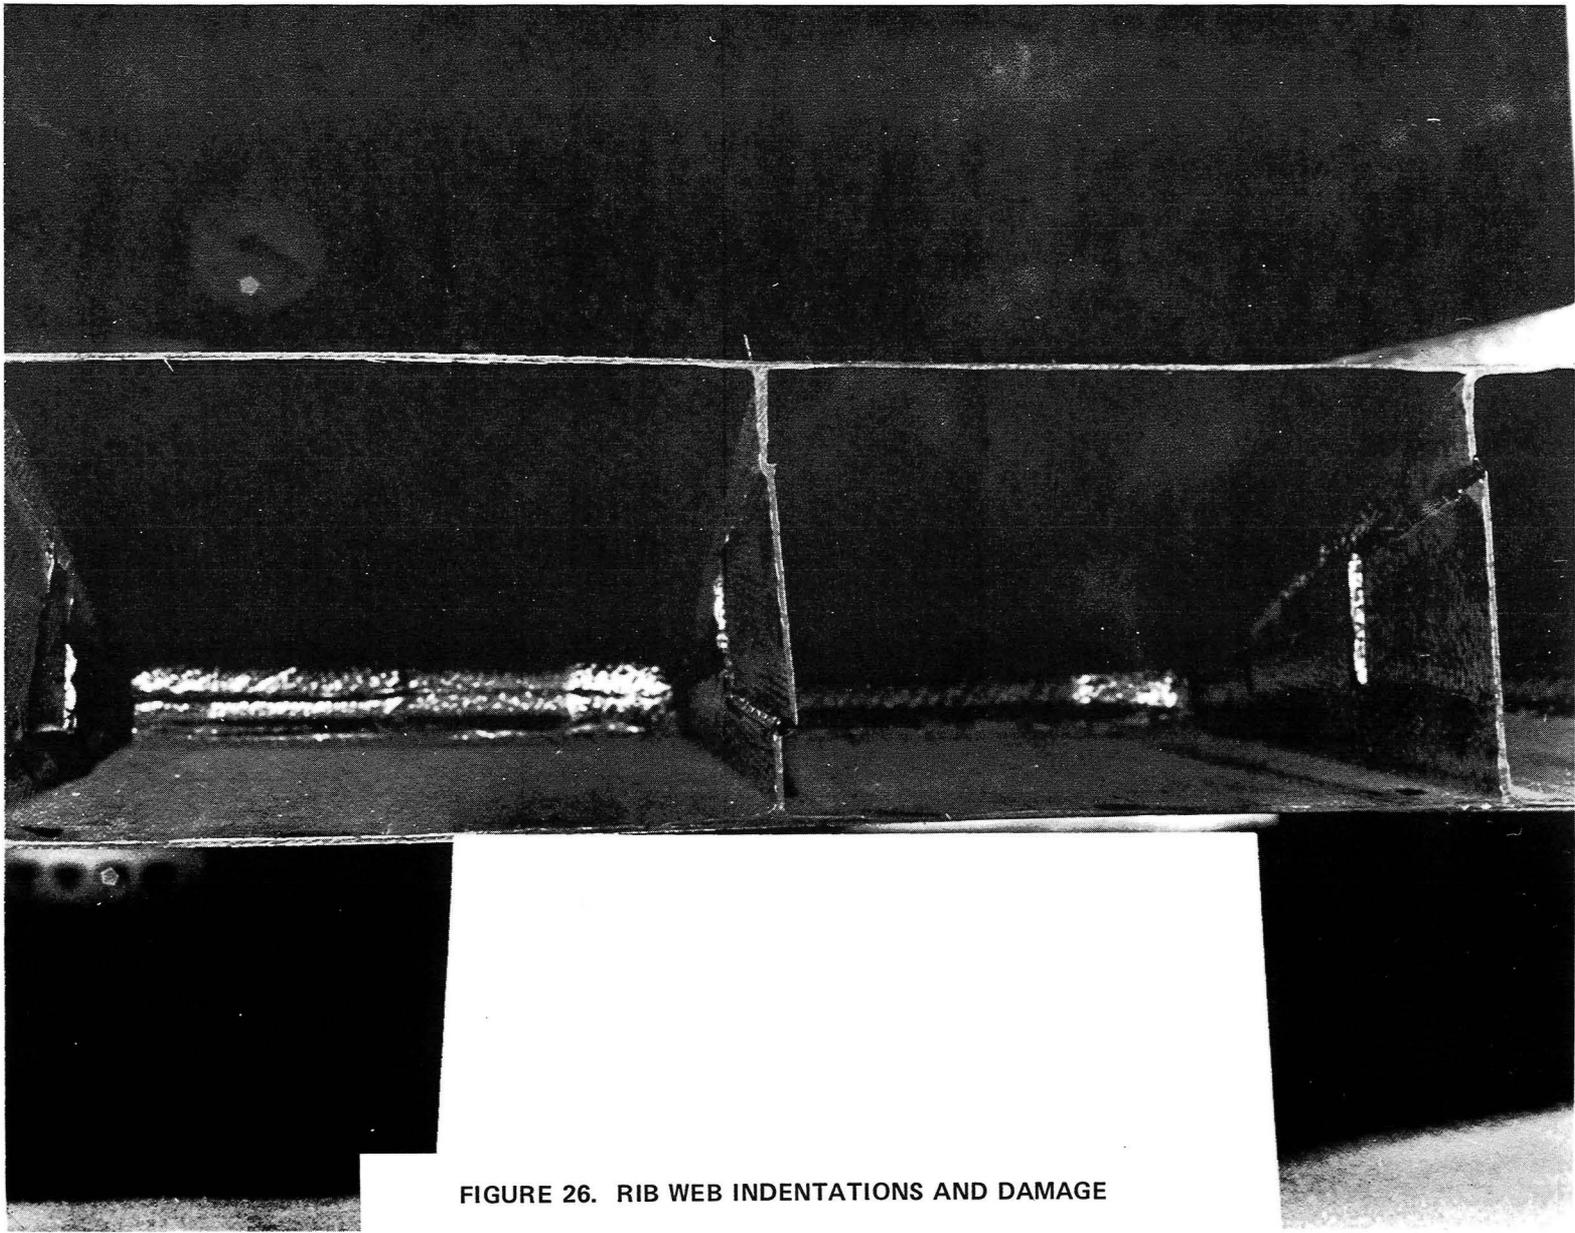
FIGURE 26. RIB WEB INDENTATIONS AND DAMAGE

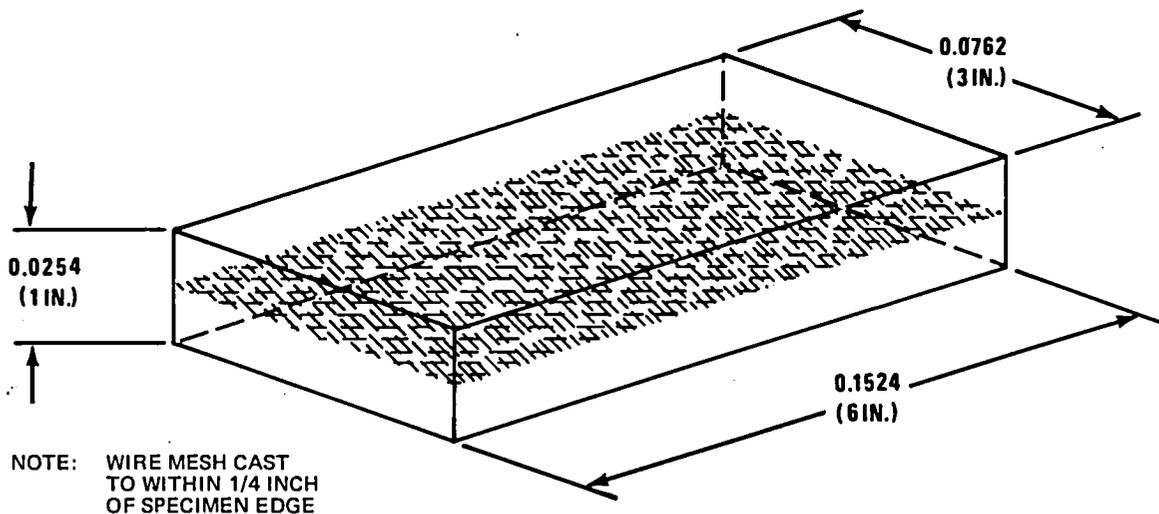
The specimens for the thermal expansion coefficient tests were made from Dapcoast 38-3 silicone rubber, three with expanded-metal mesh and three without. These specimens were cured as described for specimen No. 2 (Table 16). Specimen dimensions are shown in Figure 28. It should be noted that metal screening used with three of the specimens was placed in the middle of the specimen with the longitudinal direction in line with the 0.1524-meter (6-inch) dimension. This metal screening is described as 2.5 black metal lath, 0.79- by 1.27-cm diamonds, 26-gauge steel.

FIGURE 28. SPECIMEN – THERMAL EXPANSION COEFFICIENT TEST – DAPCOAST 38-3 SILICONE RUBBER

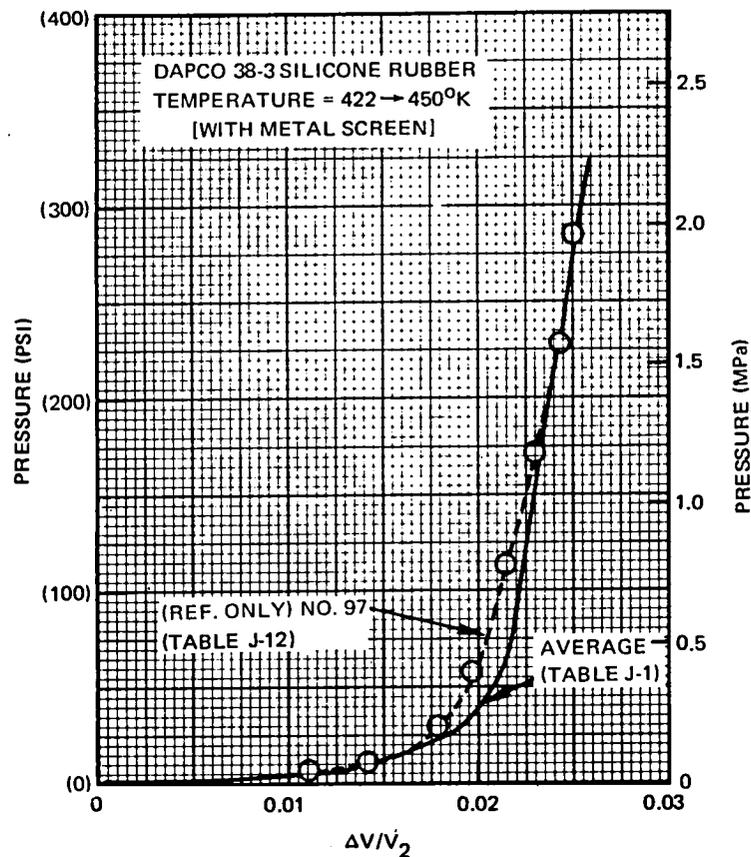
FIGURE 29. RELATIONSHIP OF PRESSURE VERSUS BULK STRAIN (DAPCO 38-3 SILICONE RUBBER)
