Manufacturing Development of DC-10 Advanced Rudder

by A. Cominsky, et al.

MCDONNELL DOUGLAS CORPORATION
DOUGLAS AIRCRAFT COMPANY
LONG BEACH, CALIFORNIA 90846

16. Abstract This is the final technical report covering design, manufacture and ground test activities during development of production methods for an advanced composite rudder for the DC-10 transport aircraft.

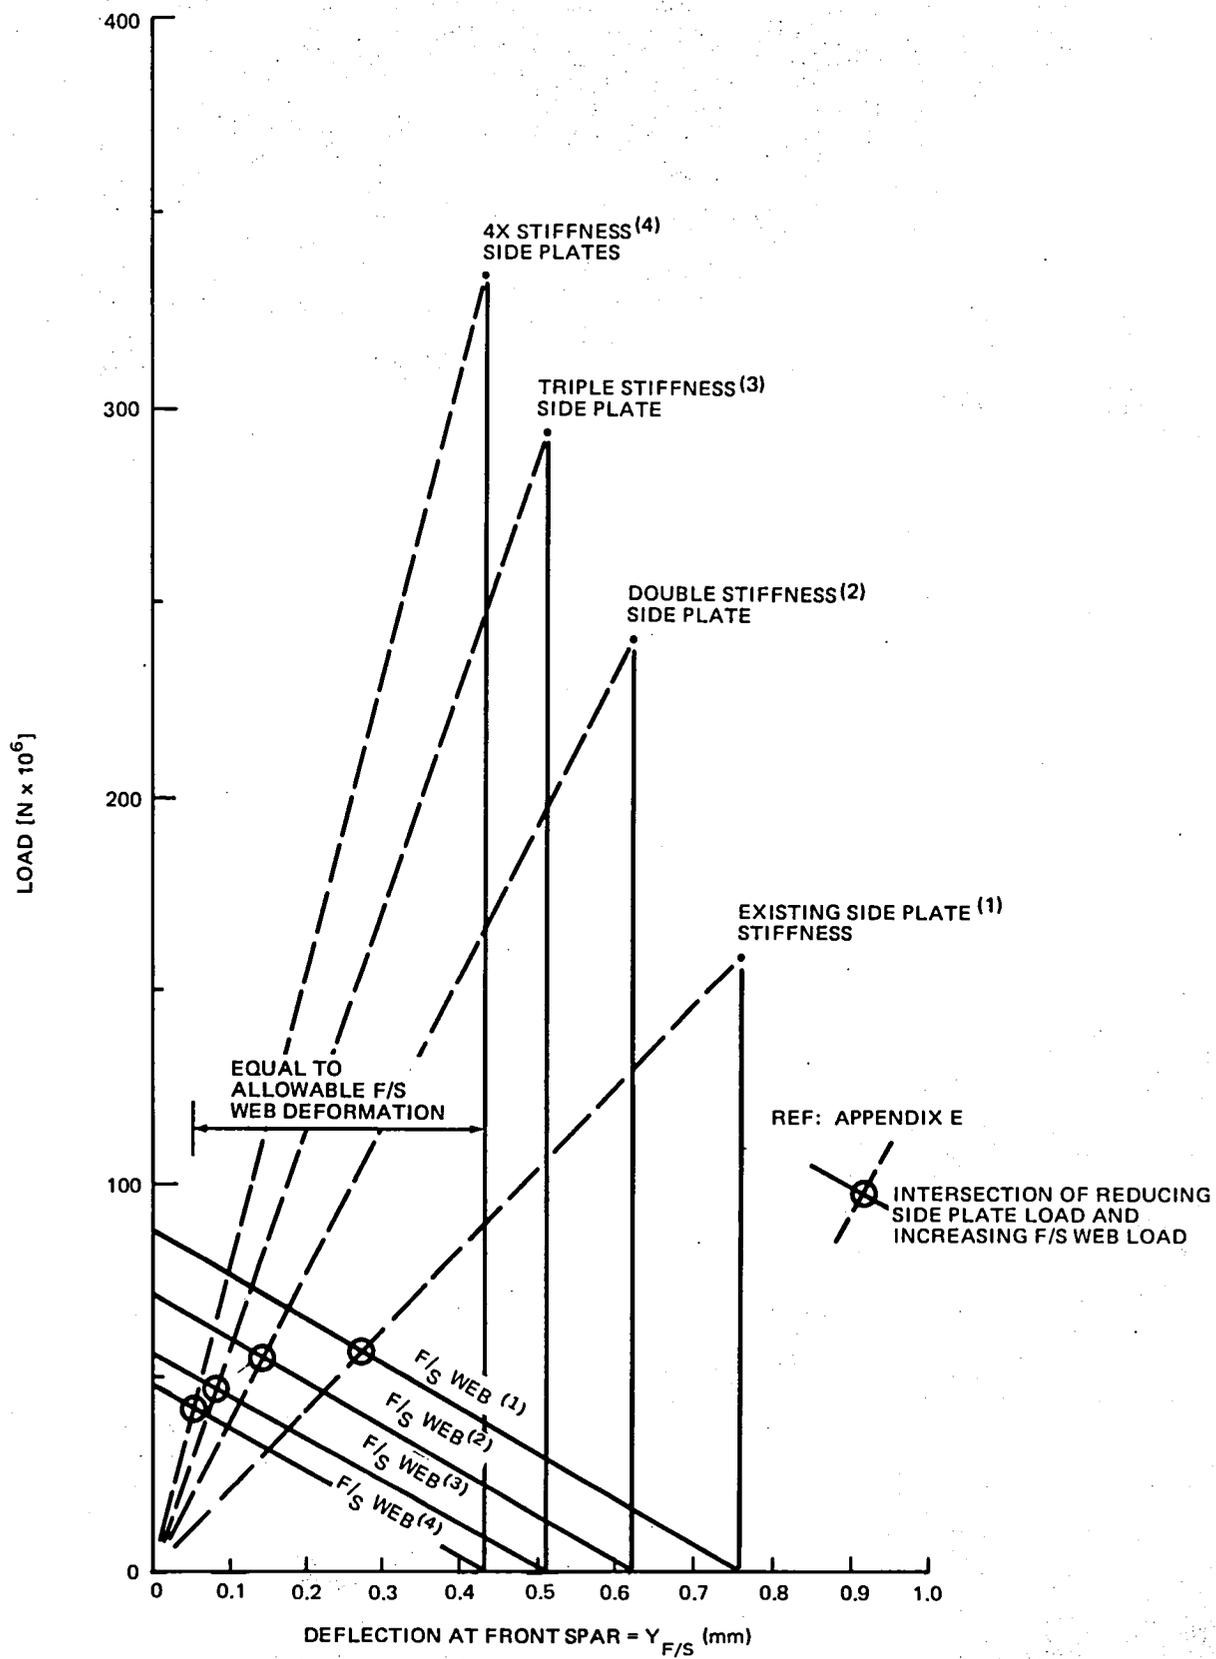
FIGURE 31. F/S LOAD VERSUS DEFLECTION DURING COOL-DOWN

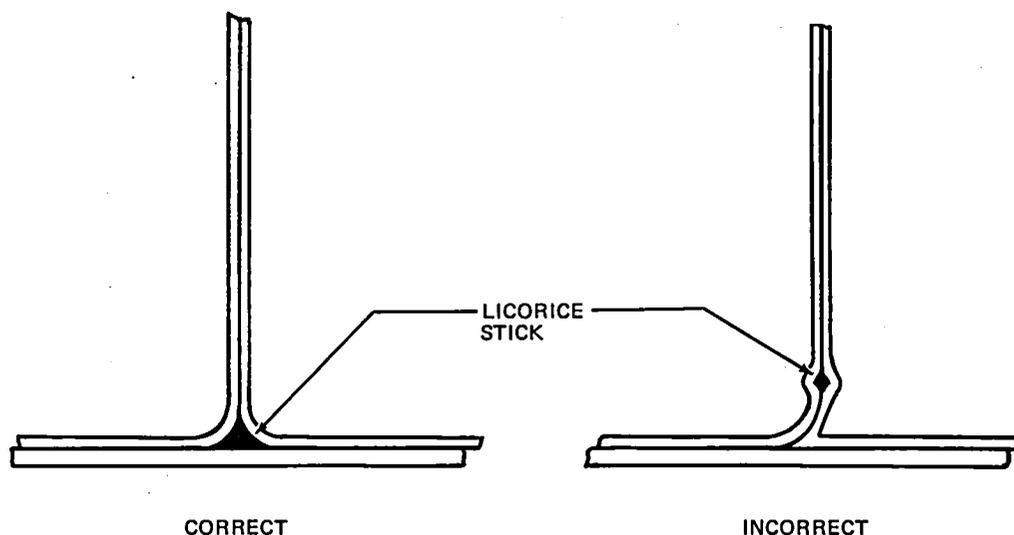
Prior to the curing of the rudder box unit No. 7, it was observed that at a few ribs, the licorice stick might be misplaced from its proper location. This misplacement could result in a reduced corner radius (see Figure 33). It was resolved to pay very close attention to the licorice stick location during the loading of the molding tool for the curing of the remaining rudders. Improperly placed licorice sticks were relocated or, if the existing one was not movable, an extra one was added.

FIGURE 33. EFFECT OF MISPLACED LICORICE STICK

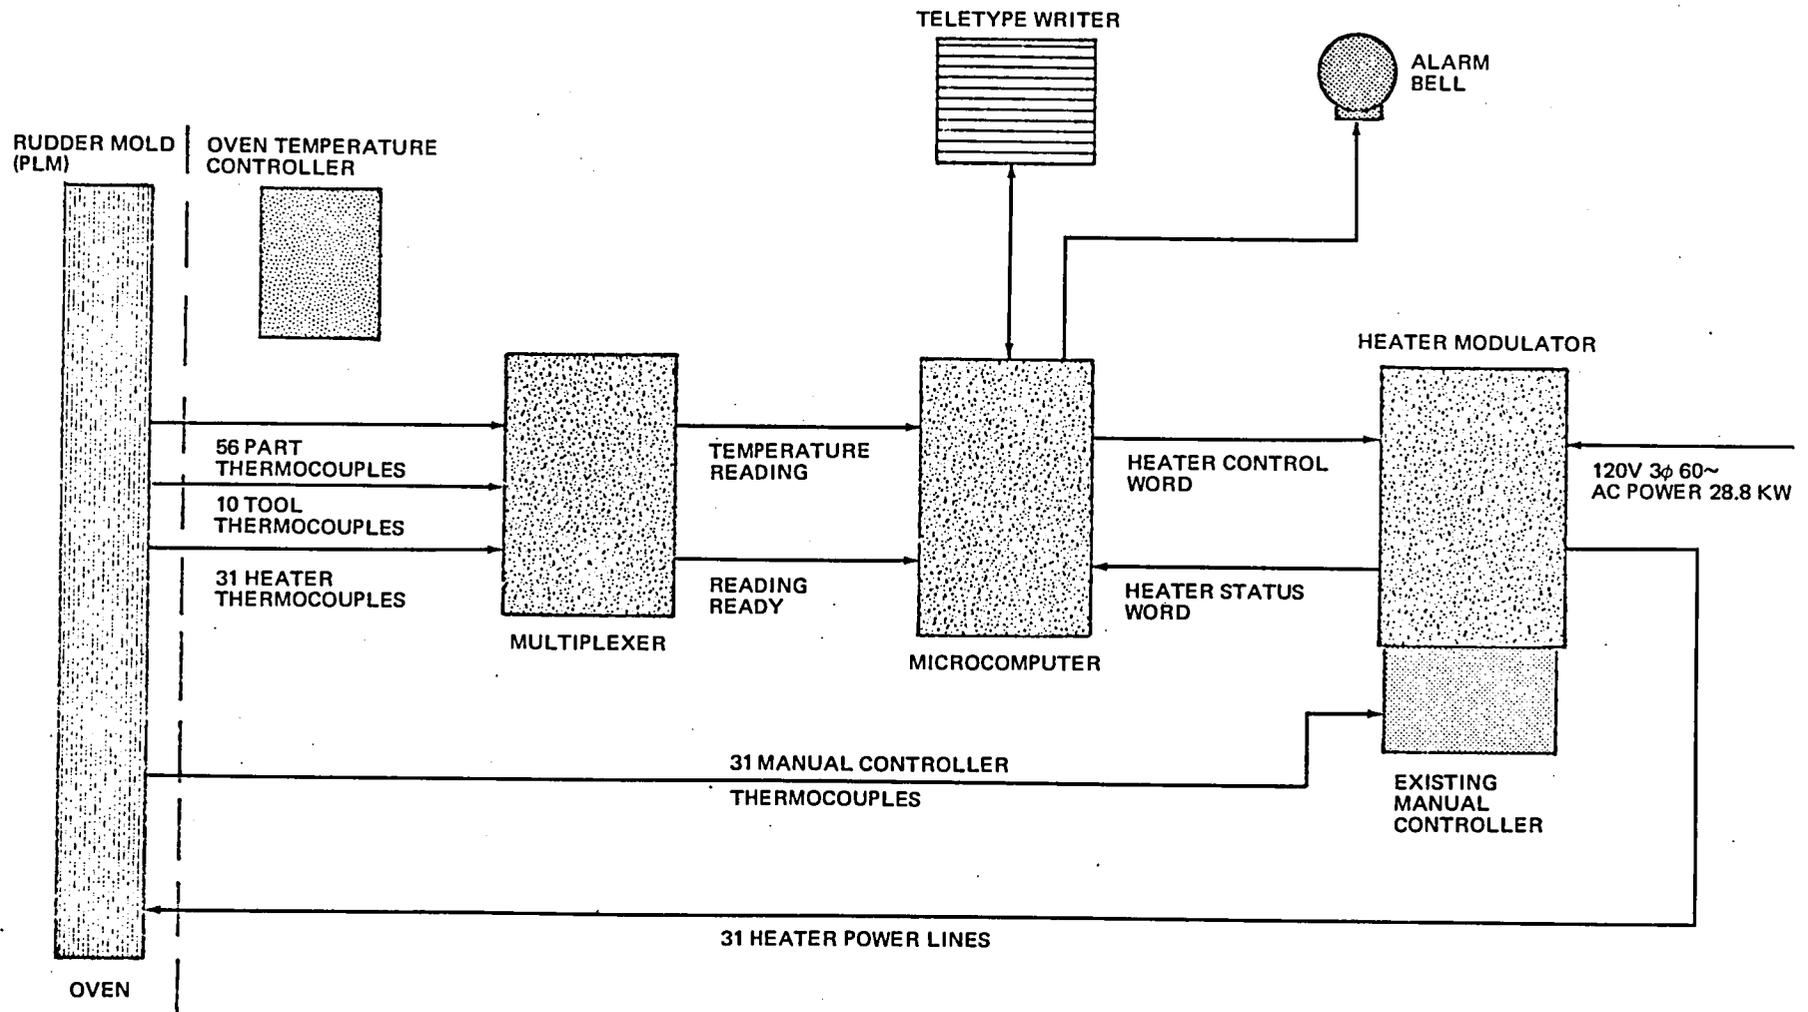
FIGURE A-1. TEMPERATURE CONTROL SYSTEM BLOCK DIAGRAM

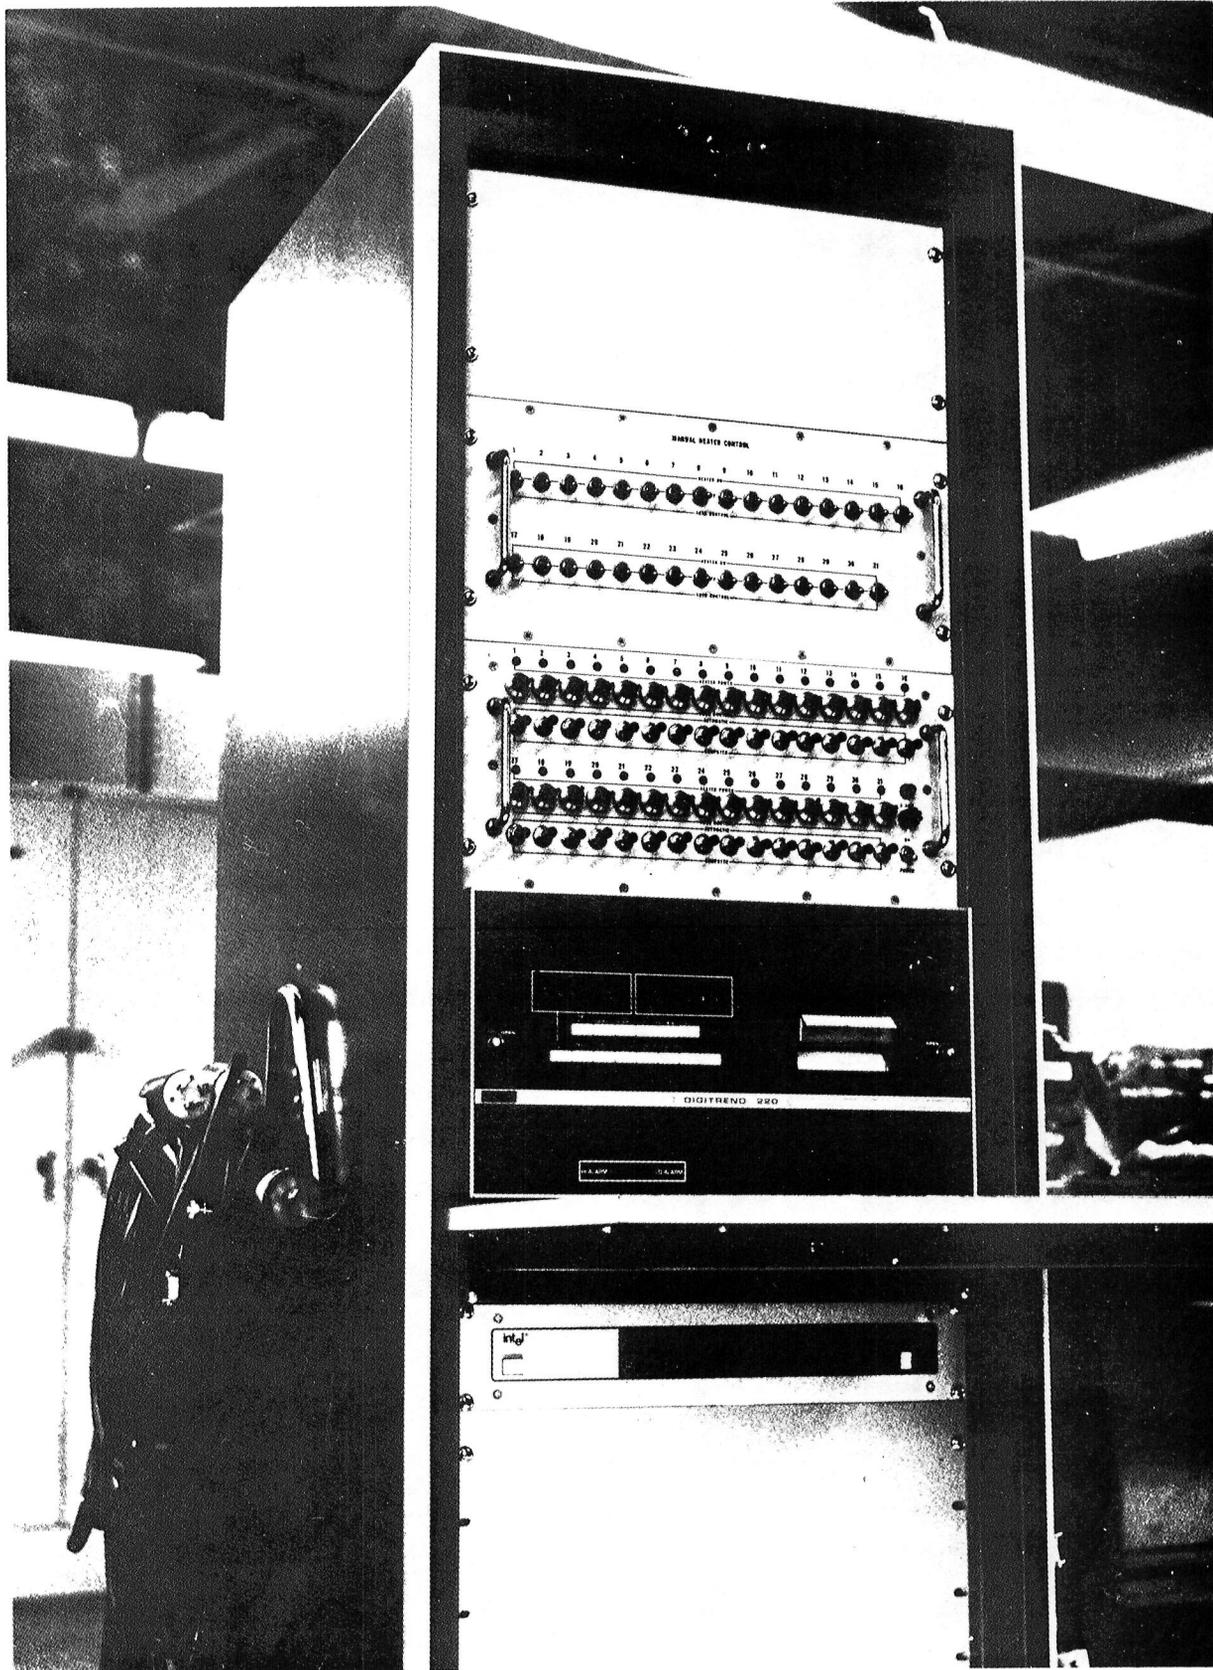
The computer (Figure A-2) is an Intel 8020 single-board type using an 8080A central processing unit (CPU). This board has 2048 (2K) eight-bit words (bytes) of read-write memory (RAM) and provisions for 4096 (4K) bytes of read-only memory (ROM). The input-output (I/O) capacity of this board, 48 lines, was insufficient for the task so the I/O capability was expanded to 96 lines with an Intel SBC 104 I/O expander board. This action also added 4K bytes of RAM and provisions for adding 4K bytes of ROM. As the software design evolved, this ROM capacity became insufficient and an Intel 416 memory expander board was added. This resulted in having a total ROM capacity of 16K bytes. Additional features of these boards, such as interval timers, a programmable interrupt controller and a universal synchronous, asynchronous

FIGURE A-2. MICROCOMPUTER PROCESS CONTROLLER FOR THE RUDDER CURE CYCLE

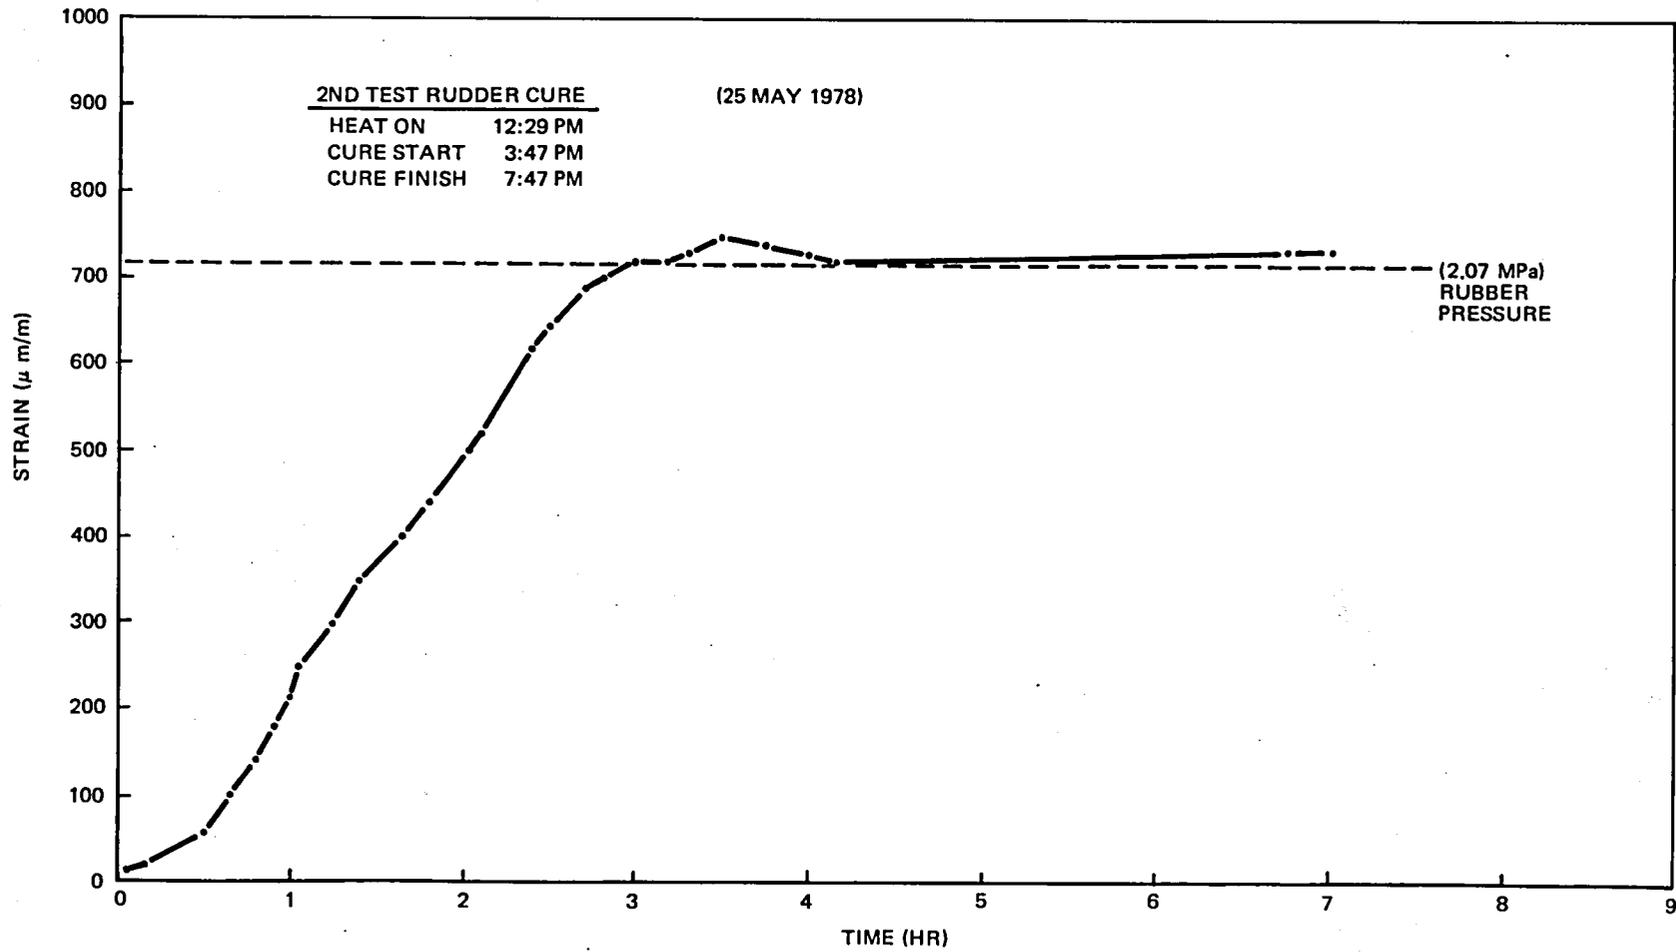
The strain gage values shown in Figure E-1 indicate that the rubber started to produce pressure shortly after the oven was turned on and the

FIGURE E-1. STRAIN READINGS OF PLM 2-INCH SIDE PLATES AT STA Z_{AR} = 461 MIDWAY BETWEEN F/S AND R/S DURING TEST RUDDER CURE

During a cure cycle, the pressure from the internal rubber mandrels would deflect the PLM side plates and produce strains. These side plate strains were compared with the results from beam theory calculations and an estimate of the rubber pressure was obtained. The relationship between the PLM side plate strains and internal rubber pressure (namely, that plate strain of $716 \mu\text{m/m}$ represents 2.07-MPa (300-psi) rubber pressure) are given in Appendix E. The results of this survey, through the curing of 11 rudder boxes, are shown in Figure E-1.

Another goal of this cure was to provide a minimum of 0.69-MPa (100-psi) rubber pressure when the resin gelled. The 0.69-MPa (100-psi) rubber pressure corresponds to $716/2.07 \times 0.69 = 239 \mu\text{mm/mm}$ of strain (Page E-2), which occurred at about 1.05 hours after the oven was started. However, the information of Figure H-4 indicates that the gel temperature of 430°K was achieved at the heat-up rate of $0.73^{\circ}\text{K/minute}$ or $(430 - 297) \times 1/0.73 \times 1/60 = 3.03$ hours after the oven was started. This indicates that the gel point was reached when the rubber pressure was $2.07/716 \times 720 = 2.08 \text{ MPa}$ (Figures E-1 and E-2).

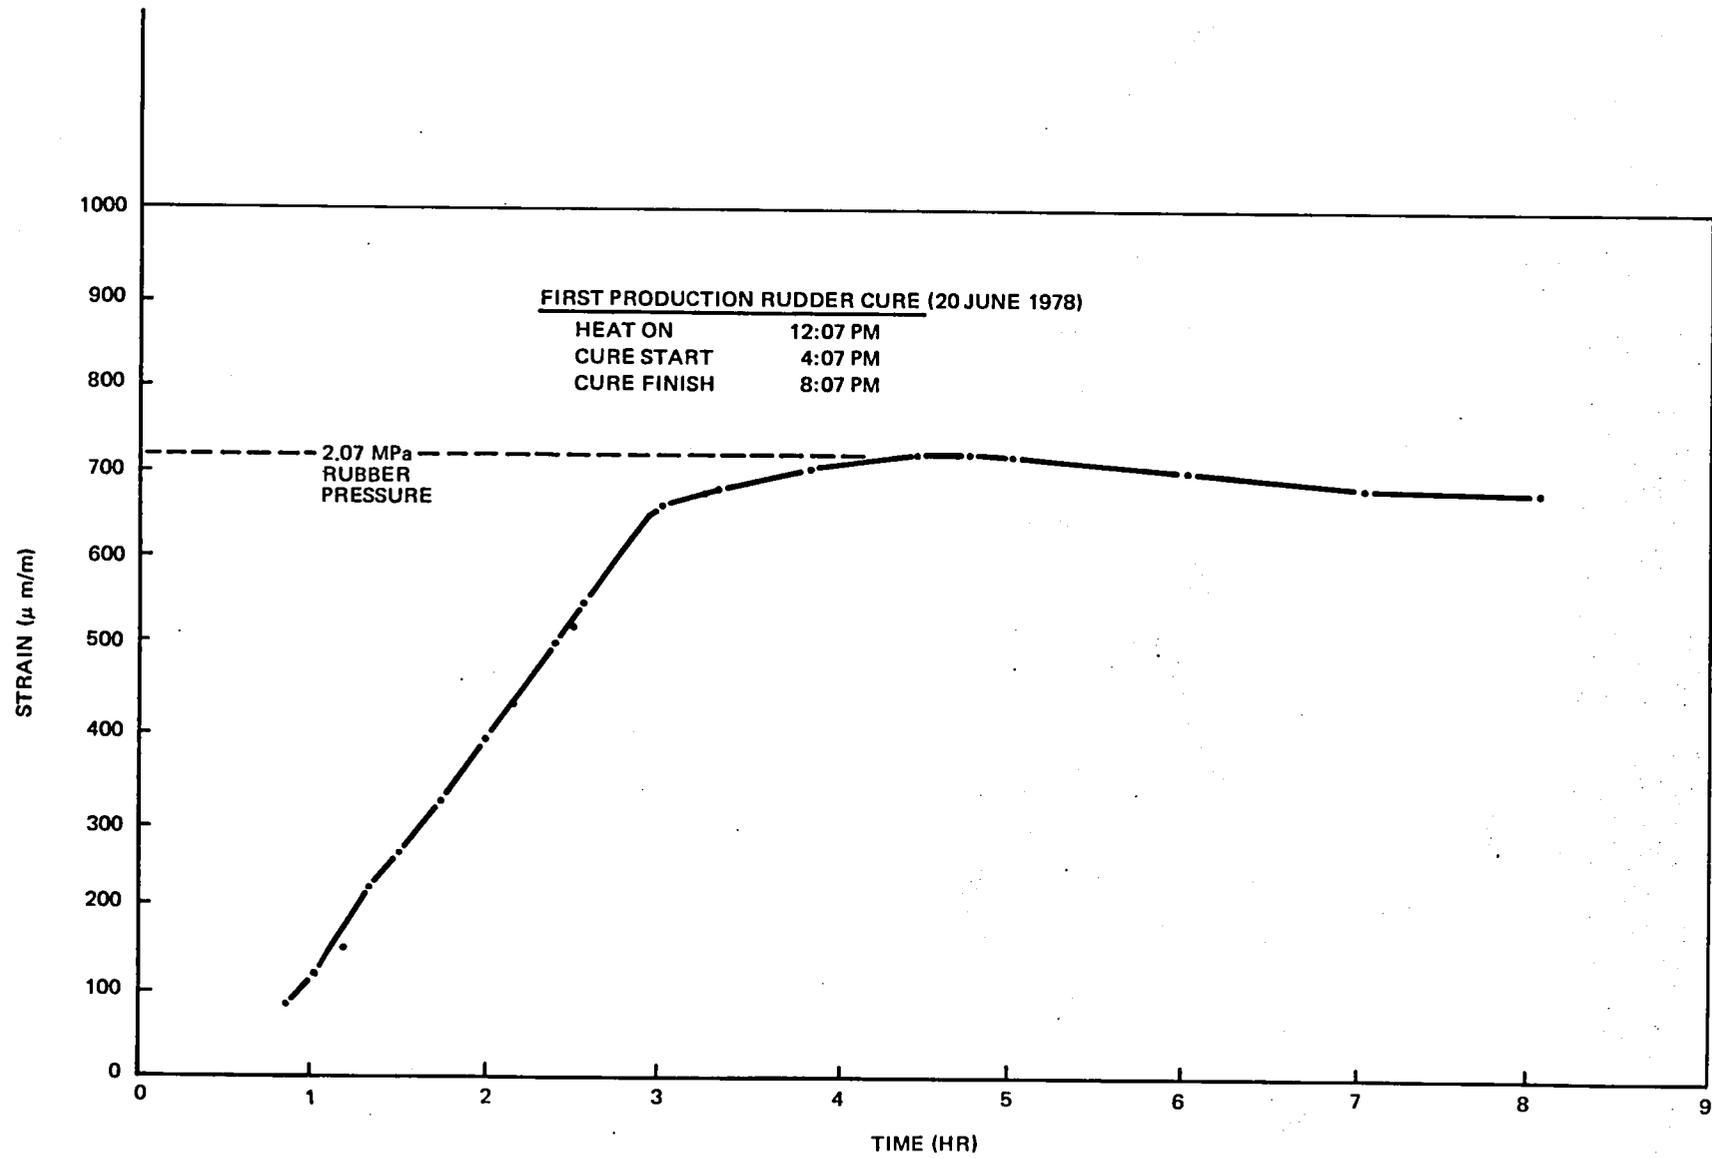
FIGURE E-2. STRAIN READINGS OF PLM 2-INCH SIDE PLATES AT STA $Z_{AR} = 461$ MIDWAY BETWEEN F/S AND R/S DURING FIRST PRODUCTION RUDDER CURE

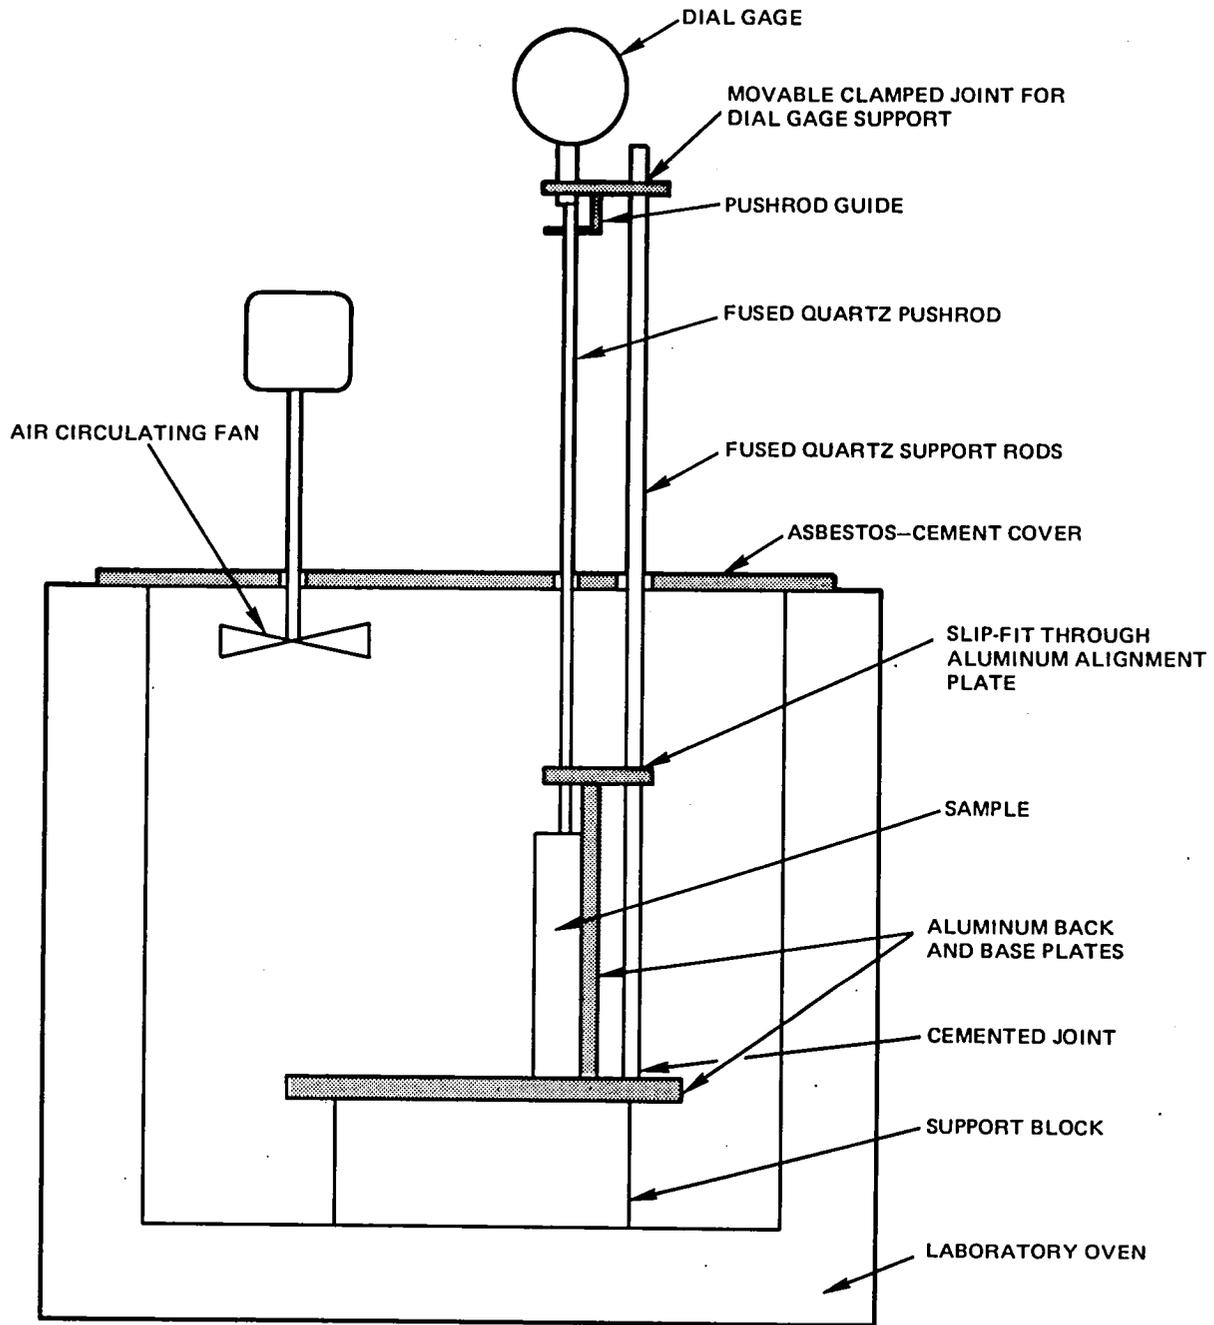
FIGURE F-1. SKETCH OF MODIFIED FUSED SILICA (QUARTZ) DILATOMETER

Some of this apparatus was specially constructed for this set of measurements. It was therefore necessary to test the proper functioning of the instrument by measurement of thermal expansion of a sample of known material. This was done using a 7.62-cm sample of 1020 steel bar stock. The data obtained with this sample agree with the literature value within 1 percent.

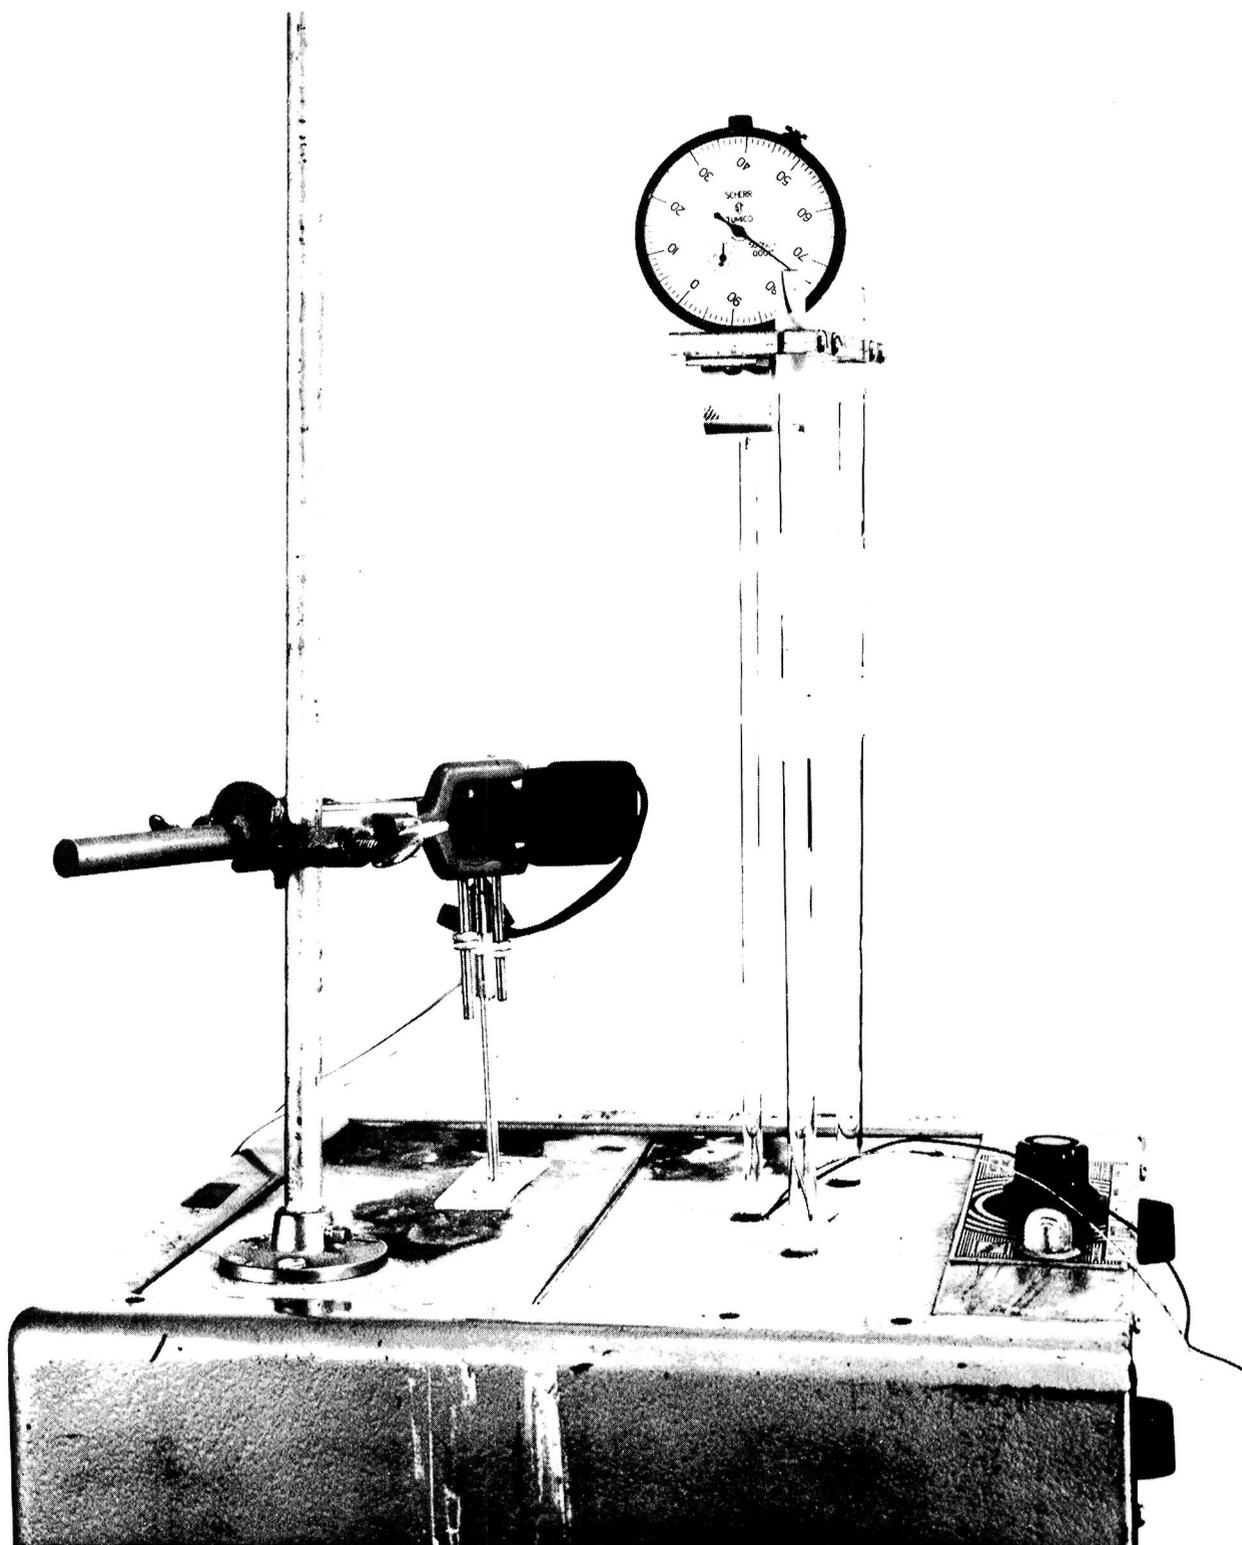
FIGURE F-2. PHOTOGRAPH OF THE MODIFIED DILATOMETER

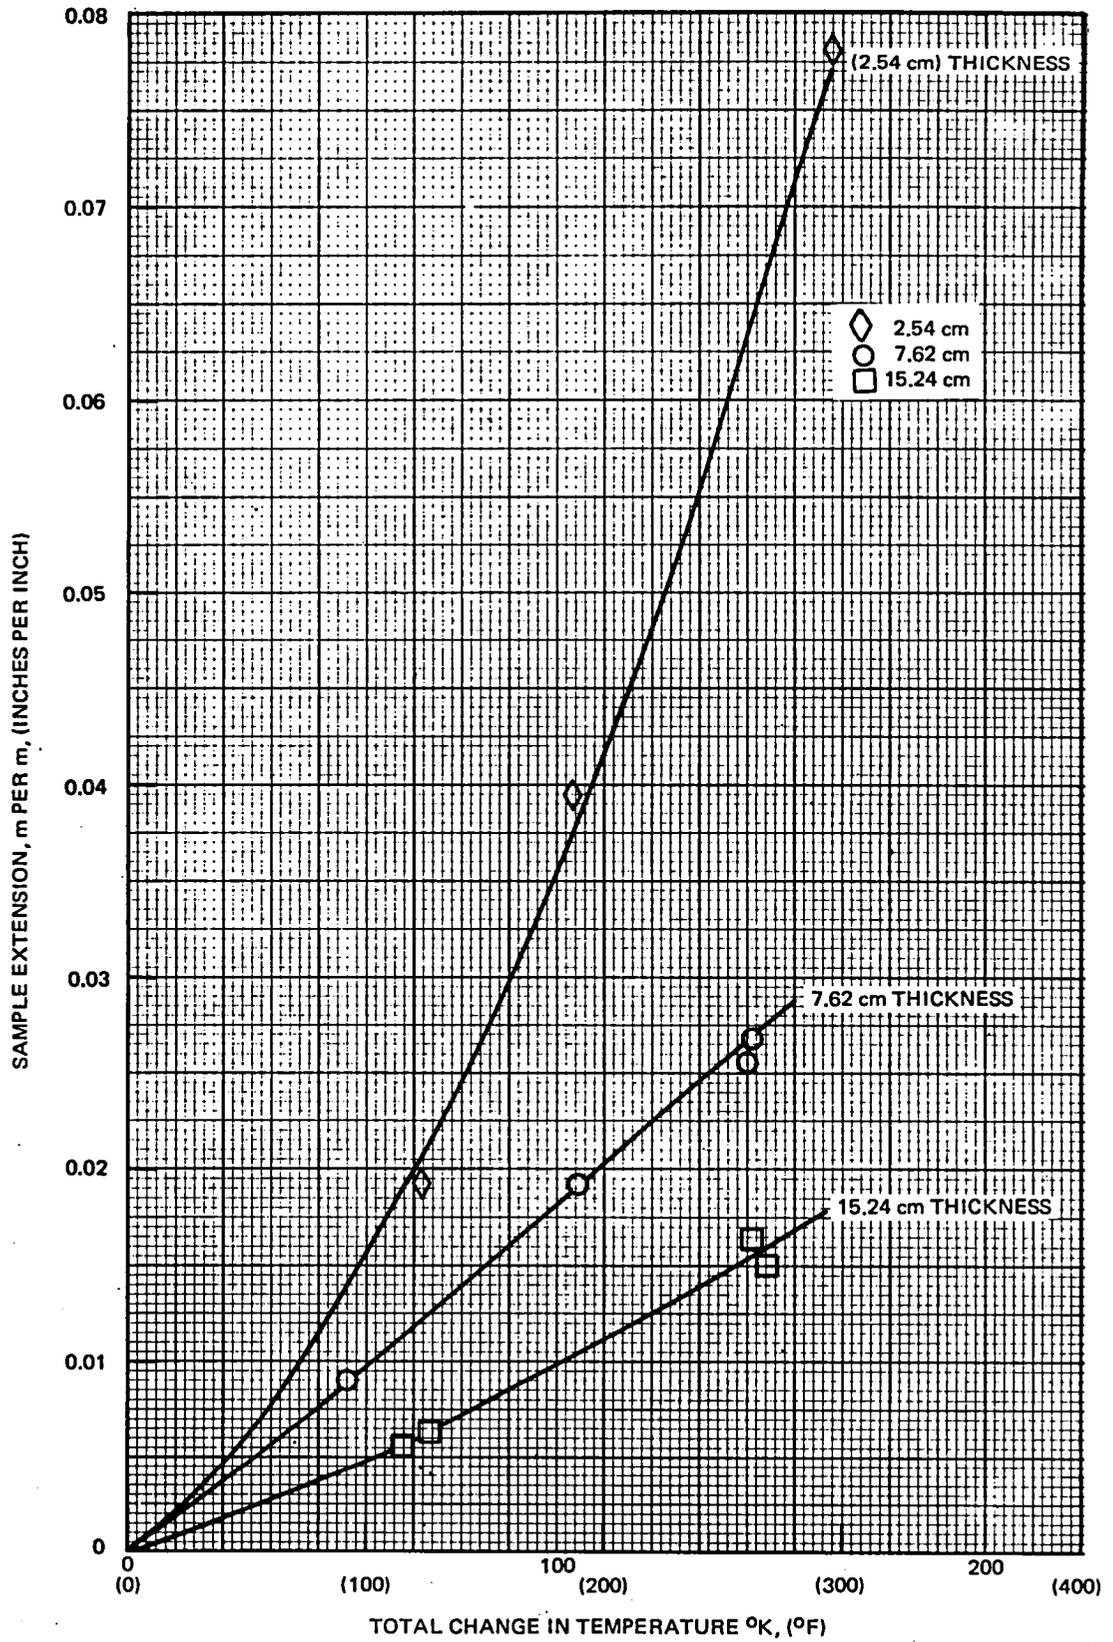
FIGURE F-3. SAMPLE NO. 1, 38-3 WITH EXPANDED METAL, 5 PERCENT THINNER

The behavior of the samples containing steel mesh may be attributed to internal stresses. These stresses can affect the sample in at least three ways. If the slab is without internal stress at room temperature, then heating

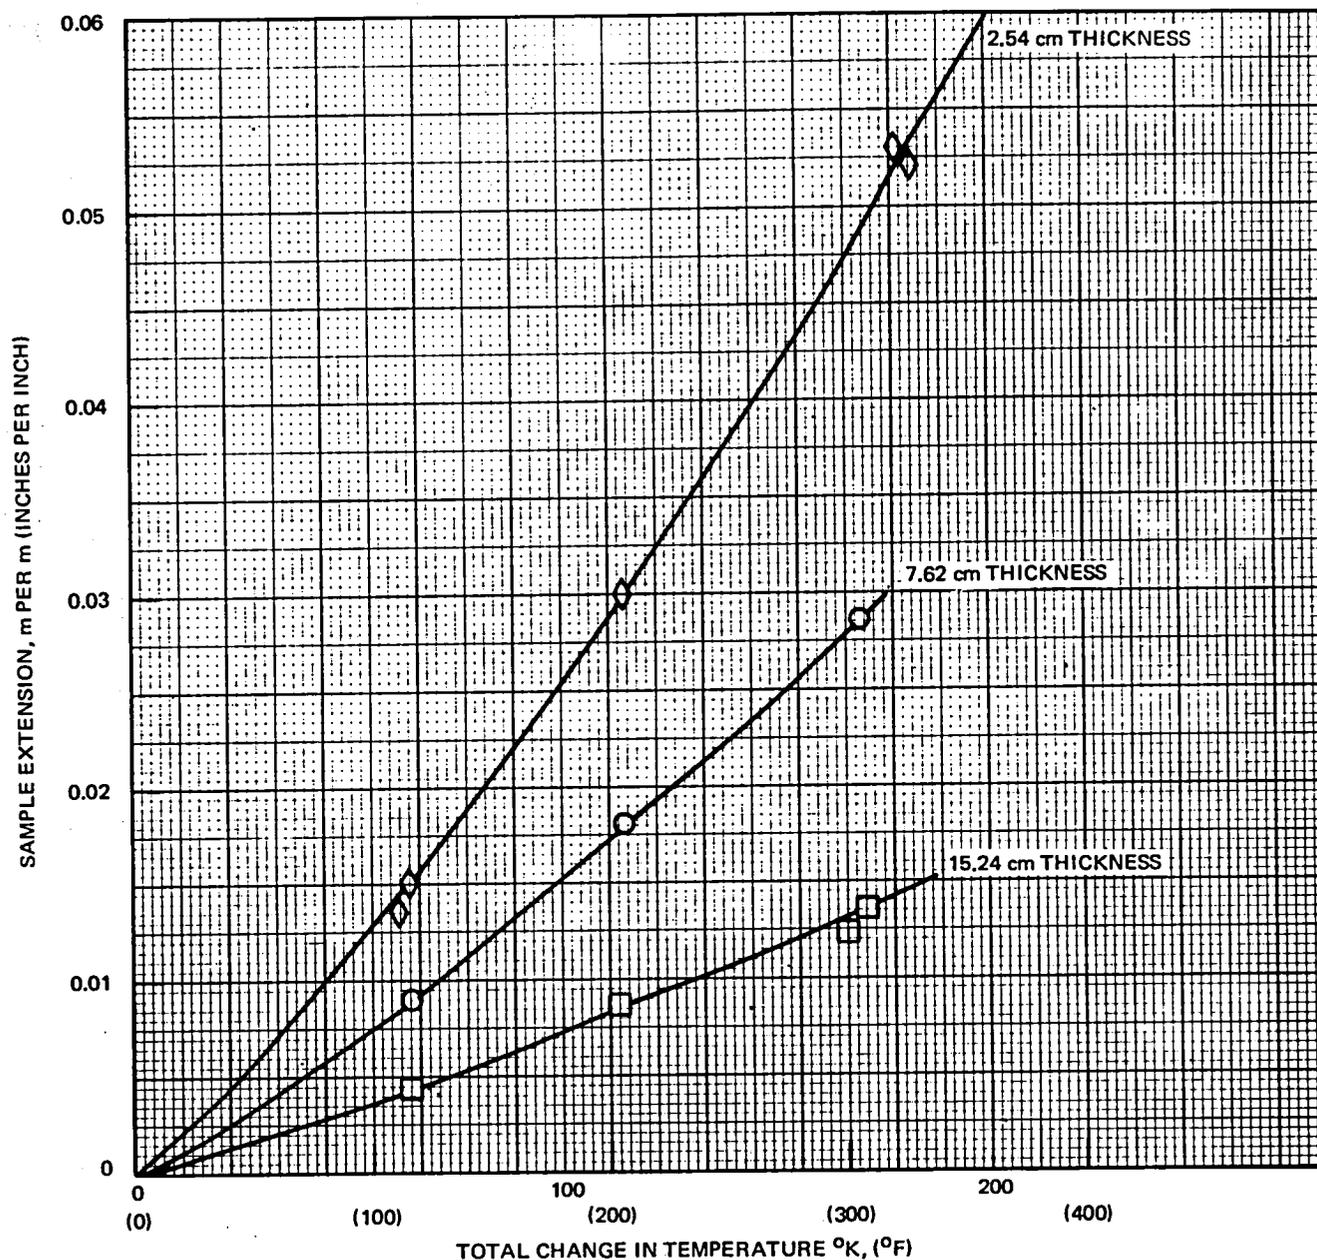
FIGURE F-5. SAMPLE NO. 3, 38-3 WITH EXPANDED METAL, 5 PERCENT THINNER

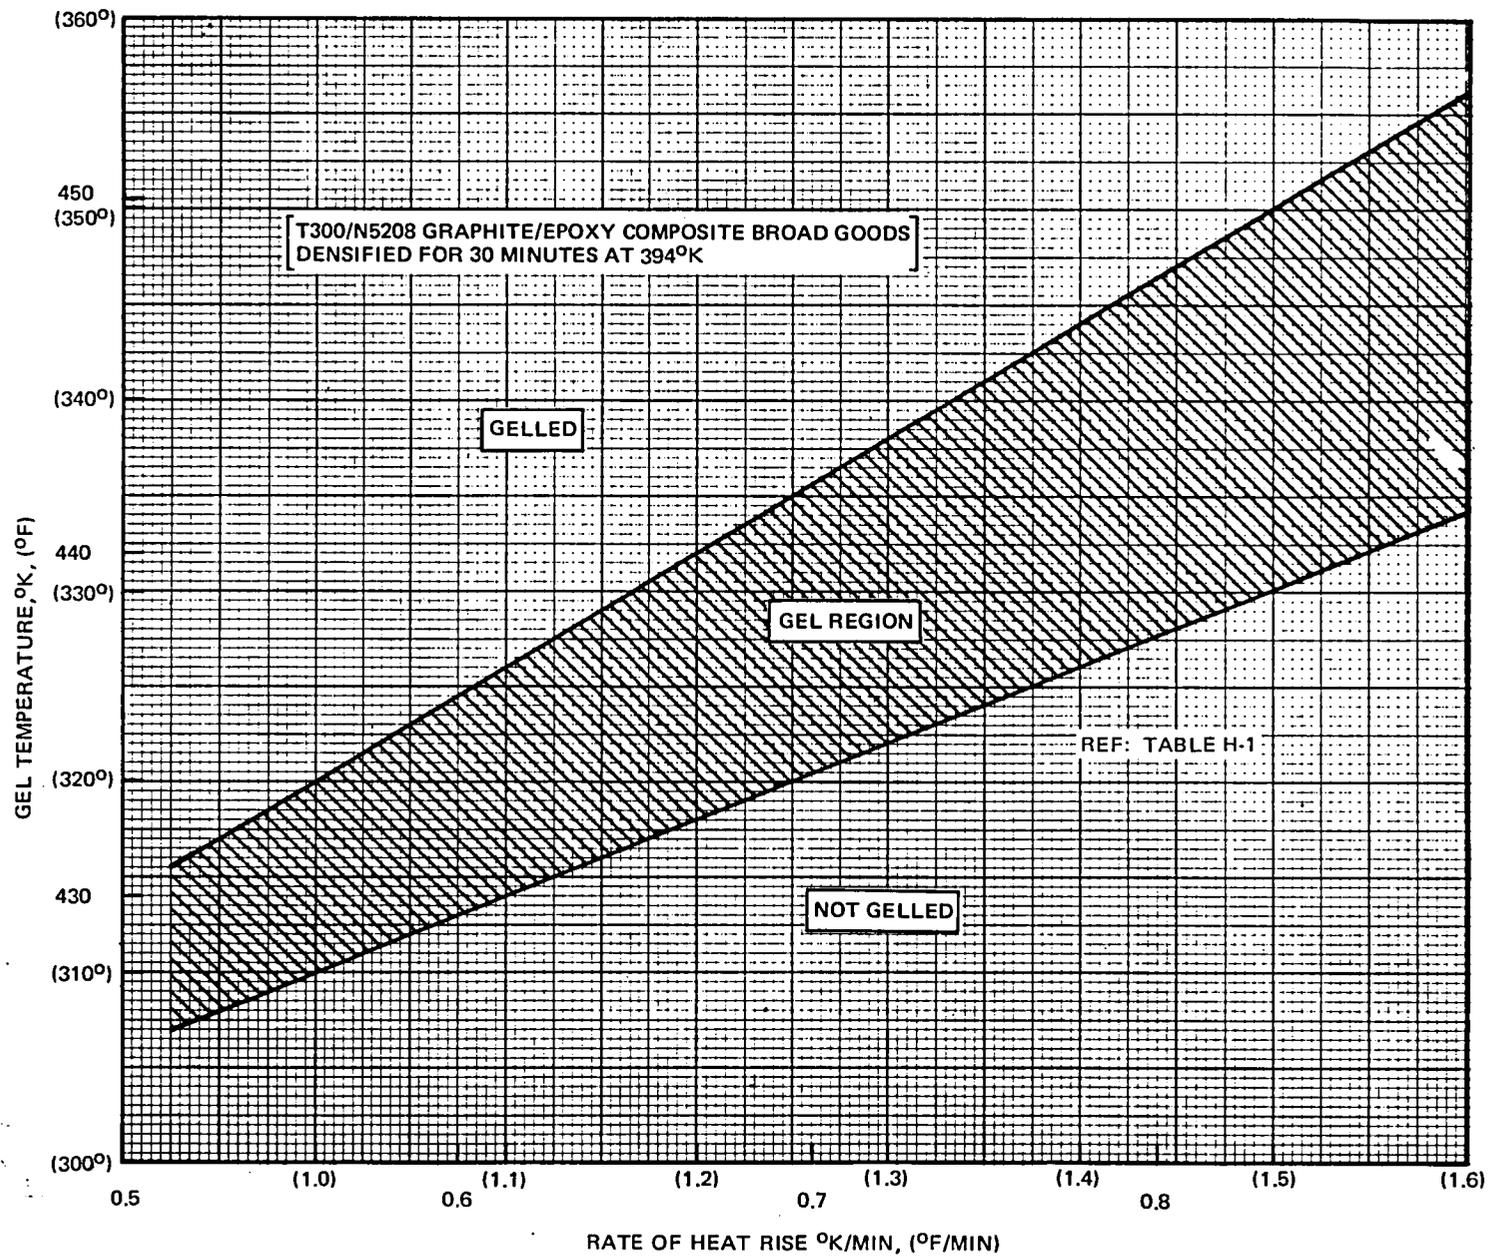
The results of the gel temperature tests are given in Table H-1 for heat rise rates of 0.556⁰K per minute 0.833⁰K per minute. The results for material previously densified for 30 minutes at 394⁰K under vacuum pressure are also shown in Figure H-1.

FIGURE H-1. RESULTS OF RESIN GEL TESTS

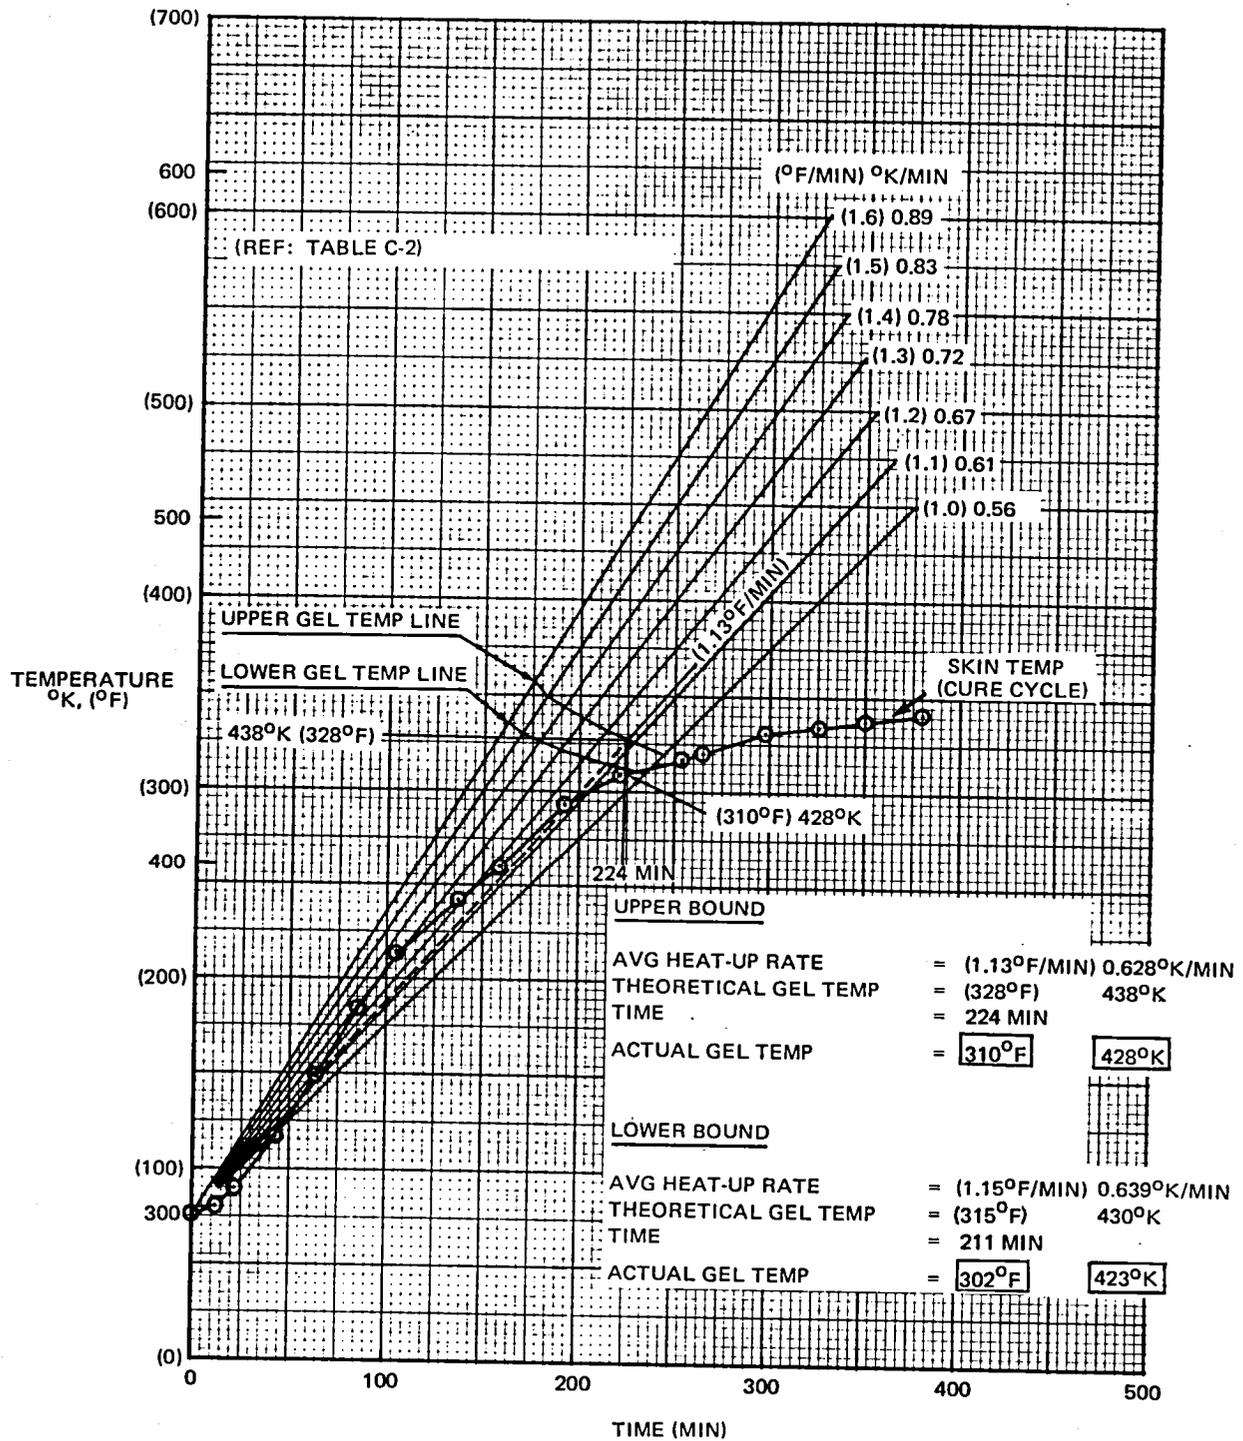
FIGURE H-2. GEL TEMPERATURE ESTIMATE AT SKIN THERMOCOUPLE NO. R65 ($Z_{AR} = 416.25$)

The gel temperature estimates at three rudder stations are shown in Figures H-2 through H-7 and the method of estimating is described in Task 11 of Section 6. The summary of rudder cure cycle gel temperatures is given in Table H-2 and the rudder cure cycle design pressure versus temperature design criteria is given in Table H-3.
