Manufacturing Development of DC-10 Advanced Rudder

by A. Cominsky, et al.

MCDONNELL DOUGLAS CORPORATION
DOUGLAS AIRCRAFT COMPANY
LONG BEACH, CALIFORNIA 90846

16. Abstract This is the final technical report covering design, manufacture and ground test activities during development of production methods for an advanced composite rudder for the DC-10 transport aircraft.

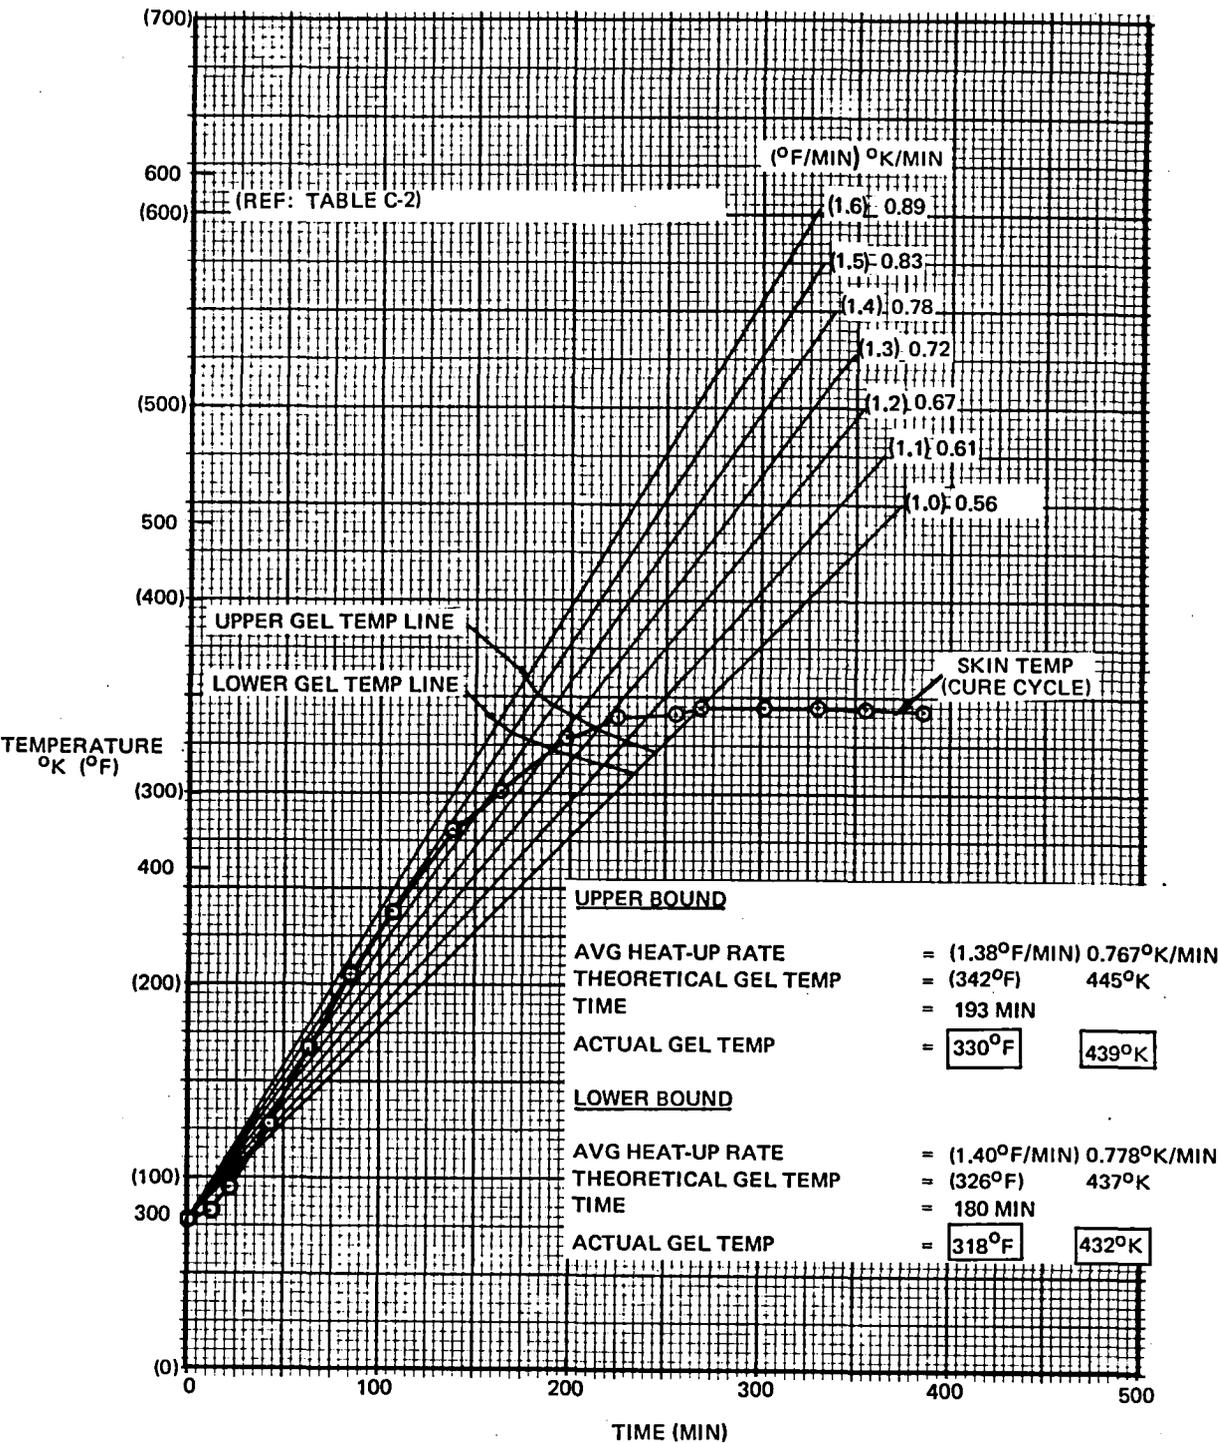
FIGURE H-3. GEL TEMPERATURE ESTIMATE AT SKIN THERMOCOUPLE NO. L64 ($Z_{AR} = 416.25$)

The gel temperature estimates at three rudder stations are shown in Figures H-2 through H-7 and the method of estimating is described in Task 11 of Section 6. The summary of rudder cure cycle gel temperatures is given in Table H-2 and the rudder cure cycle design pressure versus temperature design criteria is given in Table H-3.

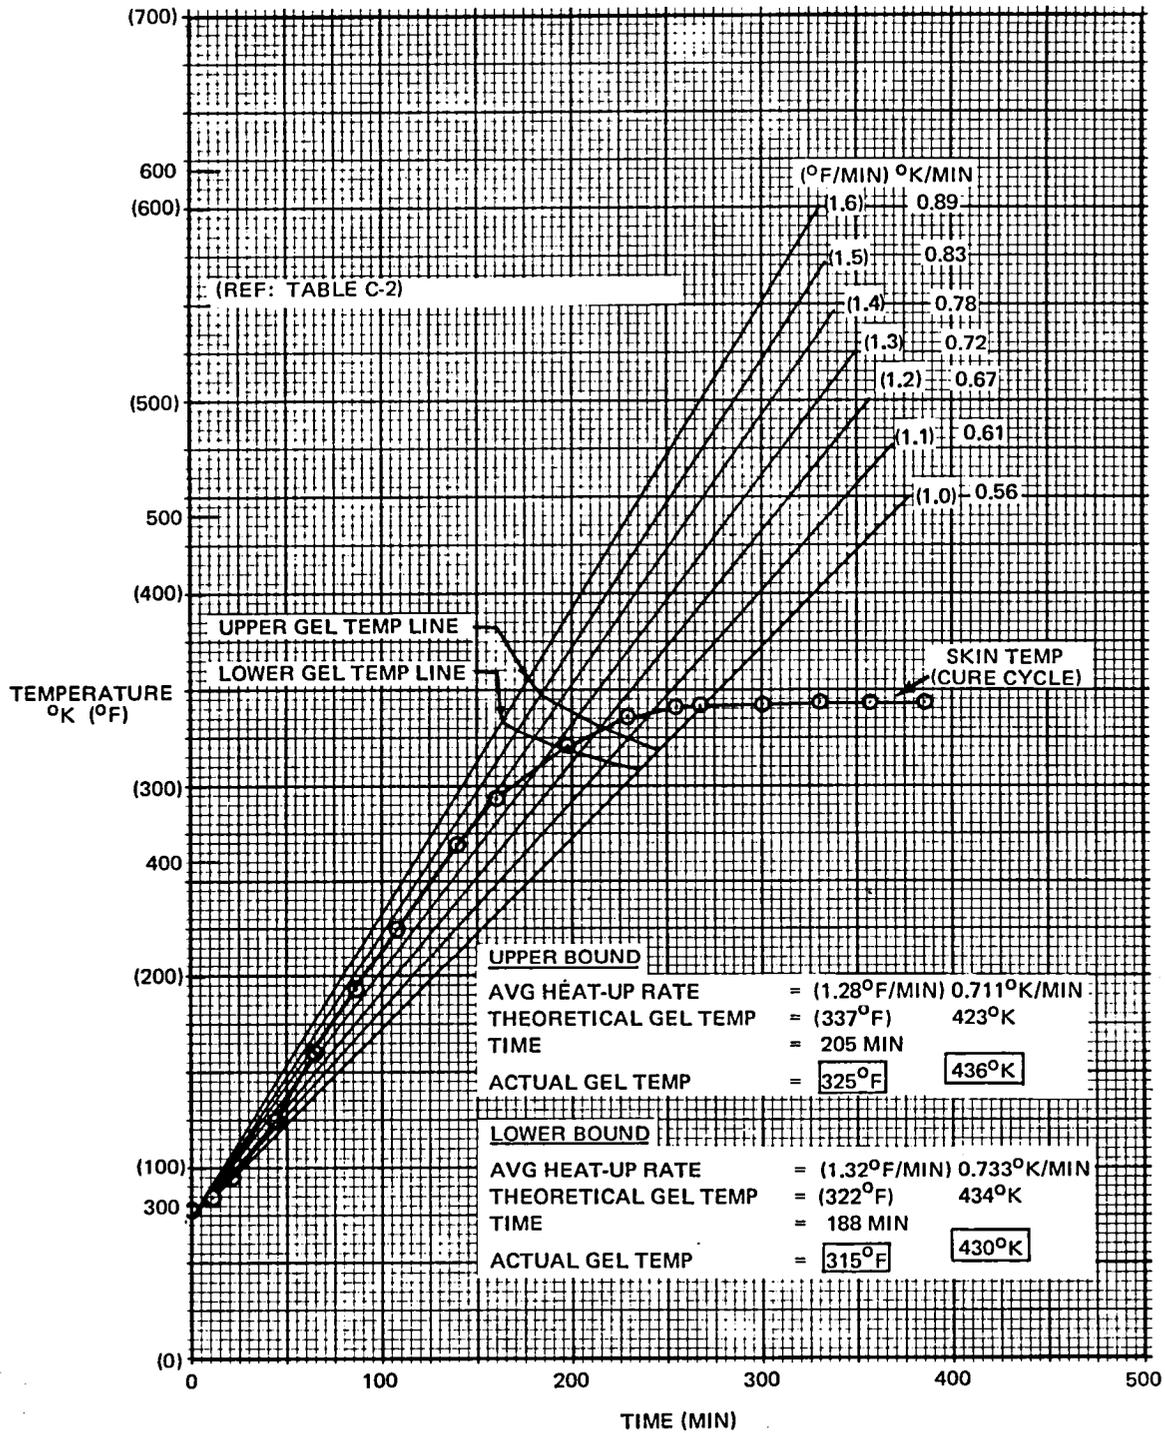
FIGURE H-4. GEL TEMPERATURE ESTIMATE AT SKIN THERMOCOUPLE NO. L78 ($Z_{AR} = 476.94$)

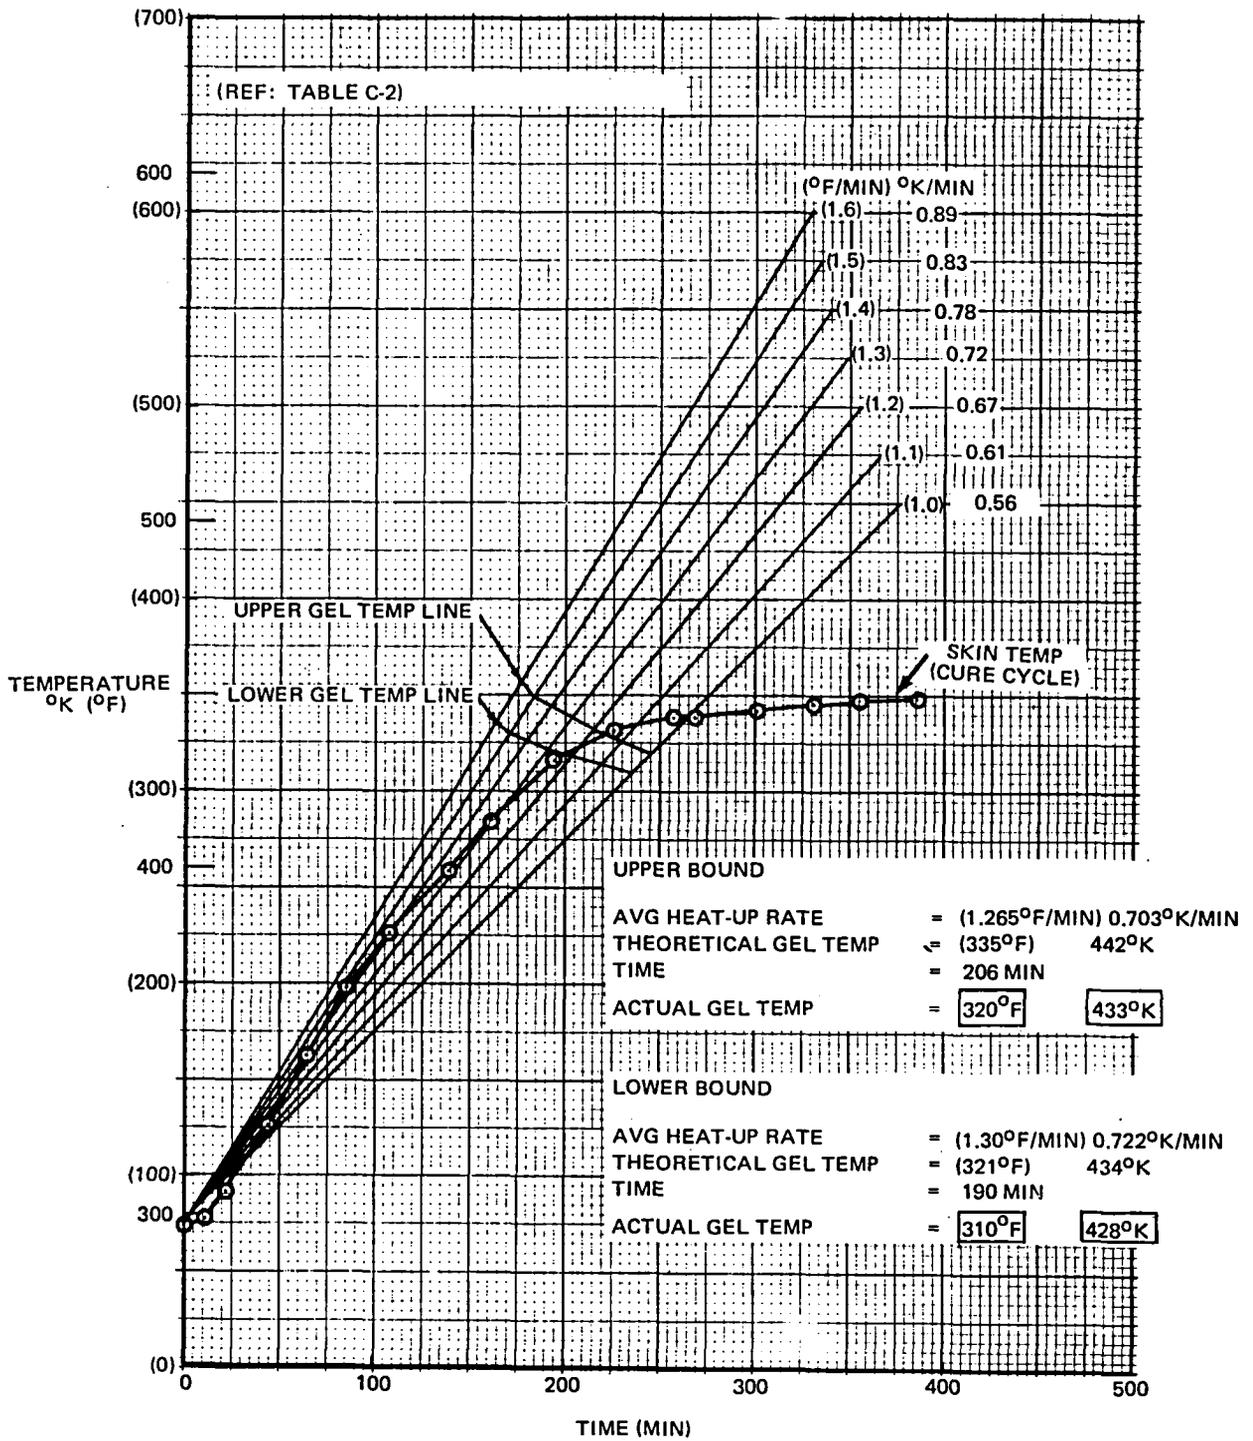
FIGURE H-5. GEL TEMPERATURE ESTIMATE AT SKIN THERMOCOUPLE NO. R80 ($Z_{AR} = 476.94$)

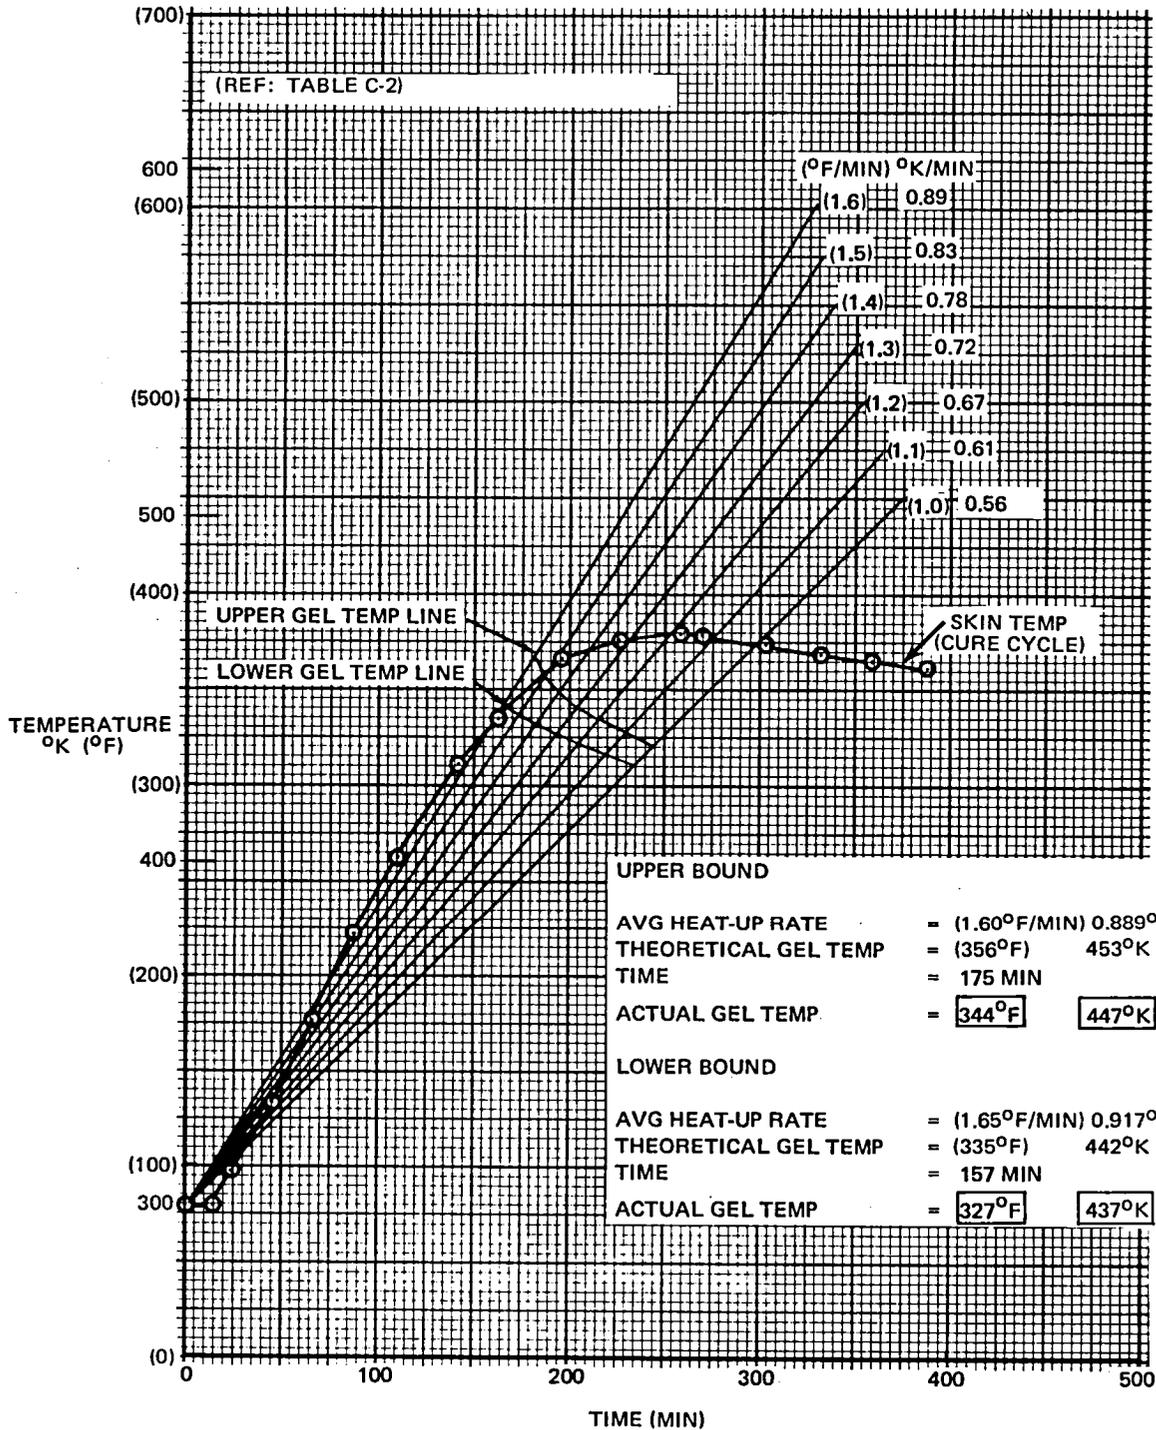
FIGURE H-6. GEL TEMPERATURE ESTIMATE AT SKIN THERMOCOUPLE NO. L96 ($Z_{AR} = 555.47$)

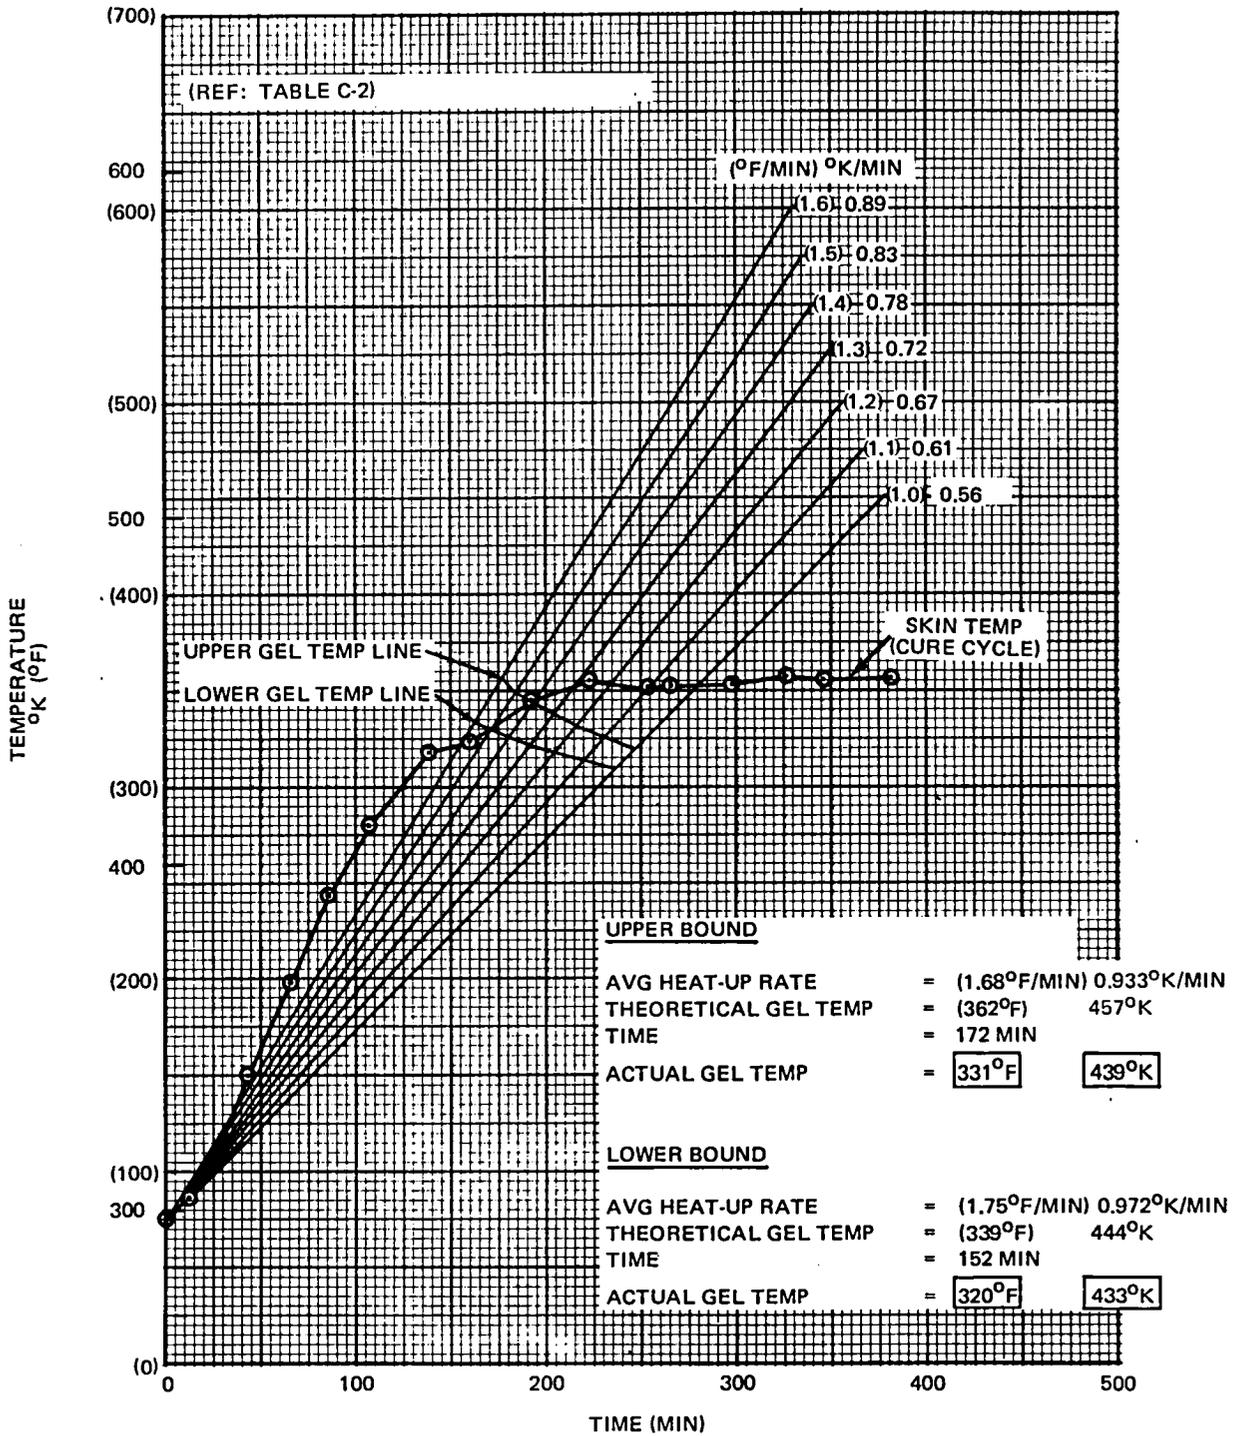
FIGURE H-7. GEL TEMPERATURE ESTIMATE AT SKIN THERMOCOUPLE NO. R97 ($Z_{AR} = 555.47$)

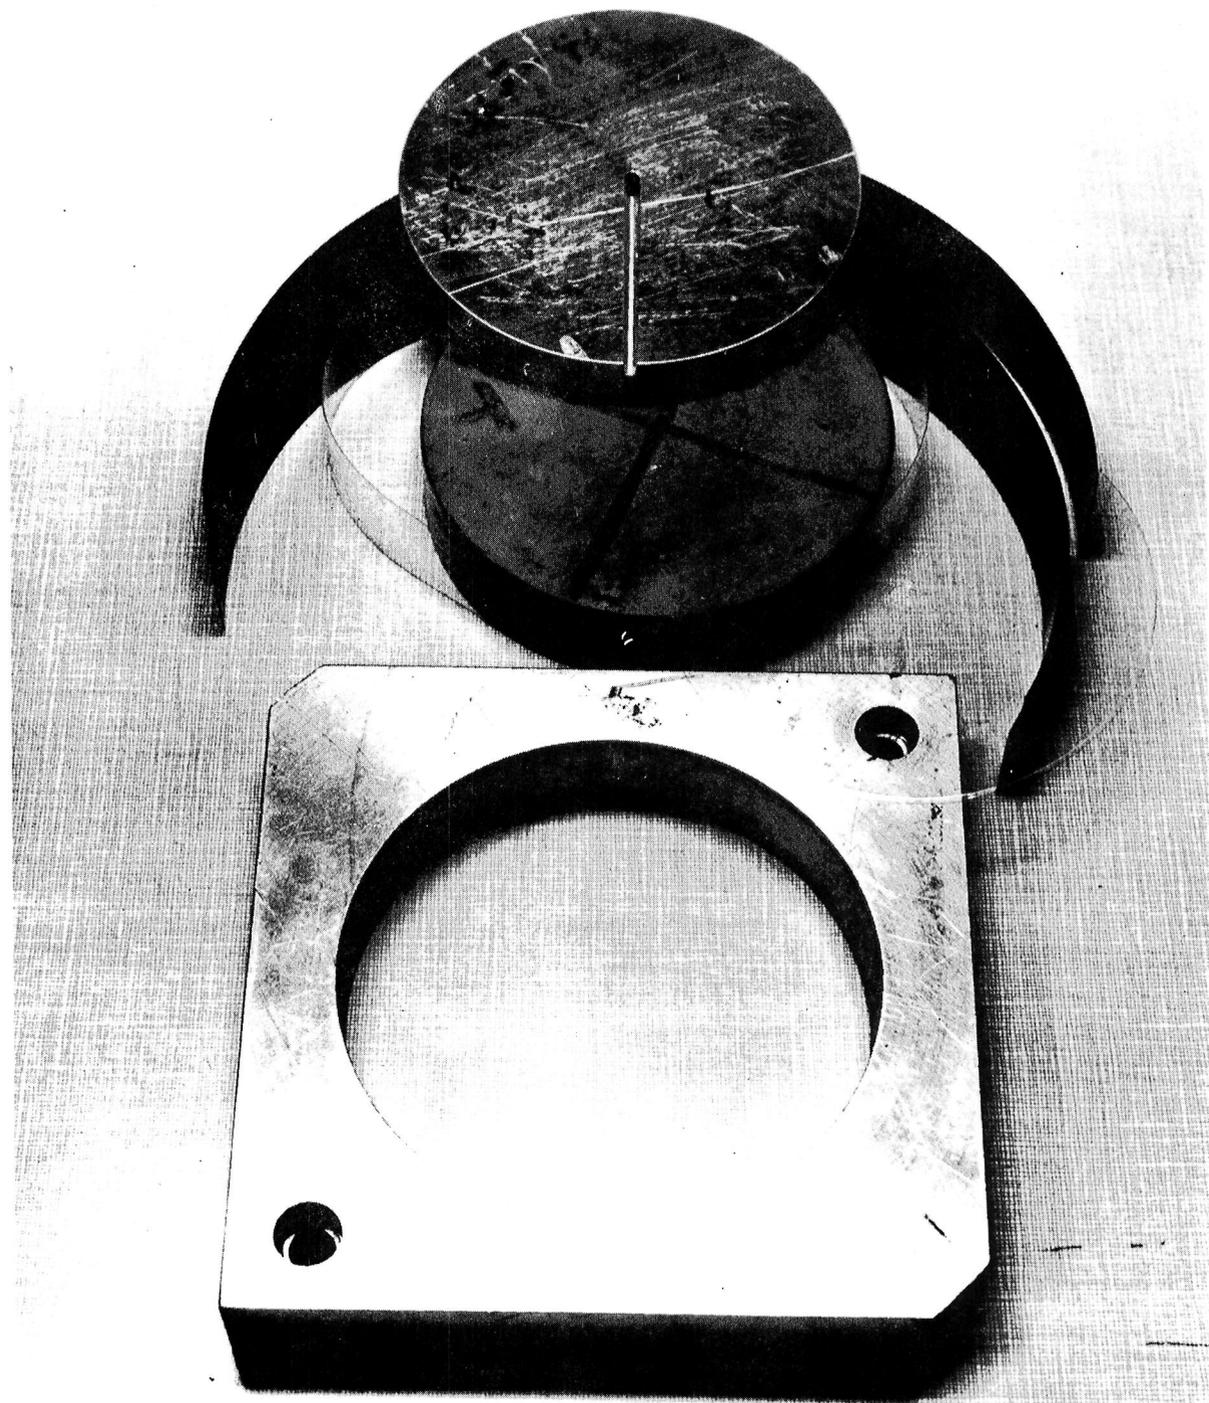
FIGURE J-4. RUBBER, RING, PRESSURE PLATE, AND METAL AND TEFLON SHIMS

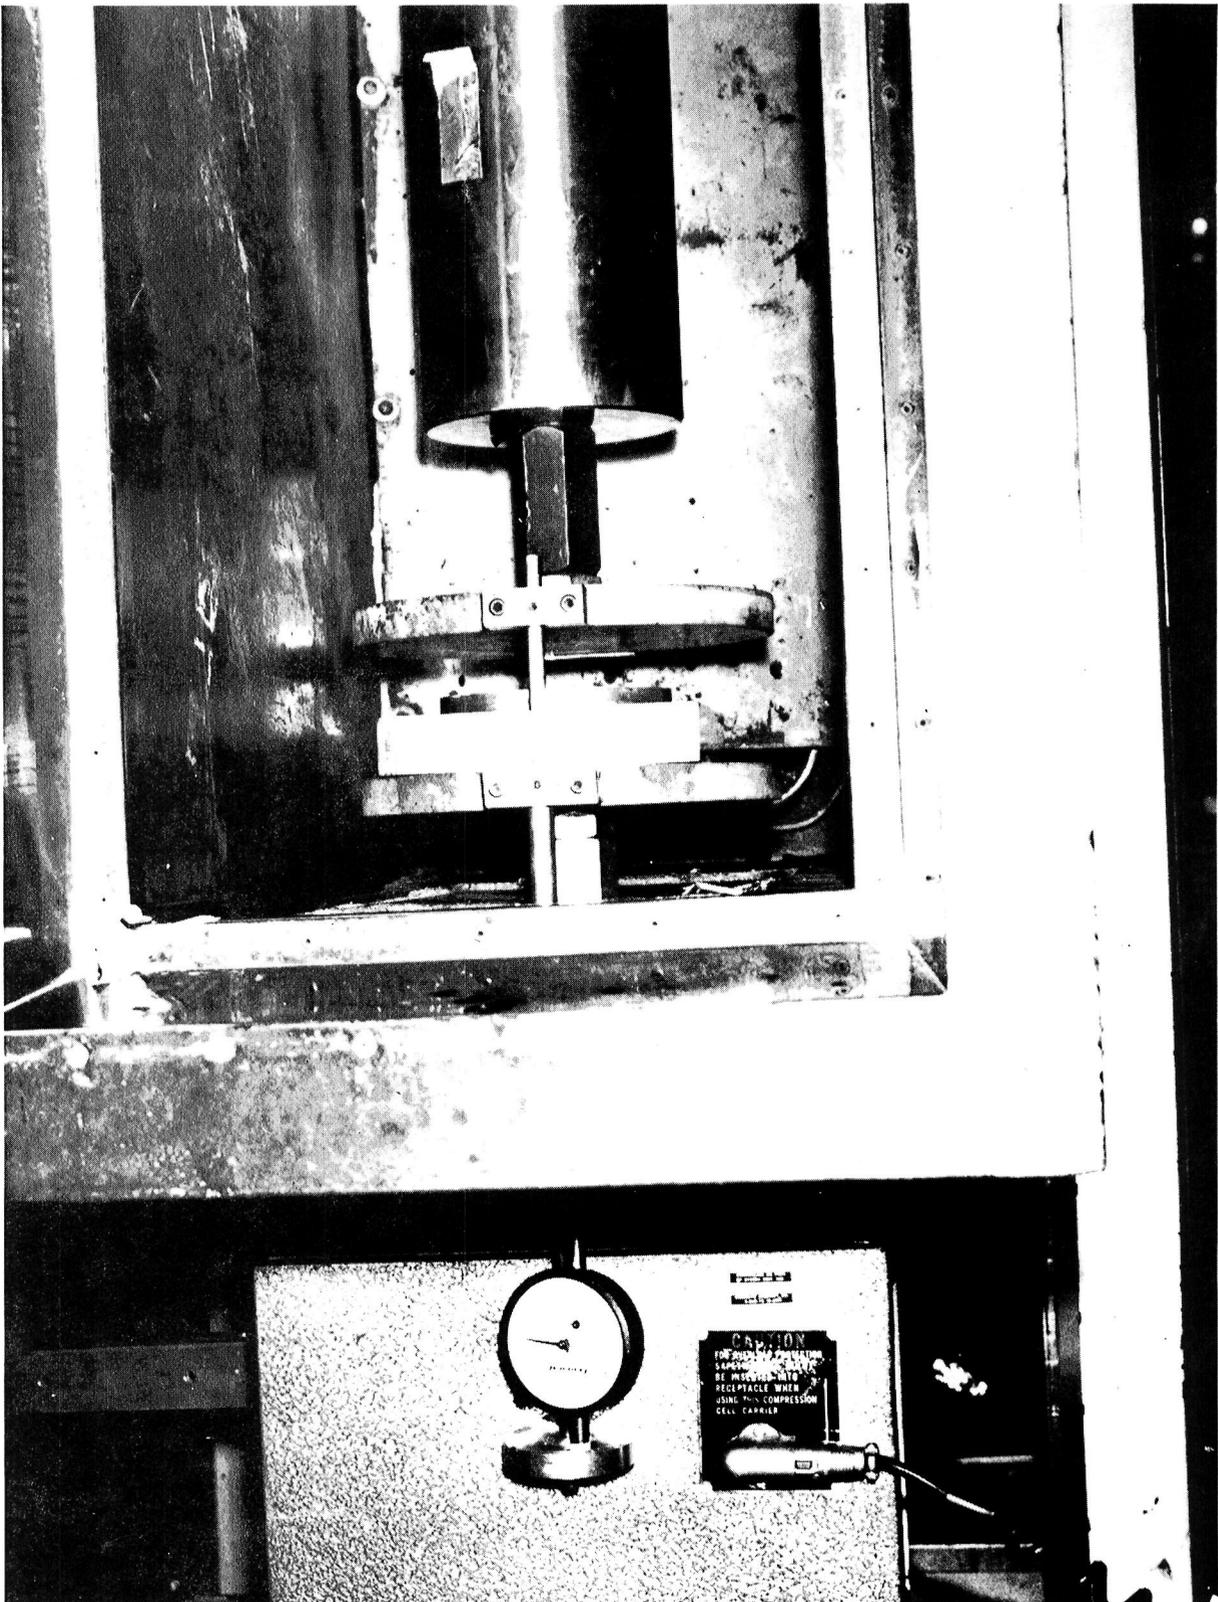
FIGURE J-5. PRESSURE MEASUREMENT SETUP IN OVEN

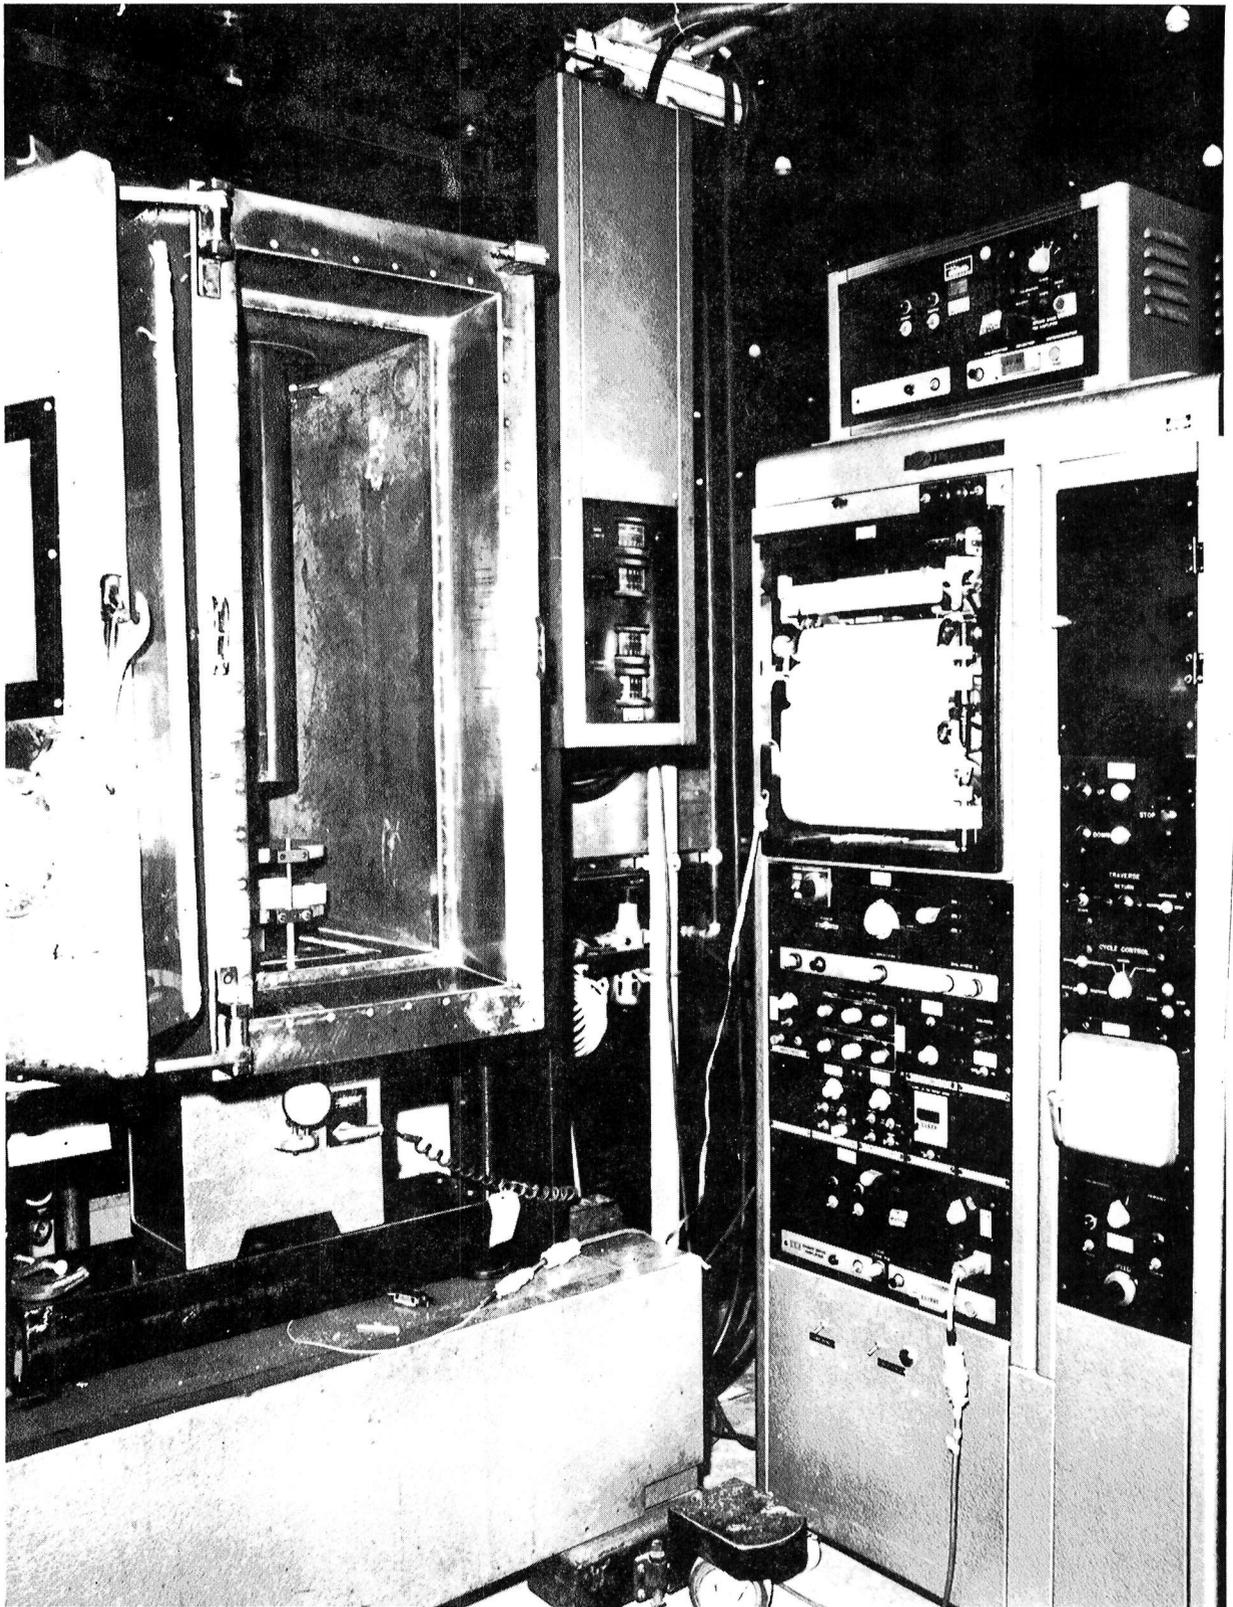
FIGURE J-6. OVEN AND INSTRON RECORDING AND CONTROL BOARD

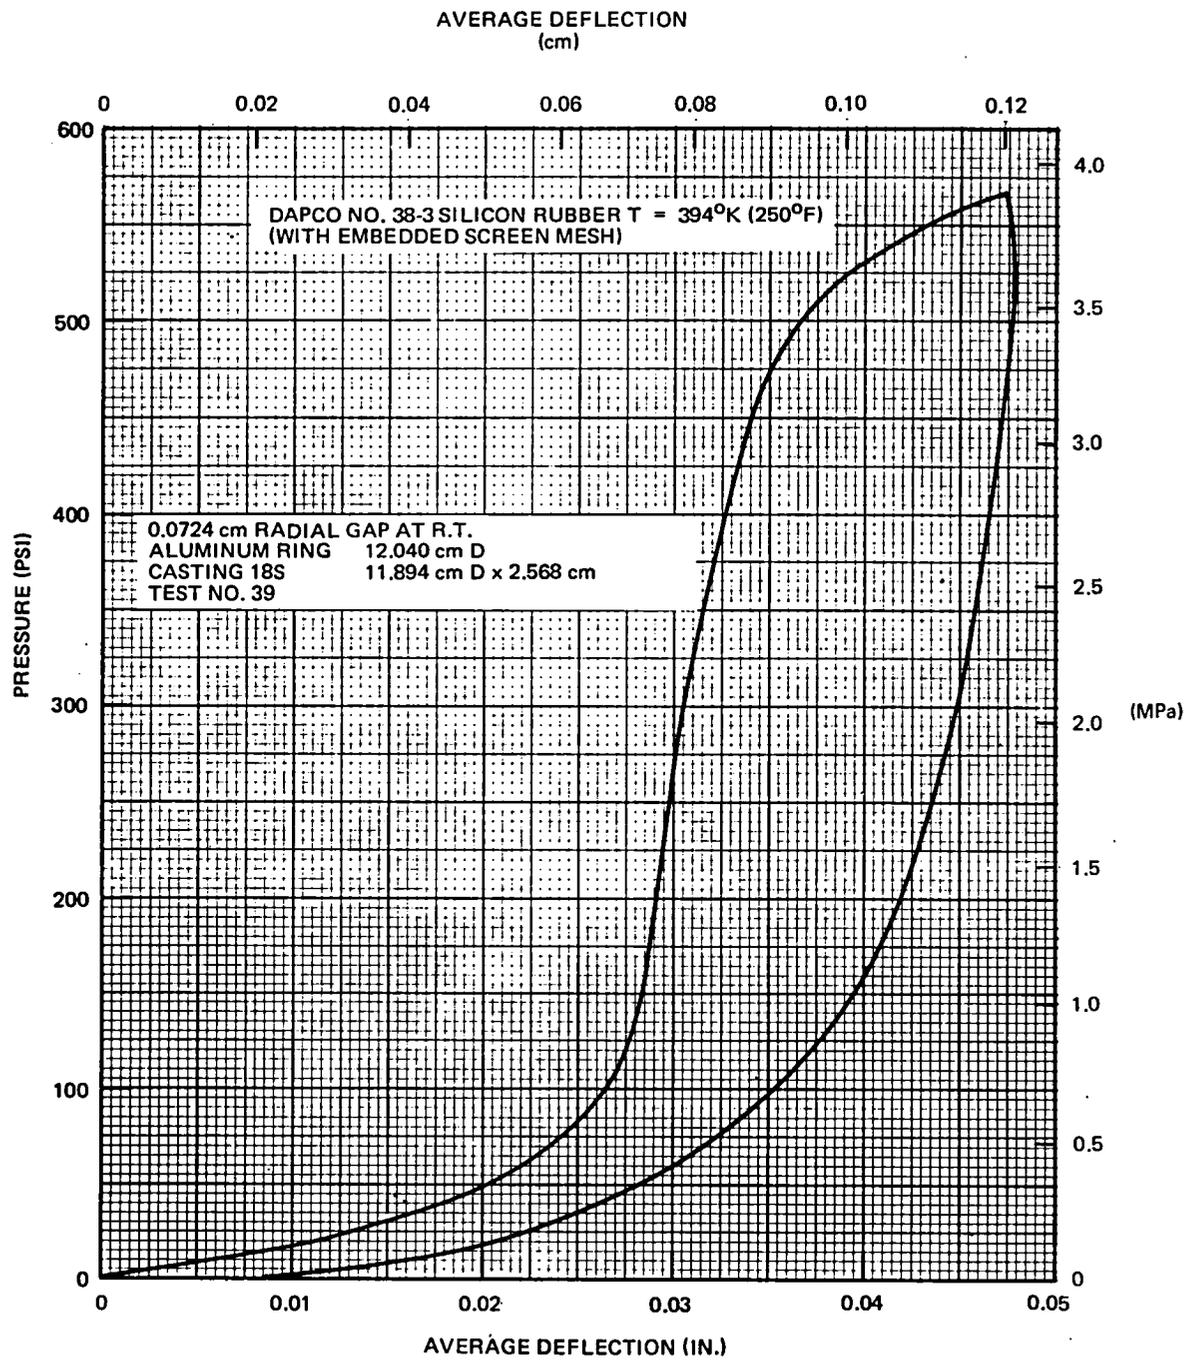
FIGURE J-8. PRESSURE VERSUS DEFLECTION

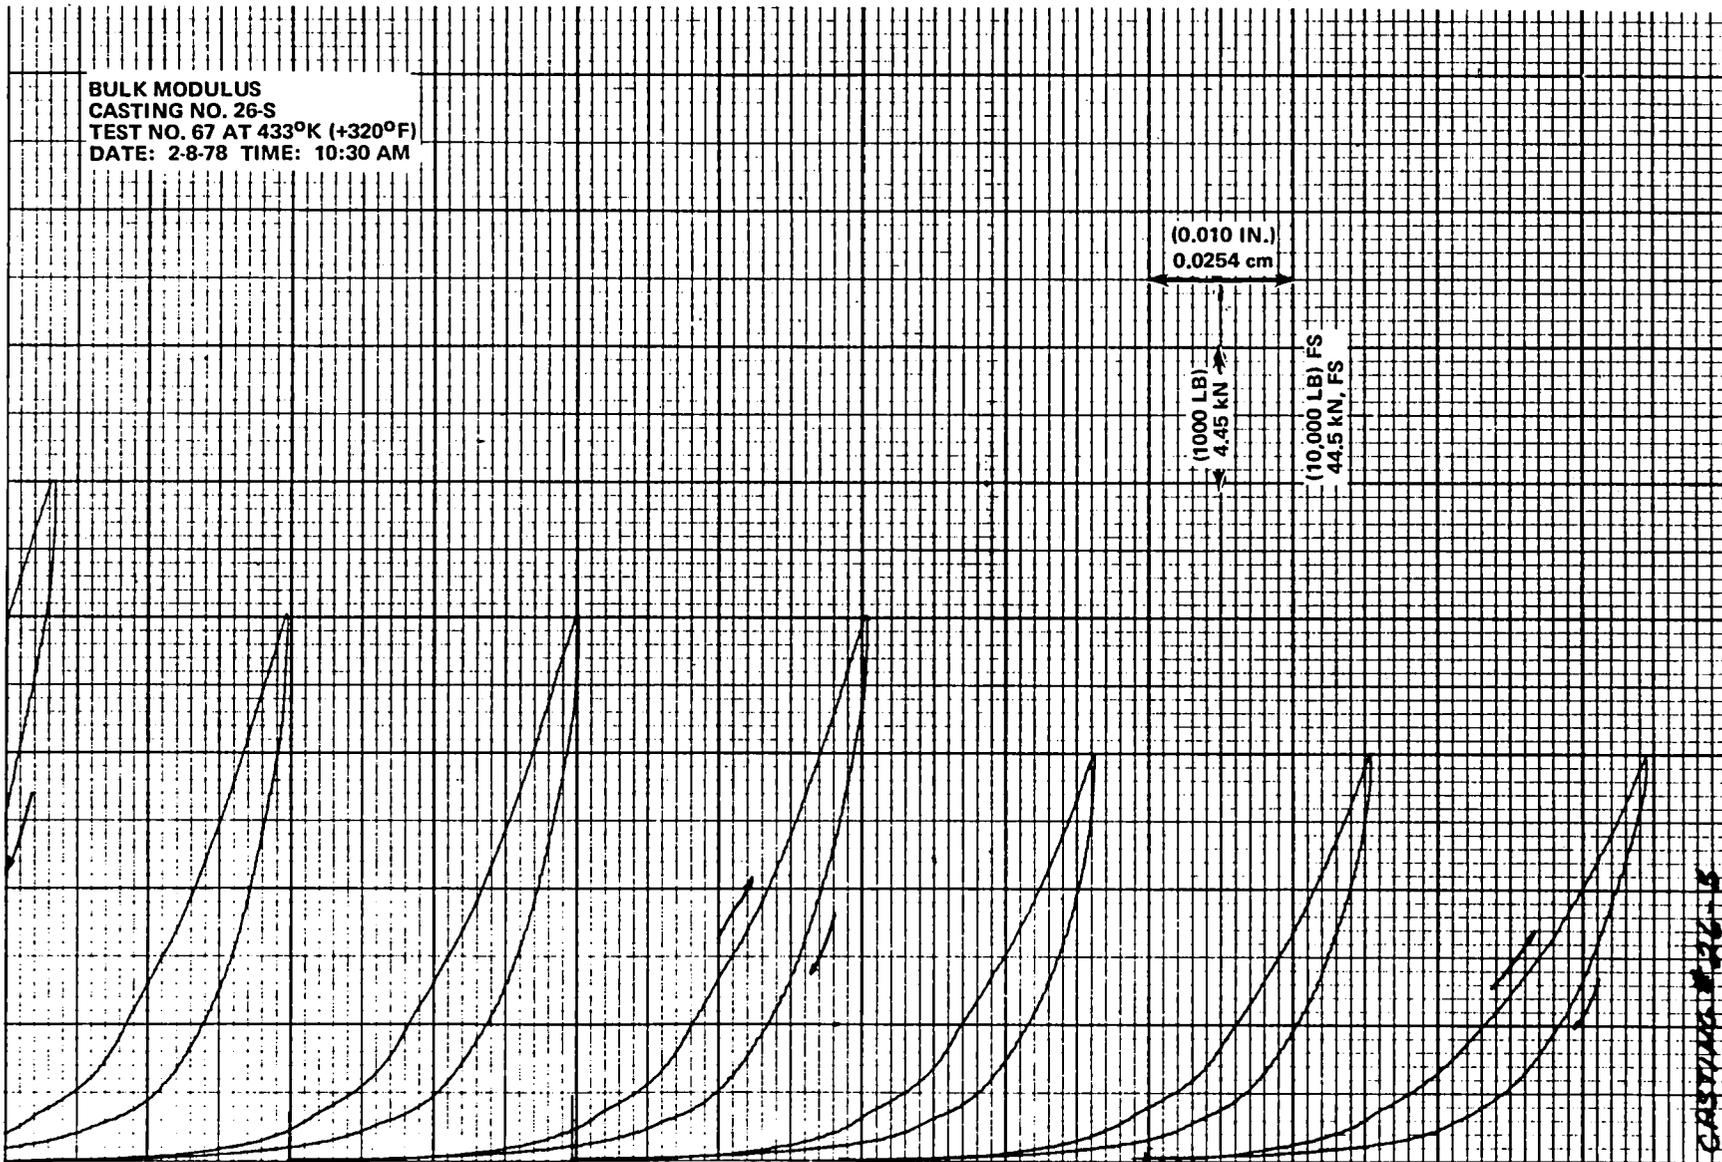
FIGURE J-14. TEST NO. 67 - EXTENSOMETER READING PLOTS, SECTION 1

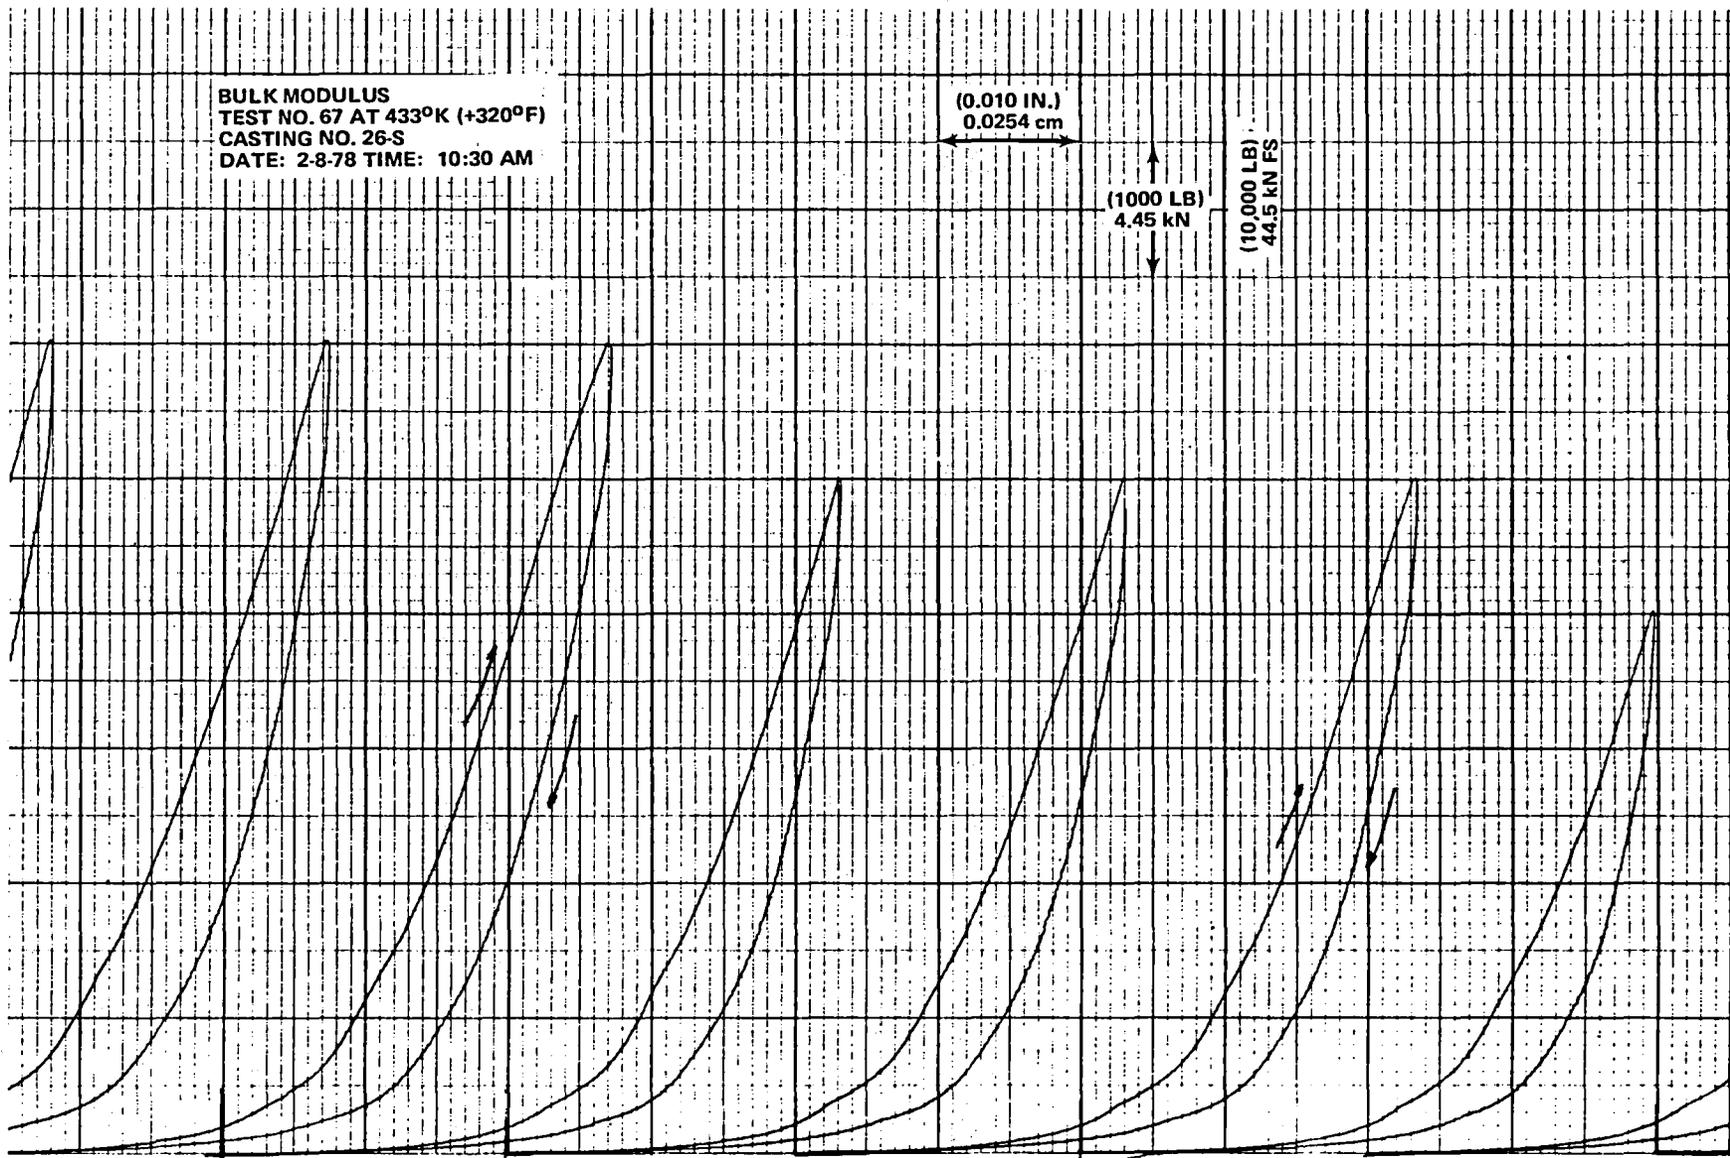
FIGURE J-15. TEST NO. 67 – EXTENSOMETER READING PLOTS, SECTION 2

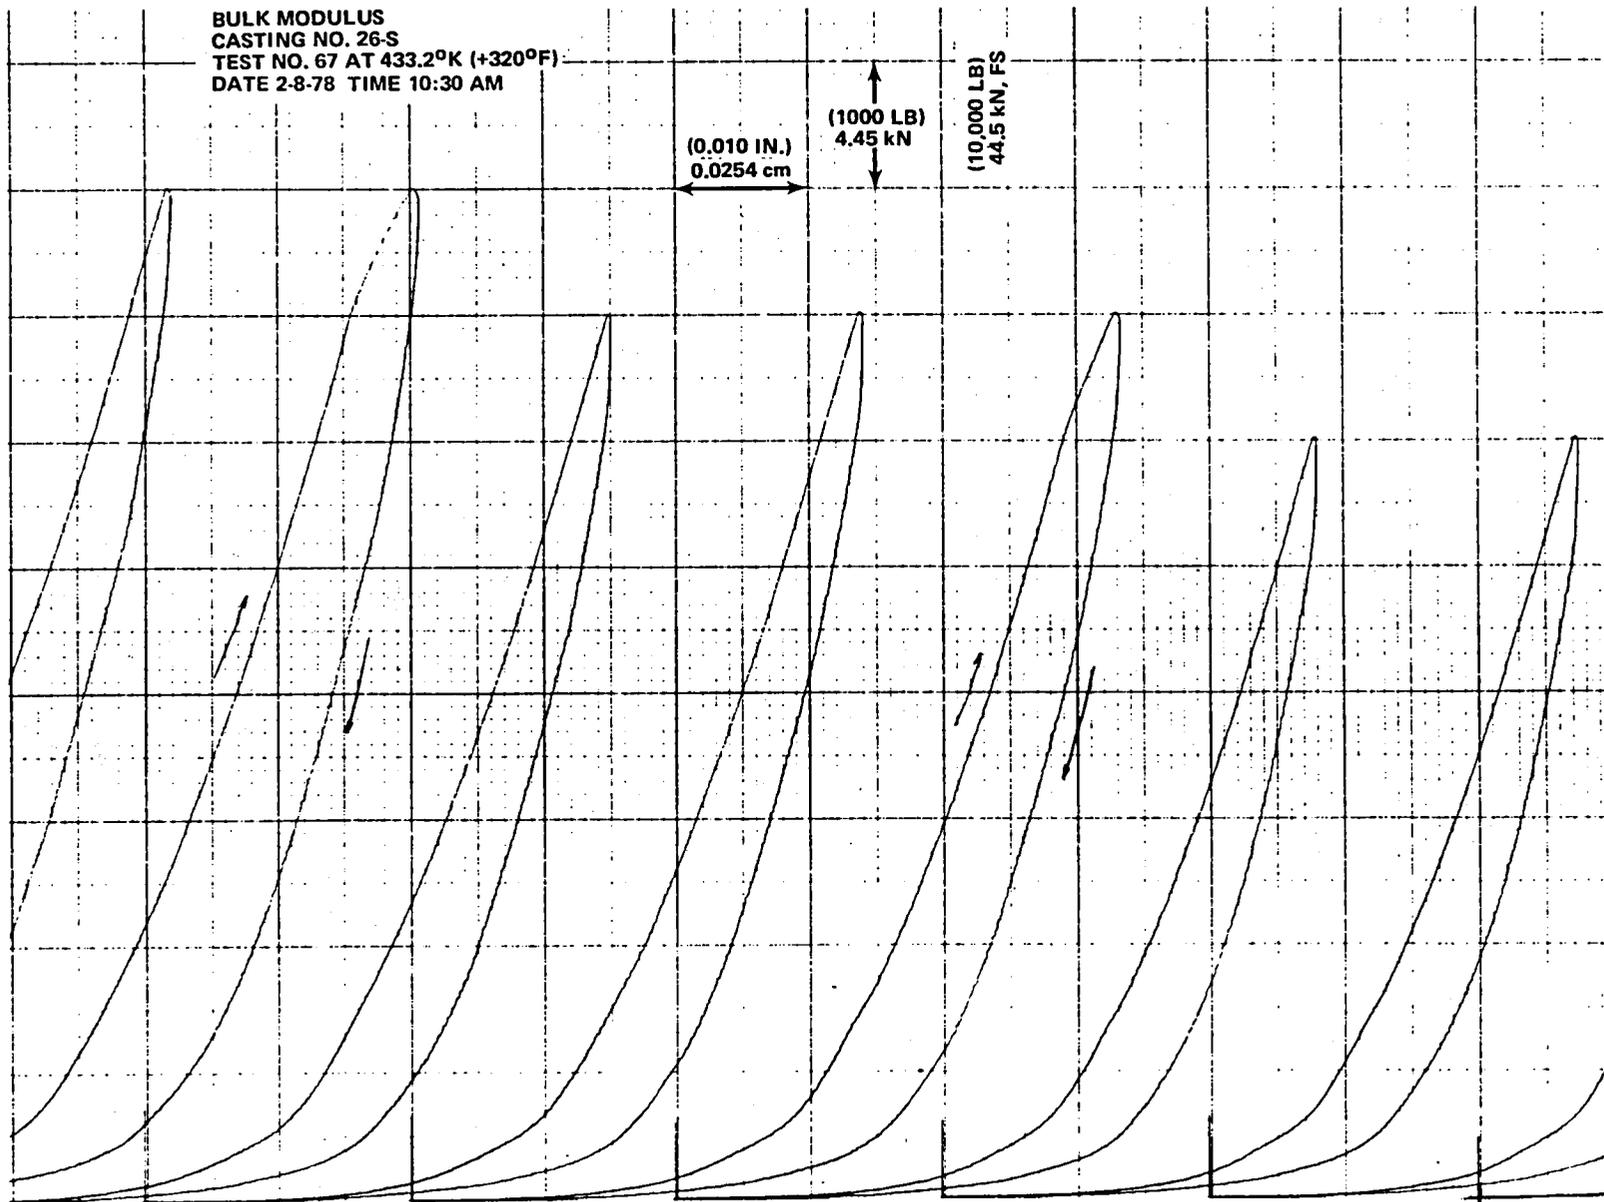
FIGURE J 16. TEST NO. 67 – EXTENSOMETER READING PLOTS, SECTION 3
