Manufacturing Development of DC-10 Advanced Rudder

by A. Cominsky, et al.

MCDONNELL DOUGLAS CORPORATION
DOUGLAS AIRCRAFT COMPANY
LONG BEACH, CALIFORNIA 90846

16. Abstract This is the final technical report covering design, manufacture and ground test activities during development of production methods for an advanced composite rudder for the DC-10 transport aircraft.

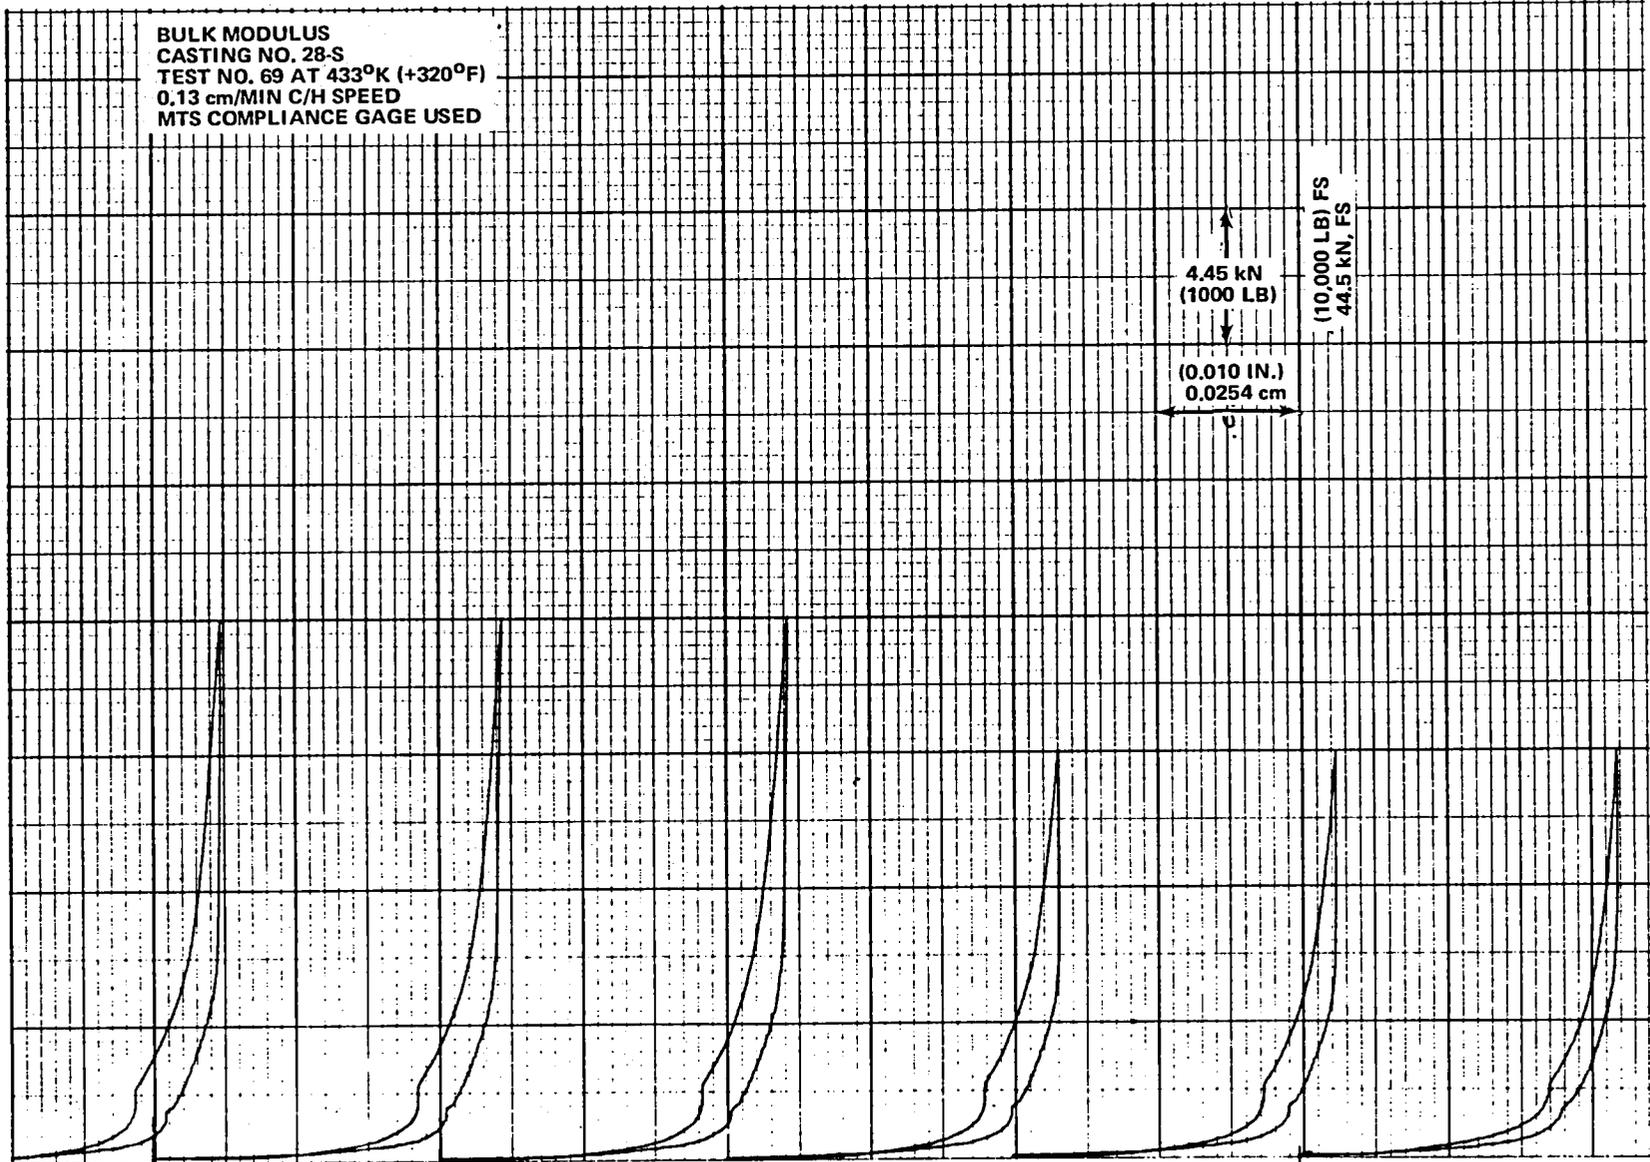
FIGURE J-17. TEST NO. 69 – EXTENSOMETER READING PLOTS, SECTION 1

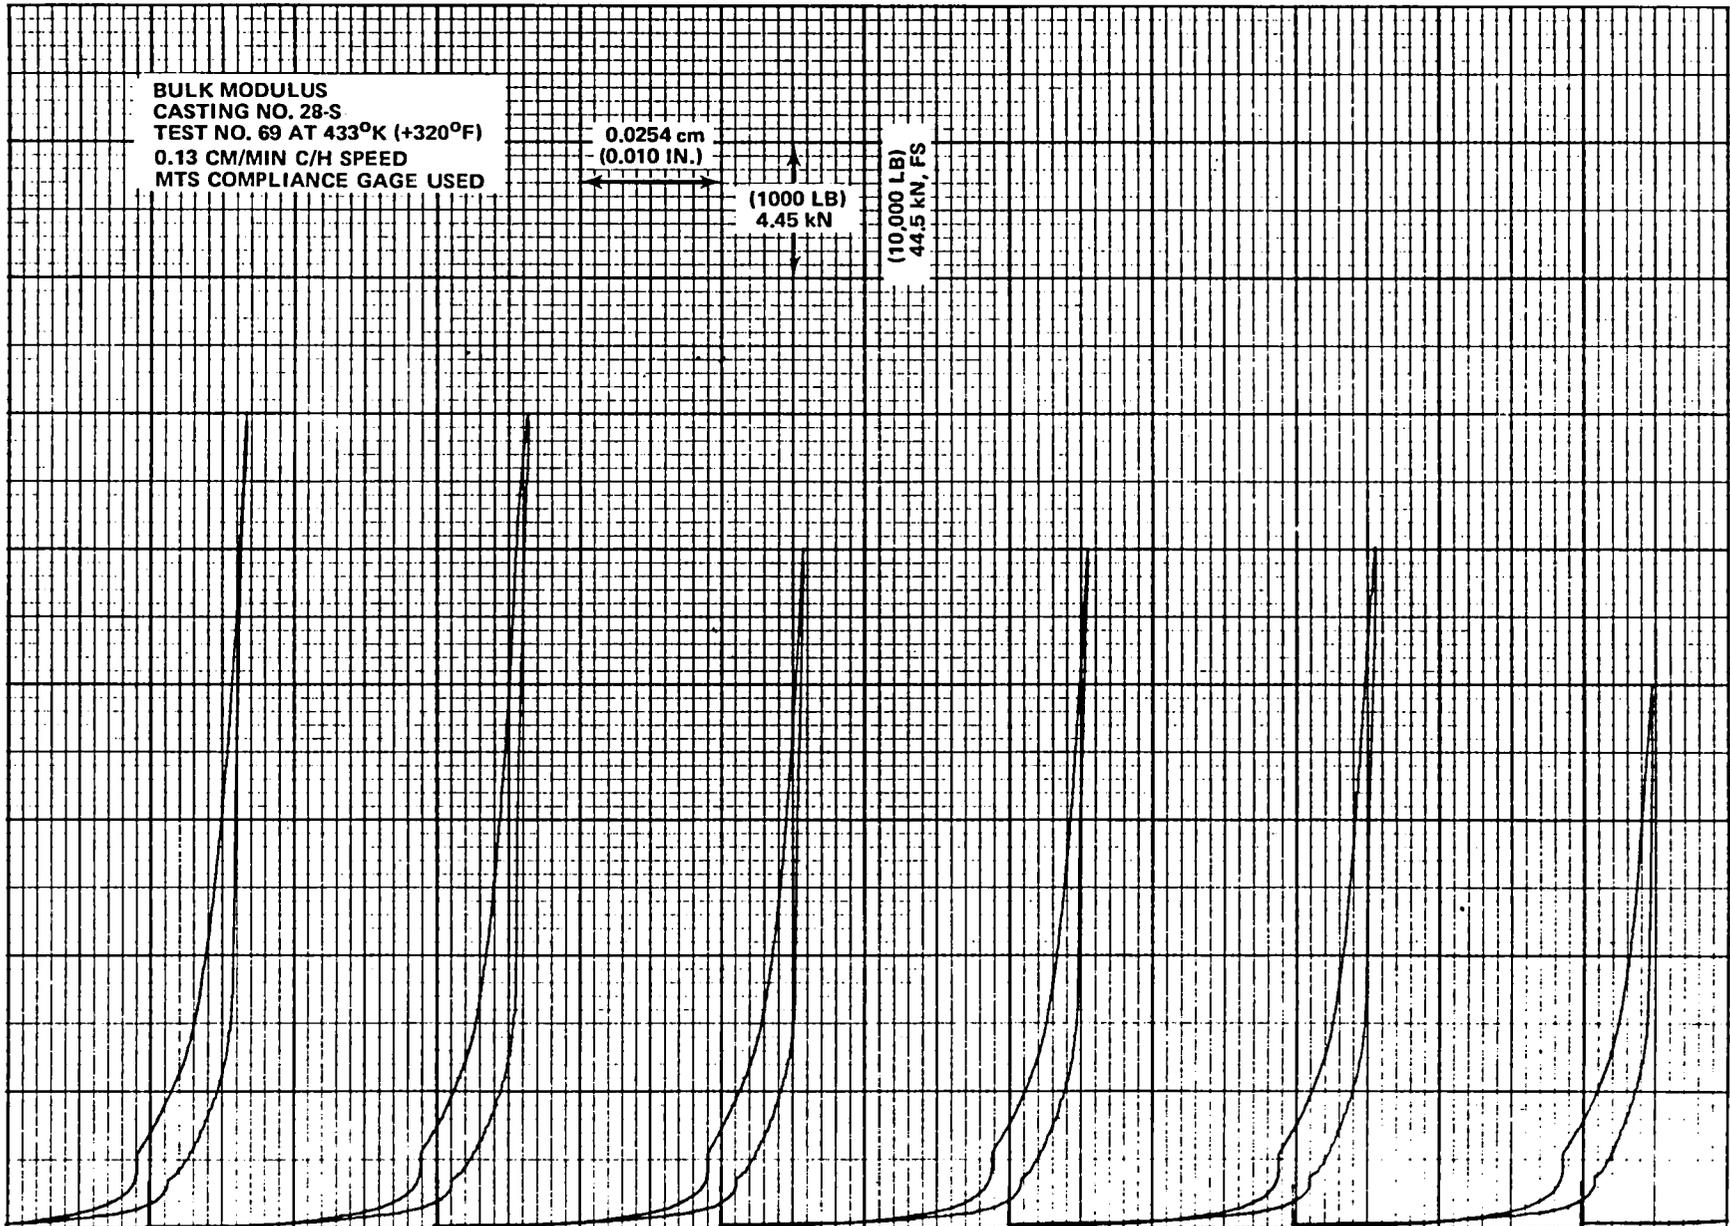
FIGURE J-18. TEST NO. 69 – EXTENSOMETER READING PLOTS, SECTION 2

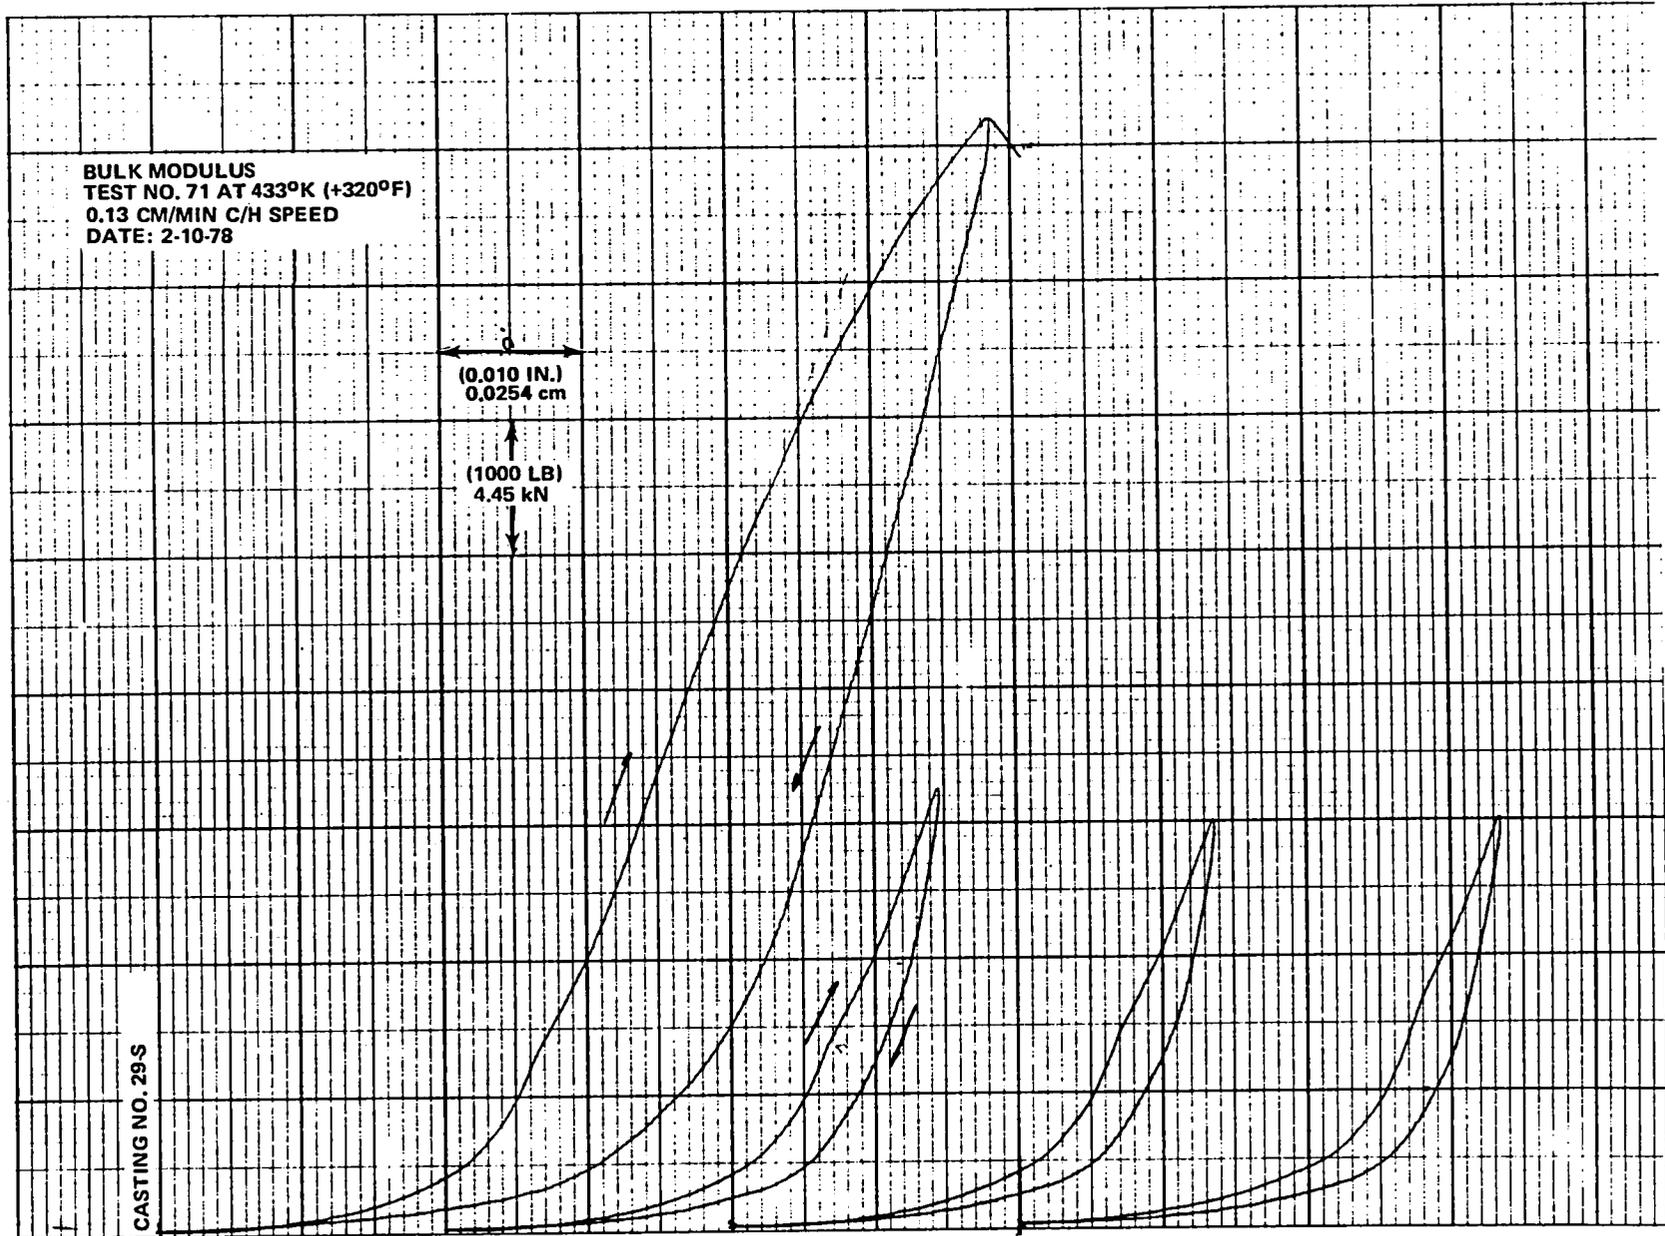
FIGURE J-19. TEST NO. 71 – EXTENSOMETER READING PLOTS

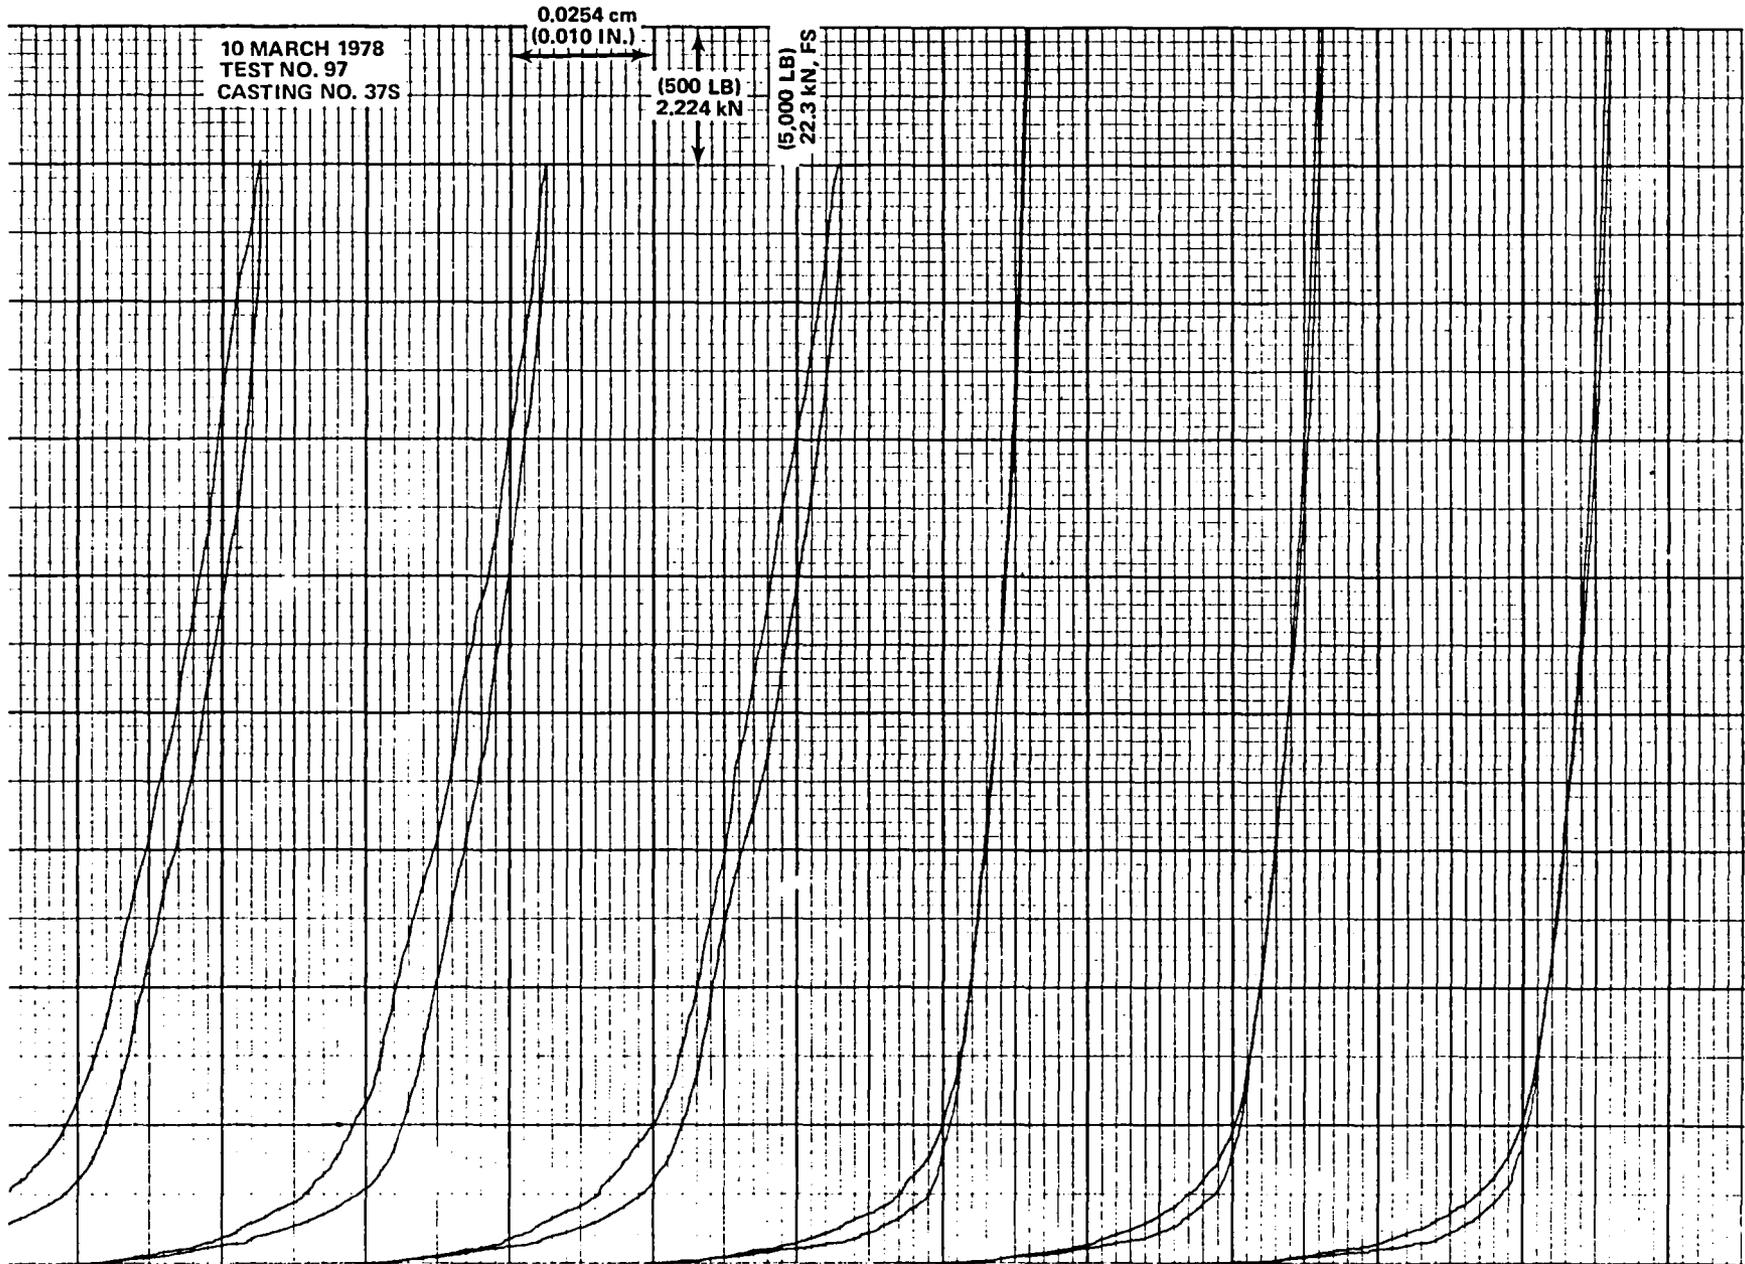
FIGURE J-20. TEST NO. 97 - EXTENSOMETER READING PLOTS, SECTION 2

The extensometer readings are plotted in Figure J-20. Table J-11 gives the extensometer and dial gage readings and the average of these. The bulk modulus properties are given in Table J-12 and are plotted in Figure J-12.

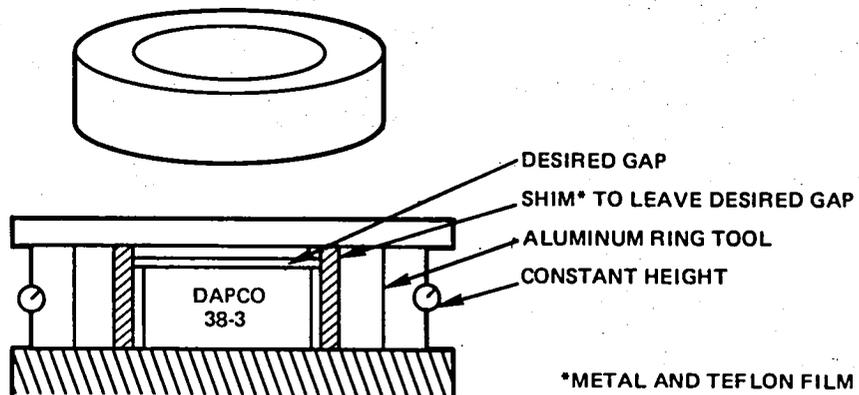
FIGURE K-2. TRAPPED RUBBER TEST SETUP
(SPECIFIED GAP)

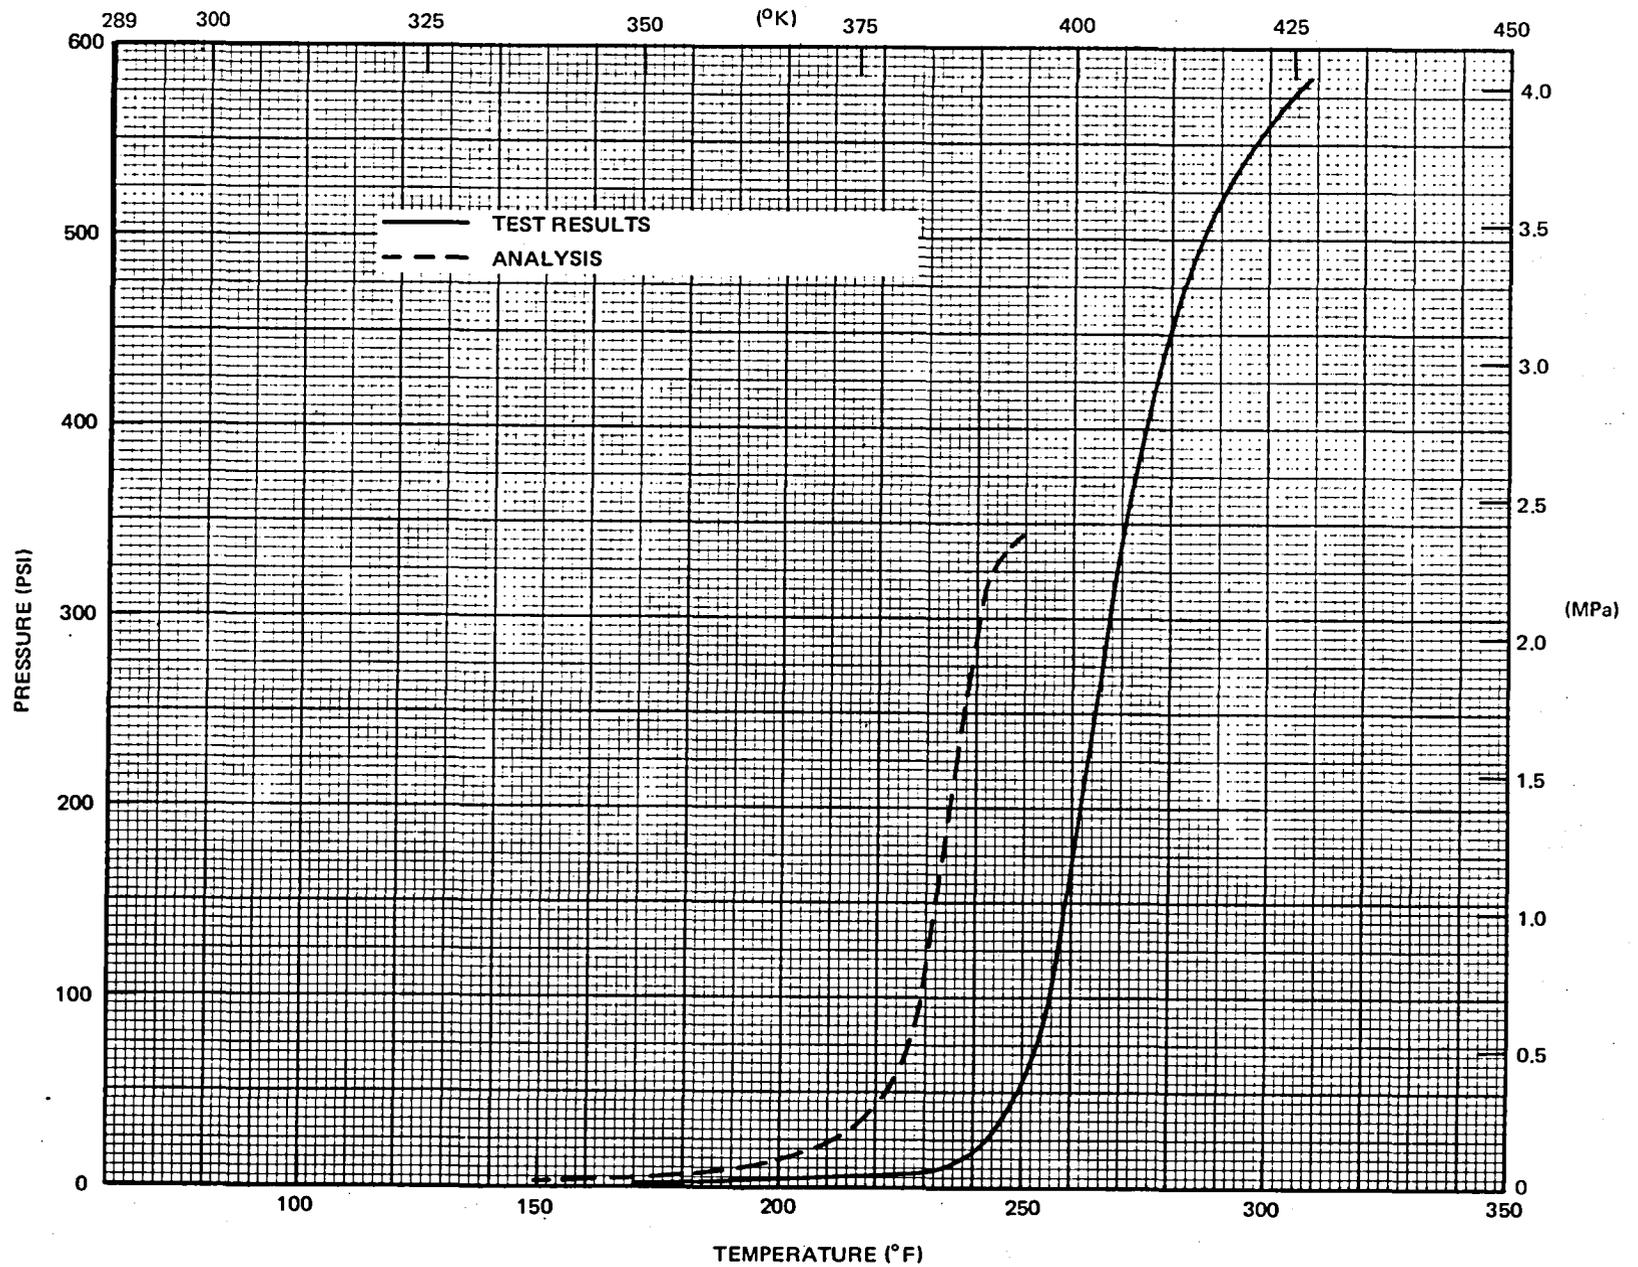
FIGURE K-5. TEST NO. 76 – PRESSURE VERSUS TEMPERATURE

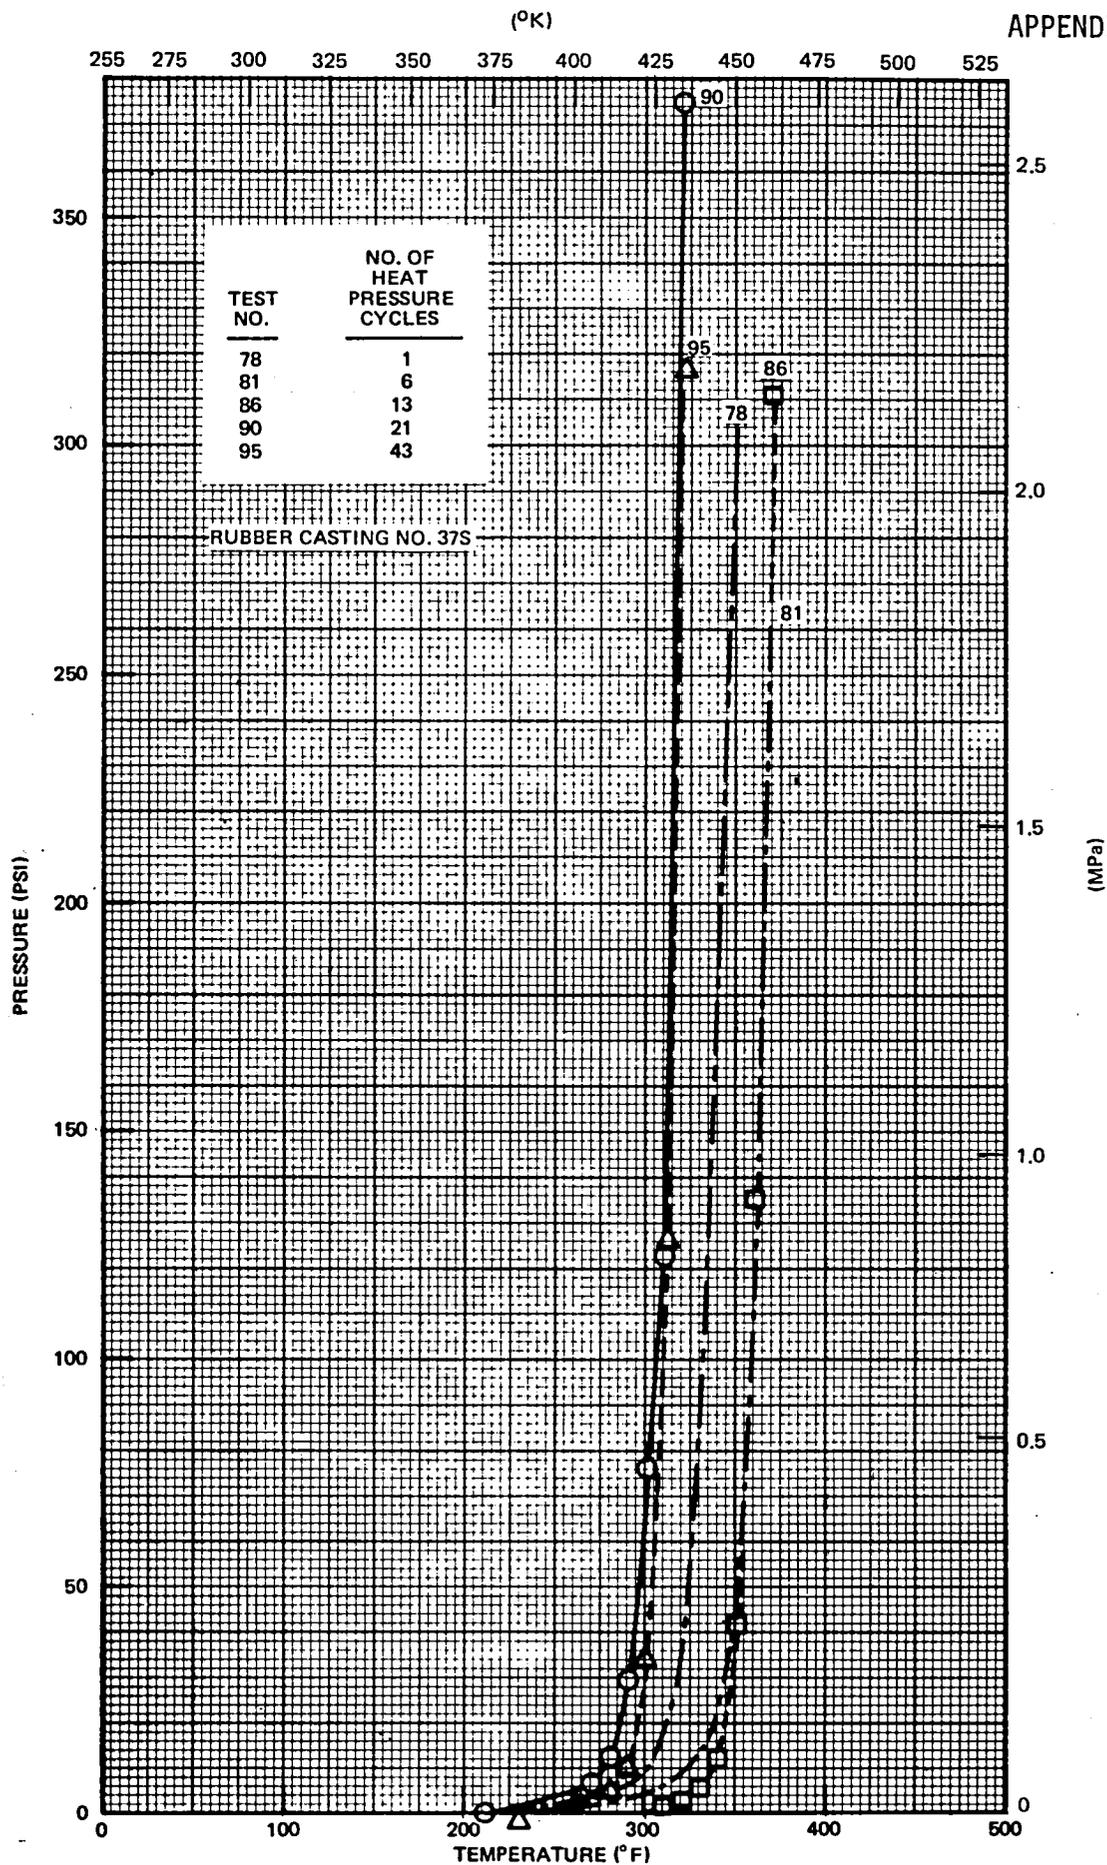
FIGURE K-9. TESTS 78, 81, 86, 90, AND 95 – PRESSURE VERSUS TEMPERATURE TEST RESULTS AFTER HEAT AND PRESSURE CYCLING

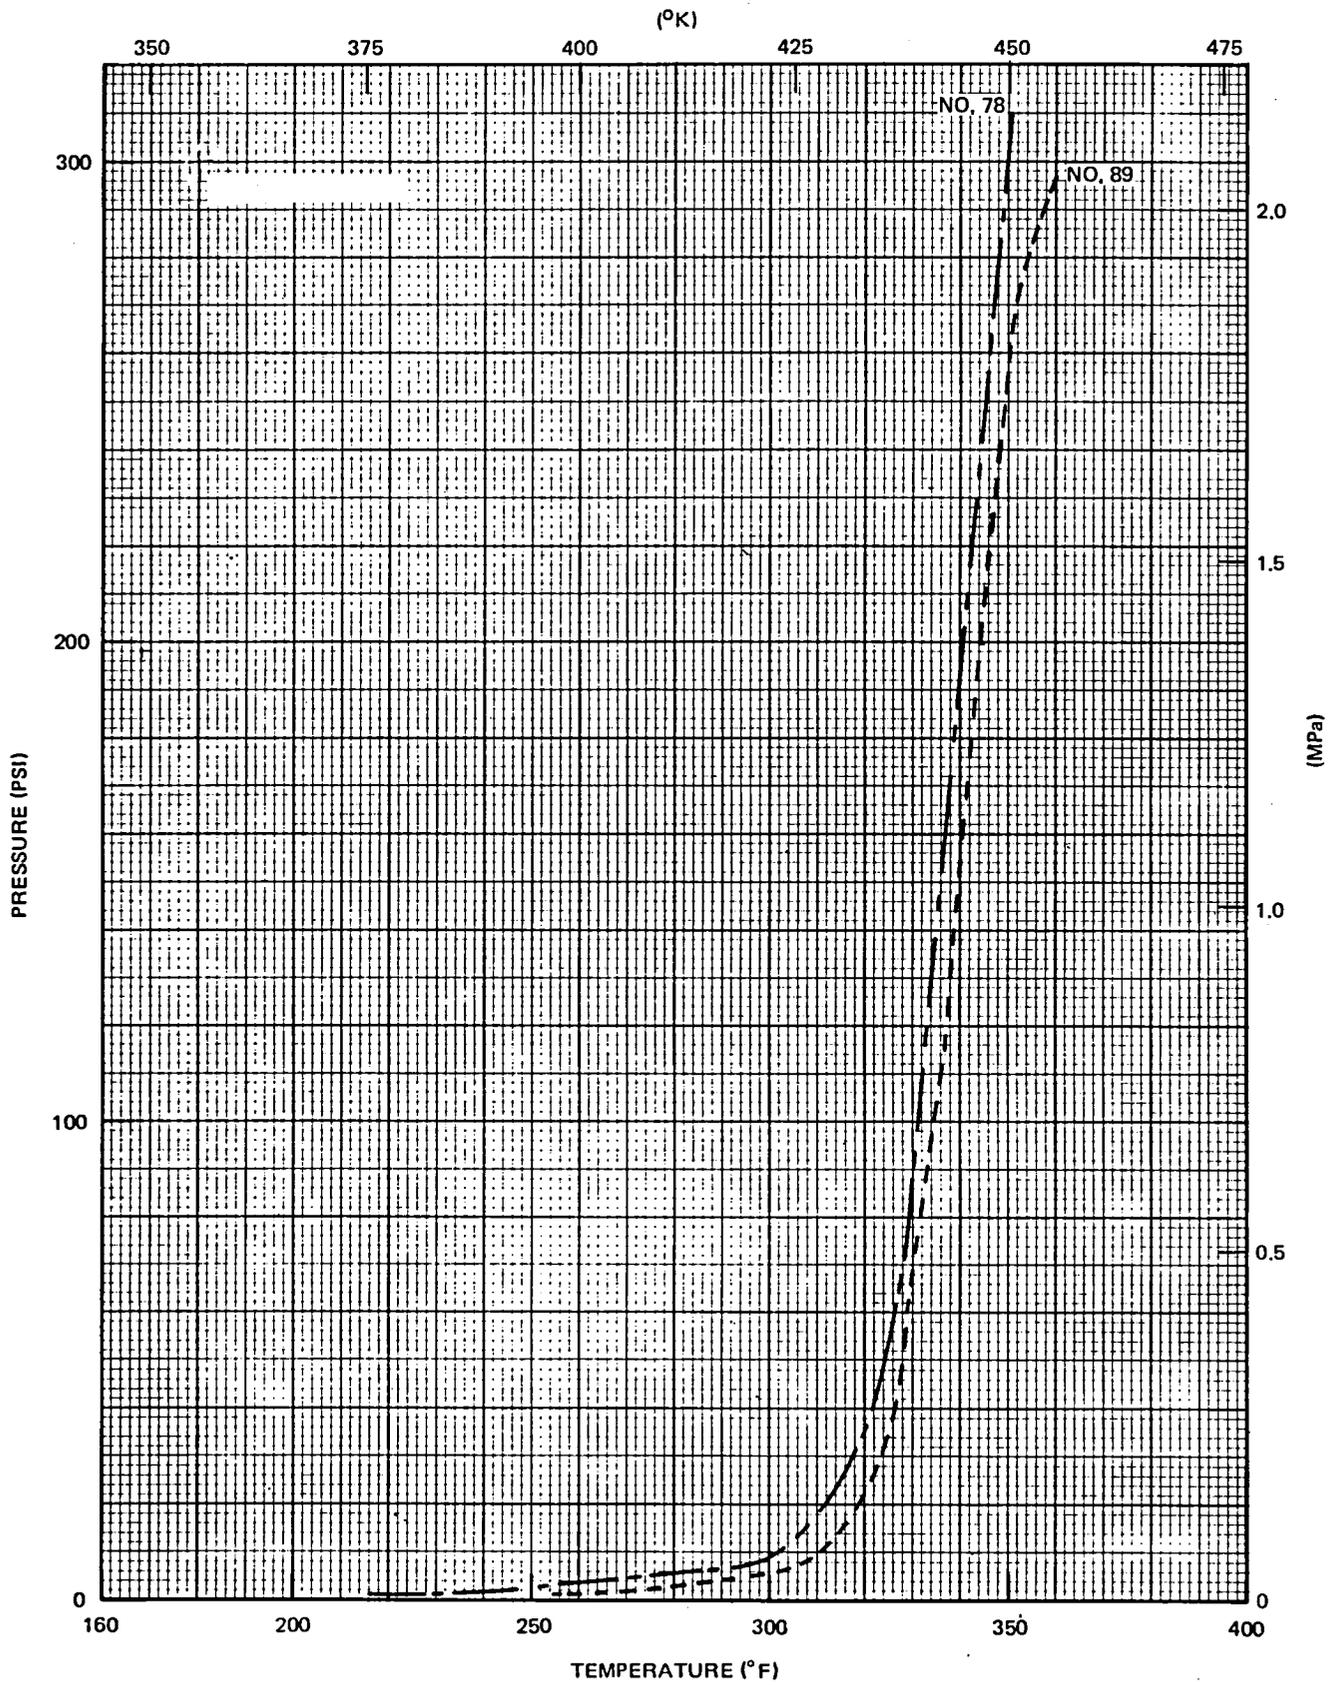
FIGURE K-10. TESTS NO. 89 AND 78 – PRESSURE VERSUS TEMPERATURE COMPARISON

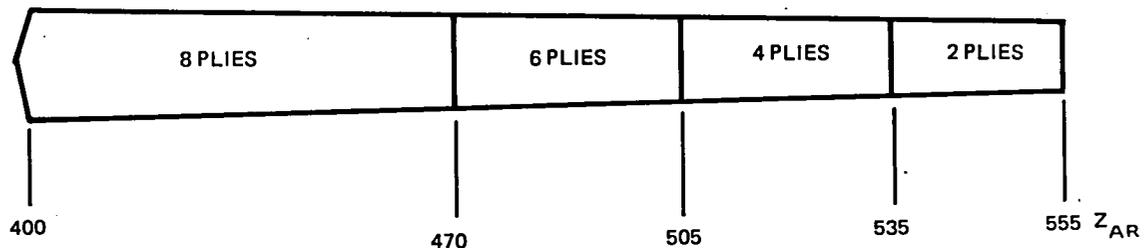
FIGURE M-1. FRONT SPAR REINFORCING PLYS

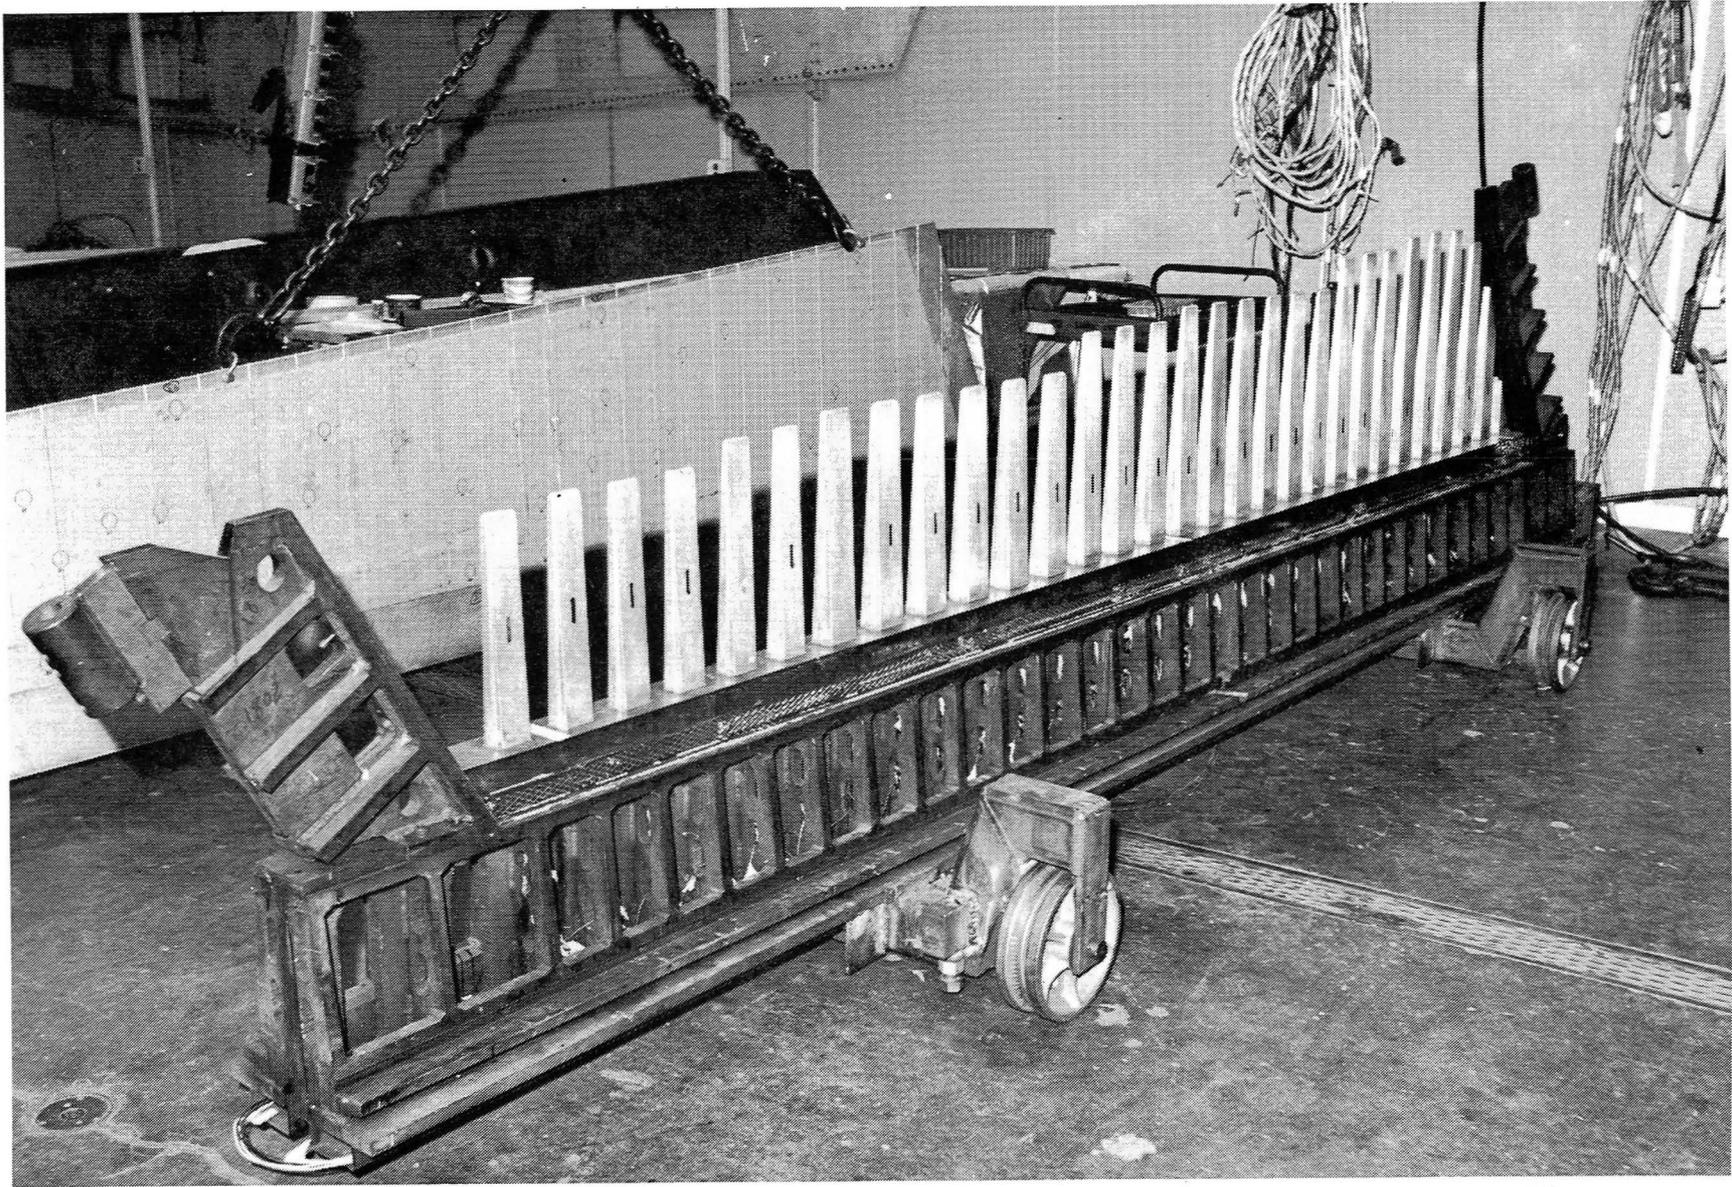
FIGURE P-1. METAL SCREEN REINFORCEMENT FOR FRONT SPAR FORWARD FLANGE RUBBER MANDRELS

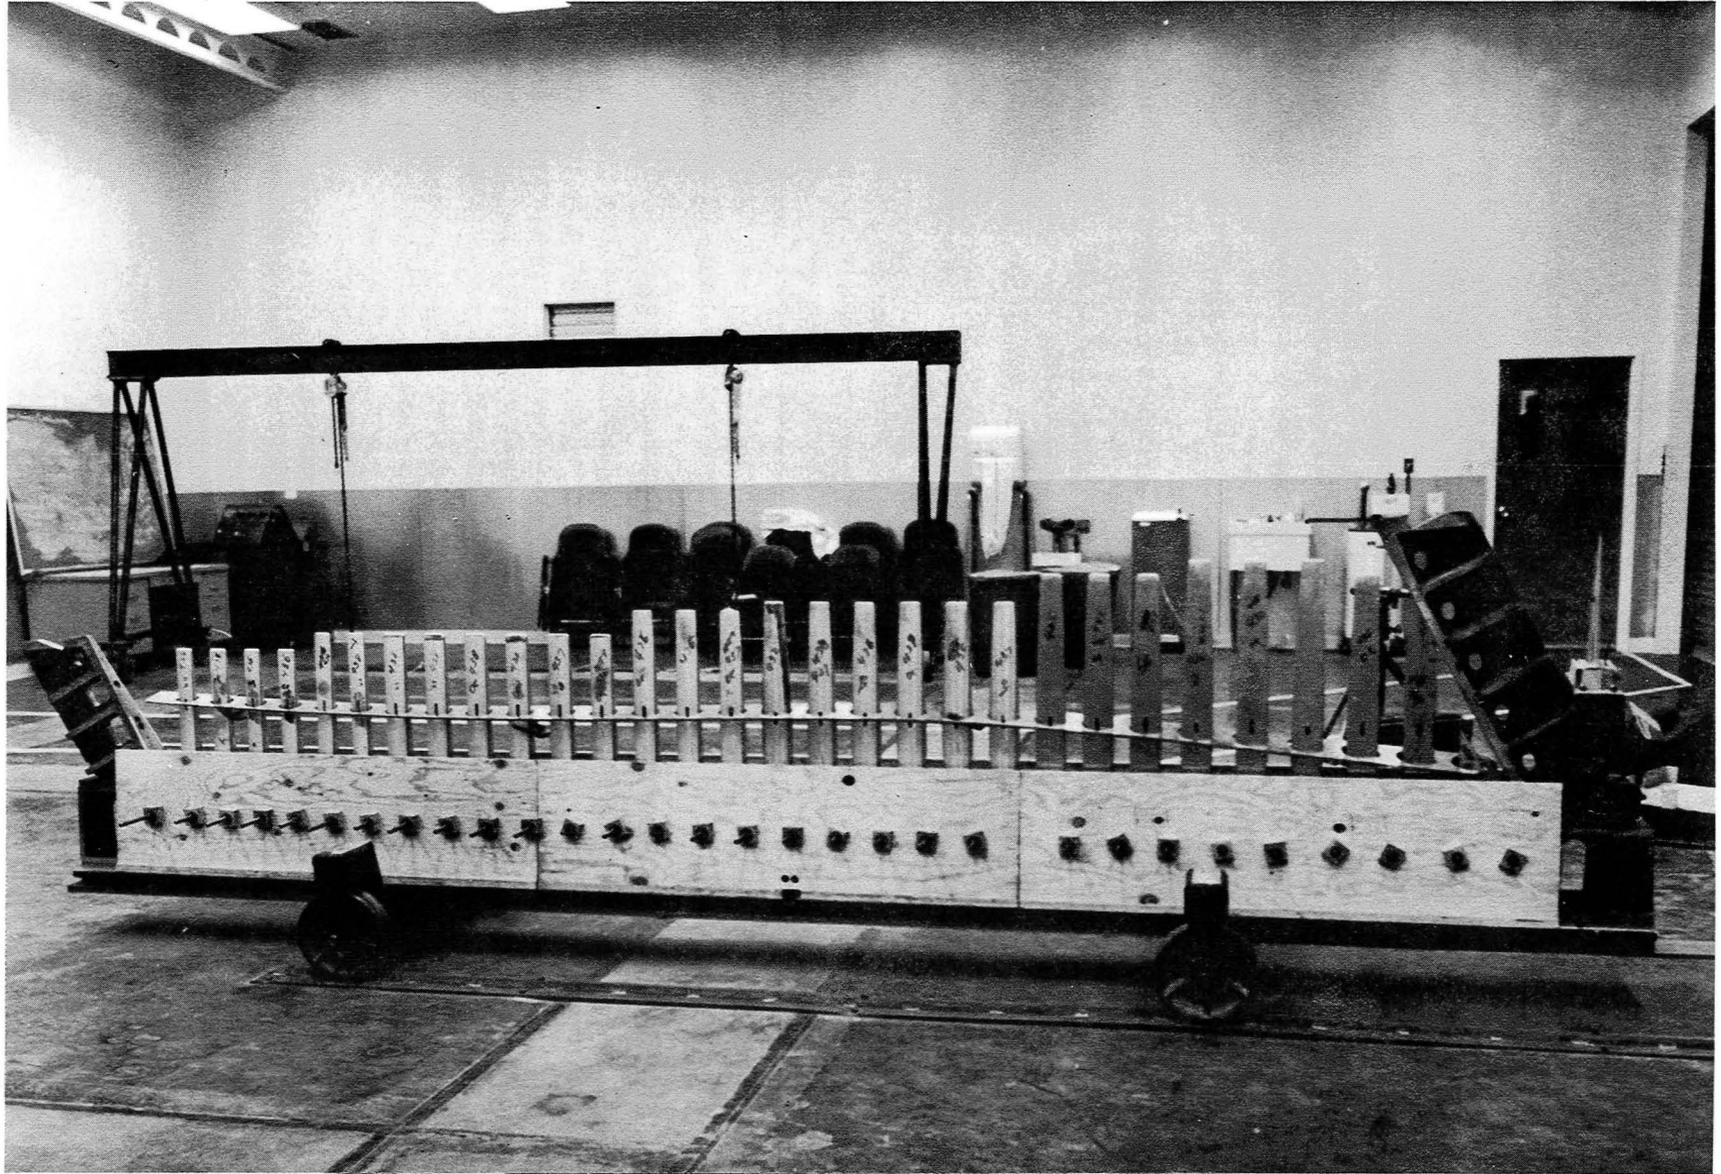
FIGURE P-2. FRONT SPAR FORWARD FLANGE DUMMY PART ASSEMBLED ON PLM

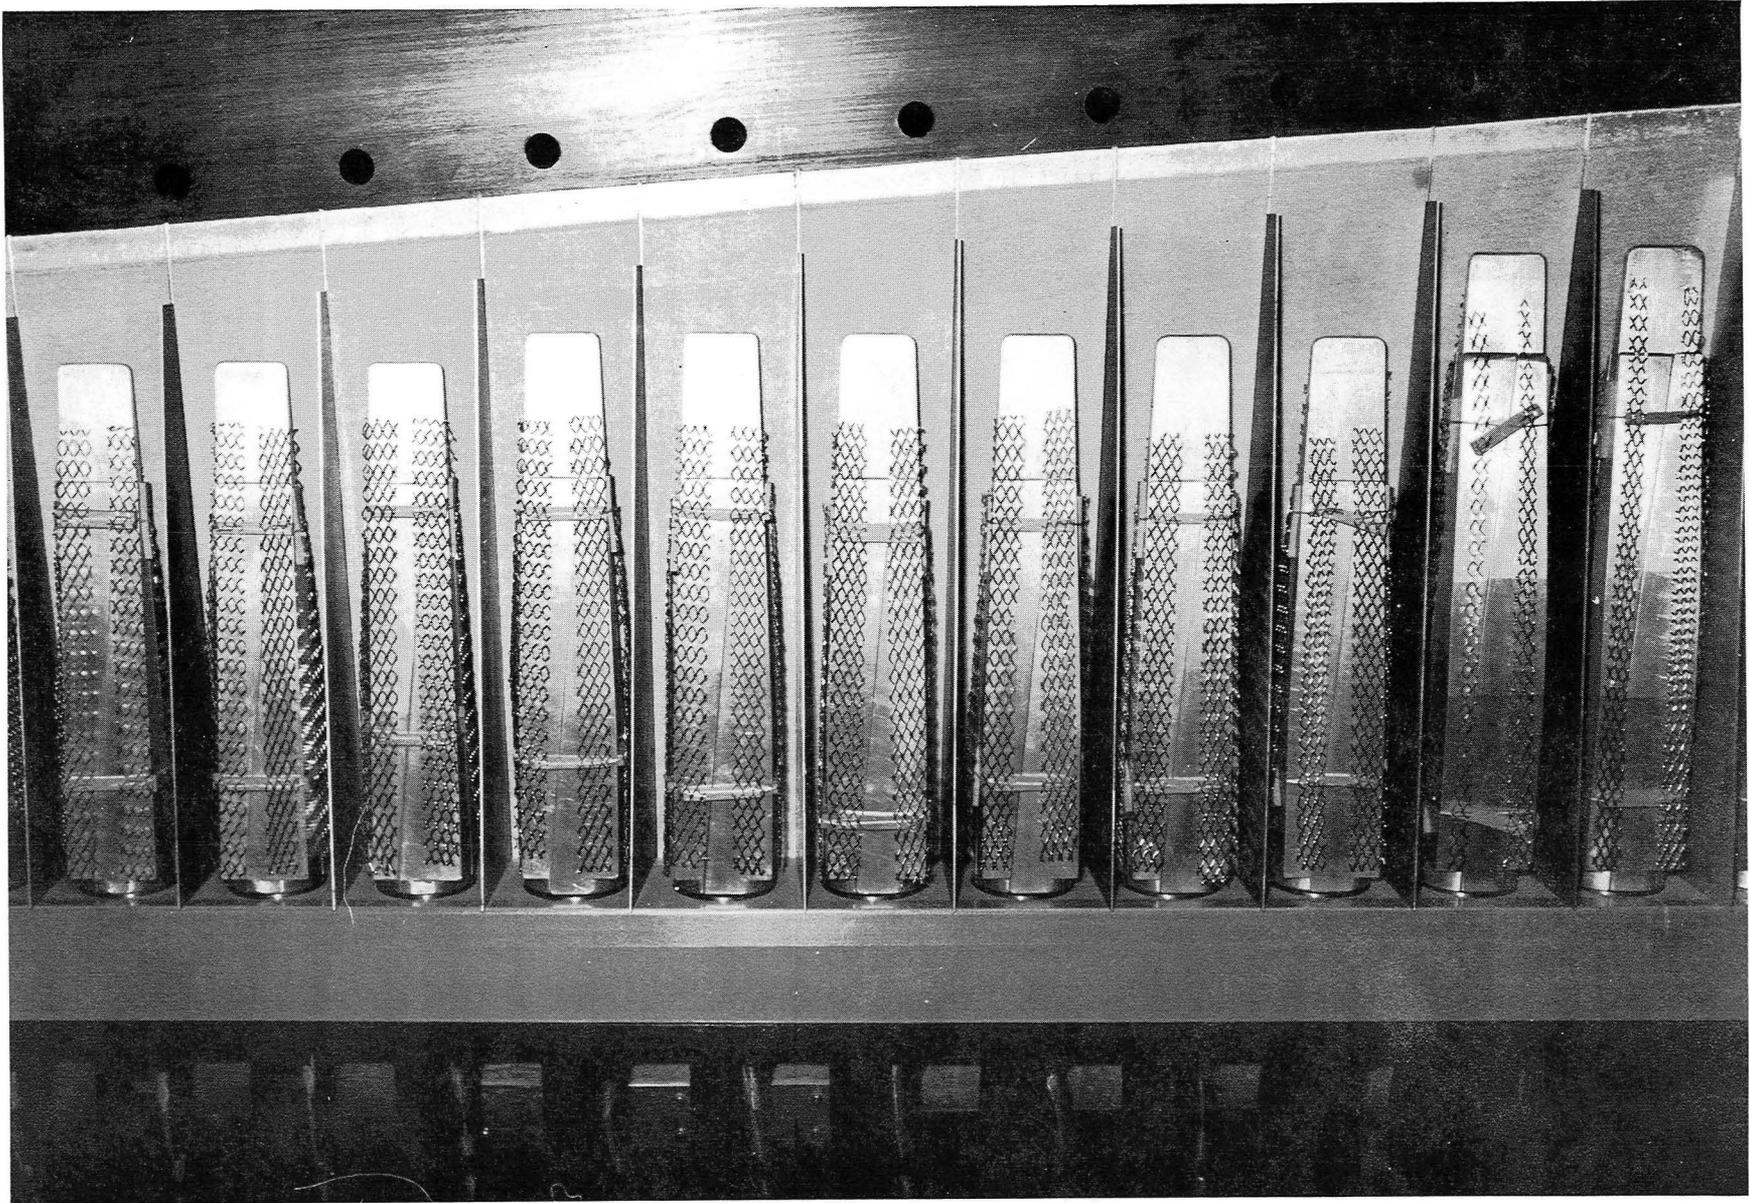
FIGURE P-3. METAL SCREEN REINFORCEMENT FOR CENTRAL MAIN RUBBER MANDRELS
