Manufacturing Development of DC-10 Advanced Rudder

by A. Cominsky, et al.

MCDONNELL DOUGLAS CORPORATION
DOUGLAS AIRCRAFT COMPANY
LONG BEACH, CALIFORNIA 90846

16. Abstract This is the final technical report covering design, manufacture and ground test activities during development of production methods for an advanced composite rudder for the DC-10 transport aircraft.

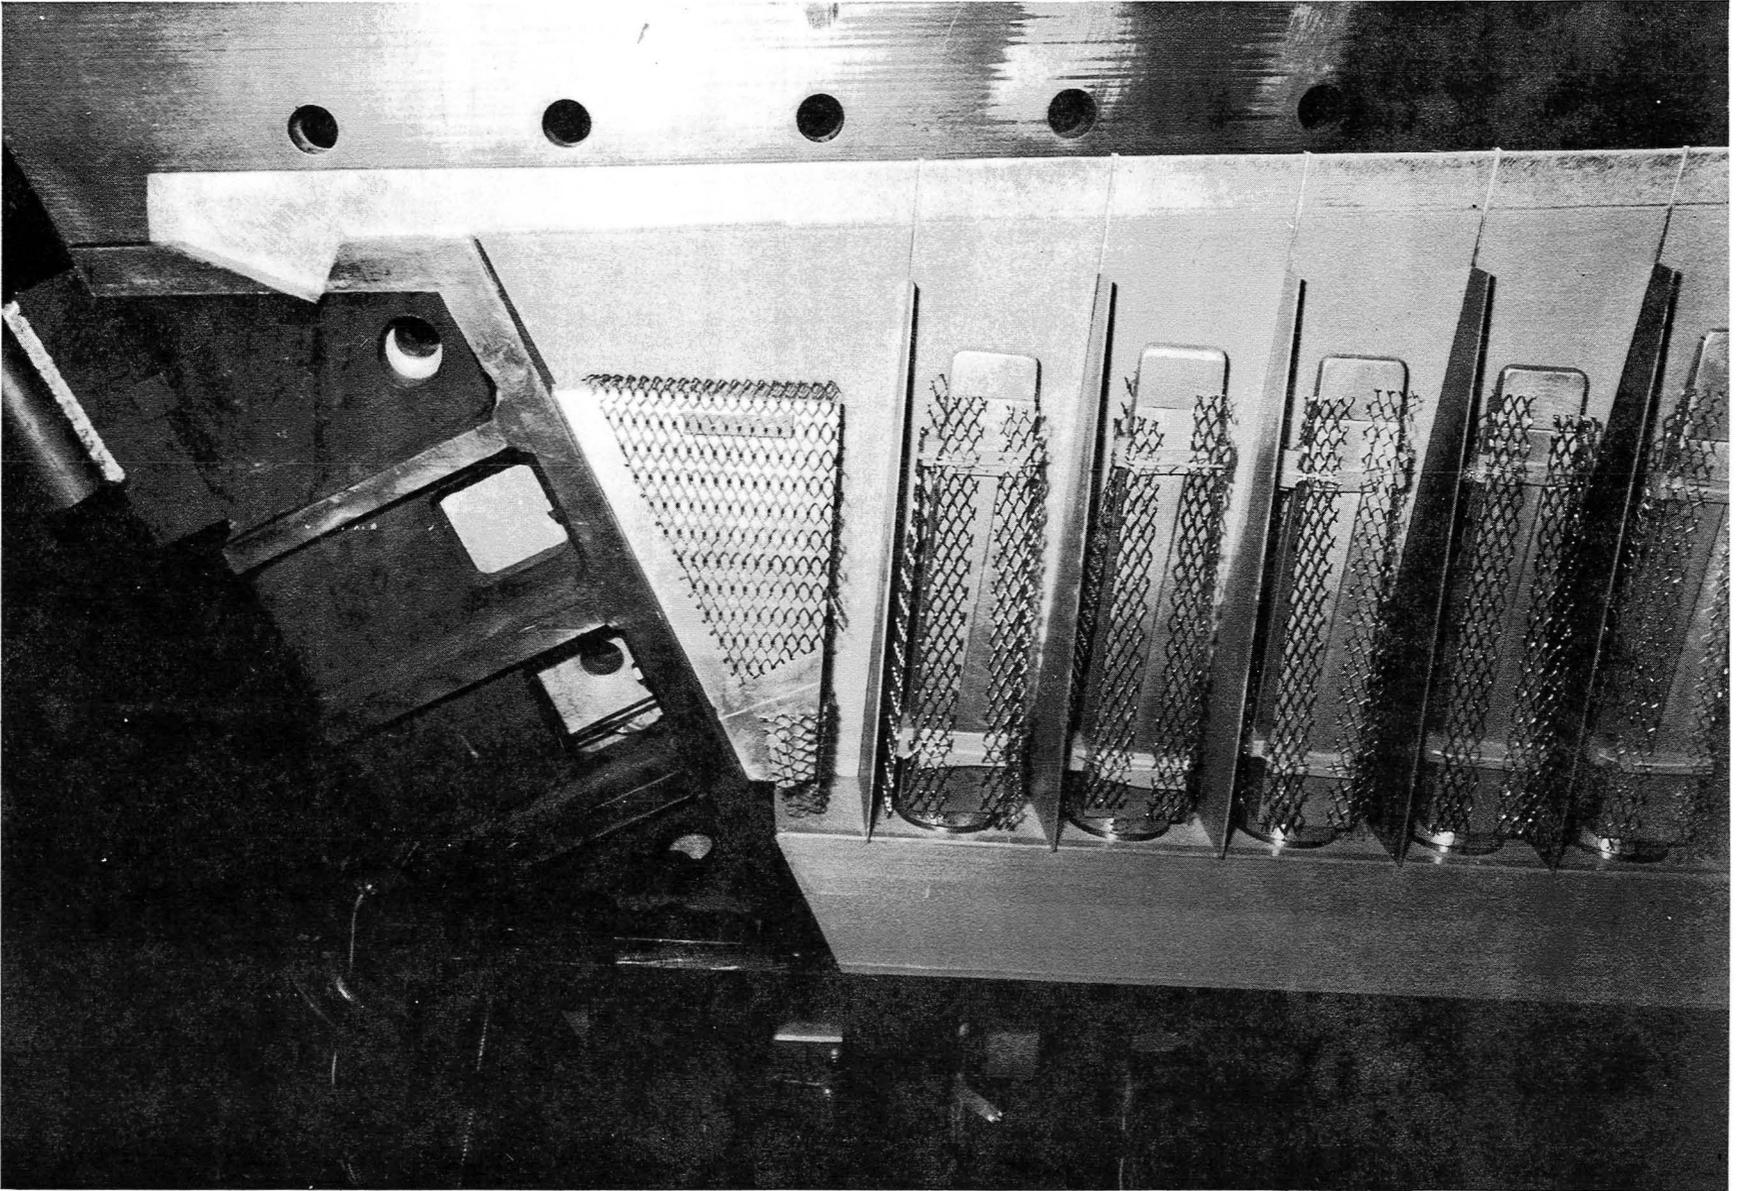
FIGURE P-4. METAL SCREEN REINFORCEMENT FOR UPPER MAIN RUBBER MANDRELS

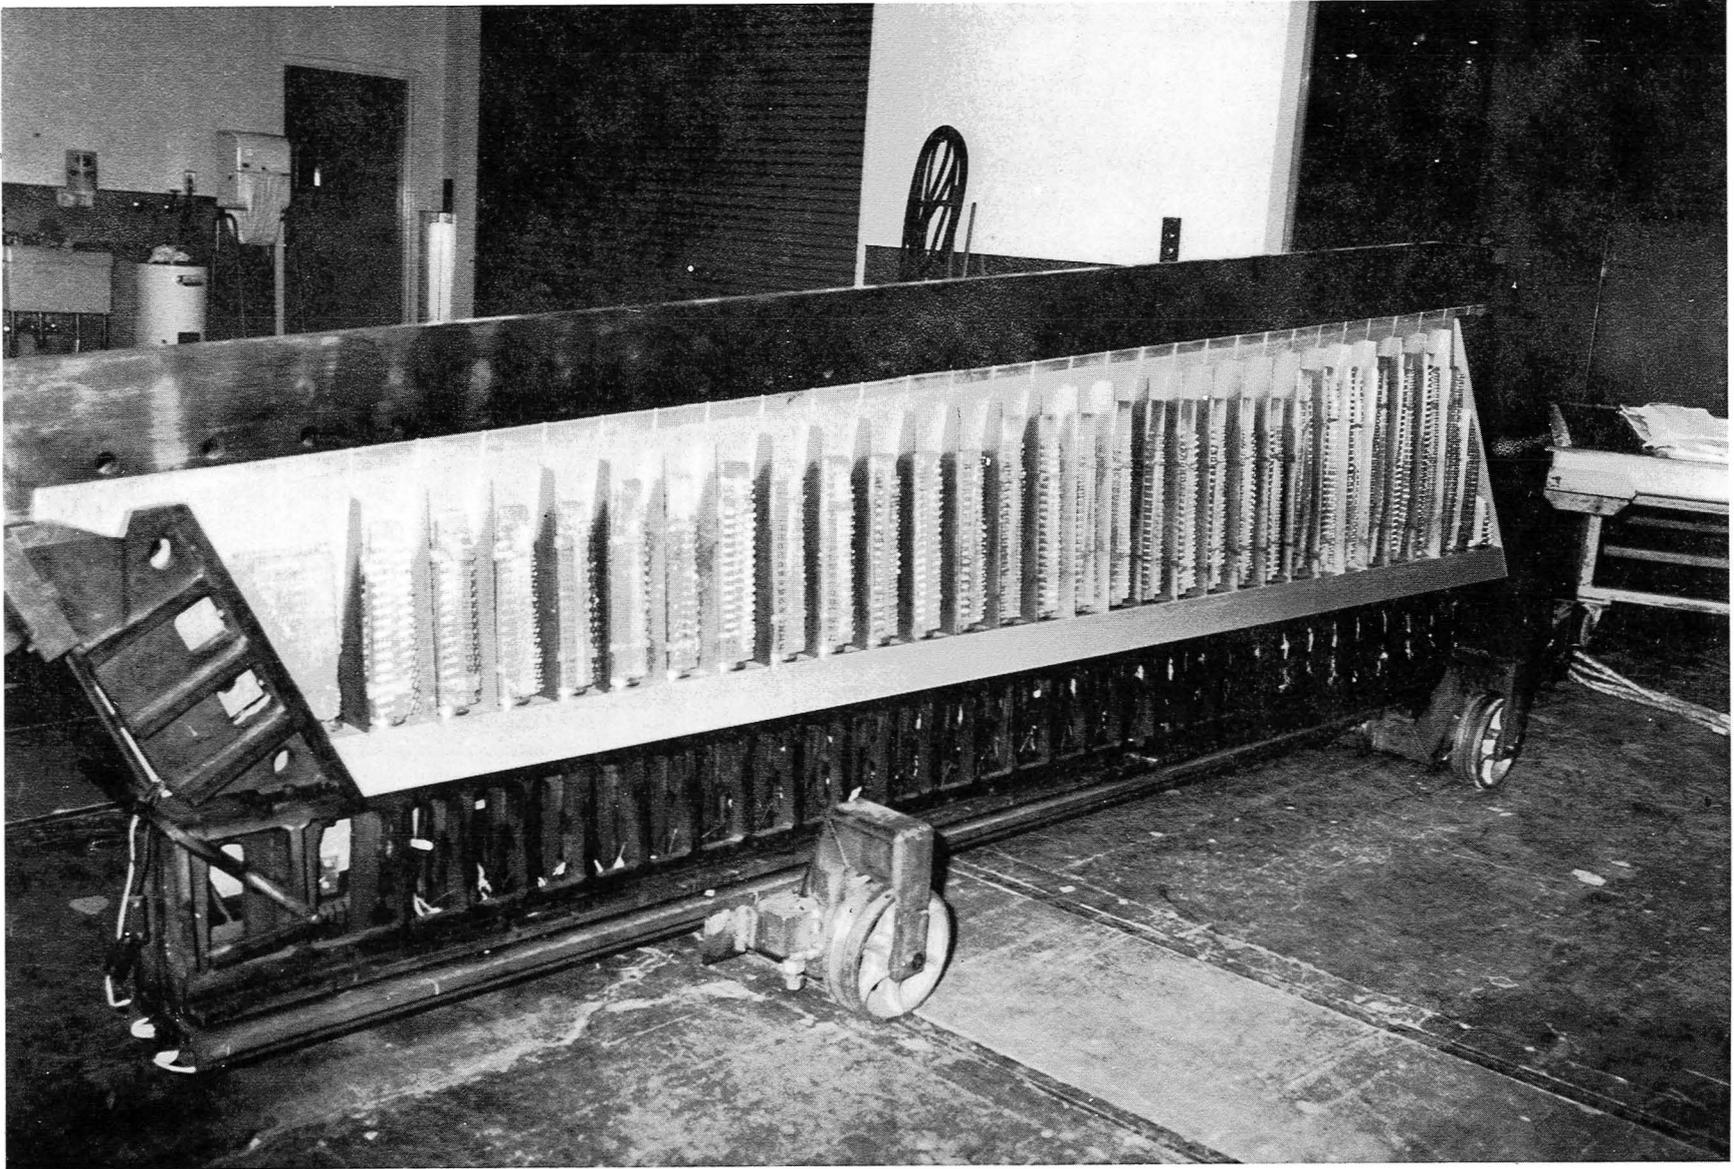
FIGURE P-5. VIEW OF R/H DUMMY SKIN, DUMMY RIBS, METAL MANDREL F/S FORWARD FLANGE RUBBER
