**EXAMINATION OF SILICON SOLAR CELLS**

**BY MEANS OF**

**THE SCANNING LASER ACOUSTIC MICROSCOPE (SLAM)**

REPORT #R117

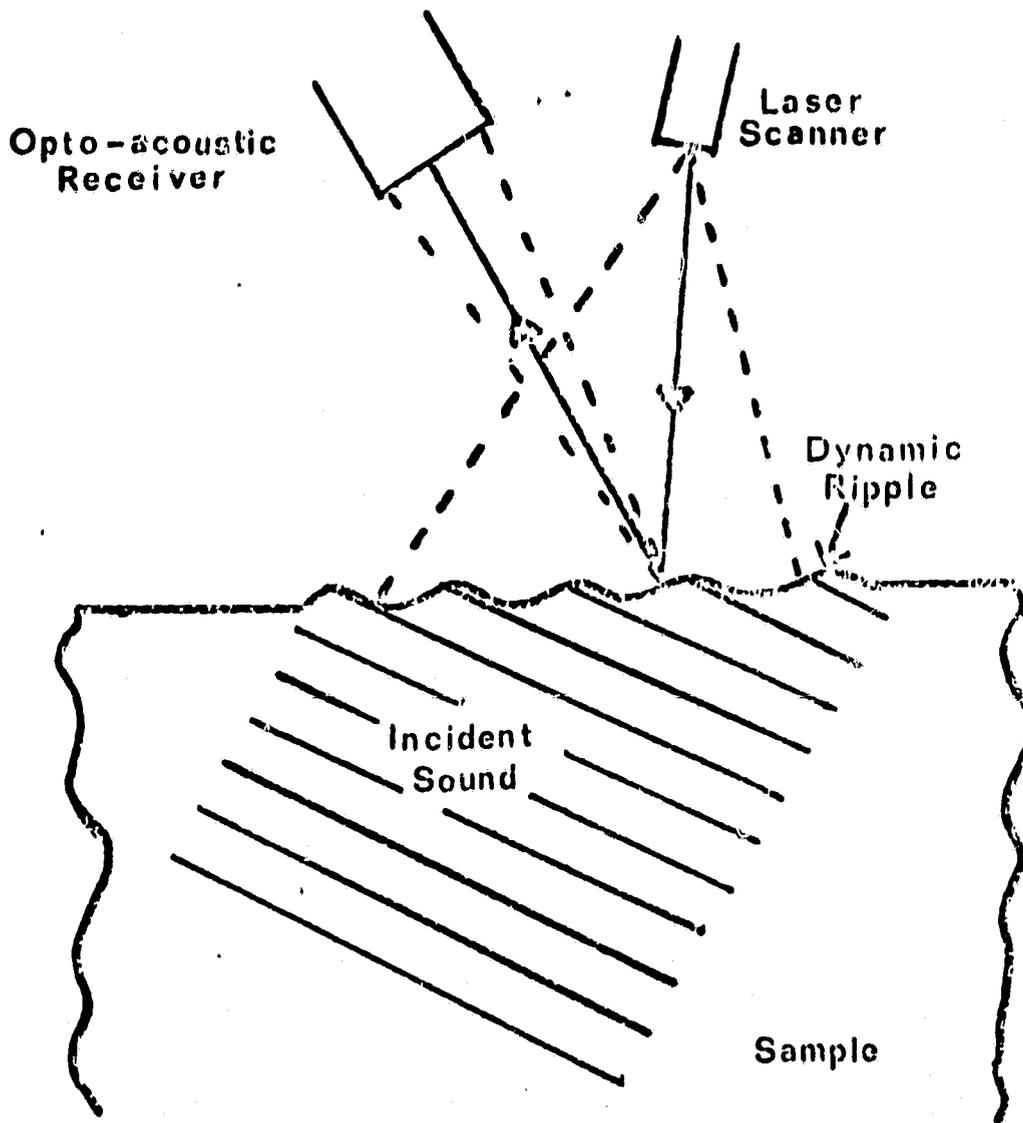
FIGURE 1

The basic insonification geometry and detection scheme employed by the SLAM is illustrated in Figure 1. Ultrasonic energy is incident on the sample from below. An insonification angle of  $10^{\circ}$  (in water) is commonly used, however, this parameter is variable. The transmitted acoustic energy imparts a slight oscillatory mechanical motion to the sample's top surface. These oscillations have the same frequency as the incident wave, but vary in amplitude depending on the acoustic attenuation and absorption properties of the underlying material. These disturbances are detected, point by point, by a rapidly scanning focused laser beam (40,000 image points per micrograph) which drives an optoacoustic receiver. The acoustic image is then displayed on the TV monitor where the white regions correspond to areas of the sample with good acoustic transmission properties, while the darker areas of the micrographs are regions of higher ultrasonic attenuation. If the sample has a good surface finish, an acoustic image can be obtained from the light specularly reflected directly from the surface. When this is not the case, a mirrored coverslip is placed in acoustic contact with the top surface of the sample and light reflected from the coverslip is used to form the acoustic image.

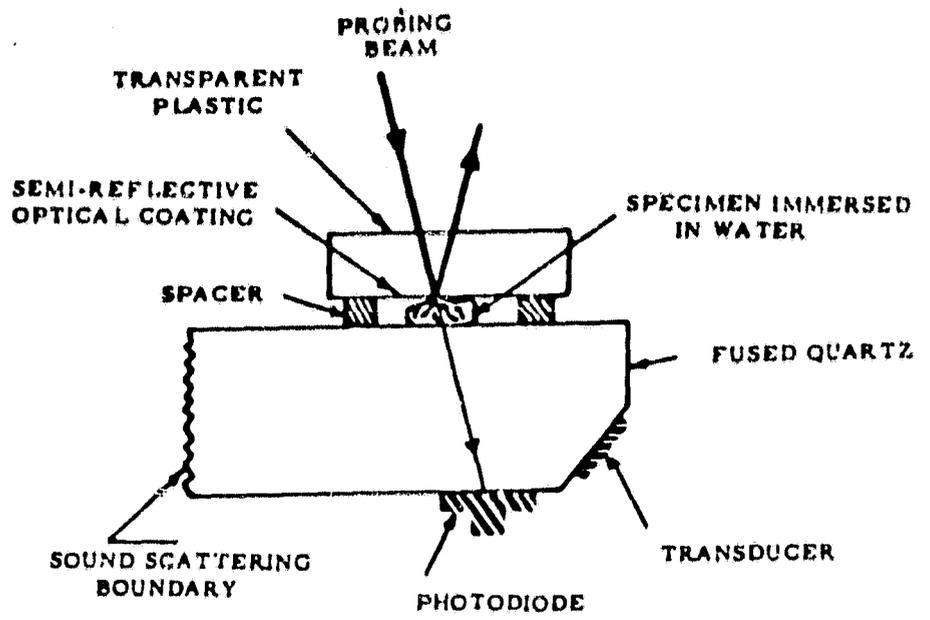
FIGURE 2

Acoustic energy is brought to the sample by the microscope stage. There are two basic types of stages which are commonly used for flat samples. In the "glass cell", illustrated in Figure 2a, a transducer is bonded to a glass block which serves as a support for the sample. The liquid cell is illustrated in Figure 2b, here the conduction of sound from transducer to sample is through a liquid which fills the chamber. In this work a liquid cell was used.

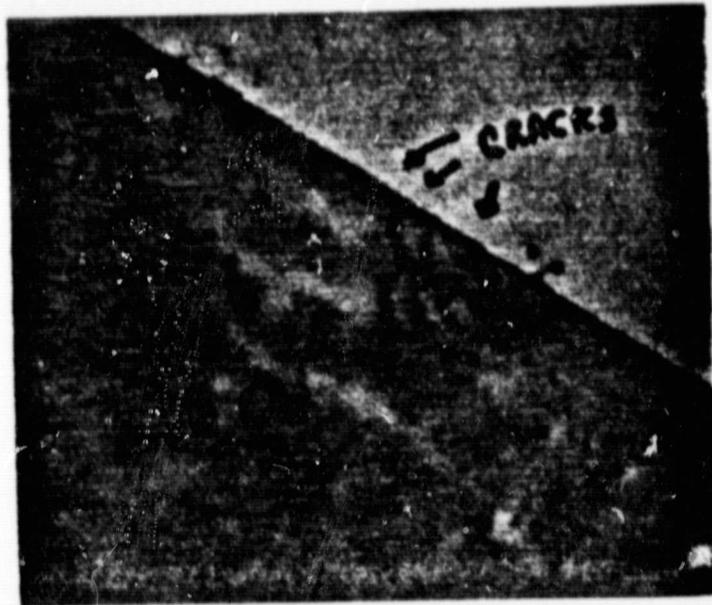
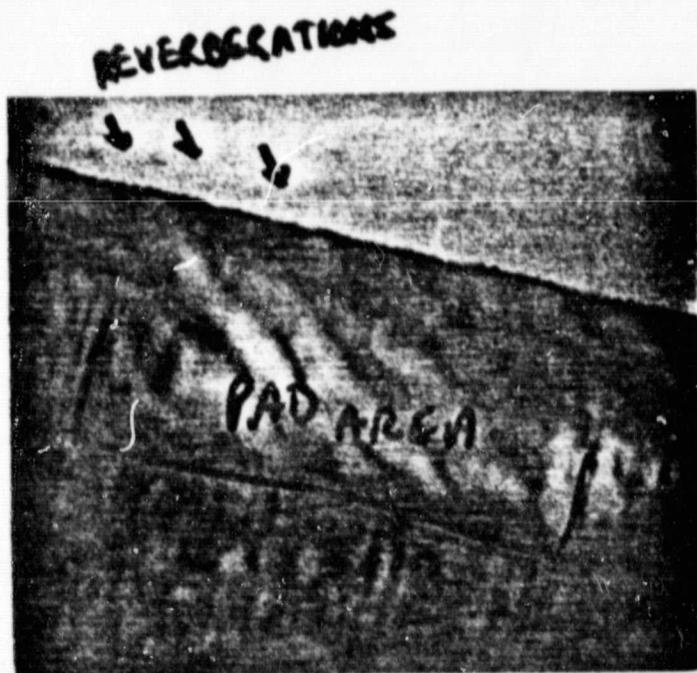
A-1 - Acoustic amplitude micrographs taken in area (a) top and (b) bottom of solar cell A1. Good acoustic transmission occurred through these areas. A crack was found in (a). Reverberation lines are seen due to the thin samples not being flat. Real time imaging prevents misinterpretation of these artifacts.

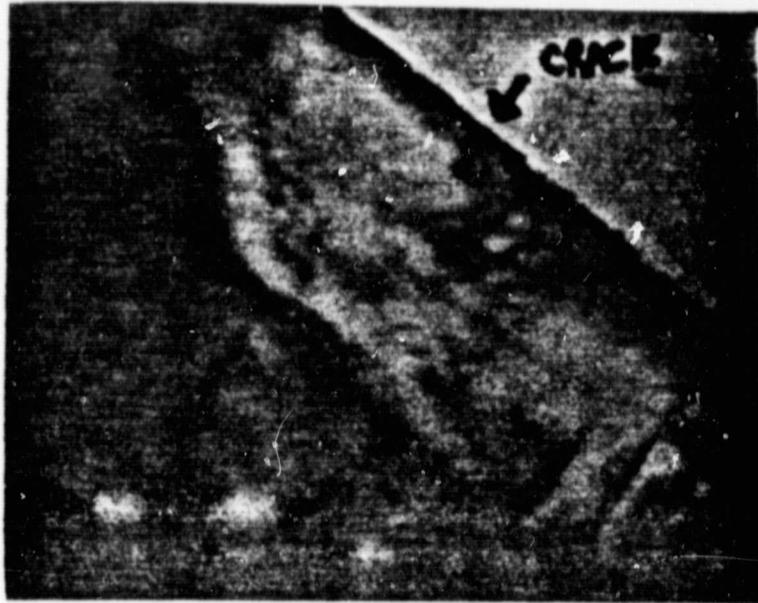
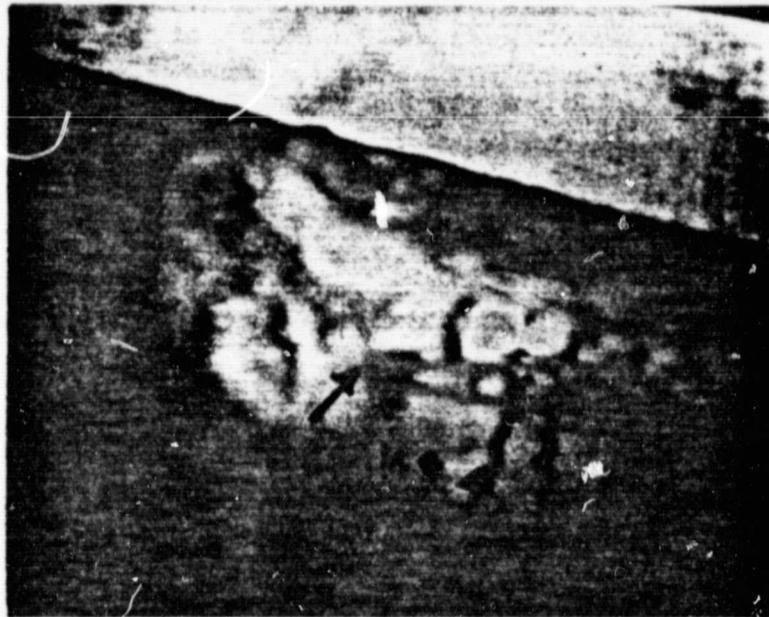
A-1. These acoustic micrographs were taken on cell A-1 after some thermal cycling. Compare these micrographs with the ones taken before and notice especially the crack in the "b" pad which was not visible earlier.

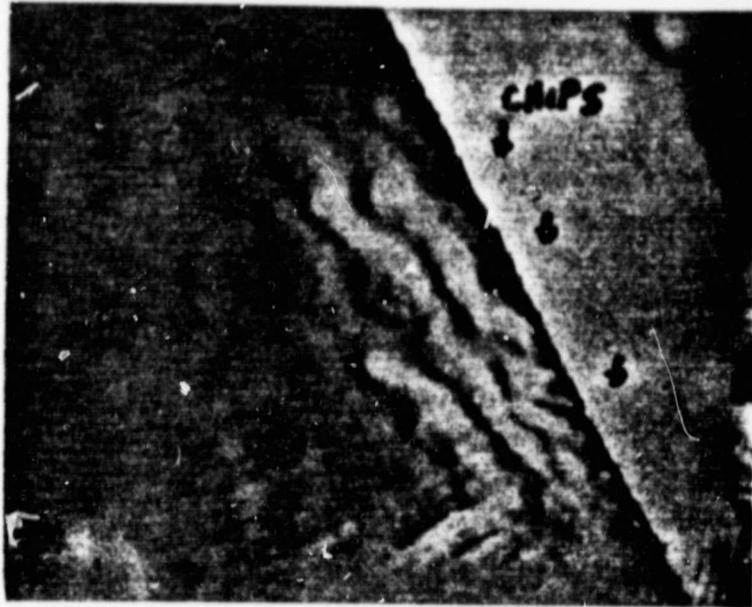
A-2 - Acoustic amplitude micrographs taken on areas (a) top and (b) bottom of solar cell A2. Good transmission occurs in both of these areas. Near the edge of the sample, some structure is seen which is probably the result of some chipping of the material.

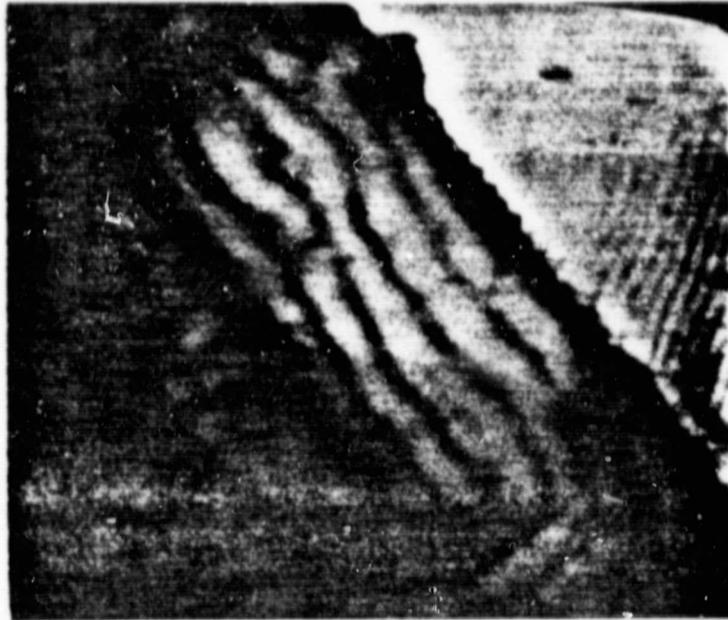
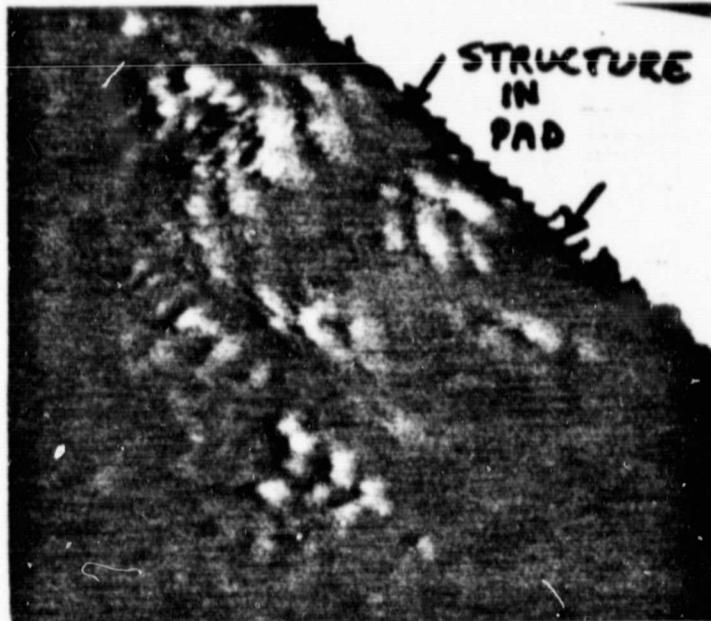
A-17. Neither pad on this solar cell had a tab welded to it. Area a (top) exhibits much better acoustic transmission than area b (bottom).

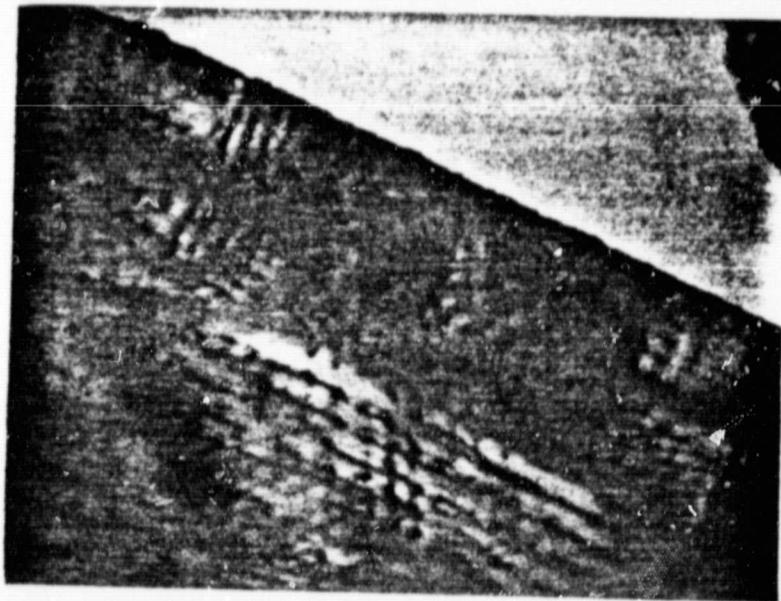
S-1 - Acoustic amplitude micrographs taken on solar cell S-1. The top was taken on area (a) and the bottom from area (b). Both are much more attenuating than the weld areas of the A 1-3 tabs. (b) also contains a great deal of structure. This attenuation difference could be due to the metal-  
lization or the bonding of the pad to the cell.

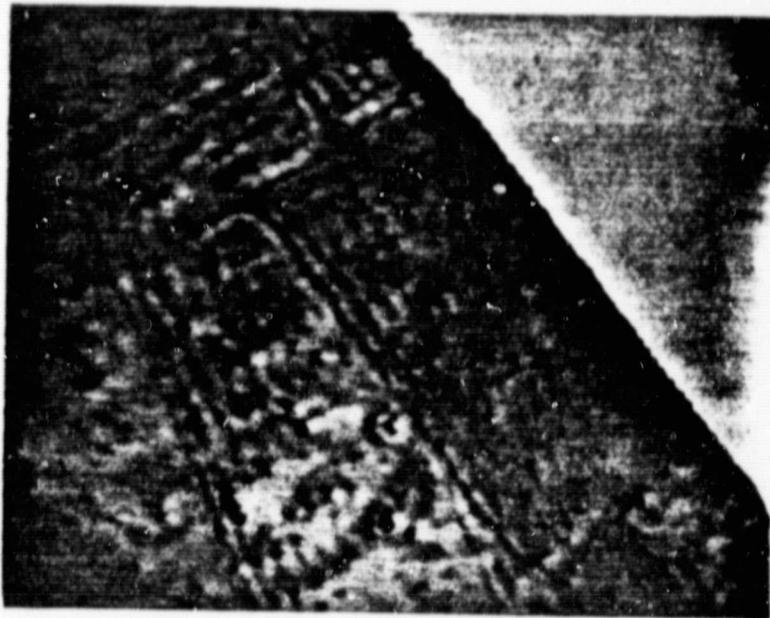
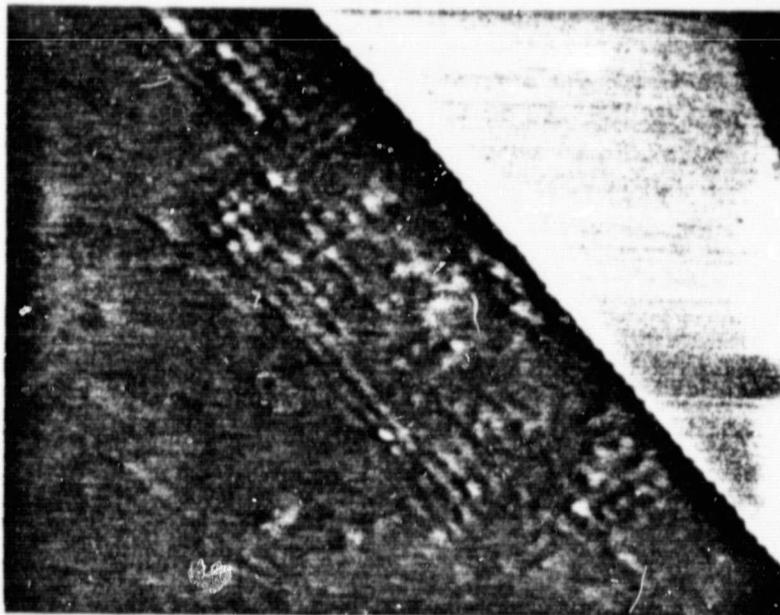
S-2 - Acoustic amplitude micrographs taken on areas (a) top and (b) bottom of solar cell S-2. Both areas contain much texture, although the weld area of (a) appears more attenuating than the cell itself.

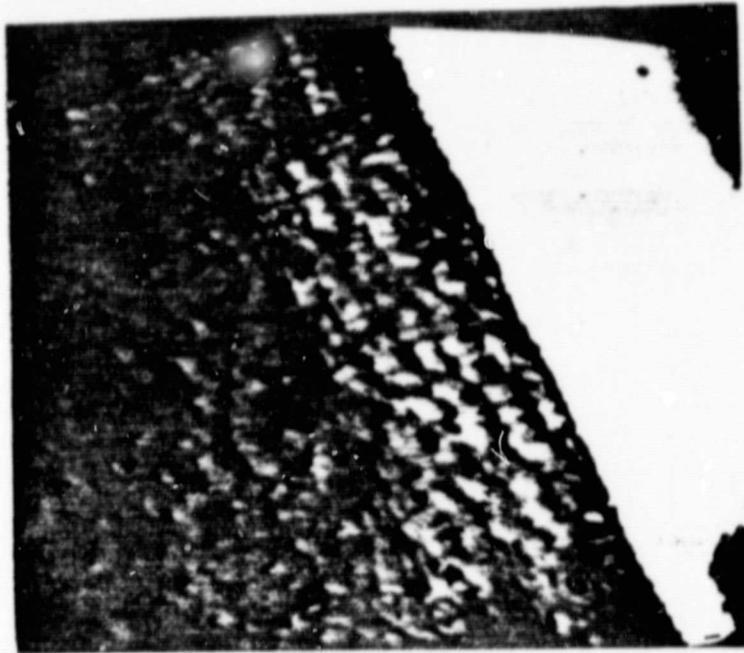
S-3 - Acoustic amplitude micrographs from solar cell S-3. The top was taken from area (a) and the bottom area (b). Both have a considerable amount of structure. The (b) area is outlined due to its low visibility. (b) is more attenuating than area (a).

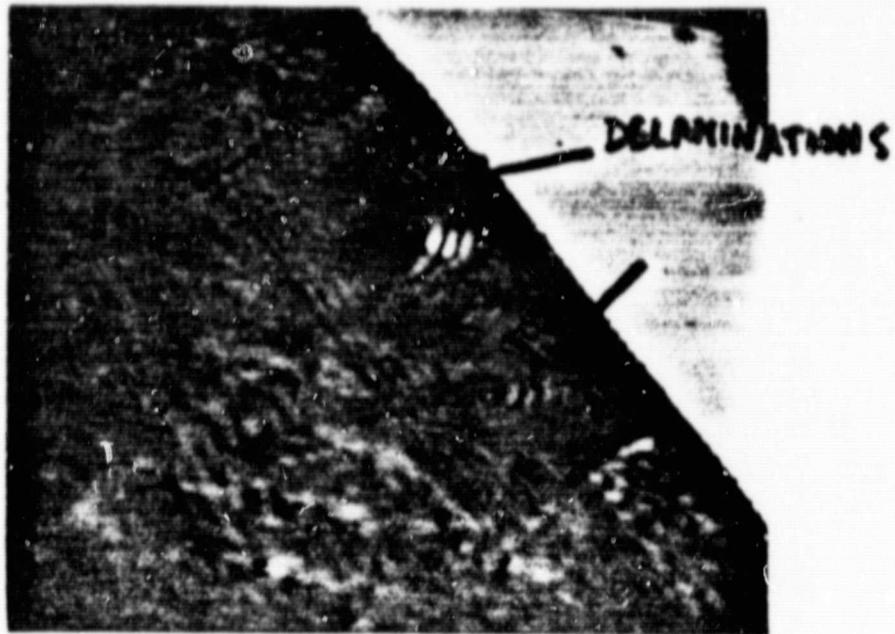
S-5 - Two acoustic amplitude micrographs both taken on solar cell S-5. The top micrograph was taken in area (a) and the bottom from area (b). Two delaminated regions are very apparent in the area (a). Area (b) has considerable structure.

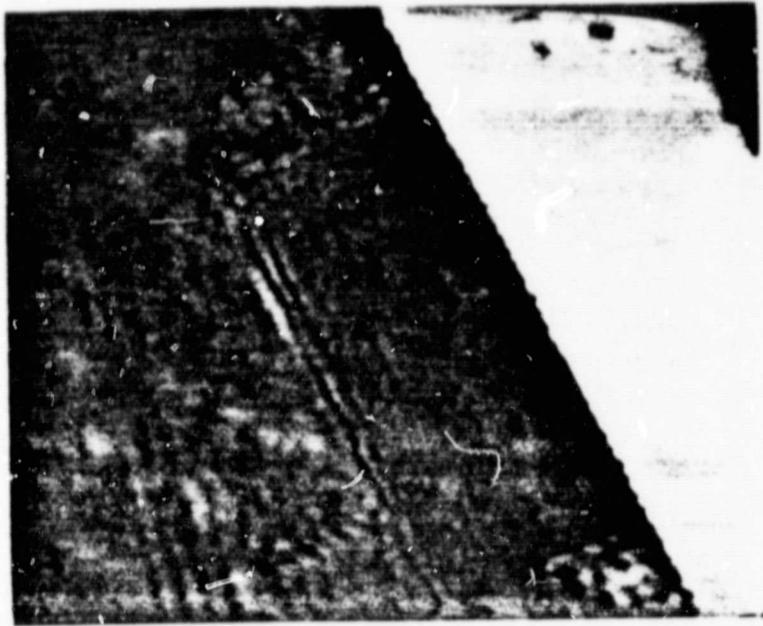
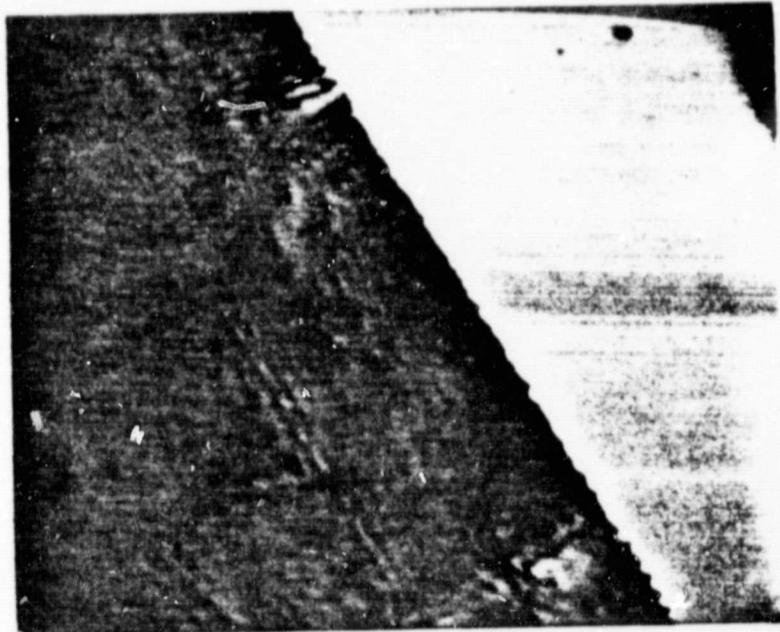
S-6 - Amplitude acoustic micrographs taken on solar cell S-6. The top micrograph taken in area 1 and contains much structure. It is also more attenuating than the cell. The bottom micrograph taken on area (b) and also shows considerable structure.

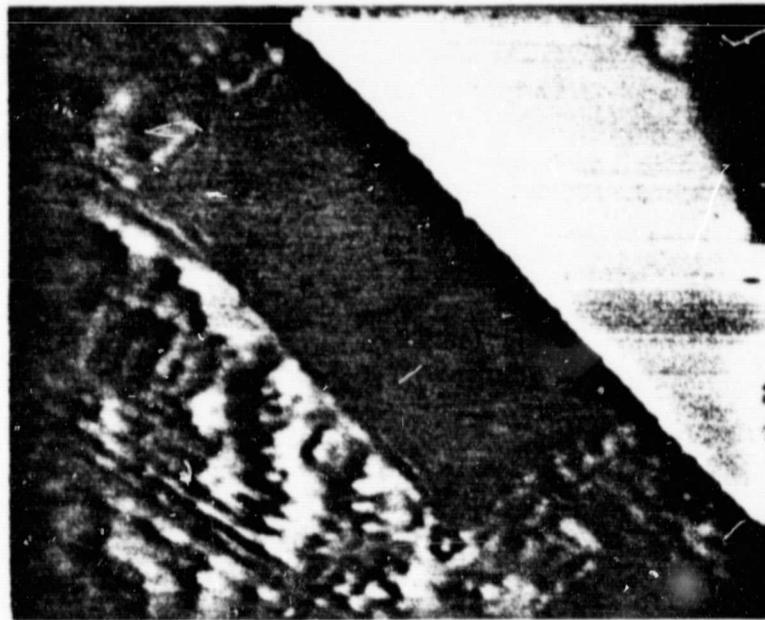
S-7 - Amplitude acoustic micrograph taken on sample S-7. Both areas a and b (top and bottom) show extreme attenuation compared to the solar cell. These areas are considered the worst of the "S" group of cells.

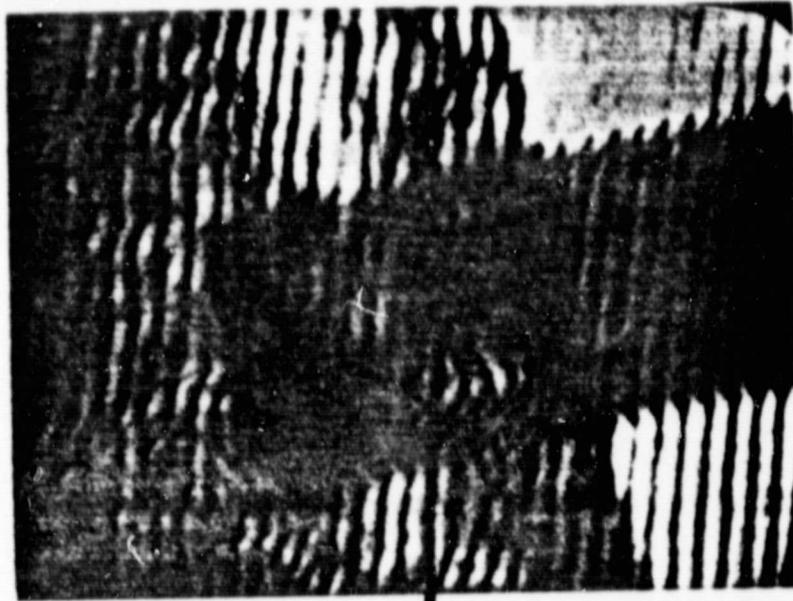
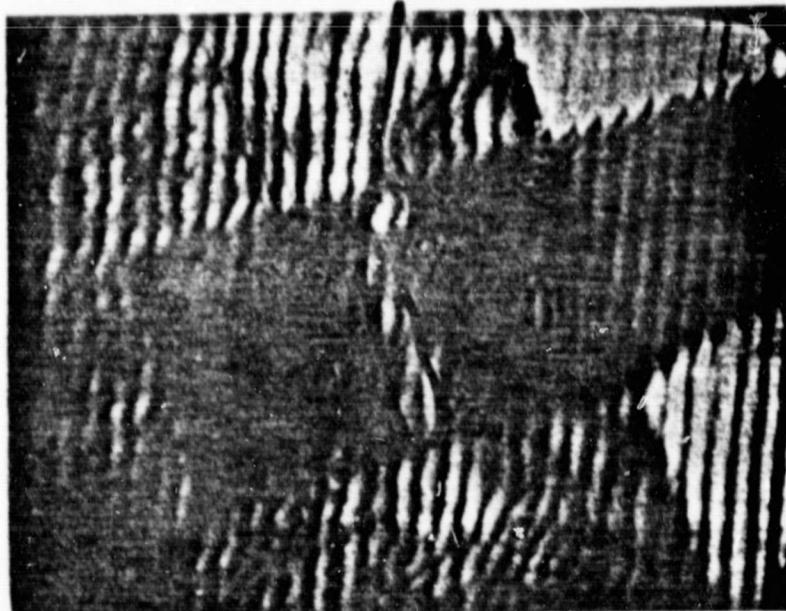
A-5. These acoustic micrographs were taken in the acoustic interferogram mode. Tab a is shown in the top micrograph. Very little acoustic transmission occurs (area of straight coherent fringes). In the lower micrograph tab b has a narrow band of good transmission although the size of area is not very great.

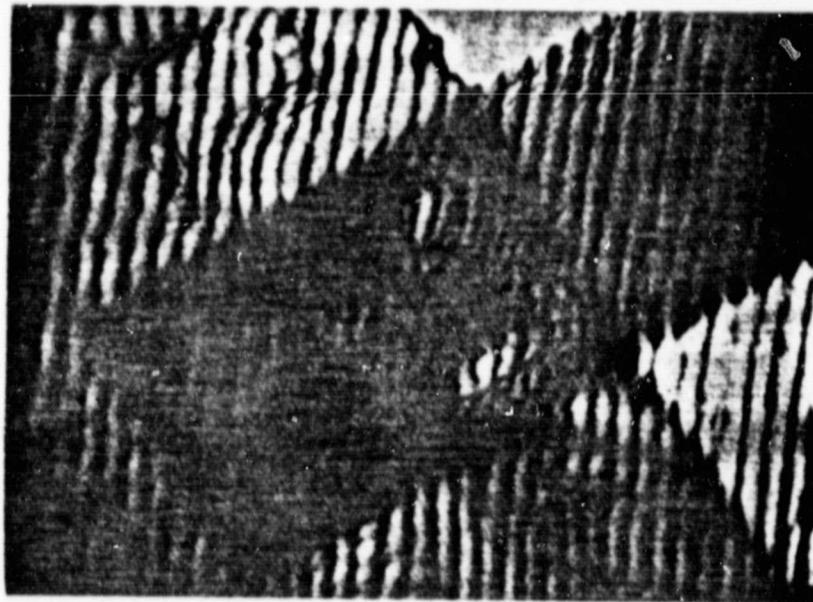
A-6. Both tab a (top) and b (bottom) were taken in the interferogram mode and appear very similar. Two small areas of good transmission occur for each weld area.

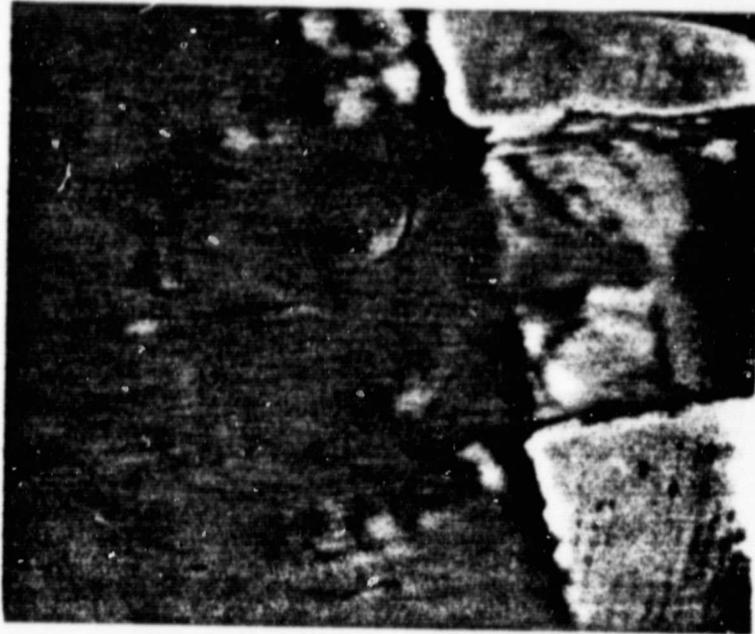
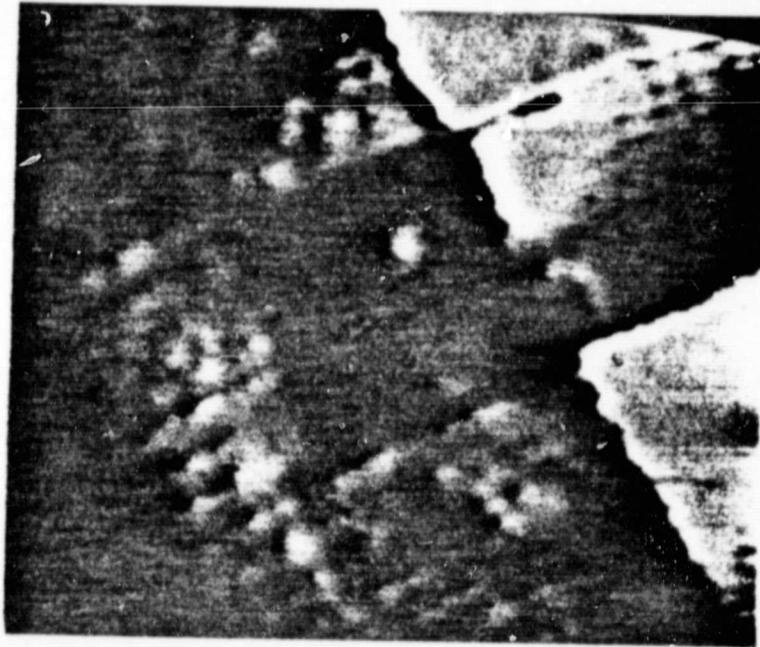
A-12. The top micrograph (tab a) shows several small areas having good acoustic transmission while in the bottom micrograph fewer areas are found (tab b).

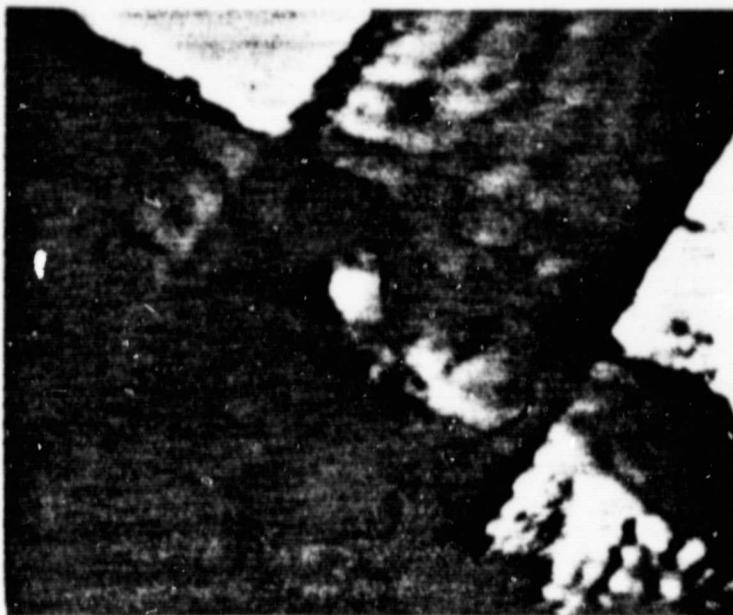
A-13. Top micrograph (tab a) illustrates a fairly large area having good acoustic transmission, while the bottom micrograph (tab b) has a smaller area but exhibits good transmission.

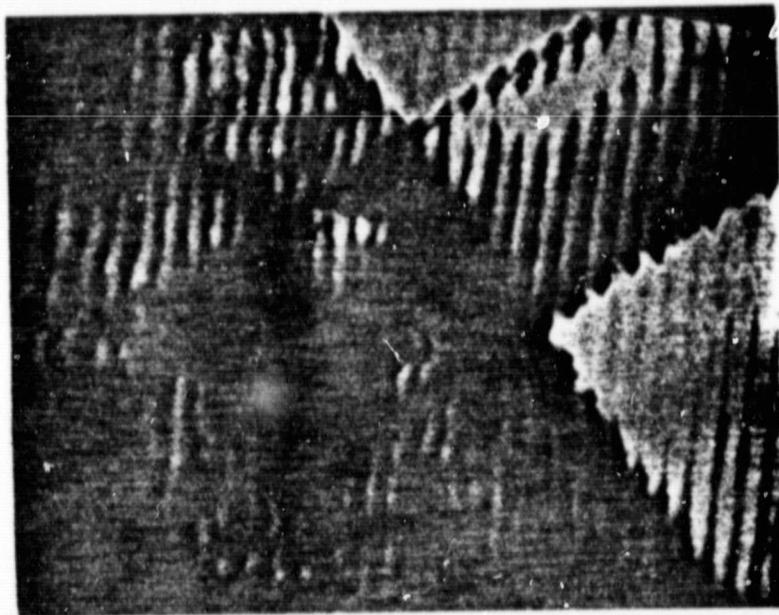
A-20. Both tab a (top) and b (bottom) exhibit similar shaped weld areas although a has slightly larger area of good acoustic transmission.

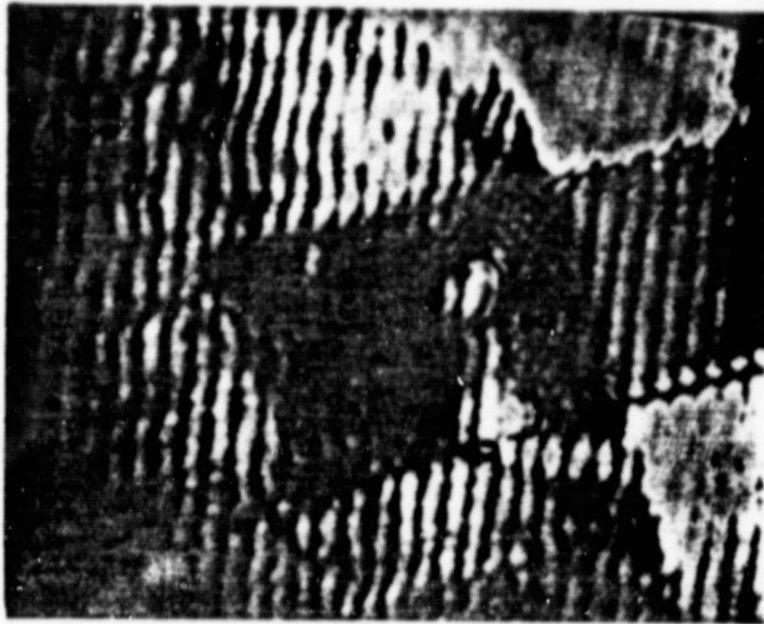
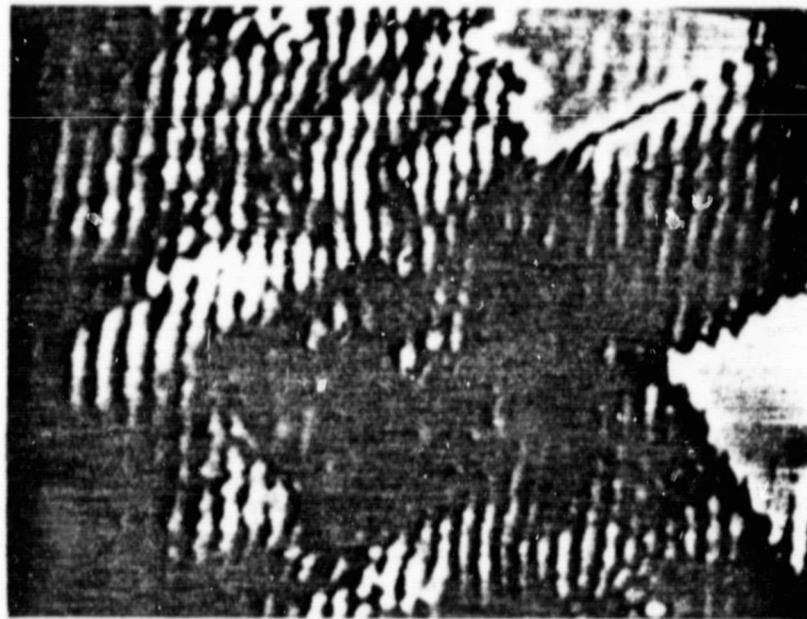
A-23. The top micrograph illustrates the "a" region having good transmission acoustically and fairly large size. The "b" region (lower micrograph) has very little acoustic transmission in the area.

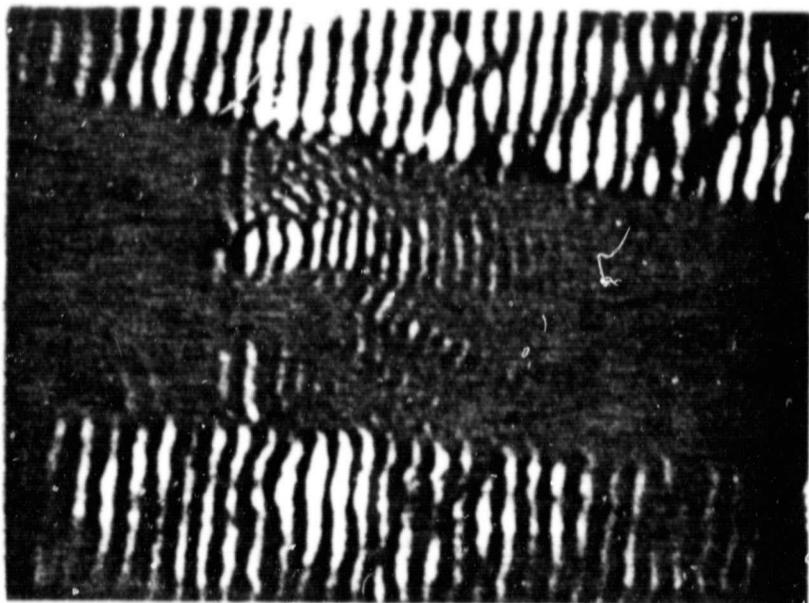
1L

The following micrographs were taken on sample A-7. Two tabs were welded, each in three places on the cell. A sketch is shown for comparing the micrographs to the area of the sample from which it was taken. The tab on the left exhibited three very small well defined weld areas while the tab on the right had very nondistinct areas of weld contact.

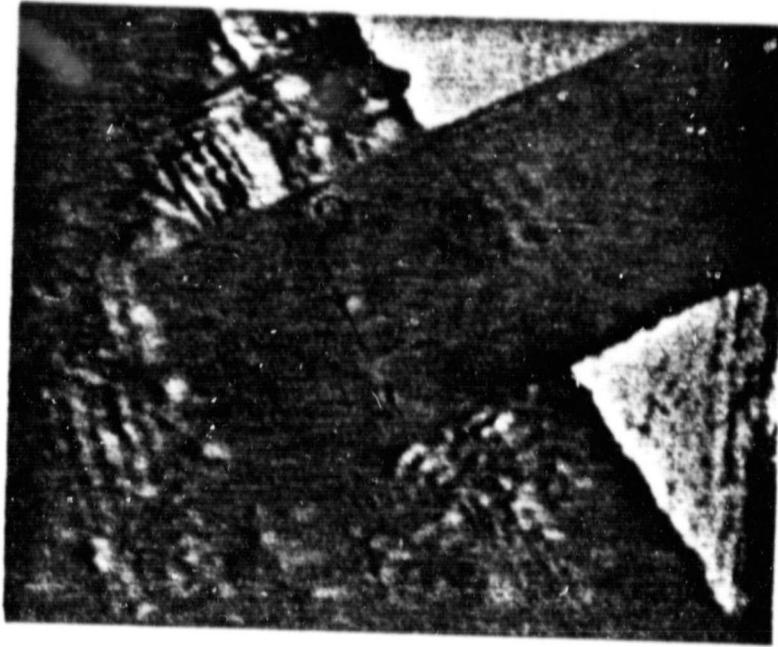
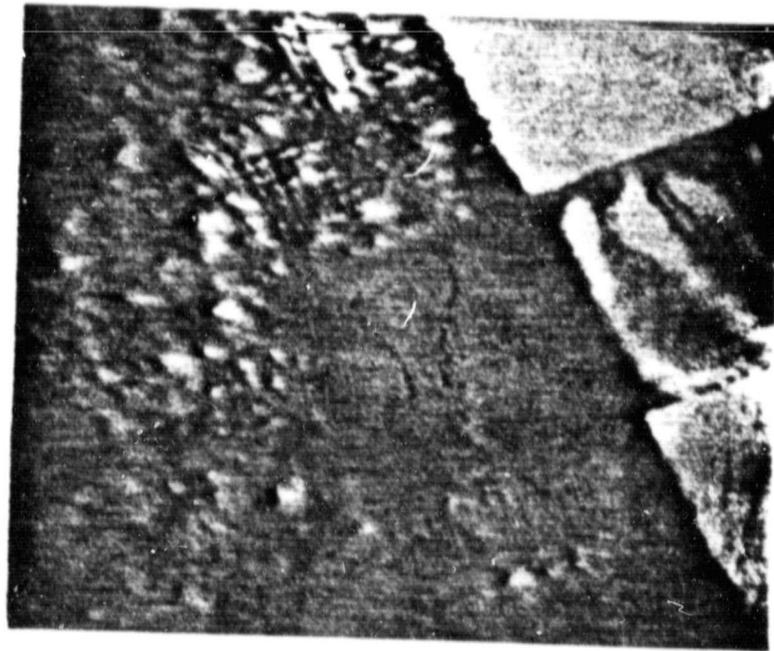
S-9. These two amplitude acoustic micrographs were taken on the weld area of tab a (top) and tab b (bottom) on cell S-9. The pad area exhibits much structure and the weld area appears fairly small. Both a and b are similar to each other.

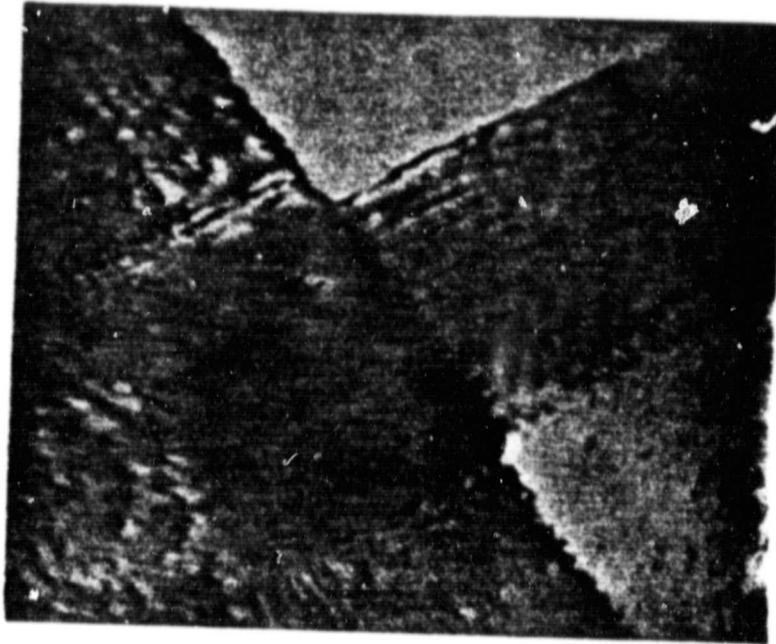
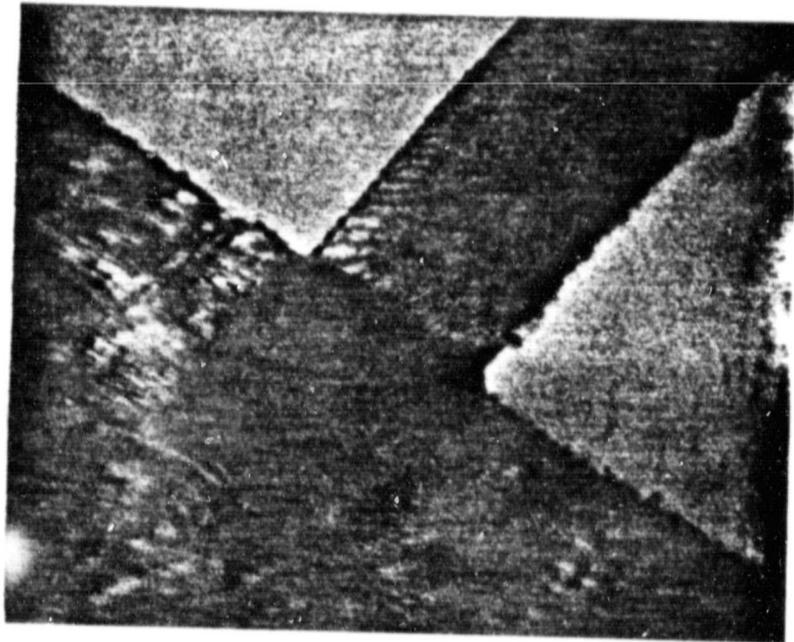
S-10. The top micrograph taken on tab a and the bottom tab b appear to have two very small weld areas. The acoustic transmission is also very poor.

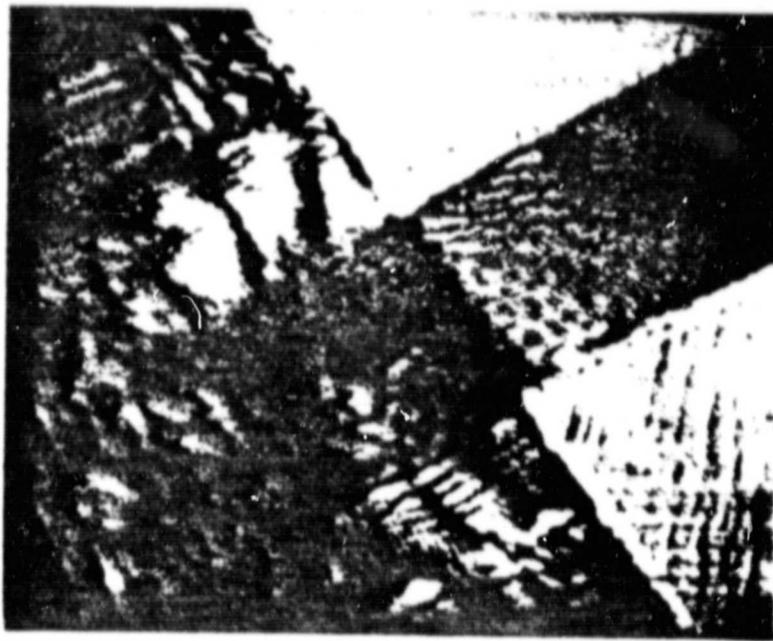
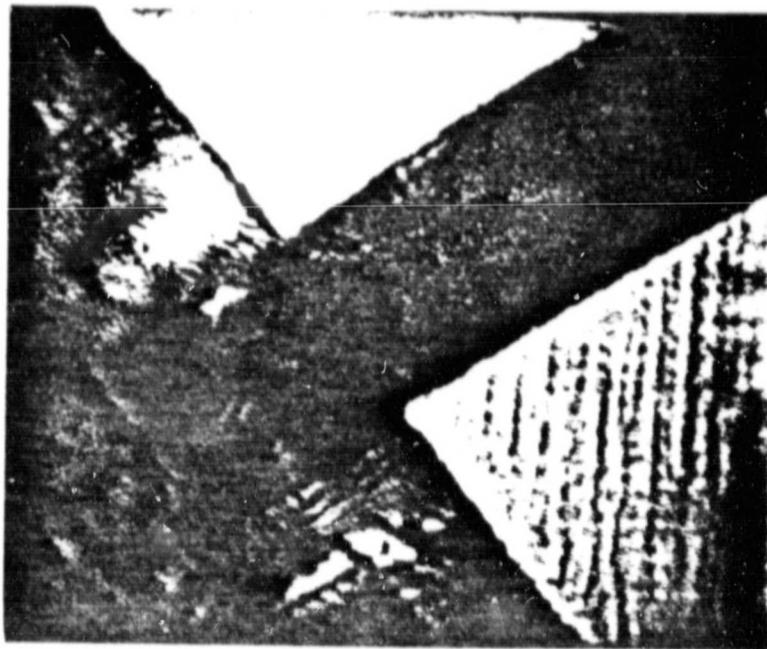
S-11 The top micrograph taken on tab a exhibits fairly good transmission over a rather large area of contact. The lower micrograph (tab b) does not have a very well defined area of transmission.

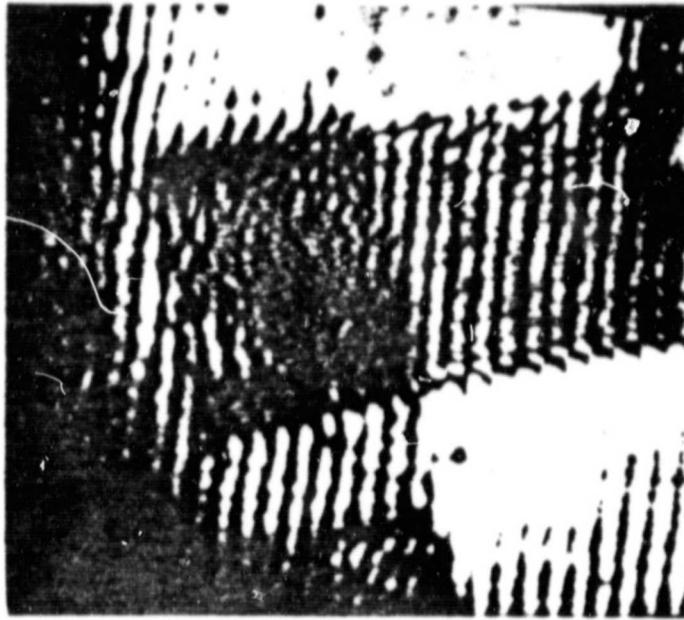
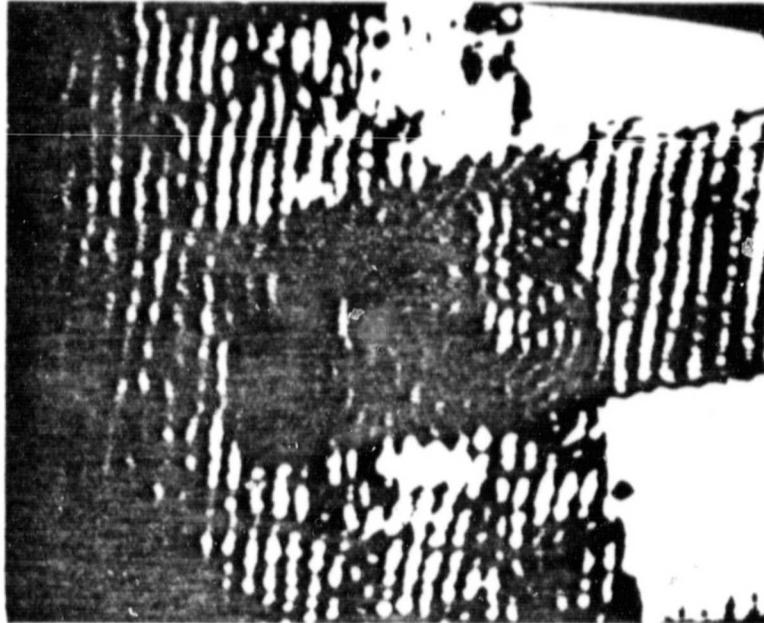
S-12. Neither tab a or b appears to have very good acoustic transmission in the weld area. Both pads have much better transmission than has normally been found in cells of this group. Tab b extends further into the sample than a and has an area with some transmission although the interference fringes are squiggled.

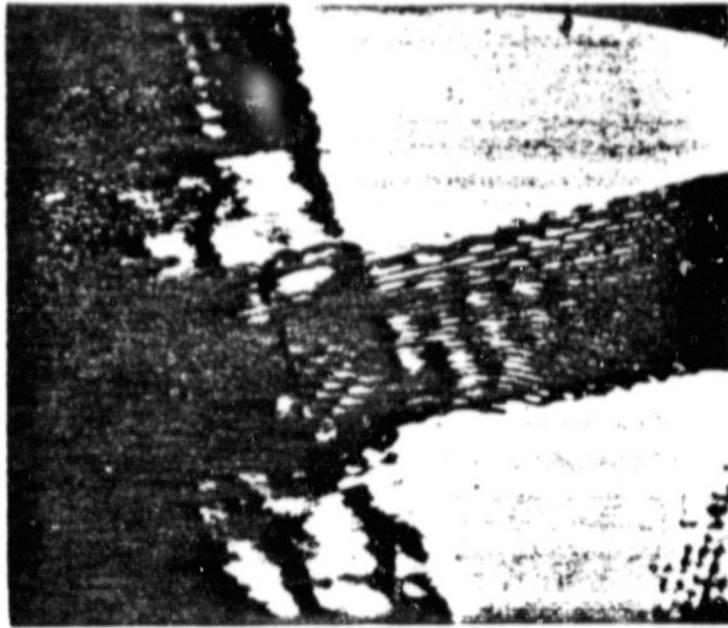
S-13. The top micrograph, tab a, exhibits much better transmission in the pad area and along the edges of the tab in the welded area than does b (bottom).

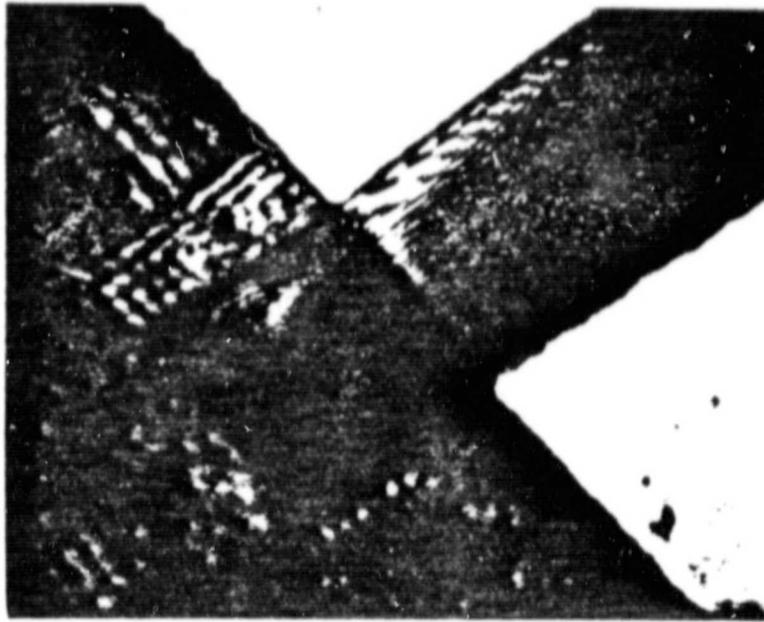
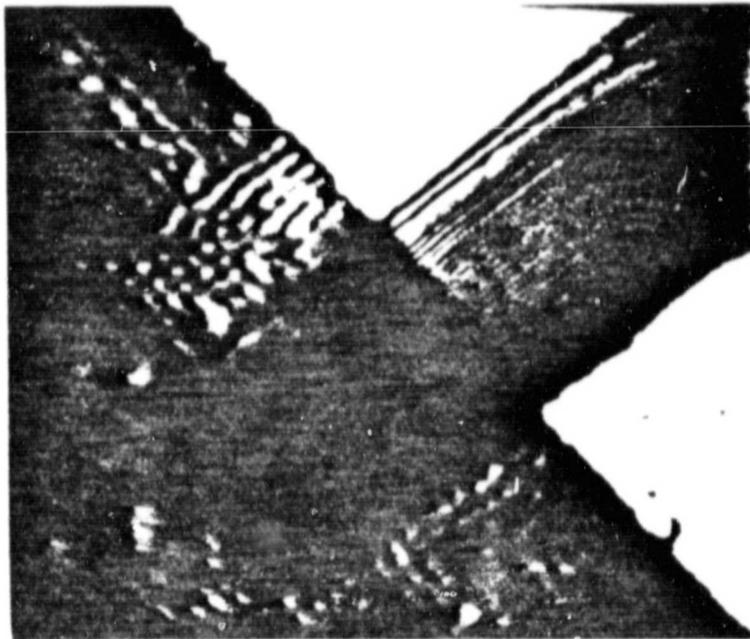
S-14. The overall structure of these pads appears more homogeneous than found in the other cells. Two large areas of contact are visible in tab a, while much less area is visible in tab b.

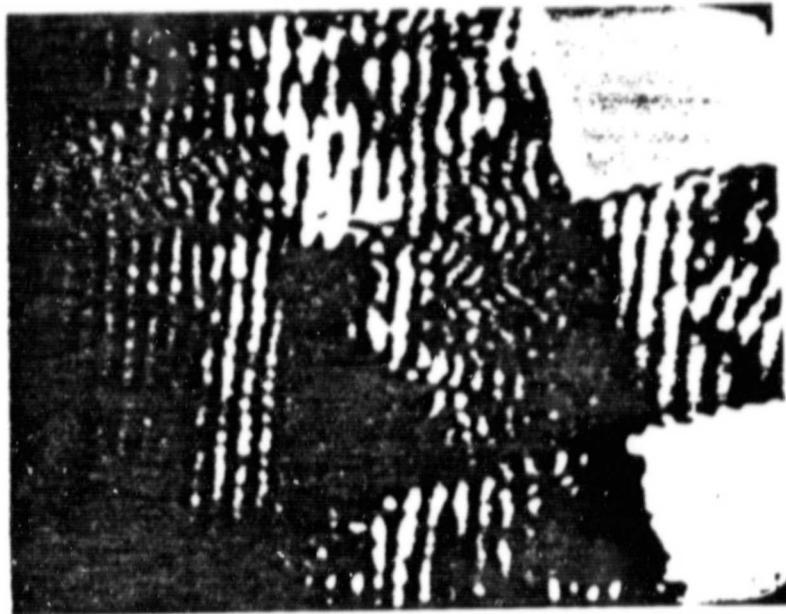
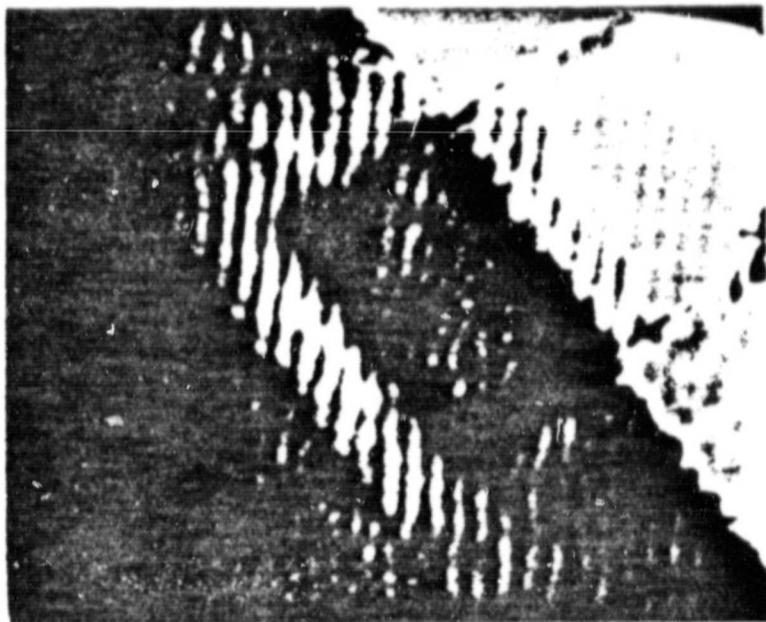
S-15. These micrographs illustrate the weld areas of both a and b tabs. While a (top) has only a very small area with some transmission, b (bottom) has relatively none.

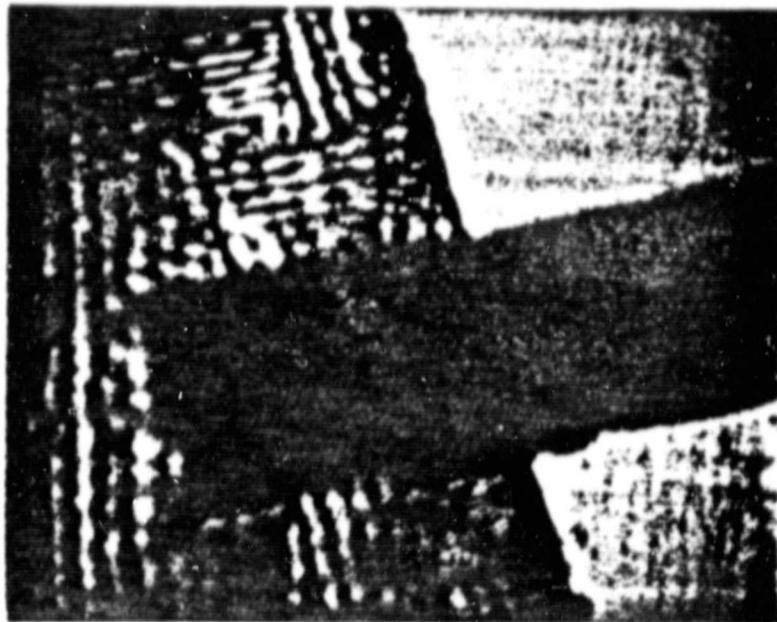
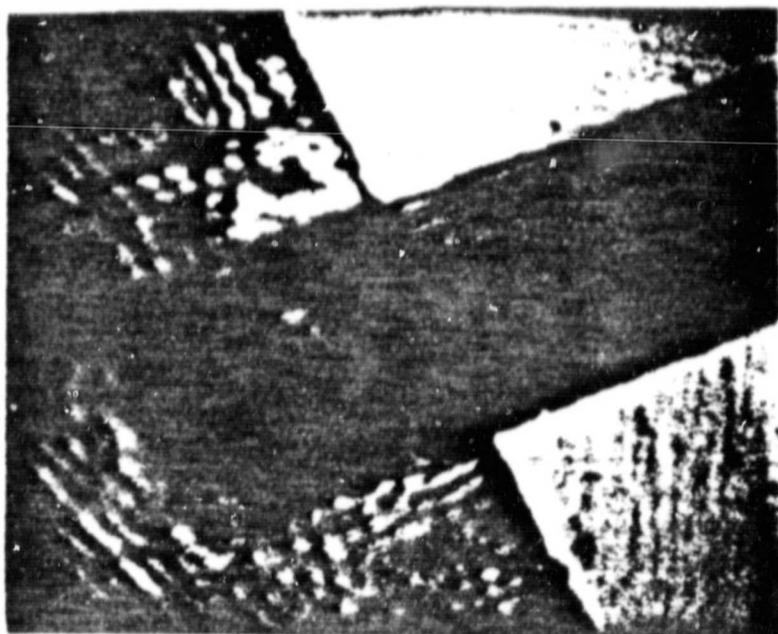
S-17. The structure of these cells also appears very clean compared with others labeled "S". The area of contact in a (top) is rather small and is much larger in b (bottom).
