**EXAMINATION OF SILICON SOLAR CELLS**

**BY MEANS OF**

**THE SCANNING LASER ACOUSTIC MICROSCOPE (SLAM)**

REPORT #R117

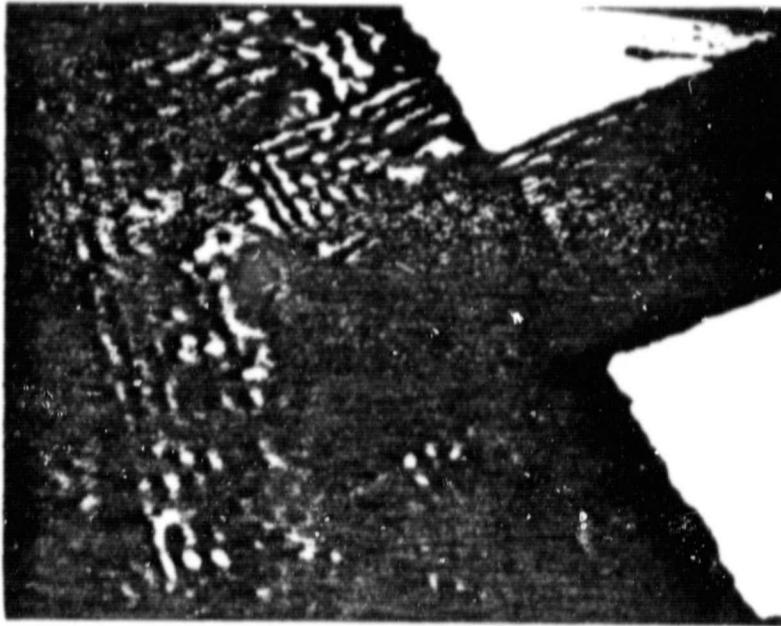
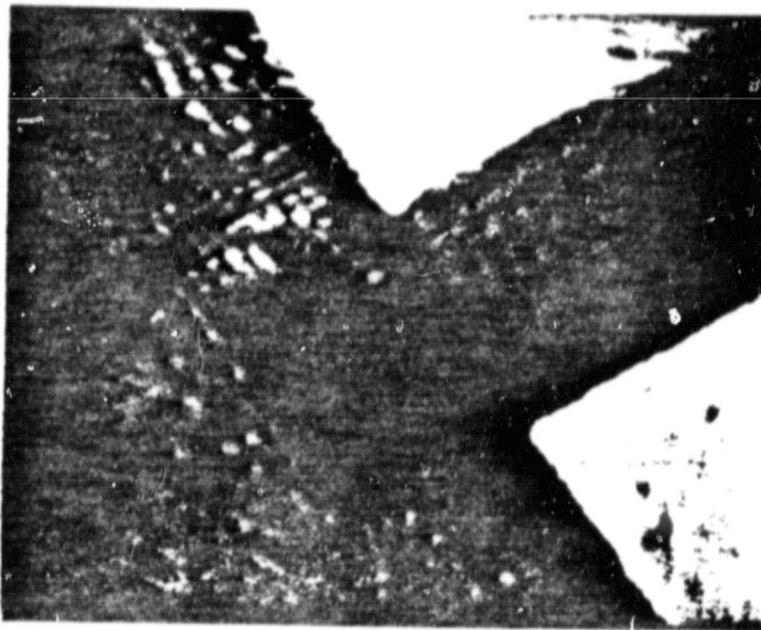
S-18. The top micrograph was taken on tab a where many small areas of contact are visible. In b, two larger areas are found near the edge of the tab. There is much structure in the cell itself.

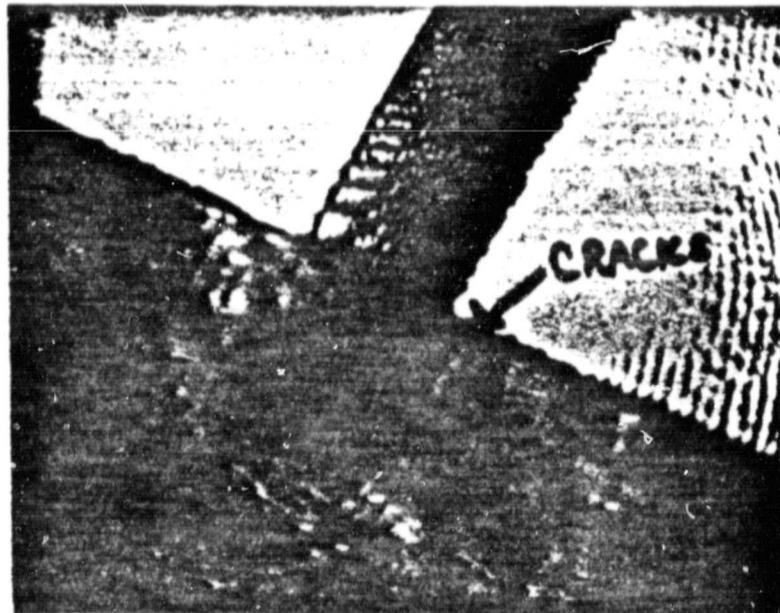
S-21. The tabs attached to this cell were different sizes as illustrated tab a (top) and tab b (bottom). A fairly large area of contact is found in a, while b is considerably smaller and more attenuating. A possible crack extends into the pad of b (circled).

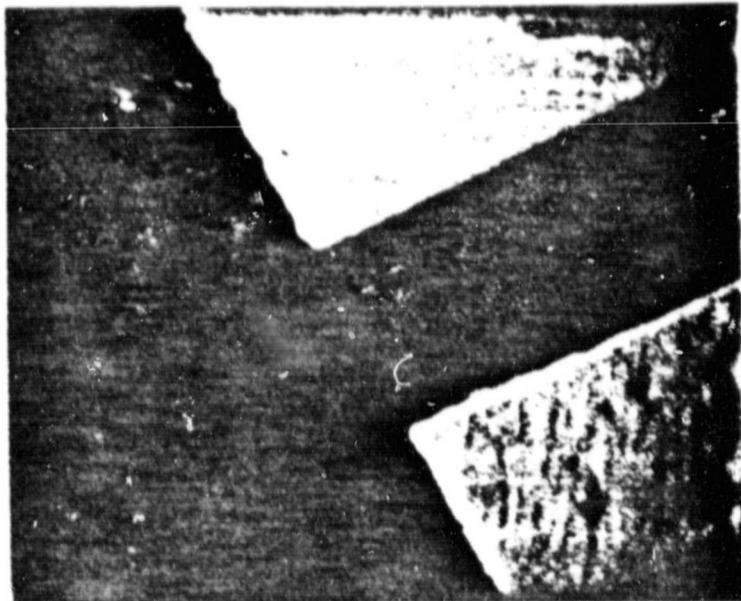
S-22. Two fairly large areas of contact are present in tab a (top) while almost no acoustic transmission is found in the weld area of tab b (bottom). The transmission is very poor in a, although a small amount of contact is assumed.

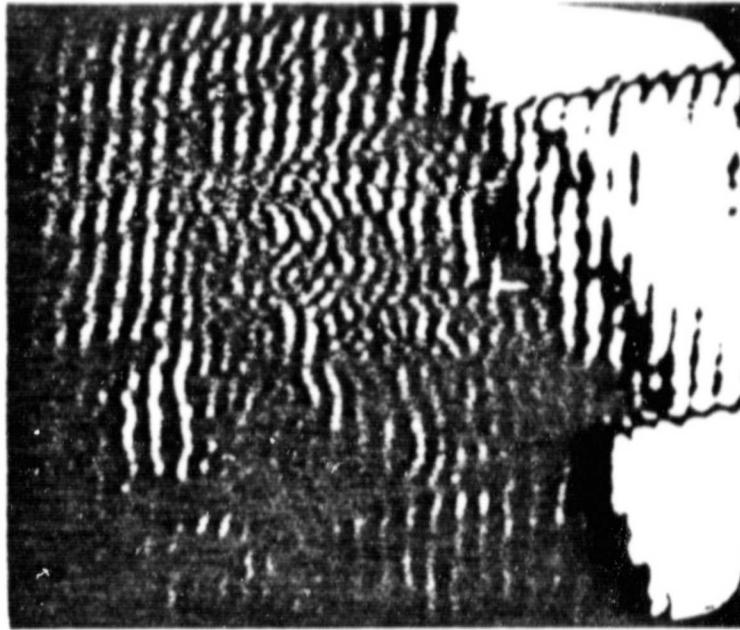
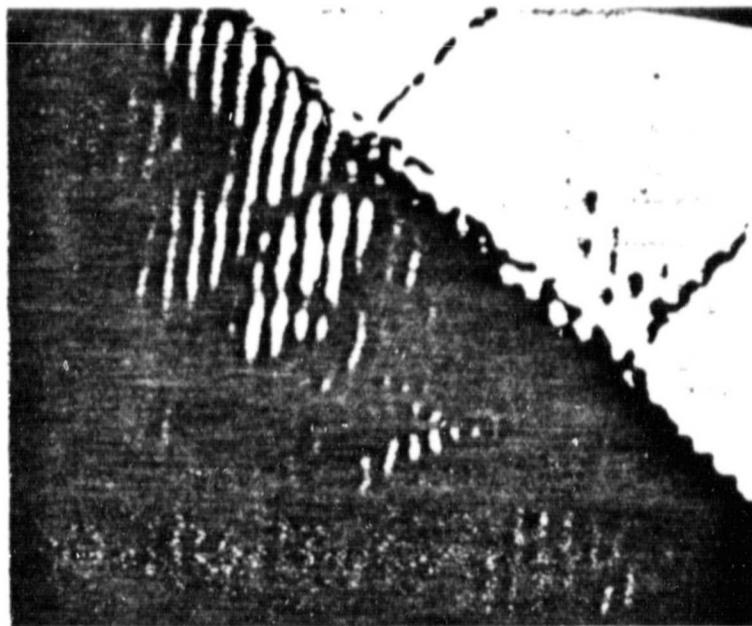
C1C1 a, b These two micrographs were taken on the tabs welded to the top surface. The top micrograph (tab a) exhibits more attenuation than was found in the bottom (tab b). Overall, the level of acoustic transmission is less due to the addition of the glass cover plate.

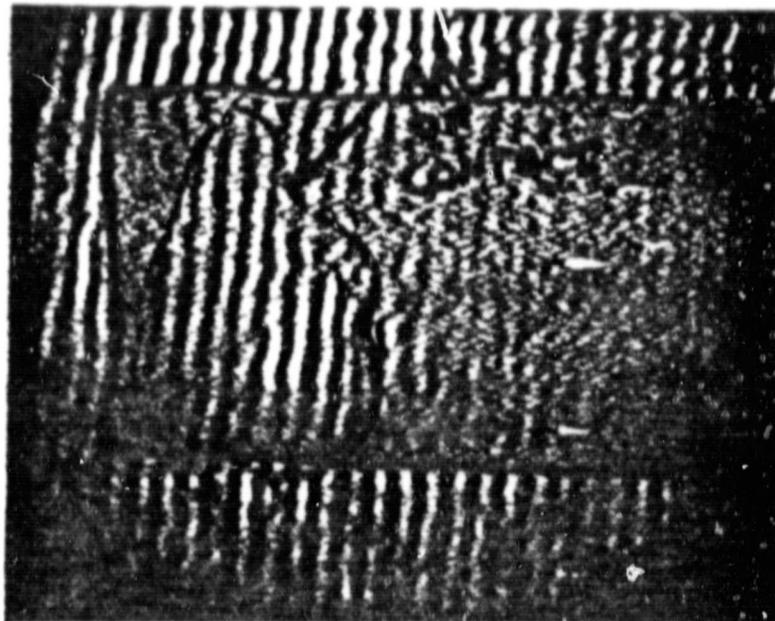
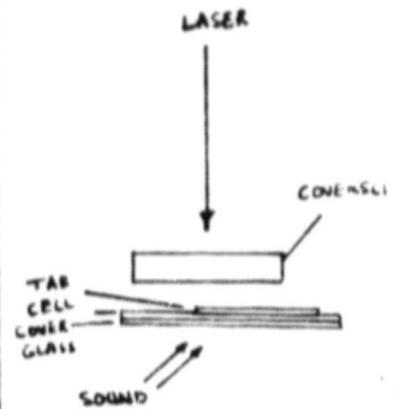
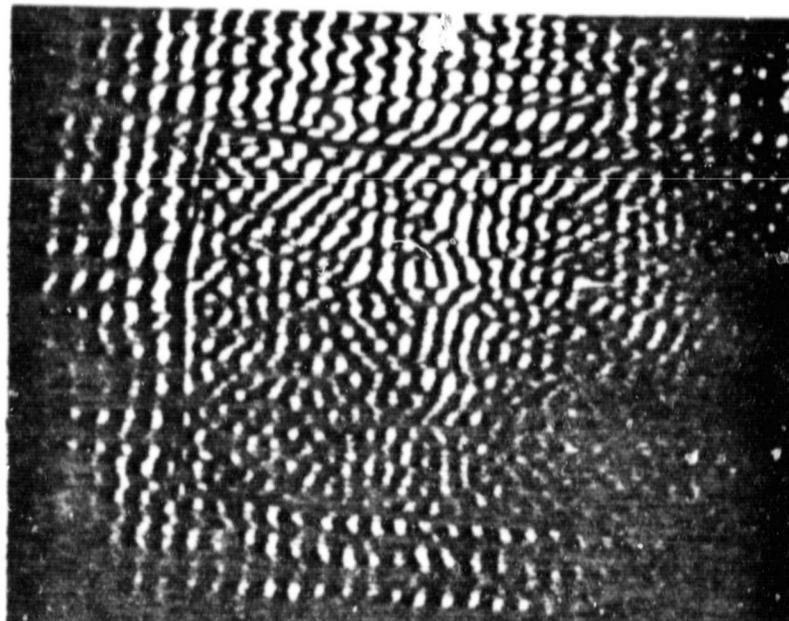
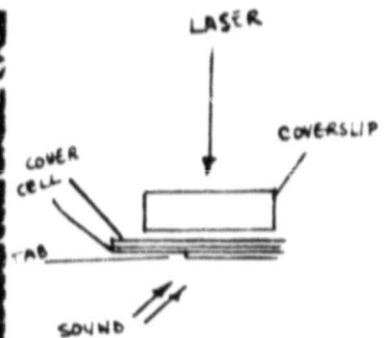
C1C1 c The top micrograph was taken with tab c on the side closest to the coverslip. In the lower micrograph the cell was flipped over and the tab was closer to the transducer. Better definition of the weld is noticed with the tab nearest the detection plane. Mode conversion and reverberation in the glass plate add to the structure and the scrambling of the fringes in the lower micrograph.

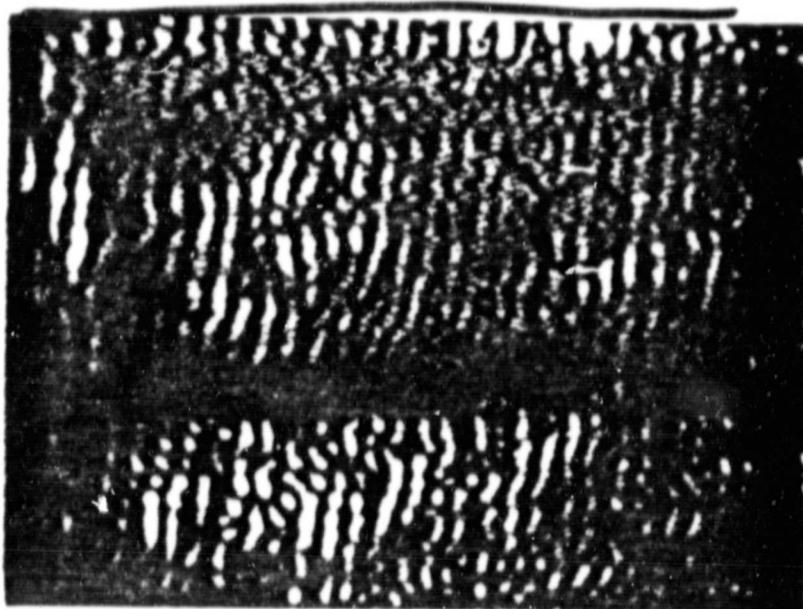
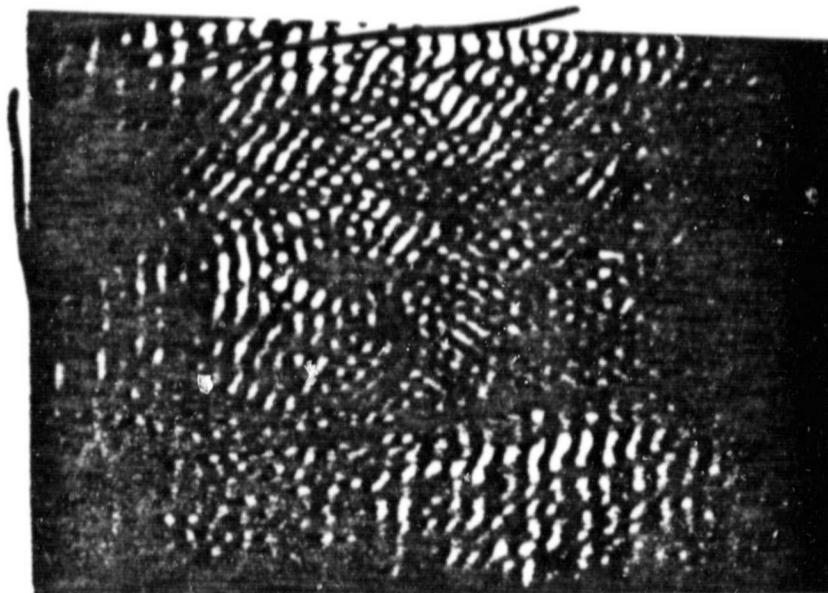
C1C1 d      The top micrograph illustrates the tab close to the coverslip and the lower, closer to the transducer. Better transmission occurs in tab d than in c (insonification geometry same as in tab c - see sketches).
