NASA CR-166704

SPACE TELESCOPE DIGICON TECHNOLOGY

FINAL STATUS REPORT

Hemmo R. Alting-Mees
Electronic Vision Co.
A Division of Science Applications, Inc.
11526 Sorrento Valley Road
San Diego, California 92121

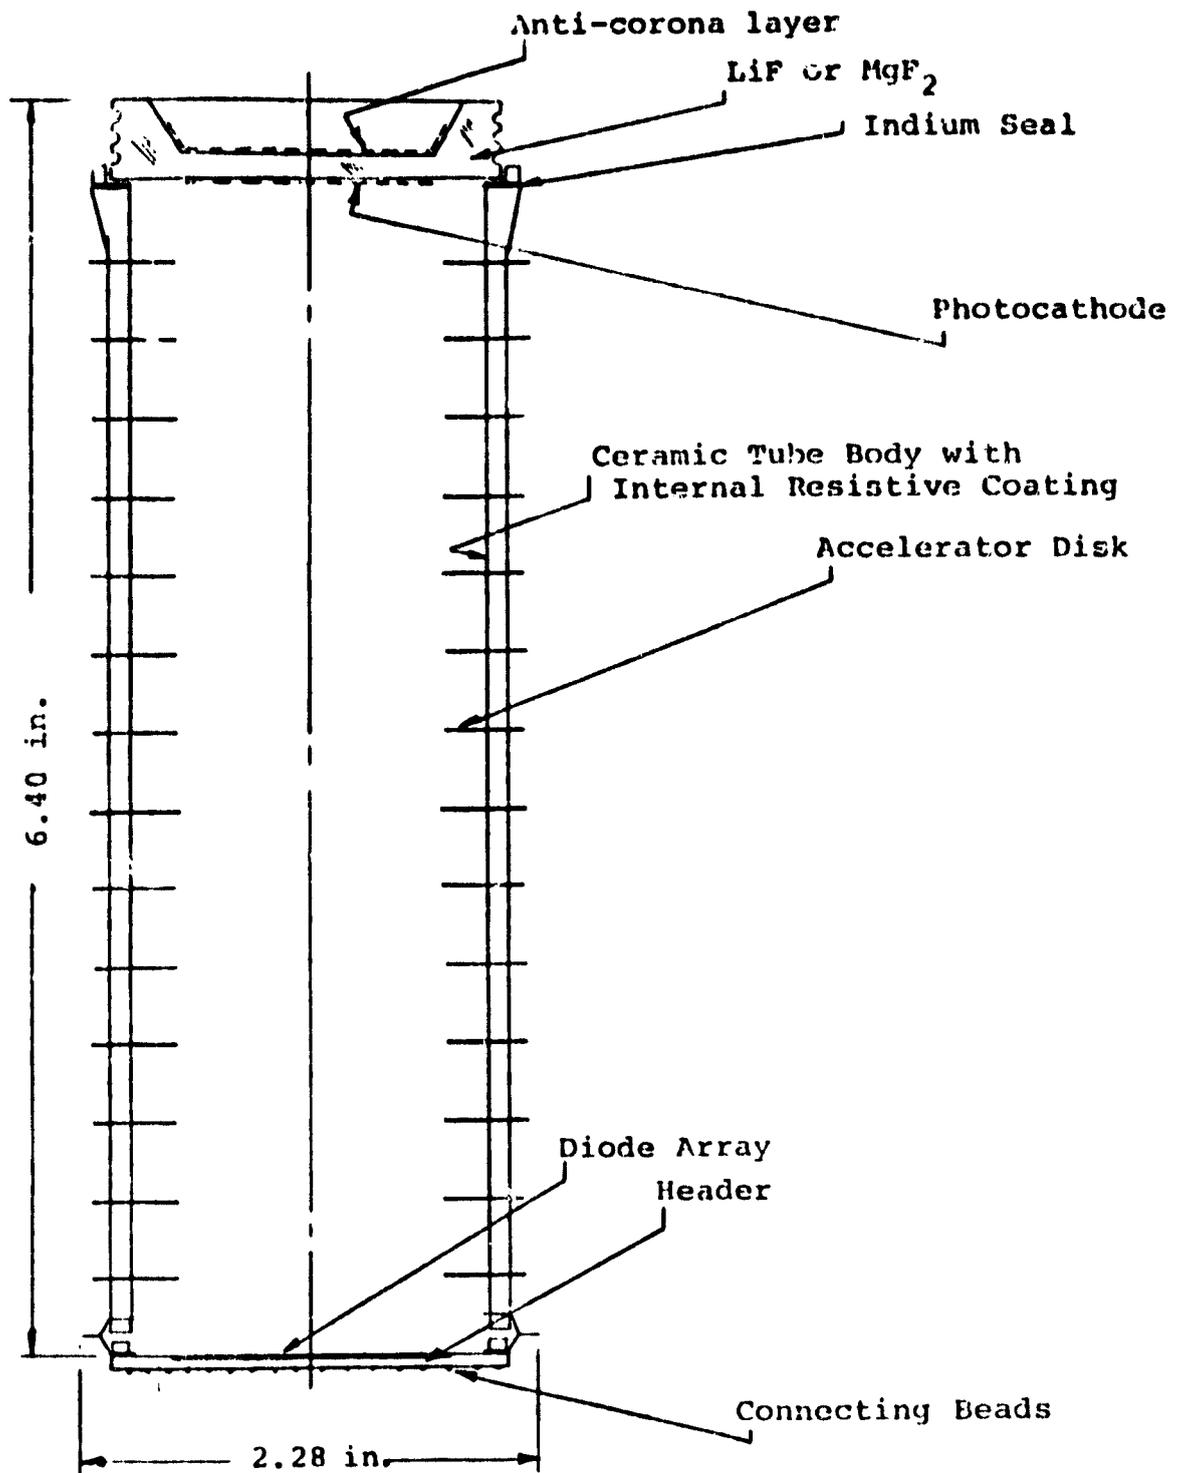
FIGURE A

512 DIGICON

The design of the 512 Digicon was based on that proposed to UCSD and completed on a previous contract. The configuration was changed to accommodate the special MgF_2 and LiF crystals used for the faceplate. This design, shown in Figure A, remained substantially unchanged through the program.

The design for the faceplate is as shown in Figure A. This design accomplishes the criteria of minimizing the thickness while maximizing the structural strength. For lithium fluoride with a yield point of 1500 psi the thickness is critical and calculations show a safety factor greater than 1.0 for a 3 mm thick 1.8 in. diameter faceplate unclamped. With the additional rigidity supplied by the 1 cm thick rim, this safety factor could increase to greater than 2.0. Magnesium fluoride has an unknown yield point, but its elastic constant is much greater than LiF and 3 mm thick faceplates of 2 in. diameter have been used at EVC with no noticeable structural problems. It is thus conceivable that the MgF_2 faceplates could have reduced thickness, but in order to maintain commonality with the LiF it was decided that additional transmission was not worth the problems of trying to match tubes with different windows in the flight package. A 3 mm thickness was thus considered standard.

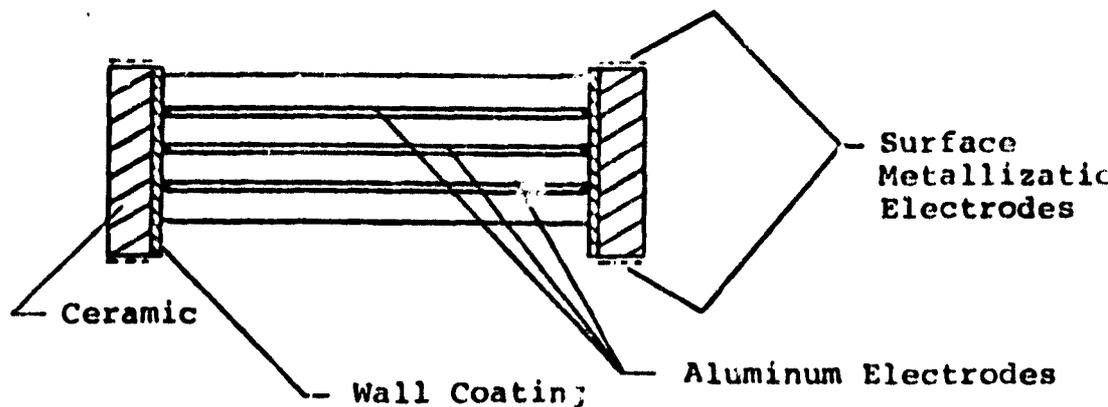
FIGURE B

SECTIONED CERAMIC RESISTANCE MEASUREMENTS

EVC Ceramic Ring No.	Current in 10^{-9} A at 2.5 kV				Comments
	Section				
	1	2	3	4	
162-1 (1kV)	6,400	38,000	34,000	6,800	Too Thick
162-2 (1kV)	200	900	500	360	Too Thick
162-3	7.6	5.1	3.2	5.8	Improved
162-4	21	24	28	7.5	End Thin
162-5	.8	.9	.9	.9 to .5	Unstable
162-6	75	175	175	145	End Thin
162-A	1.4	5.1	5.1	4.1	End Thin
162-B	1.2	7.1	6.8	1.6	End Thin
162-C	.9	1.7	1.6	1.1	Improved

The main task was to develop a rugged and uniform coating for the interior walls of the ceramic tubing. The initial results are shown in Figures B and C and as can be seen, two problems

arose. The first was that each ceramic varied from the other showing poor consistency. The second was that the uniformity, as measured vertically down the inner wall, was inadequate. The objective had been to produce a surface with a uniformity approaching 30% and a resistance between 10^{10} and 10^{13} ohms. As can be seen, variations greater than this occurred.

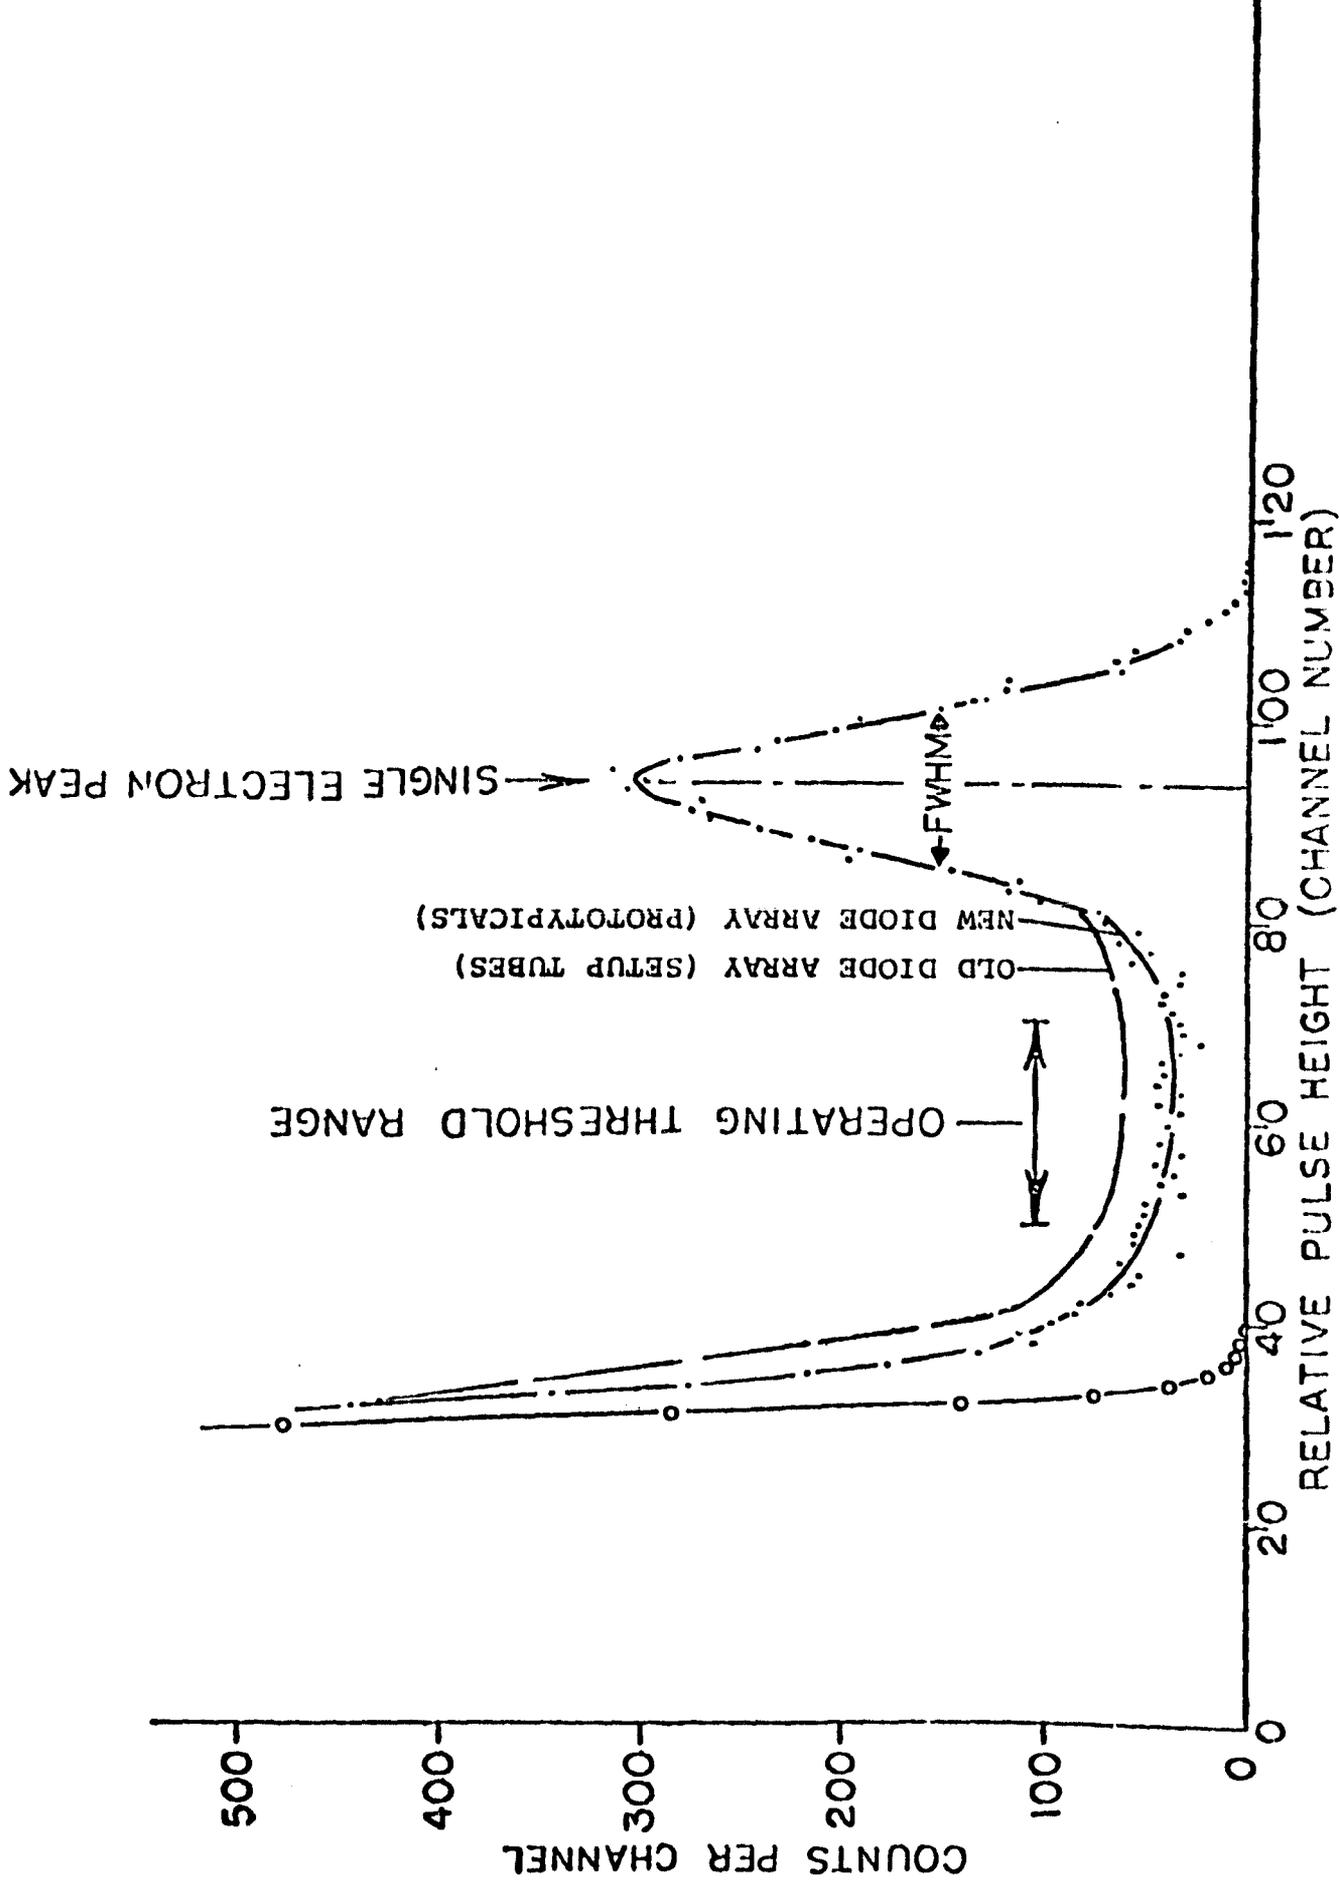
FIGURE E

SINGLE ELECTRON PULSE HEIGHT DISTRIBUTION

The new design, Figure D, diode arrays were obtained for these tubes and indications were that the pulse height distributions, Figure E, were superior to the previous design, Figure F. This was a significant design improvement justifying the effort made. The reason for the improvement was redesigning of the masks so that no aluminum covered the sensitive area of the diodes. The "old" array design resulted in a pulse height distribution (PHD) where the valley was partially filled. This was due to electrons penetrating through the aluminum layer and generating single pulse signals of lower than normal gain due to energy loss in passing through the aluminum. This aluminum overcoating was covering the diodes at the edges and enough signal would be generated that the peak-to-valley reading would not be acceptable. In order to improve the PHD of a tube made with such a diode array it would be necessary to shield the incoming radiation on the outside of the tube faceplate such that only a narrow slit of electrons would strike the diodes in the area clear of the aluminum pads. This is not practical. The new design solved this problem, and the change was incorporated in the diode array design and specification.

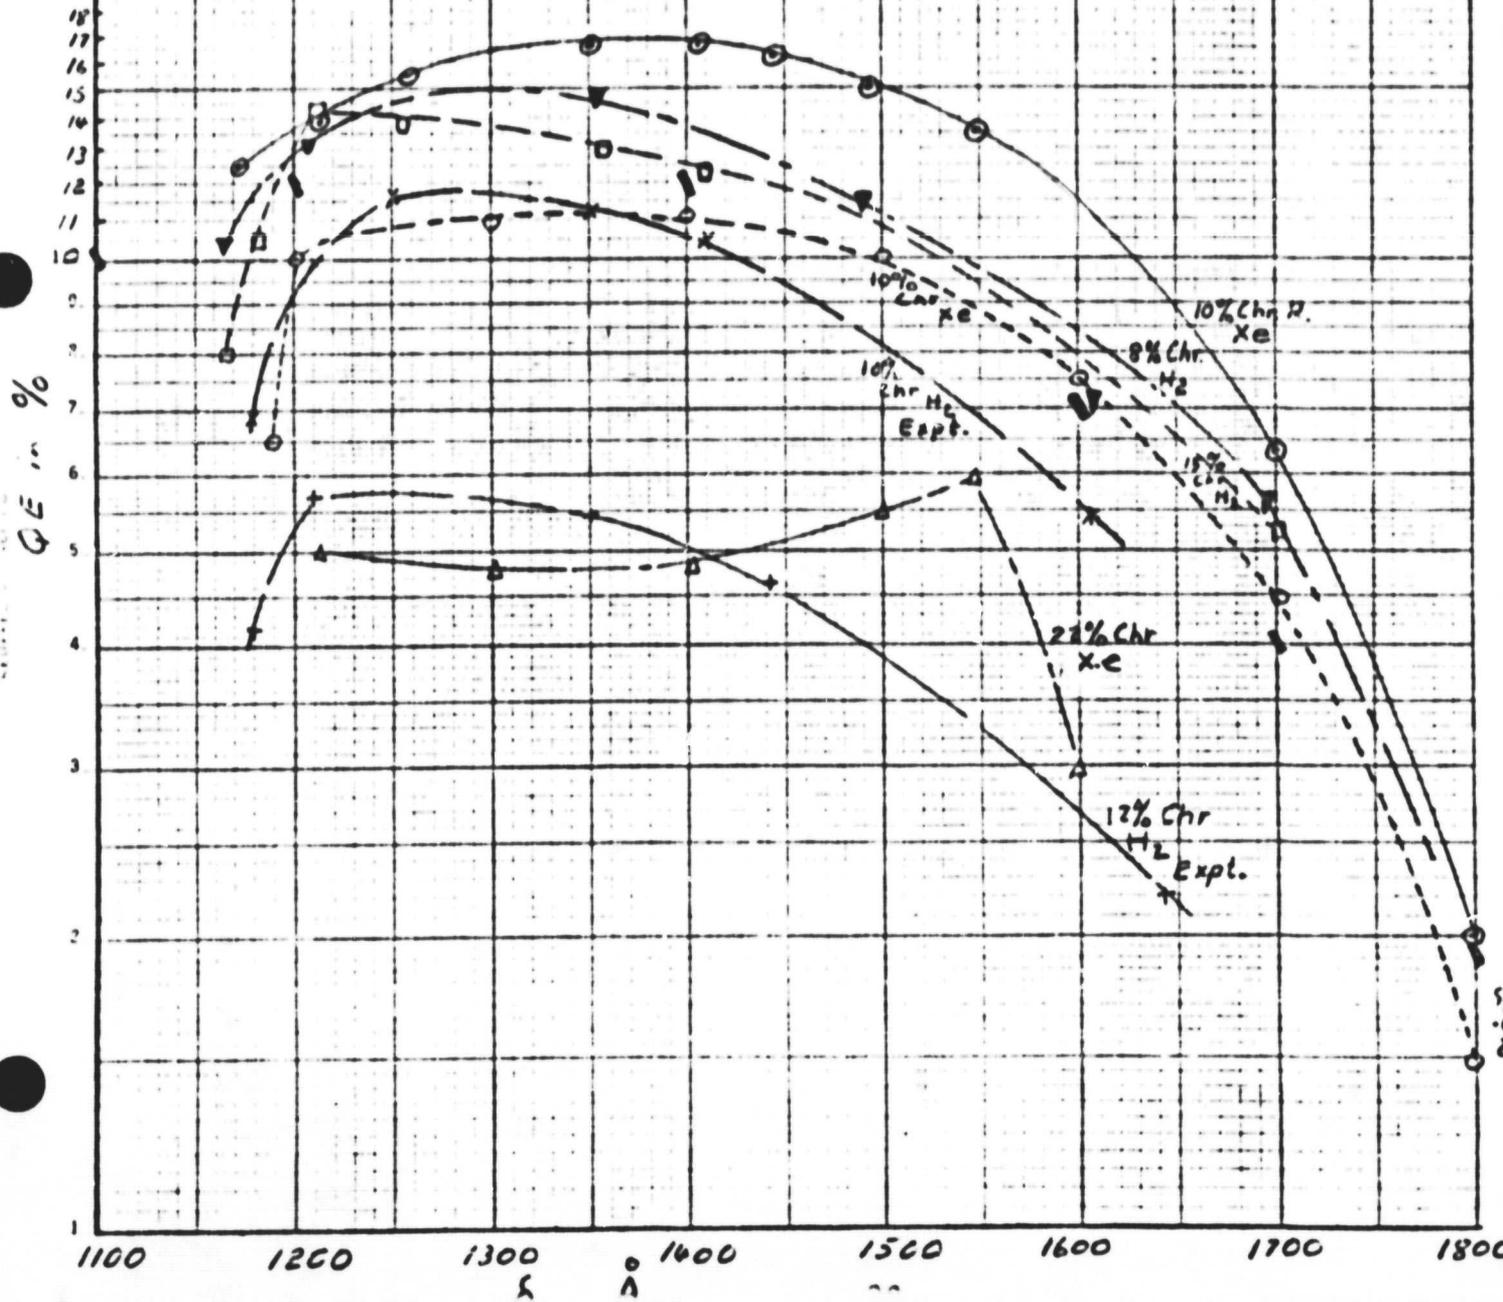
FIGURE H
CsI PHOTOCATHODES (NASA DATA)

△	473-3	shortly used
○	479-3	E2
□	481-3	E3
*	491-3	shortly
▲	492-3	shortly
□	494-3	shortly
▼	495-3	E9
◆		Specification

The quantum efficiency of all tubes, Figures H and I, showed that reasonable process control had been achieved. However, the curves showed that at less than 1216 Å the CsI cathodes were sharply below specification. This could have been due to measurement error (the NASA UV monochromator needed a major overhaul and readings below 1200 Å were suspect) or due to an absorbent or reflective surface layer with sharp cutoff characteristics. This still needs to be evaluated and tests on UV transmission of the faceplate metal undercoating will characterize the degree of cutoff.

In the case of CsI on LiF the biggest problem was thought to be cleanliness. The great affinity of LiF for water is seen as a fundamental problem. This was approached with the concept of using an abrasive cleaning operation with an anhydrous vehicle followed by a high temperature vacuum bake. It is believed that this approach worked well since the QE at 1216 Å (a main guide-point) was acceptable. There is a question, however, of the probability of some water molecules firmly bound in the surface which affects the growth of the CsI photocathode surface. Other cleanliness aspects have to do with purity of materials and general parts cleanliness.

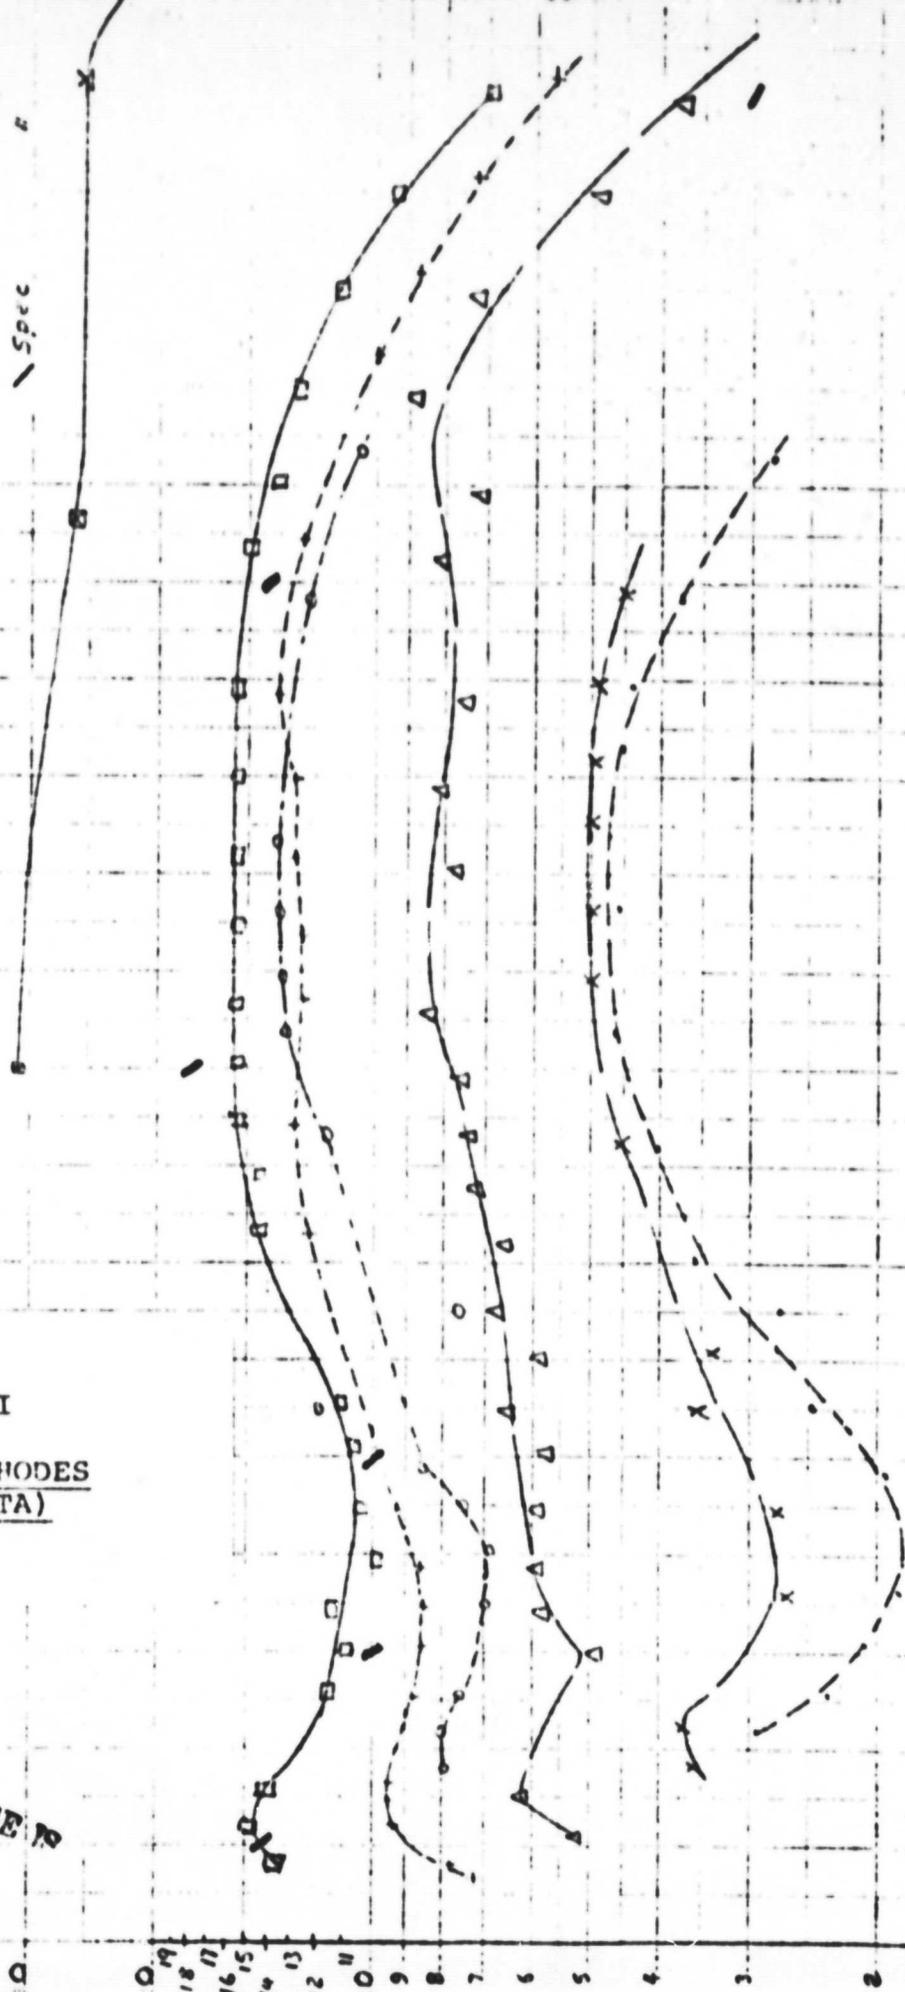
M E10 S20 7/10/56CS
 □ E7 CsTe
 ○ 1st Shorty
 † 458 Short
 × E4
 • E5
 △ E6
 ▽ E8
 \ Spec

FIGURE I
 CsTe PHOTOCATHODES
 (NASA DATA)

In the case of CsTe on MgF₂, lower average values than expected are shown. Part of the reason was that experimentation was still in progress and schedule and parts constraints decreed that even if the cathode was low the tube had to be completed.

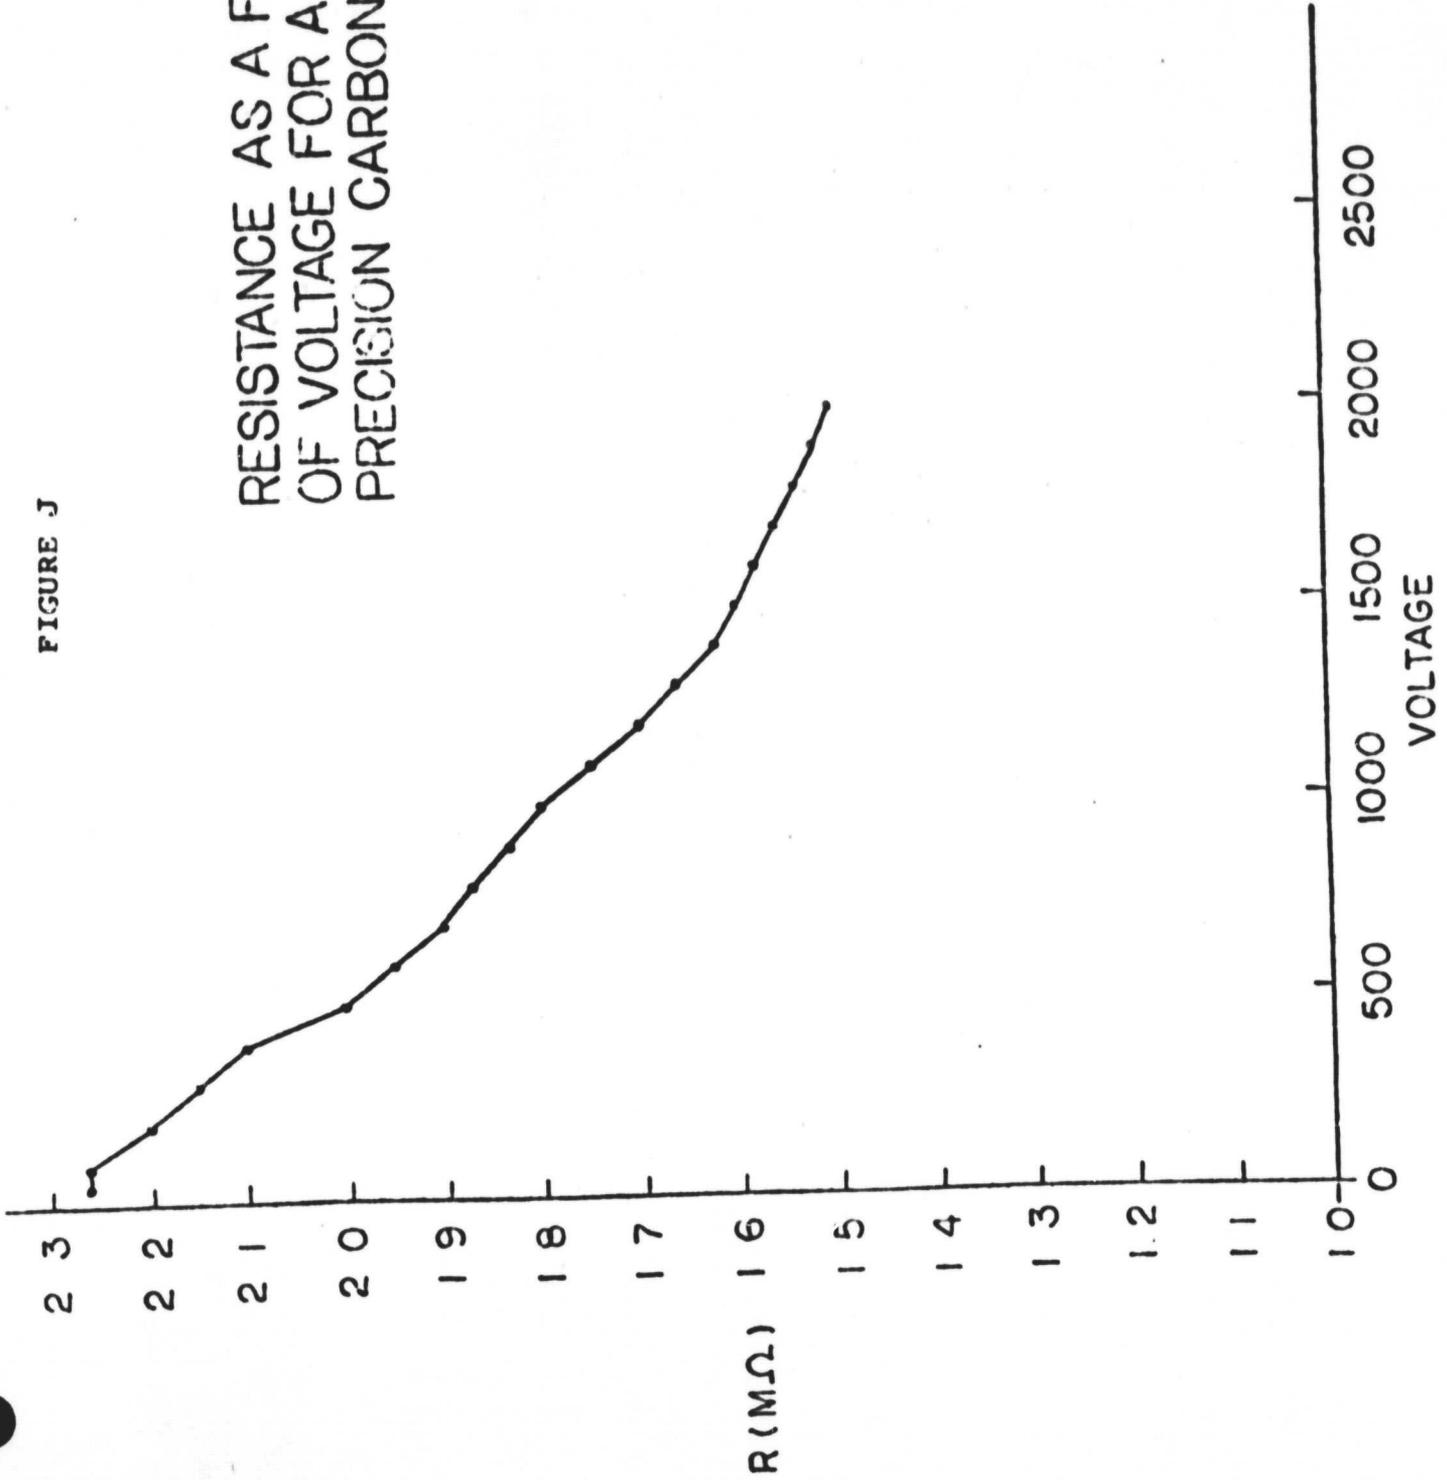
FIGURE J

RESISTANCE AS A FUNCTION
OF VOLTAGE FOR A 22M Ω
PRECISION CARBON RESISTOR

The E-O analysis showed that the external resistors were required to be within 1% in order to establish a field that would cause minimum image distortion. EVC carried out two tasks. The first was to determine the effect of voltage on the resistance value. The second was to test all the resistors at the expected applied voltage and separate them into groups of specific values. Thus an available supply of precision resistors, within .1%, could be drawn on. The voltage value chosen was 400V per resistor. Figure J shows the effect of applied voltage on a specific resistor. Other resistors tested showed the same basic curves and should behave linearly with voltage.

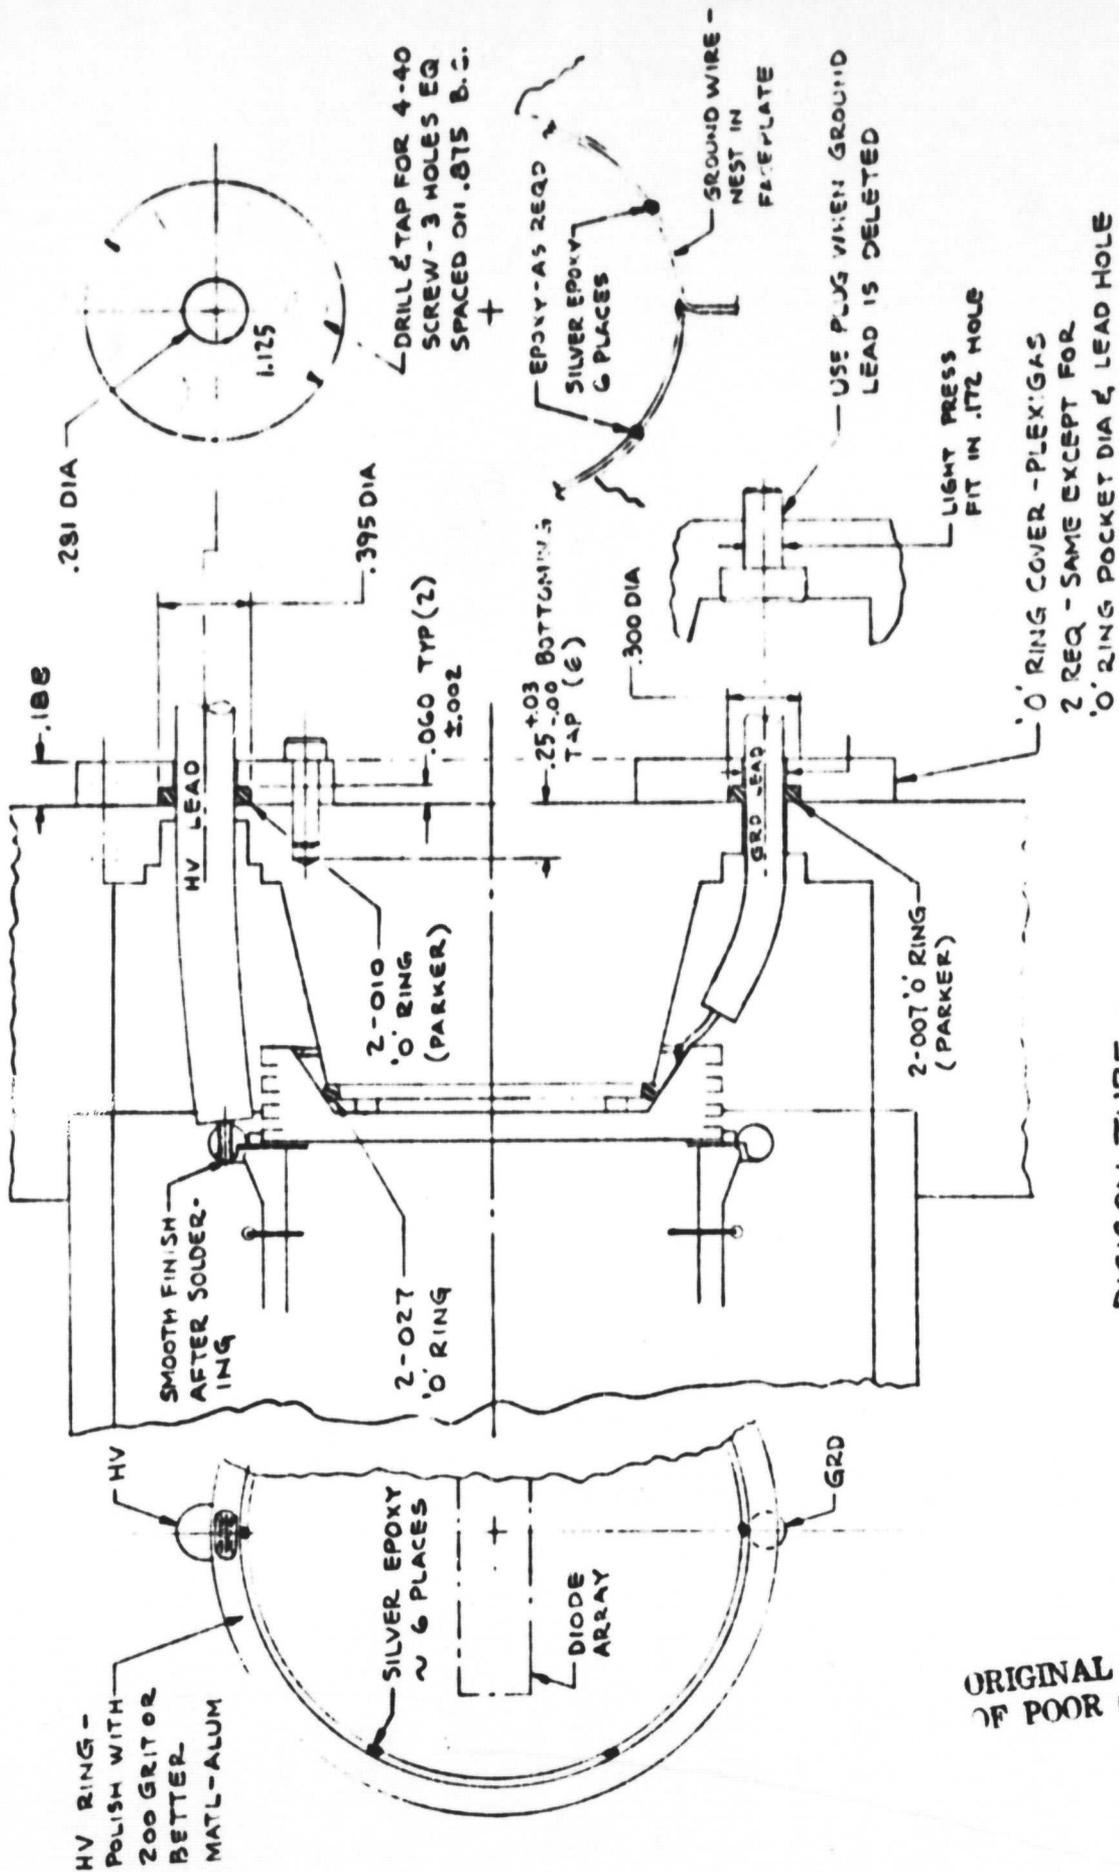
FIGURE K

DIGICON TUBE -
POTTING MOLD - 2 X SIZE

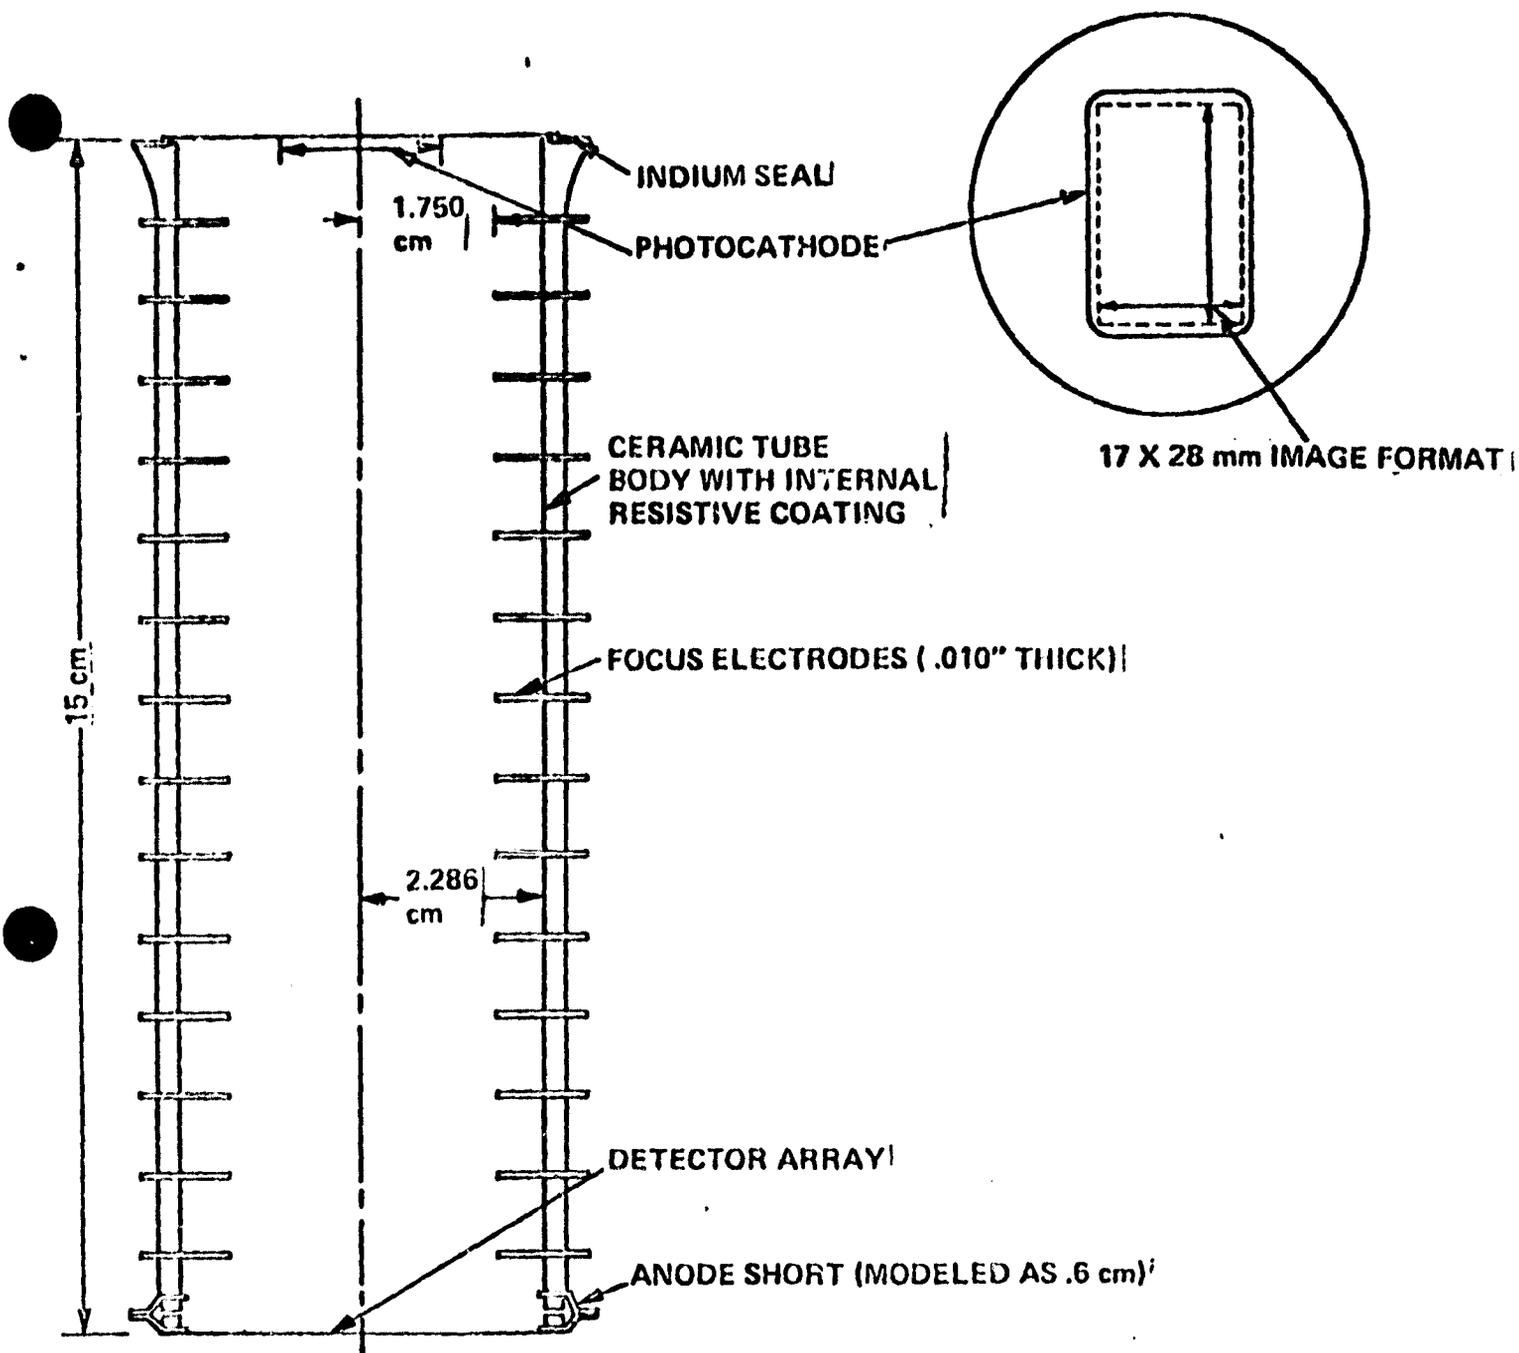
FIGURE 1. BASELINE DIGICON DESIGN MODELED IN THIS REPORT.

There are six different configurations considered here. They investigate the following:

- Distortion caused by the 10 mil indium seal
- Distortion caused by the shorted anode region (modeled as .6 cm, somewhat larger than in baseline design)
- Distortion caused by the finite thickness of the first two guard rings (the thickness of the others being judged unimportant)
- Distortion due to the first ring being at a potential 1% higher than the intended design
- Distortion due to the wall coating being 30% higher resistance at the first and last thirds (approximately) of the first centimeter than in the middle third
- Distortion due to a combination of the first three effects above

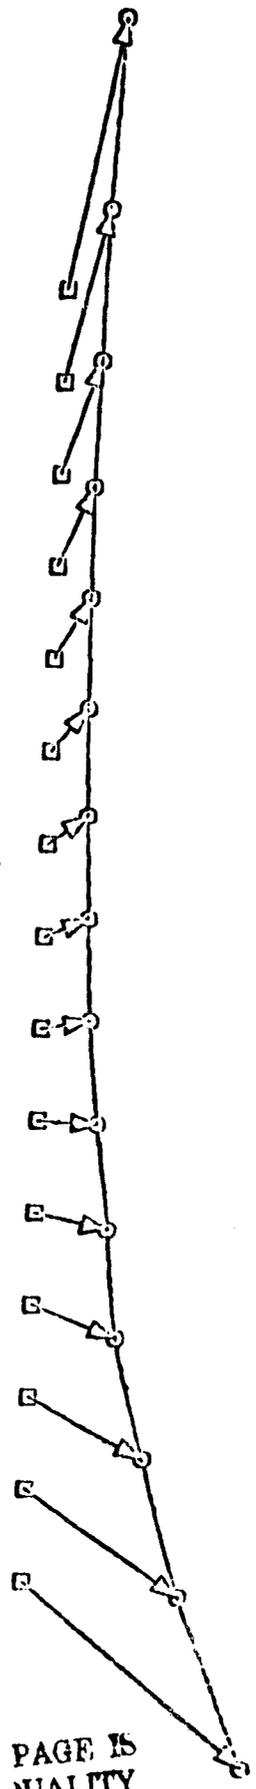
AT THE IMAGE PLANE OF A DIGICON TUBE

DISTORTION VECTORS MAGNIFIED 200 TIMES
THIS IS A 10 MICRON REFERENCE VECTOR

10 MILS OF INDIUM SEAL

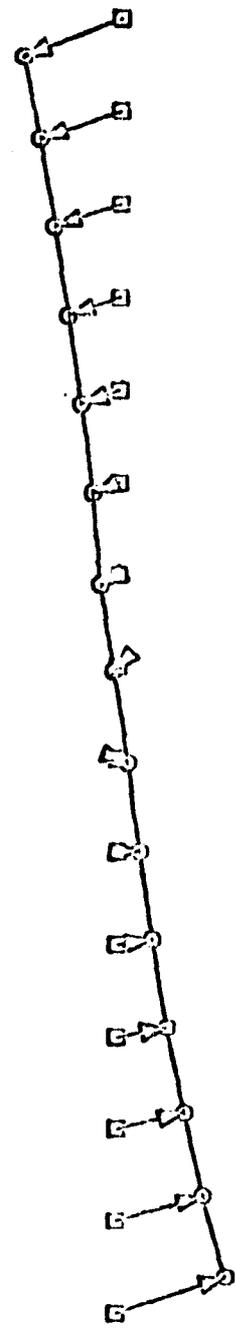
AT THE IMAGE PLANE OF A DIGICON TUBE

DISTORTION VECTORS MAGNIFIED 1000 TIMES
THIS IS A 10 MICRON REFERENCE VECTOR

.6 CM SHORTED ON THE WALL AT THE ANODE

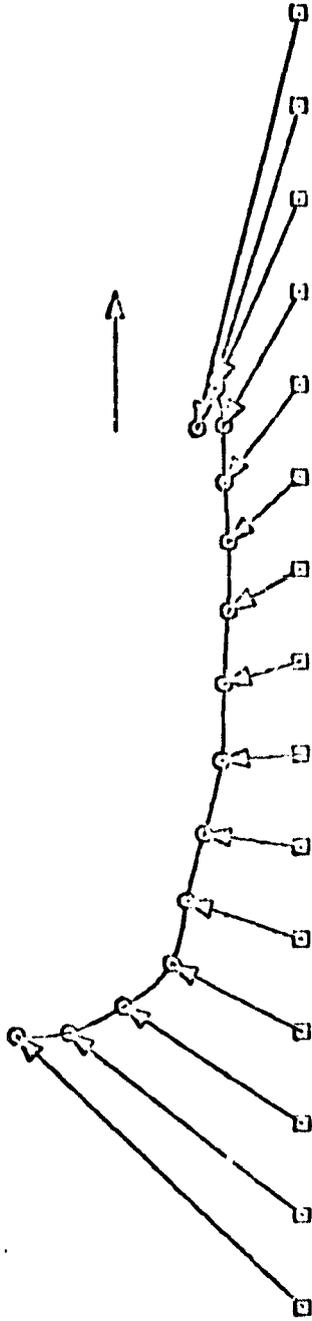
AT THE IMAGE PLANE OF A DIGICON TUBE

DISTORTION VECTORS MAGNIFIED 300 TIMES
THIS IS A 10 MICRON REFERENCE VECTOR -

FIRST TWO GUARD RINGS 10 MILS THICK

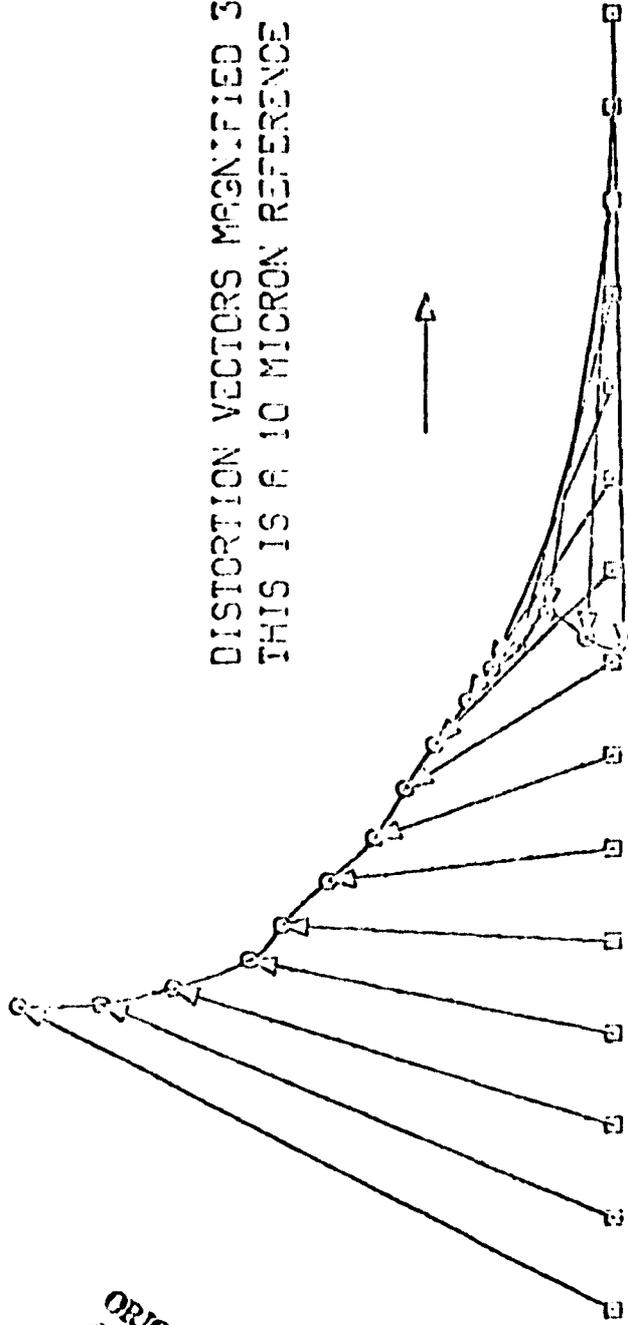
DISTORTION VECTORS MAGNIFIED 300 TIMES
THIS IS A 10 MICRON REFERENCE VECTOR

FIRST GUARD RING AT 1 PERCENT TOO HIGH A VOLTAGE

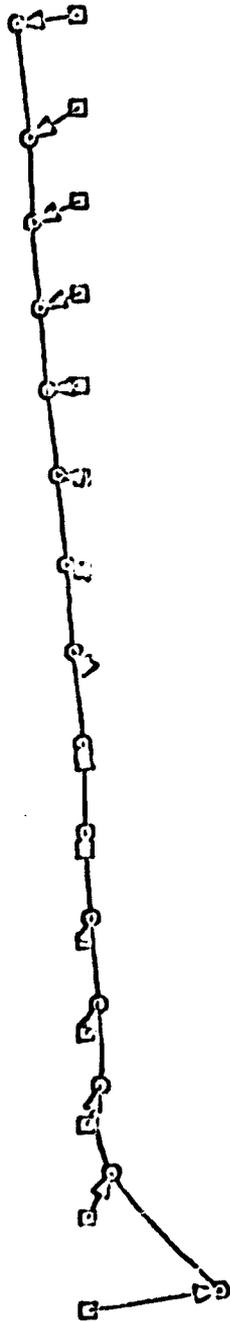
AT THE IMAGE PLANE OF A DIGICON TUBE

DISTORTION VECTORS MAGNIFIED 300 TIMES
THIS IS A 10 MICRON REFERENCE VECTOR -

COMPLETE DIGICON: INDIUM SEAL, TWO 10 MIL GUARD RINGS, & SHORTED ANODE

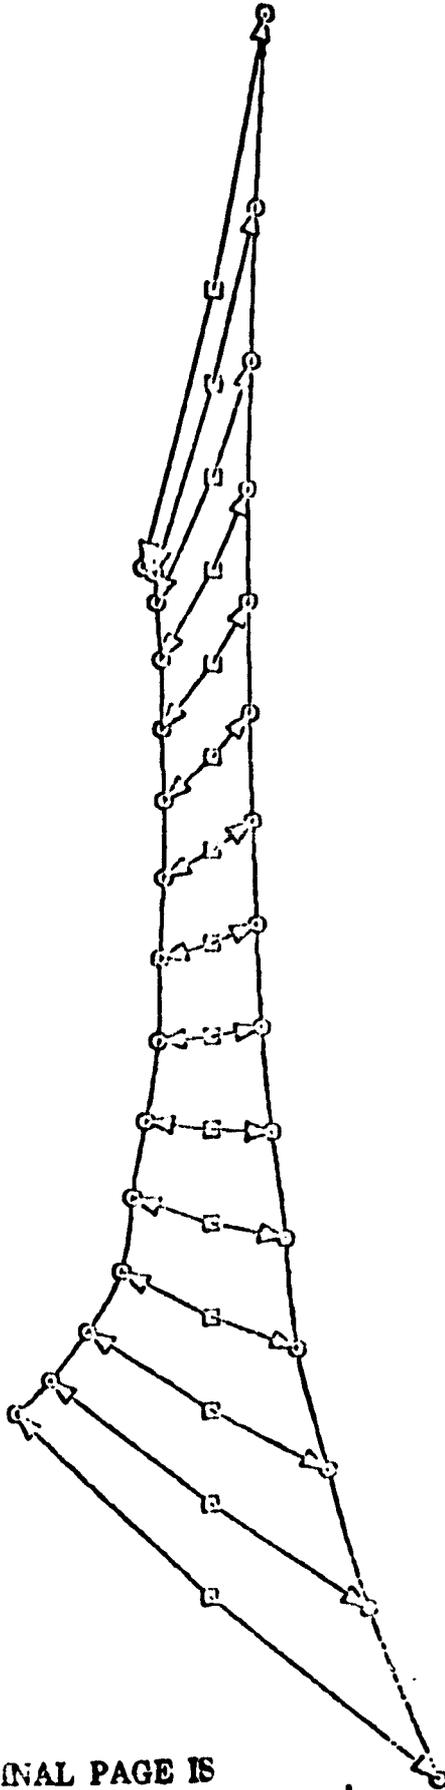
AT THE IMAGE PLANE OF A DIGICON TUBE

DISTORTION VECTORS MAGNIFIED 200 TIMES -
THIS IS A 10 MICRON REFERENCE VECTOR

OPPOSING ABERRATIONS: INDIUM SEAL VS. 10 MIL GUARD RINGS
