SEMI-ANNUAL REPORT
AN INVESTIGATION OF ADHESIVE/ADHEREND
AND FIBER MATRIX INTERACTIONS

Betty Beck, Ranjani Siriwardane and James P. Wightman

The Application of Surface Analysis to Polymer/Metal Adhesion

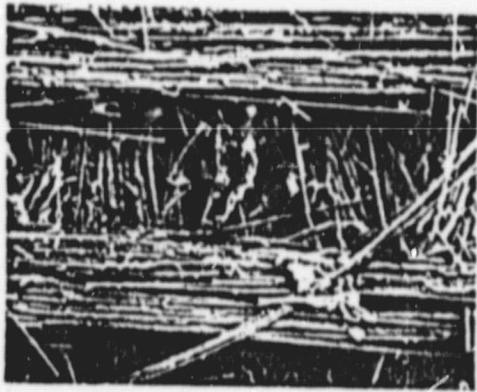
5

SEM photomicrographs of a fractured lap shear sample bonded with polyphenylquinoxaline (PPQ) are shown in Fig. 5. The synthesis of PPQ has been described elsewhere (9,10). The PPQ bonded CAA T1 6-4 adherends gave a measured lap shear strength at room temperature of 4650 psi. It is clear that no features characteristic of the T1 6-4 adherend are seen in the photomicrographs; thus, the sample failed cohesively. The XPS results for the fracture surface are shown in Table V. No Ti photopeak was observed, confirming cohesive failure. The O 1s, N 1s and C 1s photopeaks are characteristic of PPQ. Note the shift in the binding energy of the O 1s photopeak compared to the adherend (see Table II). The Si 2p photopeak is due to the glass scrim cloth which is seen in the SEM photomicrographs.
