AUTOMATED LONGWALL GUIDANCE AND CONTROL
VERTICAL CONTROL SUBSYSTEM

VOLUME I

W.R. Griffiths, M. Smirlock, J. Aplin,
R. Fish, D. Fish
Foster-Miller Associates, Inc.

January 1982

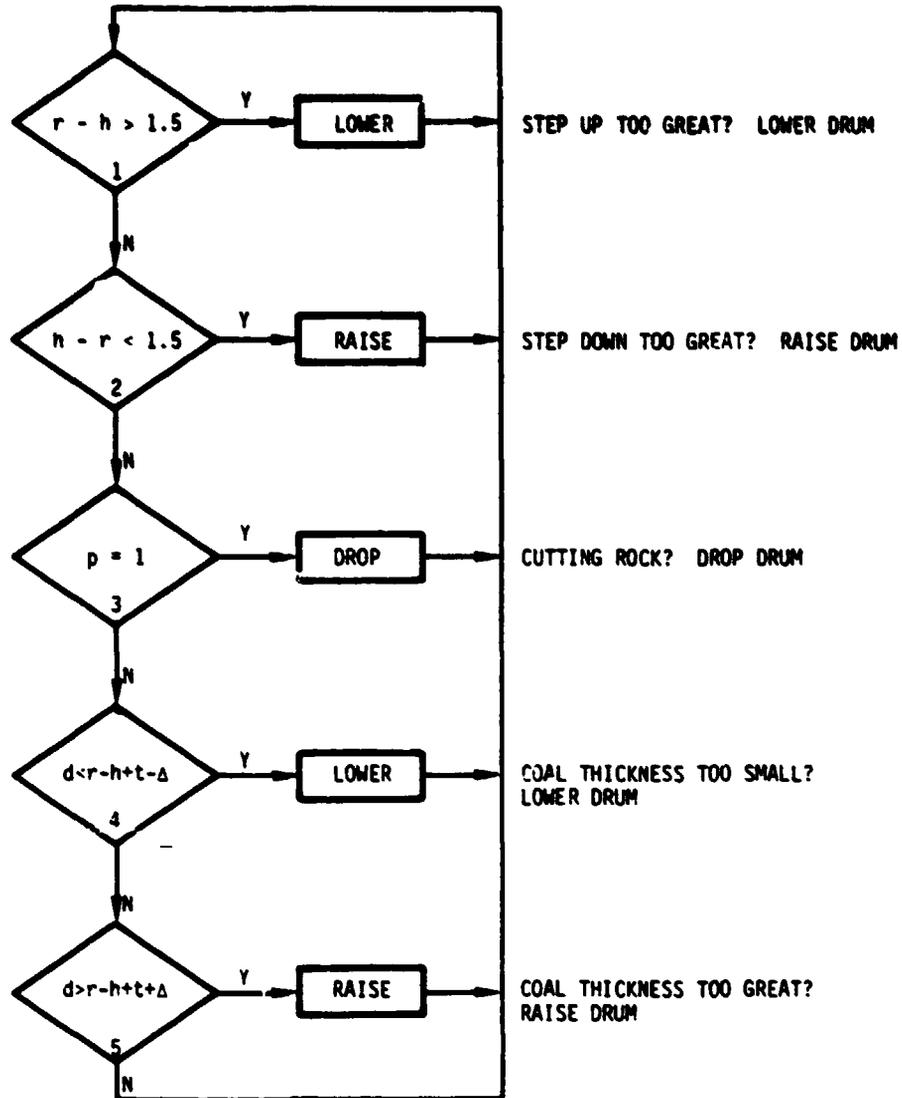
Figure 2. - Simplified flow diagram for Mode I control.

Figure 2 shows a simplified flow diagram for Mode I type operation. Note that the deadband parameter (Δ) can be set at any value such that if the measured parameters indicate the drum is in the proper position $\pm \Delta$ then no control is attempted. In actual practice, the value chosen for Δ was ± 1 in. Zero can be used for this parameter, but the resulting control system will always hunt, causing unnecessary wear on components.

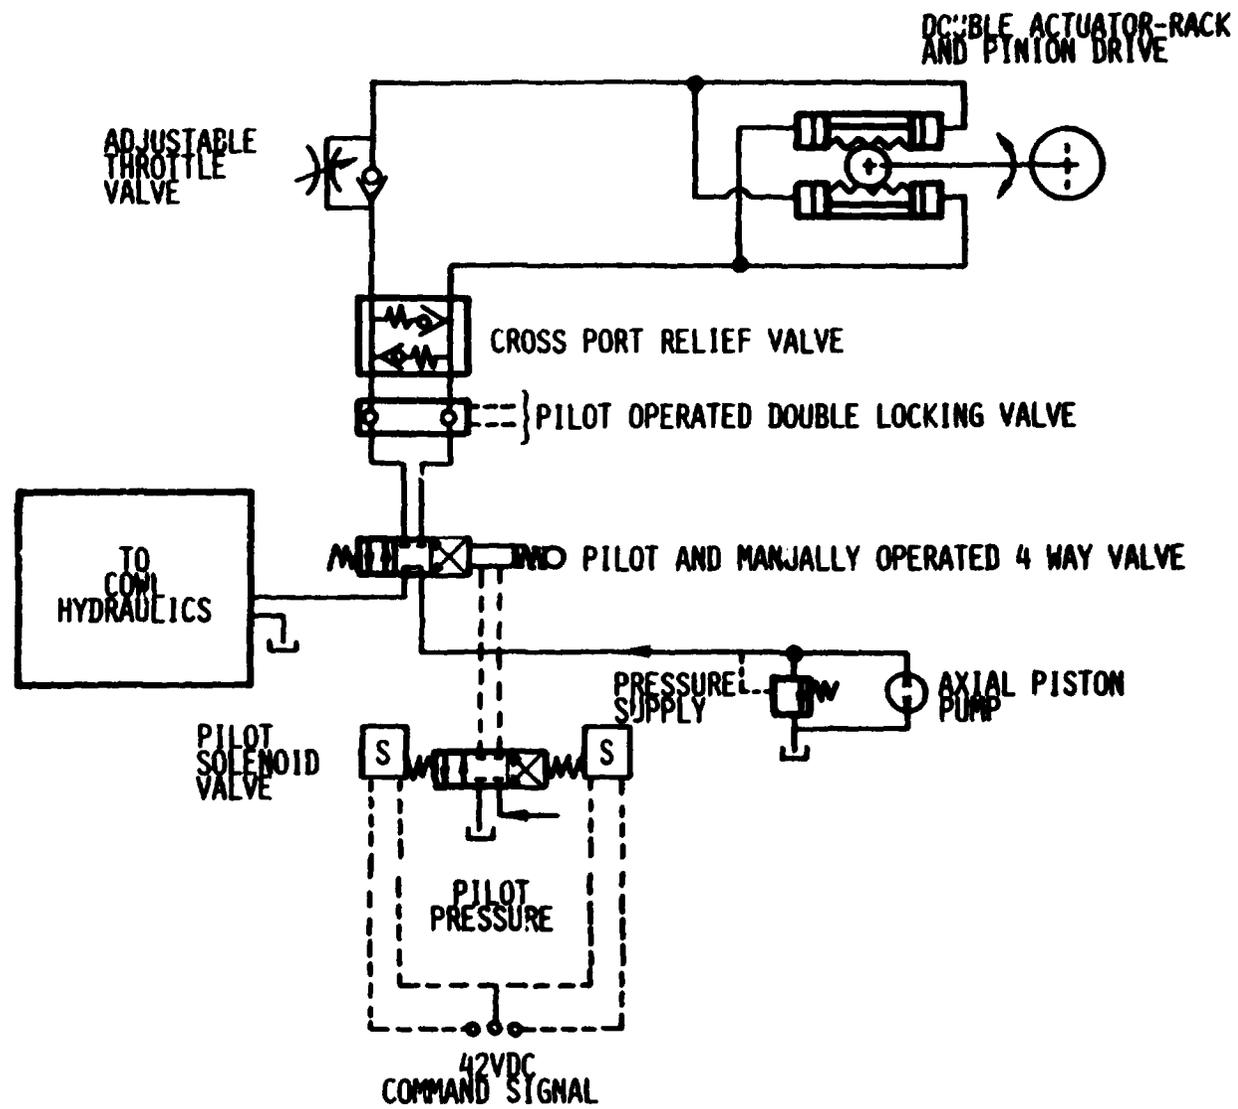
Figure 5. - Eickhoff 300-L shearer arm hydraulics.

Main supply pressure	=	2,200 lb/in. ²
Pump flow rate	=	6 gal/min
Pilot supply pressure	=	250 lb/in. ²
Main valve flow rate	=	3.2 gal/min
Drive actuator diameter	=	5.9 in.
Drive actuator stroke	=	10.77 in.
Total piston area	=	54.68 in. ²
Total trapped oil volume	=	589 in. ³
Pinion diameter	=	15.8 in.
Pressure to overcome arm weight and friction	=	1,100 lb/in. ²
Arm weight (including cowl)	=	10,900 lb
Arm moment load	=	4.47 × 10 ⁵ lb-in., minimum
	=	5.68 × 10 ⁵ lb-in., maximum
Arm calculated inertia	=	94 × 10 ³ lb-in./sec ² (max.)
	=	53 × 10 ³ lb-in./sec ² (min.)
<u>Other Arm Data</u>		
Drum diameter	=	66 in.
Arm length	=	63 in.
Arm response time	=	0.5 sec
Arm vertical speed	=	1.8 in./sec
Drum rotation	=	48 rpm
Cowls rotation	=	180° over the top

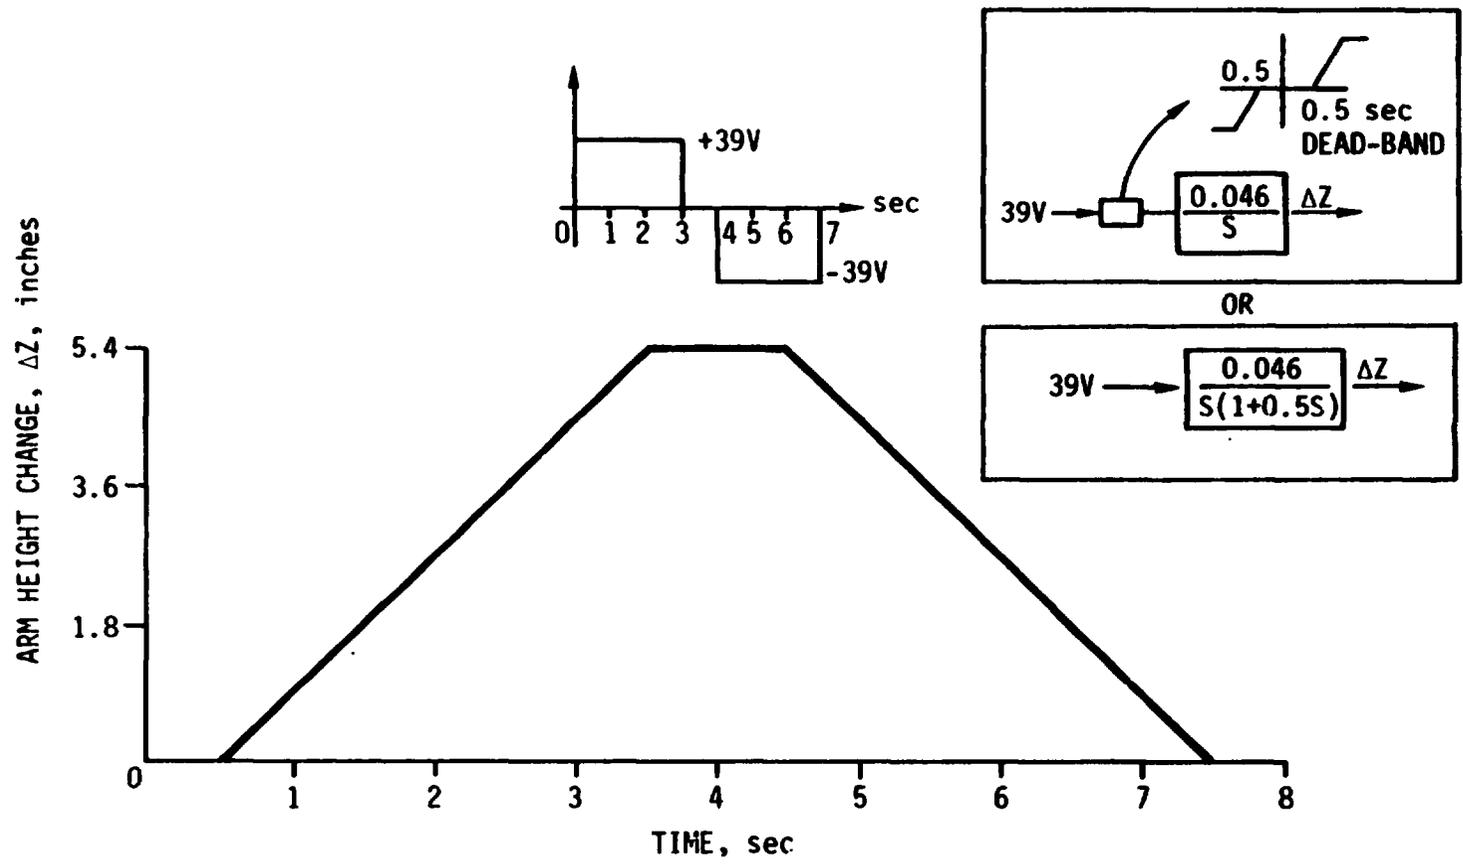
Figure 6. - Eickhoff shearer, approximate pulse input response.

Under normal operating conditions, the arm moves at about 1.8 in./sec in a vertical direction. Figure 6 shows the approximate pulse input response of the arm, which was determined experimentally. The arm has 0.5 sec deadband and acts like a linear integrator. The approximate differential equation of the arm for a step input of 39V is

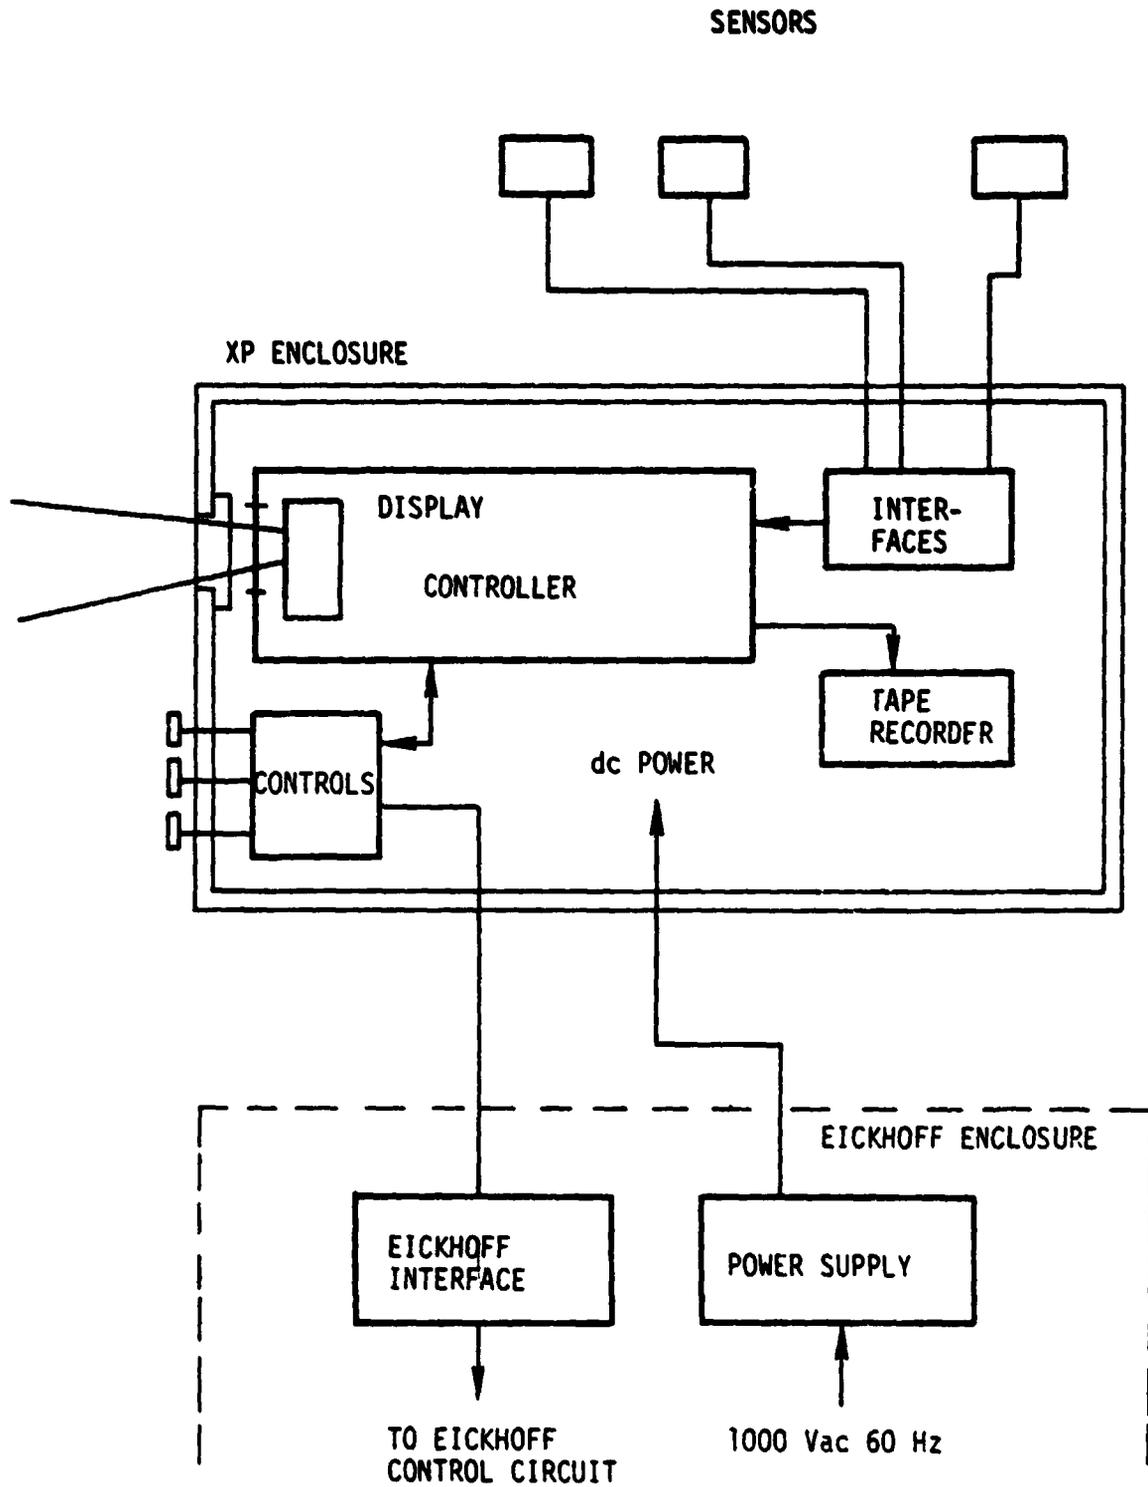
Figure 25. - System diagram.

The VCS system is controlled by a microprocessor and its associated electronics. The electronics are housed in an explosion-proof enclosure as shown in Figure 25. The microprocessor and electronics are implemented within a STD BUS structure on a number of printed circuit boards. The sensors for the system provide inputs to the controller. Voltage and current limiting barriers are used to interface the sensors, described earlier in this Section, to the electronics. The barriers keep voltages and currents at intrinsically safe levels in the cables connecting the sensors to the controller.

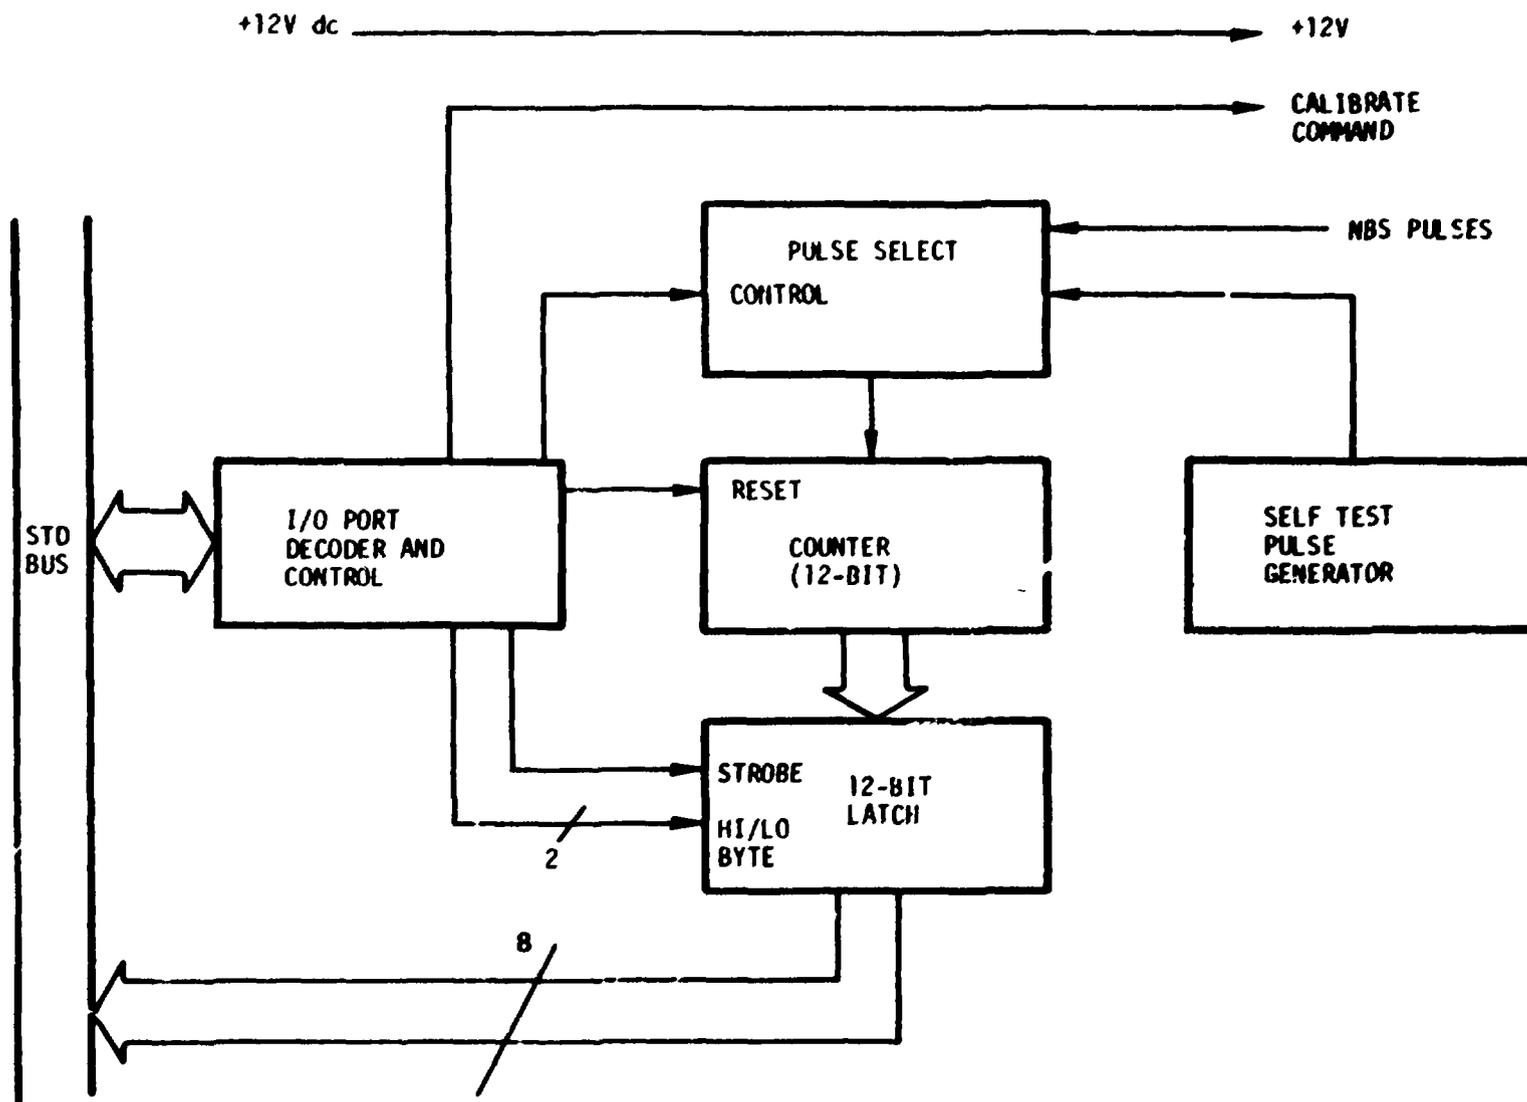
Figure 30. - NBS interface board.

A functional diagram of the NBS interface is given in Figure 30. Input counts from the NBS enter the board and are counted in a 12-bit counter made up of three 4029 CMOS counters. After 1 sec a command from the microprocessor causes the data to be latched into two 74LS374 octal latches. The counter is immediately reset to avoid missing a count. The count is then transferred from the latch to the microprocessor as two bytes.

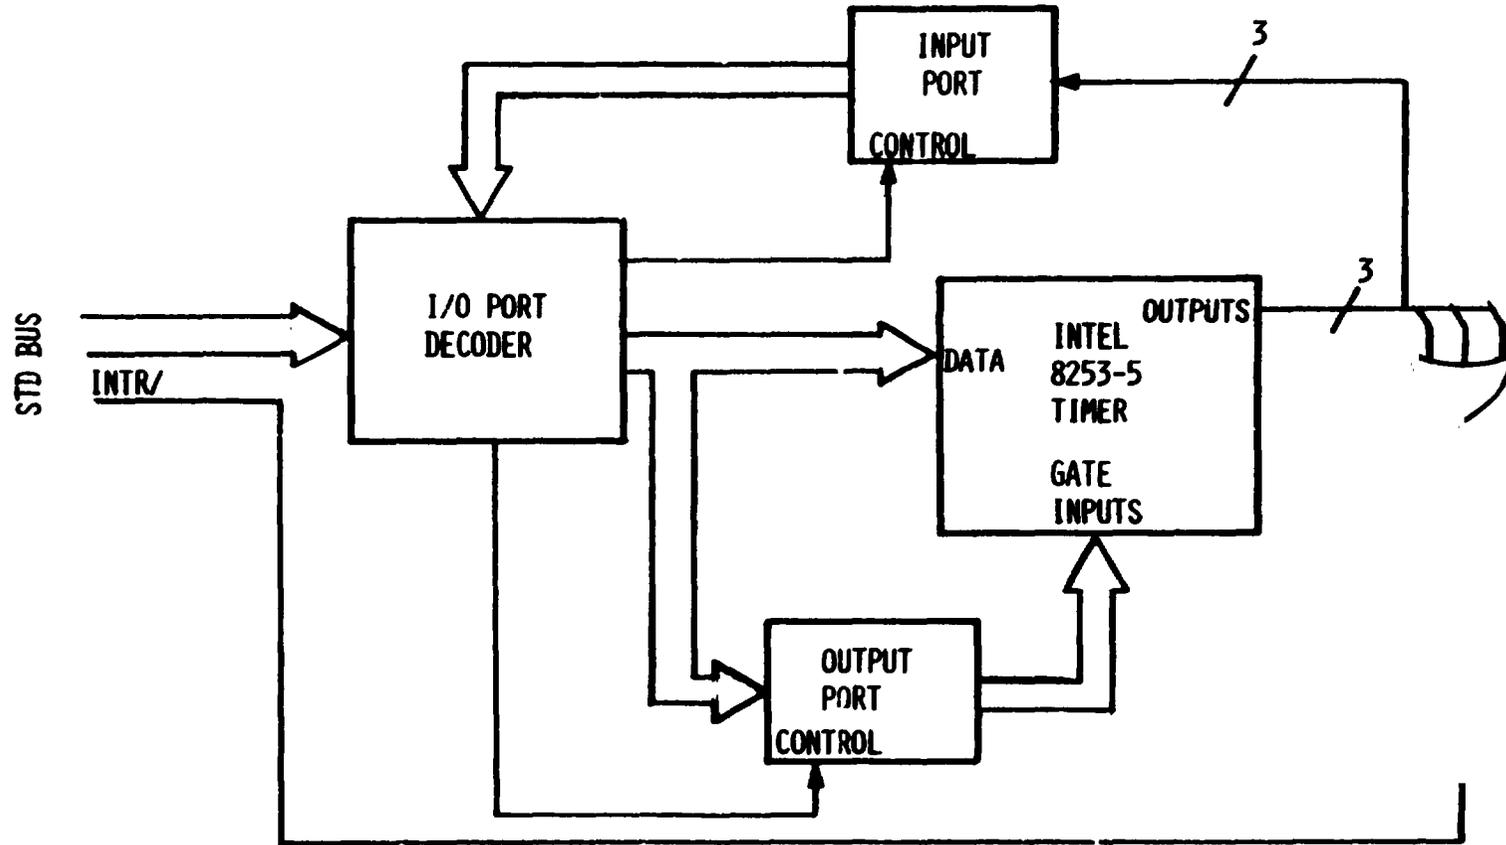
Figure 34. - Timer.

The timer board uses an Intel 8253-5 timer chip. This device contains three independent counters. The standard decoder

The counters are programmed to provide output pulses at 1 msec, 90 msec, and 1 sec. The 1-msec output is used as the clock for the 90-msec and 1-sec counters. The 90-msec and 1-sec outputs are ored together and used as an interrupt. Once interrupted the microprocessor reads Input Port 24 to determine which counter caused the interrupt.

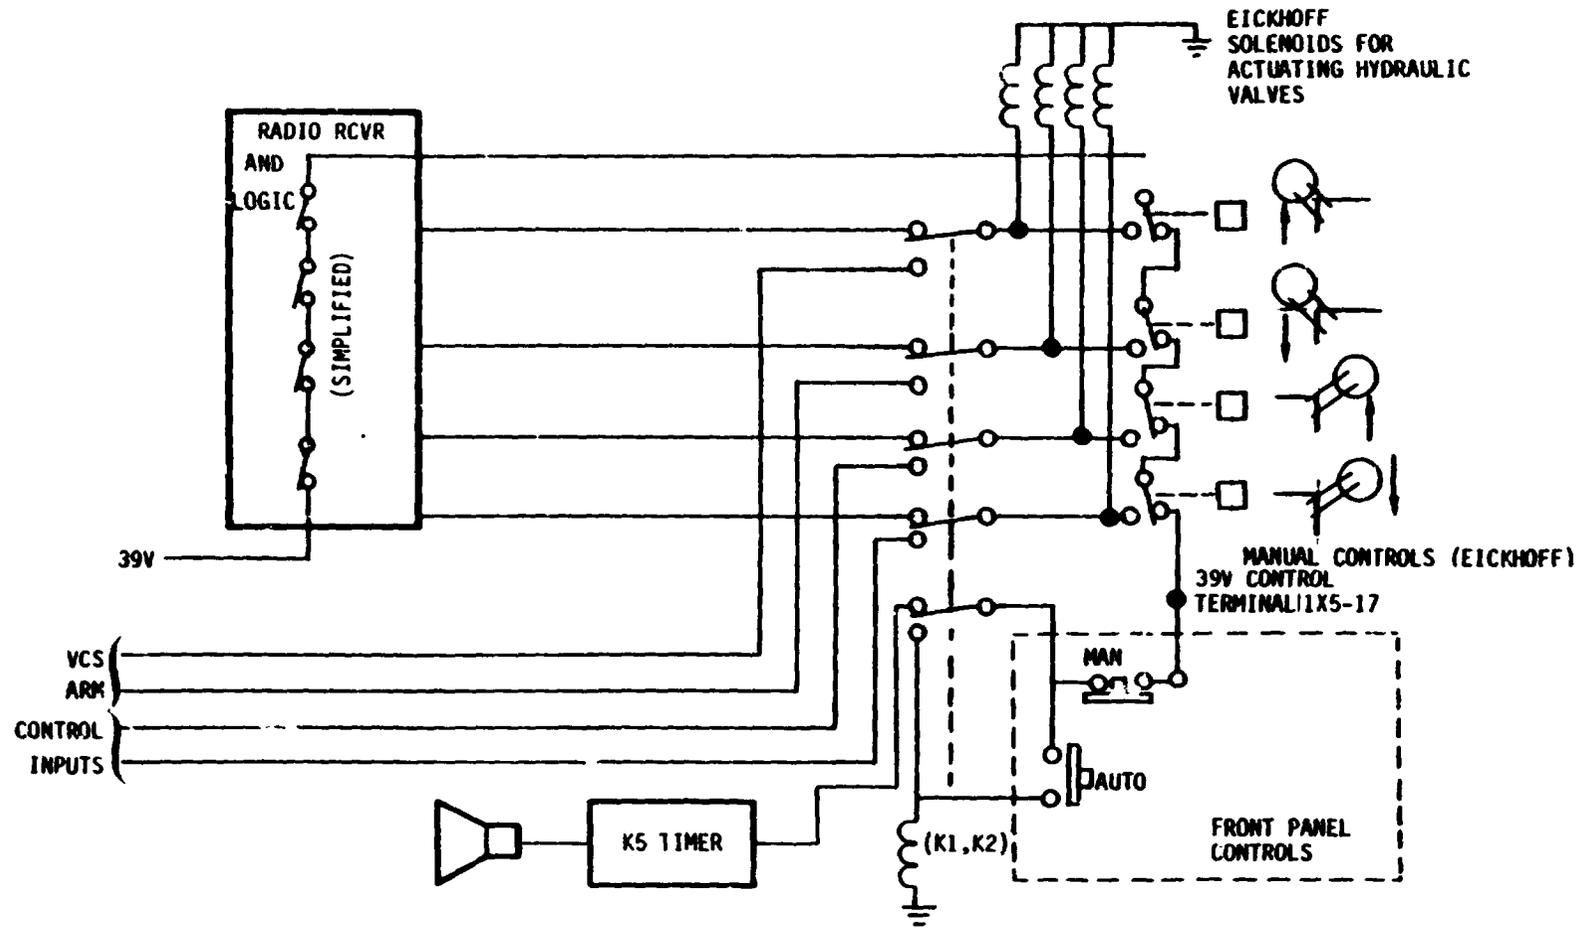
Figure 35. - Eickhoff interface diagram.

The Eickhoff interface is the relay logic interfacing the VCS controller to the solenoids in the Eickhoff 300L shearer. The solenoids actuate hydraulic valves controlling the position of the ranging arms. The two operating conditions are automatic (ranging arms under VCS control) and manual (ranging arms under operator control). A requirement imposed by Old Ben was that the operator could regain control instantly at any time by operating the ranging arm controls on the shearer or remotely by radio control. The Eickhoff schematics were examined in detail and a point in the ranging arm control circuit was found (terminal 17) that is at 39 Vdc unless the operator activates any one of his controls. Figure 35 shows a simplified version of the Eickhoff circuitry and how the manual to automatic switch-over takes place.

A latching relay is used to hold the system in automatic mode. The source of voltage for the latching action is Terminal 1X5-17 of the Eickhoff circuit on drawing No. 10872C2. If any ranging arm control is activated, the relay will drop out and the operator will have control. Two latching relays K1 and K2 were used for redundancy to guard against a relay sticking in the latched position. A warning horn is activated for 3 sec by a

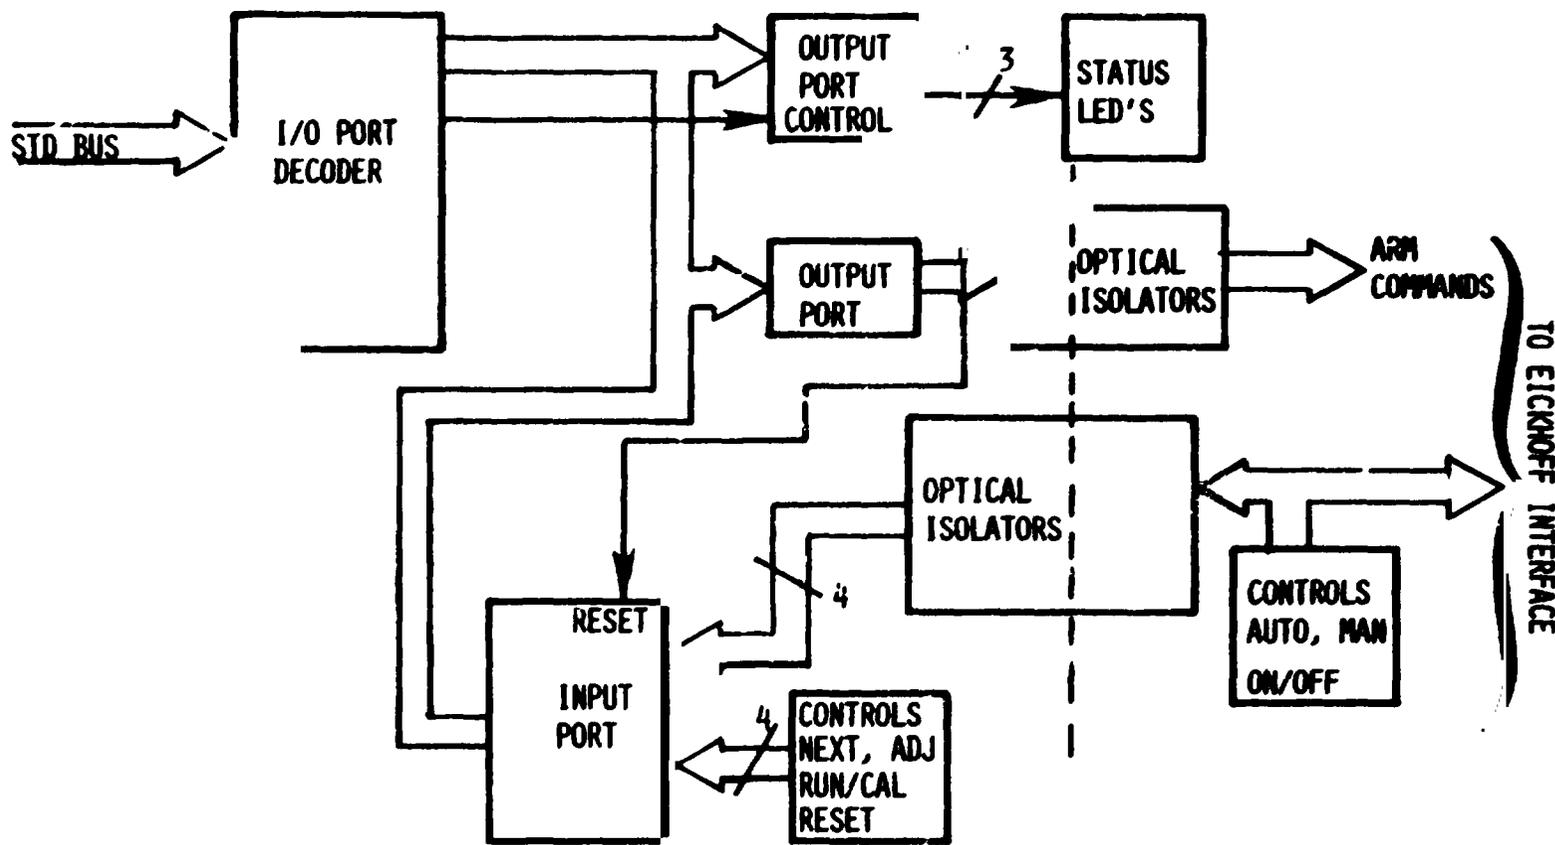
Figure 38. - Front panel interface.

5. *EICKHOFF INTERFACE AND THE FRONT PANEL* - The Front Panel Interface functional block diagram is shown in Figure 38. The I/O port decoder is identical to the decoder portion of several other boards in the system. It is composed of

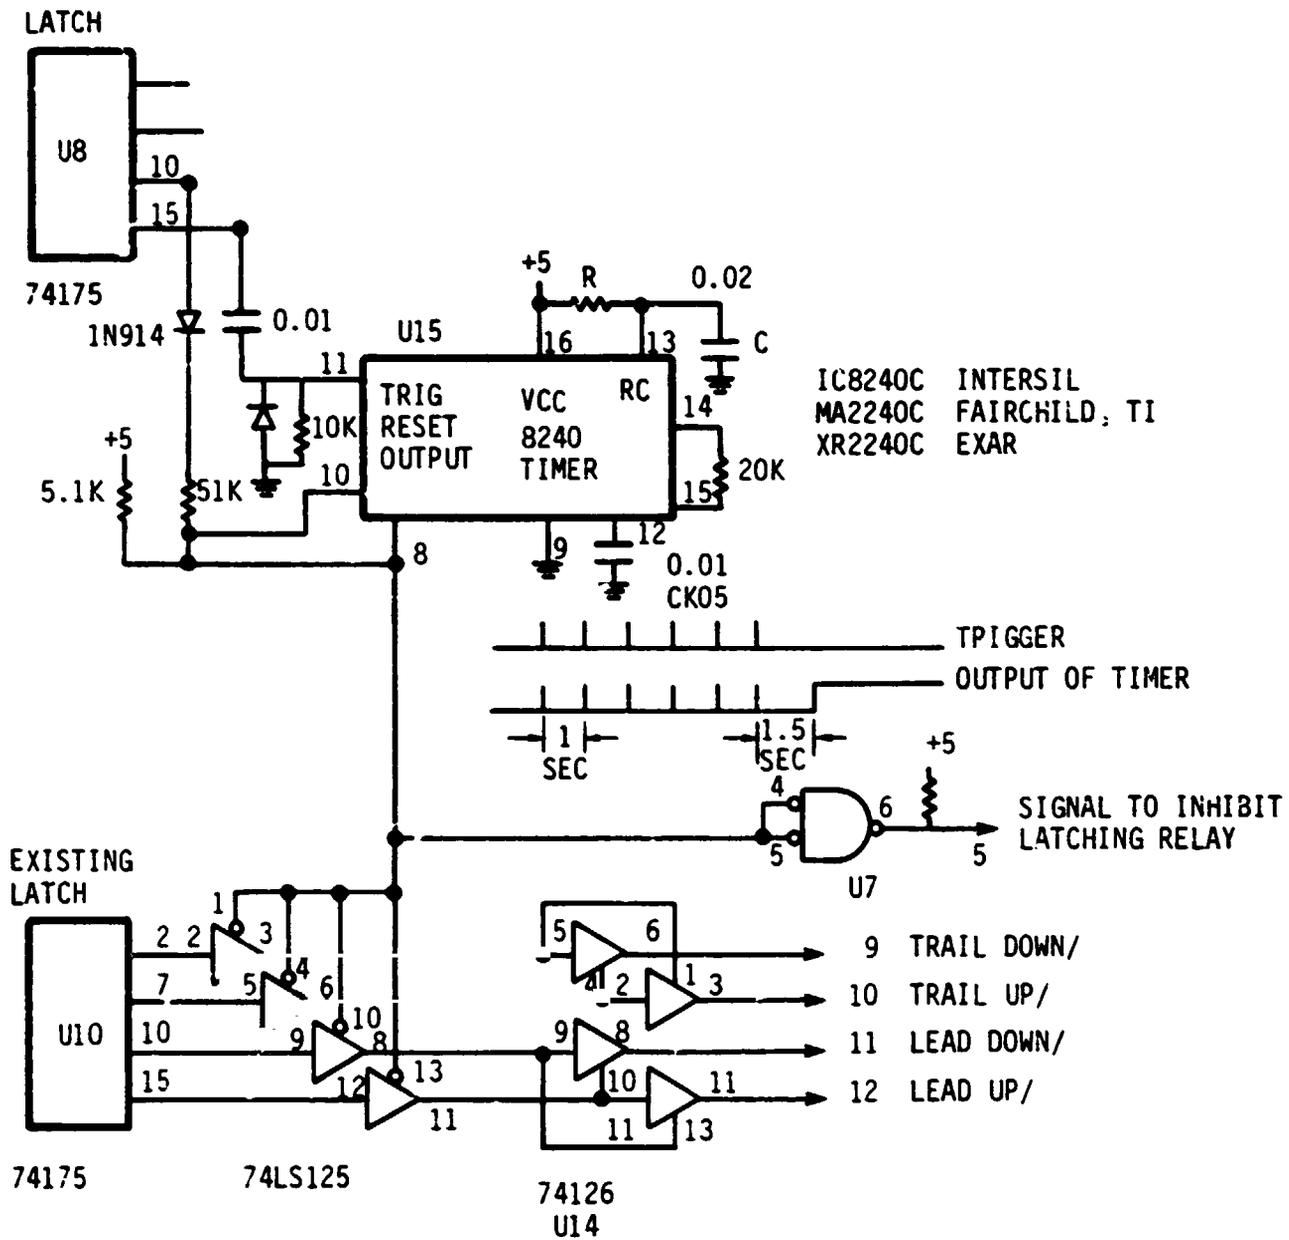
Figure 39. - Missing pulse detector.

Output port 06 (U8 and U9) provides the drive for the status LEDs *FAULT*, *AUTO*, and *MANUAL* on bits 3, 2, 1, and 0, respectively. Two other bits (bit 4 and bit 5) of port 06 are used to control a 1.5-sec timer (see Figure 39). The timer acts as a missing pulse detector. The output port 03 for controlling the ranging arms is enabled by gating U14 only if a reset pulse immediately followed by a trigger pulse occurs once per second. If there is a problem in software or system hardware and pulses cease, the timer will time-out after 1.5 sec and control of the drums will be inhibited.

The output of the timer is buffered by U7 (pin 6) and used as a signal to inhibit the latching relay in the Eickhoff interface and return system operation from automatic to manual.

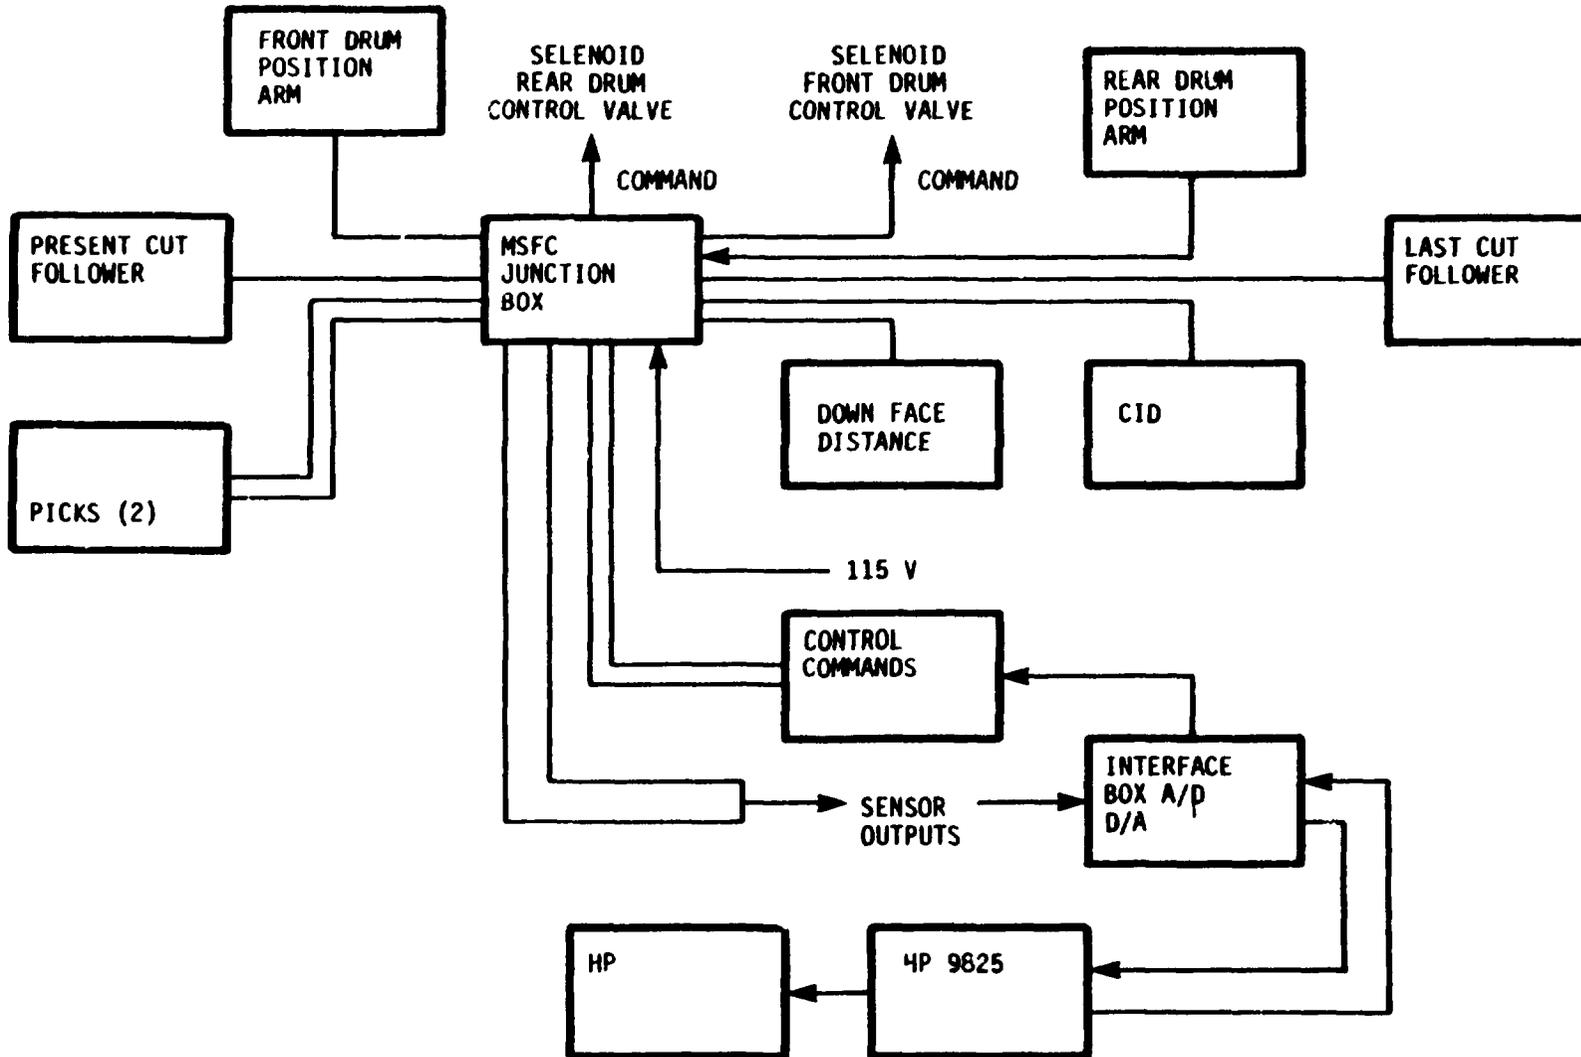
Figure 40. - Diagram of functional characteristics of the MSFC configuration.

Figure 40 is a block diagram representing the functional characteristics of what will be referred to as the MSFC configuration. Basically the analog signals from the sensors were brought together in a junction box that was physically located on the Joy shearer. Those signals were then transmitted via a 64-in. conductor cable to a trailer that housed an interface box for signal conditioning. The interface box then supplied the Hewlett Packard 9825 data base with the basic sensor information. The 9825 processed the data, generating commands for the front and rear drum control which essentially revised the process through the interface and junction boxes to the electrical solenoids on the Joy. The commands generated were digital pulse signals and defined duration and direction corresponding to the required movement of the drums. It is worth noting that as shown on Figure 40, 115V power was supplied to the junction box for conversion to the voltage requirement of the sensors.

The front and rear drum arm position was obtained from linear potentiometers attached to the shafts of the drum arm hydraulic cylinders. The present and last cut followers used 15 GHz radar and the downface distance measurement device was an extremely accurate encoder used in conjunction with the face alignment system. The sensitized picks at this time incorporated

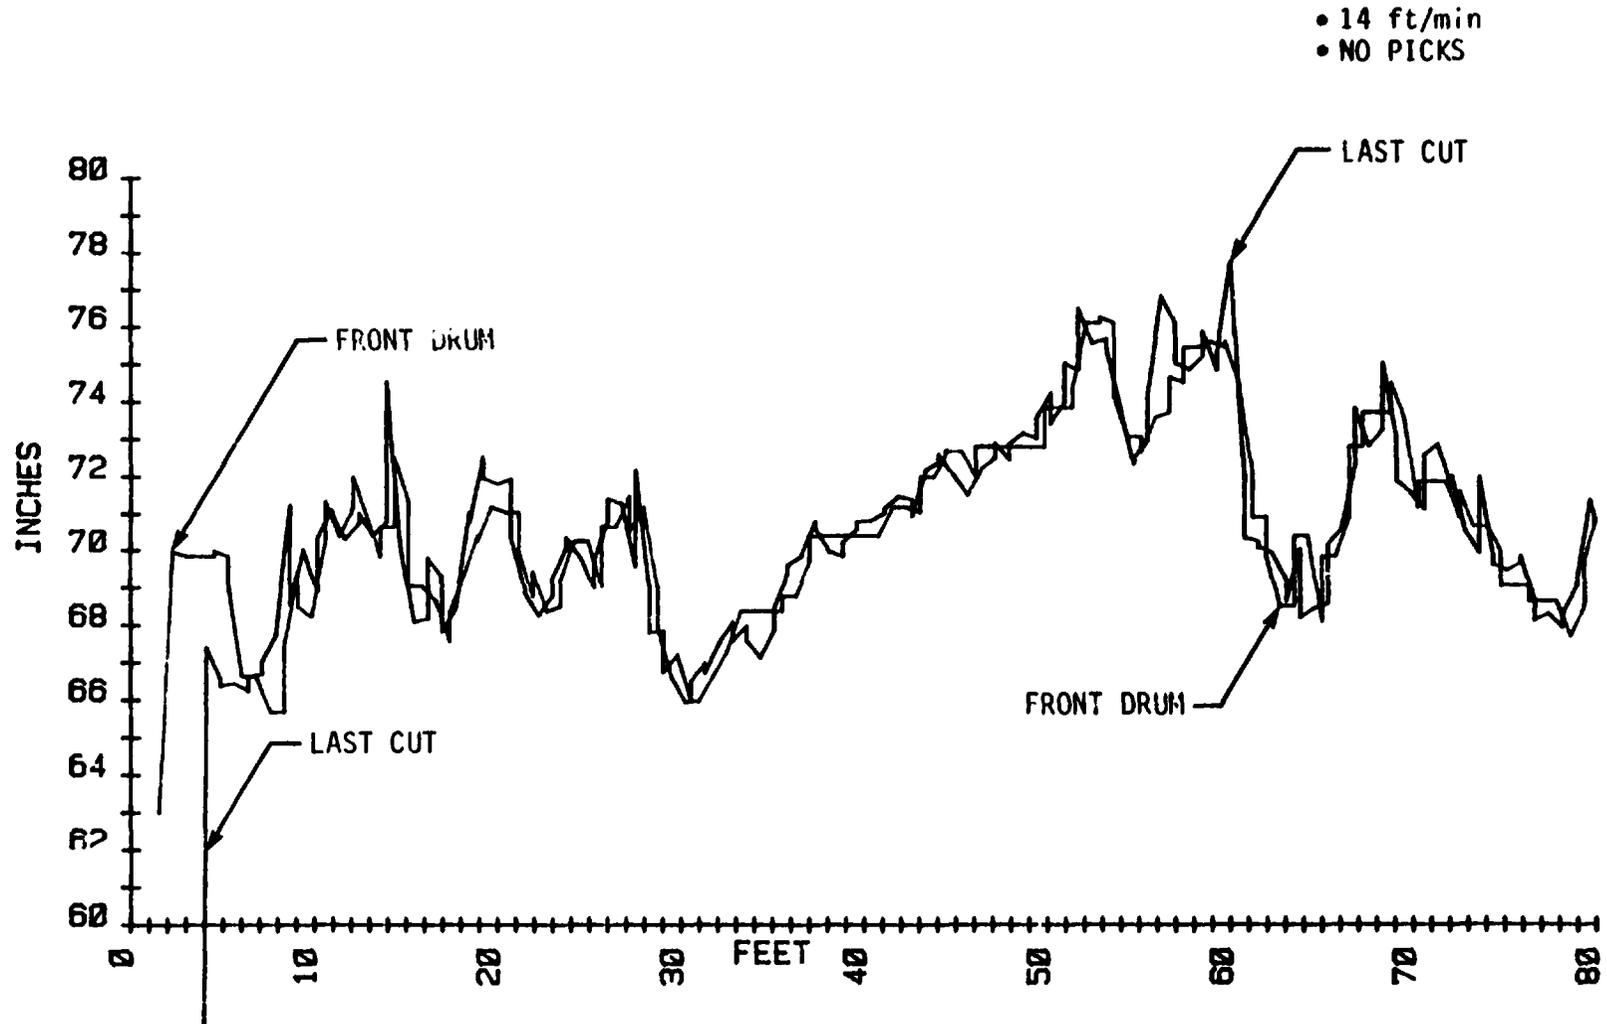
Figure 47. - Front drum with last cut - slow speed.

Figures 47 and 48 show the results of a tram test using acoustic followers for control only. This test was conducted at slow speed approximately 14 ft/min and did not use simulated picks. Figure 47 shows the comparison between the last cut follower readings and the position of the front drum. As may be noted, the correlation is very good showing a slight averaging effect as the front drum tracks the last cut readings. It is worth noting that the front drum is not activated at the 0 ft point to insure that the last cut follower is receiving a good signal. Therefore as the diagram shows, the drum is a few feet under the cap at the start of the tram test.

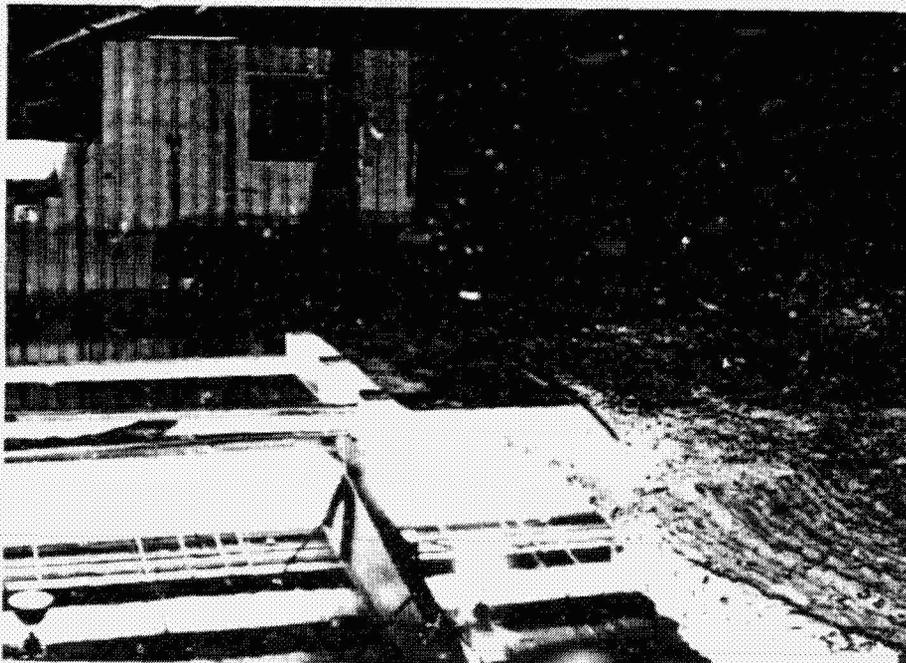
Figure 58. - Simulated shield.

The simulated shield tip was created by fabricating a plywood 4-ft wide model of a tip and covering the surface with stainless steel sheet to simulate the acoustic return characteristics of an actual shield. A photo of this simulated tip is shown in Figure 58.

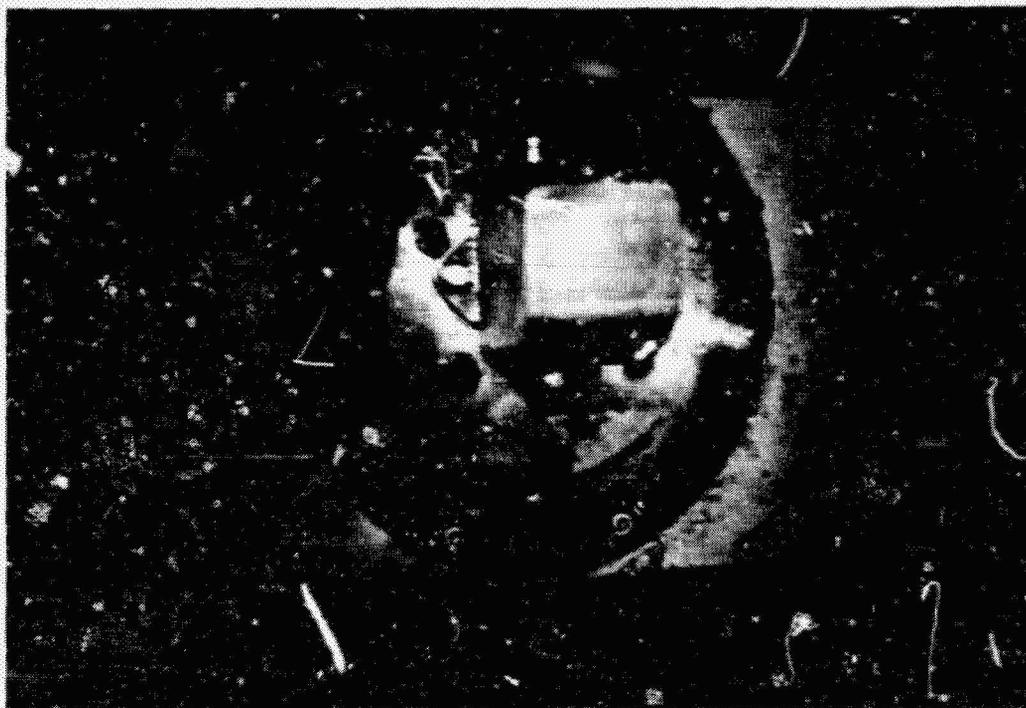
Figure 67. - Downface distance sensor installation.

The Downface Distance Sensor (DFD) assembly was installed as per plan. This is shown in Figure 67. The only problems experienced involved dust and were resolved by gasketing the cover.

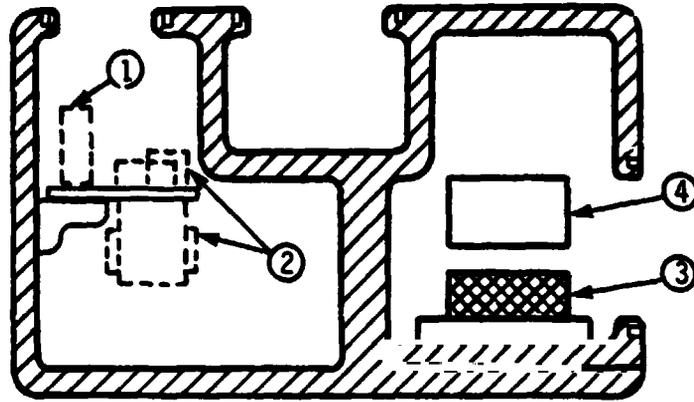
Figure 71. - Power supply locations, sectional view of Eickhoff high-voltage connection box.

- ① EICKHOFF COMPONENTS
- ② FMA HV TRANSFORMER AND FUSES
- ③ EICKHOFF POWER AND CONTROL CIRCUITS
- ④ FMA POWER SUPPLIES

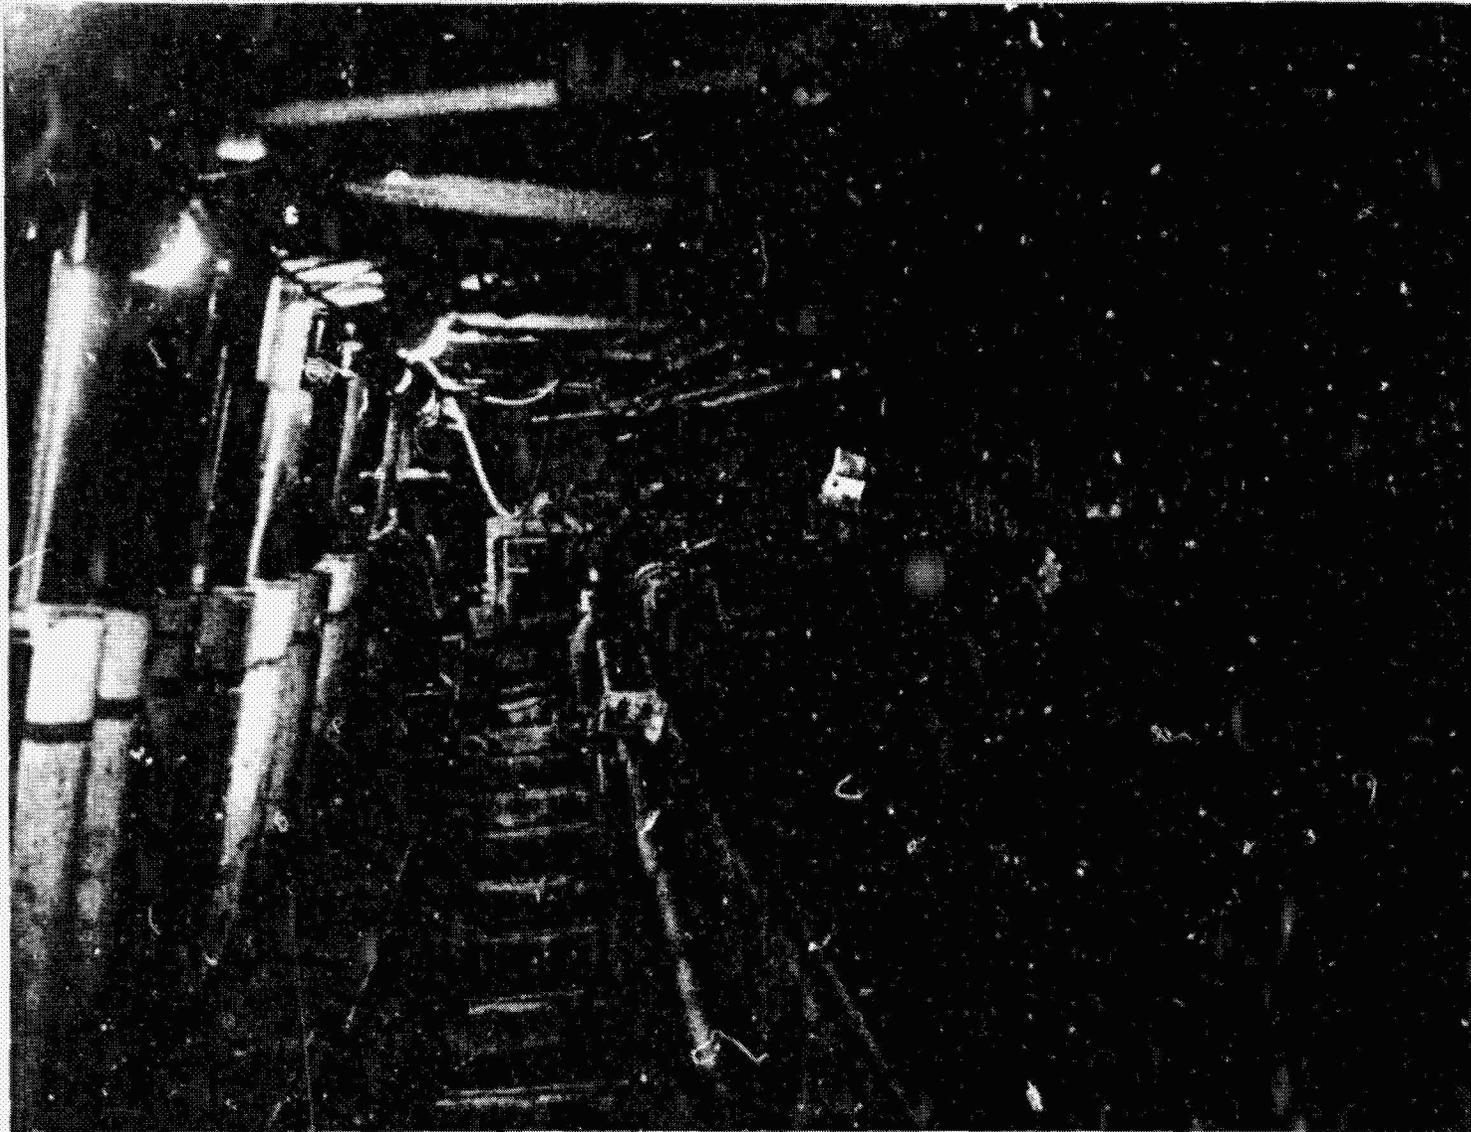
Figure 87. - Photo of NBS installation at CCC No. 1.

The mounting location chosen for the tests at CCCC was at mid-body of the shearer. The sensor mounting bracket was mounted on the top surface of the shearer body. The sensor mounting is shown in Figures 86 and 87. As can be seen in the front view, the sensor was tilted into the face at 20 deg. The sensor bracket as fabricated positioned the sensor at 25 deg but this was excessive. Wooden shims were used to set the sensor angle at 20 deg.
