# Advanced Ceramic Coating Development for Industrial/Utility Gas Turbines

James W. Vogan and Alvin R. Stetson  
Solar Turbines Incorporated

January 1982

Prepared for  
NATIONAL AERONAUTICS AND SPACE ADMINISTRATION  
Lewis-Research Center  
Cleveland, Ohio  
Under Contract DEN3-109

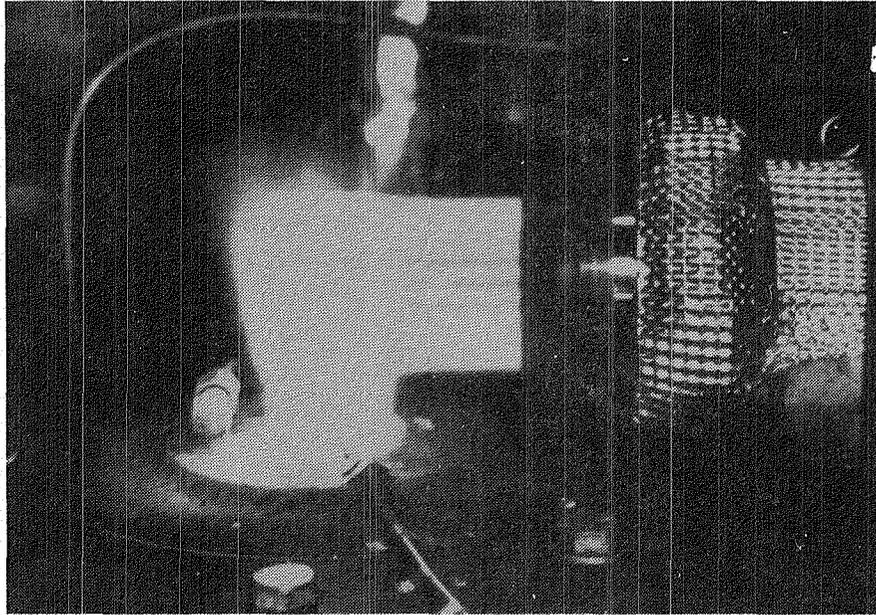
Figure 8. Burner Rig Air-Cooled Specimen Fixture

Three burner rig tests were used to determine the effect of fuel composition and combustion products on the coatings. A schematic of the test rig is given in Figure 8. This facility will test up to ten specimens at a time. The specimens were machined from hollow test bars, as shown in the insert, and thermocouples were installed at the burner centerline to monitor metal temperature. The specimen holder provides cooling air to the specimens for control of substrate temperature during test. In operation the holder is rotated at 1725 rpm. Thermocouple leads are connected through slip rings to a multipoint recorder which provides a record of temperature during the test. Figure 9 is a photograph of specimens undergoing testing. The burner rig shroud has been removed for illustrative purposes. The burners used in these tests operate on Diesel No. 2 and air. When required for test purposes, additives are used in the fuel, either as fuel-soluble compounds in the supply tank or as water-soluble compounds in synthetic sea water. The latter is introduced into the fuel immediately prior to combustion.

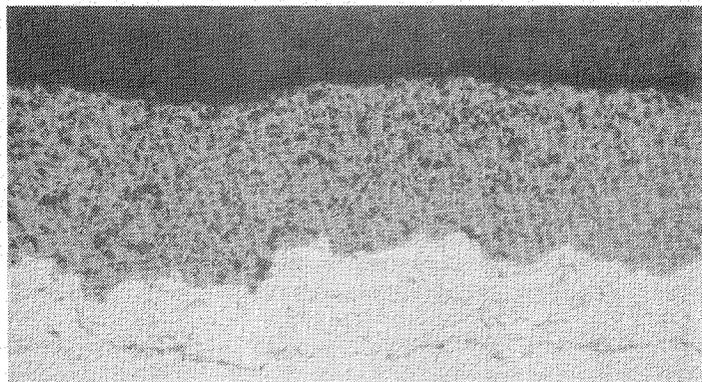
Figure 24. Calcium Titante Triplex Coating After Hot Corrosion Testing at 760°C  
Magnification: 100X; Mount No. 9532

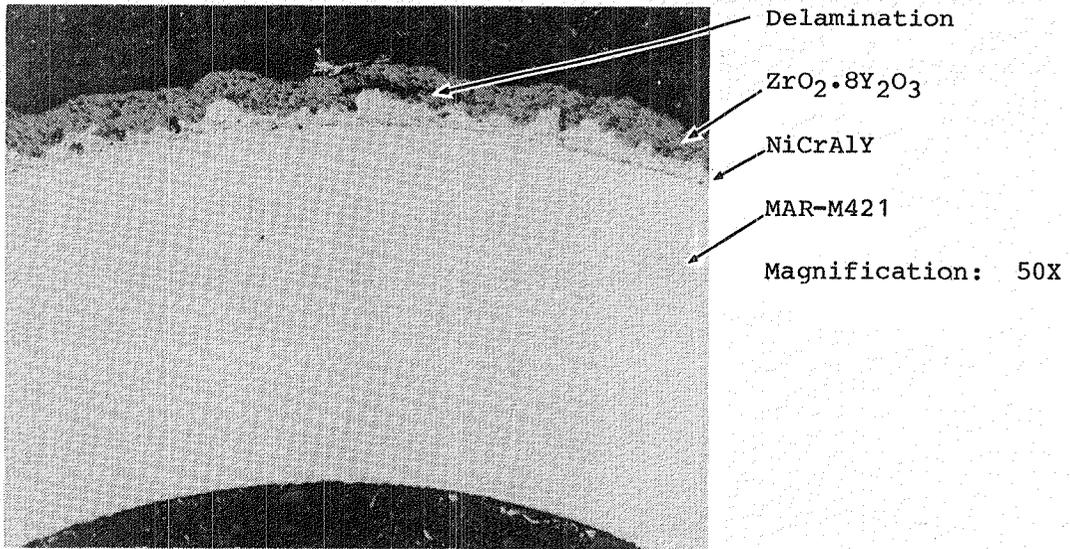
Figure 29.

Typical Burner Rig Specimen  
After Test With High Vanadium  
Fuel

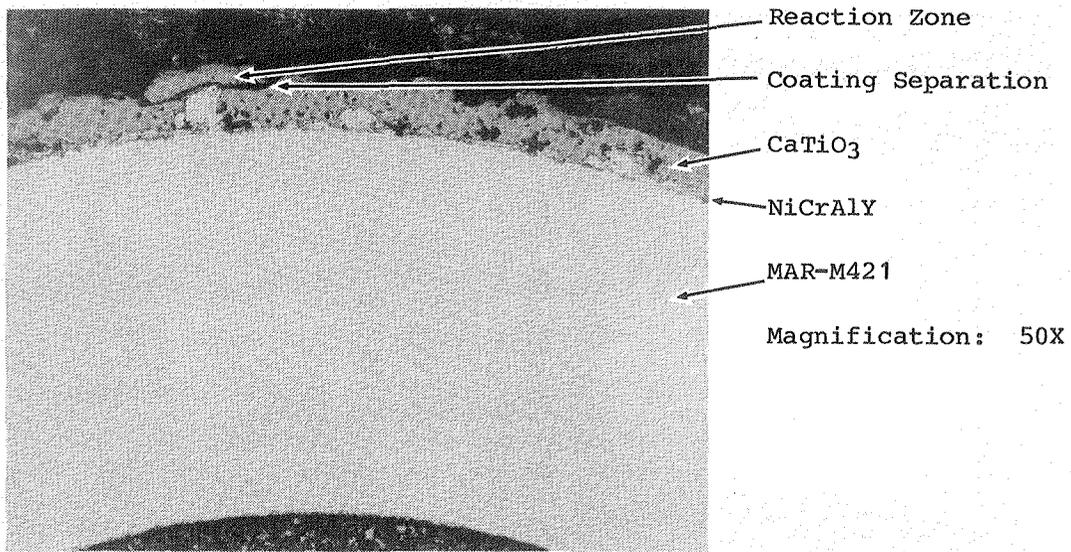
Figure 31. Duplex  $CaTiO_3$ /NiCrAlY Coating After 190 Hours Burner Rig Exposure Using High Vanadium Fuel

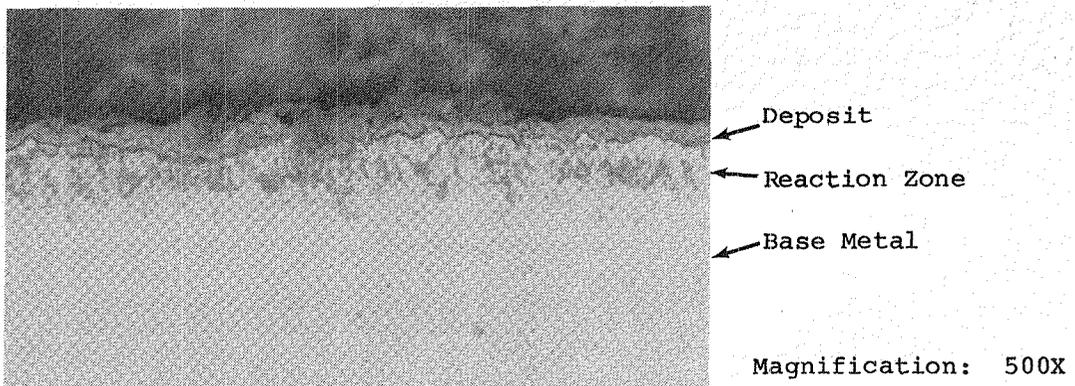
Figure 34. Uncoated MAR-M421 Test Specimen After 400 Hours Burner Rig Exposure Using High Vanadium Fuel

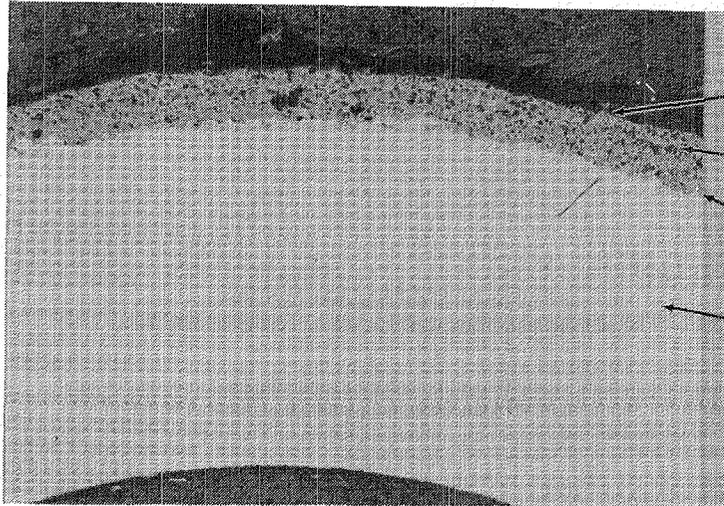
Figure 37. Duplex CaTiO<sub>3</sub>/CoCrALY Coating System After 515 Hours of Burner Rig Testing Using High Vanadium Fuel

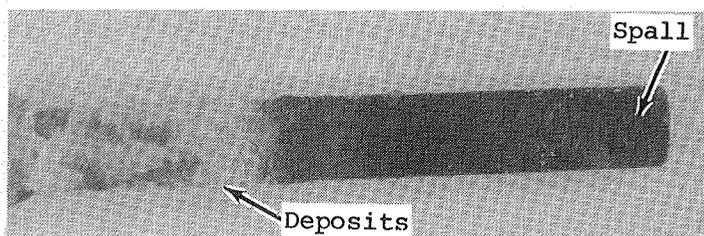
Figure 38. Duplex Fused ZrO<sub>2</sub>.8Y<sub>2</sub>O<sub>3</sub>/NiCrAlY Coating System After 515 Hours of Burner Rig Testing Using High Vanadium Fuel

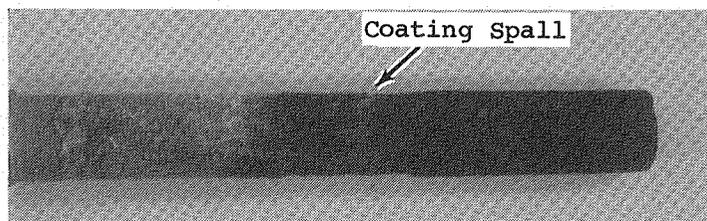
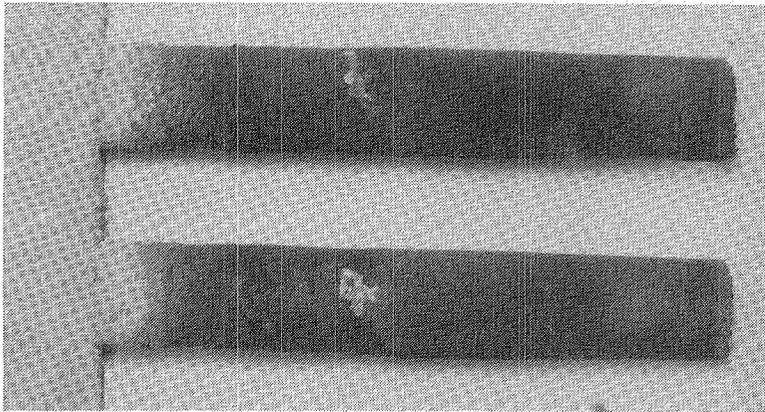
Figure 39. Test Specimens After 150 Hours of Burner Rig Testing at 932°C  
Using Fuel Containing Sulfur, Sodium and Vanadium

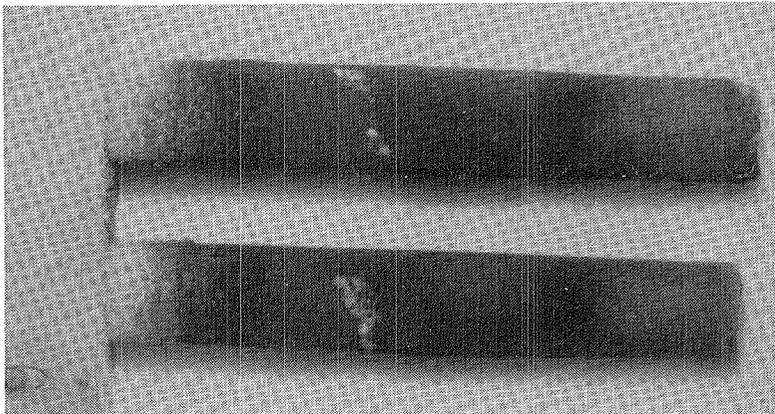
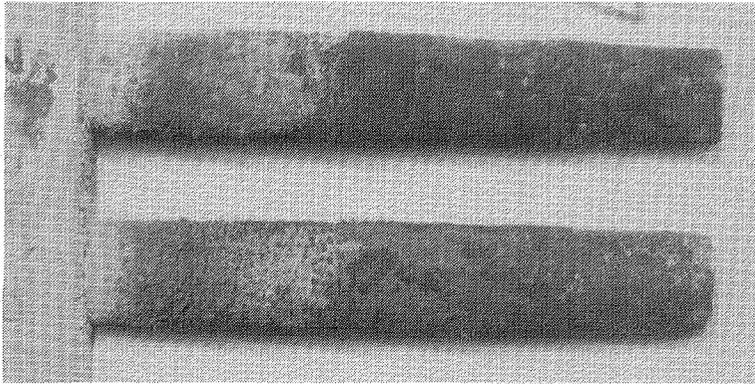
Figure 40. Test Specimens at Completion of 500-Hour Burner Rig Test at 932°C Using Fuel Containing Sulfur, Sodium and Vanadium (Sheet 1 of 2)

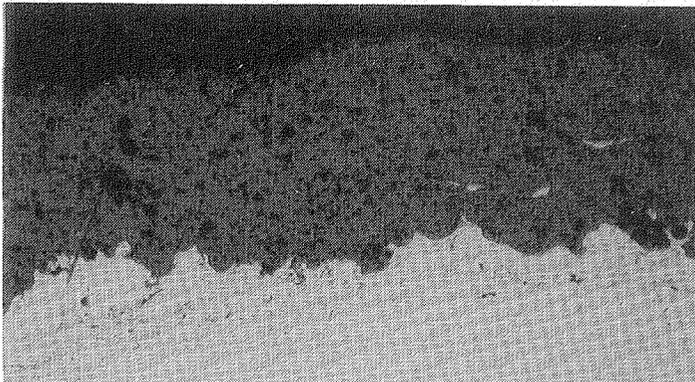
Figure 40. Test Specimens at Completion of 500-Hour Burner Rig Test at 932°C Using Fuel Containing Sulfur, Sodium and Vanadium (Sheet 2 of 2)

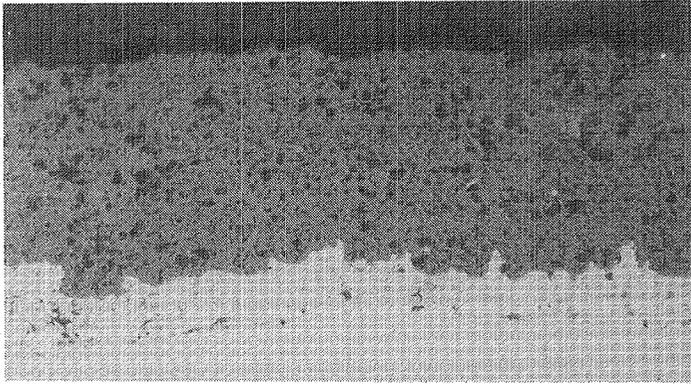
Figure 41.

Fused ZrO<sub>2</sub>.8Y<sub>2</sub>O<sub>3</sub>/NiCrAl-0.2Y  
TBC After 341 Hours of Burner  
Rig Testing at 932°C With  
Sodium, Sulfur and Vanadium  
in the Fuel

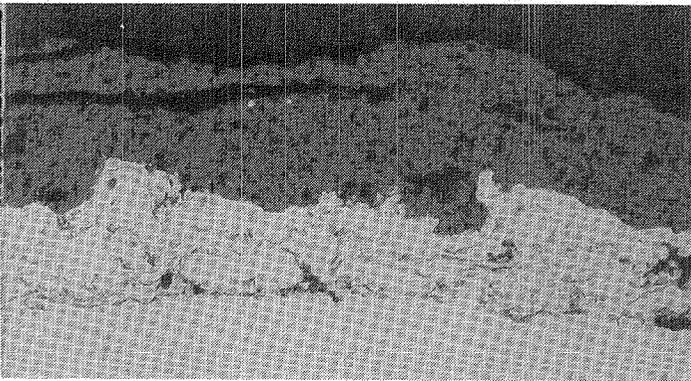
Figure 42.

Fused  $ZrO_2.8Y_2O_3/NiCrAl-0.5Y$   
TBC After 341 Hours of Burner  
Rig Testing at  $932^\circ C$  With  
Sodium, Sulfur and Vanadium  
in the Fuel

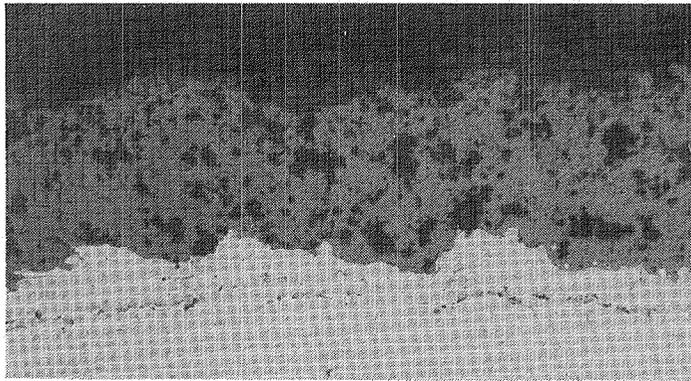
Figure 43.

Fused  $ZrO_2.8Y_2O_3/NiCrAl-0.8Y$   
TBC After 497 Hours of Burner  
Rig Testing at  $932^\circ C$  With  
Sodium, Sulfur and Vanadium  
in the Fuel

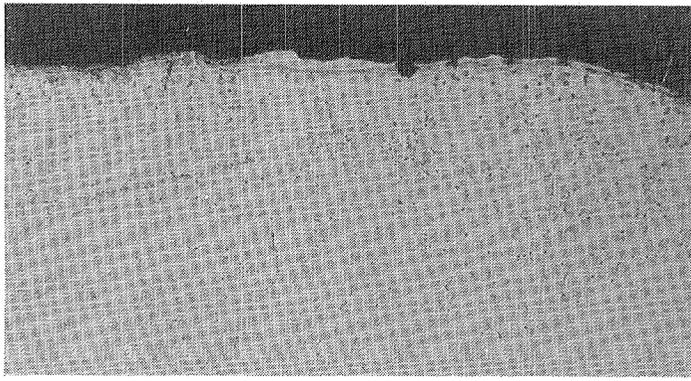
Figure 44.

$CaO.TiO_2/NiCrAl-0.5Y$  TBC  
After 341 Hours of Burner  
Rig Testing at  $932^\circ C$  With  
Sodium, Sulfur and Vanadium  
in the Fuel

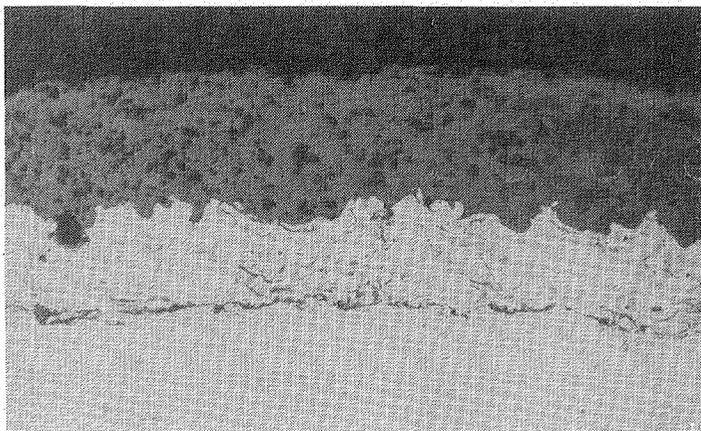
Figure 47.

Duplex Coated NiCrAlY/  
 $ZrO_2 \cdot 8Y_2O_3$  After 175 Hours  
of Burner Rig Testing at  
793°C and 3 ppm Sea Salt

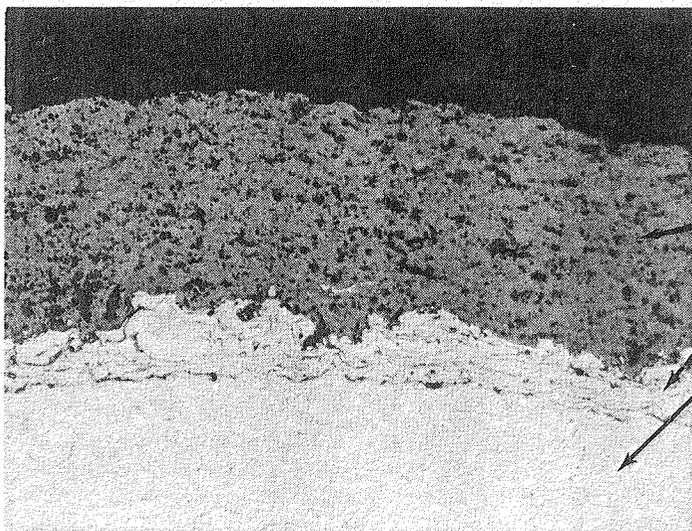
Figure 51.  $ZrO_2 \cdot 8Y_2O_3$  Coating After 500-Hour Burner Rig Test; 175 Hours at 793°C, 225 Hours at 849°C and 100 Hours at 905°C, 3 ppm Sea Salt

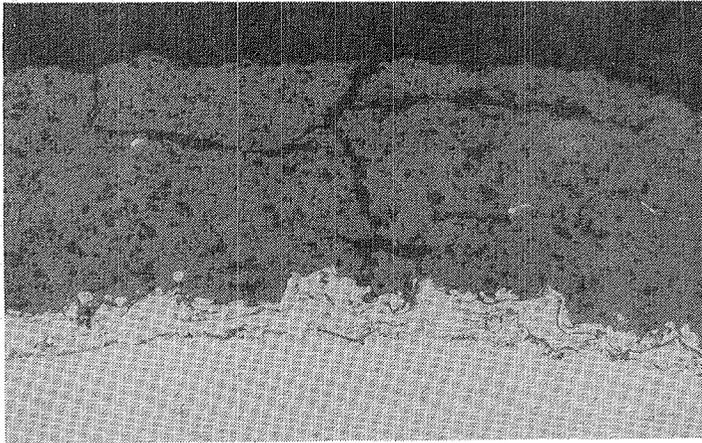
Figure 52.  $CaO \cdot TiO_2$  Specimen After 500-Hour Burner Rig Test; 175 Hours at 793°C, 225 Hours at 849°C, and 100 Hours at 905°C, 3 ppm Sea Salt

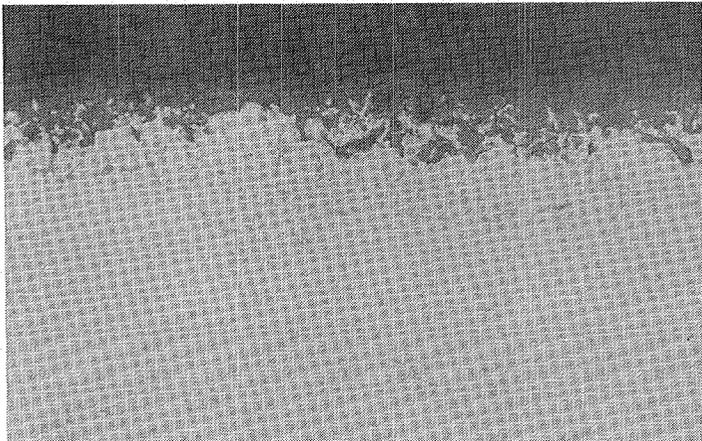
Figure 53.

Cracked Area of  $\text{CaO.TiO}_2$   
Coating After 500-Hour Test;  
175 Hours at  $793^\circ\text{C}$ , 225 Hours  
at  $849^\circ\text{C}$  and 100 Hours at  
 $905^\circ\text{C}$ , 3 ppm Sea Salt

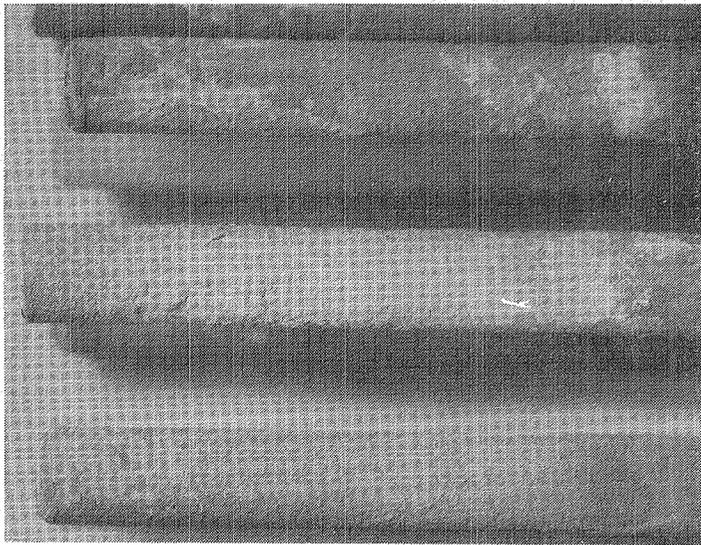
Figure 68. Endurance Specimens After 1000-Hour Hot Corrosion Test (Sheet 1 of 2)

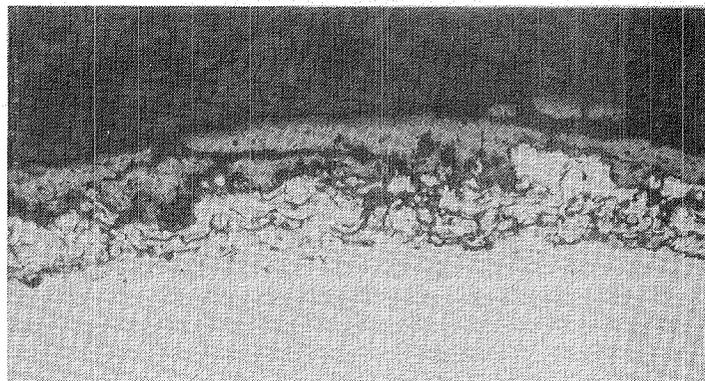
Figure 68. Endurance Specimens After 1000-Hour Hot Corrosion Test (Sheet 2 of 2)

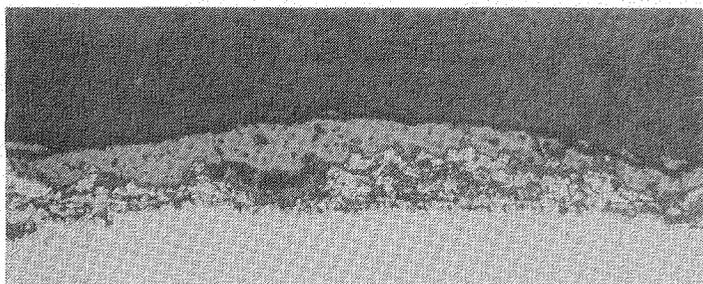
Figure 70. X-45M Specimen With  $ZrO_2.8Y_2O_3$  TBC After 1000-Hour Hot Corrosion Test (Magnification: 100X; Mount No. 3150)

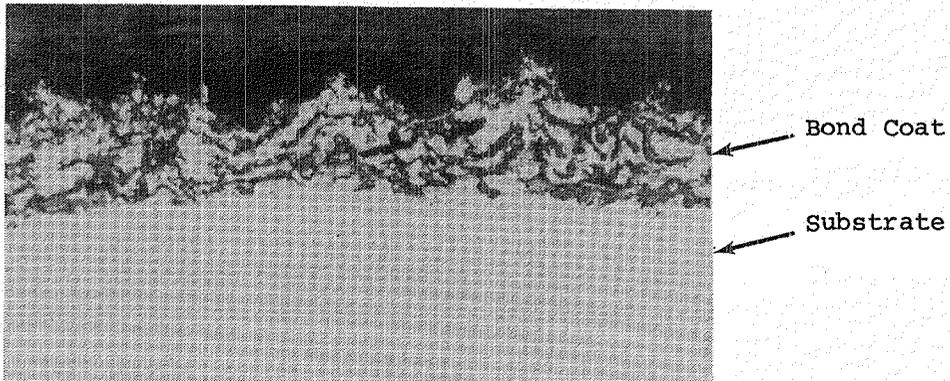
Figure 73. NASA Baseline Coating With MAR-M421 Substrate After 1000-Hour Hot Corrosion Test (Magnification: 100X; Mount No. 3145)

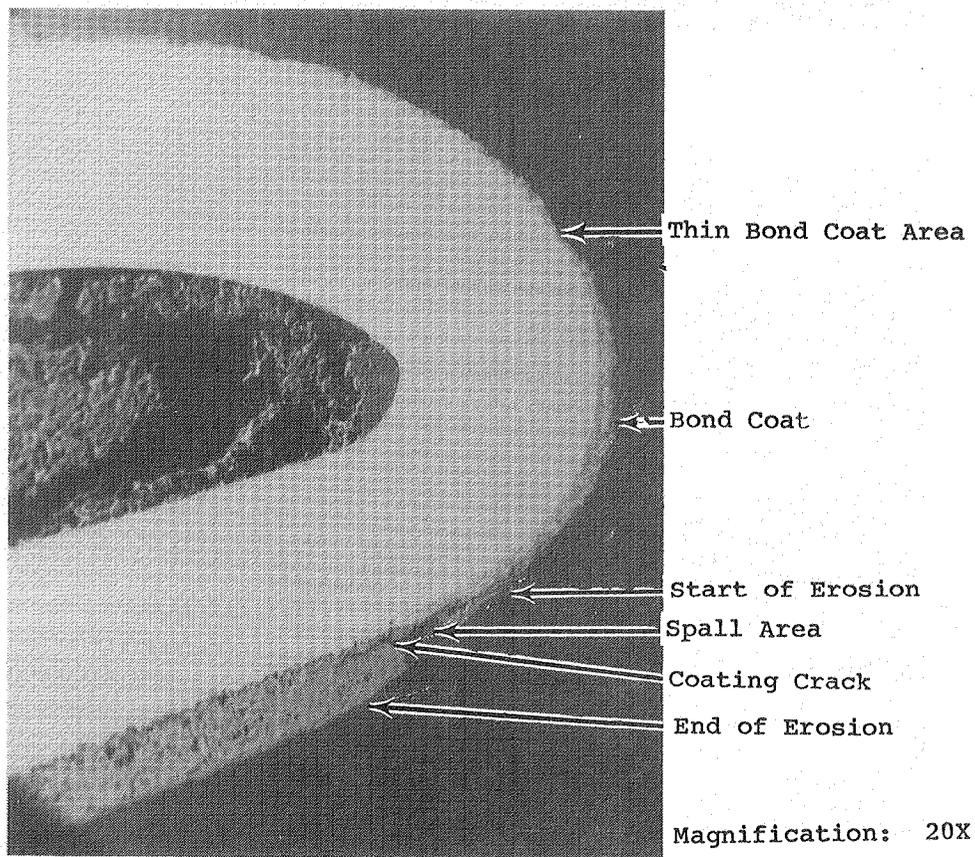
Figure 77. Calcium Silicate TBC Blade After 550-Hour Engine Endurance Test

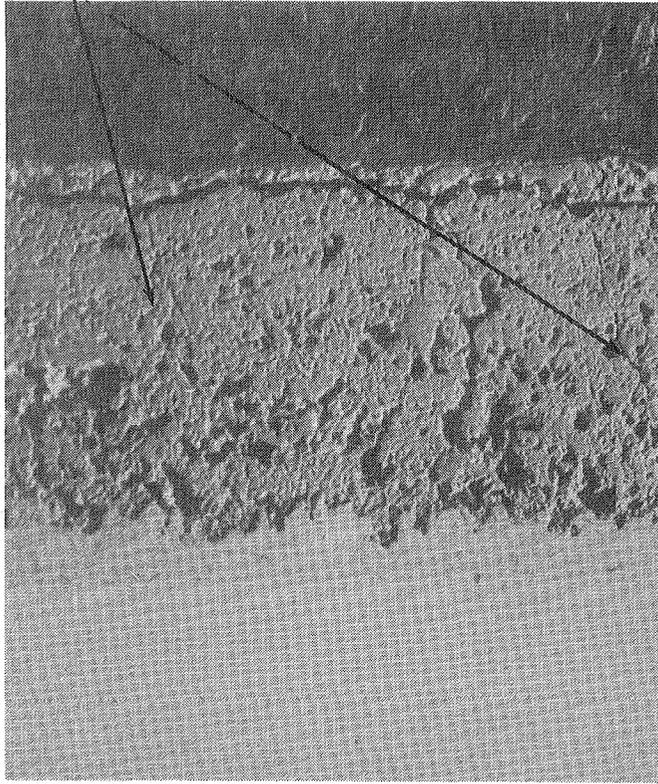
Figure 79. Bond Coat on Leading Edge of  $\text{Ca}_2\text{SiO}_3$  TBC Blade After 550-Hour Engine Endurance Test

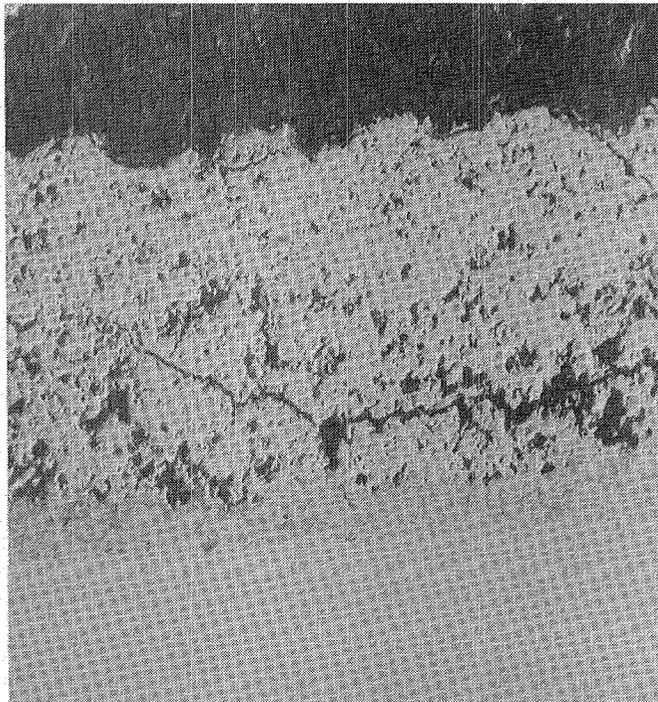
Figure 83. Section of Sintered  $ZrO_2 \cdot 8Y_2O_3$  TBC Blade After 550-Hour Engine Endurance Test

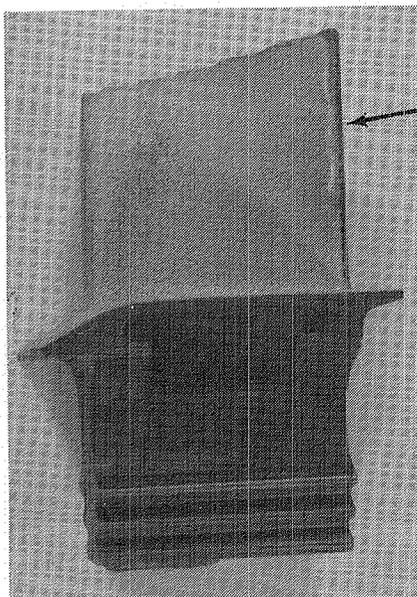
Figure 84. Sintered  $ZrO_2 \cdot 8Y_2O_3$  TBC Structure After 550-Hour Engine Endurance Test

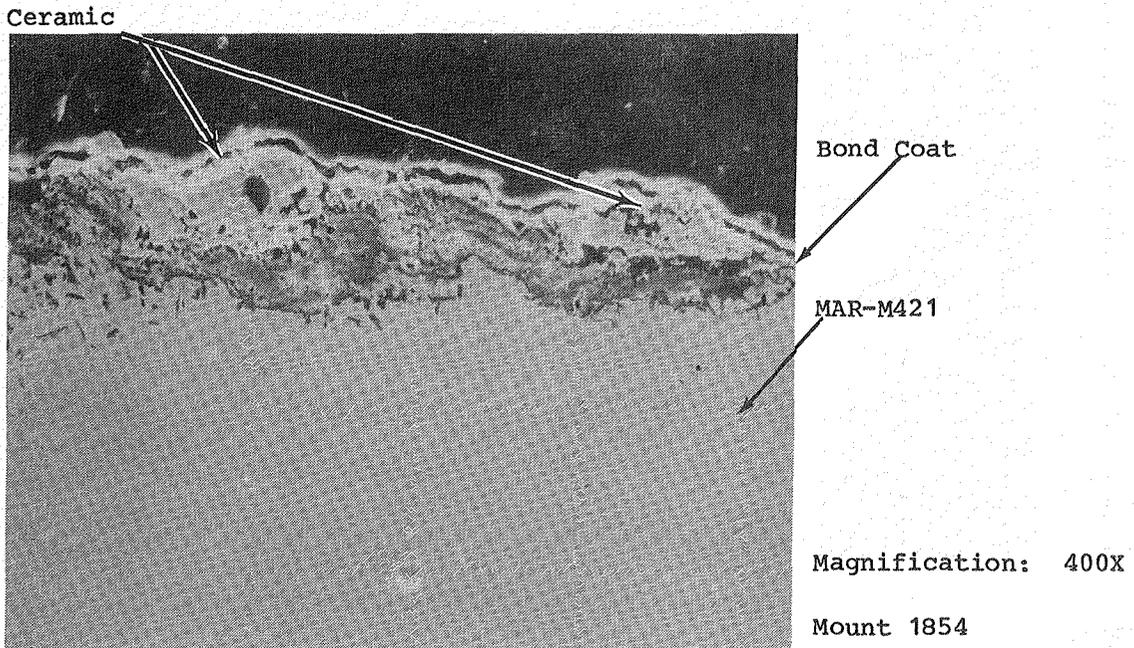
Figure 92. Fused  $ZrO_2 \cdot 8Y_2O_3$  TBC Blade Leading Edge After 550-Hour Engine Endurance Test

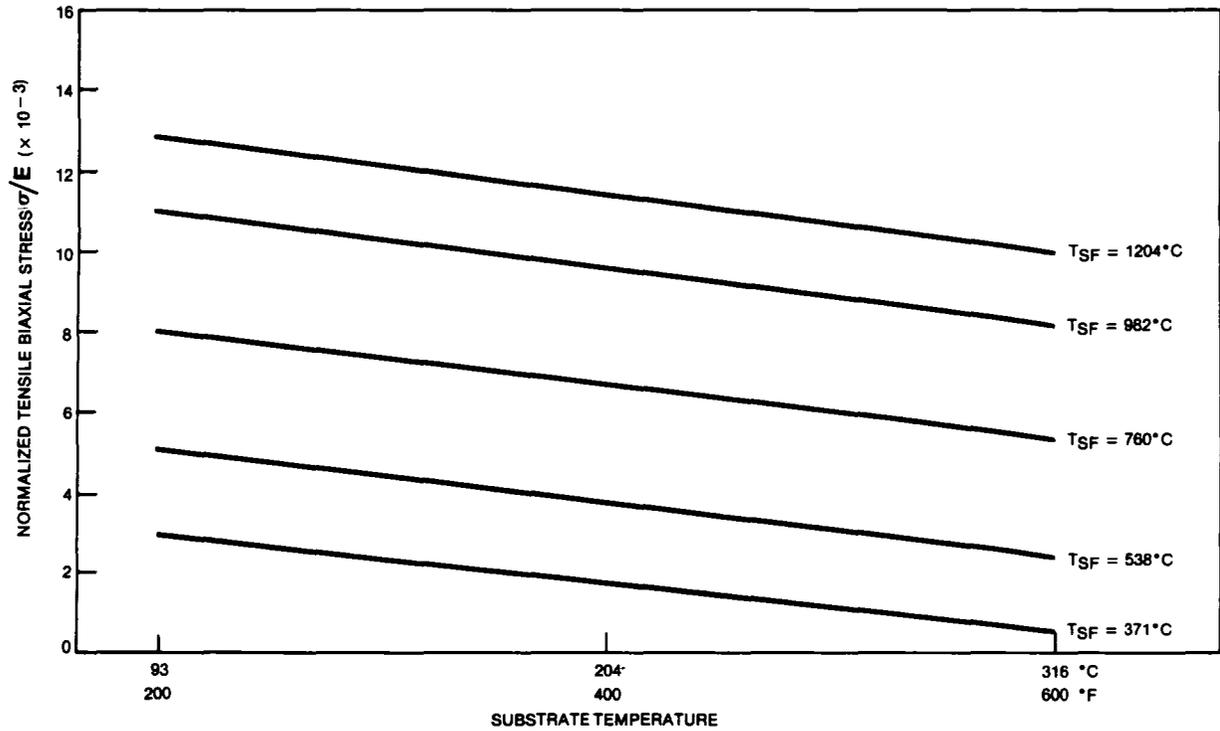
Figure 96. Stress Induced in TBC Due to Thermal Expansion at Selected Stress-Free Temperatures

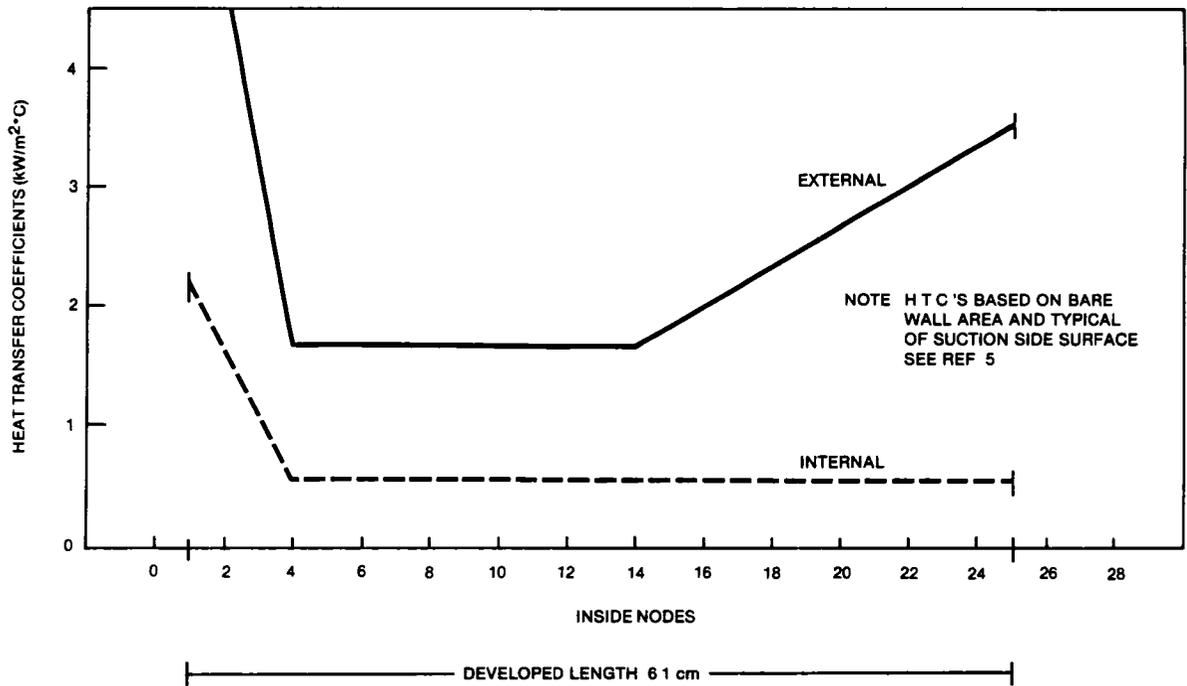
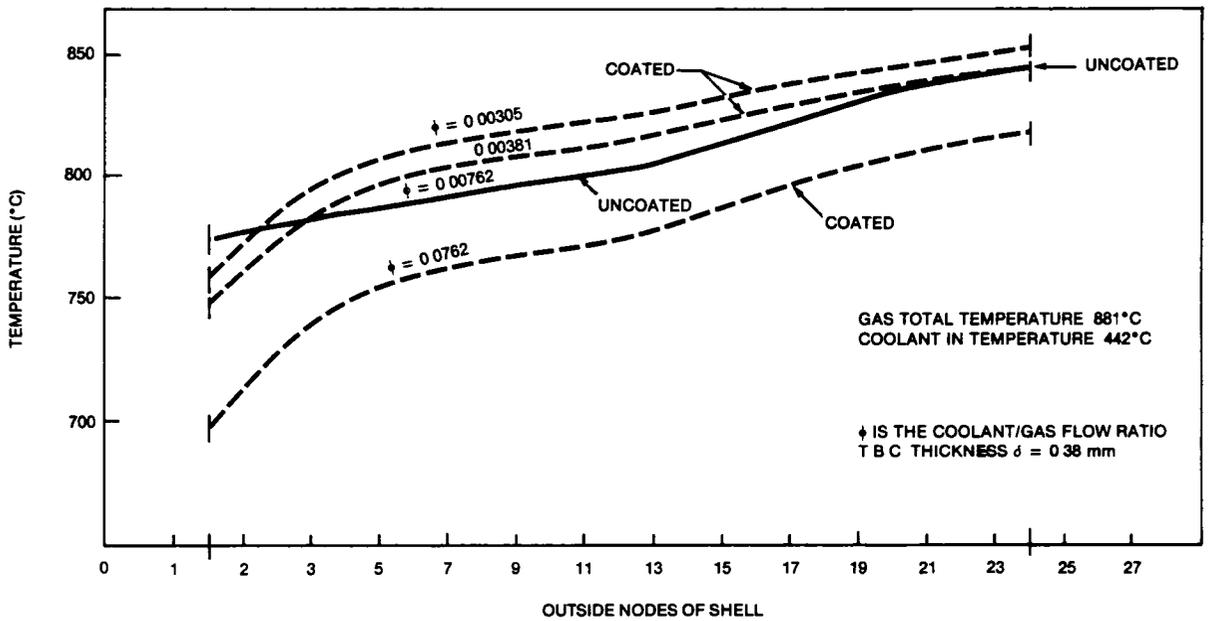
Figure 104. Model Heat Transfer Coefficients Based on Bare Wall Area

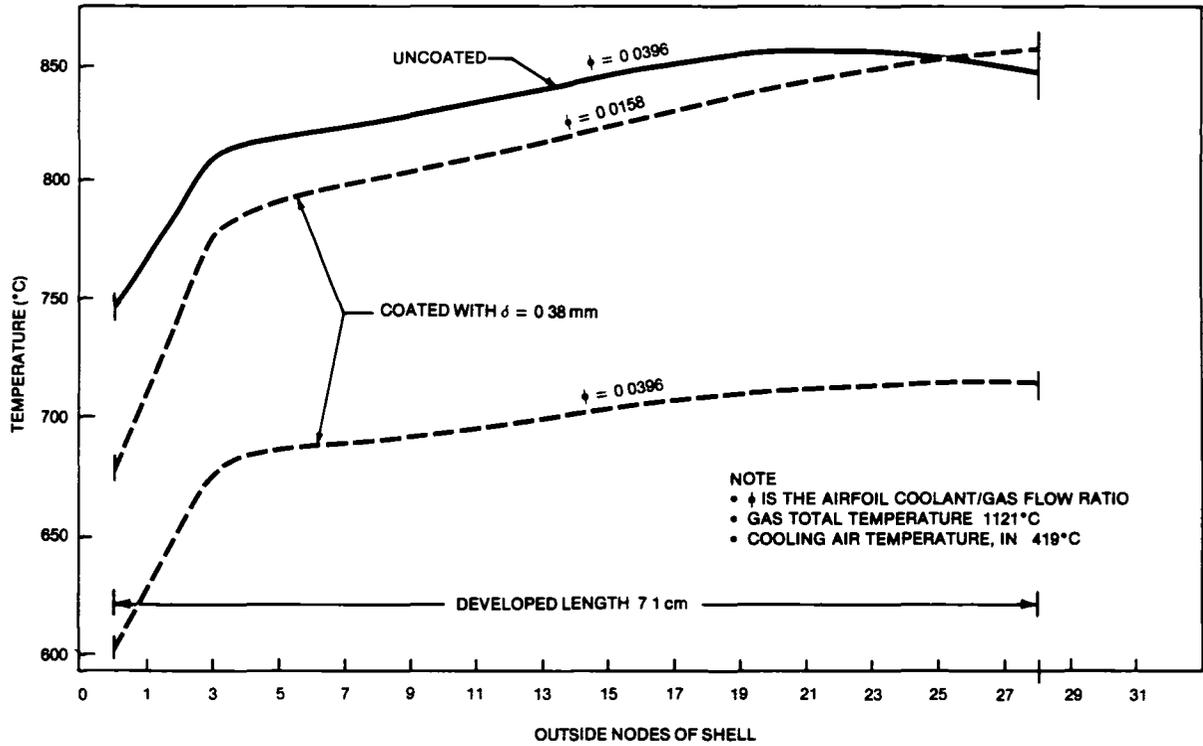
Figure 105. Effect of TBC on the Mars Second-Stage Cooled Nozzles
