REPORT OF APOLLO 204 REVIEW BOARD

APPENDIX D
PANELS 1 thru 4

**REPORT OF PANEL 1
SPACECRAFT AND GROUND SUPPORT EQUIPMENT
CONFIGURATION
APPENDIX D-1
TO
FINAL REPORT OF
APOLLO 204 REVIEW BOARD**

**REPORT OF PANEL 4
DISASSEMBLY ACTIVITIES PANEL
APPENDIX D-4
TO
FINAL REPORT OF
APOLLO 204 REVIEW BOARD**

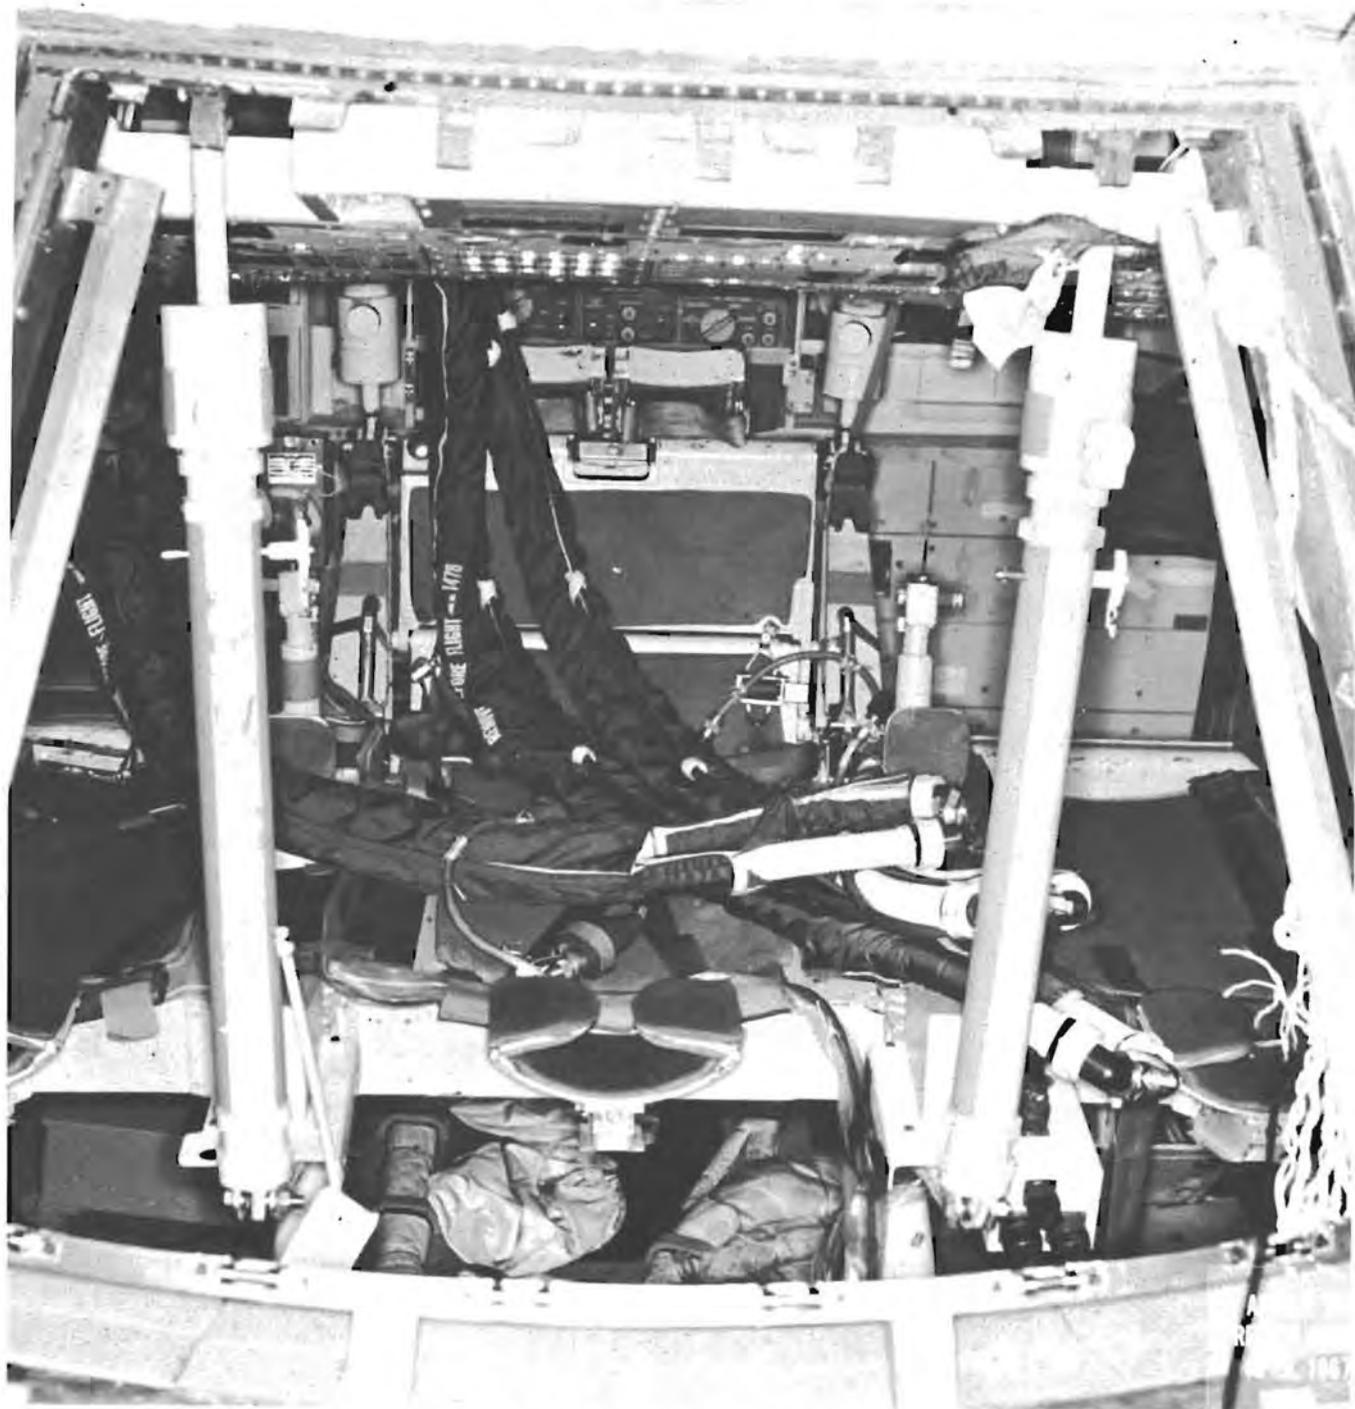
VIEW OF COMMAND MODULE MOCKUP INTERIOR, COUCHES INSTALLED

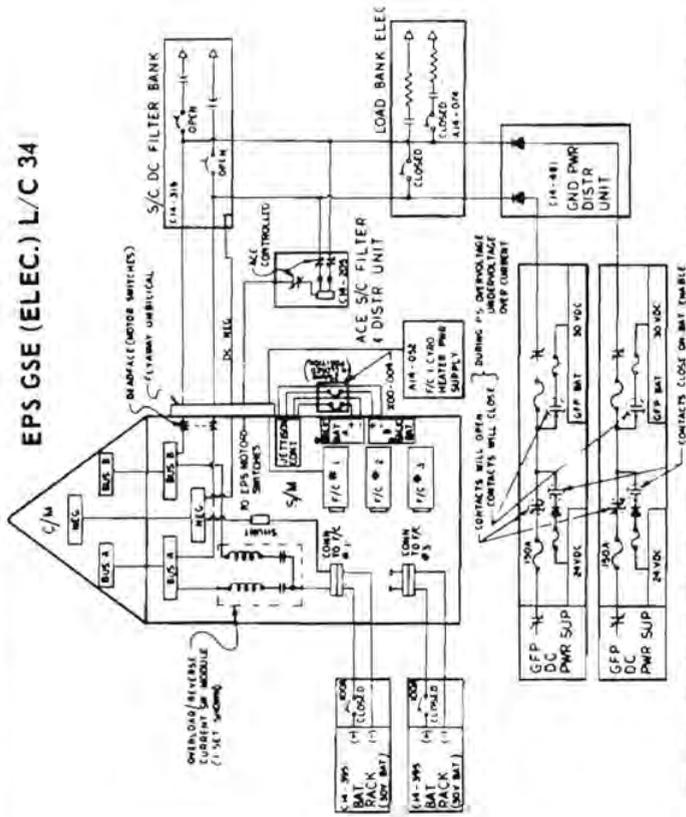
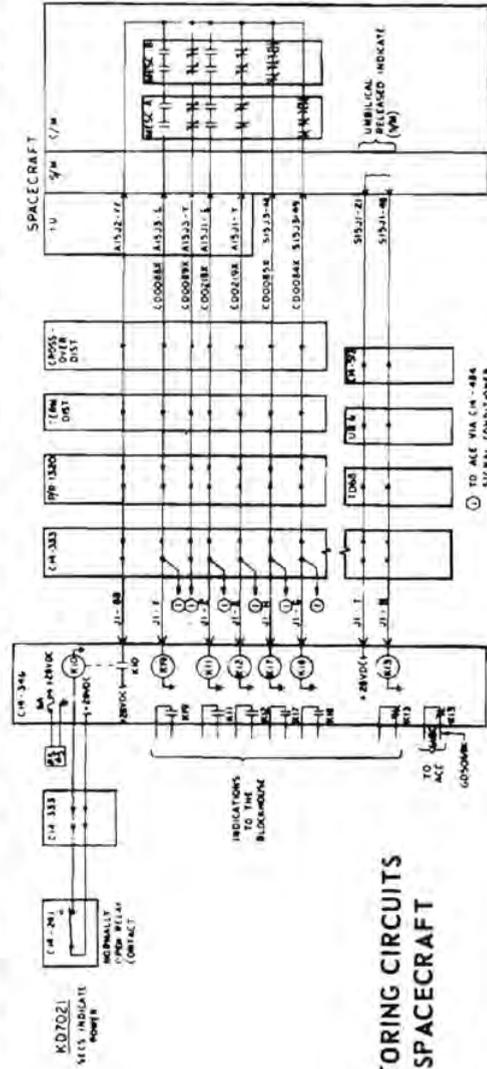
PYRO & LOGIC MONITORING CIRCUITS
SHOWING C14-346 TO SPACECRAFT
INTERFACE

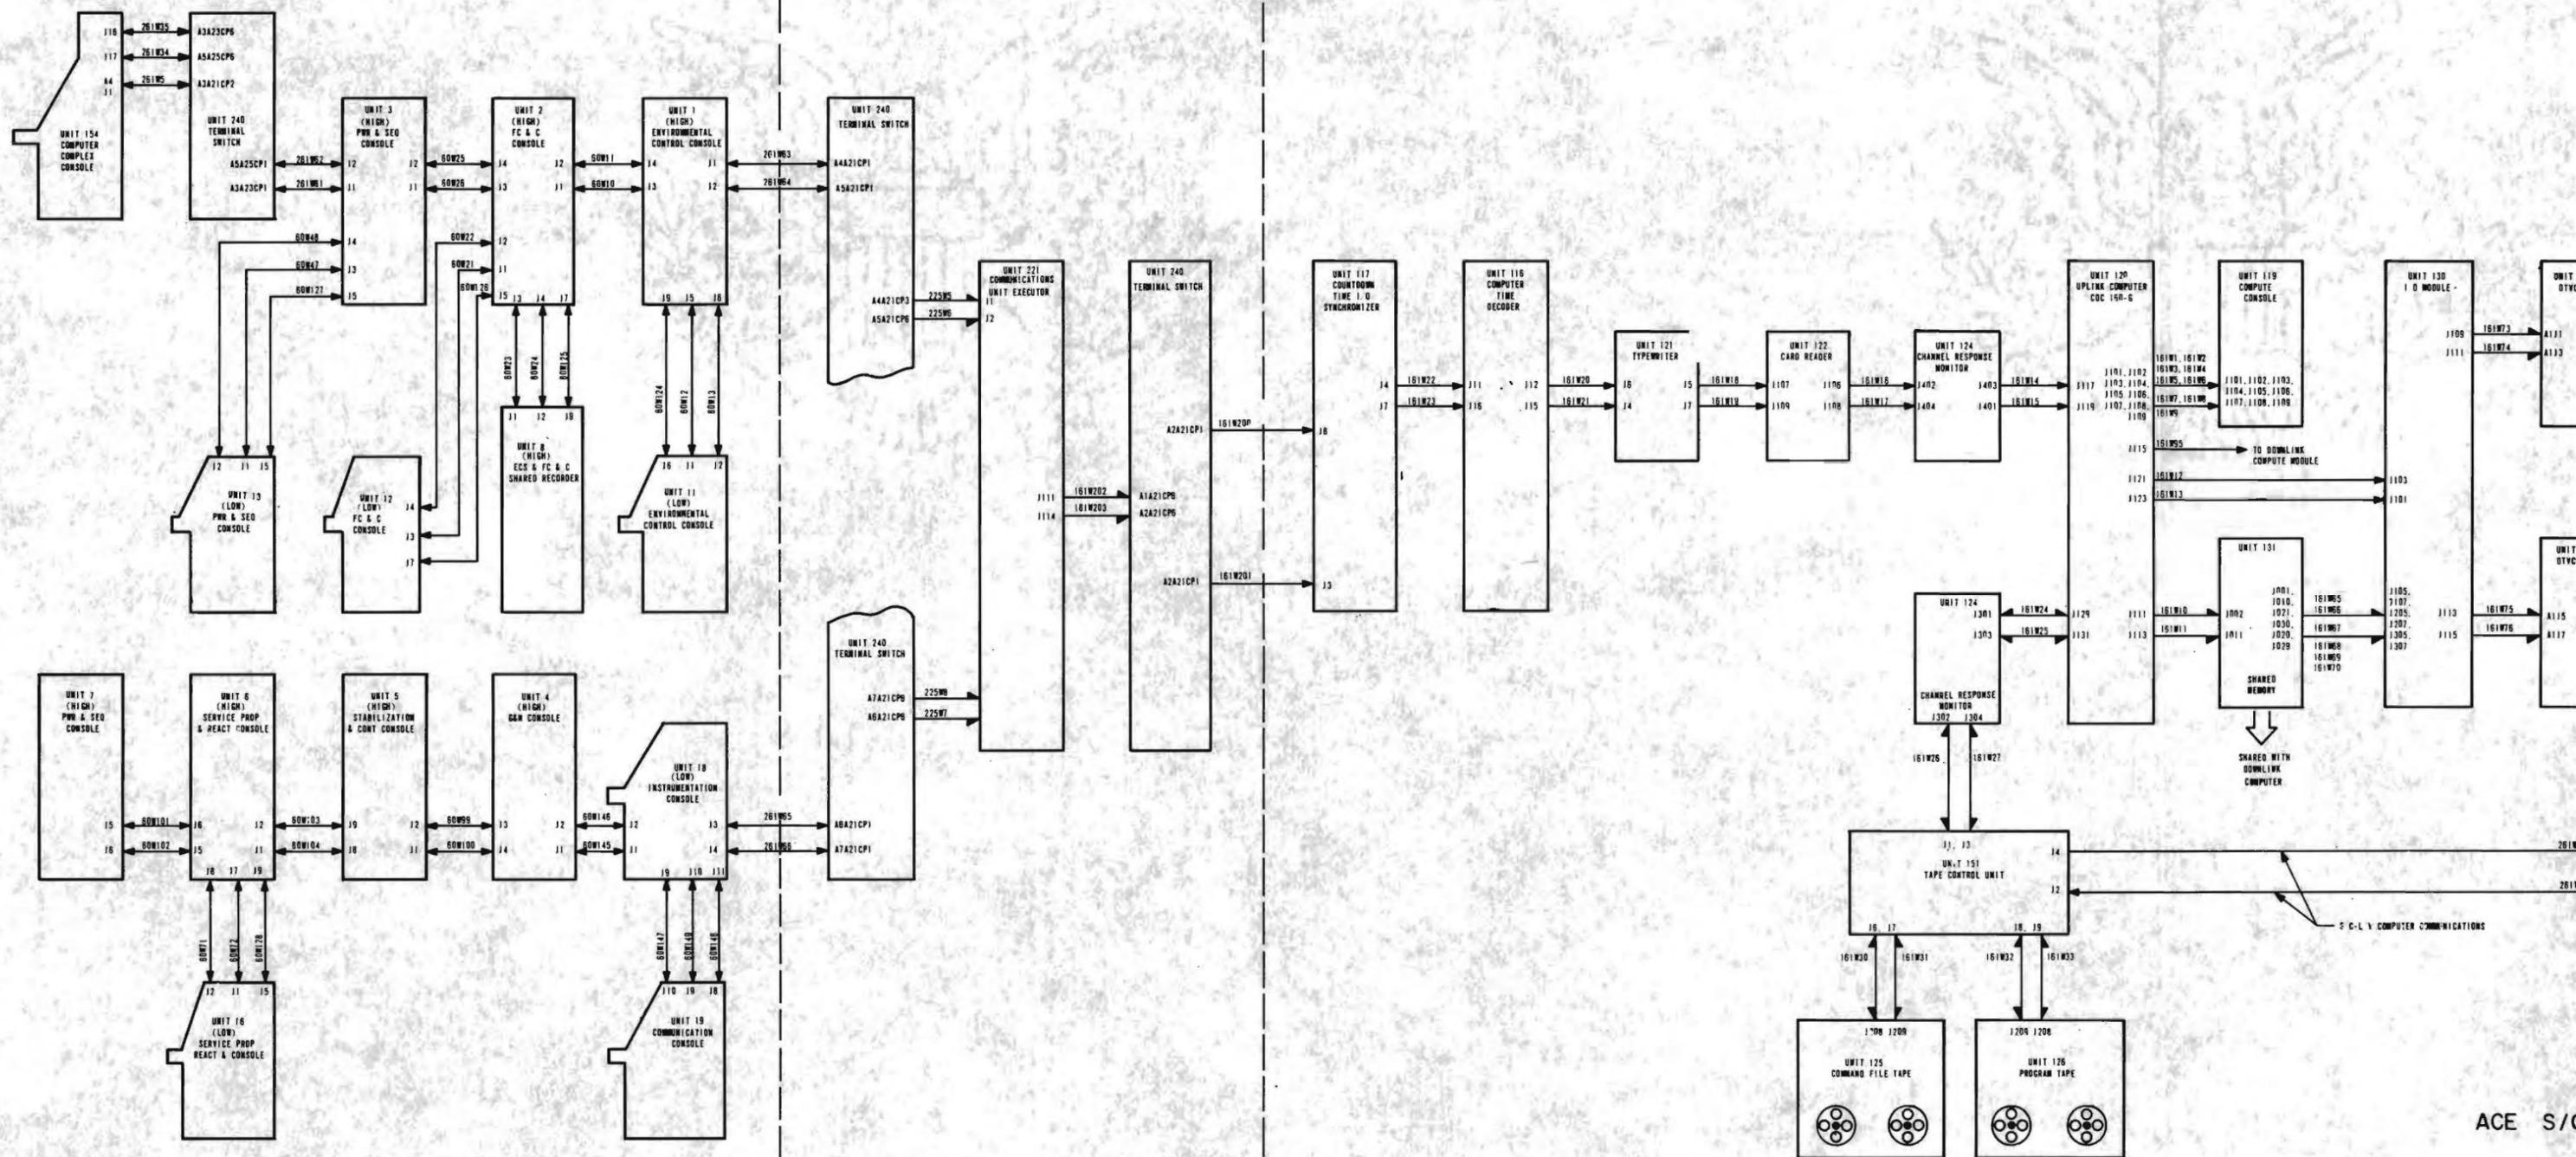
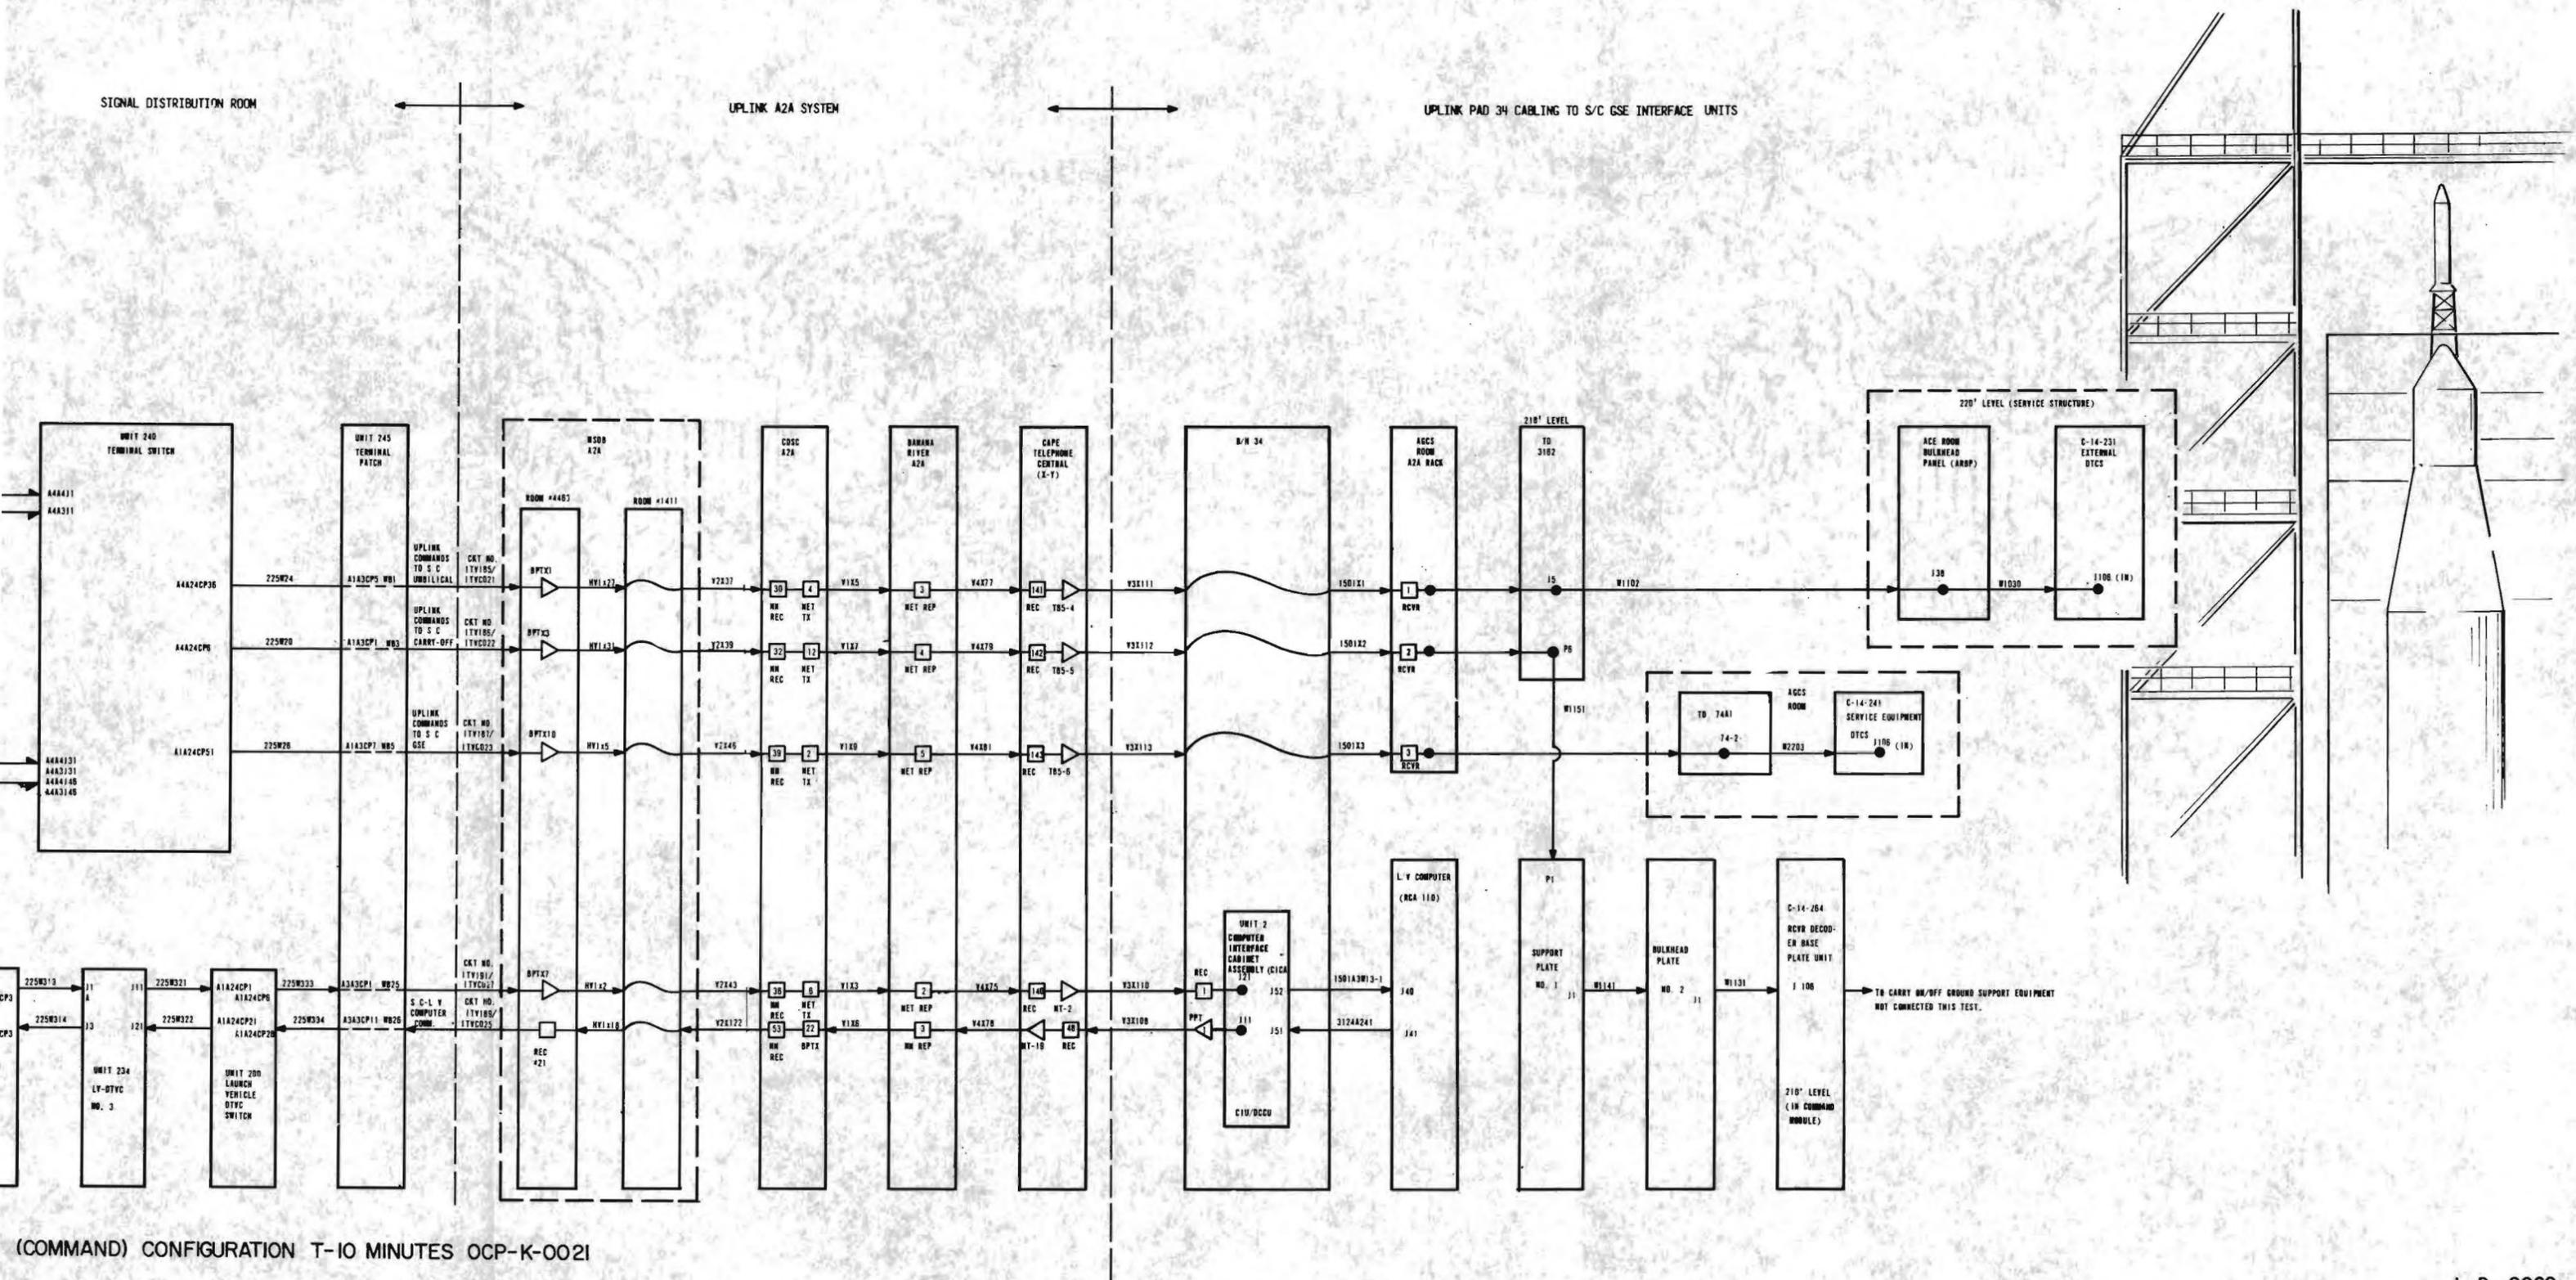
(COMMAND) CONFIGURATION T-10 MINUTES OCP-K-0021

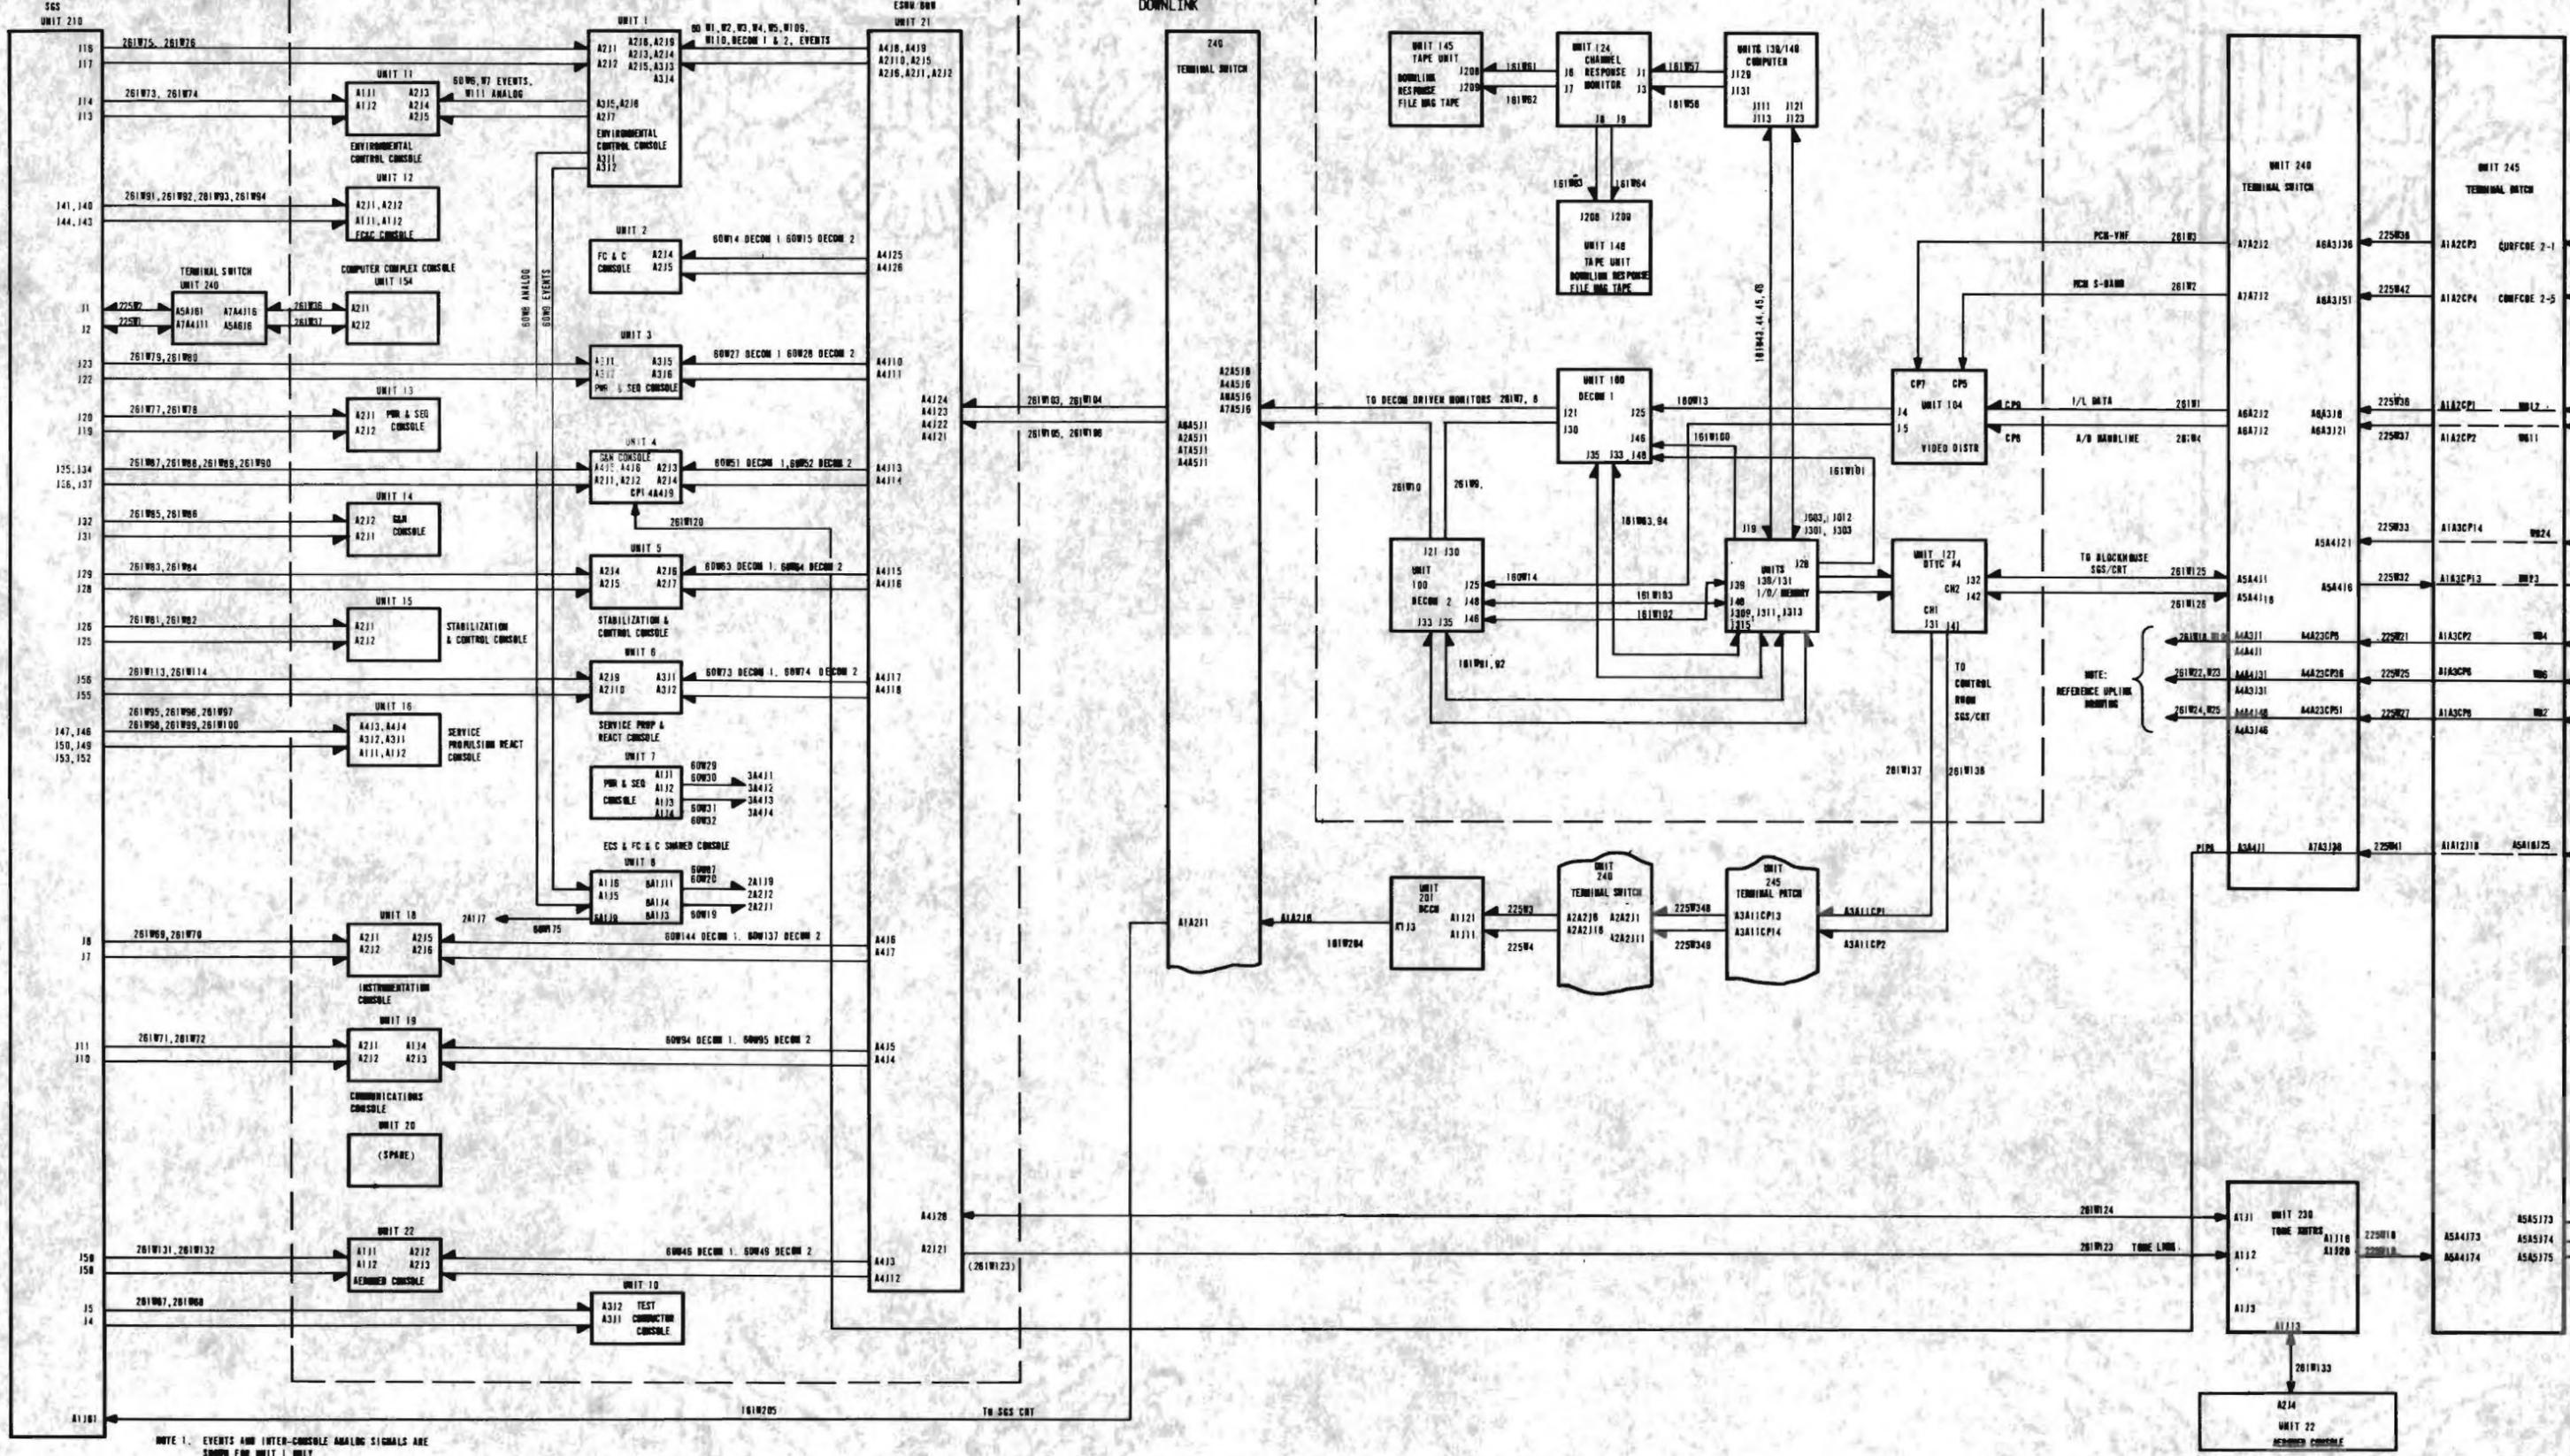
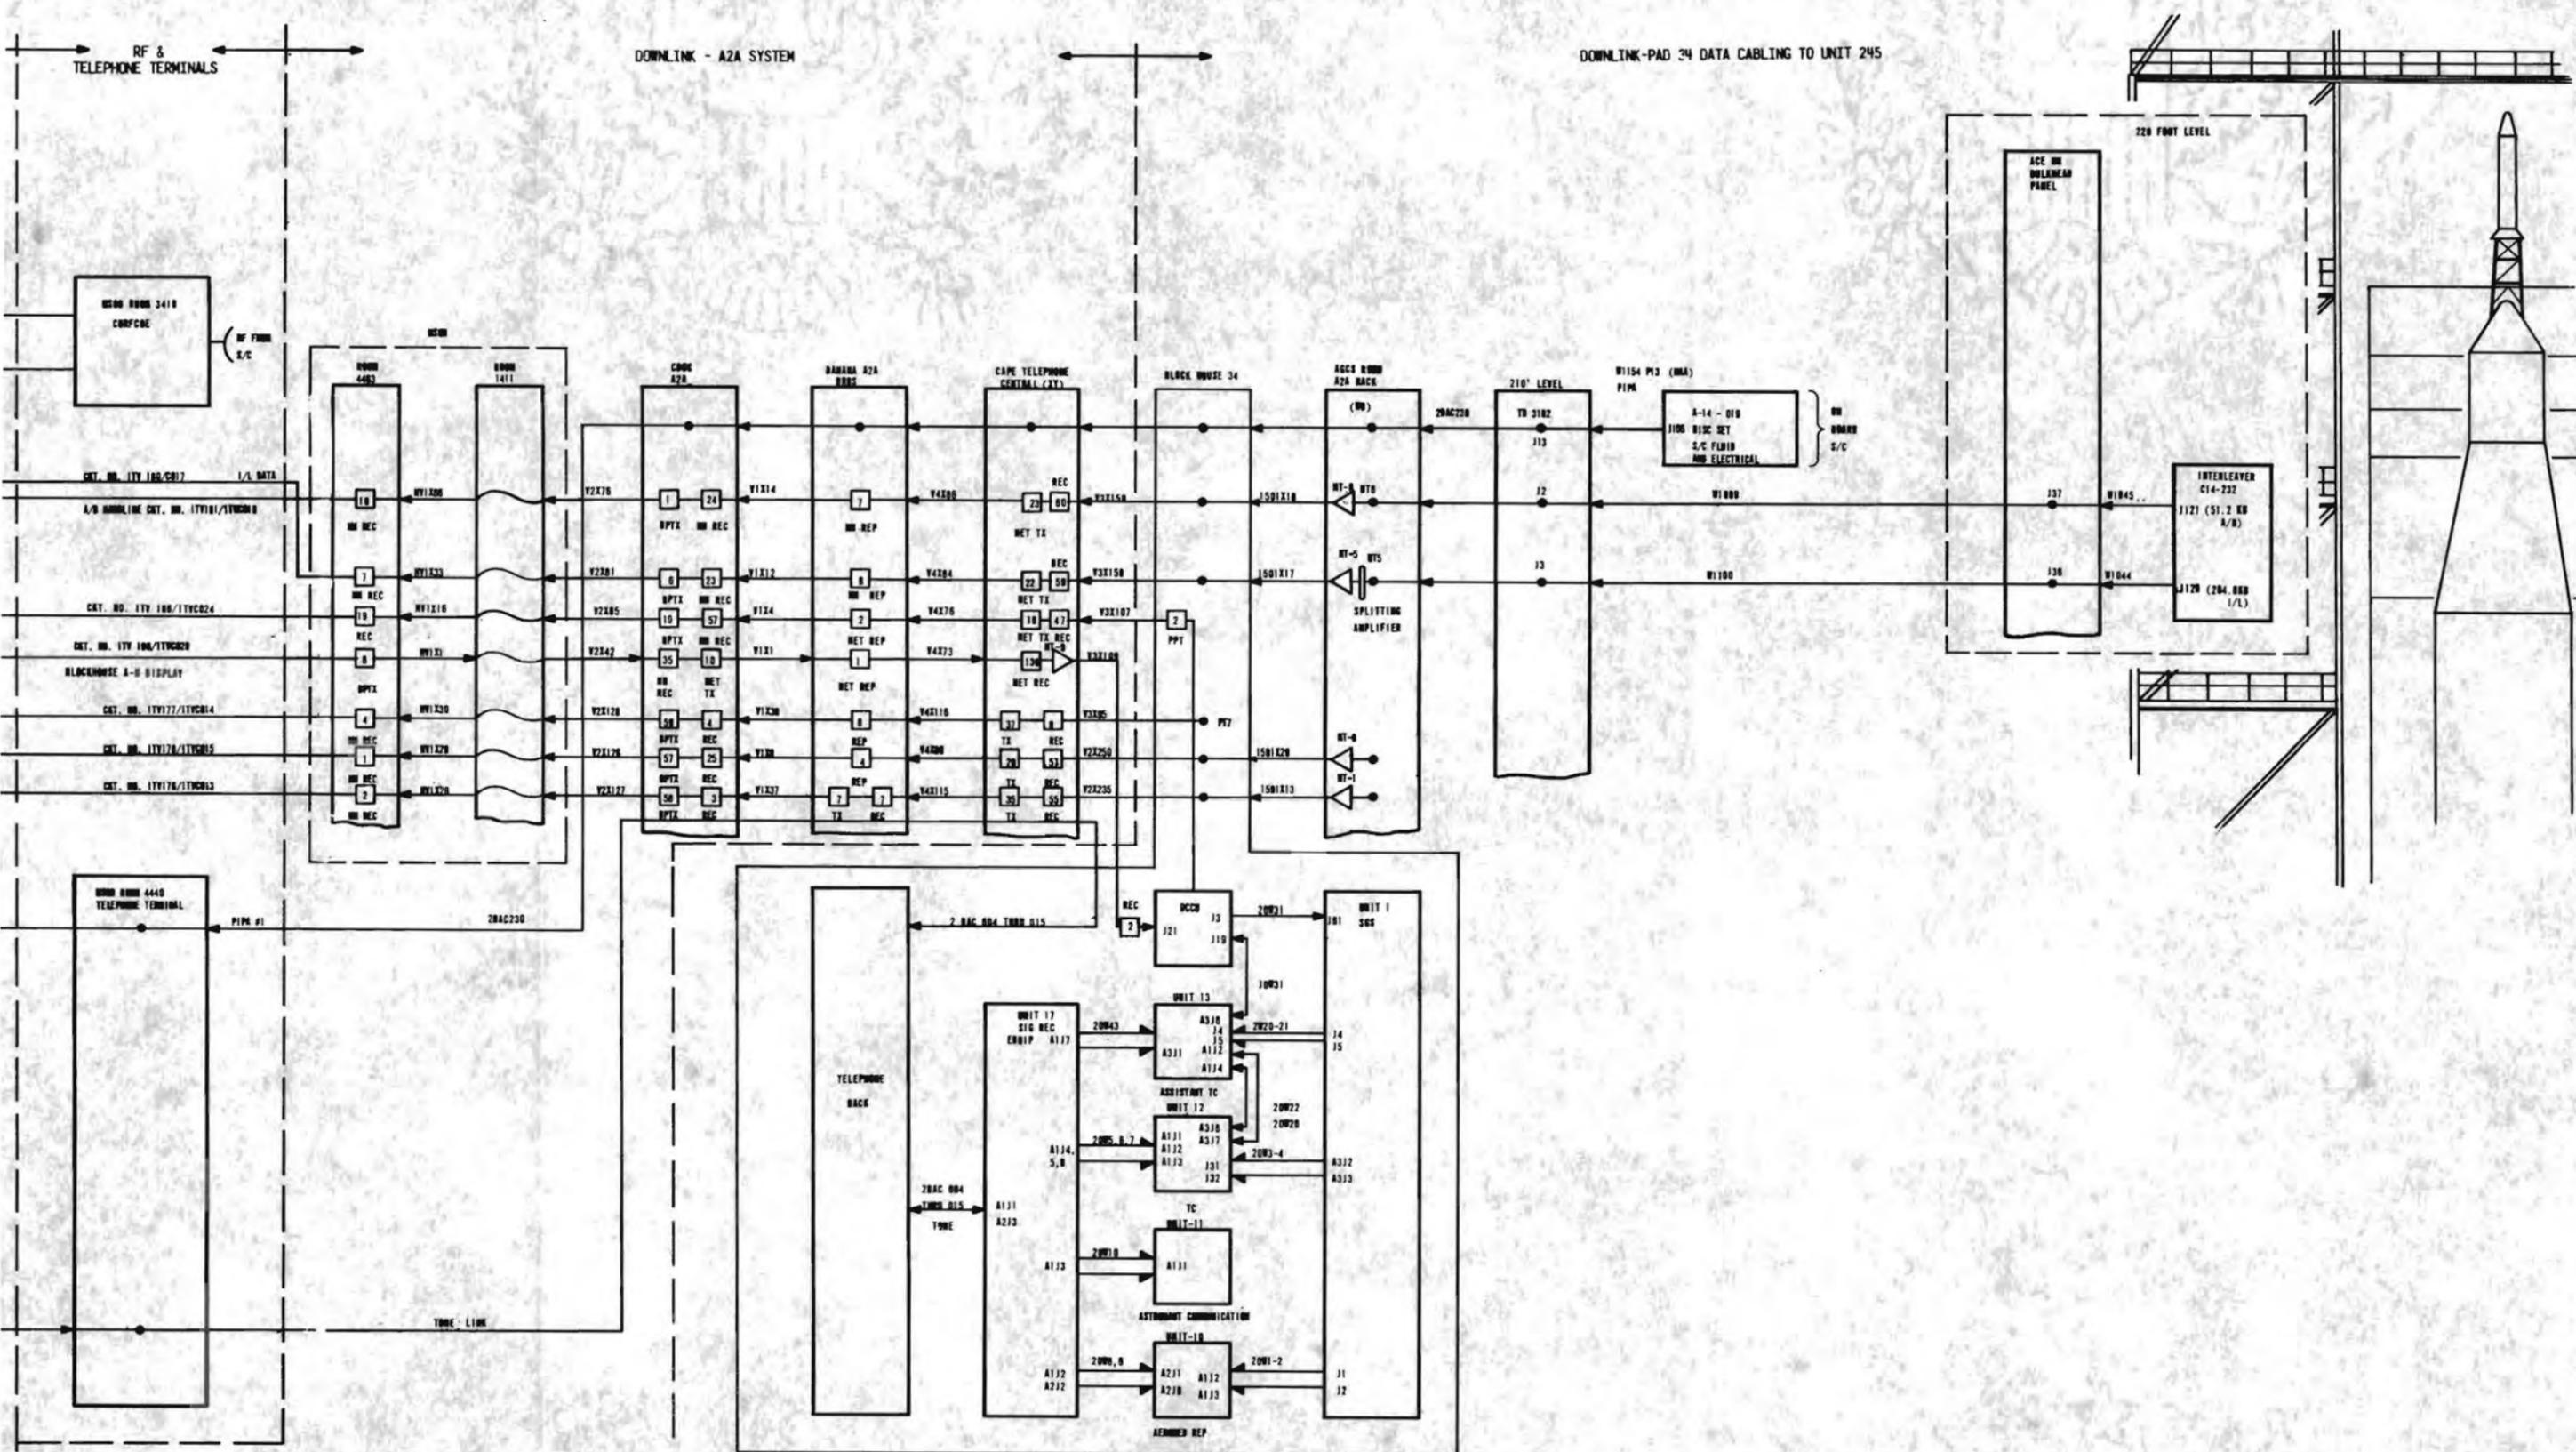
ACE S/C SYSTEM DOWNLINK (MONITOR) CONFIGURATION T-10 MINUTES OCP-K-0021

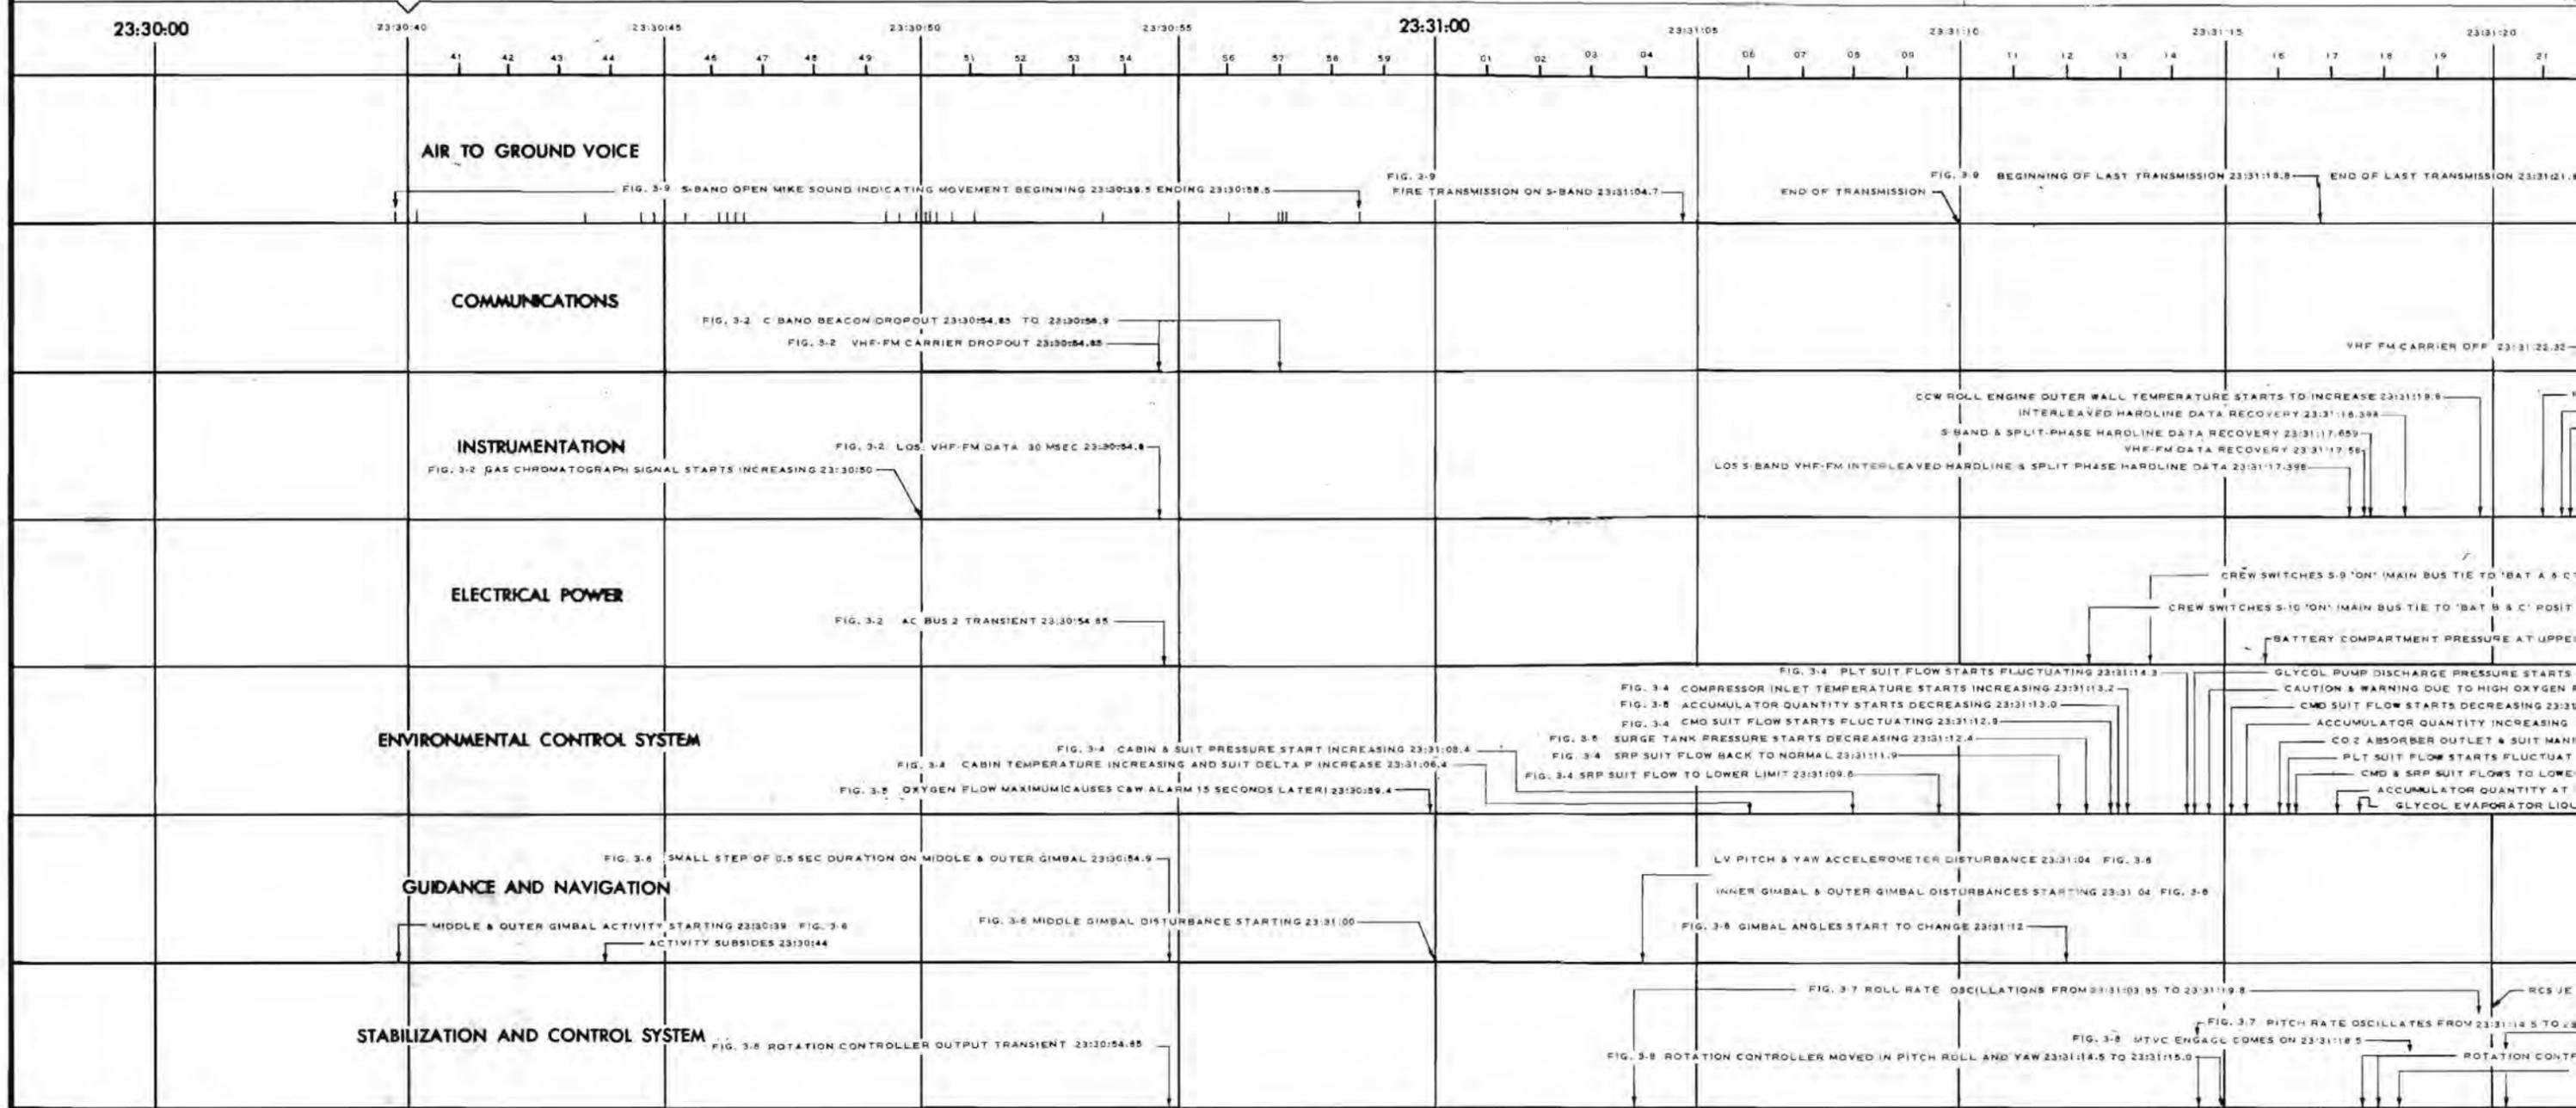
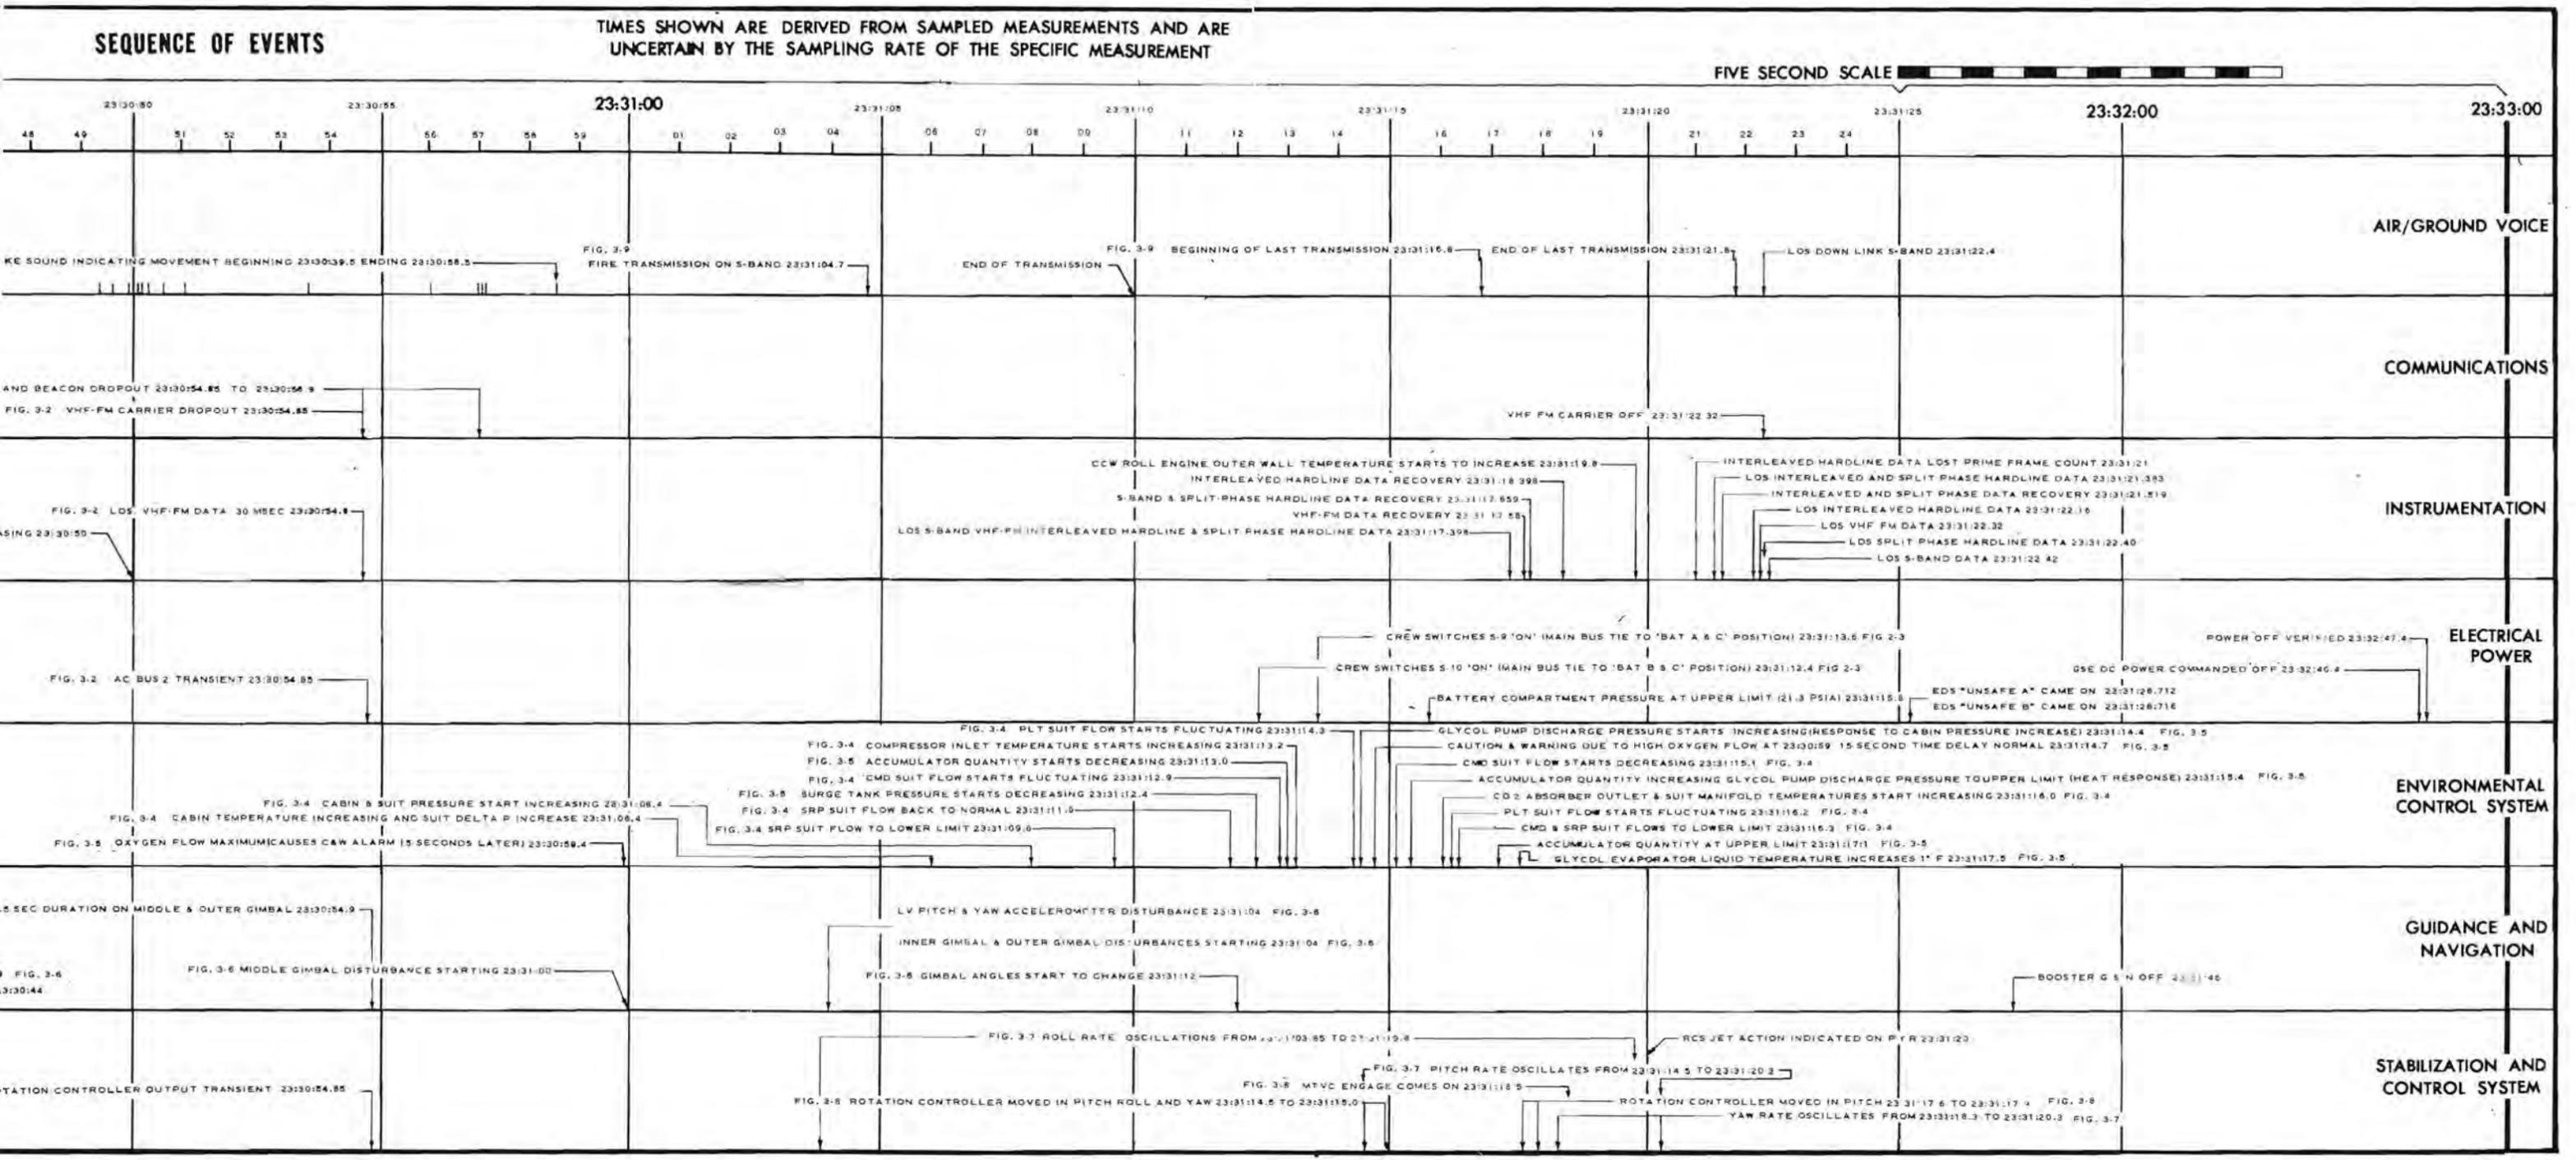
TIMES SHOWN ARE DERIVED FROM SAMPLED MEASUREMENTS AND ARE UNCERTAIN BY THE SAMPLING RATE OF THE SPECIFIC MEASUREMENT

FIGURE 3-1 SEQUENCE OF EVENTS

The illustrations contained in this section are direct reproductions of the direct-write recordings made through the ACE S/C ground station decommutator. No smoothing techniques have been employed. However, during the last 5 seconds before final LOS three additional losses of data occurred. At these times the PCM wavetrain recovered as much as a second before the ACE decommutator was able to reacquire synchronization. In order to provide information during the portion of this time when the wavetrain was available but the decommutator not in synchronization, manual data reduction was employed.
