REPORT OF APOLLO 204 REVIEW BOARD

APPENDIX D
PANELS 1 thru 4

**REPORT OF PANEL 1
SPACECRAFT AND GROUND SUPPORT EQUIPMENT
CONFIGURATION
APPENDIX D-1
TO
FINAL REPORT OF
APOLLO 204 REVIEW BOARD**

**REPORT OF PANEL 4
DISASSEMBLY ACTIVITIES PANEL
APPENDIX D-4
TO
FINAL REPORT OF
APOLLO 204 REVIEW BOARD**

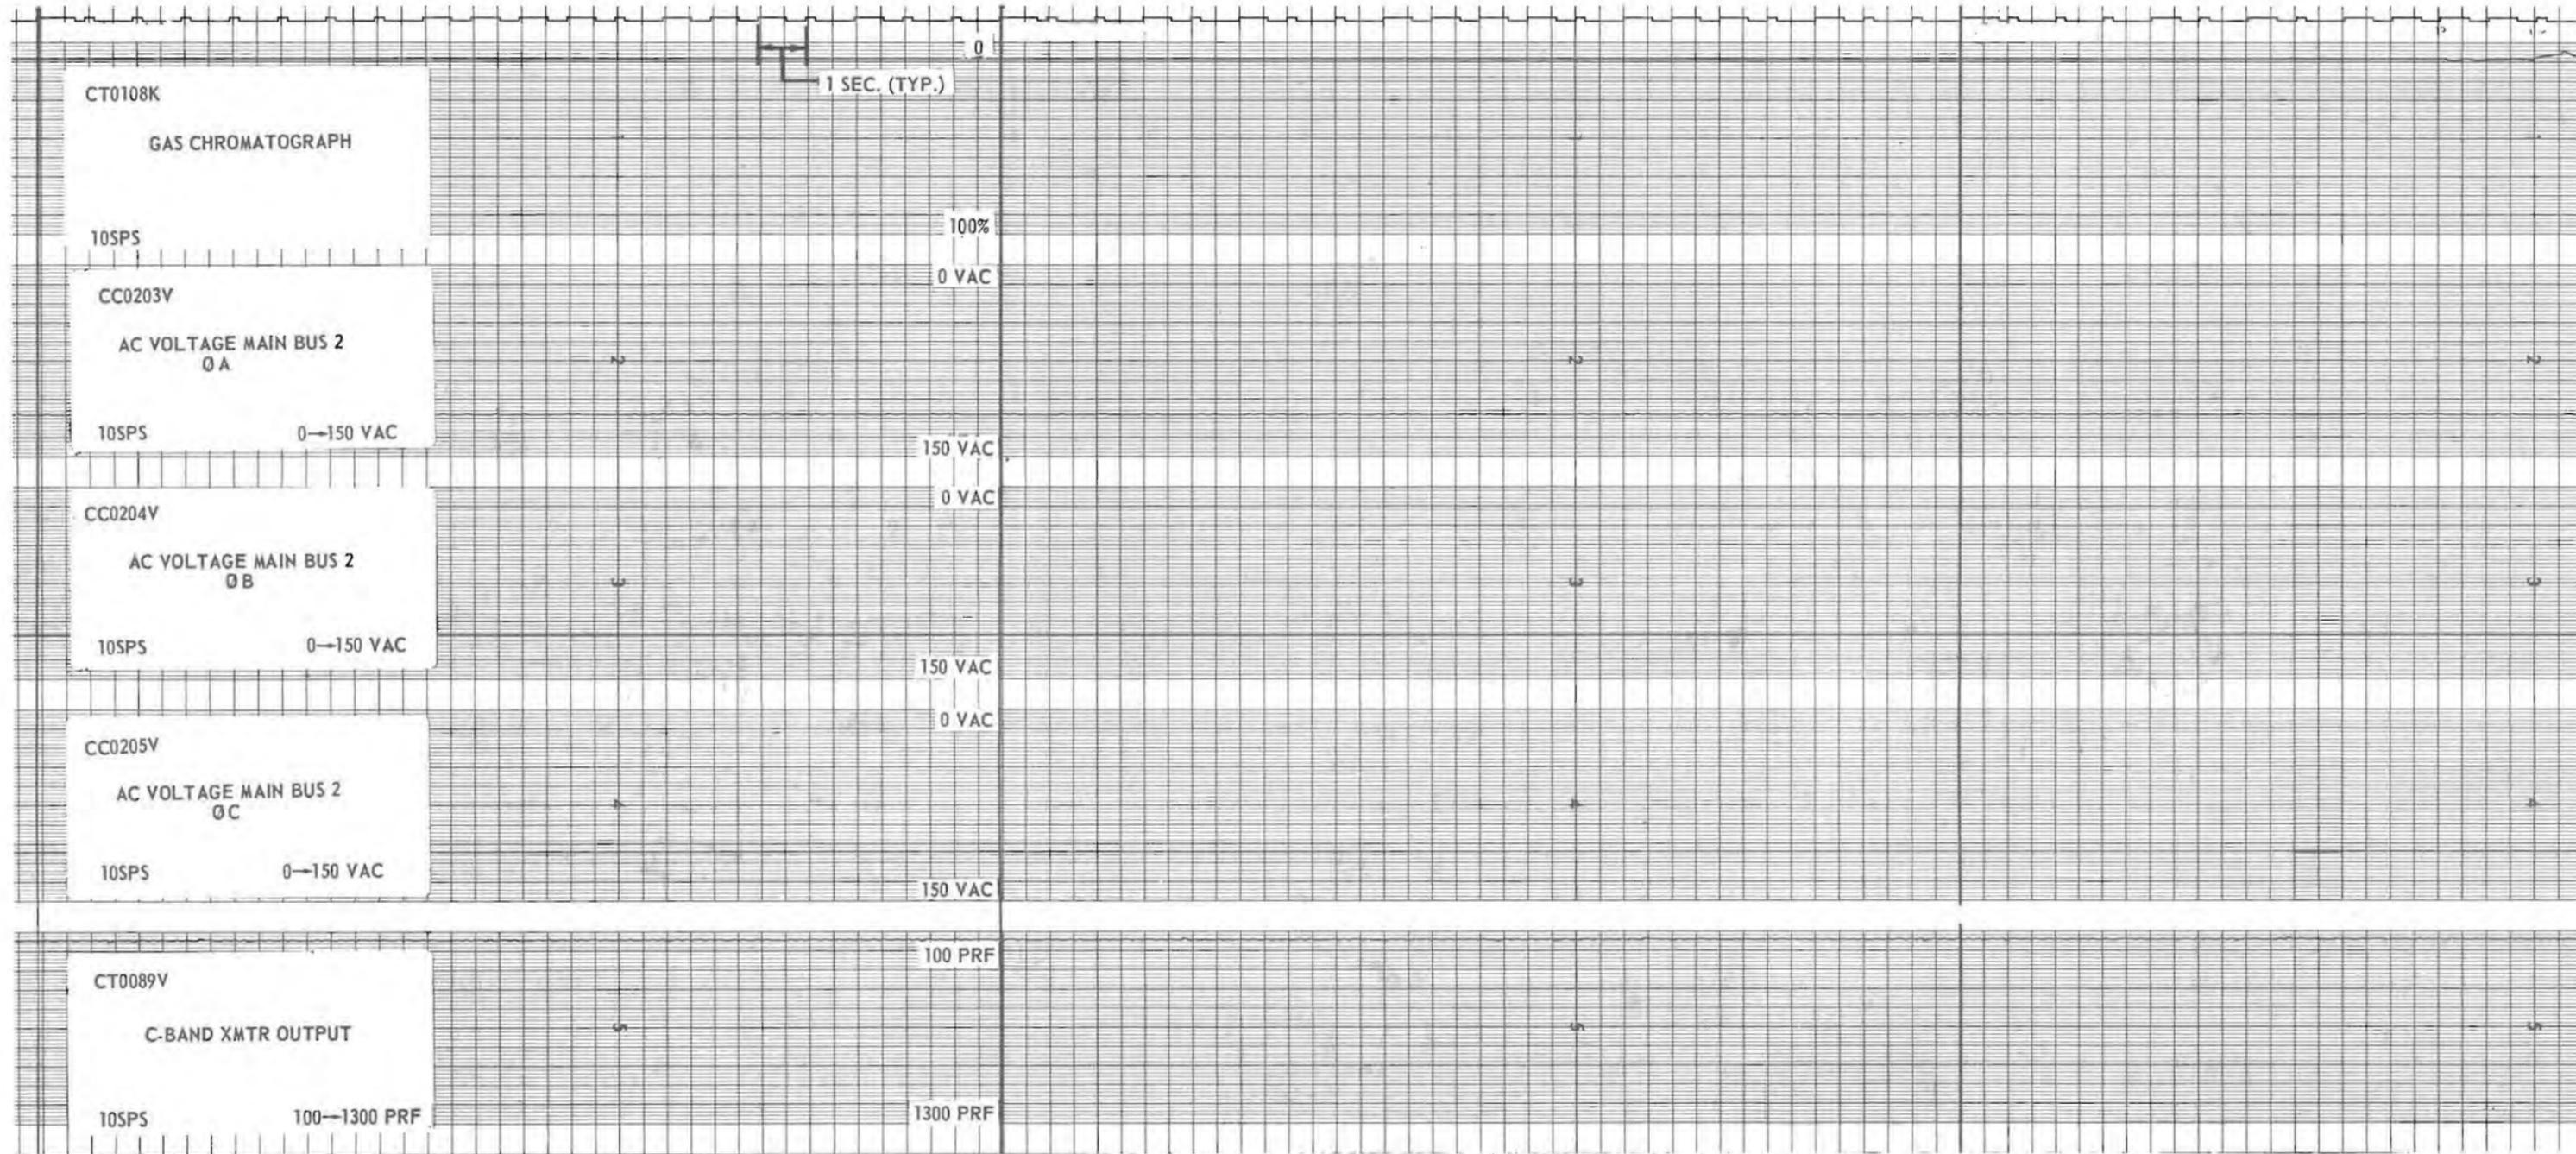
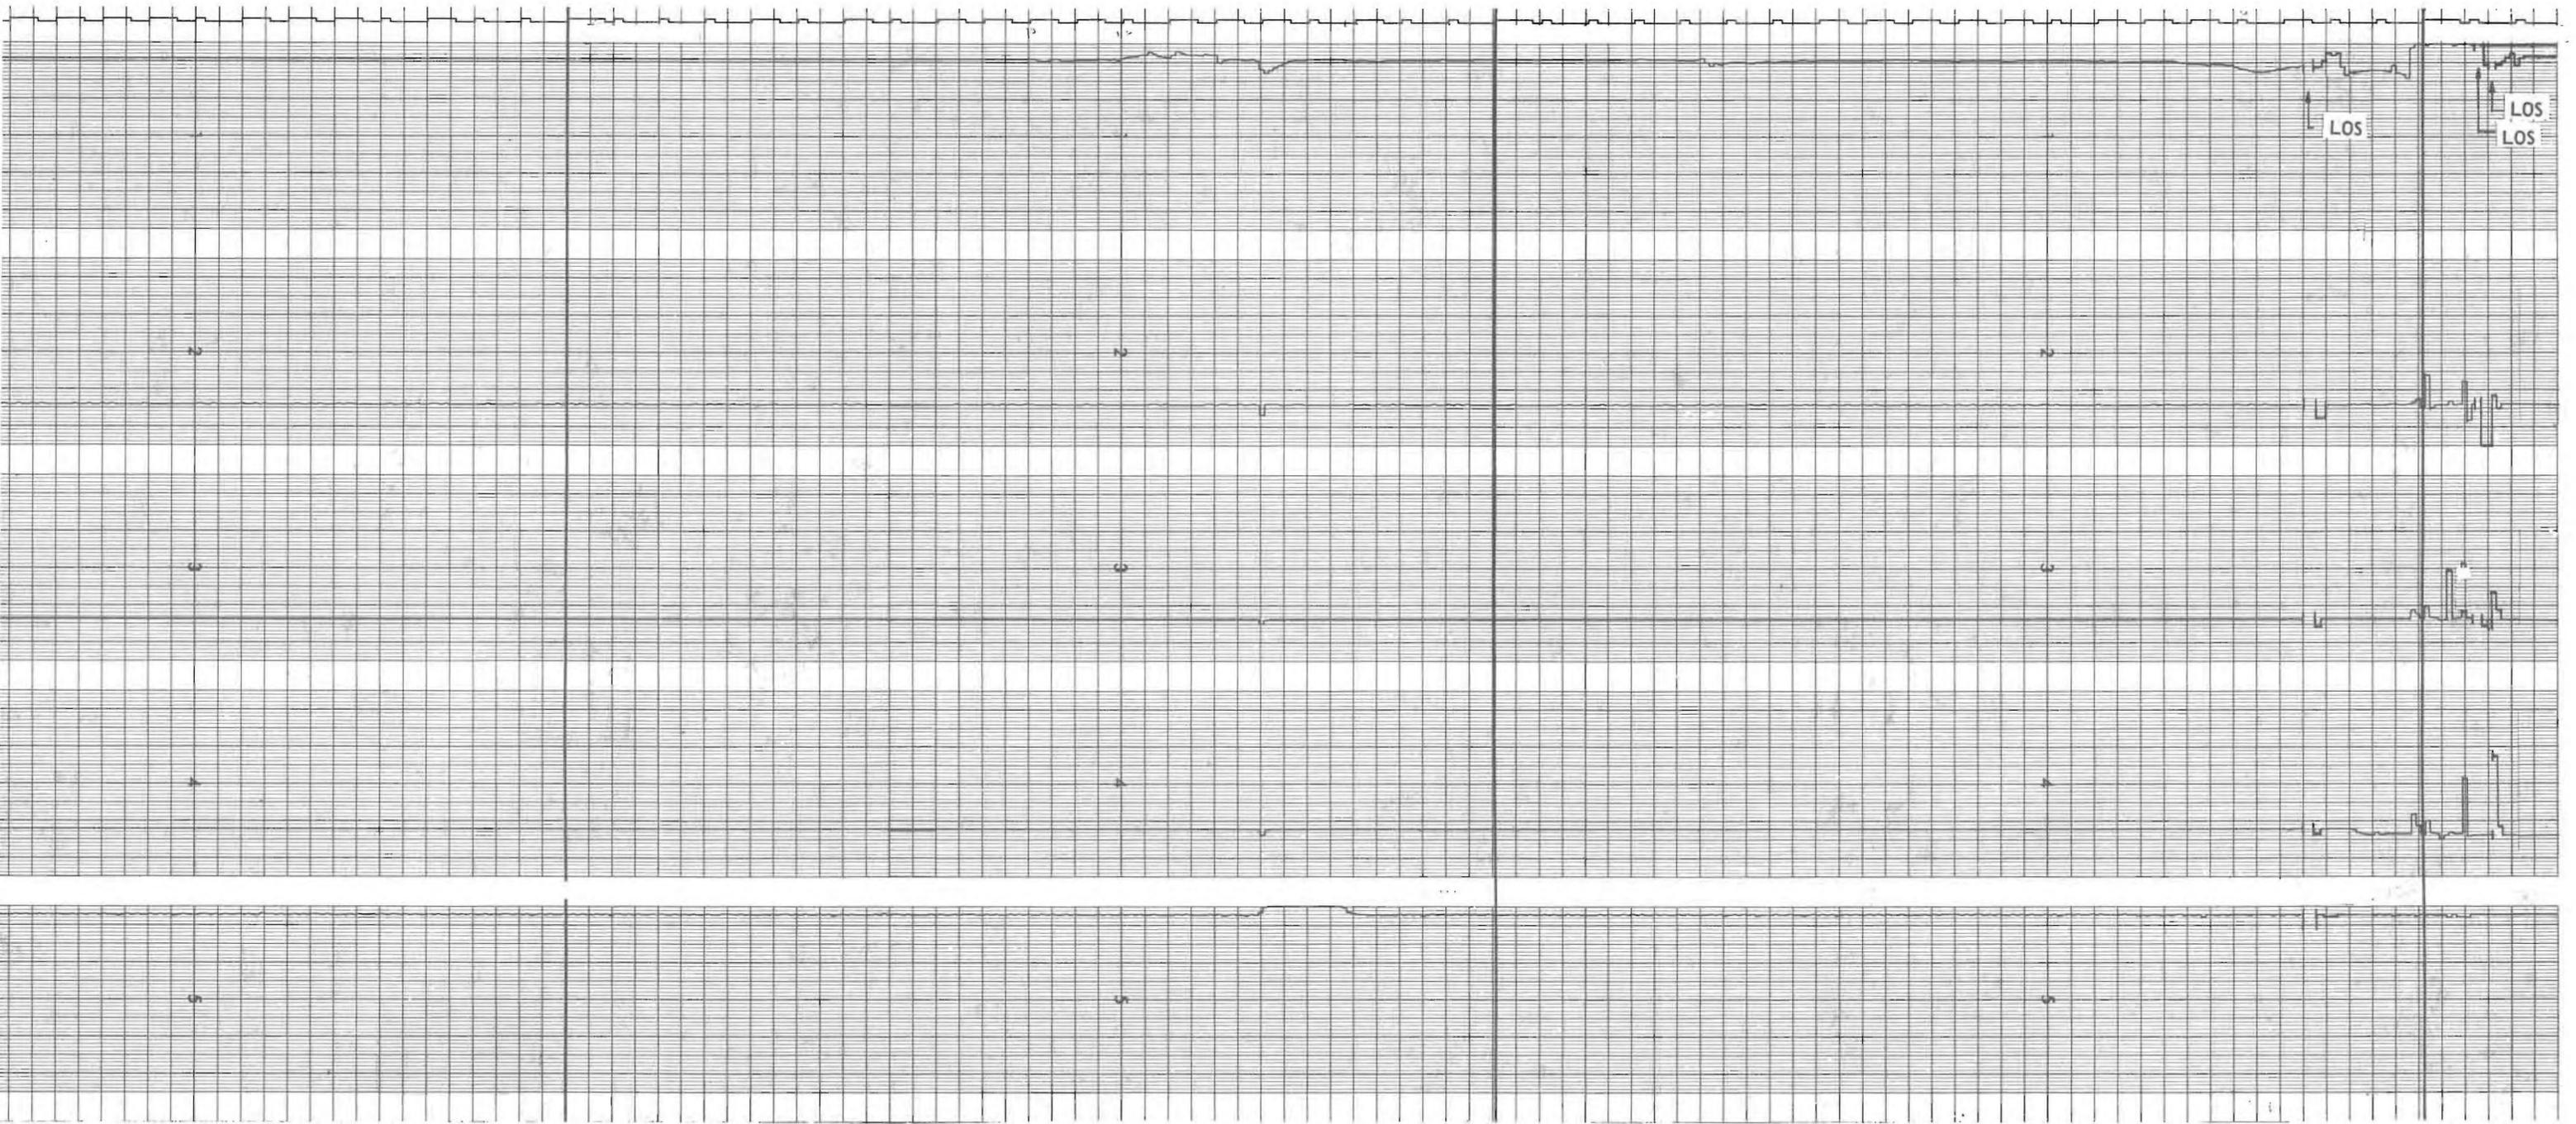
FIGURE 3-2 AC BUS 2 ASSOCIATED MEASUREMENT TRACES

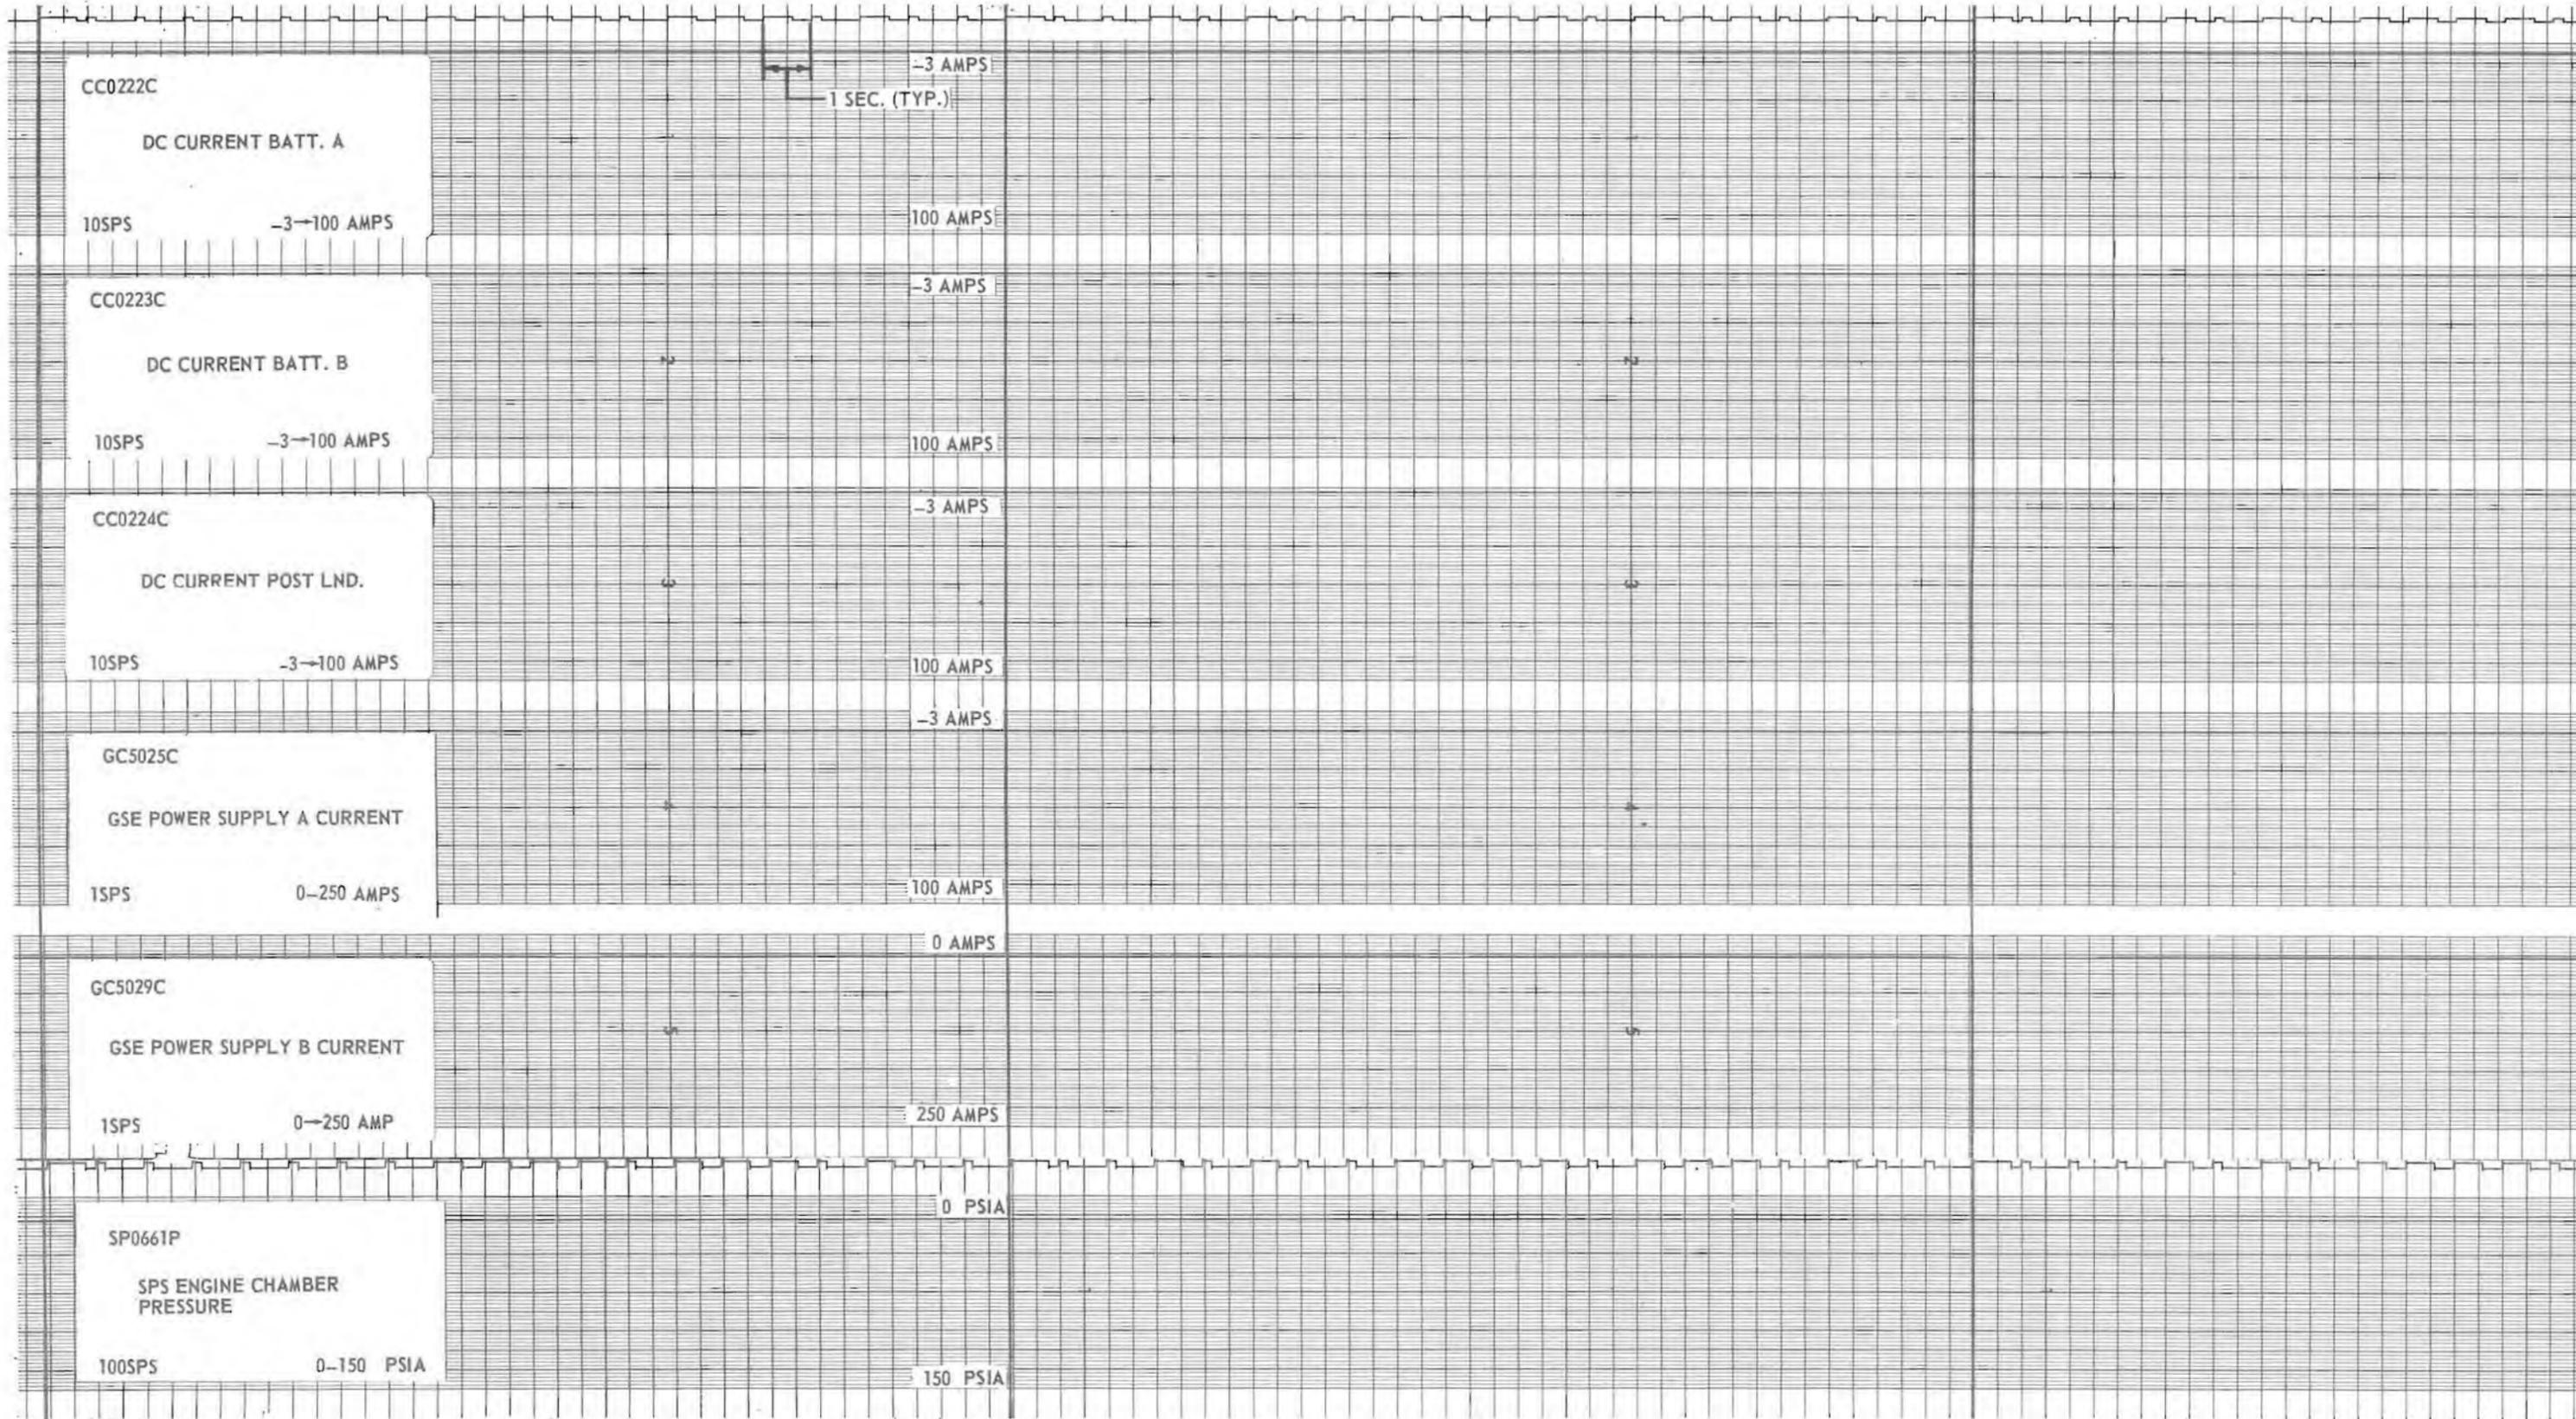
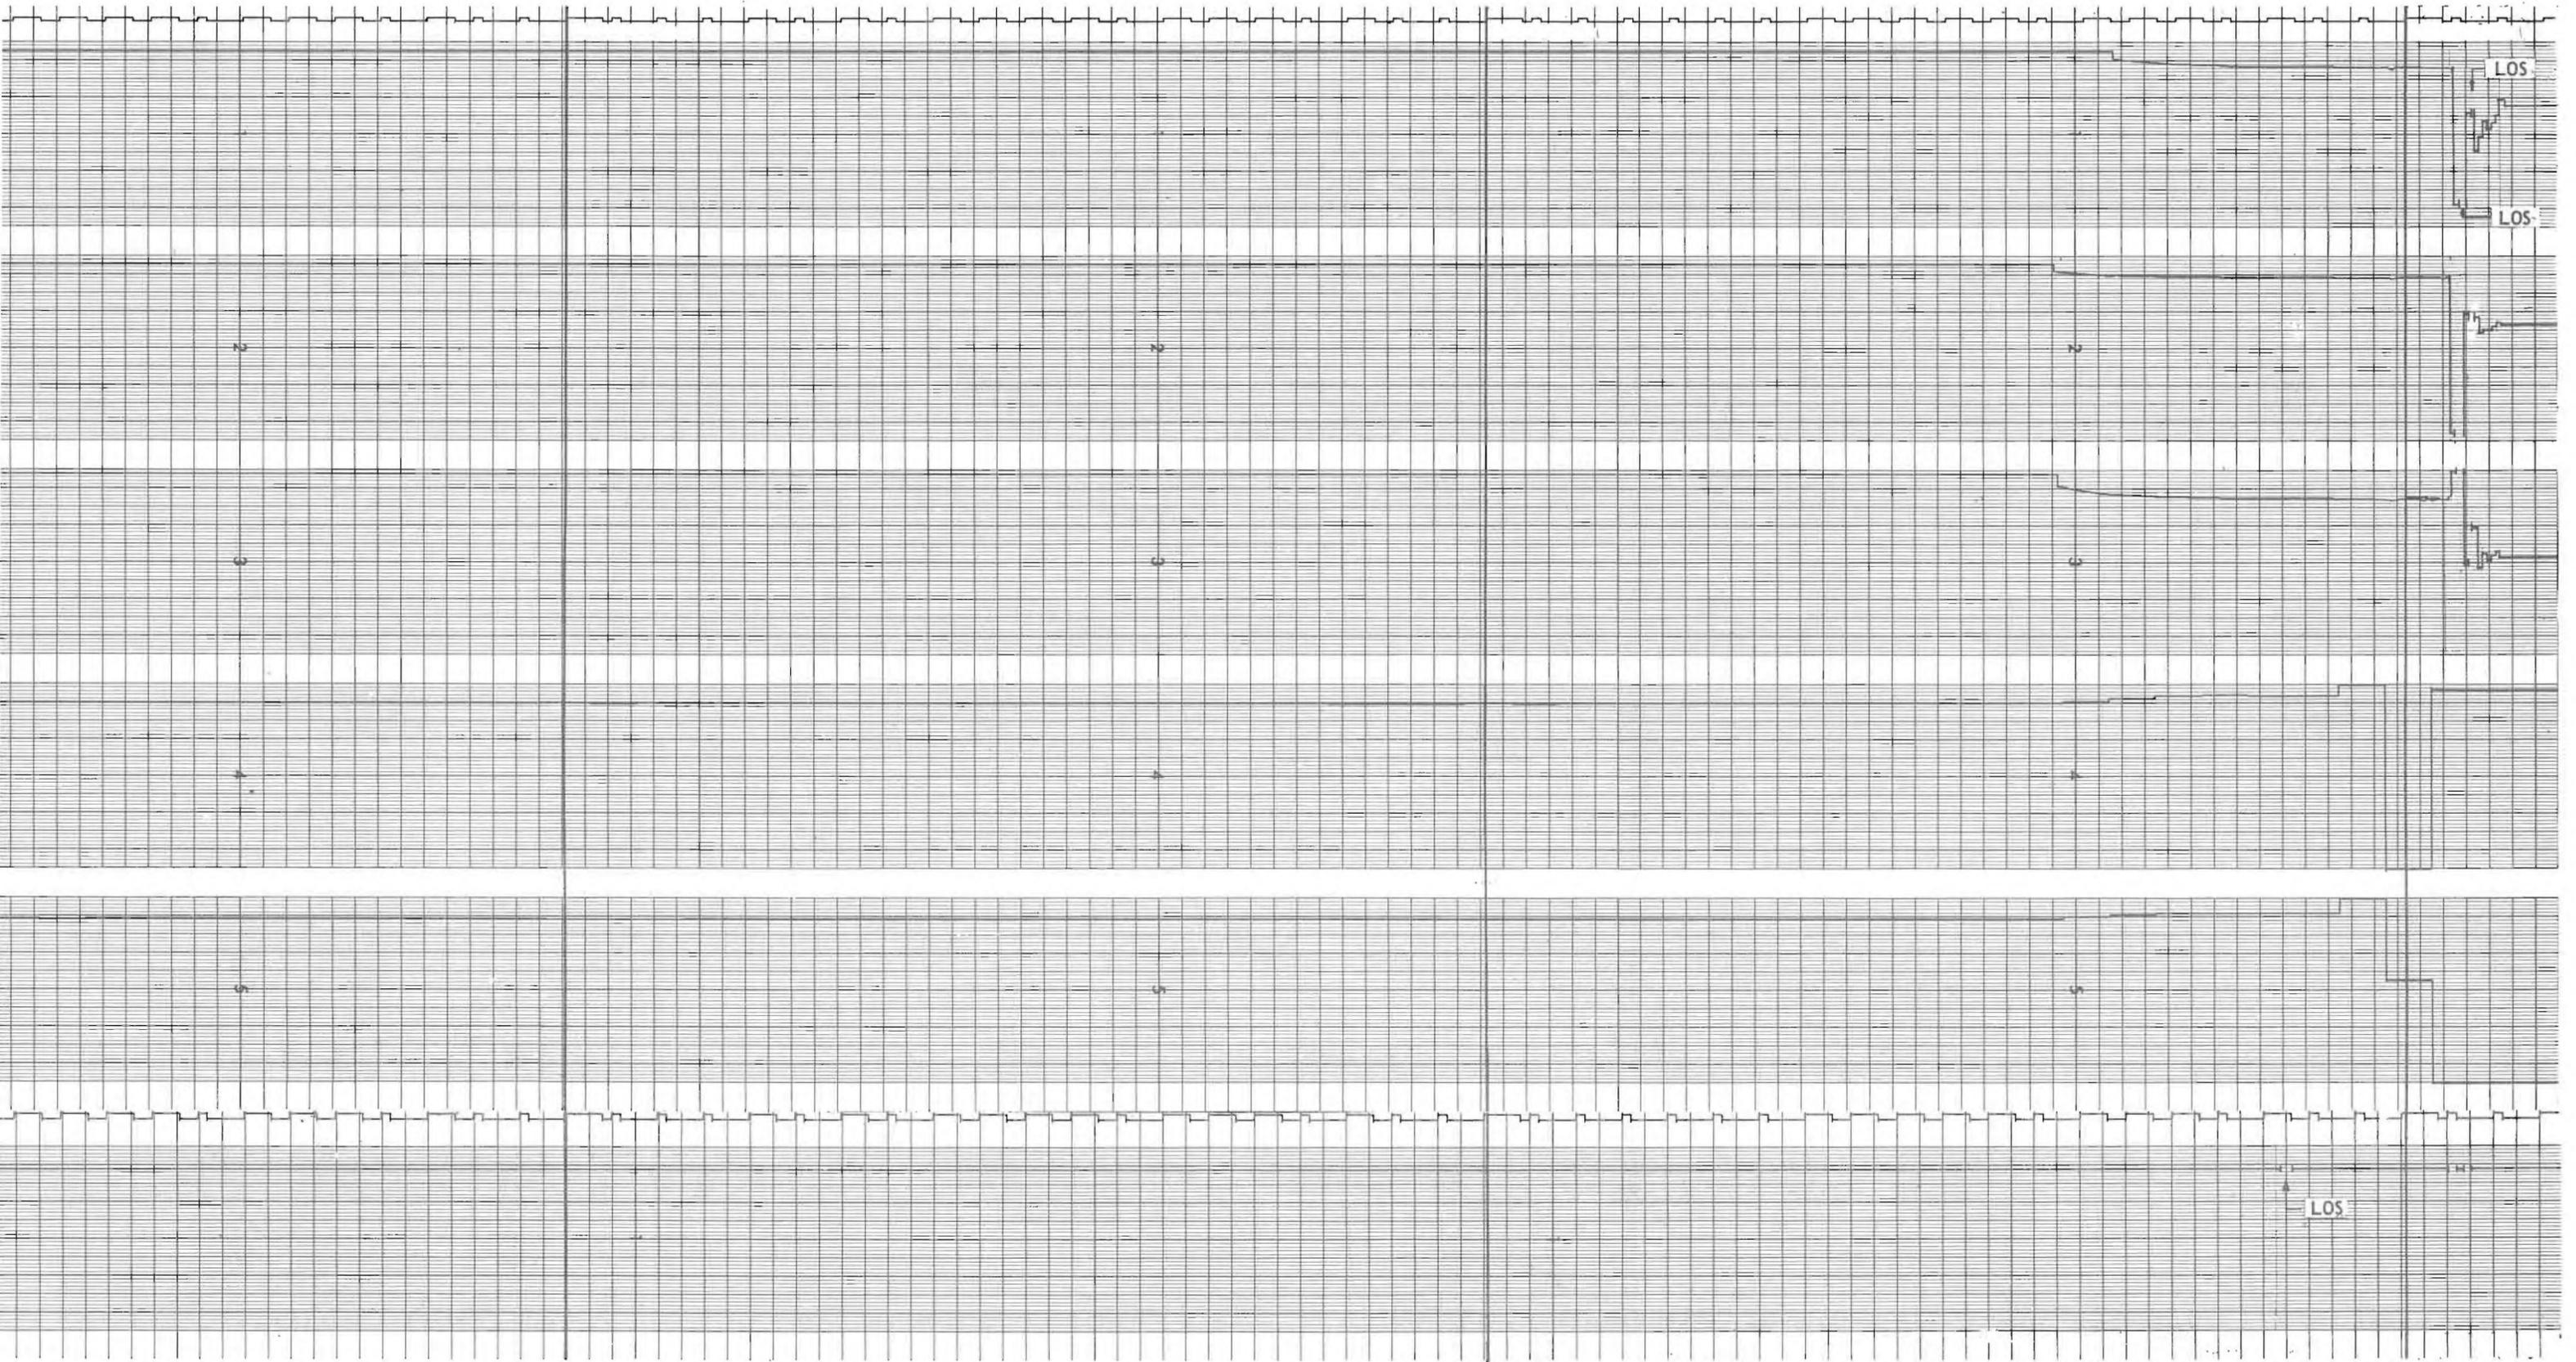
FIGURE 3-3 DC CURRENT AND ASSOCIATED MEASUREMENT TRACES

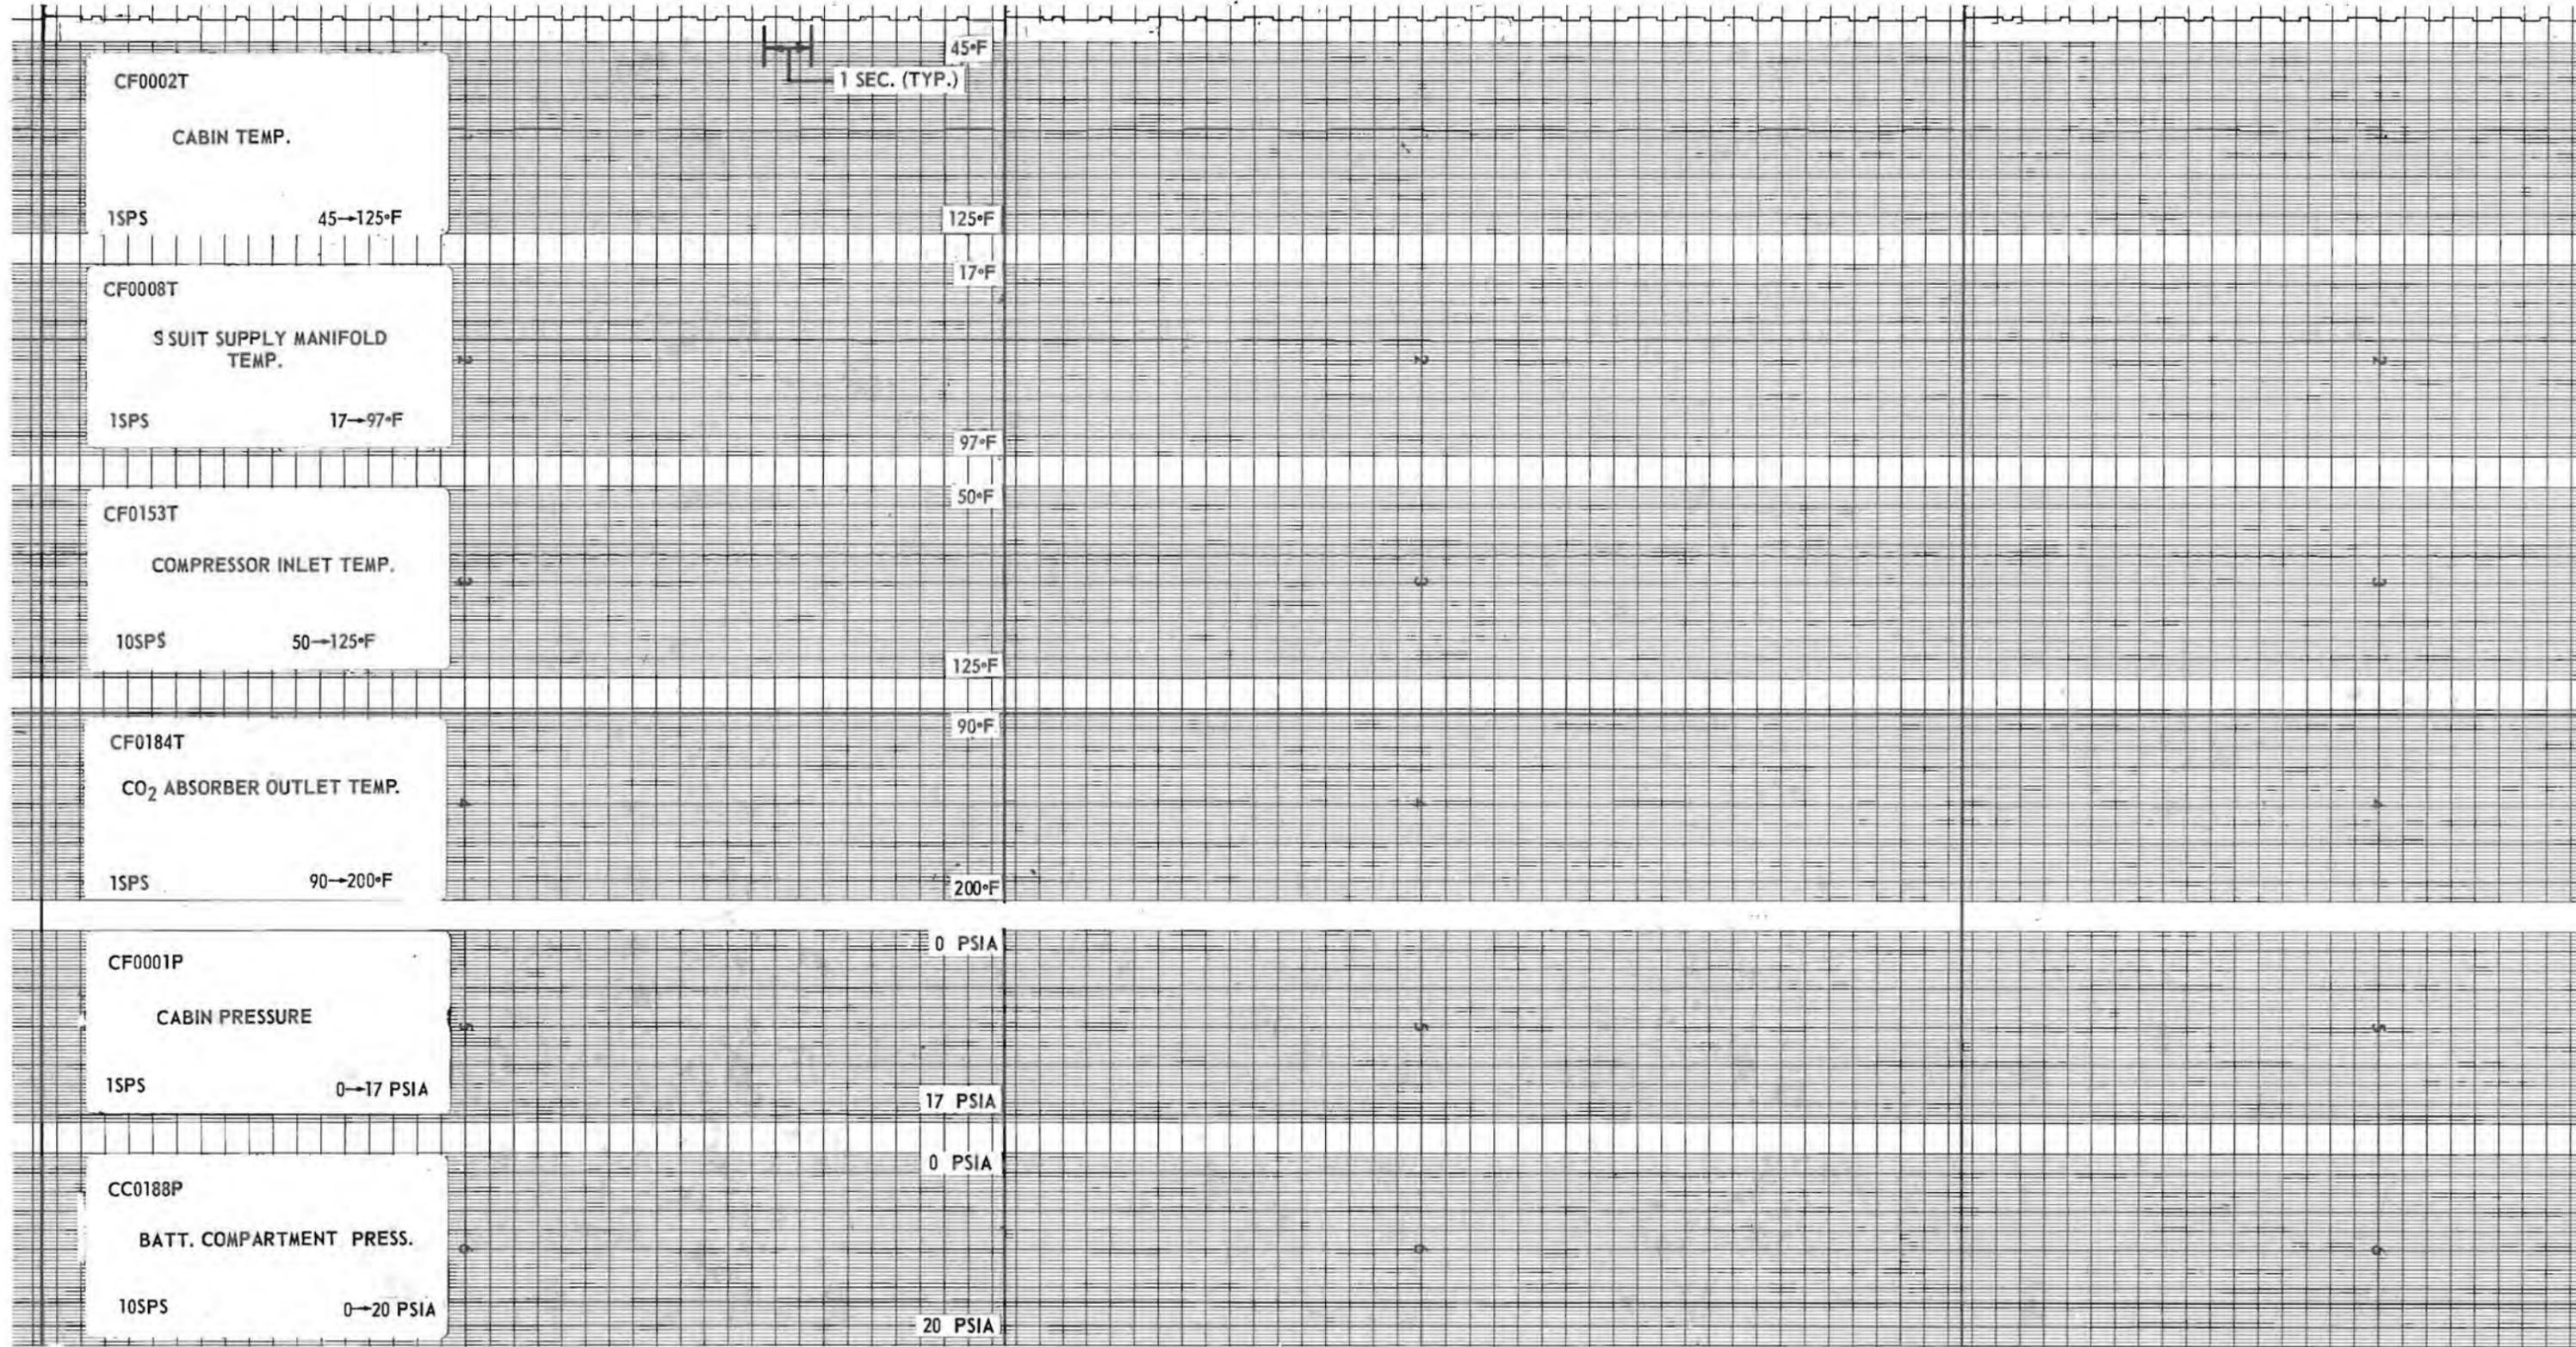
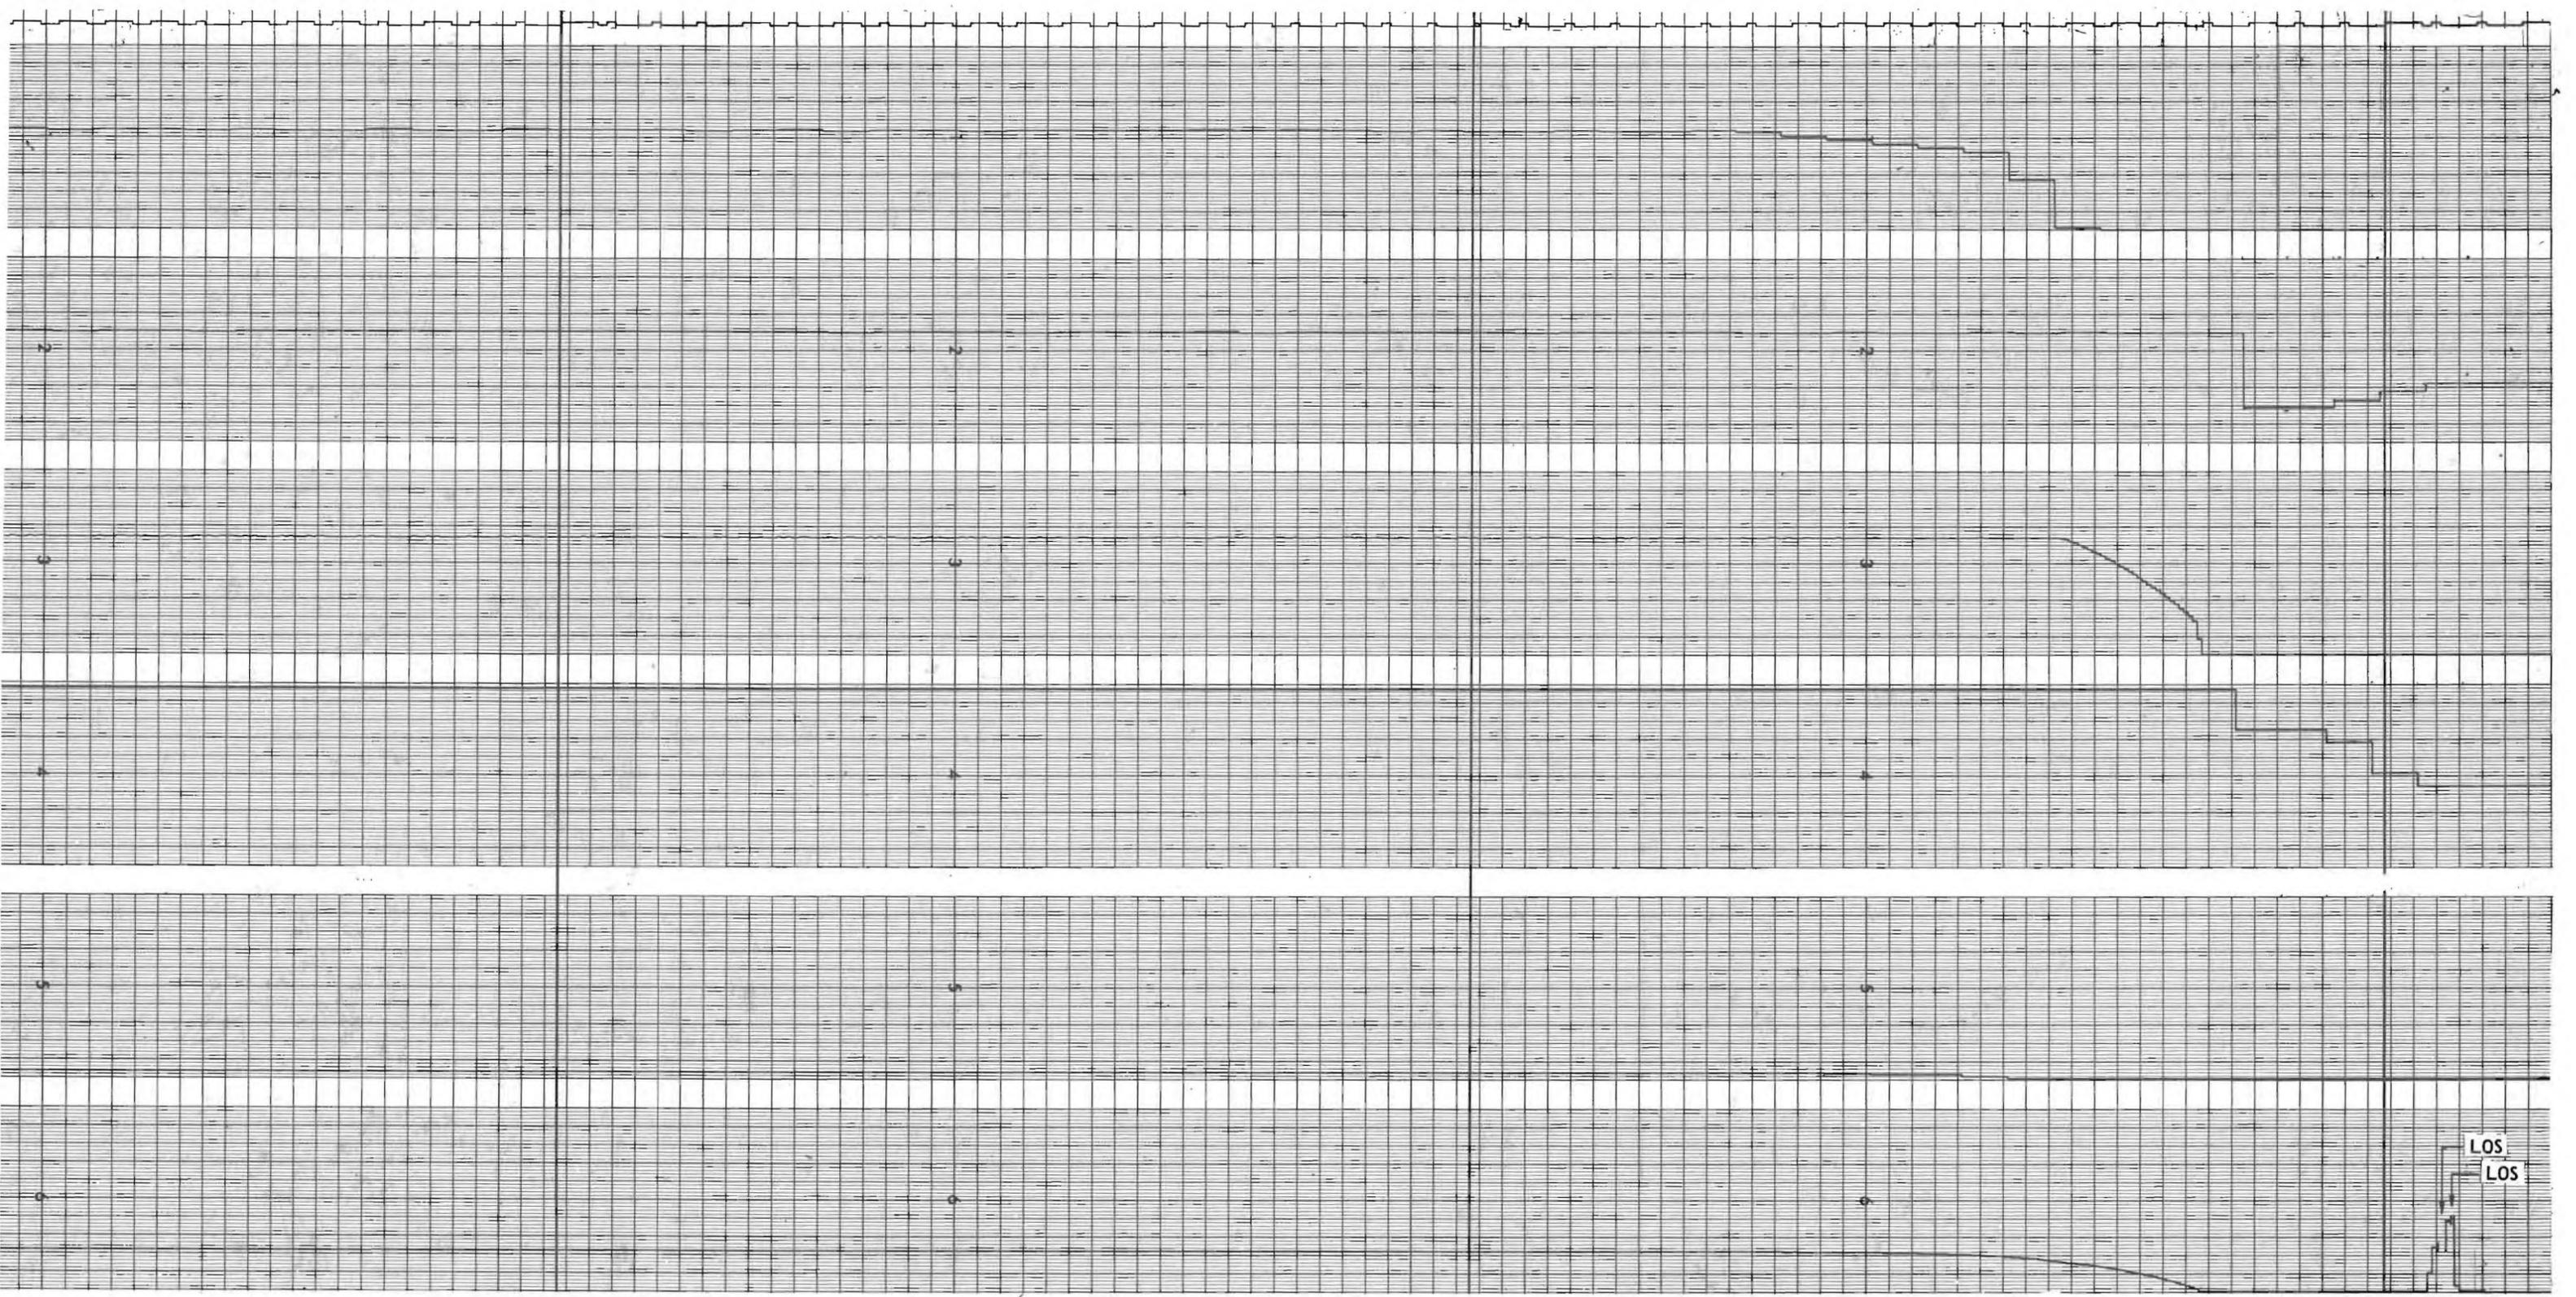
FIGURE 3-4 ECS MEASUREMENT TRACES (SHEET 1 OF 2)
