REPORT OF APOLLO 204 REVIEW BOARD

APPENDIX D
PANELS 1 thru 4

**REPORT OF PANEL 1
SPACECRAFT AND GROUND SUPPORT EQUIPMENT
CONFIGURATION
APPENDIX D-1
TO
FINAL REPORT OF
APOLLO 204 REVIEW BOARD**

**REPORT OF PANEL 4
DISASSEMBLY ACTIVITIES PANEL
APPENDIX D-4
TO
FINAL REPORT OF
APOLLO 204 REVIEW BOARD**

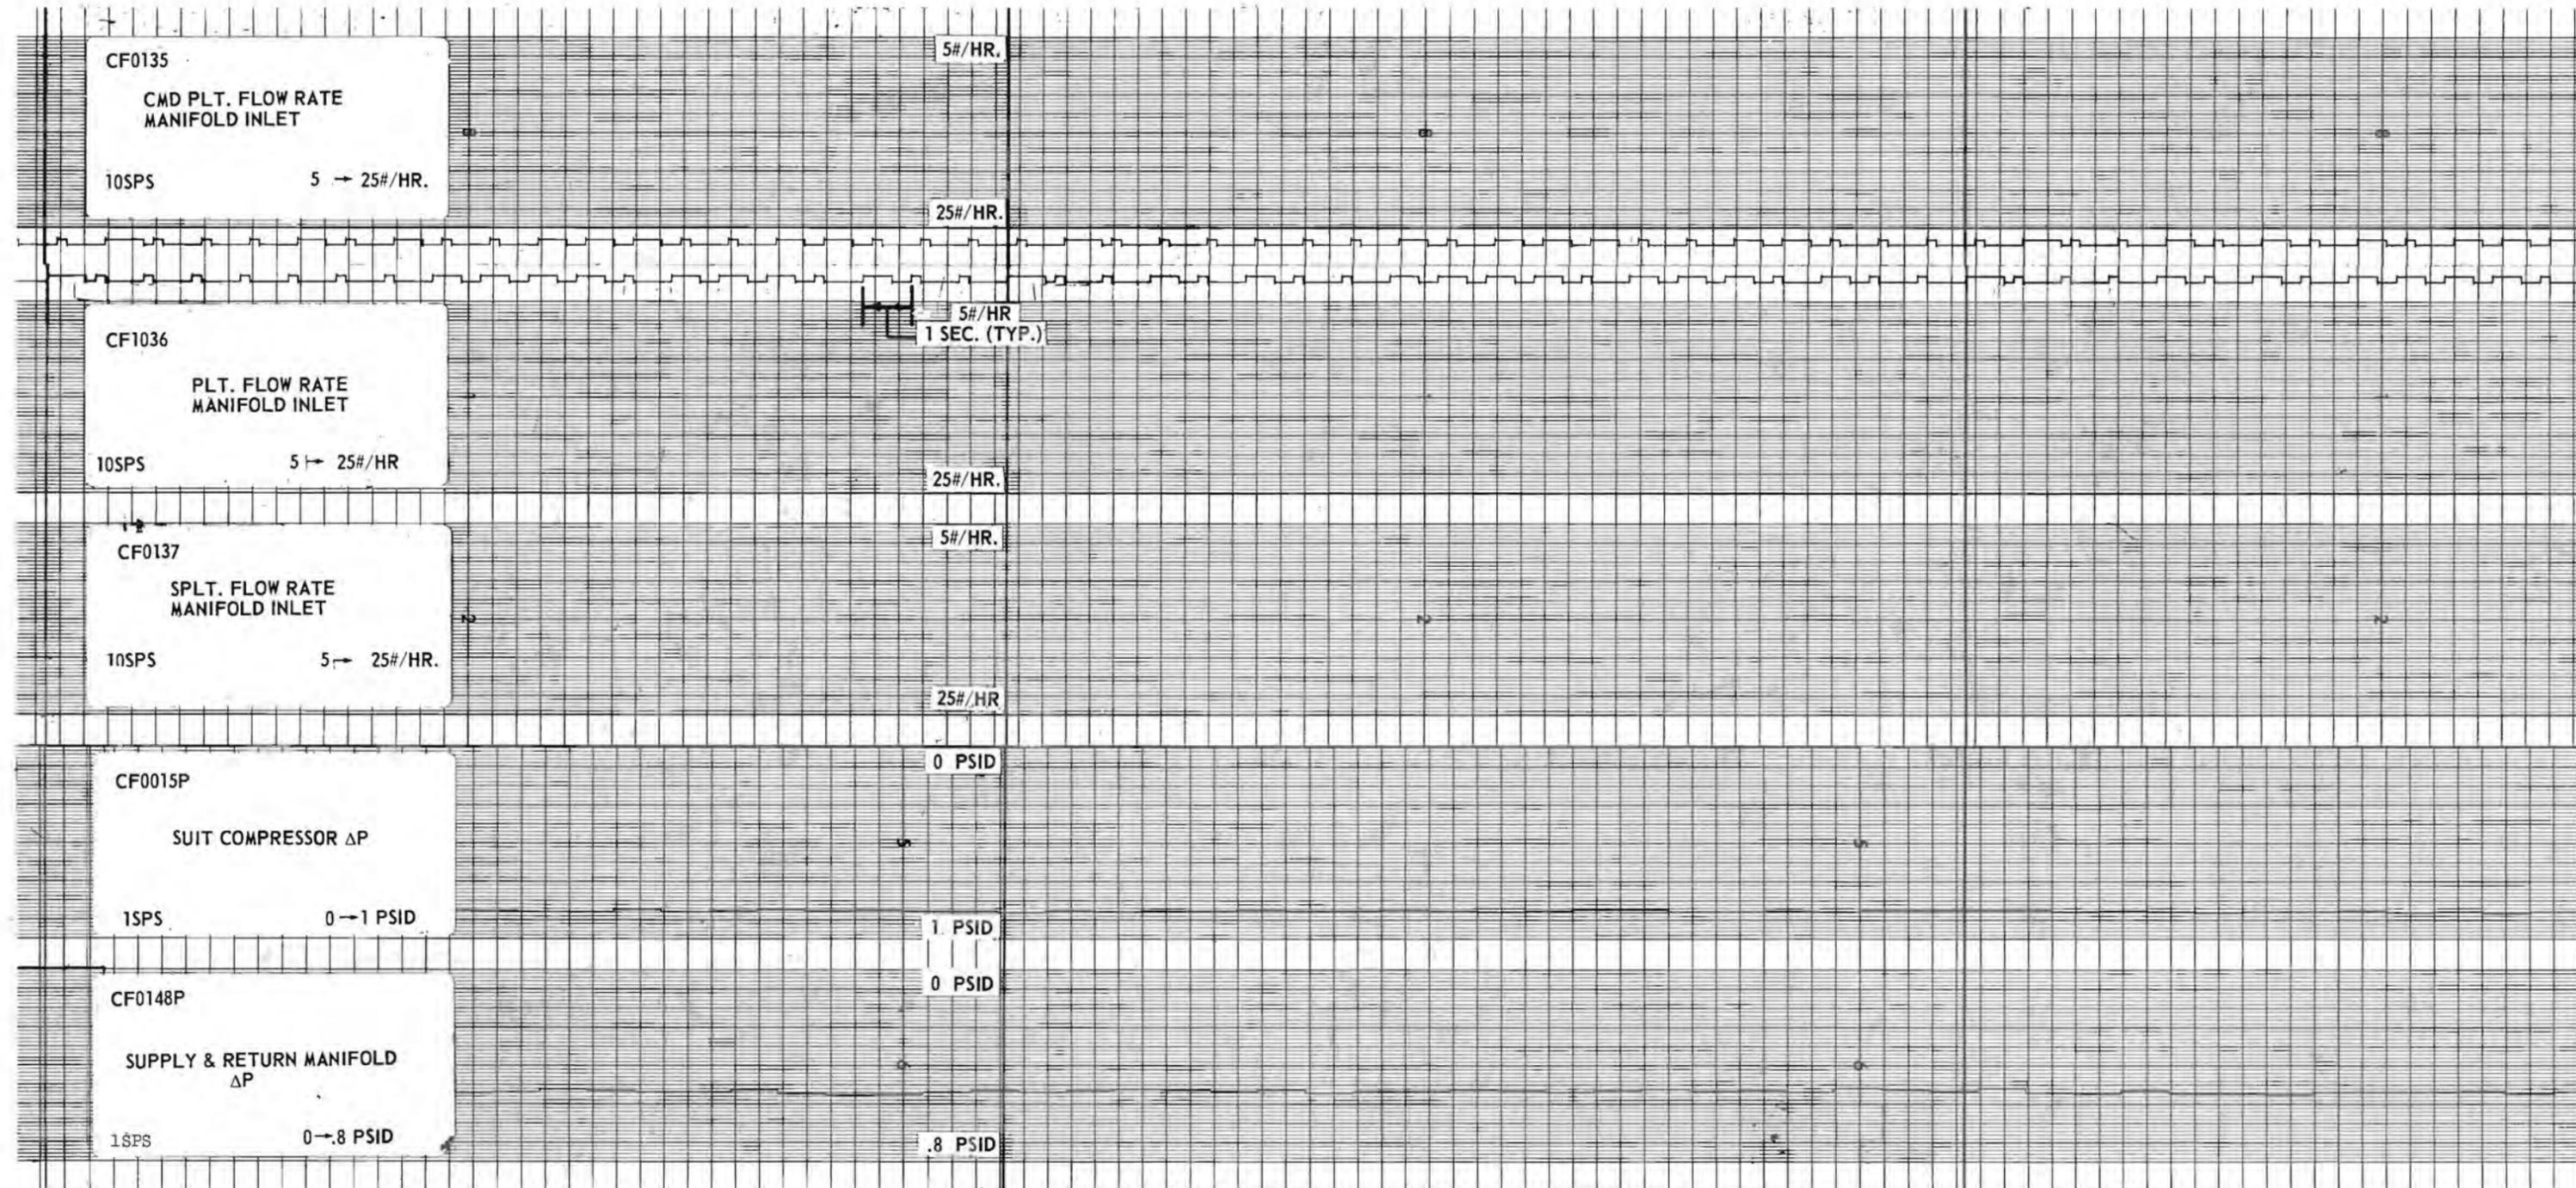
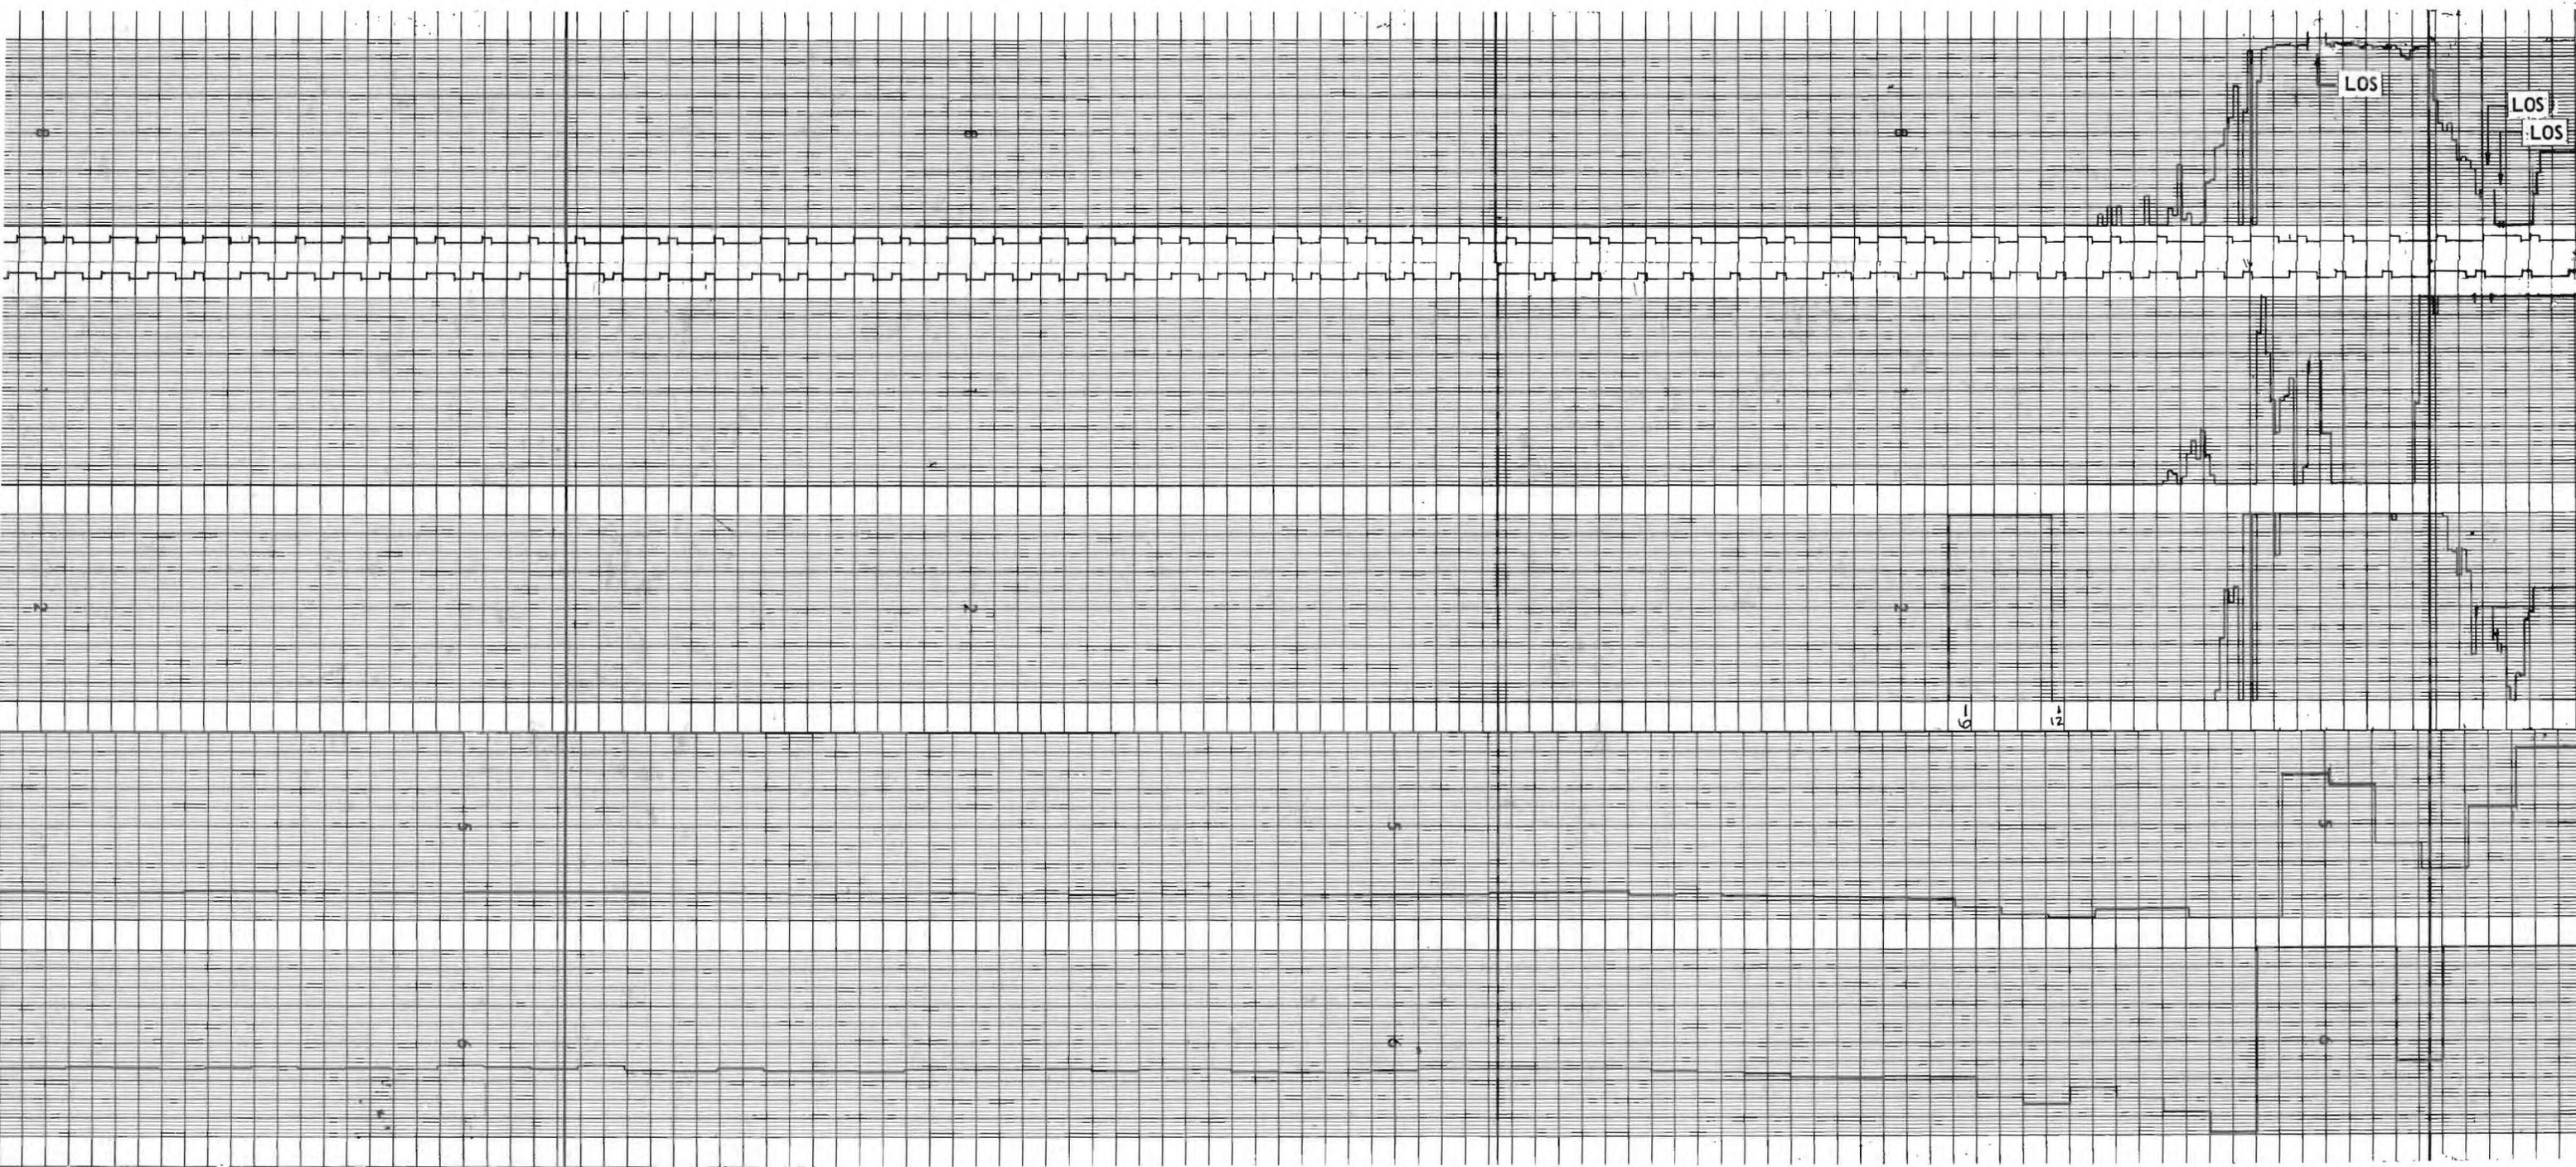
FIG. 3-4 ECS MEASUREMENT TRACES (SHEET 2 OF 2)

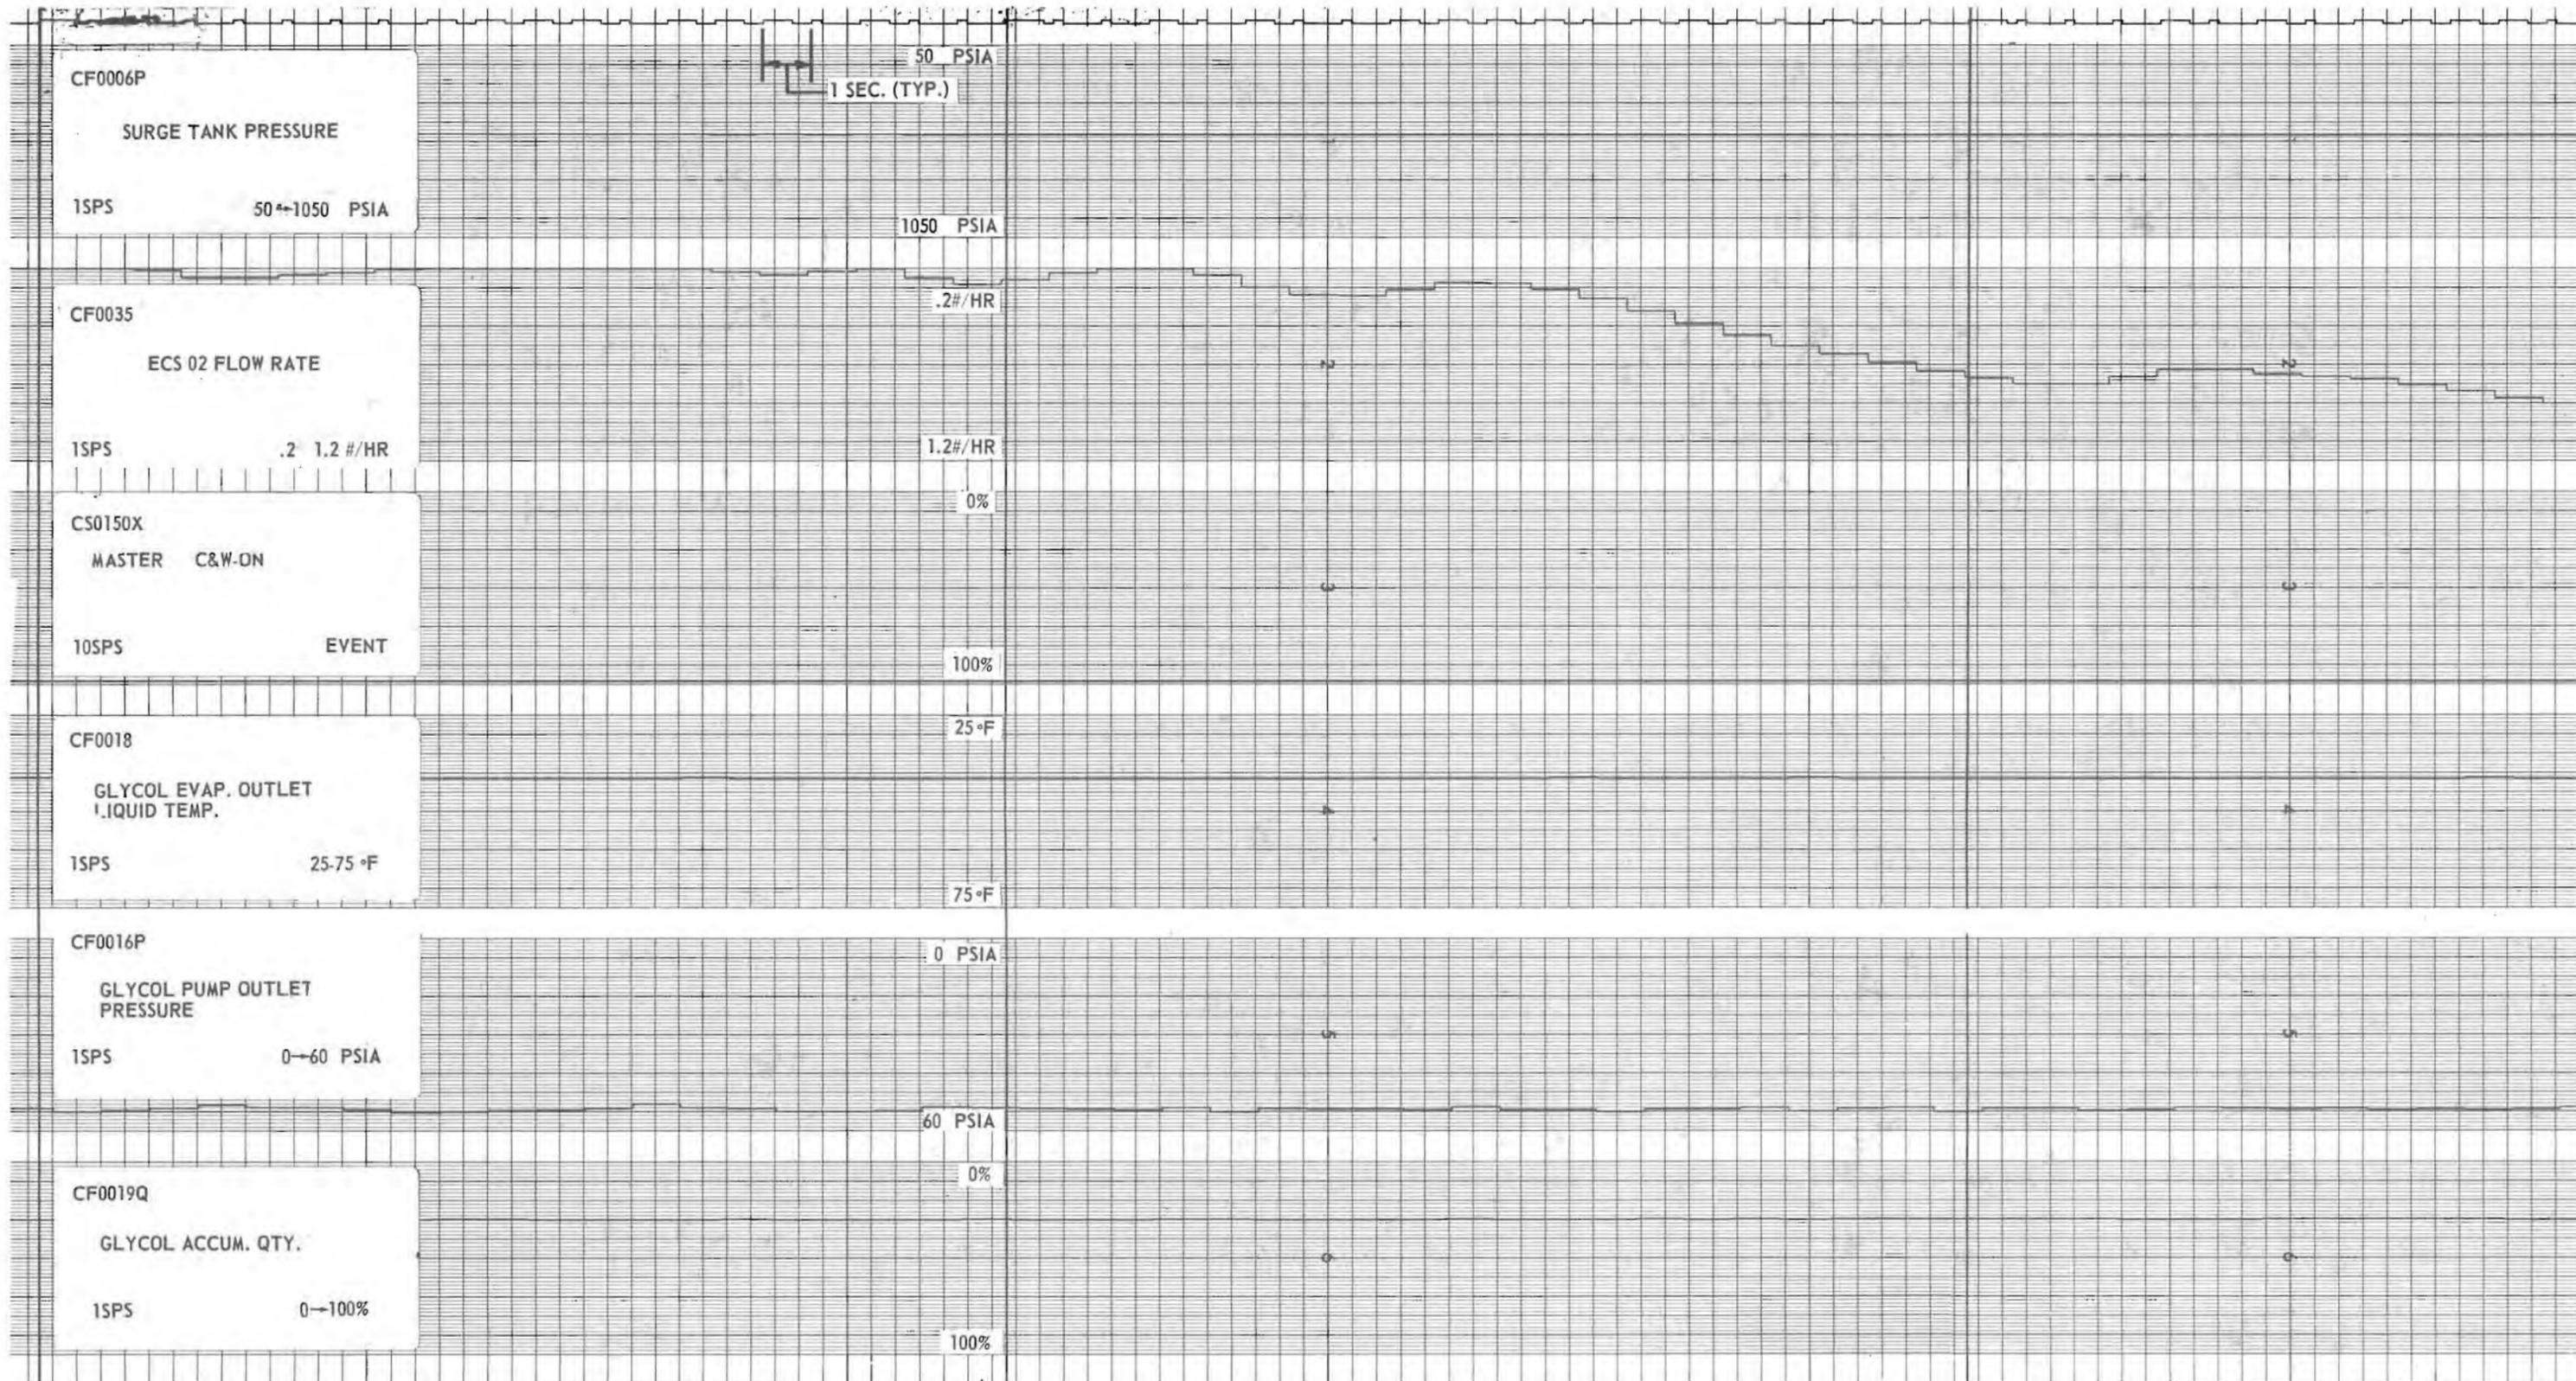
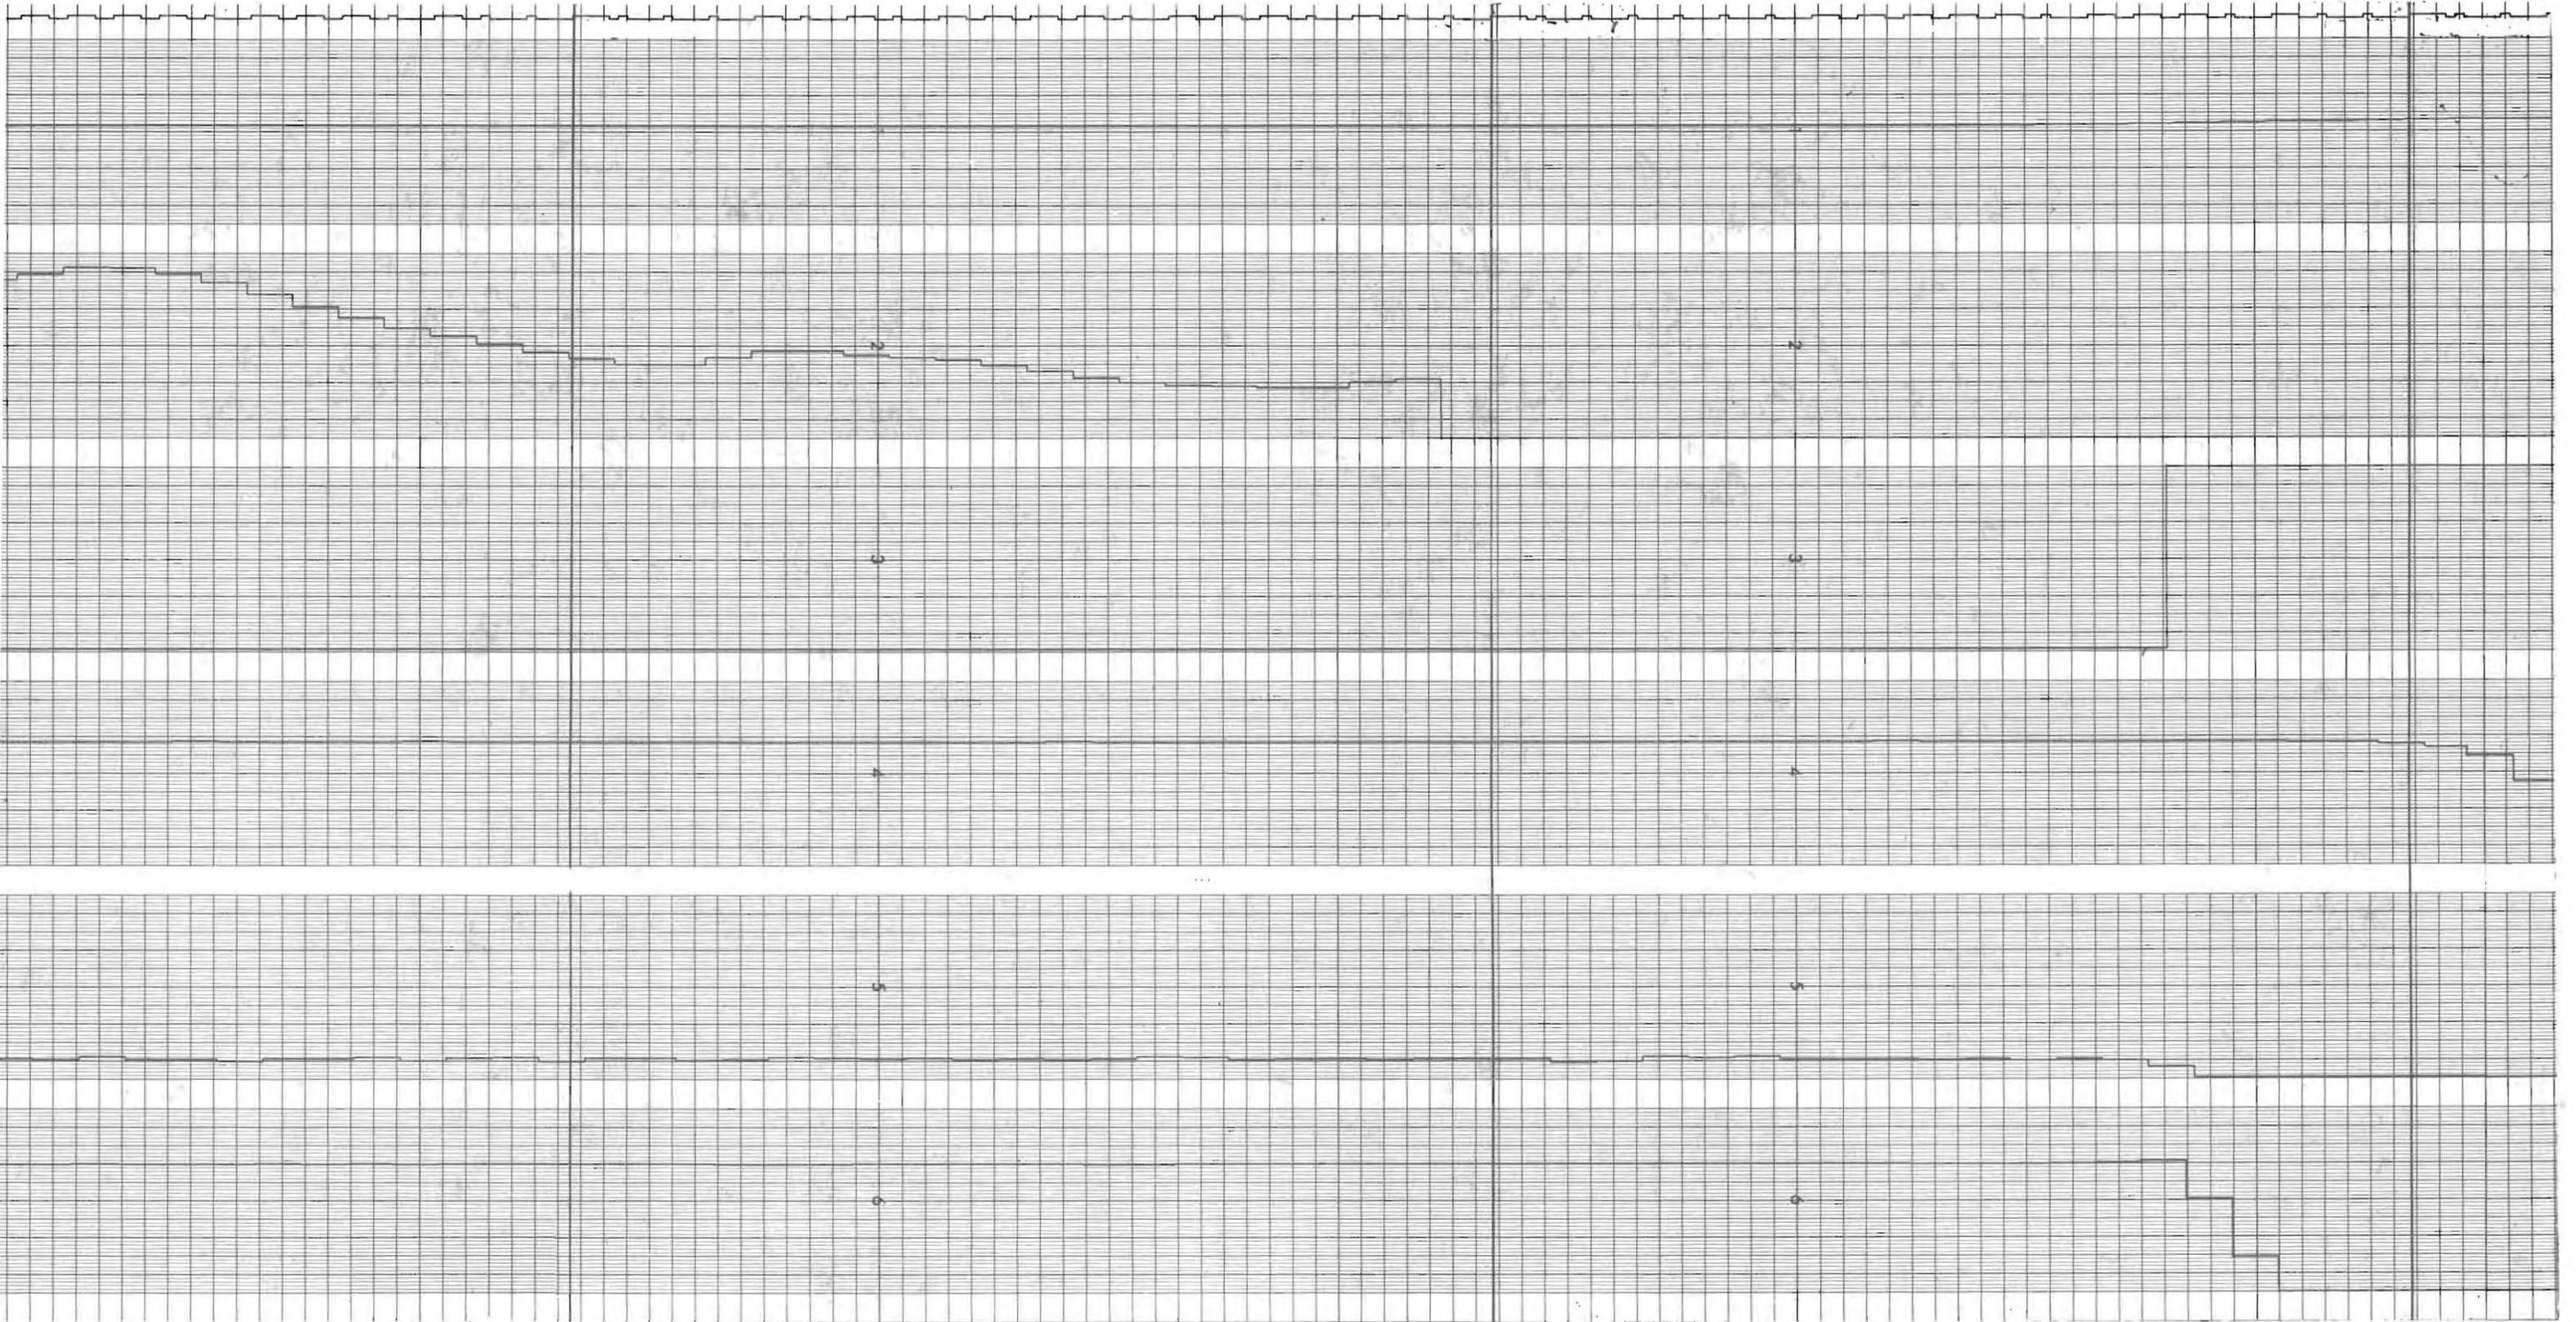
FIGURE 3-5 ECS MEASUREMENT TRACES

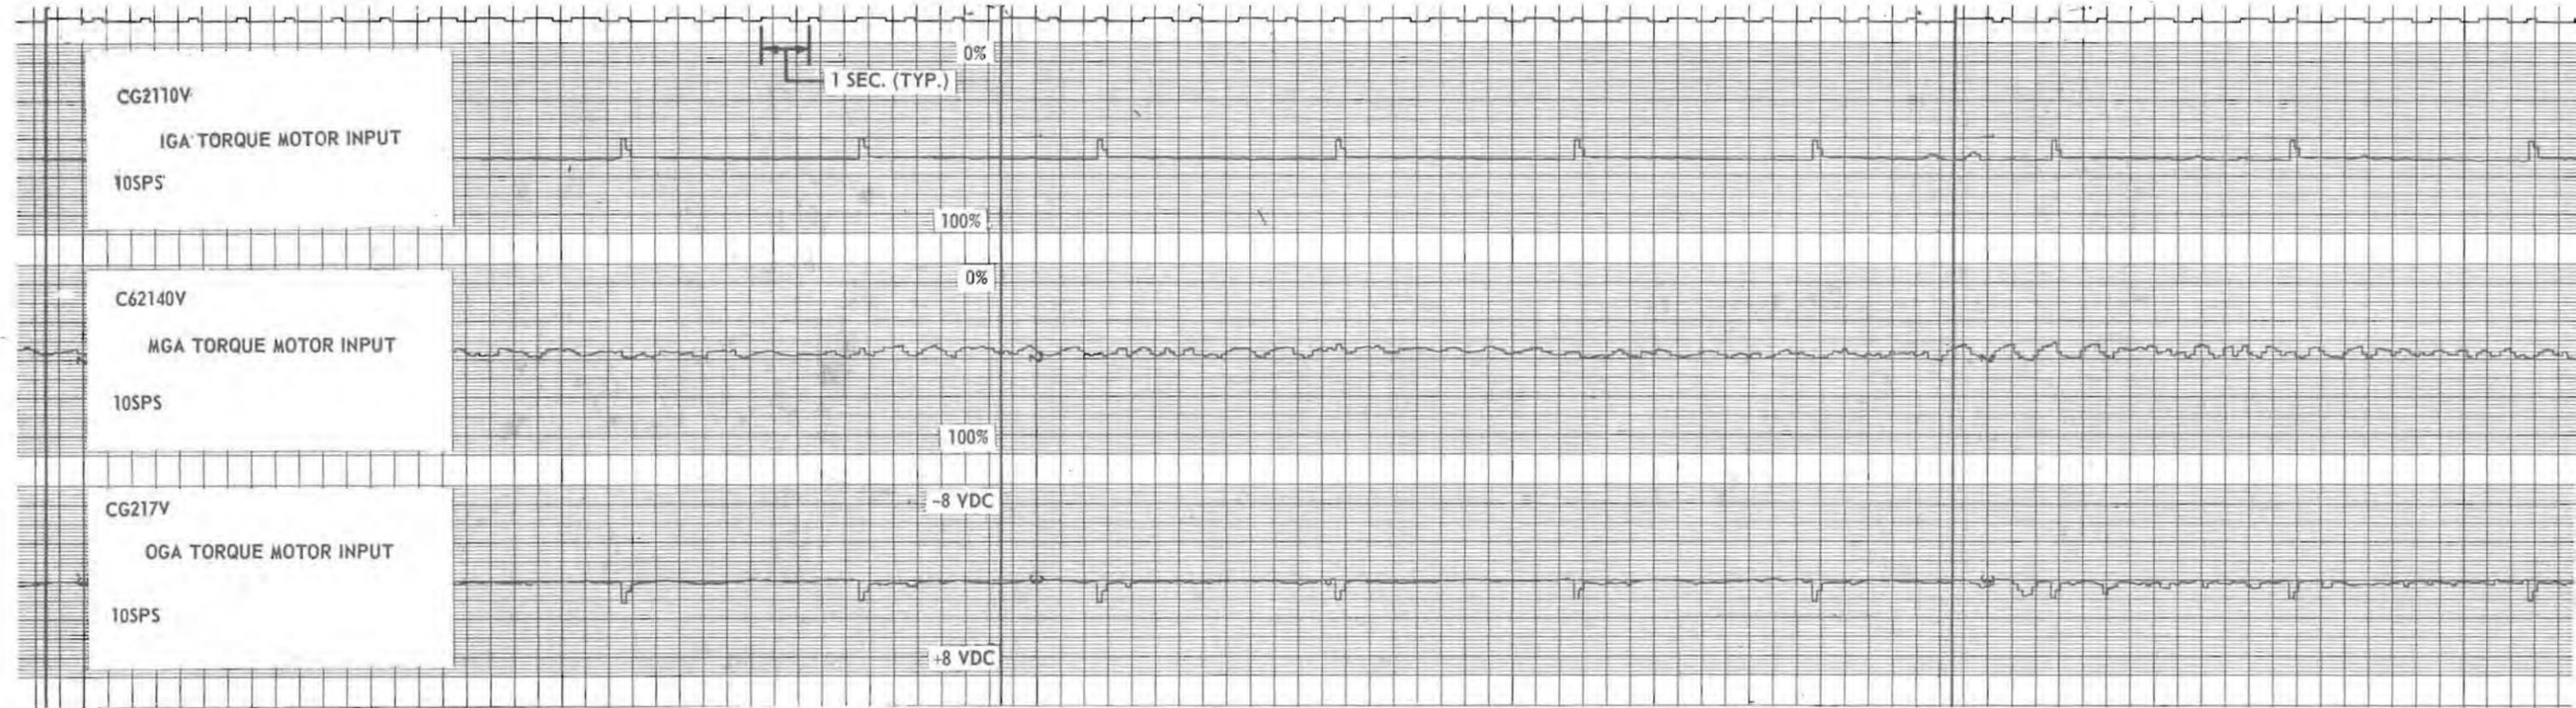
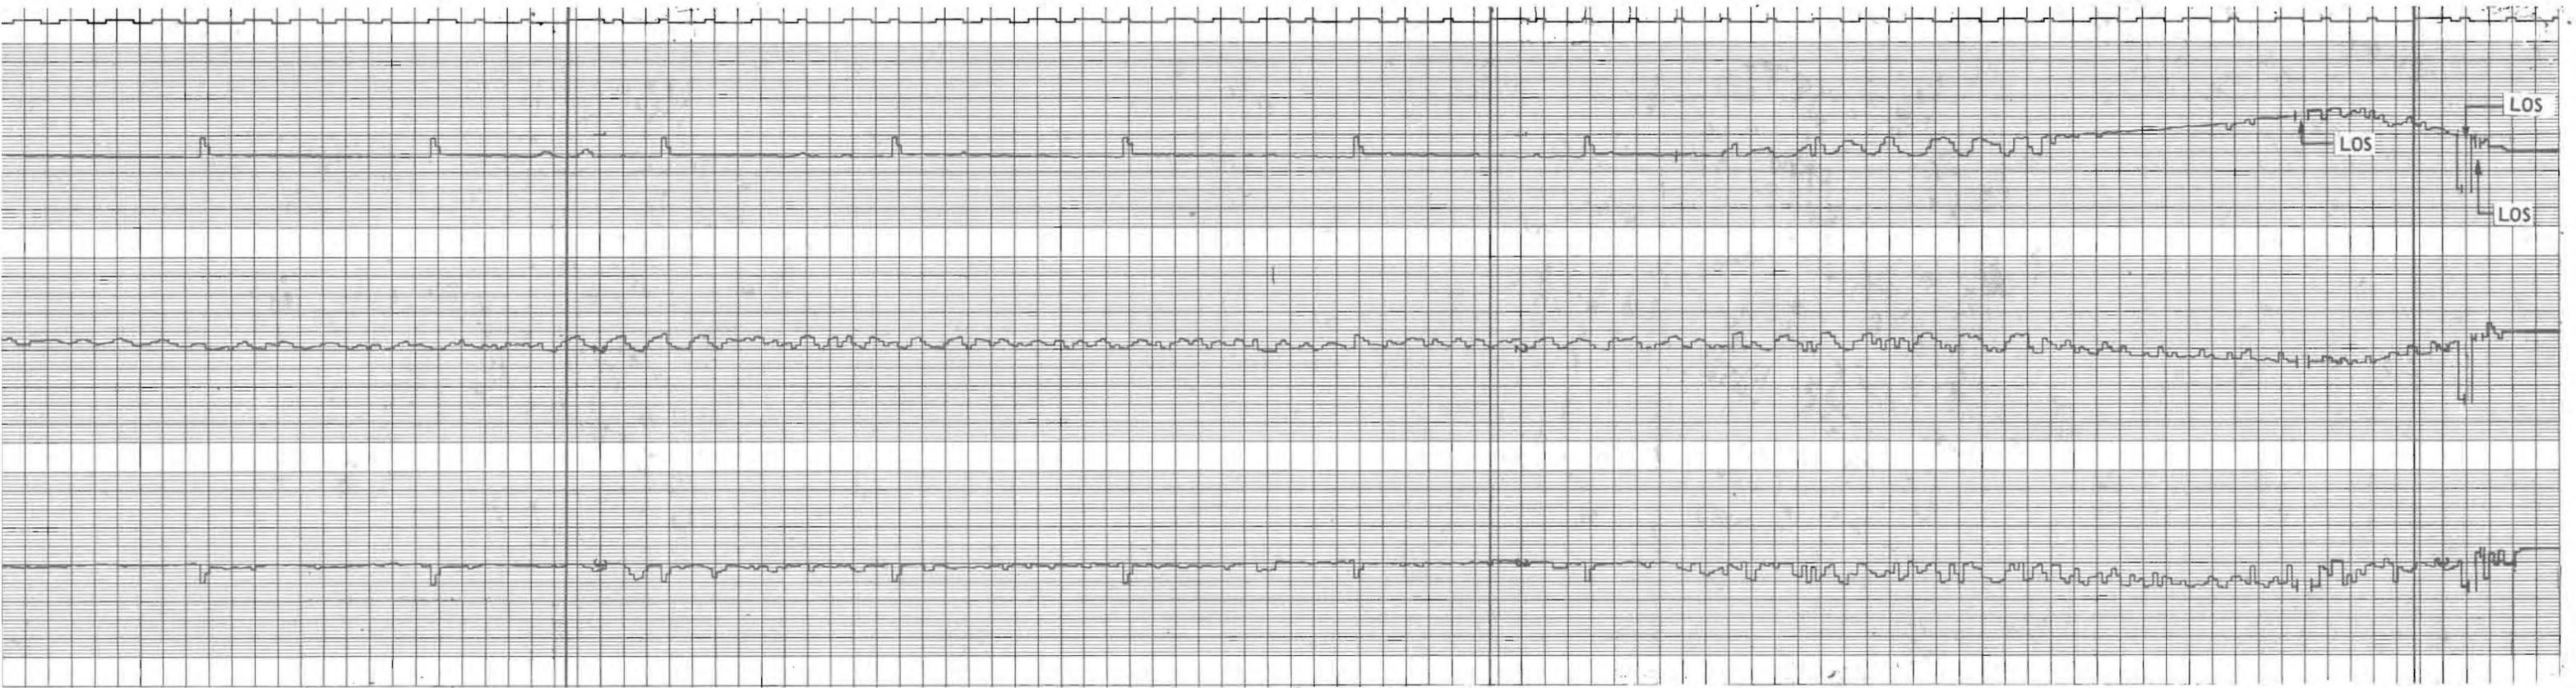
FIG 3-6 TORQUE MOTOR INPUT MEASUREMENT TRACES

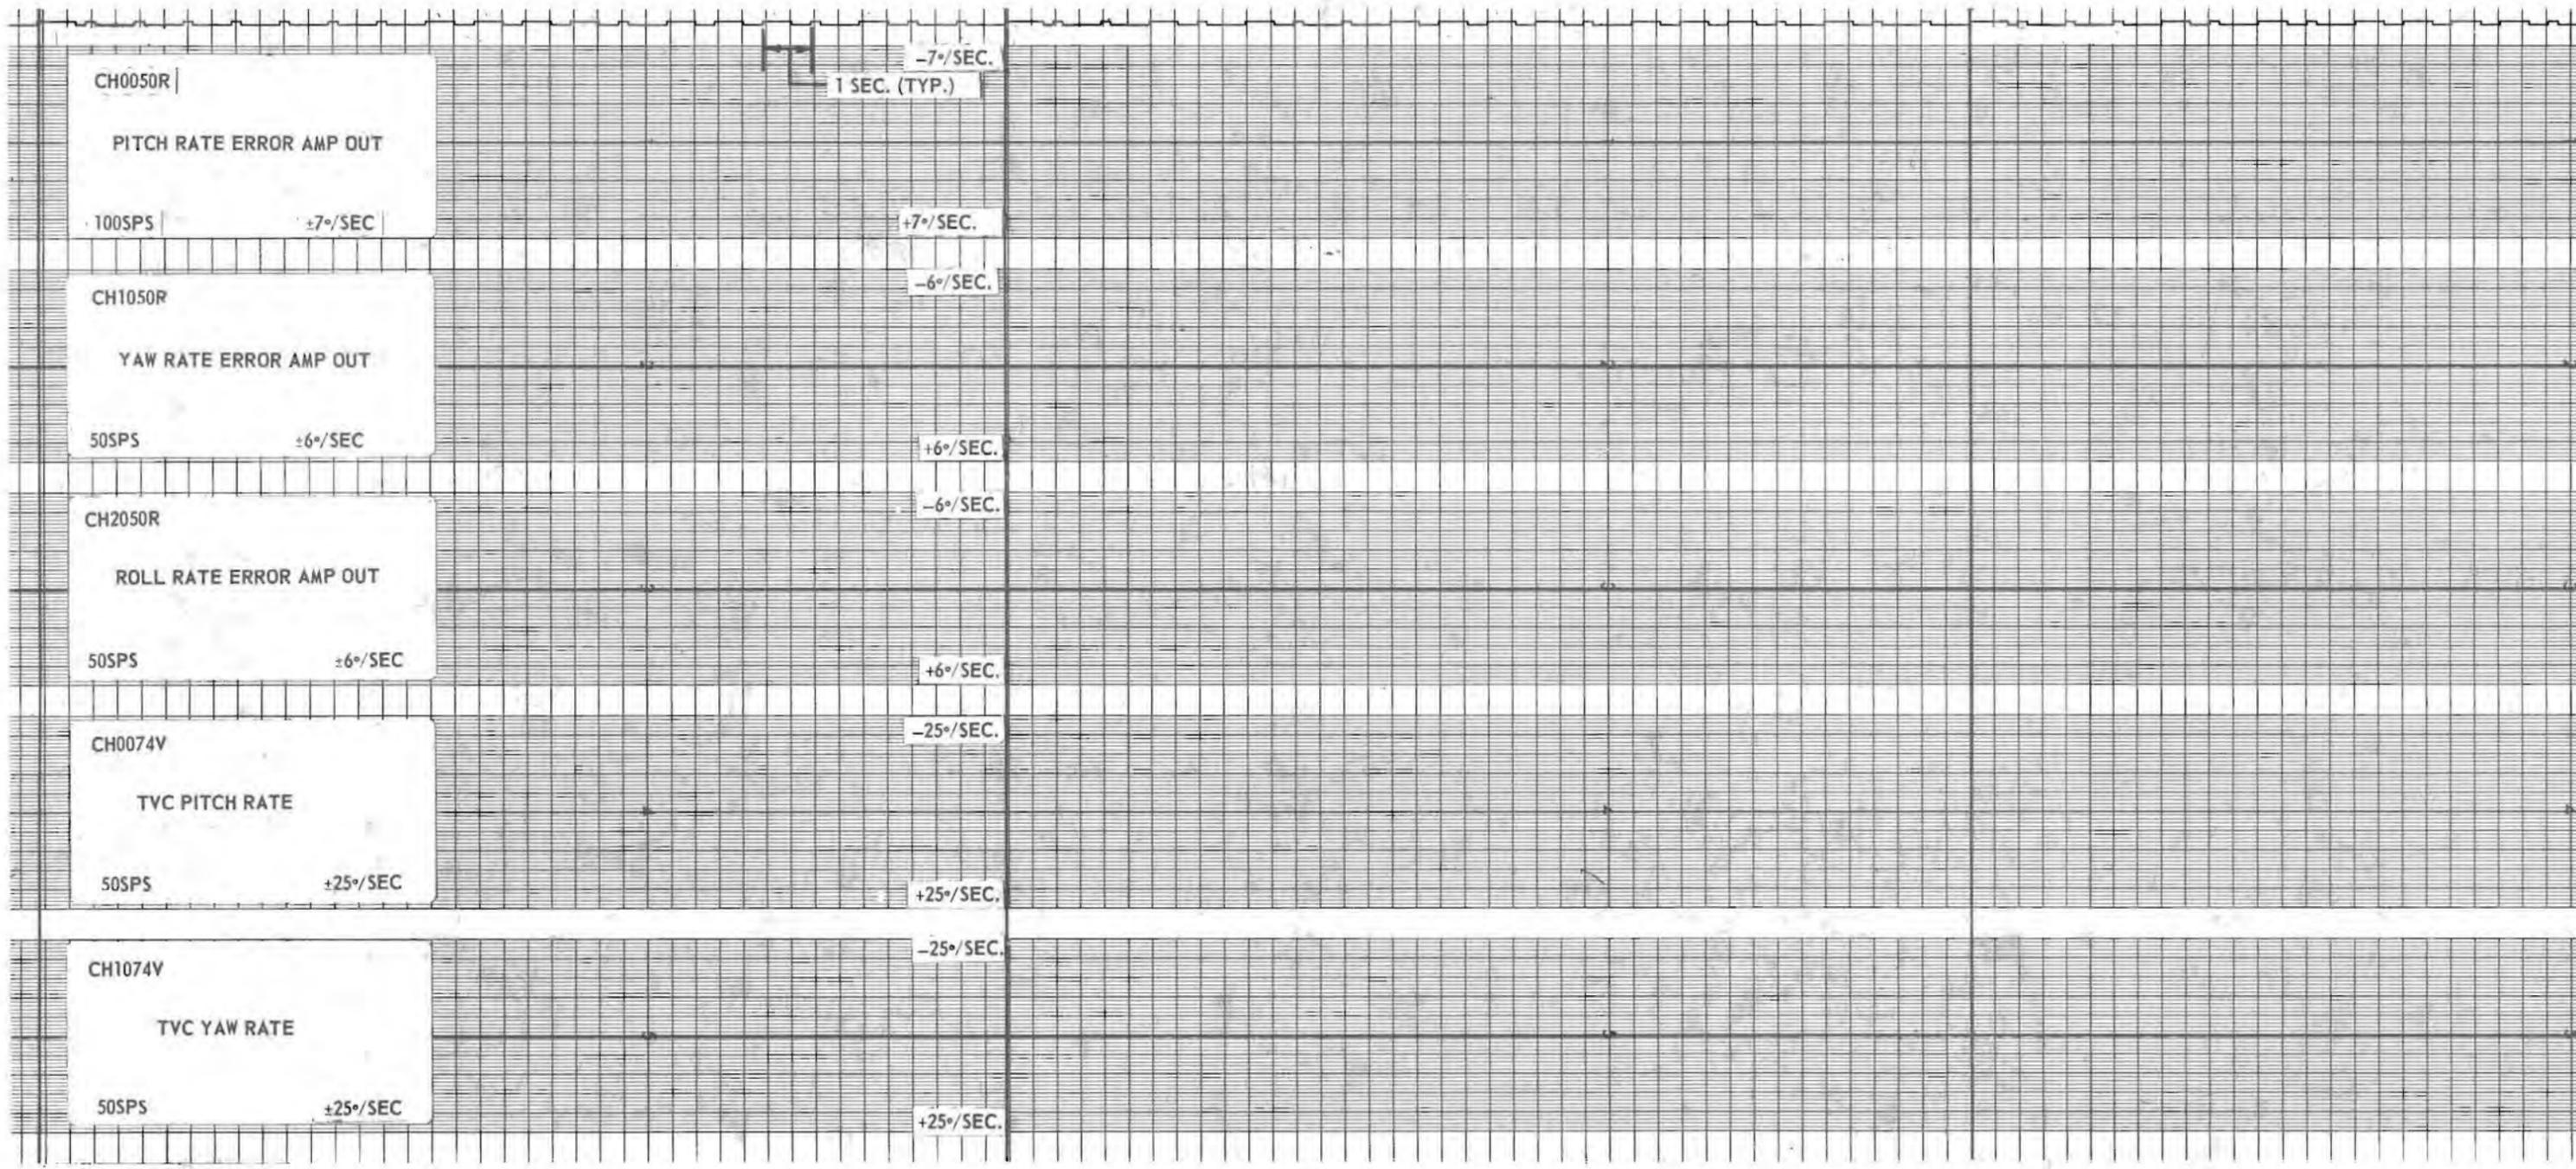
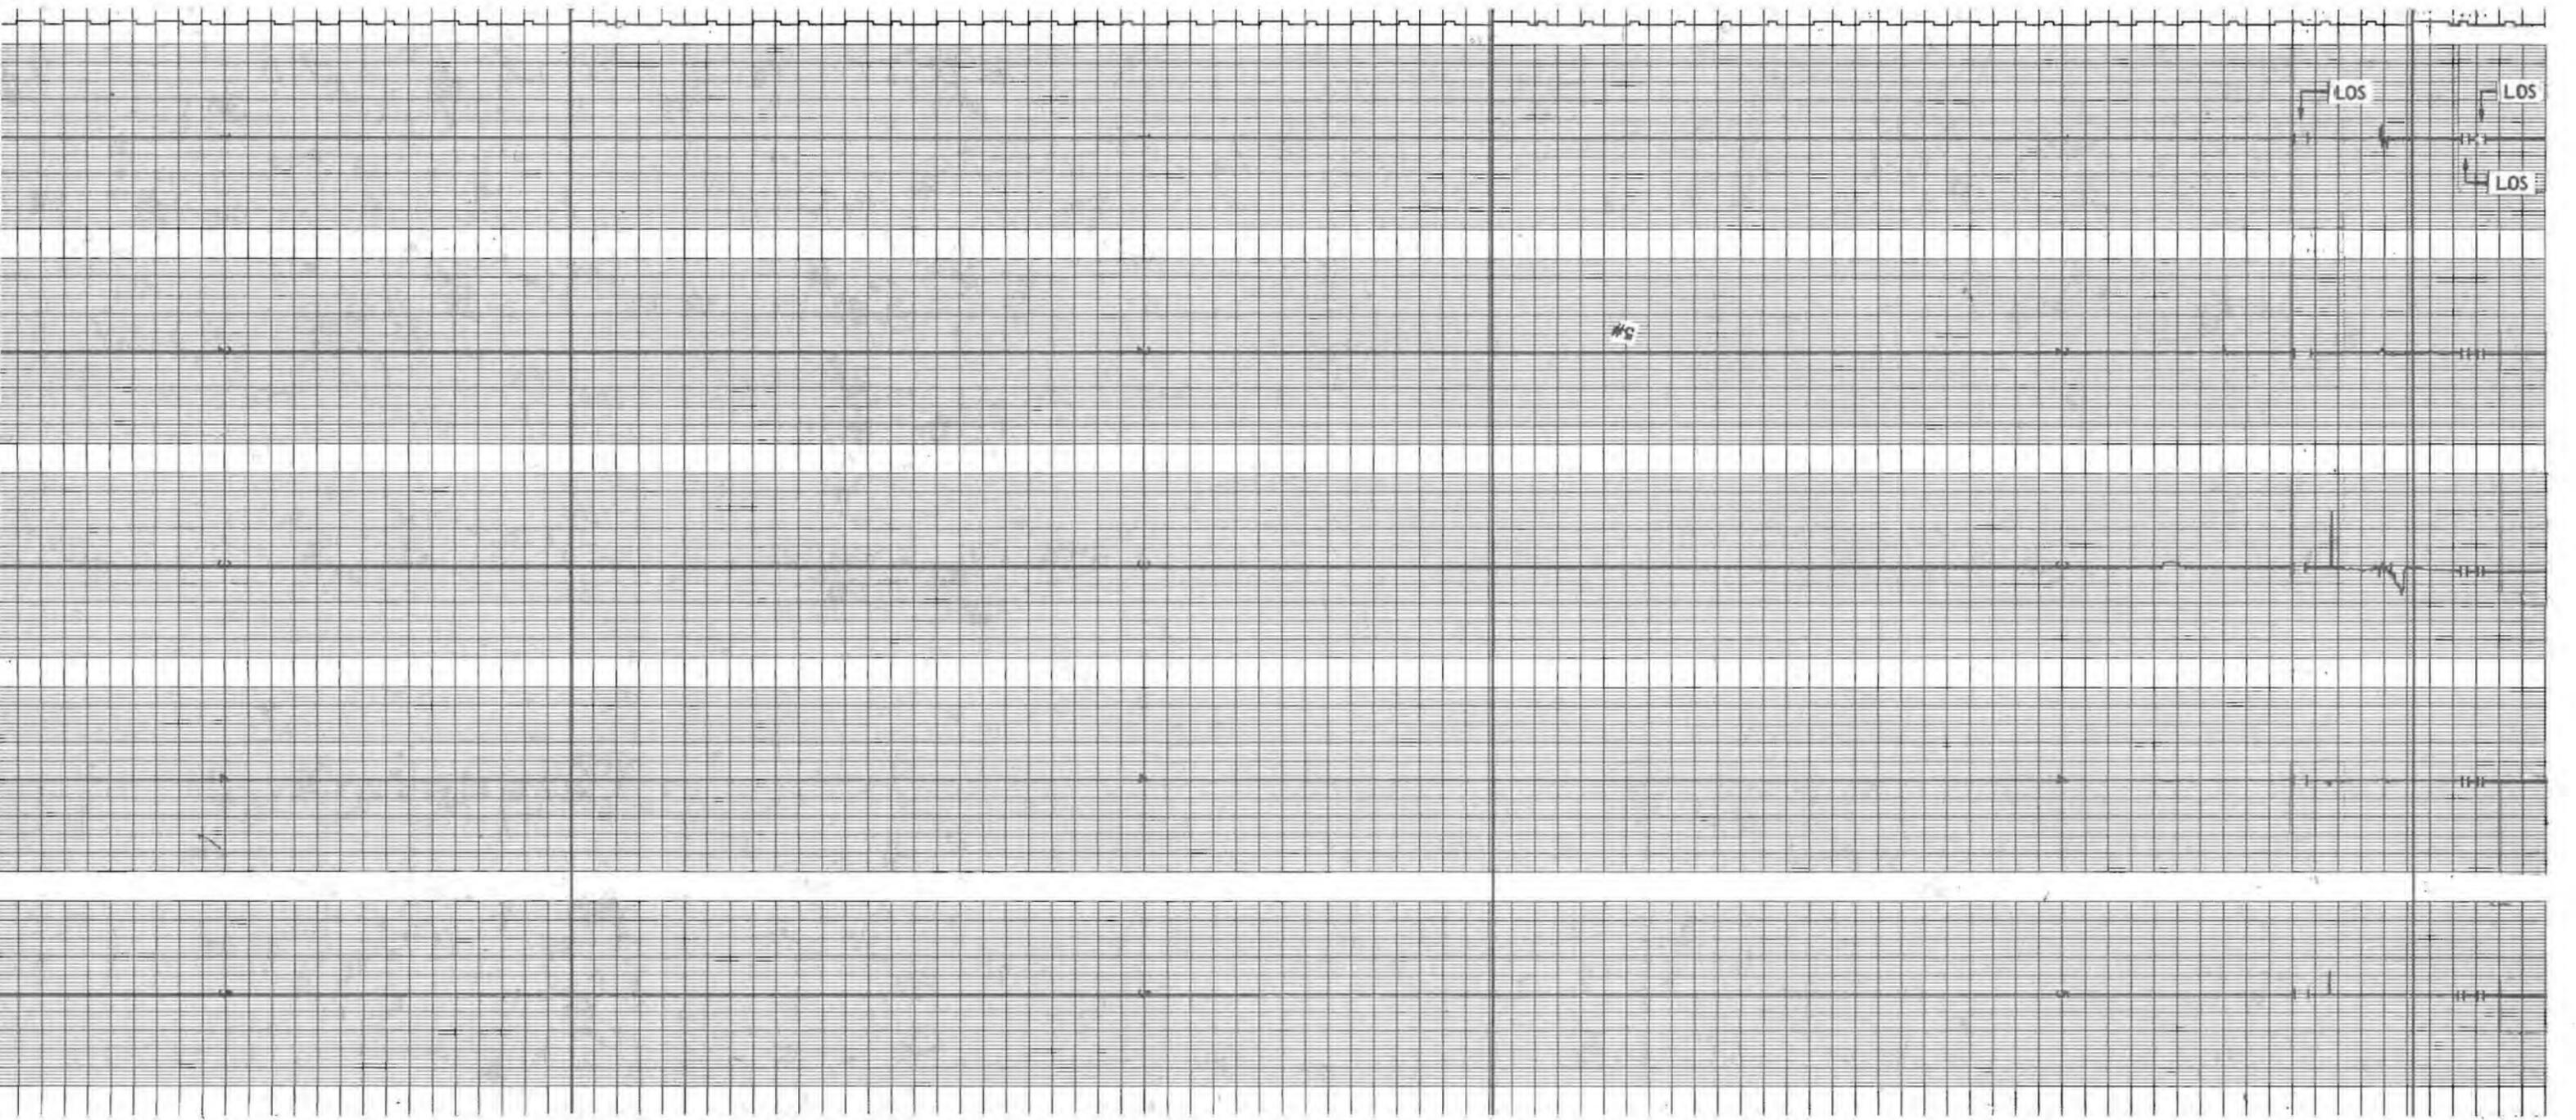
FIGURE 3-7 RATE AND RATE ERROR MEASUREMENT TRACES
