REPORT OF APOLLO 204 REVIEW BOARD

APPENDIX D
PANELS 1 thru 4

**REPORT OF PANEL 1
SPACECRAFT AND GROUND SUPPORT EQUIPMENT
CONFIGURATION
APPENDIX D-1
TO
FINAL REPORT OF
APOLLO 204 REVIEW BOARD**

**REPORT OF PANEL 4
DISASSEMBLY ACTIVITIES PANEL
APPENDIX D-4
TO
FINAL REPORT OF
APOLLO 204 REVIEW BOARD**

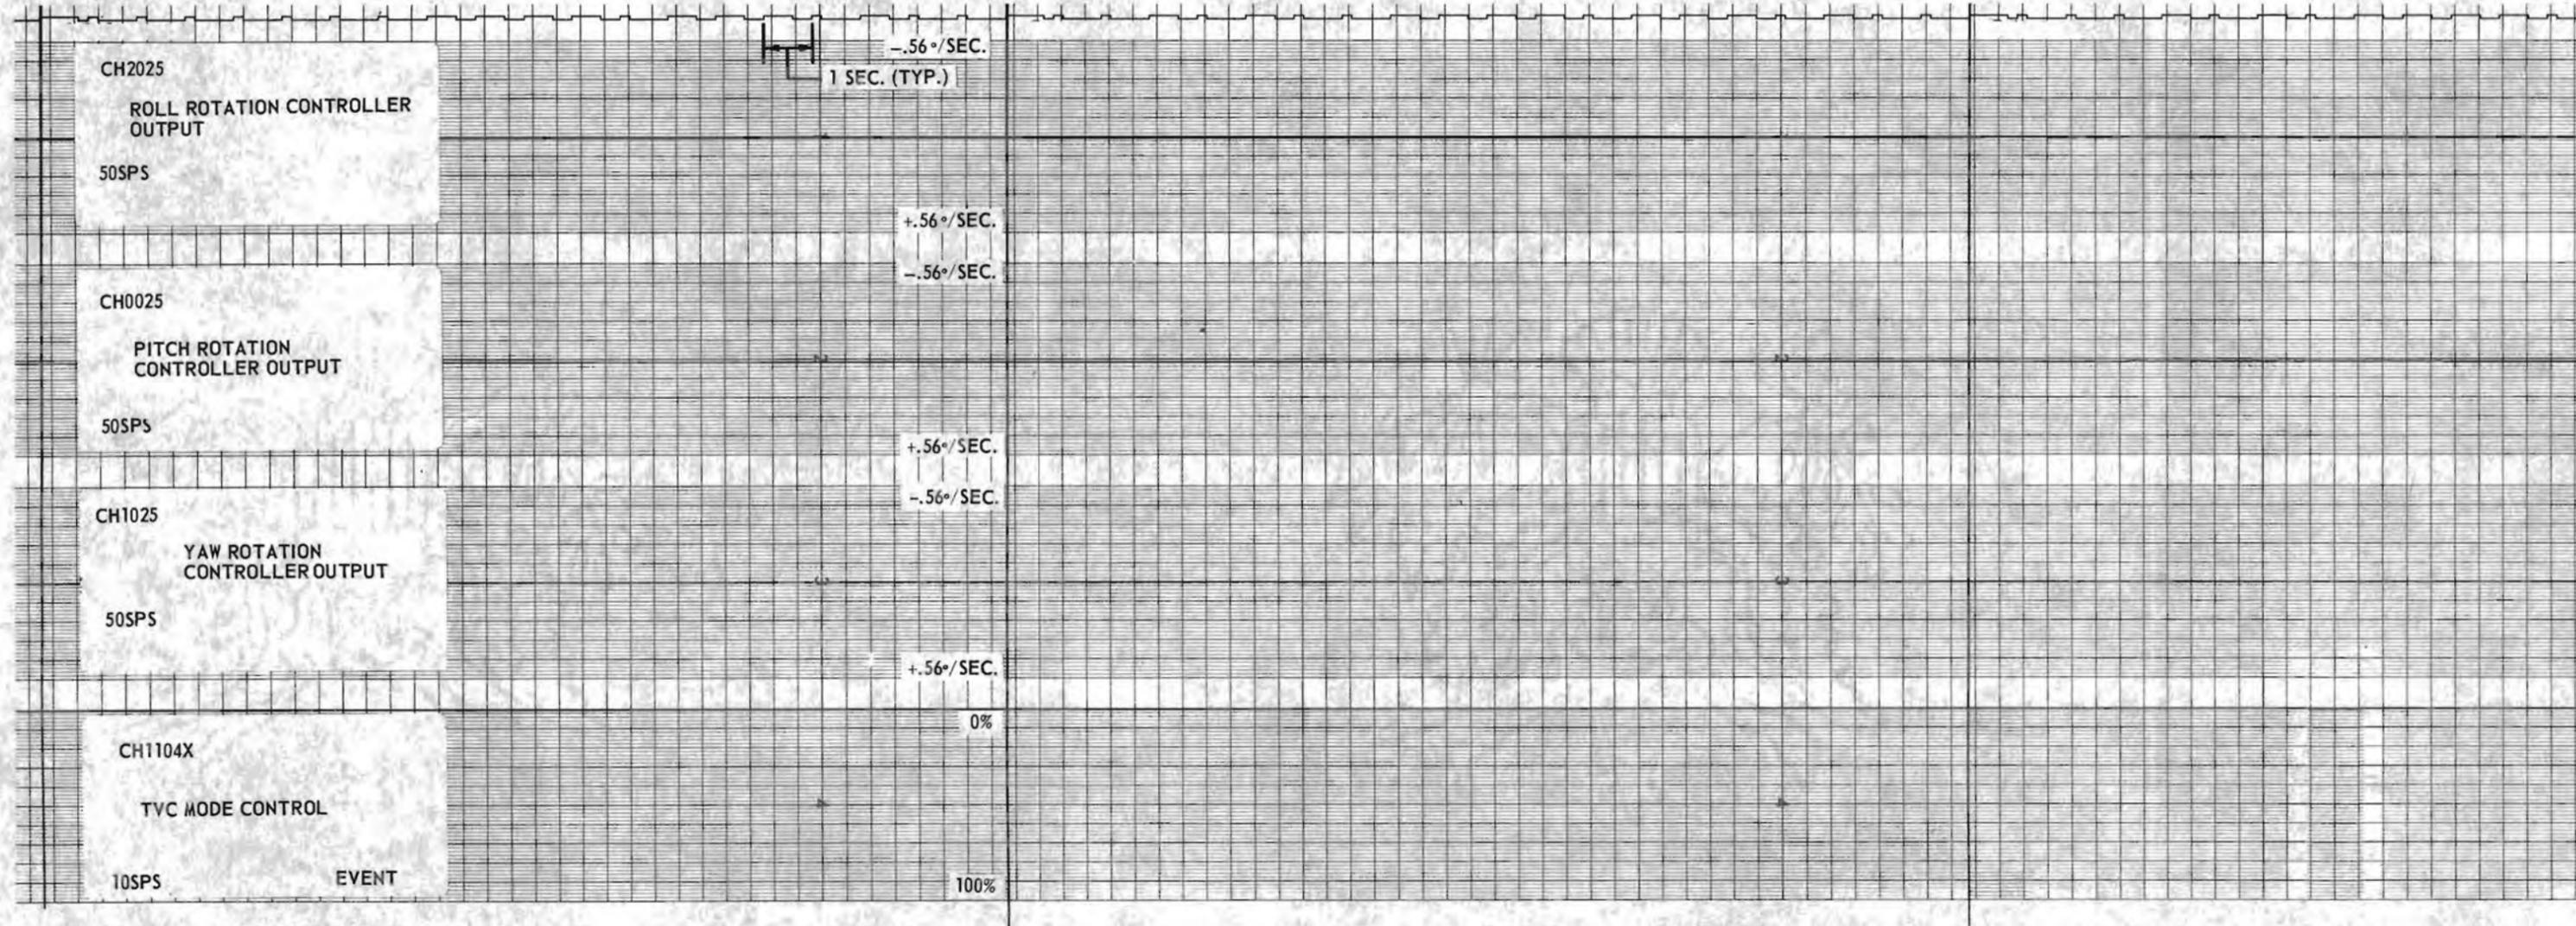
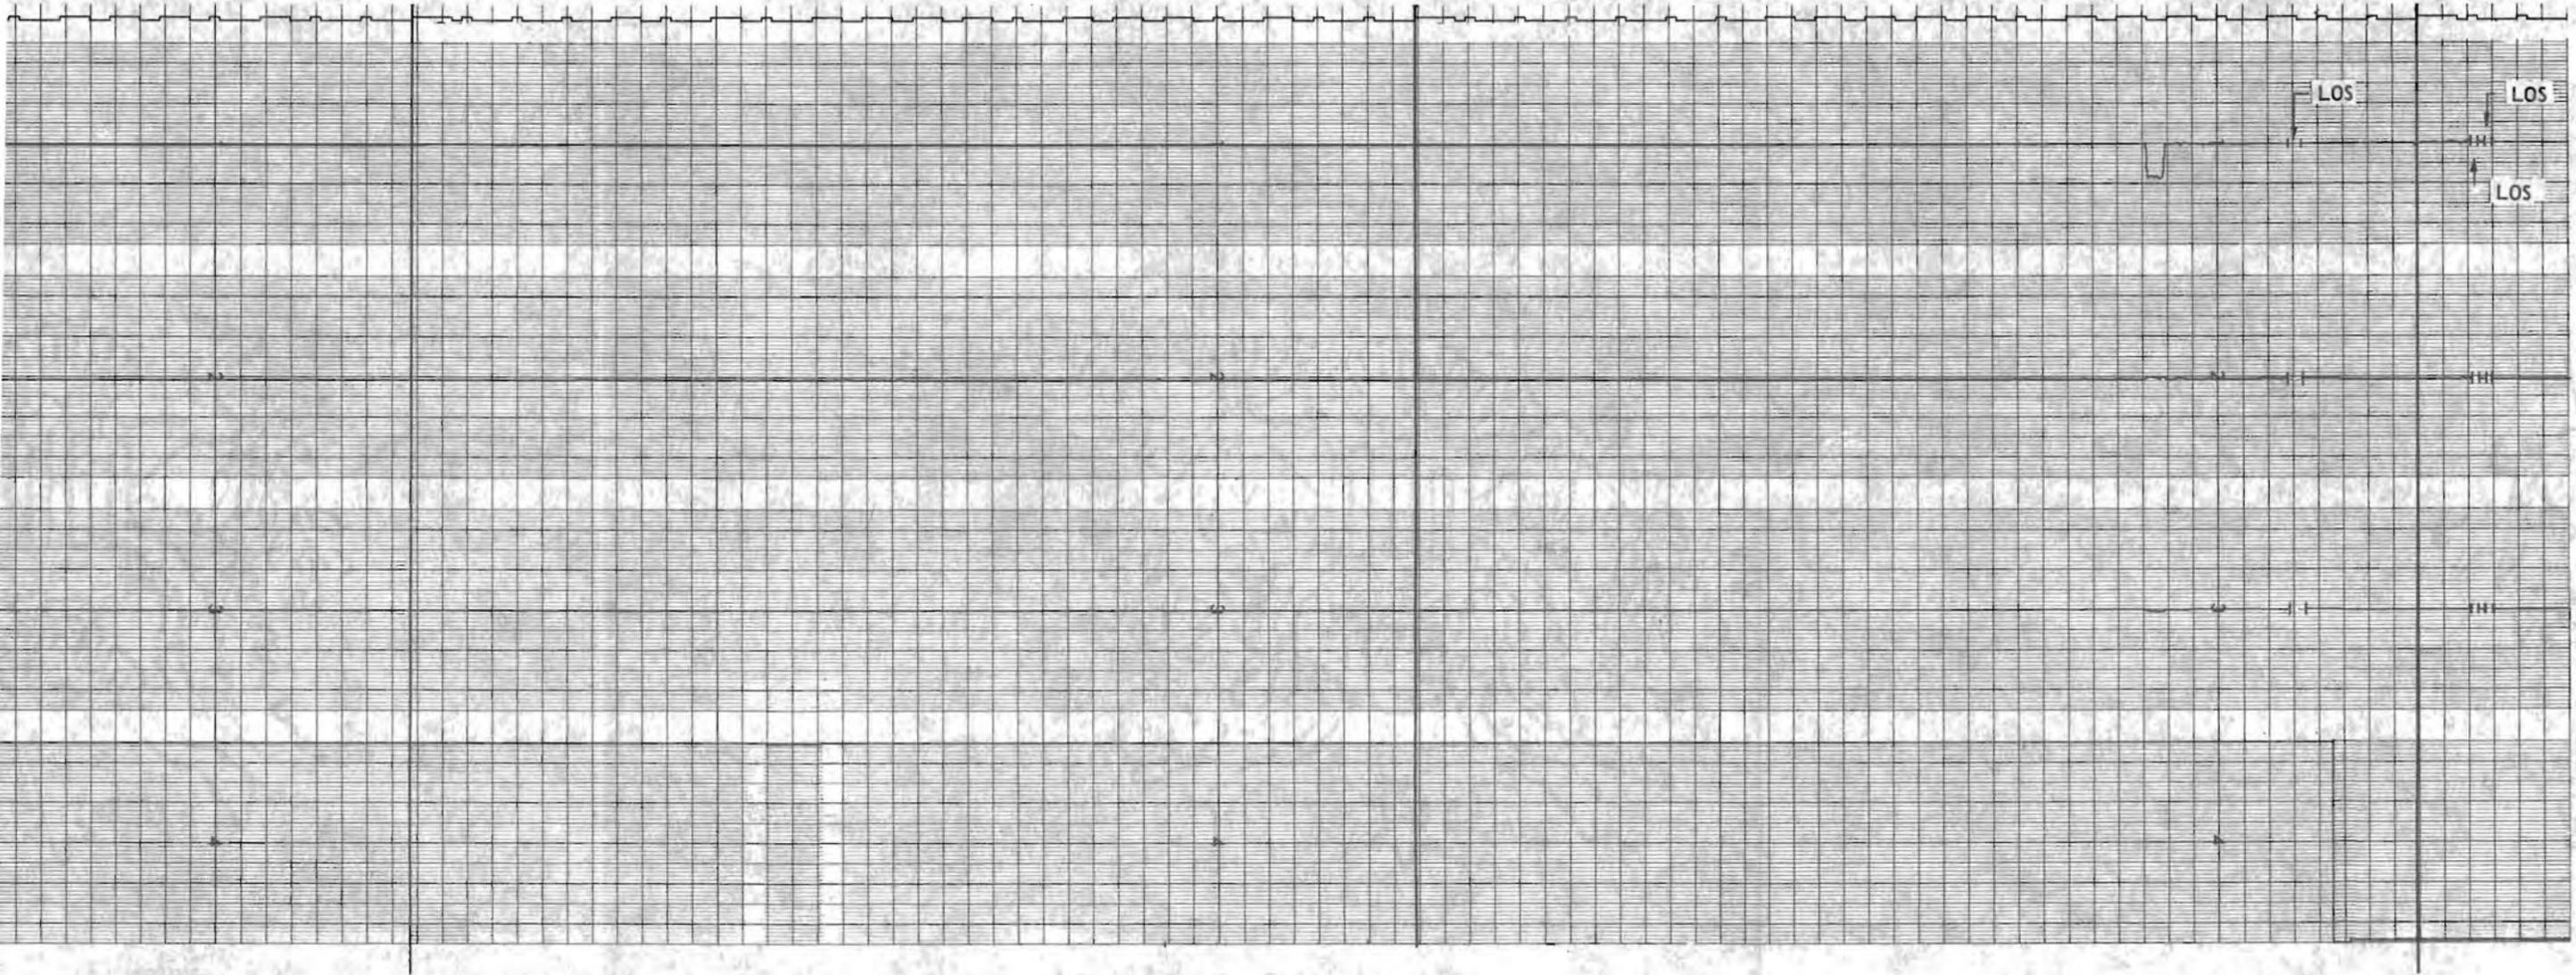
FIGURE 3-8 ROTATION CONTROLLER TVC MODE MEASUREMENT TRACES

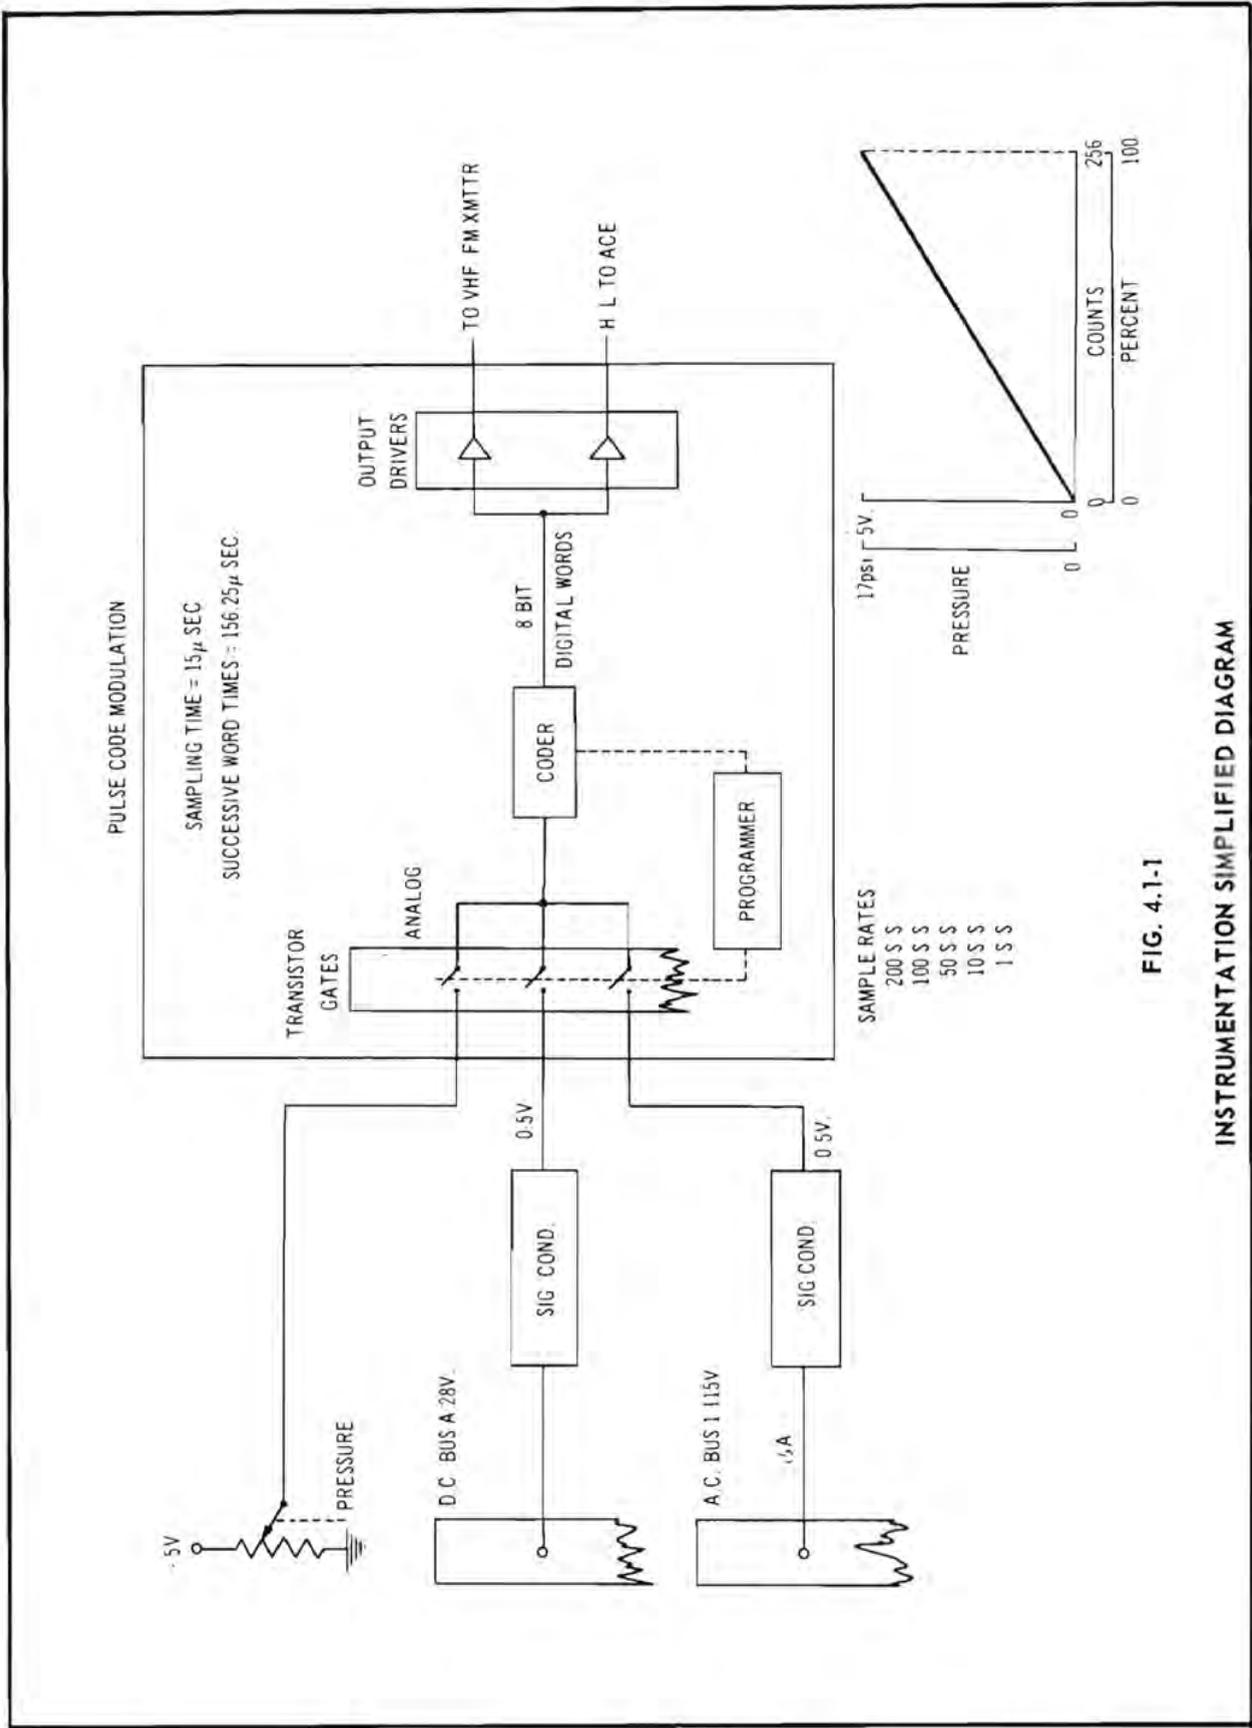
FIG. 4.1-1
 INSTRUMENTATION SIMPLIFIED DIAGRAM

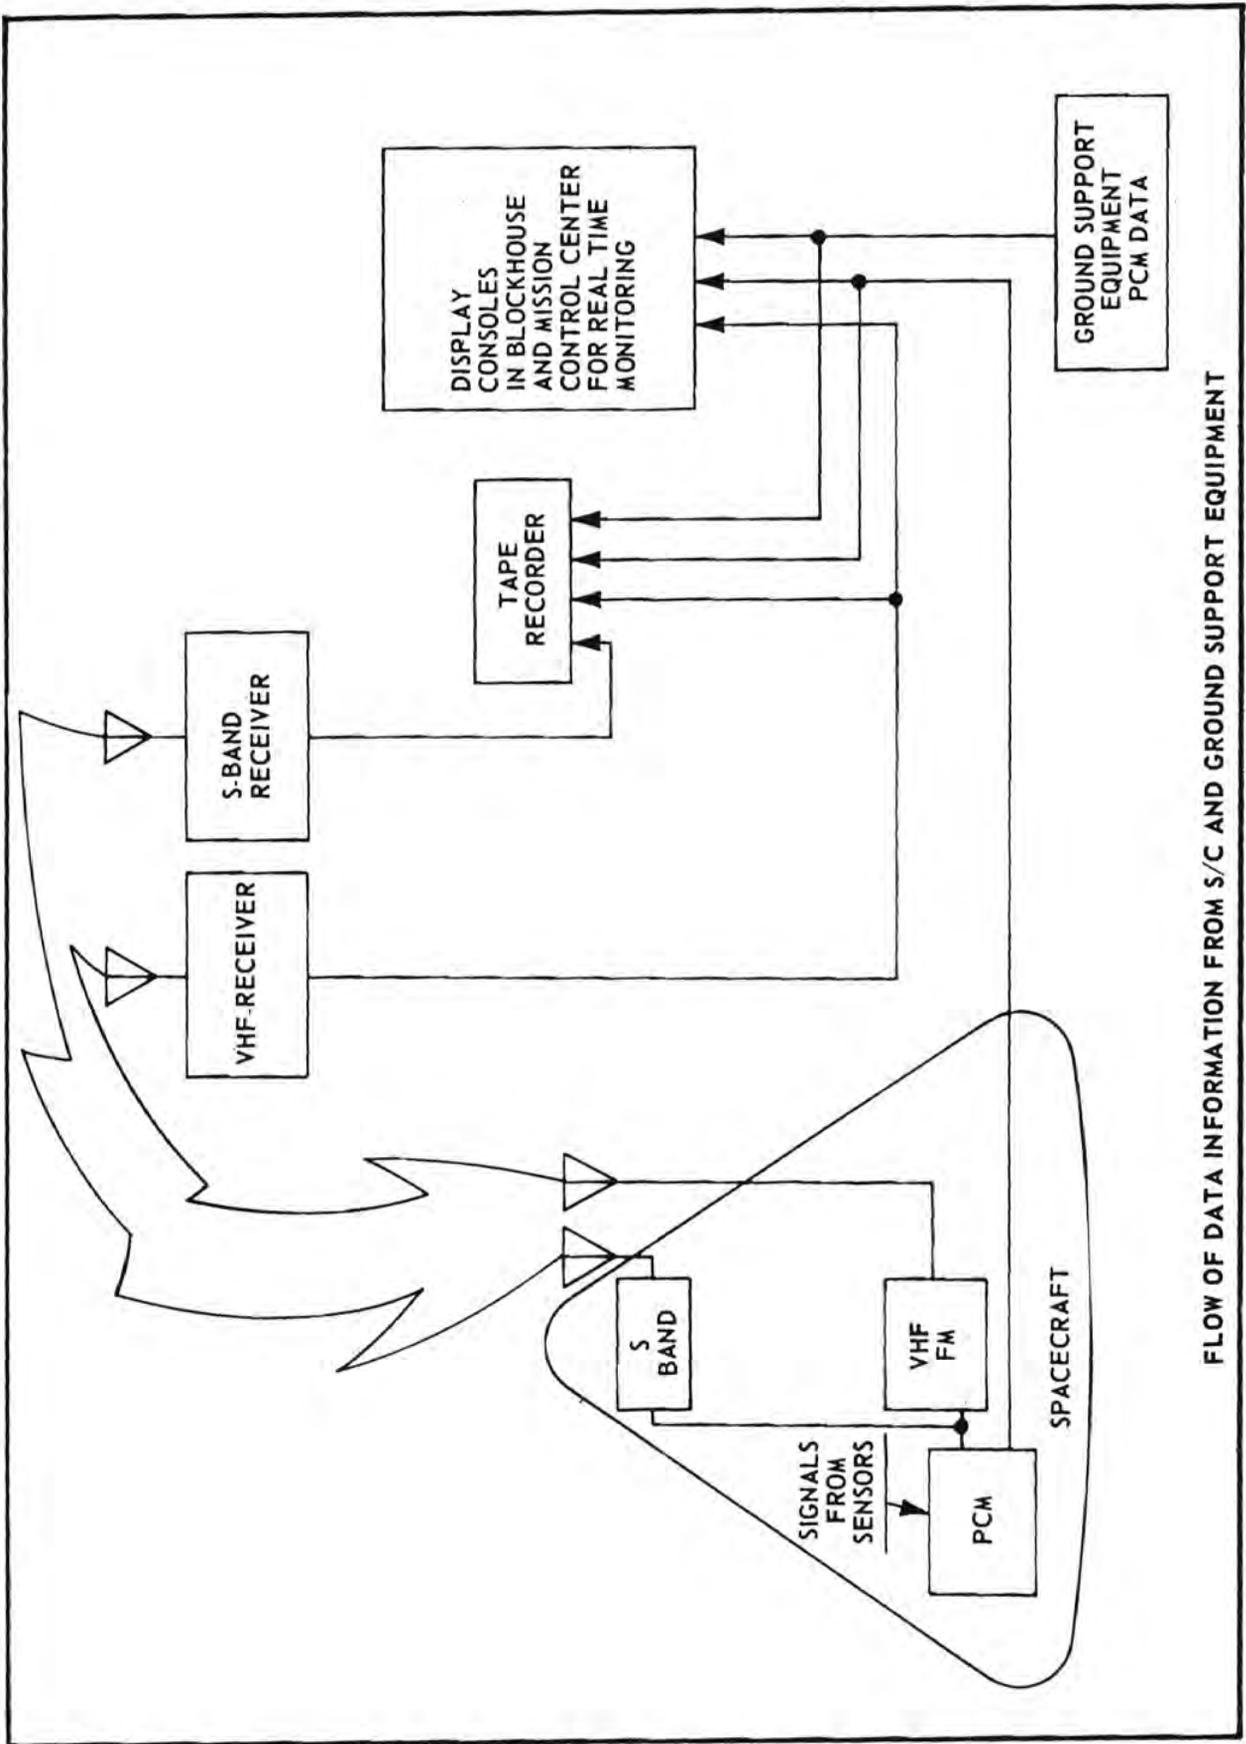
FLOW OF DATA INFORMATION FROM S/C AND GROUND SUPPORT EQUIPMENT

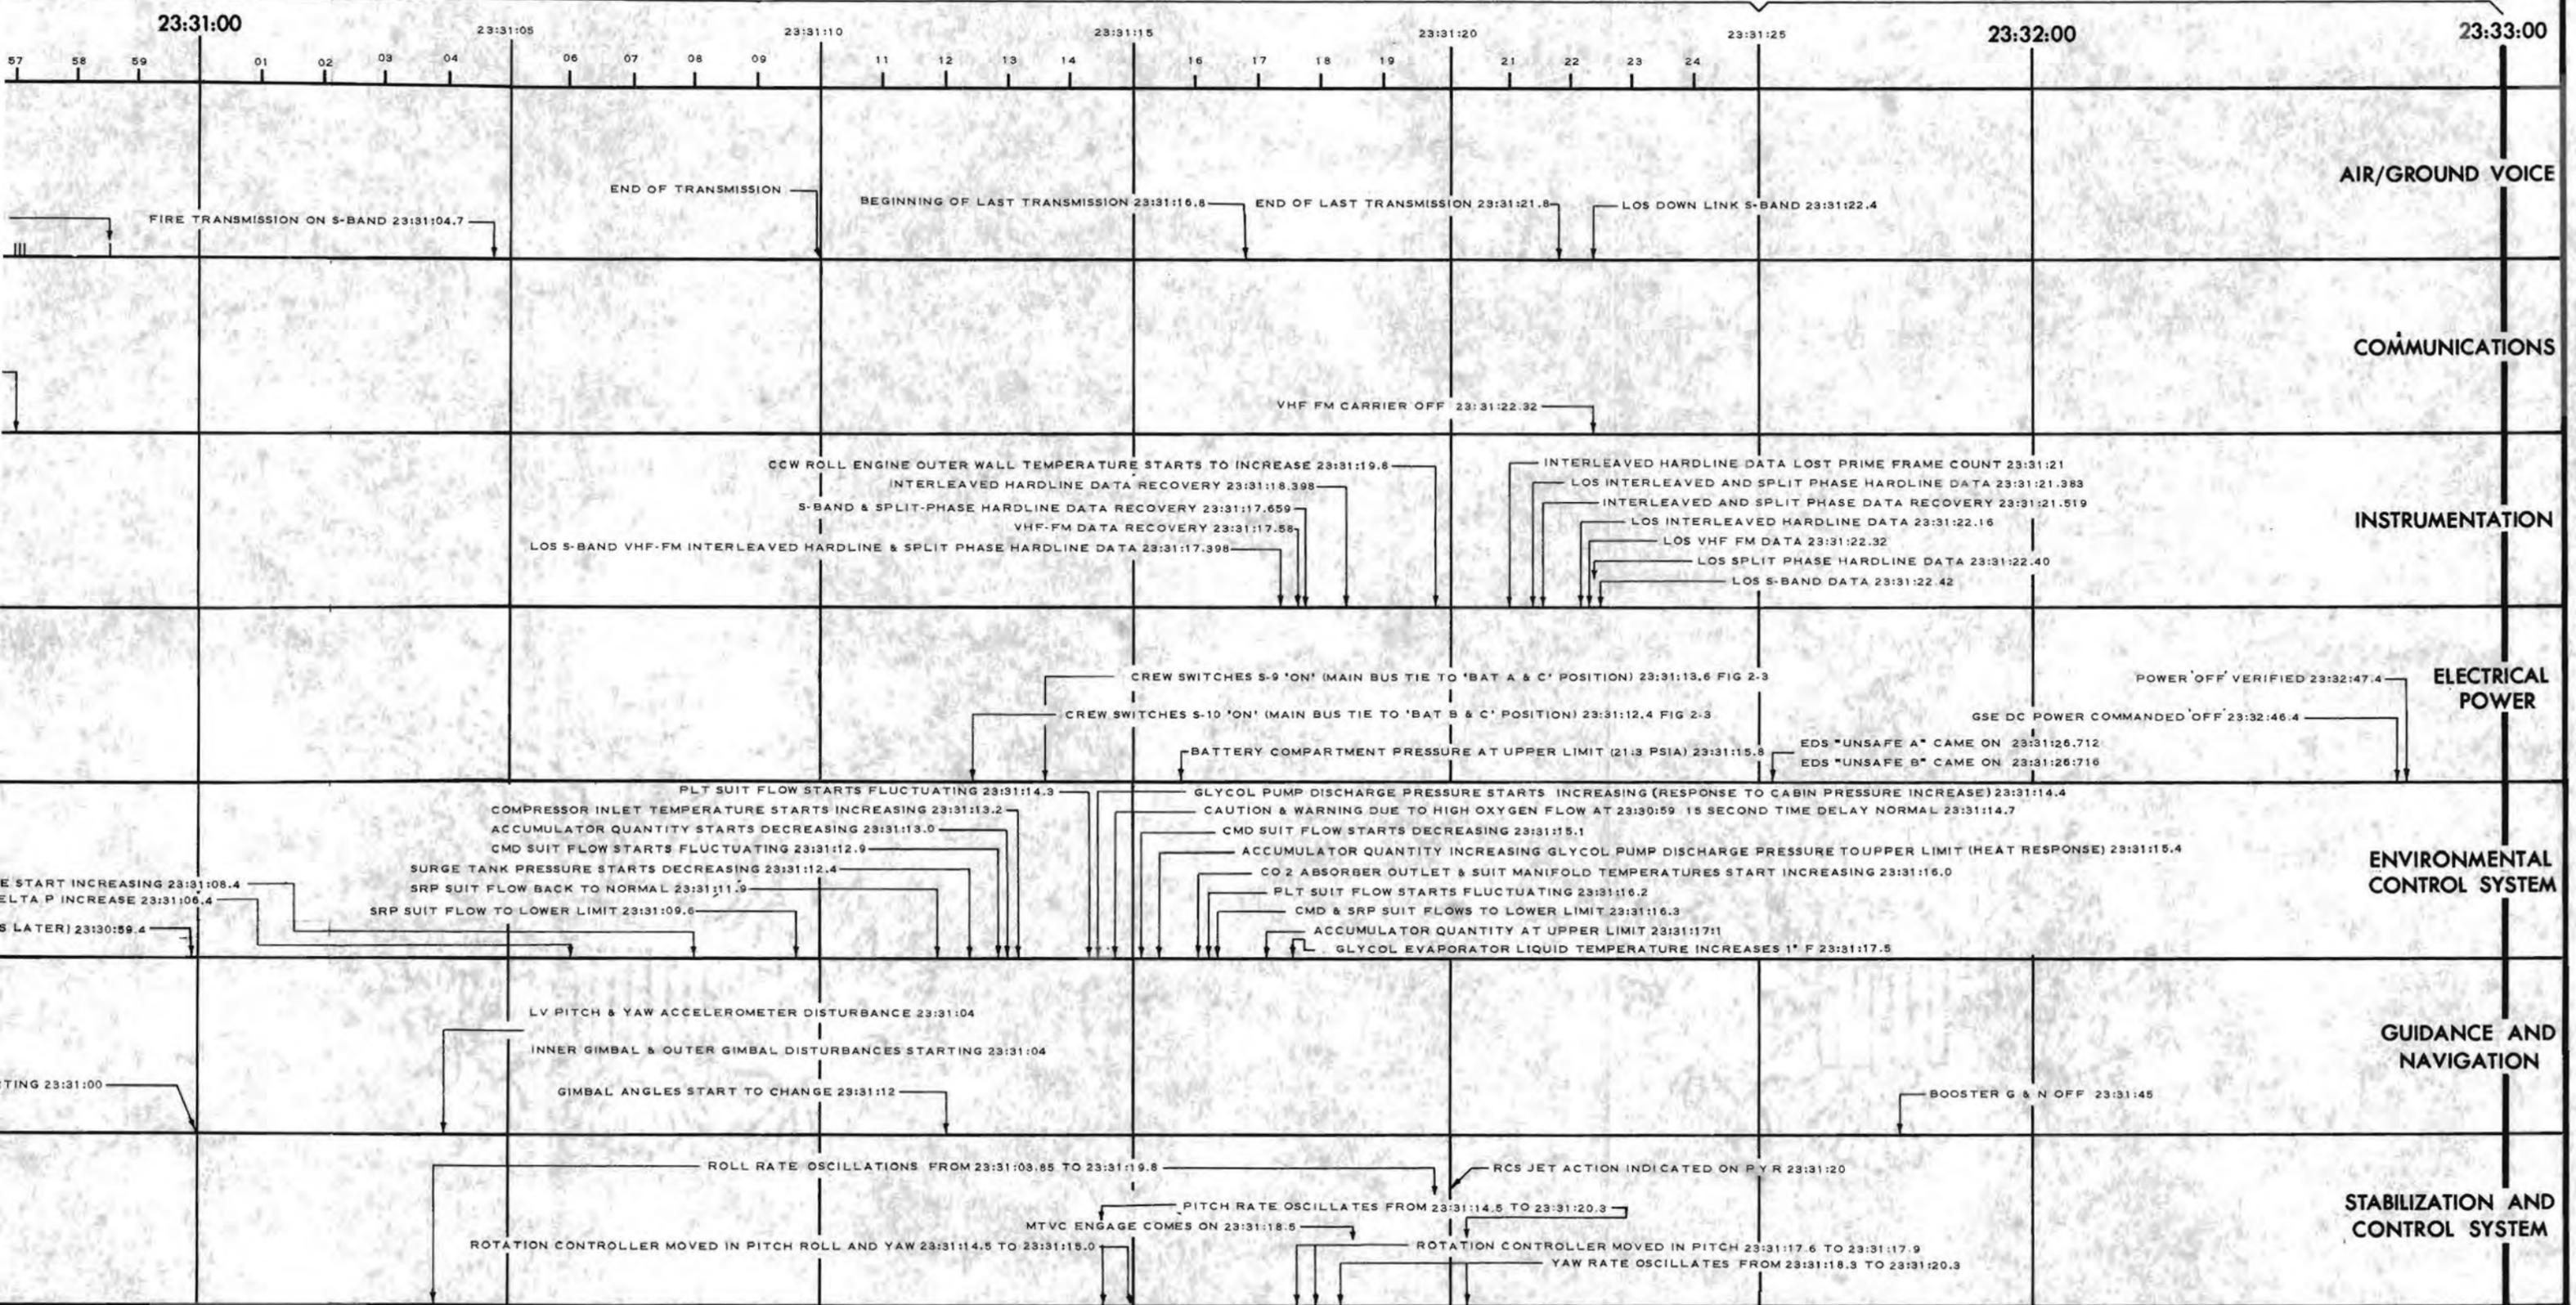
ENCLOSURE 3-3. SEQUENCE OF EVENTS

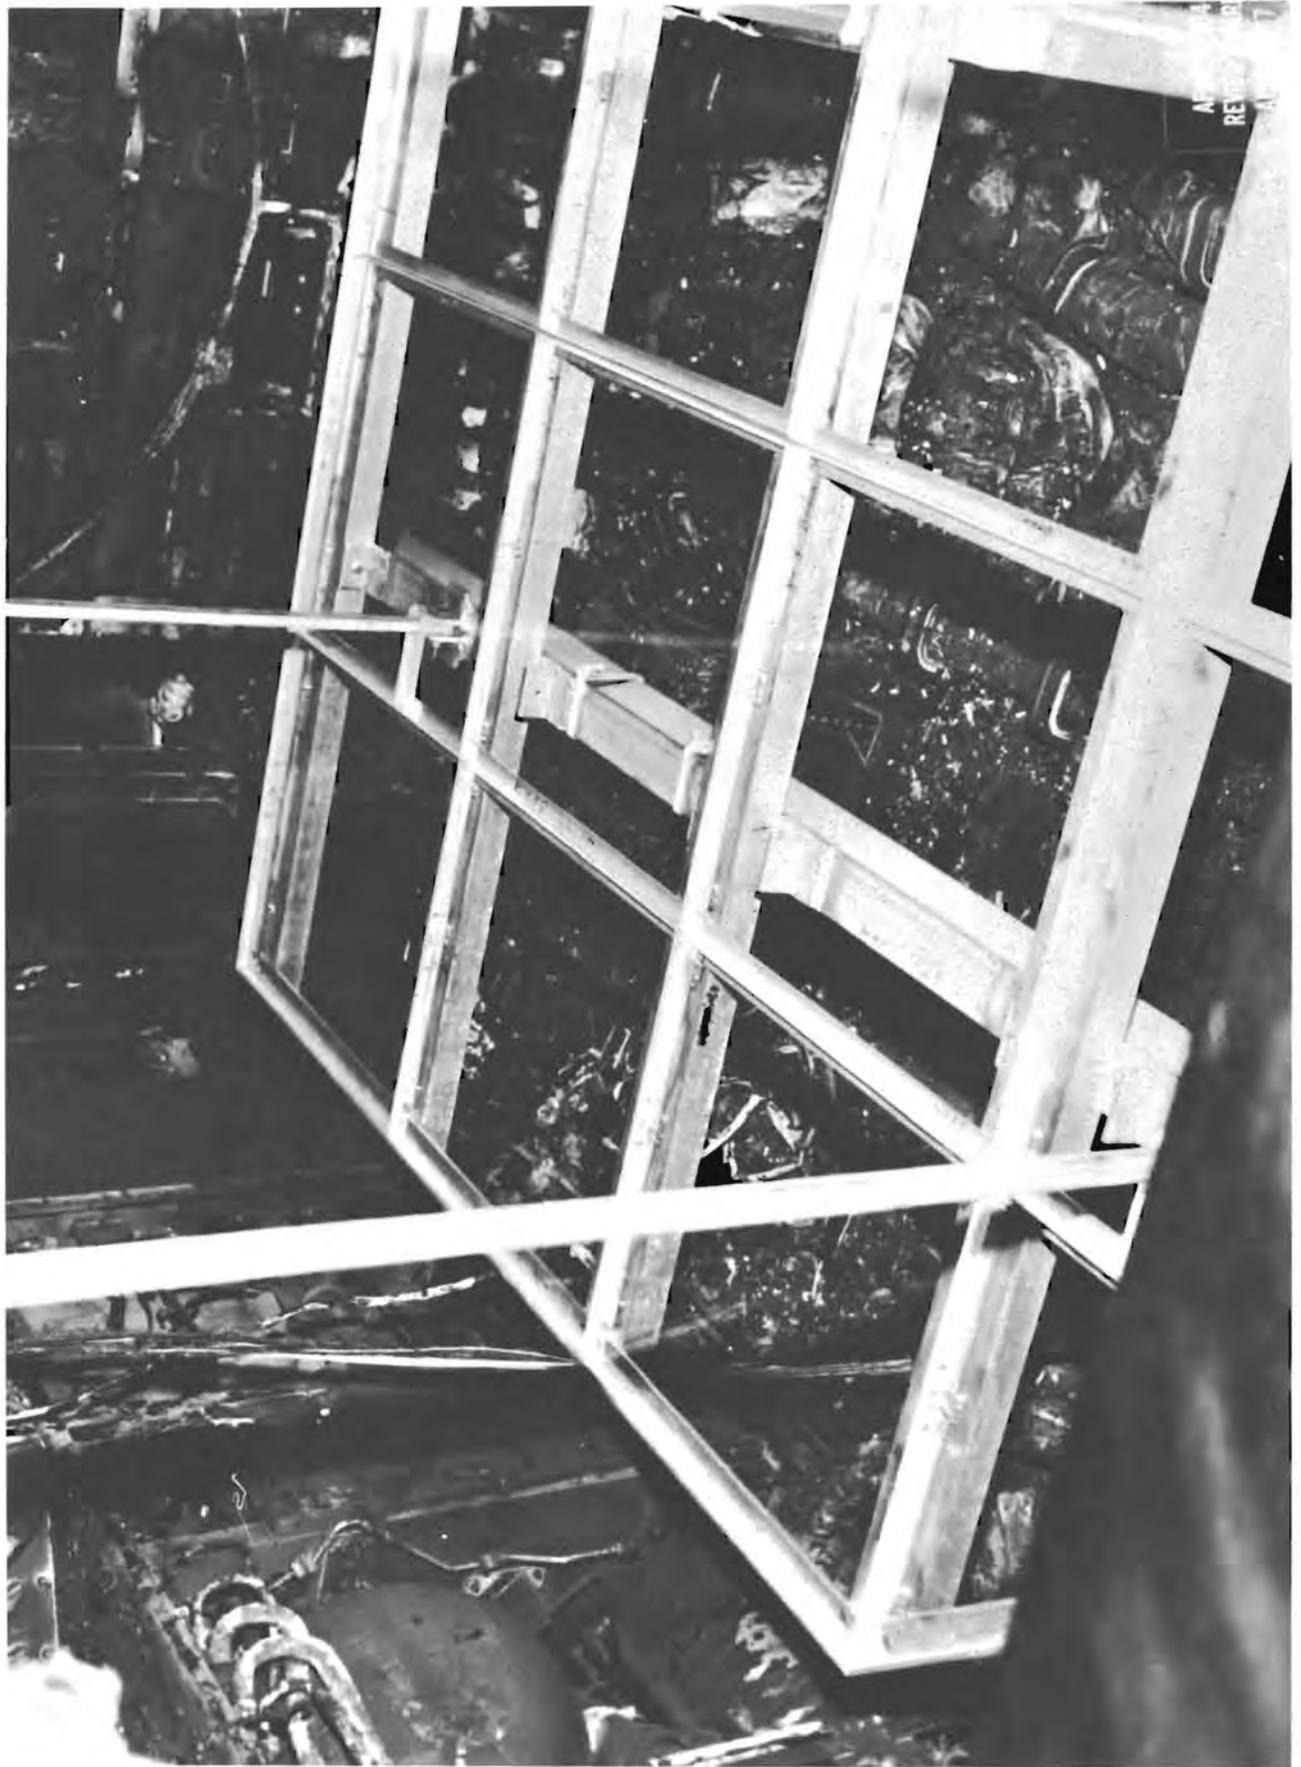
FALSE FLOOR INSTALLED IN SPACECRAFT 012

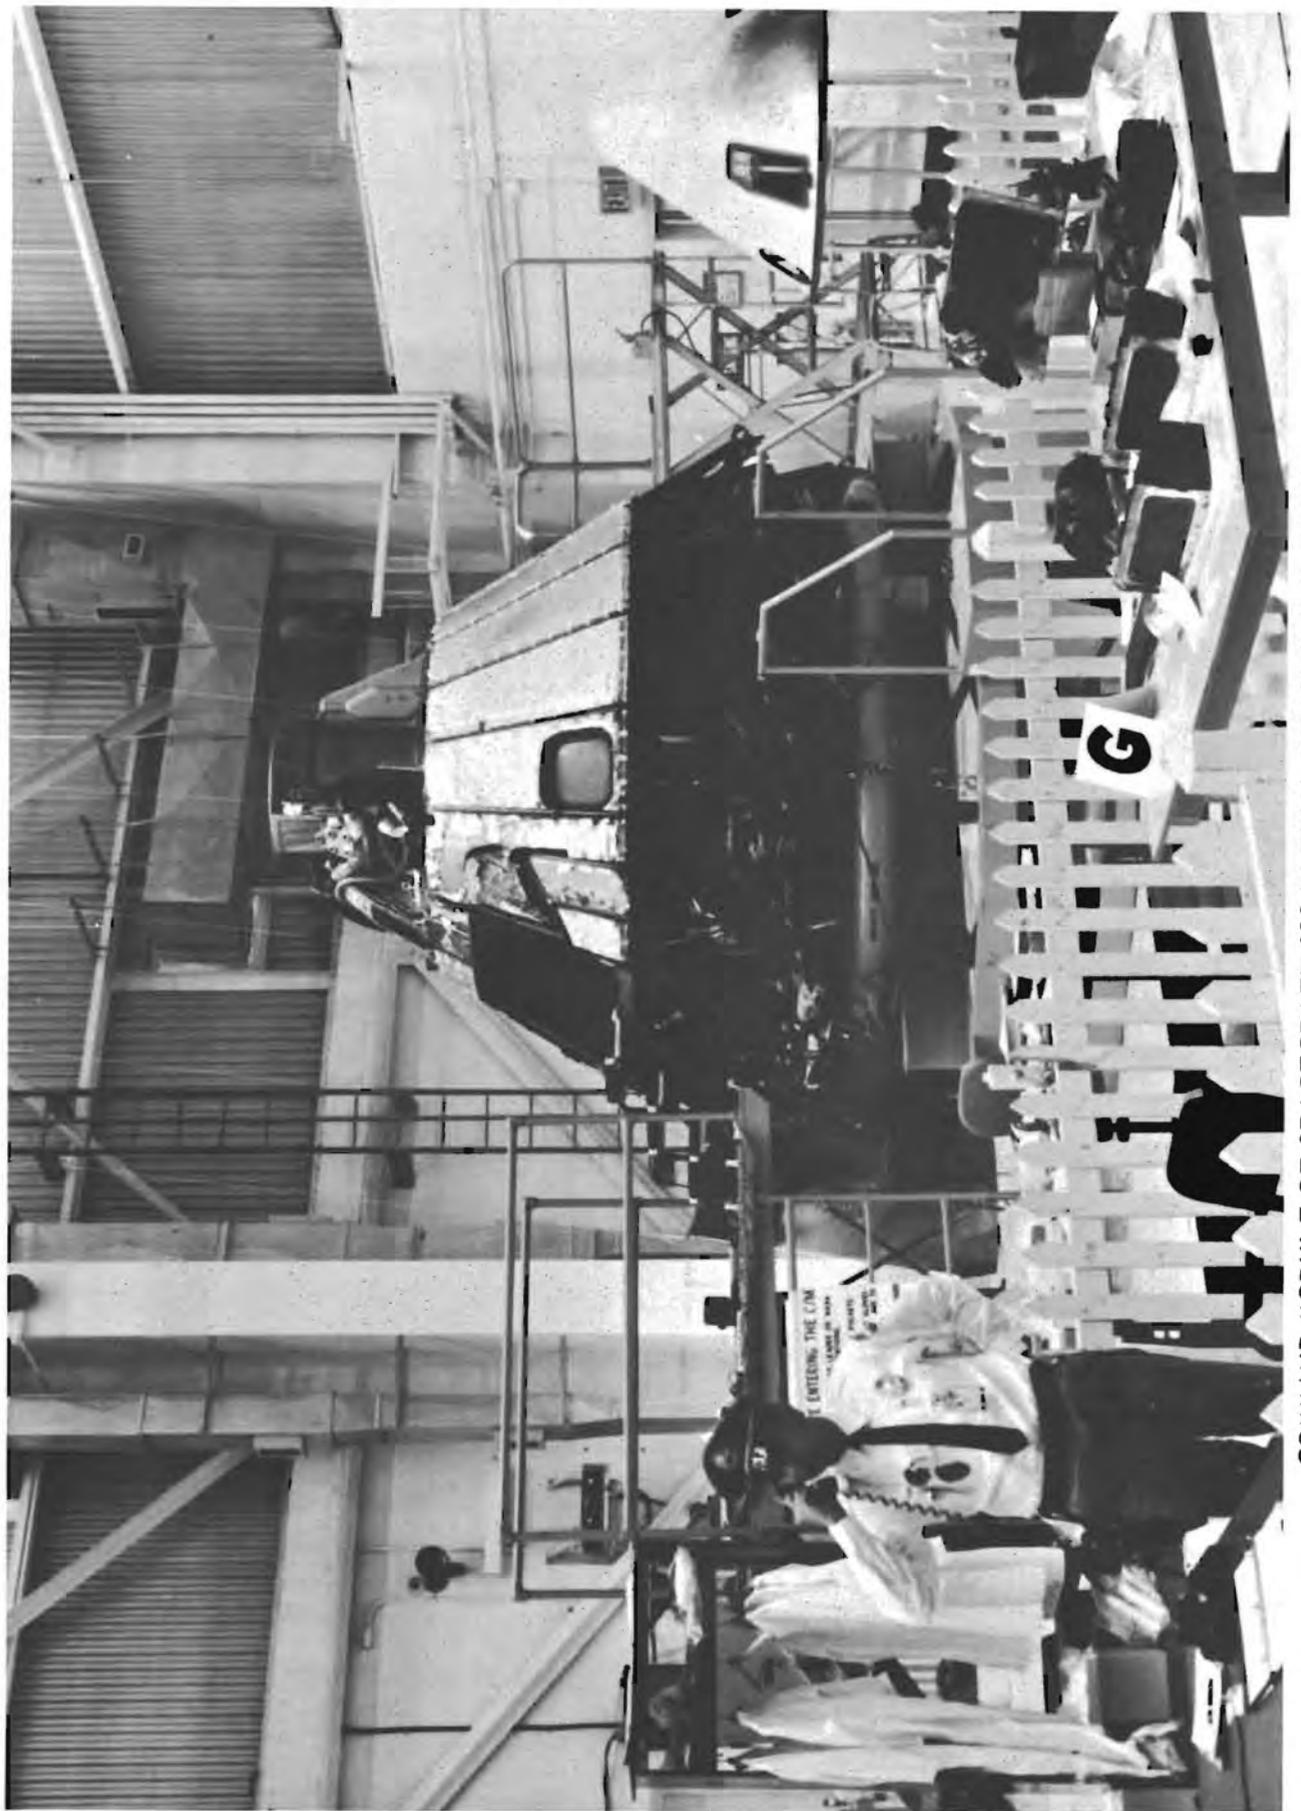
COMMAND MODULE OF SPACECRAFT 012 IN FINAL DISASSEMBLY AT THE
PYROTECHNICS INSTALLATION BUILDING
