NASA CR-168120
D210-11944-1

**LARGE ROTORCRAFT TRANSMISSION
TECHNOLOGY DEVELOPMENT PROGRAM**

by John C. Mack
Boeing Vertol Company

(NASA-CR-168120) LARGE ROTORCRAFT
TRANSMISSION TECHNOLOGY DEVELOPMENT PROGRAM
Final Test Report (Boeing Vertol Co.,
Philadelphia, Pa.) 106 p HC A06/MF A01

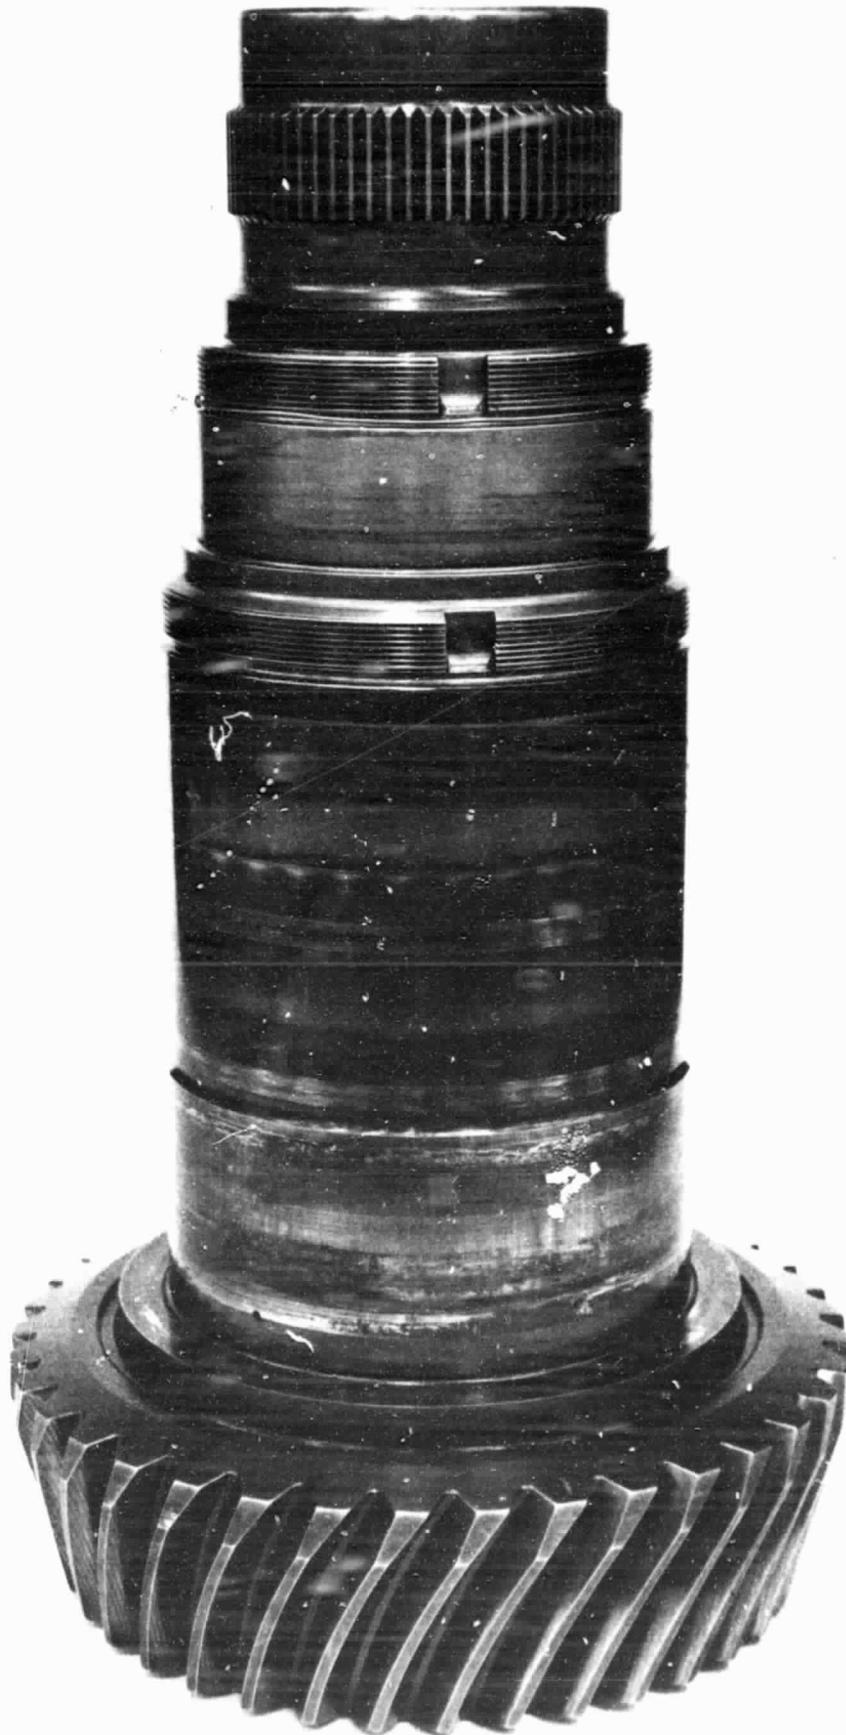
FIGURE 42 BEVEL PINION AFTER TEST

Spiral bevel pinion - (Figure 42)

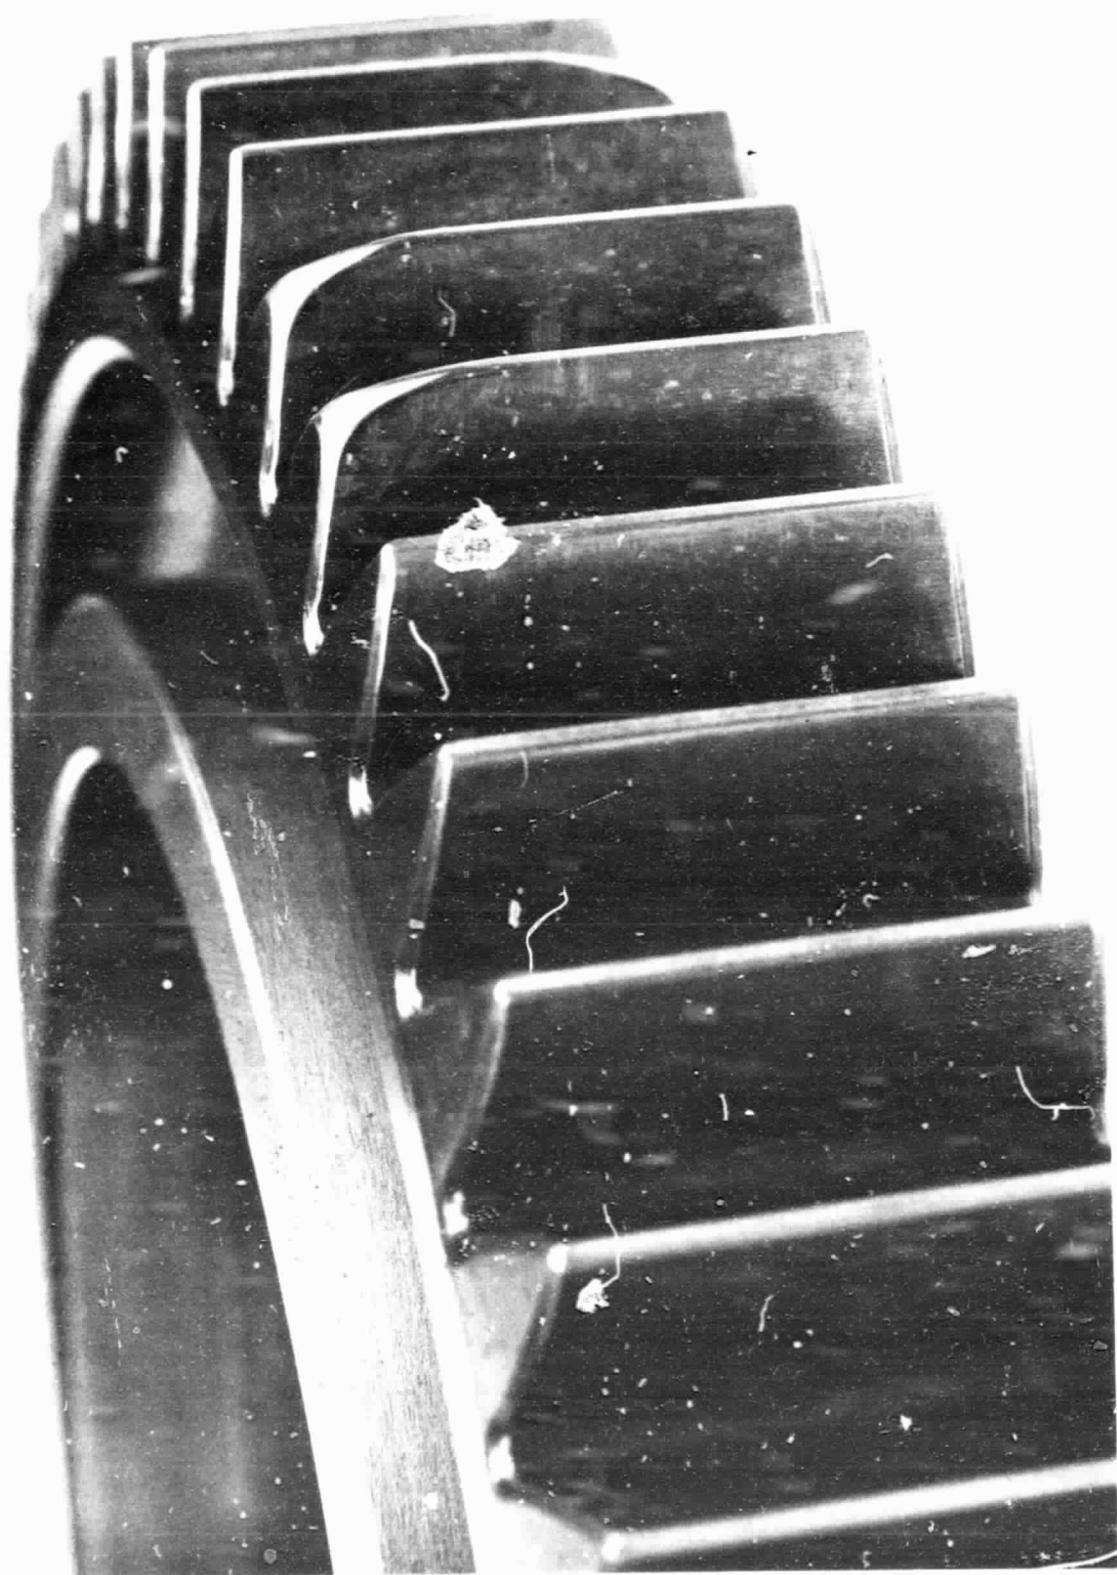
FIGURE 50 FIRST STAGE PLANET TOOTH END ROUND-OFF
ORIGINAL PAGE IS OF POOR QUALITY ORIGINAL PAGE

Some very light frosting at the very tips of the teeth on the sun side was barely visible. Increased profile modification on the sun will eliminate this. Some debris damage was noted but it was slight on the sun side and somewhat more evident on the ring side. Figure 50 illustrates the blending of the tooth ends of planet gear P152 referred to previously.
